## Pre-Demolition Assessment

The Elms  
Elm Close  
Whitefield  
Manchester

Client Name: Bury Council

Date: 30/09/2022

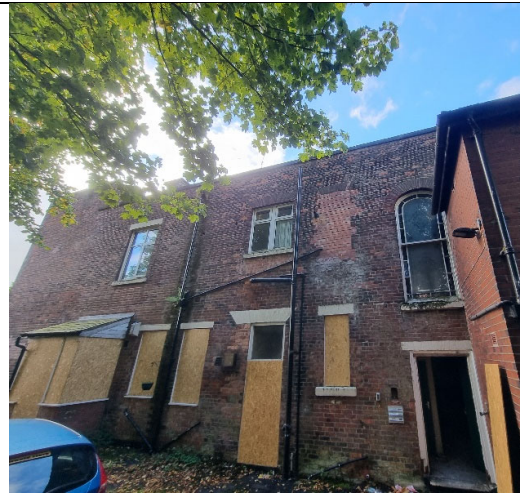
PHOTOGRAPH 4 (Above) – Partial rear elevation

- 5.2.3 There are signs of historic structural movement/settlement to rear double storey outrigger extension which appears to have pulled away from the adjoining original building. There is evidence of historic repairs to tie the outrigger extension brickwork to the original building brickwork.
