# Condition Report and Proposals on the roof at 6-8 Manchester Rd, Bury, BL9 0ED

For Horsfield Insolvency Practitioners

Dated: August 2020

Ref: C-0447

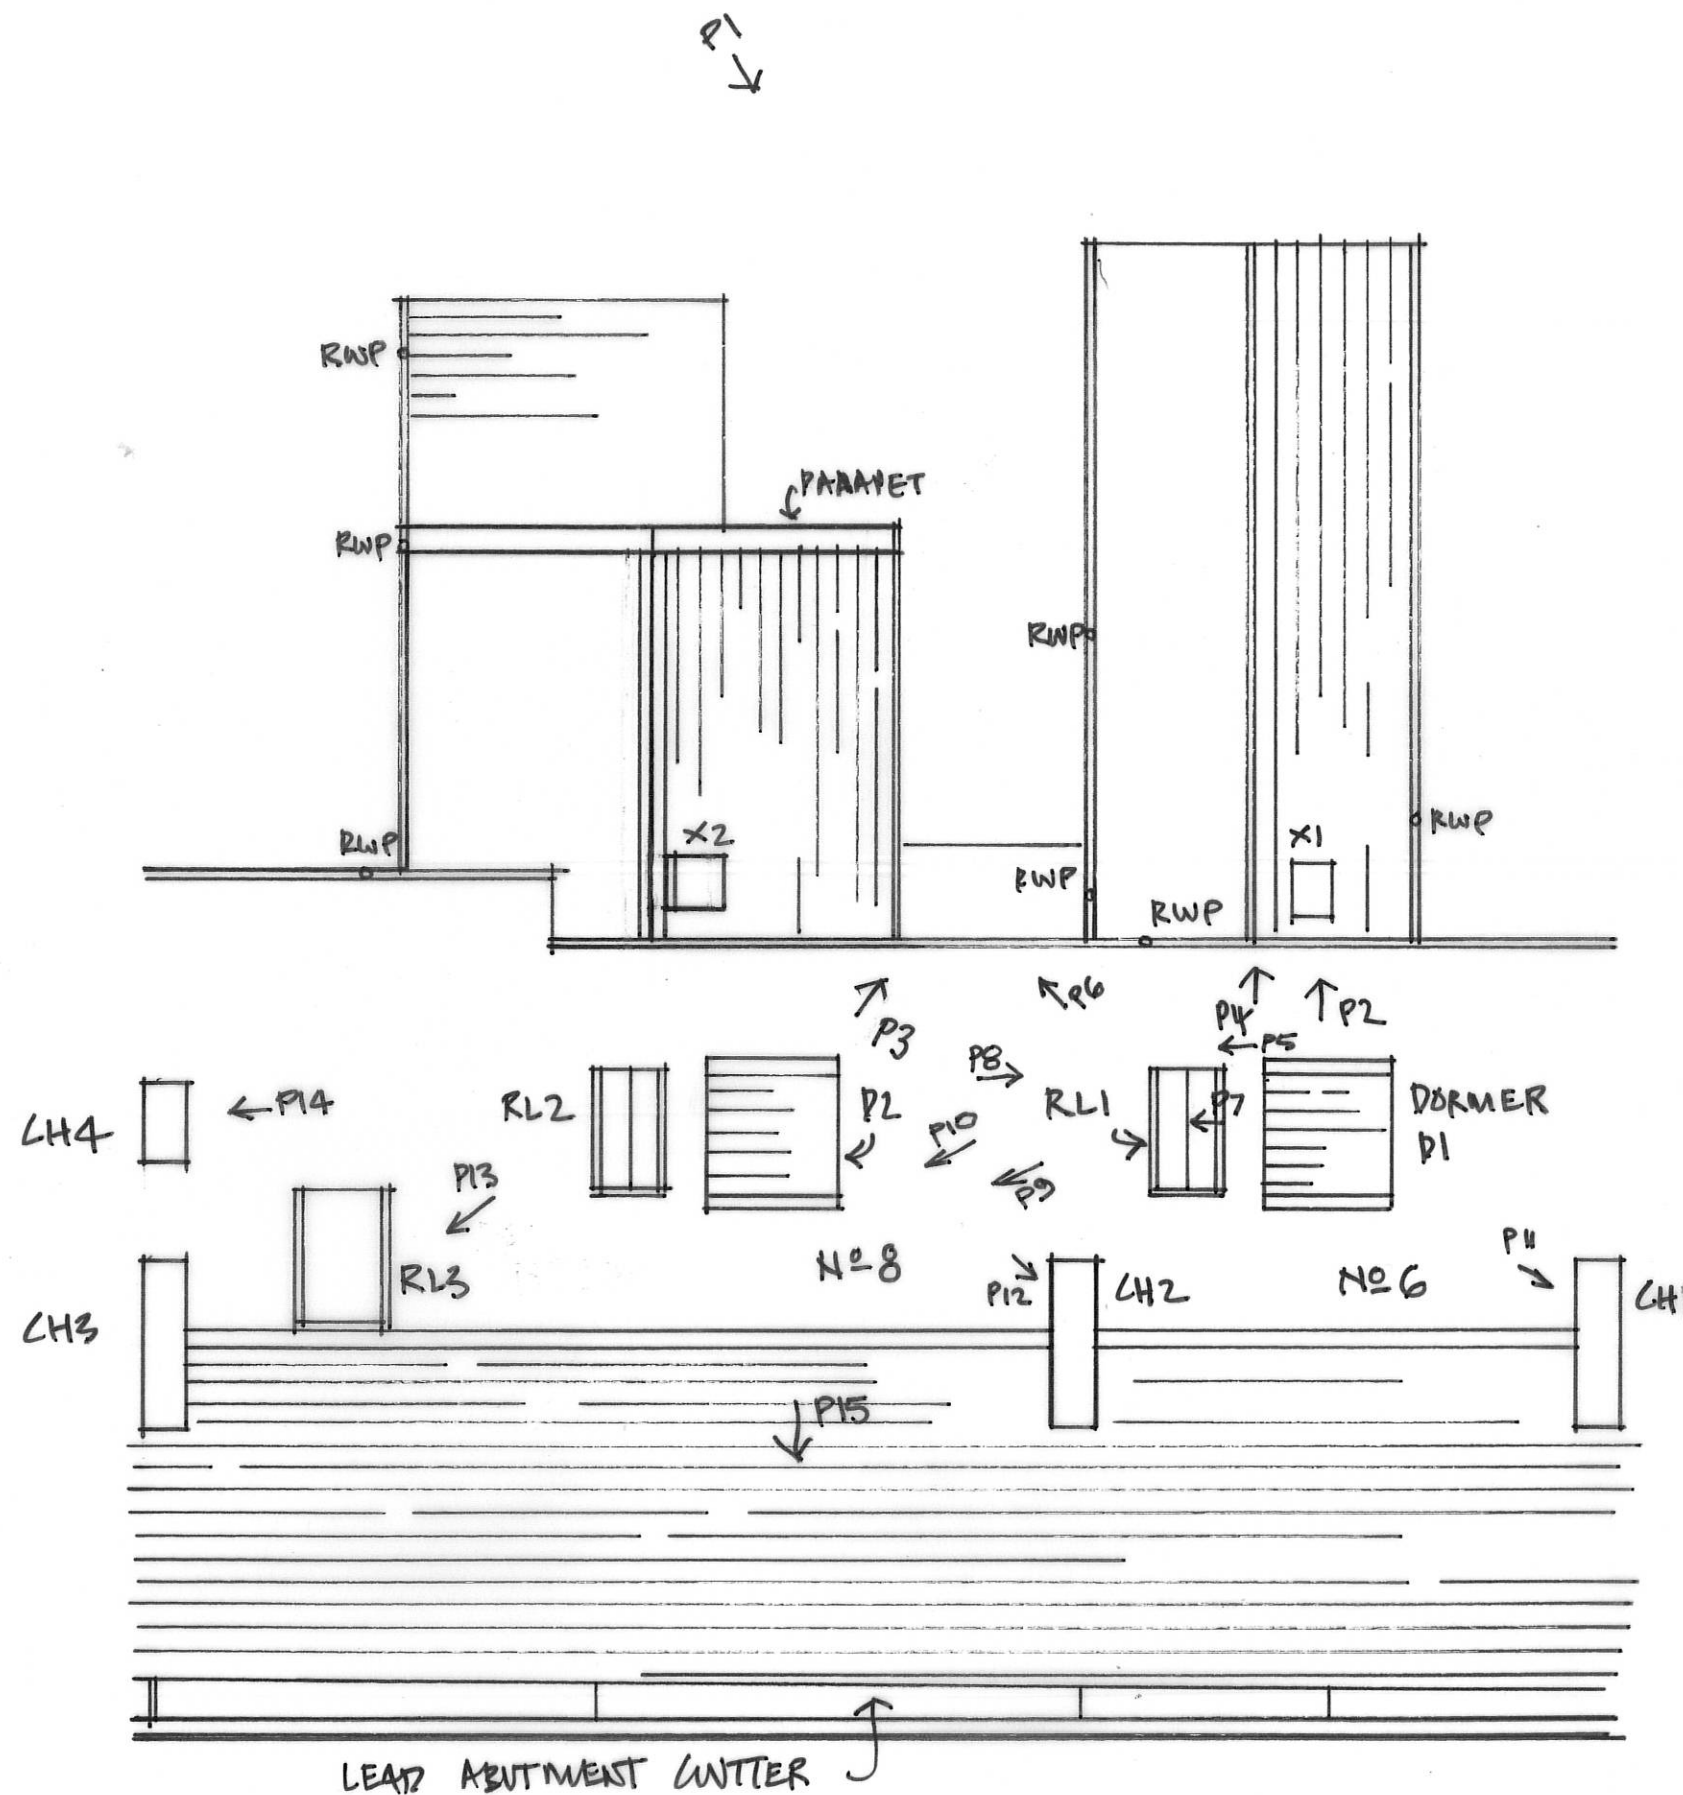
6-8 MANCHESTER RD BURY. RE-ROOFING PROPOSALS FOR HORSFIELD INSOLVENCY PRACTITIONERS.  
 PRG: ROOF PLAN AS EXISTING: SCALE 1:100 @ A3. EQUILIBRIUM ARCHITECTS LTD.

P1-P15 PHOTO REFERENCES
