# Preliminary Roost Assessment

Davenport Farm Annex  
Arthur lane  
Ainsworth  
BL2 5PW

For  
Jenkins Design Services Ltd

# Gritstone Ecology

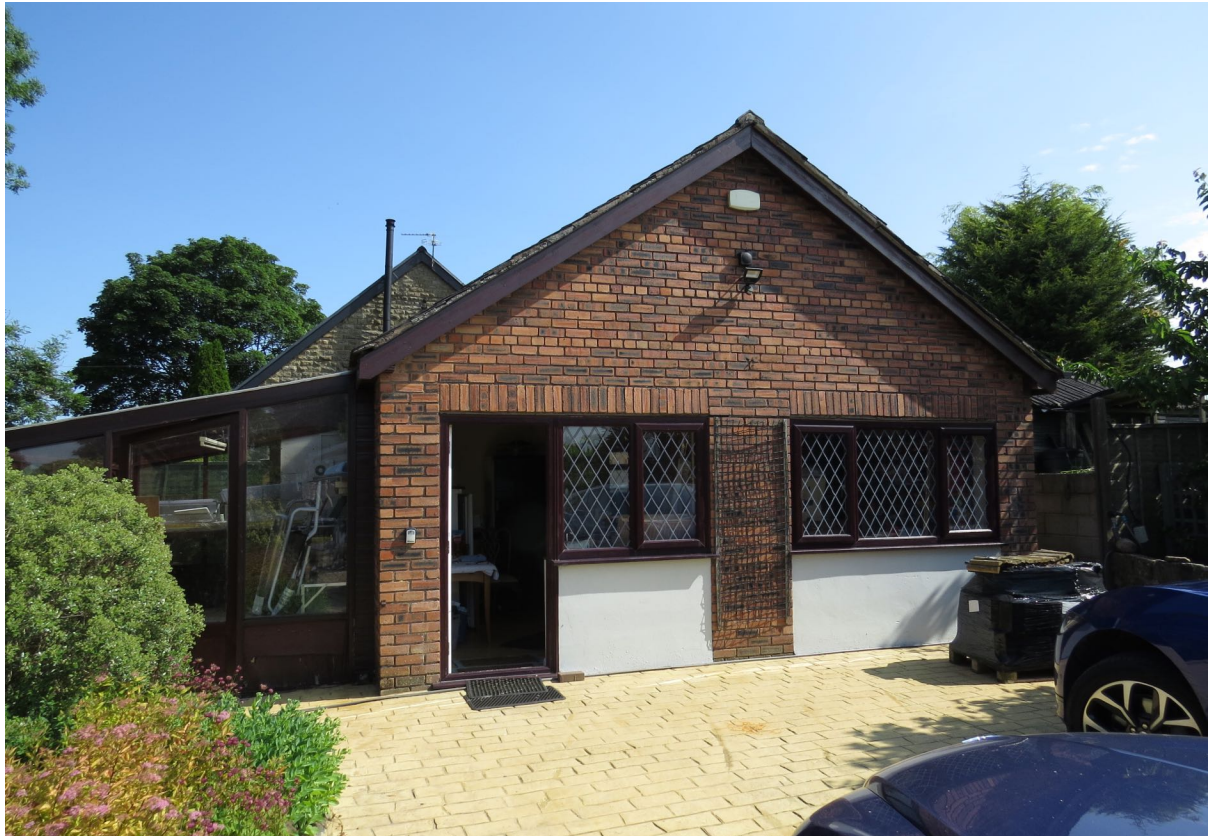
1 – The front of the annex.

The building is relatively modern, it is well maintained, and in good condition. Ridge tiles are fixed tightly, there are no damaged or missing ridge tiles. There are no damaged, slipped, or missing roof tiles. Roof tiles are tightly fitted, with no gaps between tiles.

Timber fascia boards and boxed soffits are fitted tightly against the walls gaps are filled with sealant. Walls are in good condition, with no missing mortar or cracks.
