**ENGINEERING REPORT 9622**

**THE ENGINE SHED  
ROWLANDS ROAD  
SUMMERSEAT**

**CLIENT: MR MIAH**

**02.07.2024 / 04.07.2024 MP/CH**

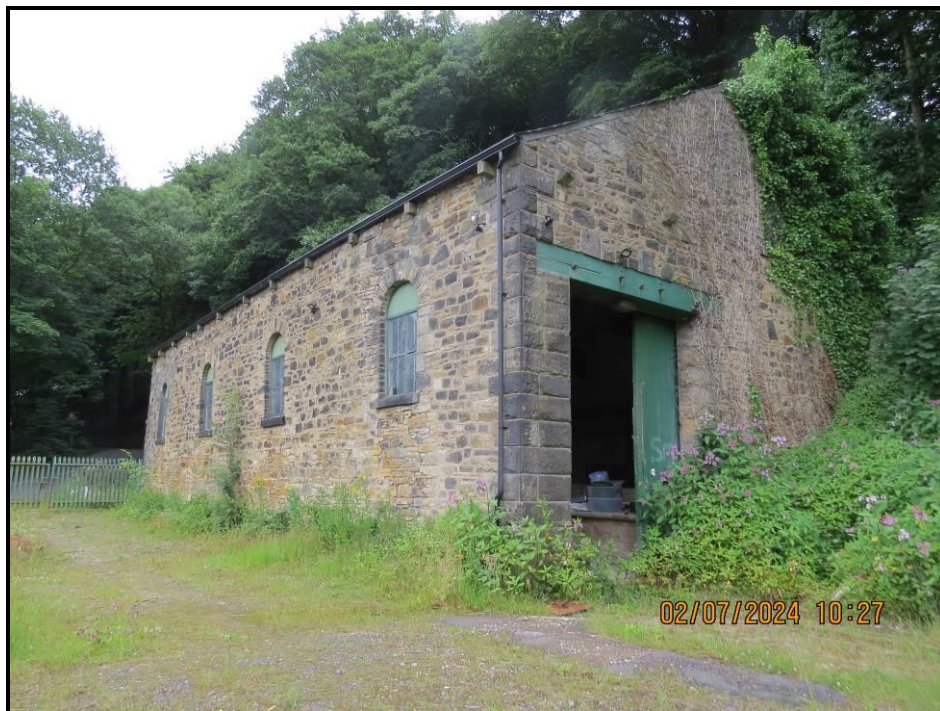
Photograph 014 Western flank and Southern gable

- 6.1 The Southern gable replicates the opposite Northern gable with a rectangular door opening on the left hand, South Western corner completed with large section stone quoins and a timber lintel. (Photograph 014).

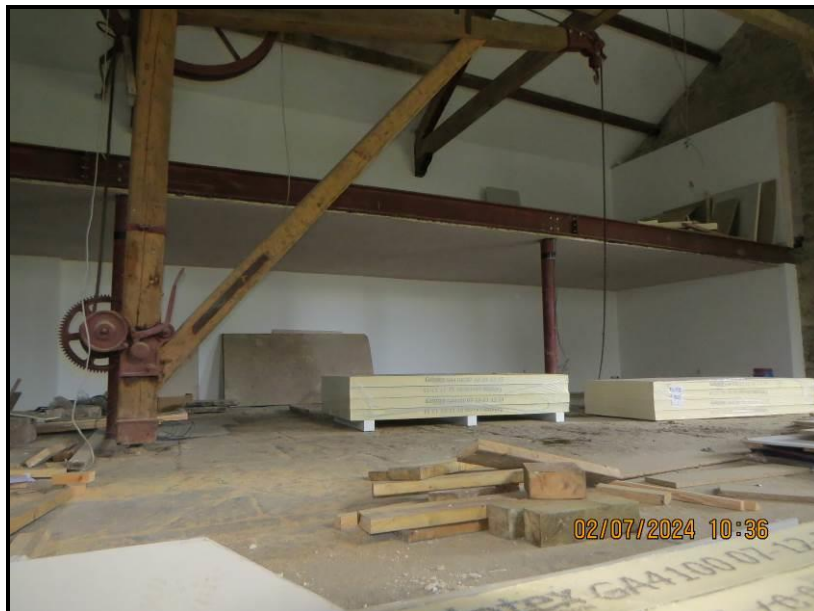
Photograph 030 Crane and loading platform

- 7.1 Internally the building retains a natural stone plinth platform occupying a footprint in the order of 90 square metres with a lifting derrick located towards the Northern aspect. (Photographs 027, 028, 030).

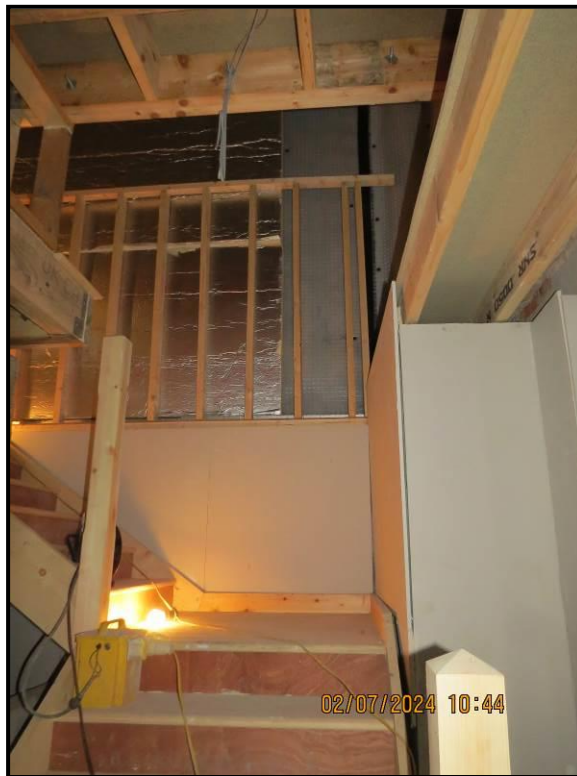
**Photograph 045 Stairs to first floor**

- 7.12 The Northern end bay has been partially infilled with steel framework to accommodate the additional accommodation levels 1 and 2 as per the approved Plans. (Photographs 032, 038, 039, 040).
- 7.13 The entry to the first floor level on the Eastern side is via a staircase on the North Eastern side of the unit giving access to the main first floor Dining Room extending for a length in the order of 17 metres to the Southern gable and width of 10 metres from East to West. (Photographs 044, 045).

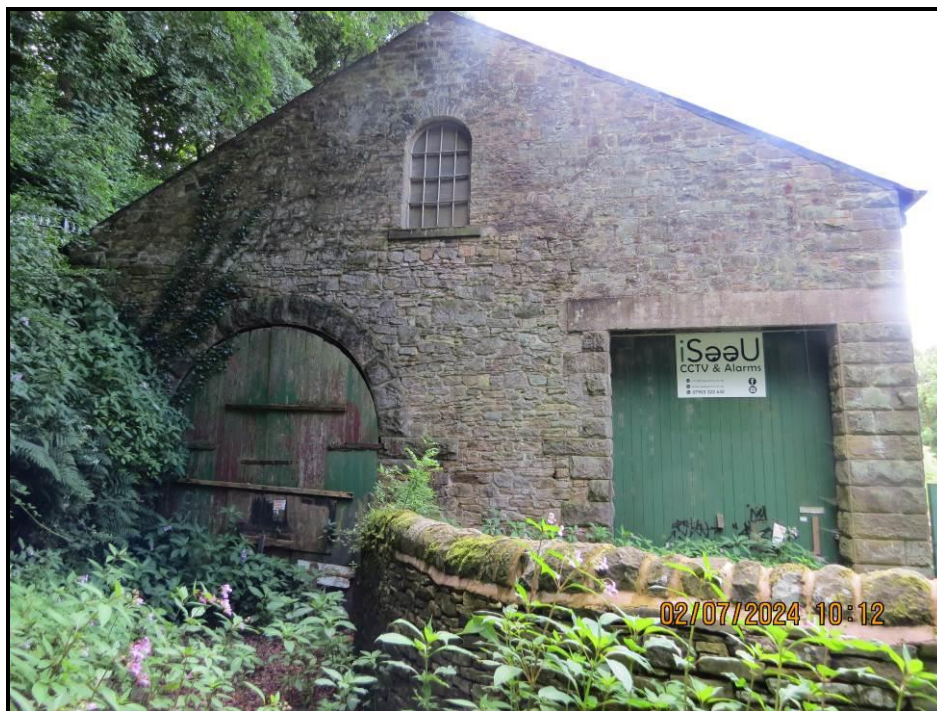
003 Northern gable

- 4.1 The Northern gable extends for a width in the order 14 metres, a height at eaves level circa 6 metres completed with a pitched roof laid to a 30° slope. (Photograph 003).

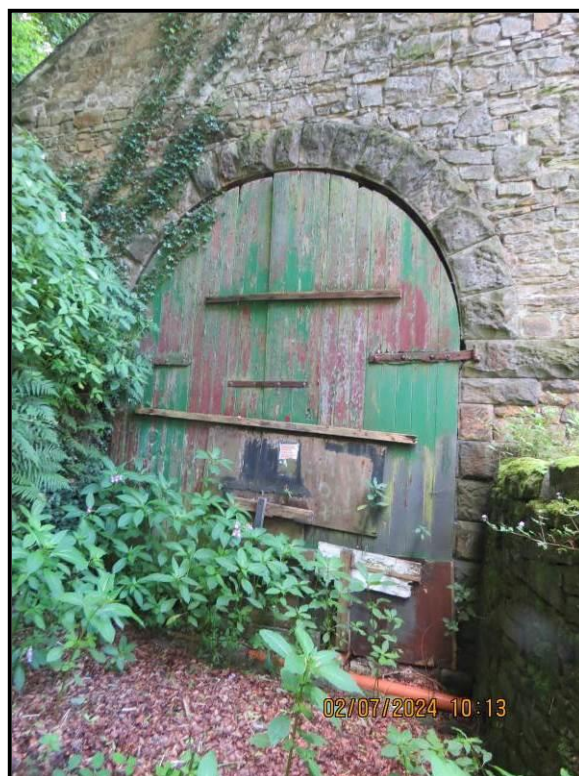
004 North Eastern arch

- 3.1 The Eastern flank wall is constructed against a 5 metres high retaining wall on a Western facing slope incorporating the original flank wall and the return Northern gable to the Engine Shed, the gable approximately 3.5 metres wide x 4.5 metres high completed with a single natural stone archway of dressed stone in the order of 450mm deep. (Photographs 003, 004).

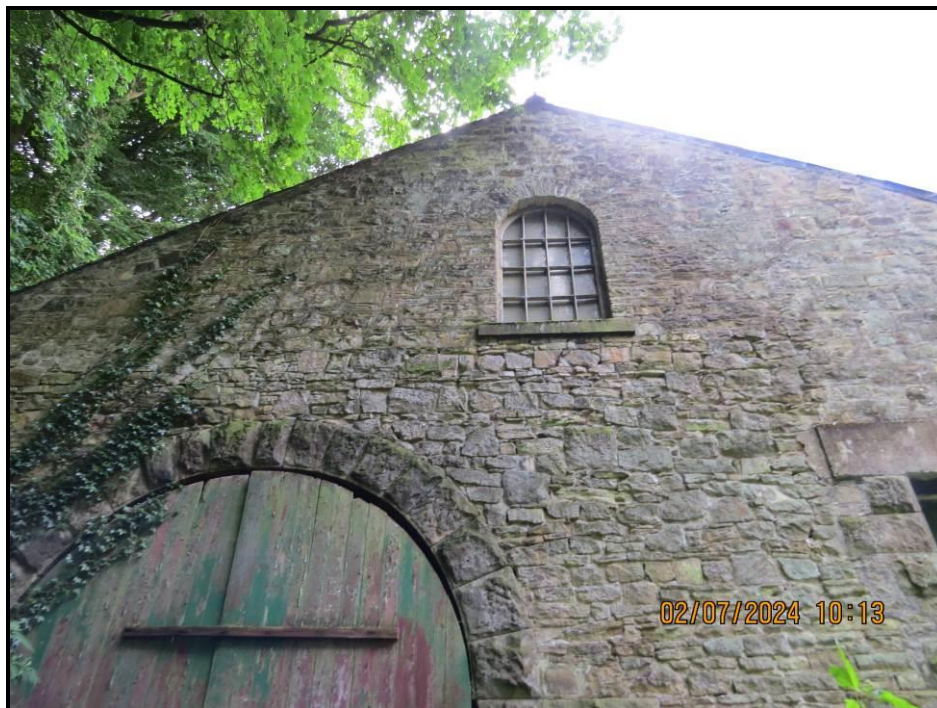
006 Upper pike

- 4.2 The left hand gable corner (North East) incorporates a 8 metre wide opening completed with a 1.5 metre radial arch construction for the former Engine traffic, flanked on the right hand (North Western) section with a rectangular opening, 6 metres wide by a height in the order of 8 metres, completed with a probable concrete lintel.
- 4.3 The profile of the arch is good and the stonework and pointing are generally in a satisfactory condition. Localised patches of pointing show some weathering, there are no distorted profiles to the gable. (Photograph 004).
- 4.4 On the left hand (Eastern) boundary wall, approximately 1.5 metres high, heavy overgrowth is present to the wall preventing a detailed wall inspection. (Photograph 005).
- 4.5 There are no signs of any distortion to the exposed areas of wall on the upper gable. (Photographs 005, 006).

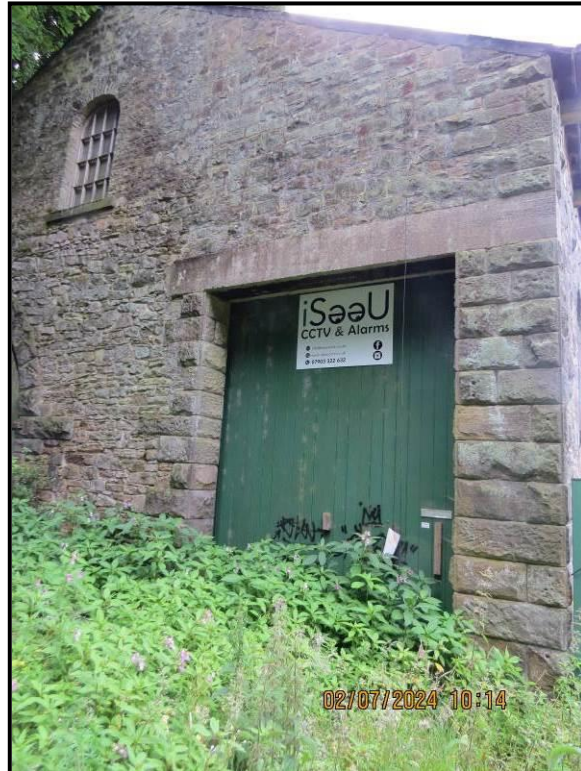
007 North Western doorway

- 4.6 The right hand rectangular opening is completed with natural stone quoins to the door reveals. The door jambs and reveals follow a satisfactory vertical alignment, and the overall vertical profile to the Northern gable is good. (Photograph 007).

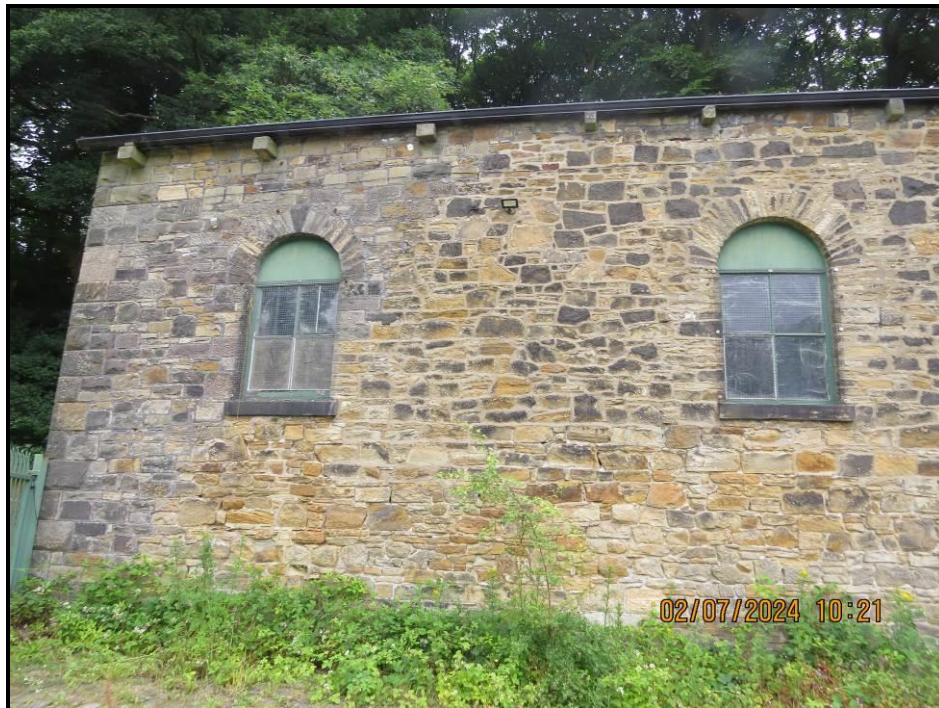
009 Western flank, 0 – 9 metres

- 5.2 Minor variations are evident in the weathering to the stonework along the elevation probably occasioned by former Ivy growth or similar (not of any structural consequence). (Photographs 009, 010, 011, 012, 013).
- 5.3 The eaves gutters are supported on stone corbels at approximately 1.5 metre centres.
- 5.4 The random stonework coursing is well maintained and in good order, the profile of all four window openings is good, and the vertical alignment along the elevation is good. (Photographs 014, 015).

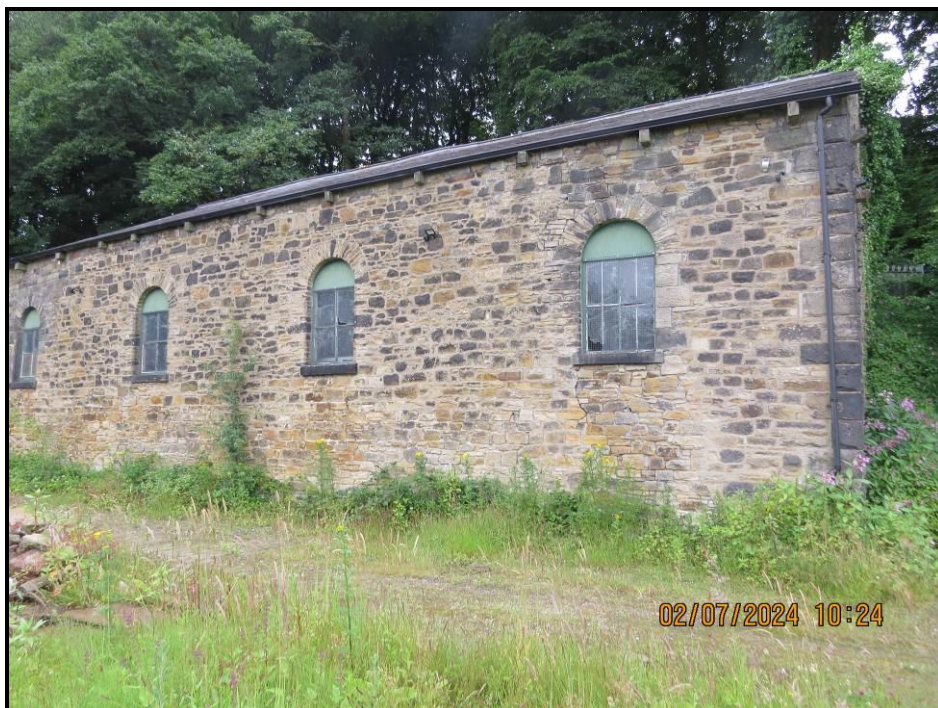
012 Western flank, 0 – 20 metres

- 5.1 The Western flank wall extends for a length in the order of 20 metres incorporating four number radial headed windows completed with stone lintels and semi-circular arch. The windows are located at approximate chainages 3, 8, 12 and 17 metres (North – South). (Photograph 012).

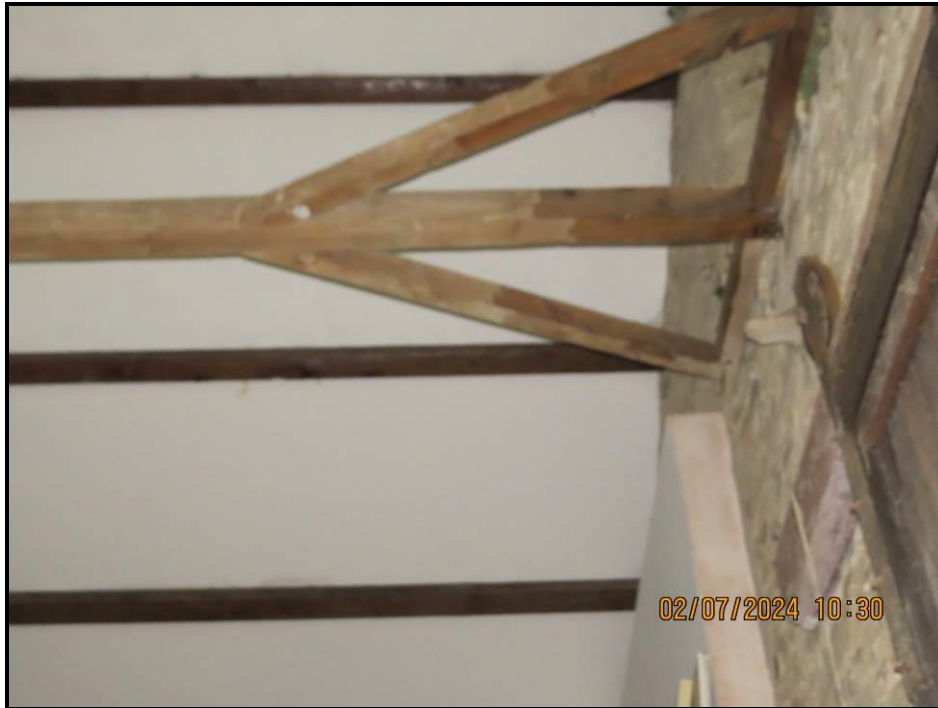
018 Longitudinal timber brace

- 7.2 The pitch roof is supported on three number trusses with three purlins to each roof slope, spanning North to South. The Northern gable, Truss 1, Truss 2, Truss 3 and Southern gable.
- 7.3 The purlins are sized in the order of 200mm (exposed) x 150mm inclined, spanning a distance circa 5 metres, seated internally on the Southern gable with a stone pier circa 350mm x 150mm giving satisfactory bearing to the purlin seatings. (Photographs 028, 029, 031, 032).
- 7.4 There are no signs of any separation where the inner gable wall adjoins the plastered ceiling lines. General arrangement shown in photographs 019, 022.
- 7.5 Longitudinal bracing is provided in the form of a 'Y' shaped brace incorporating the main tie circa 225mm square with similar sized struts spanning either side of the upper gable window. The seating of the brace is satisfactory. (Photographs 018, 019, 020).

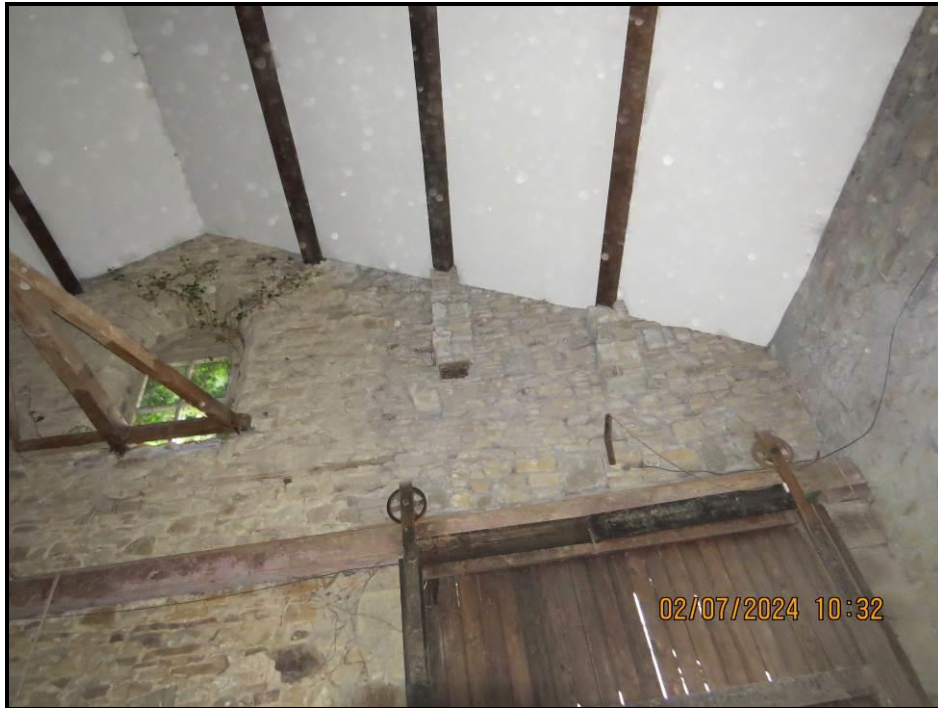
022 Upper pike, South West gable

- 7.6 The sliding rectangular timber door has a metal runway beam fixed to the inside face of the Southern gable. (Photograph 022).

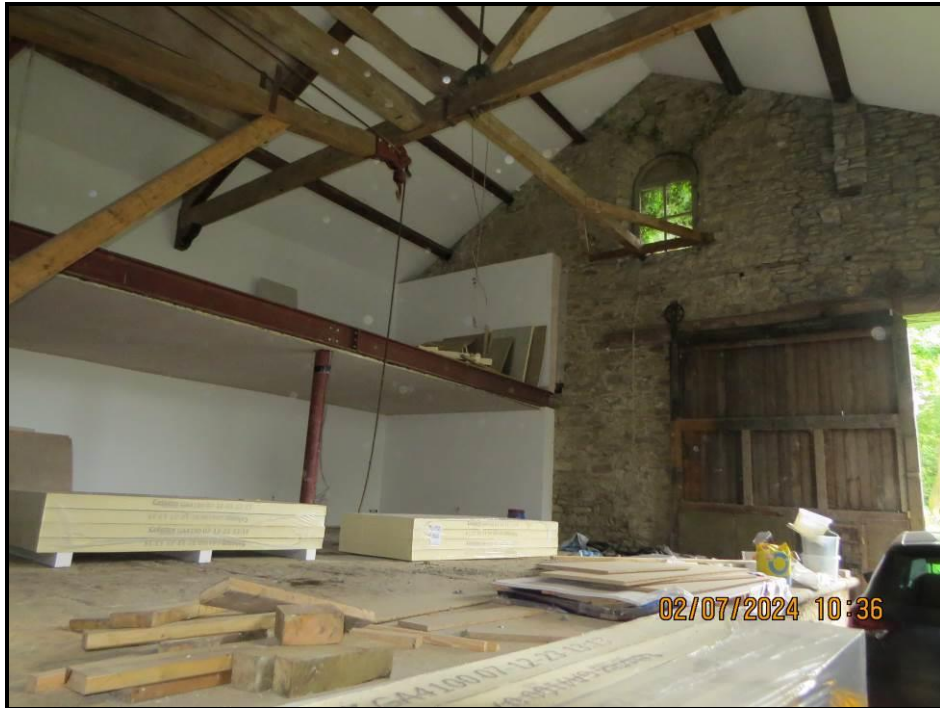
028 Southern gable (South East)

- 7.7 The timber roof construction follows a satisfactory line and level with no deviation to any of the members in either trusses nor the purlin constructions on either roof slope.
- 7.8 There are no signs of any distress or irregular seating where the trusses bear into the external walls. (Photographs 057, 058, 059, 060, 061).
- 7.9 The walls have been modified with a plaster finish, and the original roof is supported on three King Post trusses spanning the full width of the building, bottom tie sized in the order of 300mm x 100mm, with a 100mm central tie rod from the ridge down to the bottom tie with inclined struts circa 250mm x 75mm, incorporating a longitudinal tie beam with restraints to the both gables. (Photographs 028, 029, 031).

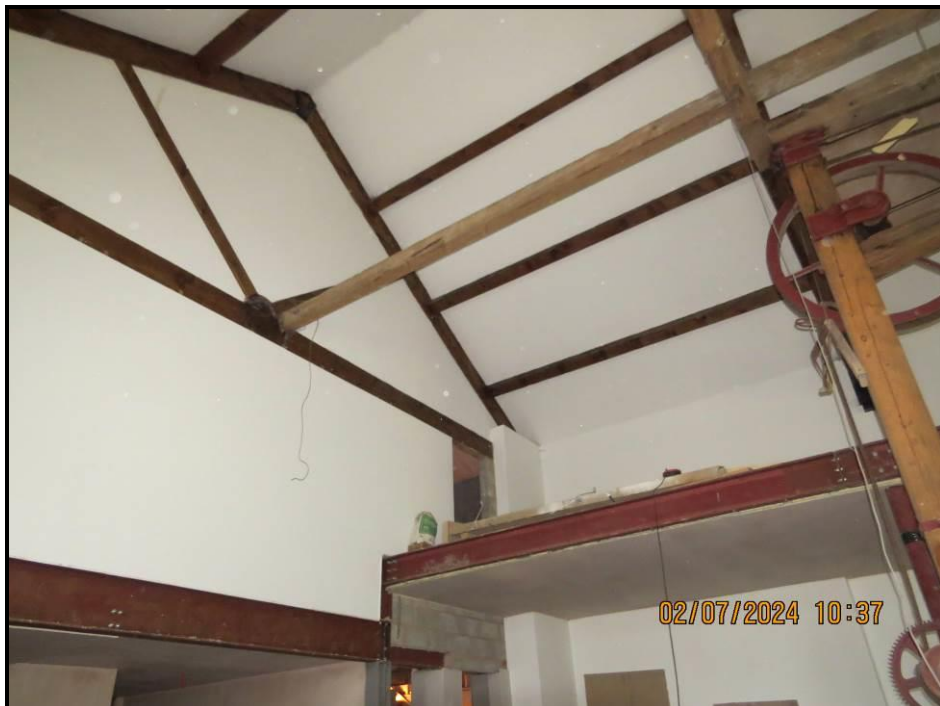
031 North Eastern truss 1 – 2

- 7.10 The roof incorporates three exposed purlins, sized in the order of 200mm x 150mm, purlins following a satisfactory line and level. (Photographs 031, 032).
- 7.11 All the timberwork, trusses, purlins and longitudinal tie are in good order.

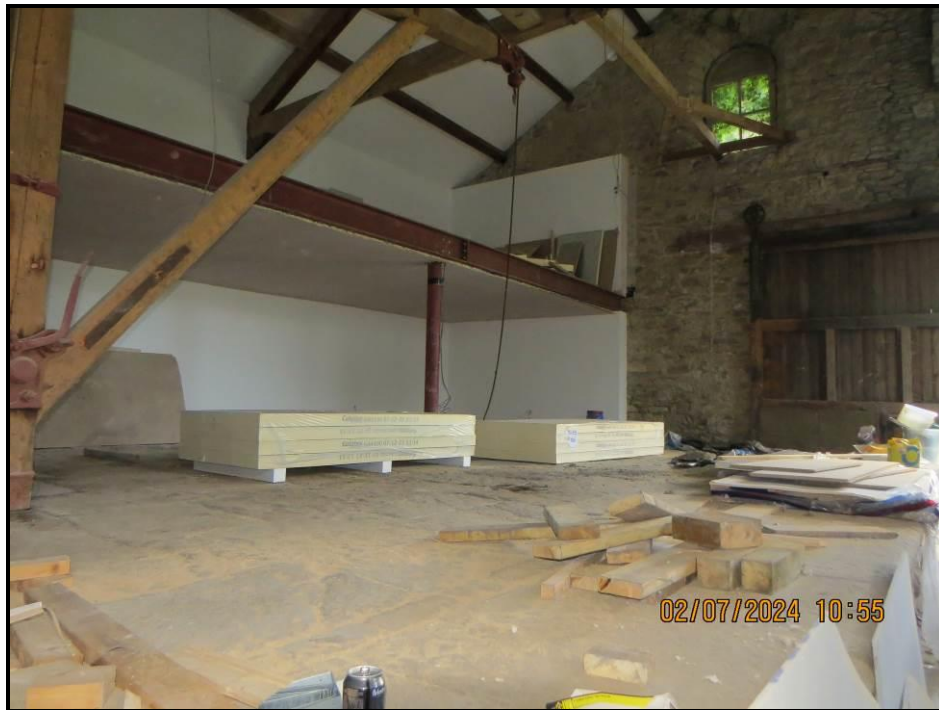
061 Loading plinth and first floor level, South East aspect
