# **POST FIRE PRELIMINARY INSPECTION REPORT**

**1 The Rock, Bury**

**Broad Property Ltd**

| <b>Title</b> | Post Fire Preliminary Inspection Report | | |

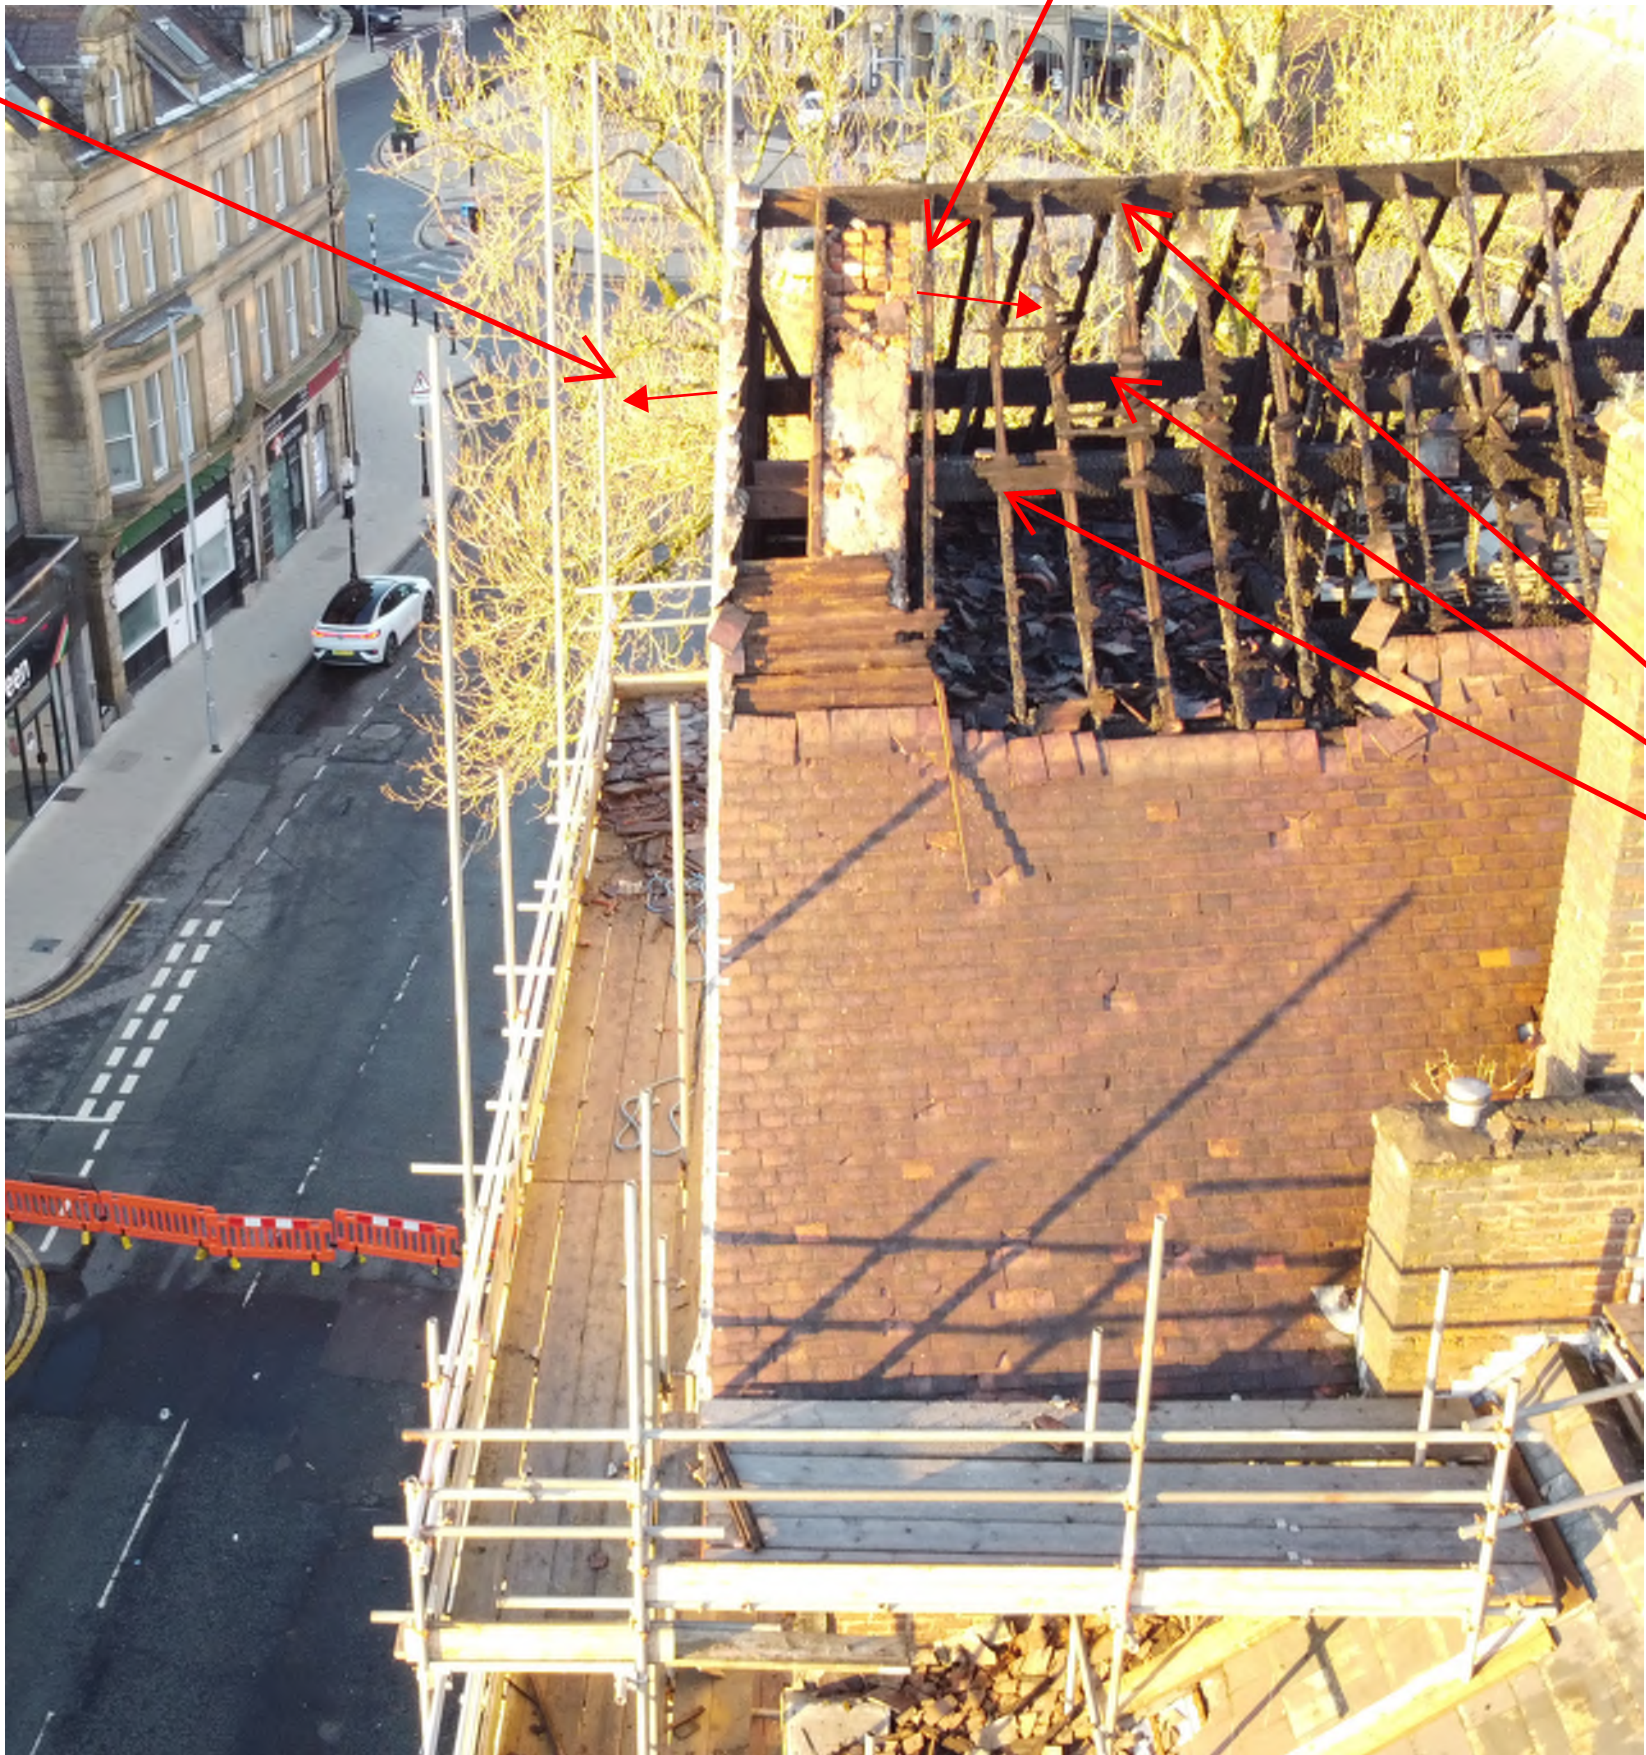
1 THE ROCK, BURY  
URGENT STRUCTURAL STABILISATION WORKS  
3rd December 2025

Gable appears to  
lean inwards slightly.

Purlins and ridge  
board not  
salvageable.

Notes  
1. Based on visual inspection undertaken on the 02/12/25.  
2. Other areas may need stabilisation once fire debris can be safely removed and building cleaned.  
3. Subject to Approval by the LPA.  
4. Sequencing and safe methods of work to be agreed with suitably qualified and experienced demolition contractor.
