# ASBESTOS SURVEY REPORT

## REFURBISHMENT/DEMOLITION ASBESTOS SURVEY

SPECIFIC AREAS, 41 ARTHUR LANE, AINSWORTH, BOLTON, BL2 5PR

REPORT NUMBER: R-17322

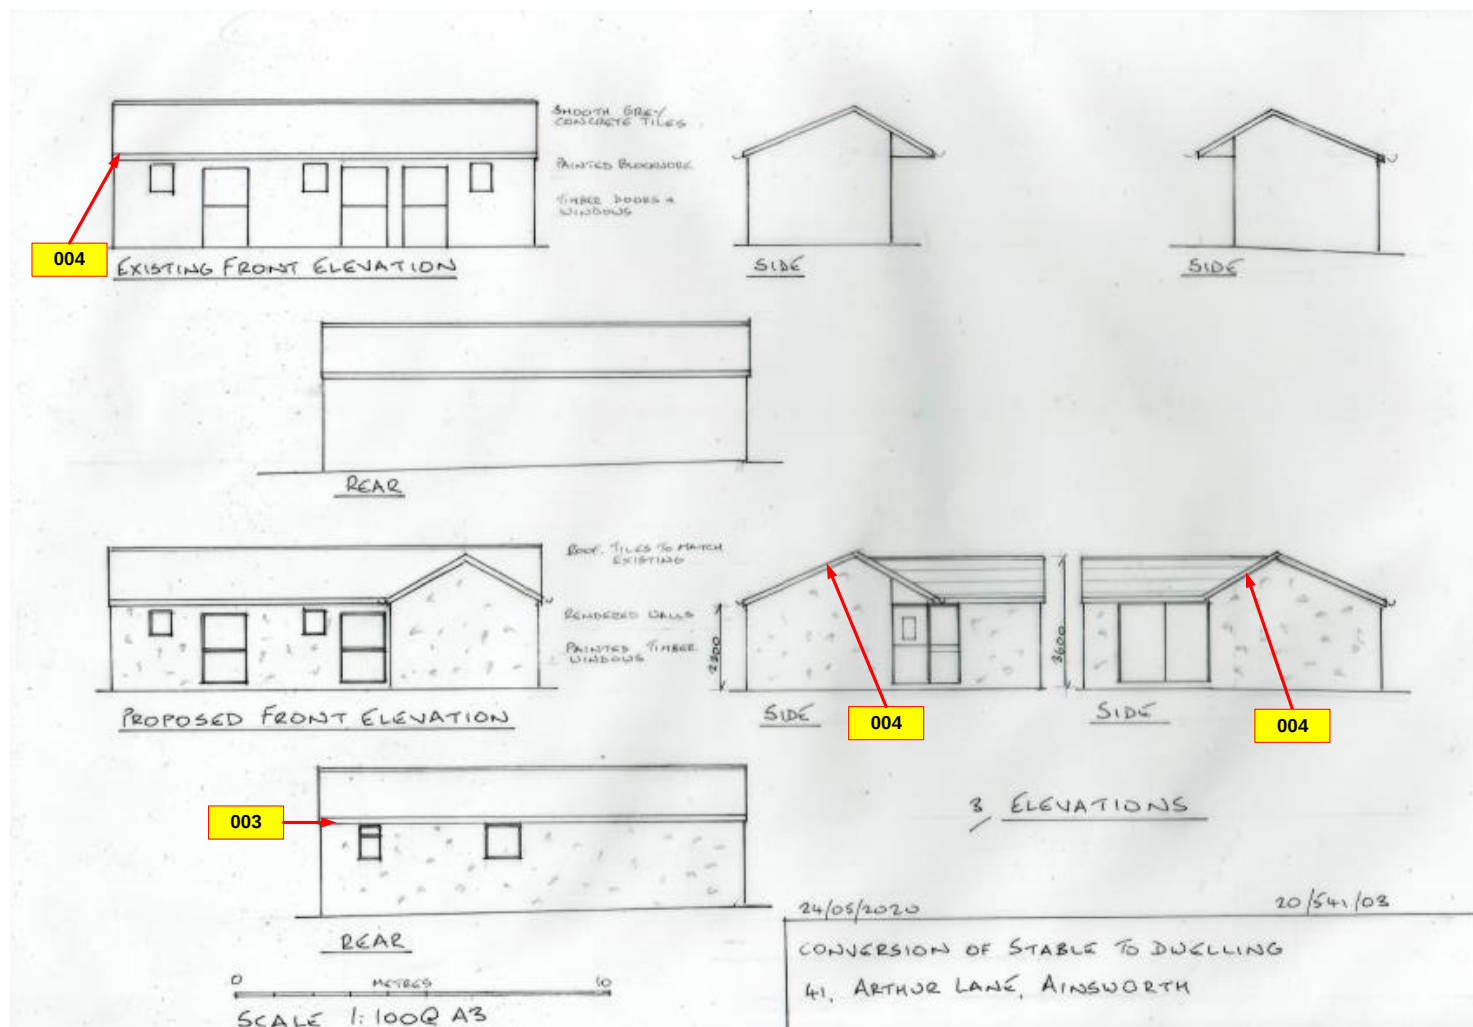
# EXTERNALS

| Photo | Plan Item No | Location | Comments |
|---|---|---|---|
| | LA1 | External | Rear of stable - Limited access gained<br>Proceed with caution - may contain asbestos<br>Extensive foliage present |
