## Preliminary Roost Assessment

Substation 3 - Fairfield General Hospital

Proposed development to convert an existing estates store into substation.

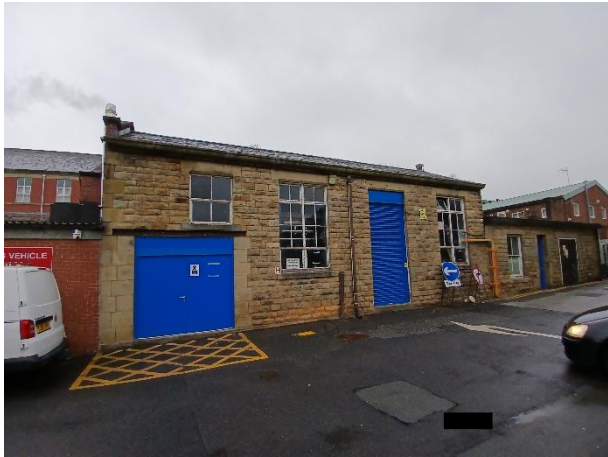
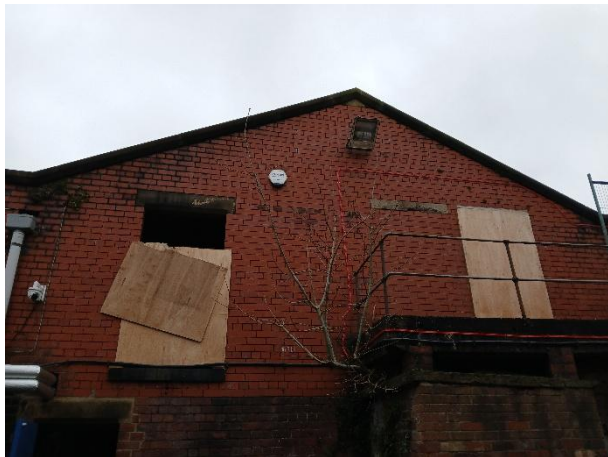
| B1 Building description | Photographs |
|---|---|
| <p><i>Summary</i></p> <p>B1 is split into three distinct sections as detailed below:</p> <p><b>B1a</b> is brick-built, two-storey, with a stone facade, located on the southern elevation of B1. This building section forms the entrance porch into B1b and houses a boiler room abutting B1c. The roof is pitched and slate tiled, internally this building section is open to the ridge with no roof space present. B1a is well lit from existing street and security lighting.</p> <p><b>B1b</b> forms the main storage building subject to development. This building section is brick-built, two-storey and connects directly to the porch section of B1a internally. The roof is pitched and slate tiled with two central dormers present. Internally this section is open to the ridge with no roof space present. B1a is well lit from existing street and security lighting.</p> <p><b>B1c</b> is a switch room located to the east of B1a on the southern elevation of B1. It is brick-built, single storey, with a stone facade. This building section has a flat concrete roof construction. There is no connectivity internally between this building and the other sections. B1a is well lit from existing street and security lighting.</p> <p>Overall, <b>B1</b> considered to offer <b>Negligible</b> roost suitability, discussed further below.</p> | <p>B1a and B1c (Southern elevation)</p><br> <p>B1b (Eastern Elevation)</p> |
