D0372 - 104 - PLANNING

## Existing Photographs

Barwood House,  
Grants Lane,  
Ramsbottom ,  
BL0 9AX

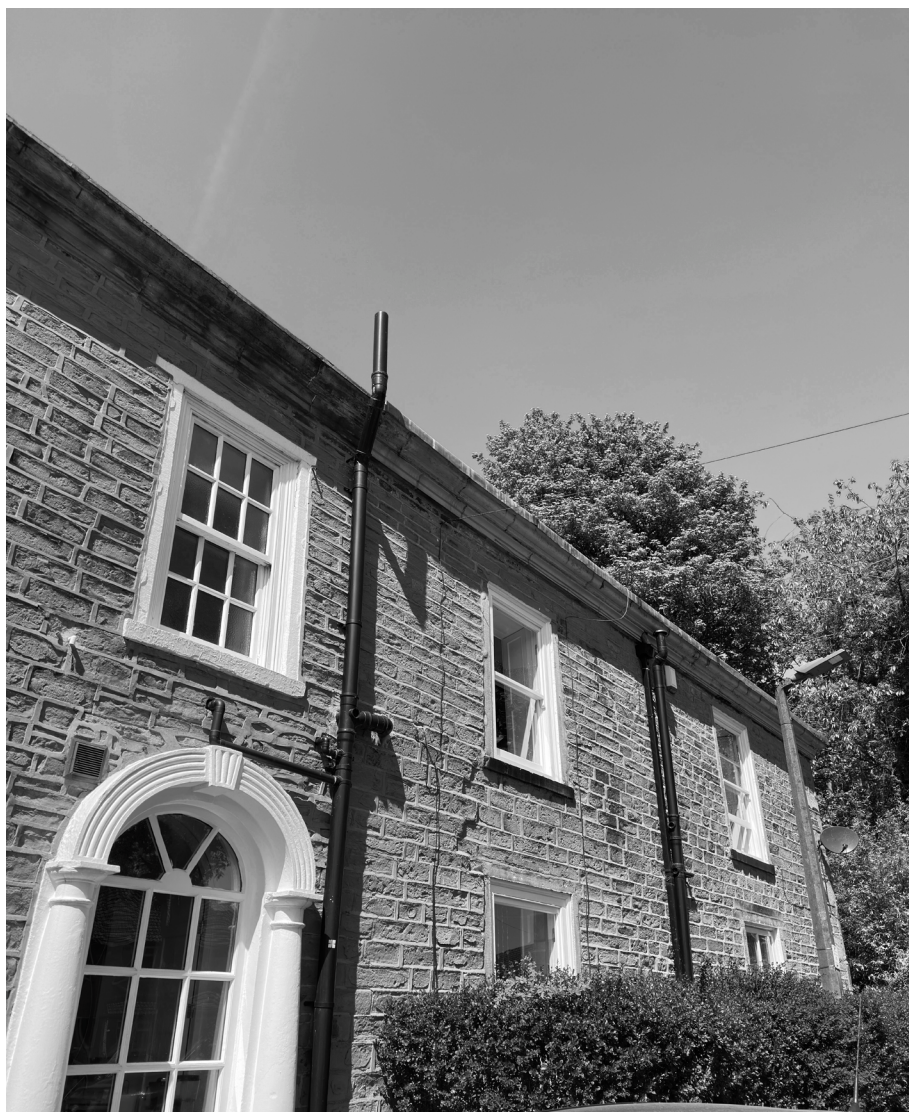
Figure 1A: Photo taken from Grants Lane looking towards Barwood House

- Existing property has a slate roof with mortared hip & ridge tiles.
- Inset stone gutter with moulded cornice.
- Neighbouring property No.19 has large lead flashing along eaves, ridge & hips.
