## BURY FUSILIERS MUSEUM

Design, Access & Heritage Impact Statement.  
Chambers Conservation Ltd, January 2023 ISSUE 1.

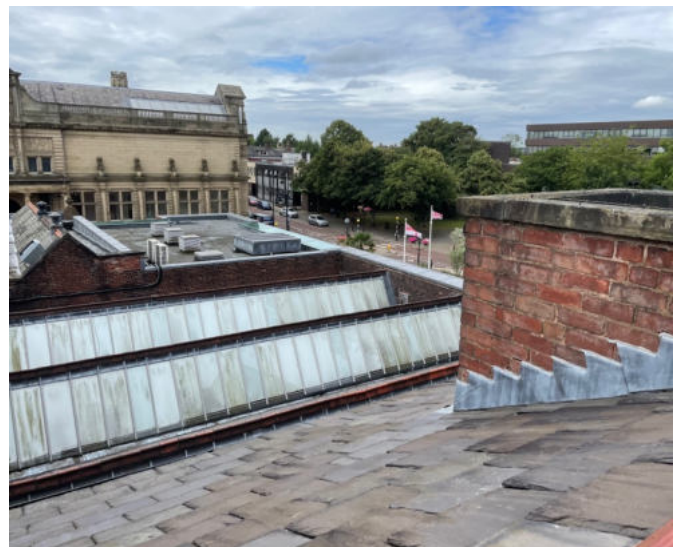
02 General view across the roofs, towards the new entrance. Note the weaving shed north-light roof and the art gallery in the background.
