## CCTV SURVEY INSPECTION REPORT

| <b>Location:</b> | Radcliffe Hub (Next to the Bridge Tavern Pub) |

**Project Name:** CONSTRUCTICON BLACKBURN STREET RADCLIFFE 060624  
**Project Date:** 06/06/2024  
**Inspection Standard:** MSCC5 Sewers & Drainage GB (SRM5 Scoring)

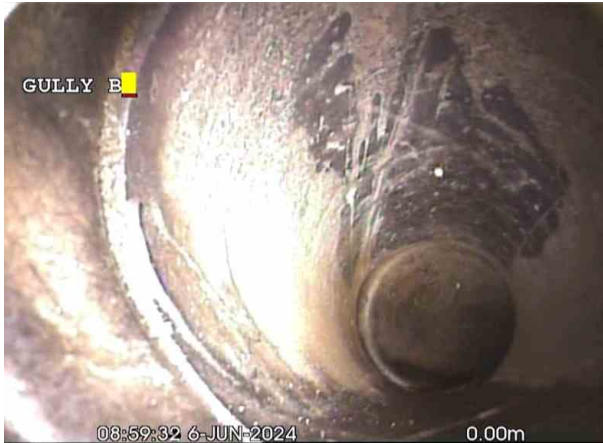
GULLY  
 BX\_62f342fd-36d7-446f-affd-e7fb434d18b6\_20240606\_13013  
 7\_393.jpg, 00:00:00, 0.00 m  
 General photograph taken at this point

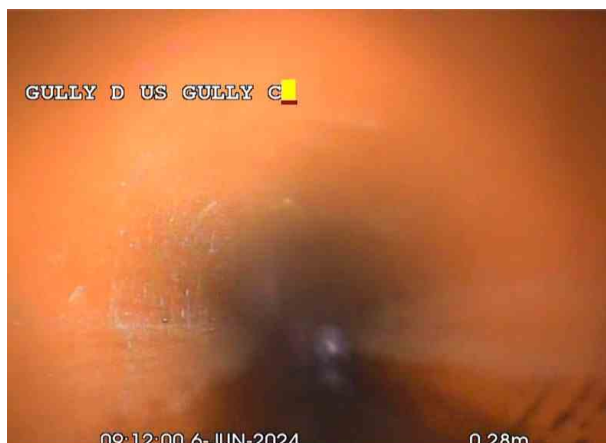
GULLY

CX\_c8a1ab03-3812-4ac4-9b1f-9df5f7630b2d\_20240606\_130  
453\_995.jpg, 00:00:02, 0.28 m

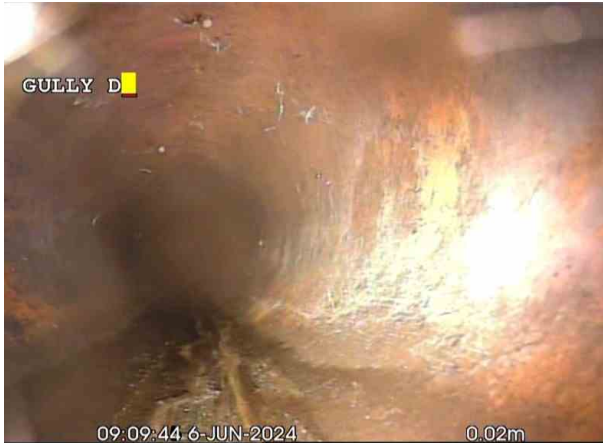
GULLY  
 DX\_0cc76a18-2810-4983-92bc-d148fe6d3e99\_20240606\_13  
 0602\_196.jpg, 00:00:00, 0.00 m  
 General photograph taken at this point

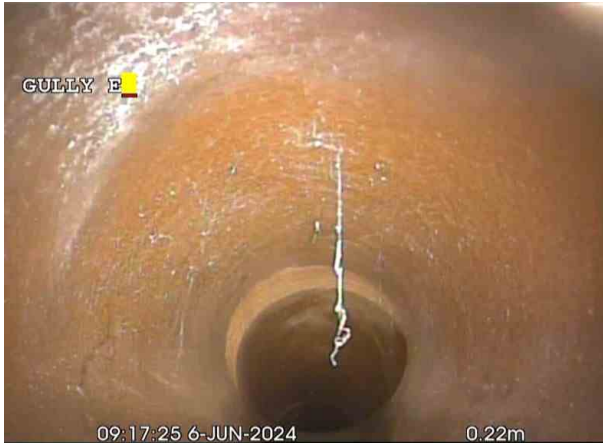
GULLY  
 EX\_50172f7d-db4c-430d-a44d-eff31edec07c\_20240606\_1307  
 26\_484.jpg, 00:00:04, 0.22 m  
 General photograph taken at this point

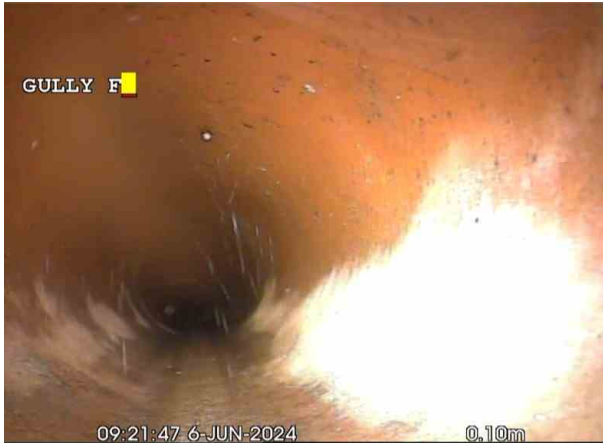
GULLY  
 FX\_a2c1a5ab-91a9-4f0b-a5cc-319c8cc1ae6b\_20240606\_131  
 009\_109.jpg, 00:00:00, 0.00 m  
 General photograph taken at this point

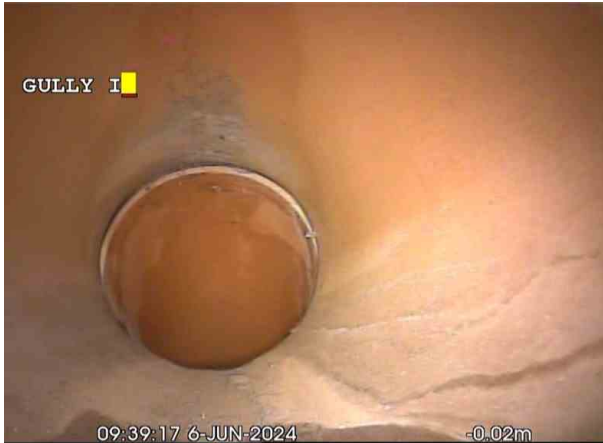
GULLY

IX\_5dbd7d51-3fa7-421e-9cee-8ed5441ee999\_20240606\_131  
231\_842.jpg, 00:00:00, 0.00 m  
General photograph taken at this point
