## Appendix E - CCTV Survey

| Reference | Title |
|---|---|
| LITTLE LEVEL - RADCLIFFE 000518 | CCTV Survey Report |

Project name :  
**LITTLE LEVER - RADCLIFFE 00051**

Date :  
**08-Sep-20**

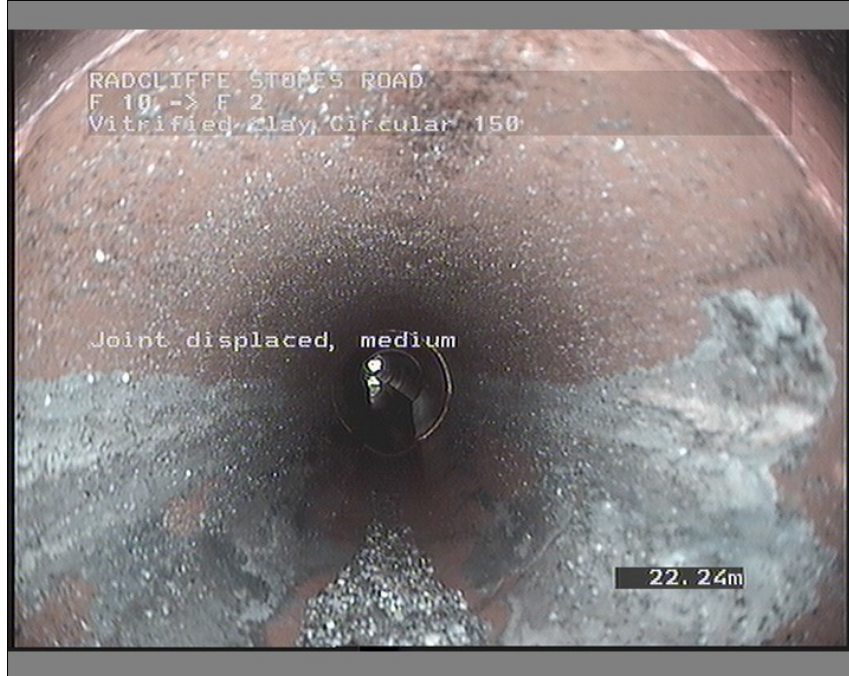
Photo: 12\_12\_70\_A.JPG  
22.24m, Joint displaced, medium

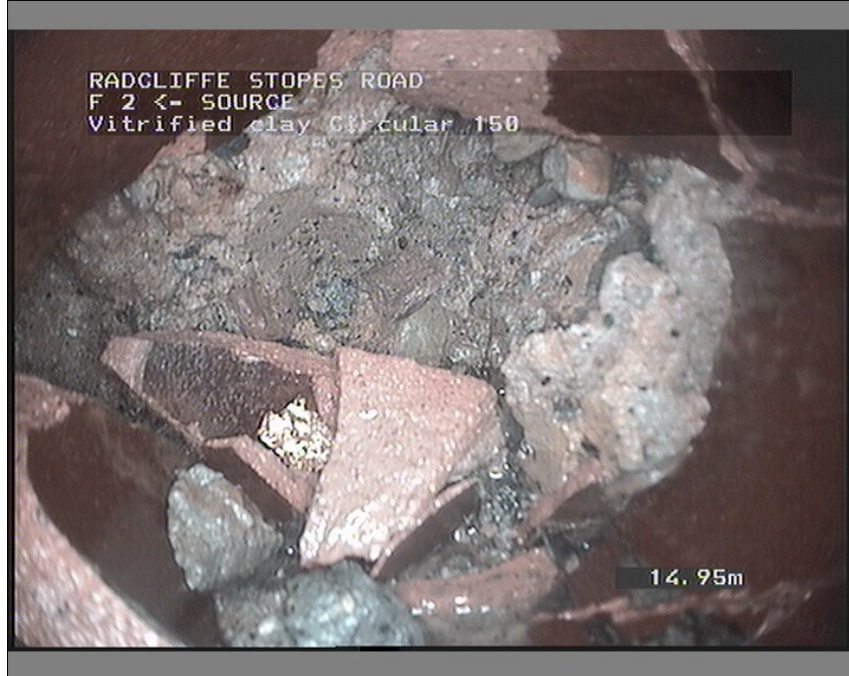
Photo: 14\_14\_83\_A.JPG  
14.95m, Collapsed drain/sewer
