The visual verification inspection was undertaken by a suitably competent IDG verification engineer, in accordance with the requirements of CIRIA C735 and the site-specific Gas Protection Measures Verification Plan.

Ground Floor Lift Pits Radon Protection – Area of Installation/ Inspection for given date highlighted Yellow

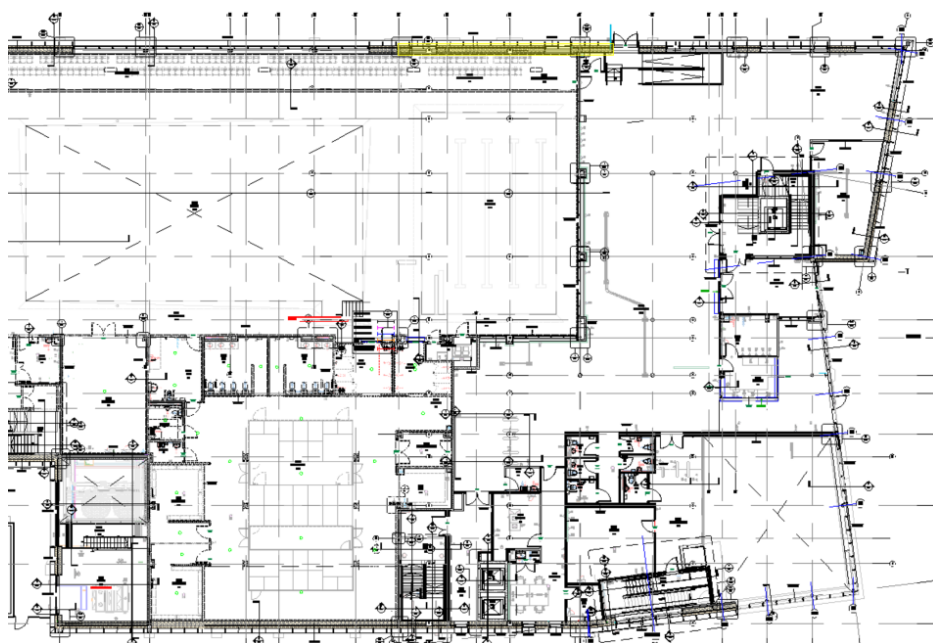
Ground floor northern external substructure around main pool (Liquid Gas Barrier) – Area of Installation/ Inspection for given date highlighted Yellow

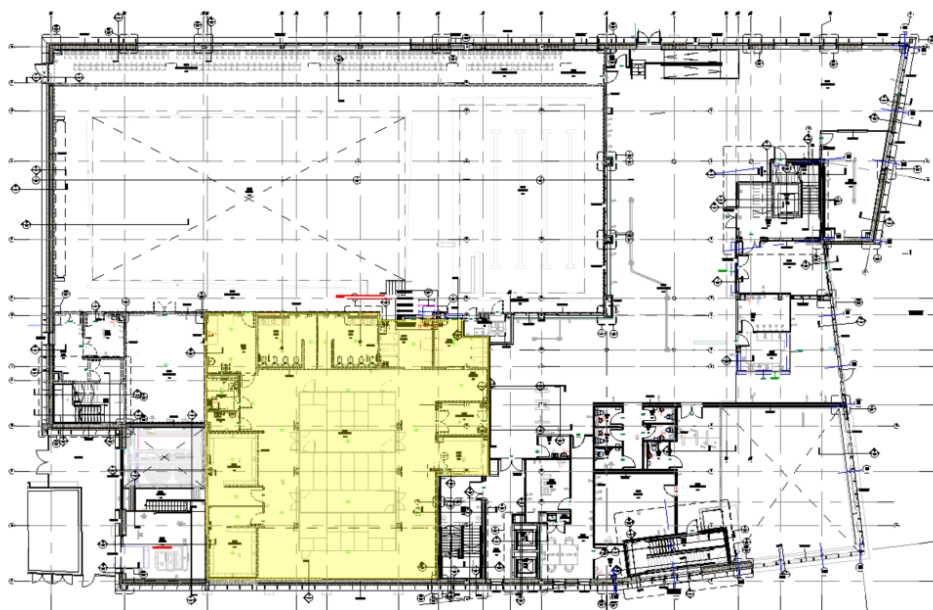
Phase 2 Ground floor area south of main swimming pool – Area of Installation/ Inspection for given date highlighted Yellow

| No. | Item | Comments (see notes) |
|---|---|---|
| 3.3 | Gas membrane condition (rips/ tears/ penetrations) | <i>Generally very good. Small number of punctures identified during visual inspection all repaired under IDG supervision prior to air-lance testing..</i> |

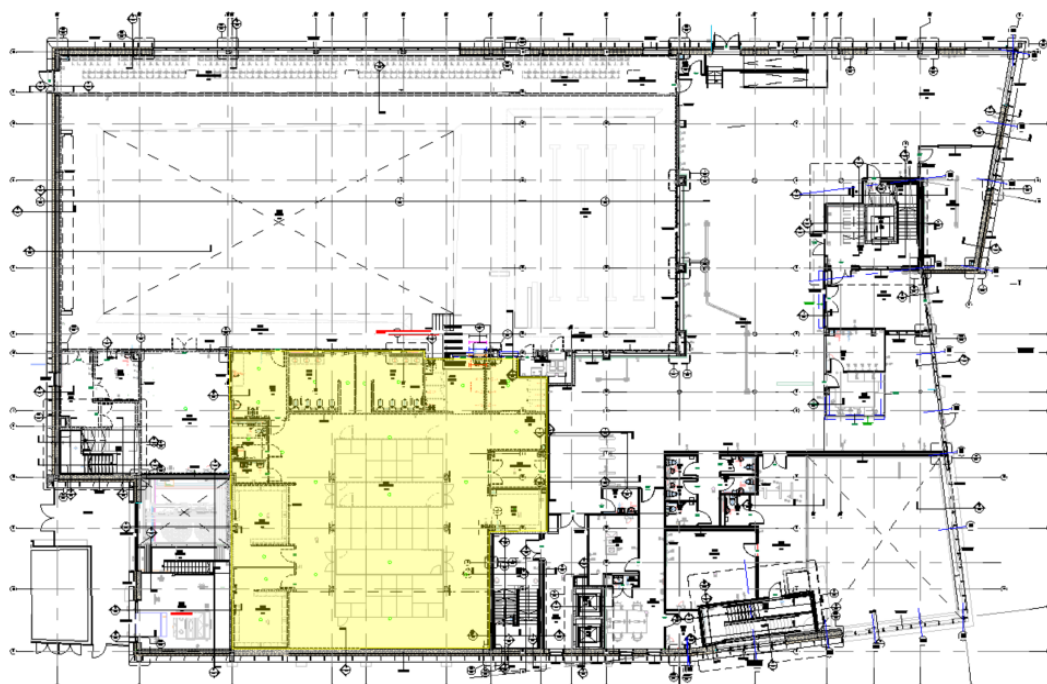
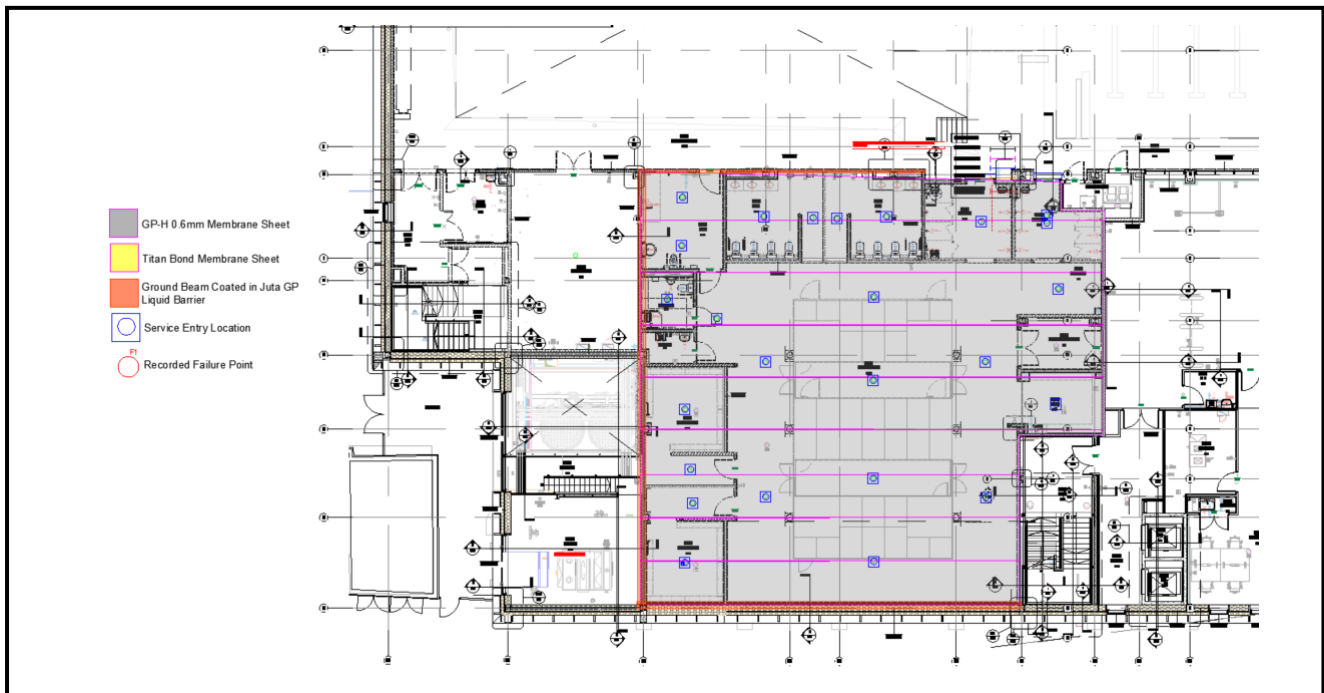
**Phase 2 Ground floor area south of main swimming pool – Area of Installation/ Inspection for given date highlighted Yellow**

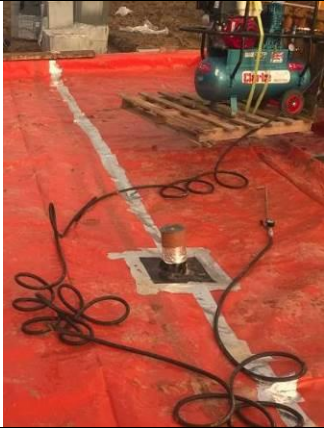
| Photograph | Description |
|---|---|
| | <p><i>IDG's typical Air lance kit set up for integrity testing of the seams/ joins and tophat seals, and compliant with ASTM D4437.</i></p> |

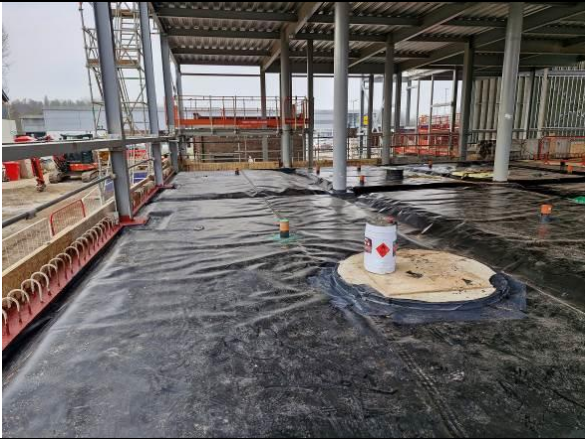
| Photograph | Description |
|---|---|
| | <p><i>Photograph showing the radon protection measures installed for the Phase 2 floor slab area. GP Liquid barrier (red) applied to all stanchion bases and substructure concrete as per design. Juta GP-H 0.6mm membrane (black) bonded to GP Liquid barrier using Titan Tape and / or GR-SAM. Membrane joins heat welded using Twinny type welder.</i></p> |

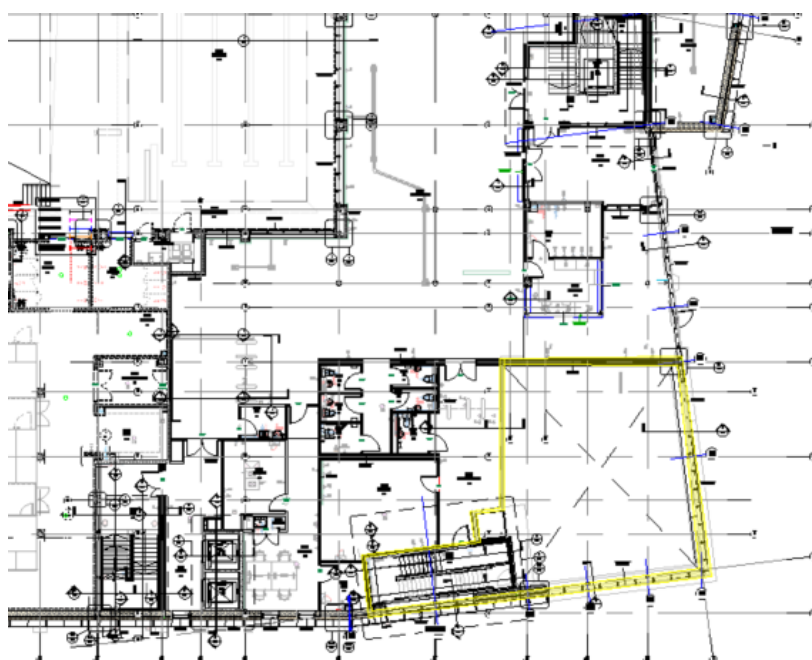
Basement 2 and associated Lower Ground Floor Substructure (Liquid Gas Barrier) – Area of Installation/ Inspection for given date highlighted Yellow

| No. | Item | Comments (see notes) |
|---|---|---|
| 3.6 | Laps, welds and joint seals | Joints generally completed to a good standard.<br>Visual and mechanical point stress testing identified two localised areas where Titan Tape had not adequately bonded to the liquid membrane on the beam – subsequently repaired by SEL on site.<br>Main Titan bond membrane sheet joints heat welded. |

Visual and mechanical point stress testing identified two localised areas where Titan Tape had not adequately bonded to the liquid membrane on the beam – subsequently repaired by SEL on site under supervision of IDG.

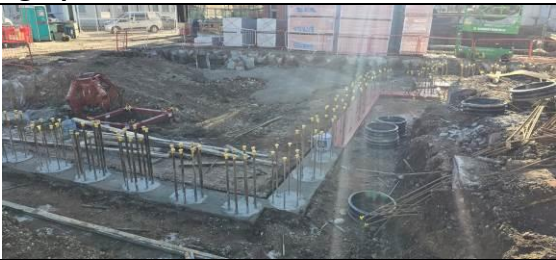
| No. | Item | Comments (see notes) |
|---|---|---|
| | | Photograph showing the GP Liquid barrier (red) being applied to all substructure concrete. |

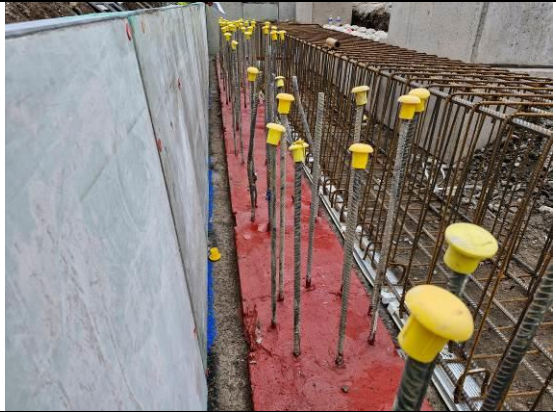
| No. | Item | Comments (see notes) |
|---|---|---|
| | | Photograph showing the GP Liquid barrier (red) applied to all substructure concrete of Basement 2 and Stairwell as per design ahead of shuttering and next phase of concrete pour. |

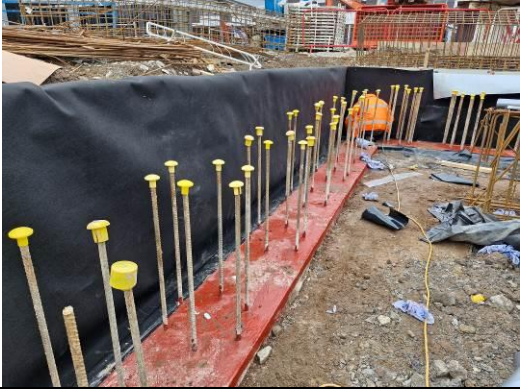
| | <p>Photograph showing the GP Liquid barrier (red) applied to all substructure concrete of Basement 2 and Stairwell as per design ahead of shuttering and next phase of concrete pour. Titan Bond Membrane joined to substructure to form vertical face ahead of next concrete pour.</p> |

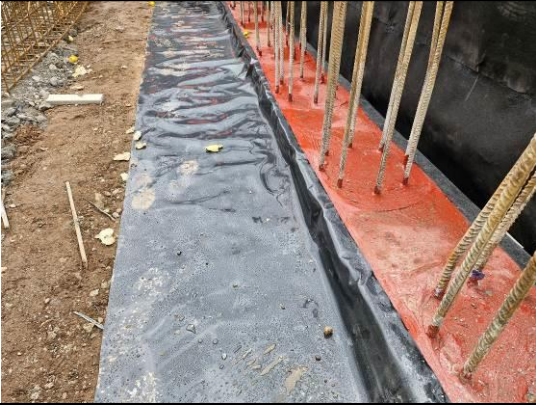
| | <p>Photograph showing the GP Liquid barrier (red) applied to all substructure concrete of Basement 2 and Stairwell as per design ahead of shuttering and next phase of concrete pour. TitanBond Membrane joined to substructure to form vertical face ahead of next concrete pour, and TitanFlex membrane joined to inner side of substructure prior to steel work and shuttering being placed.</p> |

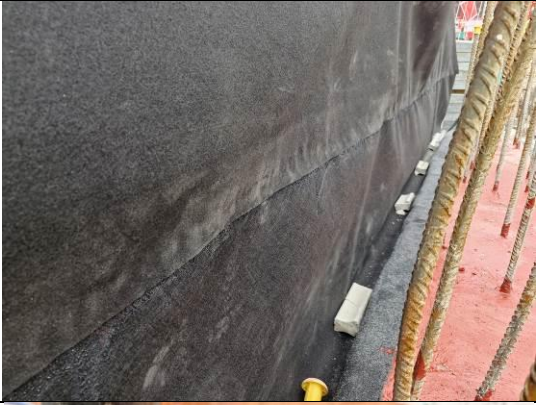
| | <p>Heat welded joints between TitanBond Membrane sheets on vertical face of external shuttering.</p> |

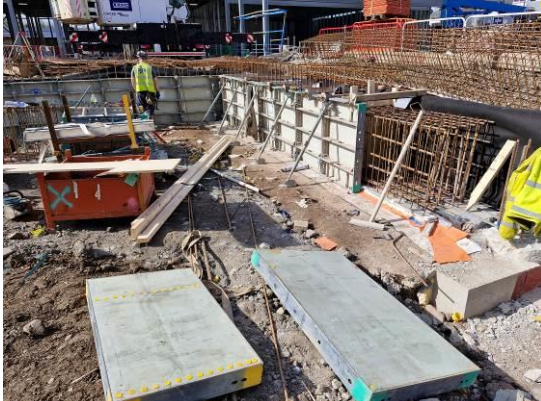
| | <p>Photograph showing steelwork and shuttering being assembled ahead of next concrete pour.</p> |

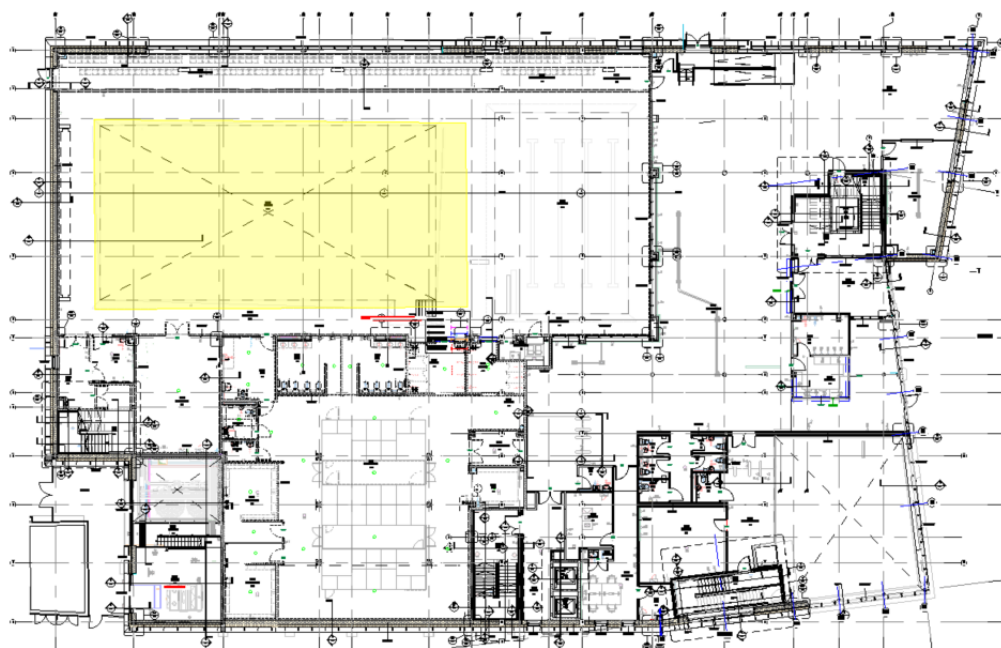
Main swimming pool base gas membrane install – Area of Installation/ Inspection for given date highlighted Yellow

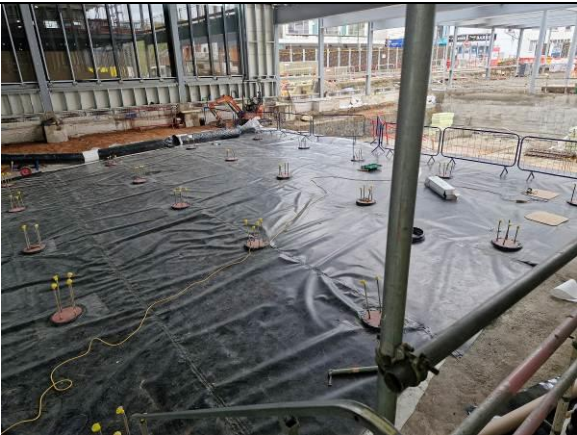
| No. | Item | Comments (see notes) |
|---|---|---|
| | | <i>Photograph showing the radon protection measures installed for the main swimming pool base area. GP Liquid barrier (red) applied to all pile heads as per design. Juta GP-H 0.6mm membrane (black) bonded to GP Liquid barrier using Titan Tape and / or GR-SAM. Membrane joins heat welded using Twinny type welder.</i> |

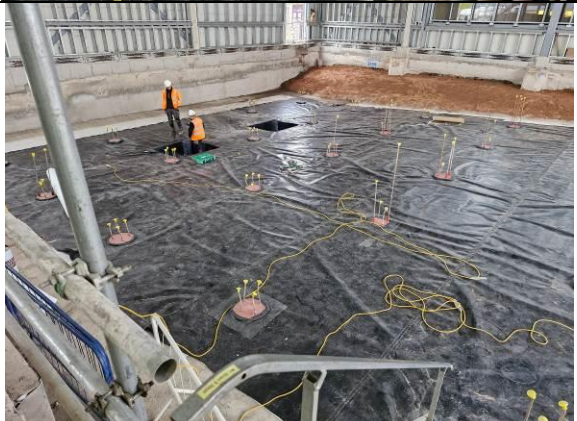
| No. | Item | Comments (see notes) |
|---|---|---|
| | | <i>Photograph showing the radon protection measures installed for the main swimming pool base area. GP Liquid barrier (red) applied to all pile heads as per design. Juta GP-H 0.6mm membrane (black) bonded to GP Liquid barrier using Titan Tape and / or GR-SAM. Membrane joins heat welded using Twinny type welder.</i> |

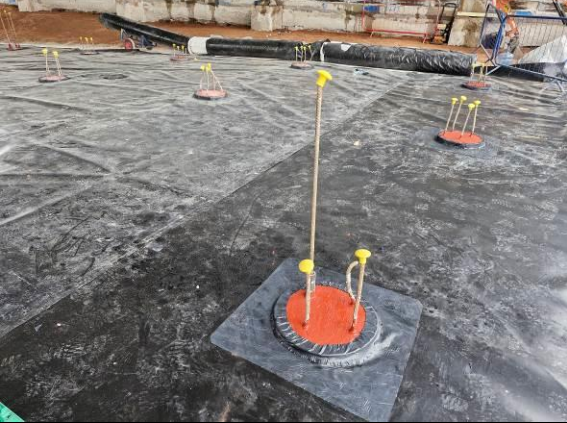
| | <p>Photograph showing the radon protection measures installed for the main swimming pool base area. GP Liquid barrier (red) applied to all pile heads as per design. Juta GP-H 0.6mm membrane (black) bonded to GP Liquid barrier using Titan Tape and / or GR-SAM. Membrane joints heat welded using Twinny type welder.</p> |

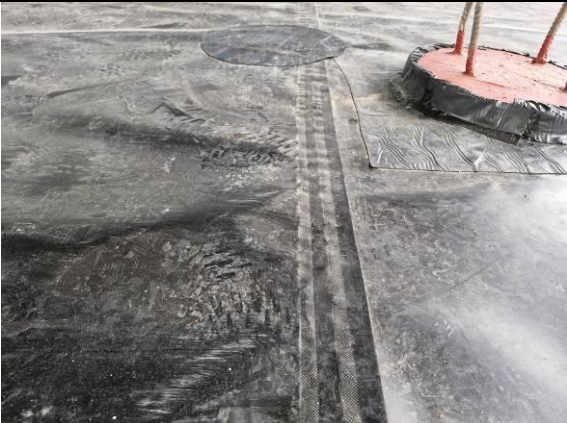
| | <p>Photograph showing the radon protection measures installed for the main swimming pool base area. Juta GP-H 0.6mm membrane sheet joints heat welded using a Twinny type welder.</p> |

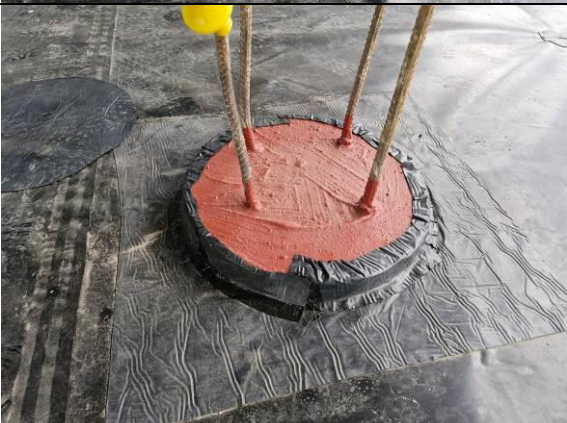
| | <p>GP Liquid barrier (red) applied to all pile heads as per design. Juta GP-H 0.6mm membrane (black) bonded to GP Liquid barrier using GR-SAM.</p> |

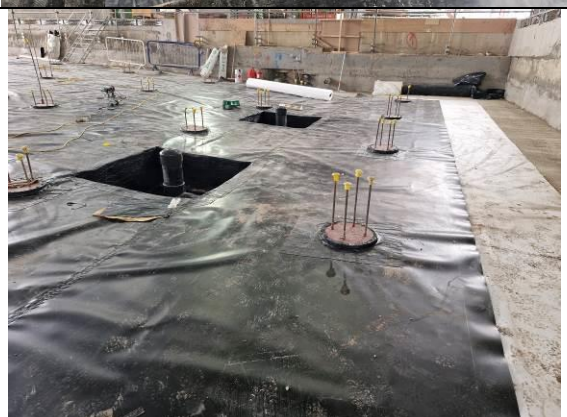
| | <p>Photograph showing the radon protection measures installed for the main swimming pool base area. GP Liquid barrier (red) applied to all pile heads as per design. Juta GP-H 0.6mm membrane (black) bonded to GP Liquid barrier using Titan Tape and / or GR-SAM. Membrane joints heat welded using Twinny type welder. Water inlet and outlet pipe sump pits visible at western end of pool.</p> |

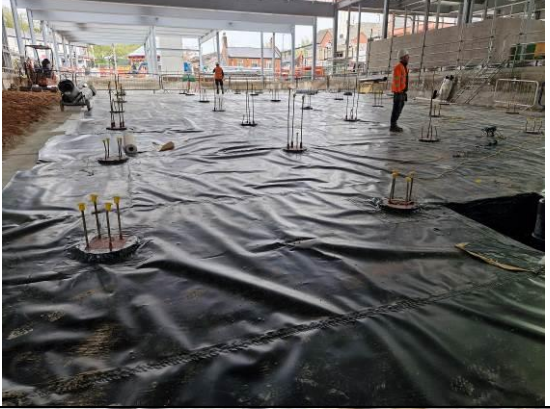
| | <p>Photograph showing the radon protection measures installed for the main swimming pool base area. GP Liquid barrier (red) applied to all pile heads as per design. Juta GP-H 0.6mm membrane (black) bonded to GP Liquid barrier using Titan Tape and / or GR-SAM. Membrane joins heat welded using Twinny type welder. Water inlet and outlet pipe sump pits visible at western end of pool.</p> |

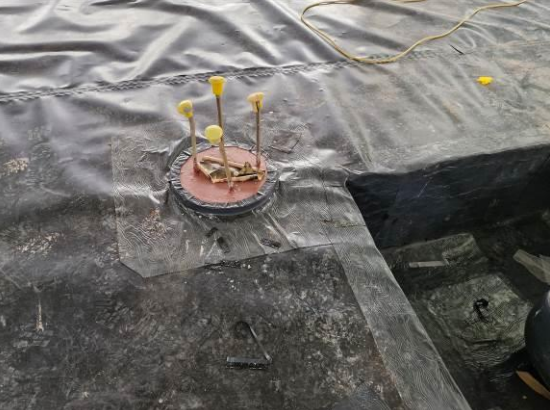
| | <p>Photograph showing the radon protection measures installed for the main swimming pool base area. GP Liquid barrier (red) applied to all pile heads as per design. Juta GP-H 0.6mm membrane (black) bonded to GP Liquid barrier using Titan Tape and / or GR-SAM. Membrane joins heat welded using Twinny type welder. Detailing around Water inlet and outlet pipe sump pits at western end of pool completed with GR-SAM.</p> |

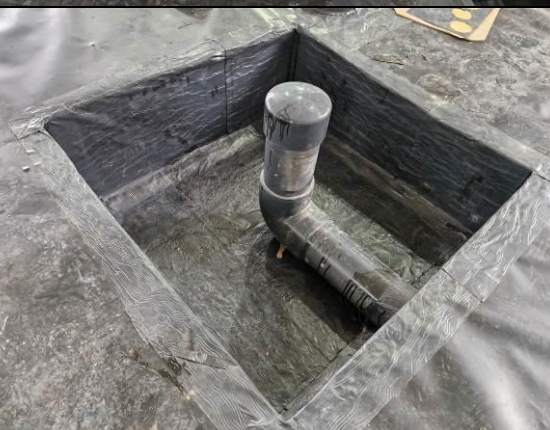
| | <p>Photograph showing Detailing around Water inlet and outlet pipe sump pits at western end of pool completed with GR-SAM.</p> |

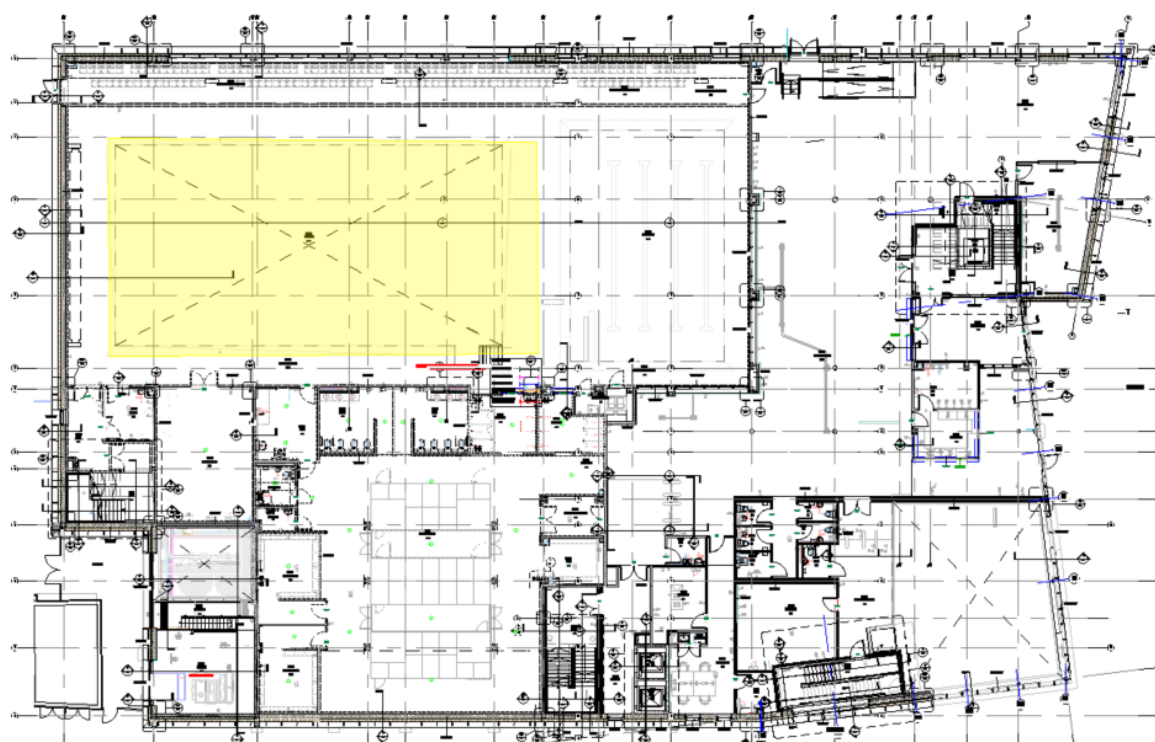
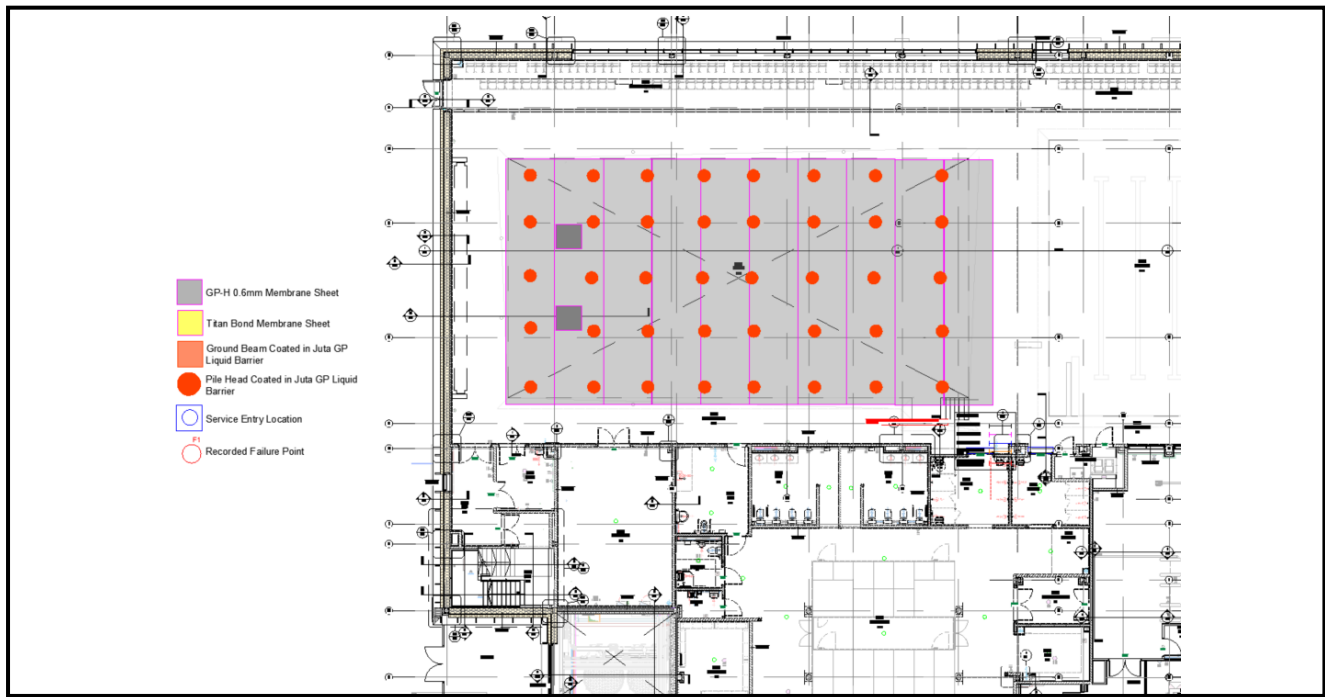
**Main swimming pool base gas membrane install – Area of Installation/ Inspection for given date highlighted Yellow**

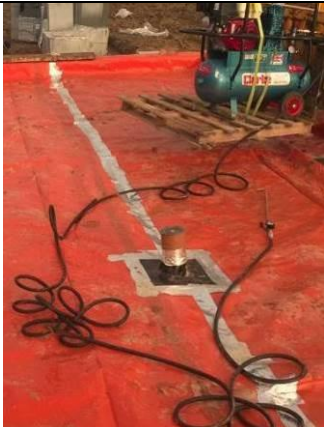
| 4 - Photographs | |
|---|---|
| | IDG's typical Air lance kit set up for integrity testing of the seams/ joints and tophat seals, and compliant with ASTM D4437. |

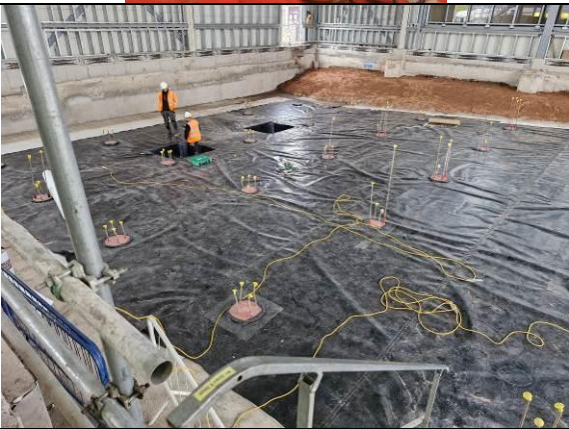
| 4 - Photographs | |
|---|---|
| | Photograph showing the radon protection measures installed for the main swimming pool base area. GP Liquid barrier (red) applied to all pile heads as per design. Juta GP-H 0.6mm membrane (black) bonded to GP Liquid barrier using Titan Tape and / or GR-SAM. Membrane joins heat welded using Twinny type welder. |

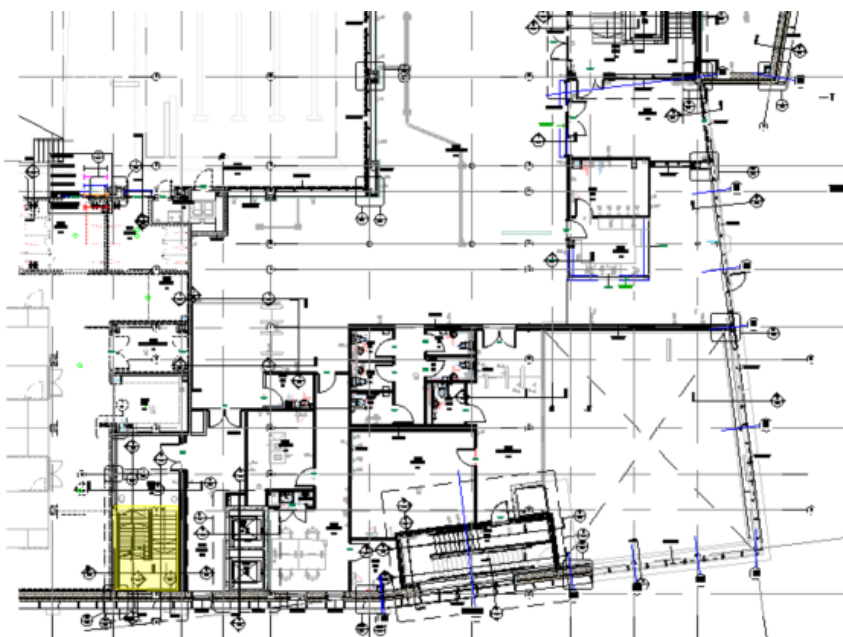
Ground Floor Lift Pit Radon Protection – Area of Installation/ Inspection for given date highlighted Yellow

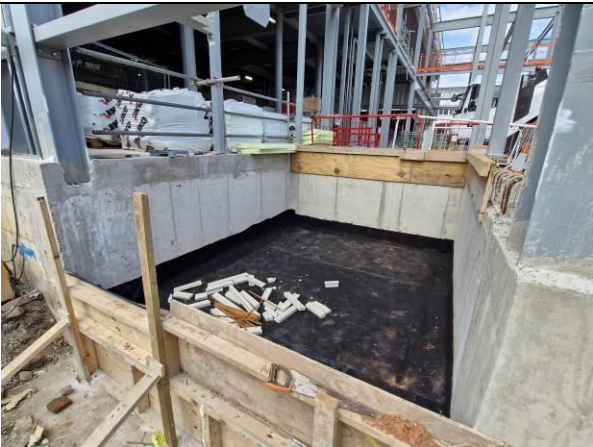
| | | <i>Photograph showing the radon protection measures installed for the emergency stairwell base. GP Liquid barrier (red) previously applied to all substructure concrete as per design. GP Titan Bond membrane (grey/black) bonded to GP Liquid barrier using Titan Tape and / or GR-SAM. Membrane lapping up shuttering ahead of next phase of concrete pour.</i> |

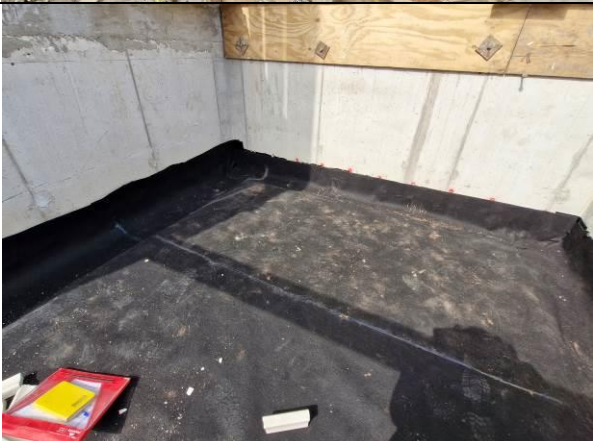
| | | <i>Photograph showing the radon protection measures installed for the emergency stairwell base. GP Liquid barrier (red) previously applied to all substructure concrete as per design. GP Titan Bond membrane (grey/black) bonded to GP Liquid barrier using Titan Tape and / or GR-SAM. Membrane lapping up shuttering ahead of next phase of concrete pour.</i> |

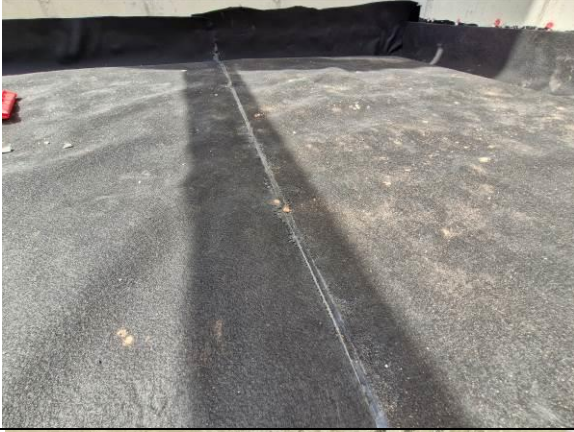
| | <p>Photograph showing the radon protection measures installed for the emergency stairwell base. GP Titan Bond membrane (grey/black) sheet joints heat welded. Membrane lapping up shuttering ahead of next phase of concrete pour.</p> |

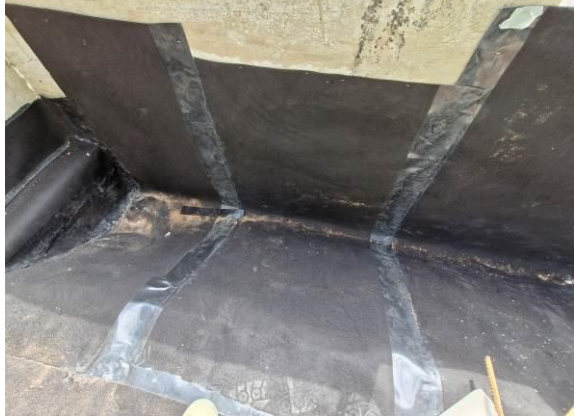
| | <p>Photograph showing the radon protection measures installed for the emergency stairwell base. GP Titan Bond membrane (grey/black) sheet joints heat welded. Membrane lapping up shuttering ahead of next phase of concrete pour.</p> |

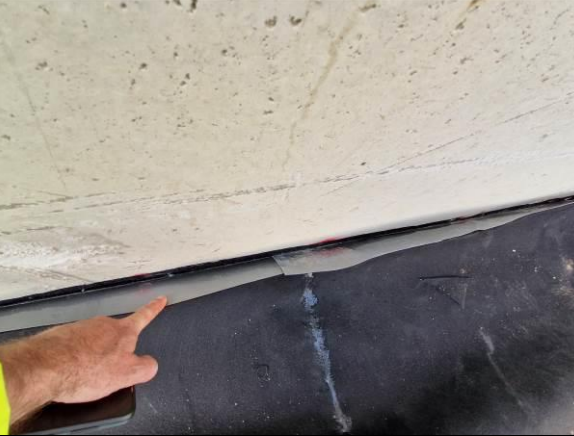
| | <p>Photograph showing the radon protection measures installed for the emergency stairwell base. GP Titan Bond membrane (grey/black) sheet joints heat welded. Membrane lapping up bonded to concrete and liquid membrane.</p> |

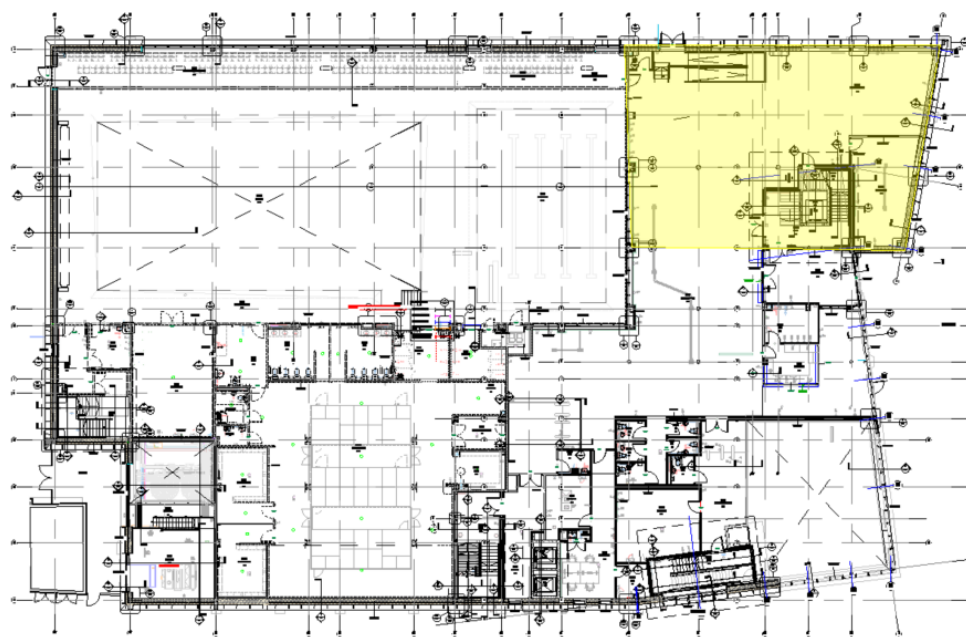
Phase 4 Floor slab area gas membrane install – Area of Installation/ Inspection for given date highlighted Yellow

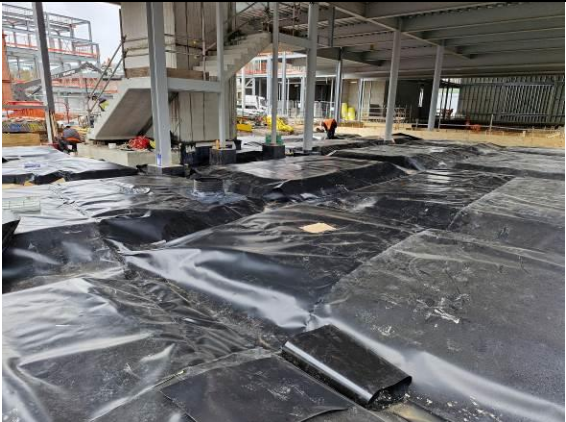
| No. | Item | Comments (see notes) |
|---|---|---|
| | | <i>Photograph showing the radon protection measures installed for the Phase 4 floor slab area. GP Liquid barrier (red) applied to all substructure concrete as per design. Juta GP-H 0.6mm membrane (black) bonded to GP Liquid barrier using Titan Tape and / or GR-SAM. Membrane joins heat welded using Twinny type welder.</i> |

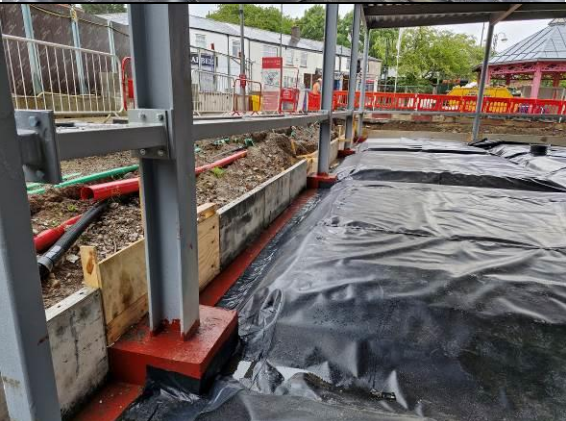
| No. | Item | Comments (see notes) |
|---|---|---|
| | | <i>Photograph showing the radon protection measures installed for the Phase 4 floor slab area. GP Liquid barrier (red) applied to all substructure concrete as per design. Juta GP-H 0.6mm membrane (black) bonded to GP Liquid barrier using Titan Tape and / or GR-SAM. Membrane joins heat welded using Twinny type welder.</i> |
