# GAS PROTECTION MEASURES VERIFICATION VISUAL INSPECTION RECORD

| Site Name: | Radcliffe Civic Hub | Gas Characteristic Situation: | Basic Radon Only |
| Gas Protection Components inspected: | Radon membrane installation and sealing to liquid membrane on concrete substructure using GR-SAM. | | |

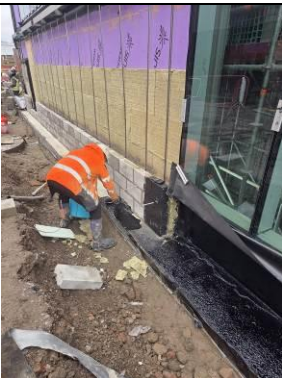
| No. | Item | Comments (see notes) |
|---|---|---|
| | | <i>Photograph showing the radon protection measures installed on southern elevation low-level external face, completing continuous seal between GR-SAM and liquid membrane on concrete substructure. All penetrations fully sealed around ties to external stone façade.</i> |

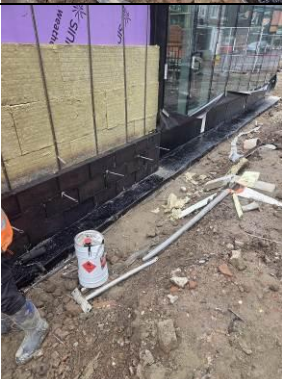
| No. | Item | Comments (see notes) |
|---|---|---|
| | | <i>Photograph showing the radon protection measures installed on southern elevation low-level external face, completing continuous seal between GR-SAM and liquid membrane on concrete substructure. All penetrations fully sealed around ties to external stone façade.</i> |

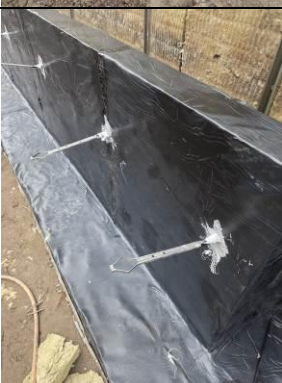
| No. | Item | Comments (see notes) |
|---|---|---|
| | | <i>Photograph showing the radon protection measures installed on southern elevation low-level external face, completing continuous seal between GR-SAM and liquid membrane on concrete substructure. All penetrations fully sealed around ties to external stone façade.</i> |

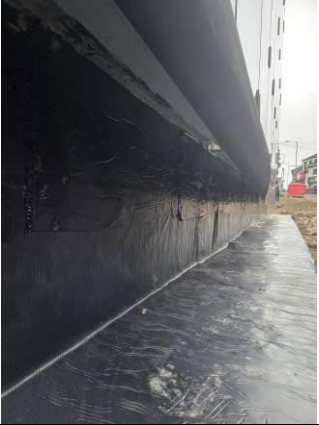
| | <p>Photograph showing the radon protection measures installed on southern elevation low-level external face, completing continuous seal between GR-SAM and liquid membrane on concrete substructure. All penetrations fully sealed around ties to external stone façade.</p> |

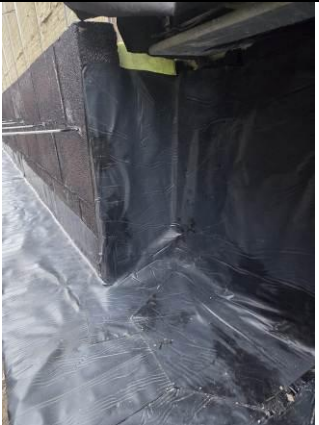
| | <p>Photograph showing the radon protection measures installed on southern elevation low-level external face, completing continuous seal between GR-SAM and liquid membrane on concrete substructure. All penetrations fully sealed around ties to external stone façade.</p> |

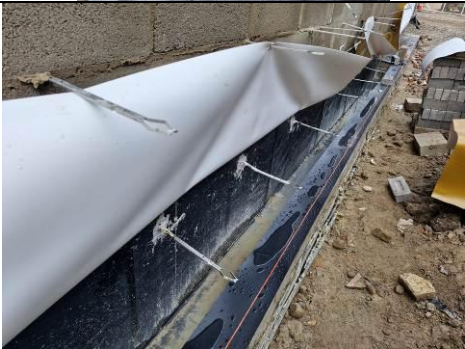
| | <p>Photograph showing the radon protection measures installed on southern elevation low-level external face, completing continuous seal between GR-SAM and liquid membrane on concrete substructure. All penetrations fully sealed around ties to external stone façade.</p> |

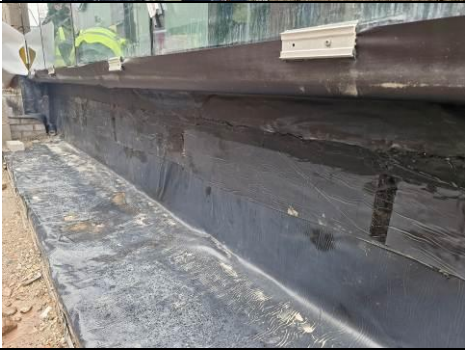
| | <p>Photograph showing the radon protection measures installed on southern elevation low-level external face, completing continuous seal between GR-SAM and liquid membrane on concrete substructure. All penetrations fully sealed around ties to external stone façade.</p> |

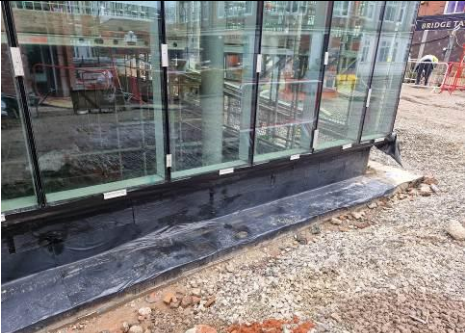
| | <p>Photograph showing the radon protection measures installed on southern elevation low-level external face, completing continuous seal between GR-SAM and liquid membrane on concrete substructure. All penetrations fully sealed around ties to external stone façade.</p> |

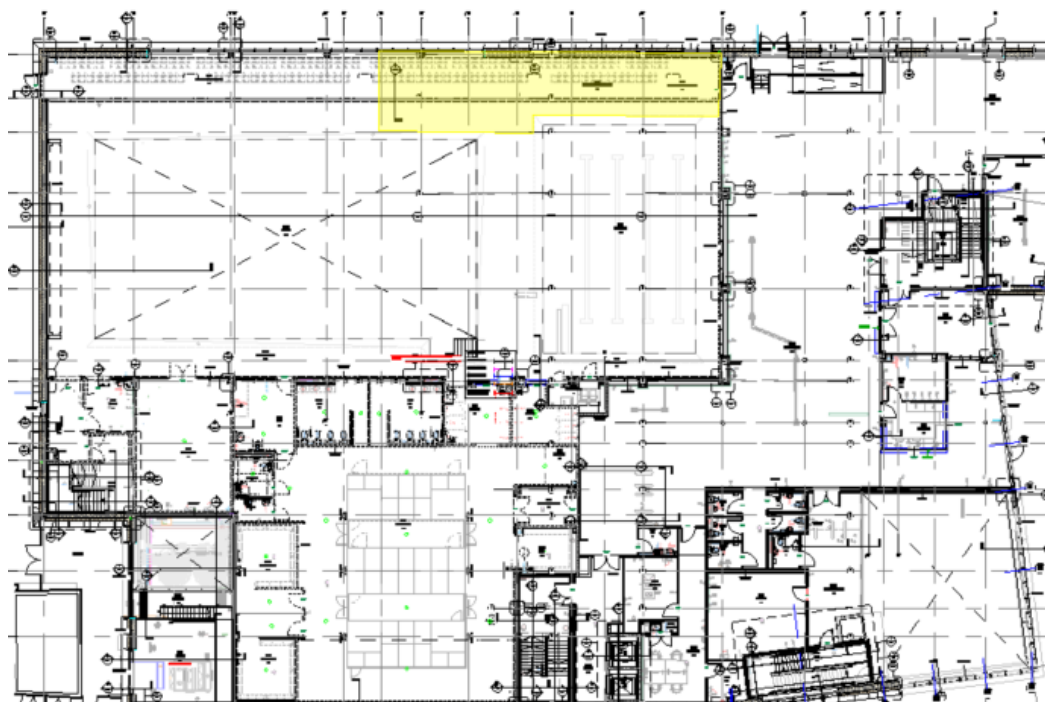
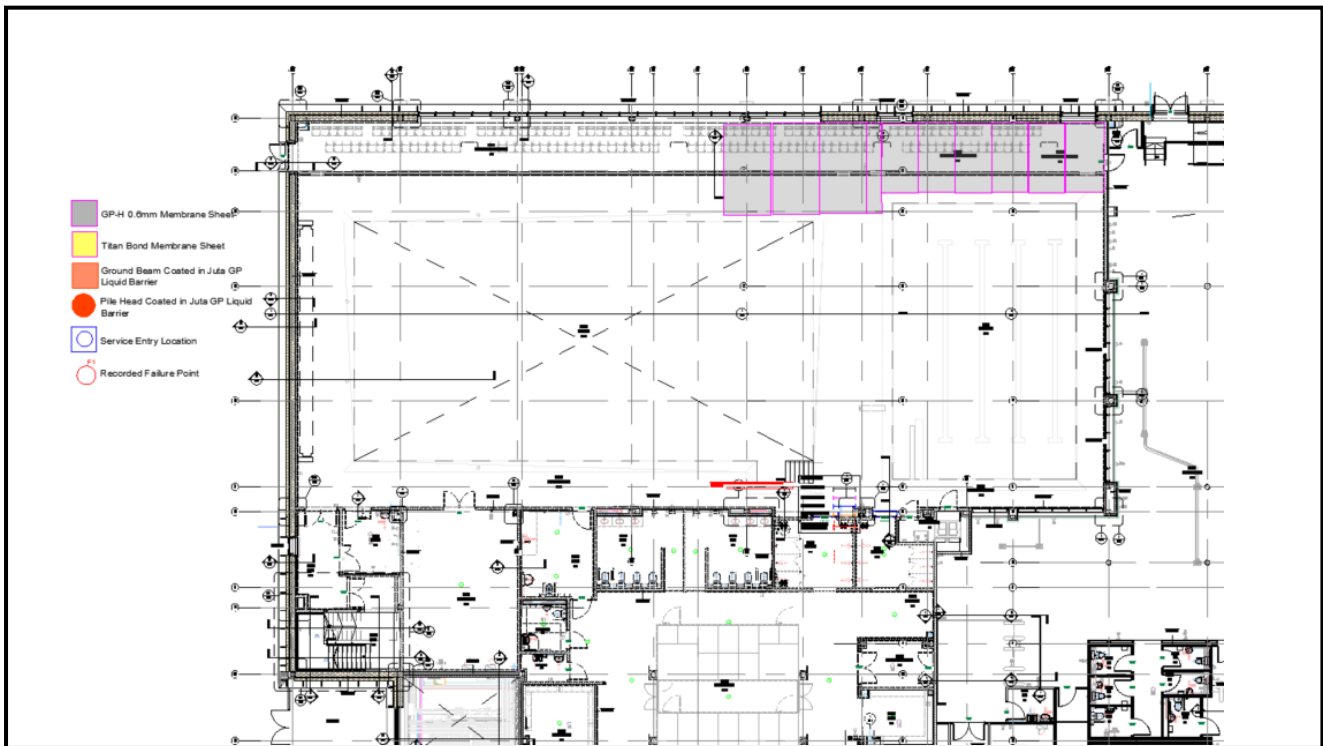
**Main swimming pool and Learner Pool northern surround gas membrane install – Area of Installation/ Inspection for given date highlighted Yellow**

| No. | Item | Comments (see notes) |
|---|---|---|
| Membrane to Liquid Barrier Joints | S | All membrane to liquid barrier joints proven to be satisfactory by IDG via ASTM D4437 air lance test. No failures recorded |
| Membrane to membrane Joints | S | All membrane to membrane seams/join length proven to be satisfactory by IDG via ASTM D4437 air lance test. No failures recorded. |

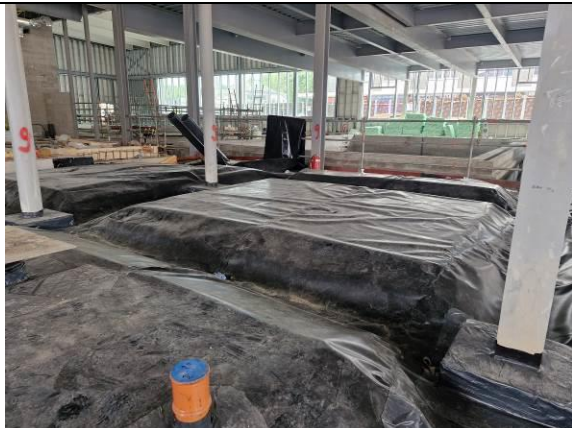
| No. | Item | Comments (see notes) |
|---|---|---|
| | | <i>Photograph showing the radon protection measures installed for the Phase 3 &amp; 4 floor slab area. GP Liquid barrier (red) applied to all substructure concrete as per design. Juta GP-H 0.6mm membrane (black) bonded to GP Liquid barrier using Titan Tape and / or GR-SAM. Membrane joints heat welded using Twinny type welder.</i> |

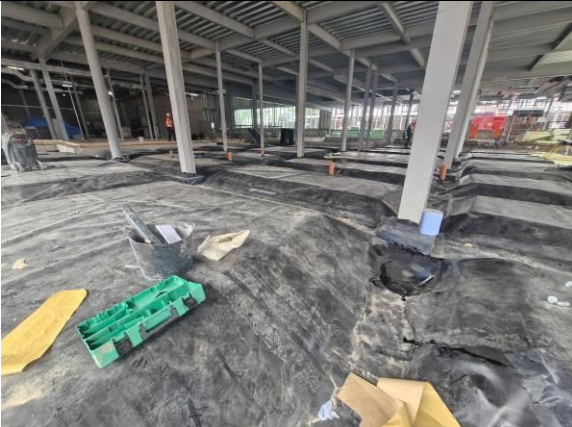
| No. | Item | Comments (see notes) |
|---|---|---|
| | | <i>Photograph showing the radon protection measures installed for the Phase 3 &amp; 4 floor slab area. GP Liquid barrier (red) applied to all substructure concrete as per design. Juta GP-H 0.6mm membrane (black) bonded to GP Liquid barrier using Titan Tape and / or GR-SAM. Membrane joints heat welded using Twinny type welder.</i> |

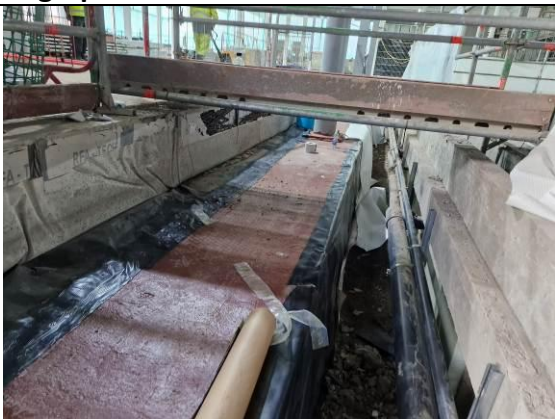
| No. | Item | Comments (see notes) |
|---|---|---|
| | | Photograph showing the radon protection measures installed for the learner pool eastern and southern surround area vertical faces being tied into main floor slab. GP Liquid barrier (red) applied to all substructure concrete as per design. Juta GP-H 0.6mm membrane (black) bonded to GP Liquid barrier using GR-SAM. Membrane joins heat welded. |

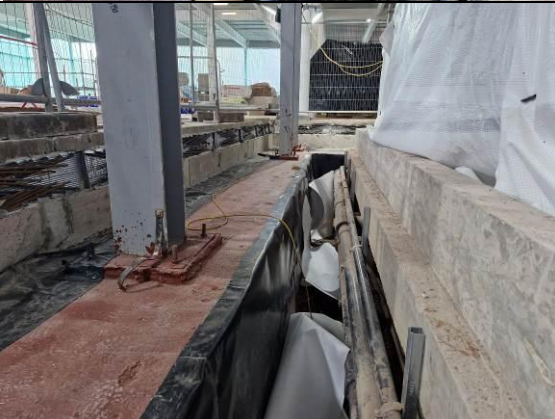
| No. | Item | Comments (see notes) |
|---|---|---|
| | | Photograph showing the radon protection measures installed for the learner pool eastern and southern surround area vertical faces being tied into main floor slab. GP Liquid barrier (red) applied to all substructure concrete as per design. Juta GP-H 0.6mm membrane (black) bonded to GP Liquid barrier using GR-SAM. Membrane joins heat welded. |
