## Appendix C

# GAS PROTECTION MEASURES VERIFICATION VISUAL INSPECTION RECORD

| Site Name: | Radcliffe Market Chambers Basement | Gas Characteristic Situation: | Basic Radon Only |
| Job Number: | 5238 | Type of development:<br>(Residential/ commercial/ other) | Commercial |

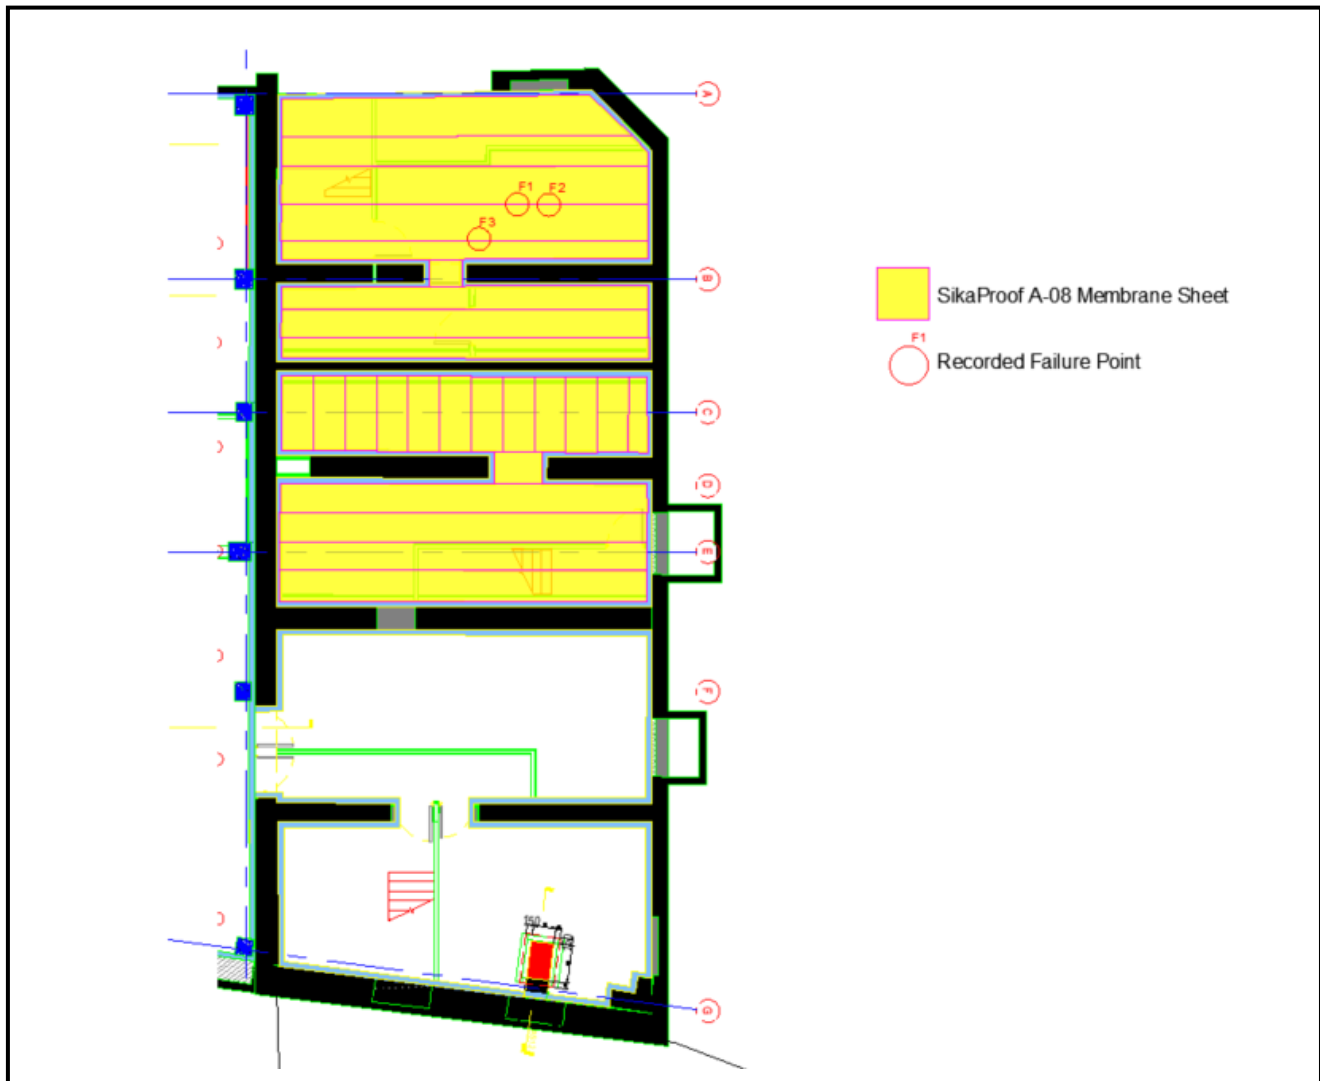
4 rooms within the 'Chambers' (Eastern section) of market hall basement Radon Protection – Area of Installation/ Inspection for given date(s) highlighted green.

| No. | Item | Comments (see notes) |
|---|---|---|
| Membrane to membrane Joints | S | All membrane to membrane seams/join length proven to be satisfactory by IDG via ASTM D4437 air lance test. Minor failures identified as detailed below. |
| 1 | F (S) | F <sub>1</sub> – Creases in the membrane formed an air channel (and therefore incomplete seal) across the self-adhesive membrane joint. Contractor was advised and these were repaired. Remedial works completed by contractor subsequently re-inspected / re-tested and determined to be satisfactory. |
| 2 | F (S) | F <sub>2</sub> – Creases in the membrane formed an air channel (and therefore incomplete seal) across the self-adhesive membrane joint. Contractor was advised and these were repaired. Remedial works completed by contractor subsequently re-inspected / re-tested and determined to be satisfactory. |
| 3 | F (S) | F <sub>3</sub> – Creases in the membrane formed an air channel (and therefore incomplete seal) across the self-adhesive membrane joint. Contractor was advised and these were repaired. Remedial works completed by contractor subsequently re-inspected / re-tested and determined to be satisfactory. |

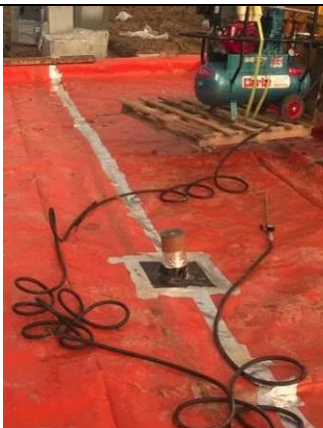
| No. | Item | Comments (see notes) |
|---|---|---|
| | | IDG's typical Air lance kit set up for integrity testing of the seams/ joints and tophat seals, and compliant with ASTM D4437. |

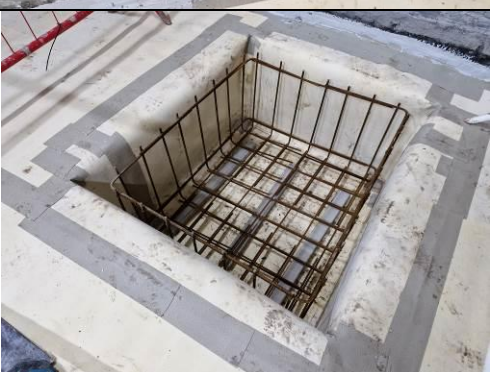
| | <p>Photograph showing SikaProof A-08 Membrane installed in Market Hall Basement chambers to form wall to wall radon barrier. Detailing completed with SikaProof Tape-150 with Sikadur Combiflex Adhesive used for joints between membrane and SikaDur 32 Epoxy Liquid Barrier on walls.</p> |

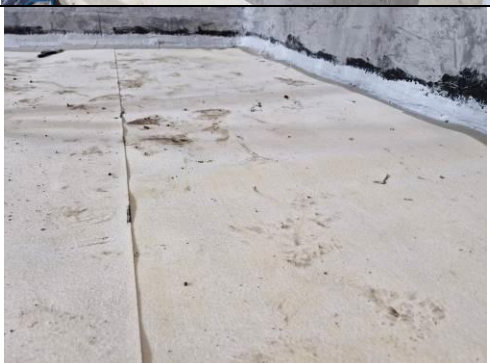
| | <p>Photograph showing SikaProof A-08 Membrane installed in Market Hall Basement chambers to form wall to wall radon barrier. Detailing completed with SikaProof Tape-150 with Sikadur Combiflex Adhesive used for joints between membrane and SikaDur 32 Epoxy Liquid Barrier on walls.</p> |

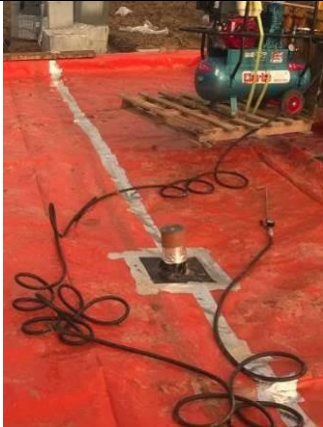
| No. | Item | Comments (see notes) |
|---|---|---|
| | IDG's typical Air lance kit set up for integrity testing of the seams/ joints and tophat seals, and compliant with ASTM D4437. | |

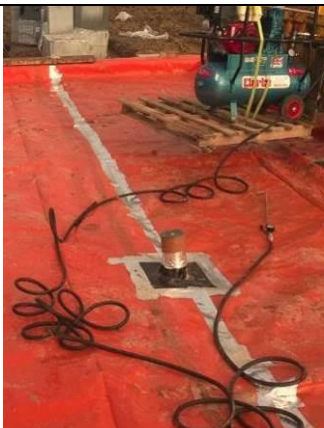
| No. | Item | Comments (see notes) |
|---|---|---|
| | IDG's typical Air lance kit set up for integrity testing of the seams/ joints and tophat seals, and compliant with ASTM D4437. | |
