# Lower Chesham Hall, Chesham Crescent, Bury

## Structural Inspection Report

Job No: 10220221  
Doc Ref: LCH-ZZ-XX-RP-S-0001  
Revision: P02  
Revision Date: 07 March 2022

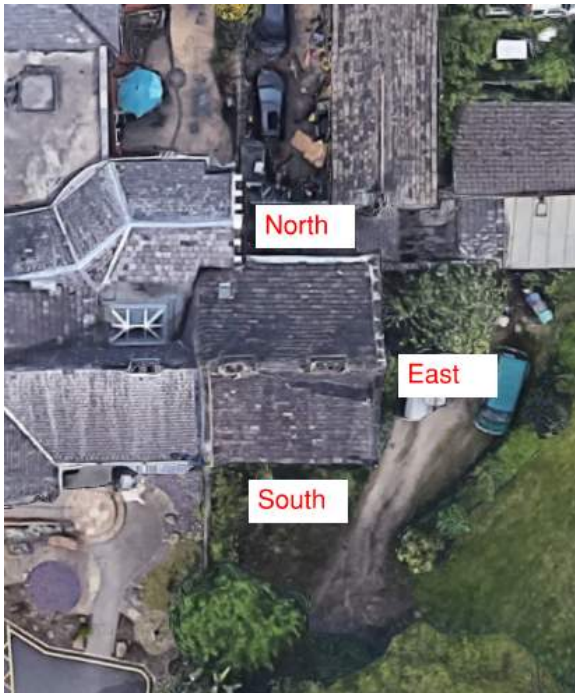
Figure 3 Elevation References

External Elevations of the property are referenced, North, East and South within this report, as identified below:
