# HIGHLIFE

### BURY FUSILIERS MUSEUM - VENTILATION TOWER INSPECTION REPORT

Inspection conducted on: 18-19 May 2023

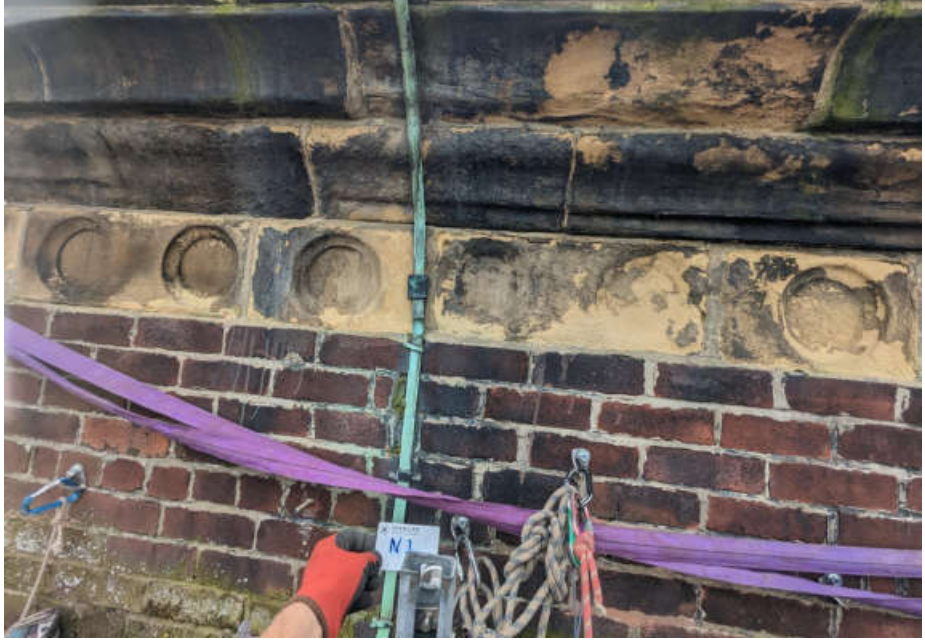
| No. | Location | Description | Proposed Solution |
|---|---|---|---|
| N1 | Brickwork above cornice level | Poor quality cementitious face pointing on 100% of brickwork above cornice level | Repoint using a suitable lime mortar if deemed high enough priority |

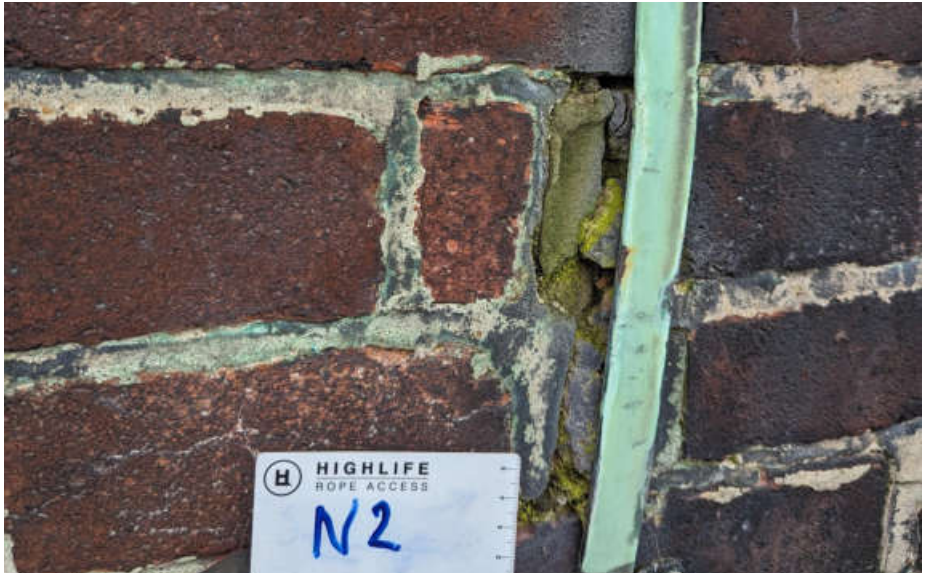
| No. | Location | Description | Proposed Solution |
|---|---|---|---|
| N2 | Brickwork above cornice level | Unpointed joints/ hole behind the lightning conductor, likely causing water ingress | Repoint using a suitable lime mortar |

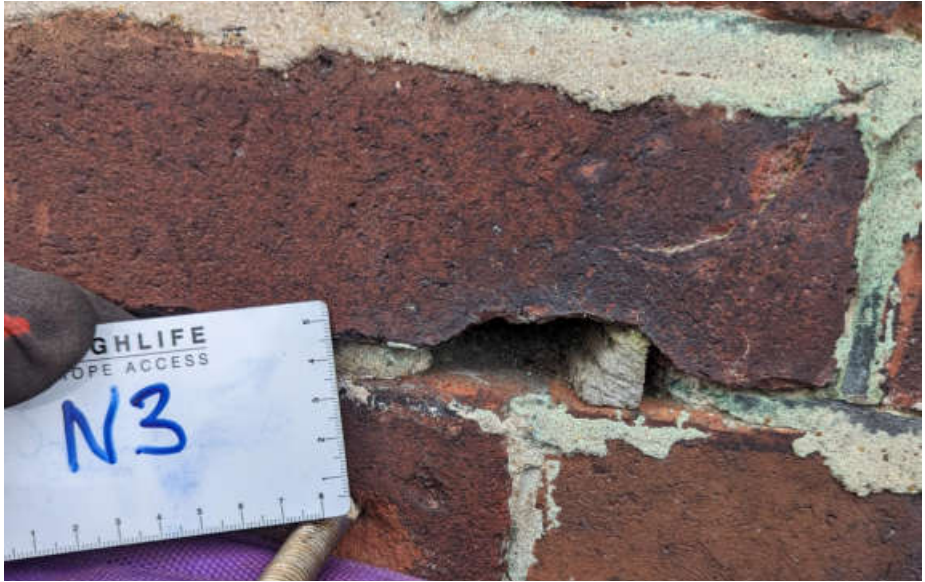
| N3 | Brickwork above cornice level | Large hole next to wooden wedge | Remove wedge and point using a suitable mortar |

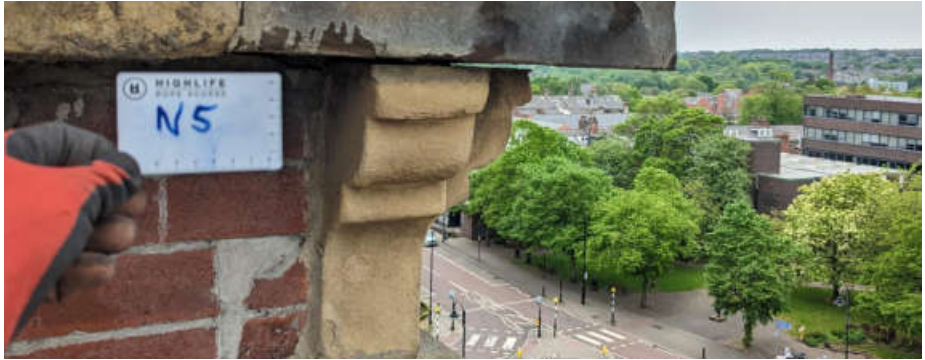
| N5 | Corbels supporting cornice | Open joints above corbels on either side of the NW arete | Repoint using a suitable lime mortar |

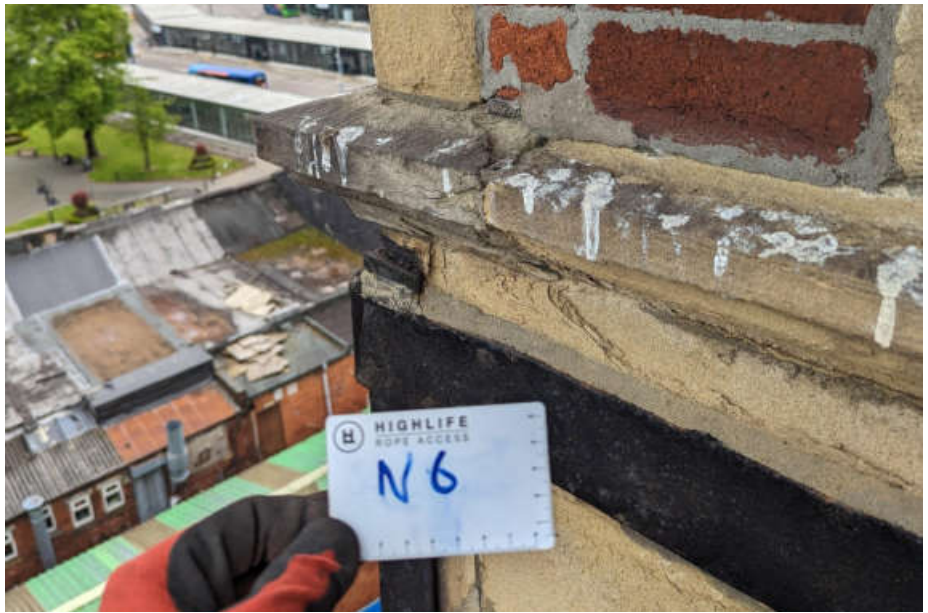
| N6 | String course below corbels | Open skyward facing perpend joints and deterioration of stone | Rake out joints and repoint with a suitable lime mortar. It may be preferable to perform minor mortar repairs to help the string course to shed water |

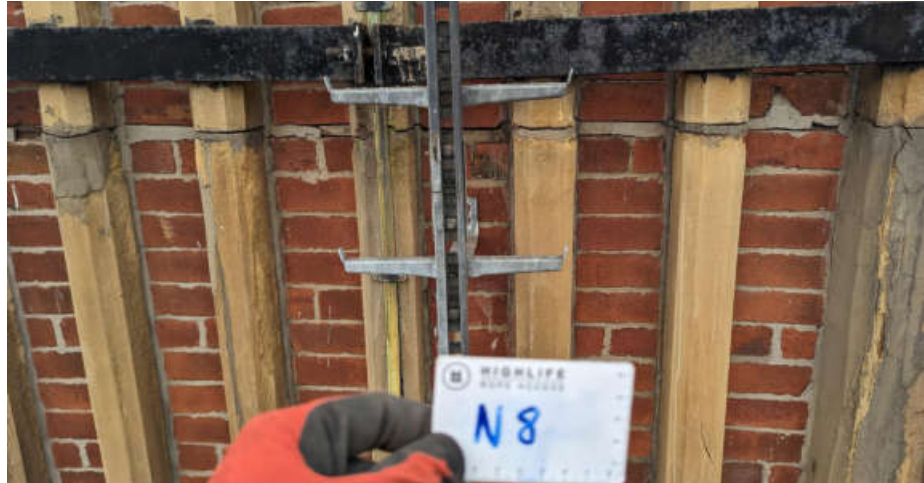
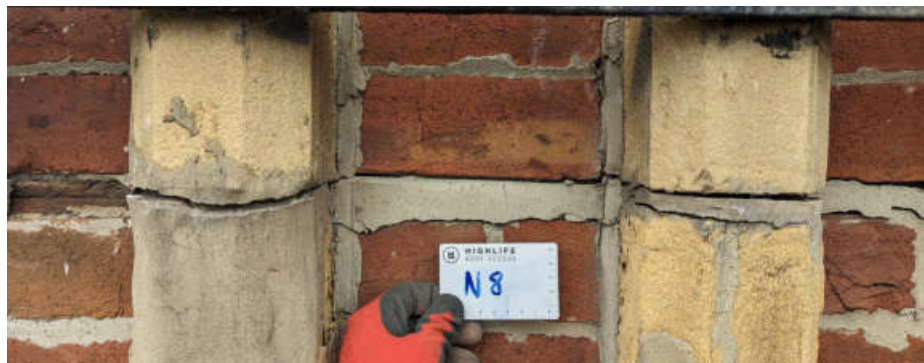
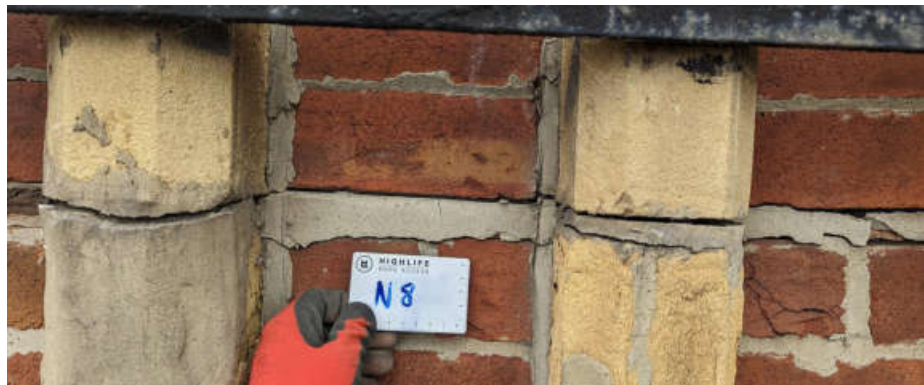
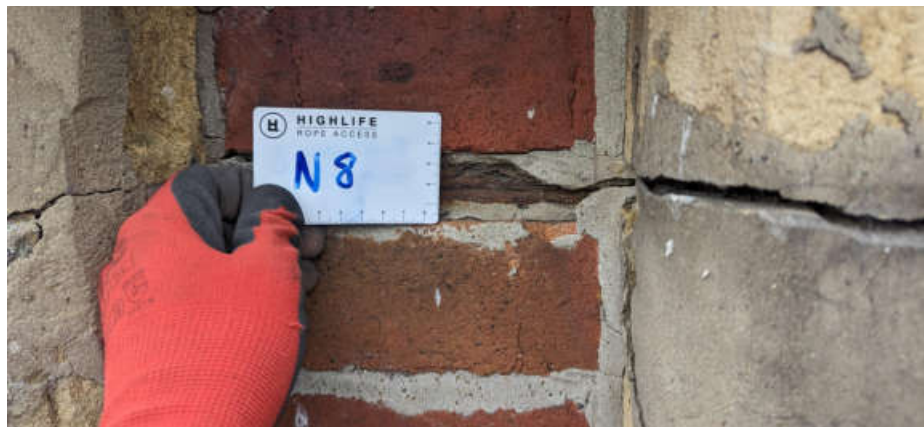
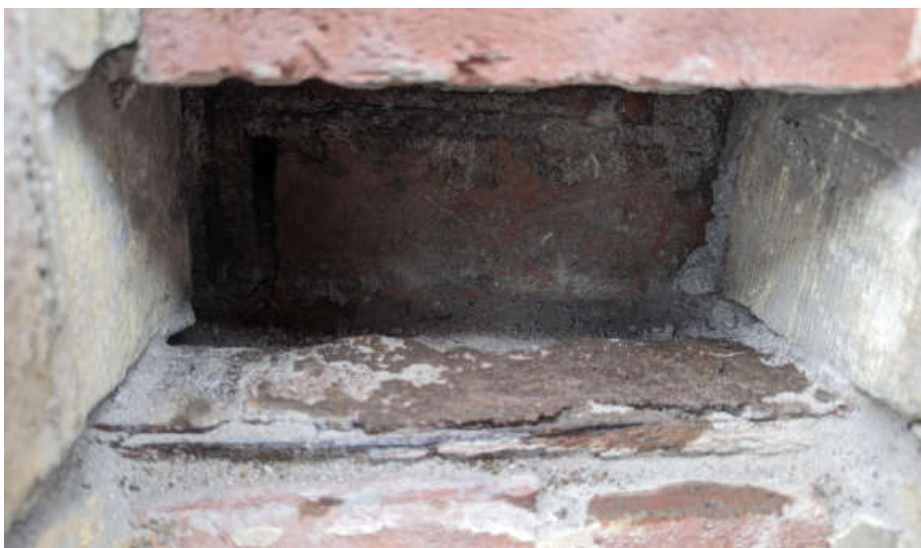
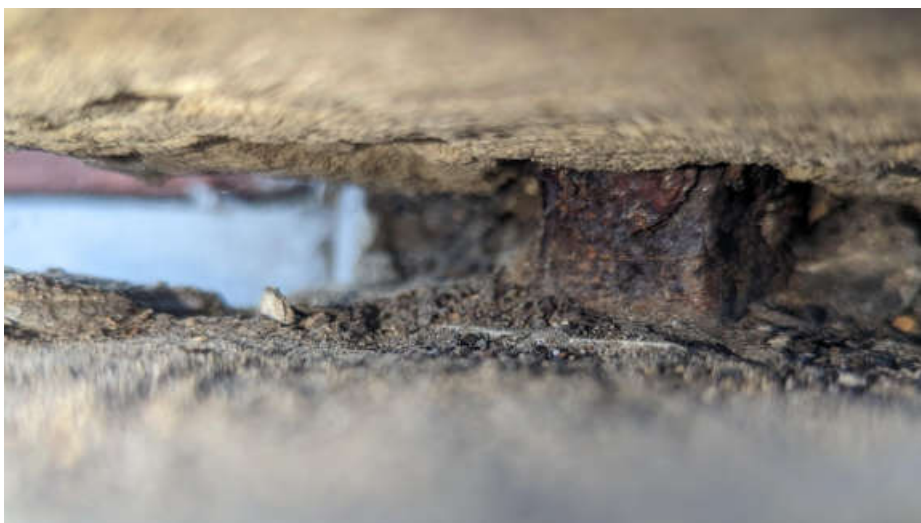
| N8 | Halfway down mullions of arched stone details | <p>Embedded iron bed reinforcement has corroded significantly, jacking up the structure above in the region of 10mm. Possibly the metal cage/ armature boxing in this area was installed to combat this, but the issue will persist until either the corrosion can be stopped or the metalwork removed. Following conversation with architect Rob Chambers an investigation was performed by removing a brick to assess the depth of the bed reinforcement - this was 60mm. A sample of the metal was taken so that it can be assessed</p> | <p>Given the heavily corroded nature of the metal work, our recommendation would be to remove and replace the bed reinforcement. Following our close investigation we feel that this would be fairly straightforward given that it is only one brick deep. This would likely require the temporary removal of a course of bricks. Given that the dowels in the mullions have caused some of the mullions to spall, it may be desirable to also remove these at the same time, which would make removing and replacing the bed reinforcement more straightforward. The solution for removing the dowels would likely involve cutting out a section spanning the joint with the dowel, and indenting some new stone with stainless dowels to secure</p> |

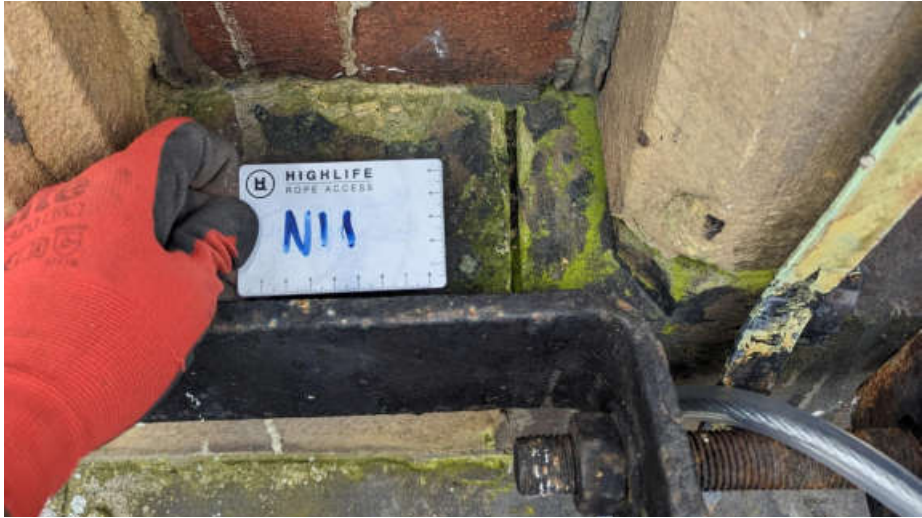
| N11 | Sill at base of mullions | Large open perpend joint | Clean joint and repoint with a suitable lime mortar |

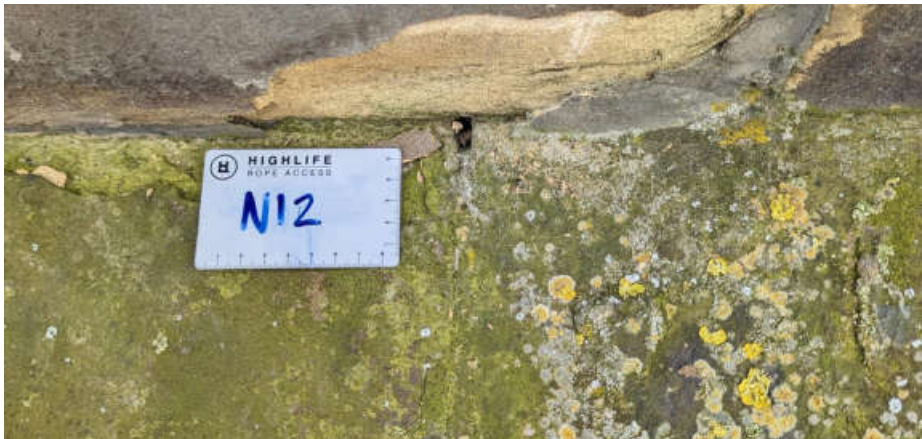
| N12 | Sill at base of mullions | Hole in perpend joints | Rake out joint and repoint with suitable lime mortar |

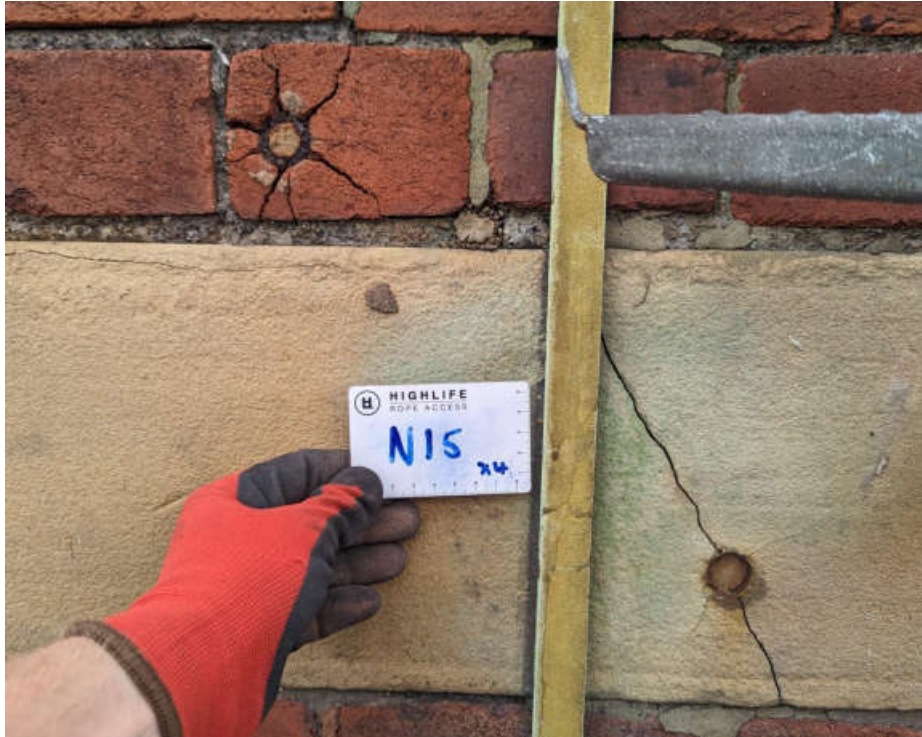
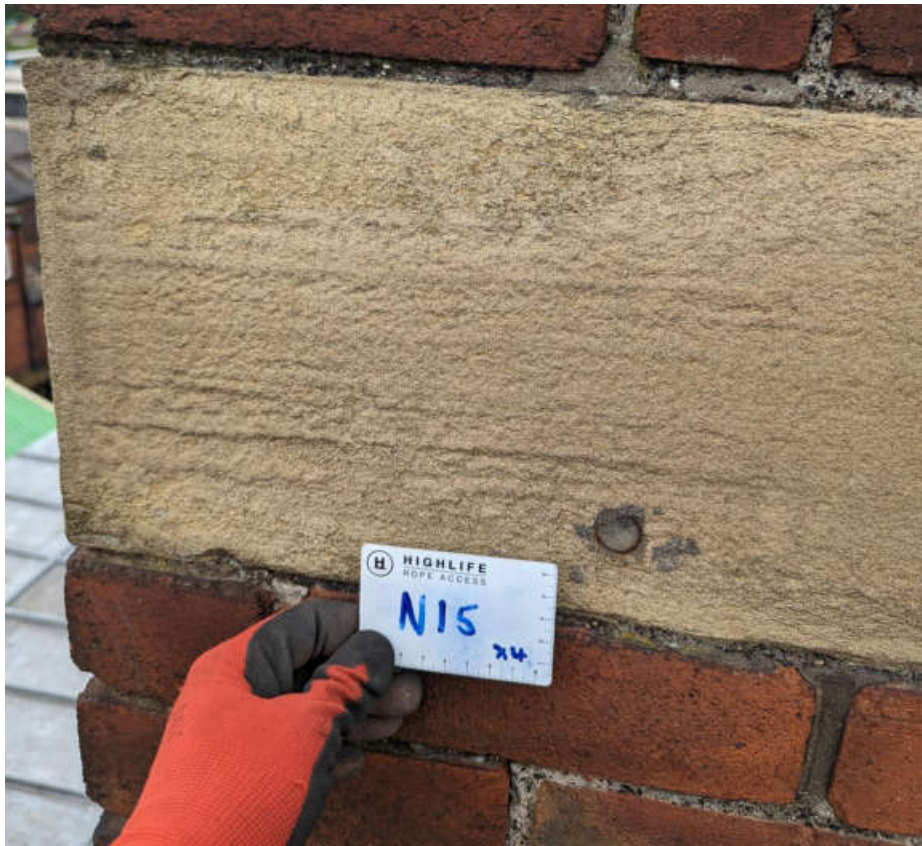
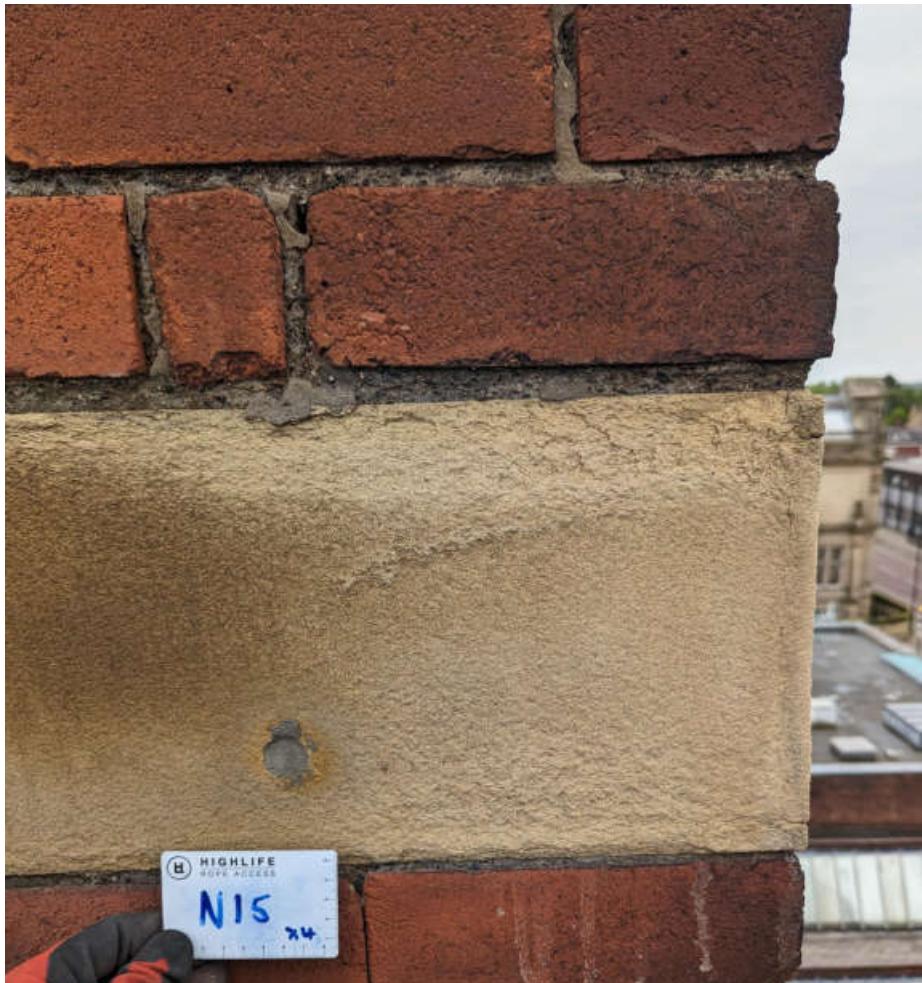
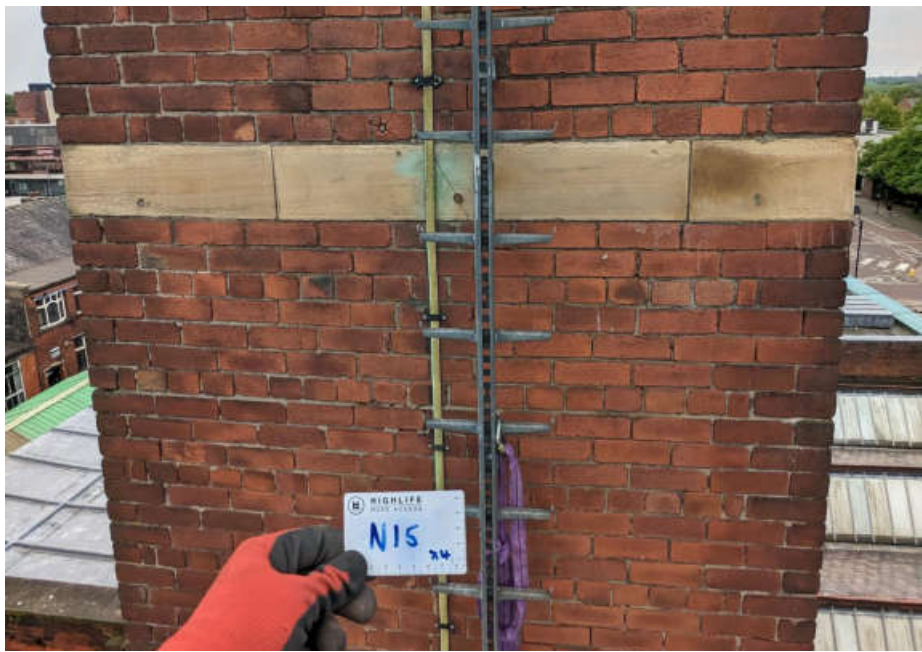
| N15 | Stone string course | 4no. Ferrous scaffold fixings. The central pair have caused the surrounding masonry to crack | Where a fixing has cracked a brick, replace and repoint the brick. The other 3 will need to be cored out and repointed, including the crack in the stone |

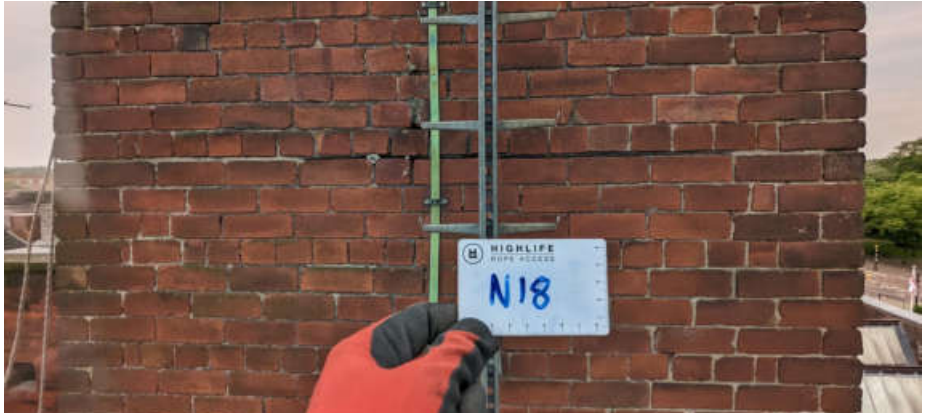
| N18 | Lower brick work | Crack along full length of bed appears to be bed lift, which may indicate further ferrous bed reinforcement, however we could not find evidence of any embedded metal | Given that the damage caused in this instance of bed lift is currently much less consequential than the bed lift further up the tower, it is unlikely that removal would be necessary, and a lower impact method such as cathodic protection might prove adequate if further investigation can prove that there is indeed embedded metalwork |

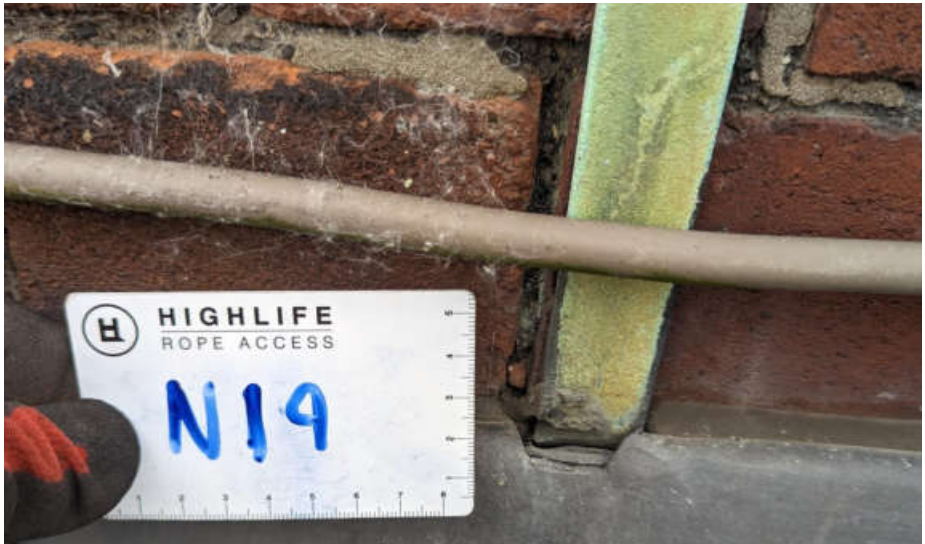
| N19 | Bottom of lightning conductor | Poorly sealed joint where the lightning conductor enters the roof below | Apply sealant to seal the joint. Point open perpend joint to the left with a suitable lime mortar |

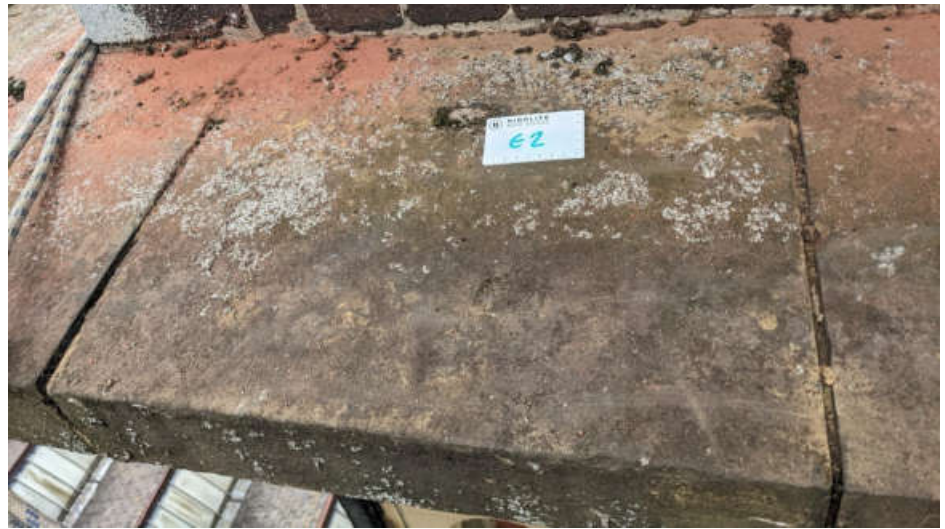
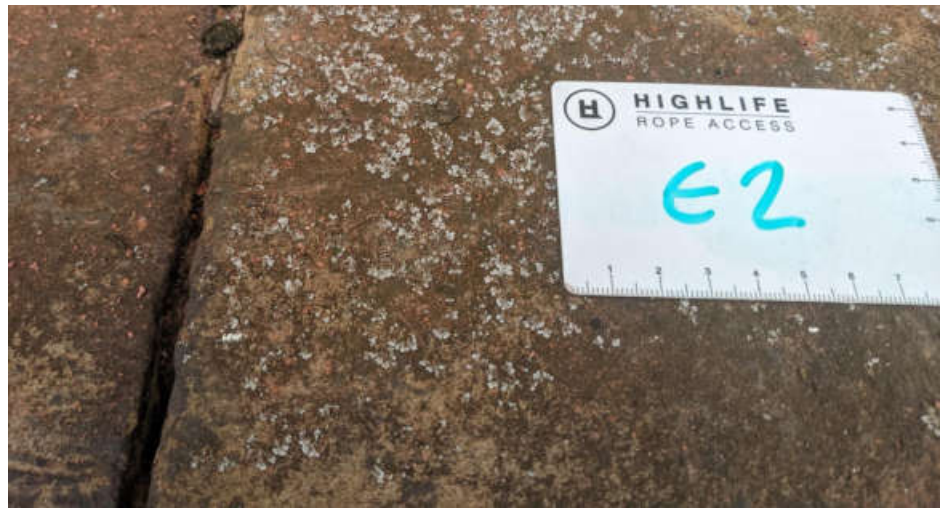
| No. | Location | Description | Proposed Solution |
|---|---|---|---|
| E2 | Cornice | Perpend joints are starting to deteriorate | Rake out joints and repoint using a suitable mortar. A lead covering on the cornice may be desirable as this could also be used to create a drip - currently there is no drip detail on the bottom edge of the cornice which may cause water to track down the masonry below, and may also be contributing to deterioration of the corbels (see E3). |

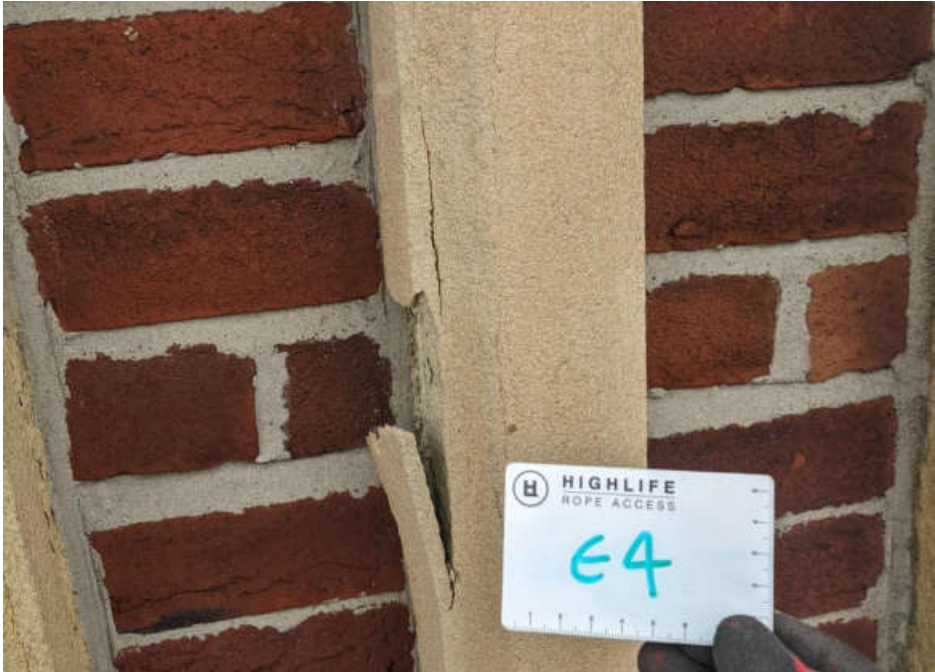
| E4 | Mullions of arched stone details | Some delamination of the stone, loose parts were removed. Historic mortar repairs suggest this is an ongoing issue | Further mortar repairs may be desirable. The old mortar repairs on this face are currently stable |

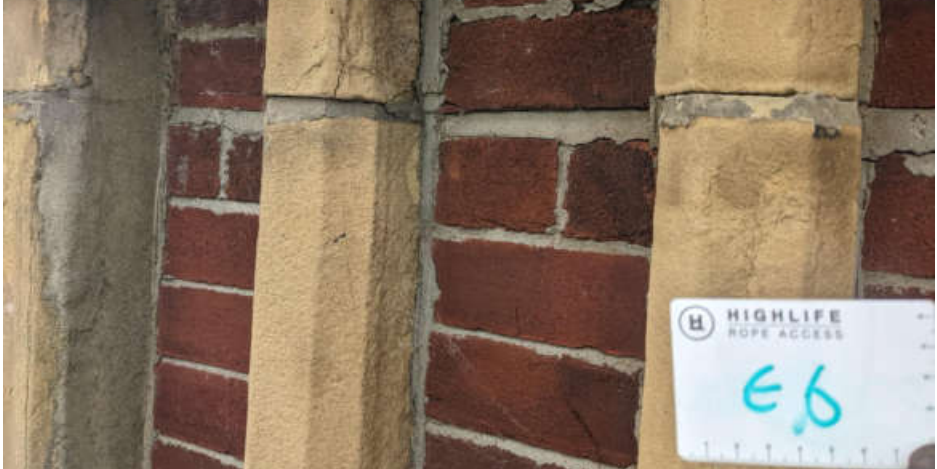
| E6 | Mid height on the mullions | Bed lift from ferrous bed reinforcement as per N8. Photos show that the bed lift decreases from north to south. One photo also shows one of the ferrous dowels in the mullions, which has spalled a large section off the mullion. | As per N8 |

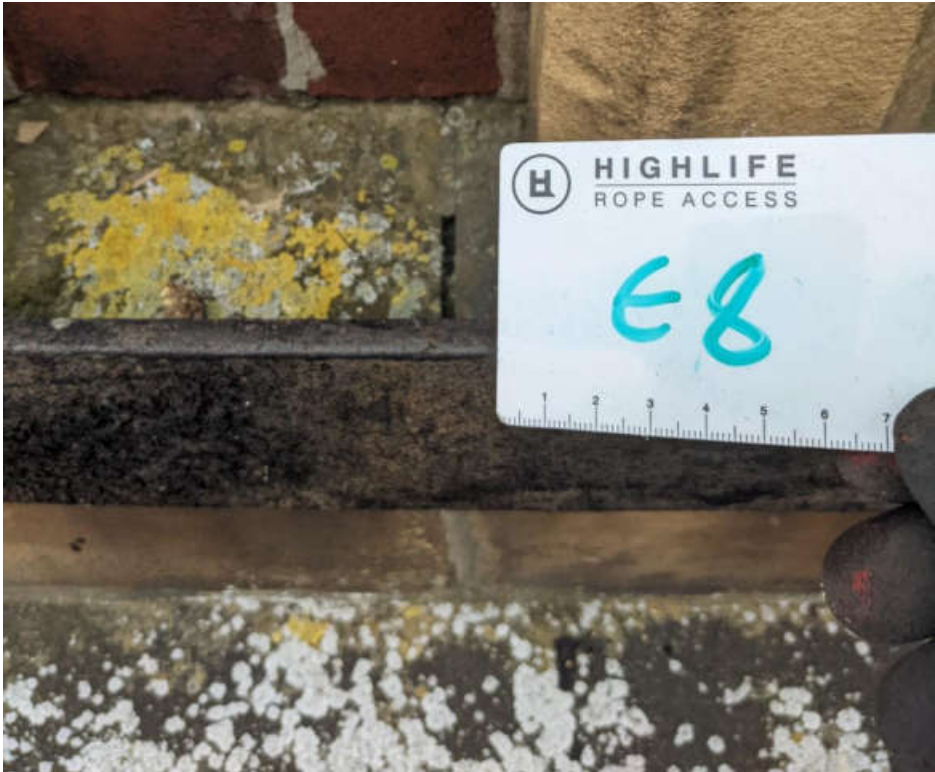
| E8 | Sill below mullions | Hole in a perpend joint on the sill is likely accepting water | Rake out joint and repoint with a suitable lime mortar |

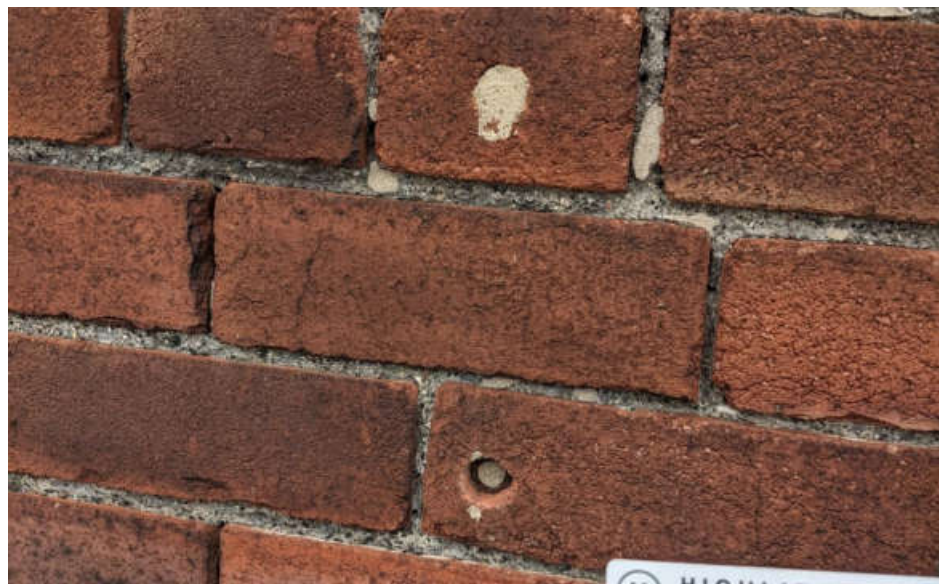
| E10 | Brickwork between mullions and stone string course | 6no. Ferrous scaffolding fixings. Some of these have corroded badly and cracked the surrounding bricks. On the NE arete this has caused significant displacement of several bricks which may compromise the structural integrity of the arete. | Where the bricks are not broken core out the fixings and point with a suitable lime mortar. On the NE arete it may be necessary to replace around 7no. Bricks which have been moved by the corroded ties, or to simply replace the broken bricks and use stainless bed reinforcement to tie the other bricks back into the structure |

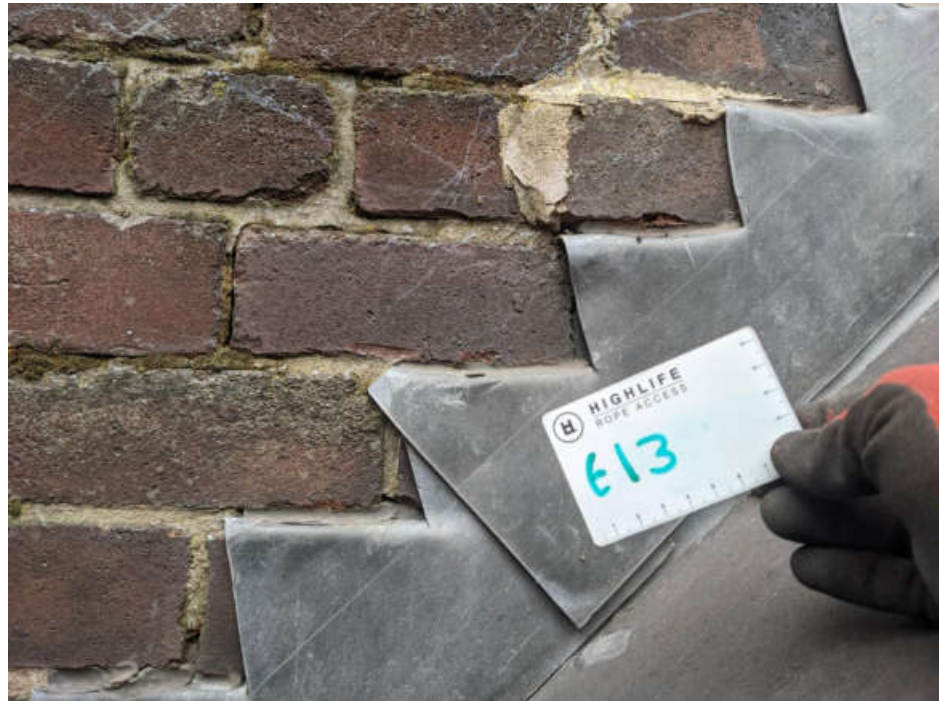
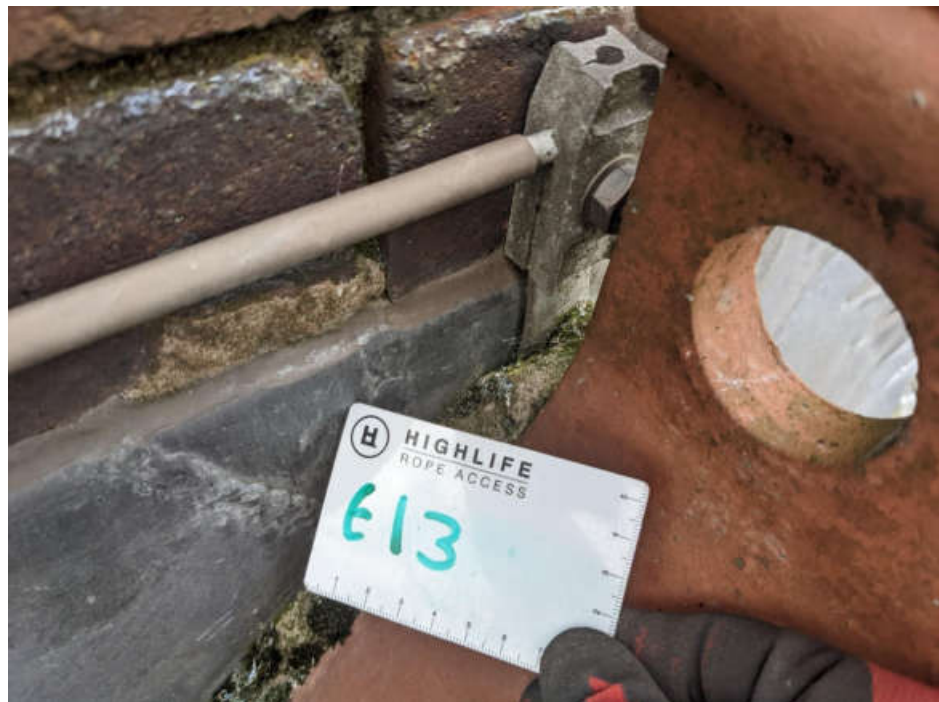
| E13 | Step flashings at roof | Some of the sealant is growing tired and the point where the lightning conductor meets the roof is likely a small leak | Renew tired sealant and seal lightning conductor joint, or repoint it all with a suitable lime mortar |

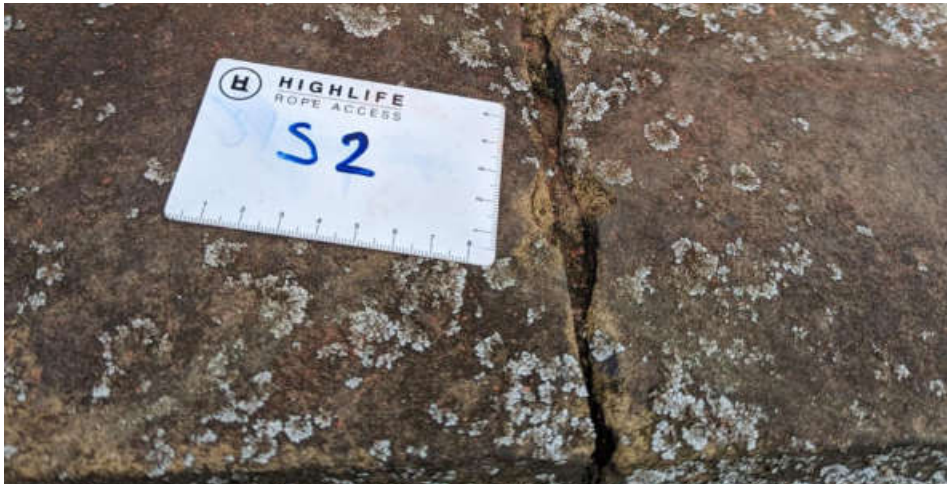
| No. | Location | Description | Proposed Solution |
|---|---|---|---|
| S2 | Cornice | Pointing is starting to deteriorate in perpendicular joints | Rake out and repoint with a suitable lime mortar. As per E2 a lead covering may be desirable |

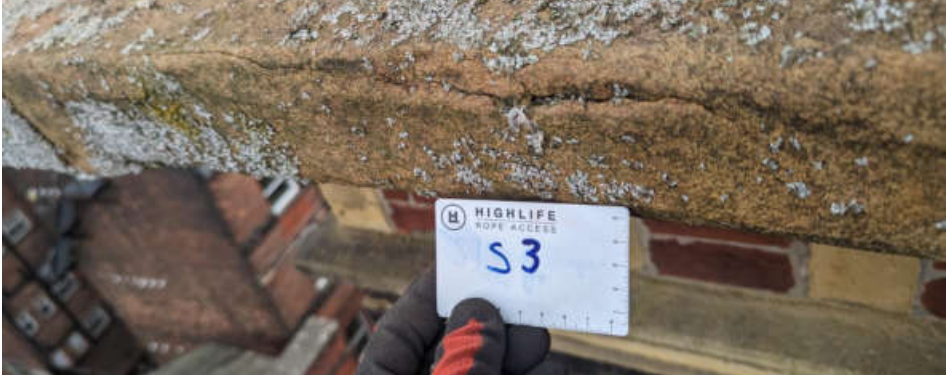
| S3 | Cornice | Spalling masonry on lip of cornice, stable at the time of inspection | If a lead covering is installed on the cornice as proposed elsewhere that would likely stop this fault from progressing to failure |

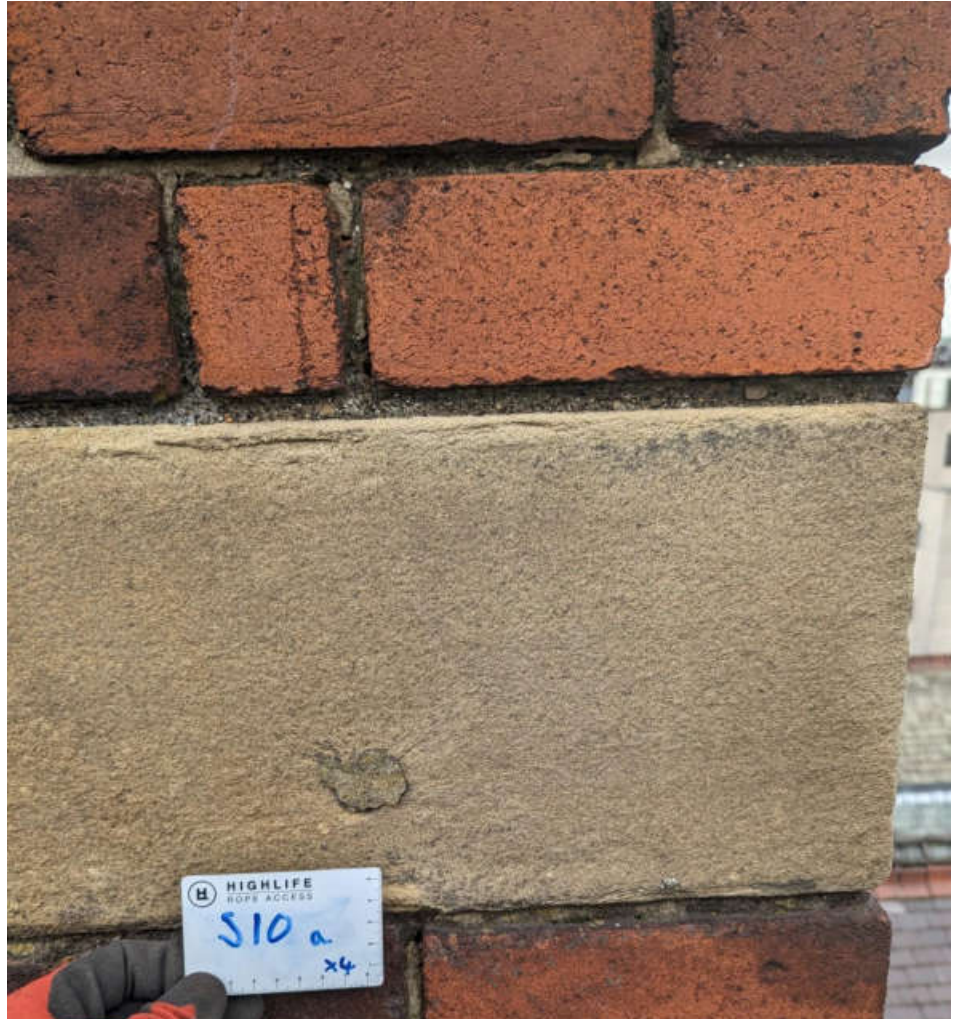
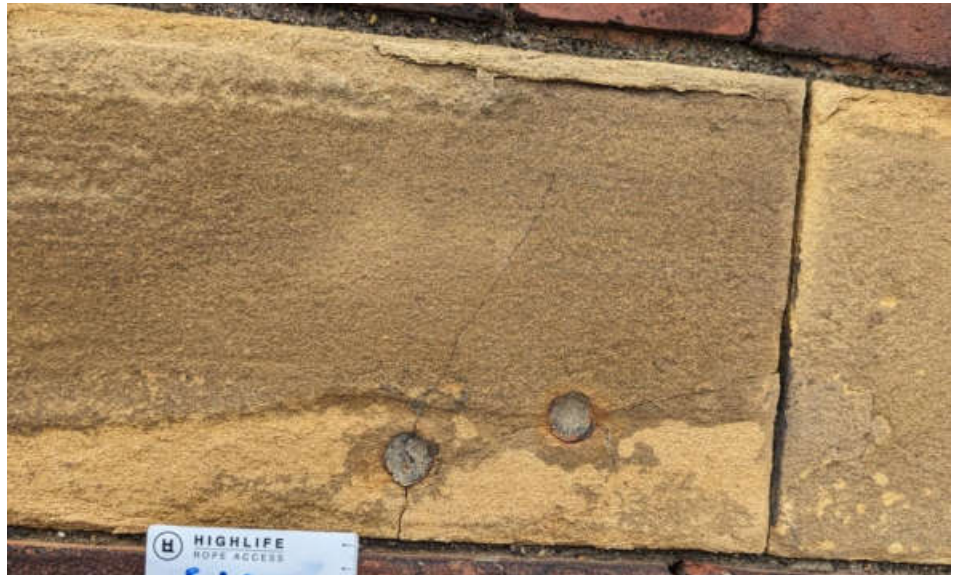
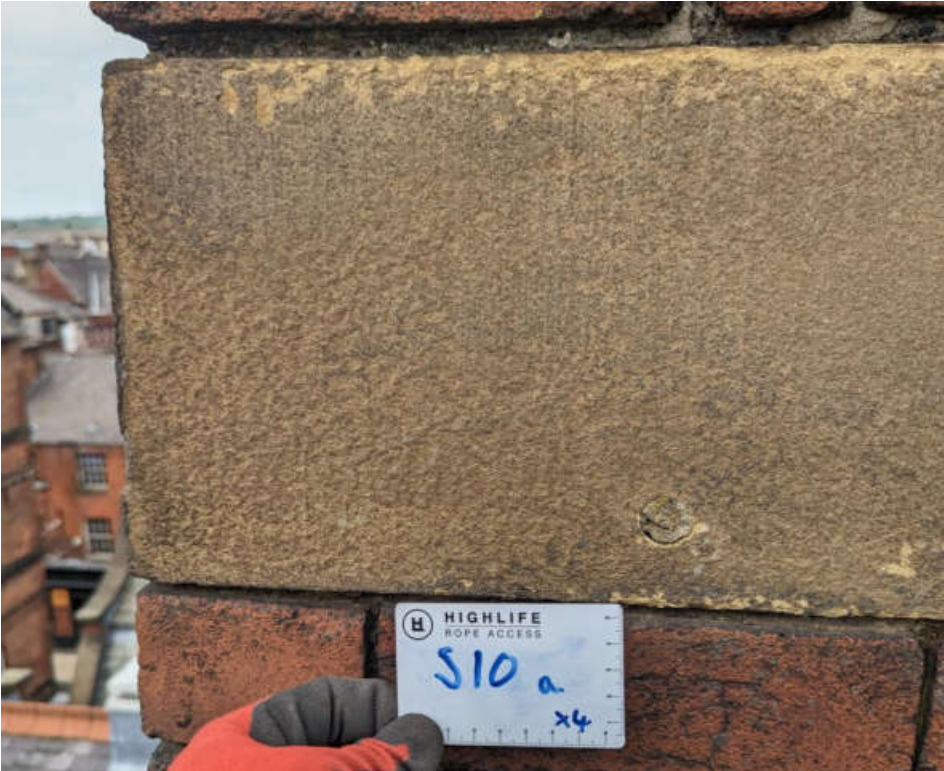
S10  
a

| S10<br>a | Stone string<br>course | 4no. Ferrous scaffold<br>fixings, the central pair<br>have caused minor<br>cracking | Core out fixings and point with a suitable lime<br>mortar |

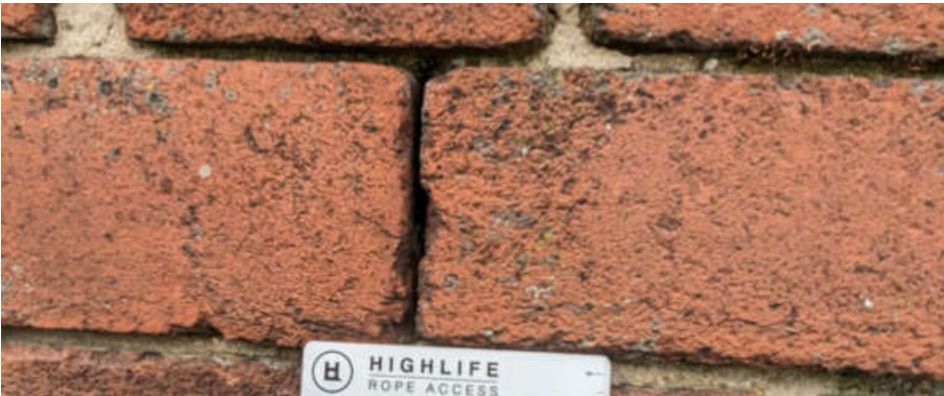
| S12 | Brickwork below string course | Photos illustrating condition of the pointing which is generally acceptable if not slightly recessed, with occasional open perpend joints | Rake out and repoint open perpend joints |

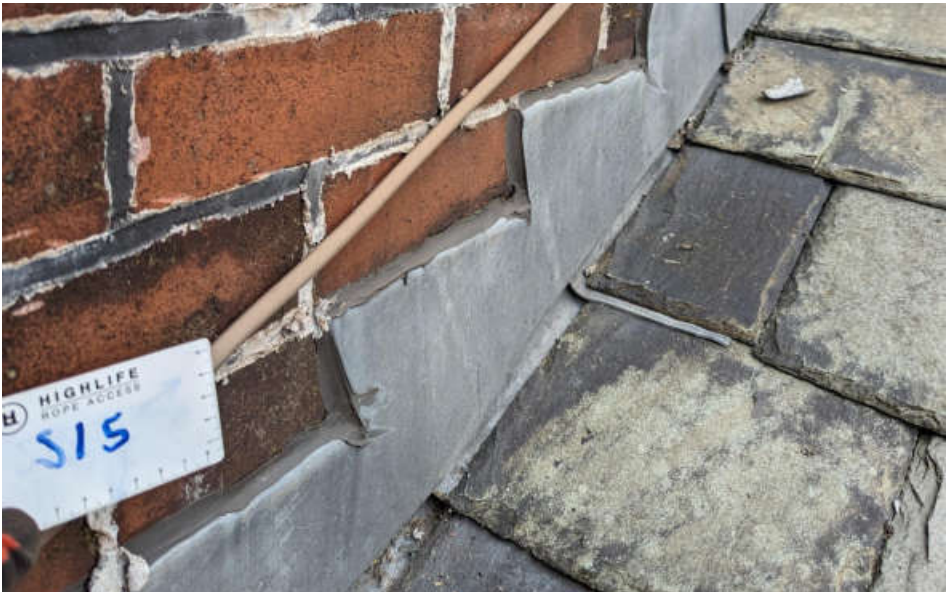
| S15 | Step flashings | Sealant is growing tired with small cracks which will be accepting water | Remove old sealant and reseal or point with a suitable lime mortar |

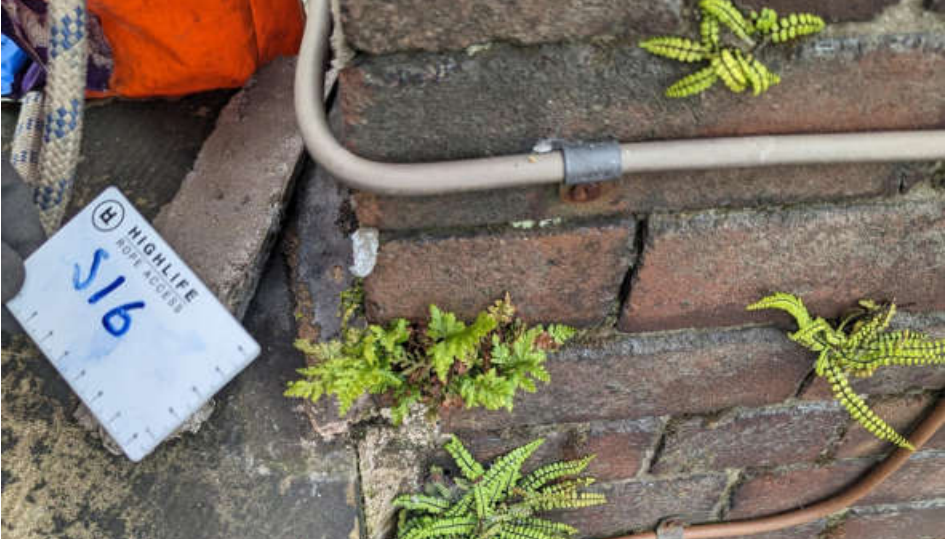
| S16 | Photos | | |

| S16 | Parapet | Where a parapet wall joins the tower there is a poor mortar filet which is loose and likely accepting water behind | Rake out joint and repoint with a suitable lime mortar |

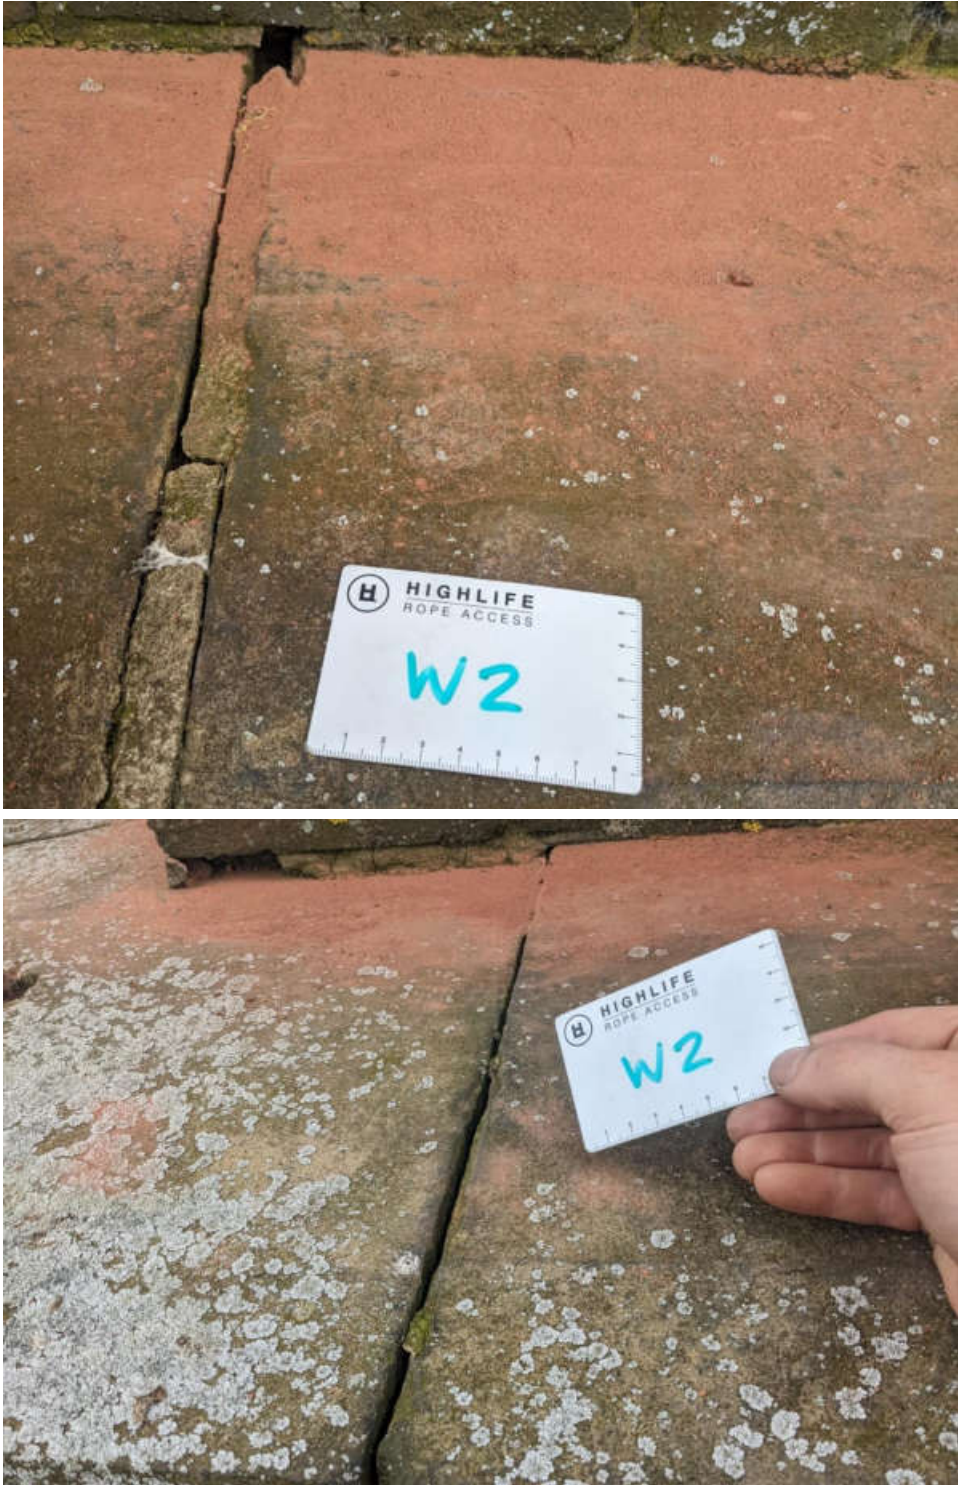
| W2 | Photos | | |

| W2 | Cornice | Large open perpend joints in the cornice likely accepting a large amount of water | Rake out and repoint with a suitable lime mortar. As mentioned previously a lead covering may be preferable to help form a drip on the cornice. |

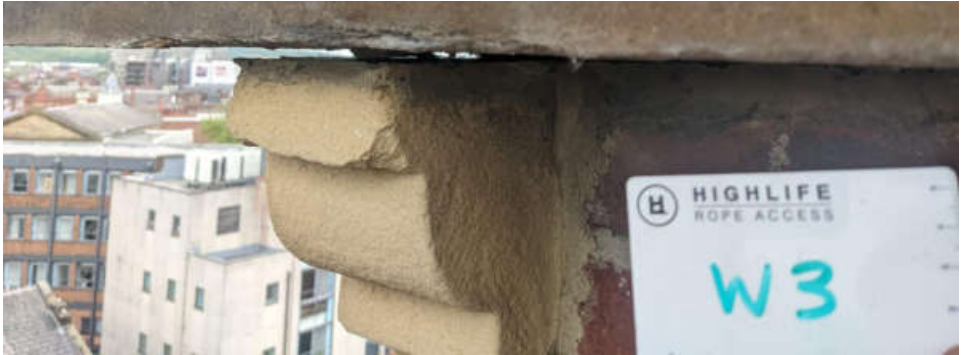
| W3 | Photos | | |

| W3 | Corbels | Open joints on top of the corbels on the NW arete as per N5 | Repoint using a suitable lime mortar |

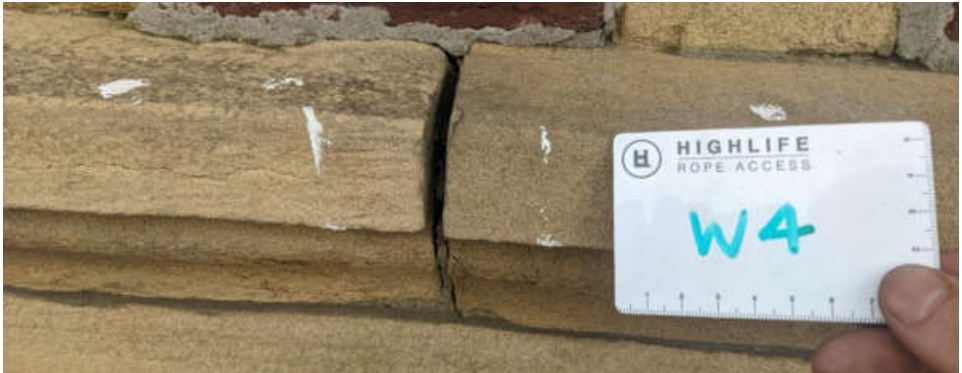
| W4 | Photos | | |

| W4 | Sill above arched stone details | Open joint certainly accepting water | Rake out and repoint with a suitable lime mortar |
