# HIGHLIFE

### BURY FUSILIERS MUSEUM - VENTILATION TOWER INSPECTION REPORT

Inspection conducted on: 18-19 May 2023

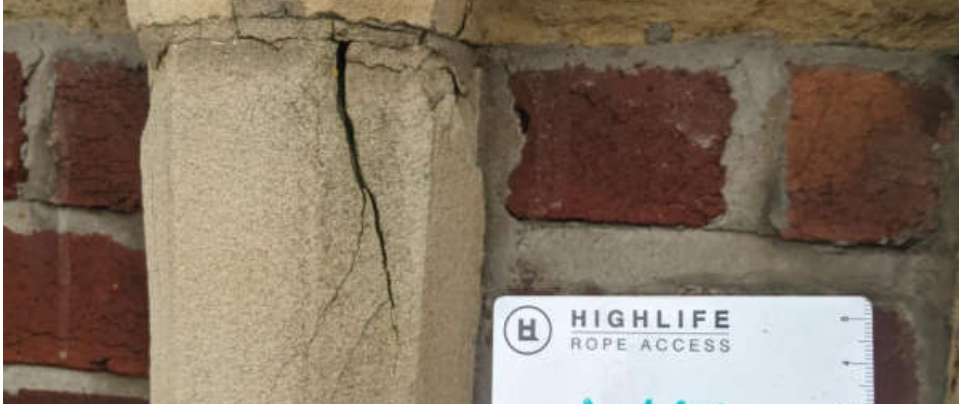
| W5 | Photos | | |

| W5 | Top of mullions | Historic mortar repair starting to fail, likely caused by ferrous dowel. Stable at time of inspection | It may be adequate to replace the mortar repair, however the issue may persist if caused by a corroding dowel |

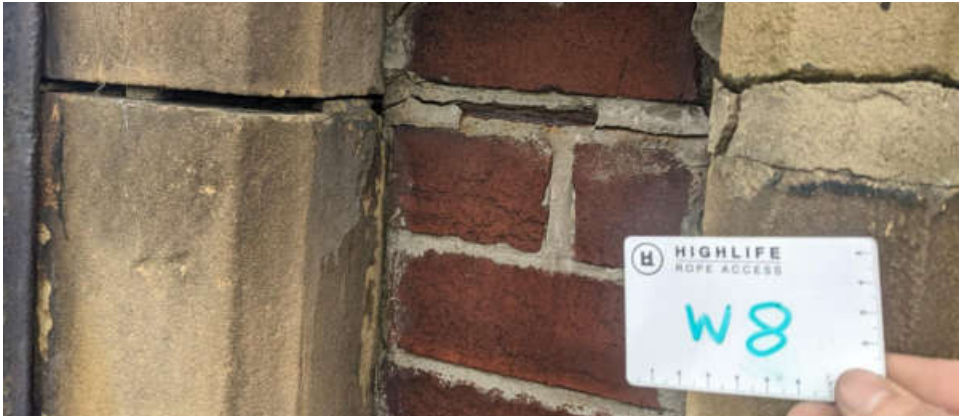
| W8 | Mid height on the mullions | <p>Bed lift from ferrous bed reinforcement as per N8. Photos show that the bed lift decreases from north to south. One photo also shows that one of the ferrous dowels in the mullions is spalling a large section off the mullion. This was stable at the time of inspection</p> | As per N8 |

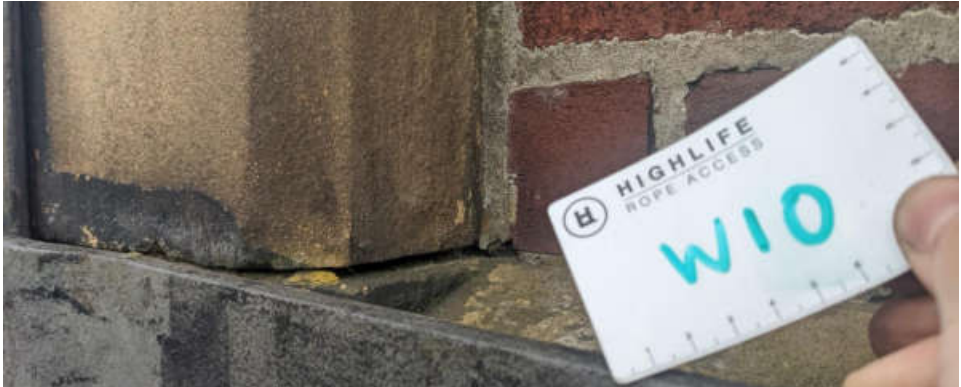
| W10 | Photos | | |

| W10 | Mullion on NW arete | Open bed at the bottom of the mullion may well be tracking water into the building | Rake out and repoint with a suitable lime mortar |

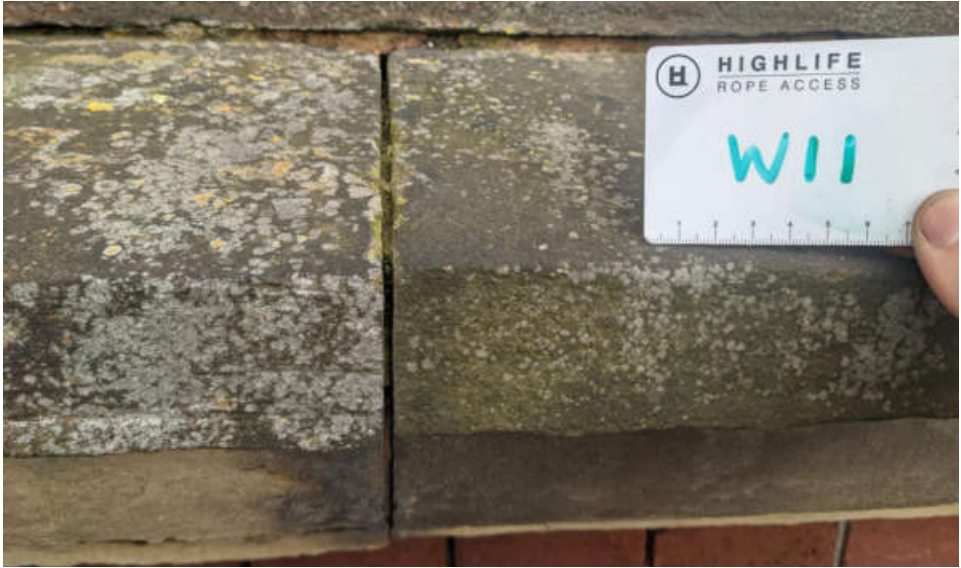
| W11 | Sill/ offset course below mullions | Open perpend and bed in the offset course likely tracking water into the building | Rake out and repoint with a suitable lime mortar |

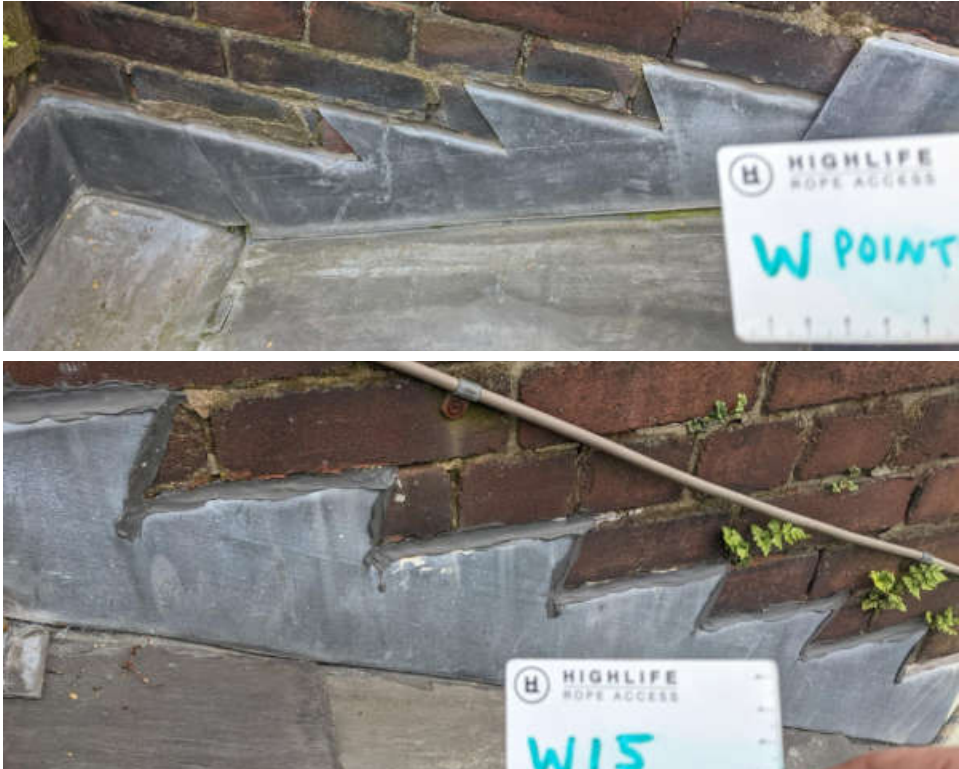
| W15 | Photos | | |

| W15 | Step flashings | Some of the sealant used to seal the step flashings is growing tired and is likely tracking water into the building | Remove old sealant and reseal or point with a suitable lime mortar |

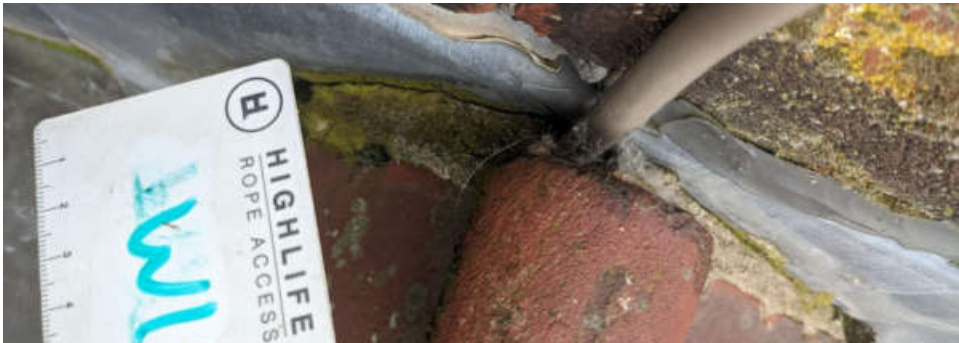
| W16 | Photos | | |

| W16 | Lightning conductor | Point where the lightning conductor joins the roof is poorly sealed and likely accepting water | Seal hole with sealant or repoint |

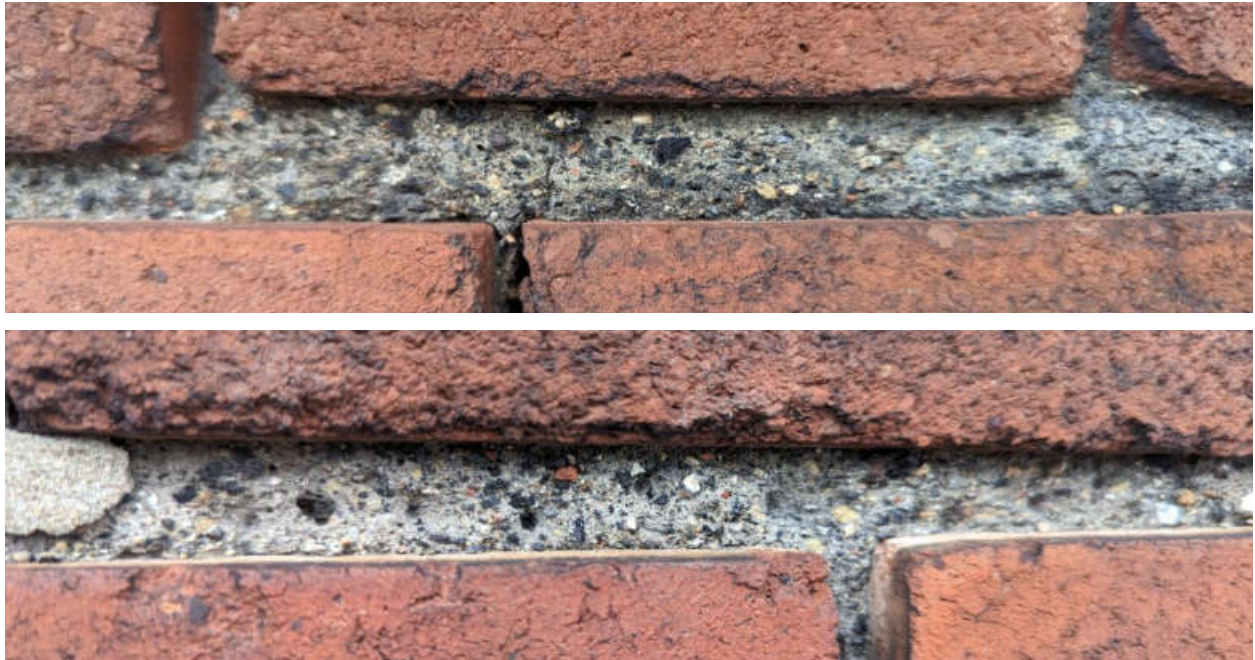
## Mortar:

Where there is no cementitious face pointing the original mortar is still well visible. This appears to be a hot mixed ash mortar; the numerous coal flecks suggest that coal ash was used as the primary aggregate, with only a small amount of silica aggregate and some visible flecks of brick, likely from the kilning process. The mortar was very soft beneath a tool, suggesting only a minor pozzolanic effect from the brick.
