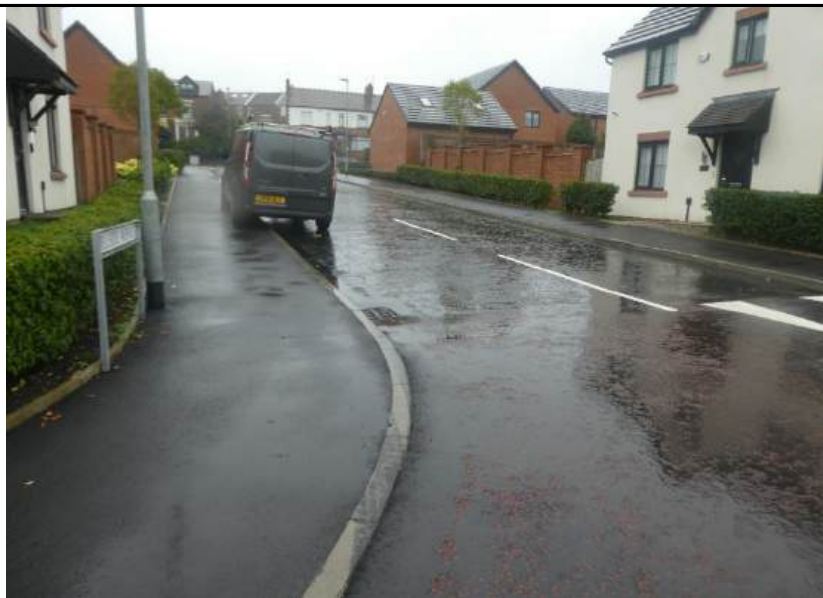
Photograph 2. Recently formed roadway and footpath surfacing

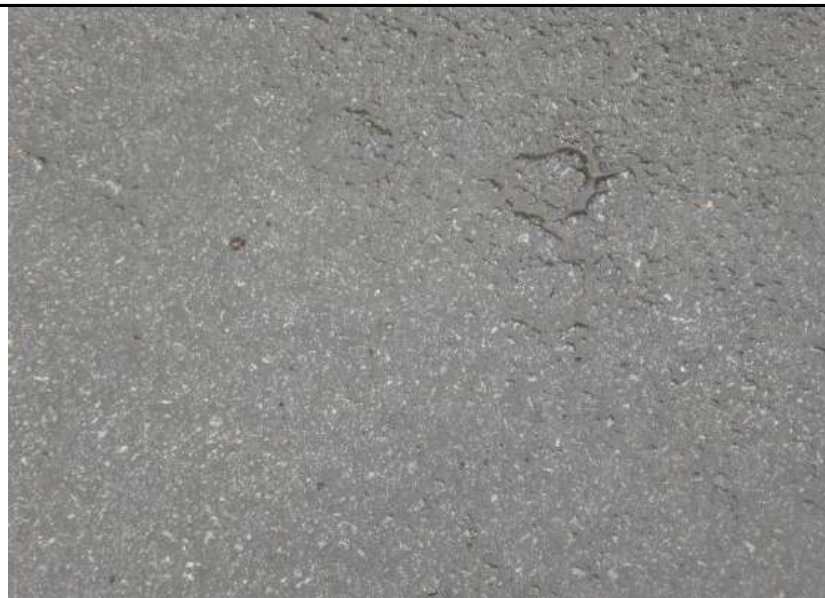
Photograph 10. Localised indentations to footpath areas

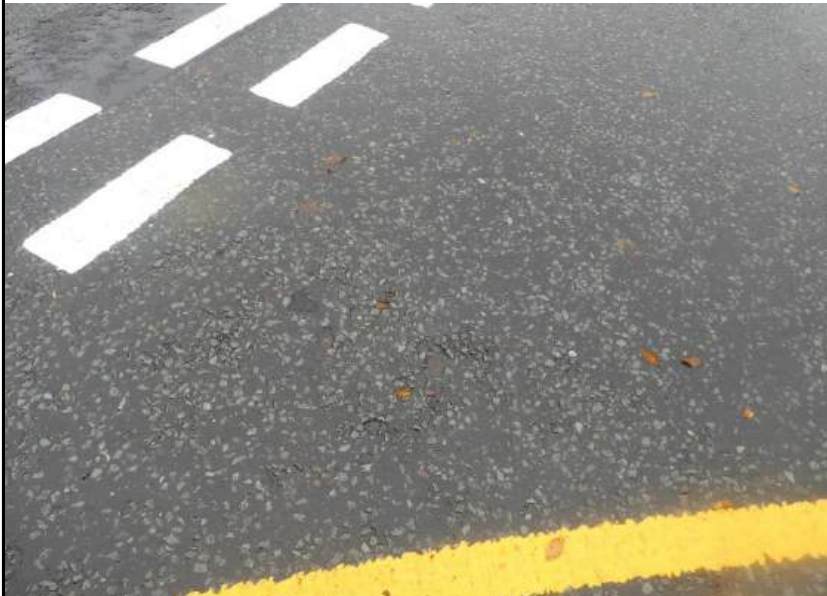
Photograph 11. Minor erosion to the surfacing at the junction with George Street.

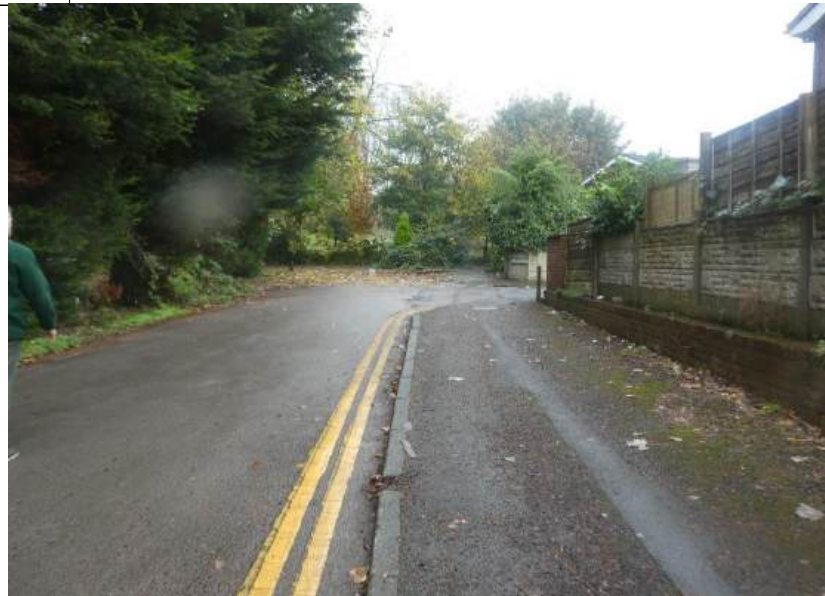
Photograph 12. Roadway directly adjacent to the site entrance area

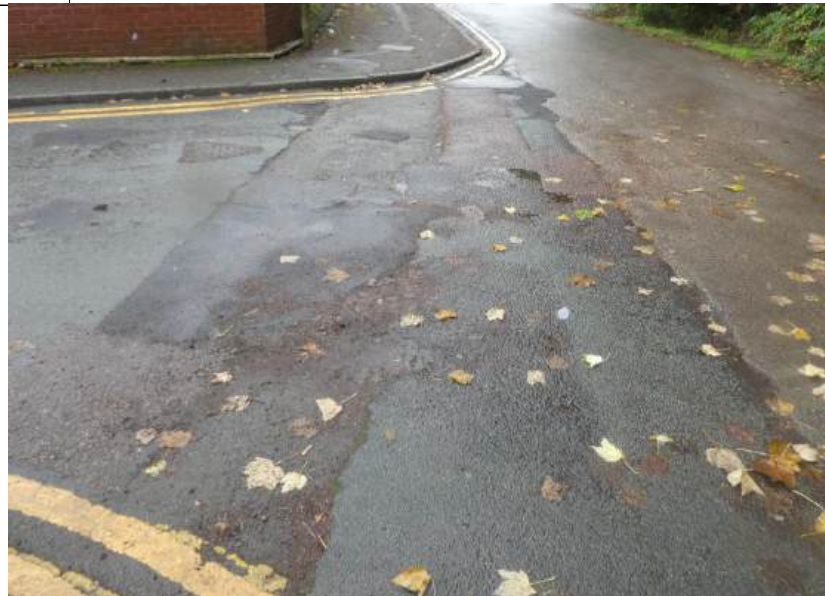
Photograph 16. Localised reinstatement of road surfacing to Norwood junction slightly eroded

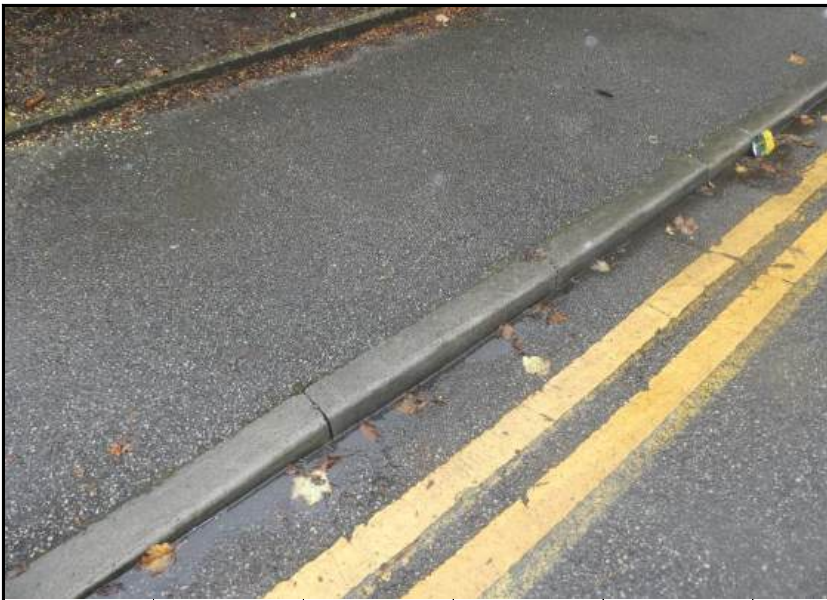
Photograph 29. Adjoining footpath in reasonable condition

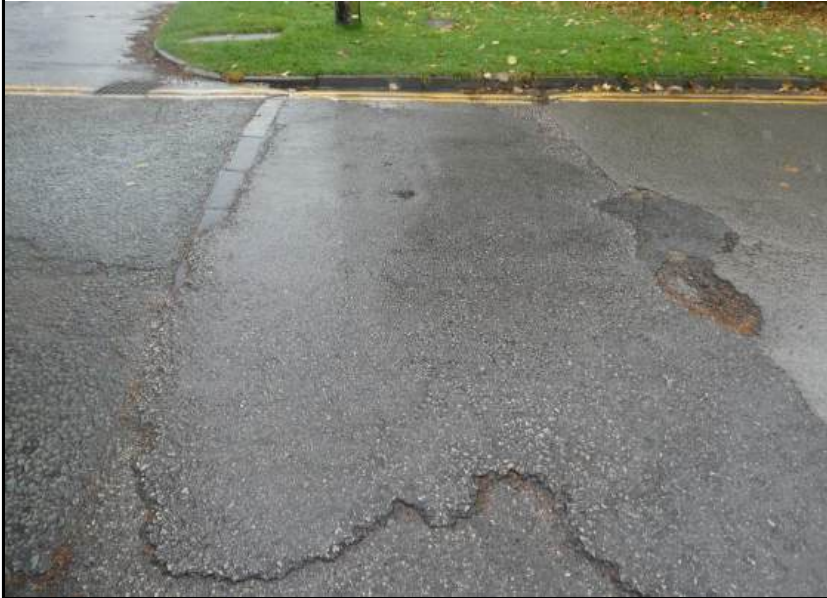
Photograph 31. Localised erosion to surfacing

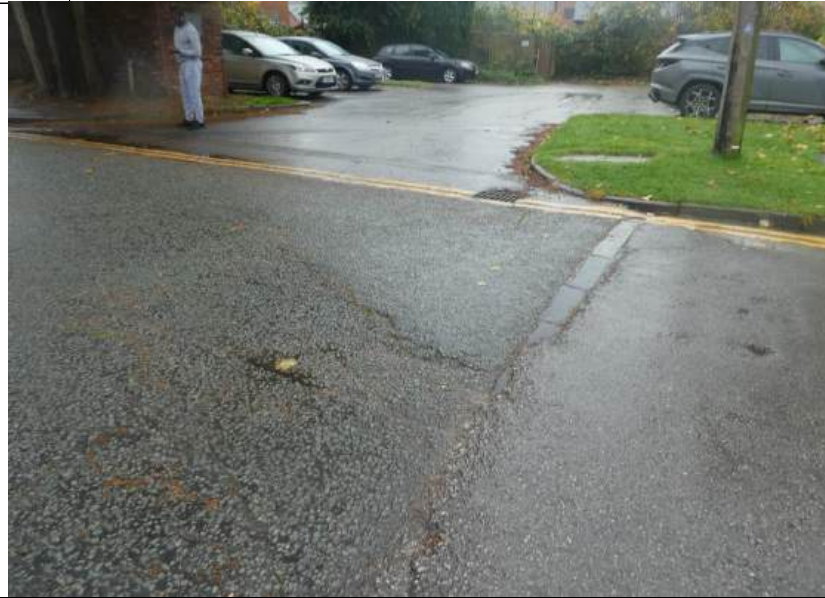
Photograph 32. Erosion to road surfacing near to site entrance on George Street

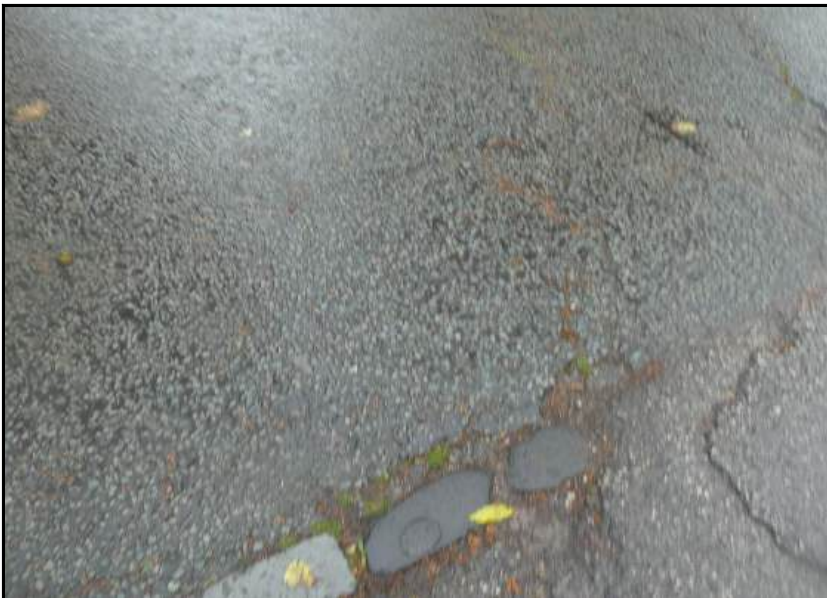
Photograph 33. Localised erosion to surfacing

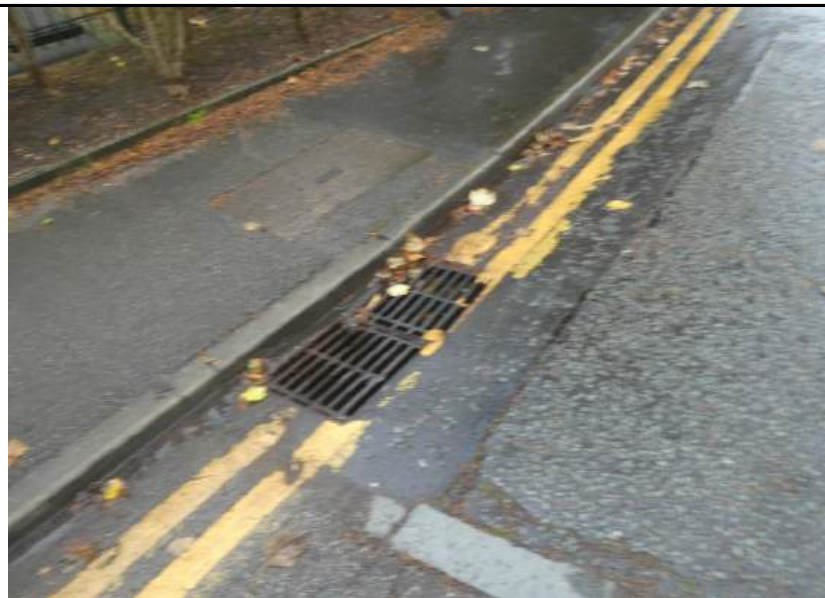
Photograph 34. Localised erosion to surfacing

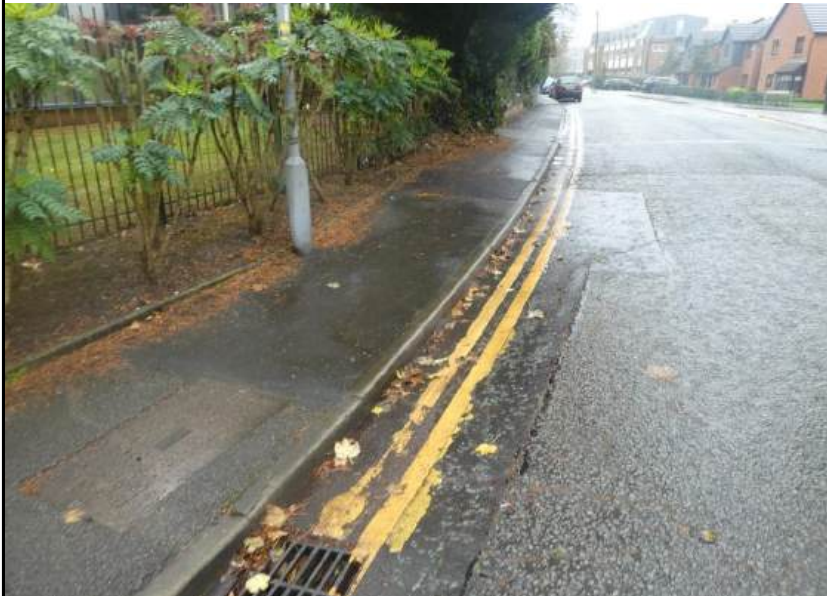
Photograph 35. Line marking eroding

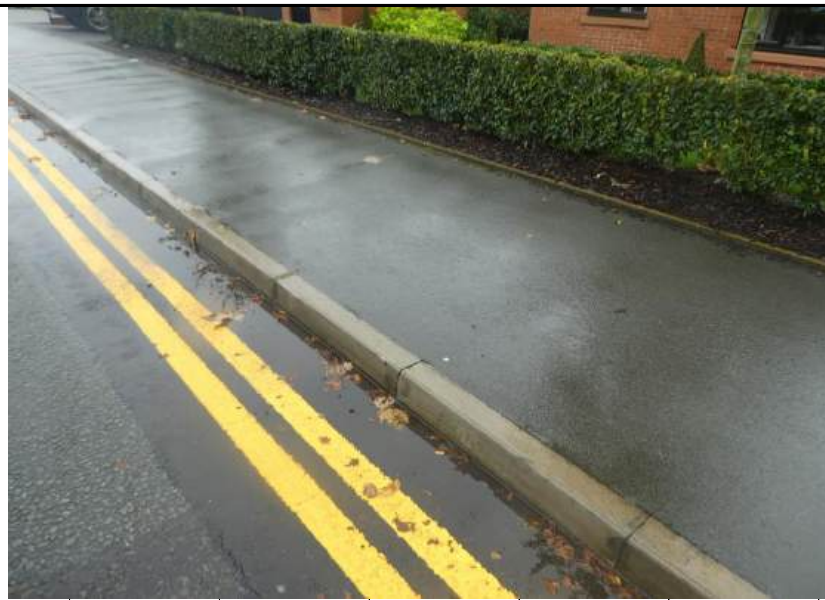
Photograph 54. Footpath in reasonable condition

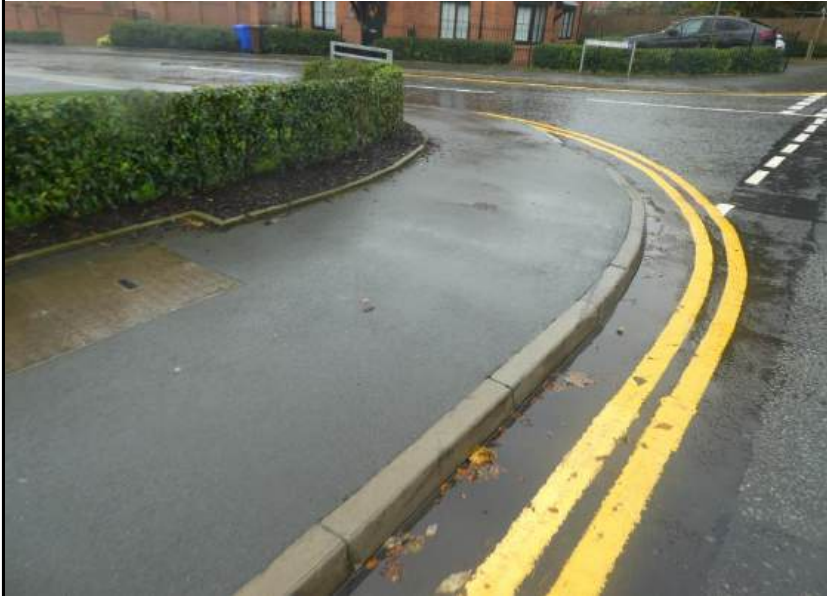
Photograph 55. Footpath in reasonable condition

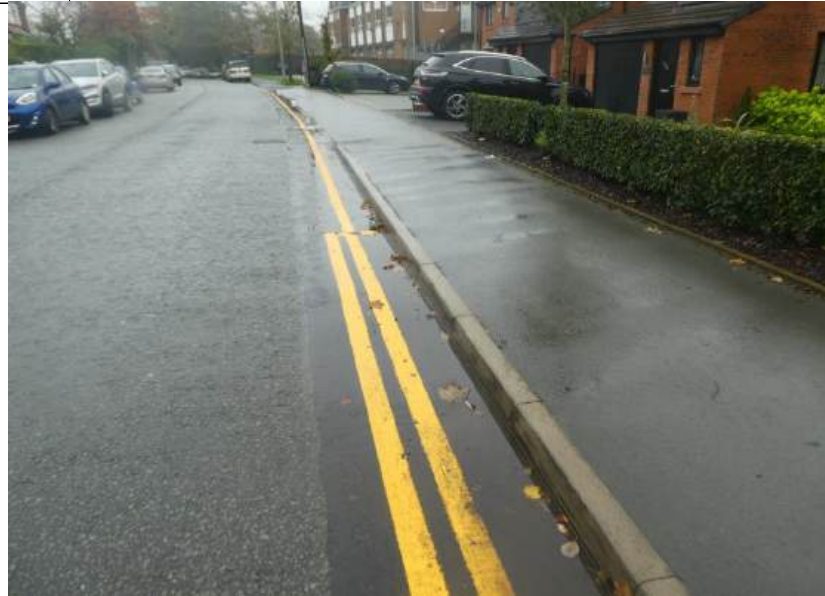
Photograph 56. Footpath in reasonable condition

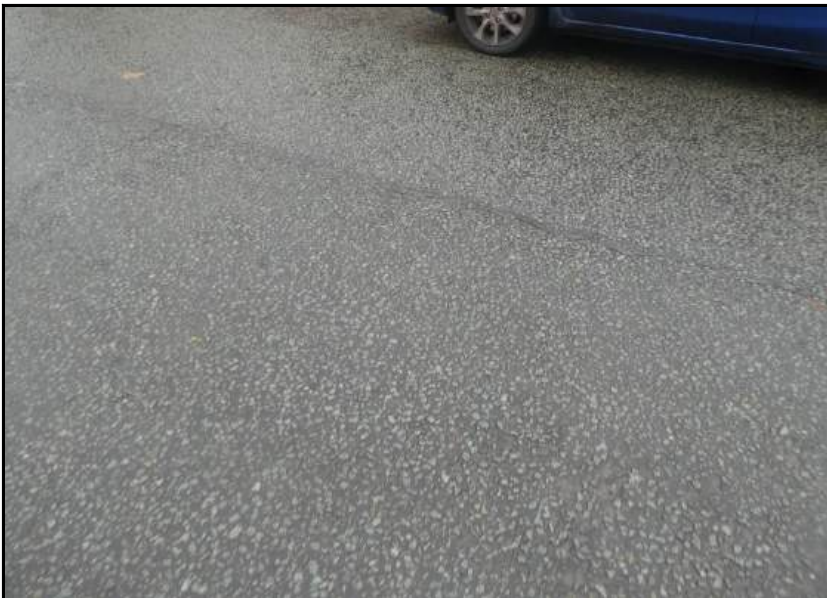
Photograph 57 Surfacing in reasonable condition.

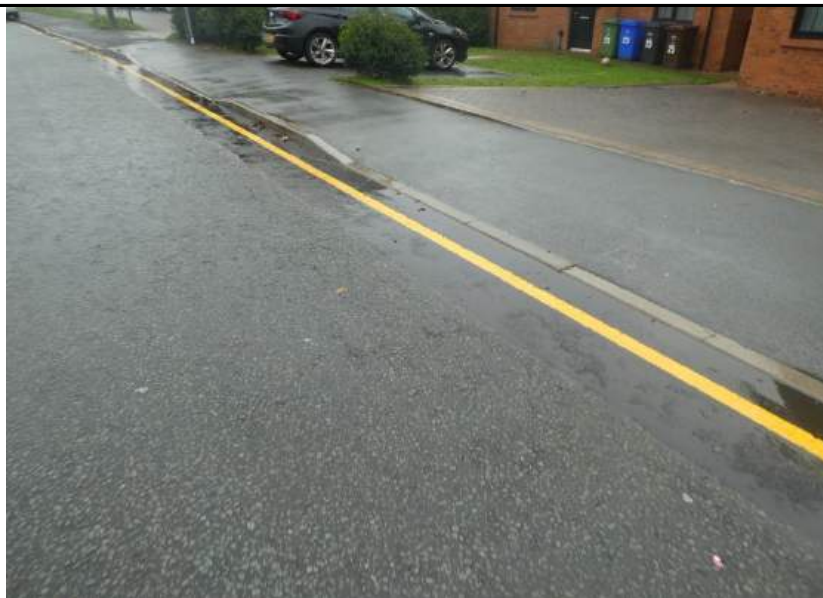
Photograph 58. Surfacing in reasonable condition.

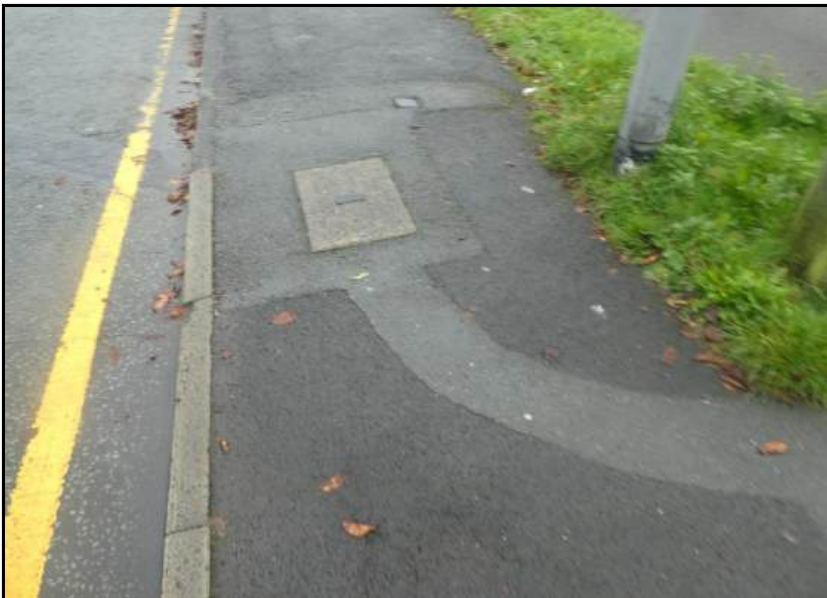
Photograph 65. Localised reinstatement to footpath

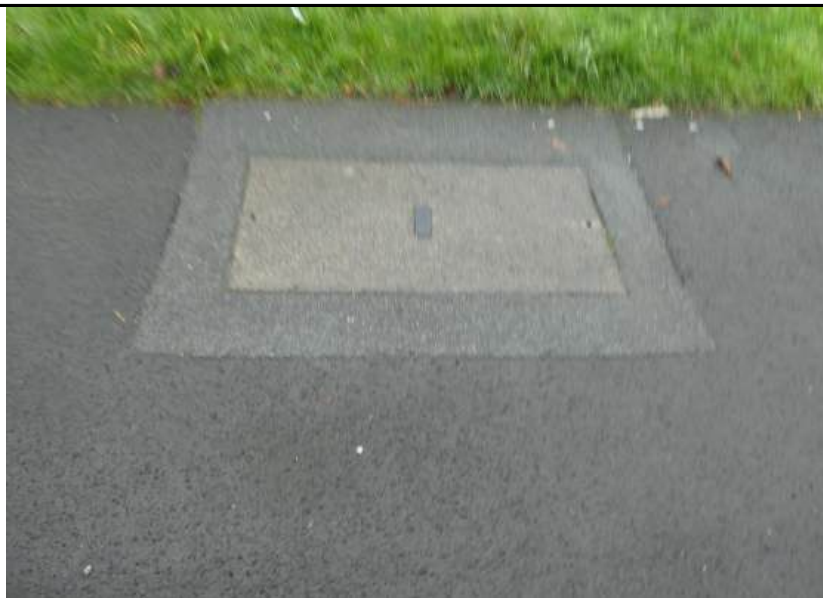
Photograph 66. Localised reinstatement to footpath

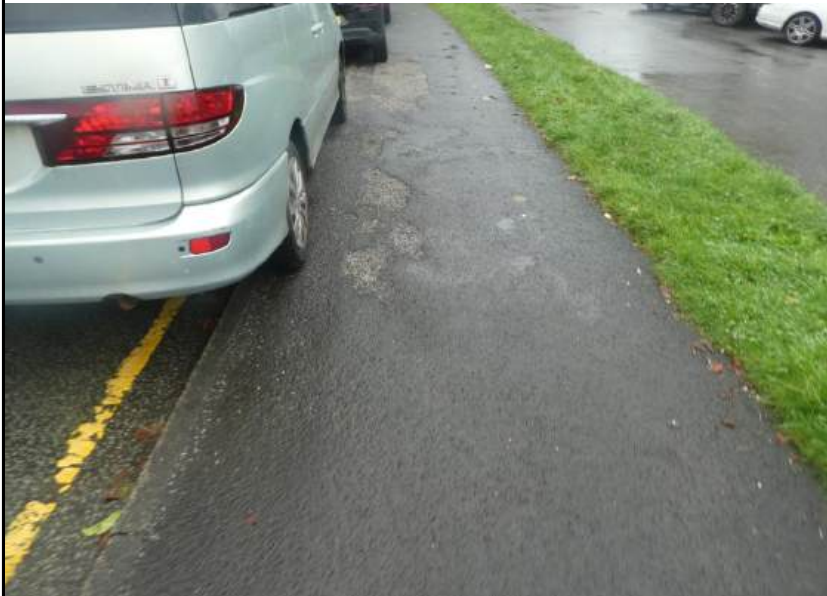
Photograph 67. Erosion to footpath

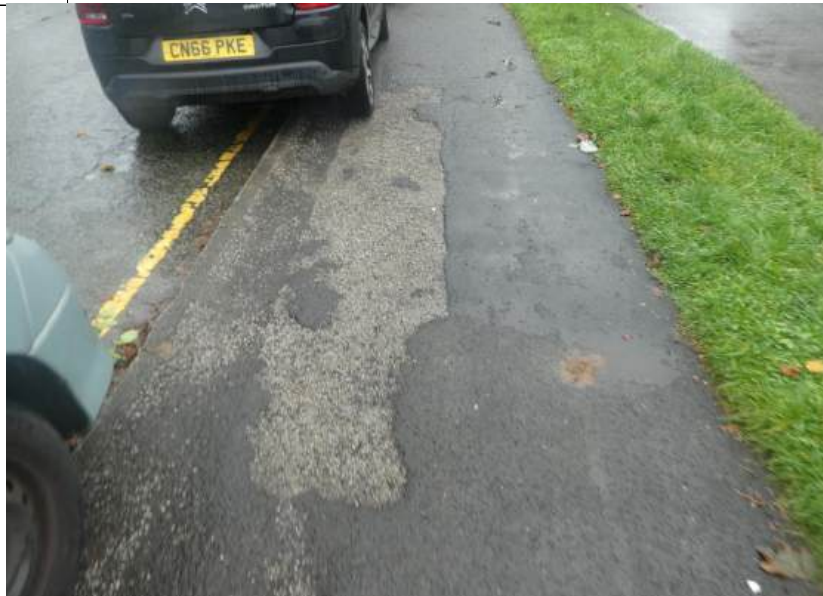
Photograph 68. Erosion to footpath

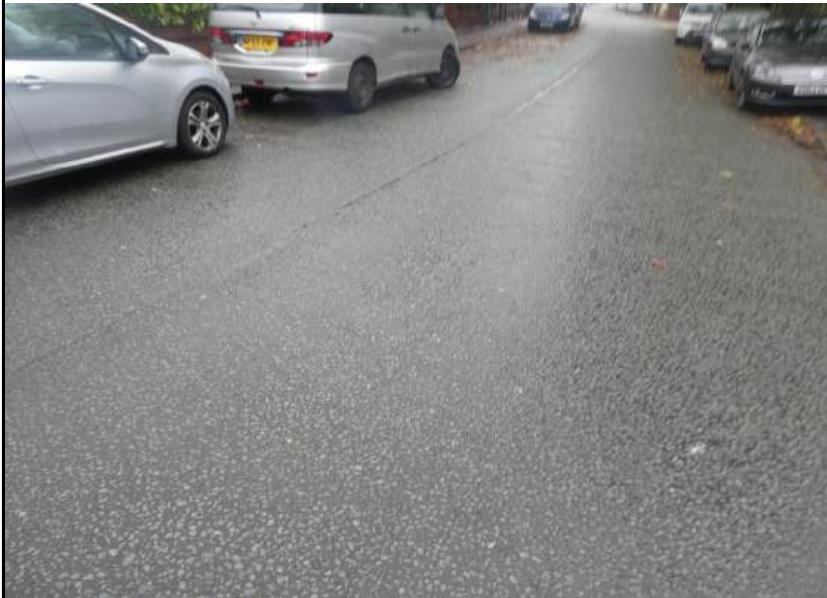
Photograph 71. Road surfacing in reasonable condition

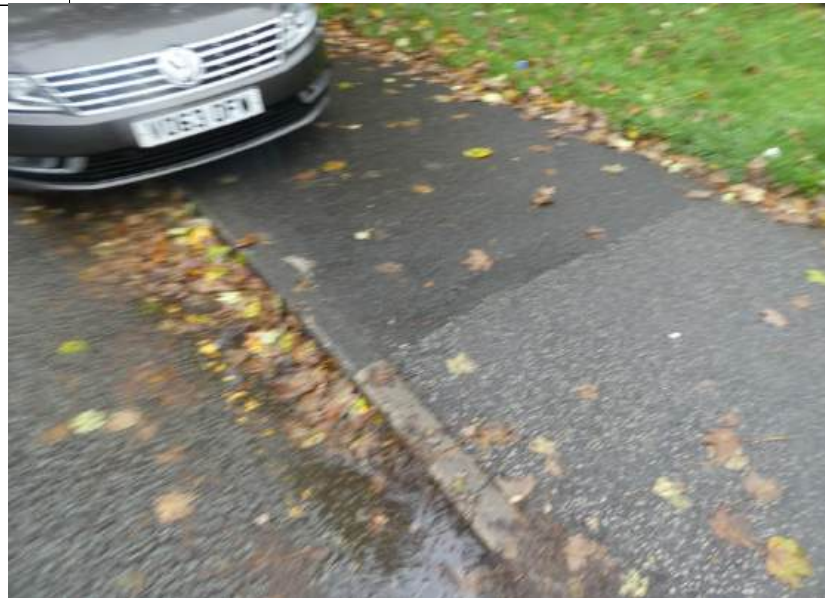
Photograph 72. Footpath in reasonable condition

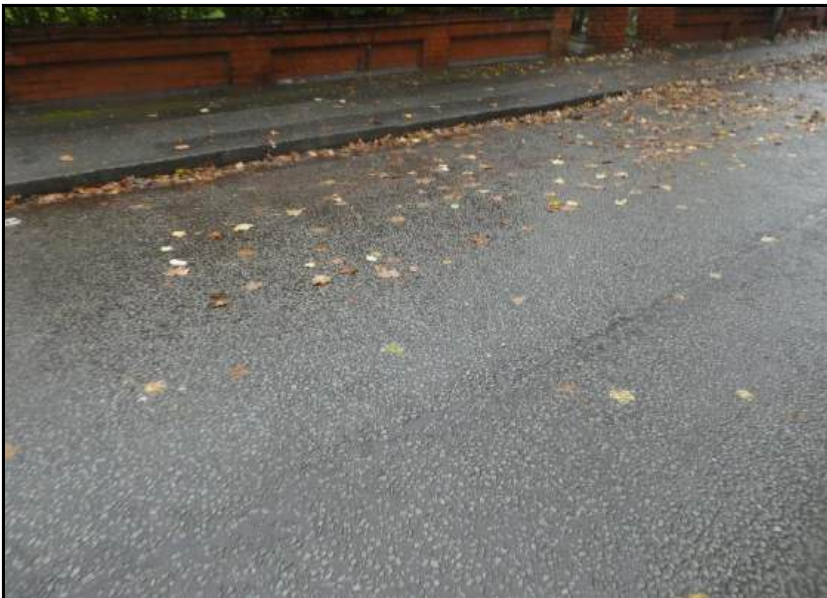
Photograph 73. Road surfacing in reasonable condition

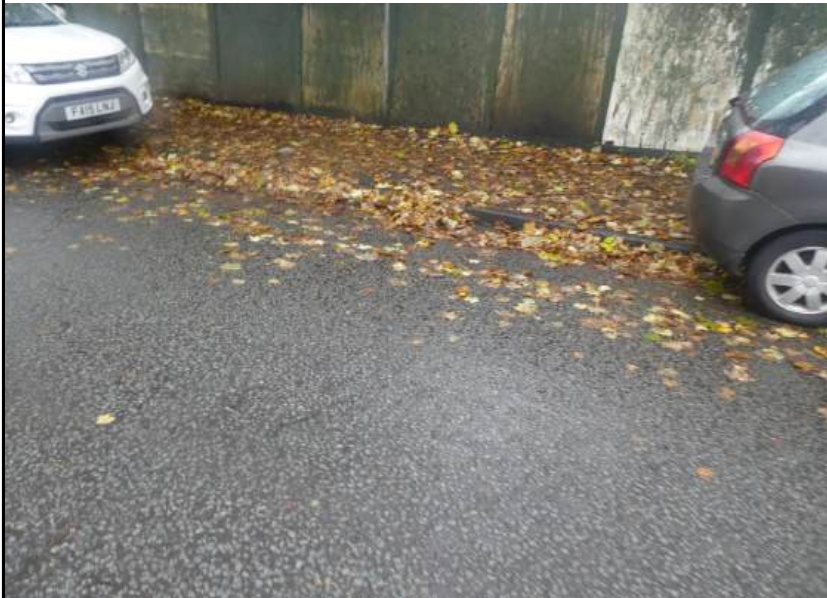
Photograph 75. Road surfacing in reasonable condition

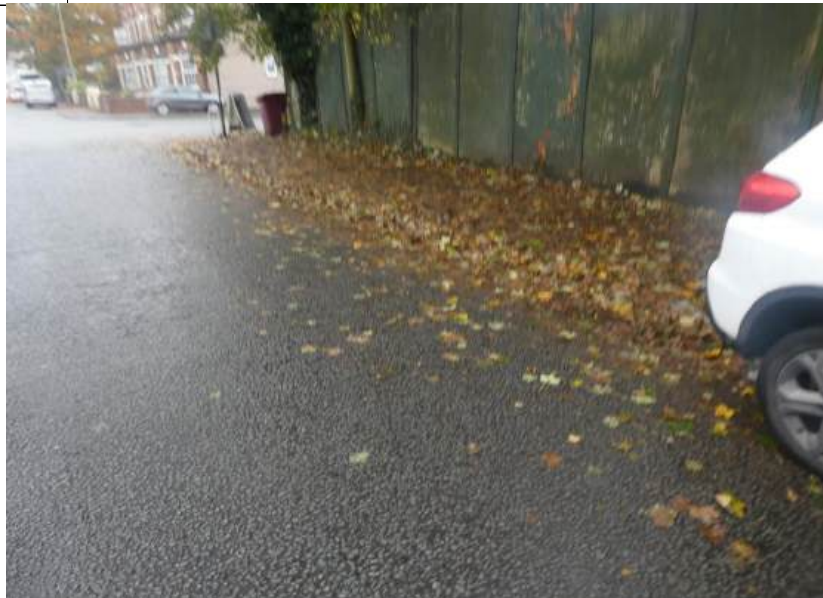
Photograph 76. Road surfacing in reasonable condition

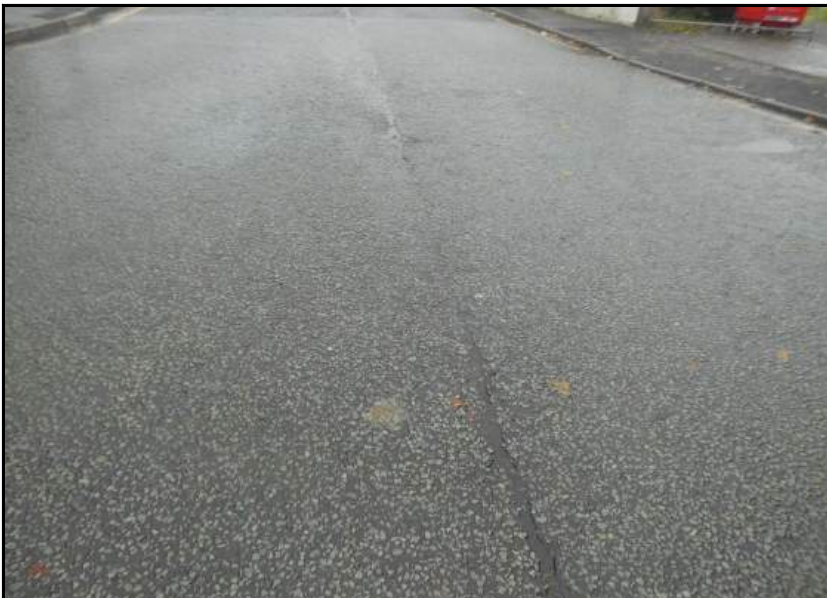
Photograph 81.Exposed joint to centre of roadway

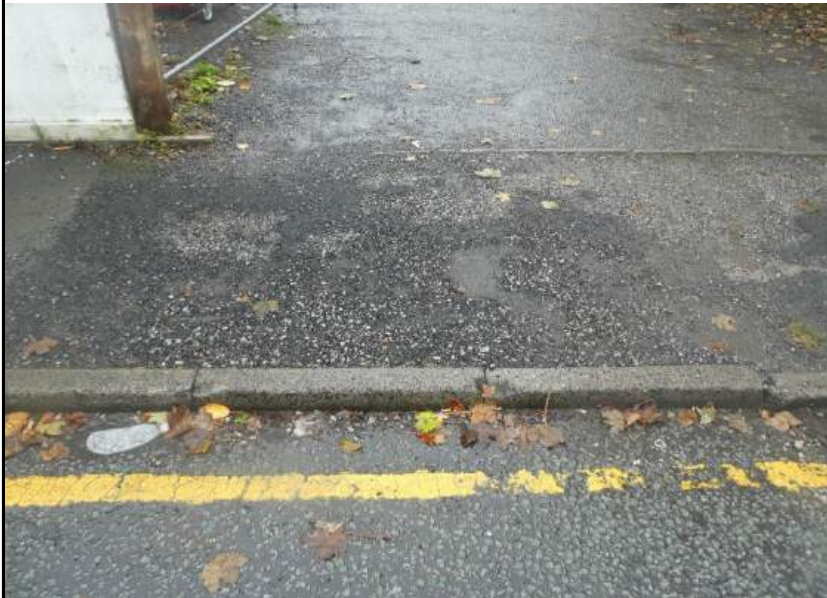
Photograph 83. Localised erosion to footpath

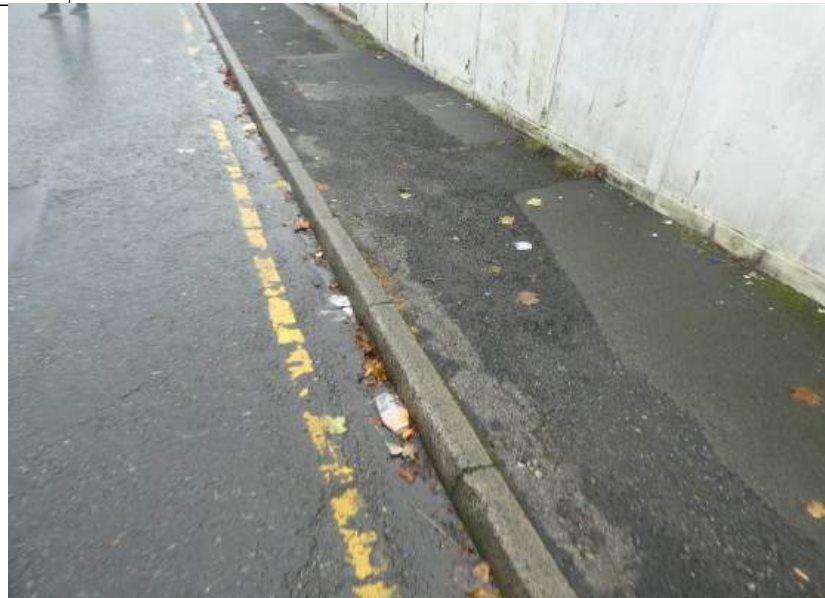
Photograph 84. Localised erosion to footpath.

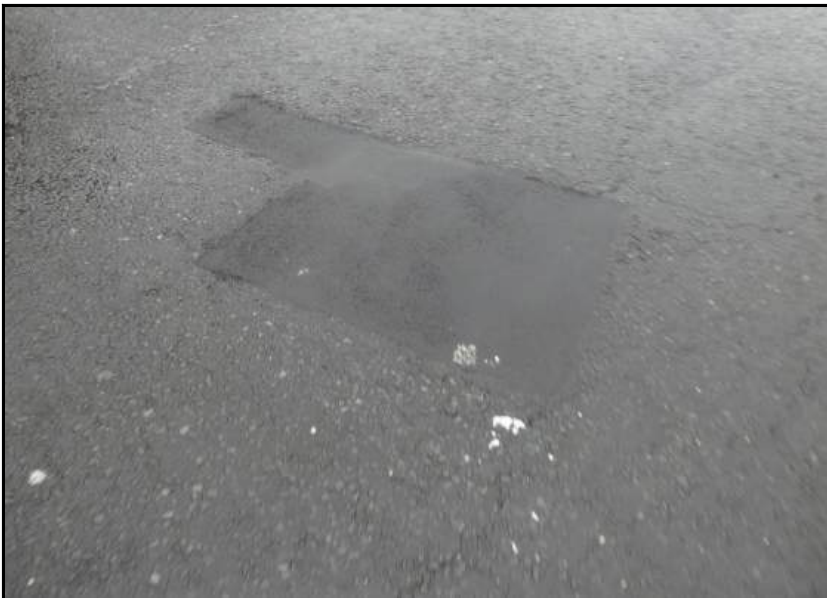
Photograph 85. Localised reinstatement of road surfacing.

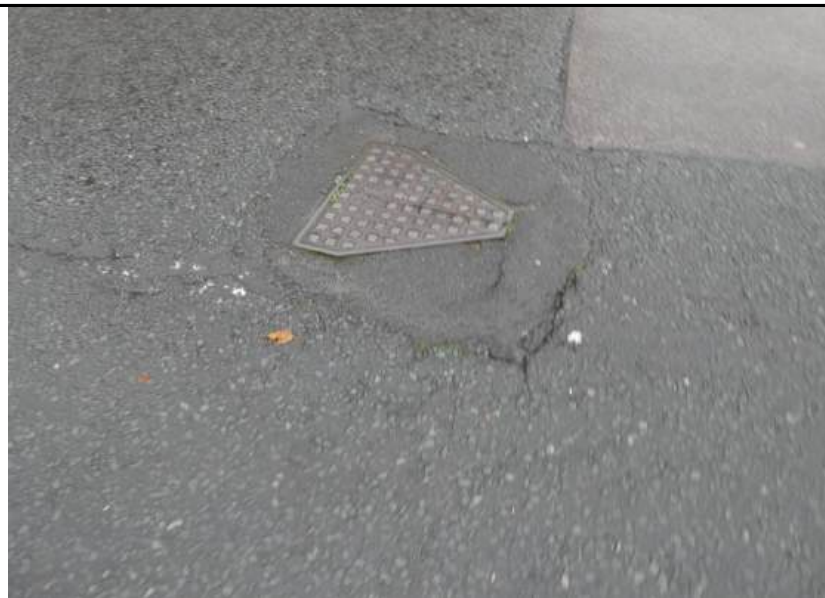
Photograph 86. Erosion to surfacing around inspection chamber.

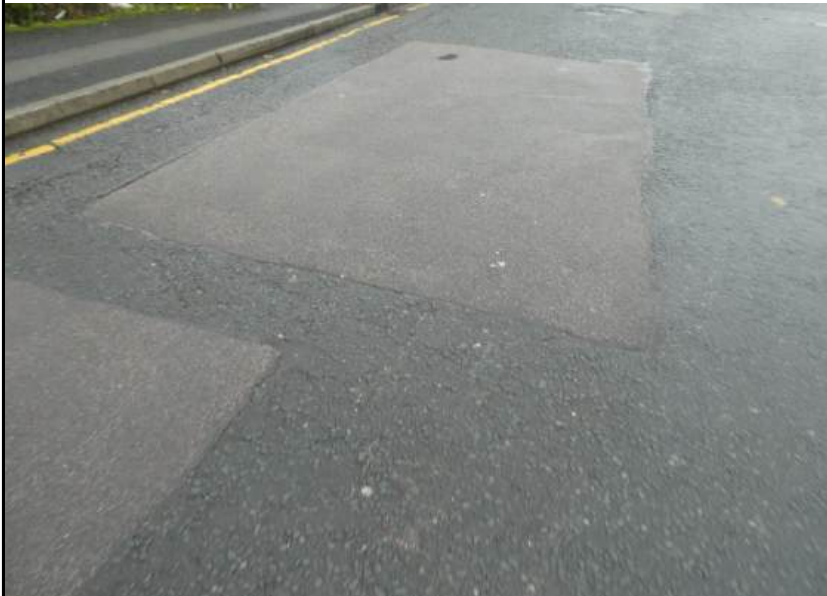
Photograph 87. Reinstatement of road surfacing.

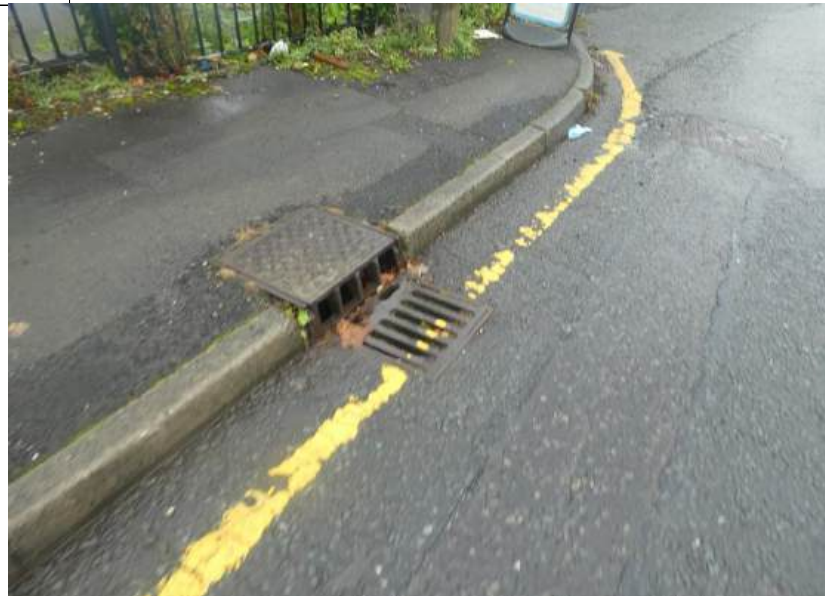
Photograph 88. Erosion to line marking.
