**PROPERTY ADDRESS: Baron St Loco Works, Baron St, Bury BL9 0TY**

**REPORT TYPE: Asbestos Refurbishment/Demolition Survey**

**REPORT NUMBER: B-15727**

**REPORT DATE: 14/11/2017**

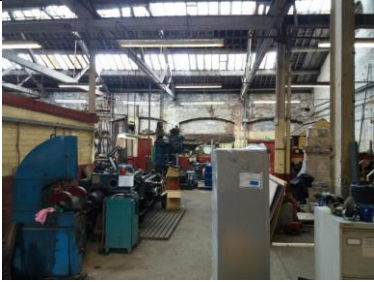
| East Lancs Locomotive Works, Baron St, Bury BL9 | | | | |
|---|---|---|---|---|
| Ground Floor | R002 | | Walls: Brick<br>Roof: Timber<br>Floor: Concrete<br>Window Frames : Metal<br>Rainwater goods : No<br>Suspect Material | |

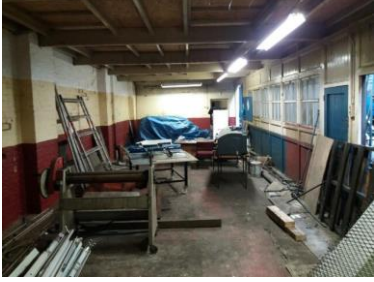
| East Lancs Locomotive Works, Baron St, Bury BL9 | | | | |
|---|---|---|---|---|
| Ground Floor | R003 | | Floor : Concrete<br>Walls: Brick<br>Stud walls : Timber<br>Ceiling : Timber<br>Rainwater goods : No<br>Suspect Material<br>Electrical Equipment : No<br>Suspect Material | |

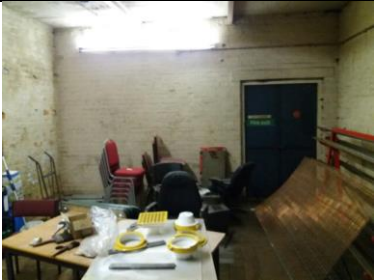
| Ground Floor | R004 | | Floor : Concrete<br>Walls: Brick<br>Floor Covering : Quarry /<br>ceramic tiled<br>Ceiling : Concrete | |

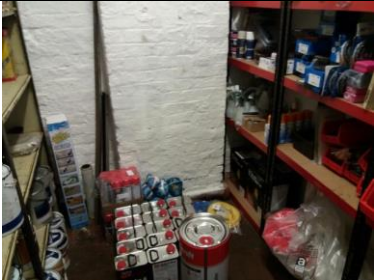
| Ground Floor | R005 | | Floor : Concrete<br>Walls: Brick<br>Floor Covering : Quarry /<br>ceramic tiled<br>Ceiling : Concrete | |

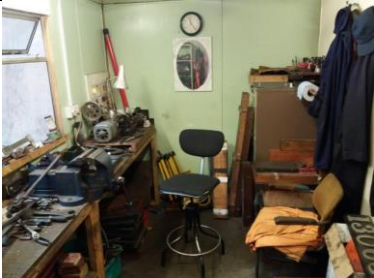
| Ground Floor | R006 | | Floor : Timber<br>Walls: Timber<br>Floor Covering : Linoleum<br>covered<br>Ceiling : Timber | |

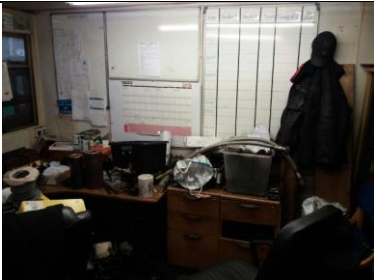
| Ground Floor | R007 | | Floor : Timber<br>Walls: Timber<br>Floor Covering : Linoleum<br>covered<br>Ceiling : Timber | |

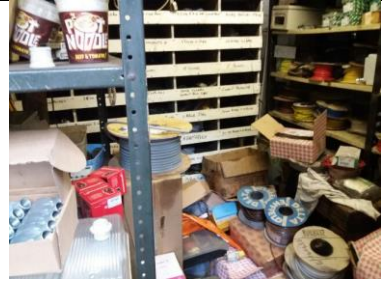
| Ground Floor | R008 | | Floor : Timber<br>Walls: Timber<br>Floor Covering : Carpetted / carpet tiled<br>Ceiling : Timber | |

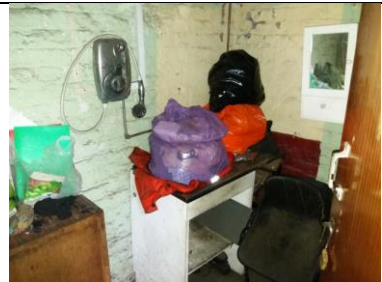
| Ground Floor | R010 | | Floor : Timber<br>Walls: Brick<br>Stud walls : Timber<br>Ceiling : Timber | |

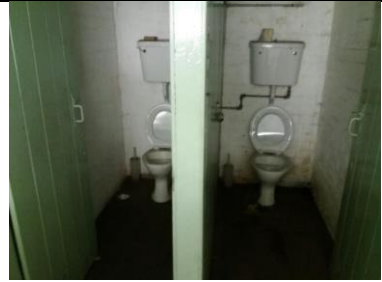
| Ground Floor | R011 | | Floor : Concrete<br>Walls: Brick<br>Floor Covering : Quarry / ceramic tiled<br>Ceiling : Timber<br>Fixtures : No Suspect Material | |

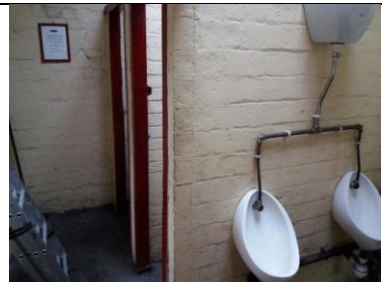
| Ground Floor | R012 | | Floor : Concrete<br>Walls: Brick | |

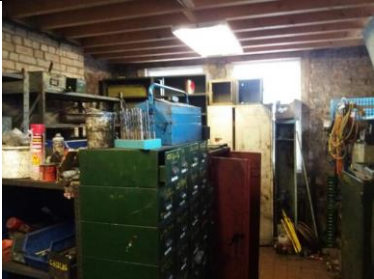
| Ground Floor | R013 | | Floor : Concrete<br>Floor Covering : Quarry / ceramic tiled<br>Walls: Brick<br>Ceiling : Timber | |

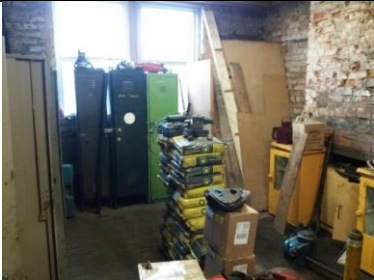
| Ground Floor | R014 | | Floor : Timber<br>Walls: Brick<br>Ceiling : Timber | |

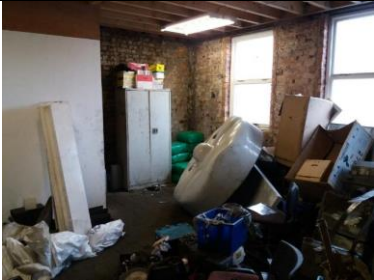
| Ground Floor | R015 | | Floor : Timber<br>Stairs : Timber<br>Walls: Brick<br>Ceiling : Timber | |

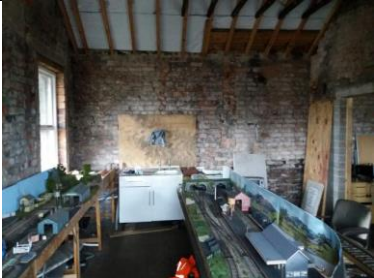
| 1st Floor | R016 | | Floor : Timber<br>Walls : Brick<br>Sarking Material : No<br>Suspect Material<br>Trusses : Timber | |

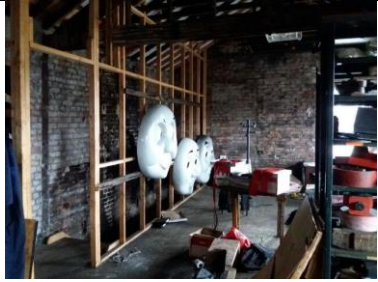
| 1st Floor | R017 | | Floor : Timber<br>Walls : Brick<br>Sarking Material : No<br>Suspect Material<br>Trusses : Timber | |

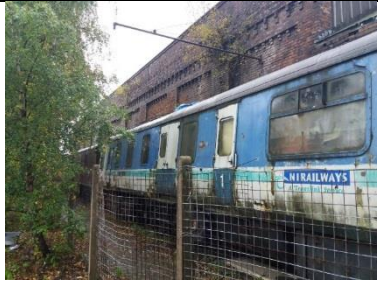
| External | R001 | | Walls: Brick<br>Roof: No Suspect Material<br>Rainwater Goods: No<br>Suspect Material<br>Window Frames : Metal | |
