| Document Control | | | | |
|---|---|---|---|---|
| Project Name: | | Proffitts | | |
| Report Title: | | Preliminary Roost Assessment Report | | |

- 1.1.1 Avian Ecology Ltd. was commissioned by Proffitts to undertake a Preliminary Roost Assessment (PRA) in relation to the proposed enhancements and landscaping of Whitehead Gardens, Tottington, Bury, BL8 4AL (henceforth referred the 'Site'),

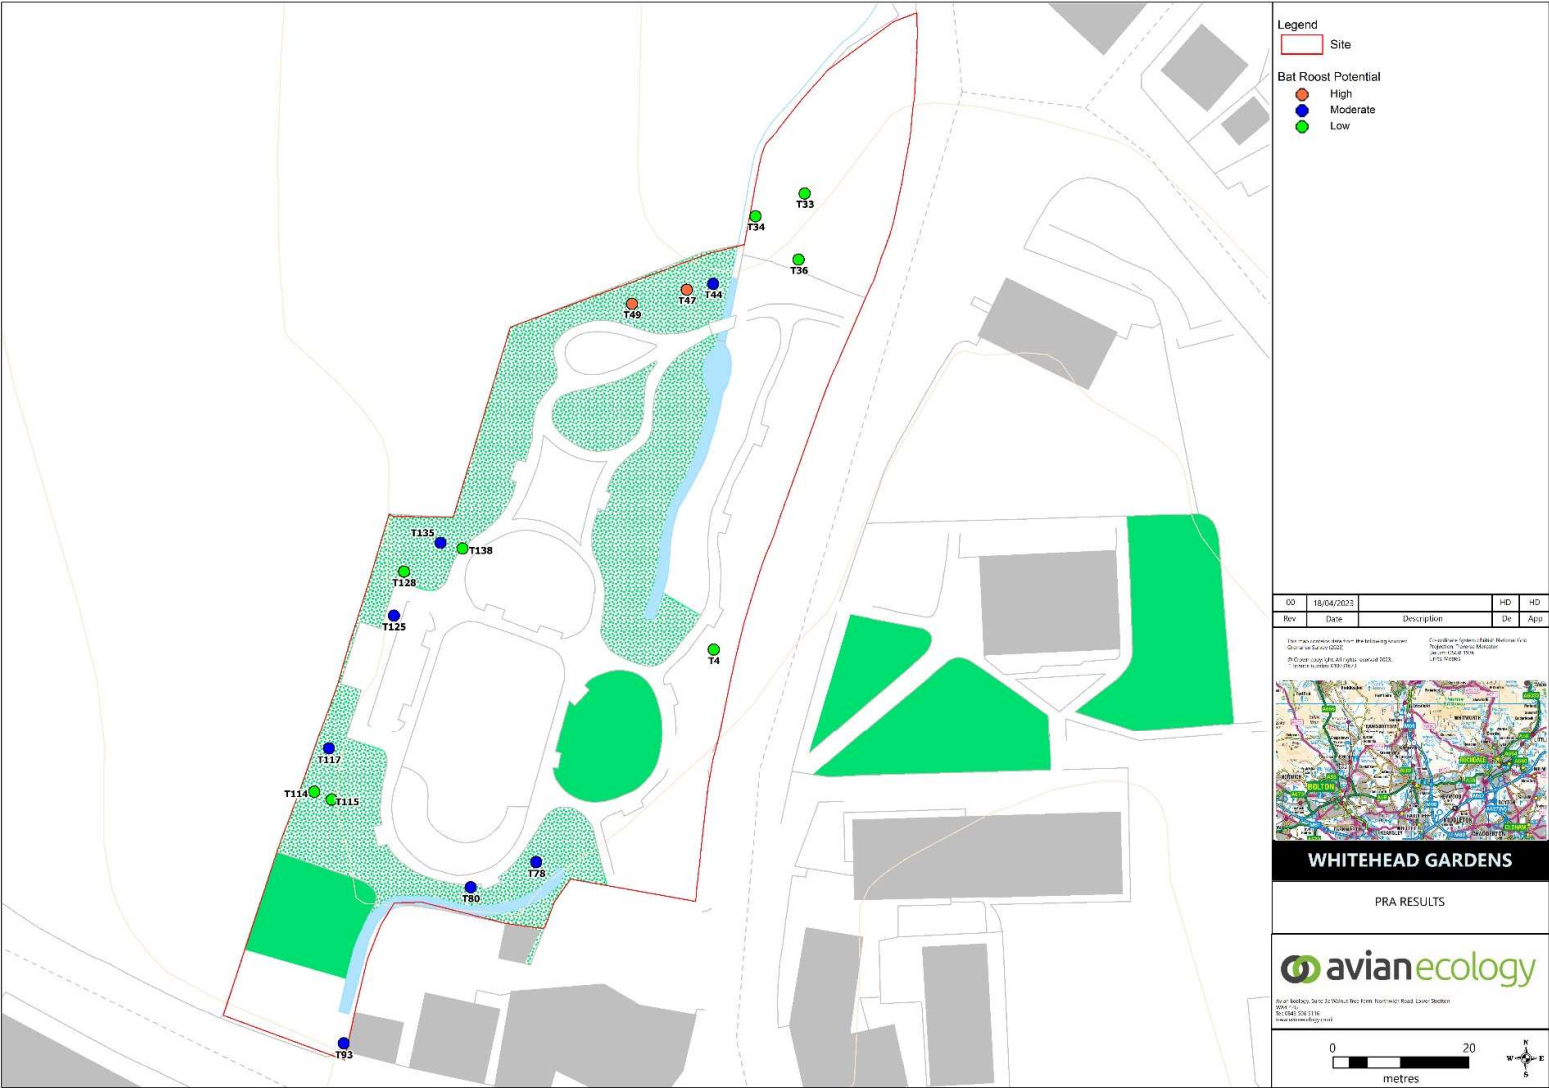
FIGURE 1: PRA Site Plan

- 3.1.1 A total of 141 trees were previously identified on-Site via an independent arboriculture survey.
- 3.1.2 Of trees on-Site, a total of seventeen trees assessed during the PRA were identified as featuring roosting suitability for bats, with roosting potential ranging from **Low** to **High** suitability, in line with descriptions outlined in current BCT guidance (Collins, 2016).
- 3.1.3 A summary of PRA results for all seventeen trees noted to have roost potential is provided in **Table 3.1** below, with supporting images included in **Appendix 2**; the locations of these trees relative to Site are also presented in **Figure 1**.
