CBRE  
**Radcliffe Town Centre**  
Constraints Desk Study

RAD-ARP-RP-CG-0001

Issue 2 | 12 April 2021

Purpose of visit Preliminary site inspection as part of a constraints study

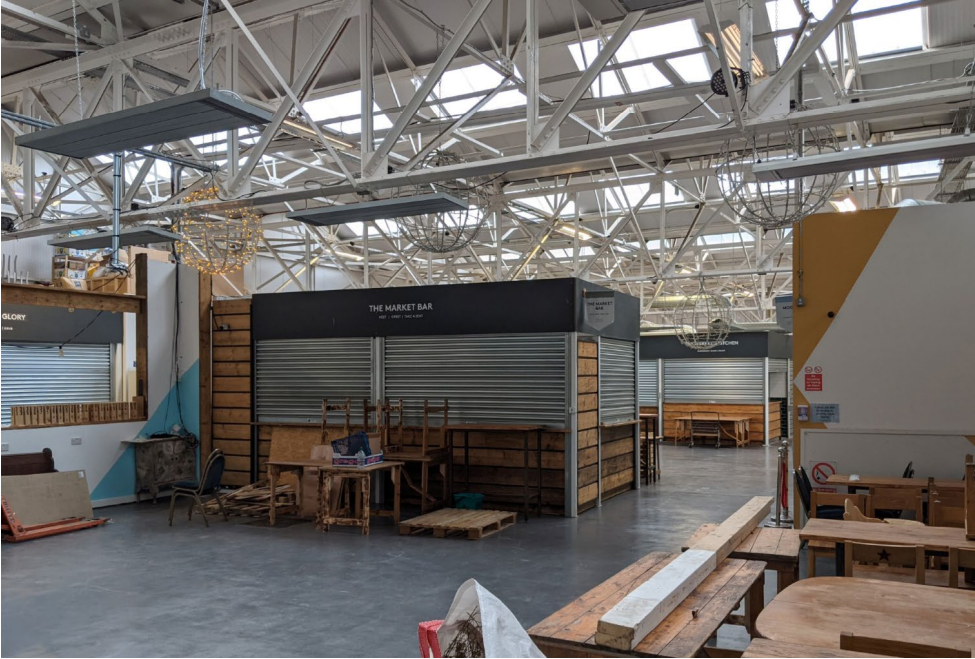
Central area looking north

| Notes | Action by |
|---|---|
| <p><b>Market Hall –</b><br/>Met with Ricky Davies (Market management) and his colleague Chris<br/>Existing market level – Largely brick masonry walled with steel lattice supported roof and concrete floor slab.<br/>RD reported that site was formerly a sweet factory, snooker hall and air raid shelter</p> | |

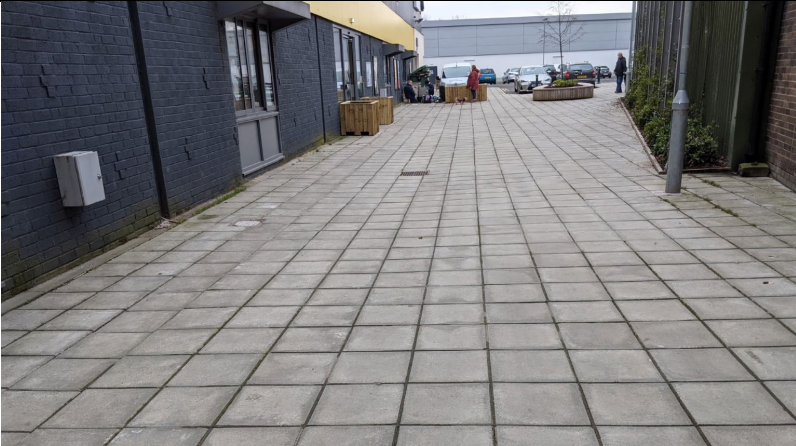
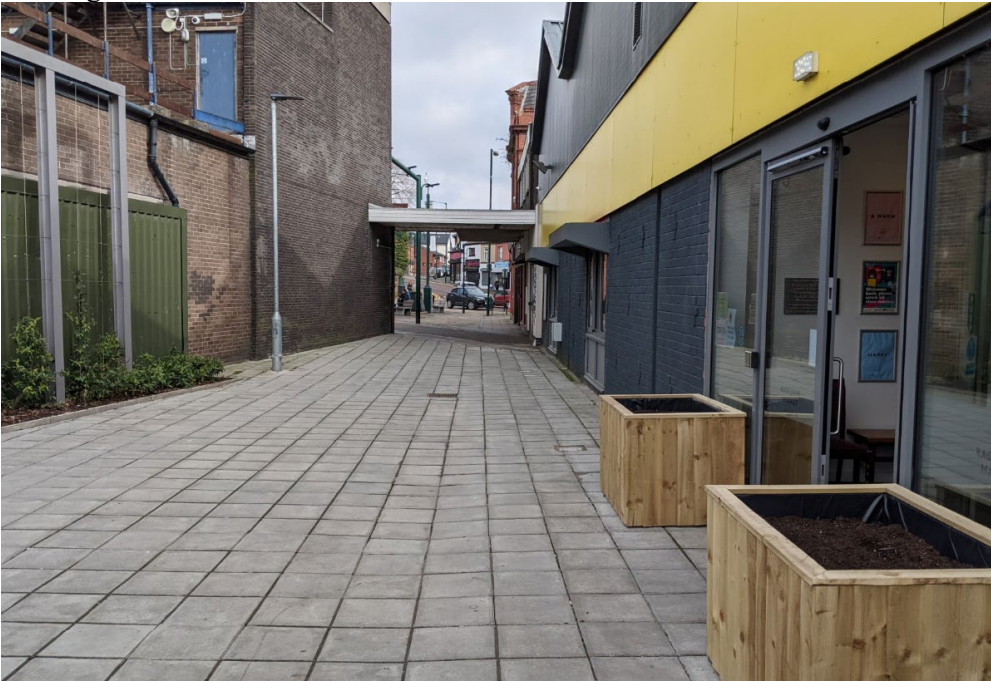
| Notes | Action by |
|---|---|
| <p>Looking west – Market Hall on left</p> <p>Looking east – Market Hall on right.</p> <p>Building to east of market – Market Chambers – Currently disused. Two storeys plus roof space brick building. No access possible. Appears to have a stone walled basement at similar levels.</p> | <p>Topo survey and further inspection of properties required</p> |

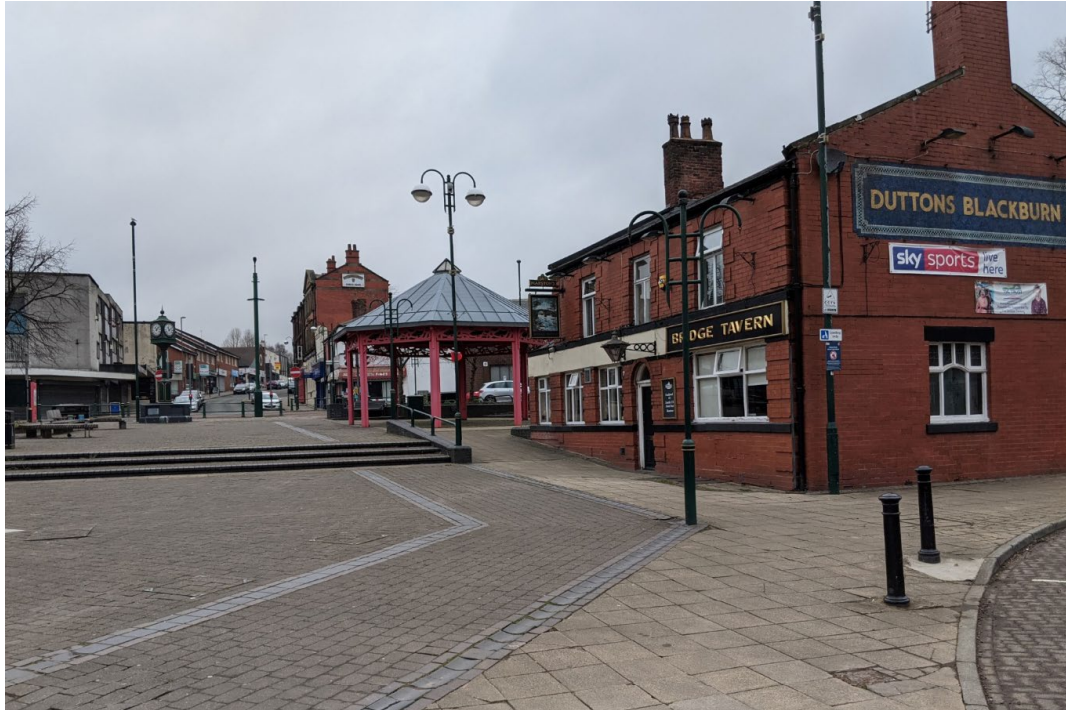
| <p><b>Other areas within South block –</b></p> <p>Bridge Tavern and plaza area/bandstand - Looking north.</p> | |

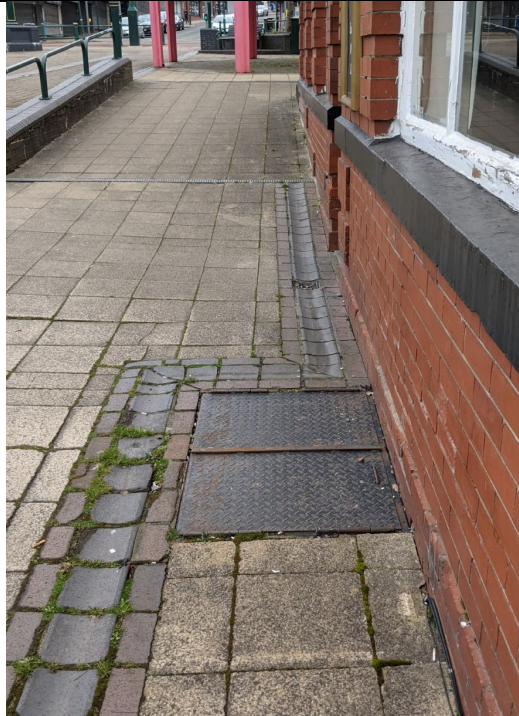
| Notes | Action by |
|---|---|
| <p>Likely cellar access</p> | |

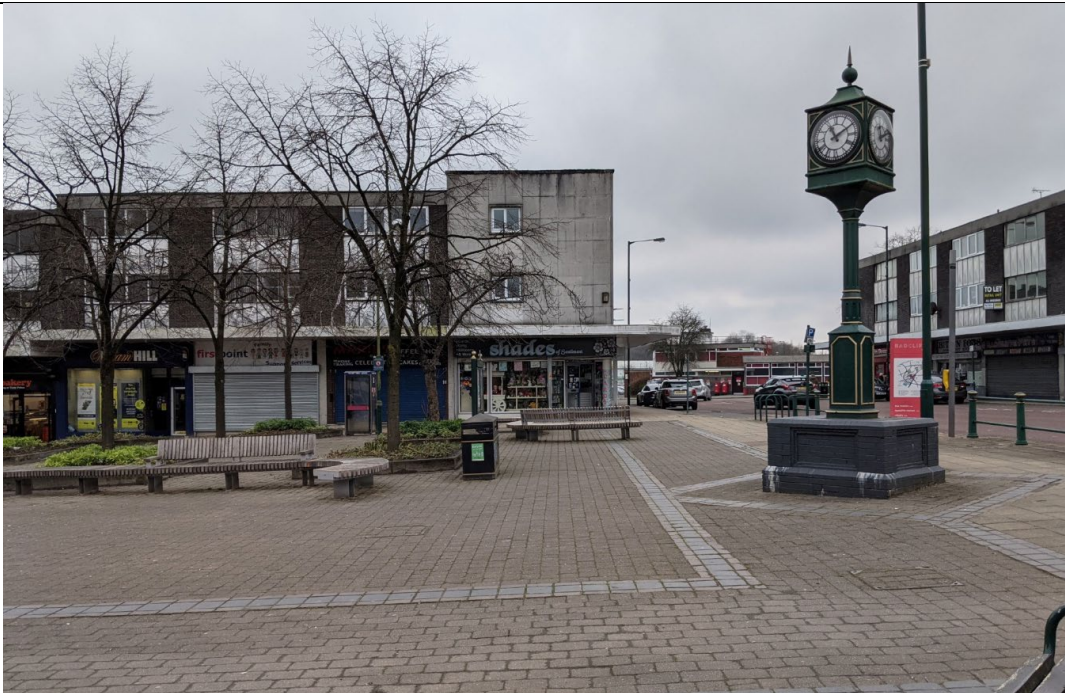
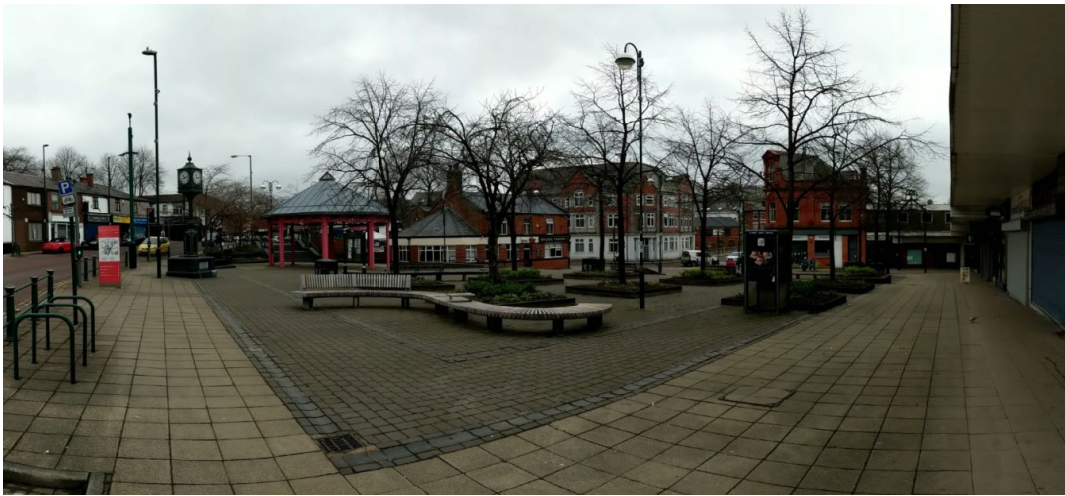
| Notes | Action by |
|---|---|
| <p>Plaza area – looking west to 3 storey retail units</p> <p>Plaza area looking east</p> | |

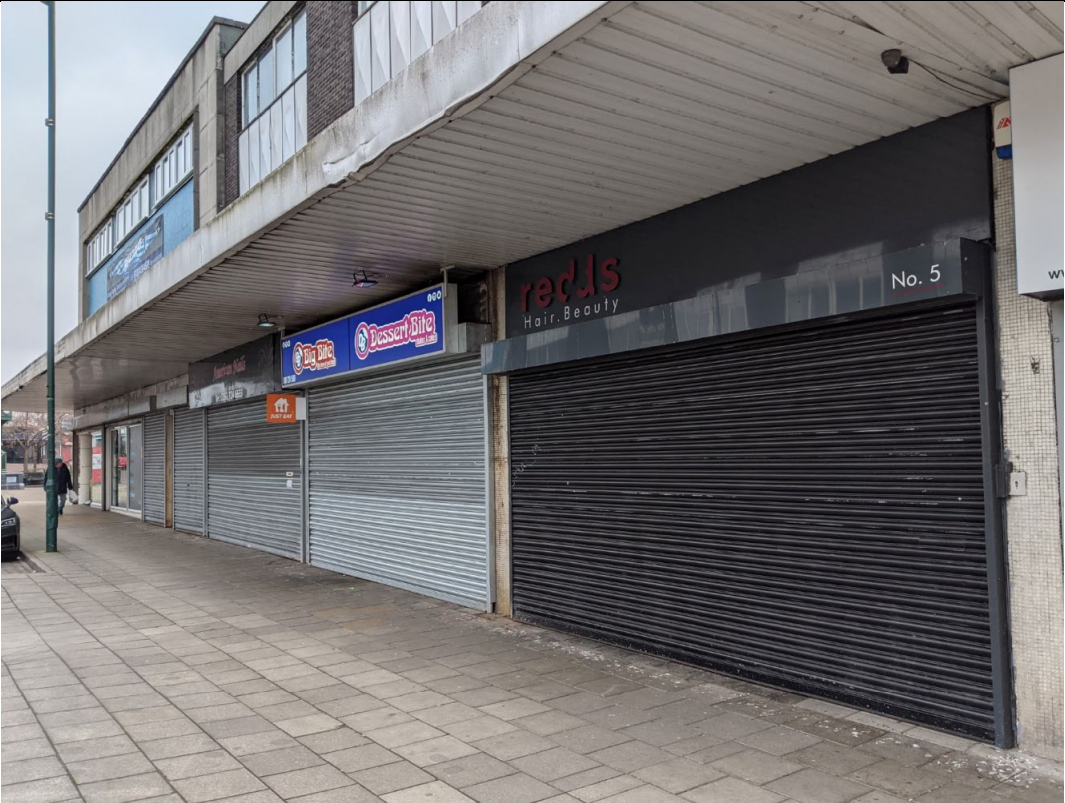
| Notes | Action by |
|---|---|
| <p>Retail units looking east</p> | |

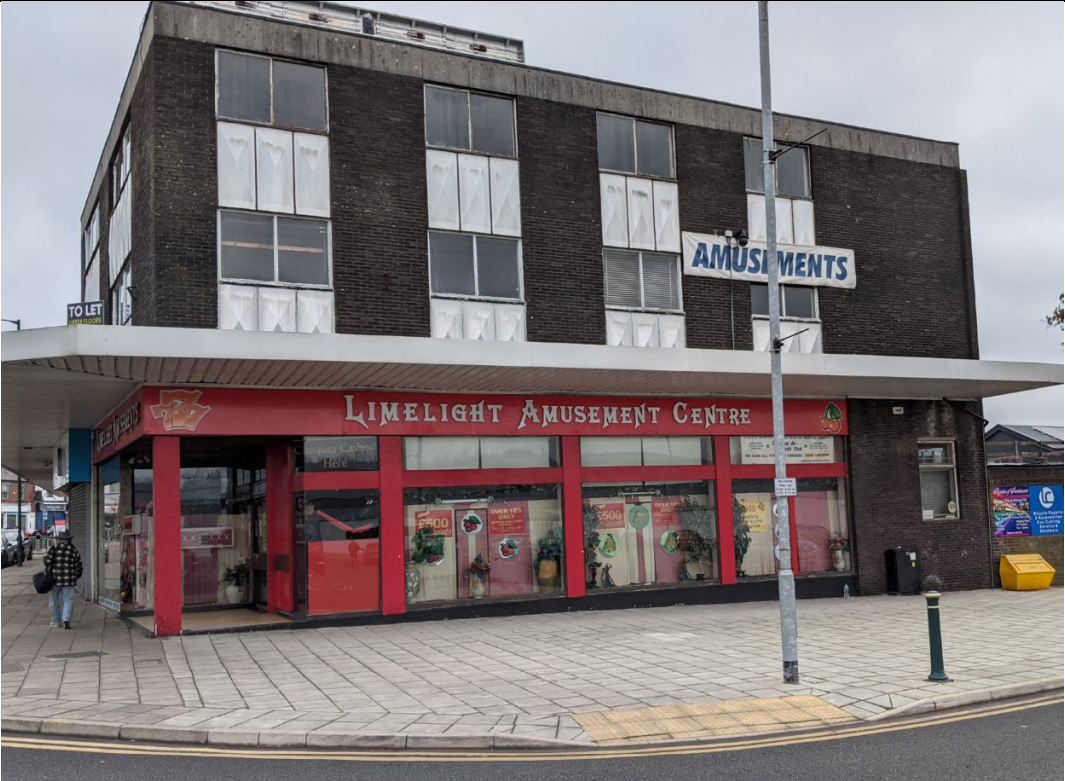
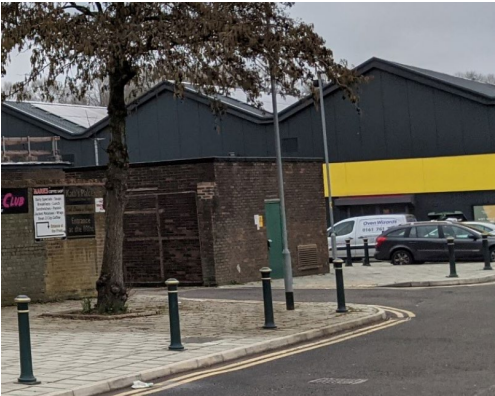
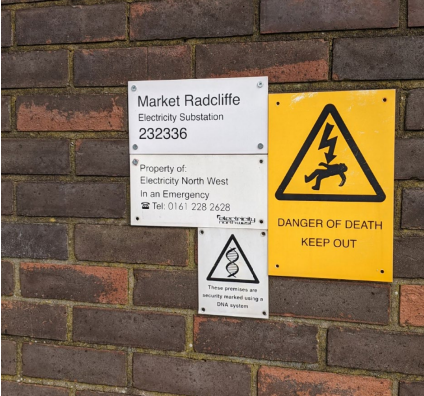
| Notes | Action by |
|---|---|
| <div></div> <p>Retail units corner of Dale and Lidl car park entrance</p> <div></div> <p>ENW Sub station opposite market</p> | |

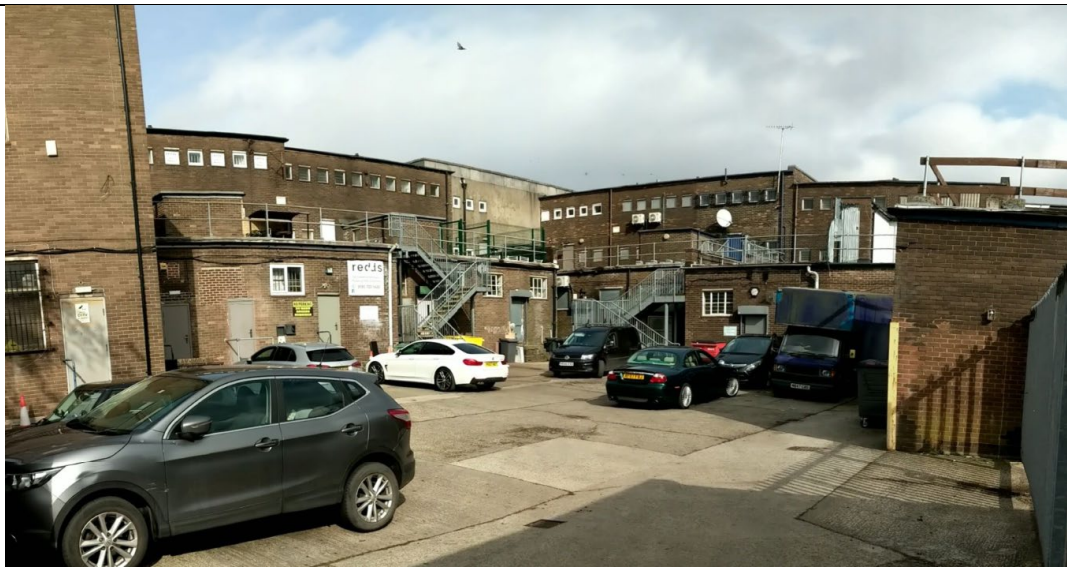
| Notes | Action by |
|---|---|
| <p>South block – back of retail – some single storey</p> | |

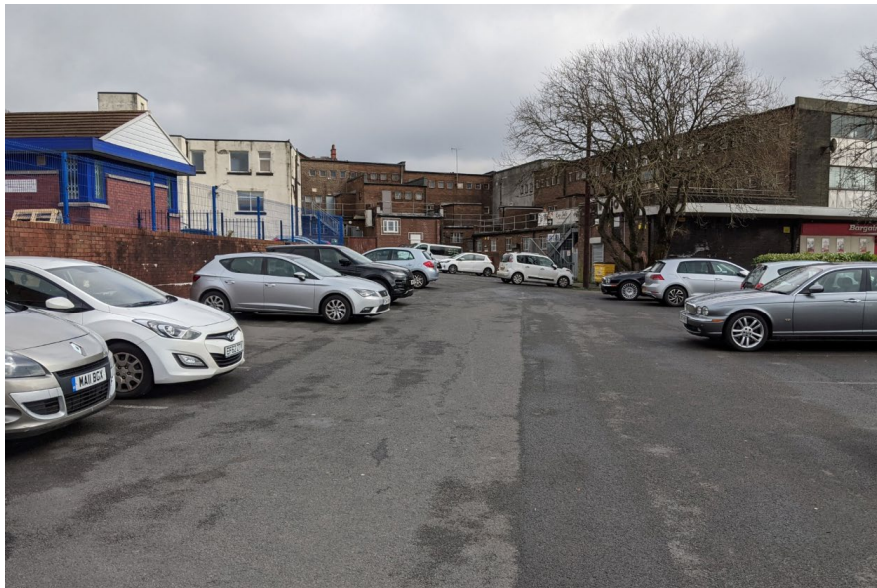
| Notes | Action by |
|---|---|
| <p><b>North block –</b></p> <p>Comprises an existing surface car park – Railway St and 3 storey retail/office buildings</p> | |

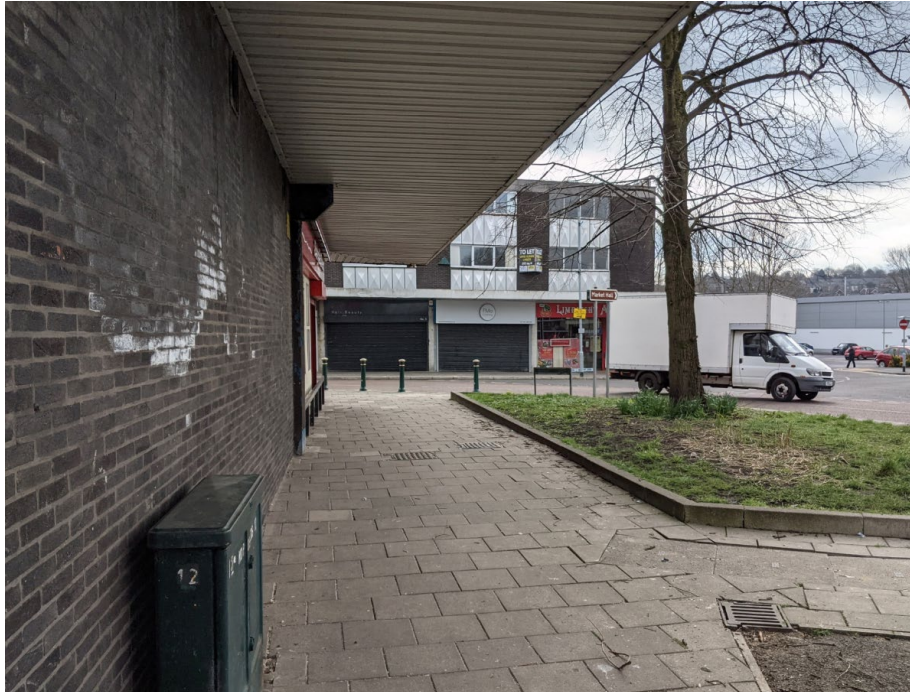
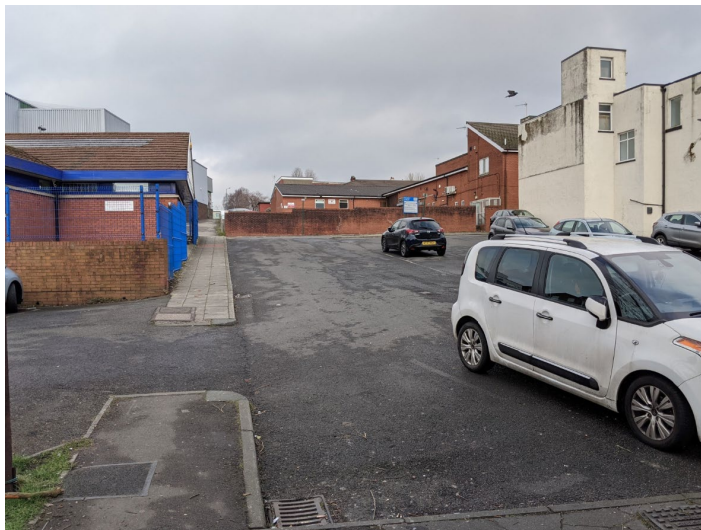
| Notes | Action by |
|---|---|
| <p>Railway St – Public car park</p> <p>Western edge of north block, looking south.</p> <p>Increase in ground levels towards Railway St – Looking North</p> | |

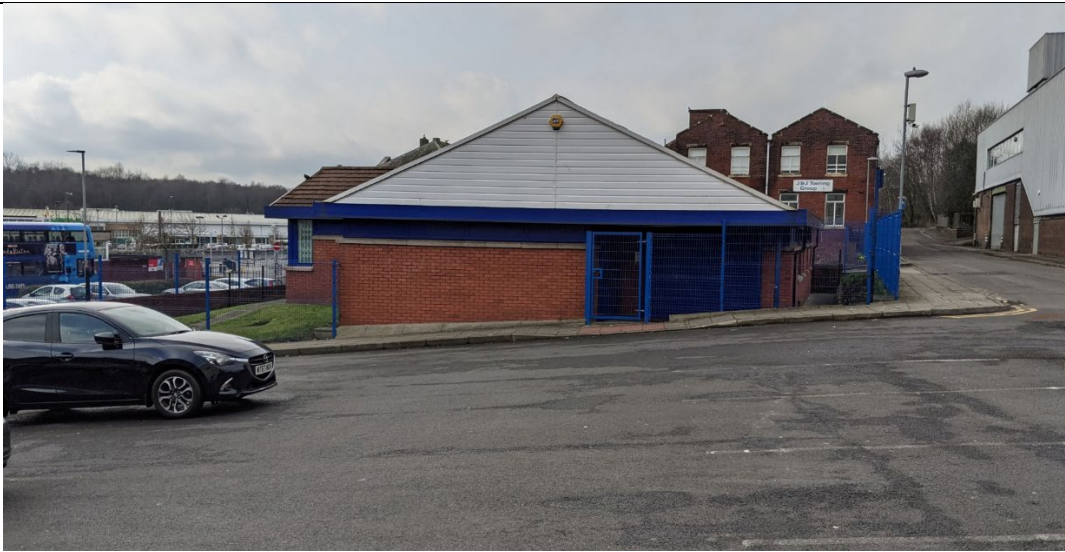
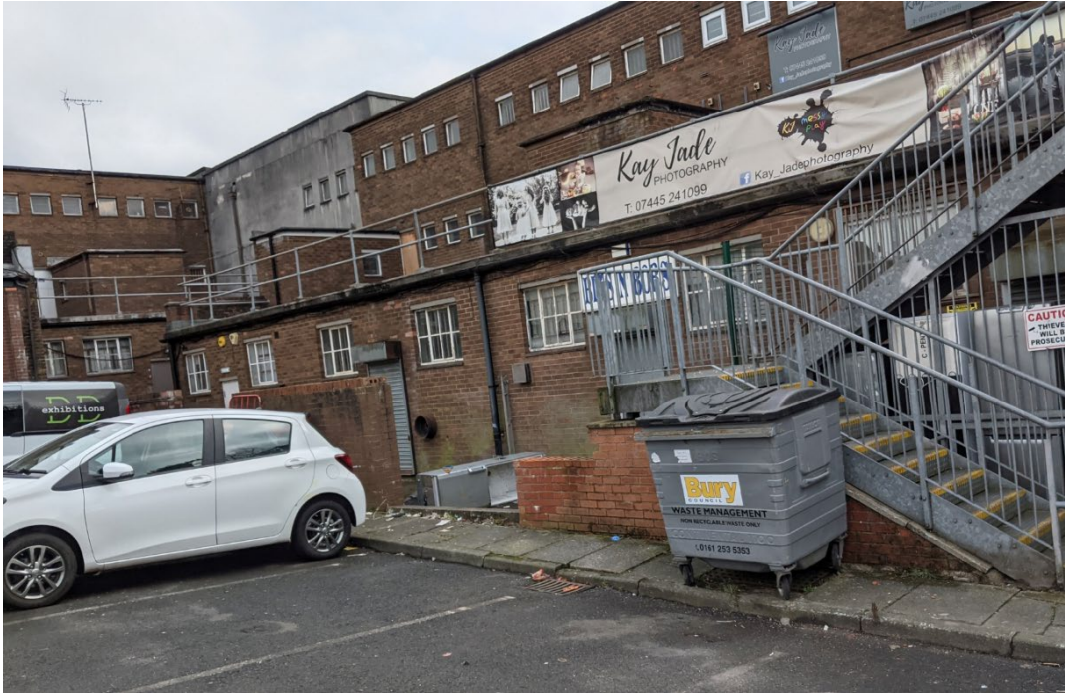
| Notes | Action by |
|---|---|
| <p>Increase in ground levels towards Railway St – Looking West</p> <p>Back of North Block retail.</p> | |

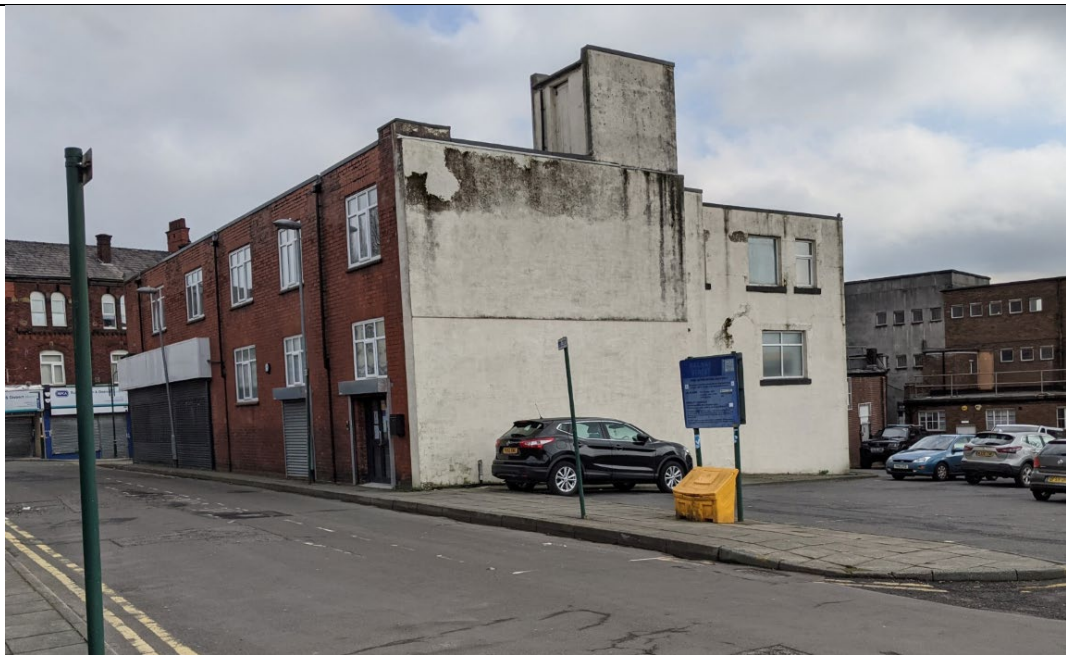
| Notes | Action by |
|---|---|
| <p>Retail/Commercial block – Railway St</p> | |

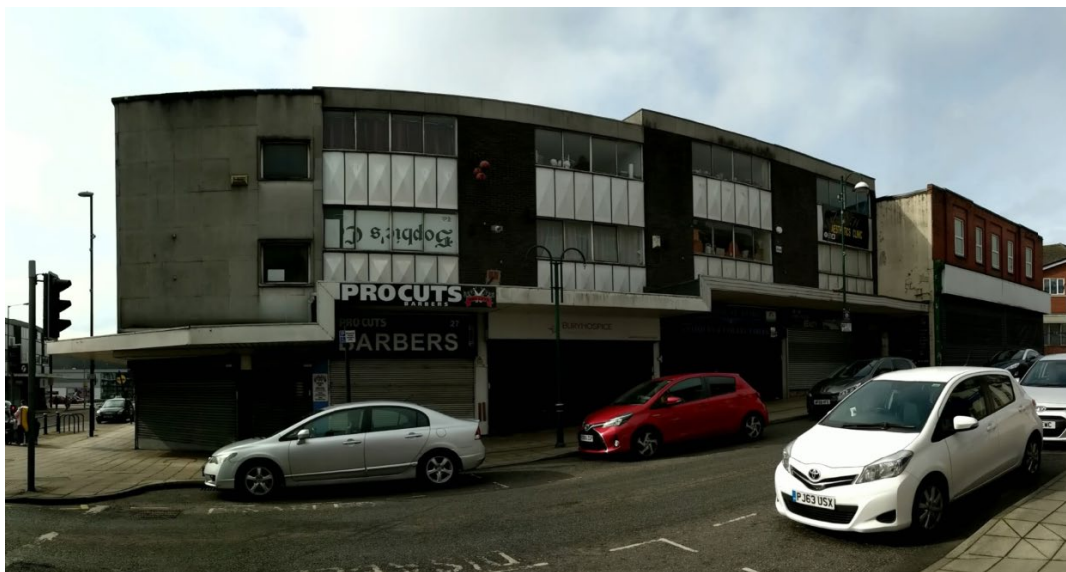
| Notes | Action by |
|---|---|
| <p>Eastern façade of North block – looking west</p> | |

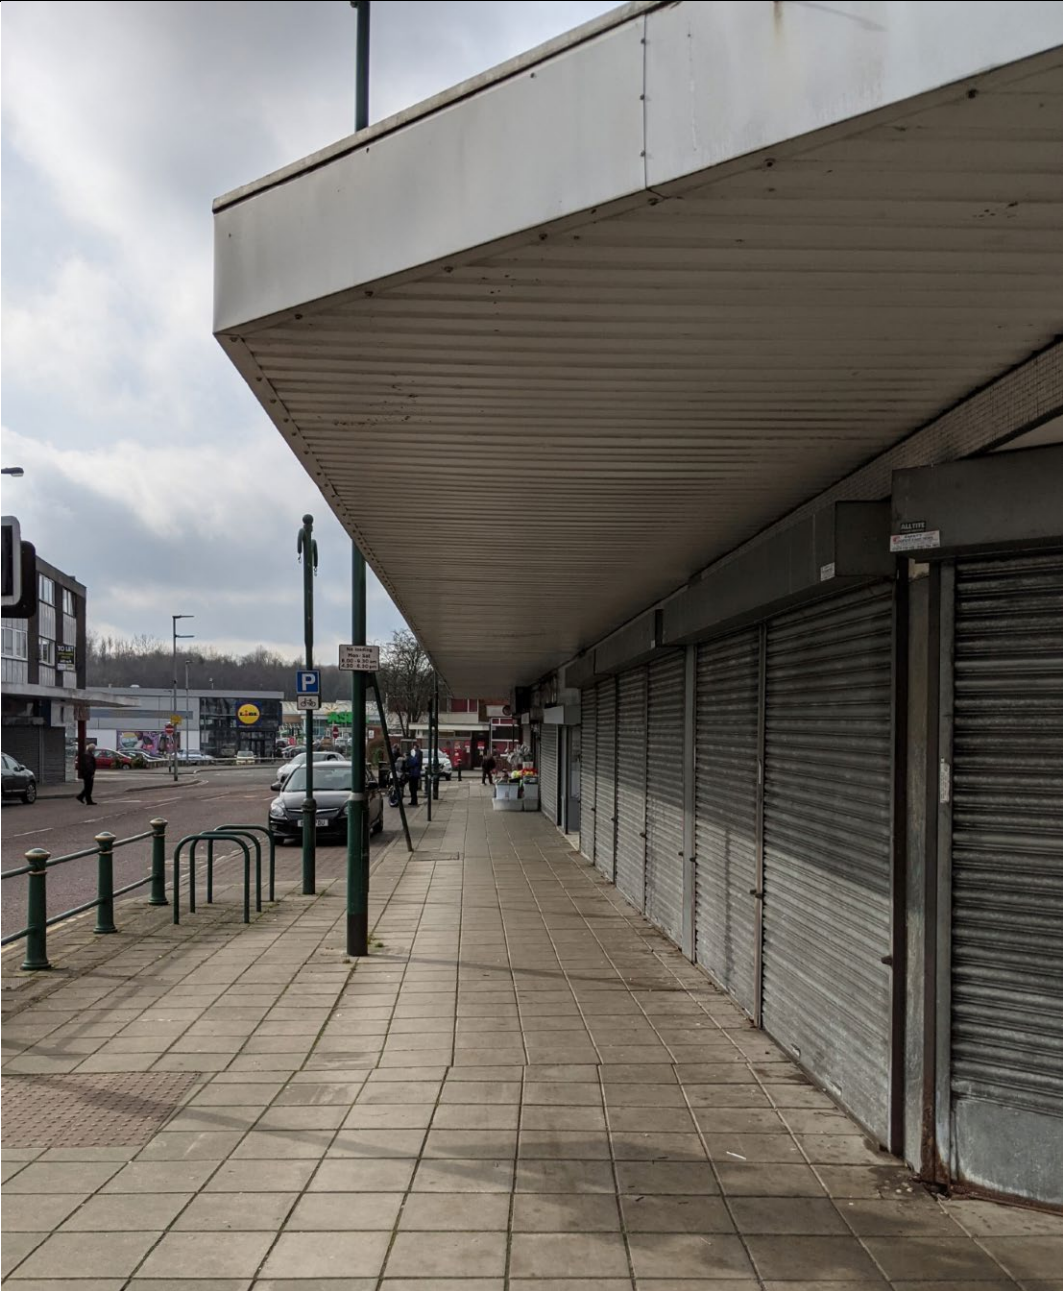
| Notes | Action by |
|---|---|
| <p>SE Corner of North block – Blackburn and Dale St – looking west</p> | |
