# Highway Condition Report

## Stopes Road, Little Lever – S278 Highway Improvements

### Taylor Wimpey Manchester

27 August 2024

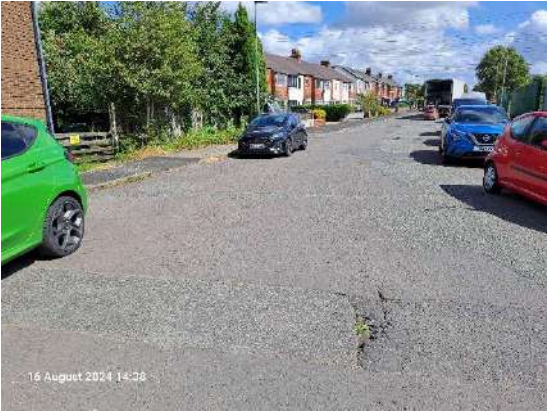
**Photographs 32 to 38** illustrate the numerous areas of patch surfacing repairs to the existing carriageway, either because of utilities works or general localised failure of the road surface due to trafficking. The images presented within appendix B also demonstrate cracking and complete failure of the road surface, with weed growth along the kerb/channel and within the failed areas of the surface.

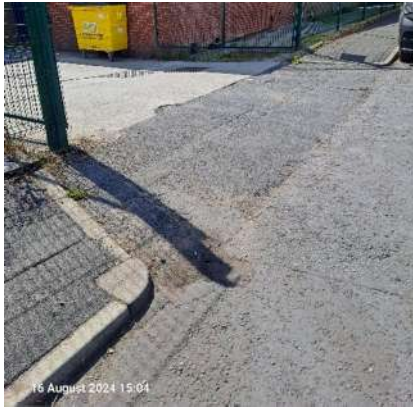
**Photographs 39 to 42** show damage to the carriageway in the vicinity of the existing access to 'Aurora Foods'. The entrance area itself is in poor condition, with deterioration of the road surface along the channel / joint resulting in an uneven channel profile (which may result in poor drainage and surface ponding). The utilities trench scar across the access is showing signs deterioration and there is a section where the binder is worn down to expose the aggregates within the road surface.
