**SITE VISIT REPORT 15220-HYD-XX-XX-SVR-GE-1018**

**SHEET NO.: 6 of 18**

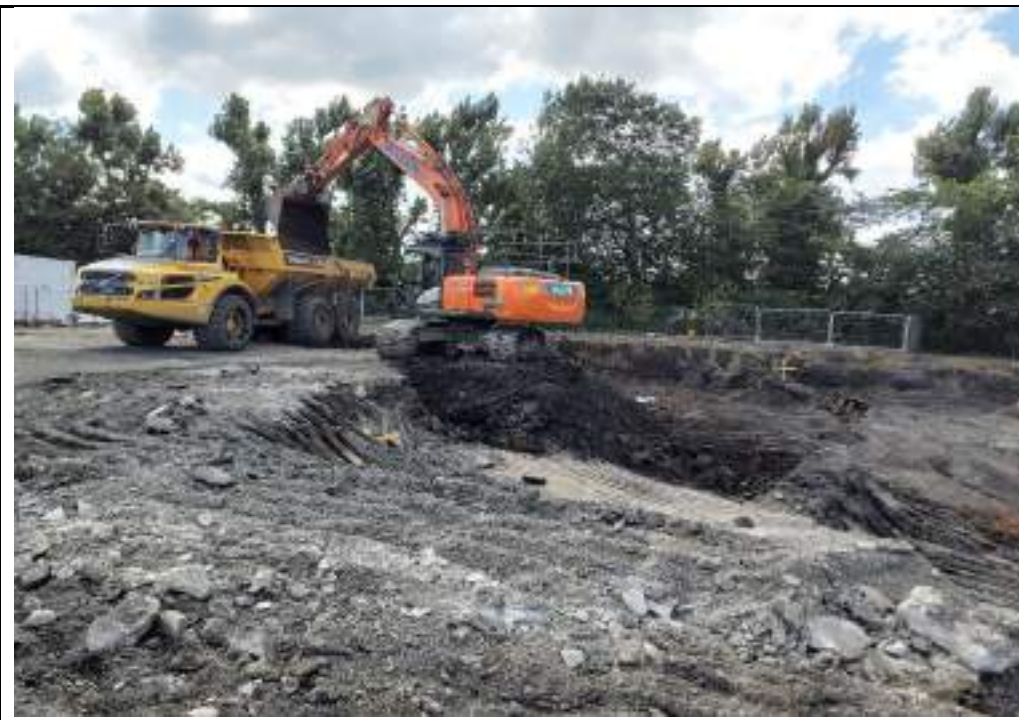
Photograph 2: Excavation of landfill Made Ground in south of the site.

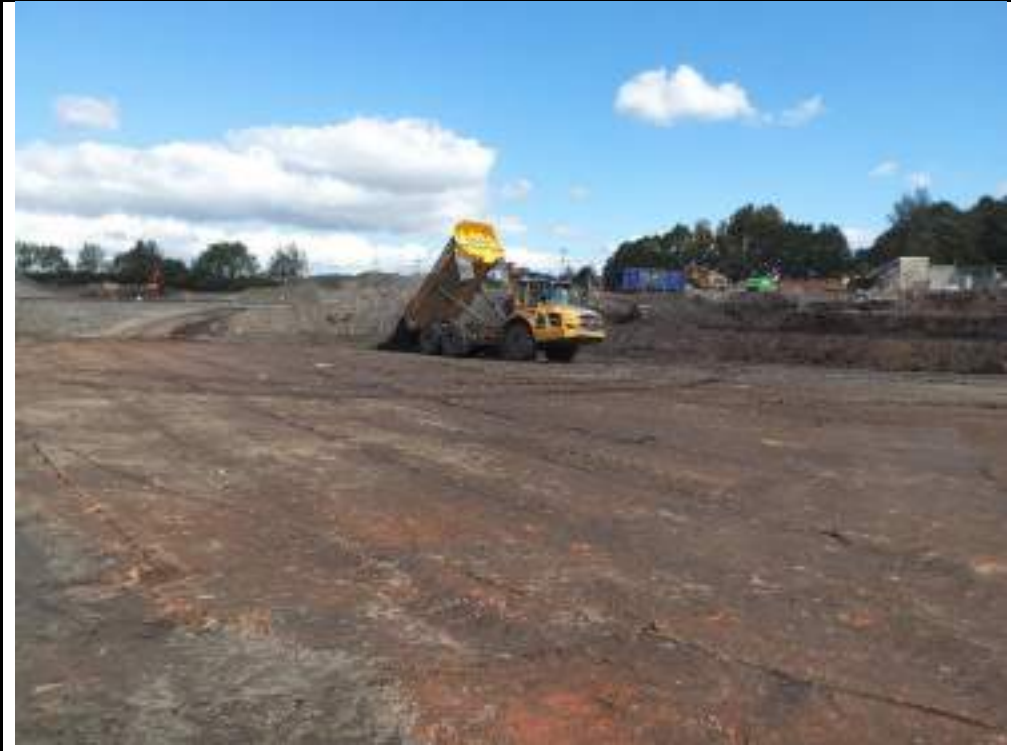
Photograph 3: Backfilling of central part of the site using excavated material from south of the site.

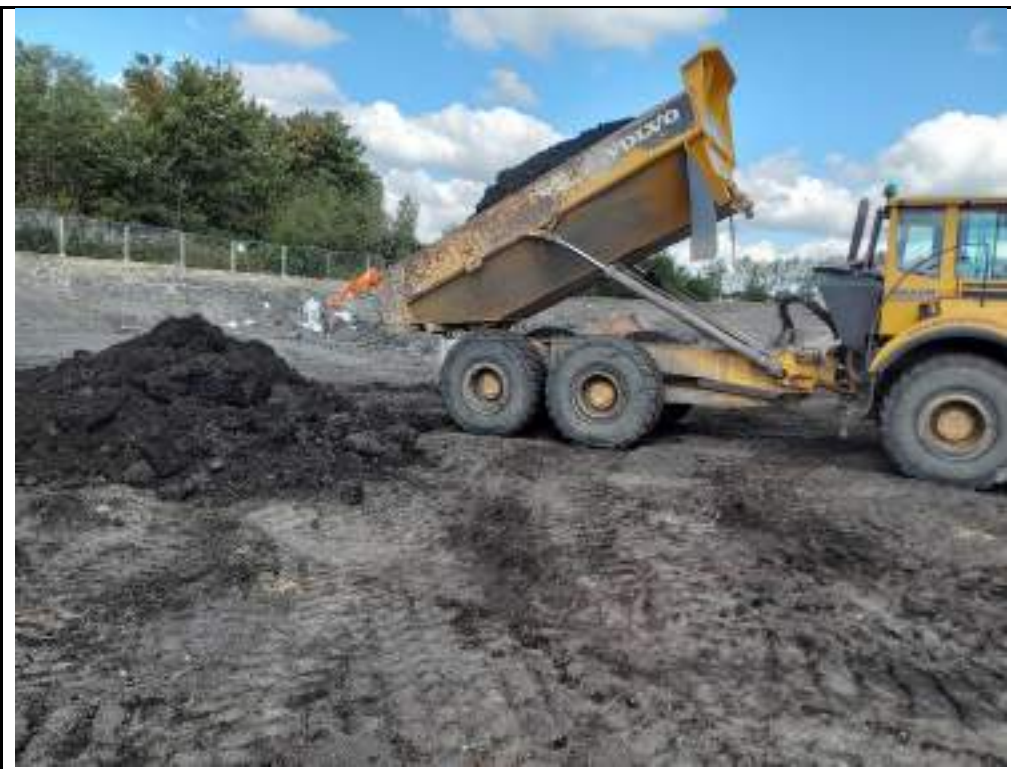
Photograph 4: Backfilling of western part of the site using excavated material from south of the site.

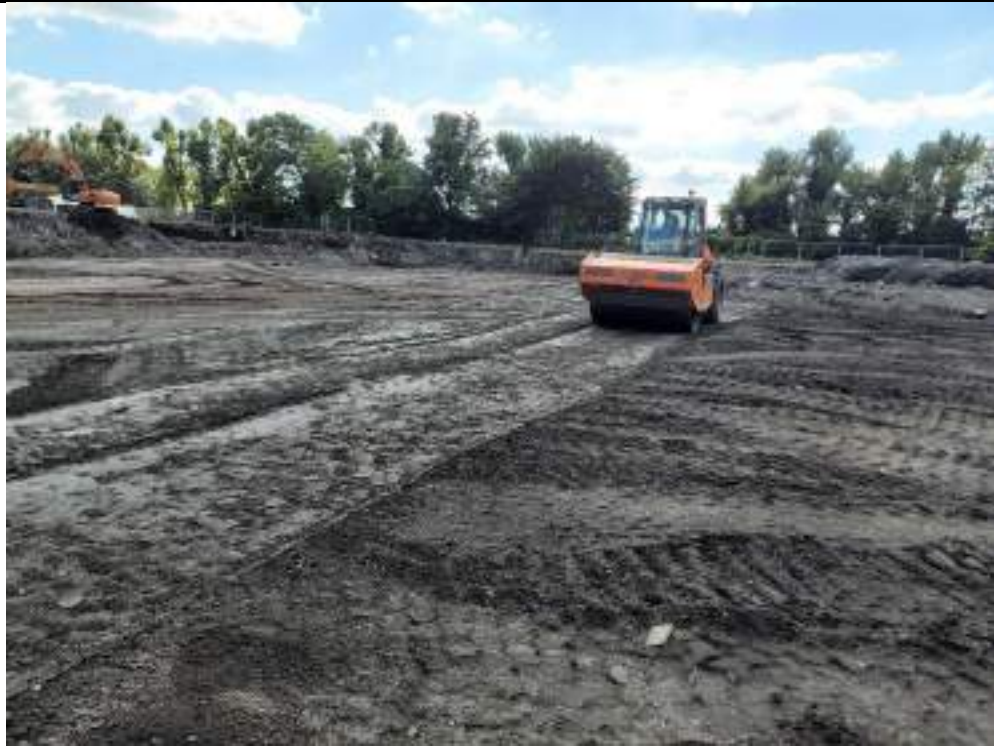
Photograph 5: Proof rolling of fill material in southern part of the site.

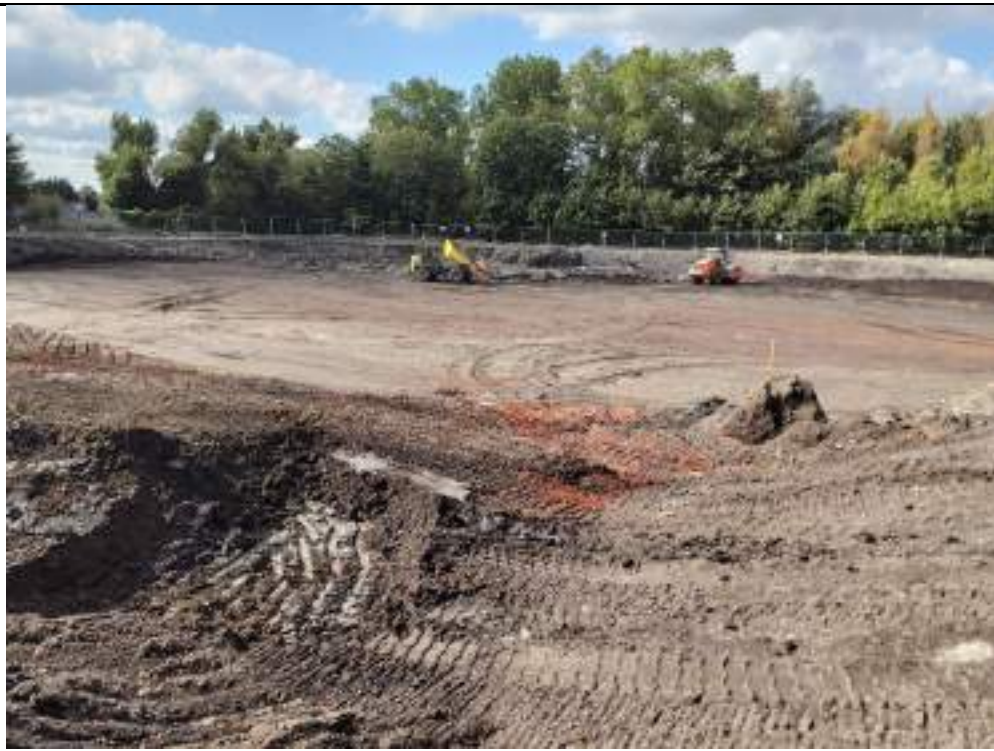
Photograph 6: Proof rolling of fill material in western part of the site.

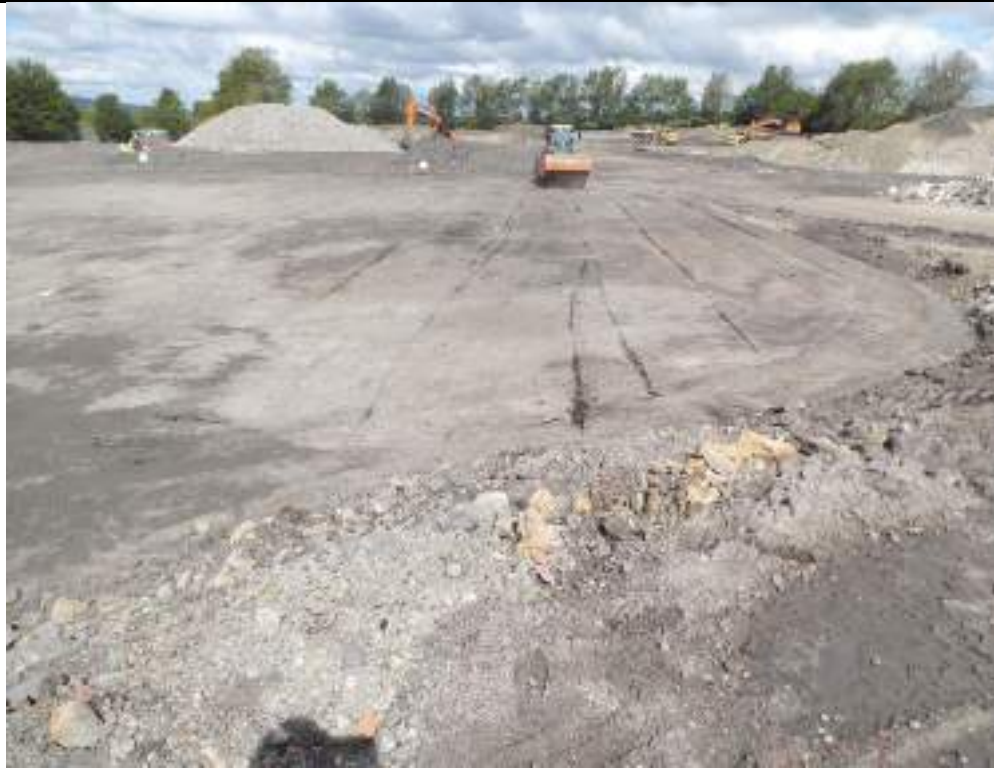
Photograph 7: Proof rolling of fill material in northern part of the culvert.

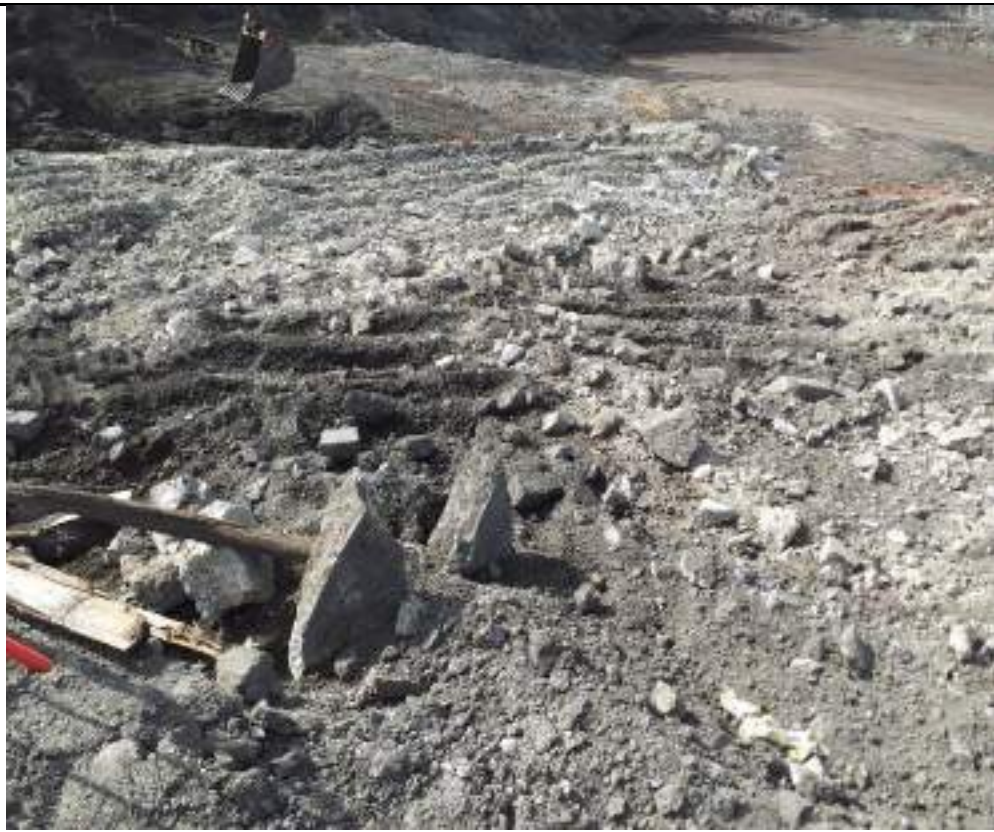
Photograph 8: Deleterious material in excavation in southern part of the site.

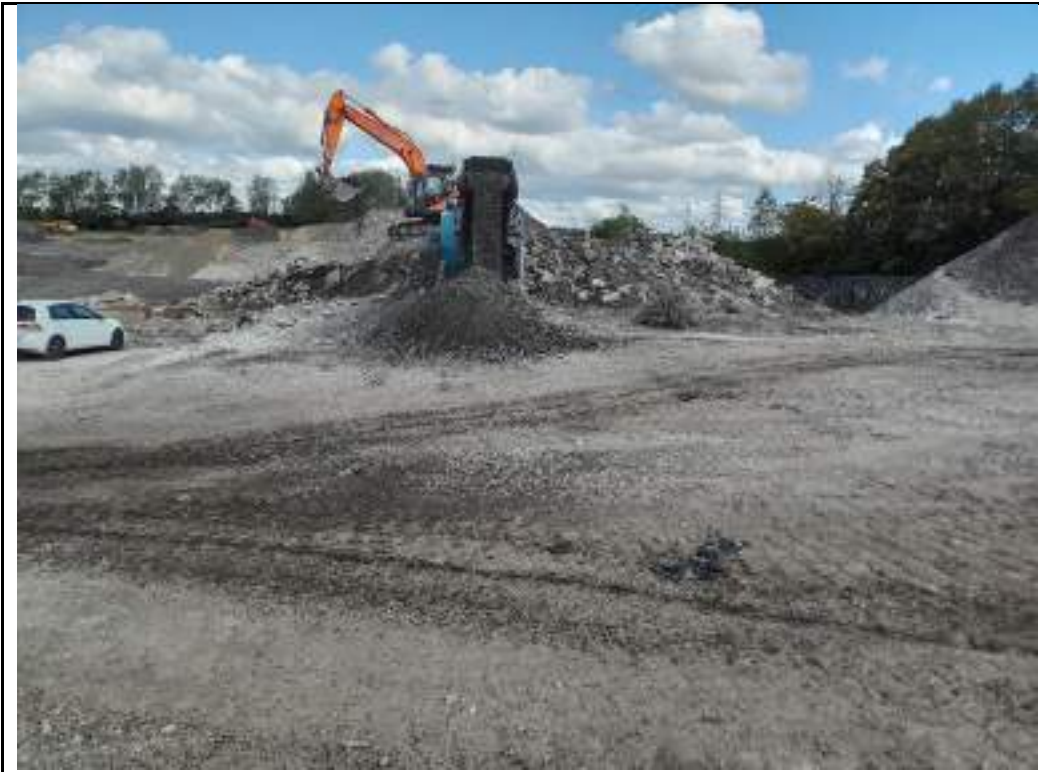
Photograph 91: Crushing concrete and asphalt in eastern part of the site.

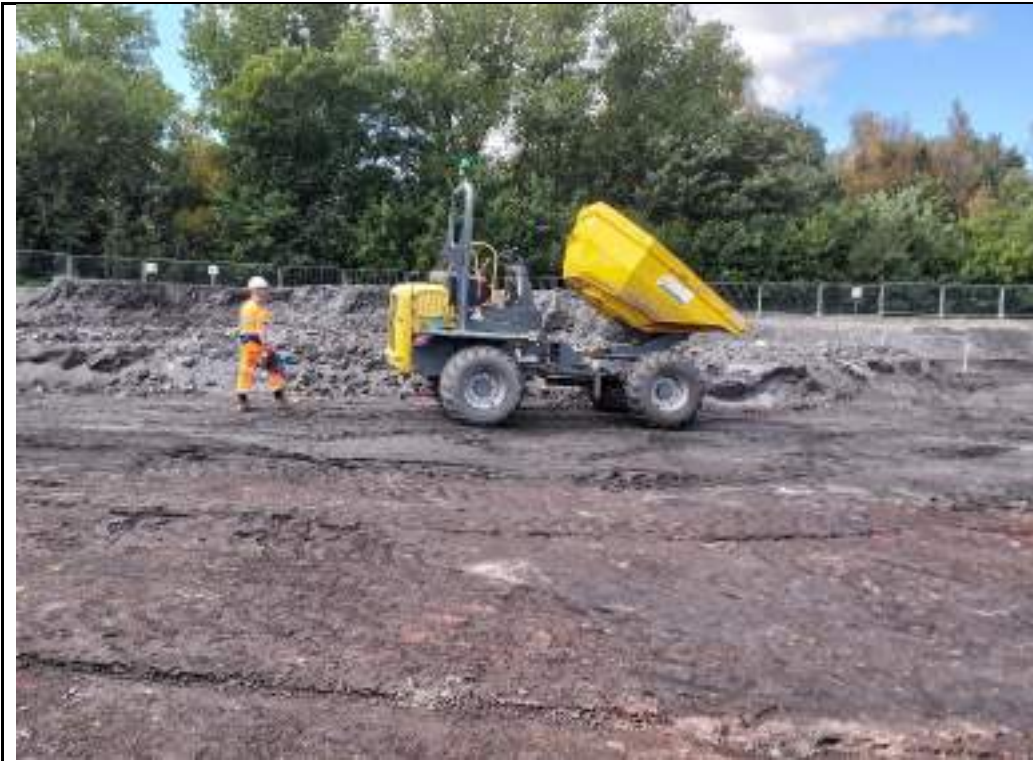
Photograph 125: Hand picking of deleterious material in southwest of the site.

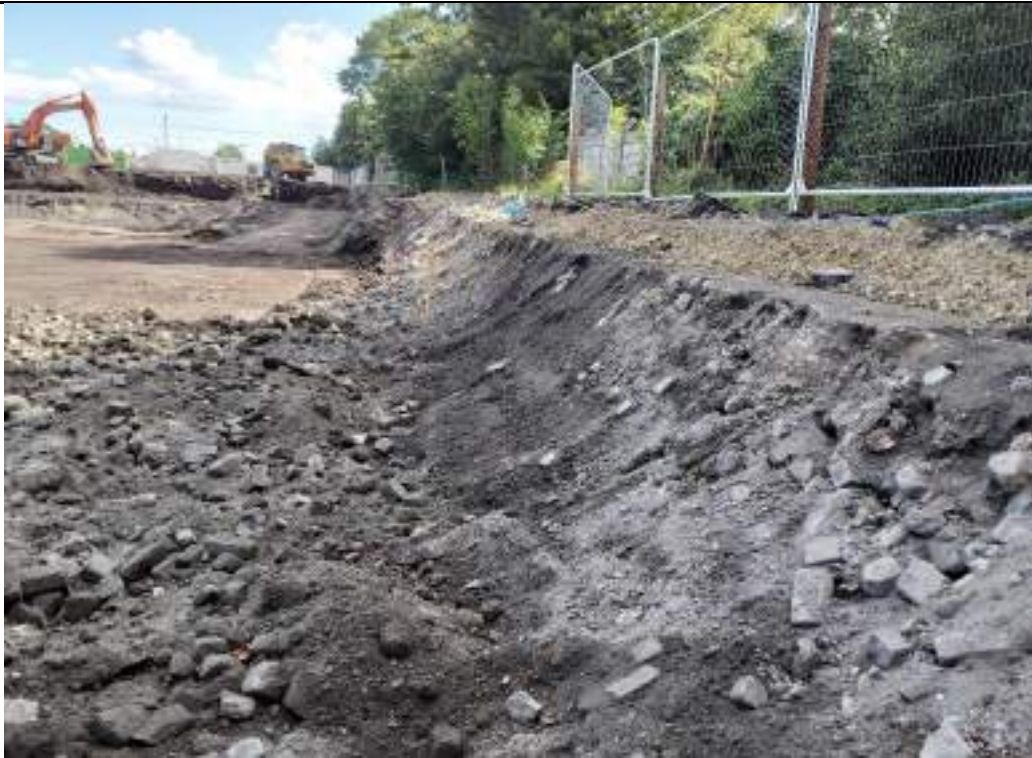
Photograph 136: Southern boundary of the site. Looking towards the east.

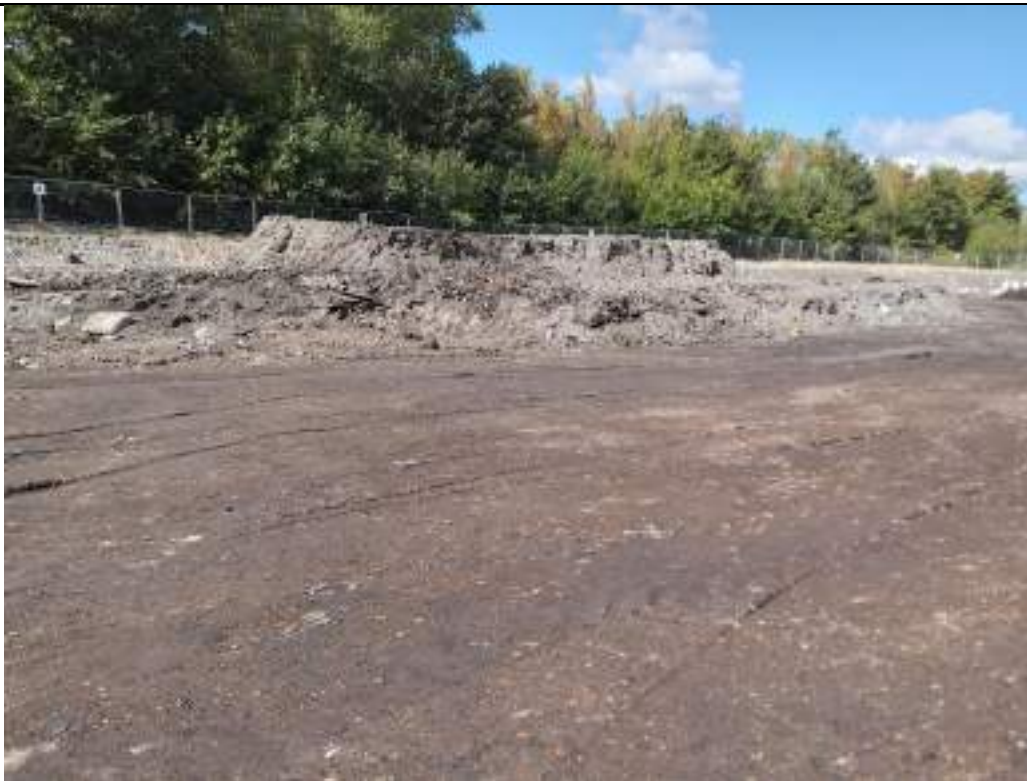
Photograph 158: Asbestos contaminated stockpile after asbestos picking operation in southwest of the site.

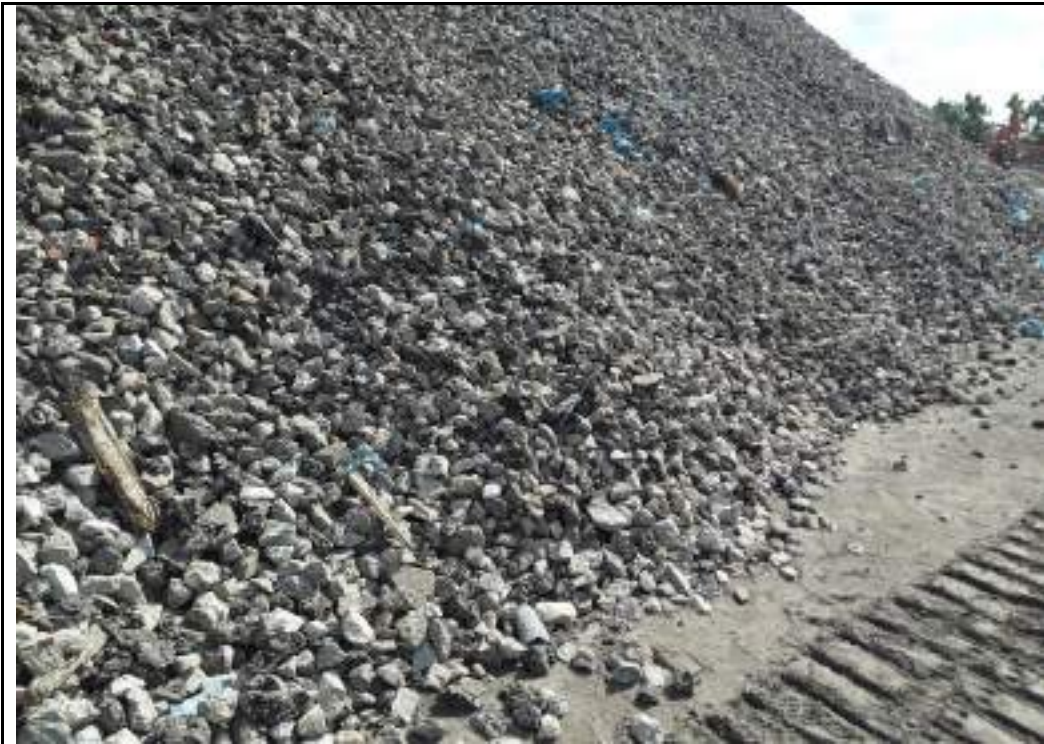
Photograph 169: Wood and plastic in crushed concrete and asphalt stockpile in northwest of the site. VHE to provide constituent parts testing

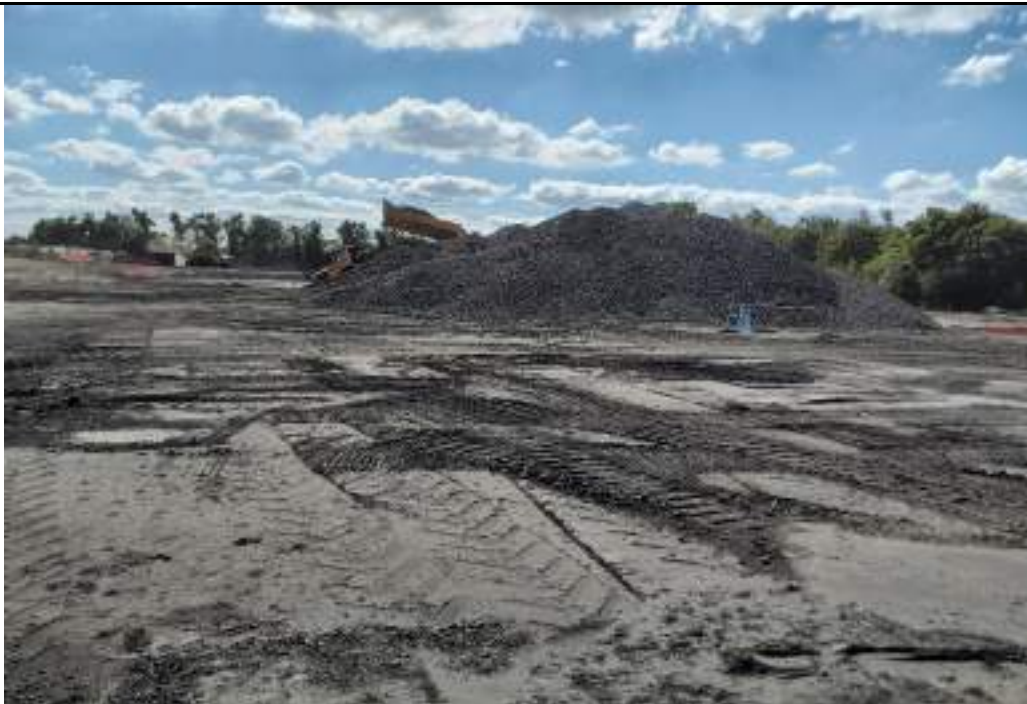
Photograph 20: Stockpiling crushed concrete and asphalt in northwest of the site.

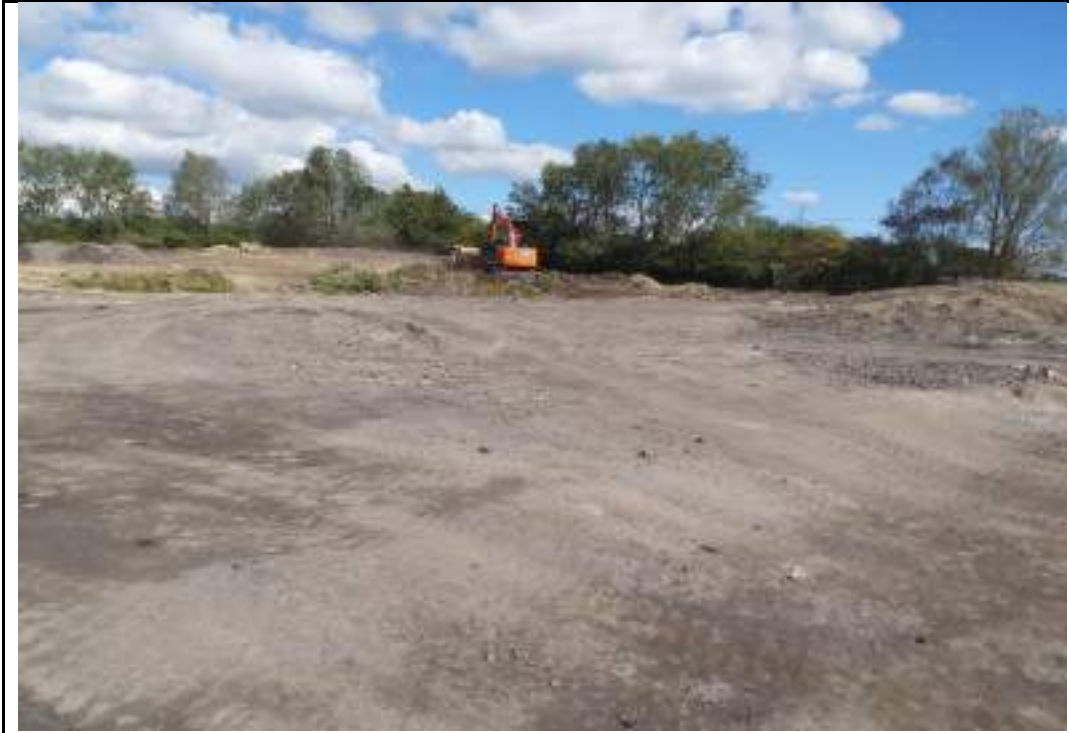
Photograph 179: Excavation of topsoil in northeast of the site.

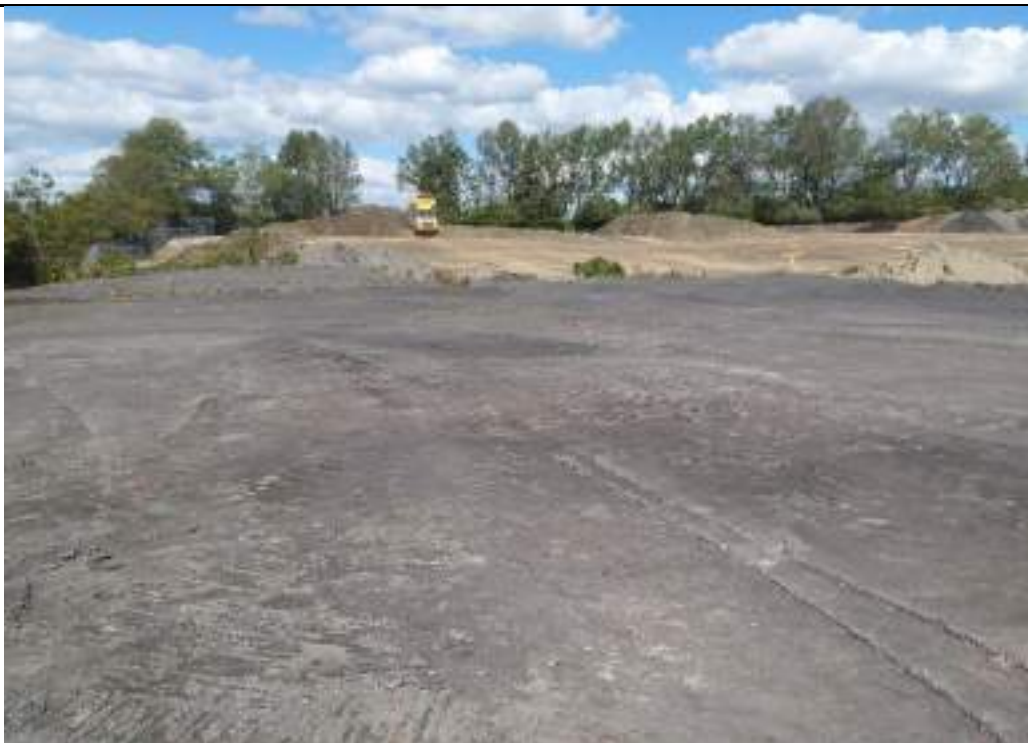
Photograph 20: Stockpiling excavated topsoil from northeastern part of the site in northwest of the site.

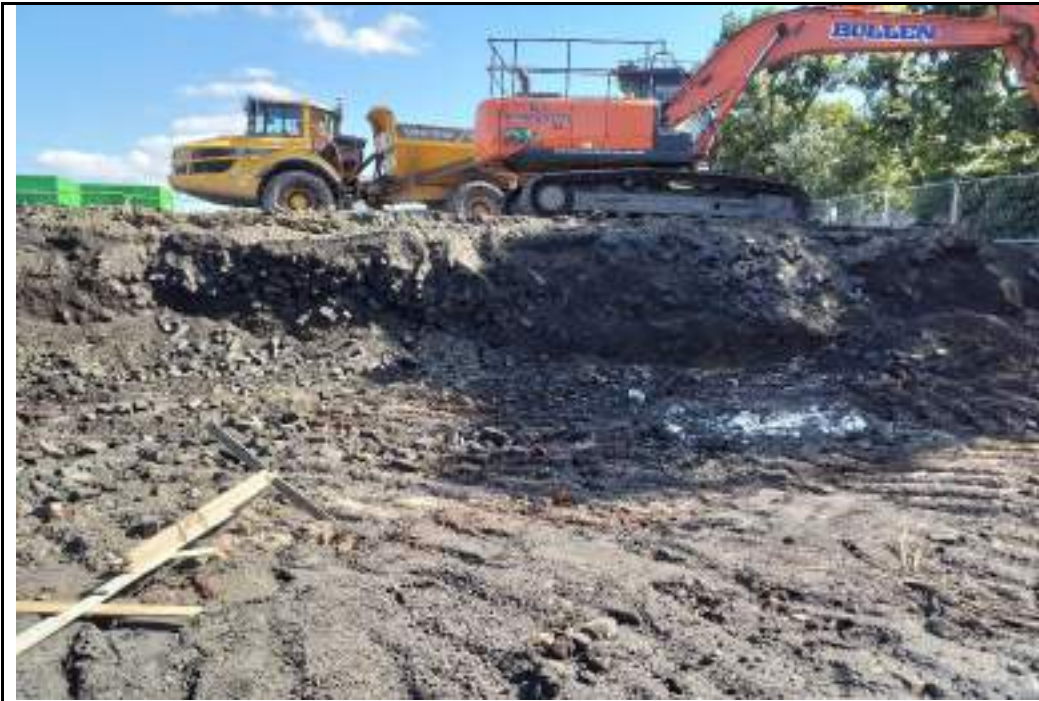
Photograph 189: High quantity of bricks and deleterious material in excavation in southern part of the site. Avoid transporting to fill areas

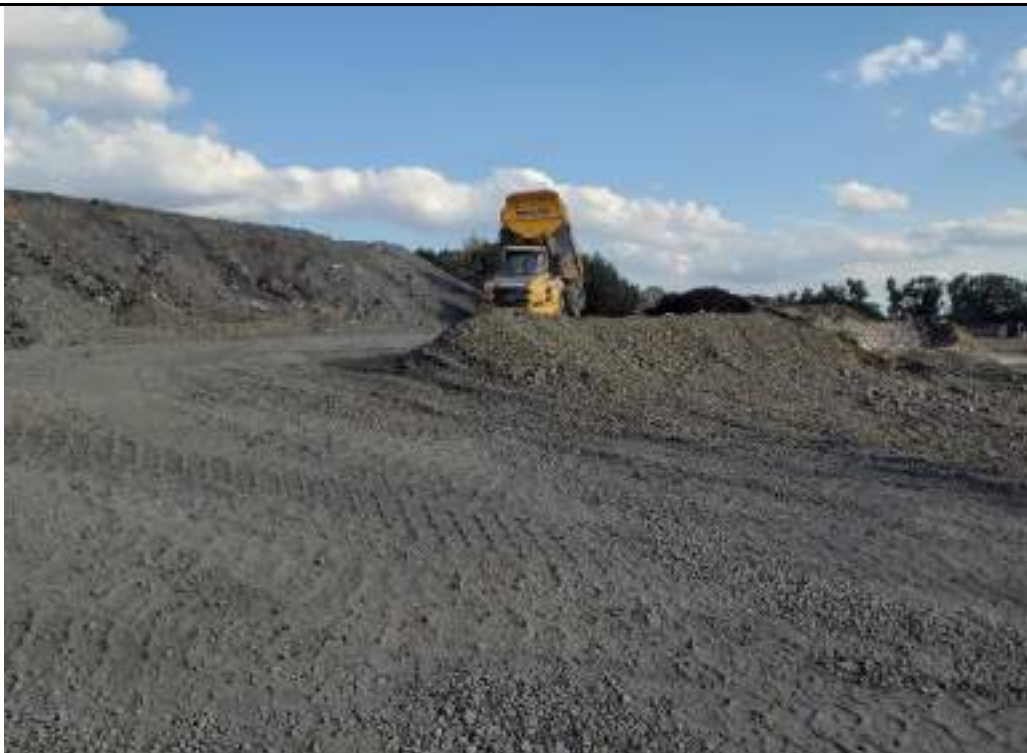
Photograph 20: Stockpiling excavated landfill Made Ground from southern part of the site in stockpile in northeast of the site.

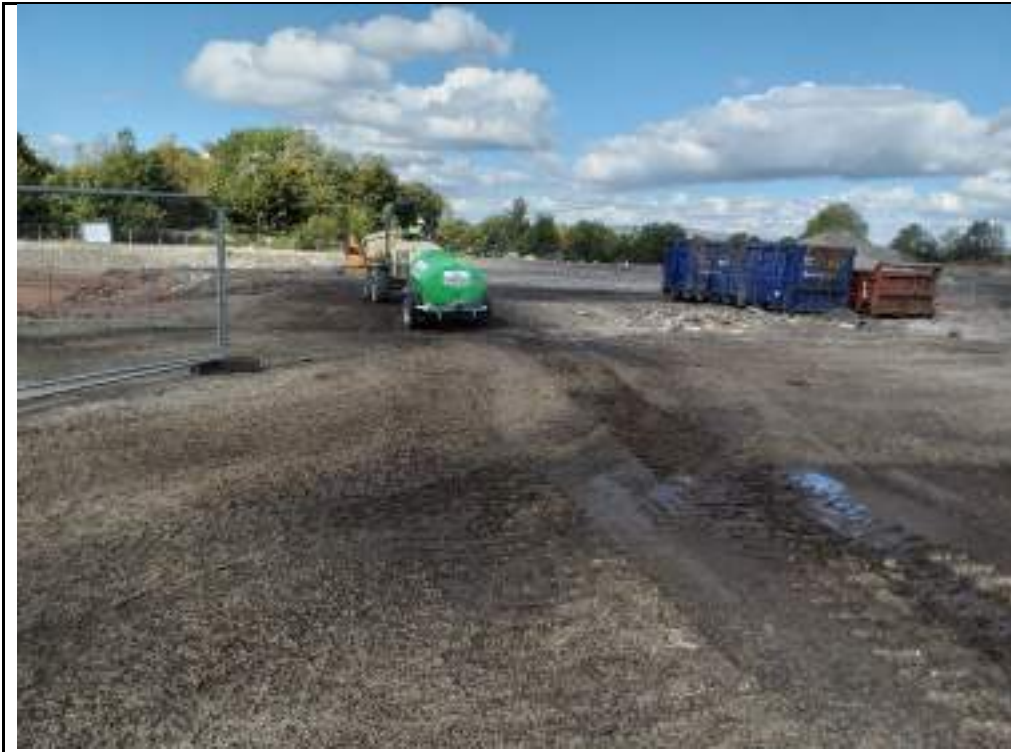
Photograph 199: Reducing dust on site using dust suppression unit.

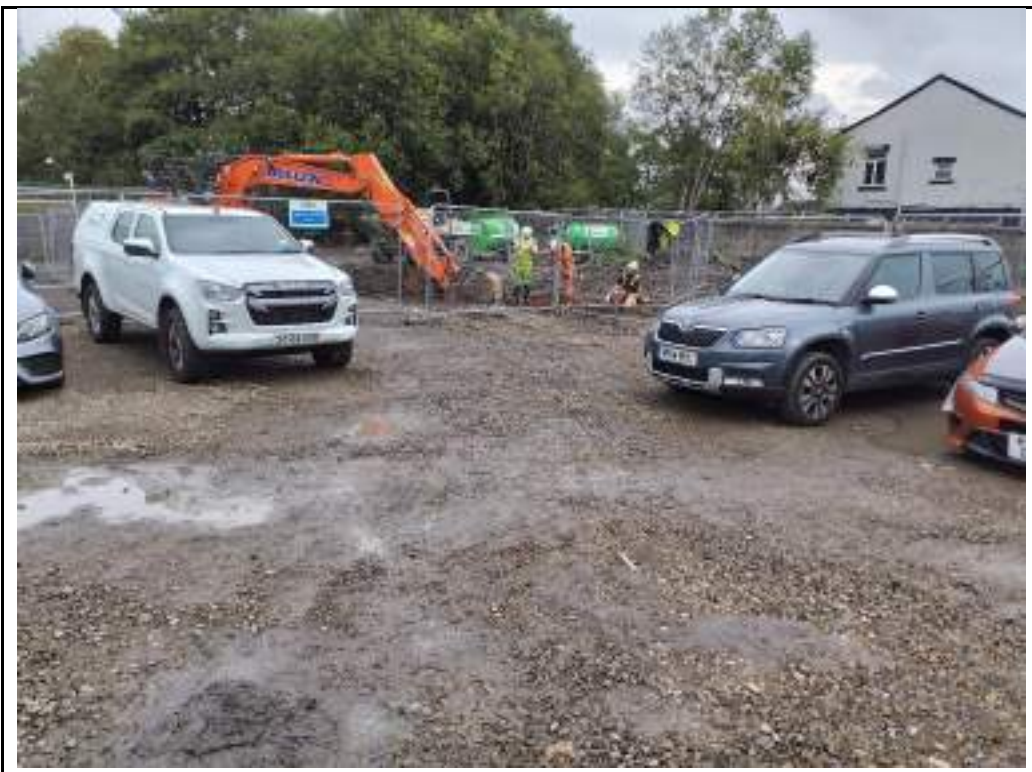
Photograph 2: Excavation for electricity cable in southeastern part of the site.

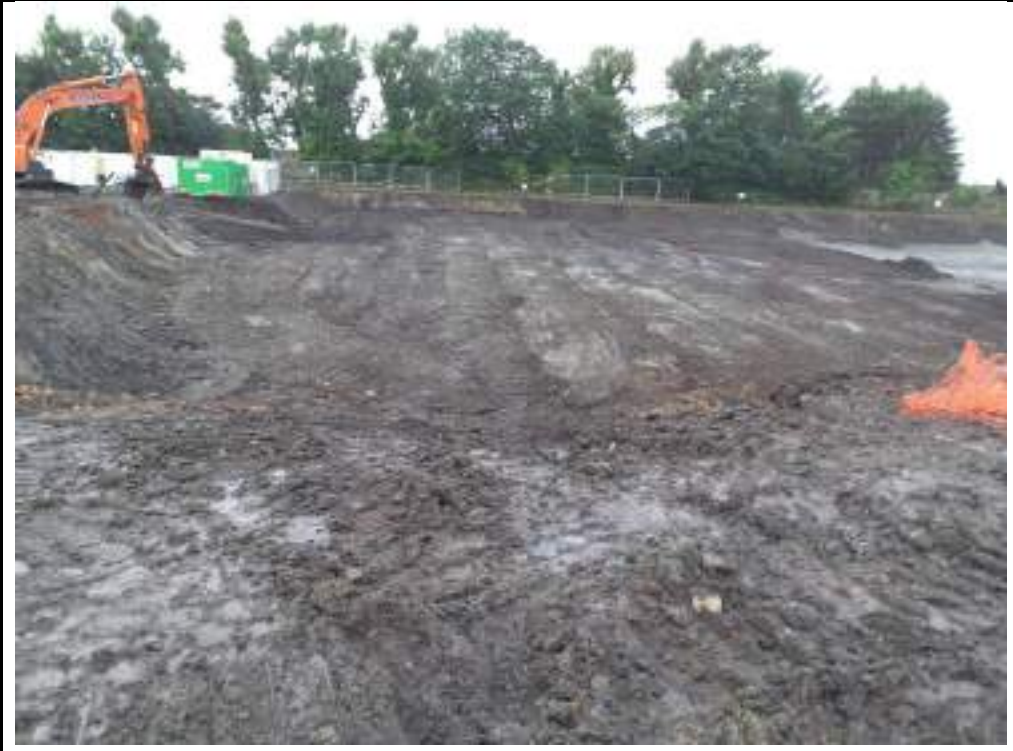
Photograph 3: Battered excavation in southern part of the site.

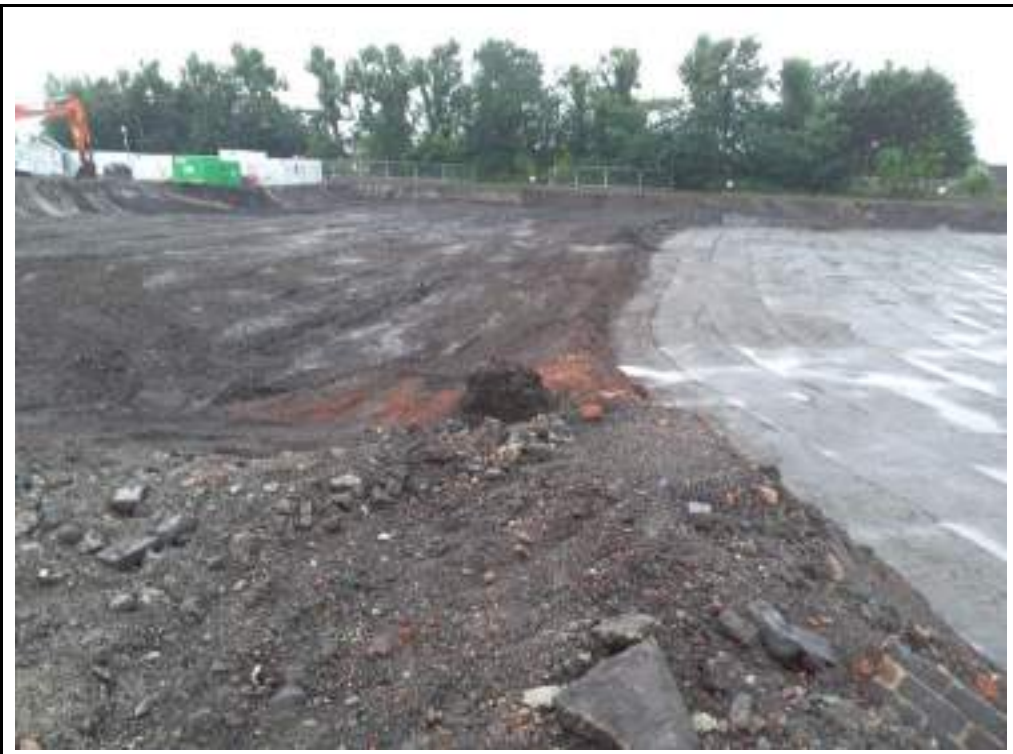
Photograph 4: Boundary between 1.5m cut and 3m cut areas in southern part of the site.

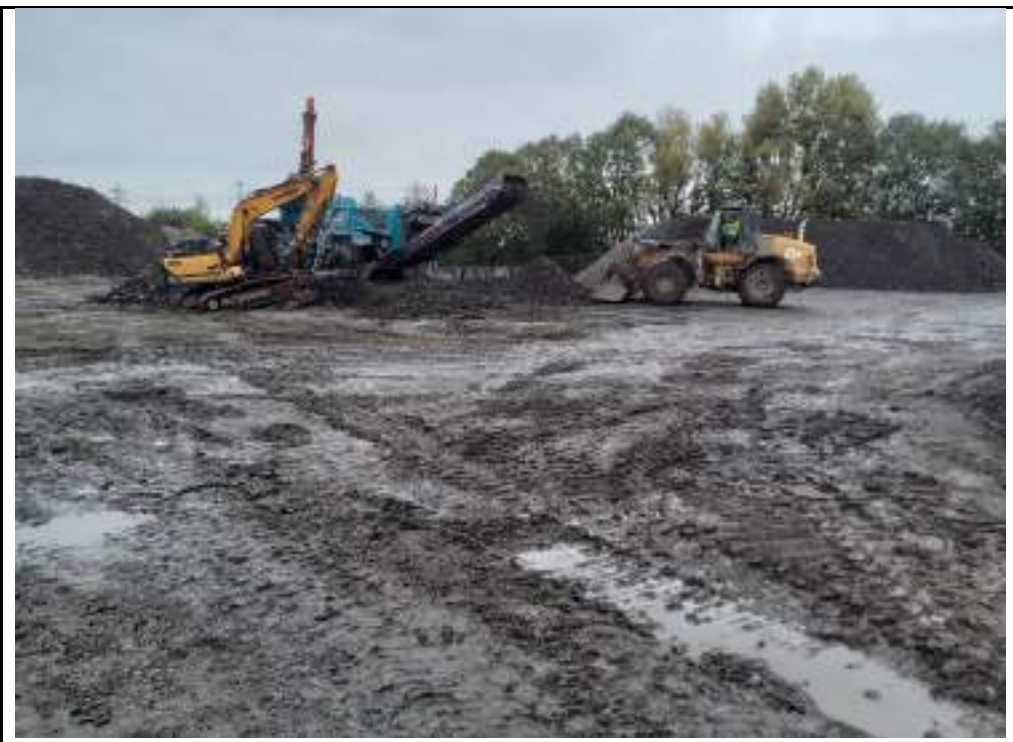
Photograph 6: Crushing concrete and asphalt in eastern part of the site.

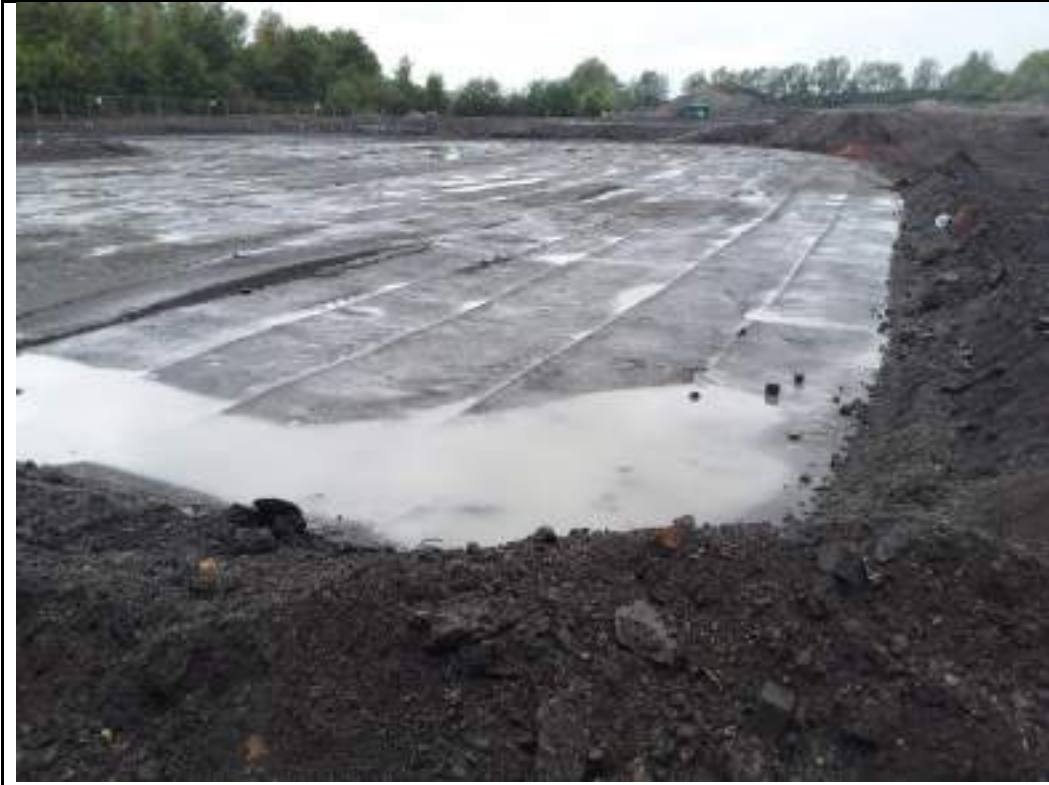
Photograph 7: Standing water in southern part of the site.

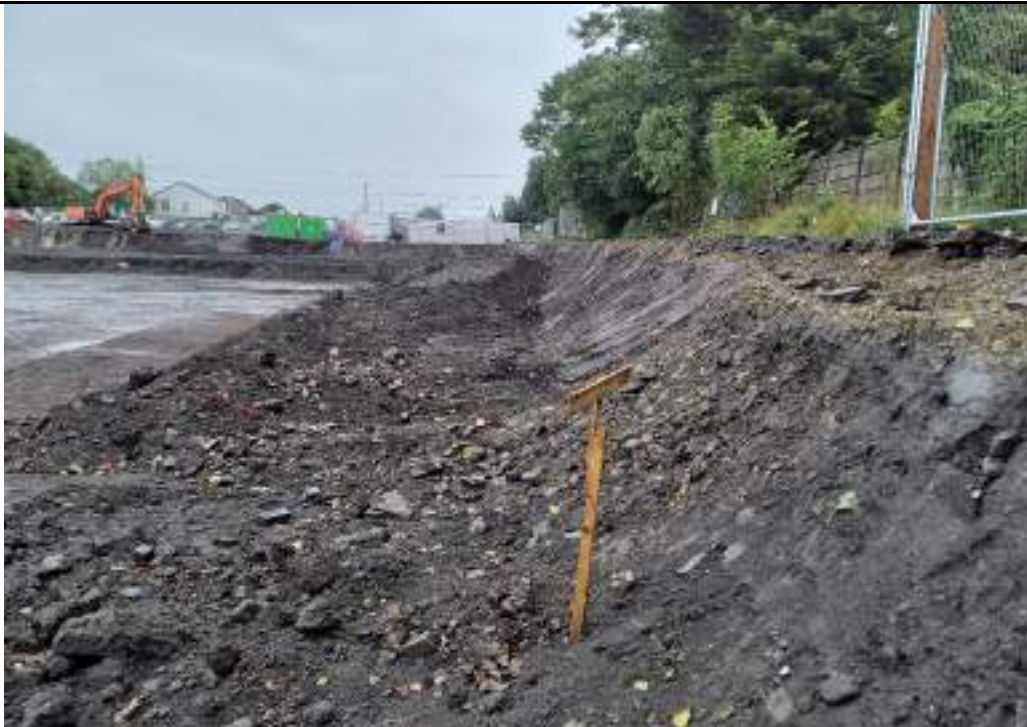
Photograph 8: Southern boundary of the site. Looking towards the east.

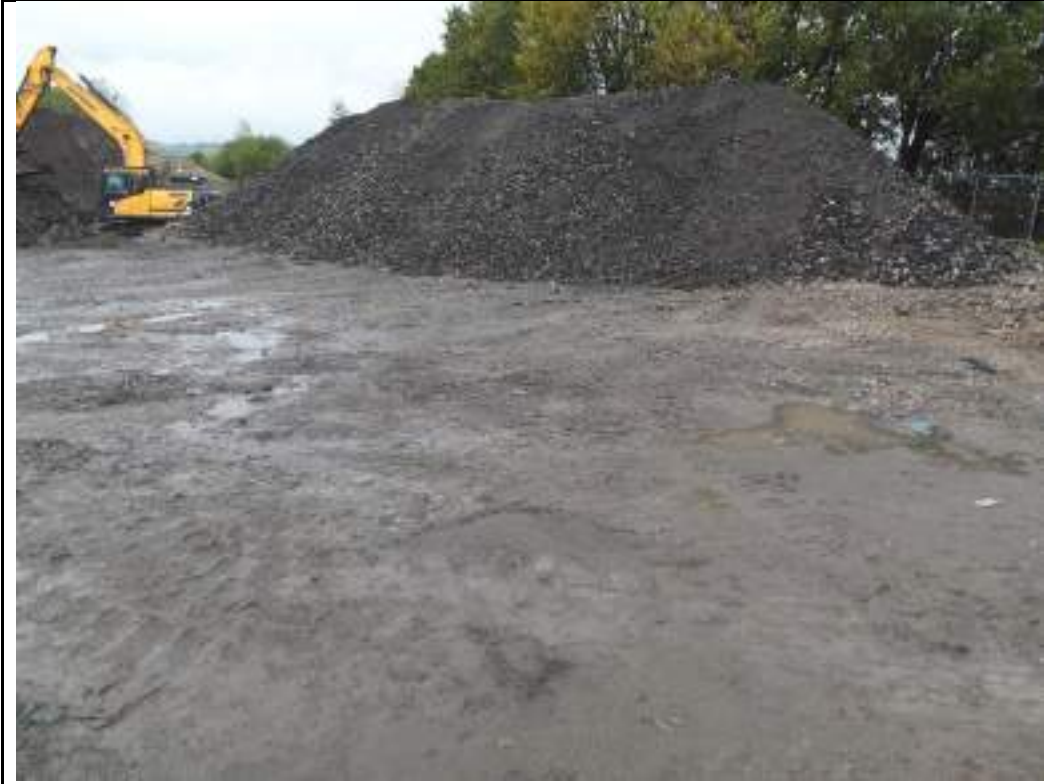
Photograph 9: Stockpiles of crushed concrete and asphalt in eastern part of the site.

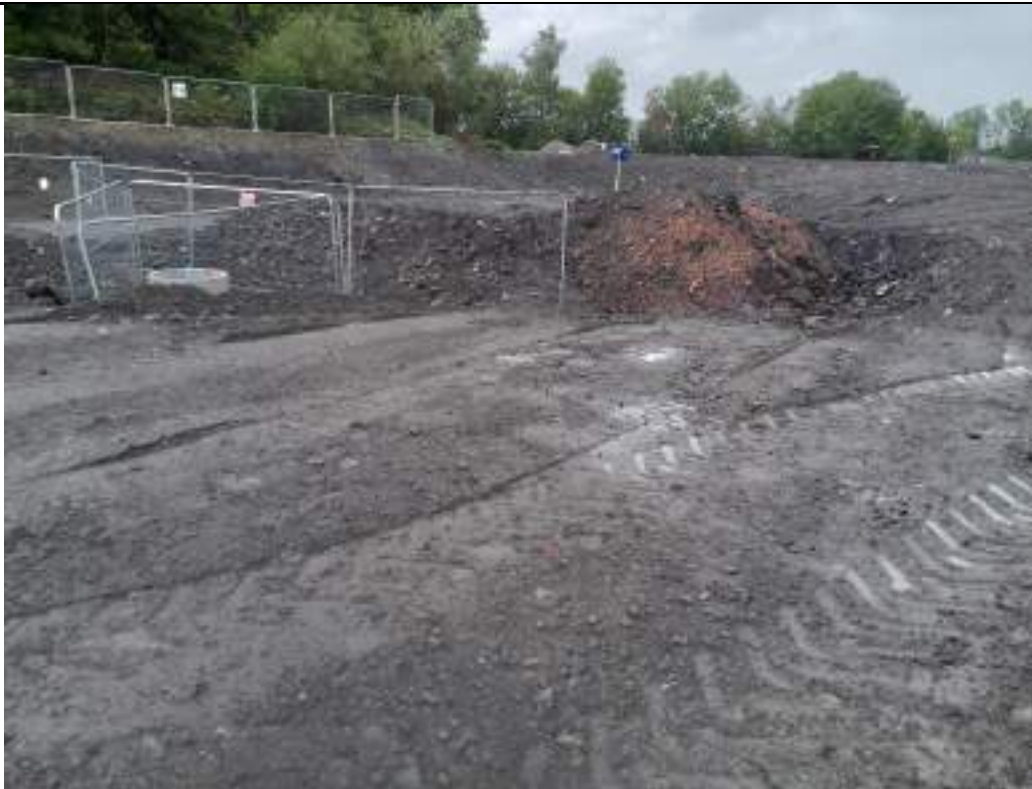
Photograph 10: Asbestos contaminated material stockpile in western part of the site.

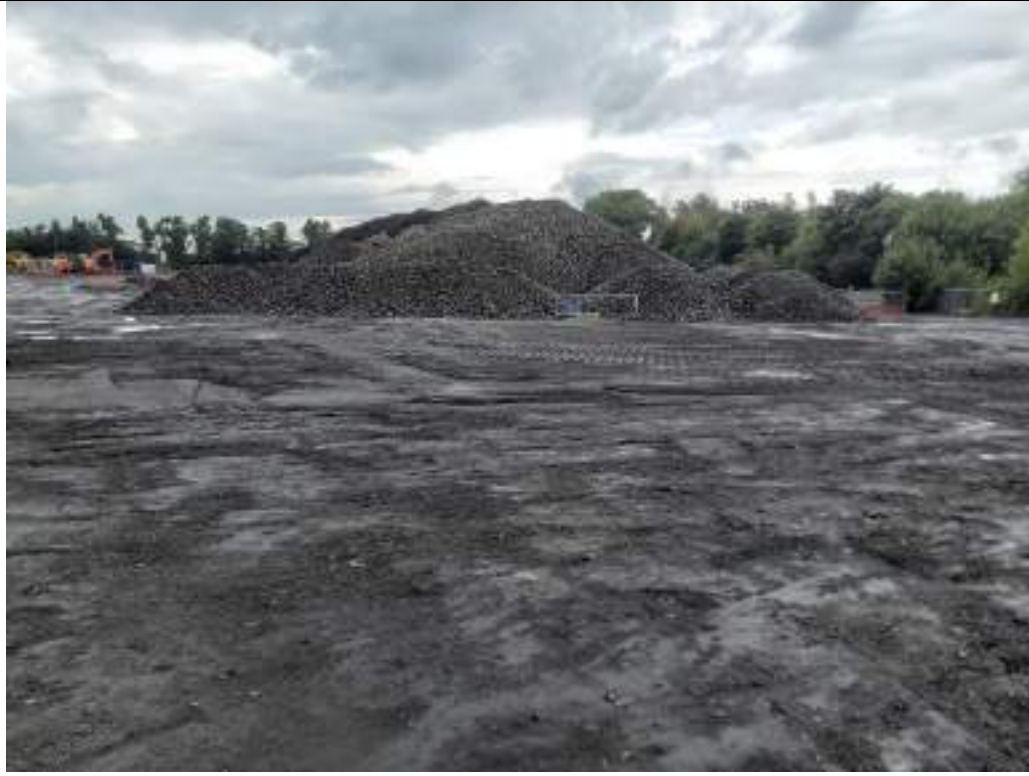
Photograph 11: Crushed concrete and asphalt stockpile in northwest of the site. Looking towards the south.

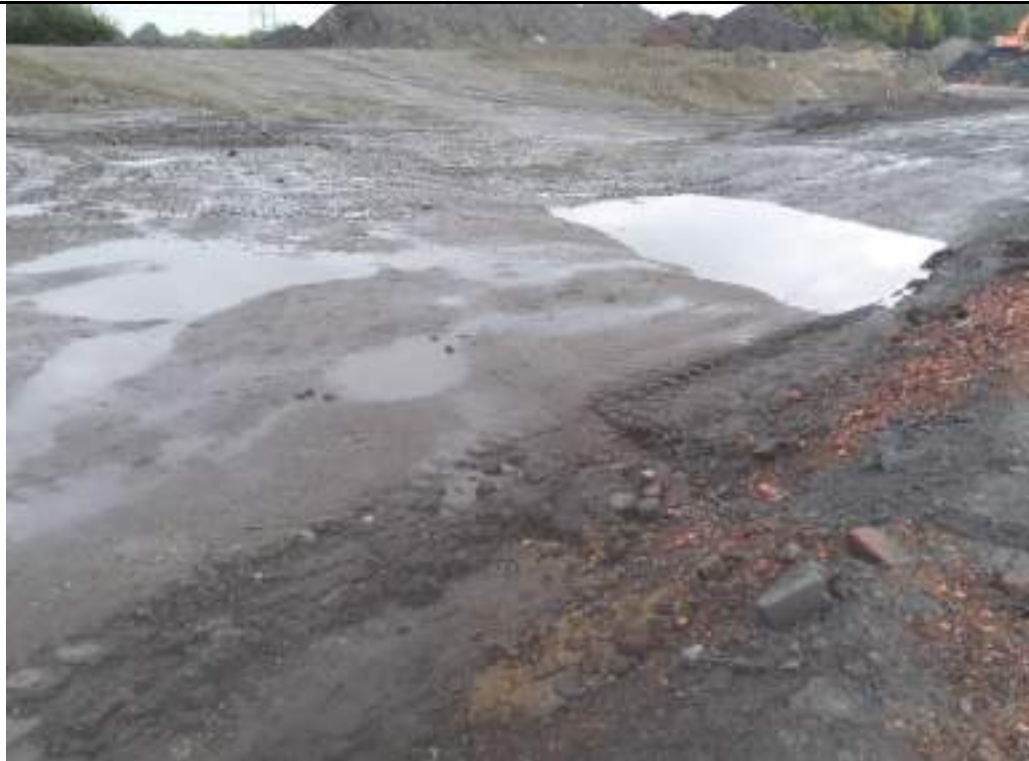
Photograph 12: Standing water in northern part of the site.

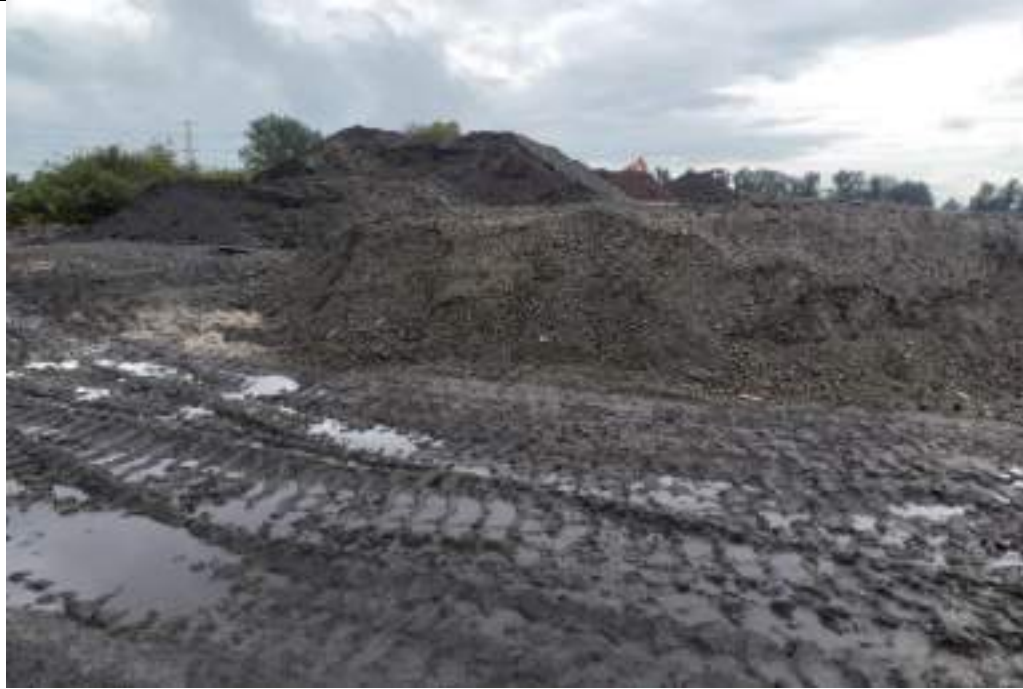
Photograph 53: Stockpiles of granular and landfill Made Ground in northeastern part of the site. Looking towards the east.
