**SITE VISIT REPORT 15220-HYD-XX-XX-SVR-GE-1018**

**SHEET NO.: 6 of 18**

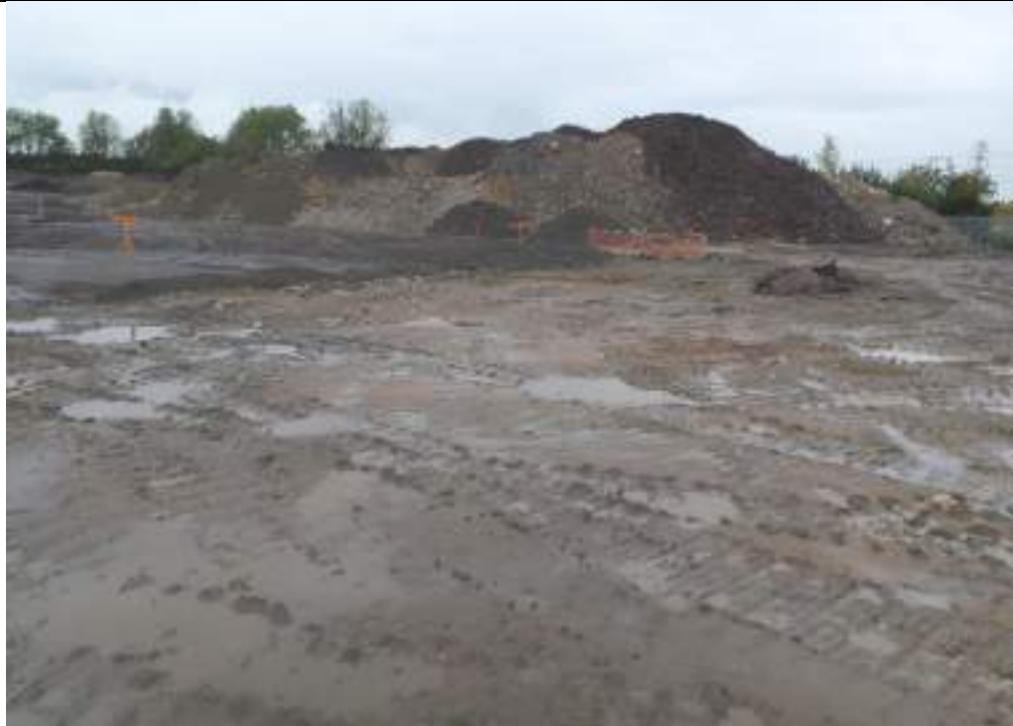
Photograph 14: Stockpile of general, granular and landfill Made Ground in northeastern part of the site. Looking towards the north.

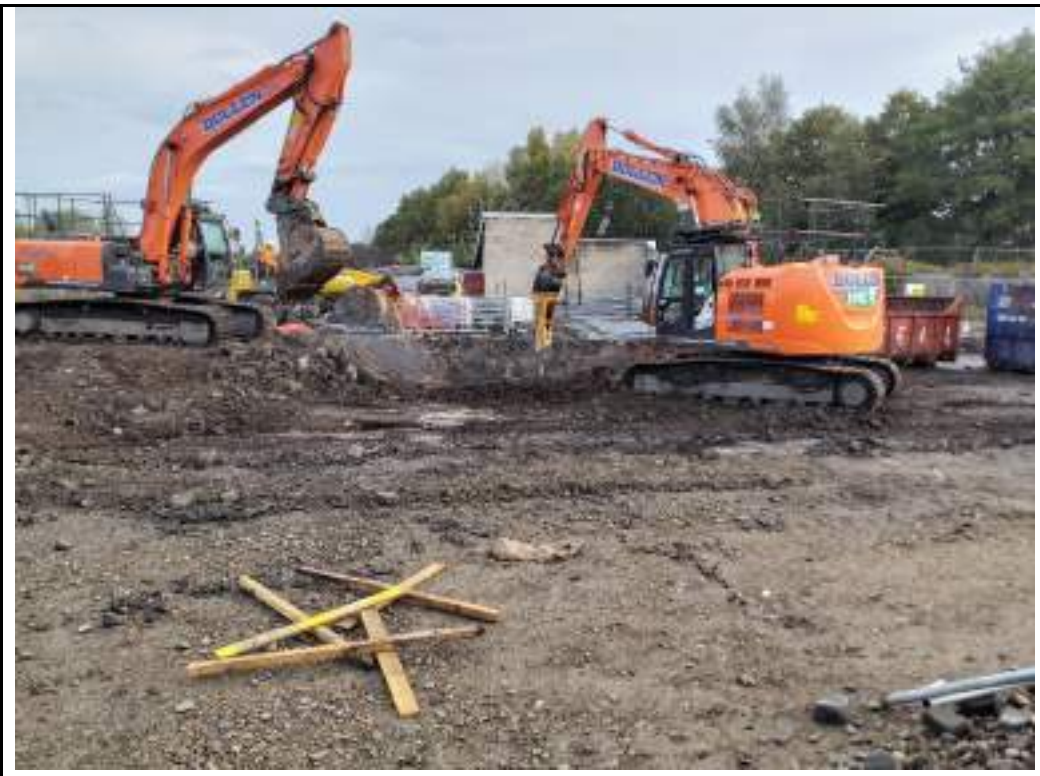
Photograph 2: Excavation of concrete and landfill Made Ground in southeast of the site.

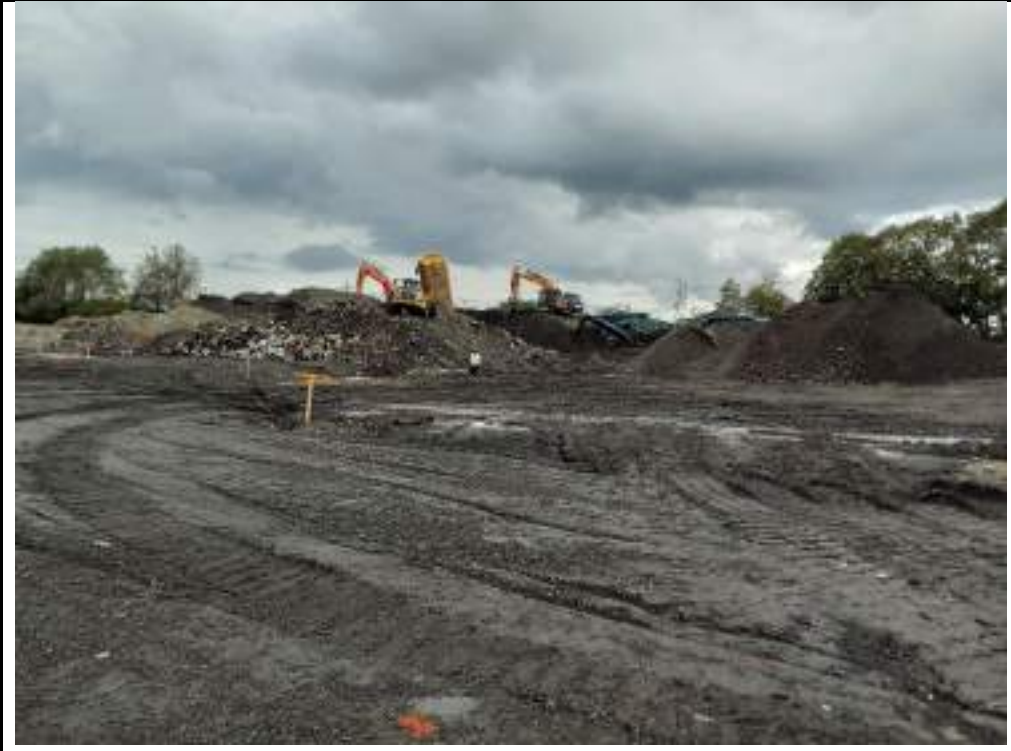
Photograph 3: Unloading excavated material from southeastern part of the site in stockpile in the northeast.

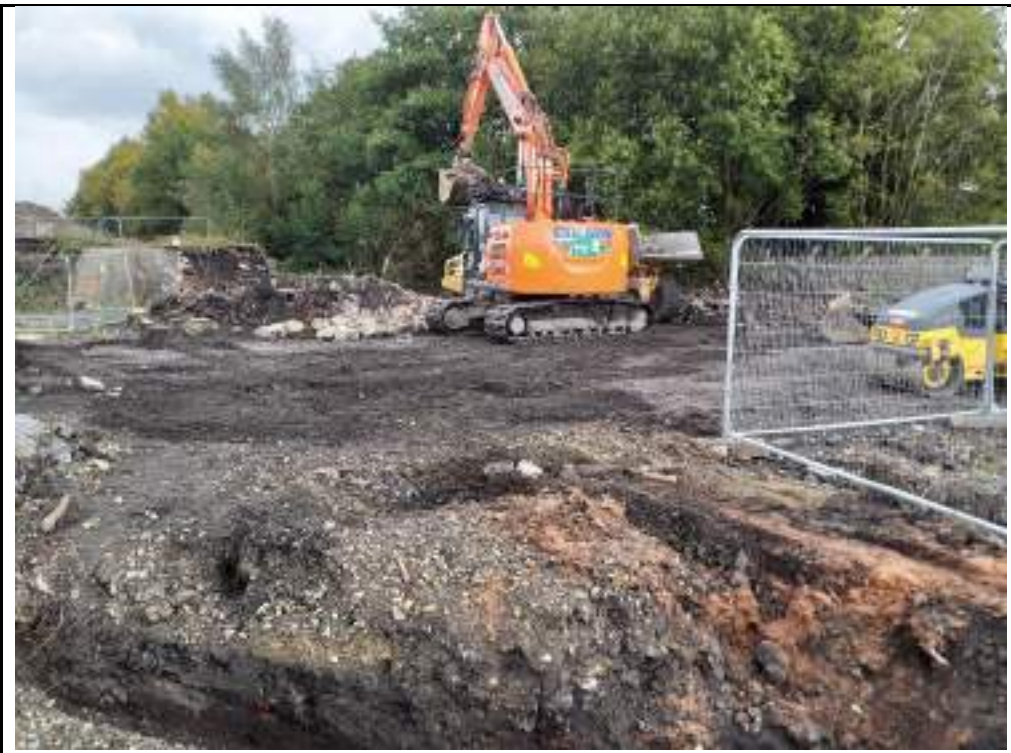
Photograph 4: Excavation of concrete in eastern part of the site.

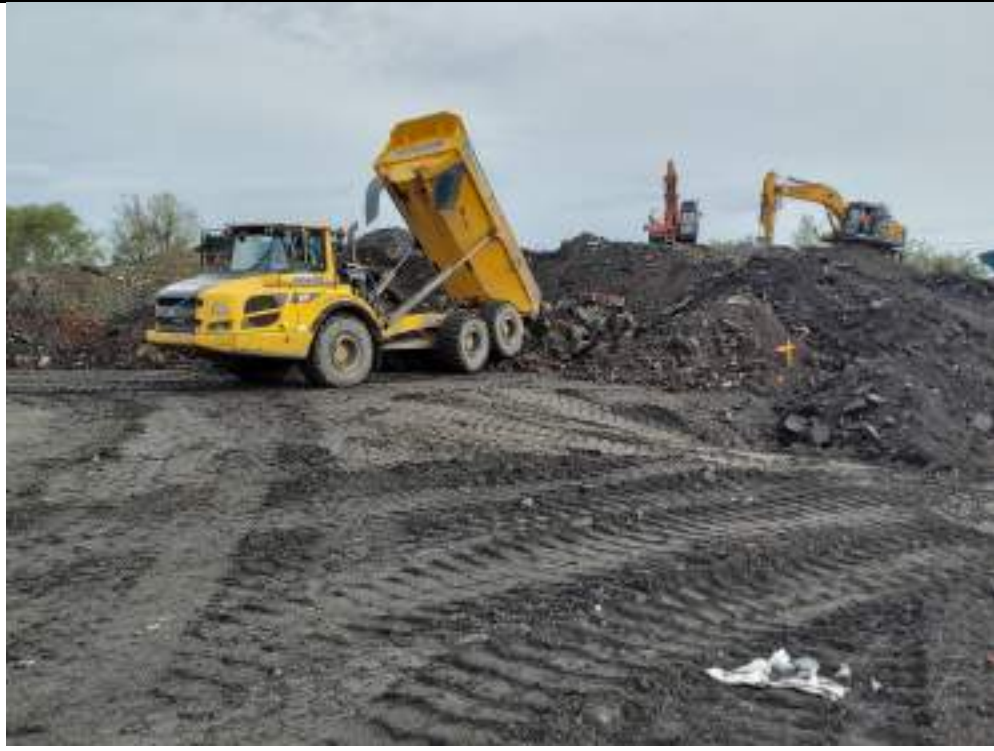
Photograph 5: Unloading excavated concrete from eastern part of the site in northeastern stockpile.

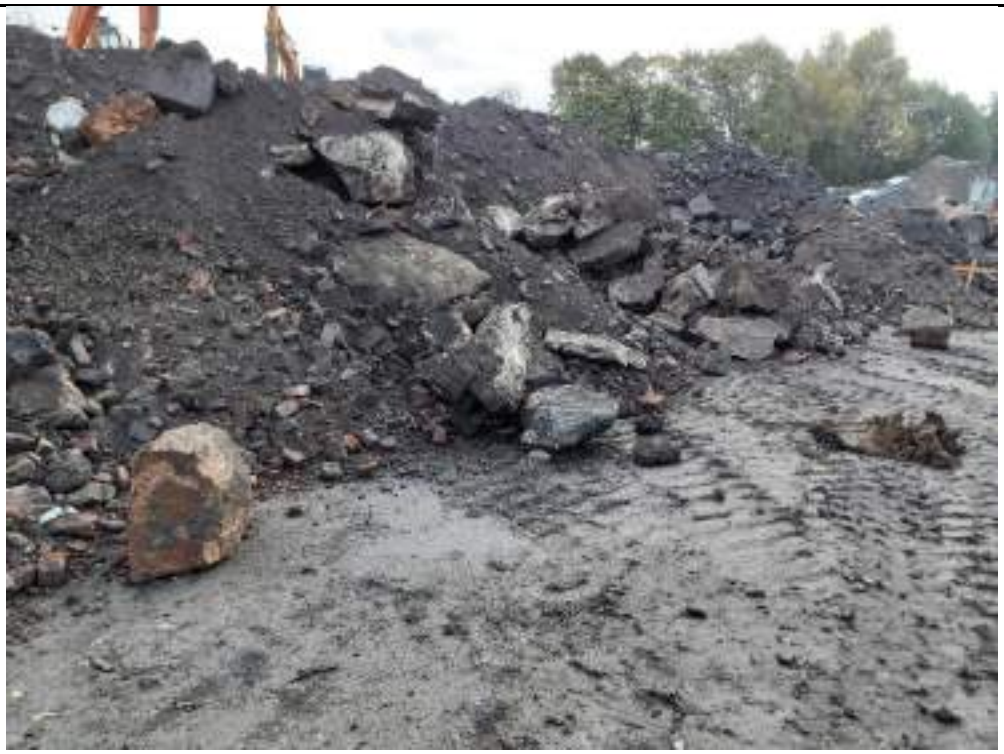
Photograph 6: Oversize and deleterious materials in northeastern stockpile.

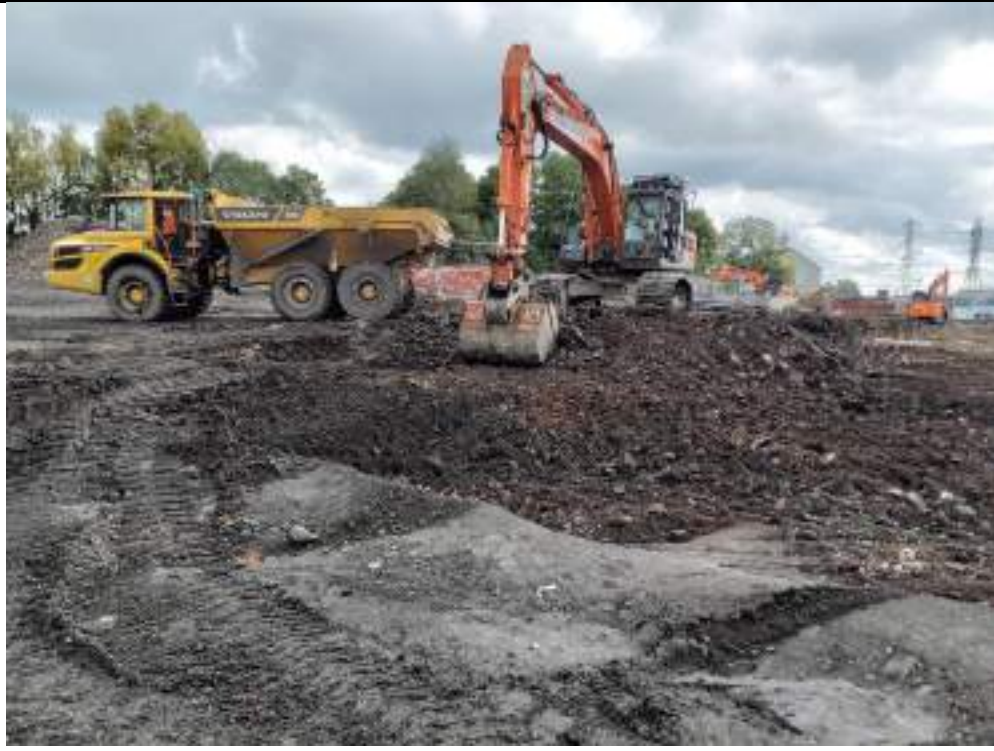
Photograph 7: Removing landfill Made Ground in southeastern part of the site.

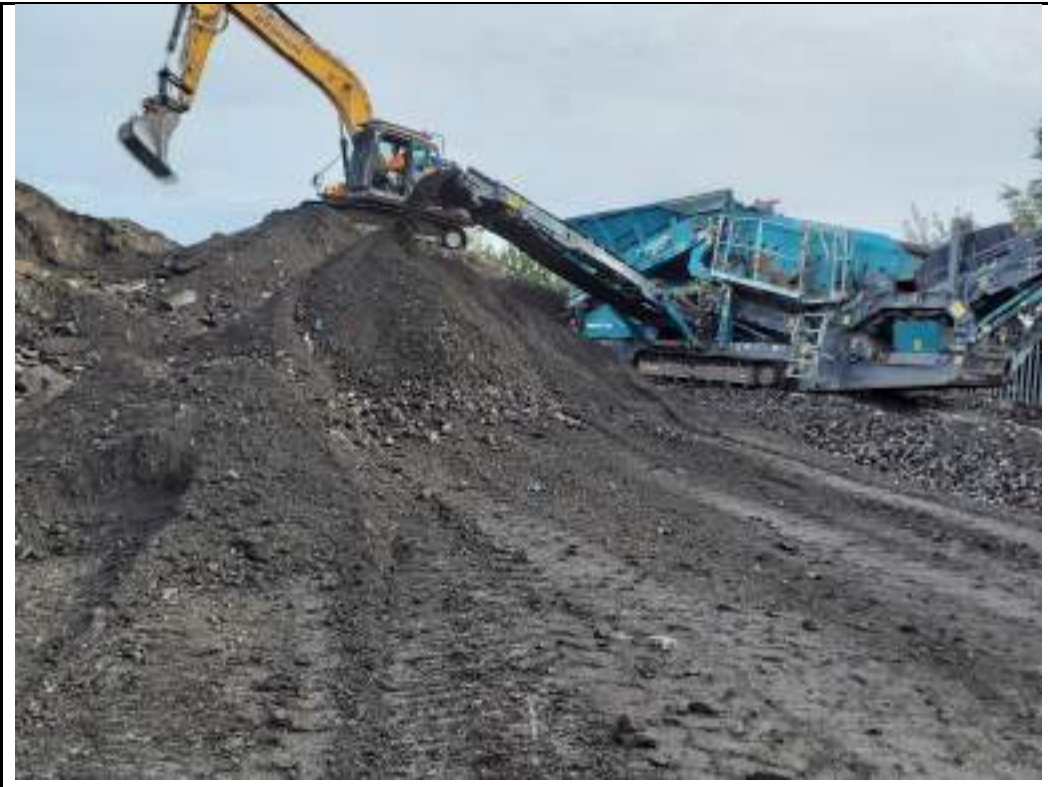
Photograph 9: Screener in northeastern part of the site processing material.

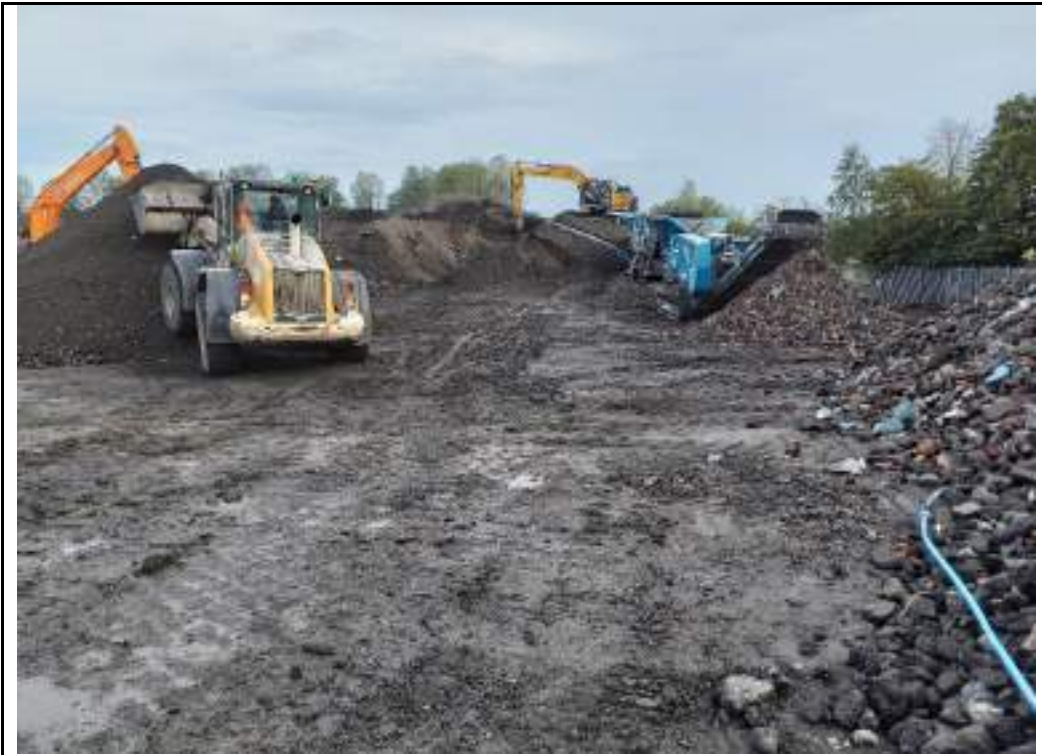
Photograph 91: Screener, crusher and stockpiles in northeastern part of the site.

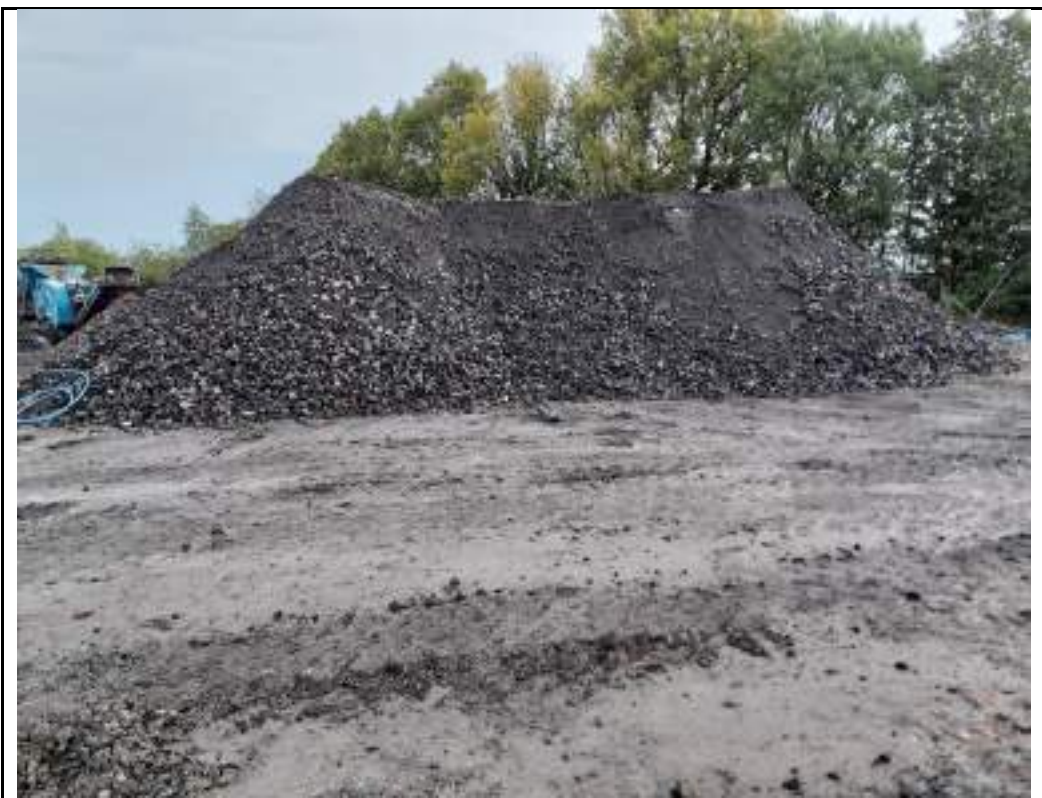
Photograph 110: Stockpile of crushed material from oversize material of the screener in eastern part of the site.

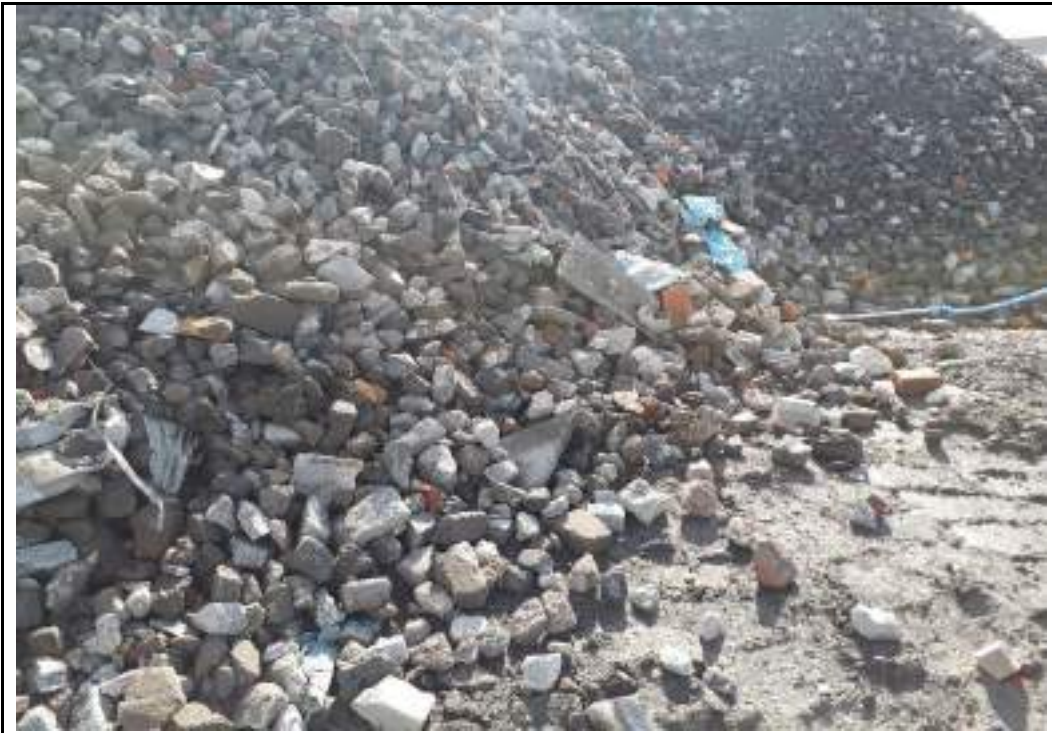
Photograph 113: Existence of deleterious material in stockpile of crushed material from oversize of the screener in eastern part of the site. VHE to confirm classification of coarse graded material

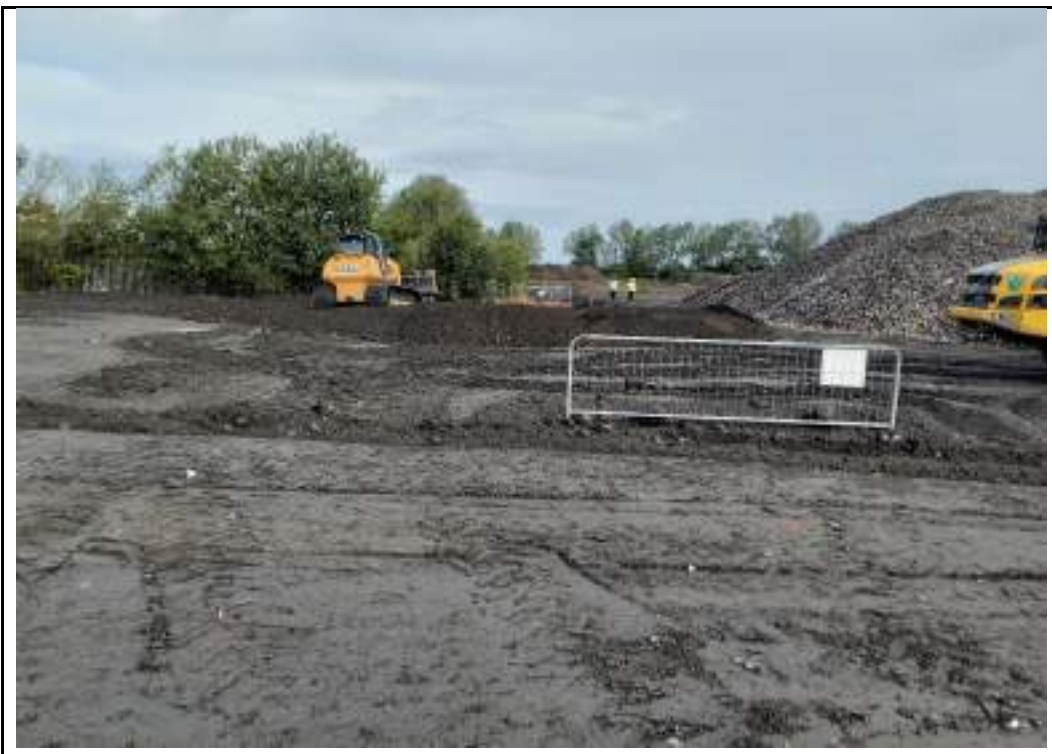
Photograph 14: Backfilling northwest of the site using undersize material from the screener.

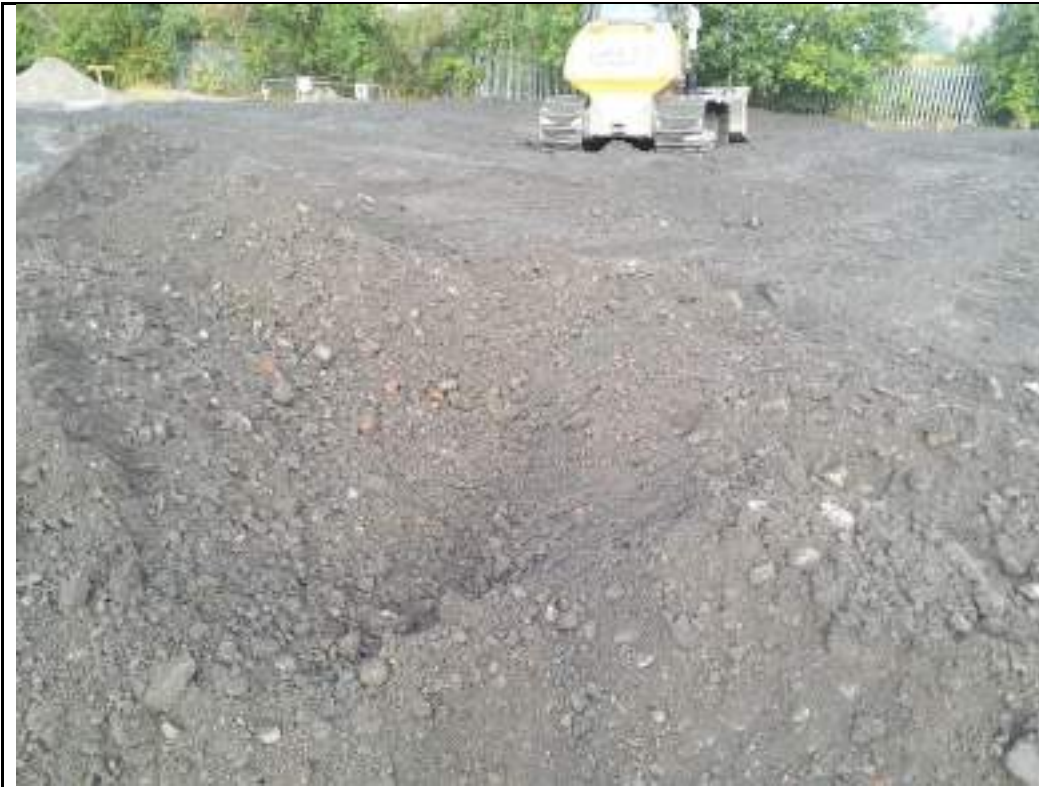
Photograph 125: Fill material in northwest of the site with improved quality.

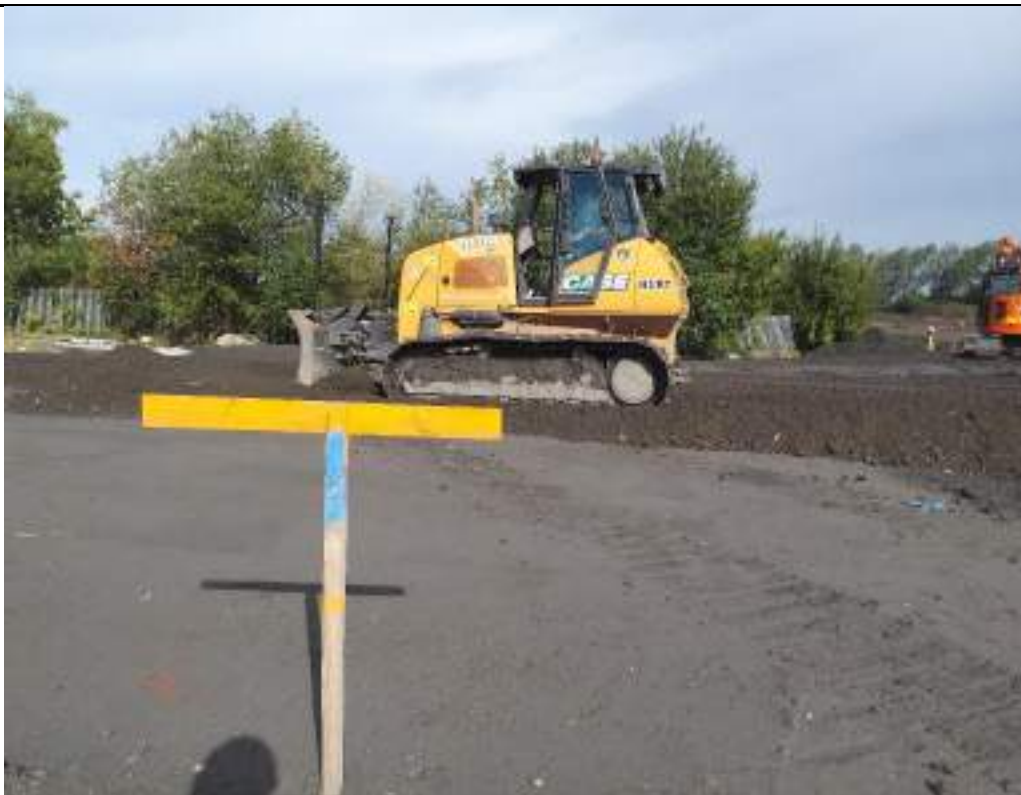
Photograph 136: Installed GPS on dozer to control ground level in northwest of the site.

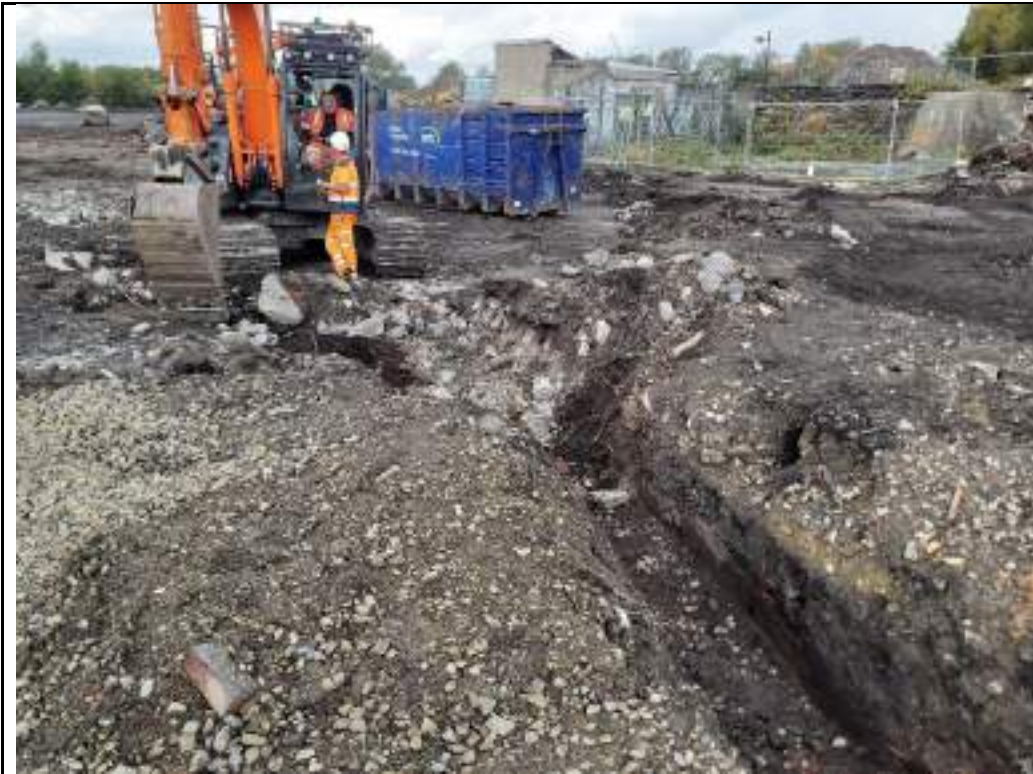
Photograph 147: Excavation for electricity cable in southeastern part of the site.

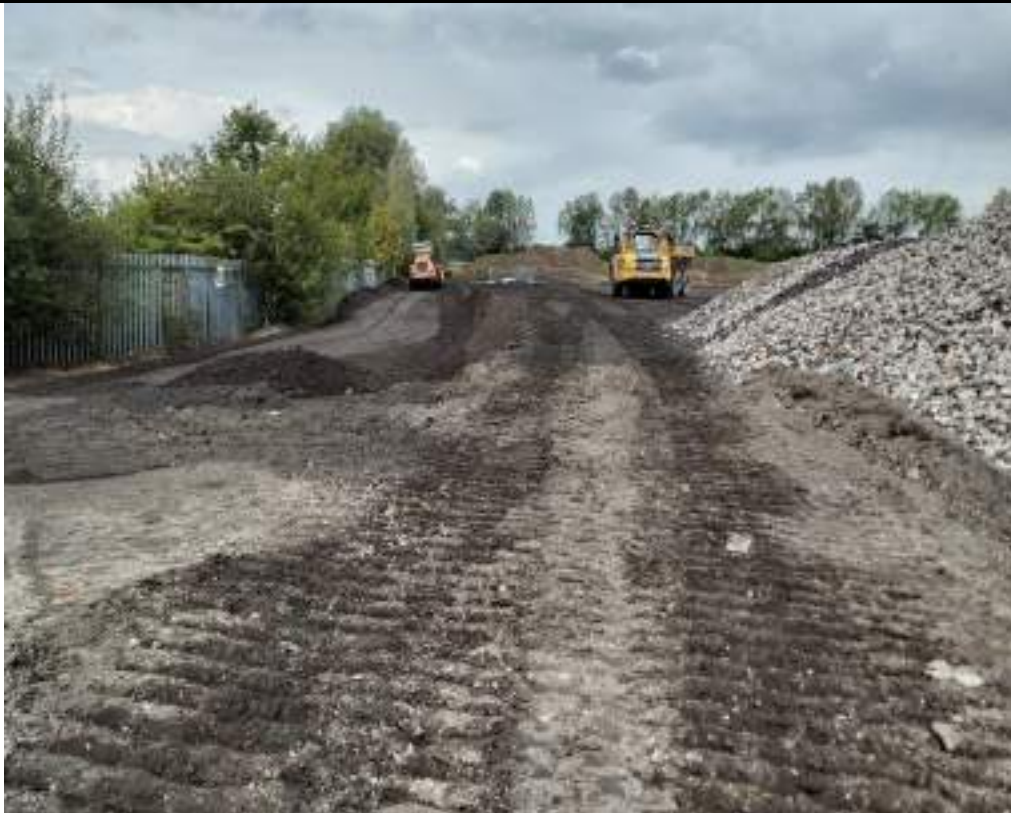
Photograph 158: Proof rolling of northwestern boundary of the site.

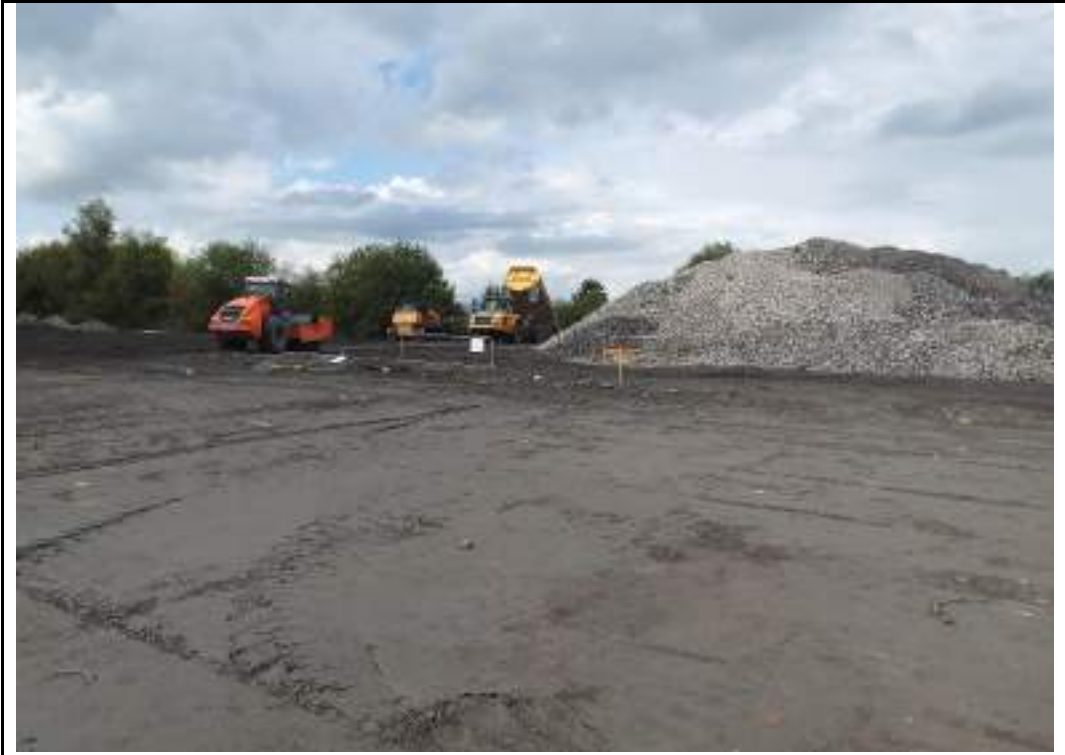
Photograph 169: Backfilling and proof rolling of northwestern part of the site.

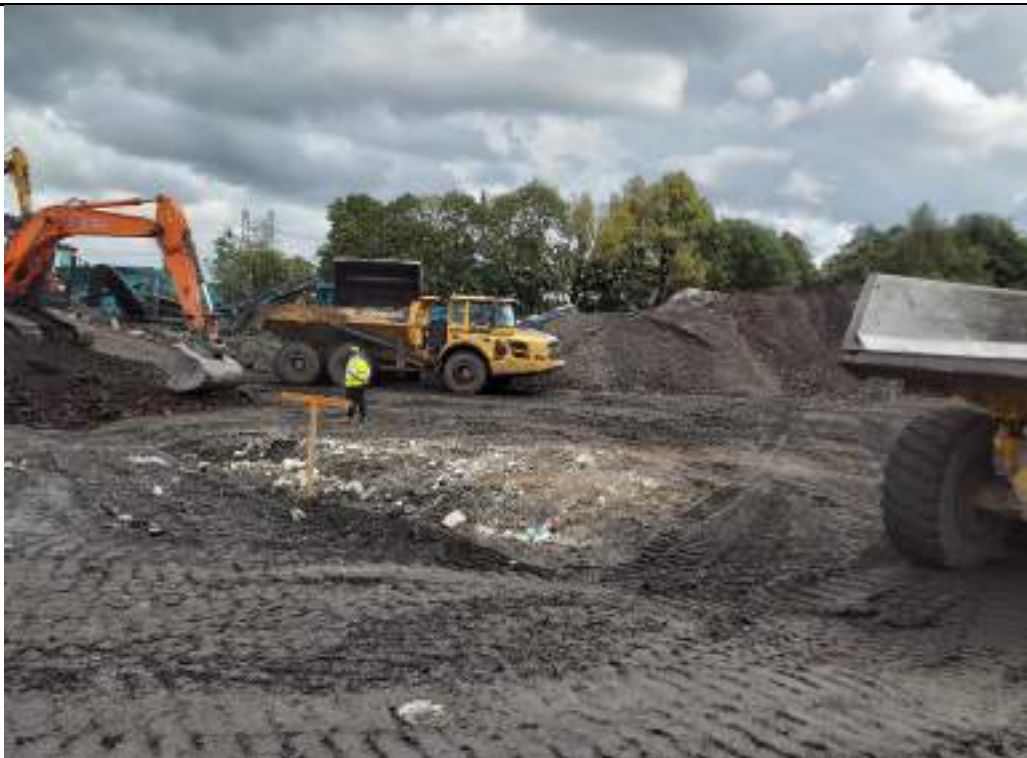
Photograph 20: Loading of fine material (dark ashy) from screener to backfill northwestern part of the site.

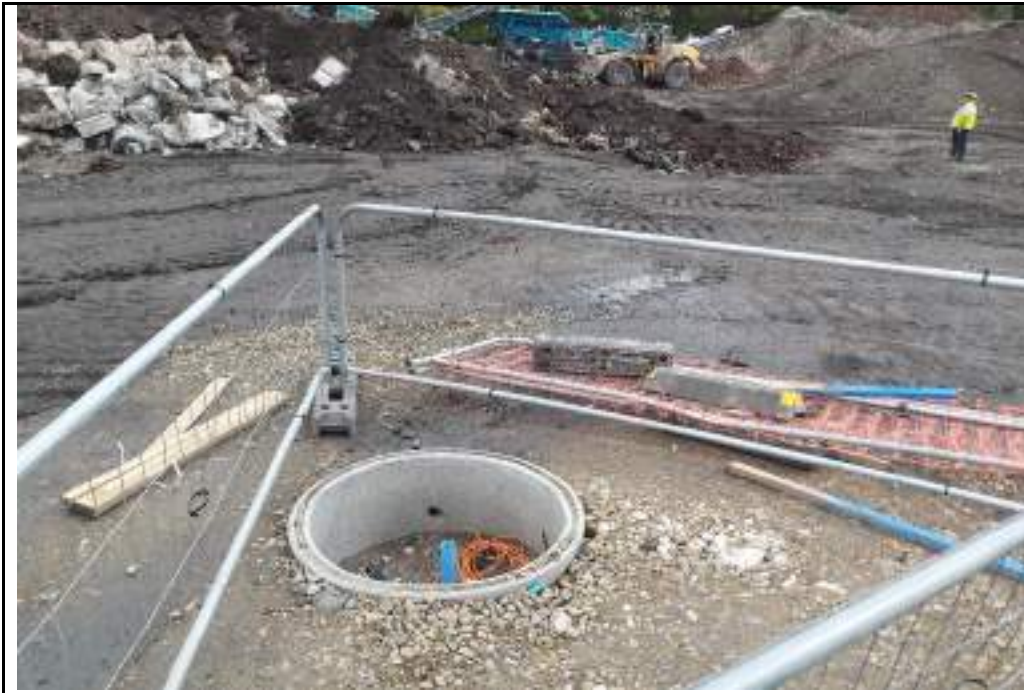
Photograph 179: Rod Settlement Gauge and Vibrating Wire piezometer in eastern part of the site.

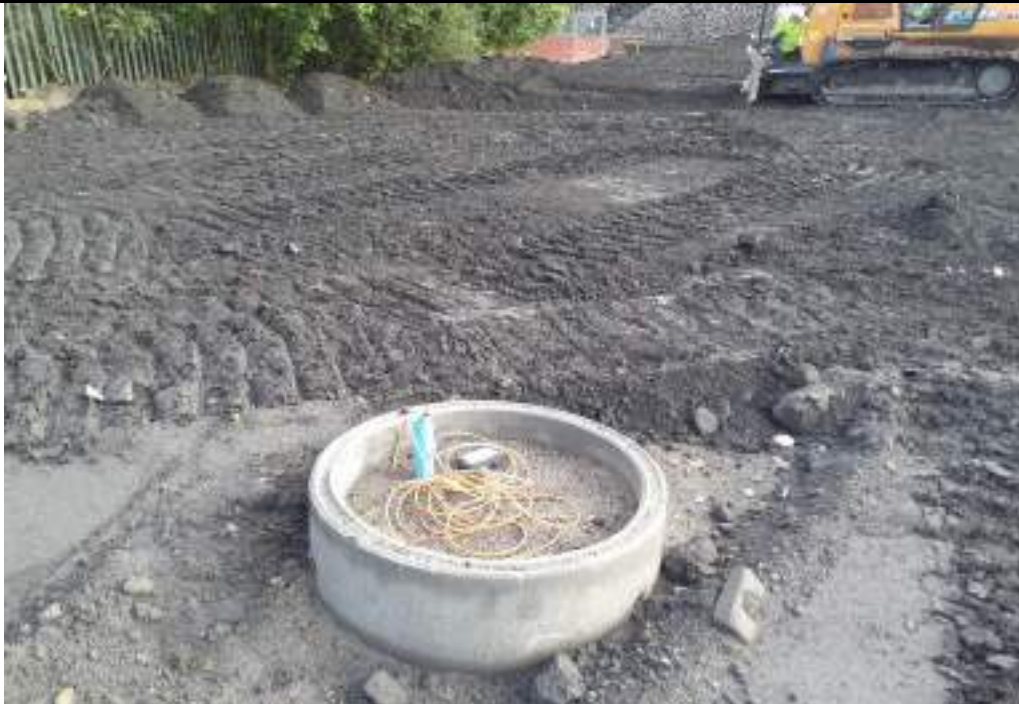
Photograph 20: Rod Settlement Gauge and Vibrating Wire piezometer in western part of the site.

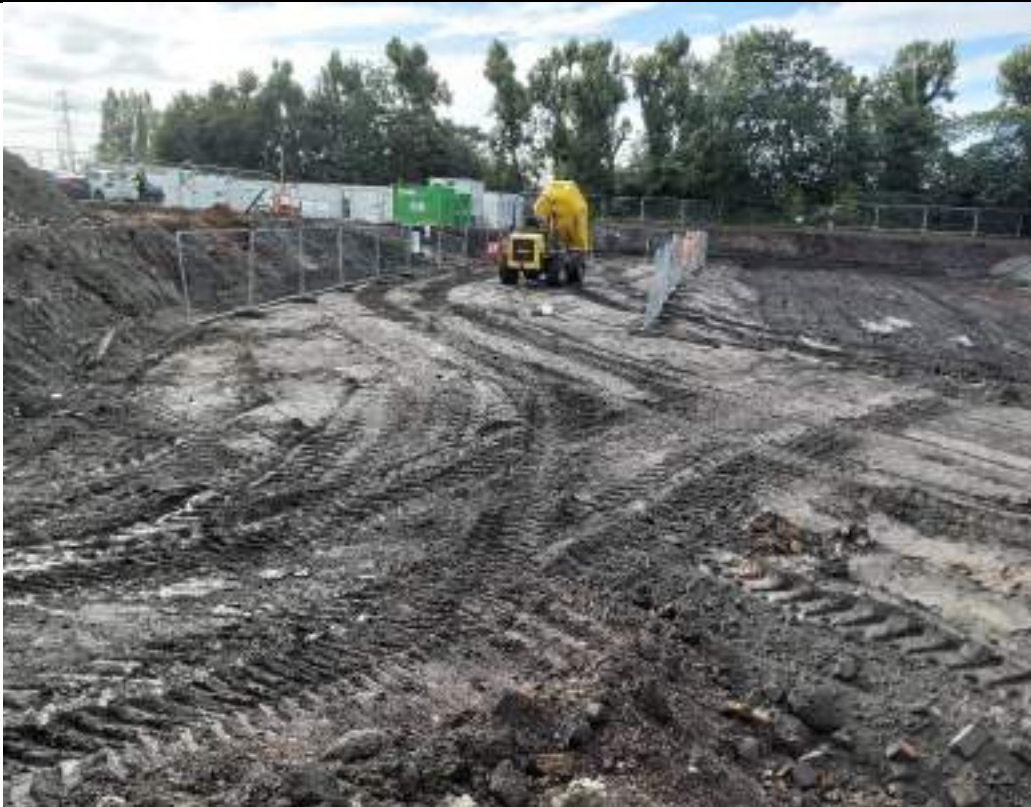
Photograph 20: New parking for VHE's trucks and equipment in southern part of the site.

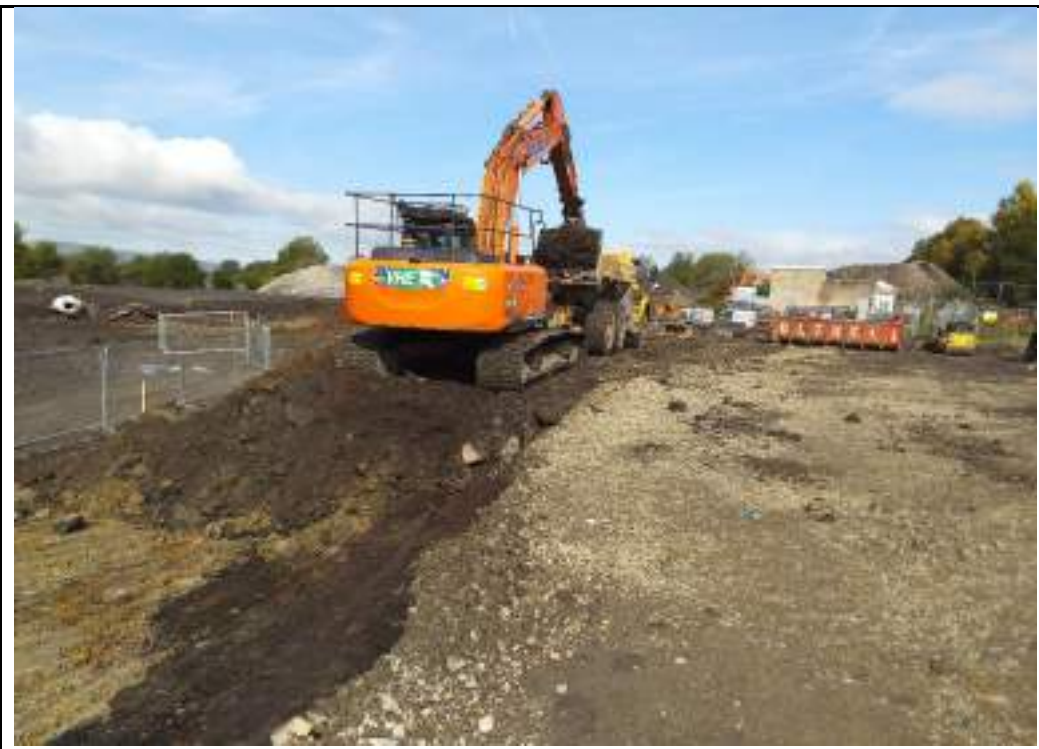
Photograph 2: Excavation of landfill Made Ground in southern part of the site.

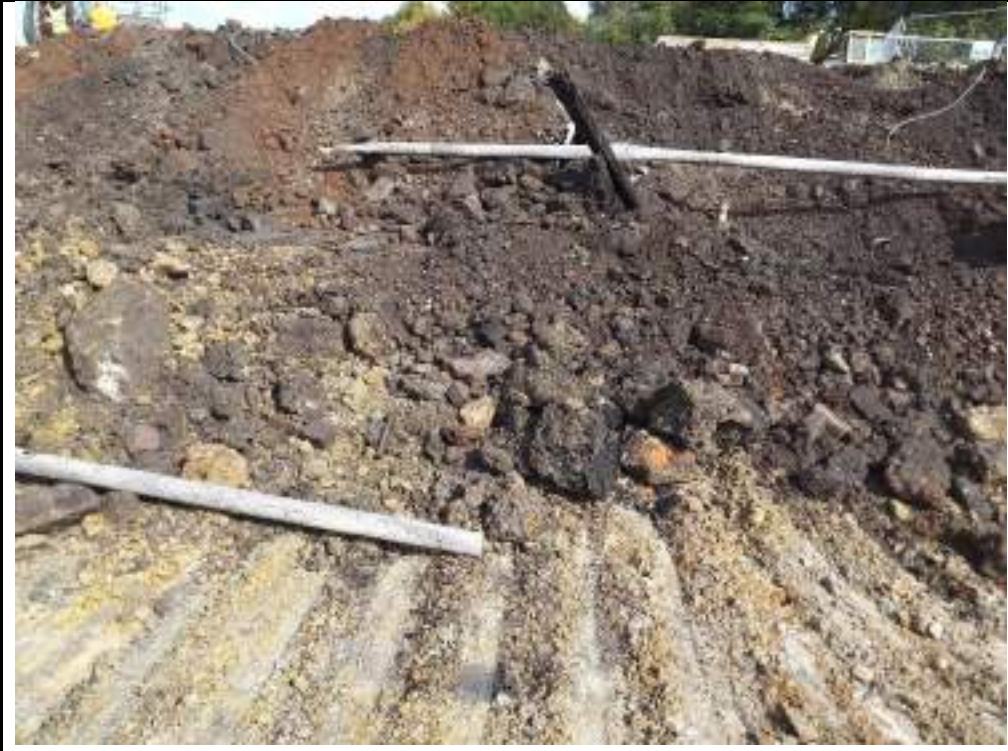
Photograph 3: Deleterious material in excavation in southern part of the site.

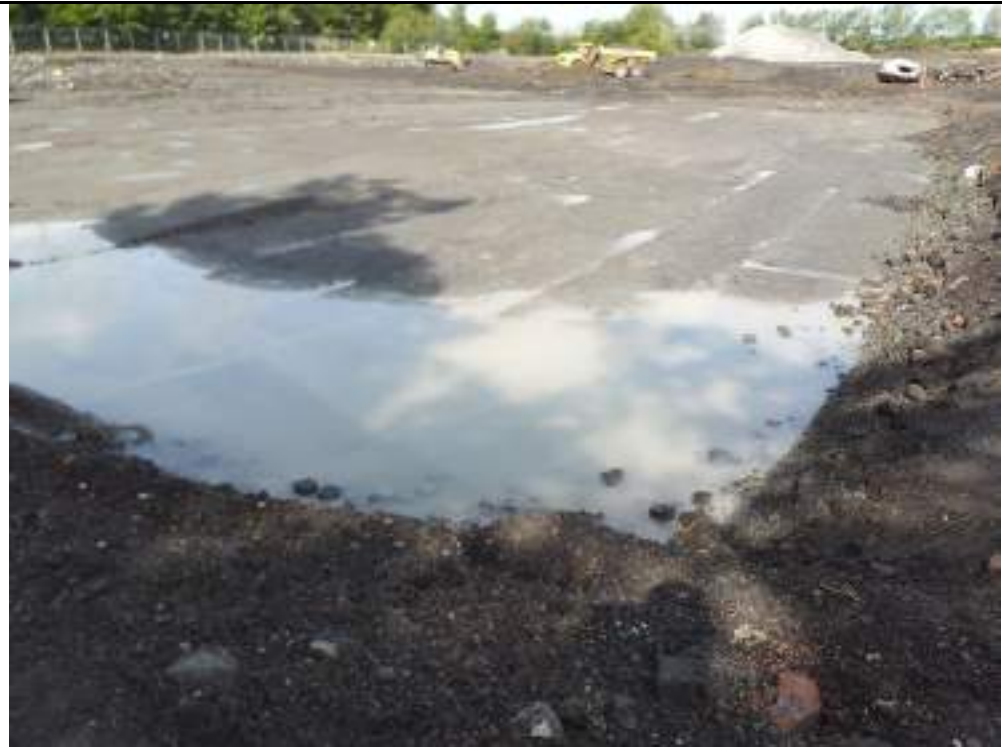
Photograph 4: Standing water in excavation in southern part of the site.

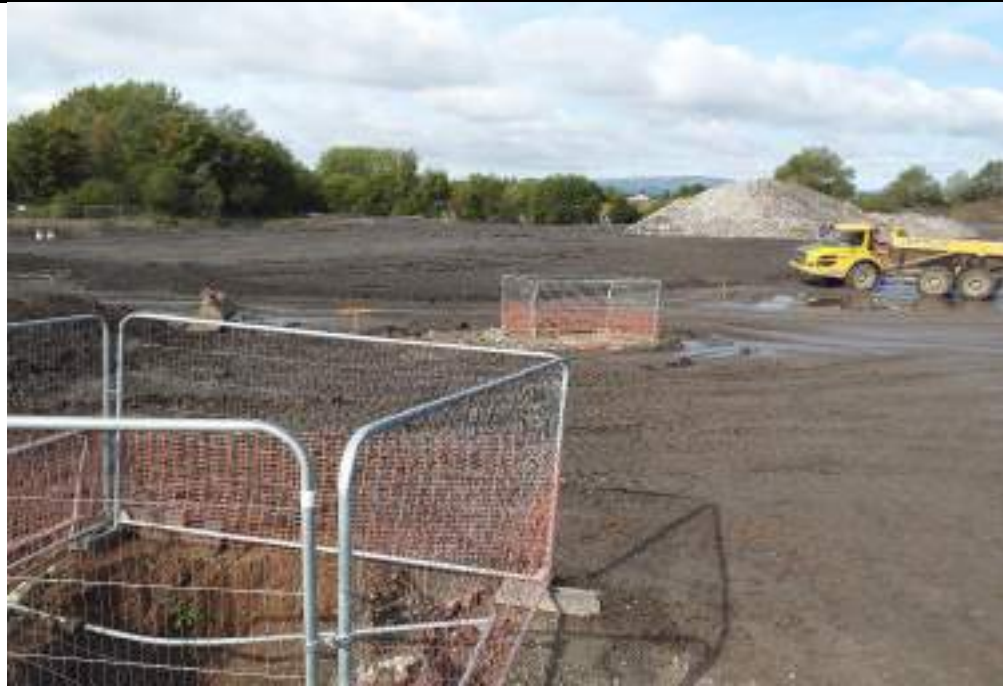
Photograph 5: Final ground level (general fill) in northwest of the site.

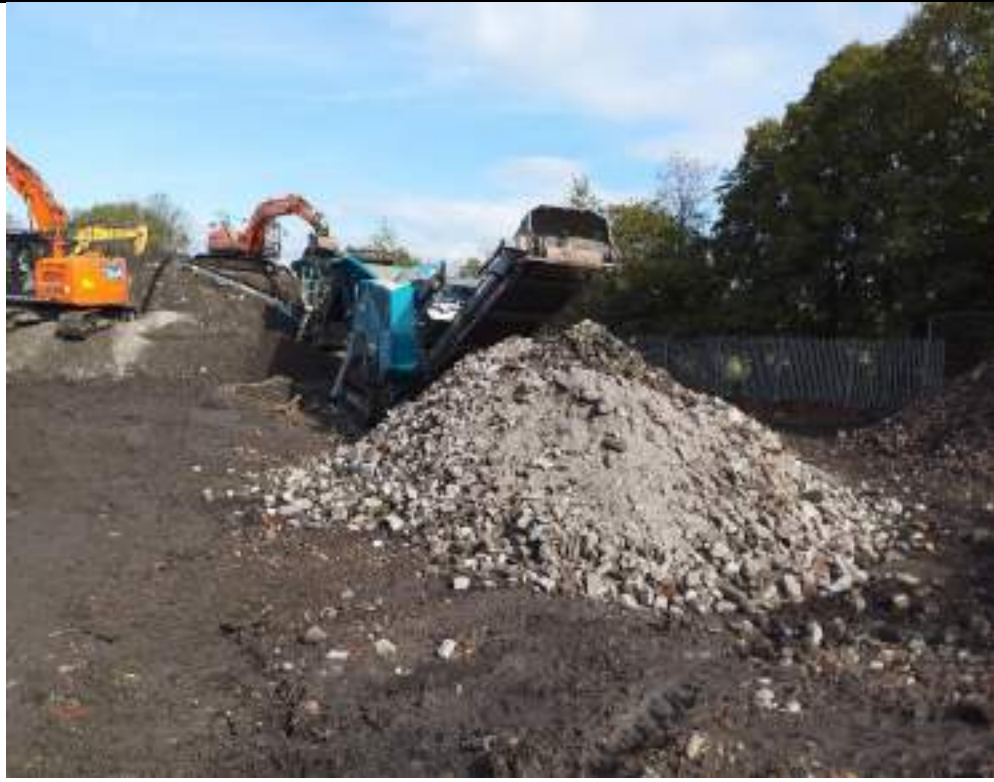
Photograph 7: Crushing oversize material from screener in northeast of the site.

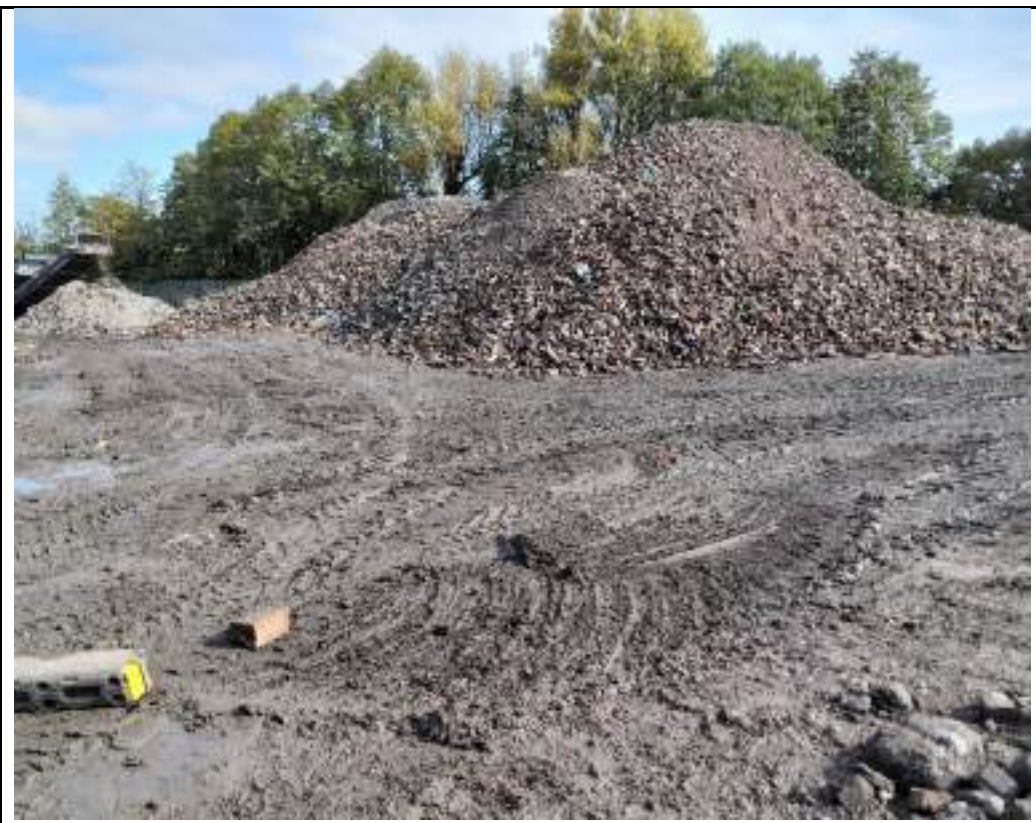
Photograph 10: Overview of stockpile of crushed material from oversize off screener.

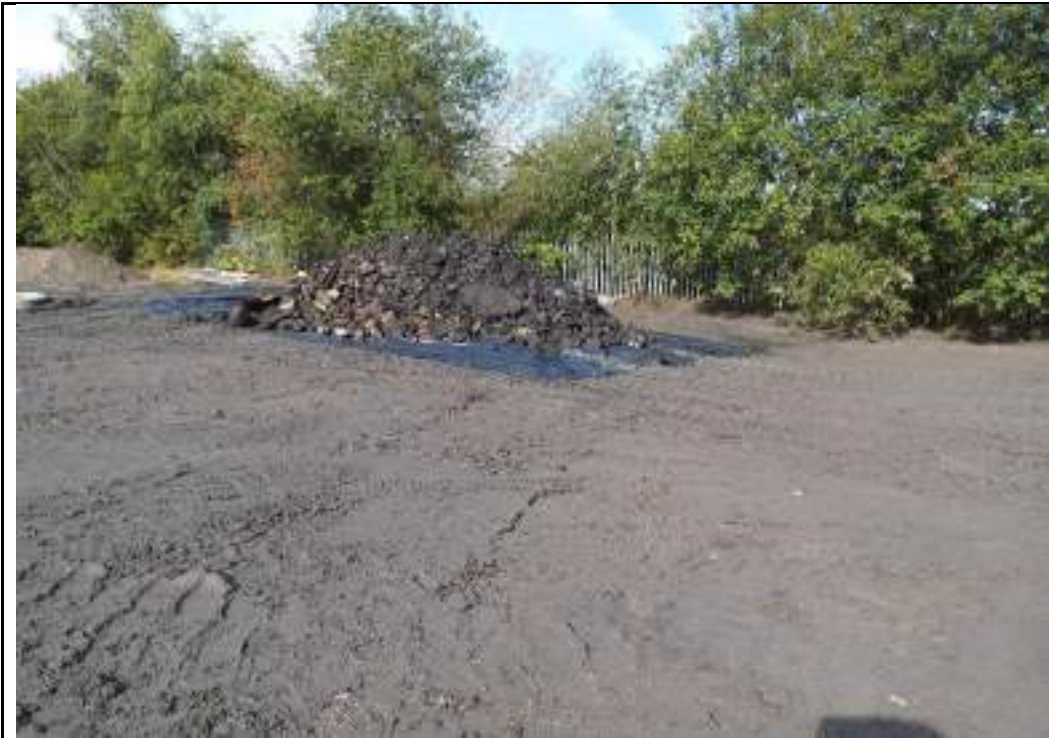
Photograph 91: Stockpile of potentially asbestos contaminated material in northwest of the site.  
Material from excavation in southeastern part of the site.

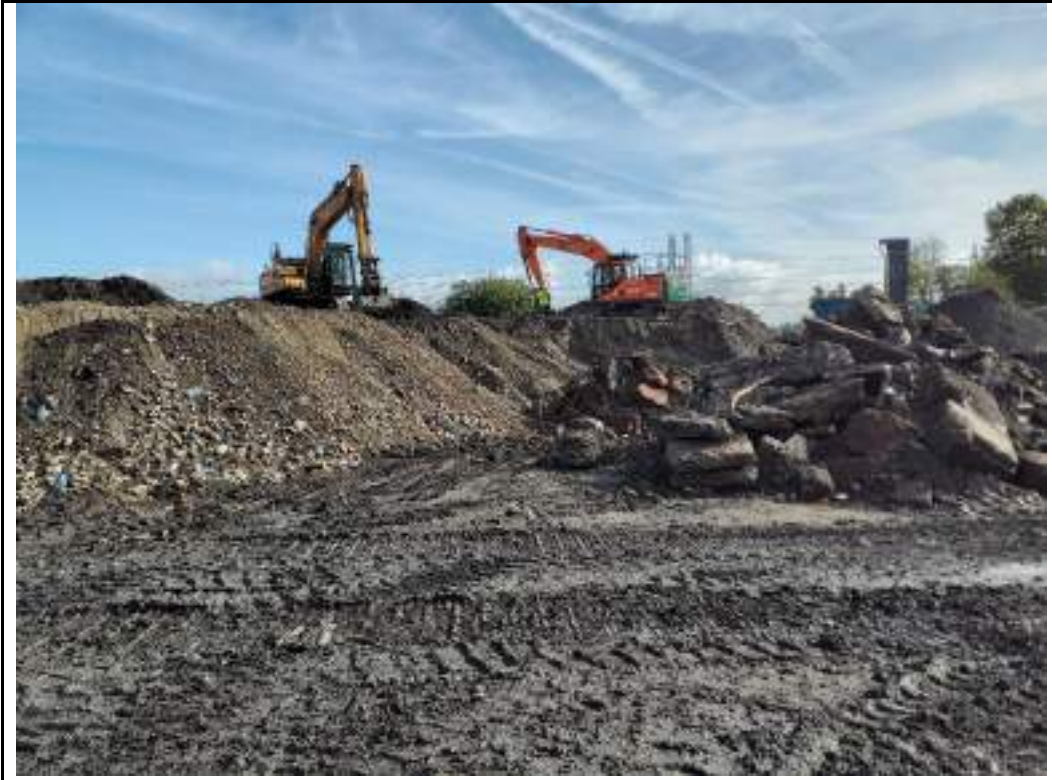
Photograph 113: Surveying of stockpiles in northeastern part of the site.
