**SITE VISIT REPORT 15220-HYD-XX-XX-SVR-GE-1018**

**SHEET NO.: 6 of 18**

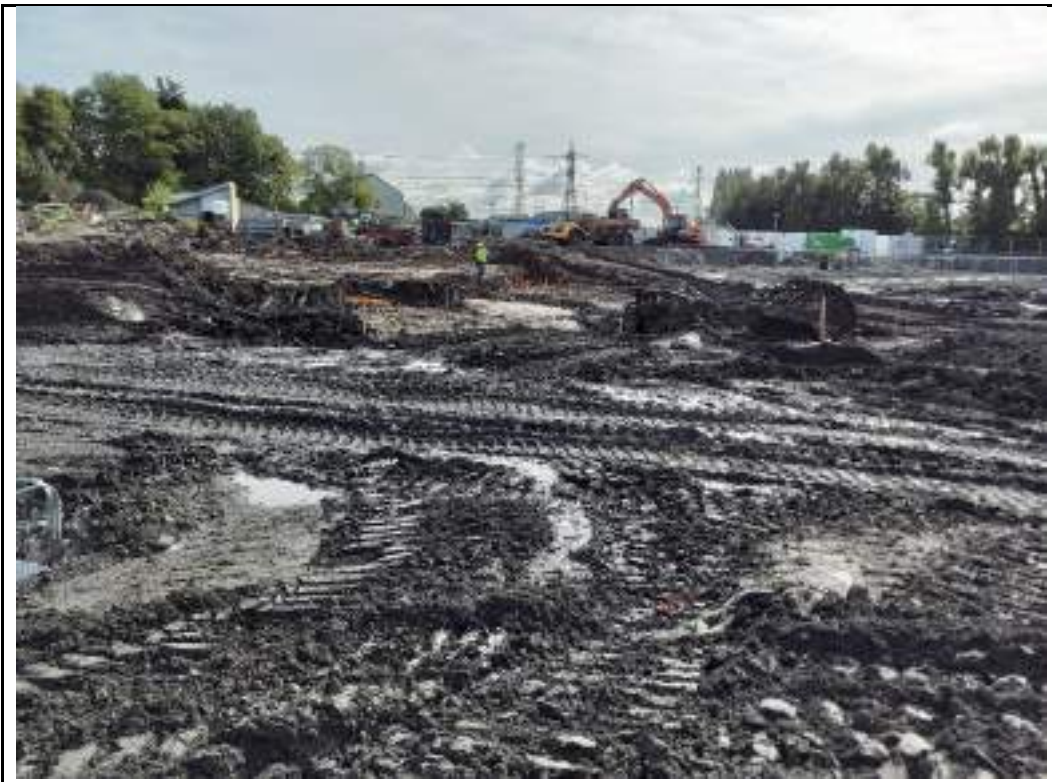
Photograph 14: Surveying of excavations in southeastern part of the site.

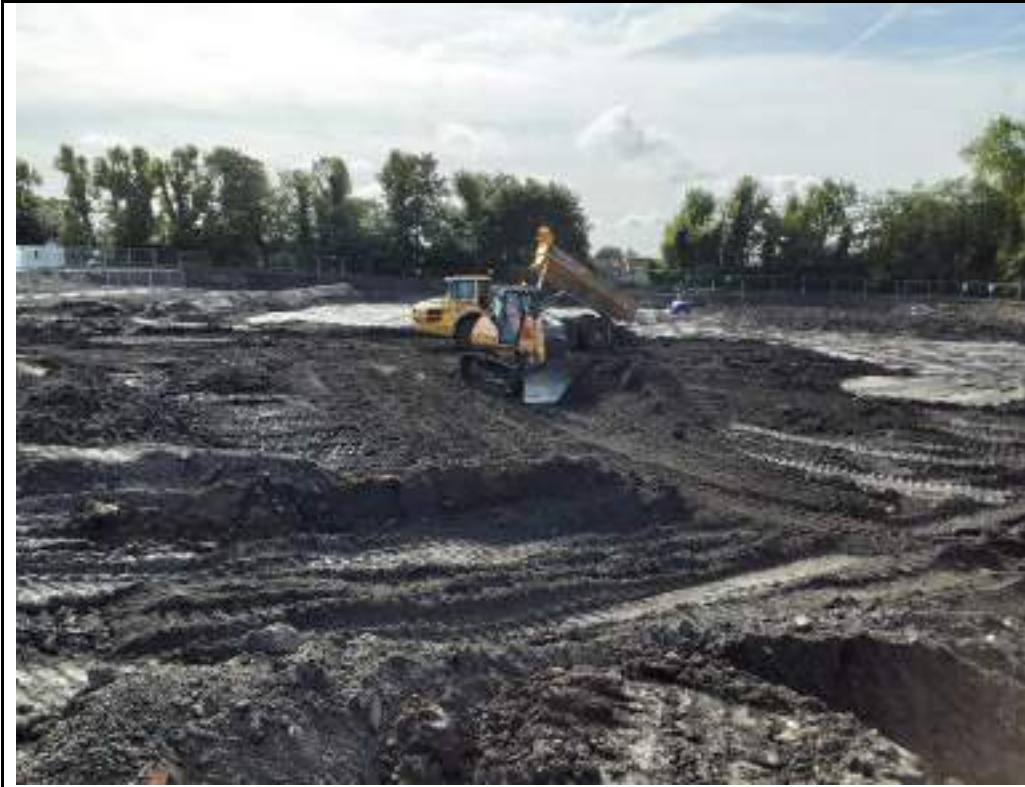
Photograph 125: Backfilling of southern part of the site using undersize material of screener.

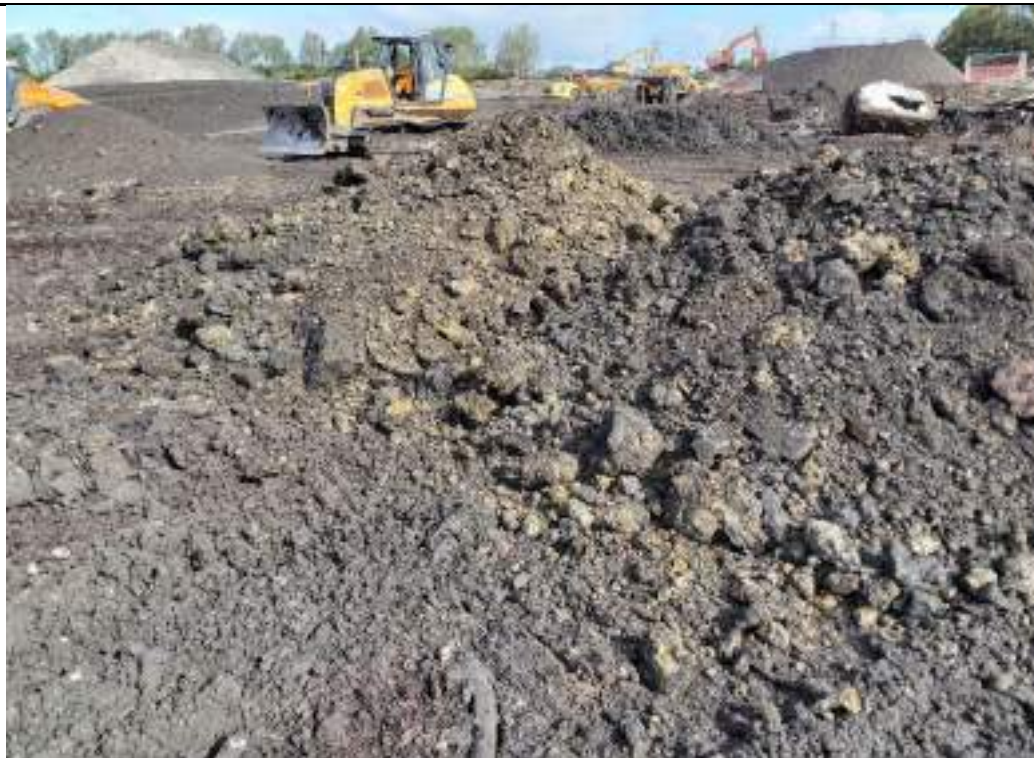
Photograph 136: Excavated material from southeast to backfill southern part of the site.

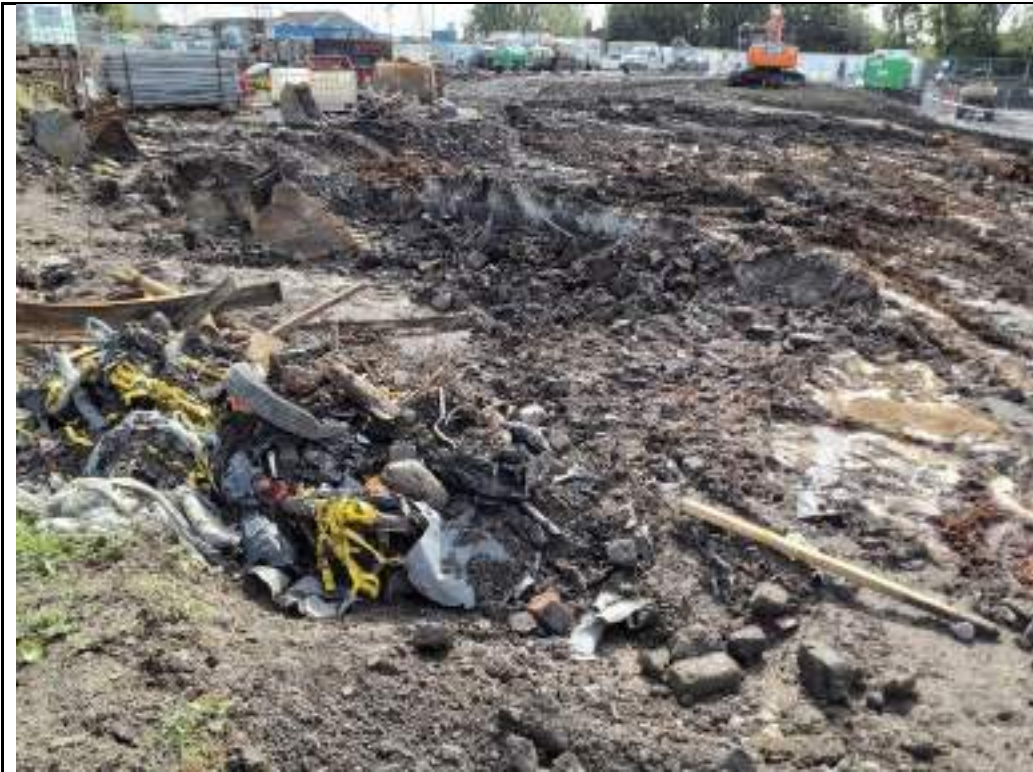
Photograph 147: Deleterious material in southeastern part of the site.

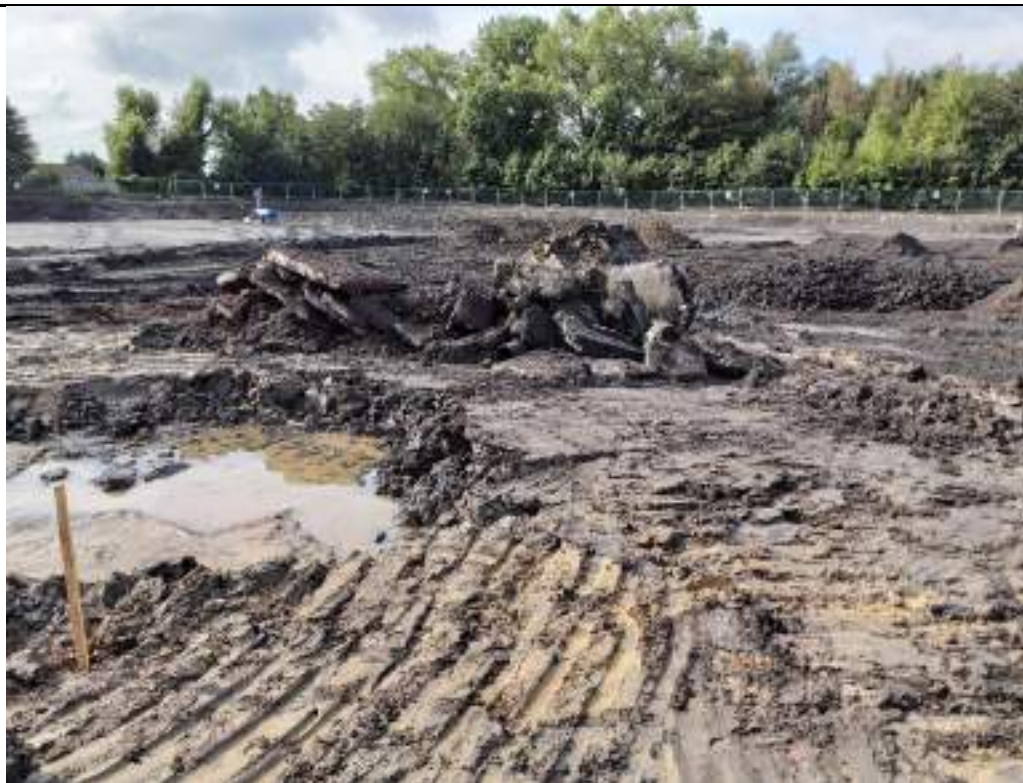
Photograph 158: Stockpile of excavated concrete in southeast of the site.

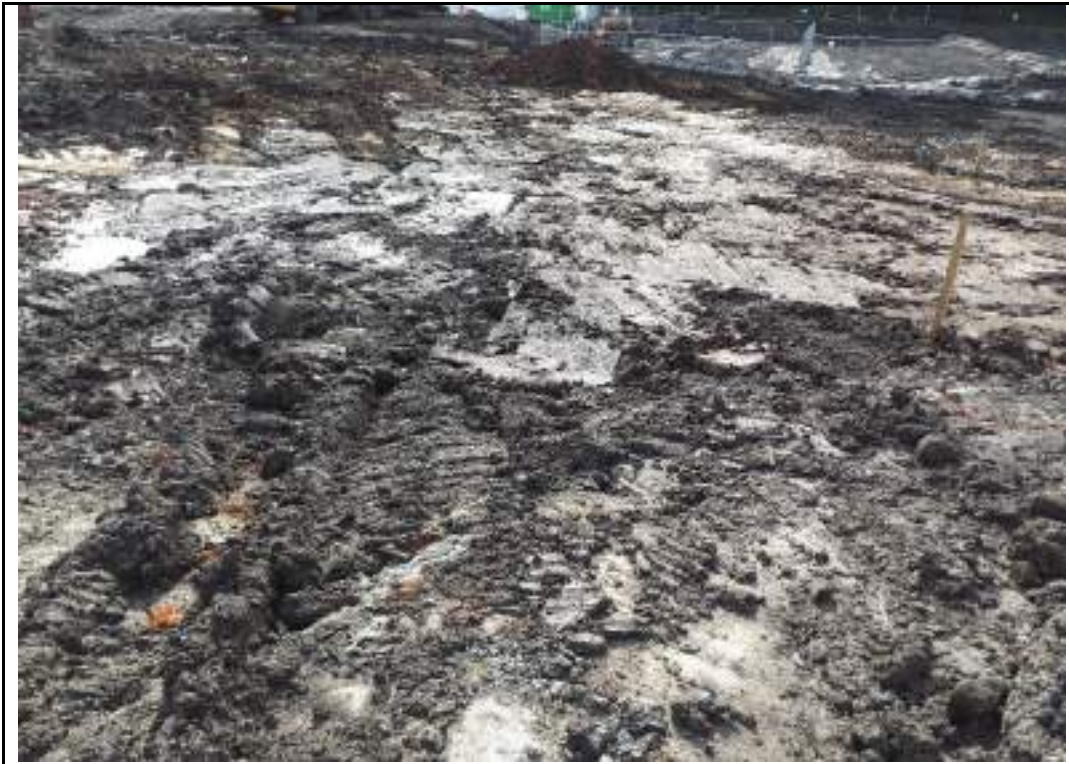
Photograph 169: Potentially TPH contaminated area in excavation in southeastern part of the site.

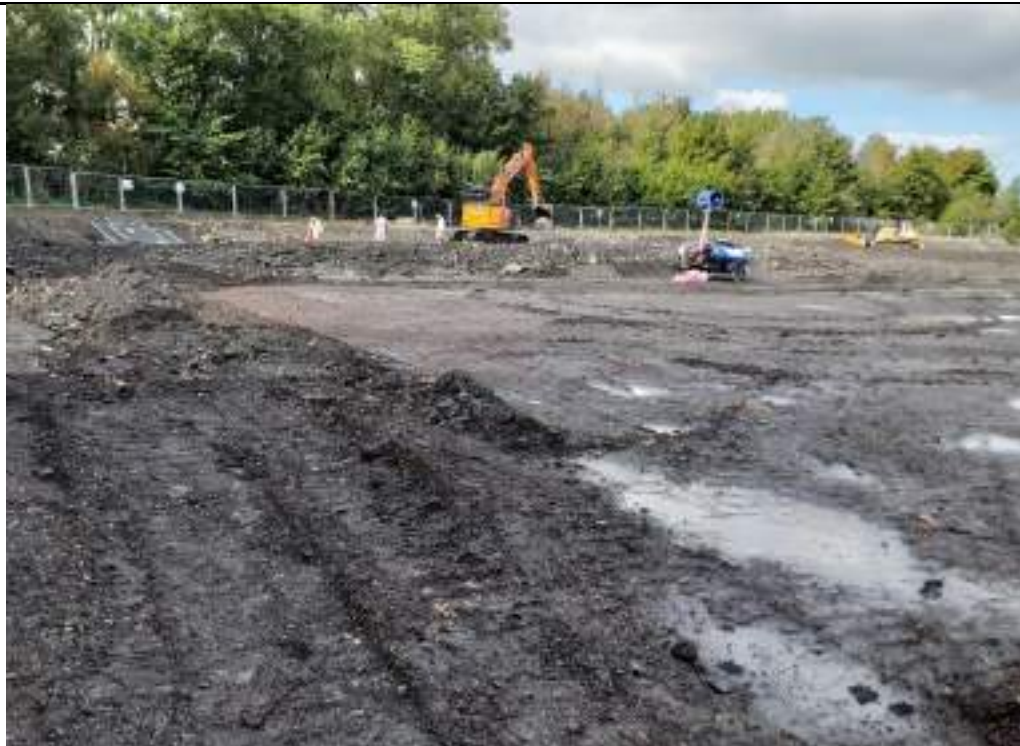
Photograph 20: Handpicking of asbestos from asbestos contaminated stockpile in southwestern part of the site.

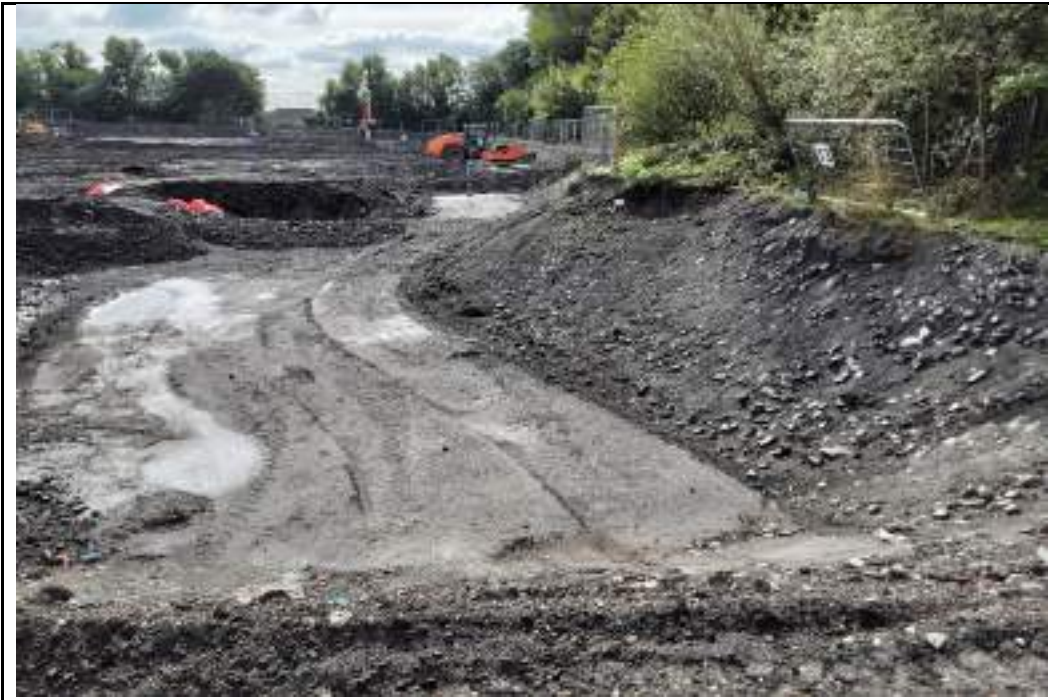
Photograph 21: Western boundary of the site. Looking towards the south.

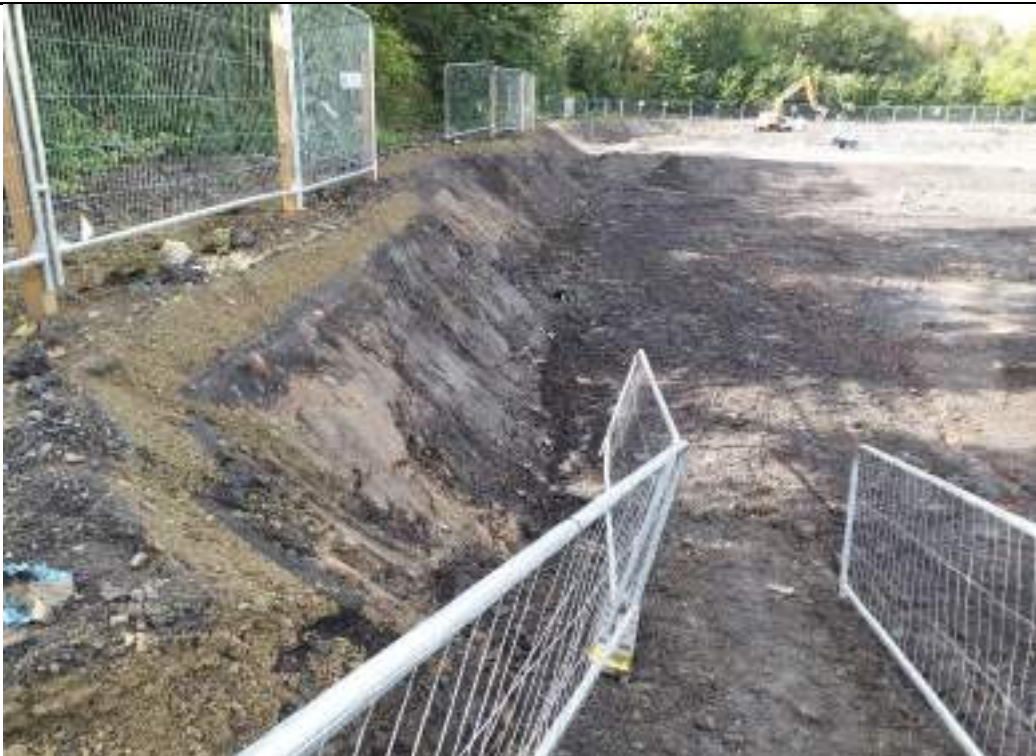
Photograph 22: Southern boundary of the site. Looking towards the west.

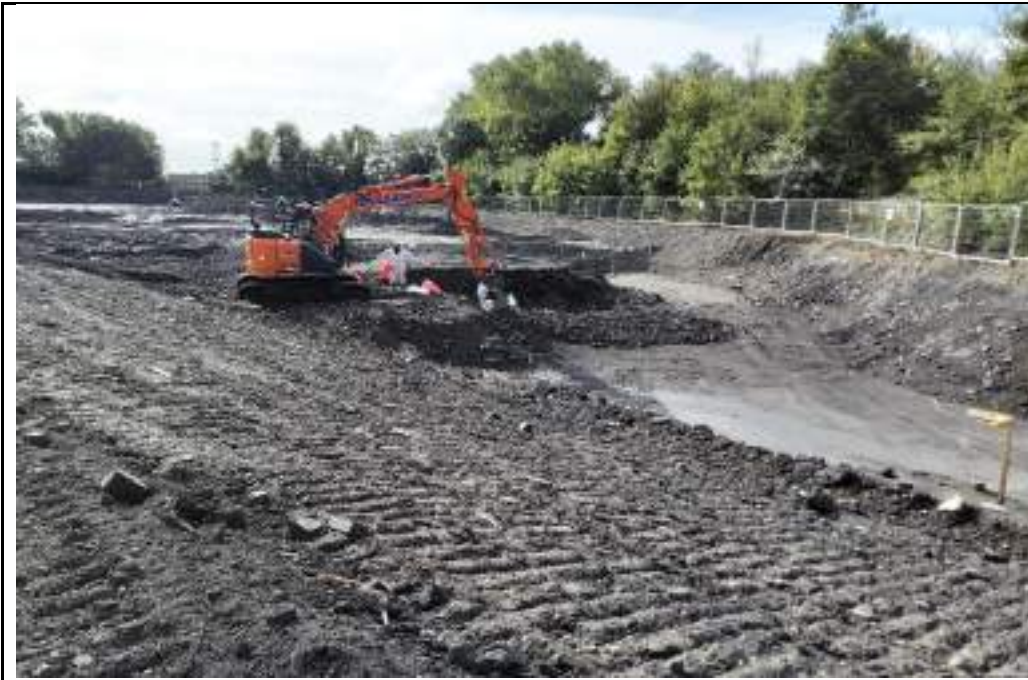
Photograph 23: Hand picking of asbestos from asbestos contaminated stockpile in western part of the site.

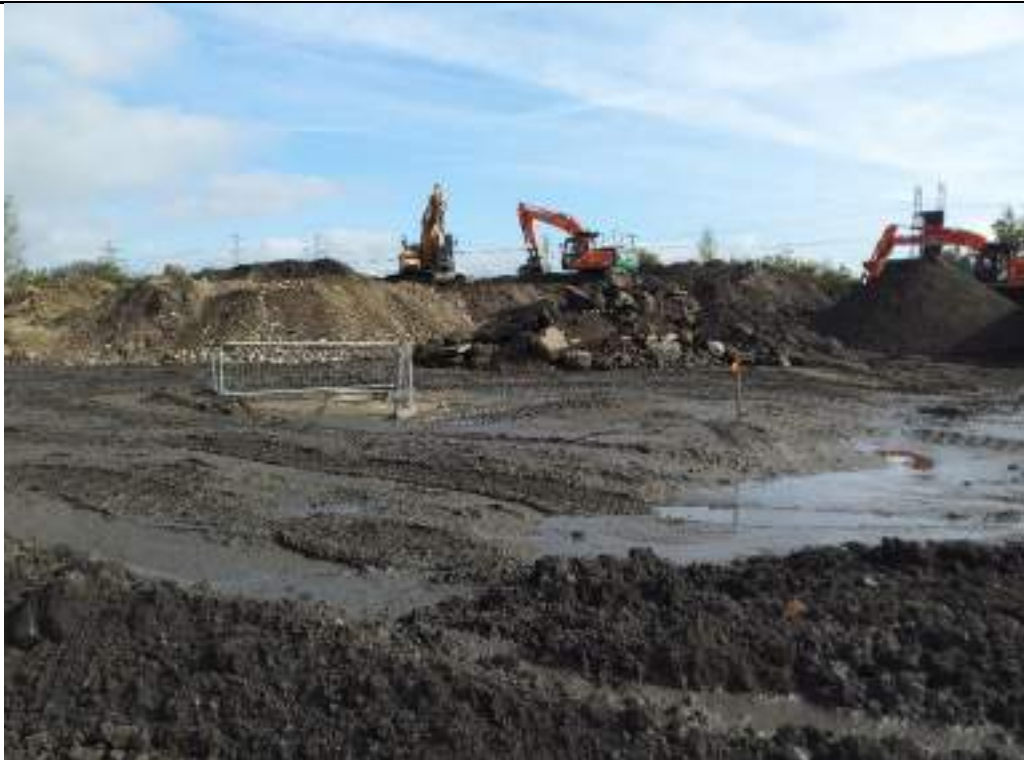
Photograph 24: Overview of stockpiles of excavated material in northeast of the site.

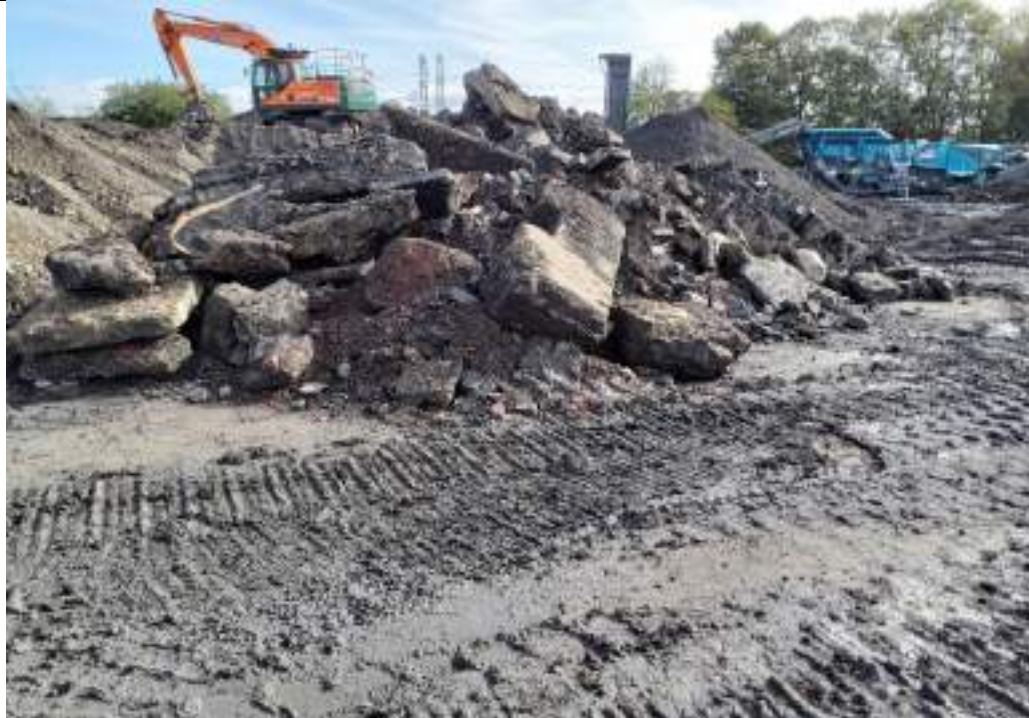
Photograph 26: Stockpile of excavated concrete in northeastern part of the site. Concrete excavated from southeast of the site.

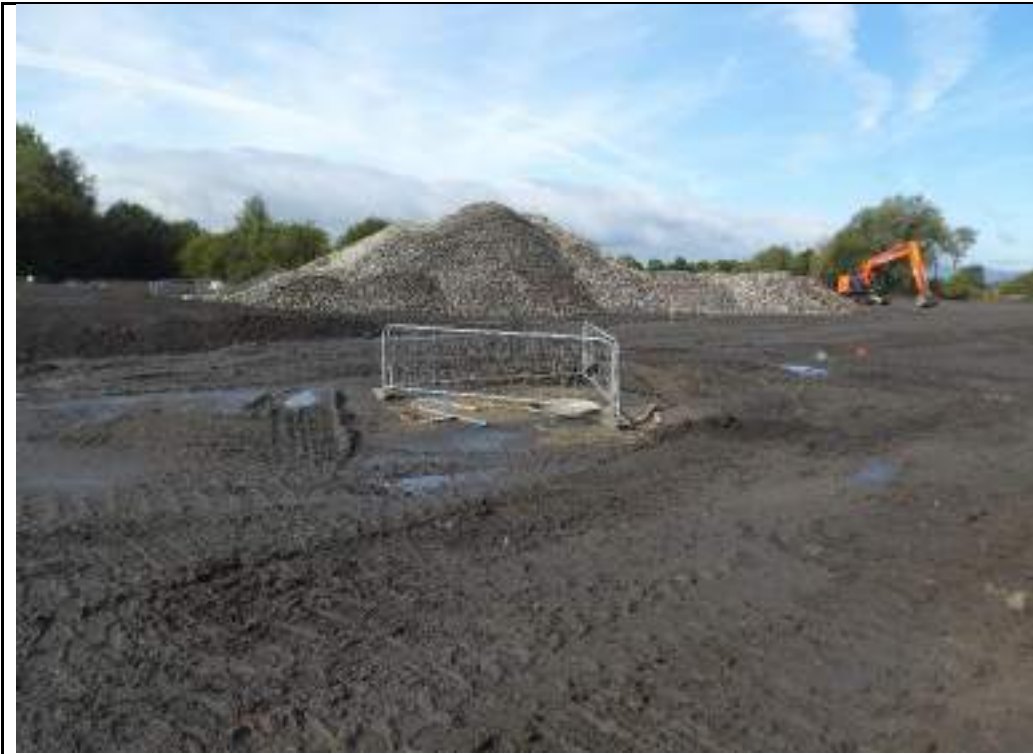
Photograph 27: Stockpile of crushed concrete in northwest of the site.

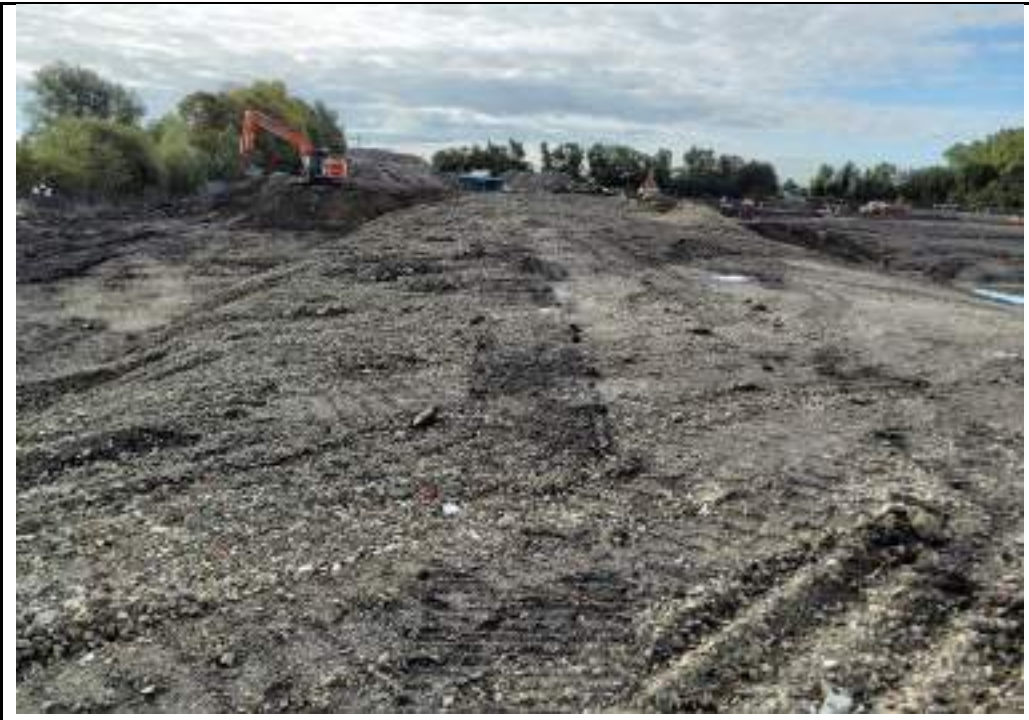
Photograph 1: Overview of the site. Looking towards the south.

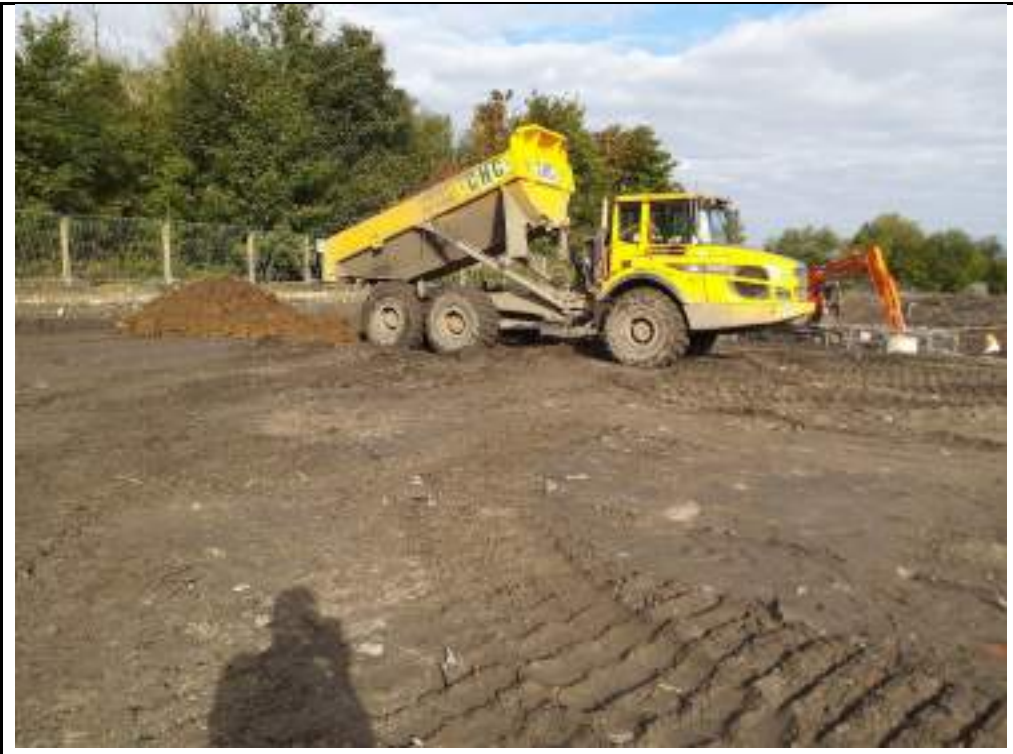
Photograph 3: Backfilling western part of the site with excavated material from southeast of the site.

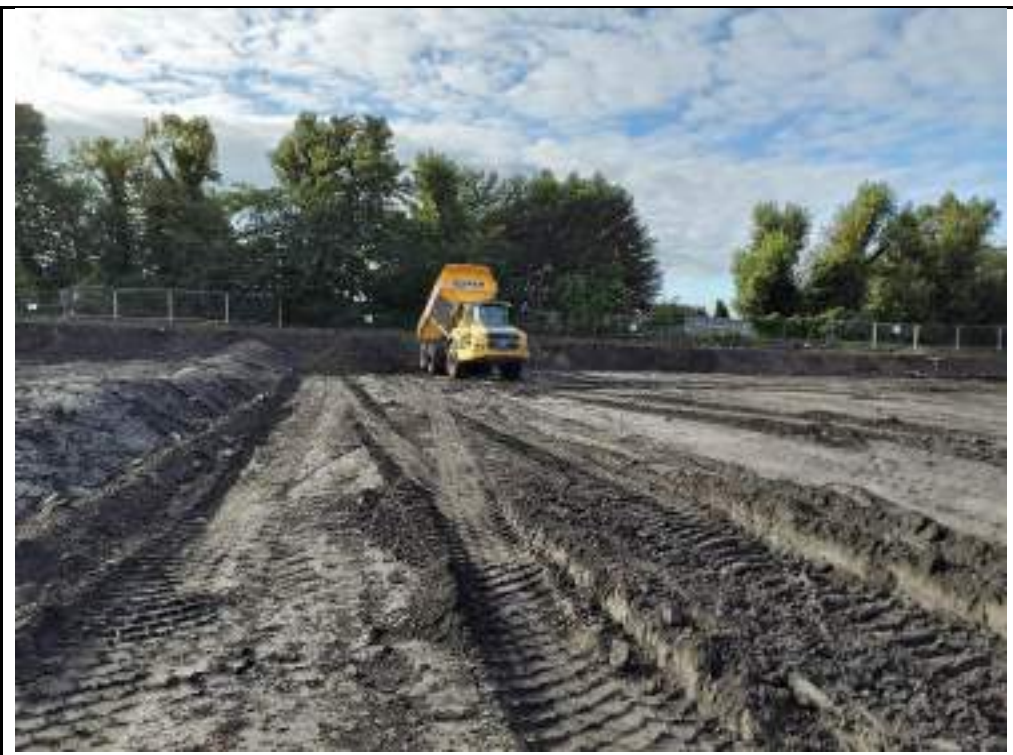
Photograph 4: Backfilling southern part of the site with material from northeastern stockpile.

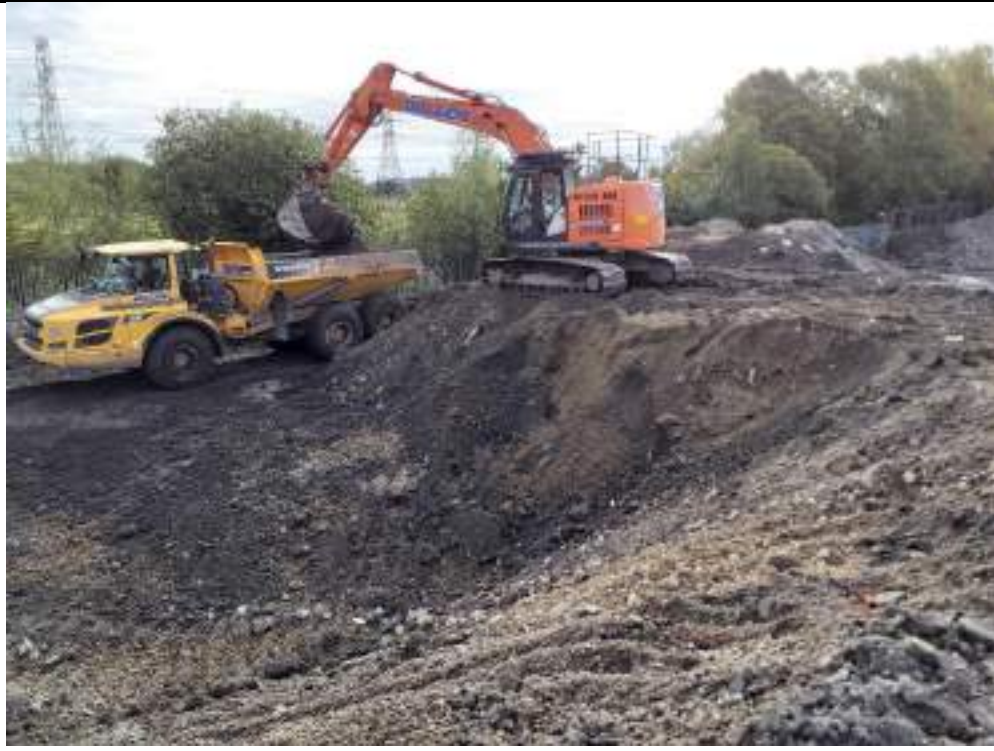
Photograph 5: Transferring material from northeastern stockpile to backfill southern and western part of the site.

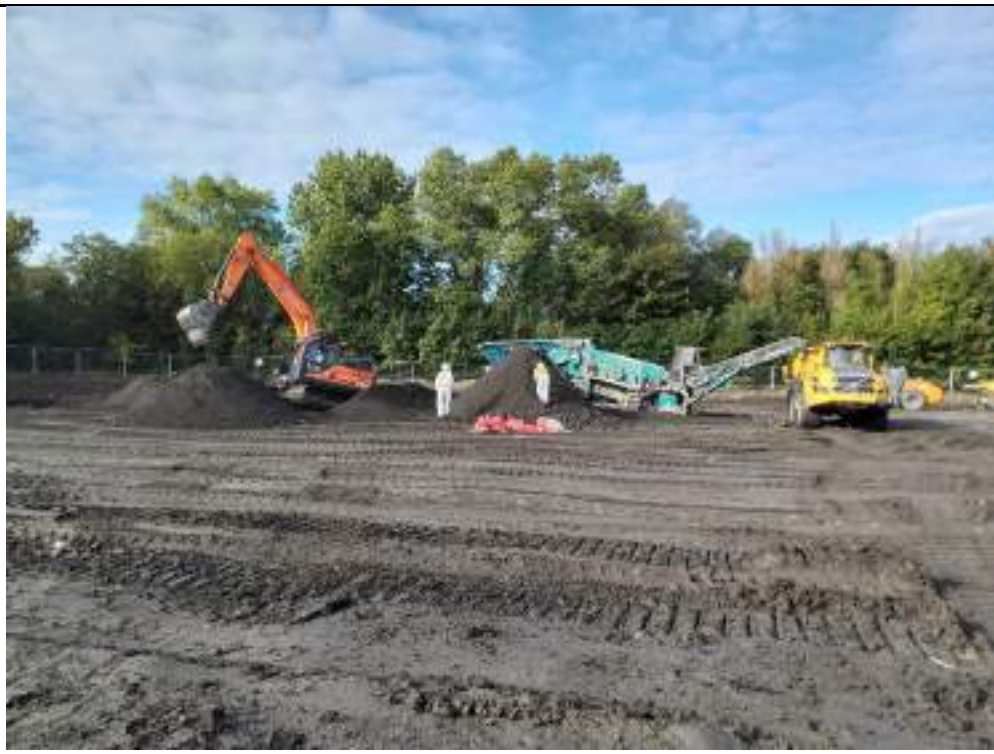
Photograph 6: Screening of asbestos stockpile and hand picking of asbestos in southwestern part of the site.

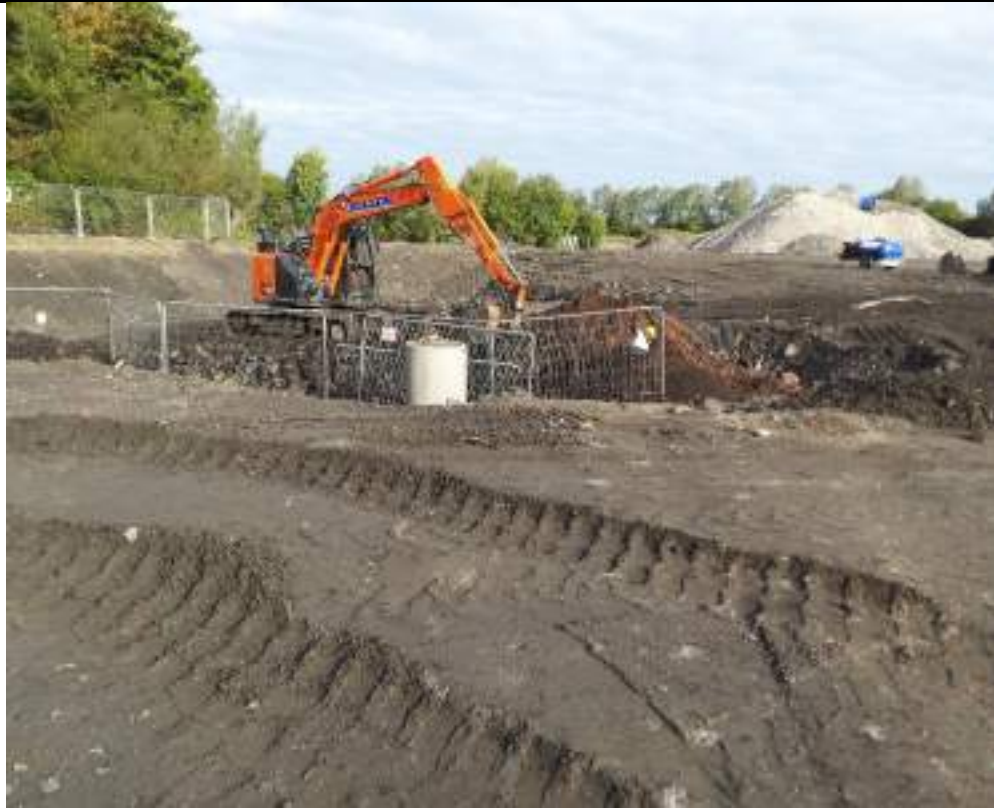
Photograph 7: Hand picking of asbestos in western part of the site

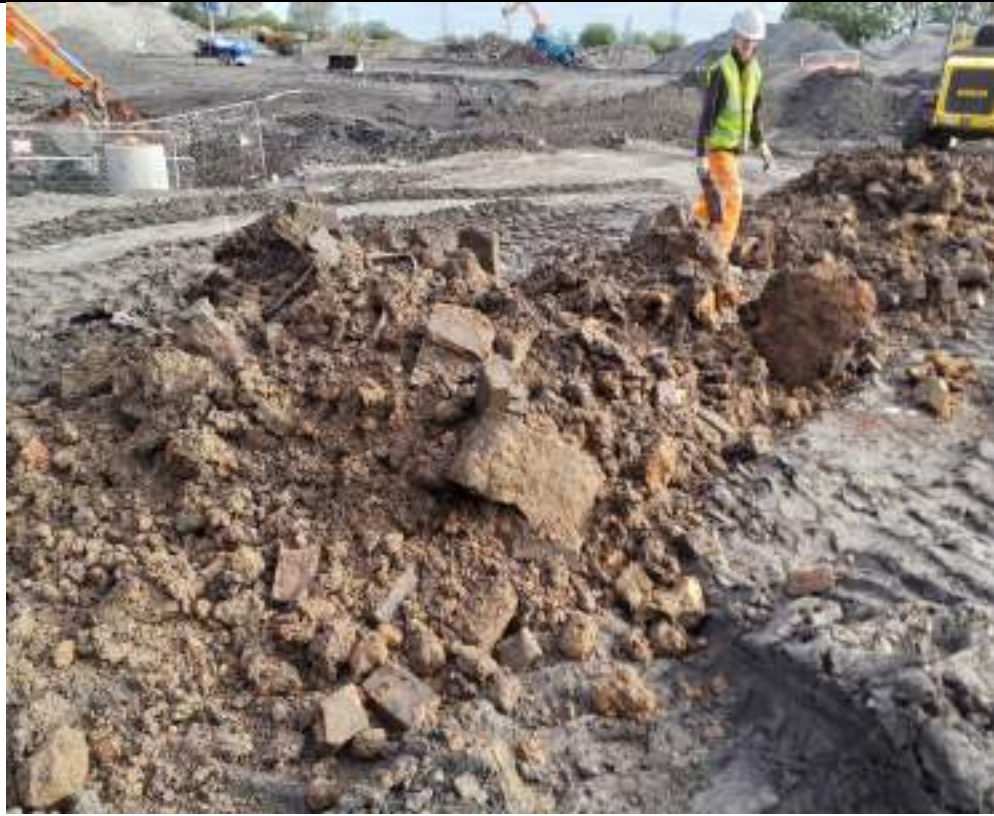
Photograph 8: Hand picking of deleterious material in southern part of the site.

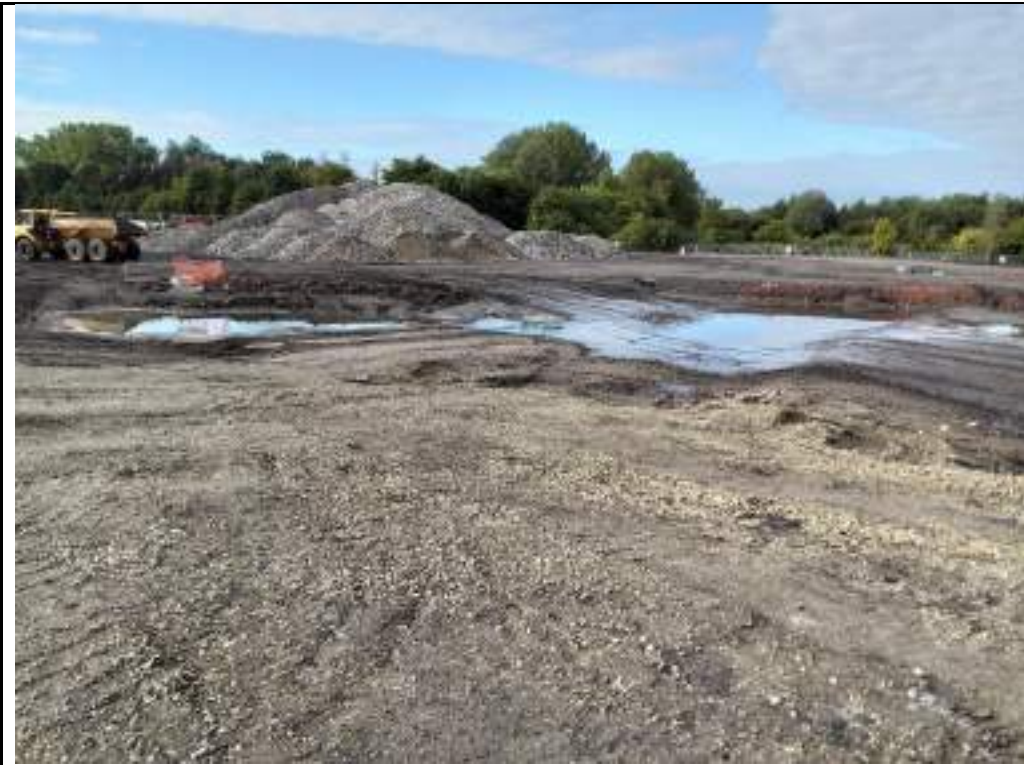
Photograph 9: Standing water in northern part of the site.

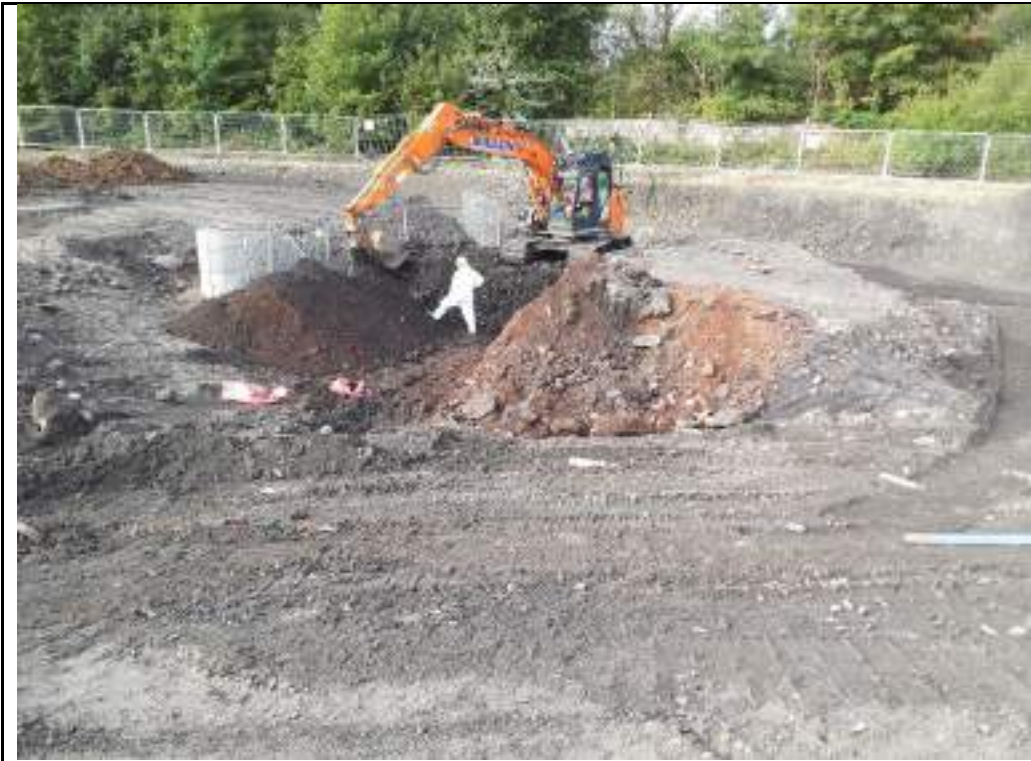
Photograph 91: Screening of the asbestos contaminated stockpile using riddle bucket excavator.

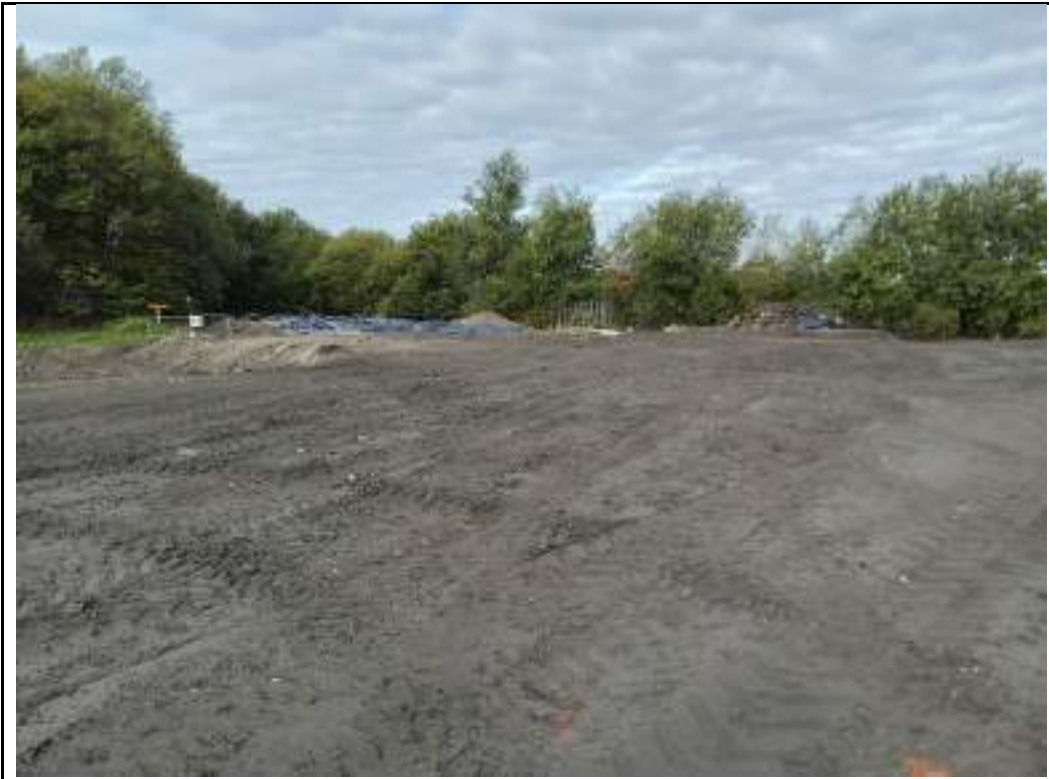
Photograph 113: TPH and asbestos contaminated stockpiles in northwestern part of the site.

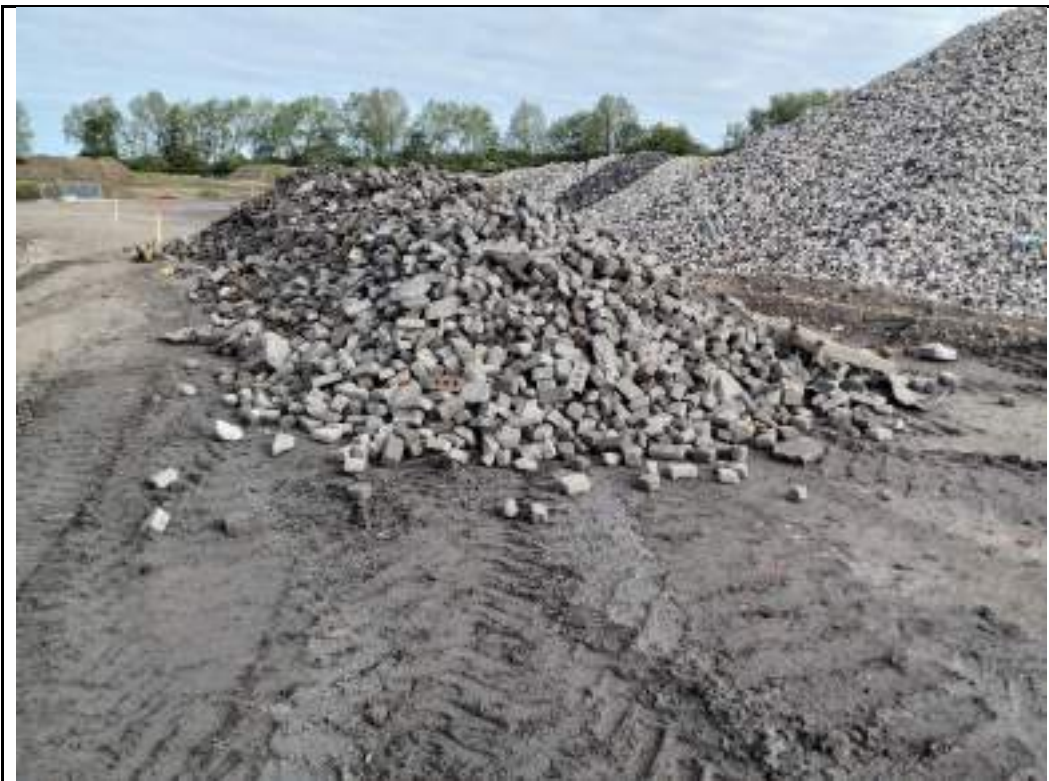
Photograph 14: Deleterious material and bricks stockpile in northwestern part of the site.

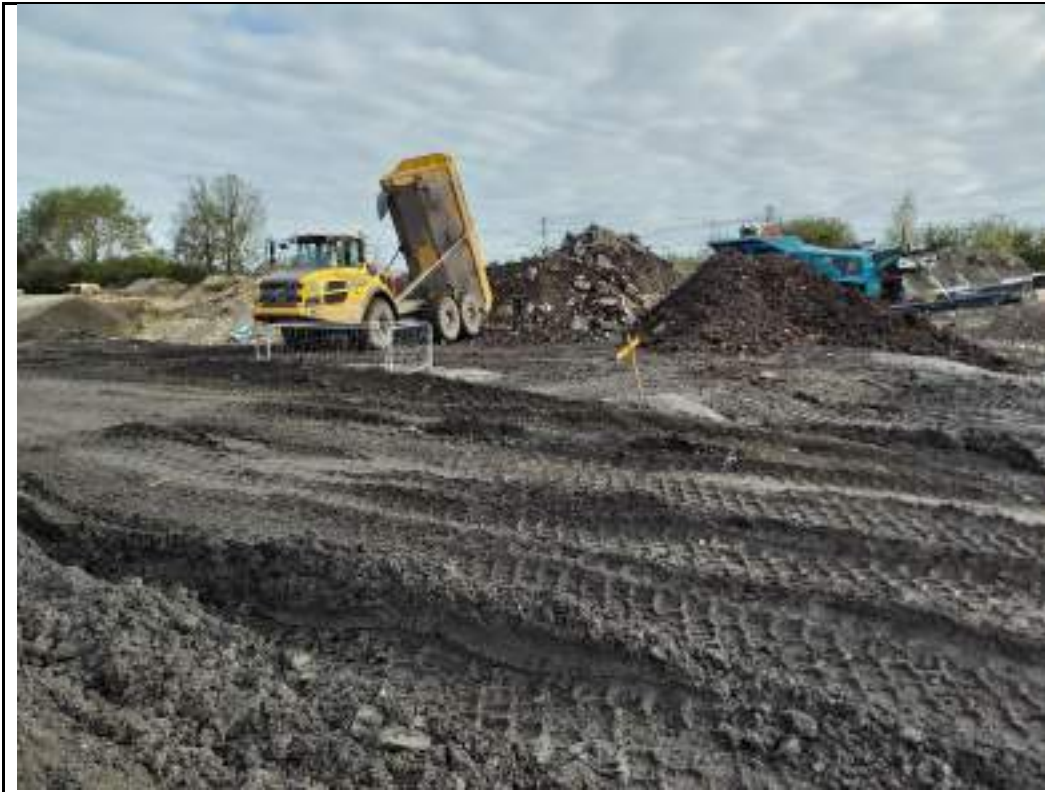
Photograph 125: Stockpiling concrete and oversize material in northeastern part of the site.

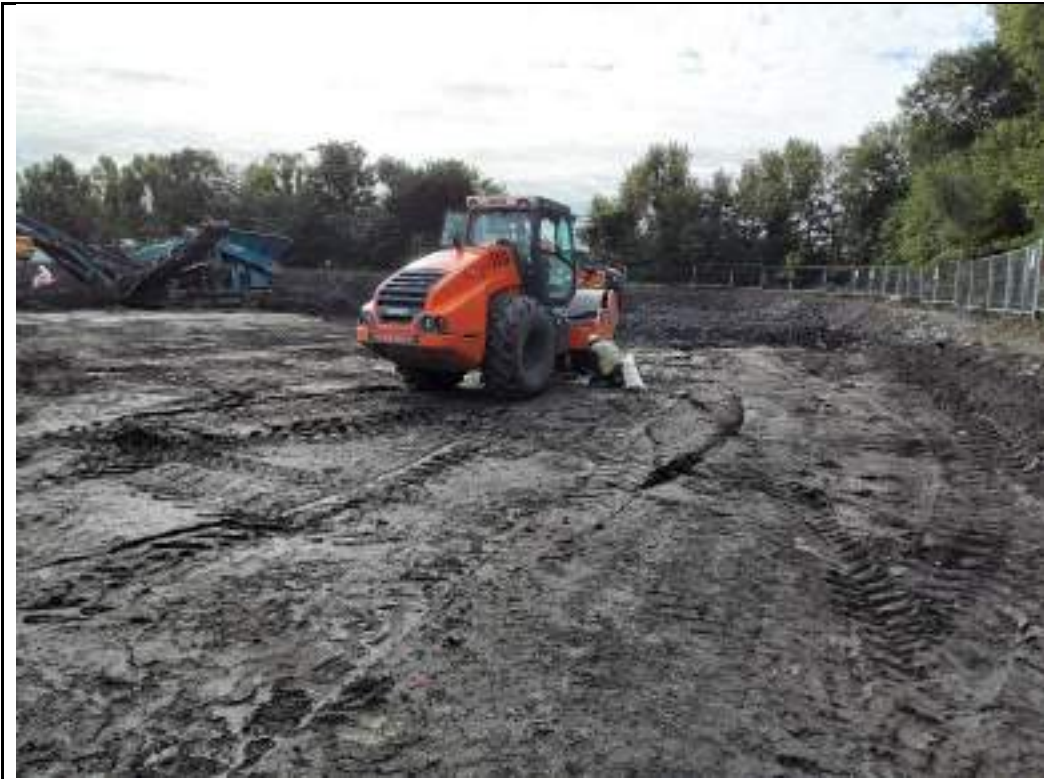
Photograph 147: Plate load testing in western part of the site.

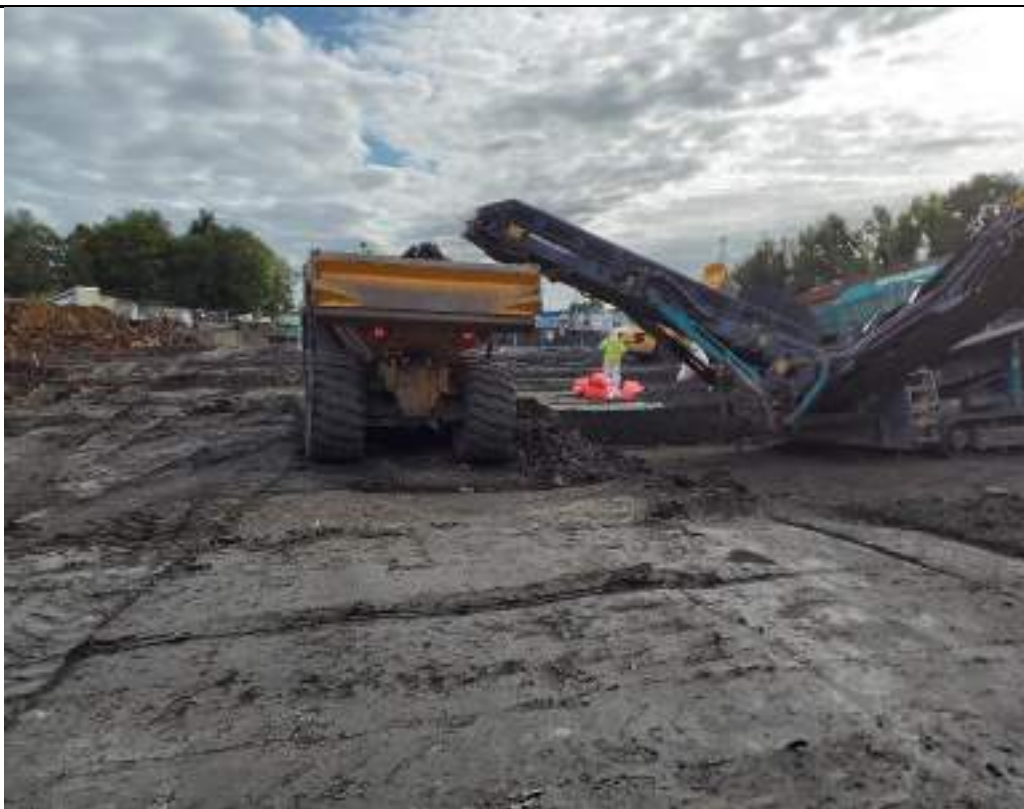
Photograph 158: Separation of oversize material (bricks) from asbestos contaminated stockpile in southwestern part of the site.

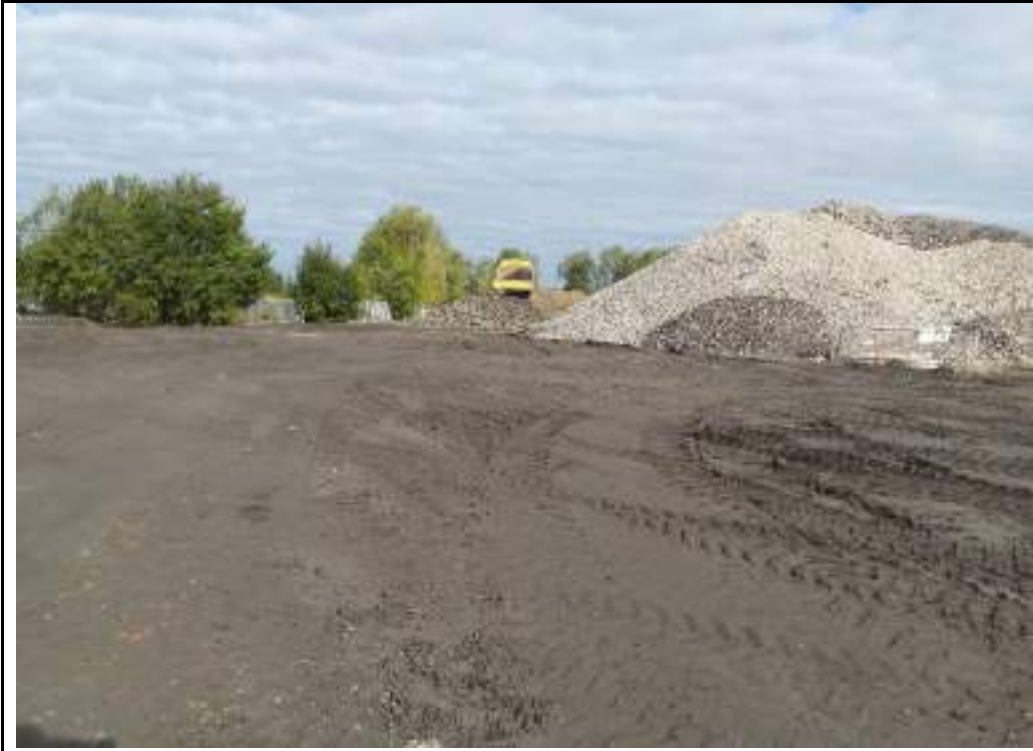
Photograph 169: Unloading bricks in northwest of the site.

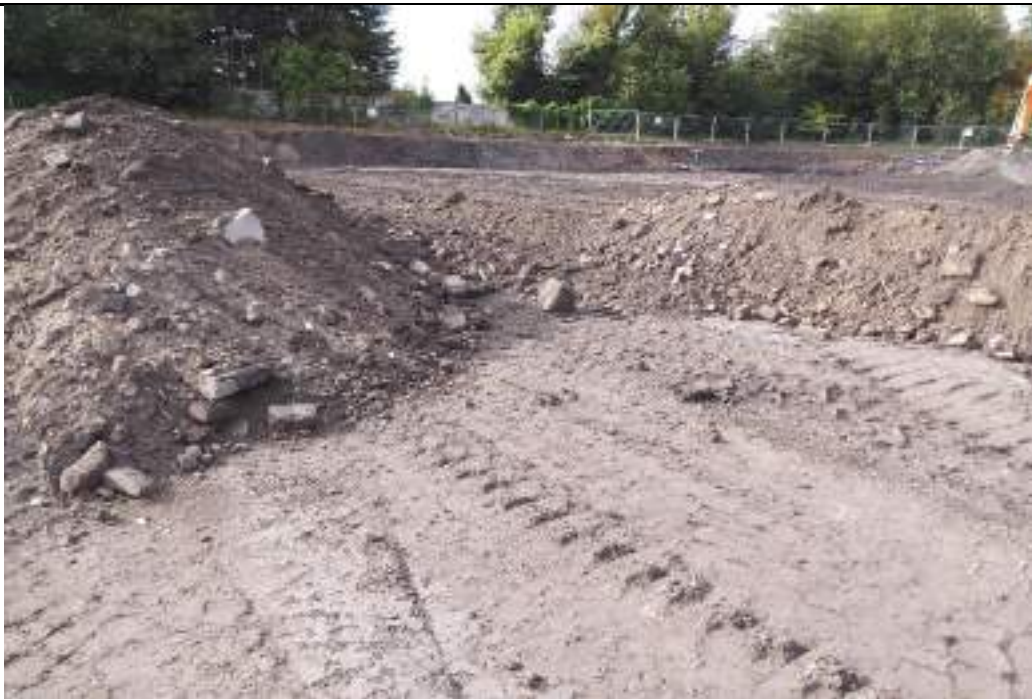
Photograph 20: Existence of oversize in fill material in southern part of the site. Material from northeastern stockpile.
