**SITE VISIT REPORT 15220-HYD-XX-XX-SVR-GE-1018**

**SHEET NO.: 6 of 18**

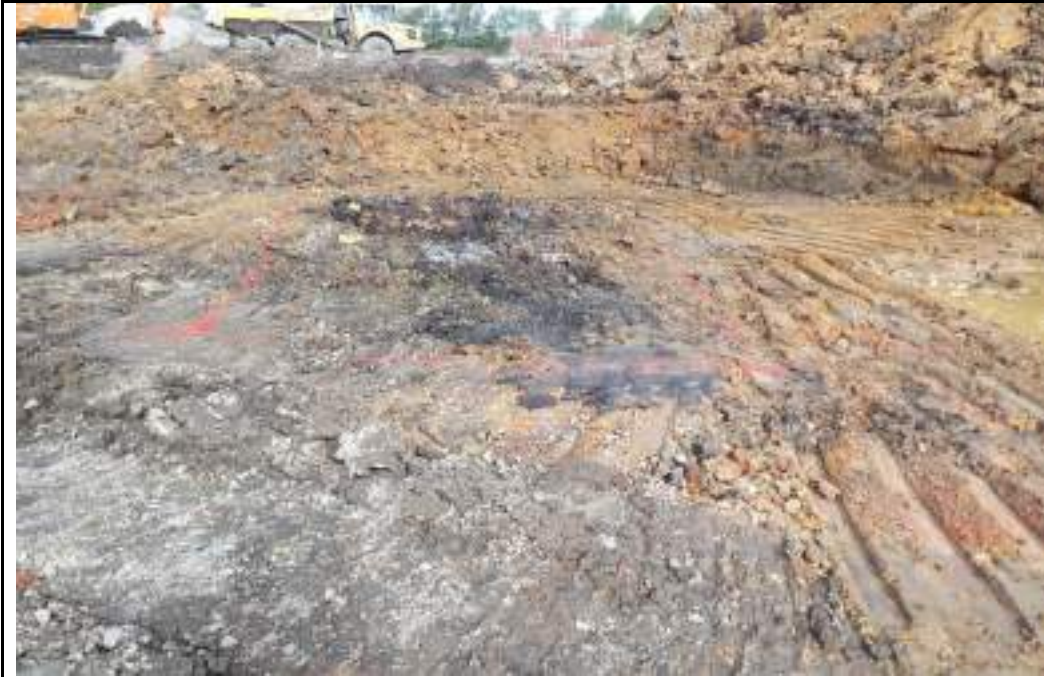
Photograph 21: Potentially TPH contaminated area in southeastern part of the site

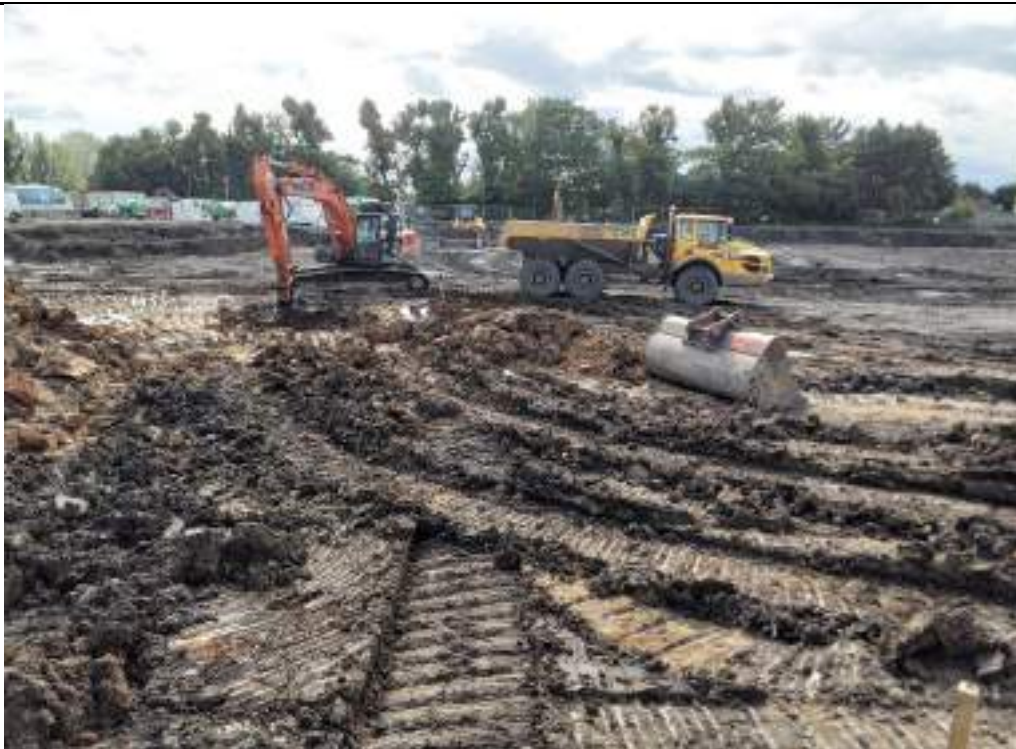
Photograph 22: Excavation of potentially TPH contaminated area in southeastern part of the site.

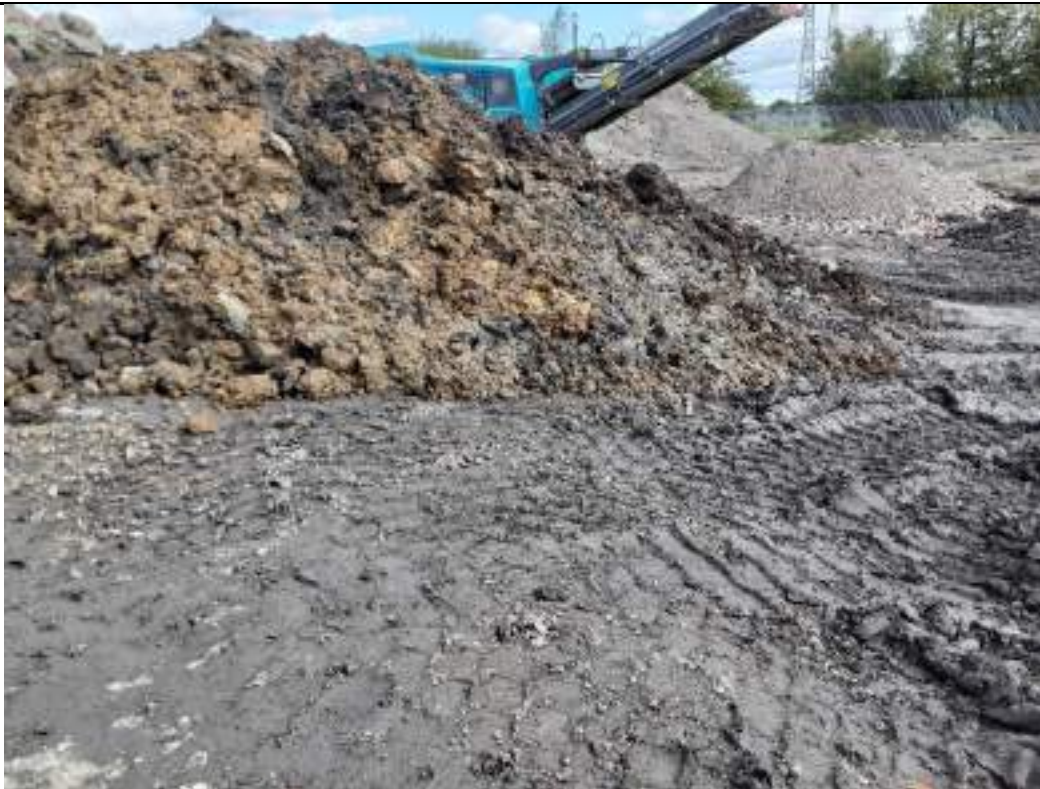
Photograph 24: Stockpiling potentially TPH contaminated material in northeastern part of the site.

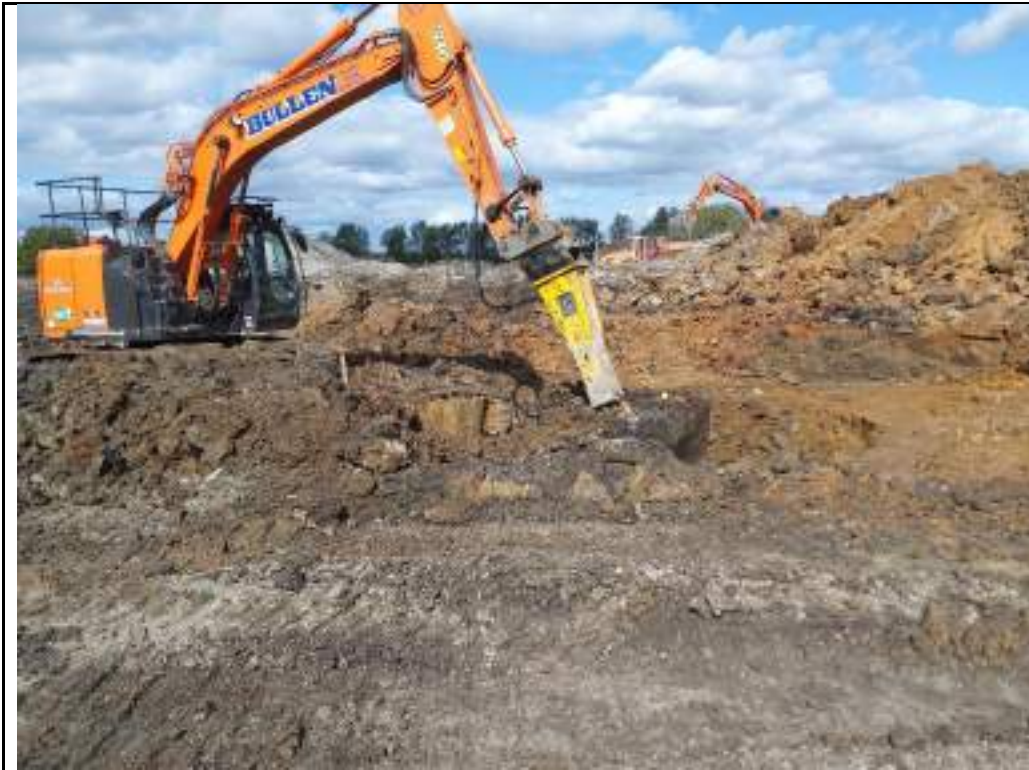
Photograph 25: Breaking concrete in southeastern part of the site.

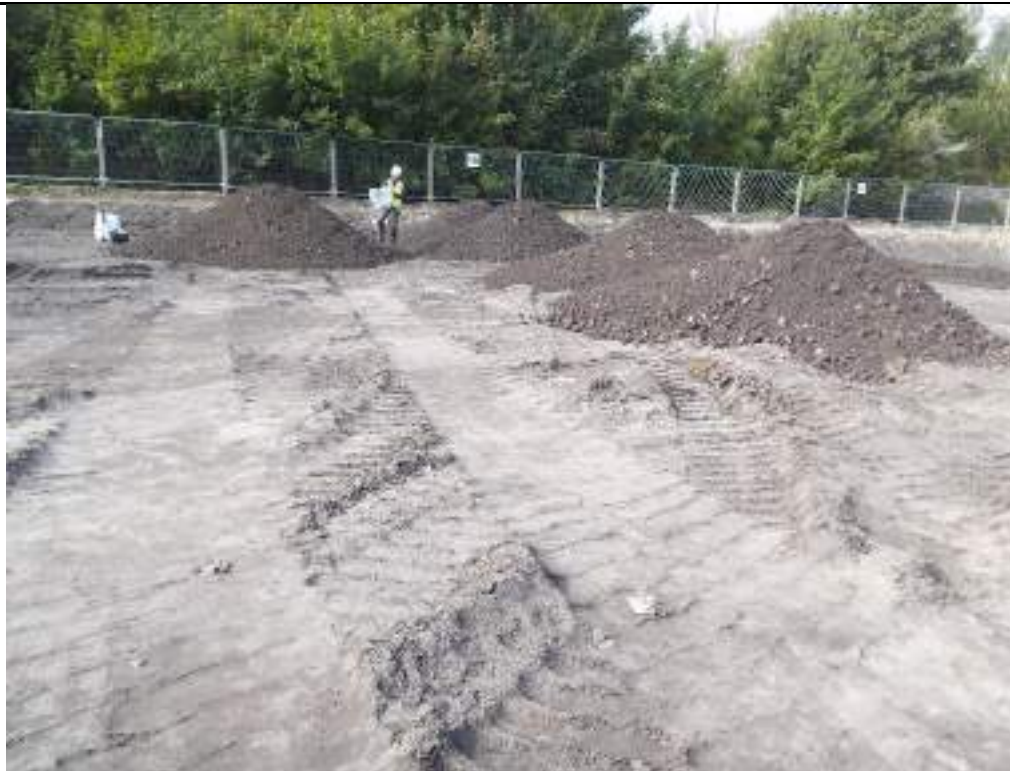
Photograph 26: Collection of geotechnical samples from fill material in western part of the site.  
Processed material from eastern stockpile.

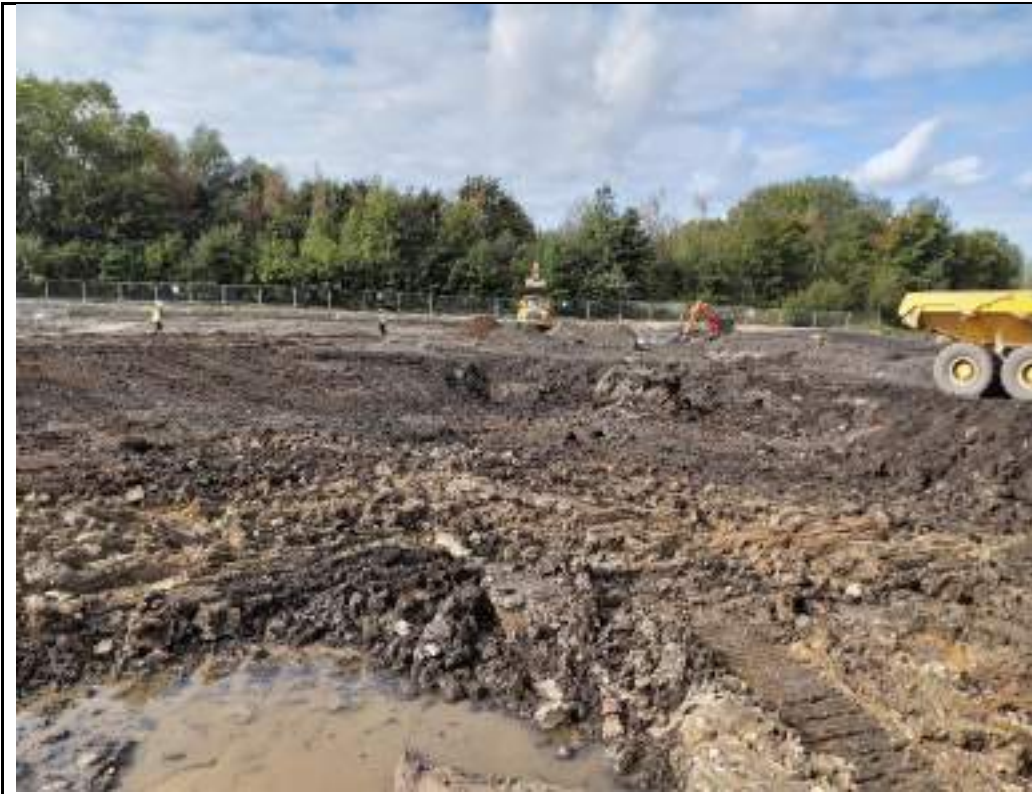
Photograph 27: Loading unsuitable fill from western part of the site to stockpile in northeastern stockpile.

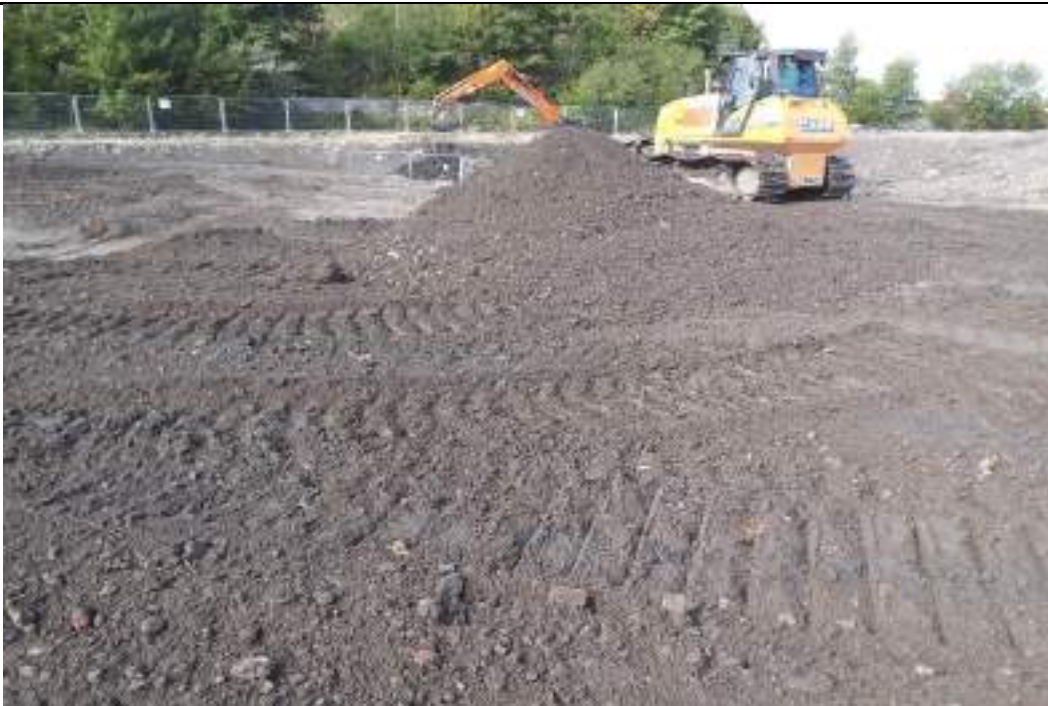
Photograph 28: Dozer pushing processed fill material in southwestern part of the site.

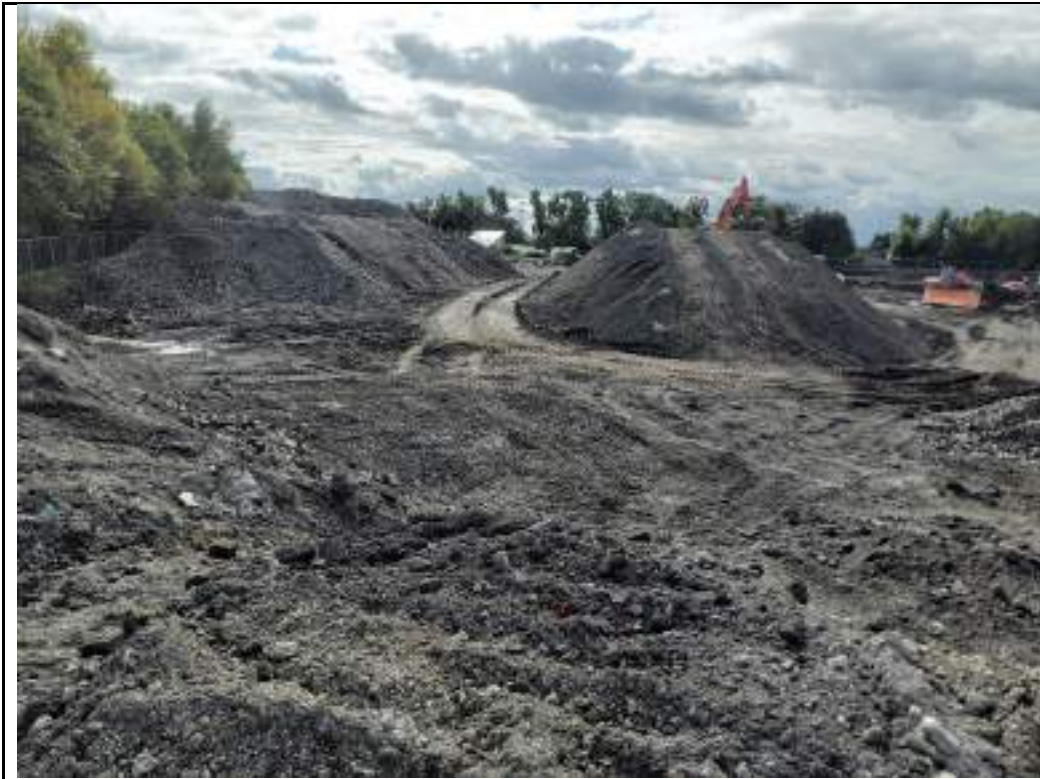
Photograph 29: Stockpiles of crushed materials from crusher and undersize materials from screener in eastern part of the site.

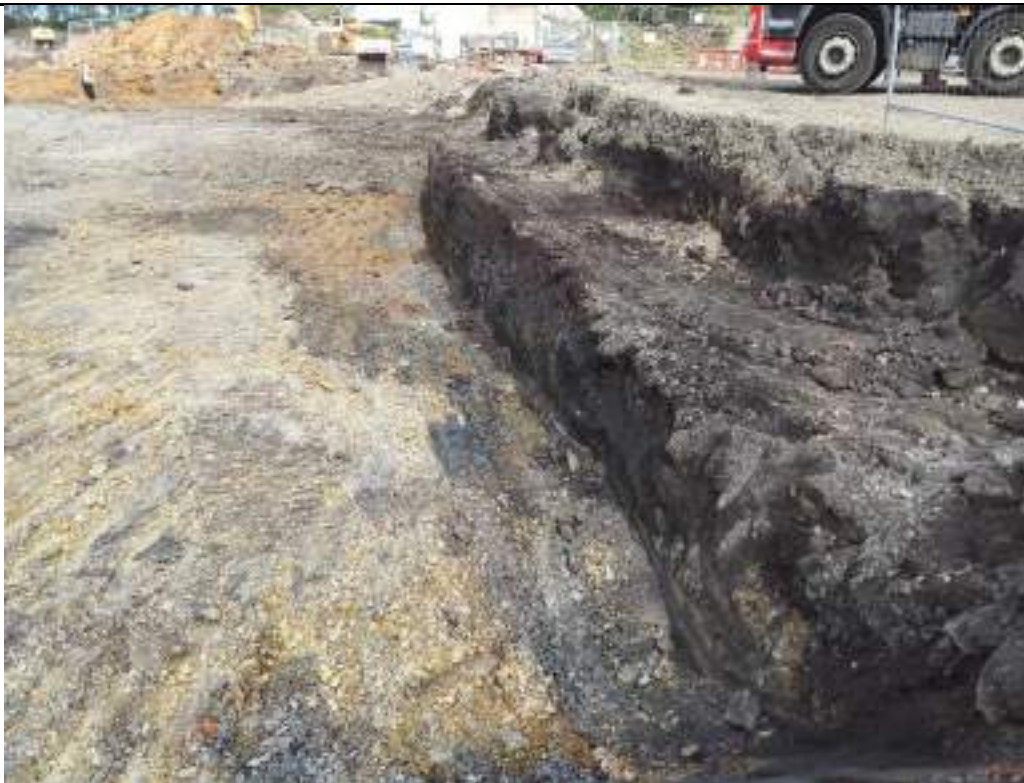
Photograph 30: Battered and stepped excavation in southeast of the site.

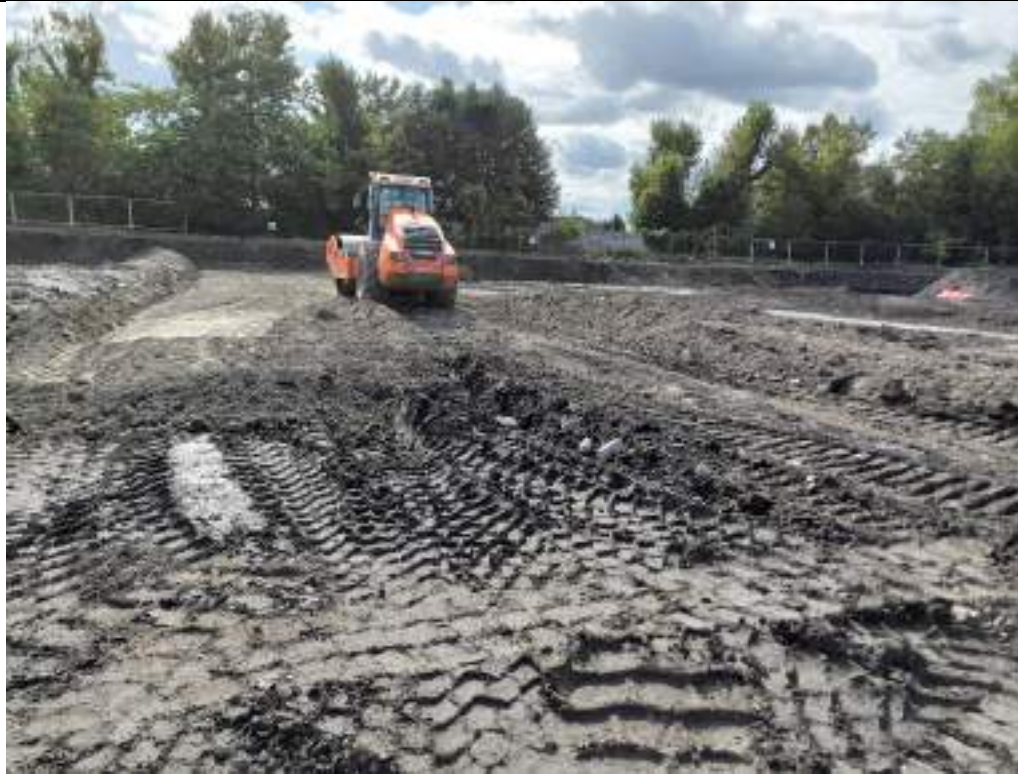
Photograph 31: Proof rolling in southern part of the site.

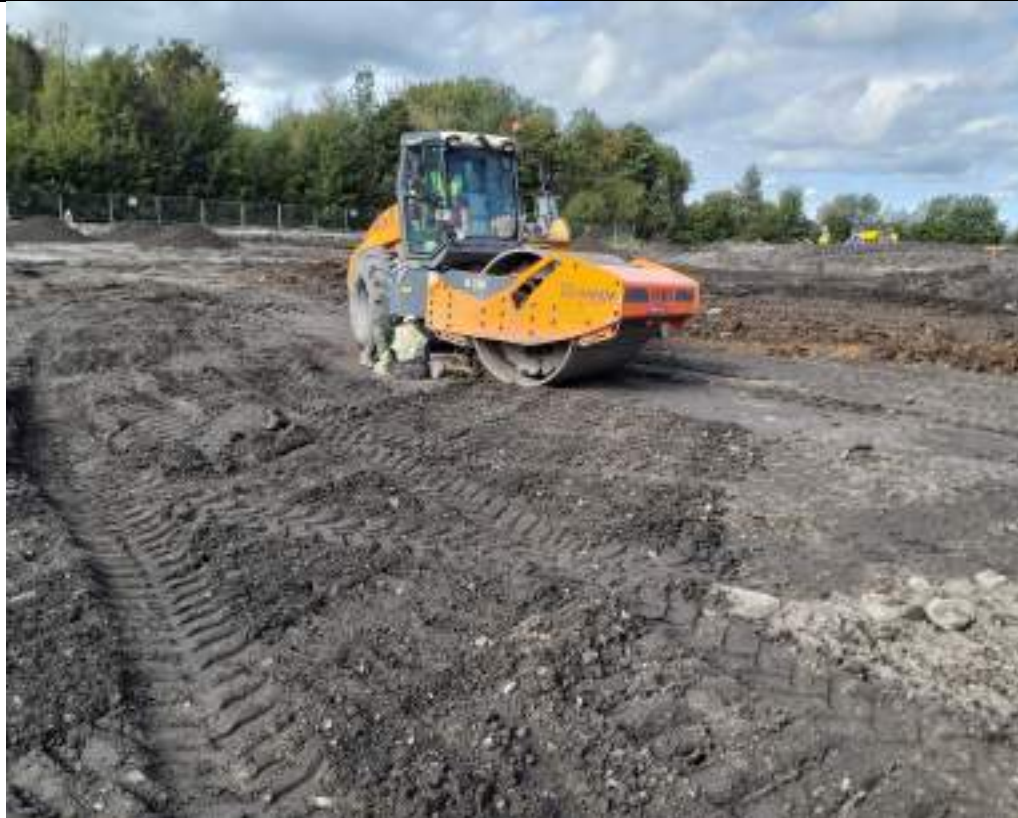
Photograph 32: Plate load testing in southern part of the site.

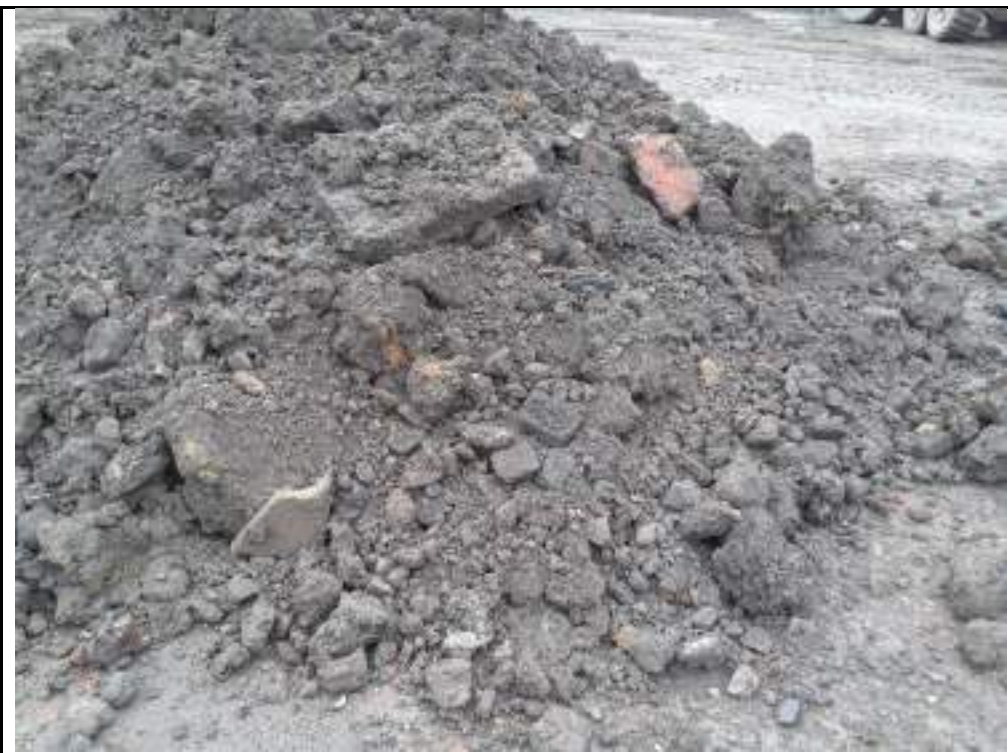
Photograph 4: Oversize in fill material in western part of the site.

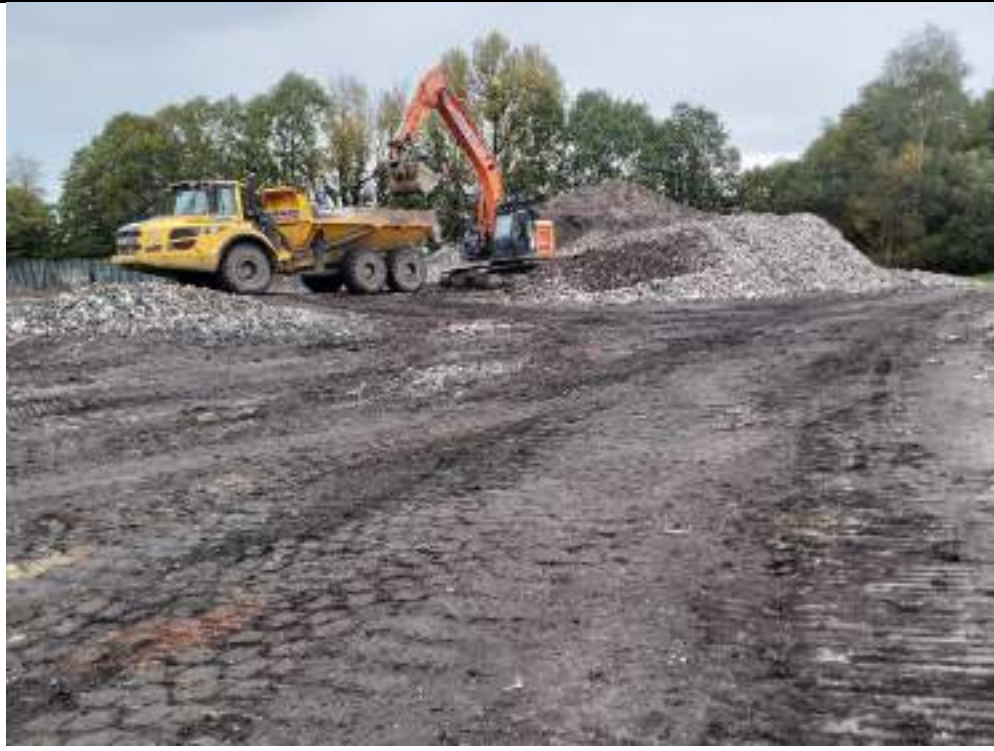
Photograph 5: Transferring crushed material from eastern stockpile to stockpile in northwestern part of the site.

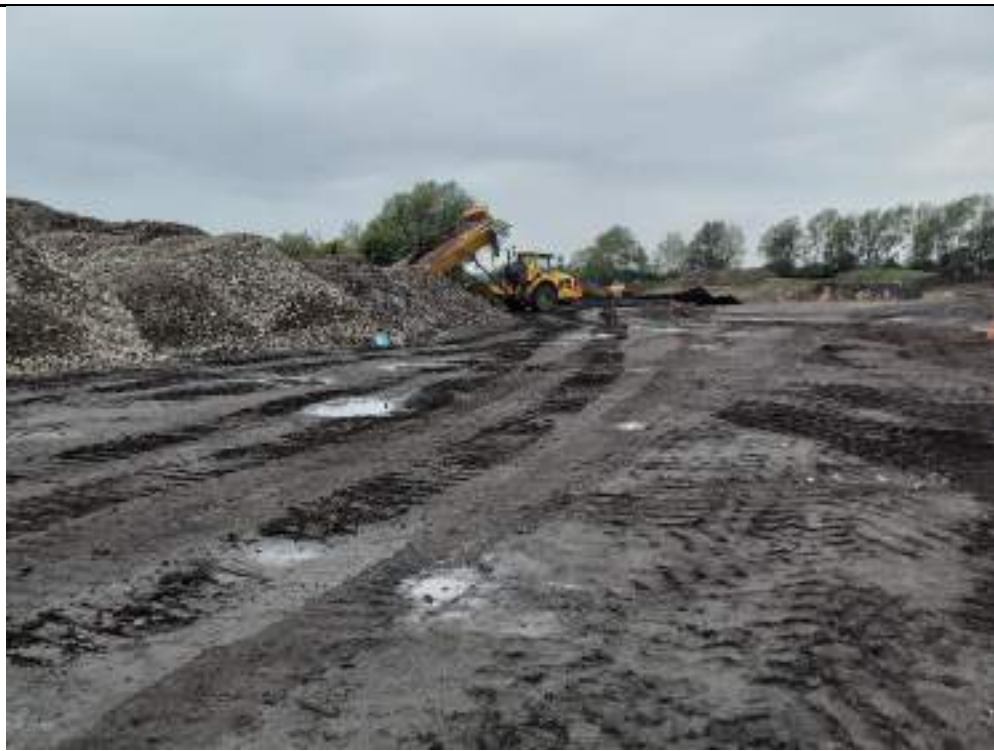
Photograph 6: Unloading crushed material from eastern stockpile in northwestern stockpile.

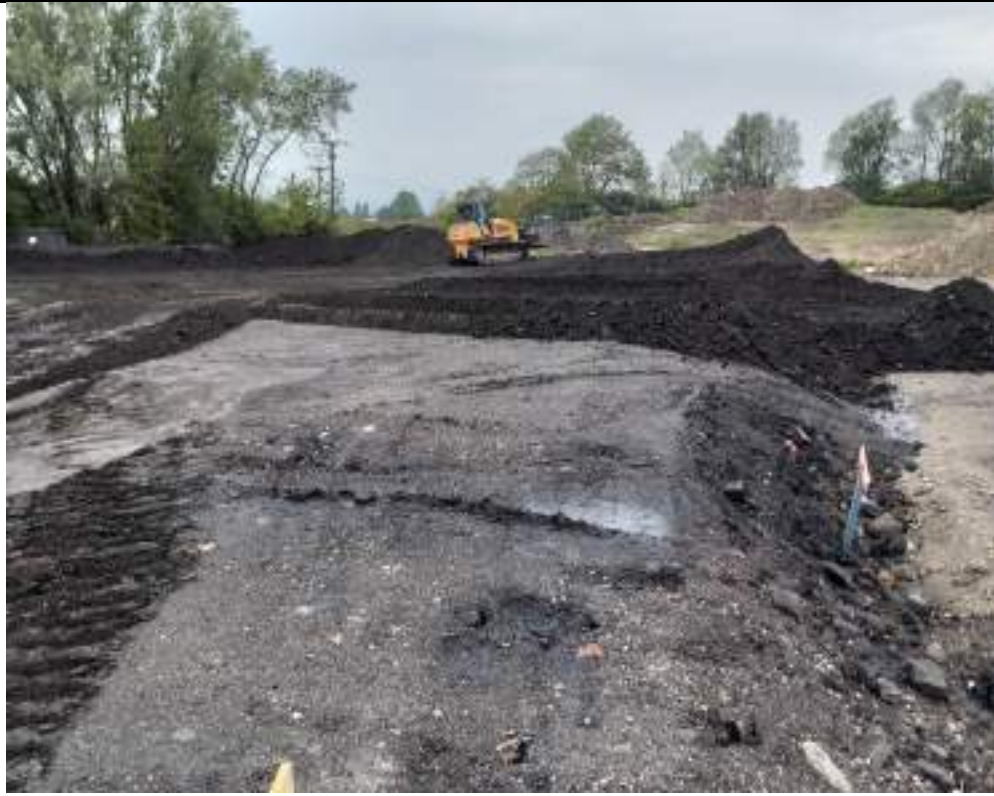
Photograph 7: Backfilling northwestern part of the site.

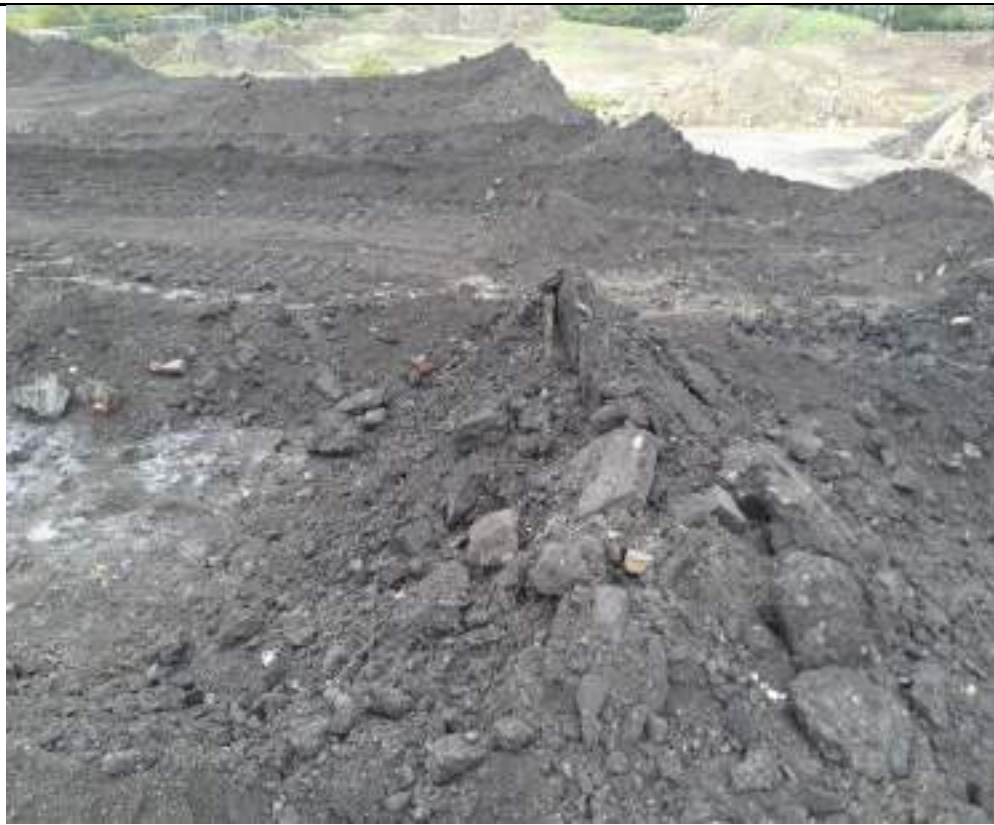
Photograph 8: Oversize in fill material in northwestern part of the site.

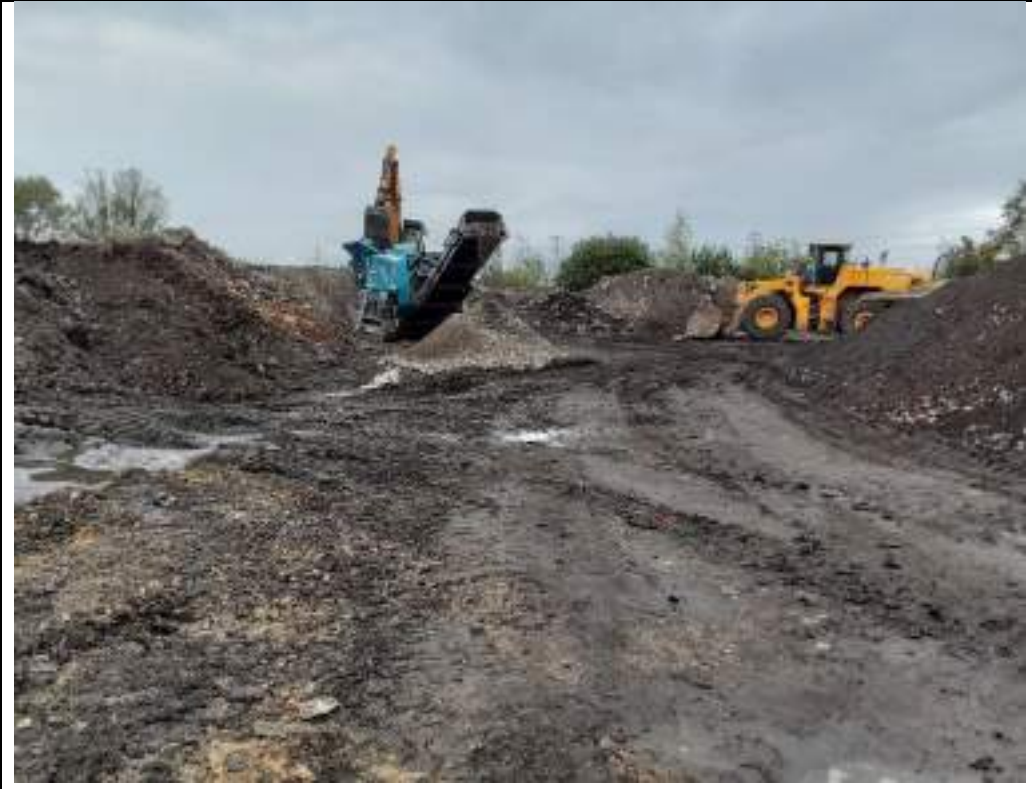
Photograph 9: Crushing oversize material from northeastern stockpile.

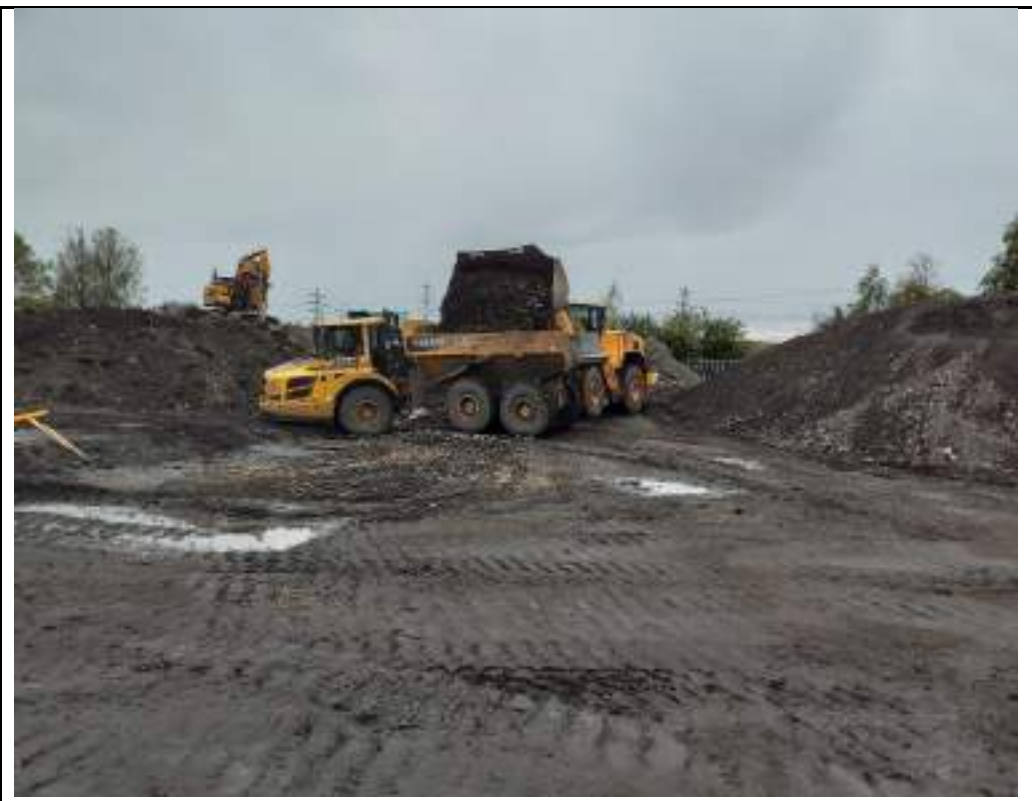
Photograph 10: Loading crushed material in northeastern part of the site.

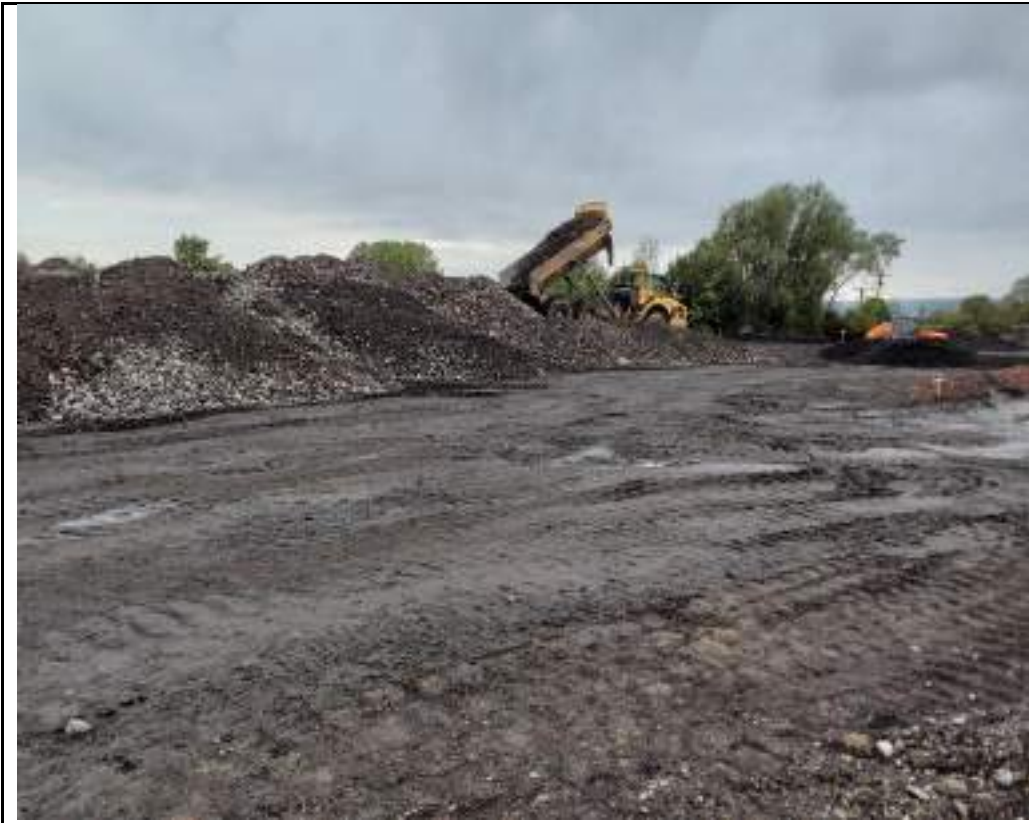
Photograph 91: Stockpiling crushed material in northwestern part of the site.

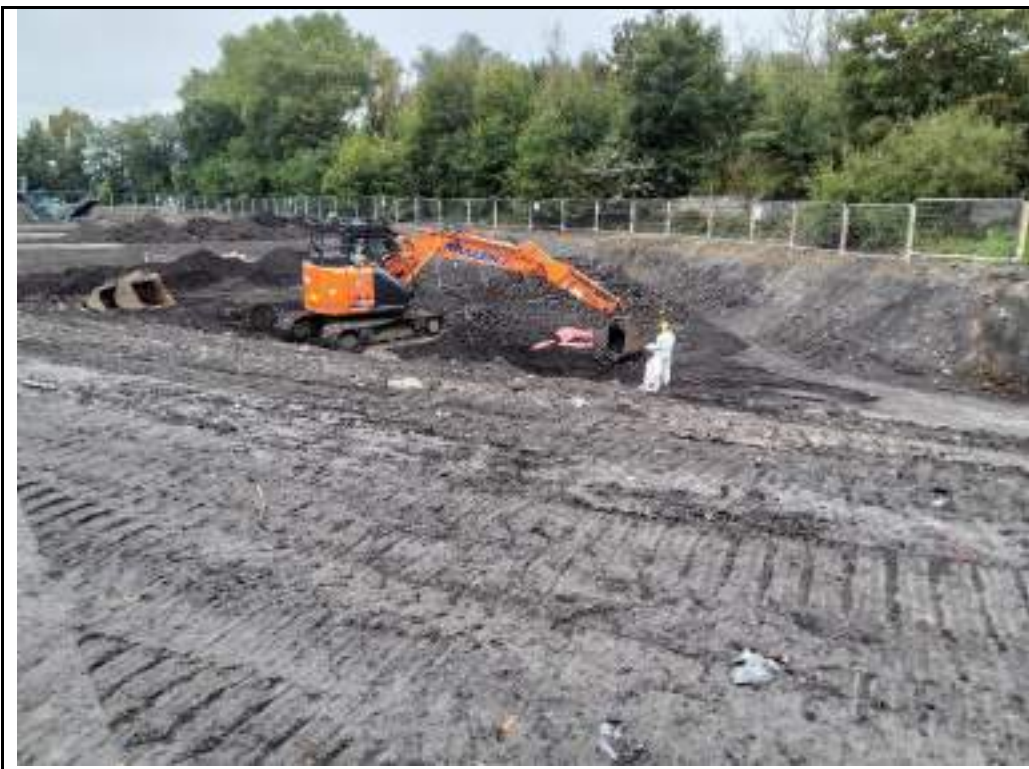
Photograph 110: Hand picking of asbestos in western part of the site.

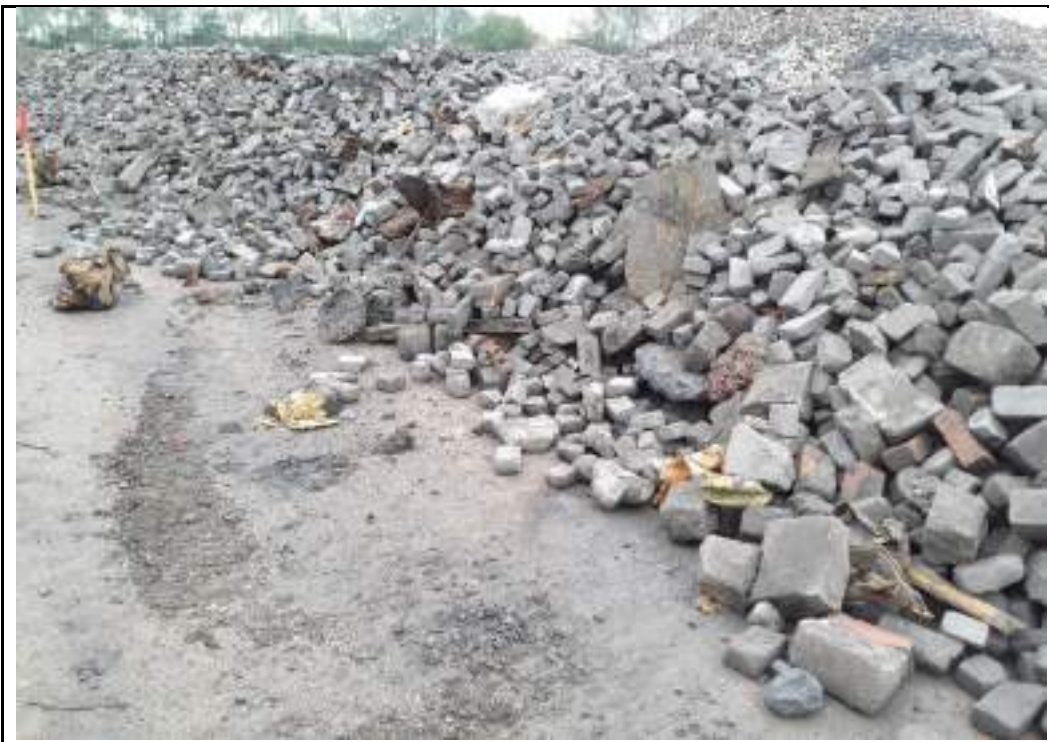
Photograph 14: Deleterious material in bricks stockpile in northwestern part of the site.

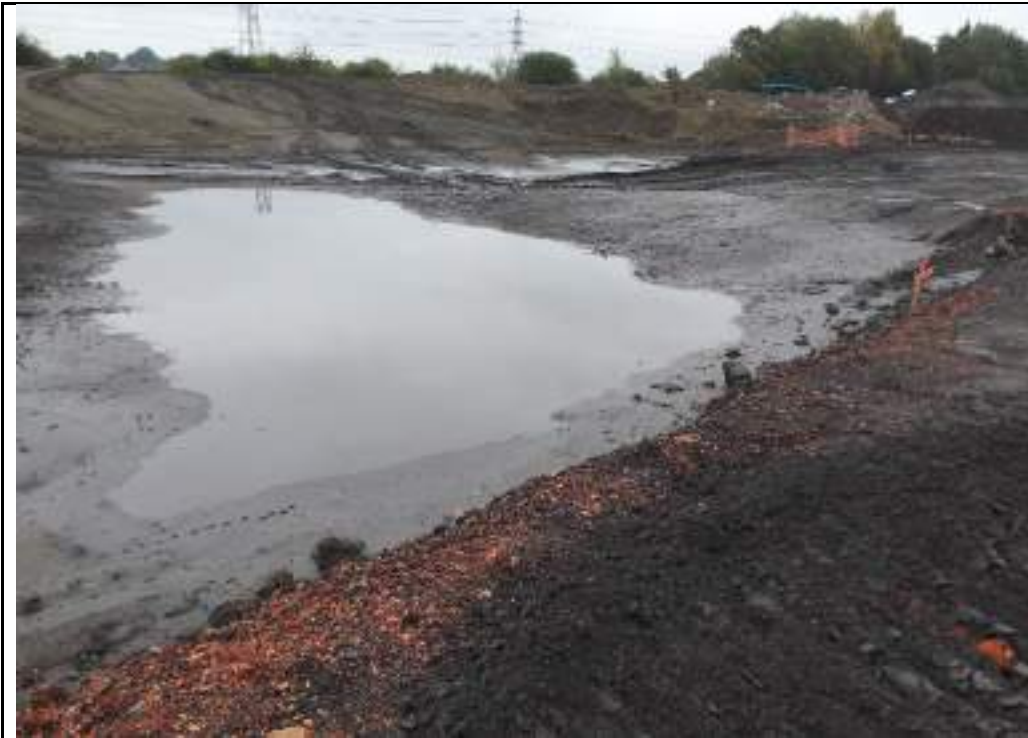
Photograph 125: Standing water in northern part of the site.

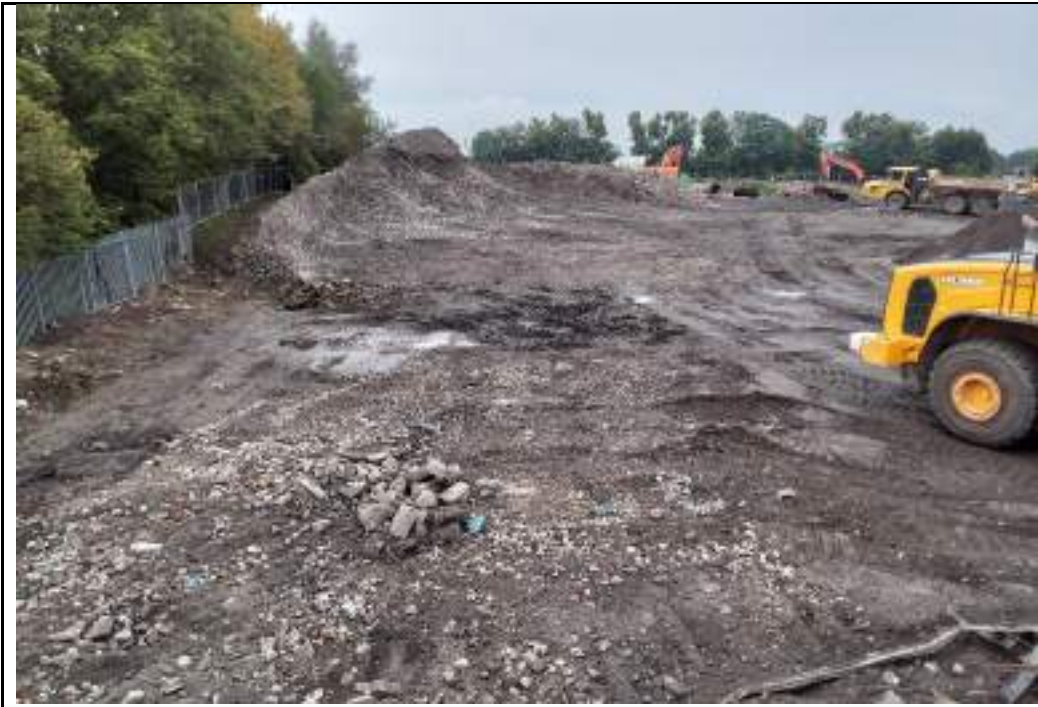
Photograph 147: Stockpile of crushed material in eastern part of the site.

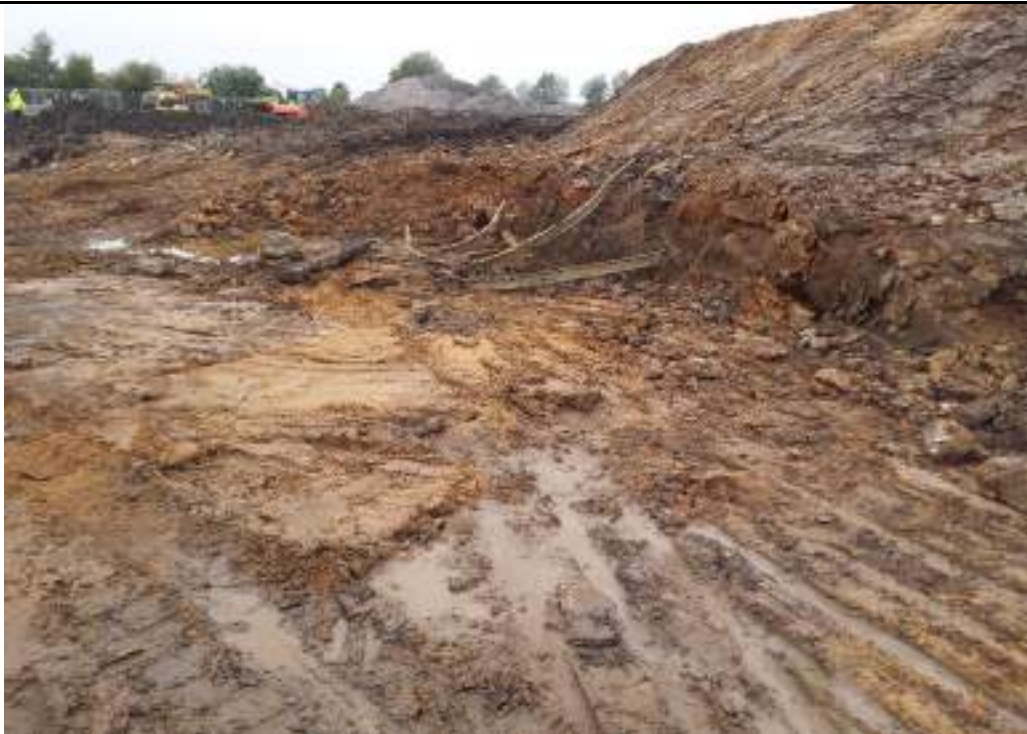
Photograph 20: Deleterious material in excavation in southeastern part of the site.

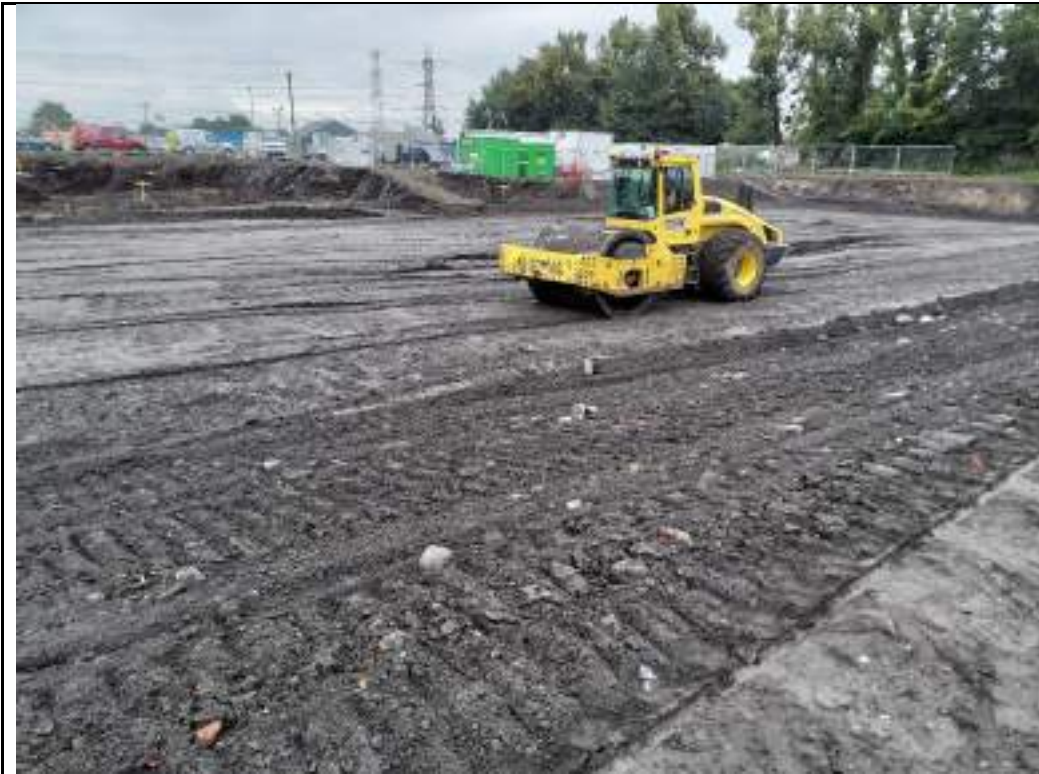
Photograph 21: Compacting formation using polygonal roller in southern part of the site.

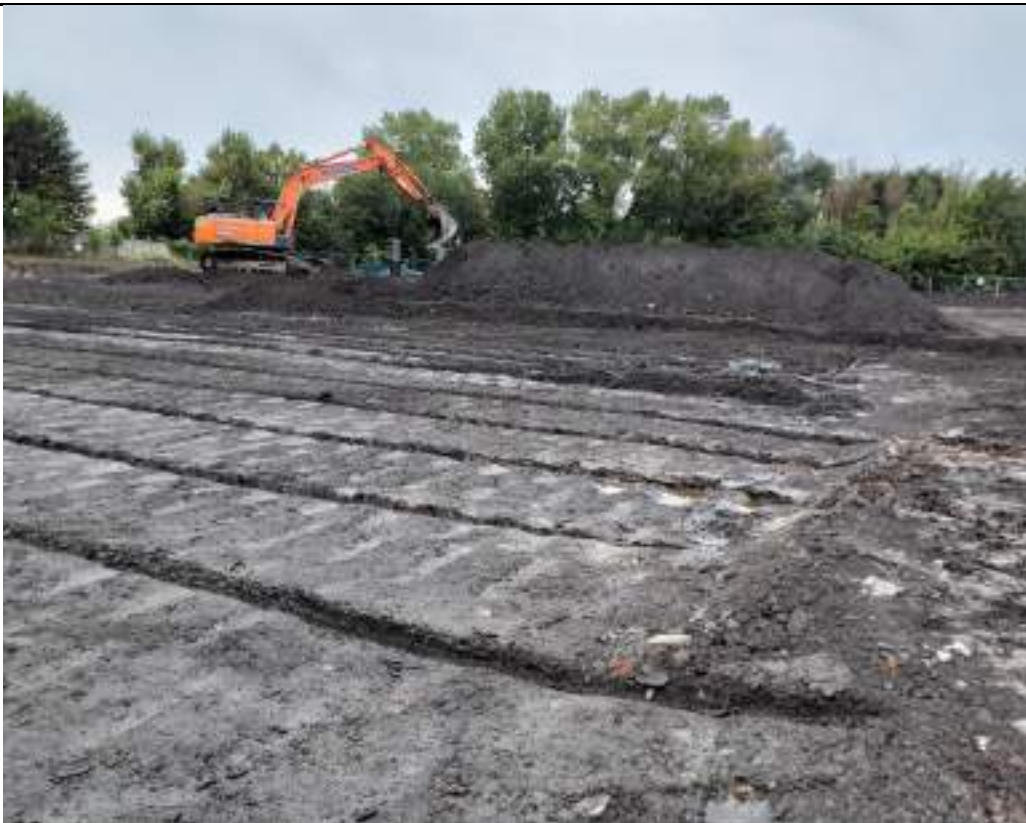
Photograph 22: Excavation of landfill Made Ground in southern part of the site.

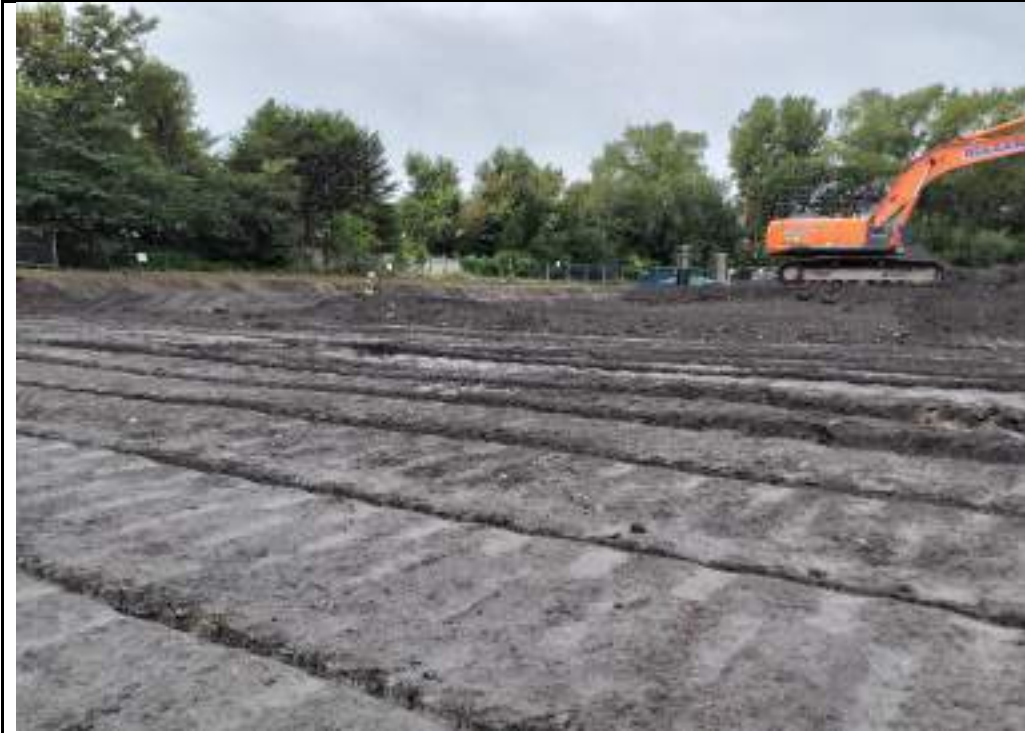
Photograph 23: Surveying of excavation in southern part of the site.

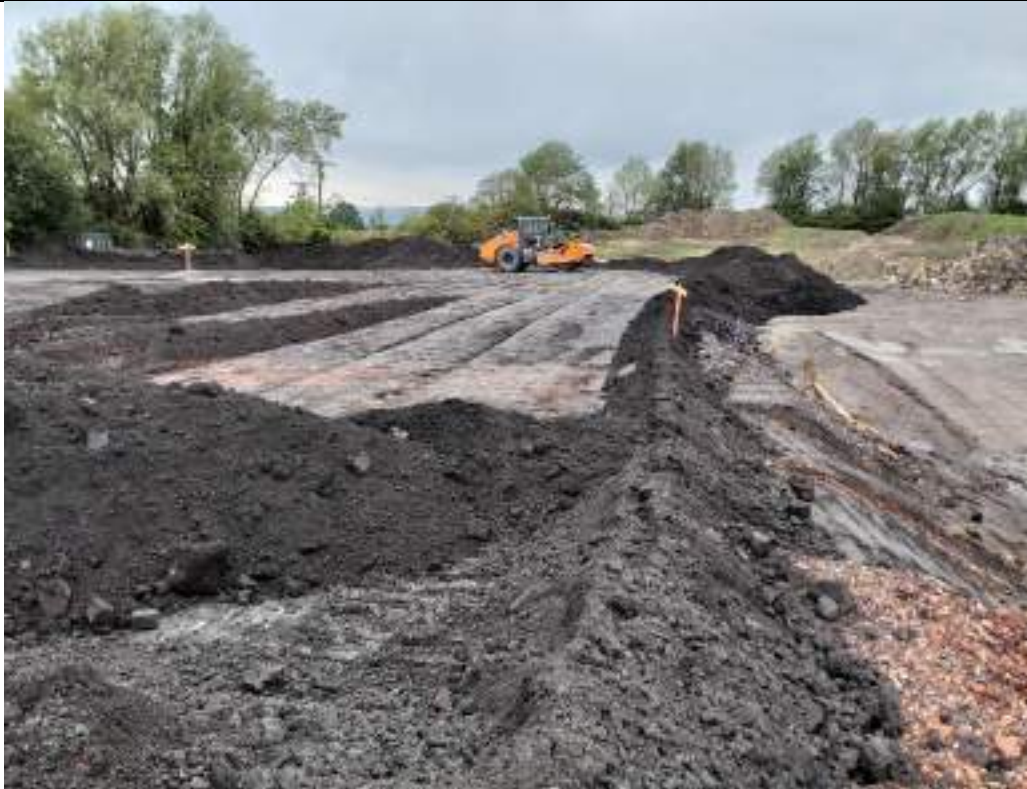
Photograph 24: Proof rolling over fill material in northwestern part of the site.
