**SITE VISIT REPORT 15220-HYD-XX-XX-SVR-GE-1018**

**SHEET NO.: 6 of 18**

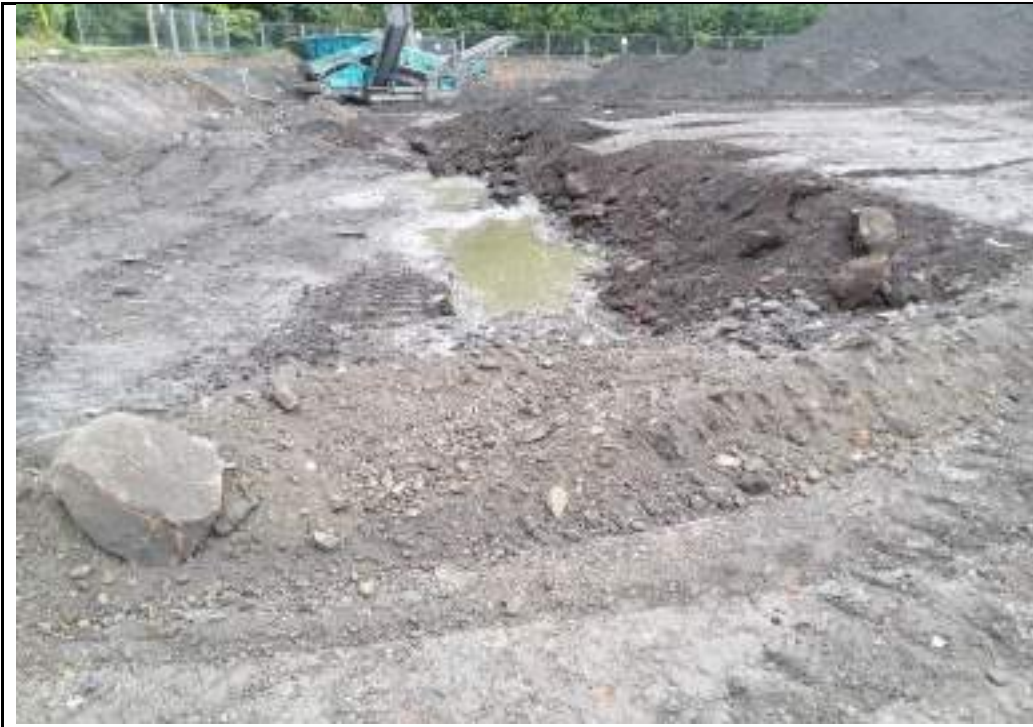
Photograph 25: Oversize in fill material in southern part of the site.

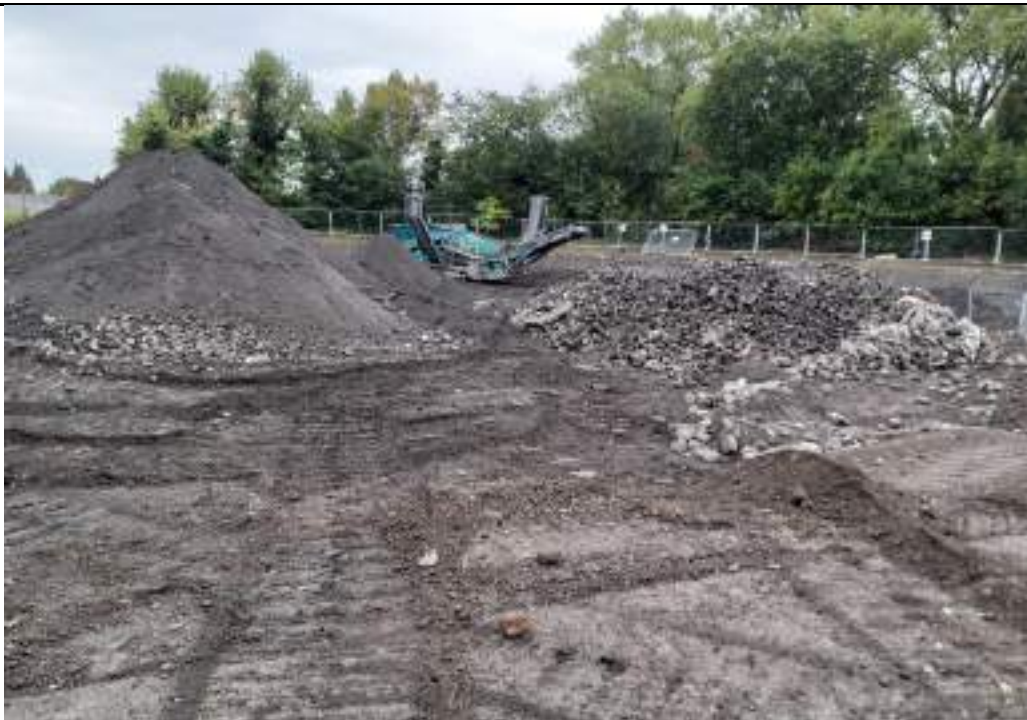
Photograph 26: Stockpile of asbestos contaminated material in southwestern part of the site after completion of processing and hand picking of asbestos.

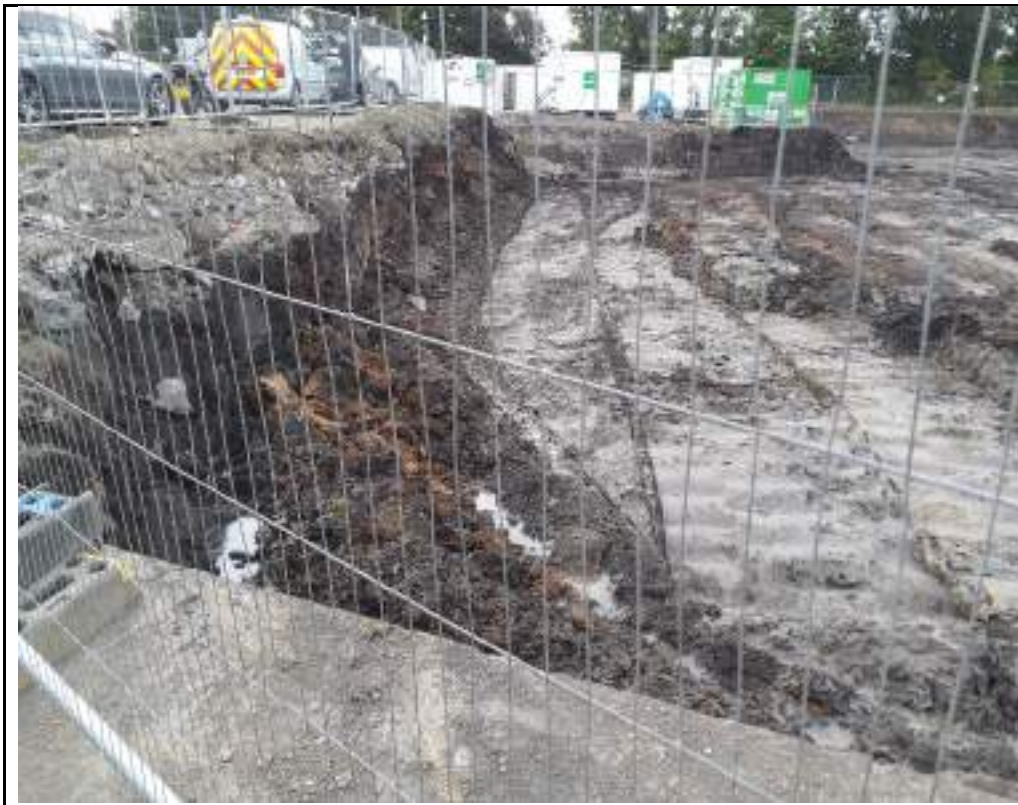
Photograph 2: Unbattered excavation in southeast of the site.

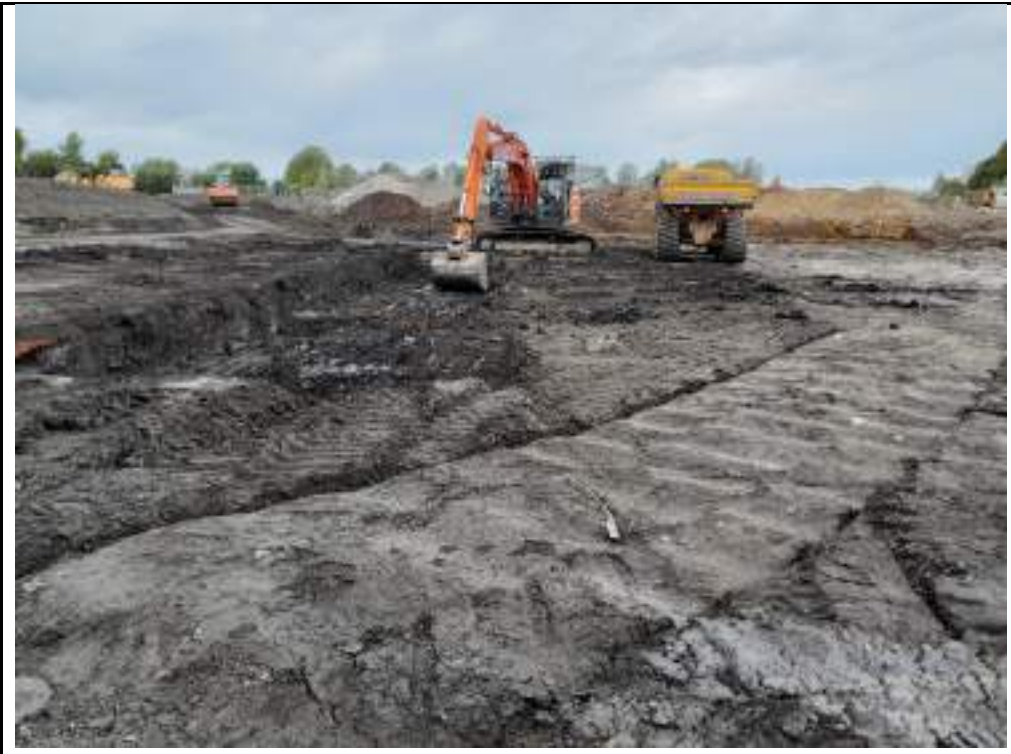
Photograph 3: Excavation of soft spot in southern part of the site.

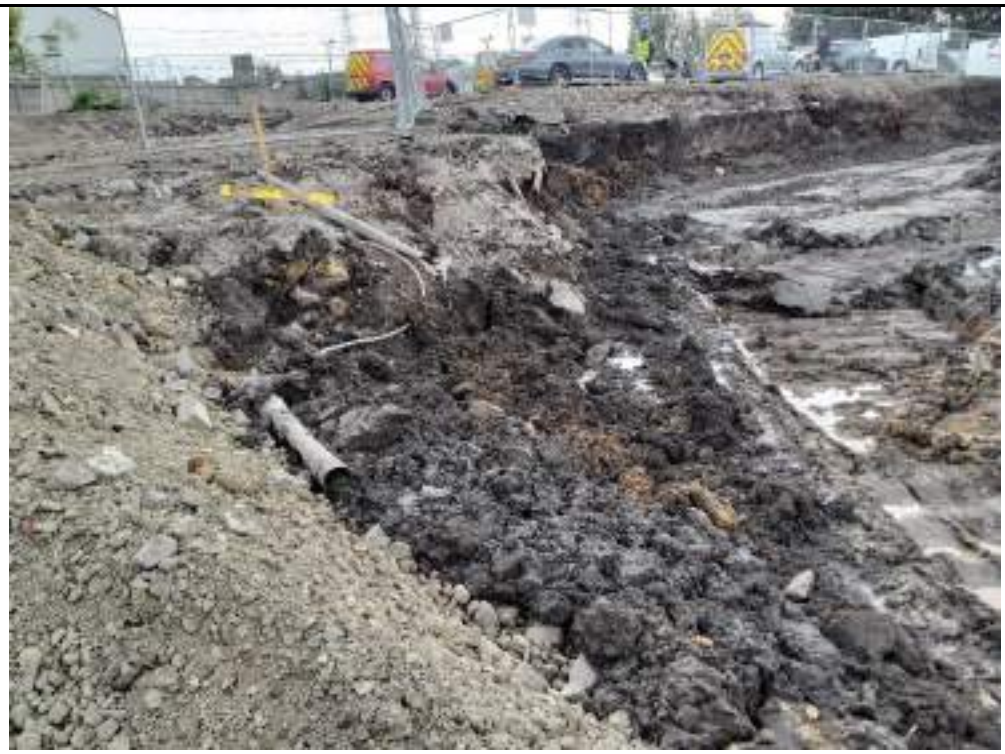
Photograph 4: Deleterious material in southeastern excavation.

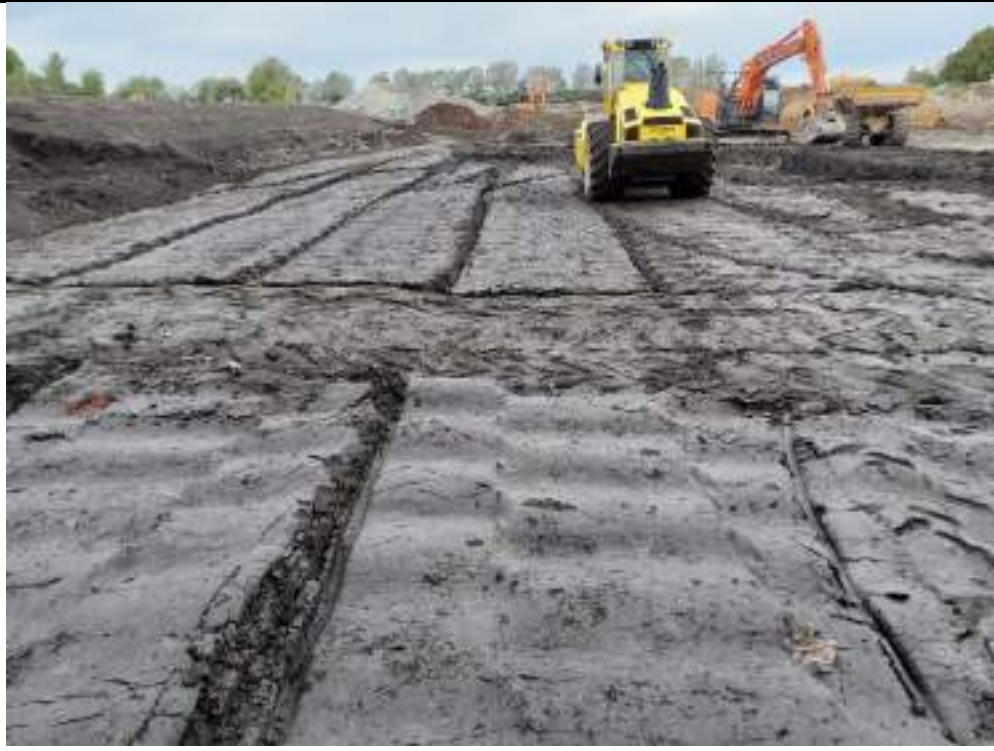
Photograph 5: Compaction of formation by polygonal roller in southern part of the site.

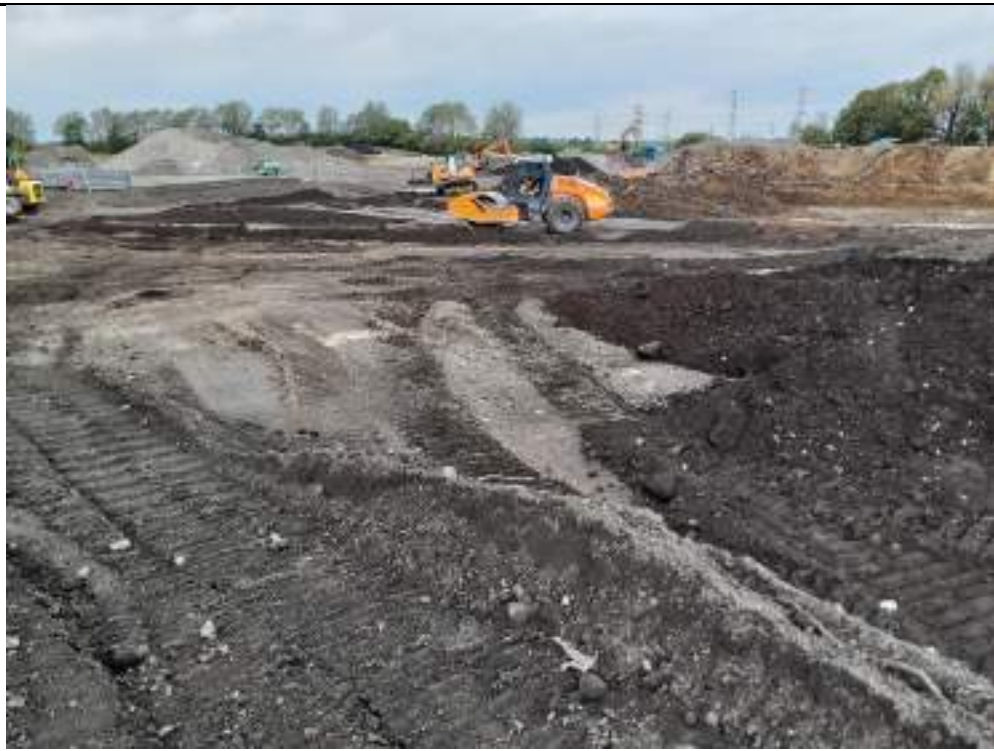
Photograph 6: Proof rolling of fill in central part of the site.

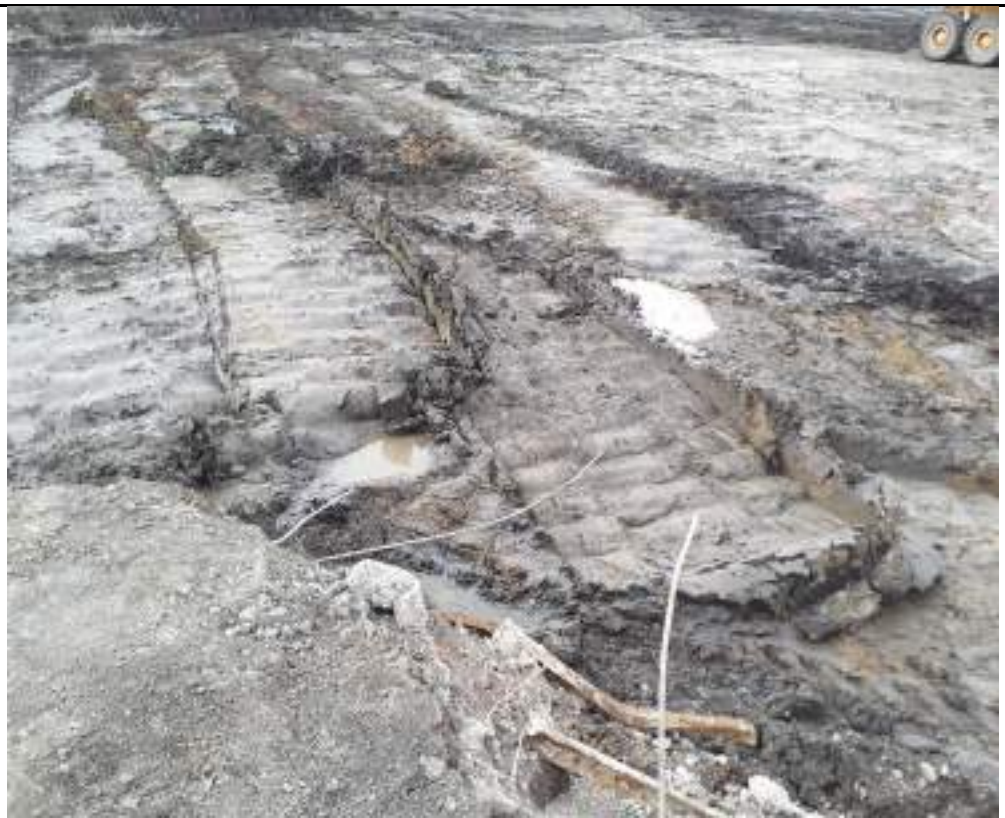
Photograph 8: Soft spot in southeastern part of the site.

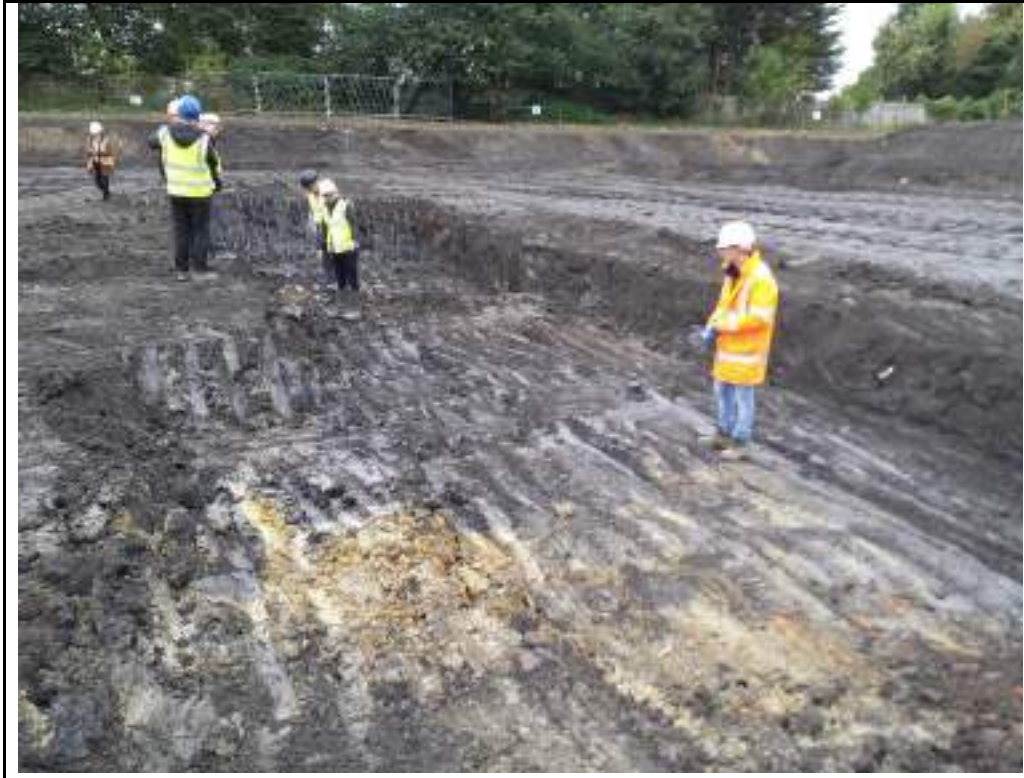
Photograph 9: Soft spot excavation in southern part of the site.

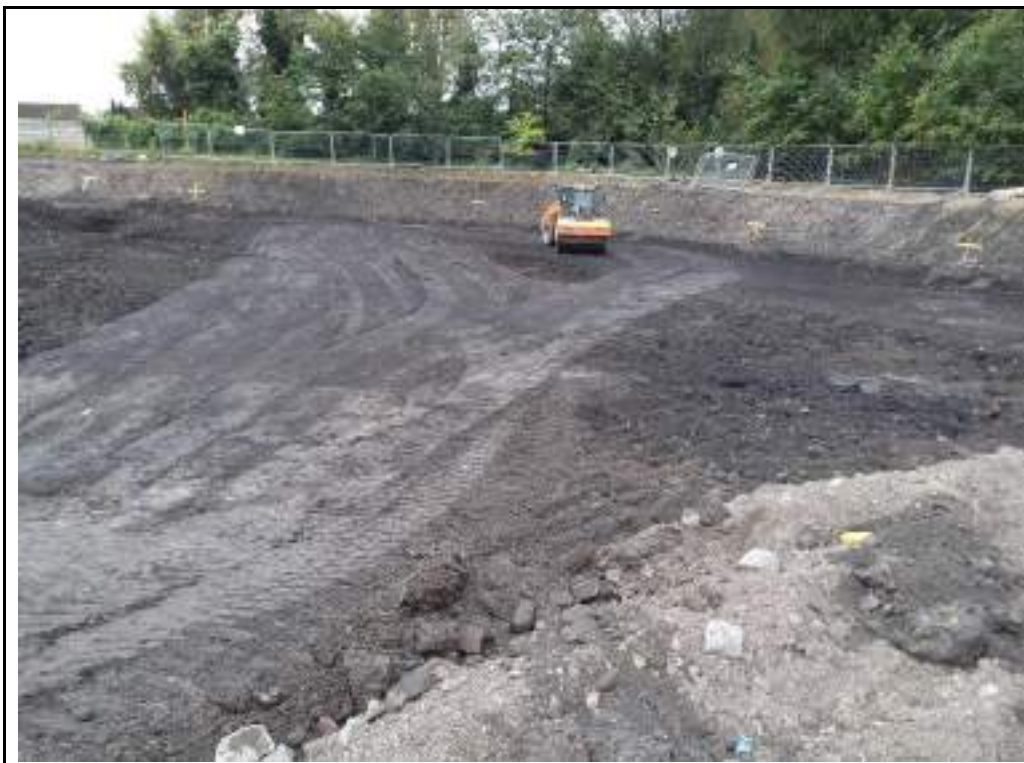
Photograph 10: Proof rolling of fill in southwestern part of the site.

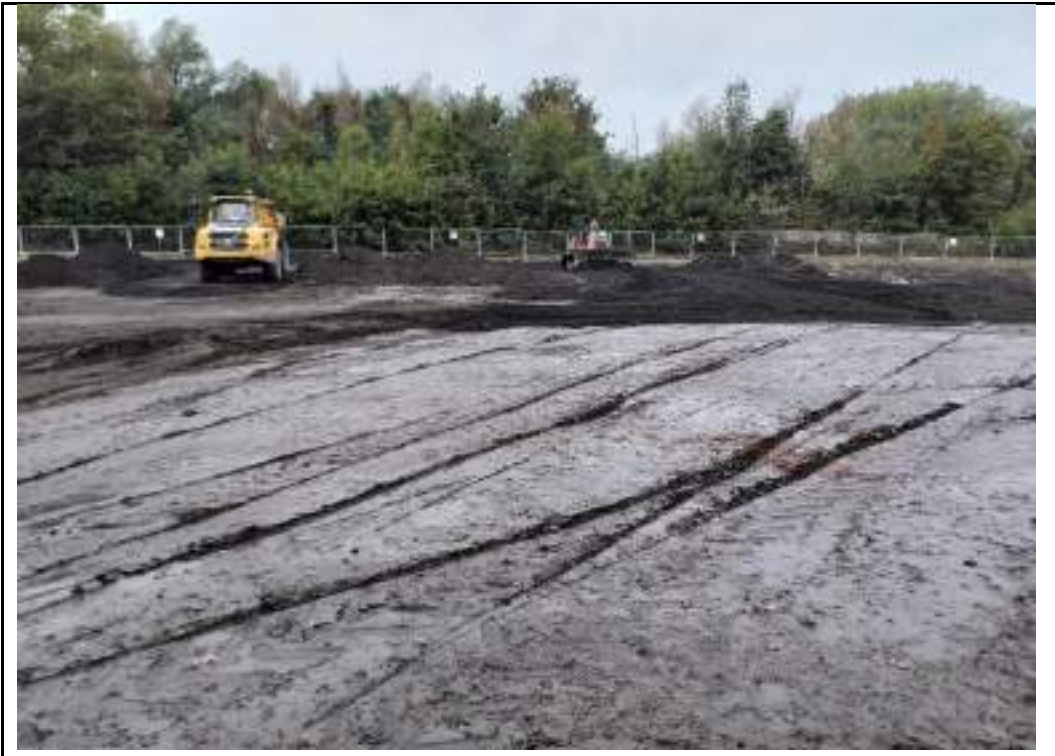
Photograph 11: Backfilling of western part of the site using material from excavation in southwestern part of the site.

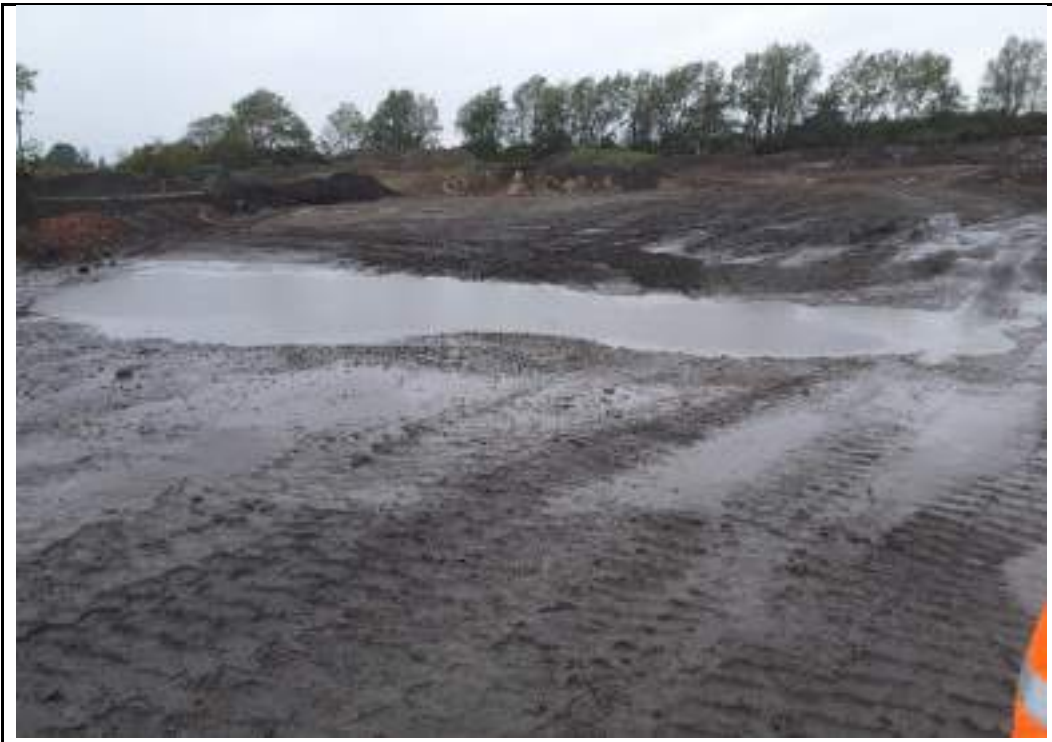
Photograph 14: Standing water in northern part of the site.

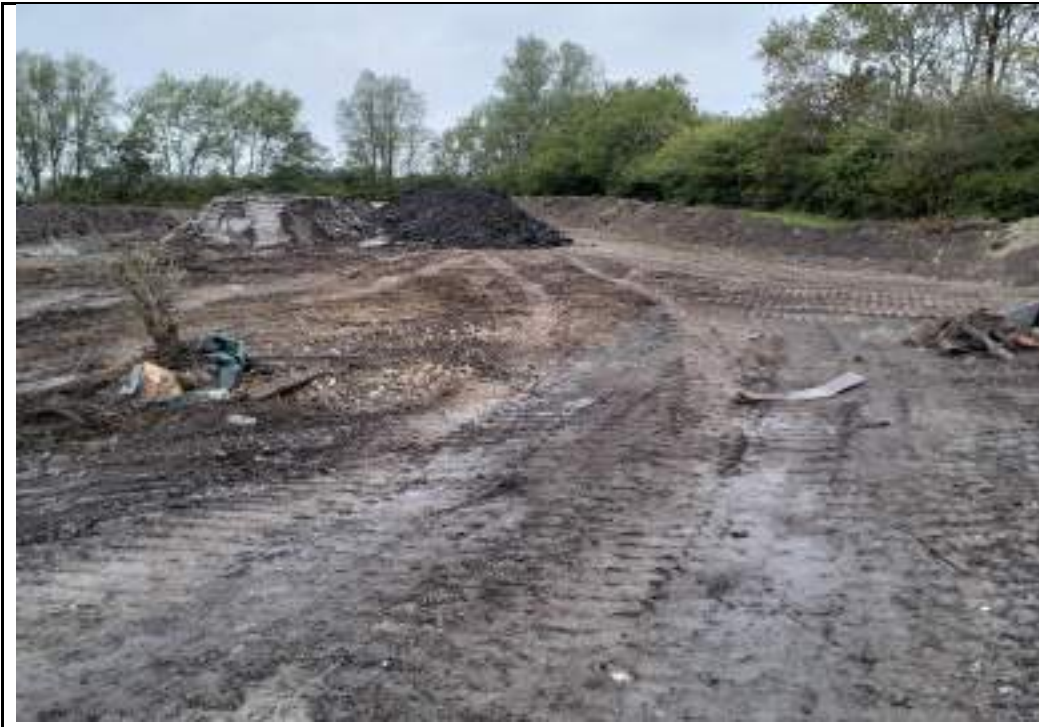
Photograph 15: Stockpile of excavated material from soft spot excavation in northeastern part of the site.

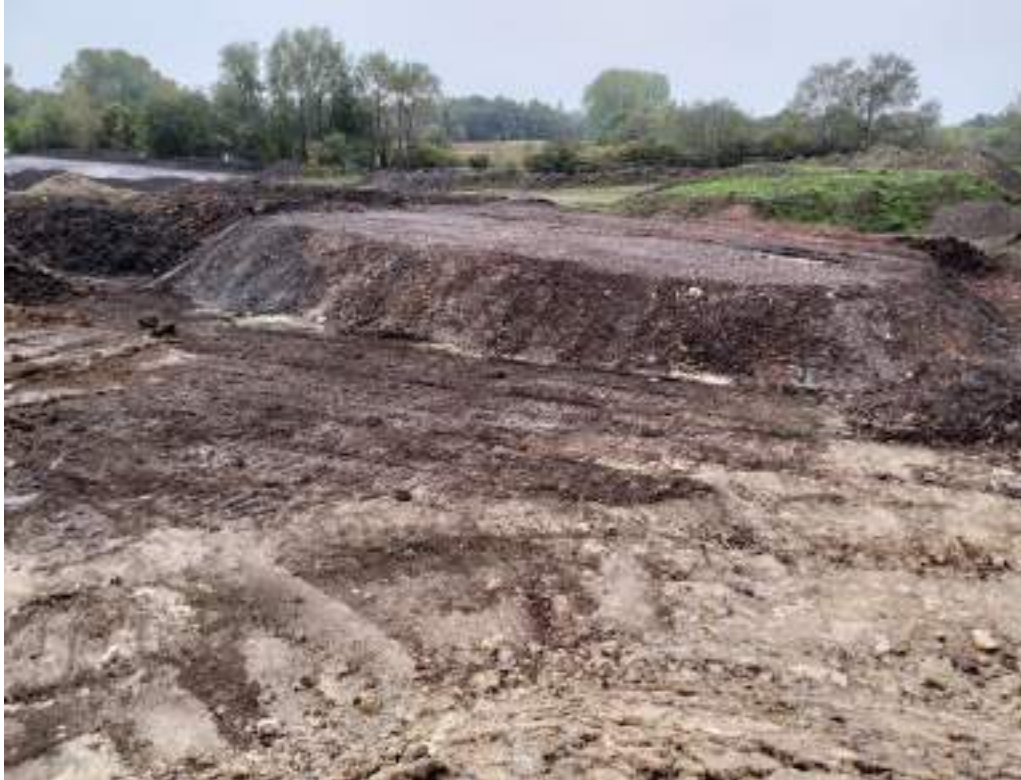
Photograph 16: Topsoil stockpile in northern part of the site.

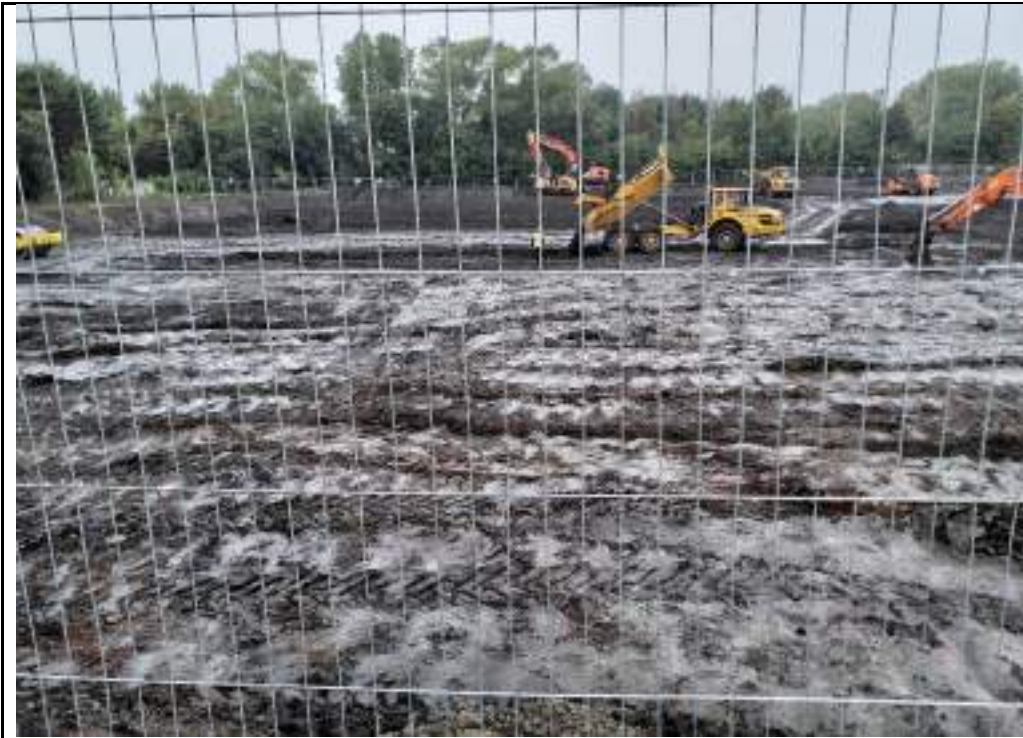
Photograph 17: Backfilling of soft spot excavation using general fill as base material.

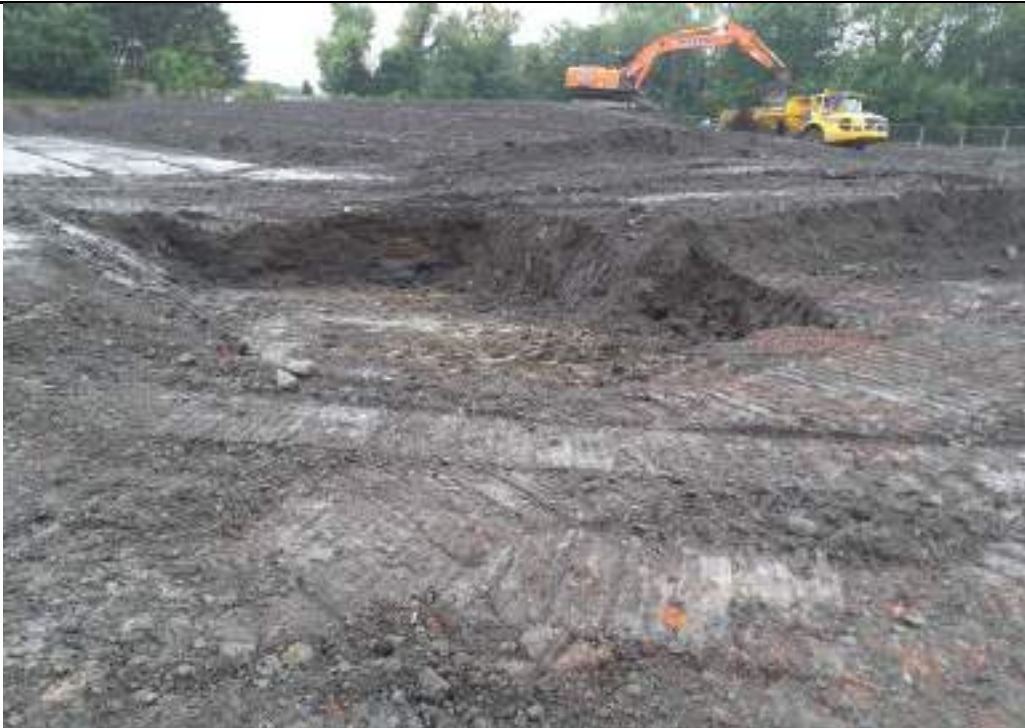
Photograph 20: Soft spot Excavation in southwestern part of the site.

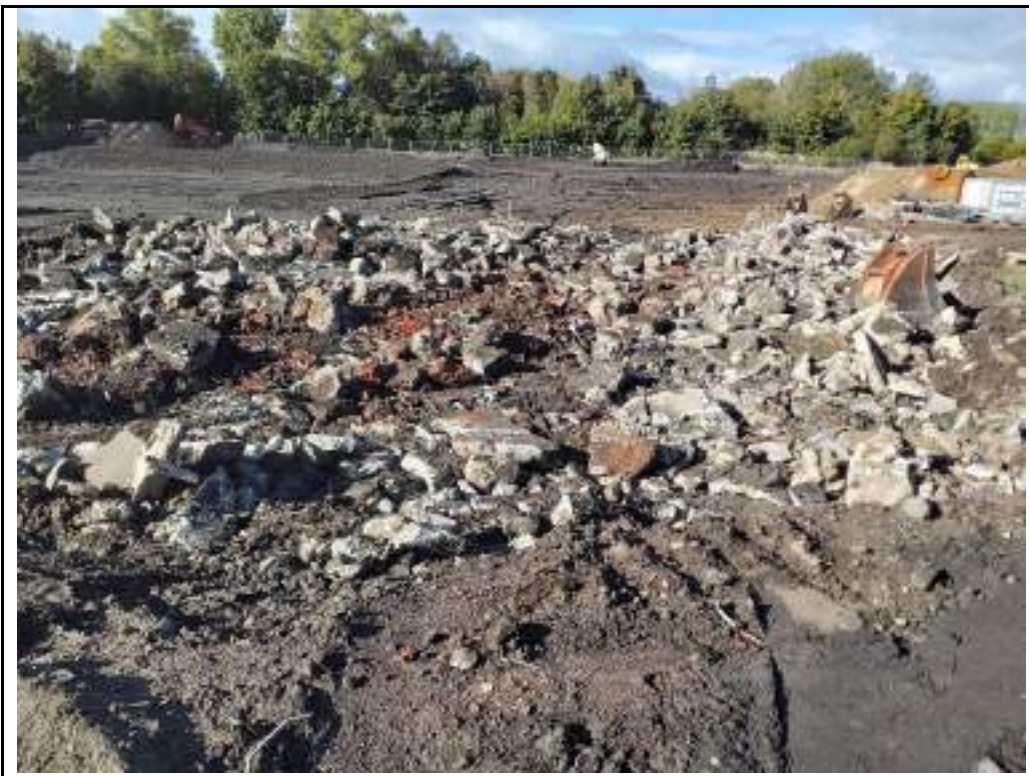
Photograph 2: Broken out concrete slab in southeastern part of the site.

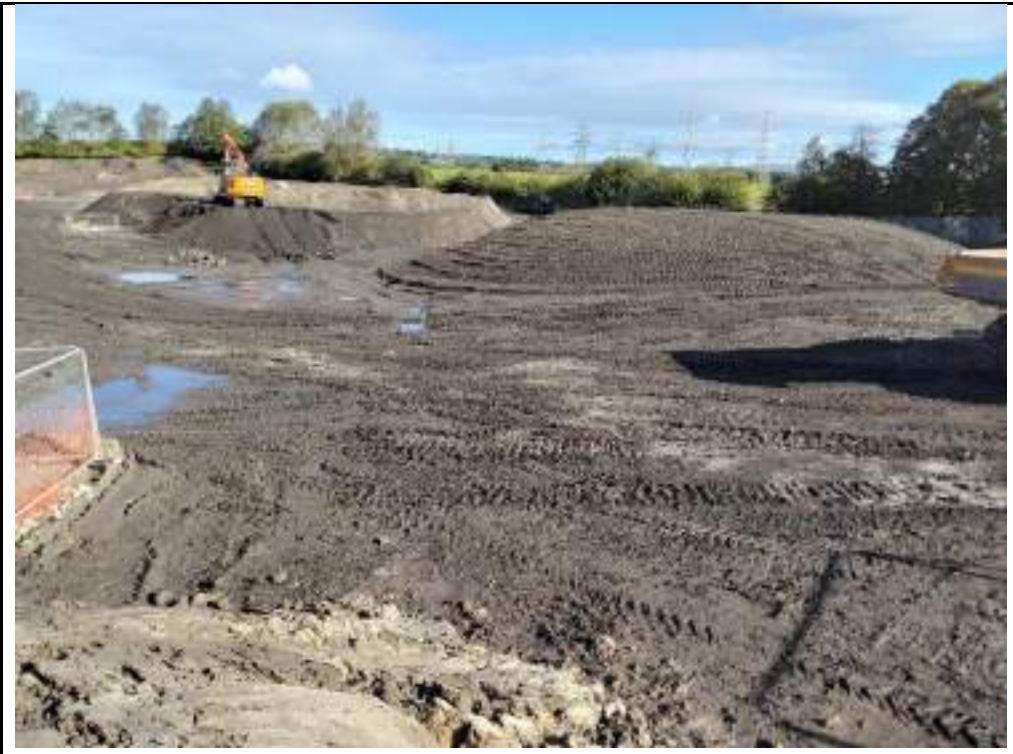
Photograph 3: Stockpiles of processed and excavated materials in eastern and northeastern part of the site.

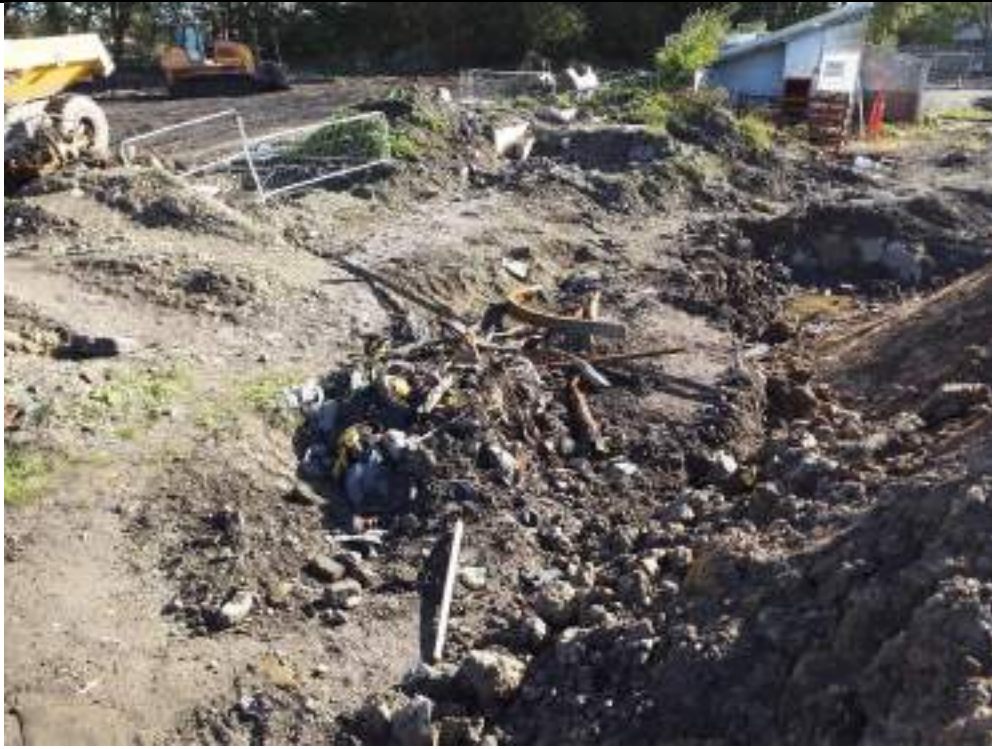
Photograph 5: Deleterious material in eastern part of the site.

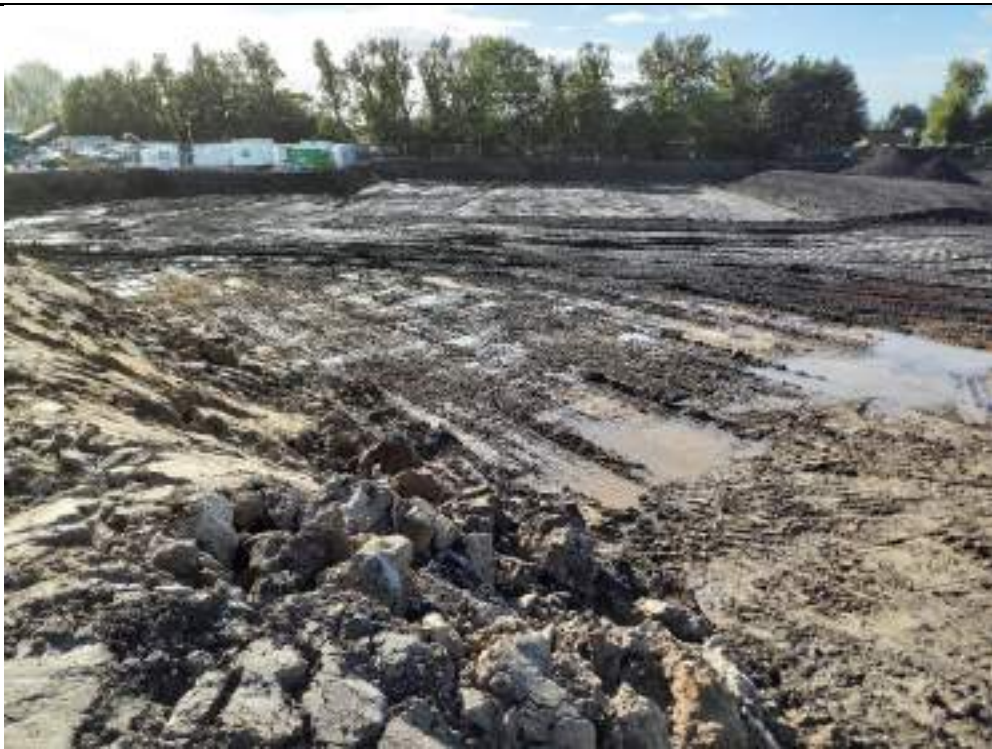
Photograph 6: Standing water in excavation in central part of the site.

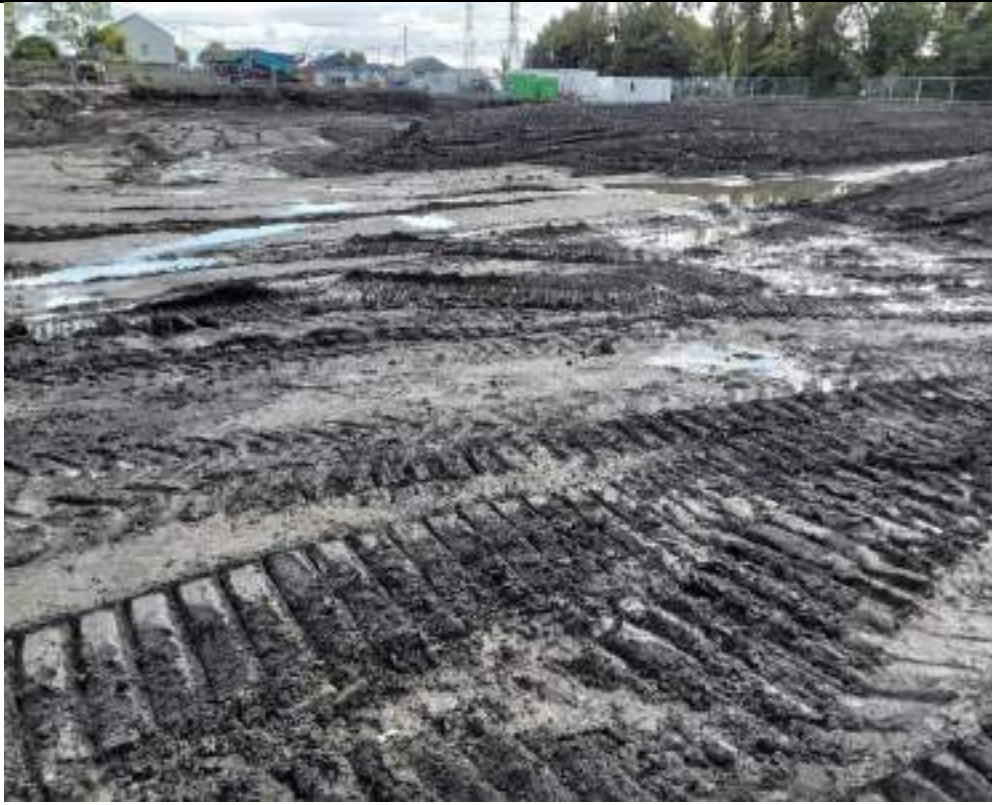
Photograph 7: Standing water in excavation in southern part of the site.

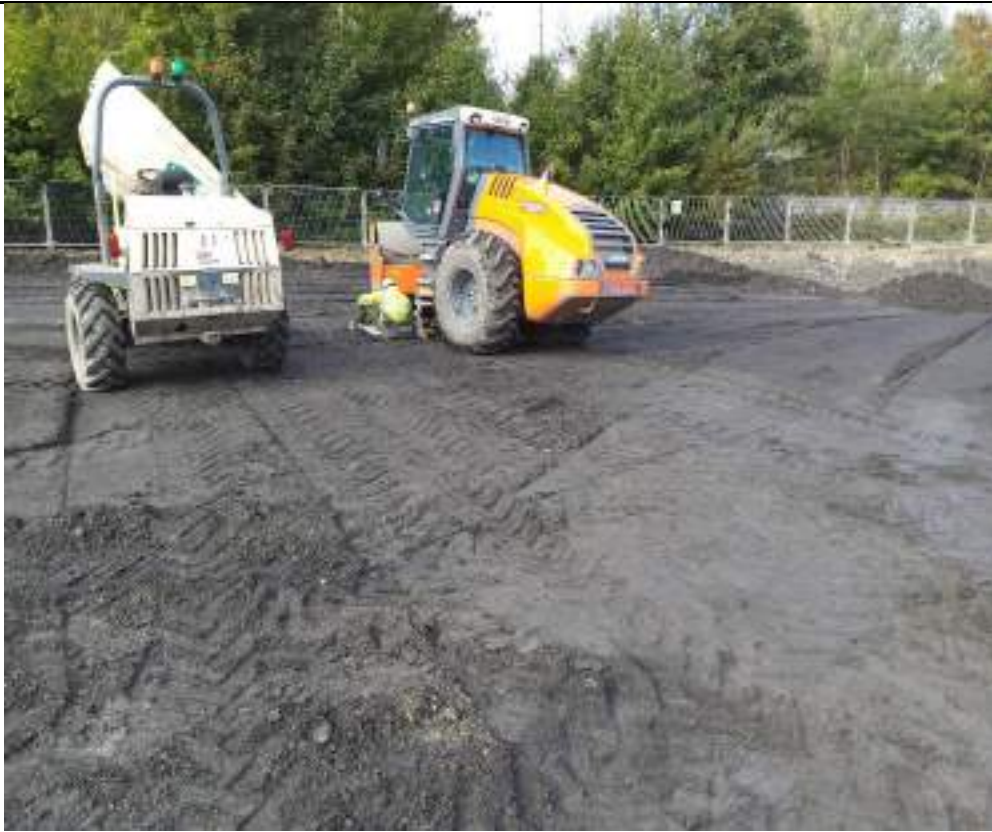
Photograph 8: Plate load testing on fill material in western part of the site.

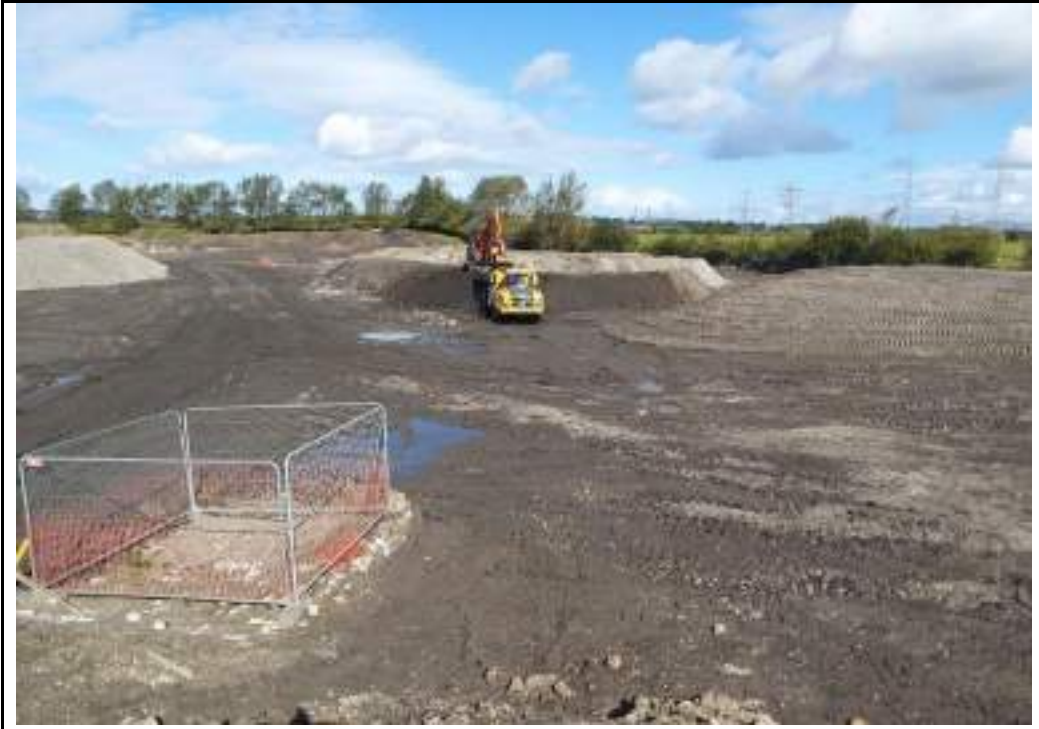
Photograph 9: Transferring material from northeastern stockpile for construction of shaft grouting platform.

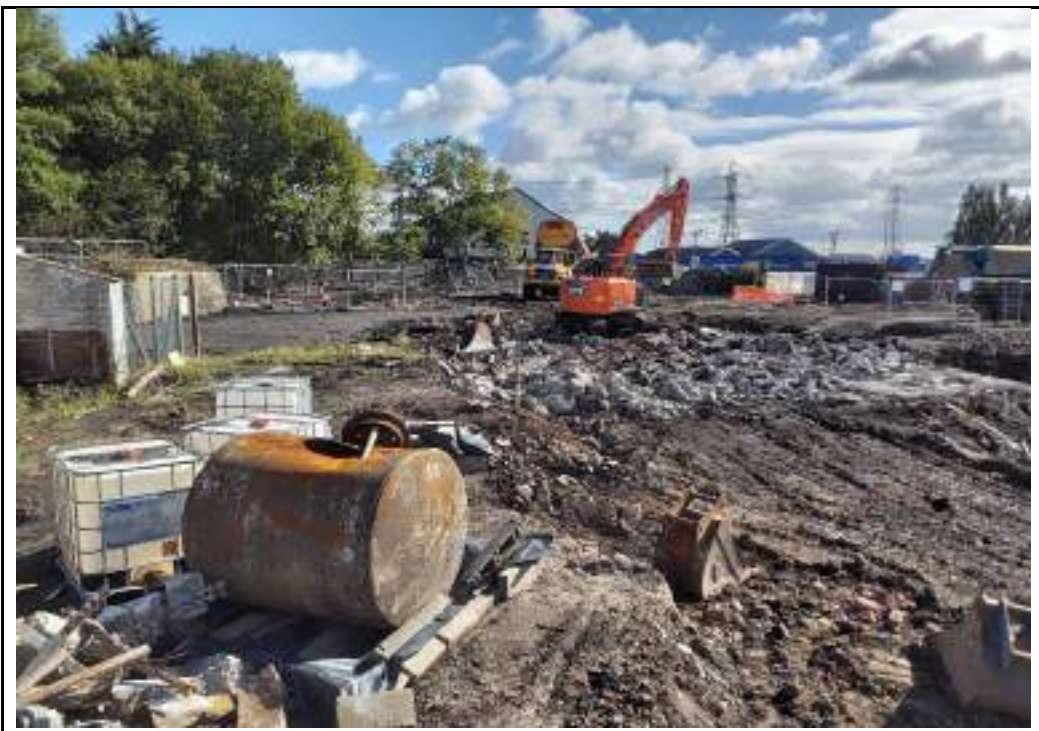
Photograph 10: Unloading material in southeastern part of the site to construct shaft grouting platform.

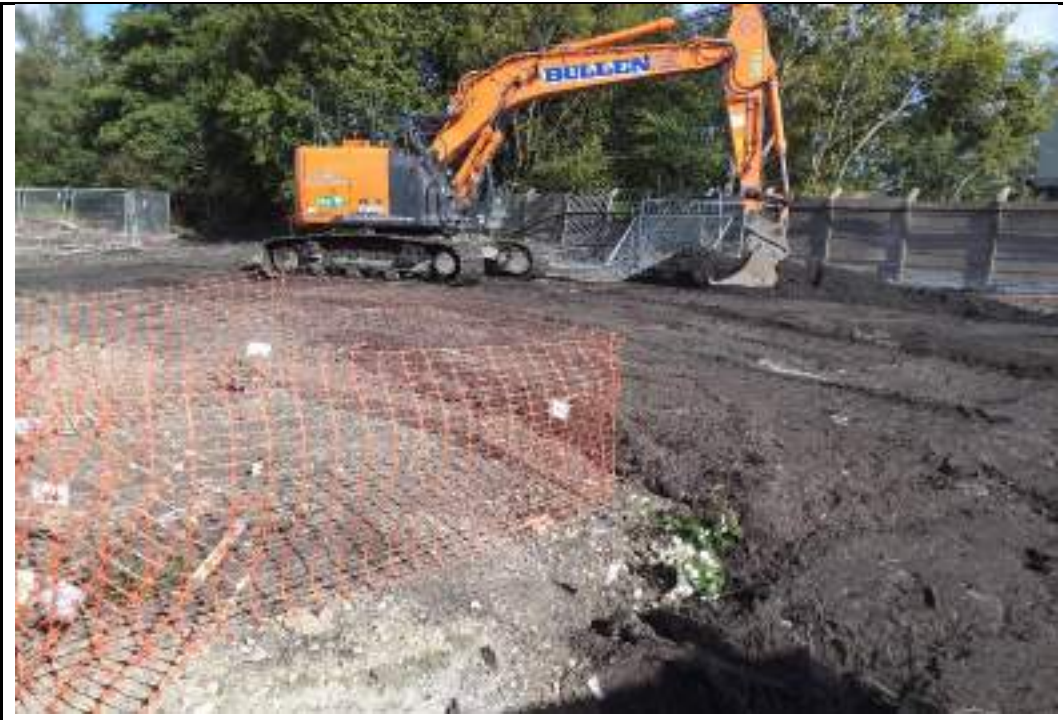
Photograph 11: Construction of shaft grouting platform in southeastern part of the site.

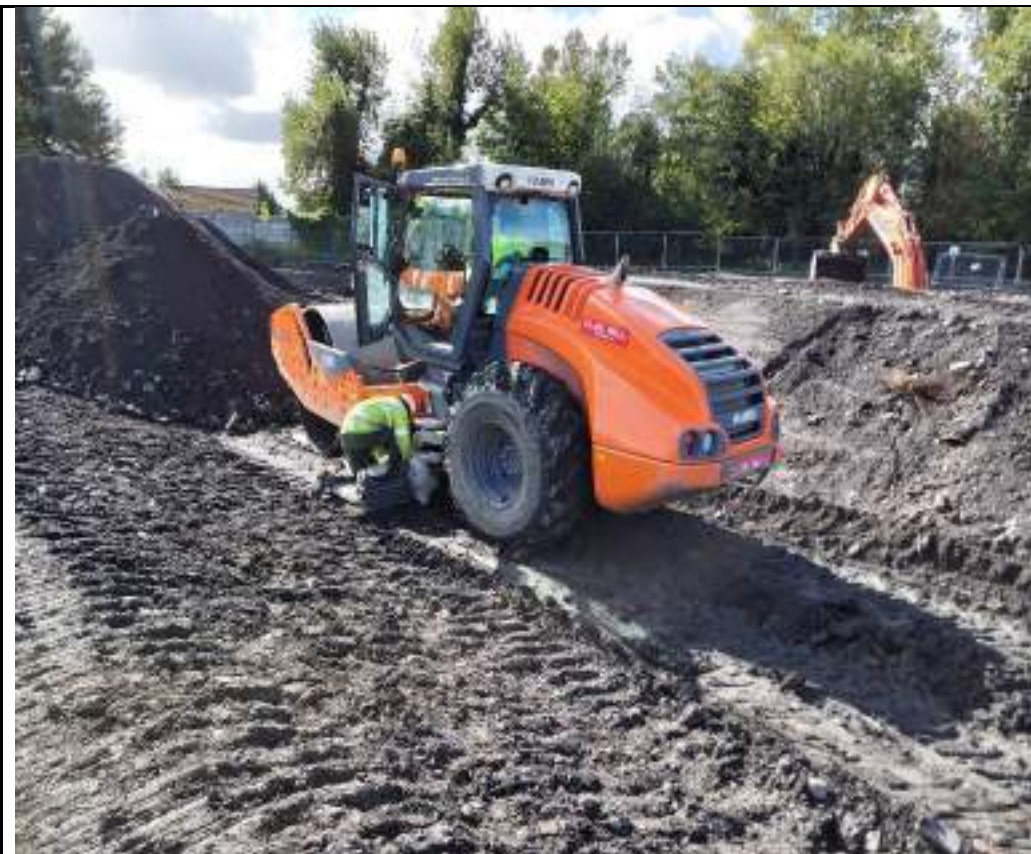
Photograph 12: Plate load testing in southwestern part of the site.

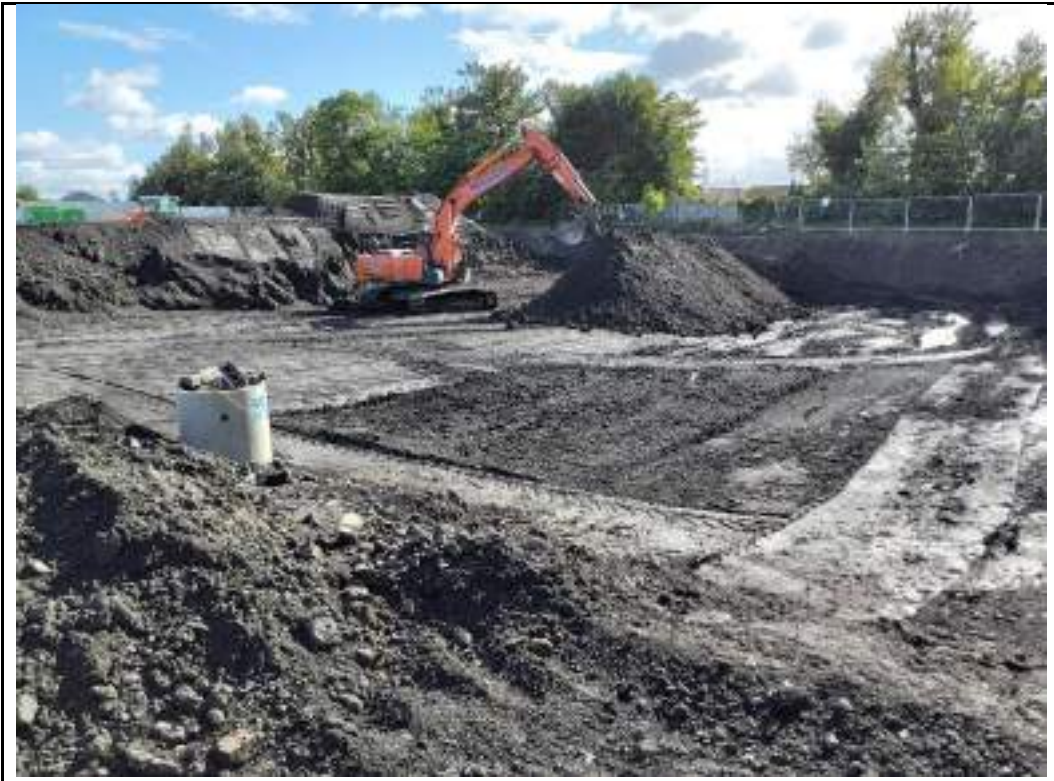
Photograph 93: Excavation of landfill Made Ground in southwestern part of the site.

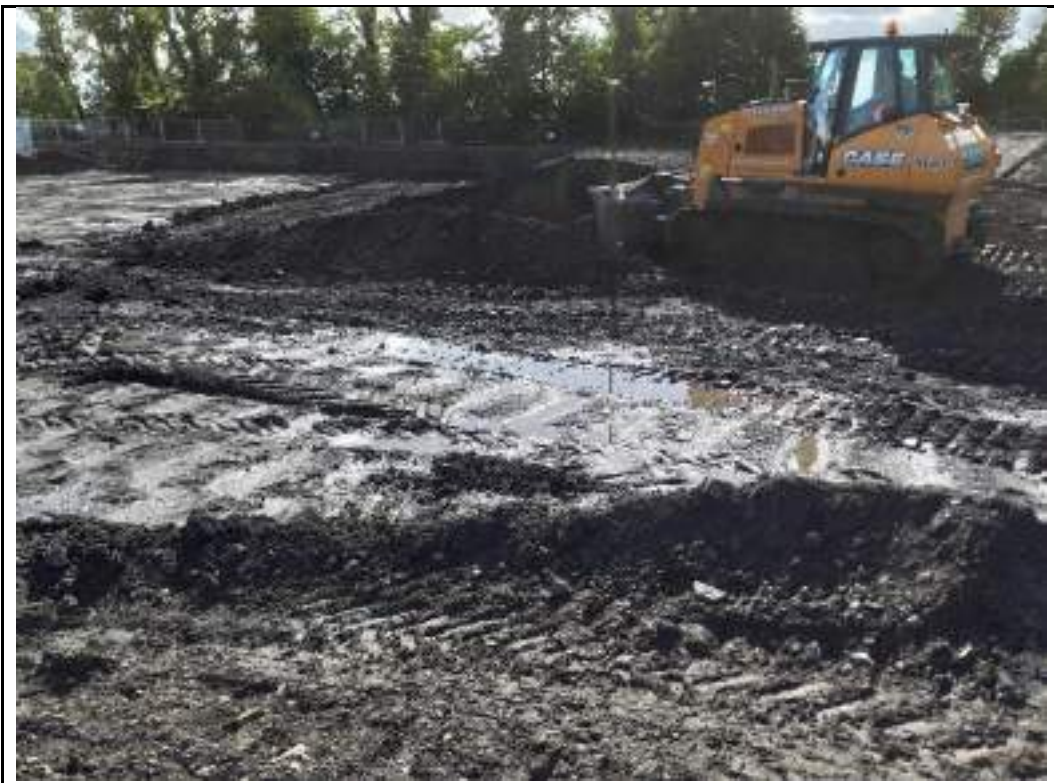
Photograph 14: Backfilling southern part of the site using material from excavation in southwestern part of the site.

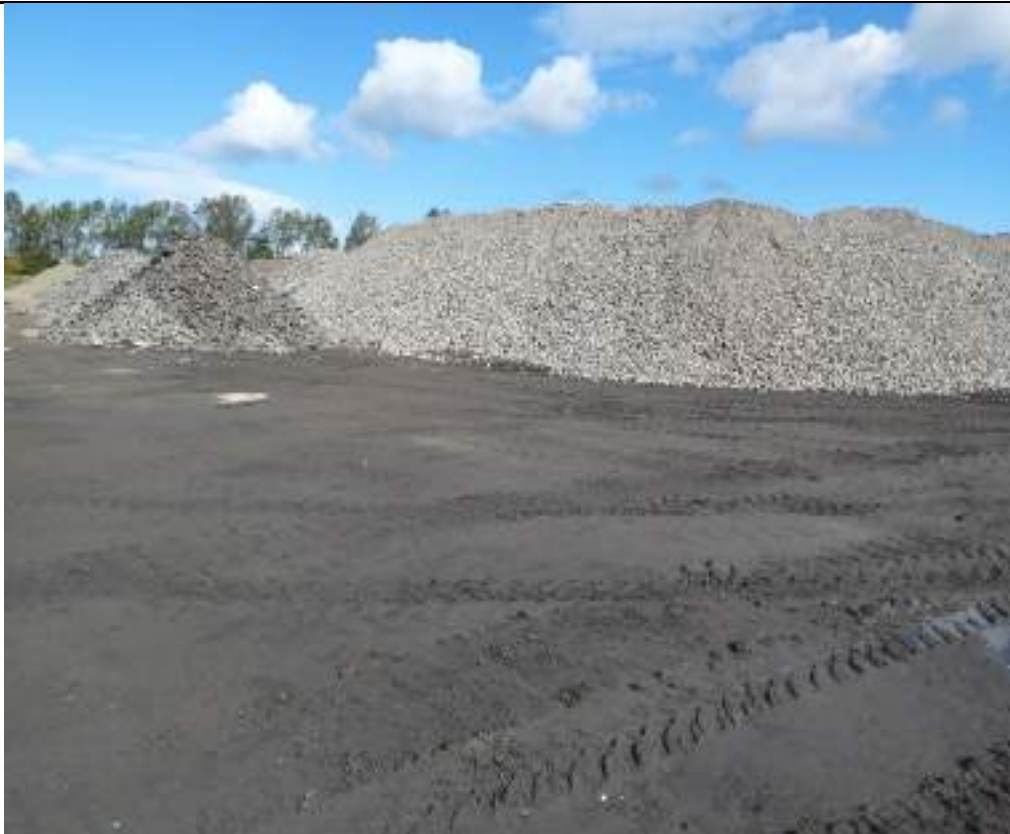
Photograph 16: Brick and crushed materials stockpiles in northwestern part of the site.
