**SITE VISIT REPORT 15220-HYD-XX-XX-SVR-GE-1018**

**SHEET NO.: 6 of 18**

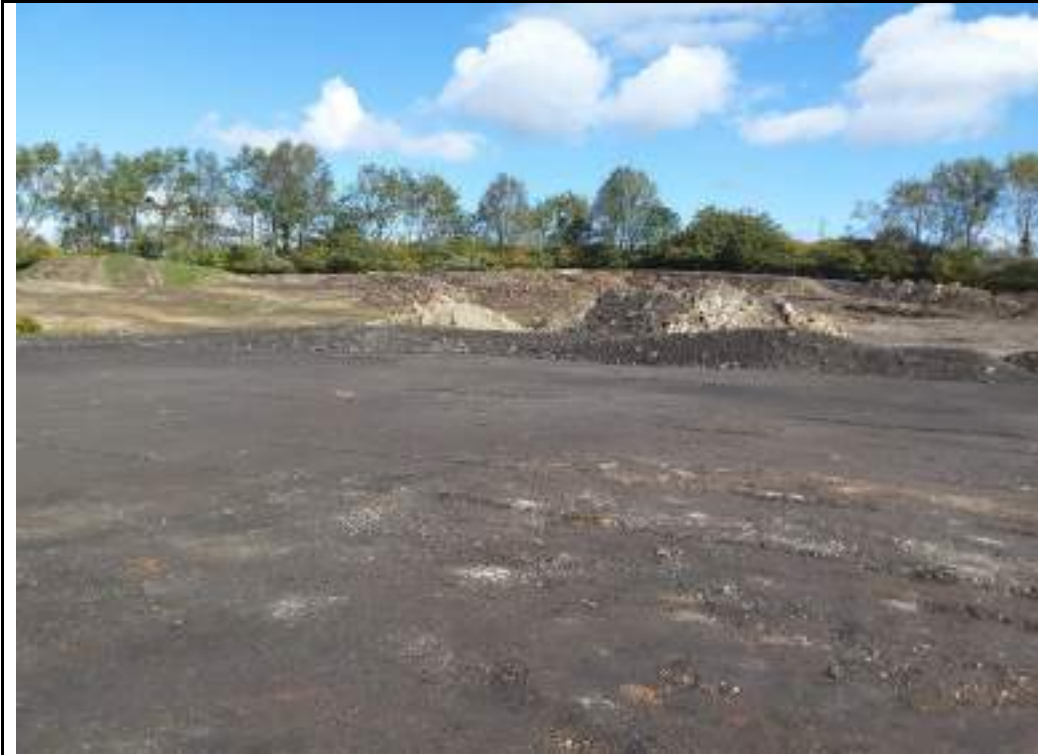
Photograph 17: Topsoil and soft spot materials stockpiles in northern part of the site.

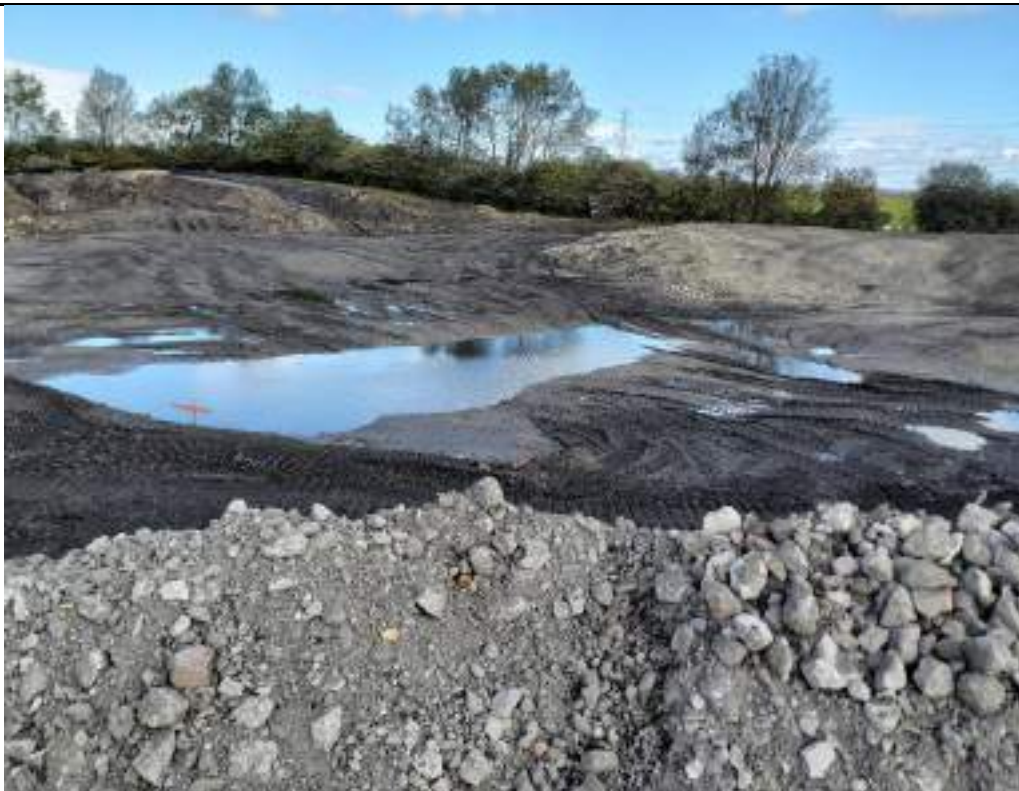
Photograph 18: Standing water in northern part of the site.

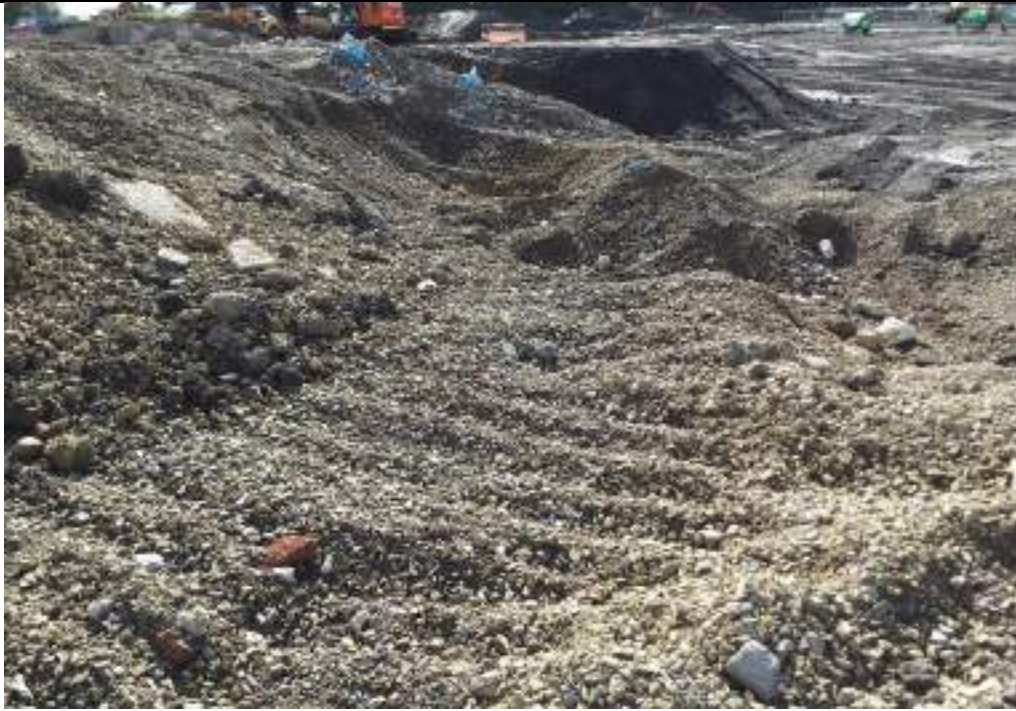
Photograph 19: Oversize materials in granular stockpile in northeast of the site.

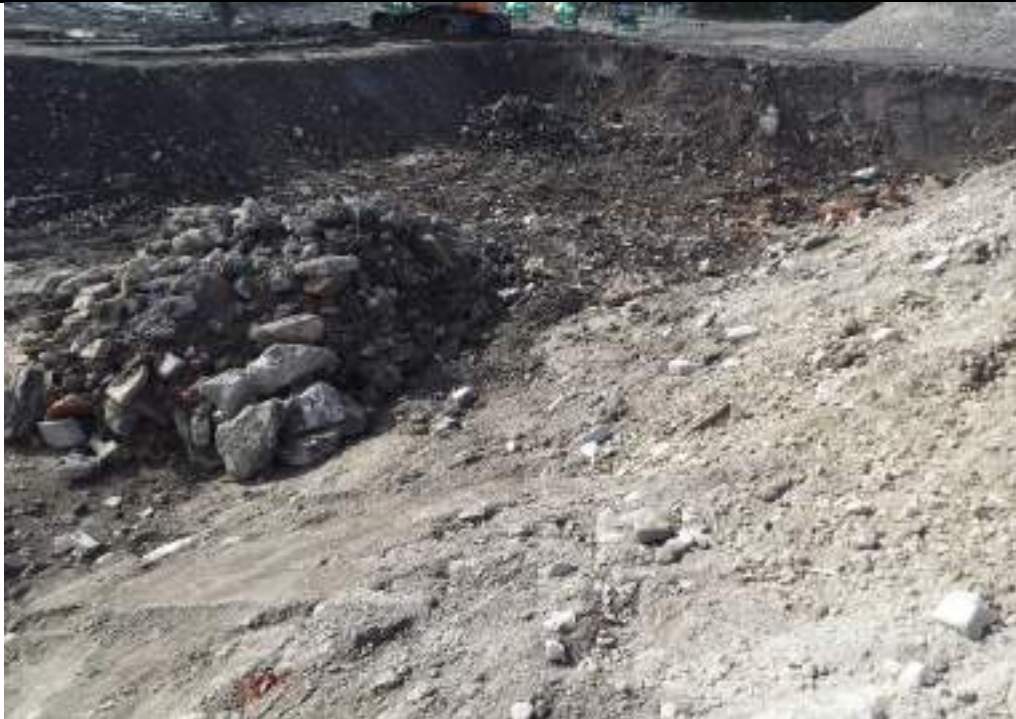
Photograph 20: Stockpile of oversize and deleterious materials in northeastern part of the site.

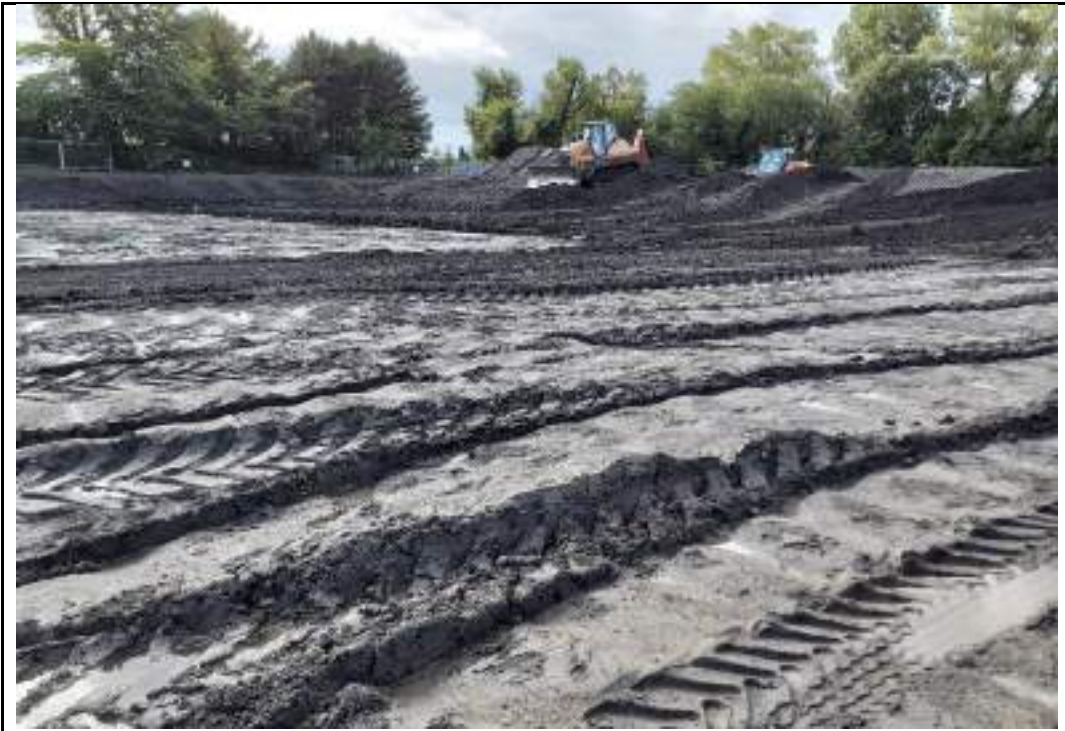
Photograph 21: Dozer pushing fill material to backfill southern part of the site.

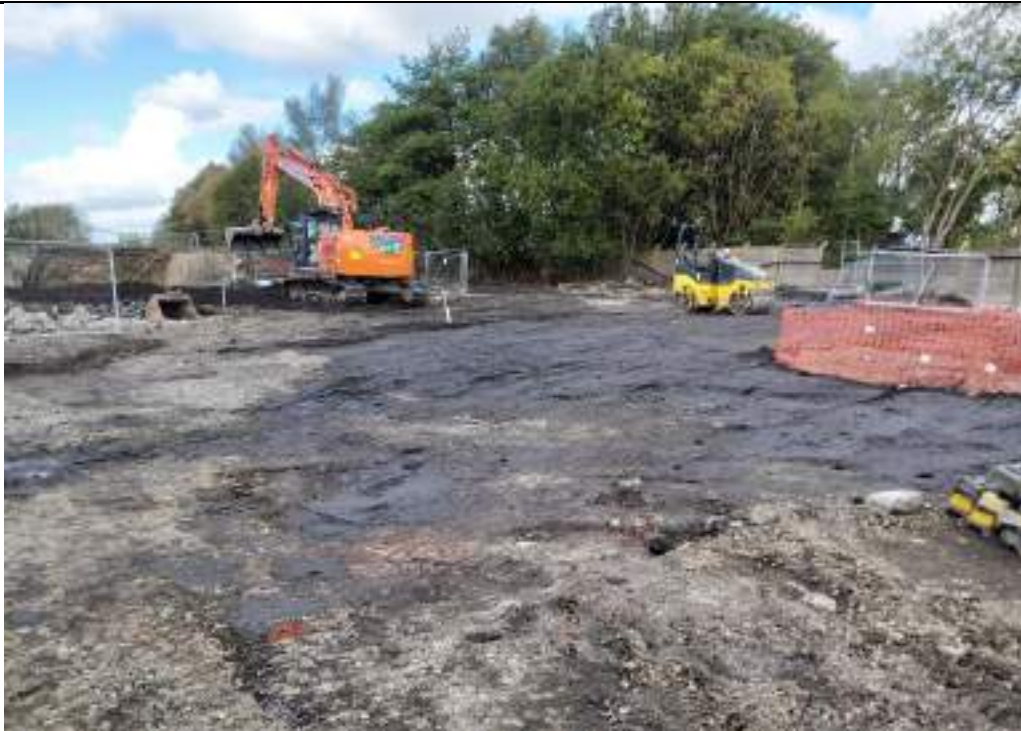
Photograph 22: Construction of shaft grouting platform in southeastern part of the site.

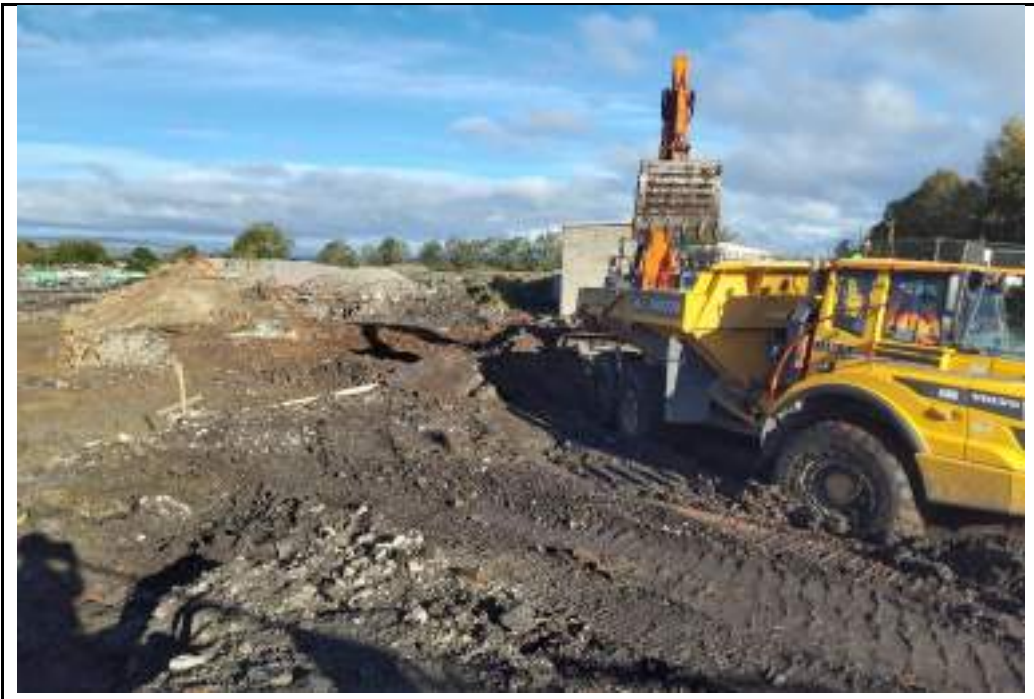
Photograph 2: Excavation of landfill Made Ground and Glacial Till in southeastern part of the site.

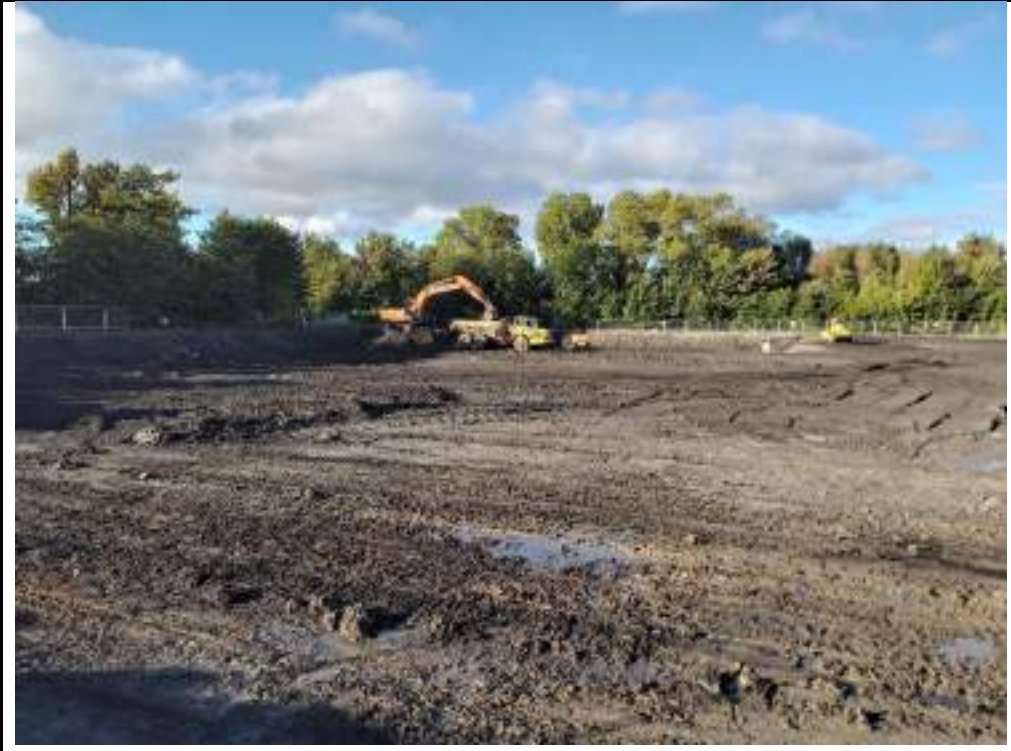
Photograph 3: Excavation of landfill Made Ground in southern part of the site.

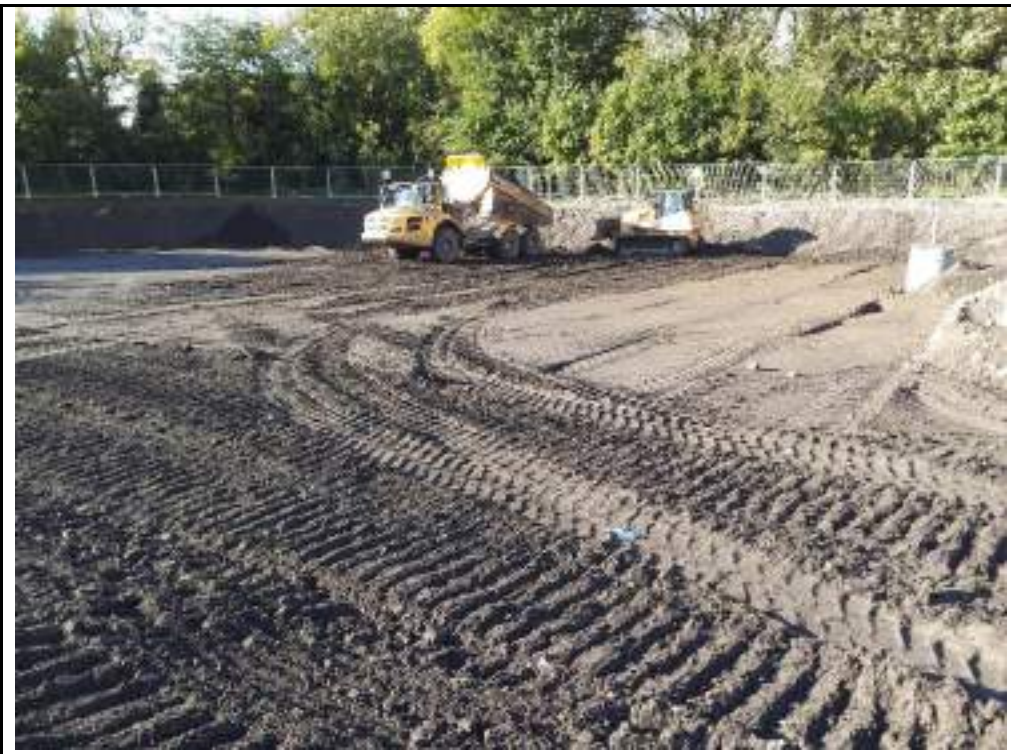
Photograph 4: Backfilling of southwestern part of the site using excavated material from southern part of the site.

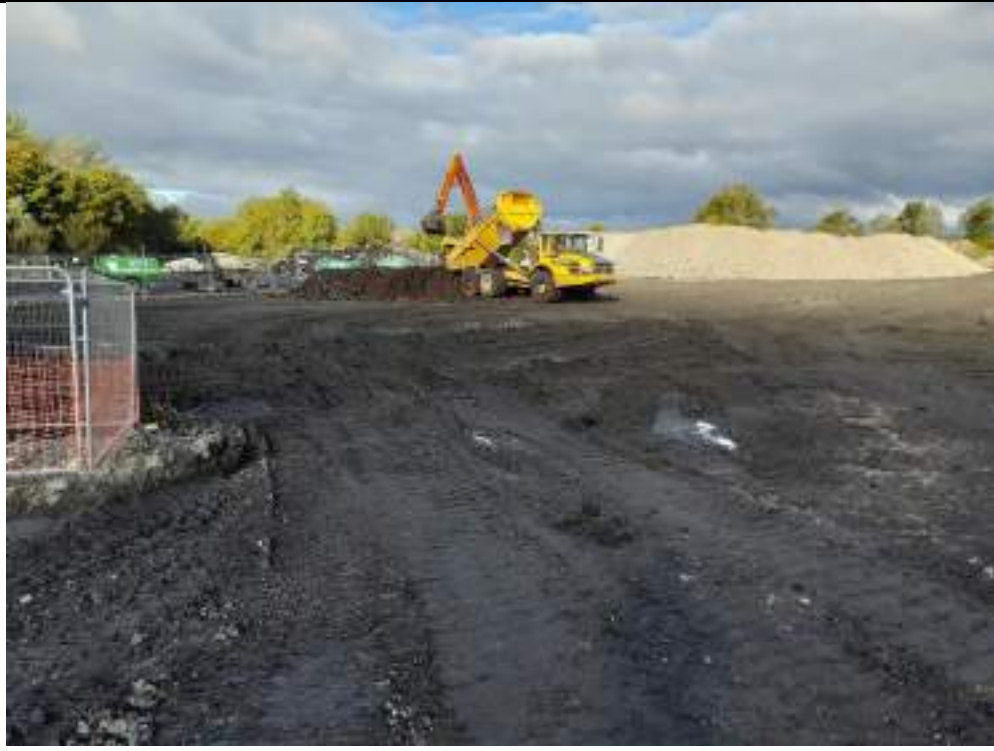
Photograph 5: Stockpiling excavated material from southeastern excavation in northwestern part of the site.

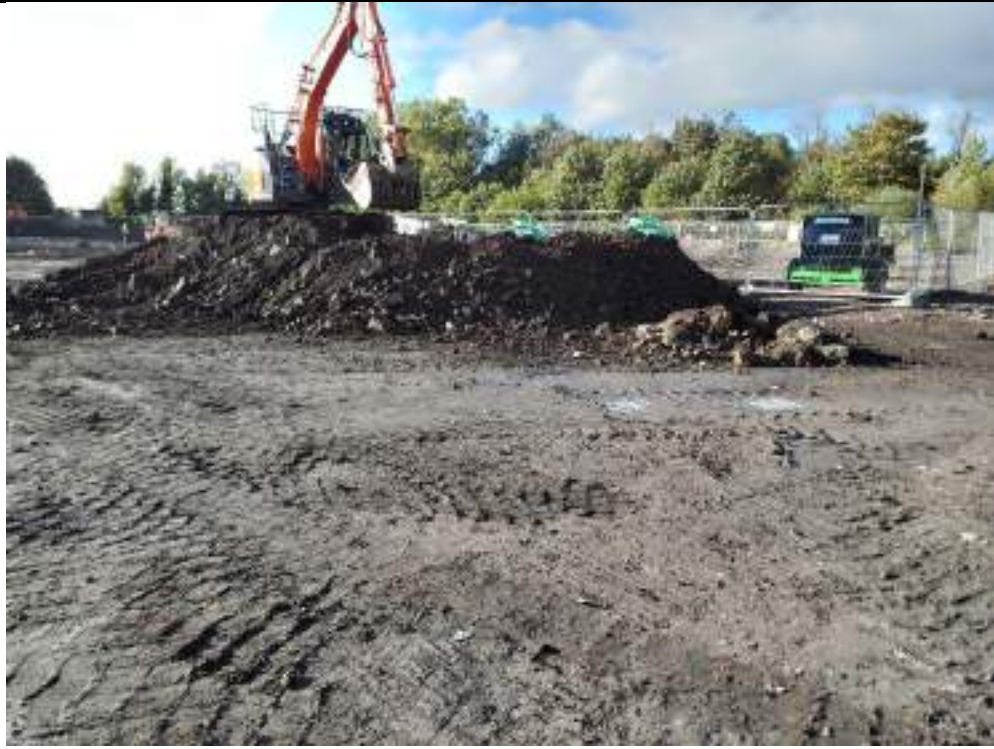
Photograph 7: Removing oversize from excavated material from southeastern part of the site using riddle bucket excavator in northwestern stockpile.

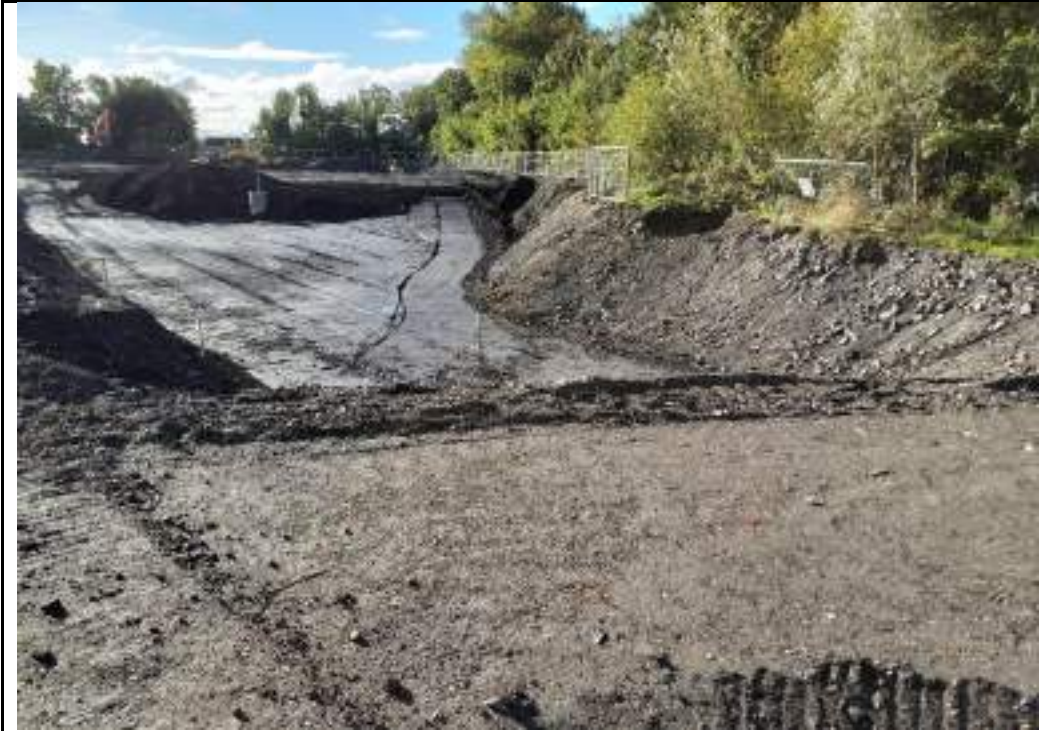
Photograph 11: Western boundary of the site. Looking towards the south.

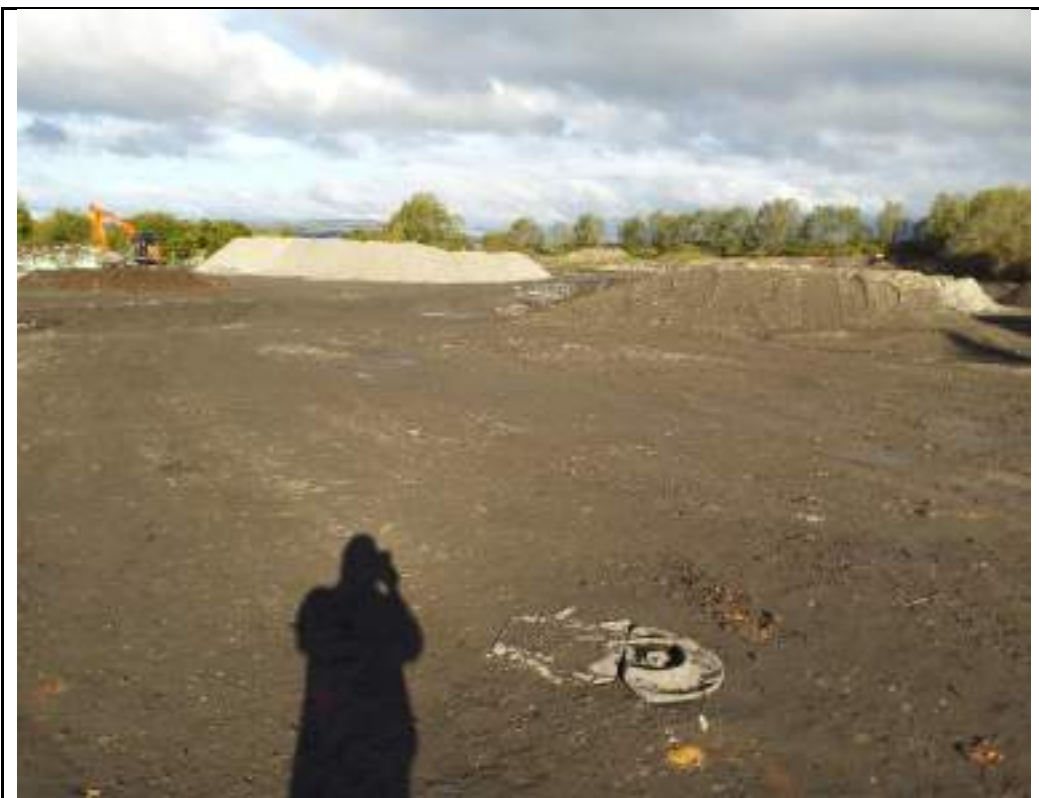
Photograph 12: Overview of stockpiles in northern part of the site. Looking towards the North.

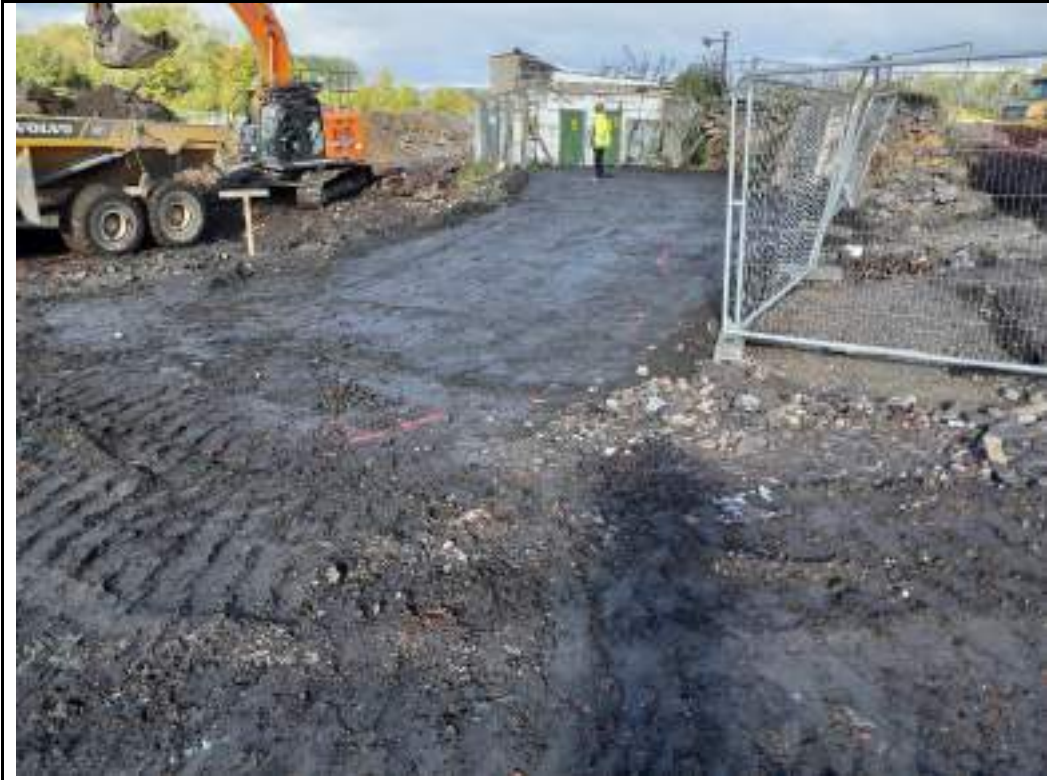
Photograph 93: Constructed platform for mine shaft no.6 grouting operation.

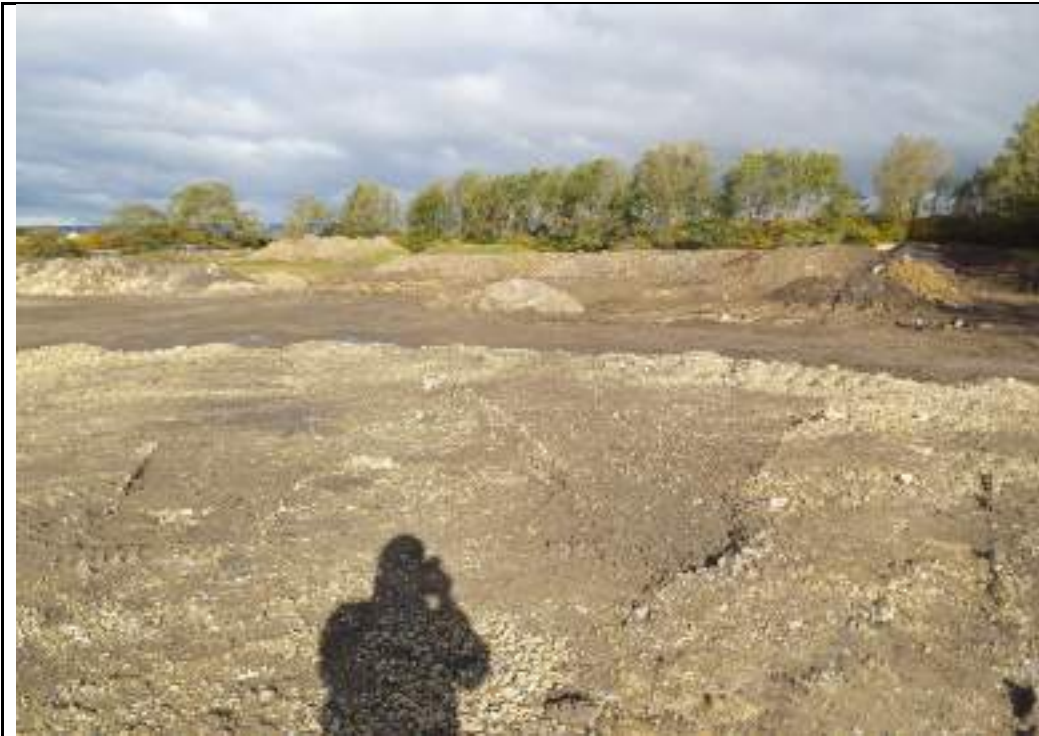
Photograph 15: Stockpile of Topsoil and materials from soft spots excavations in northern part of the site.

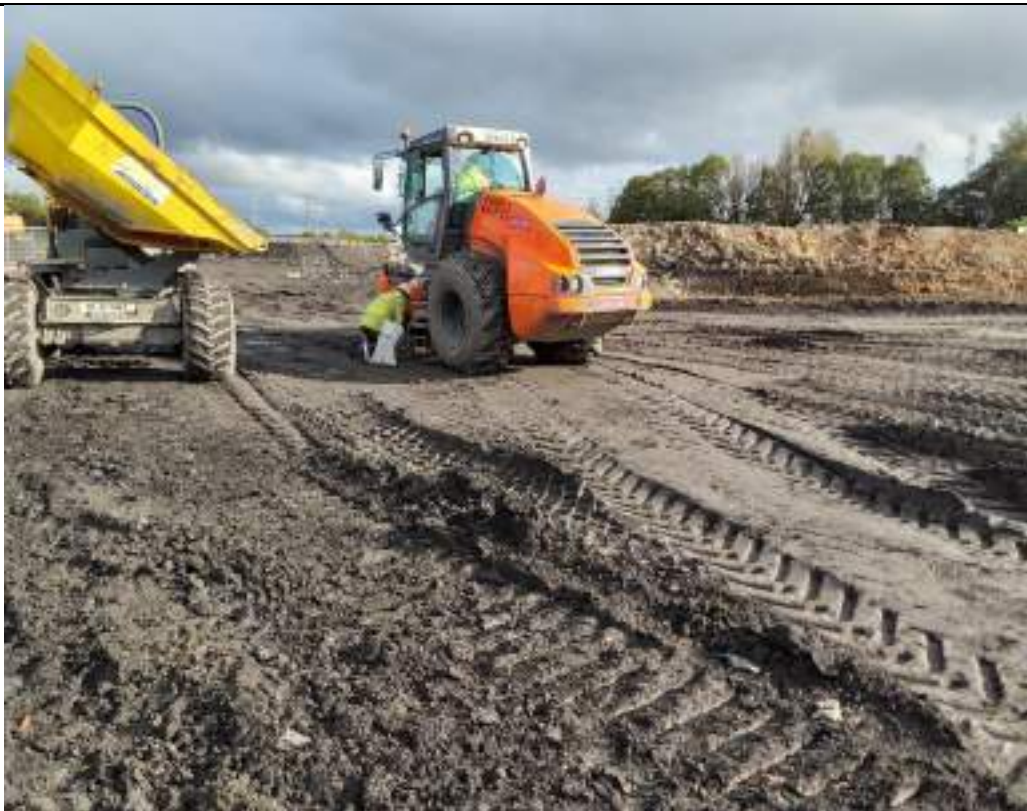
Photograph 16: Plate load testing in southern part of the site.

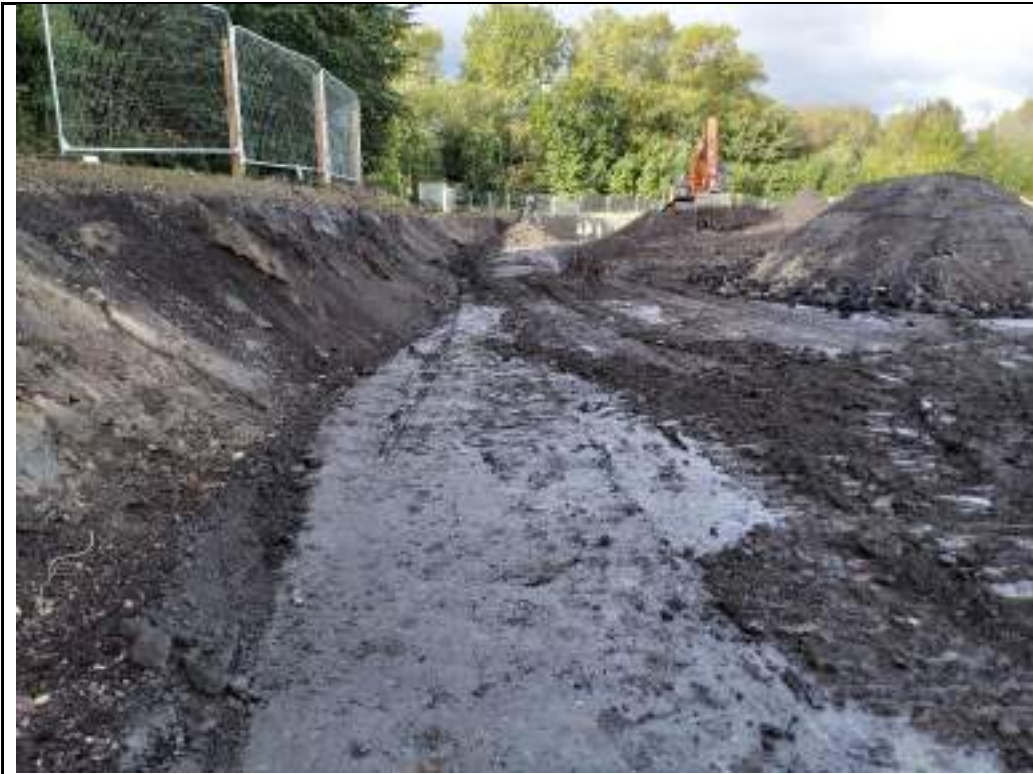
Photograph 17: Southern boundary of the site. Looking towards the west.

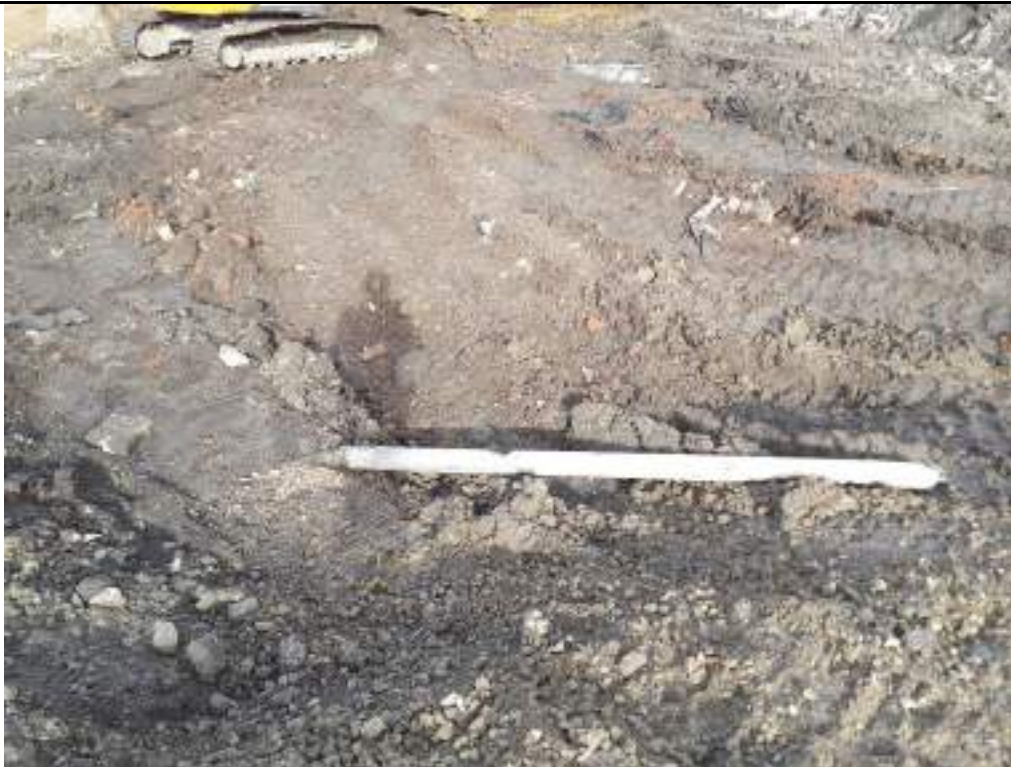
Photograph 18: Deleterious material in excavation in southeastern part of the site.

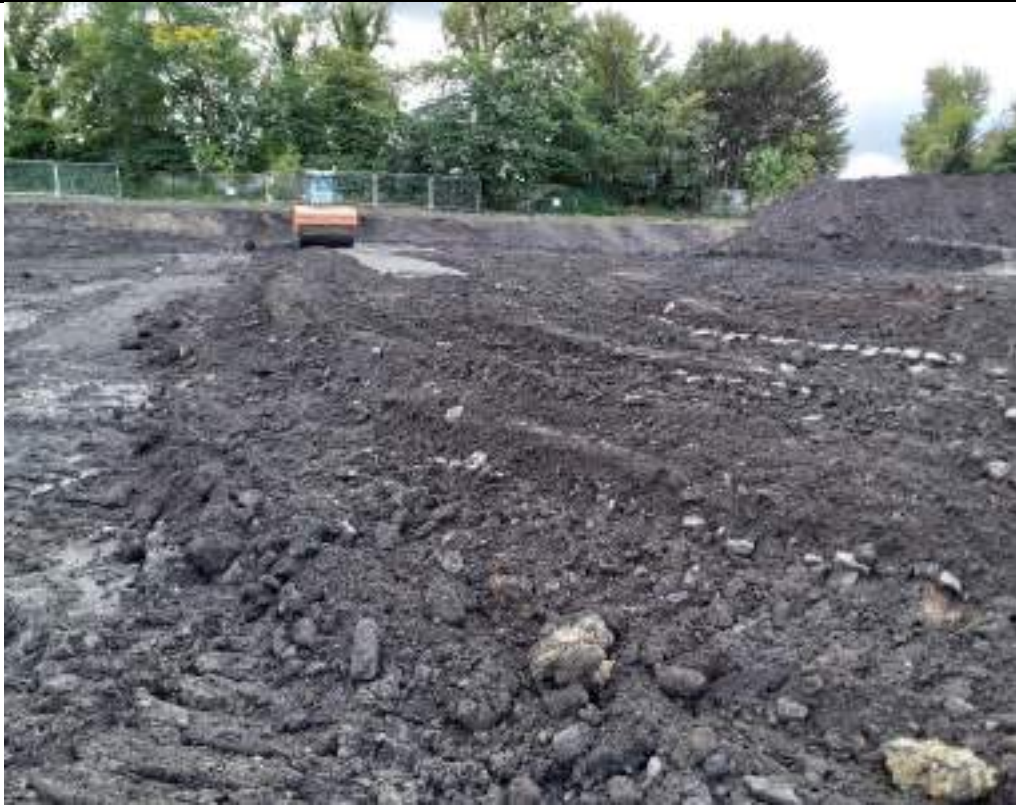
Photograph 19: Proof rolling of fill material in southern part of the site.

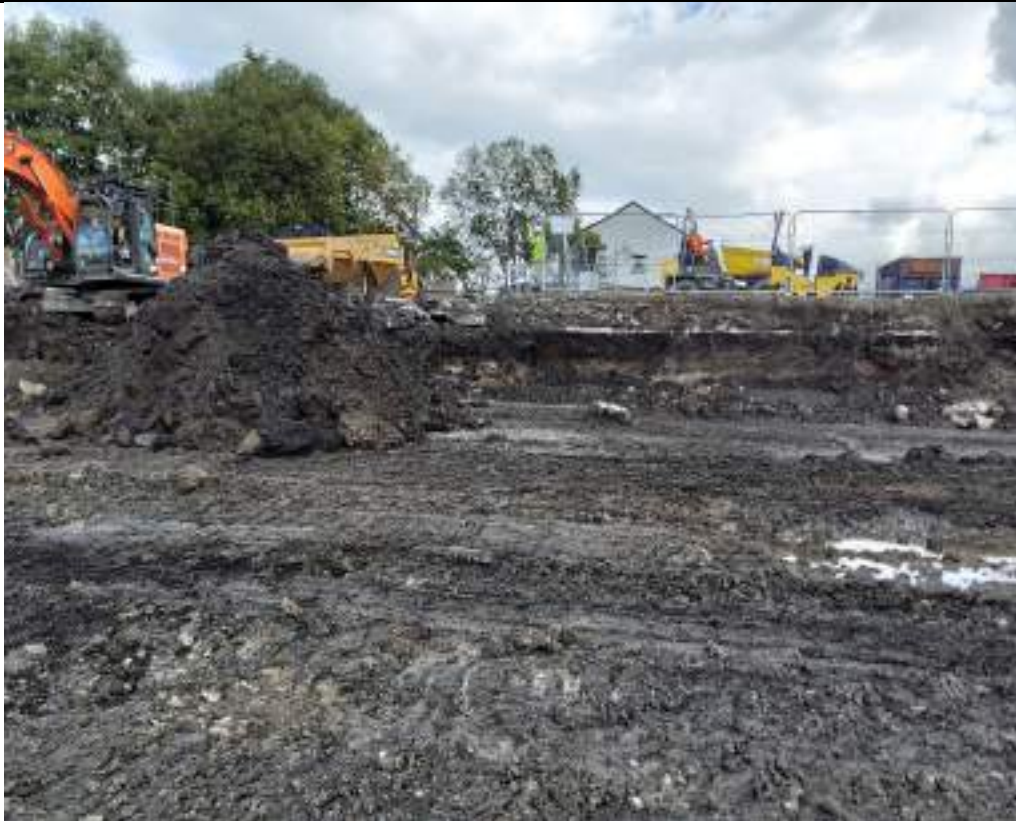
Photograph 20: Surveying of excavations in southeastern part of the site.

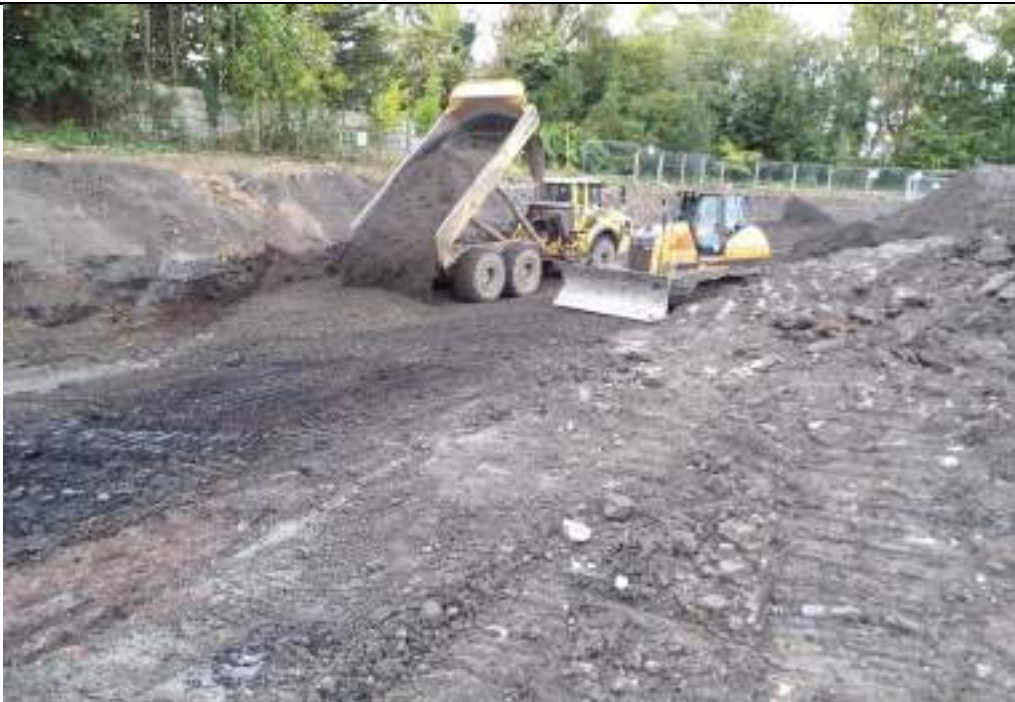
Photograph 22: Backfilling southwestern part of the site using processed material from eastern stockpile.

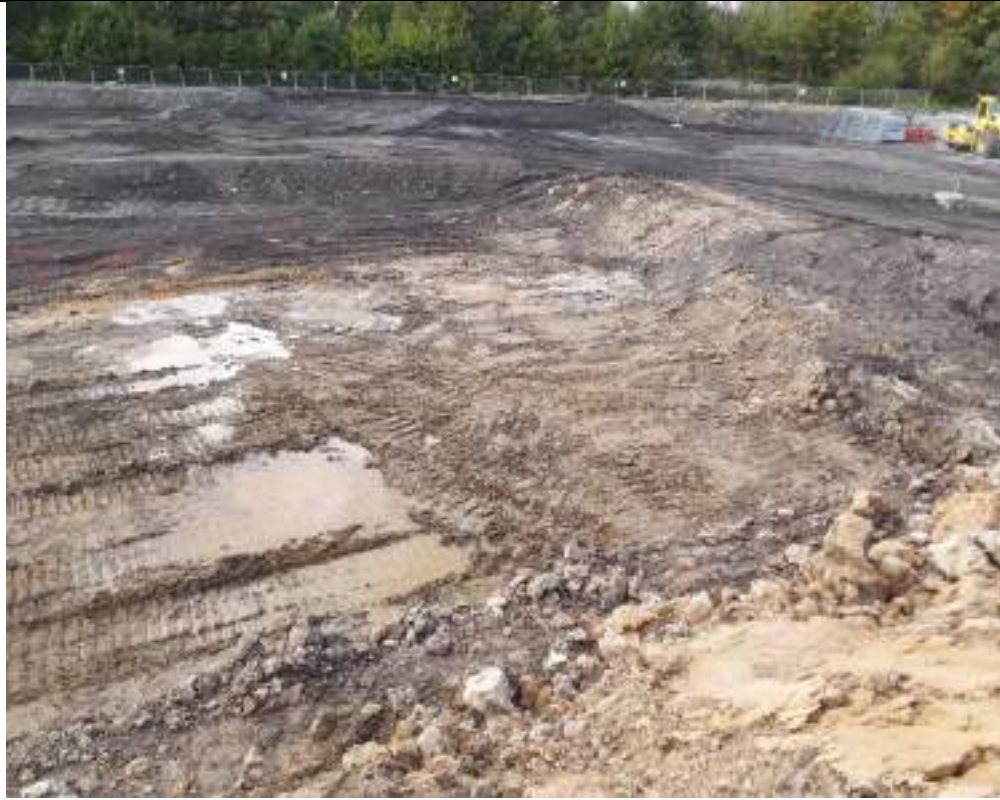
Photograph 23: Standing water in southeastern excavation.

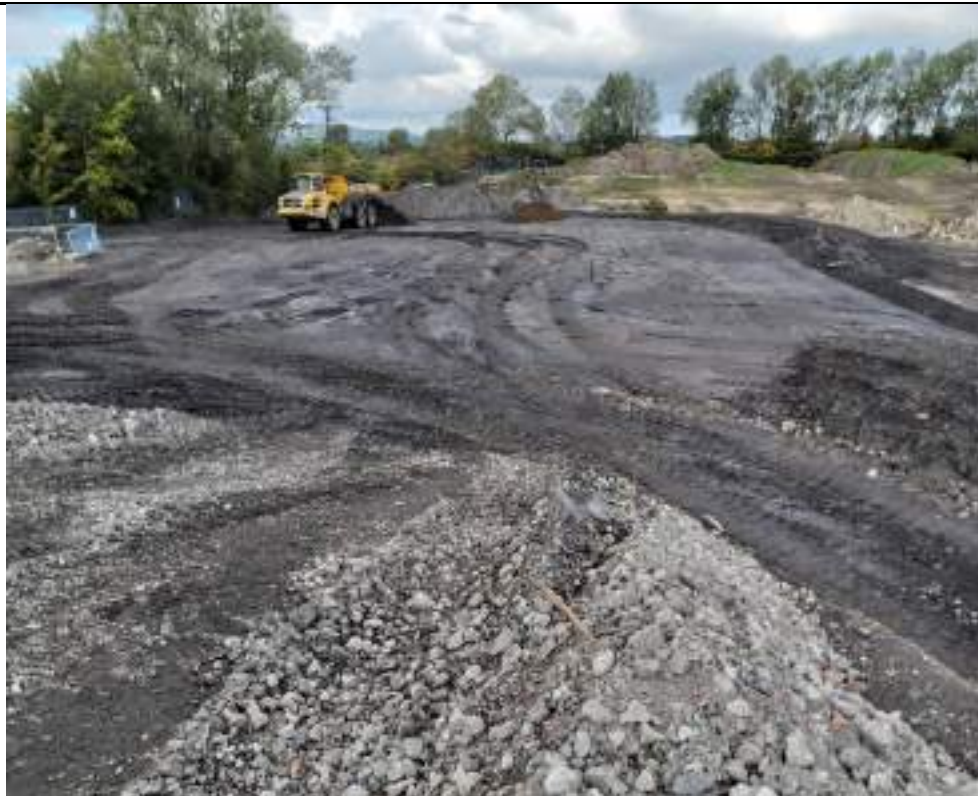
Photograph 24: Stockpiling excavated material from southeastern part of the site in northwest of the site.

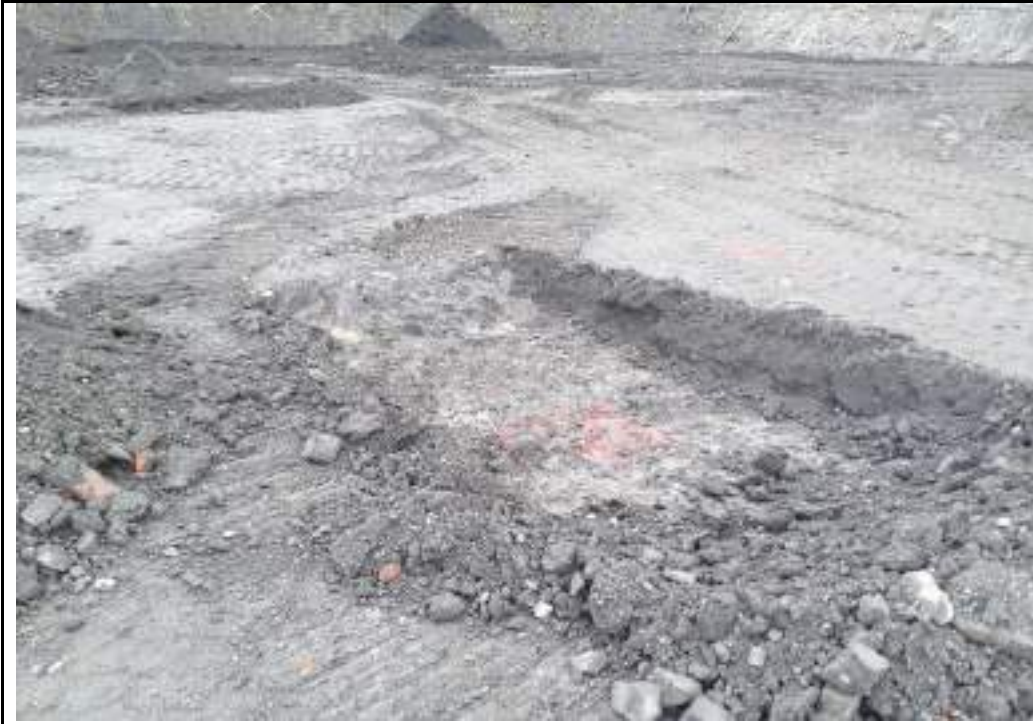
Photograph 25: Locations of NDM tests on fill material in southwest of the site.

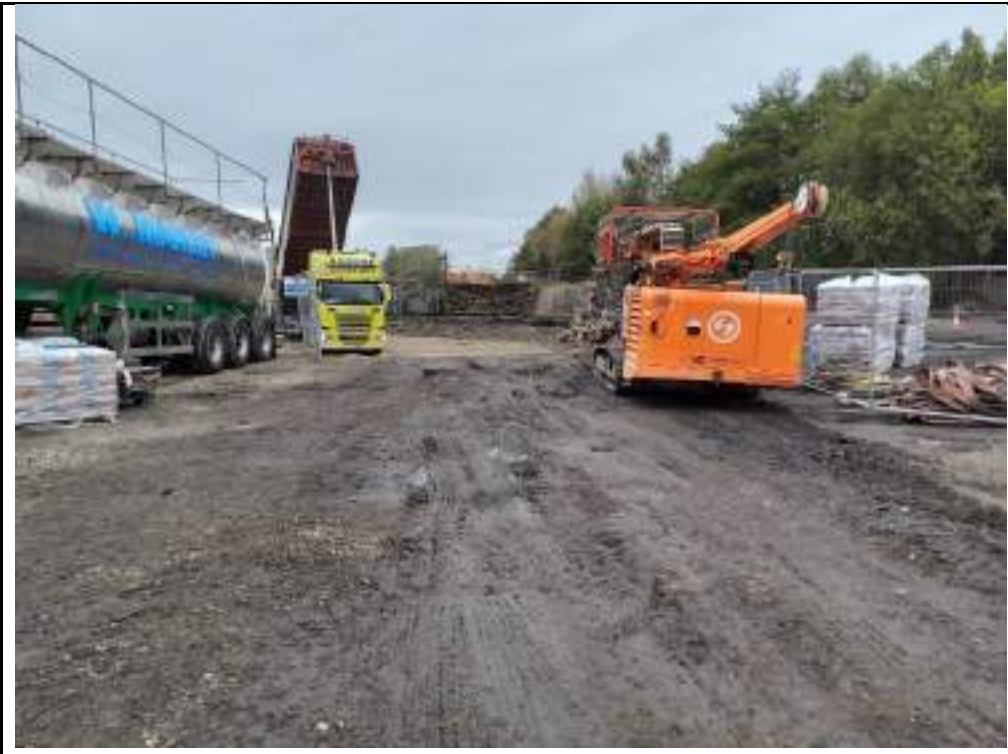
Photograph 3: Shaft grouting platform preparation and grouting rig in eastern part of the site.

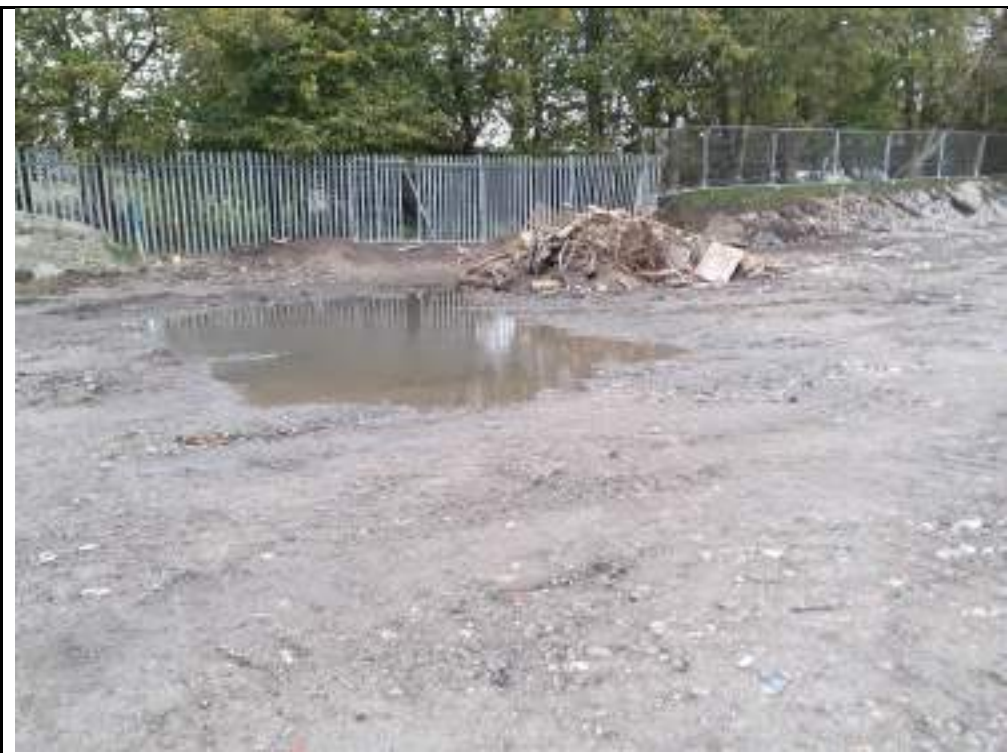
Photograph 4: Standing water and deleterious material in eastern boundary of the site.

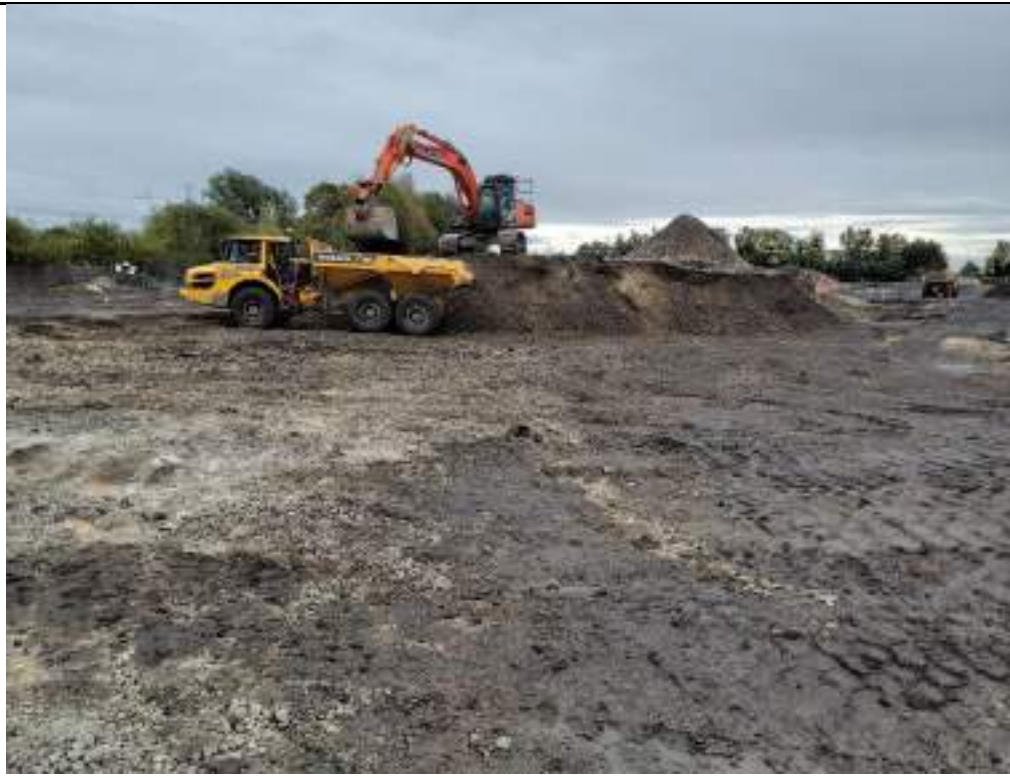
Photograph 6: Transferring granular material from northeastern stockpile to stockpile in northwestern part of the site and backfill southwest of the site.

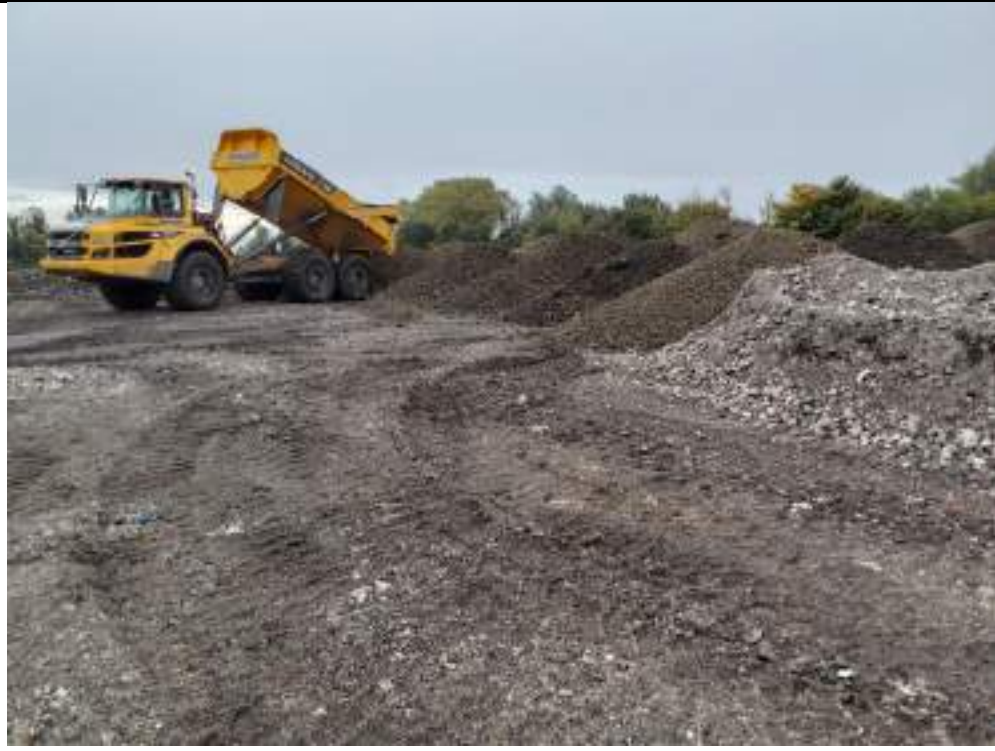
Photograph 7: Stockpiling granular material in northwestern part of the site over crushed material stockpile in northwestern part of the site.

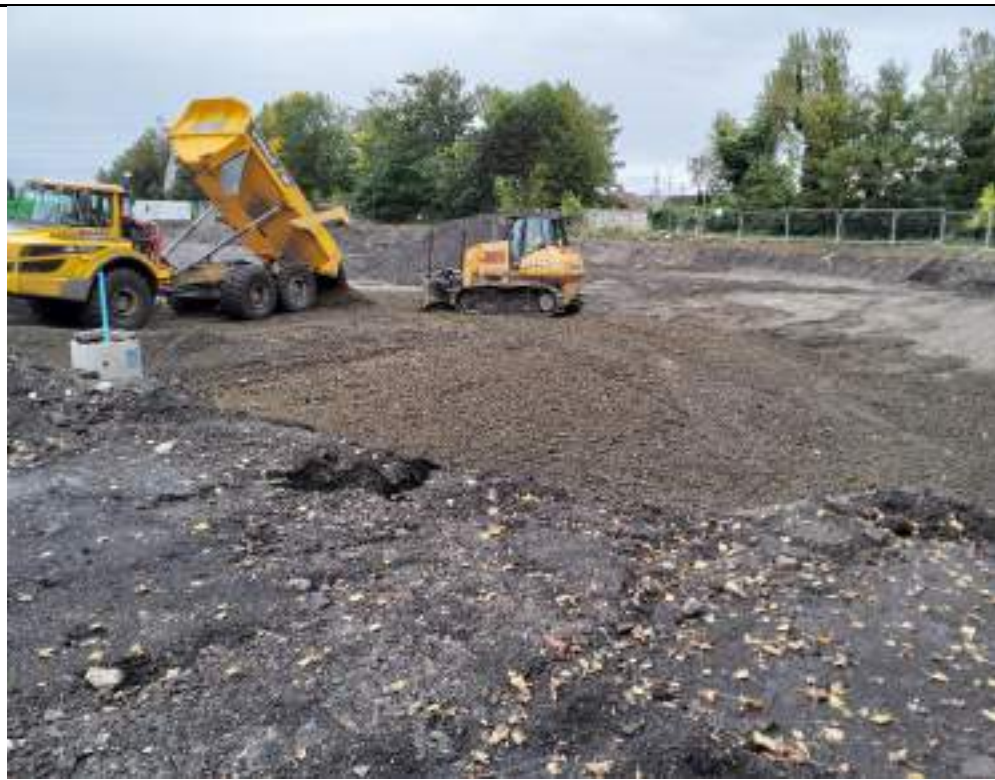
Photograph 8: Backfilling southwest of the site using granular material from northeastern stockpile.
