**SITE VISIT REPORT 15220-HYD-XX-XX-SVR-GE-1018**

**SHEET NO.: 6 of 18**

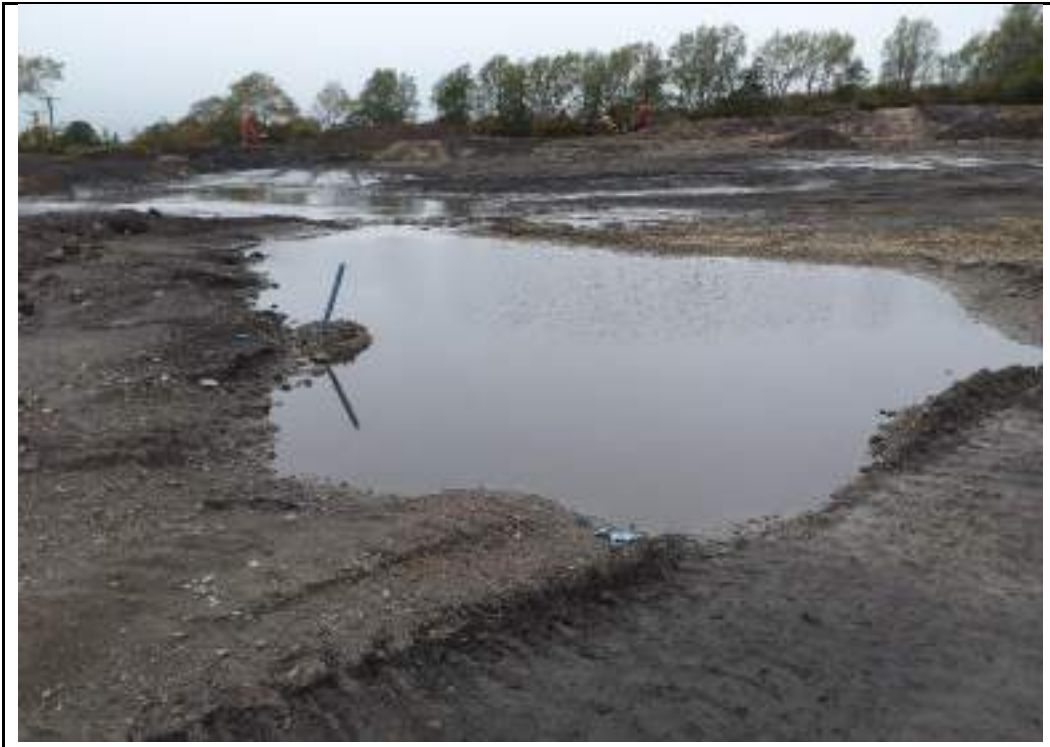
Photograph 9: Standing water in northern part of the site.

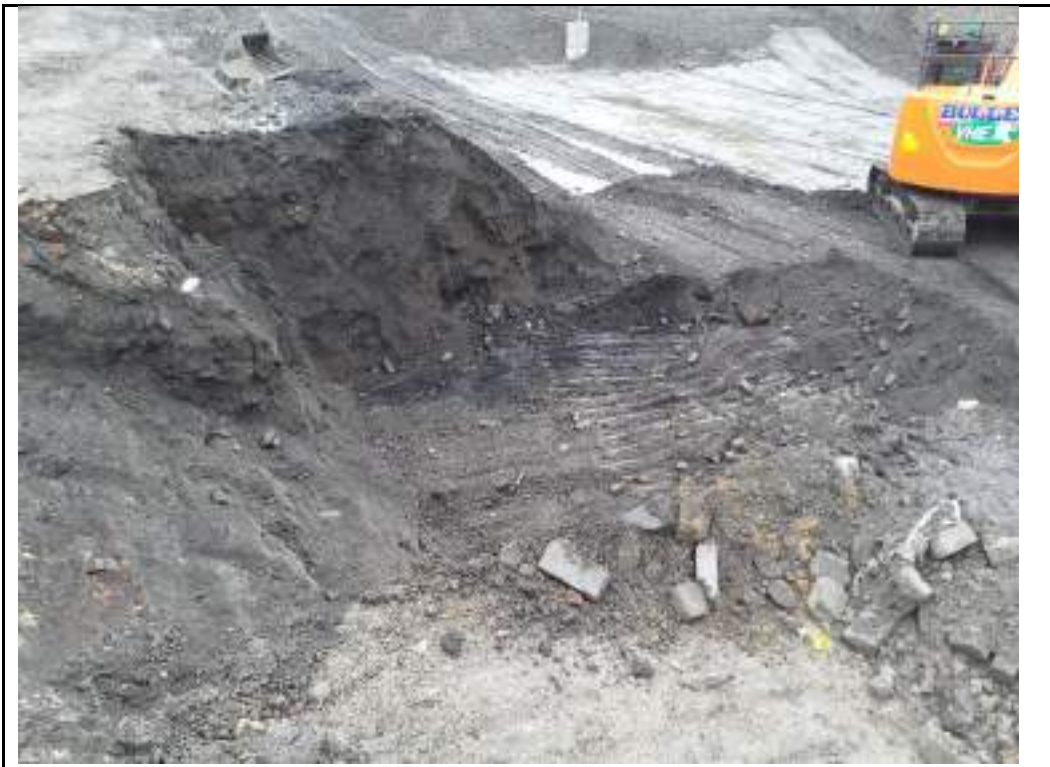
Photograph 10: Excavation of landfill Made Ground to find abstraction well in western part of the site.

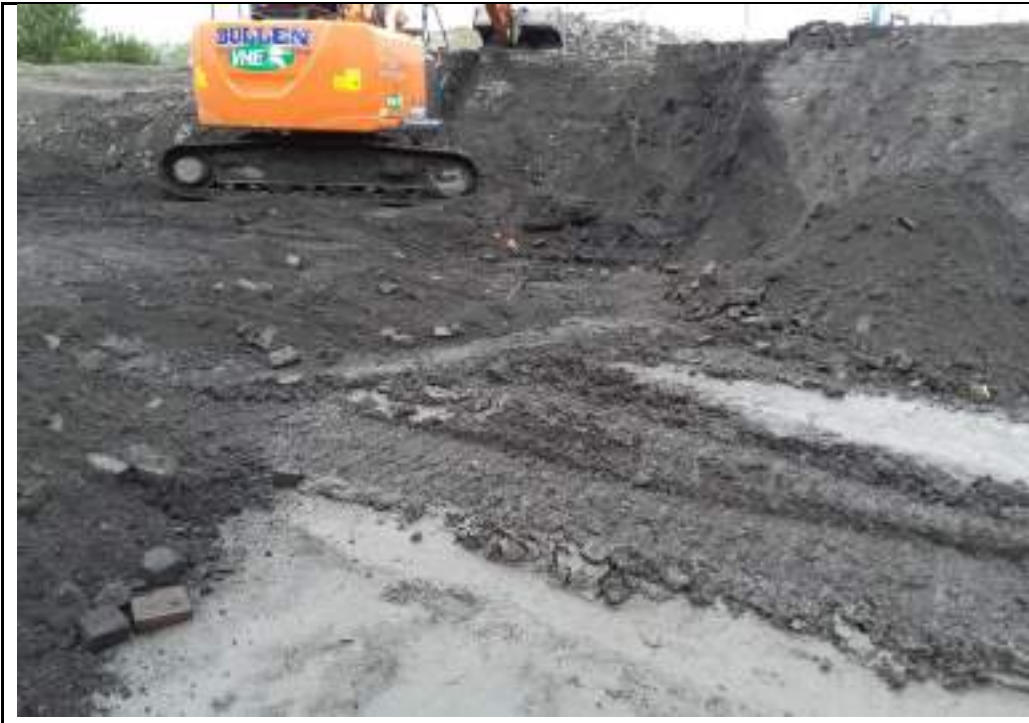
Photograph 11: Deleterious material in excavation in western part of the site.

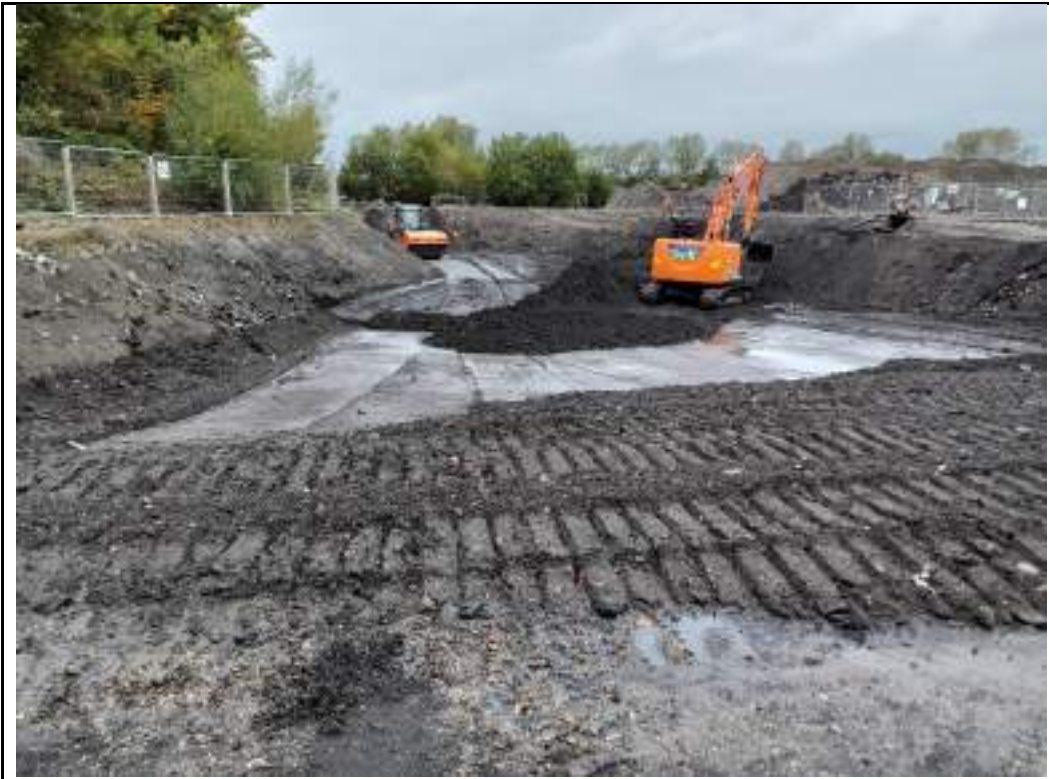
Photograph 93: Proof rolling of fill material in western part of the site.

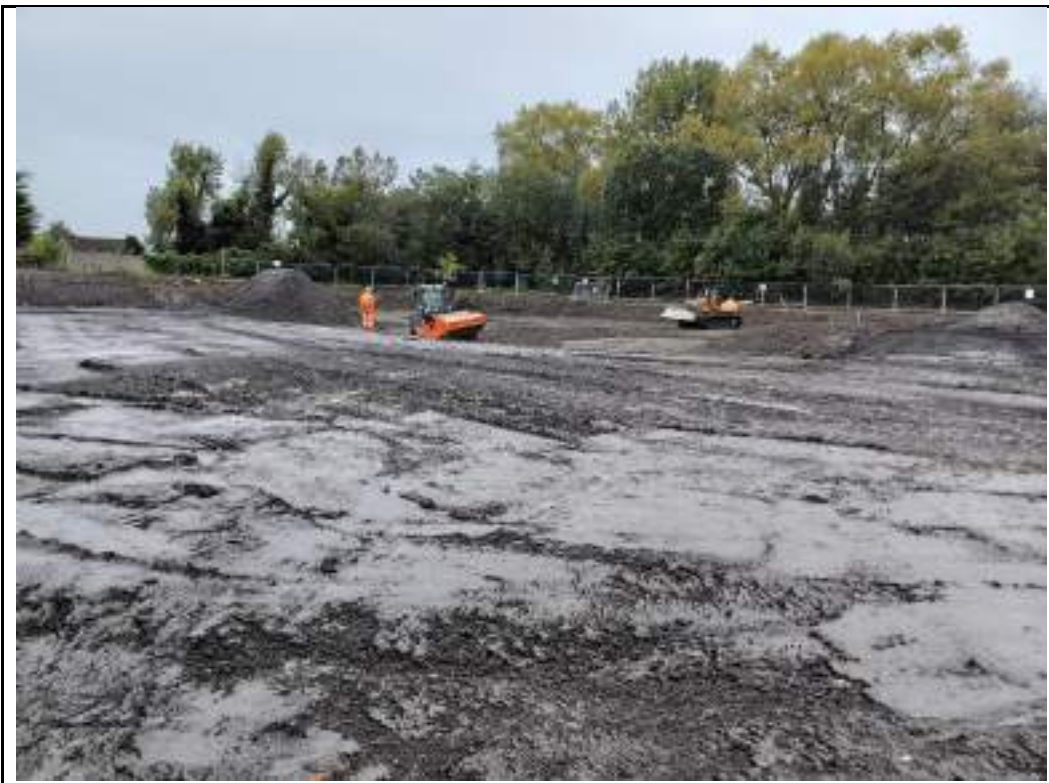
Photograph 14: Proof rolling of granular fill material in southwestern part of the site.

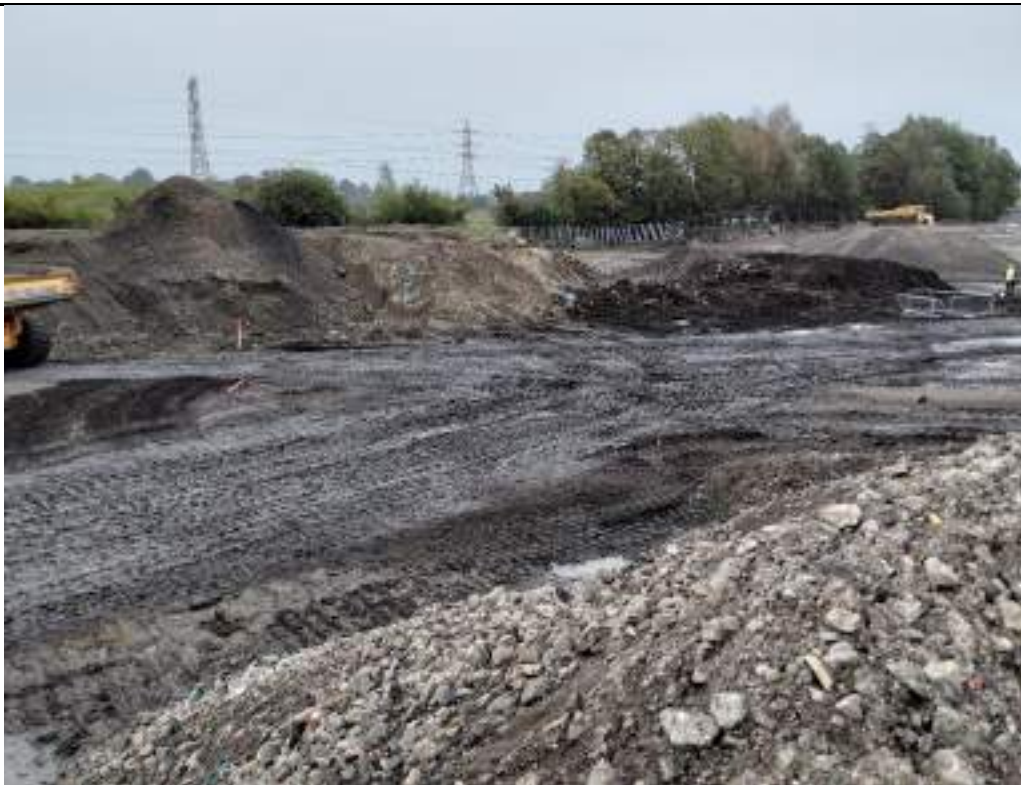
Photograph 16: Stockpiles of processed and excavated material in eastern part of the site.

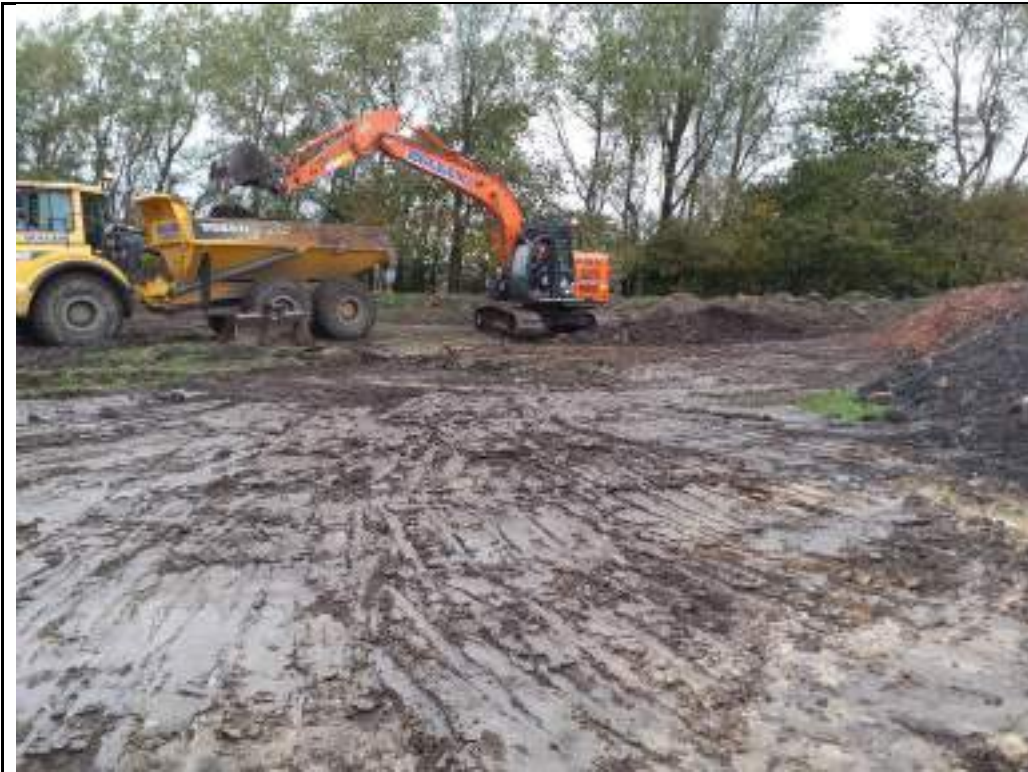
Photograph 17: Transferring stockpile of soft spot material from the north to the northwest.

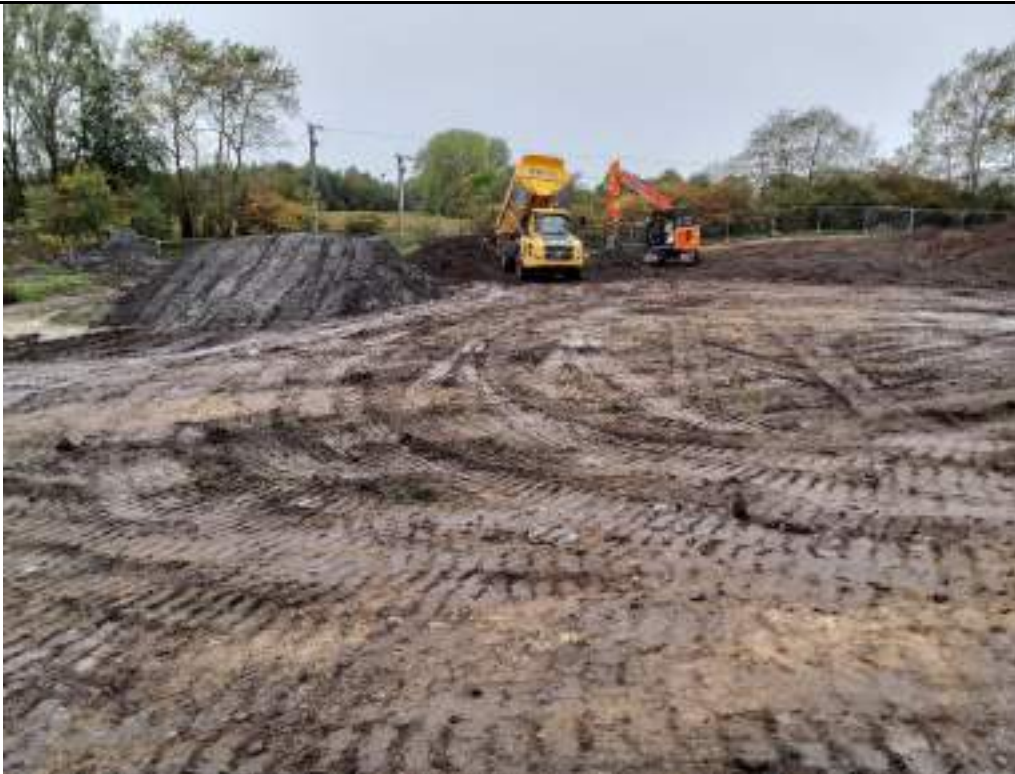
Photograph 18: Stockpiling soft spot material from northern stockpile in northwestern part of the site.

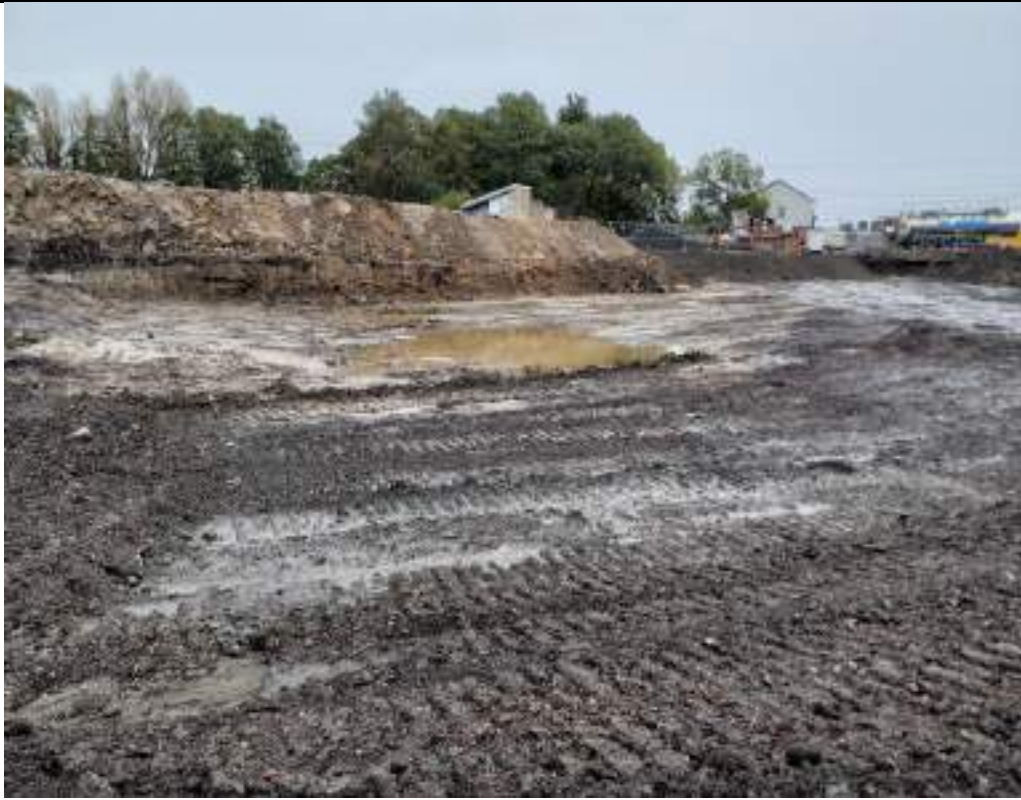
Photograph 19: Standing water in southeastern part of the site.

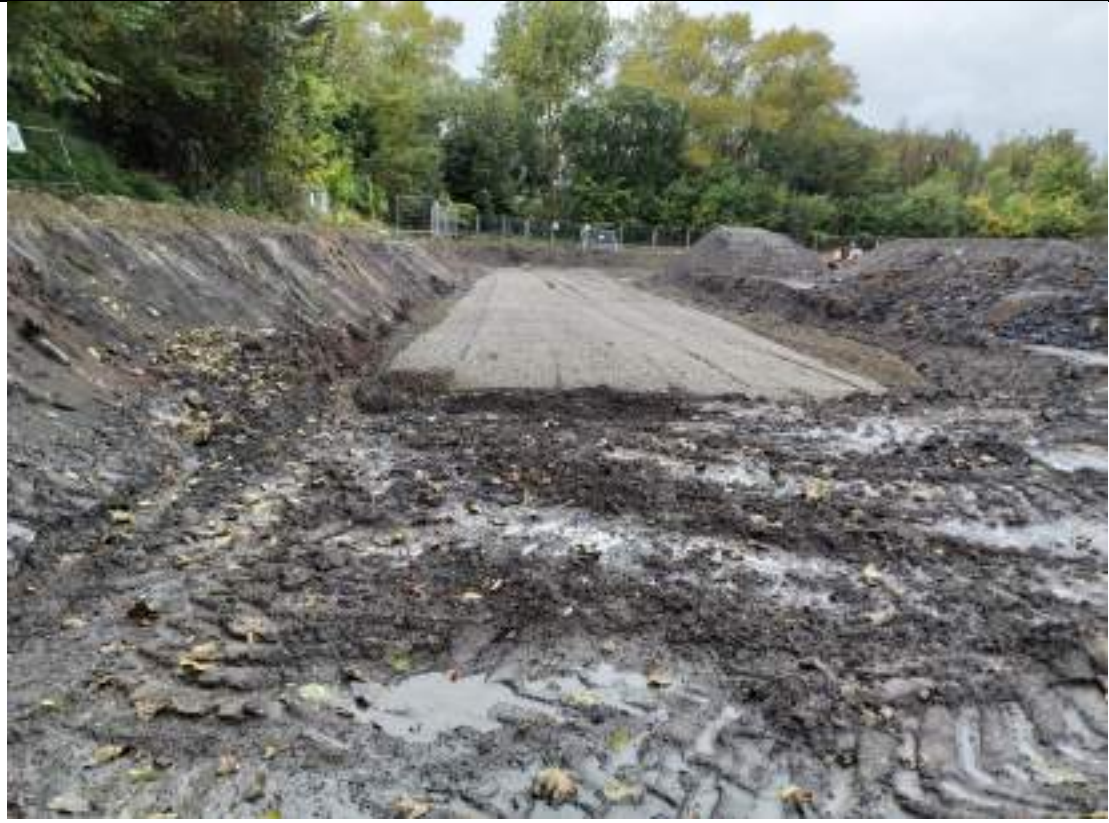
Photograph 21: Southern boundary of the site. Looking towards the west.

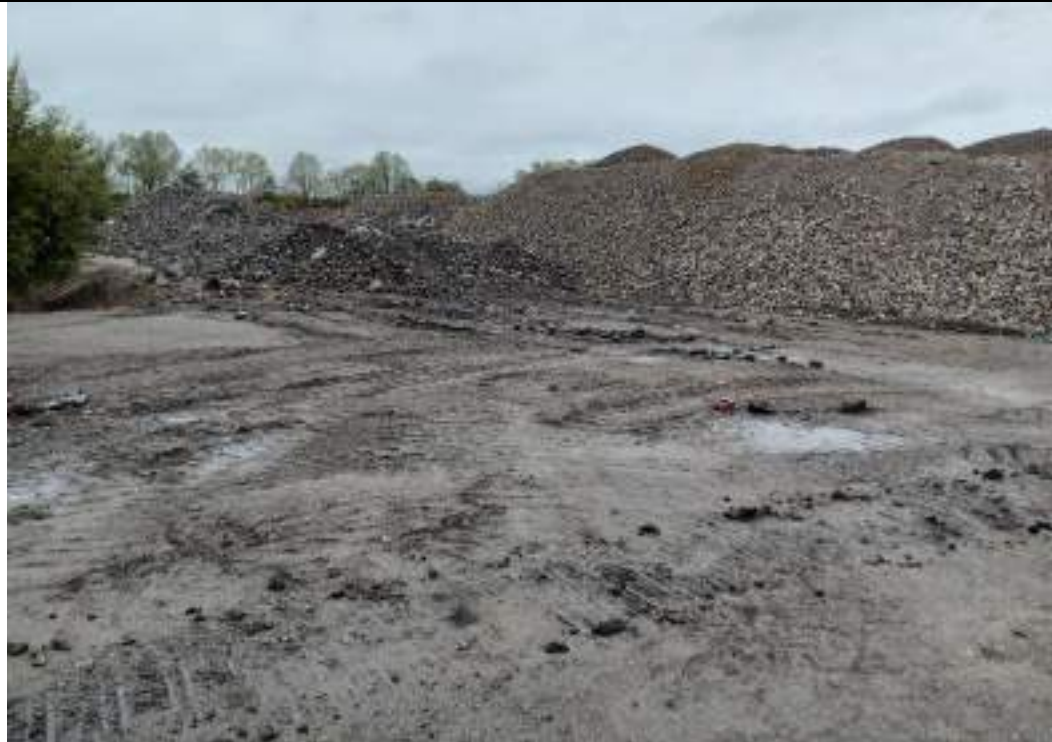
Photograph 22: Stockpile of bricks and crushed material in northwestern part of the site.

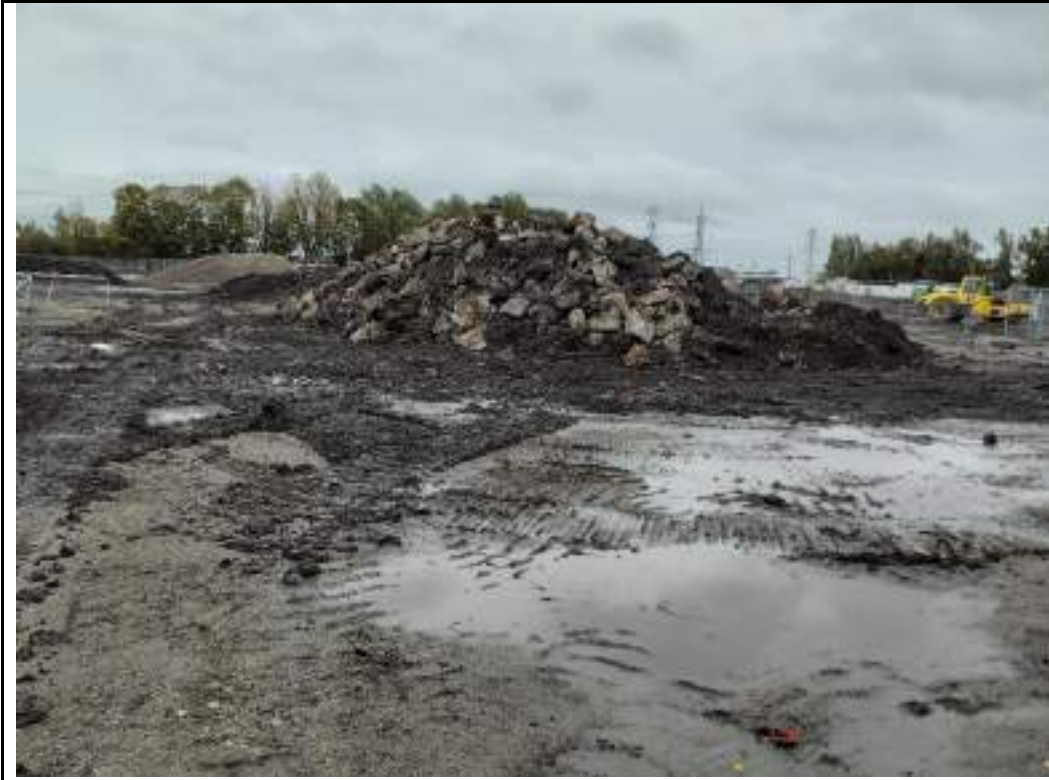
Photograph 23: Stockpile of excavated concrete in central part of the site.

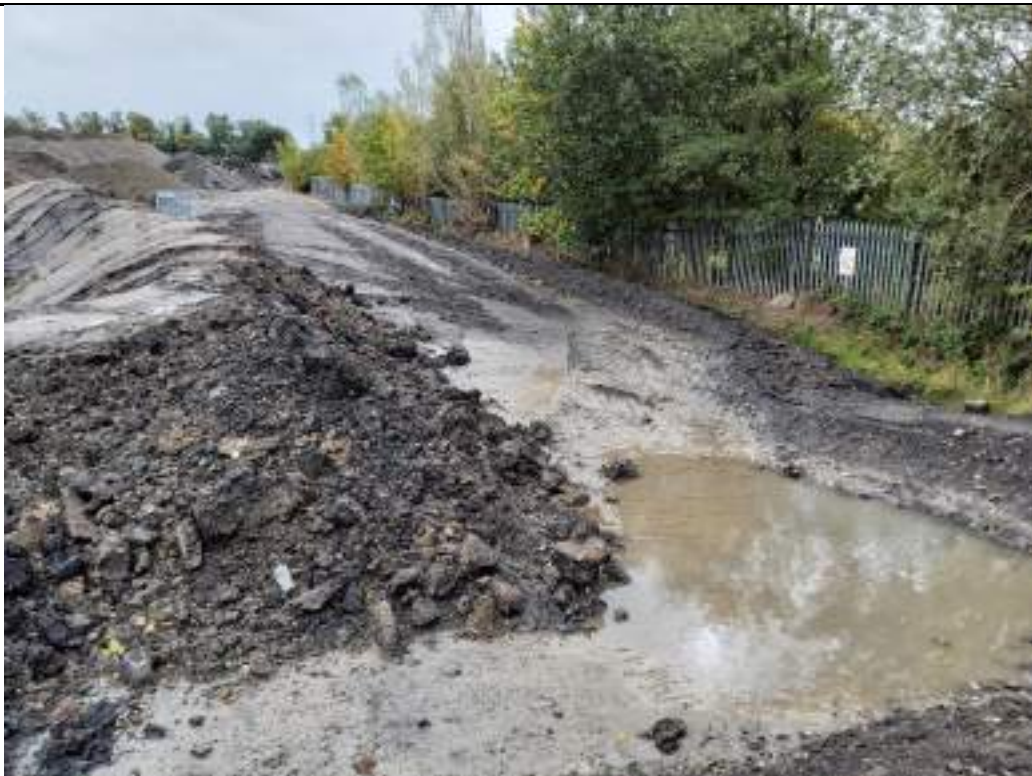
Photograph 24: Northwestern boundary of the site. Looking towards the south.

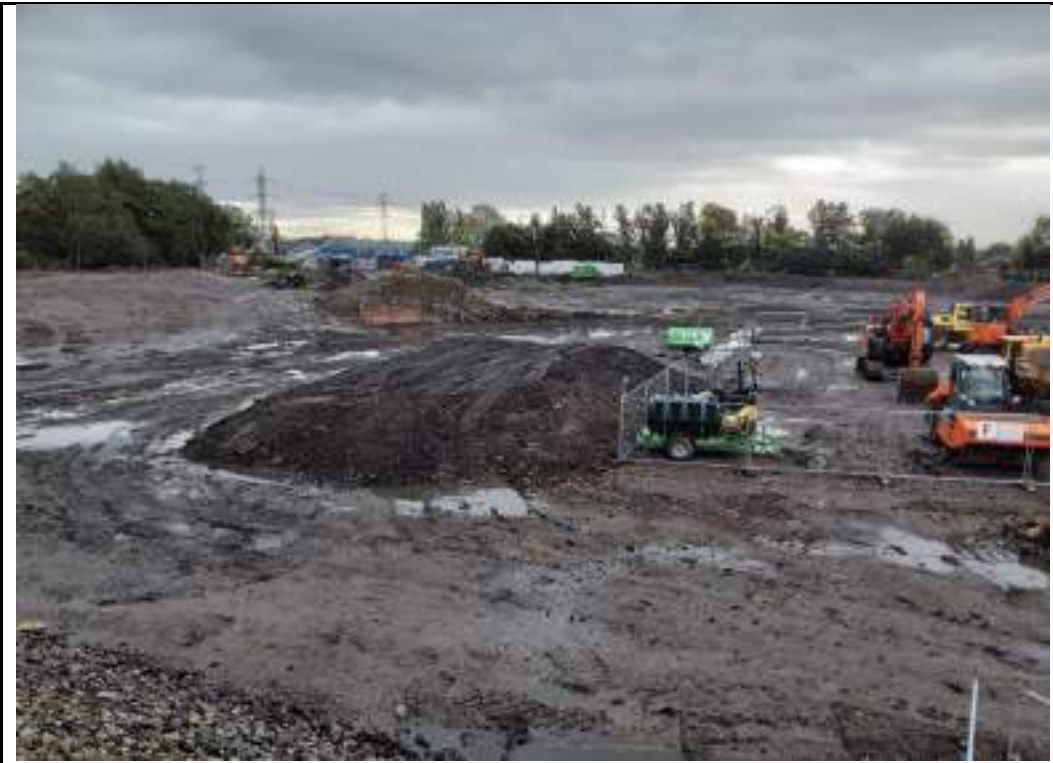
Photograph 1: Overview of the site. Looking towards the south.

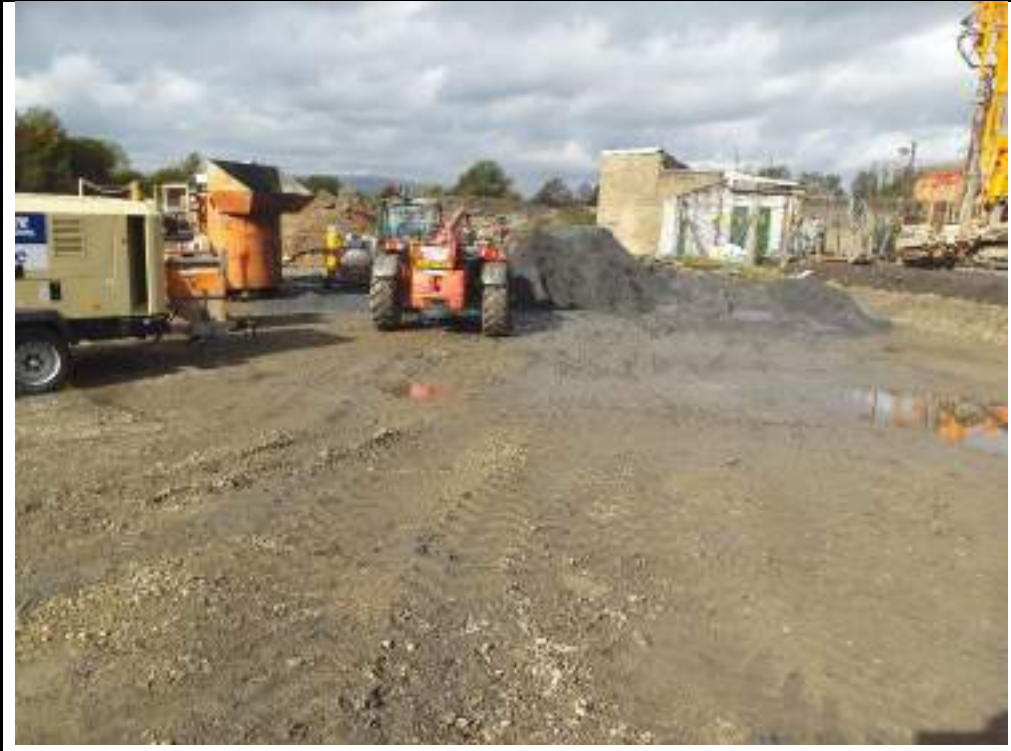
Photograph 3: Grout mixer and grout delivery in eastern part of the site.

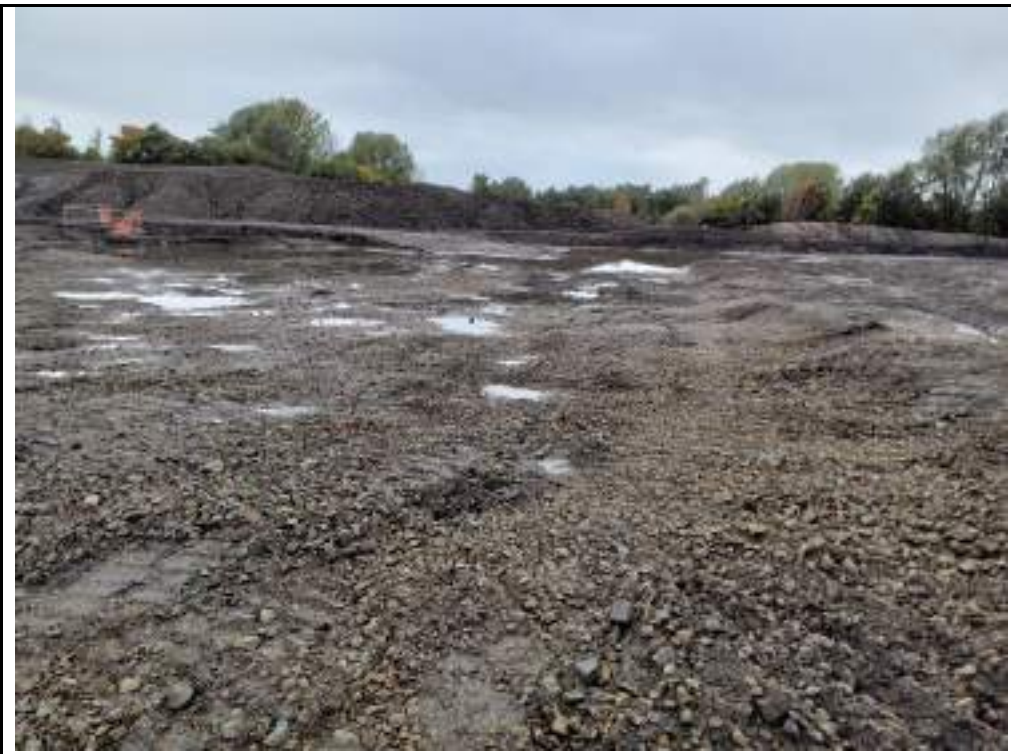
Photograph 4: Standing water in northern part of the site.

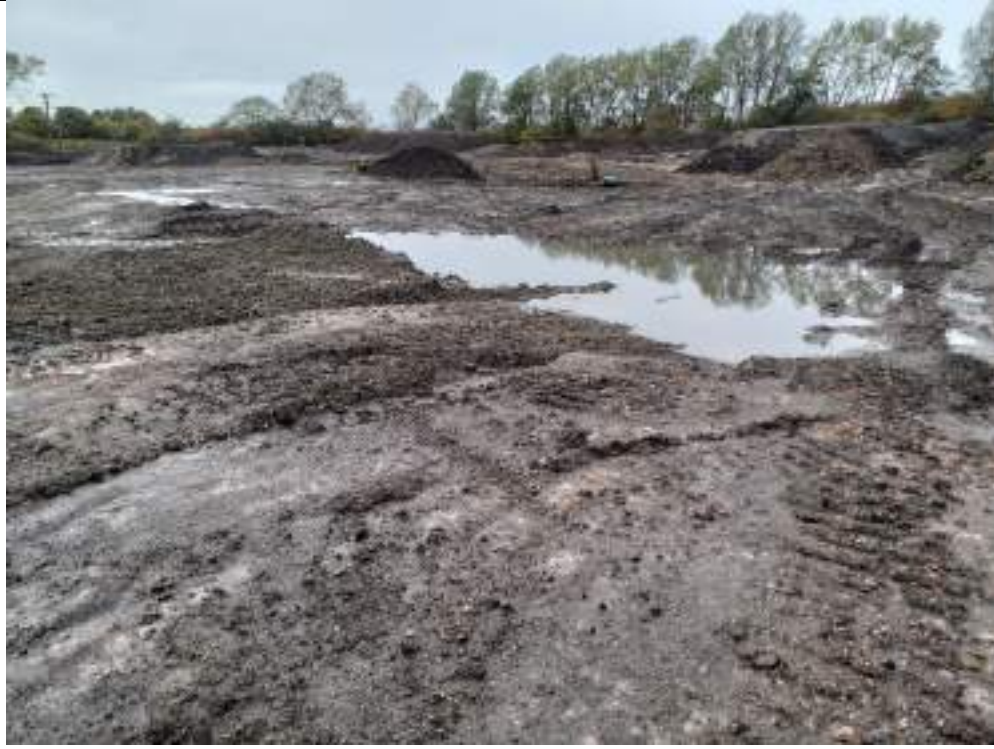
Photograph 5: Standing water in northeastern part of the site.

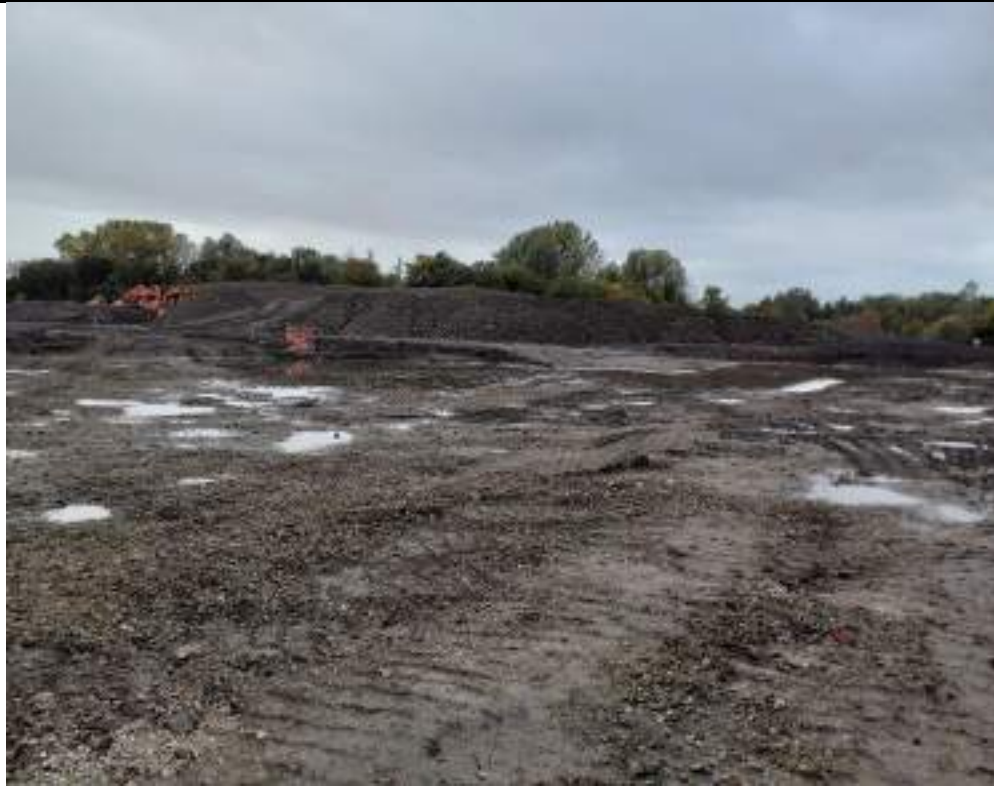
Photograph 7: Stockpile of crushed and granular material in northwestern part of the site.

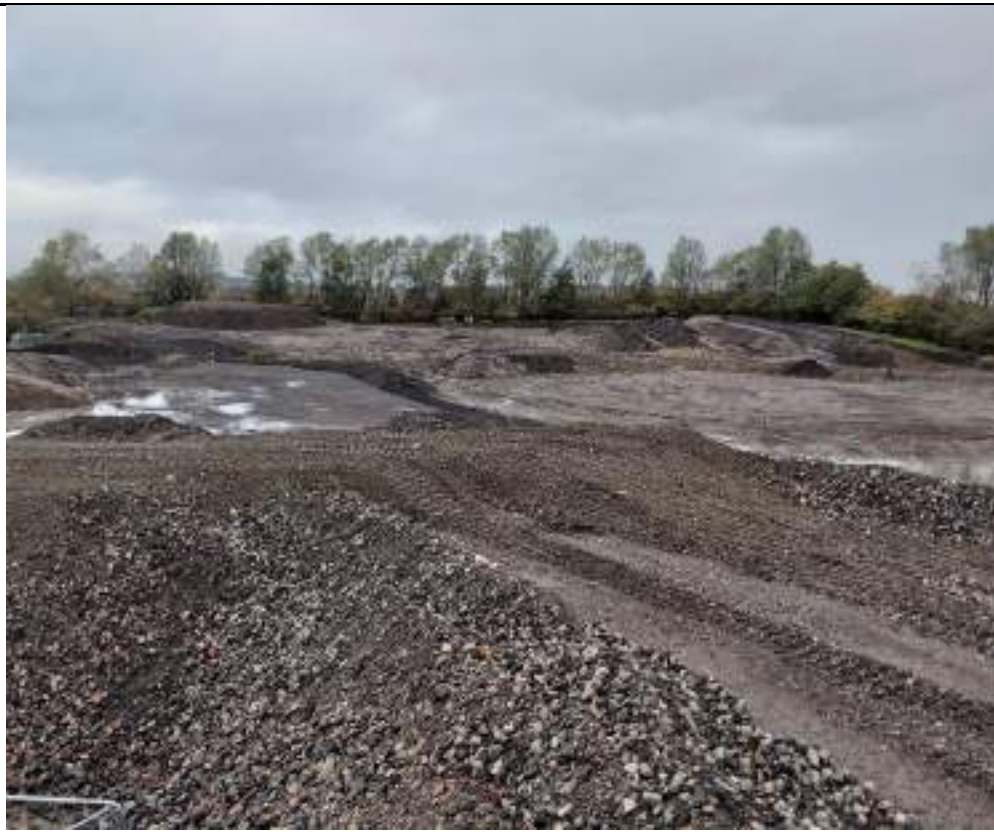
Photograph 8: Overview of northern stockpiles (Topsoil and material from soft spots)

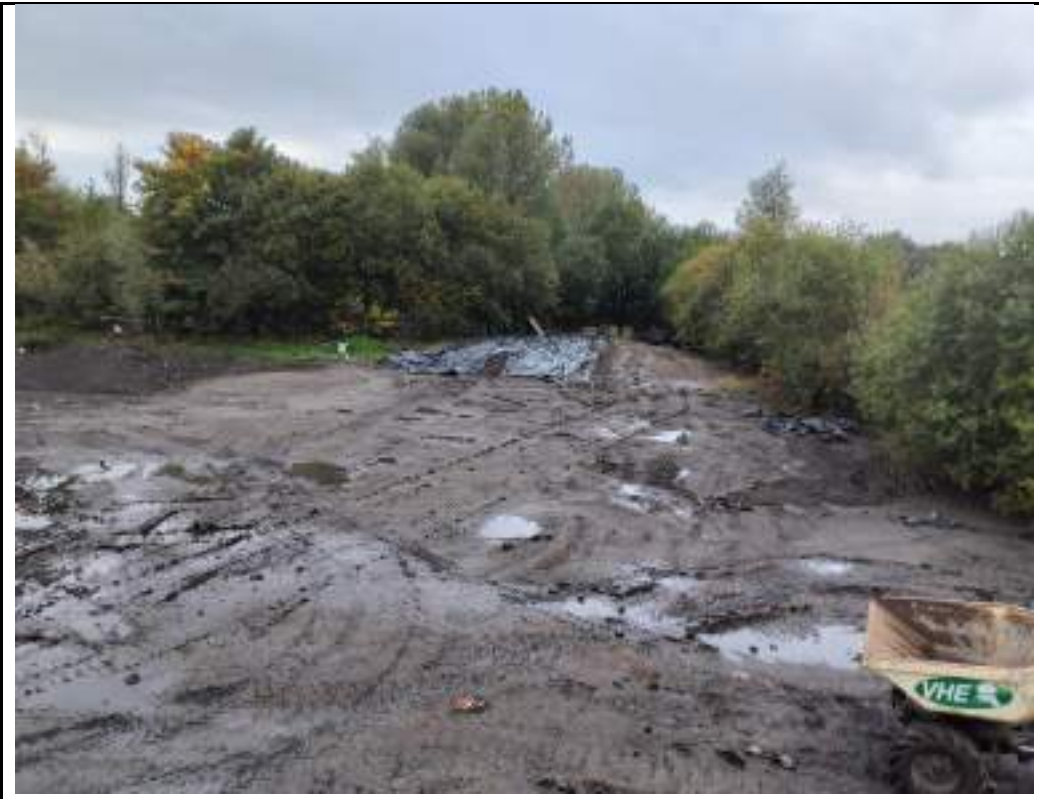
Photograph 9: Stockpile of potentially TPH contaminated material in western boundary of the site.

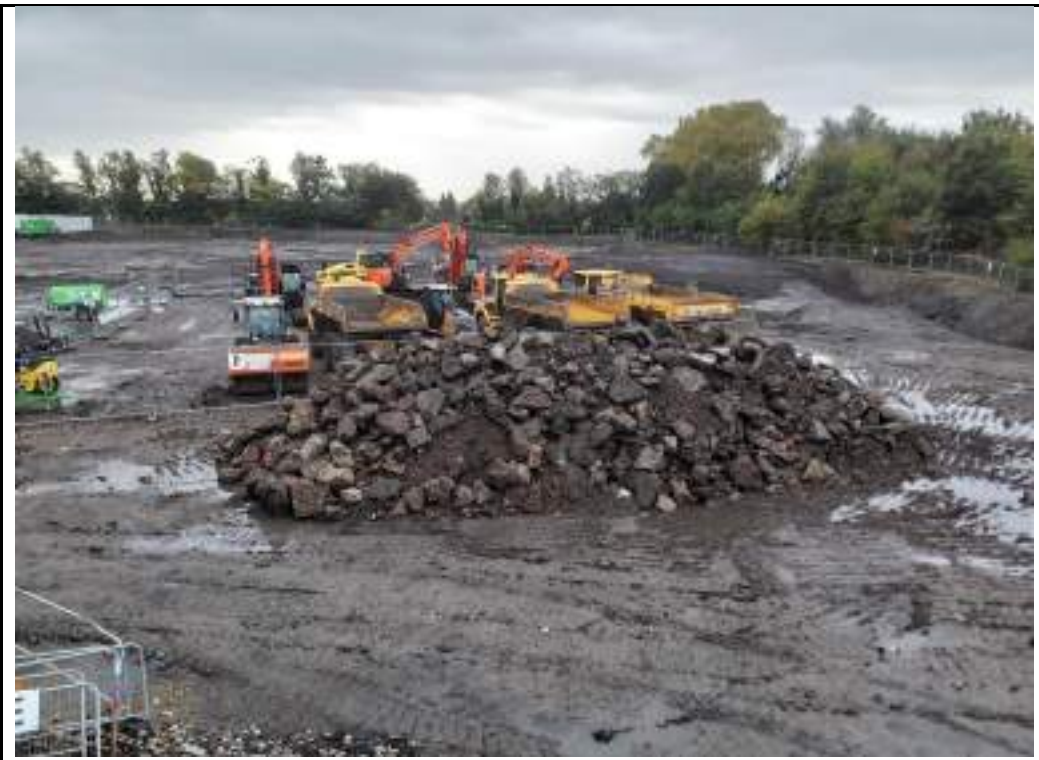
Photograph 10: Stockpile of excavated concrete and oversized material in southern part of truck parking.

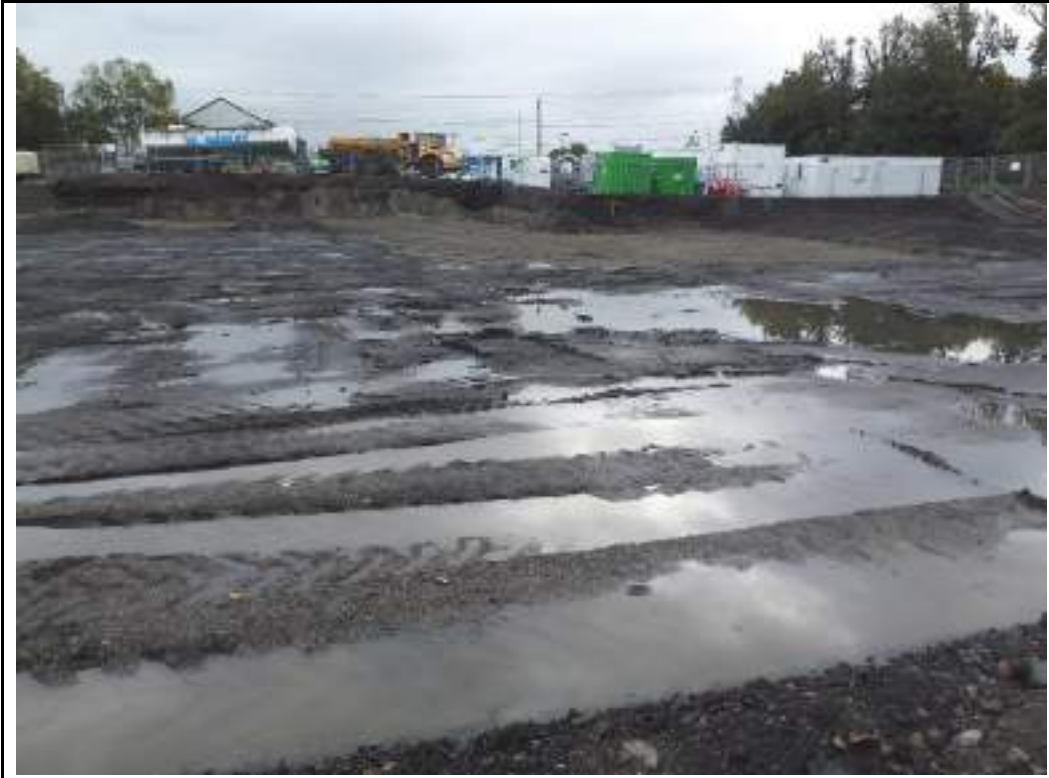
Photograph 93: Standing water and stockpile of soft spot material in southern part of the site.

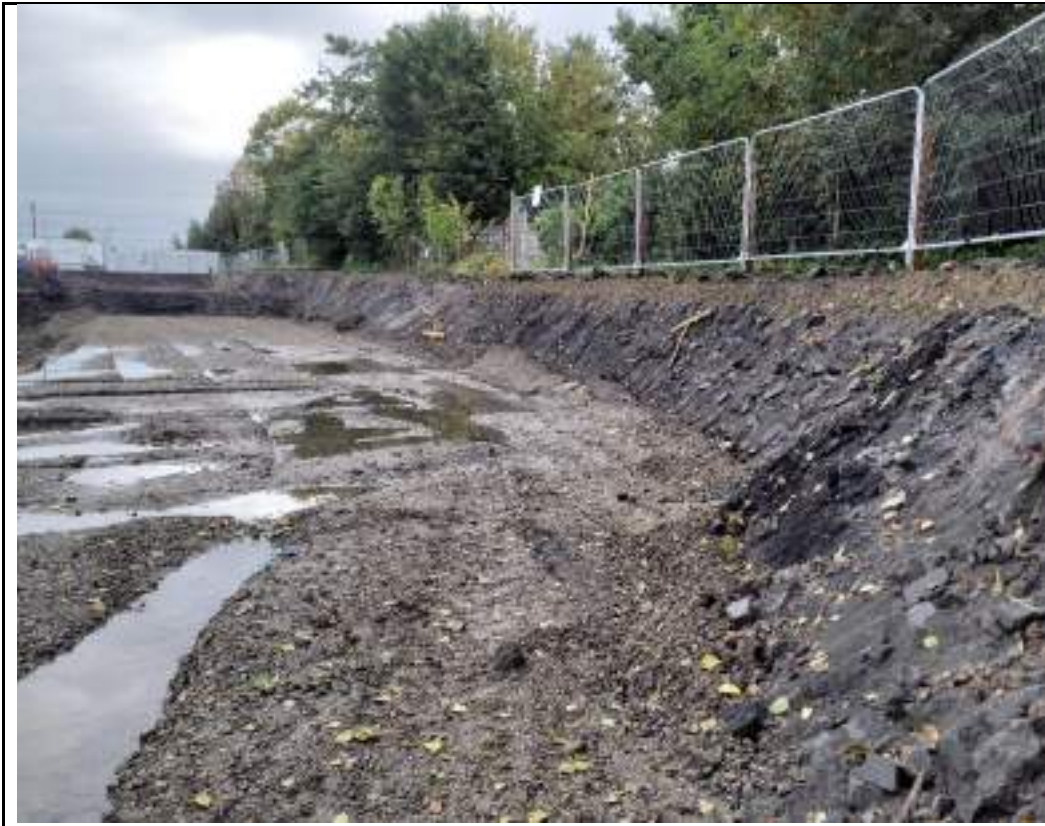
Photograph 15: Southern boundary of the site. Looking towards the east.

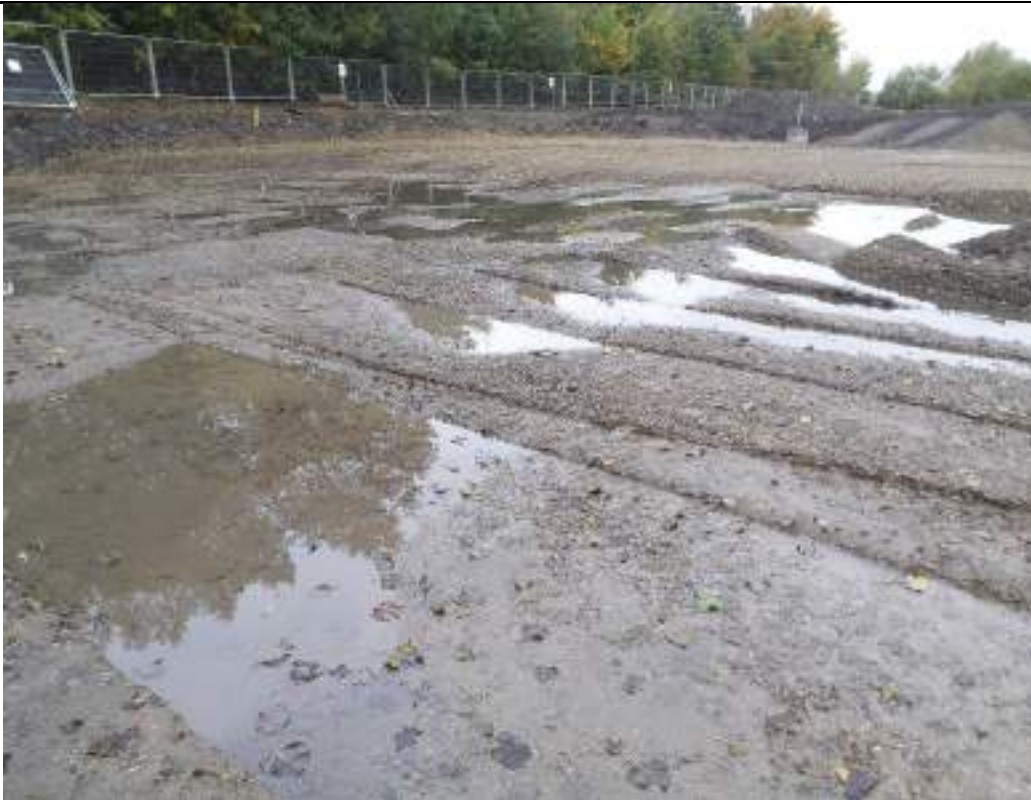
Photograph 16: Standing water in southwestern part of the site.

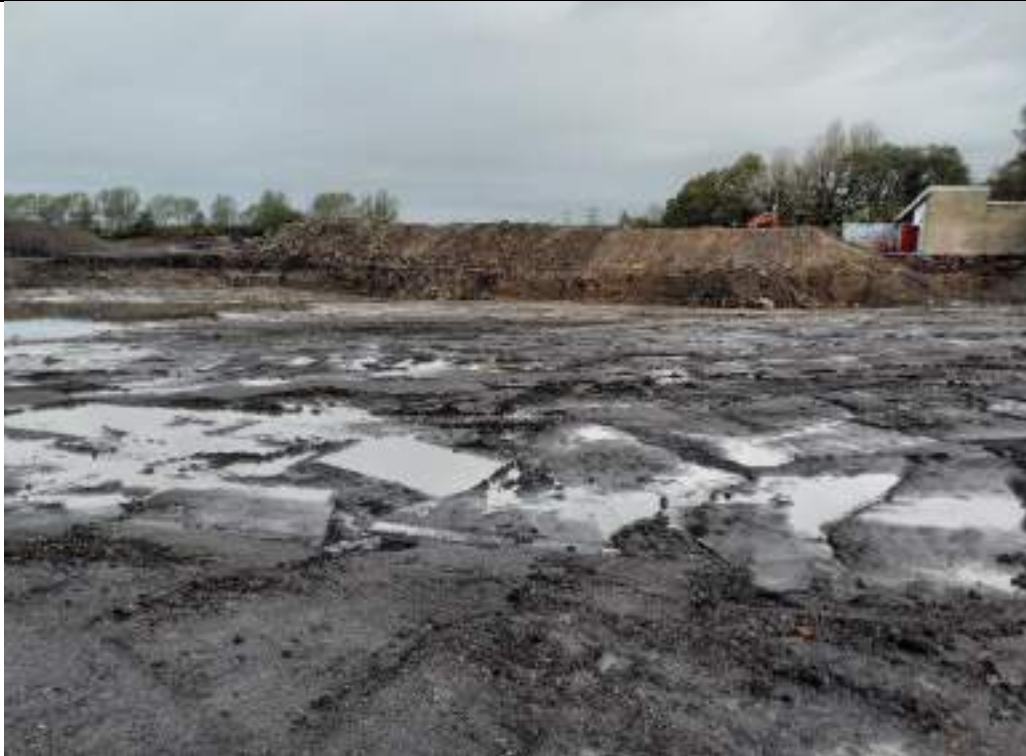
Photograph 18: Stockpile of excavated Glacial Till and standing water in southeast of the site.

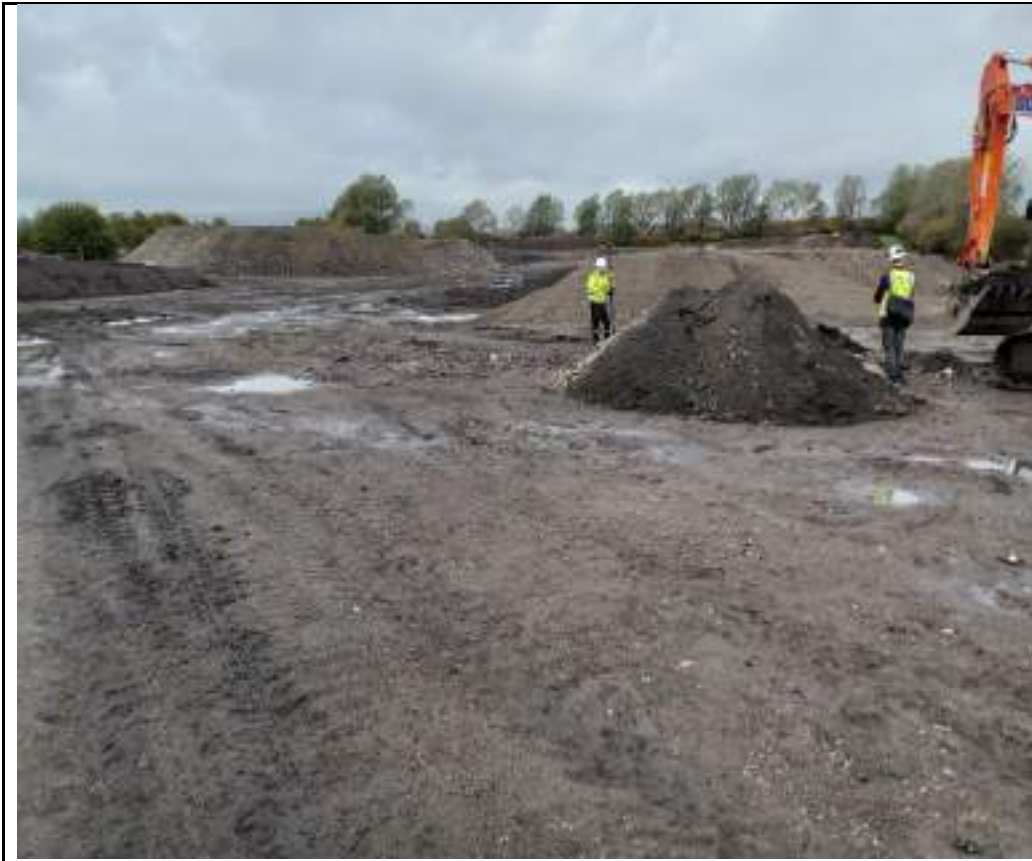
Photograph 19: Excavation of trial pit in eastern part of the site.

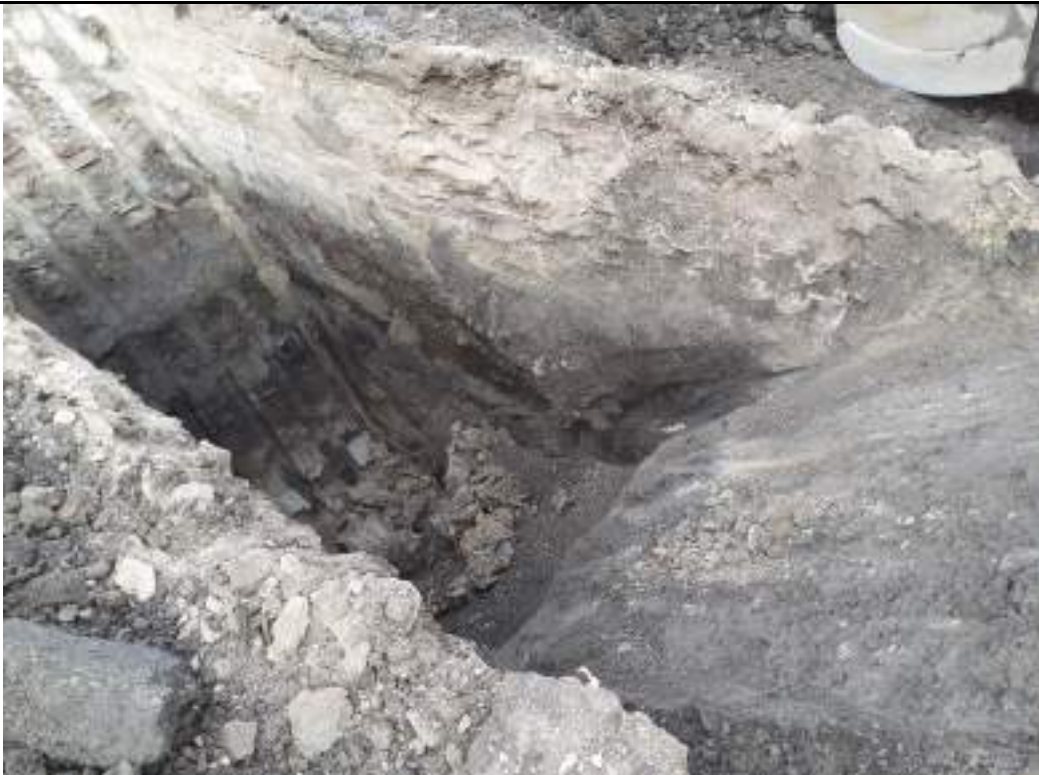
Photograph 20: Trial pit in eastern part of the site.

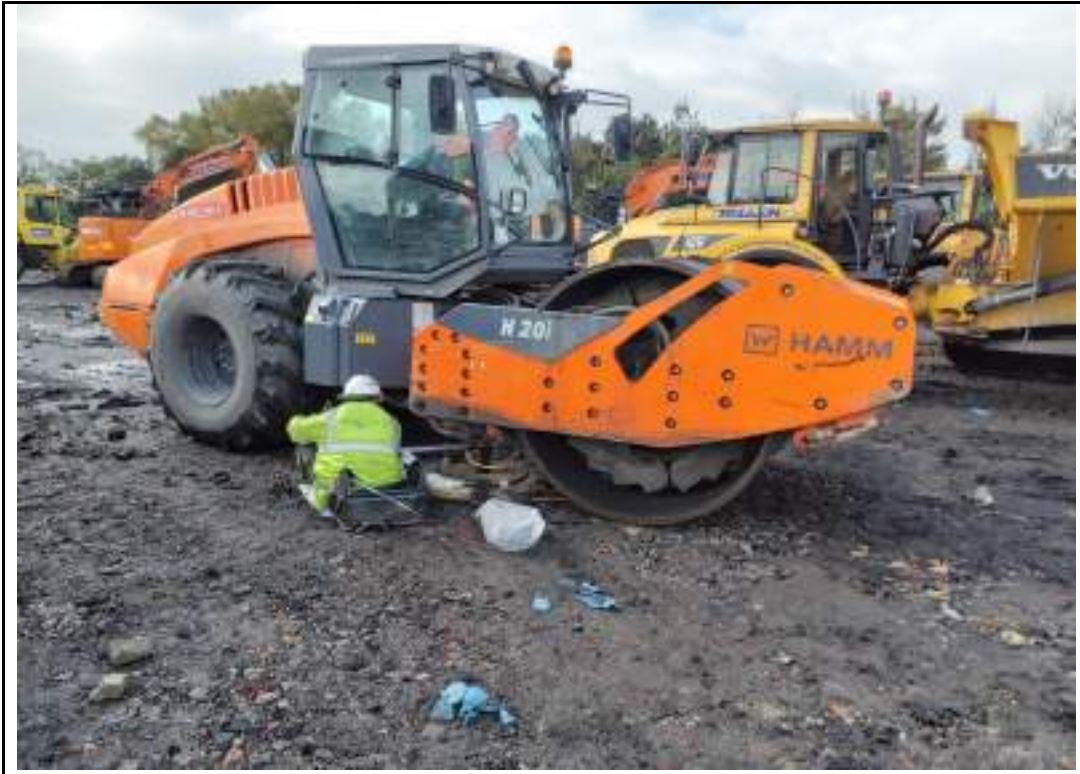
Photograph 23: Plate load testing in truck parking area in northwest of the site.
