**SITE VISIT REPORT 15220-HYD-XX-XX-SVR-GE-1018**

**SHEET NO.: 6 of 18**

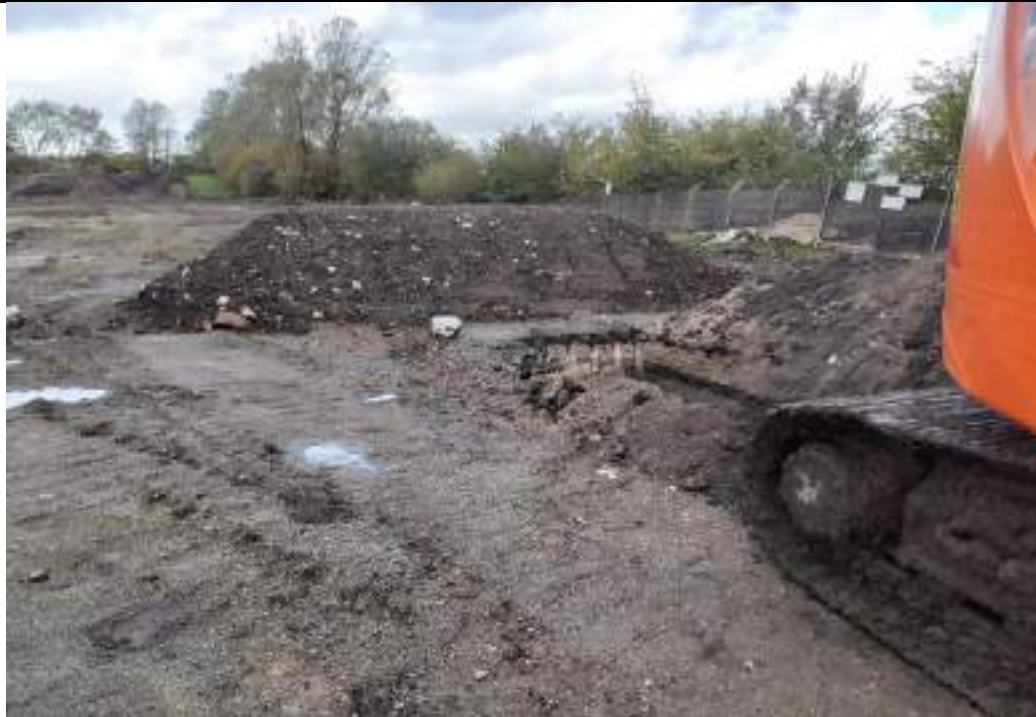
Photograph 24: Trial pit in location of organic Made Ground deposit in northeastern boundary of the site.

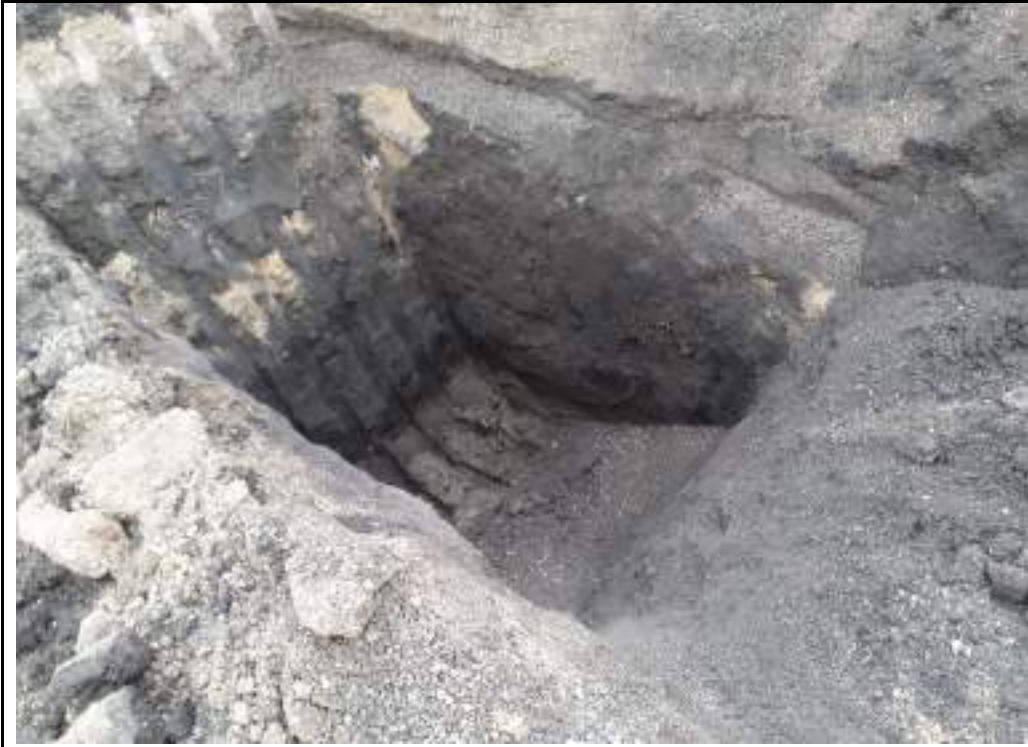
Photograph 23: Trial pit in location of organic Made Ground deposit in northeastern boundary of the site.

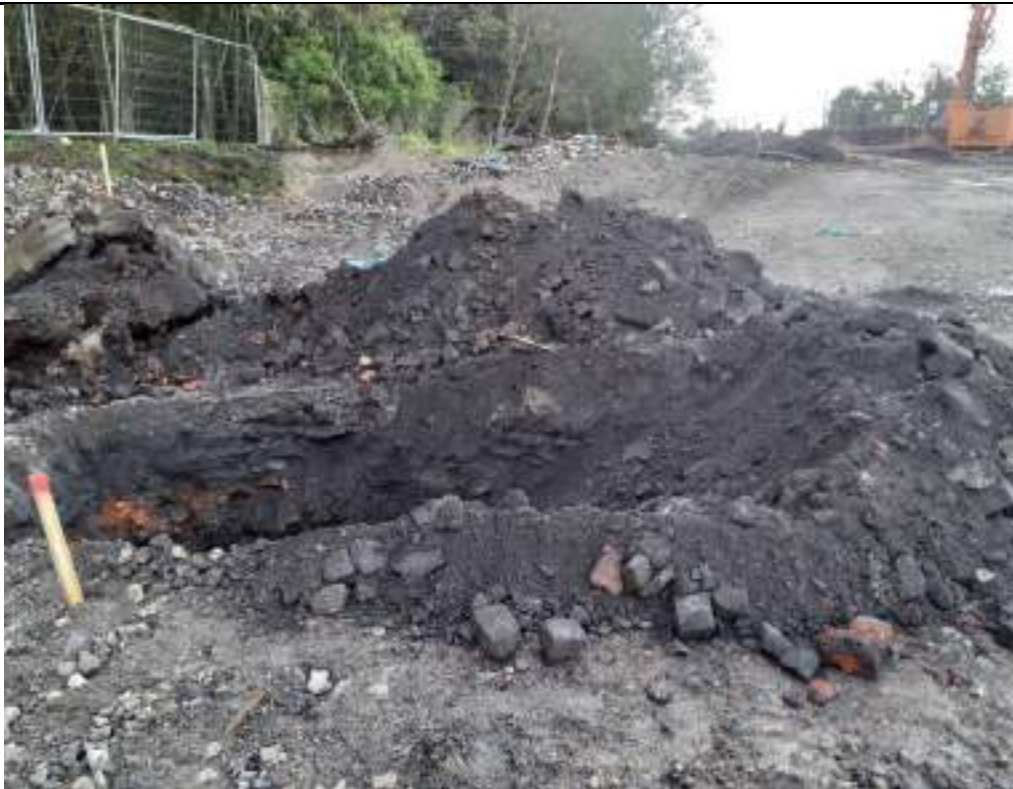
Photograph 24: Trial pit in eastern boundary of the site.

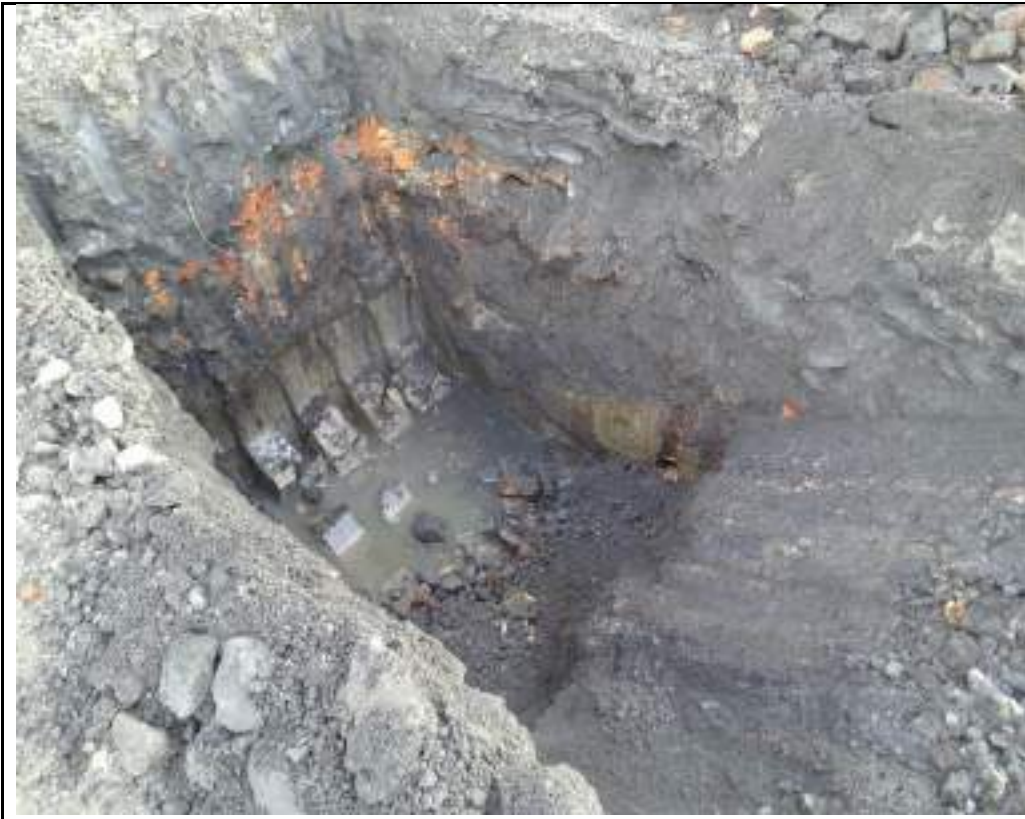
Photograph 23: Trial pit in eastern boundary of the site.

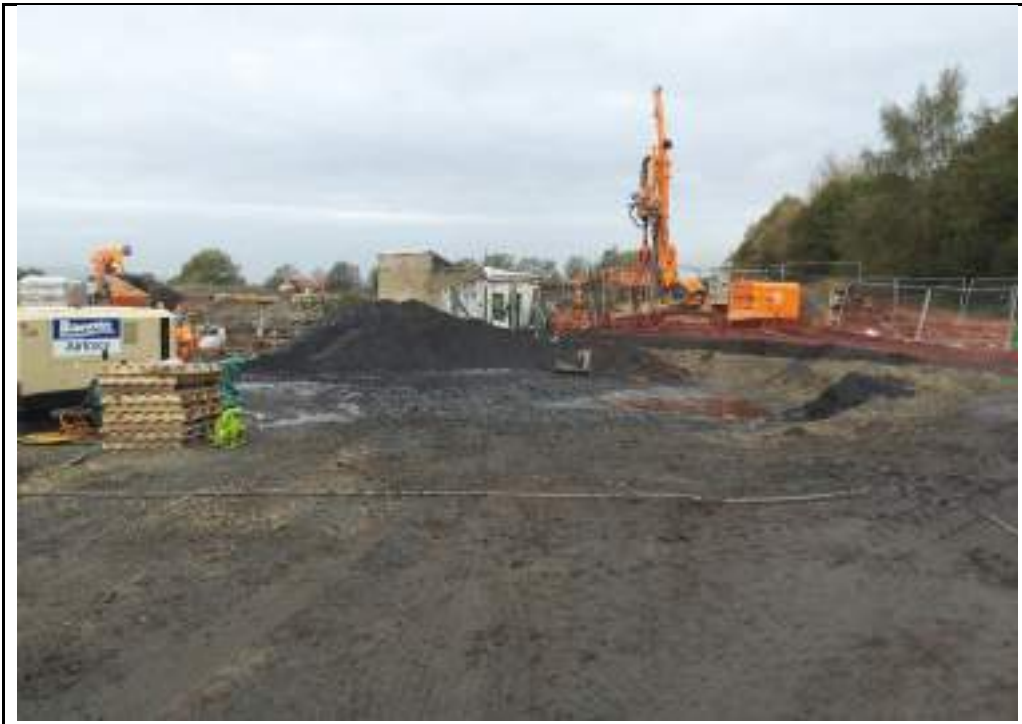
Mine shaft treatment of shaft no.6 is ongoing. VHE stated that Van Elle is experiencing grout loss. Van Elle has been injecting a PFA : Sand : OPC mix at 8 : 2 : 1 ratio since Monday.

Photograph 2: Grouting shaft no.6 in eastern part of the site.

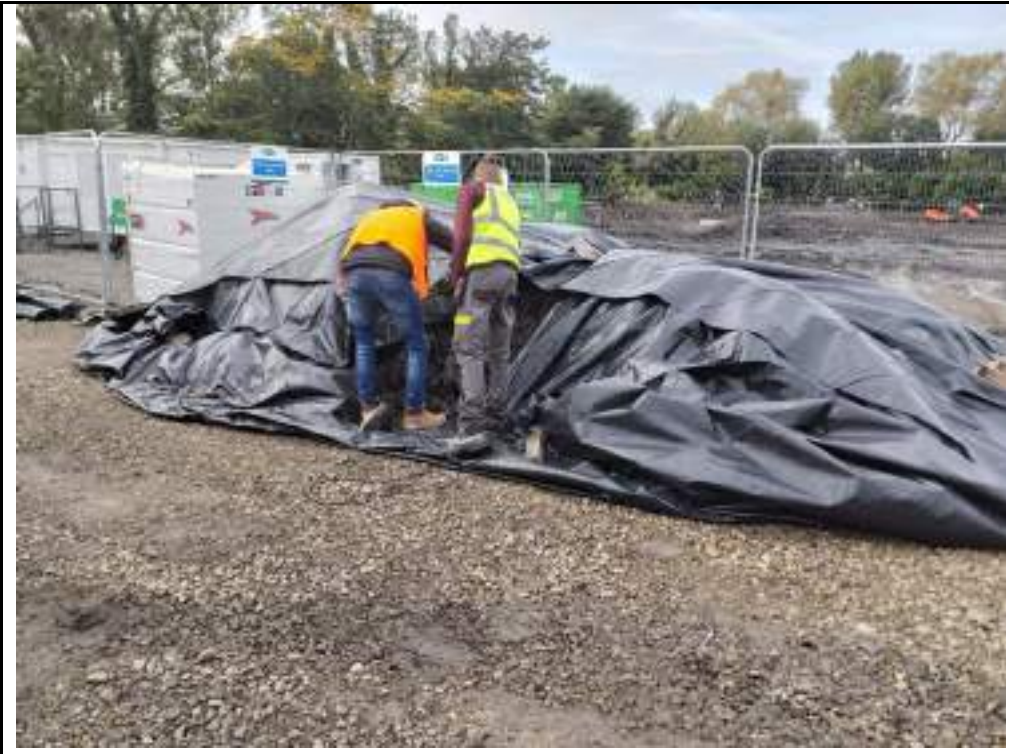
Photograph 3: Sample collection from potentially asbestos contaminated material in car park area.

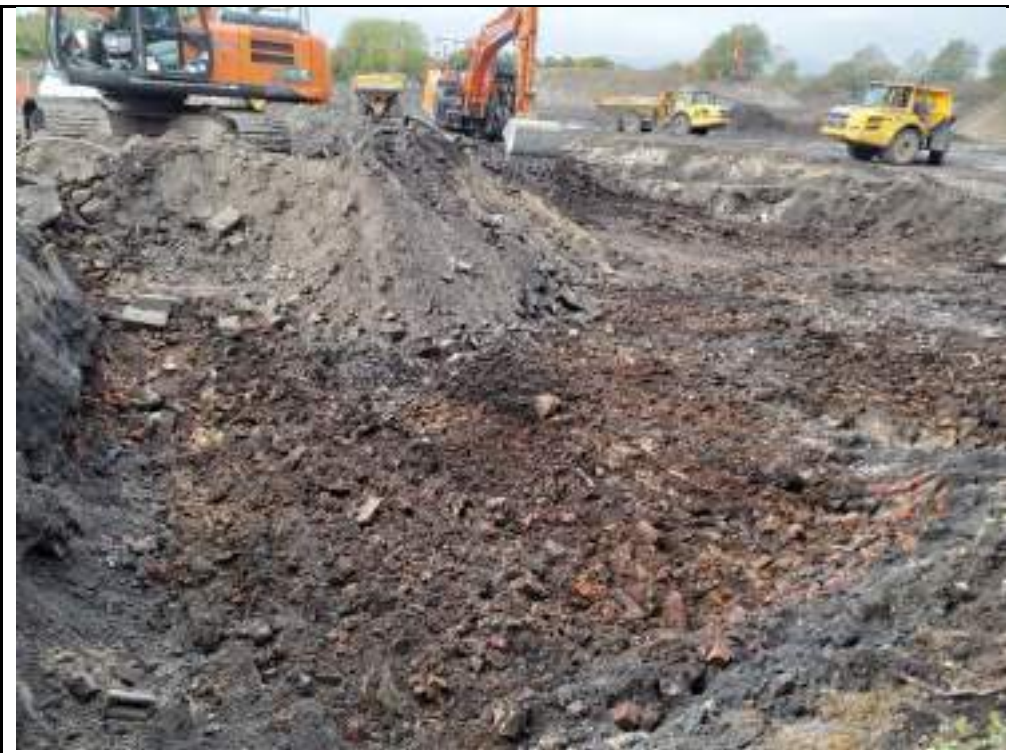
Photograph 4: Excavation of landfill Made Ground in eastern part of the site.

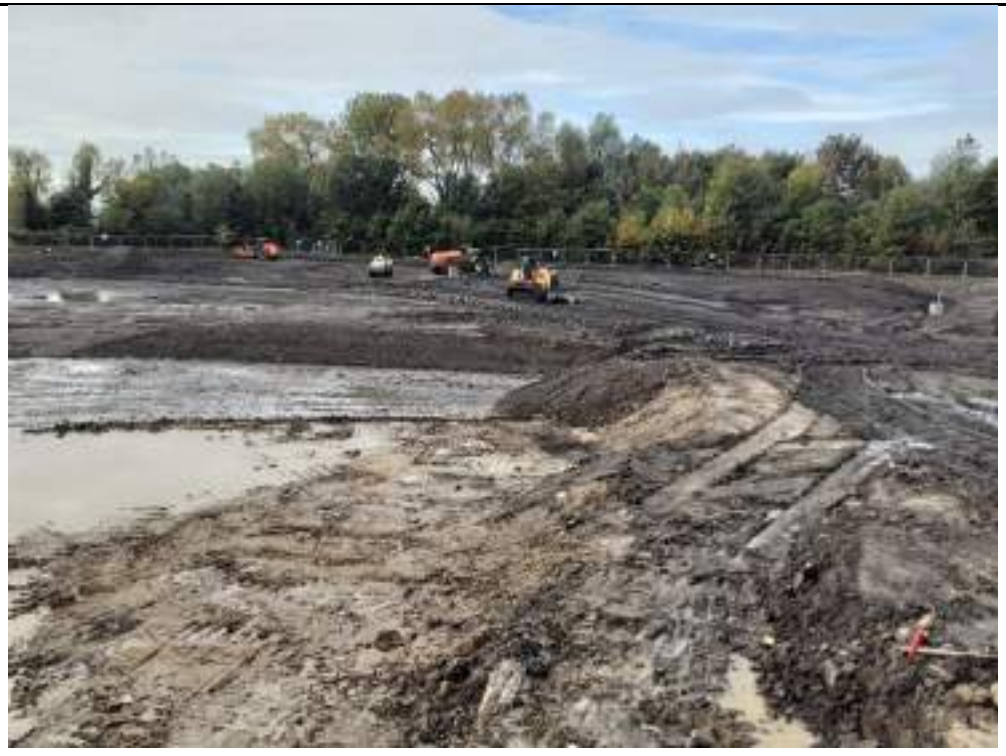
Photograph 6: Temporary Road construction in southern part of the site.

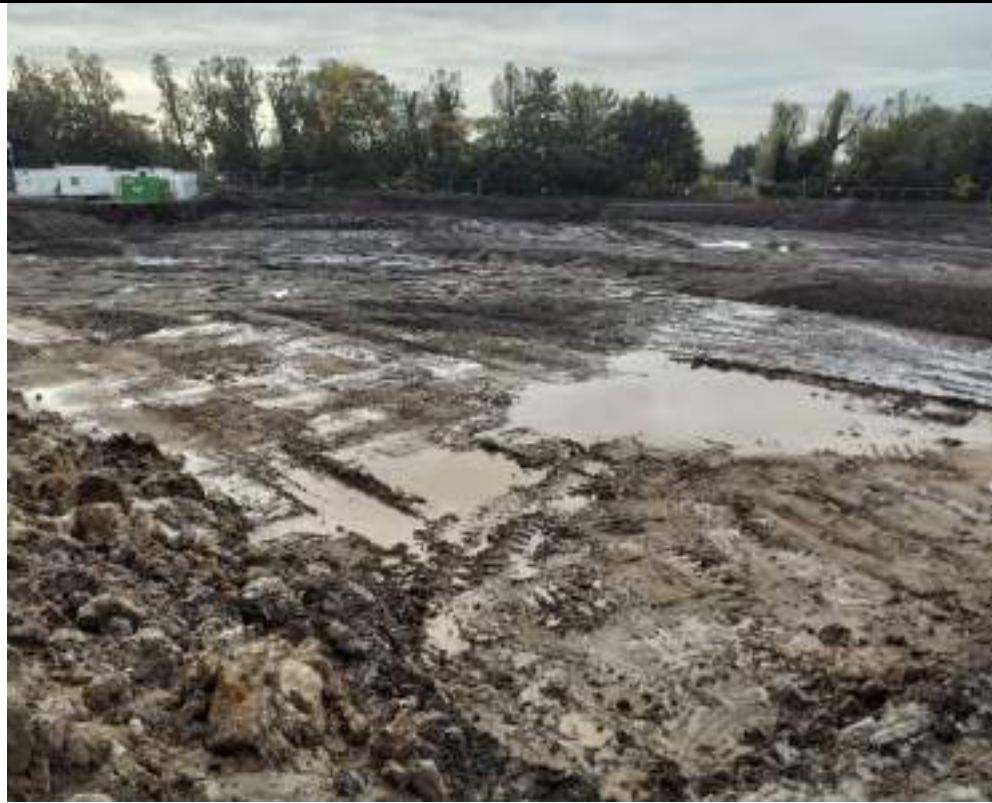
Photograph 7: Standing water in southeastern part of the site.

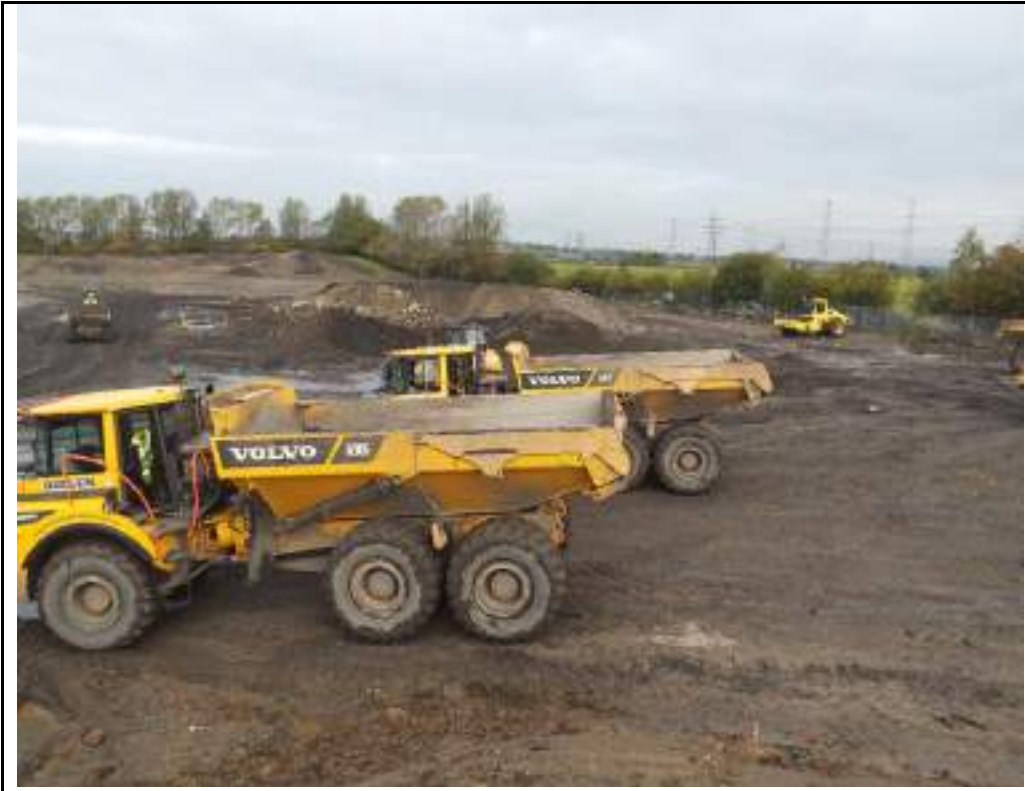
Photograph 9: Overview of northeastern stockpiles.

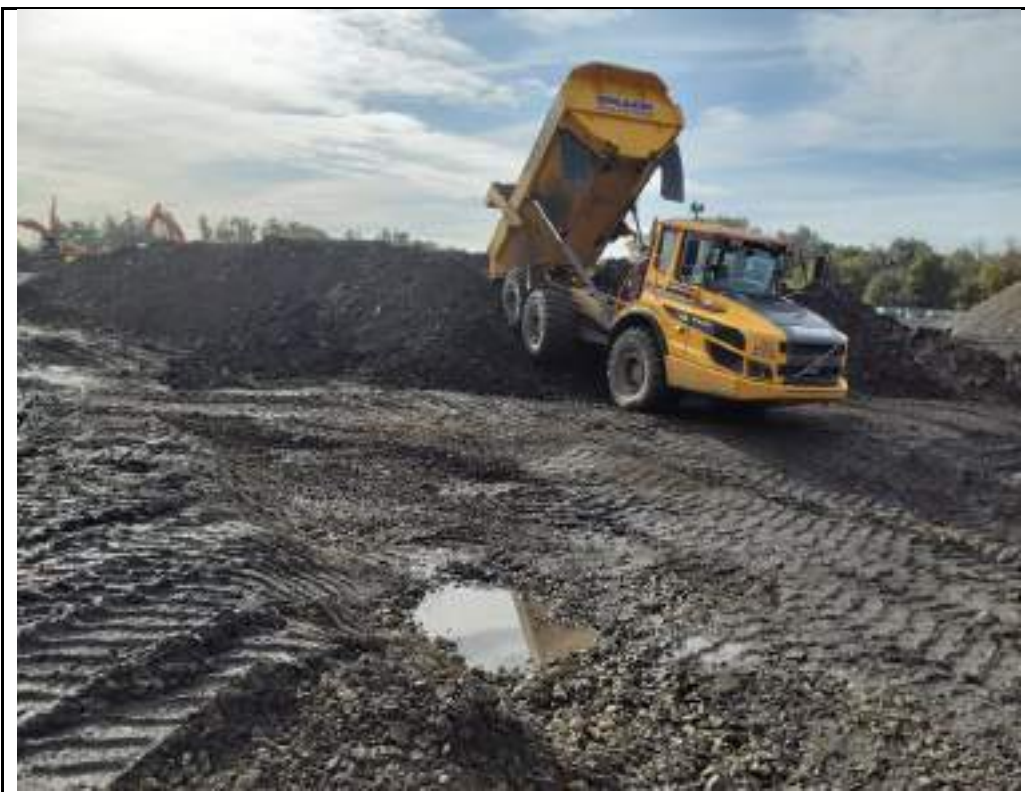
Photograph 10: Stockpiling excavated materials from eastern part of the site in northeastern stockpile.

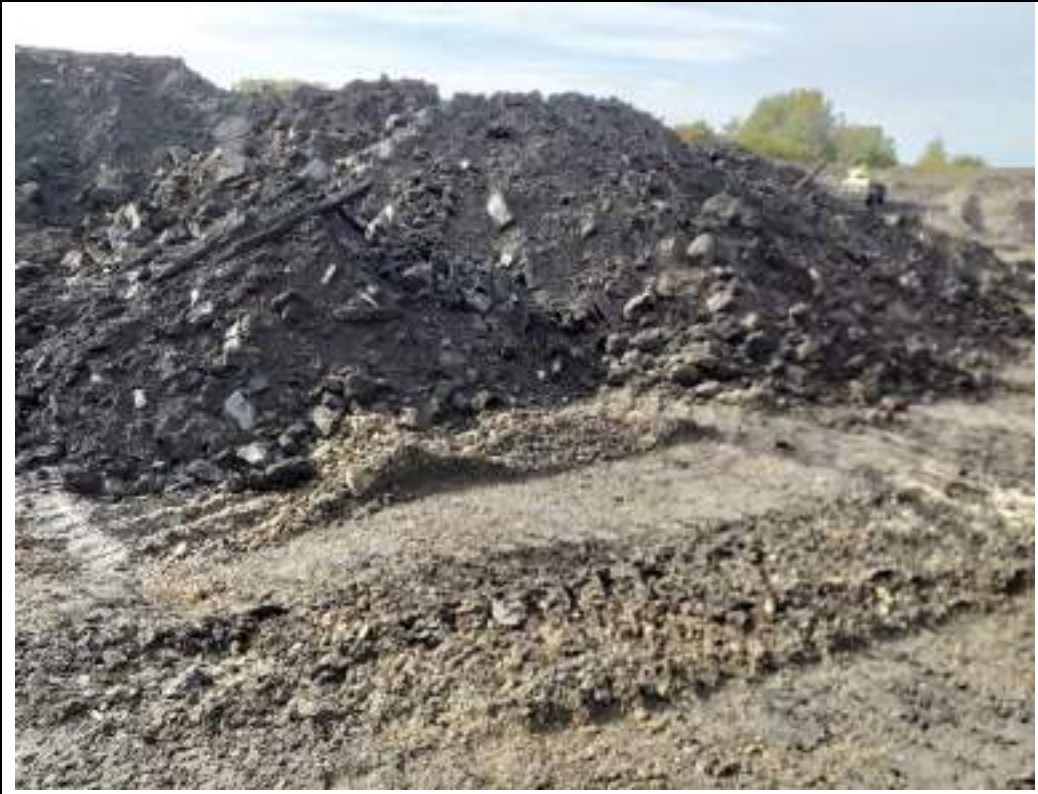
Photograph 11: Oversize and deleterious materials in northwestern part of the site.

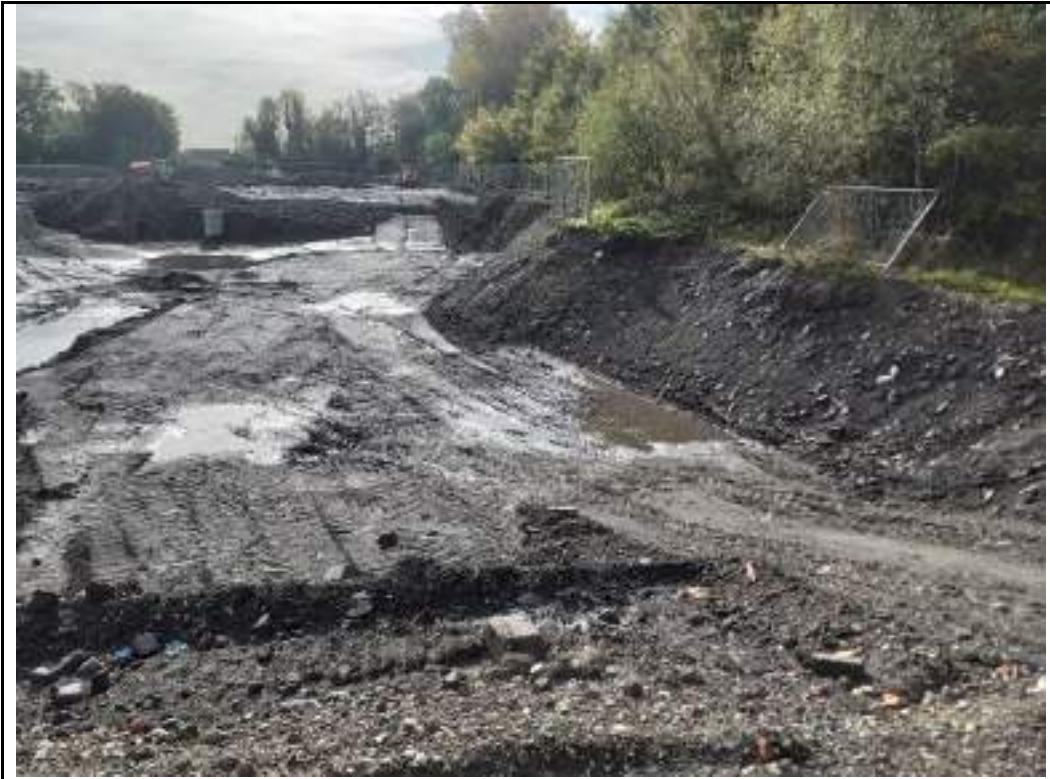
Photograph 93: Western boundary of the site. Looking towards the south.

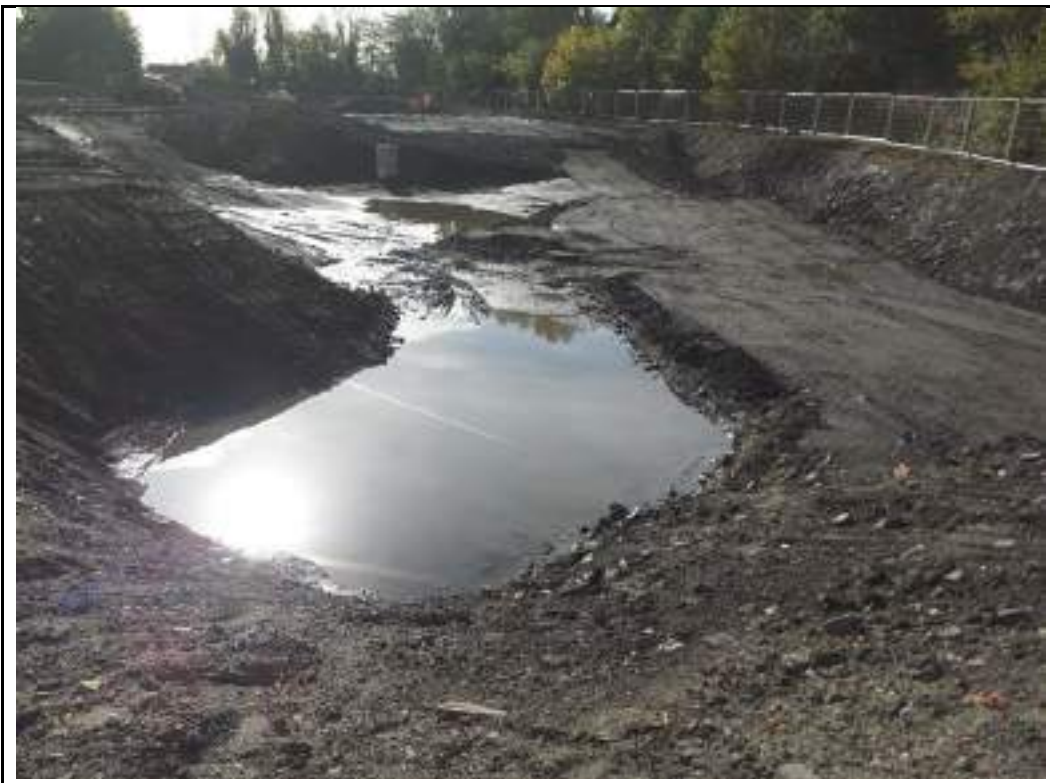
Photograph 14: Standing water in excavation in western part of the site.

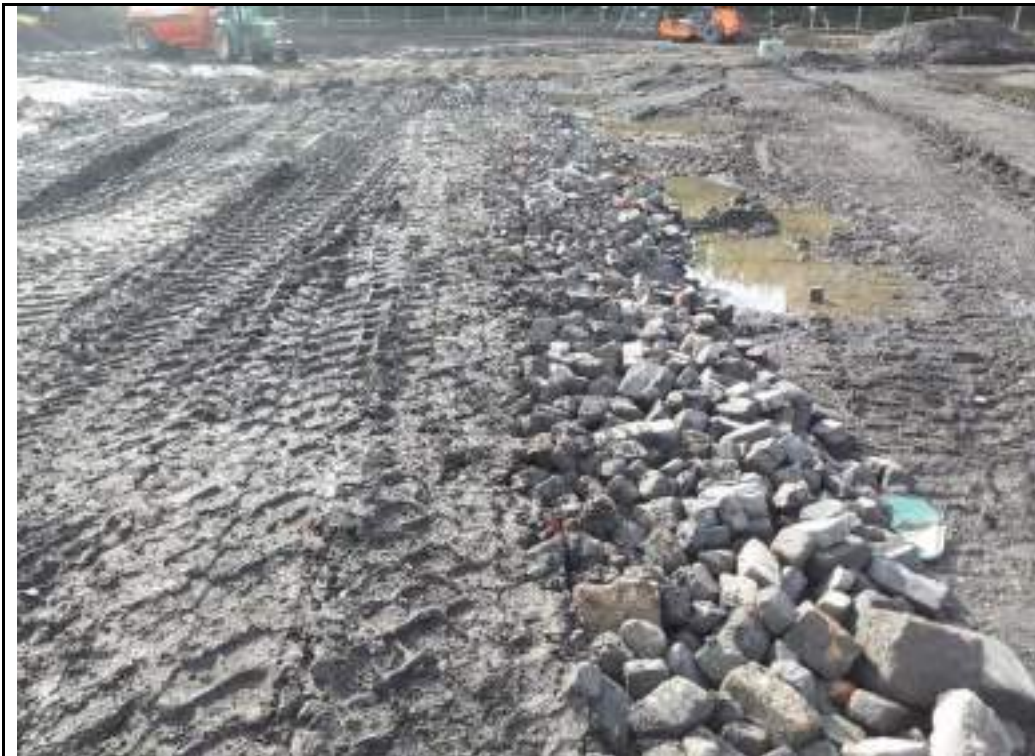
Photograph 15: Temporary Road construction using bricks and general fill materials in southwestern part of the site.

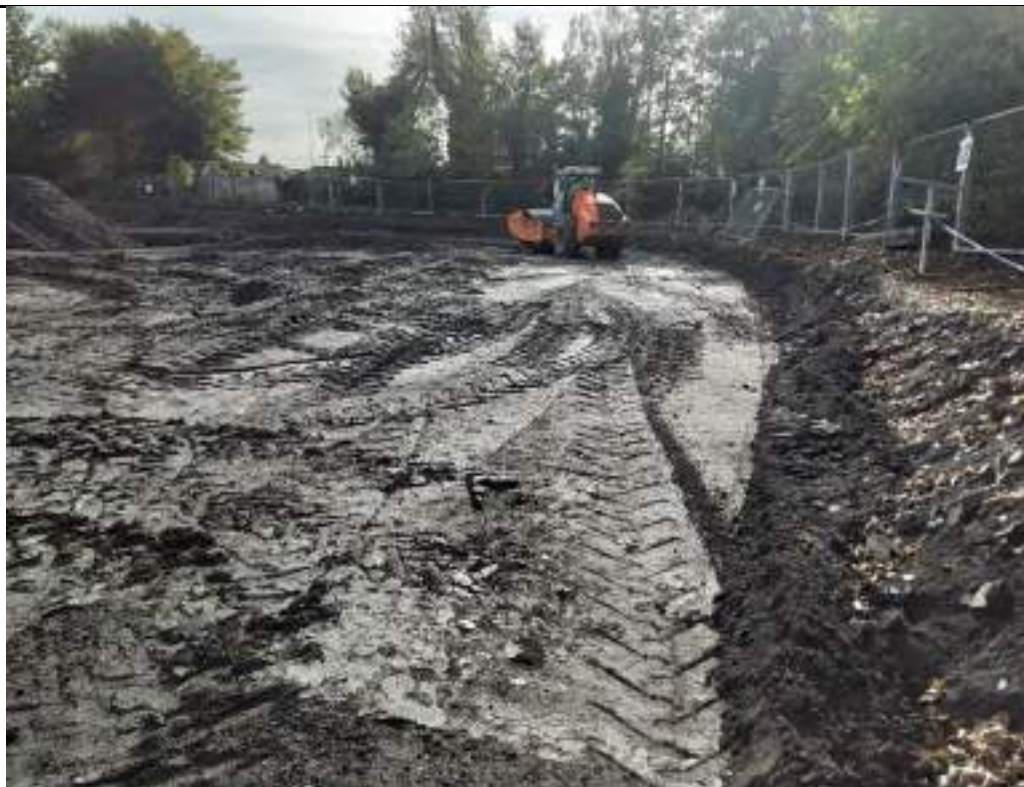
Photograph 16: Proof rolling over fill material in southwestern part of the site.

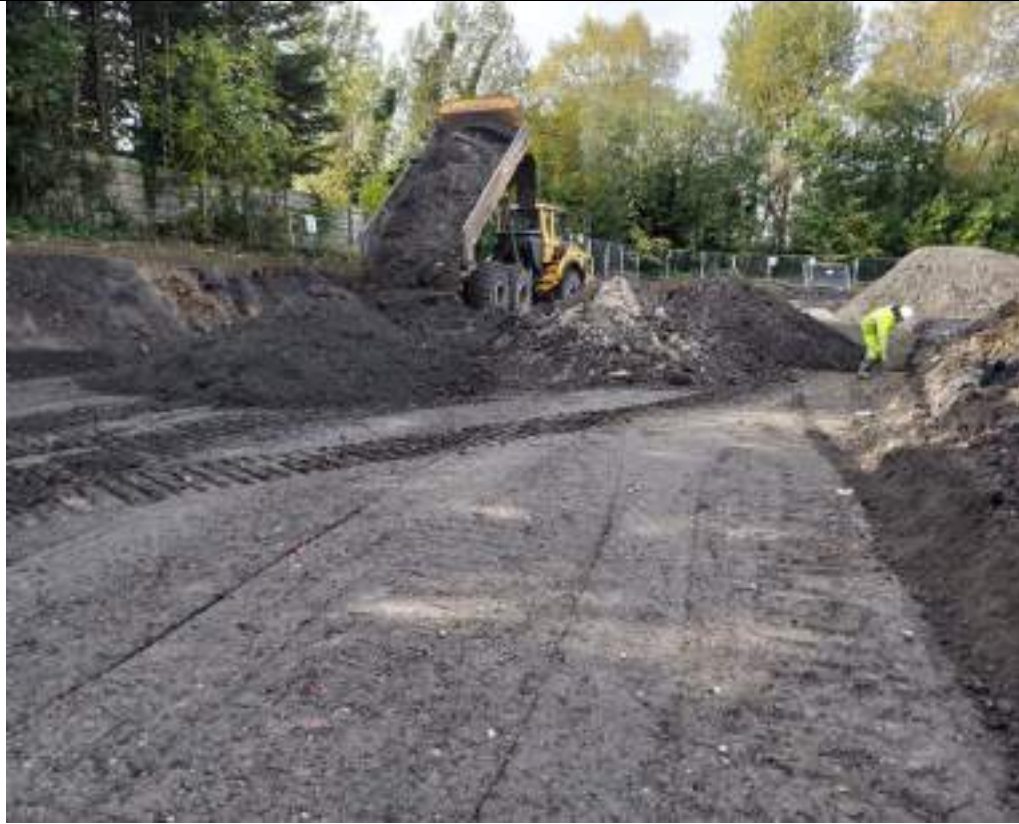
Photograph 17: Backfilling southwestern part of the site using materials from eastern excavation.

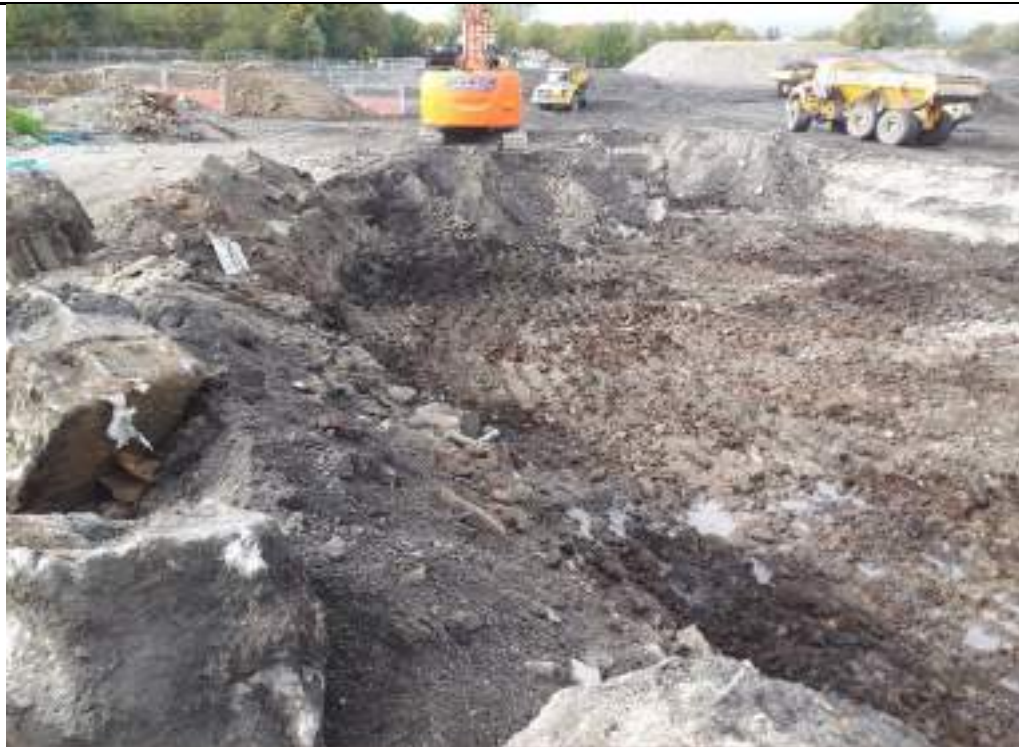
Photograph 18: Oversize and deleterious material in excavation in eastern part of the site.

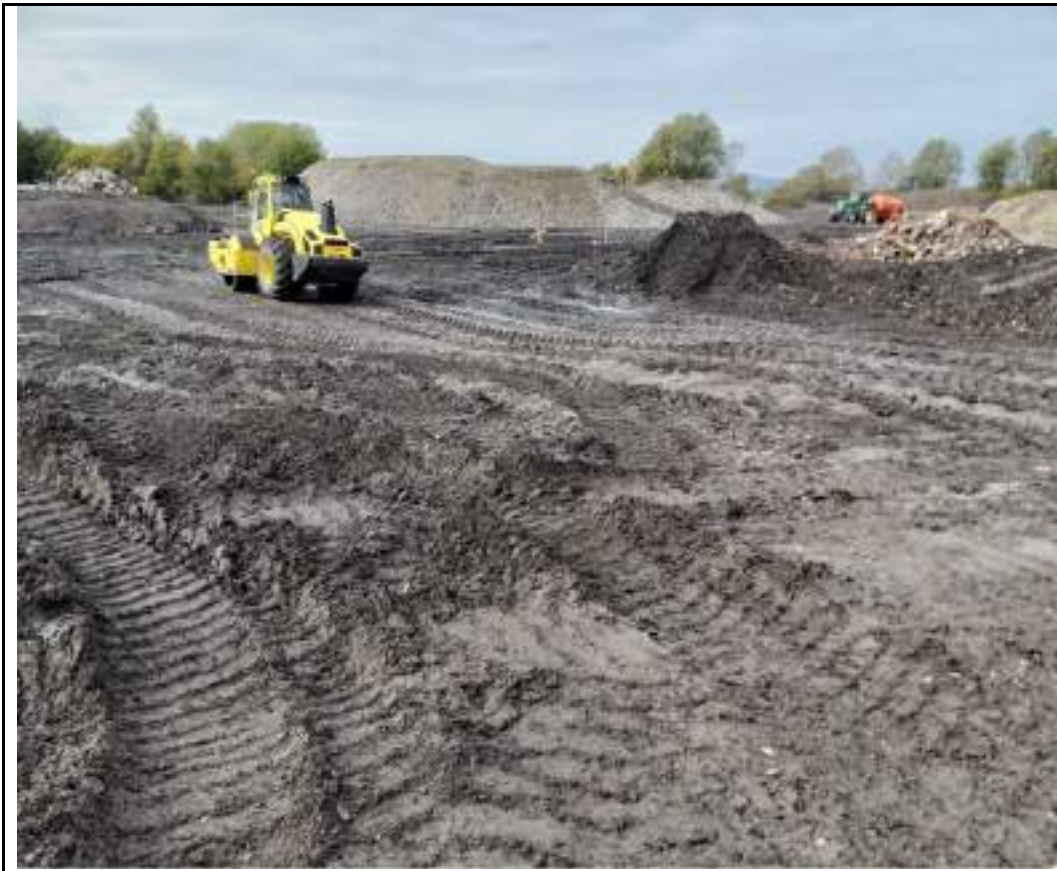
Photograph 19: Dynamic compaction in northeastern part of the site.

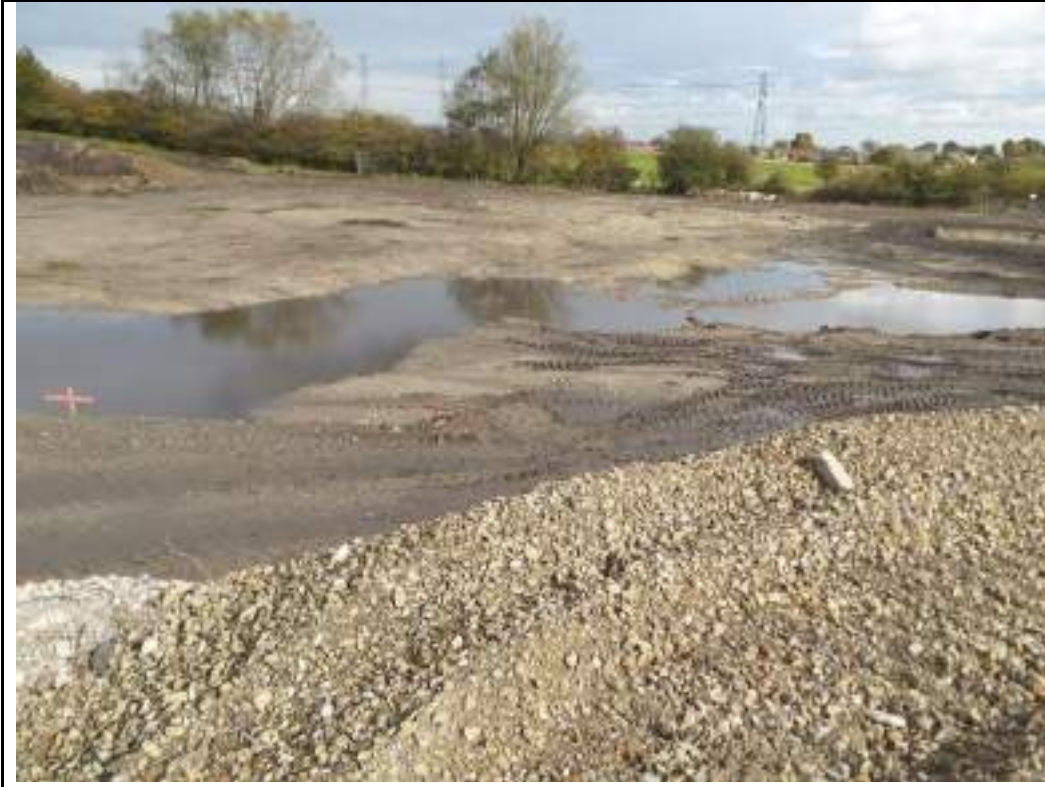
Photograph 21: Standing water in northern part of the site.

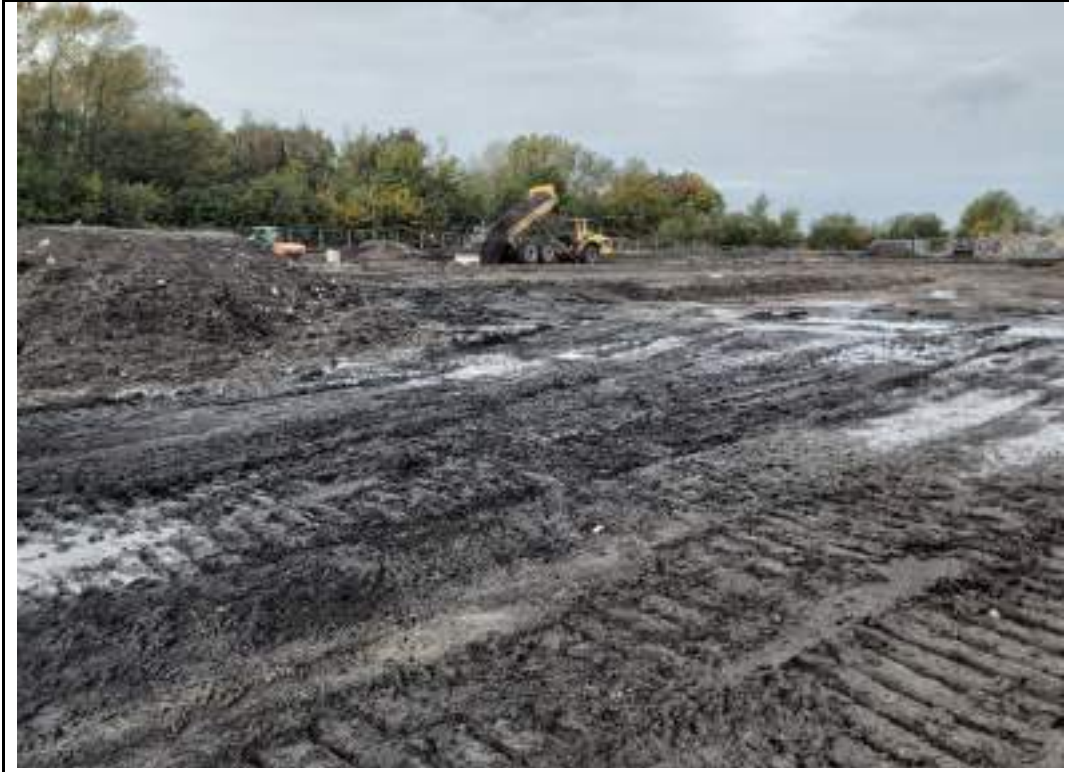
Photograph 23: Backfilling southwestern part of the site using excavated materials from eastern excavation.

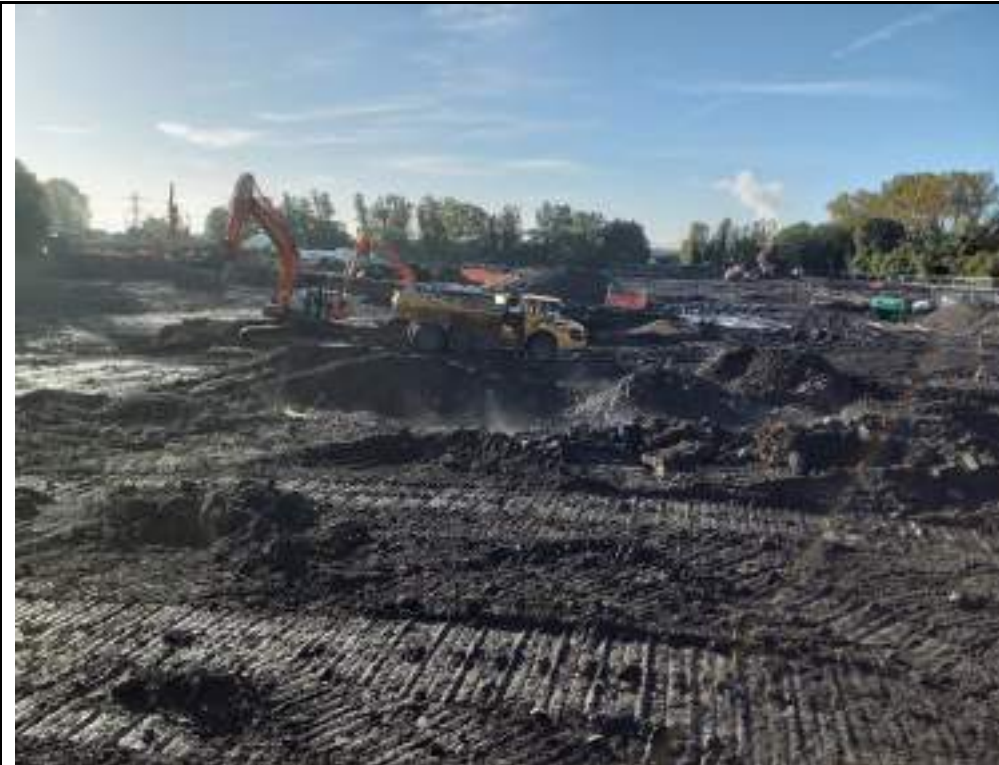
Photograph 1: Overview of the site. Looking towards the south.

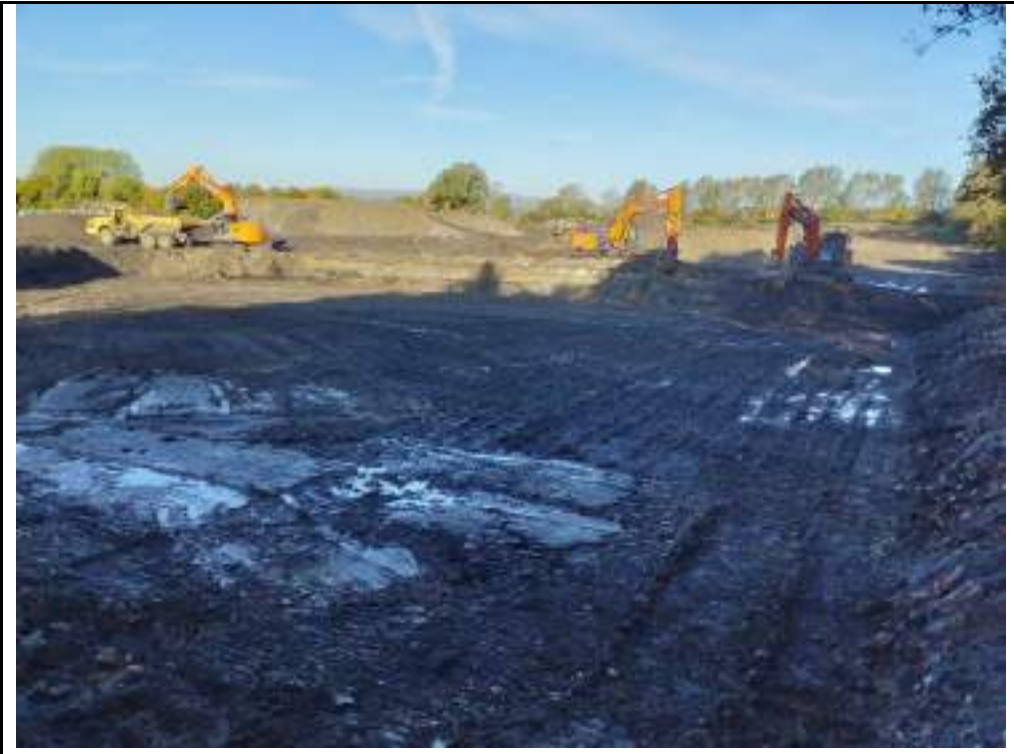
Photograph 3: Excavation of Made Ground in eastern part of the site.

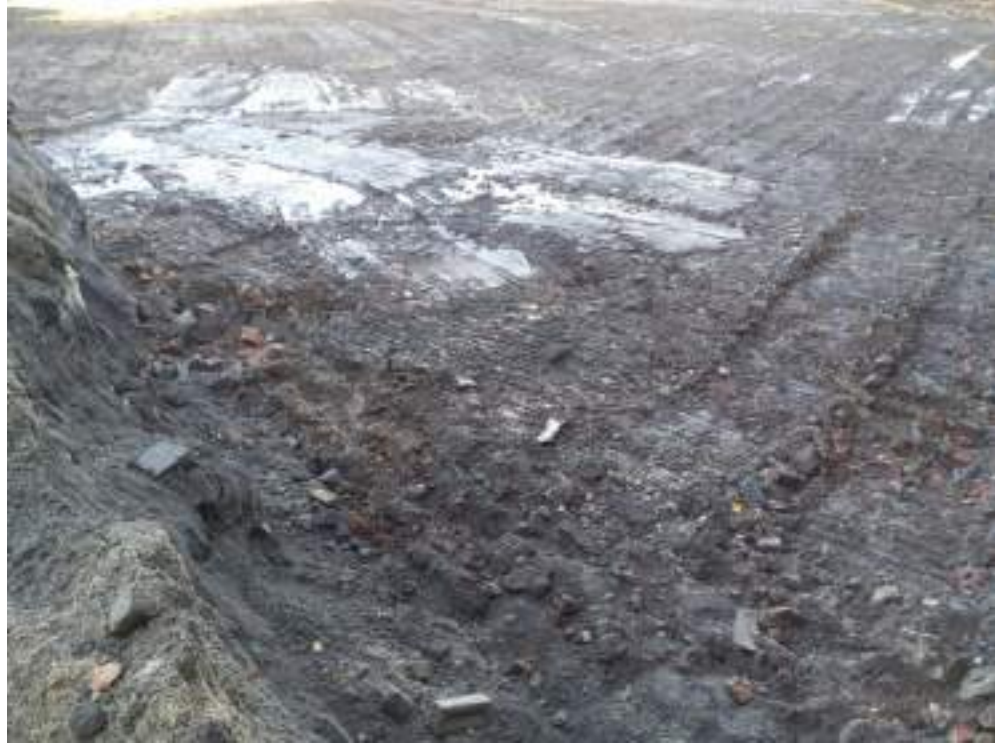
Photograph 5: Glacial Till formation in excavation in eastern part of the site.

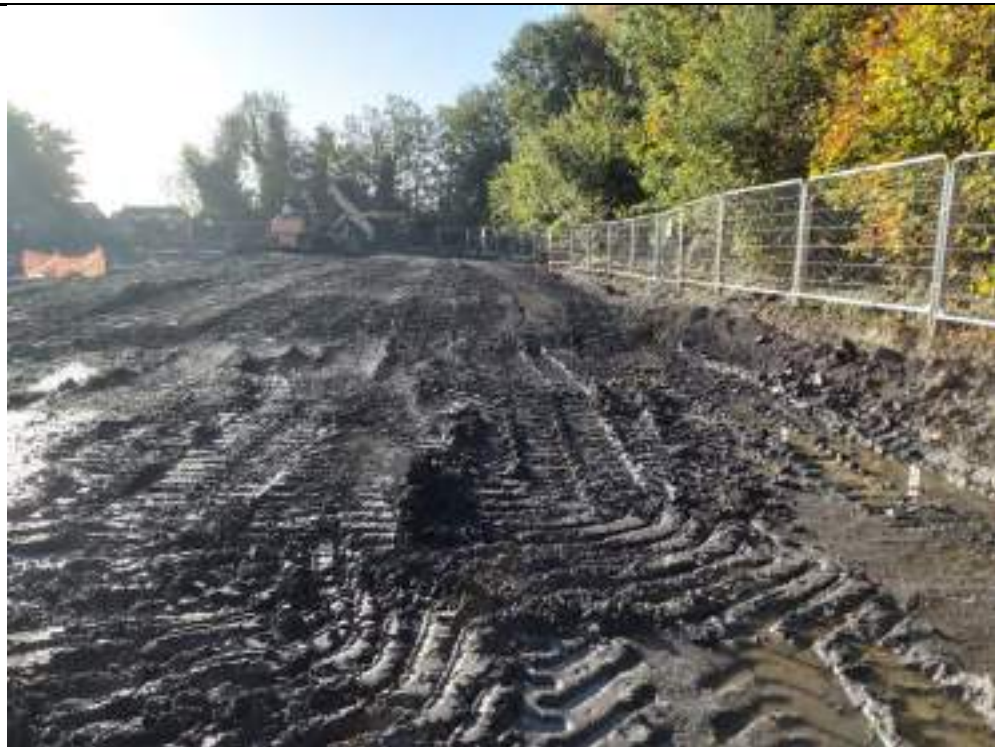
Photograph 6: Backfilling southwestern part of the site using material from eastern excavation

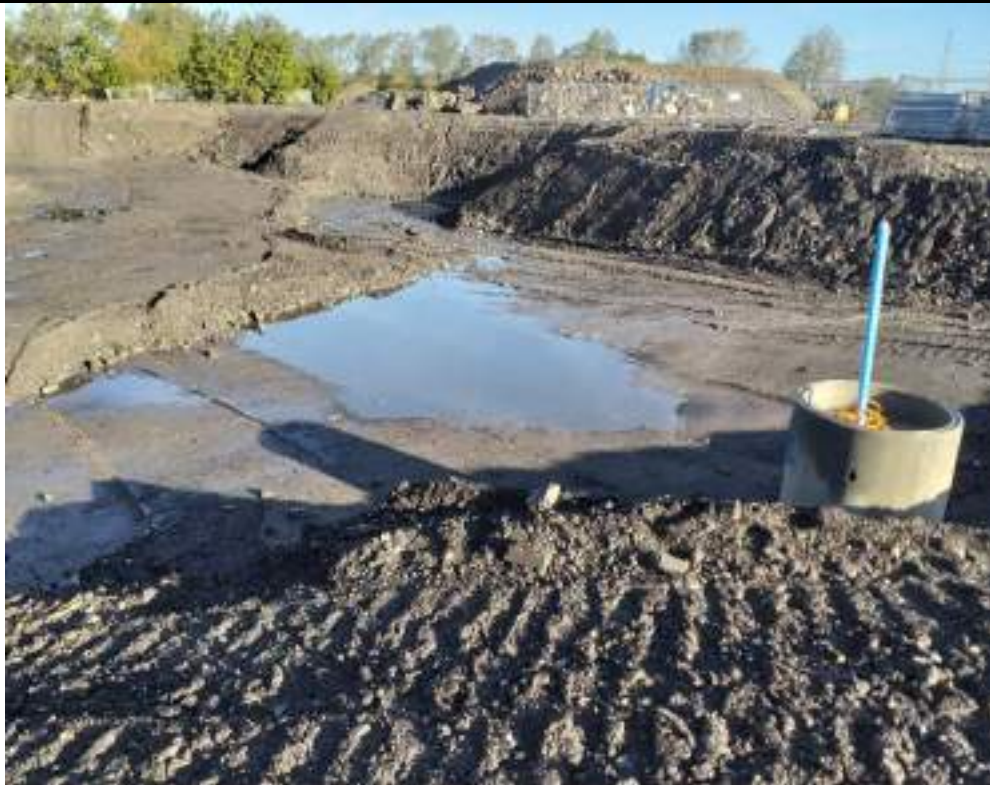
Photograph 7: Standing water in western part of the site.

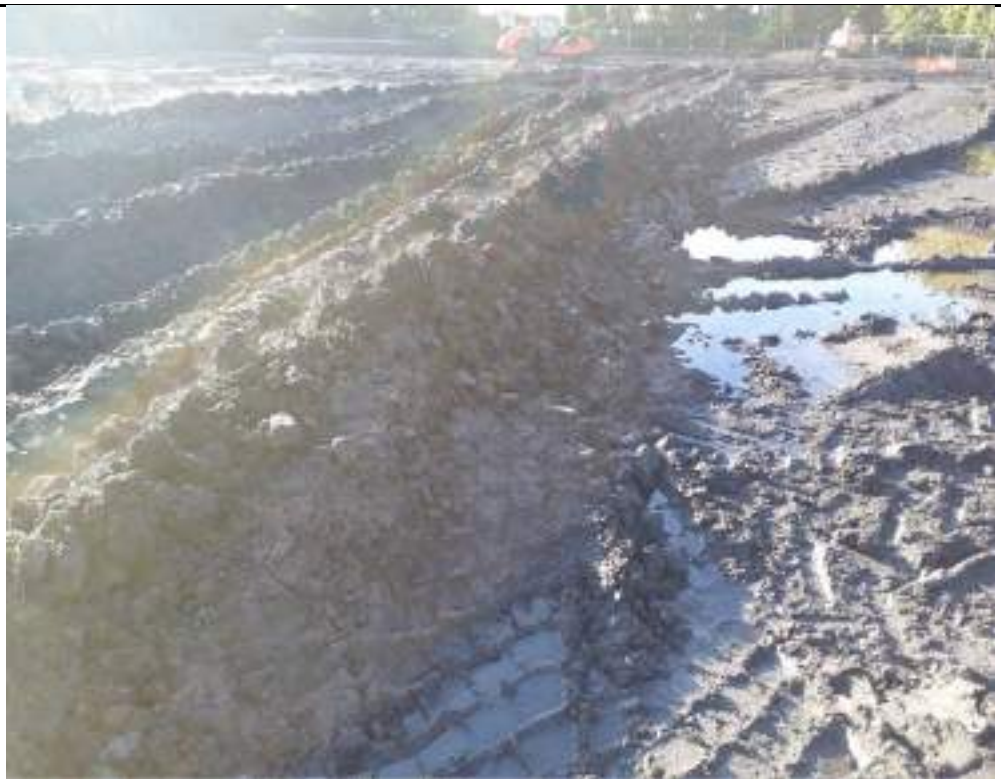
Photograph 8: Constructed temporary road using bricks and general fill to get access to southwestern part of the site.

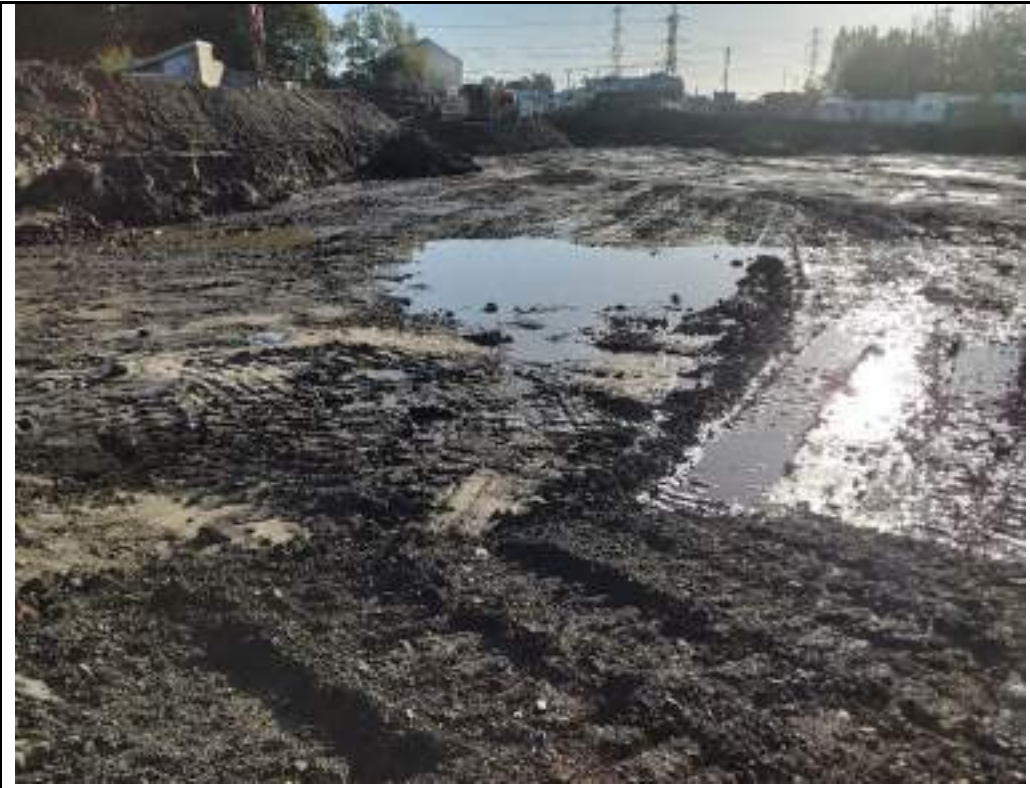
Photograph 9: Standing water in southeastern part of the site.
