**SITE VISIT REPORT 15220-HYD-XX-XX-SVR-GE-1018**

**SHEET NO.: 6 of 18**

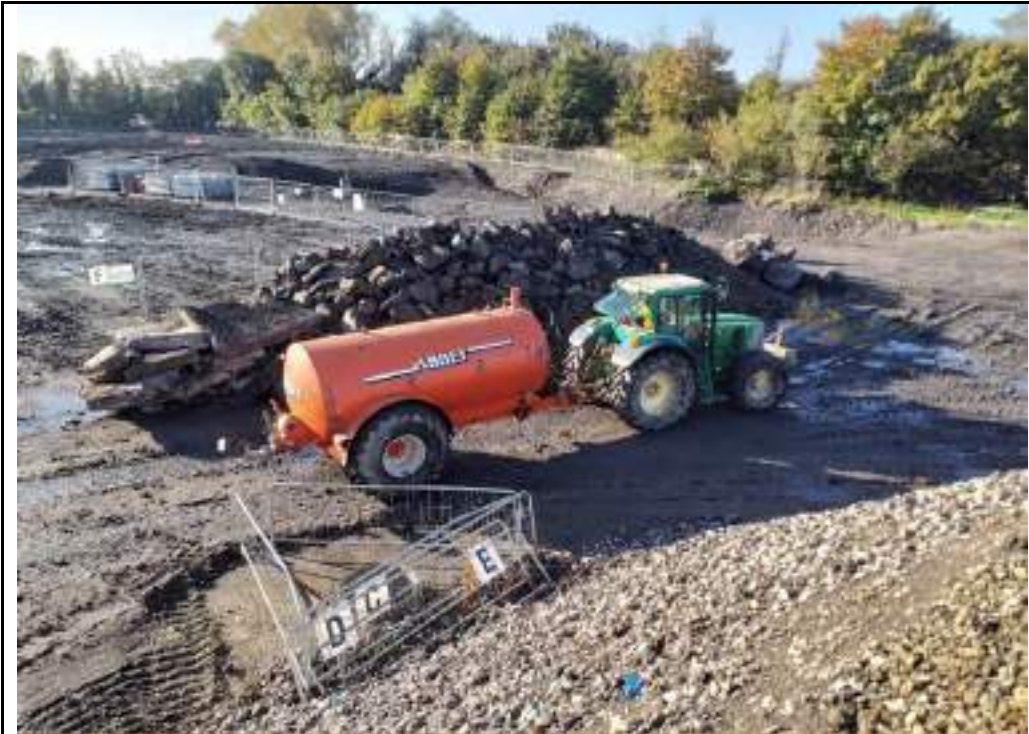
Photograph 11: Oversize and concrete stockpile in northwestern part of the site.

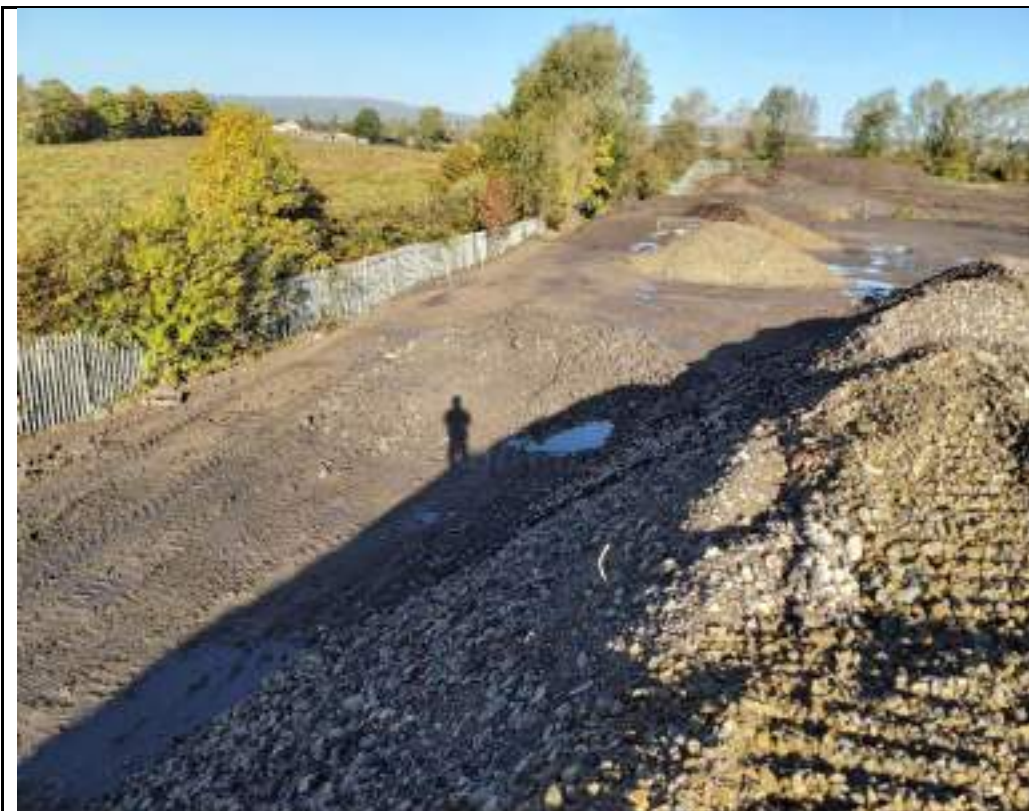
Photograph 12: Stockpiles of bricks, granular and soft spot materials in northwestern part of the site.

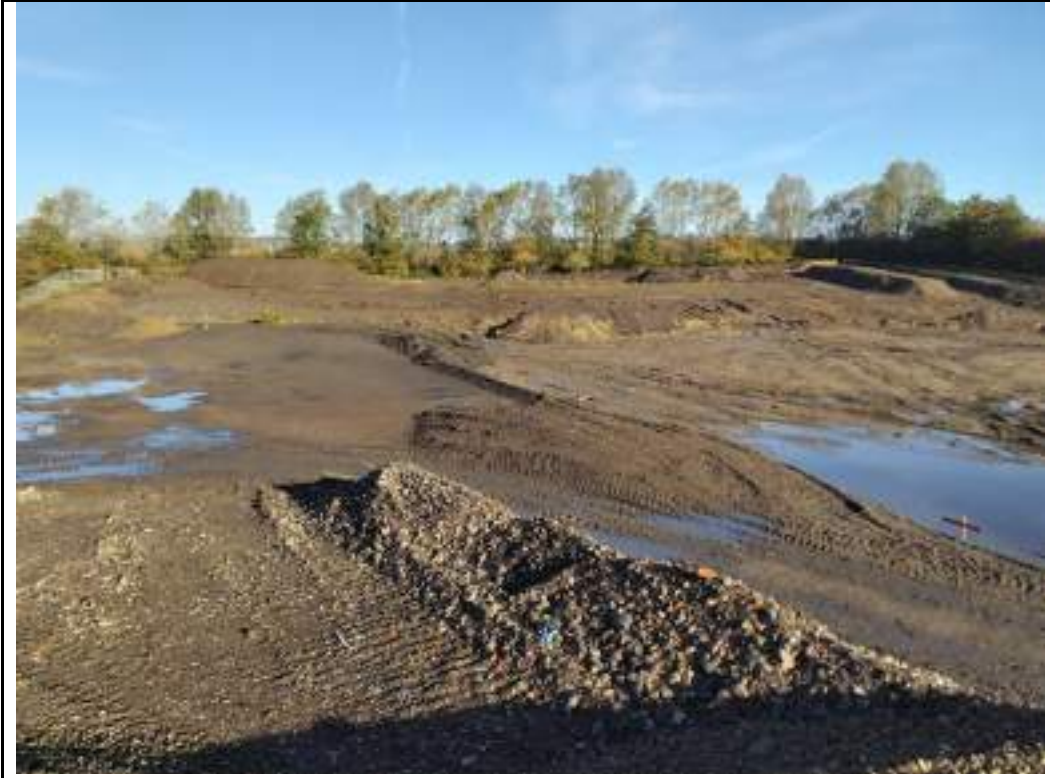
Photograph 93: overview of soft spot and Topsoil stockpiles in northern part of the site.

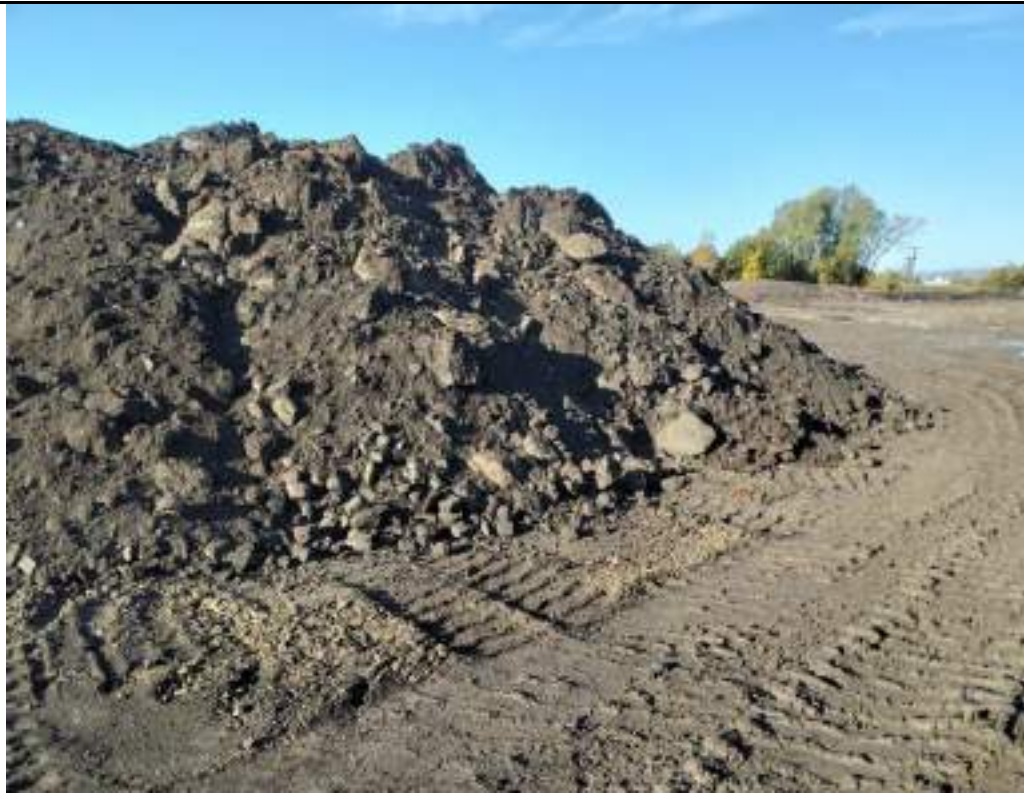
Photograph 15: Deleterious and oversized materials in stockpiled material in northeast of the site. Materials excavated from eastern excavation.

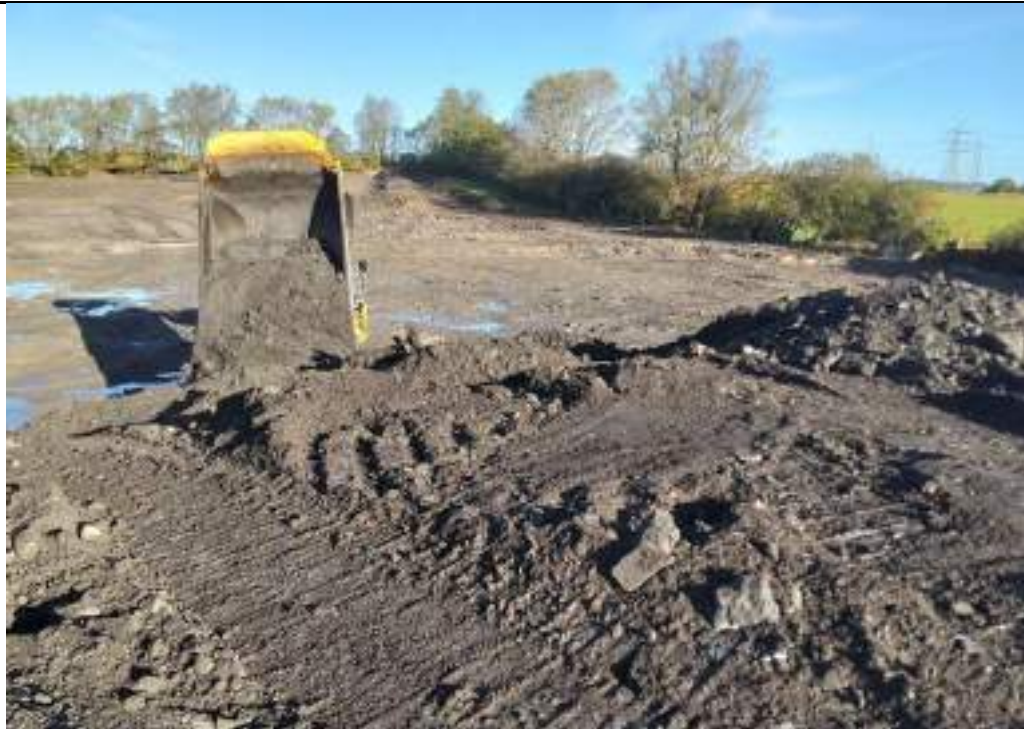
Photograph 16: Unloading excavated material from eastern excavation in northeastern part of the site.

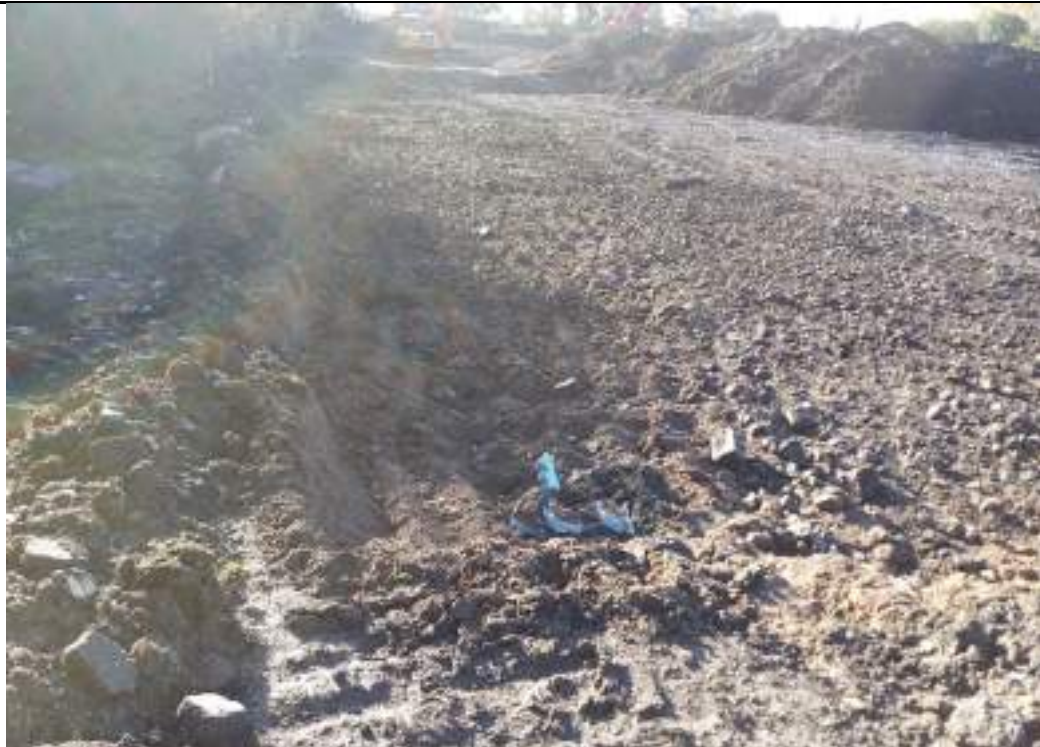
Photograph 18: northeastern boundary of the site. Looking towards the south.

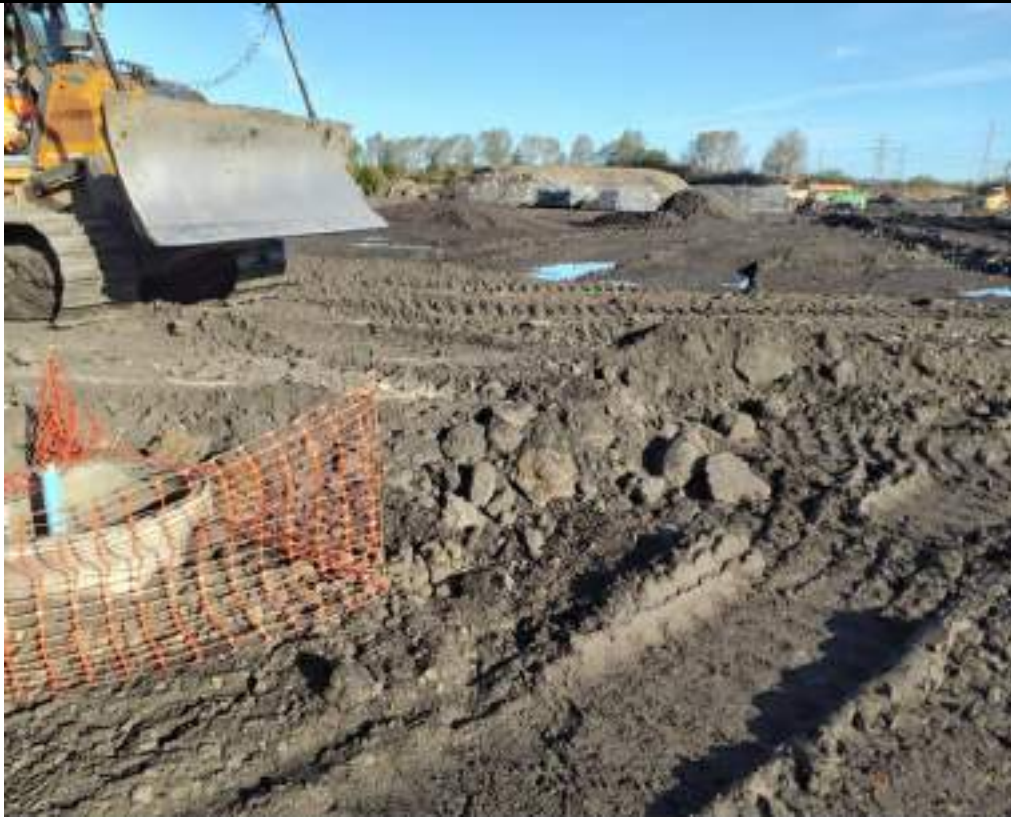
Photograph 19: Existence of oversized materials in fill in southwestern part of the site.

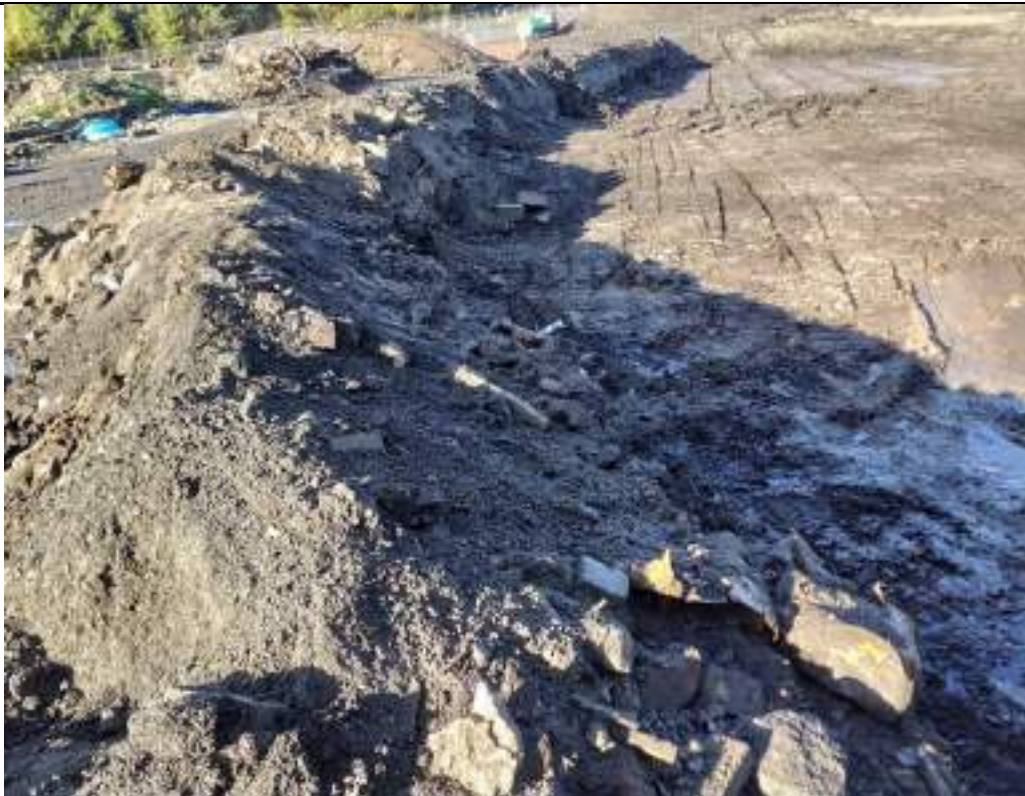
Photograph 20: Deleterious and oversized materials in excavation in eastern part of the site.

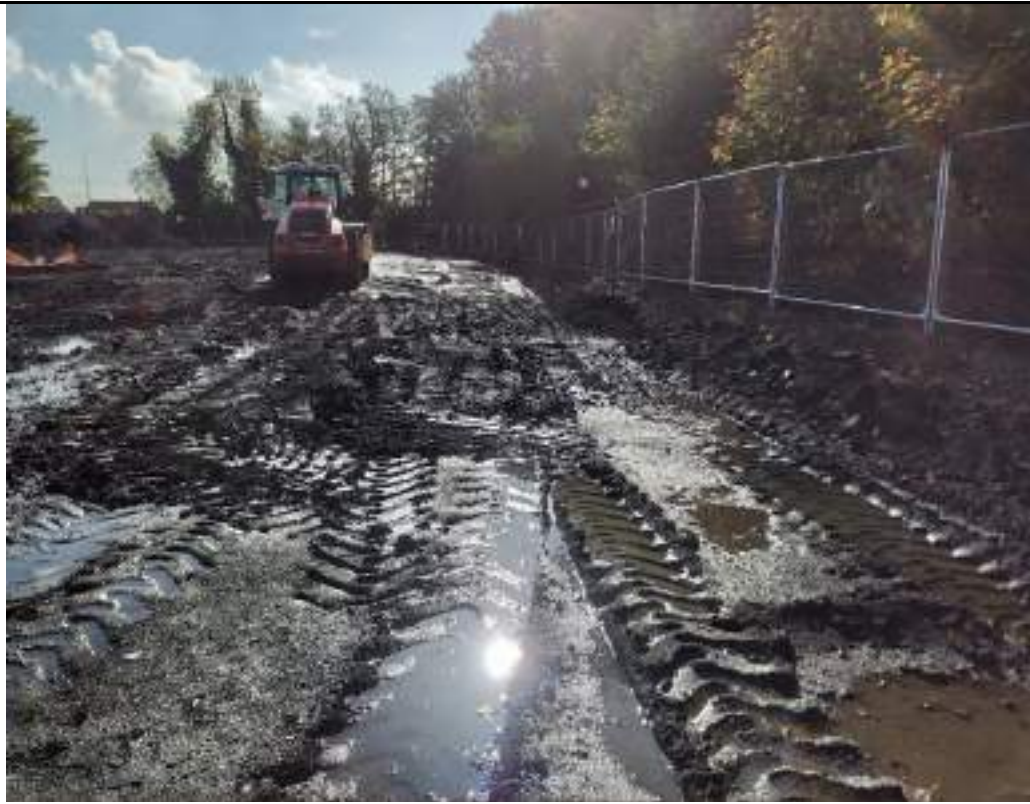
Photograph 21: Proof rolling of fill materials using smooth roller in southwestern part of the site.

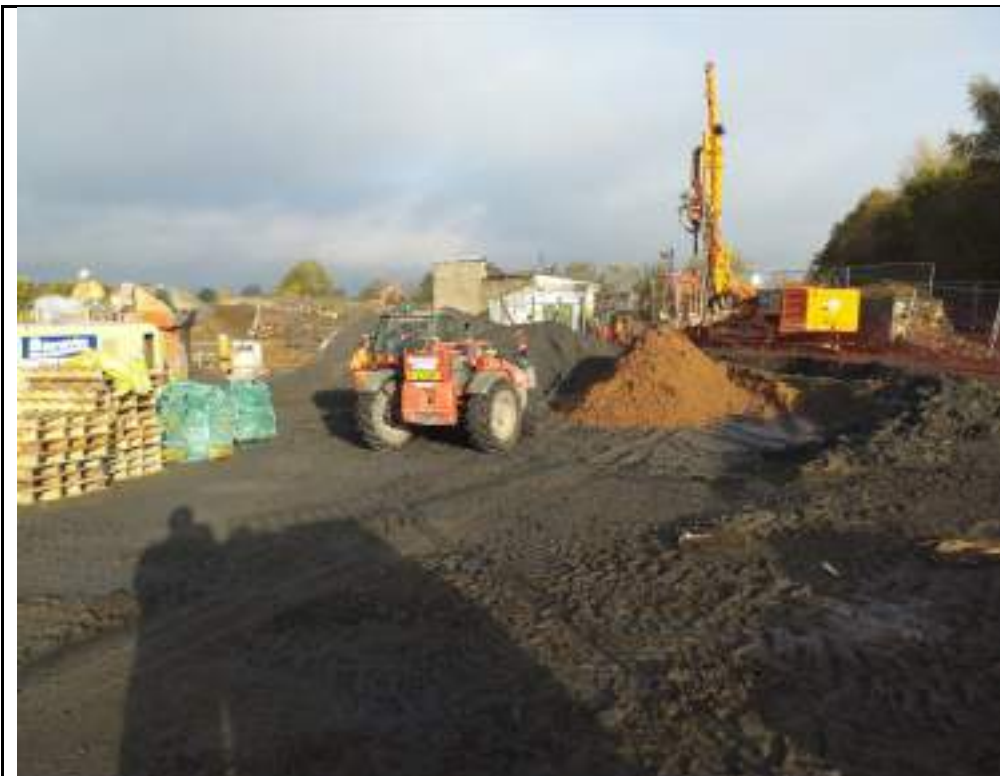
Mine shaft treatment of shaft no.6 is ongoing. VHE stated that Van Elle is experiencing grout loss. Van Elle has been injecting a PFA : Sand : OPC mix at 8 : 2 : 1 ratio. No improvement has been reported so far.

Photograph 2: Grouting shaft no.6 in eastern part of the site.

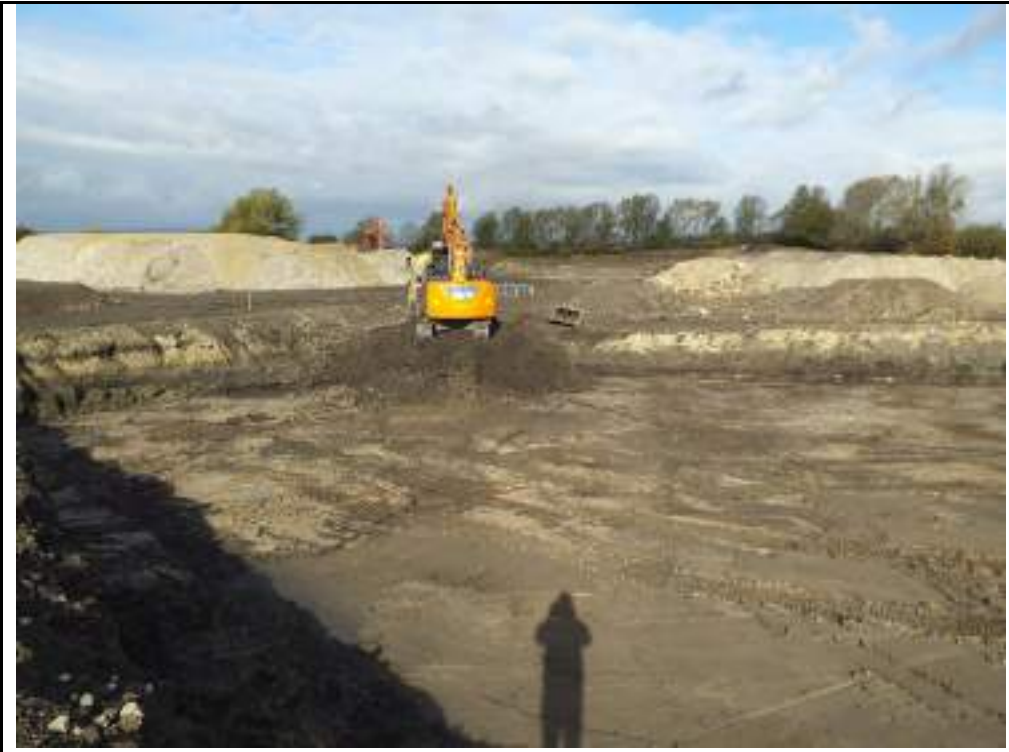
VHE stated that extra peat material has been found in eastern part of the site (southern part of the culvert). VHE to stockpile peat material in the northwest.

Photograph 3: Excavation of discovered peat in eastern part of the site (southern part of the culvert).

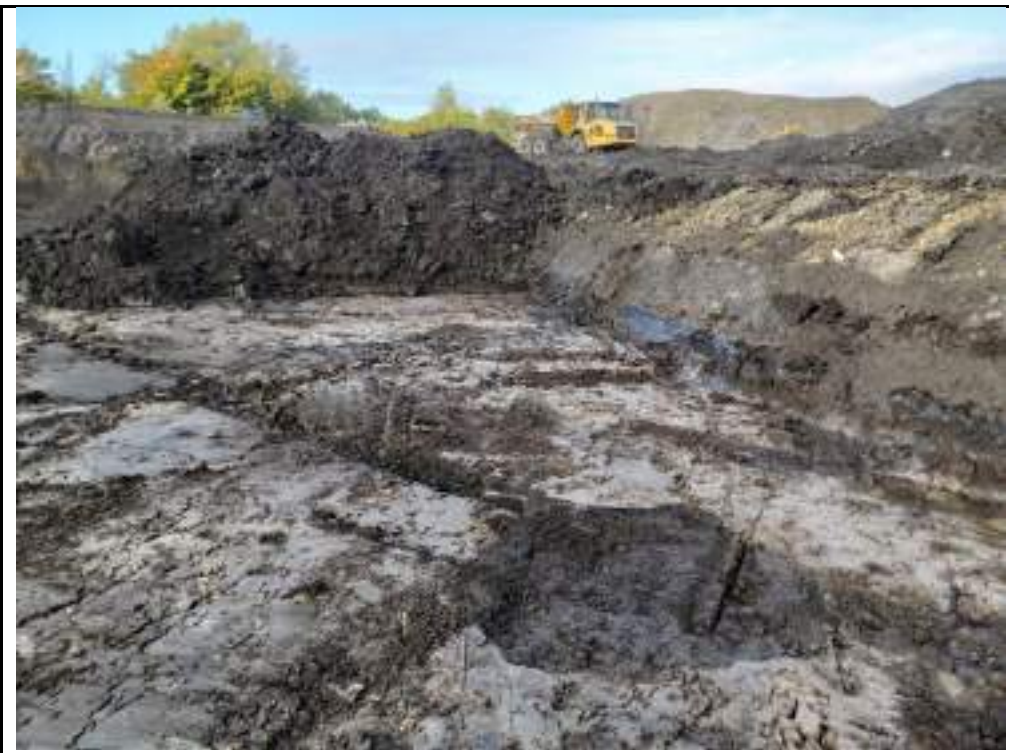
Photograph 4: Discovered peat in eastern part of the site (southern part of the culvert).

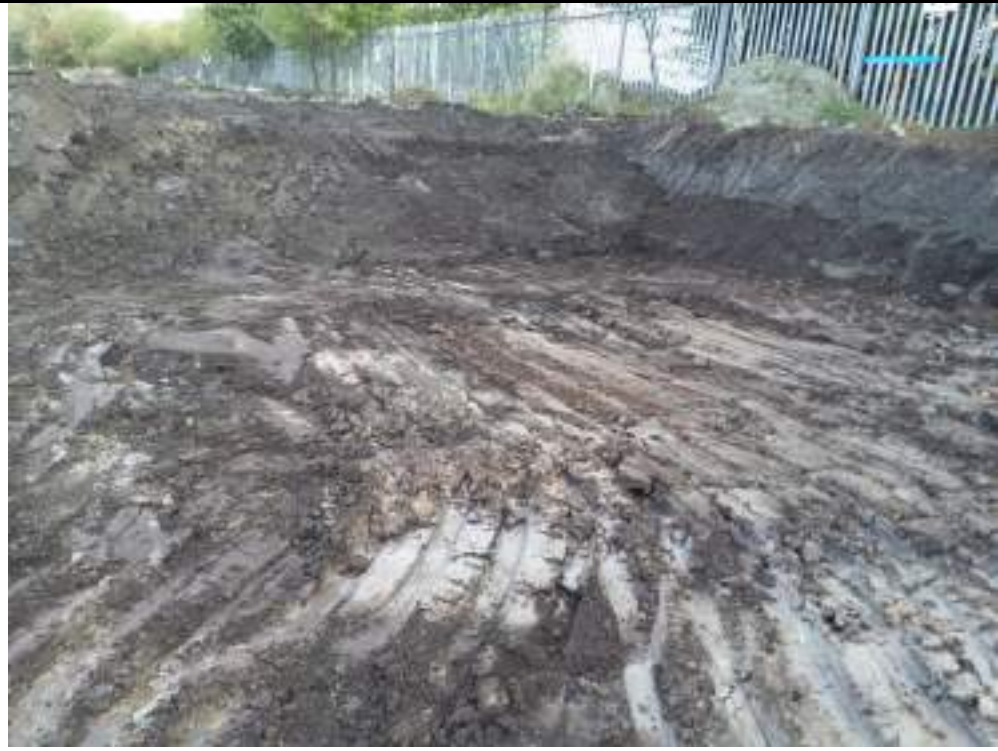
Photograph 5: Peat excavation in eastern boundary of the site (southern part of the culvert)

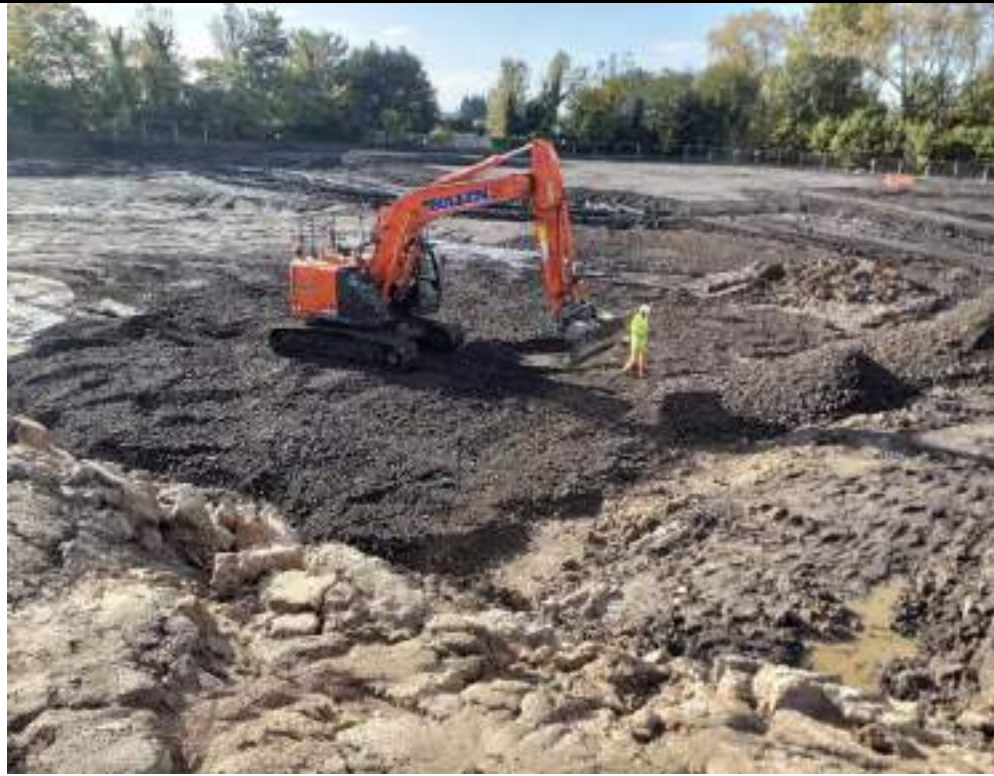
Photograph 7: Placing crushed fill material from northwestern stockpile in the southeast.

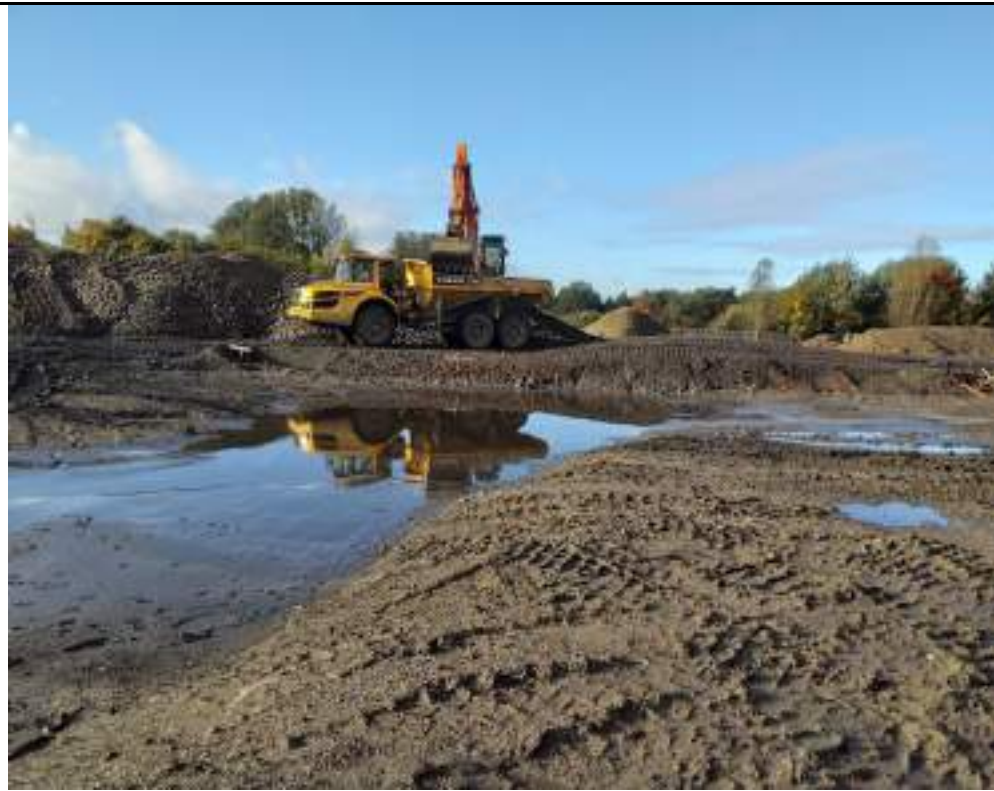
Photograph 8: Transferring crushed material from northwestern stockpile to backfill southeastern part of the site.

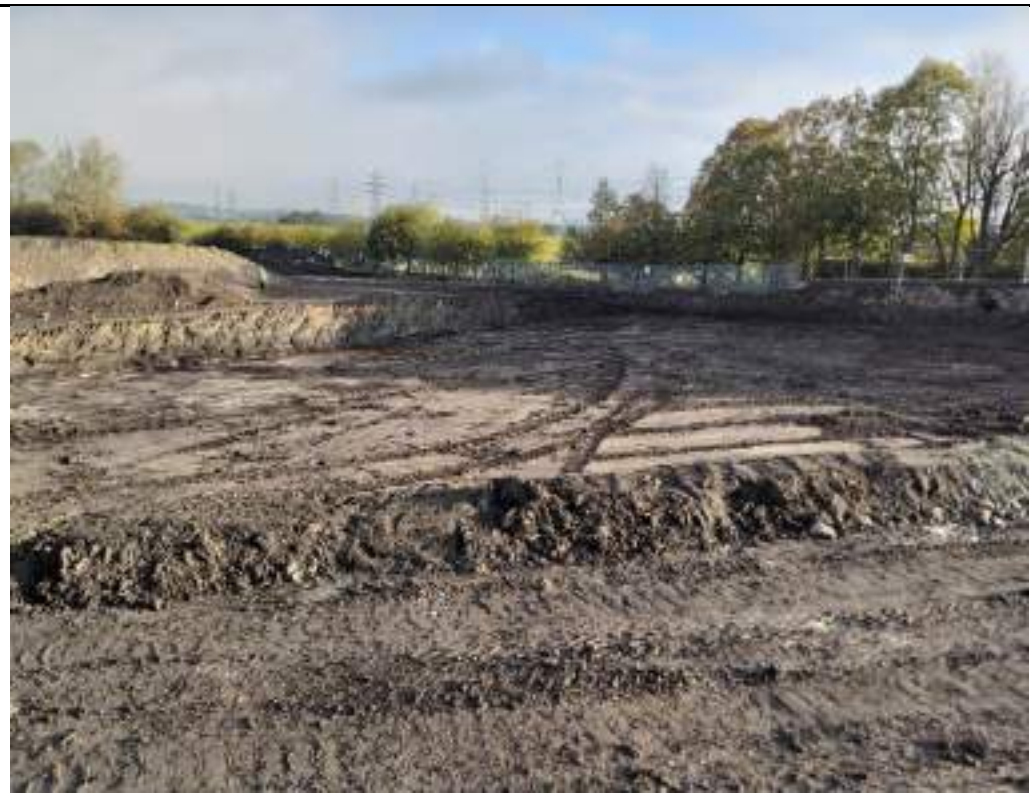
Photograph 10: Surveying of excavations and stockpiles.

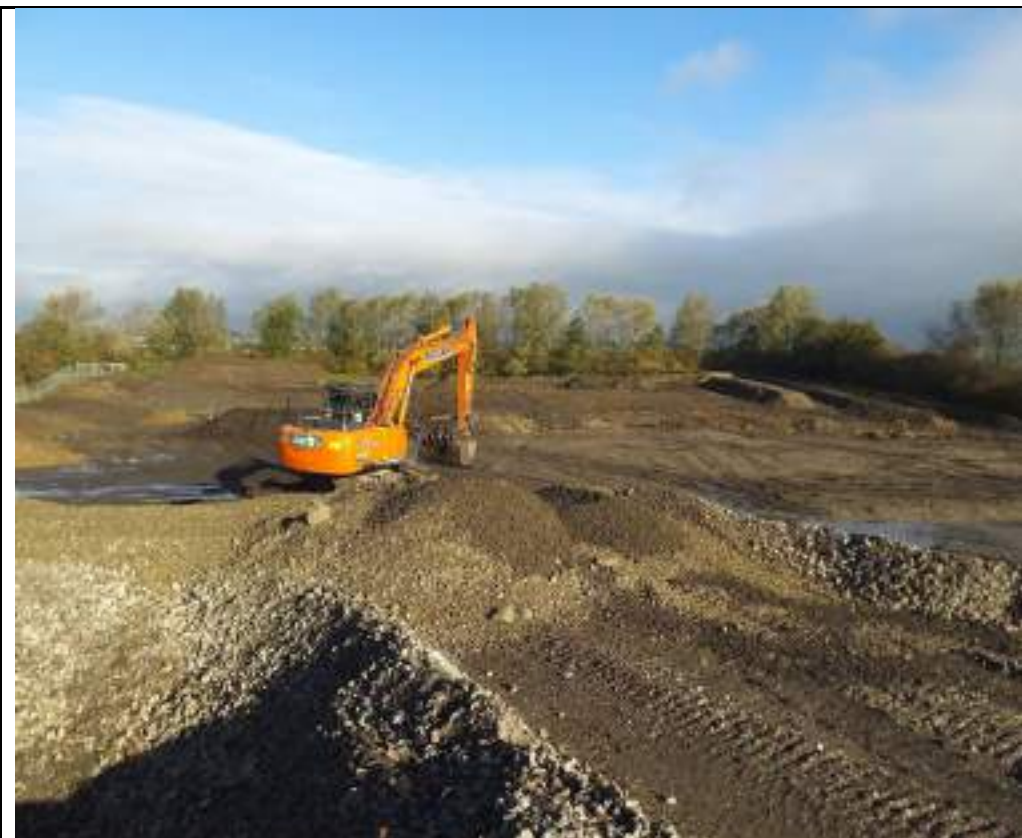
Photograph 12: Overview of stockpiles in northern part of the site.

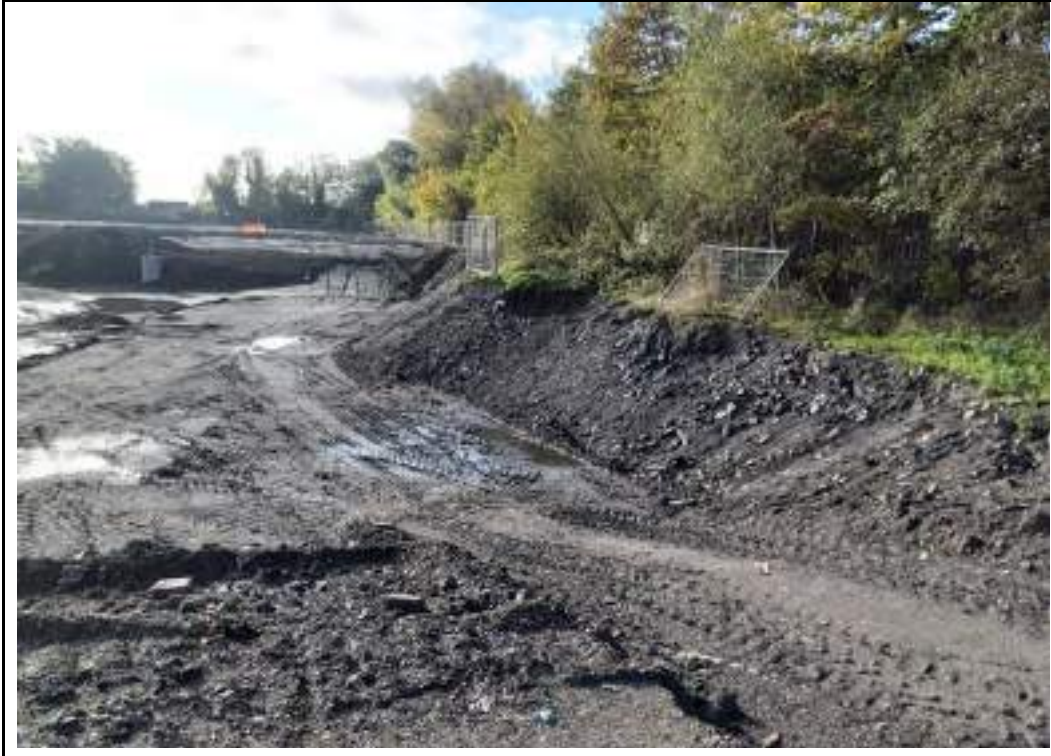
Photograph 93: Western boundary of the site. Looking towards the south.

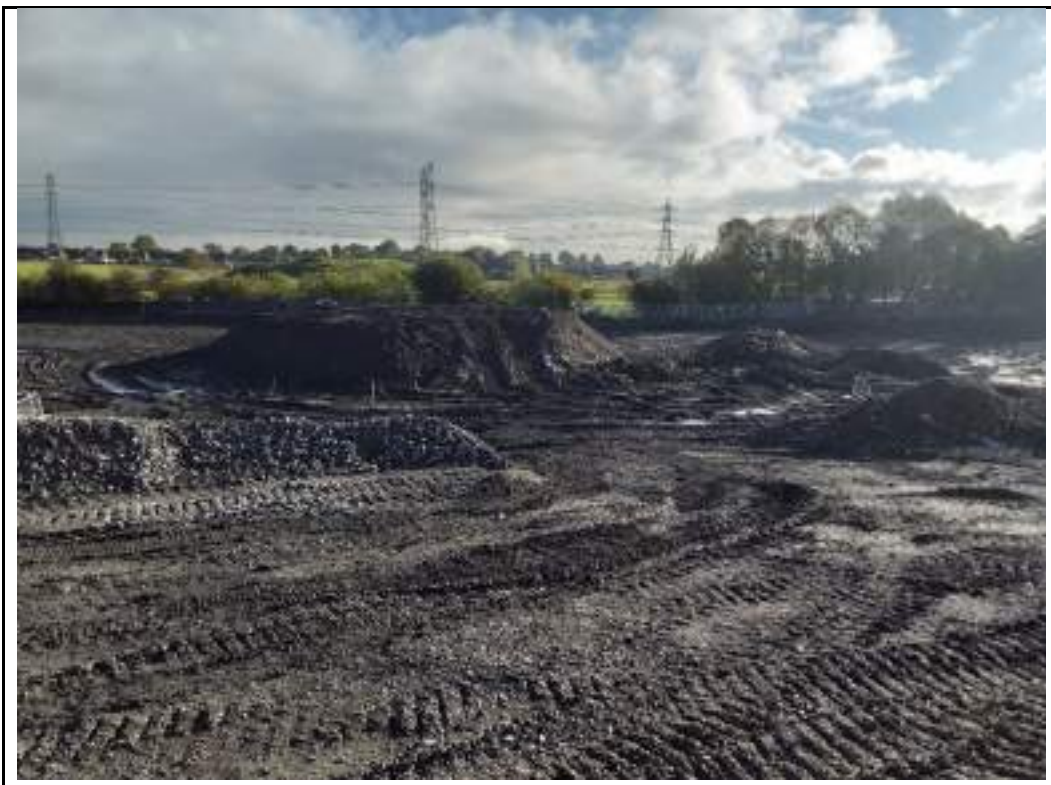
Photograph 14: Stockpiles of excavated materials in the northeastern boundary of the site.

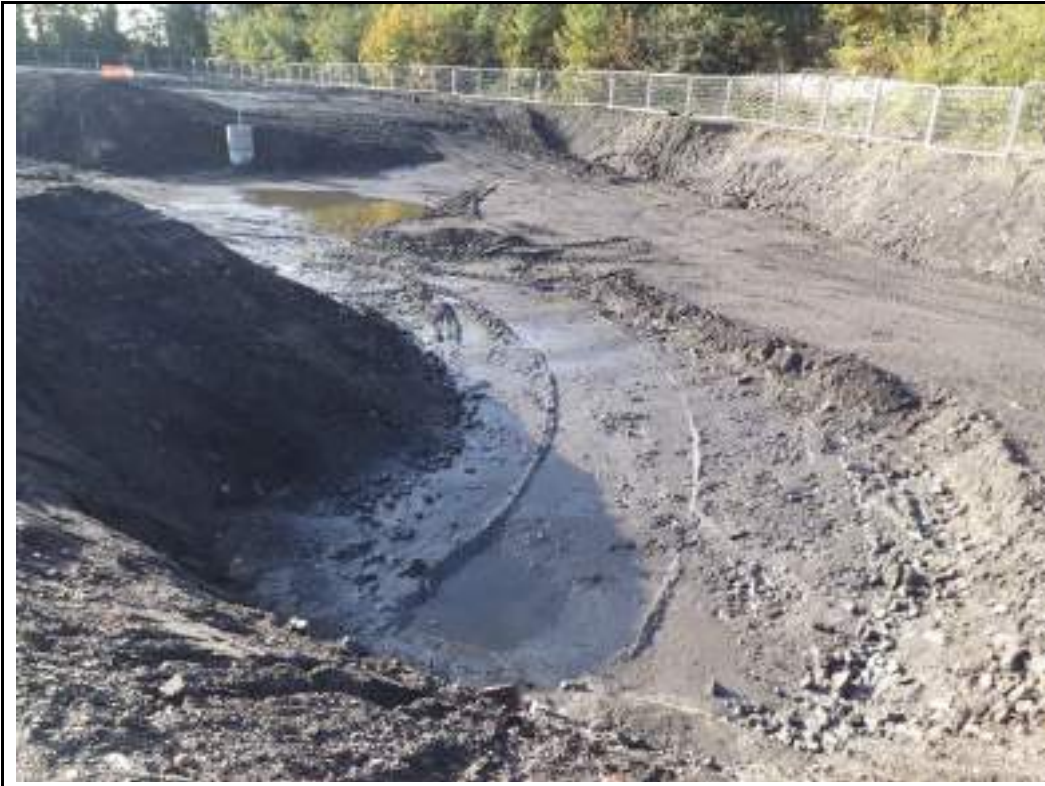
Photograph 17: Standing water in excavation in western boundary of the site.

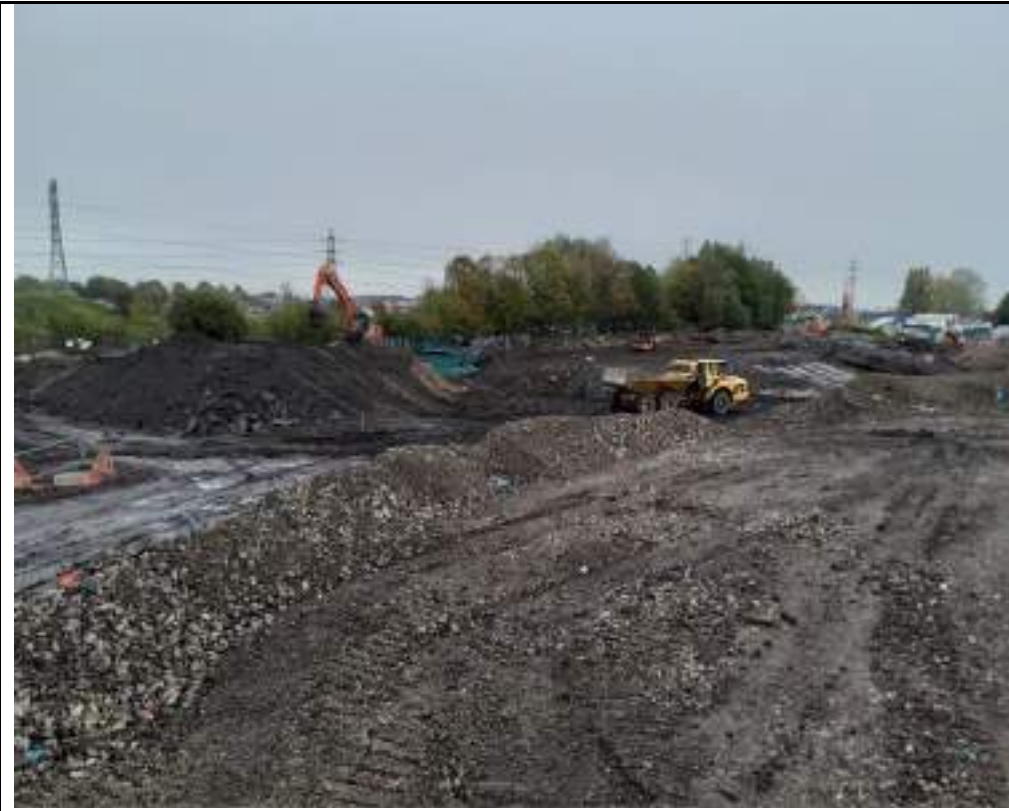
Photograph 1: Overview of the site. Looking towards the south.

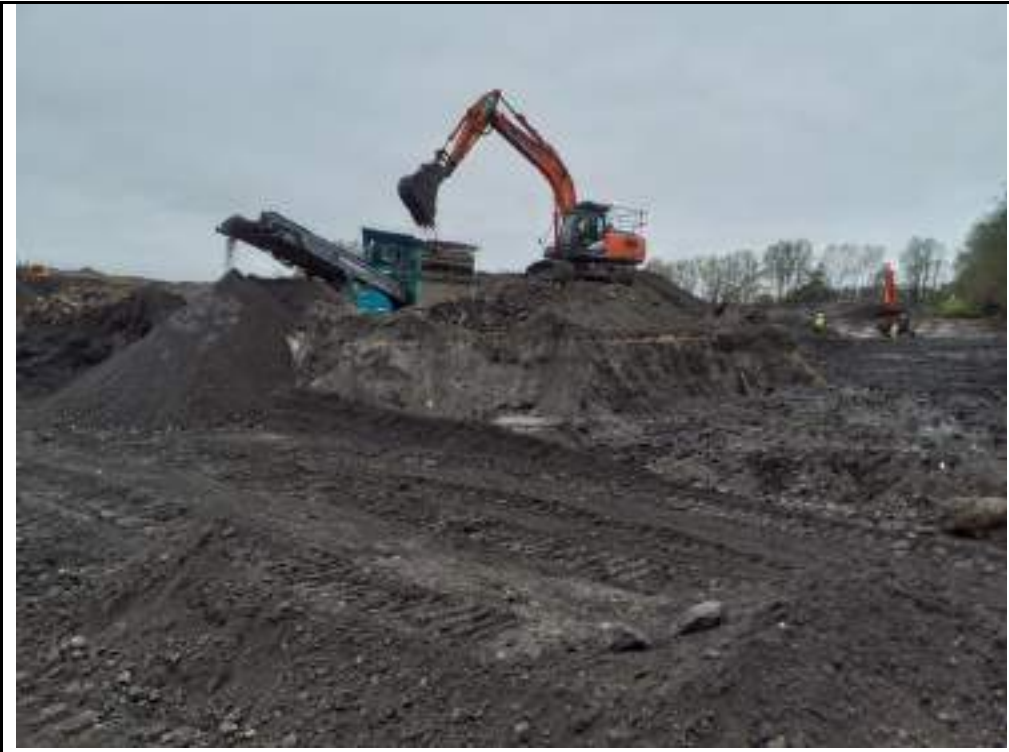
Photograph 3: Screening of stockpiled Made Ground material in northeastern part of the site.

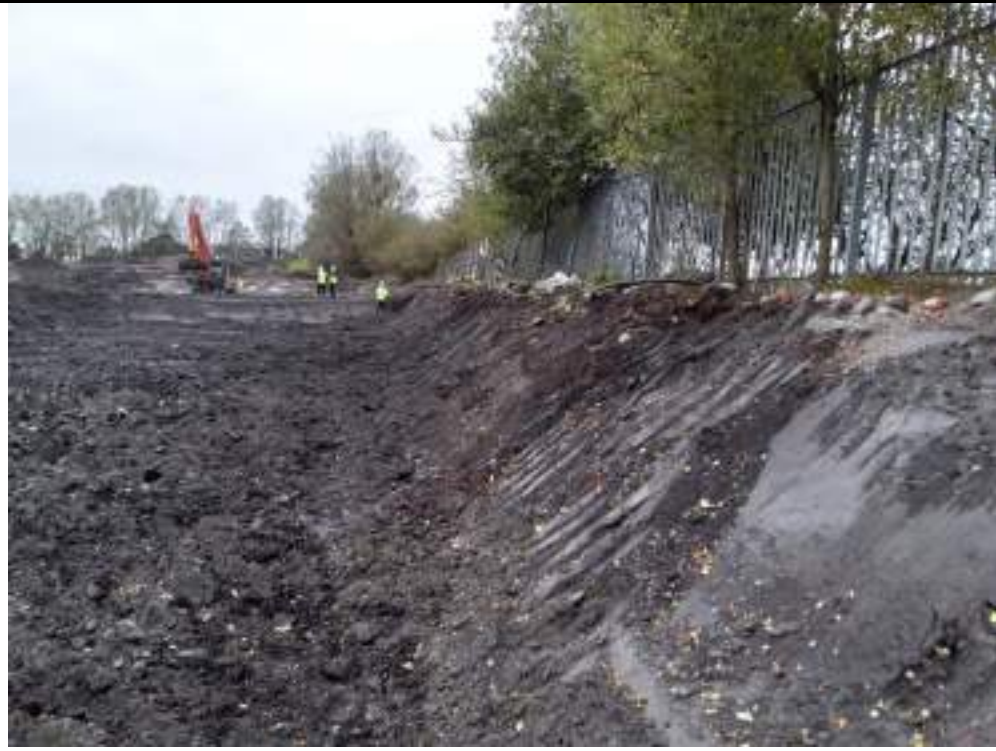
Photograph 5: Excavated peat area in northeastern part of the site and surveying of excavations.

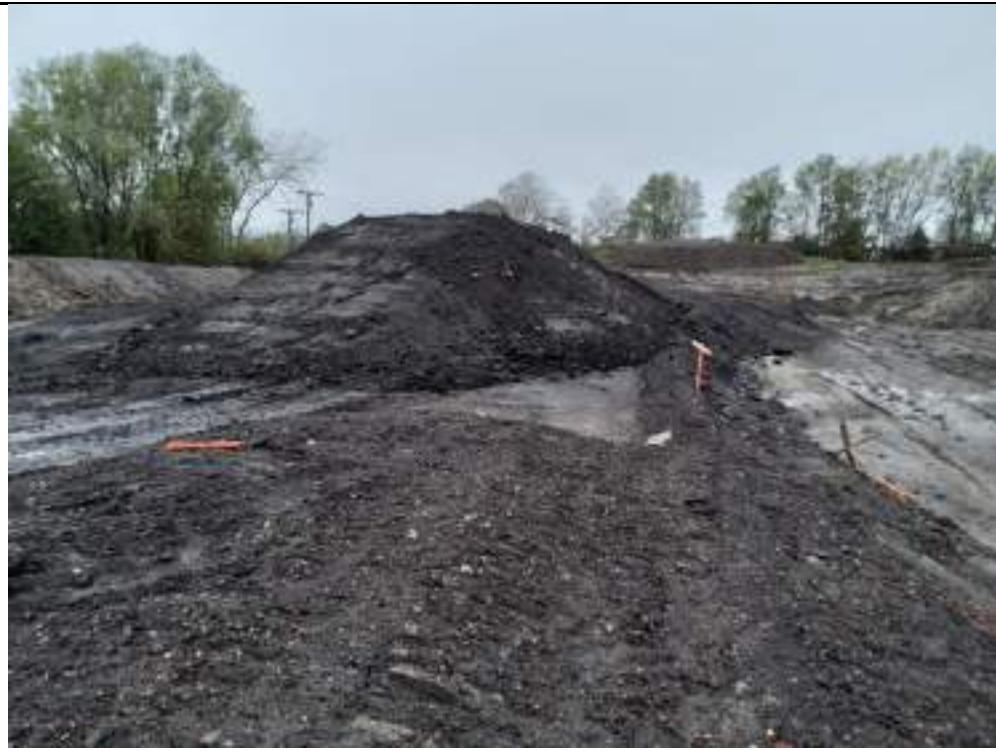
Photograph 6: Excavated peat stockpile in northwestern part of the site.

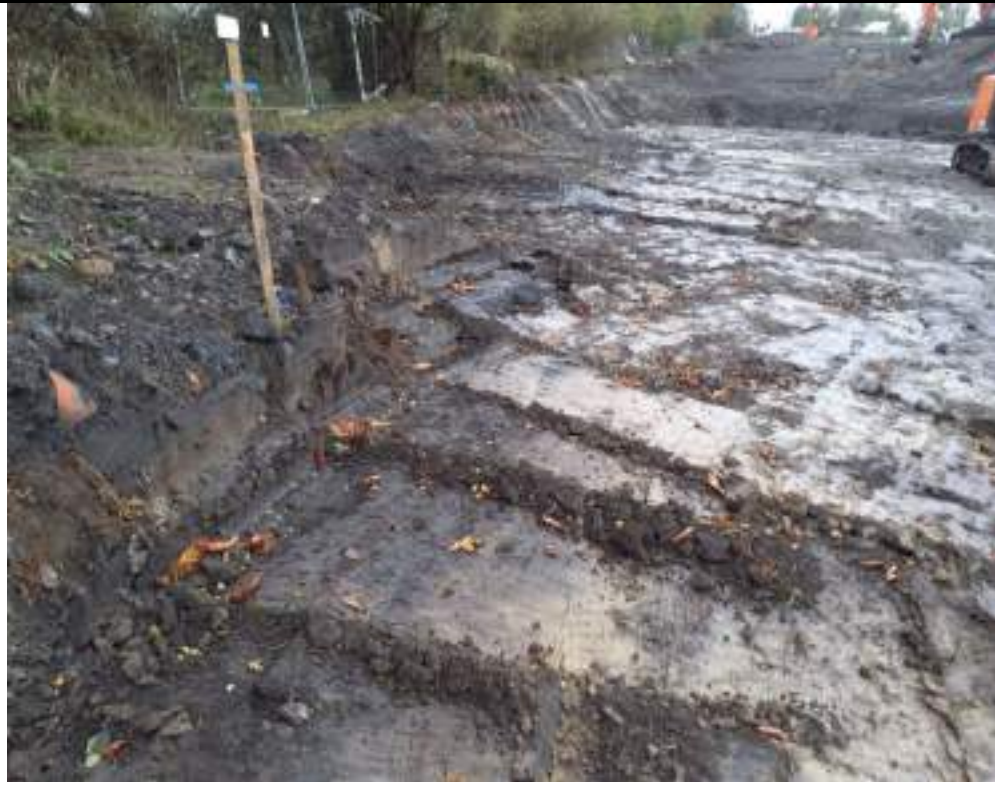
Photograph 7: Excavation of organic Made Ground area up to formation level in northeast of the site.

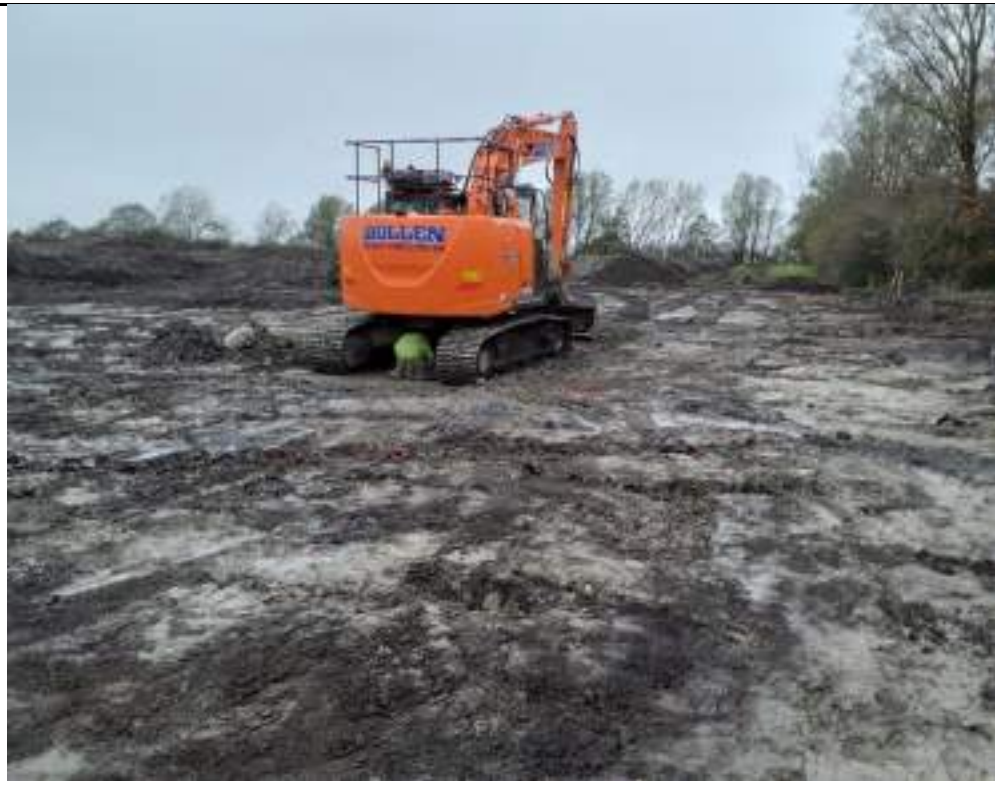
Photograph 8: Plate load testing on formation level (Glacial Till) in northeast of the site.

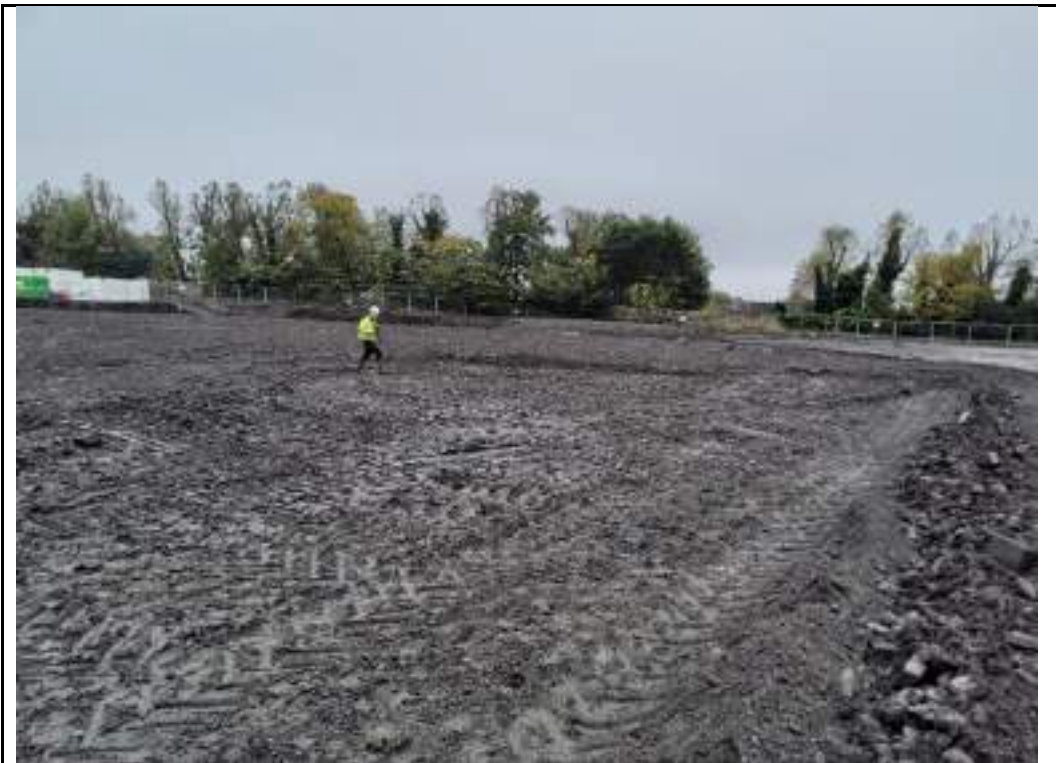
Photograph 10: Surveying of the site.

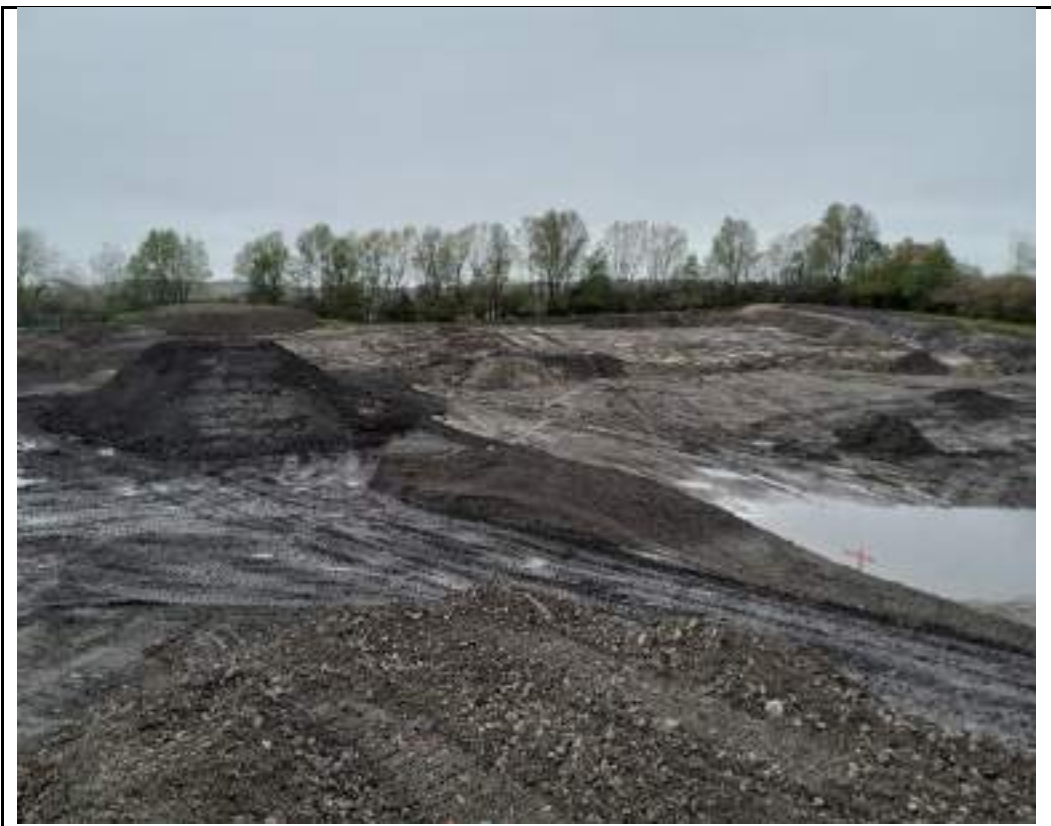
Photograph 12: Overview of stockpiles in northern part of the site.
