**SITE VISIT REPORT 15220-HYD-XX-XX-SVR-GE-1018**

**SHEET NO.: 6 of 18**

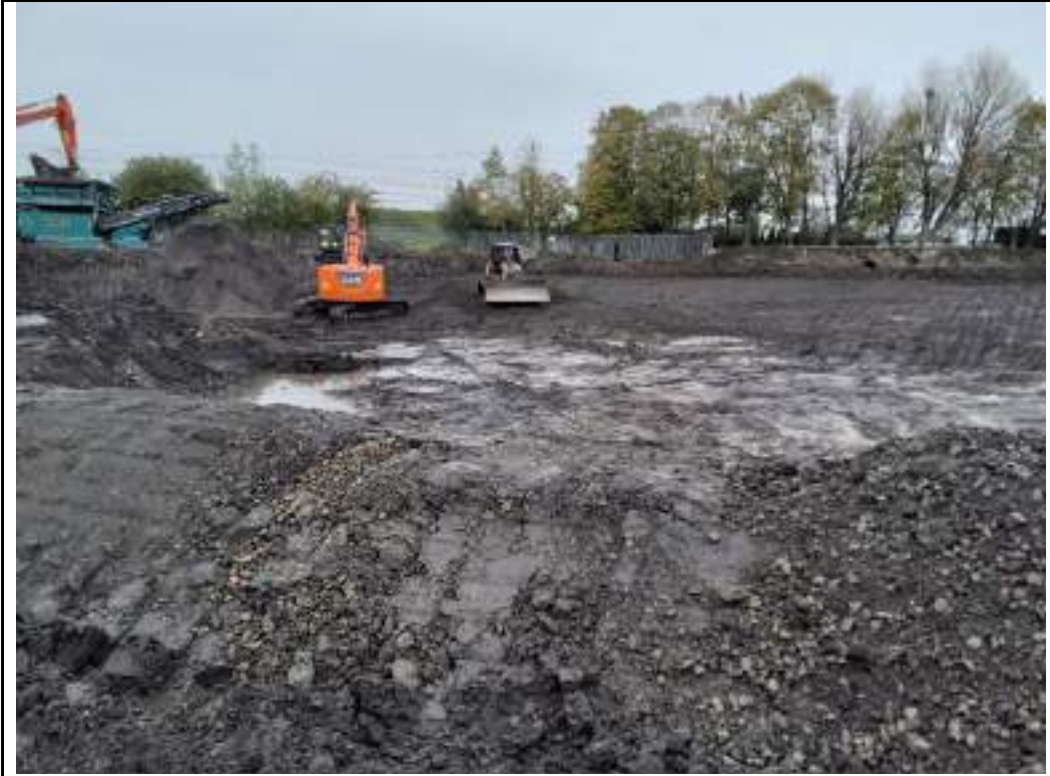
Photograph 93: Backfilling northeastern part of the site using processed material.

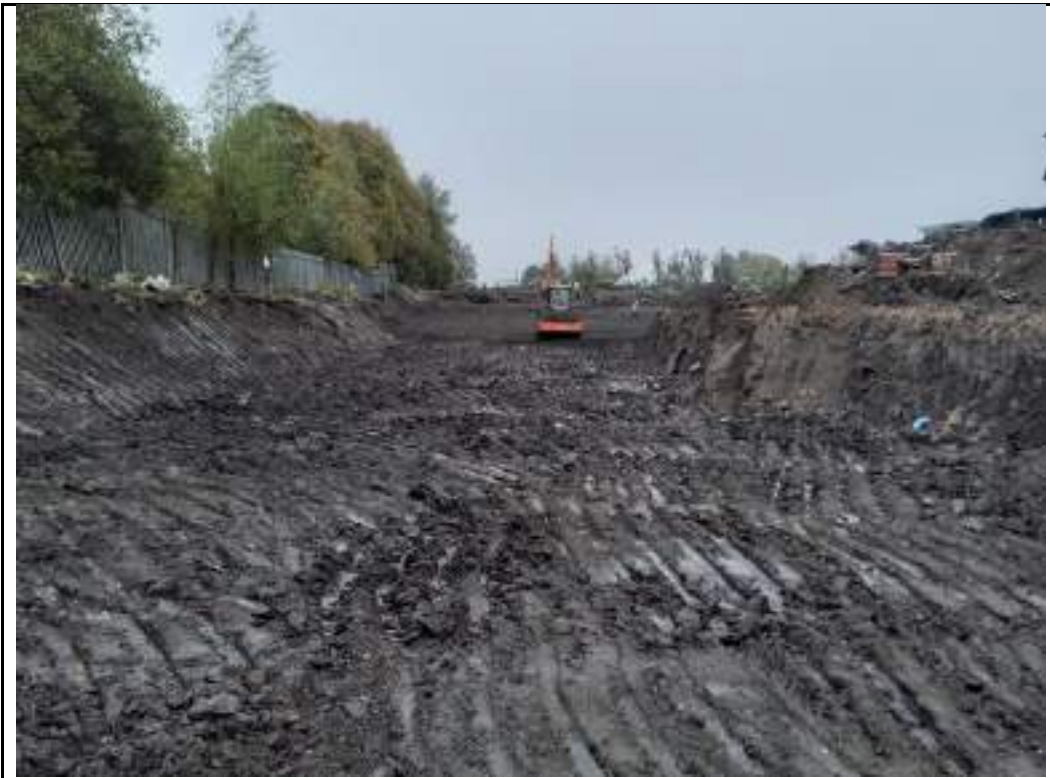
Photograph 14: Proof rolling of fill using sheepsfoot roller in northeast of the site.

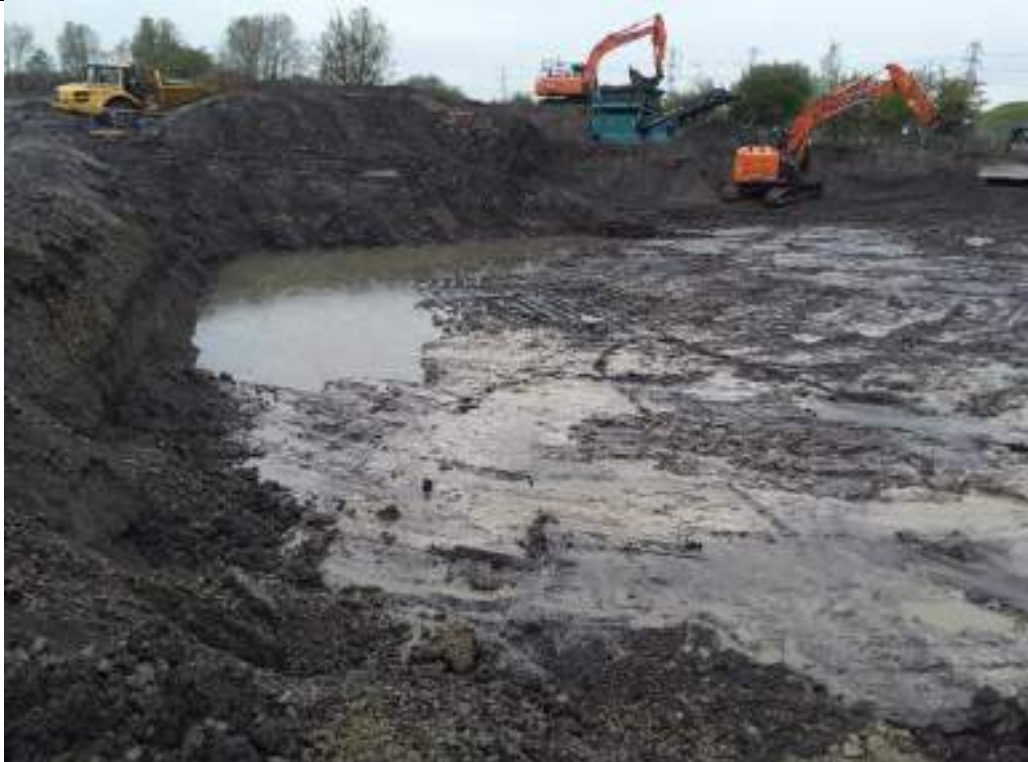
Photograph 16: Standing water in northeastern excavation.

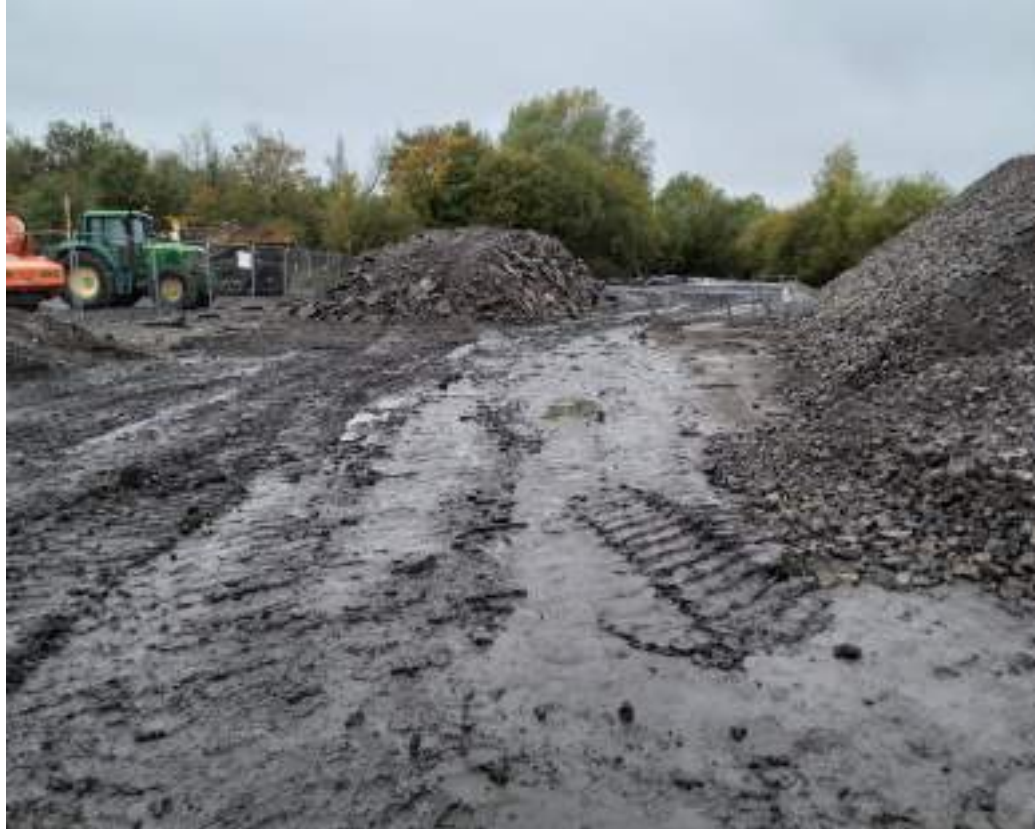
Photograph 17: Stockpile of concrete and oversize materials in northwest of the site.

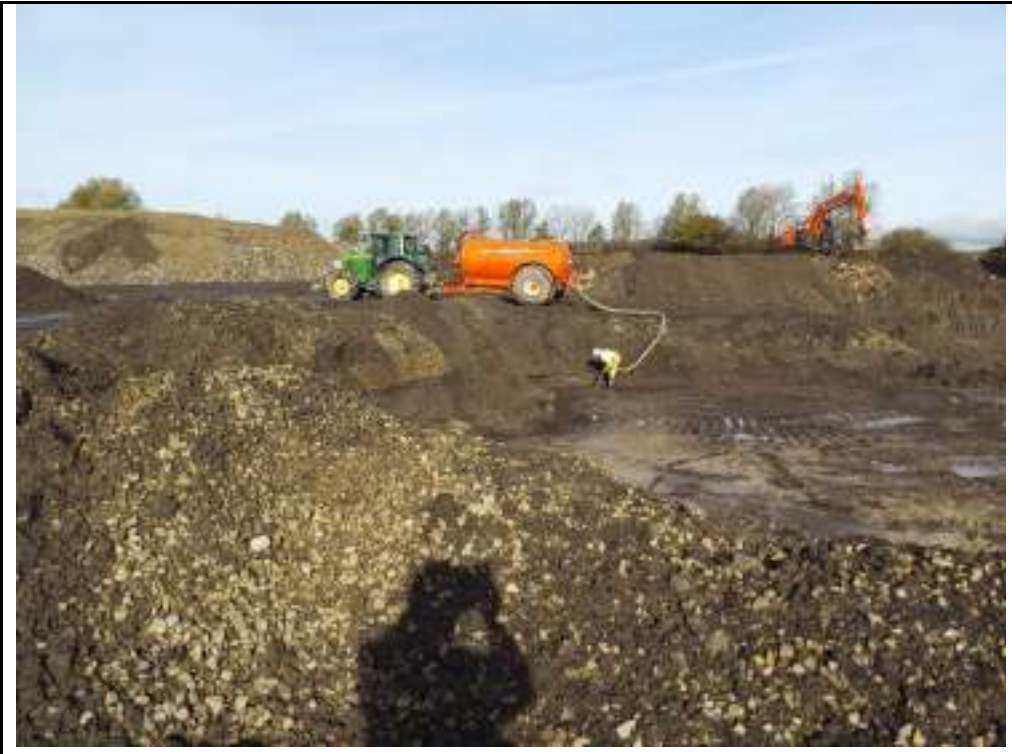
Photograph 3: Dewatering of excavation using tractor mounted pump in northeastern part of the site.

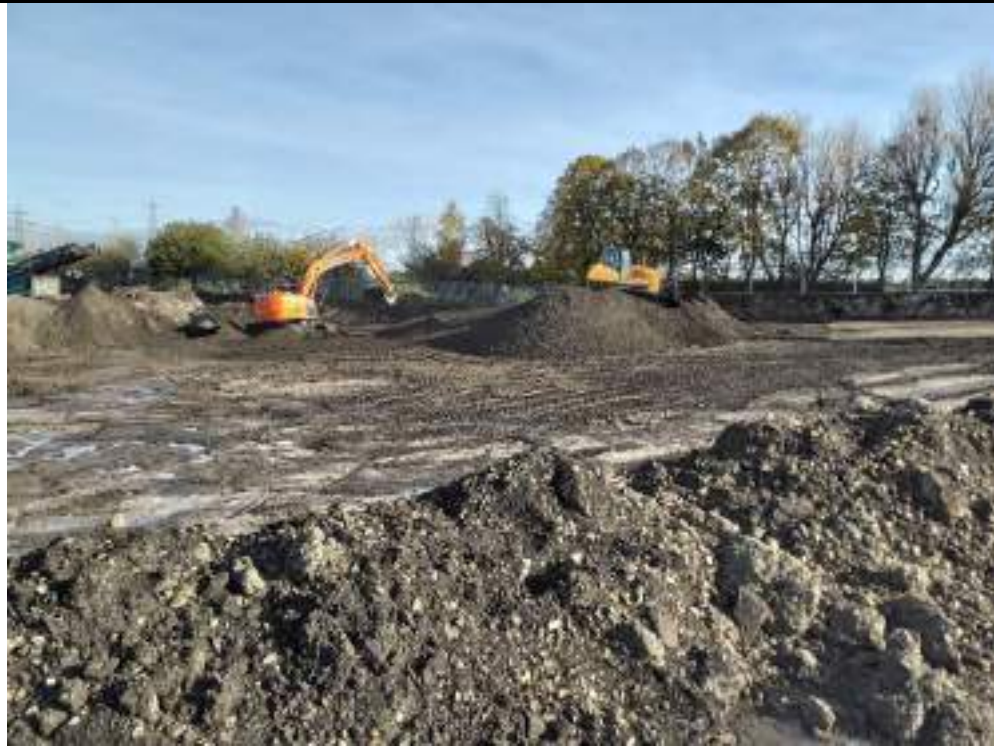
Photograph 5: Stockpiling processed material in northeastern part of the site.

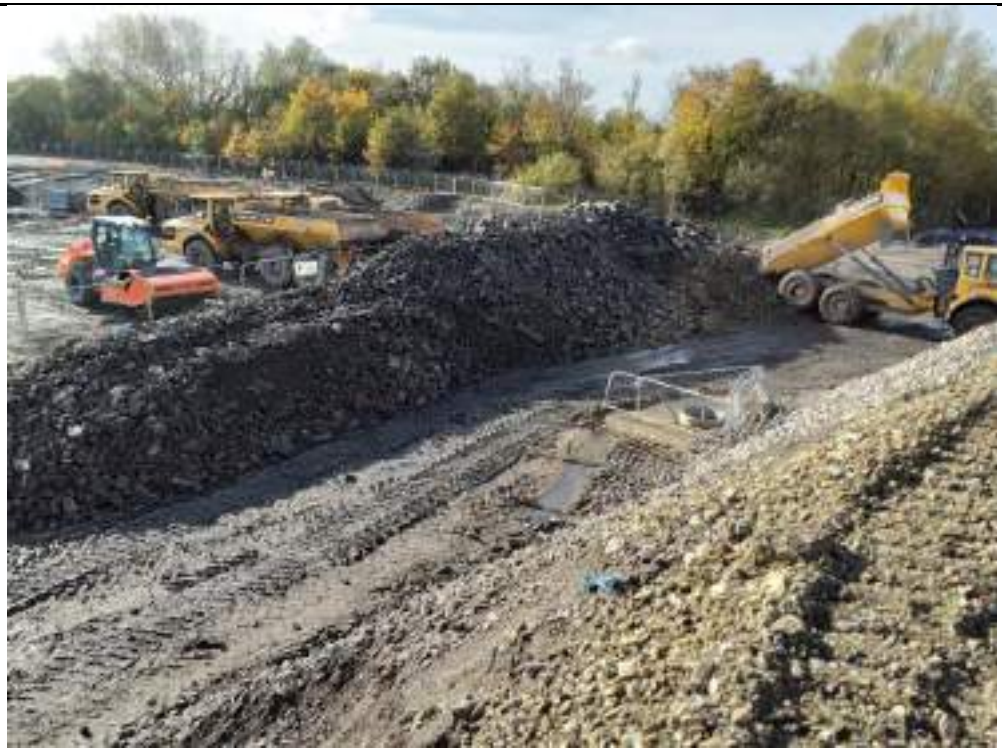
Photograph 6: Stockpiling oversized materials of screener in northwestern stockpile.

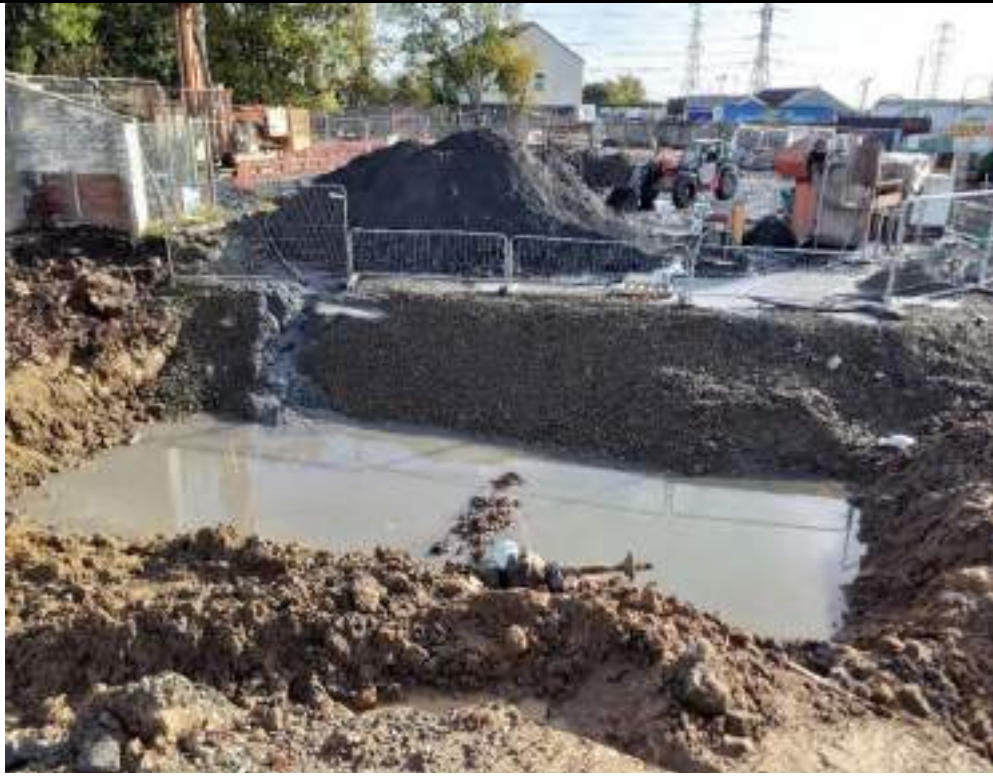
Photograph 7: Standing water in southeastern part of the site.

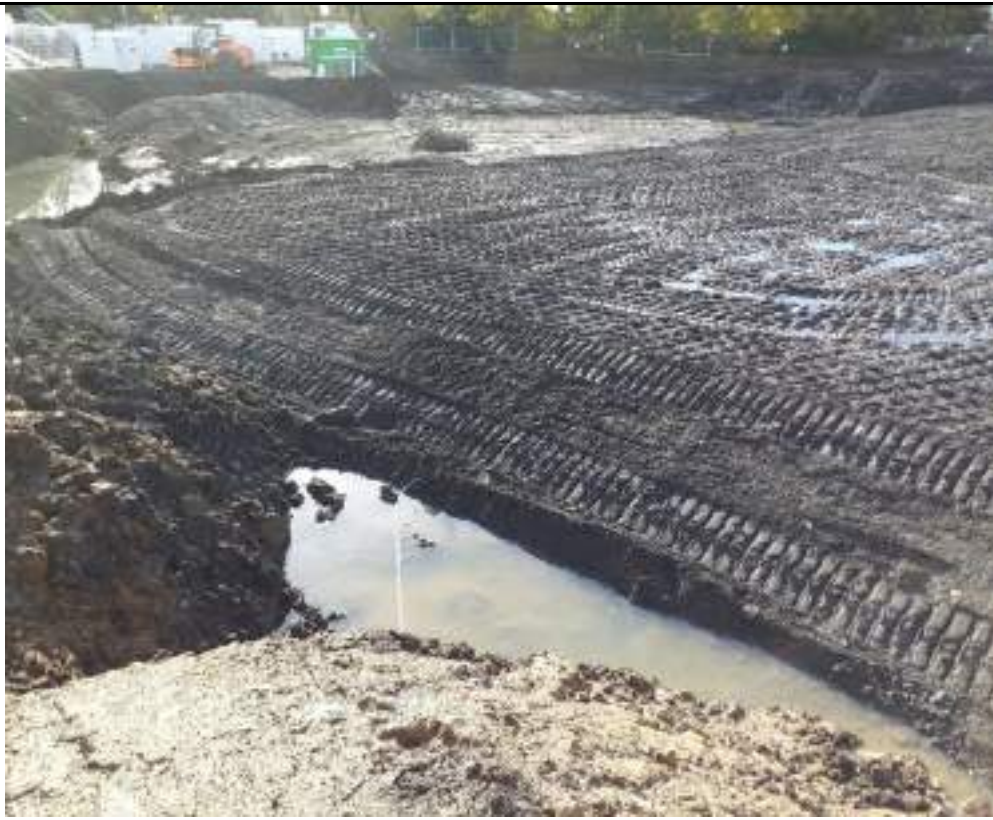
Photograph 8: Backfilled area and standing water in southeastern part of the site.

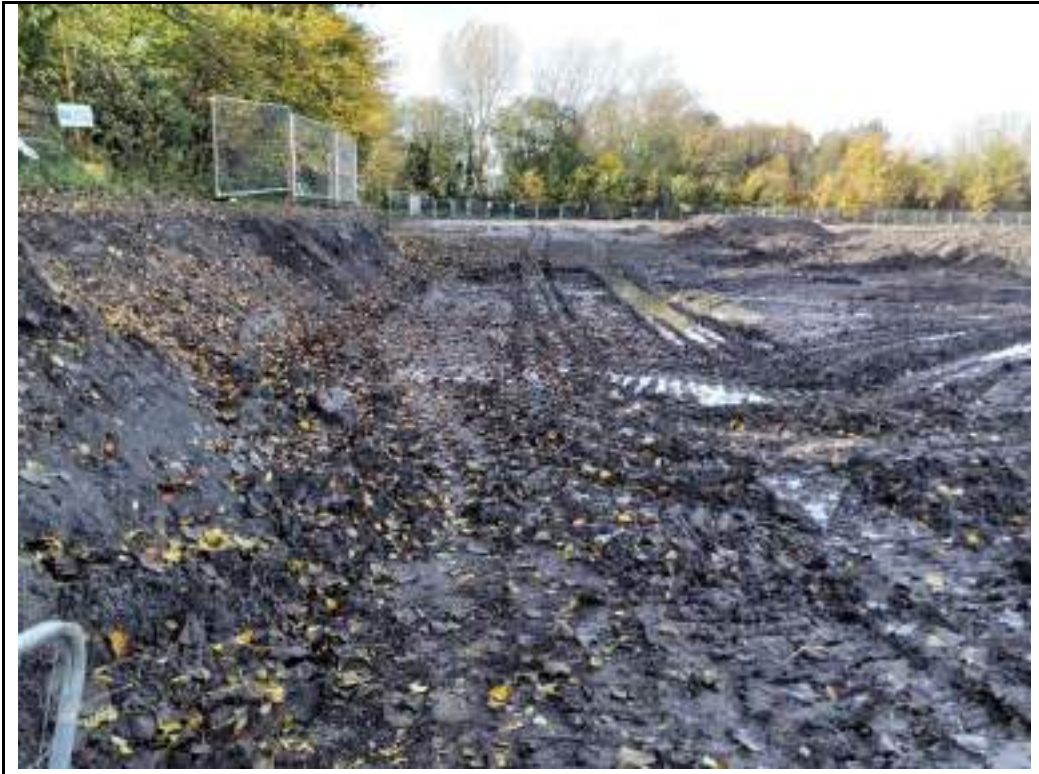
Photograph 9: Southern boundary of the site. Looking towards the west.

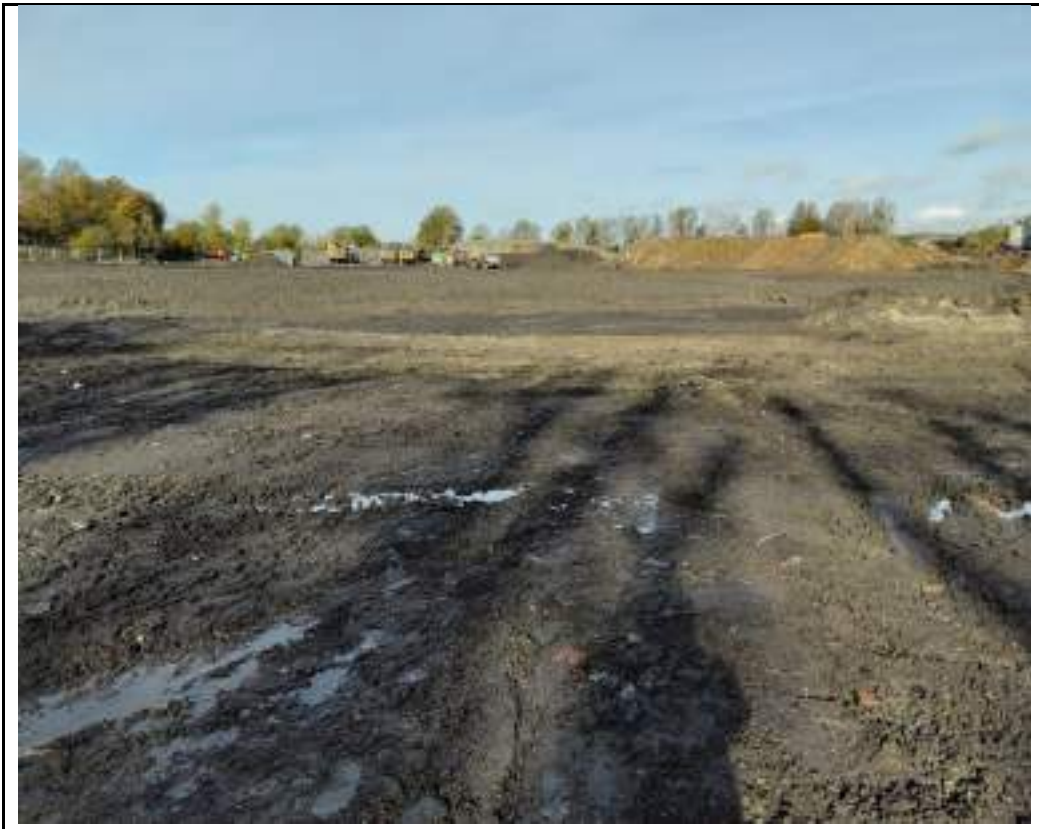
Photograph 10: Overview of backfilled area in southern part of the site. Looking towards the northwest.

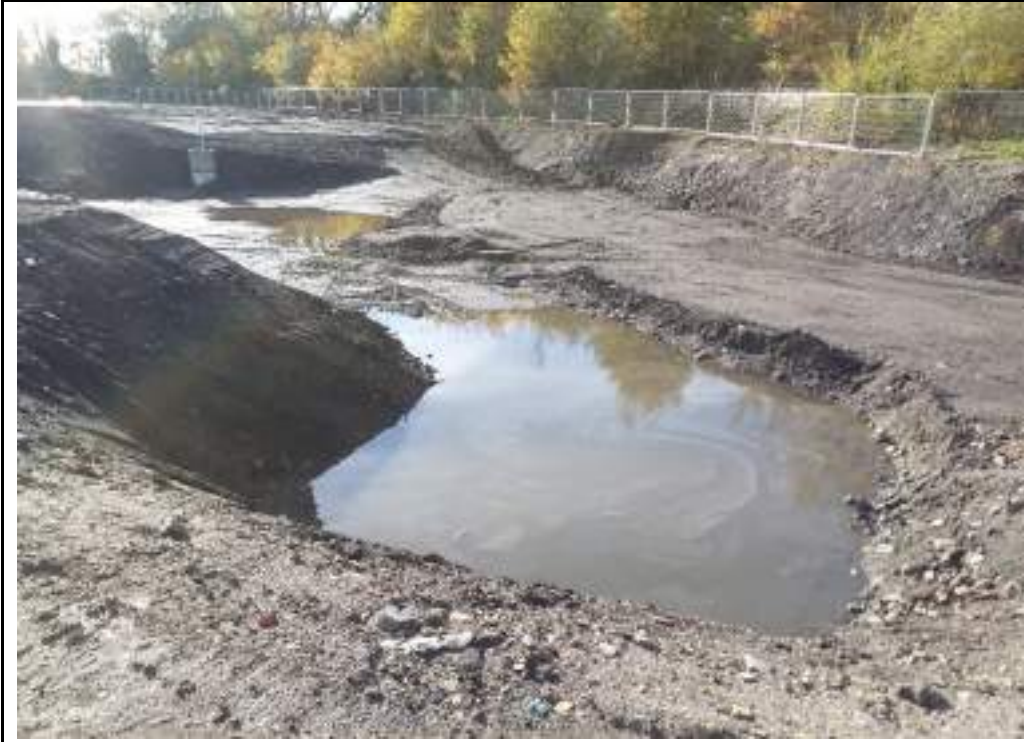
Photograph 11: Standing water in western part of the site.

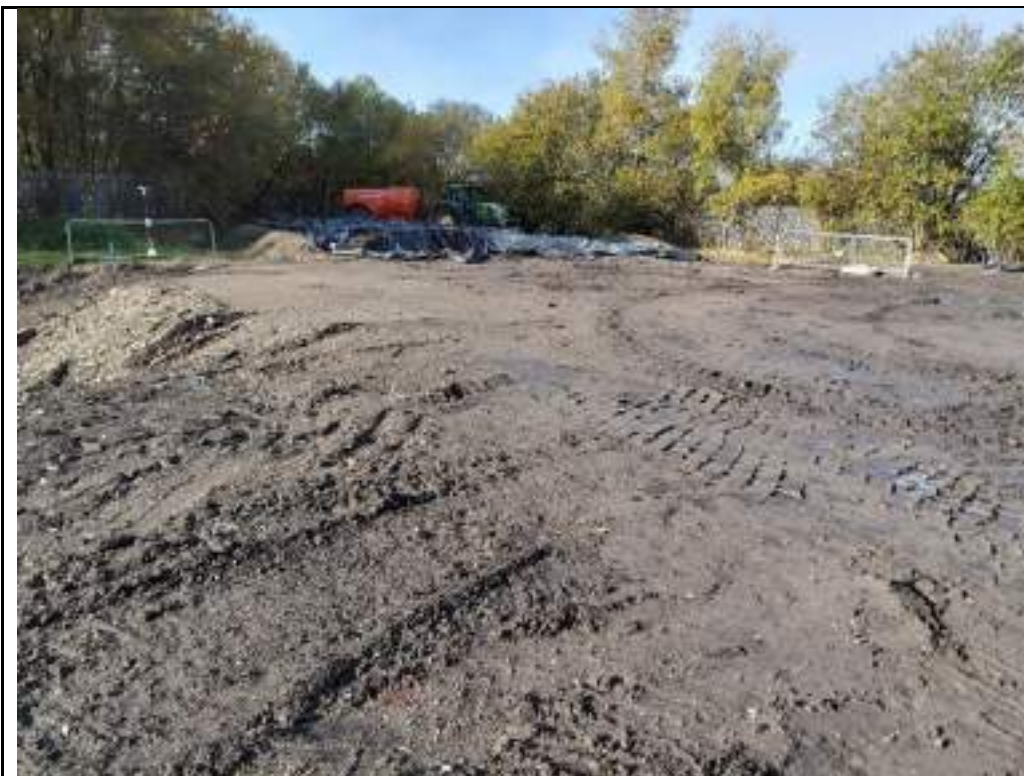
Photograph 12: Stockpile of TPH contaminated materials in northwestern boundary of the site.

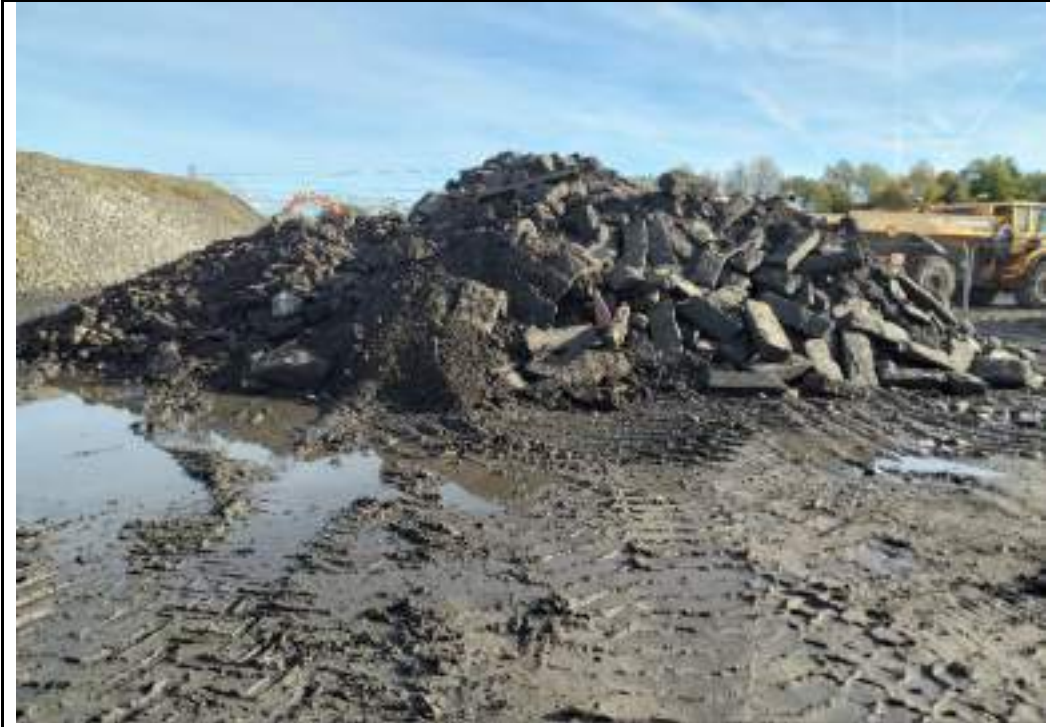
Photograph 93: Deleterious materials in stockpile of concrete and oversize materials in northwestern part of the site.

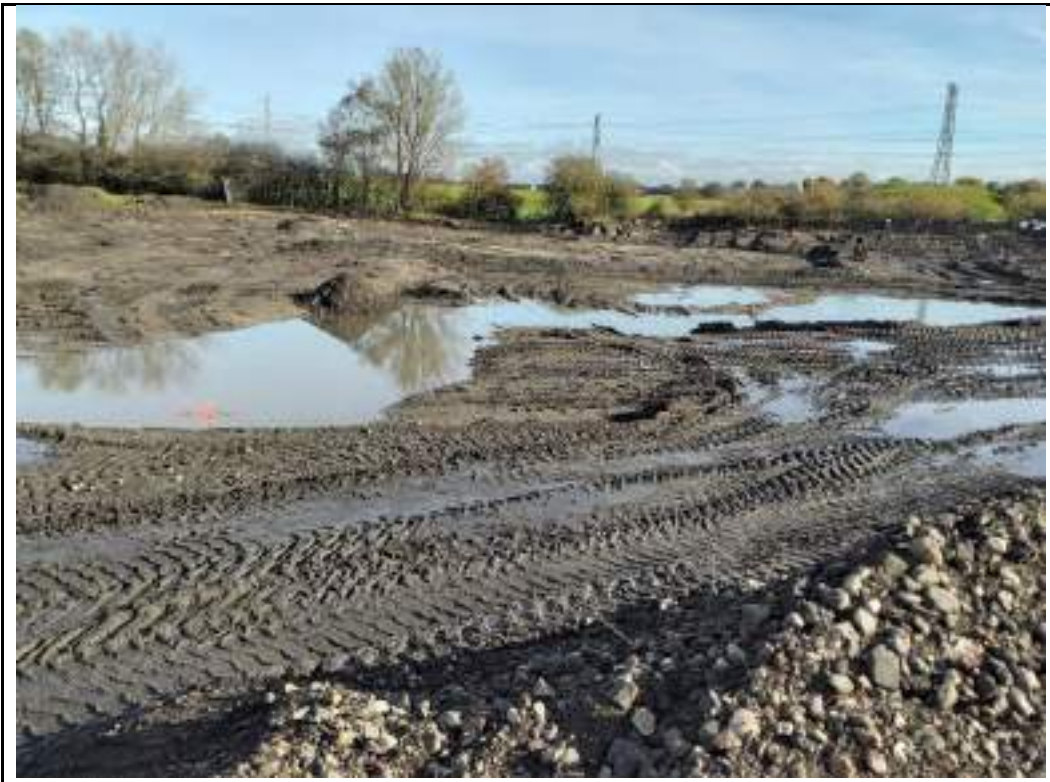
Photograph 14: Standing water in northern part of the site.

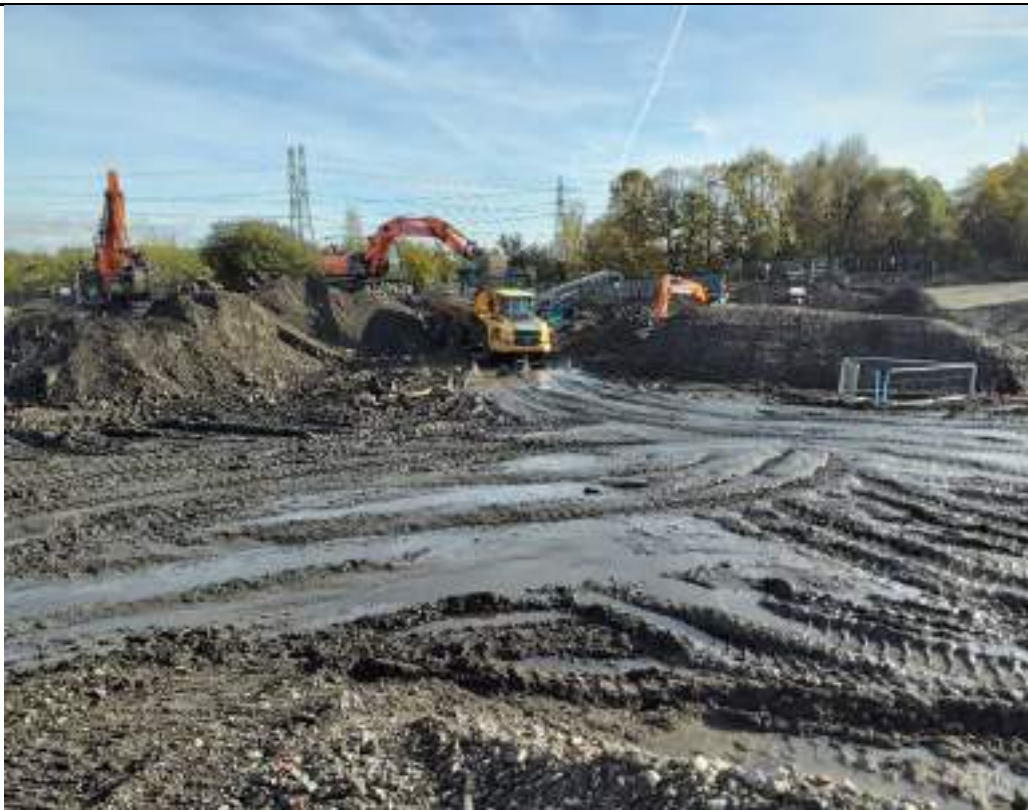
Photograph 16: Loading oversized materials to stockpile in northwestern stockpile.

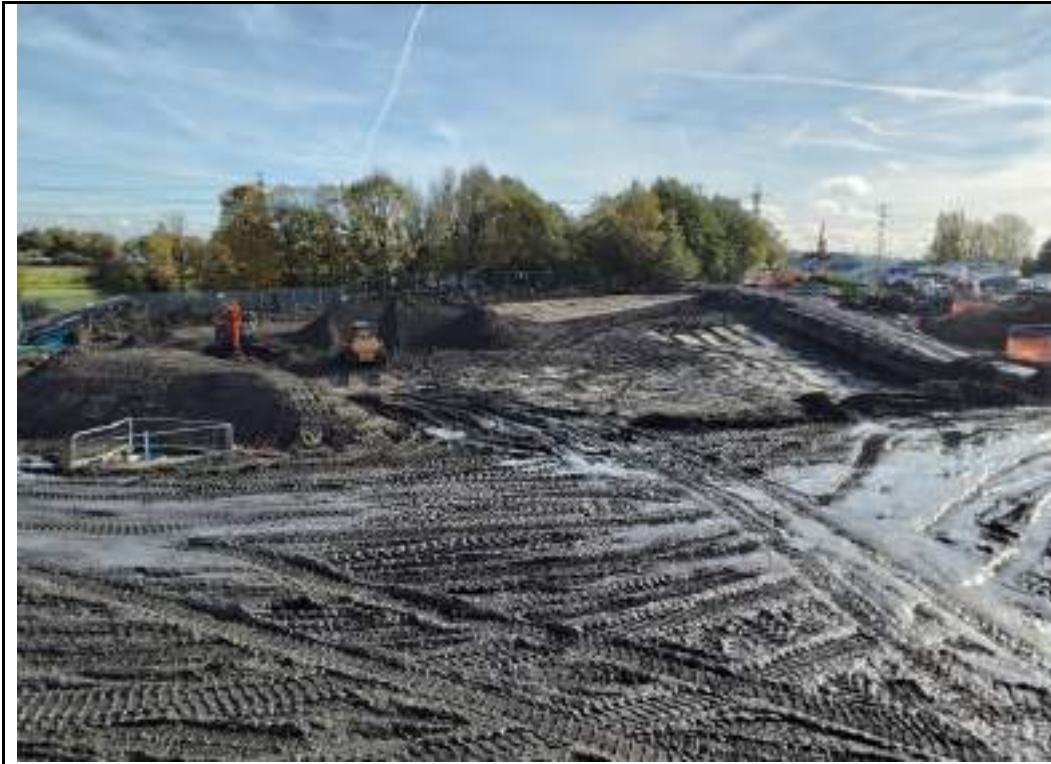
Photograph 17: Placed fill and stockpile of processed materials in eastern part of the site.

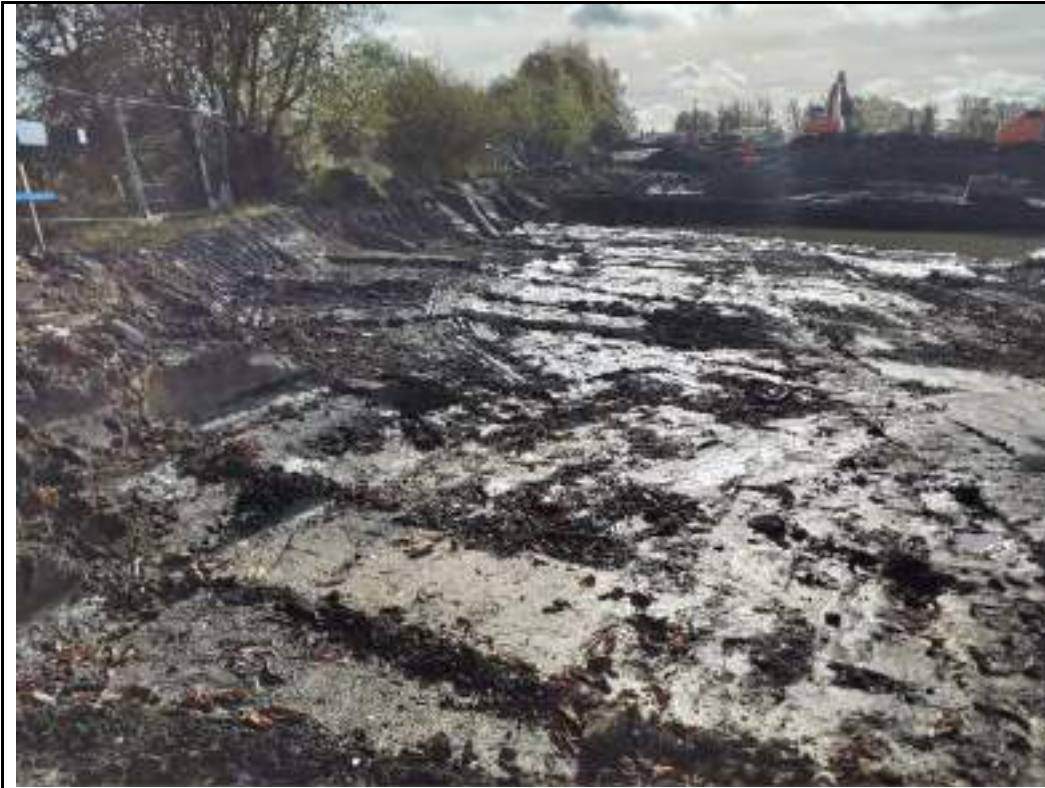
Photograph 19: Northeastern boundary of the site. Looking towards the south.

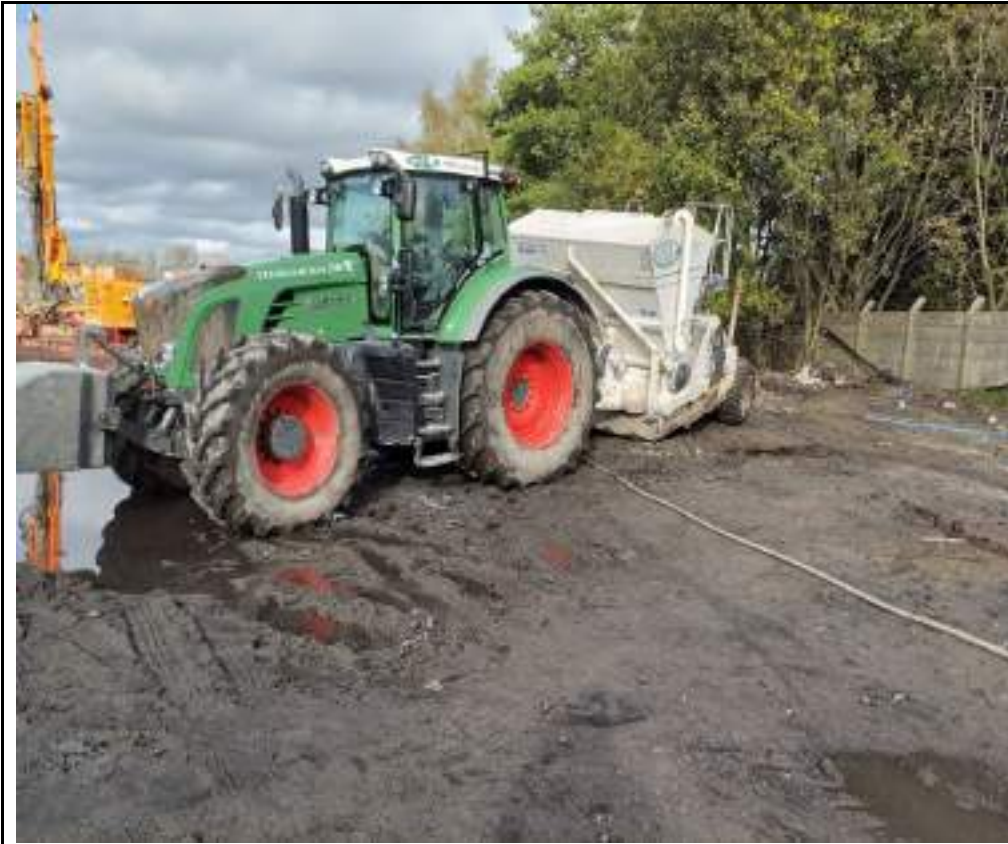
Photograph 21: Lime stabilization tractor in southeastern part of the site.

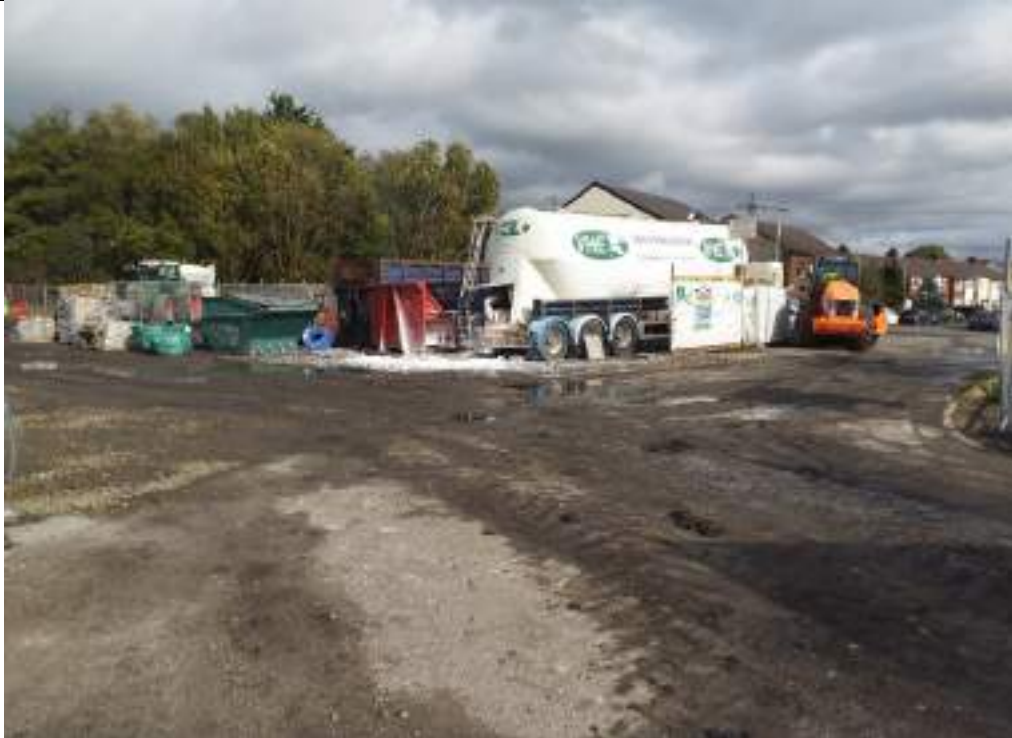
Photograph 22: Lime modification storage tanker in southeastern part of the site.

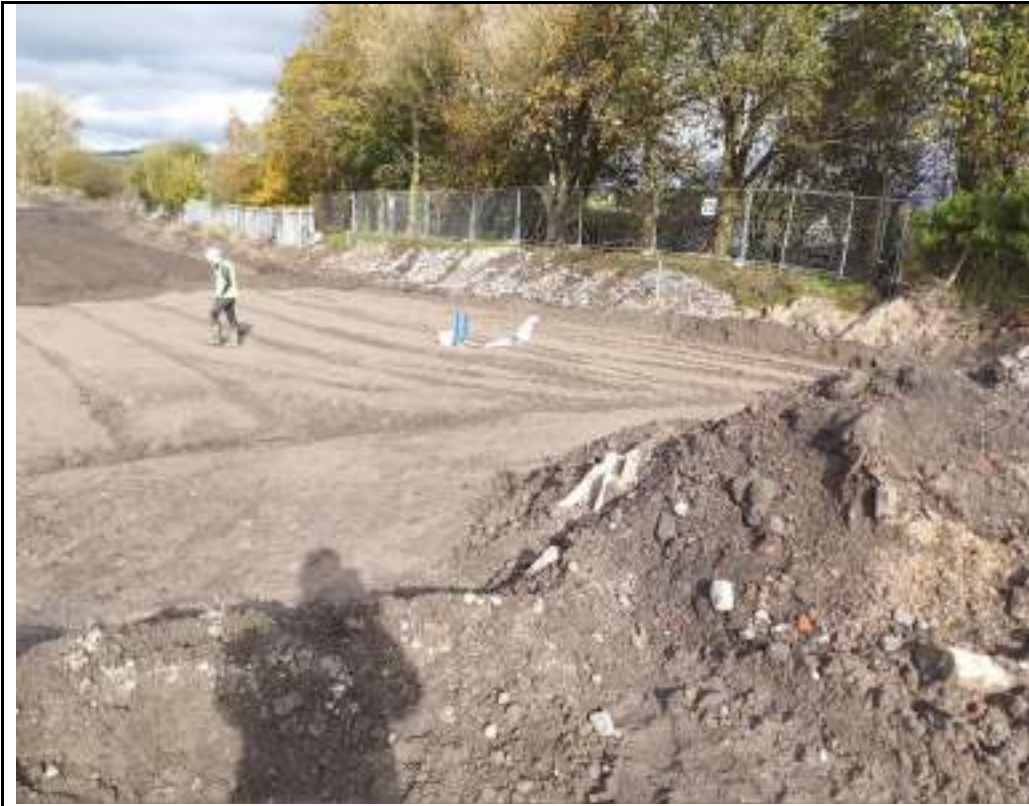
Photograph 23: Sand Replacement Testing in eastern part of the site.

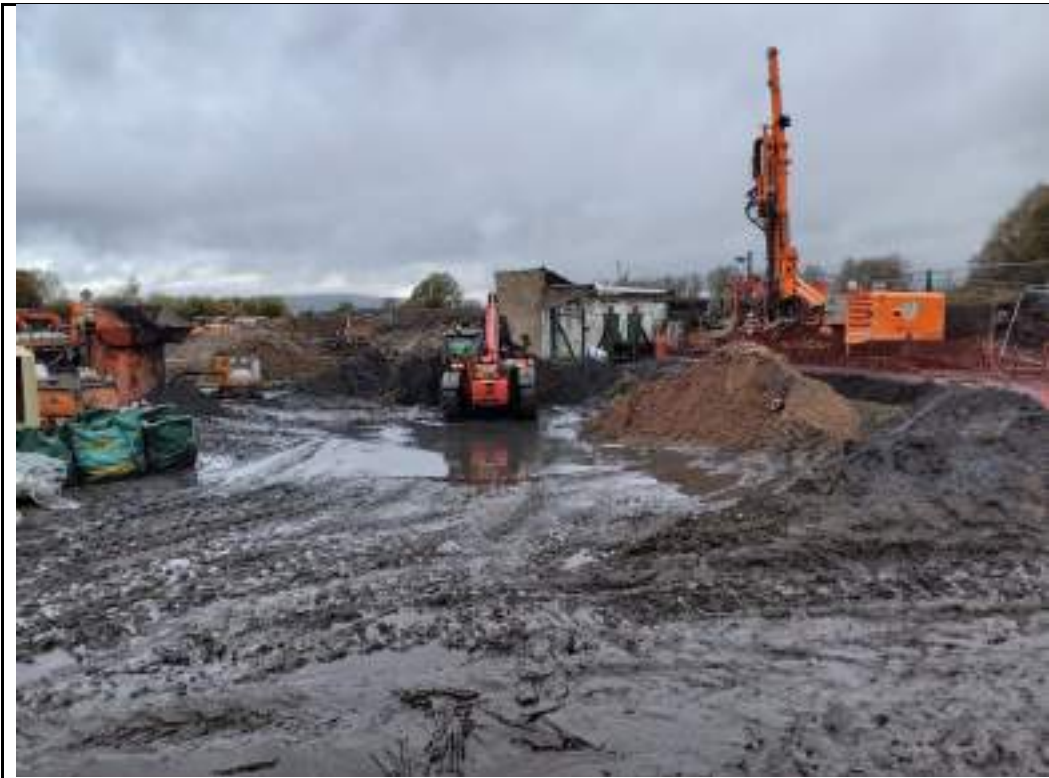
Photograph 2: Grouting shaft no.6 in eastern part of the site.

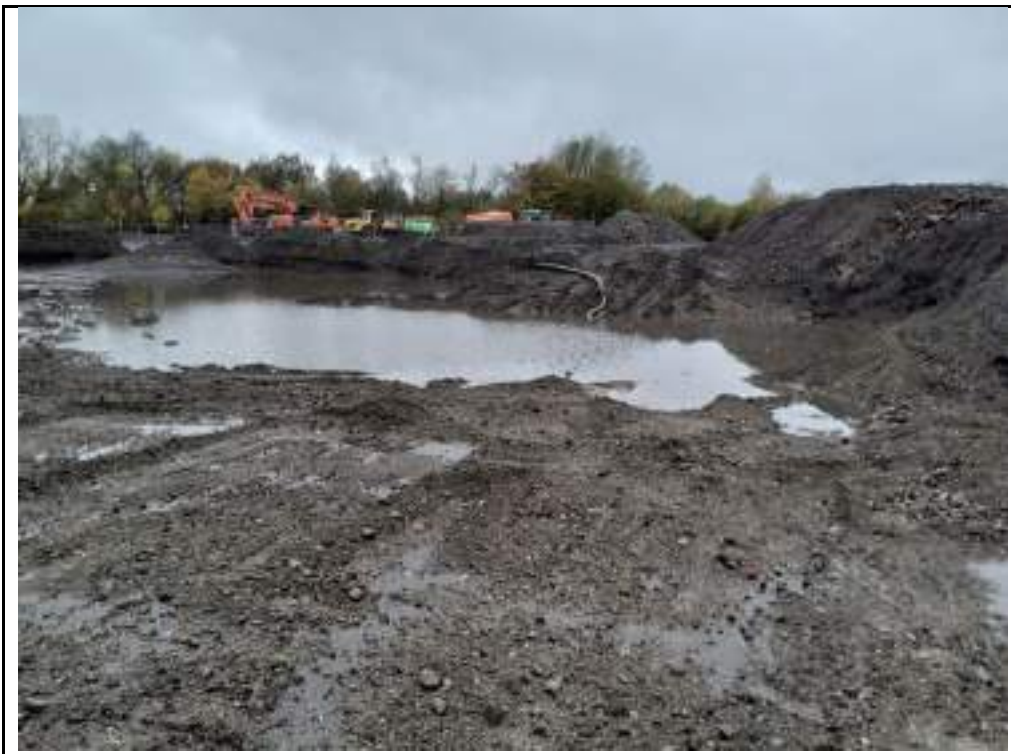
Photograph 4: Standing water in northeastern part of the site.

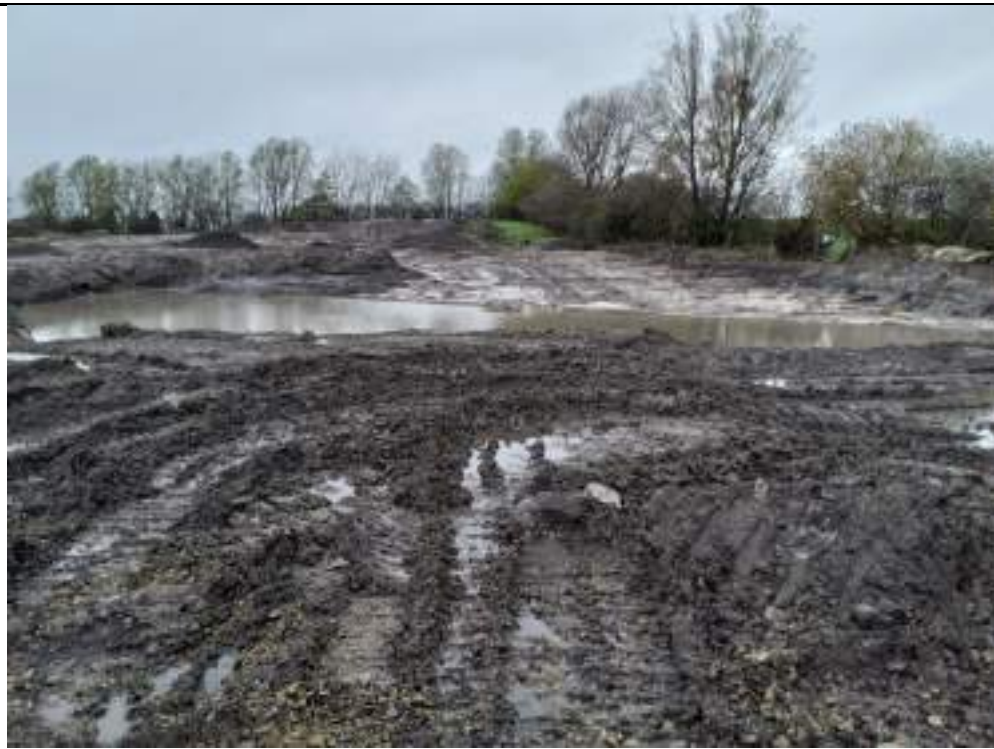
Photograph 6: Standing water in northern part of the site.

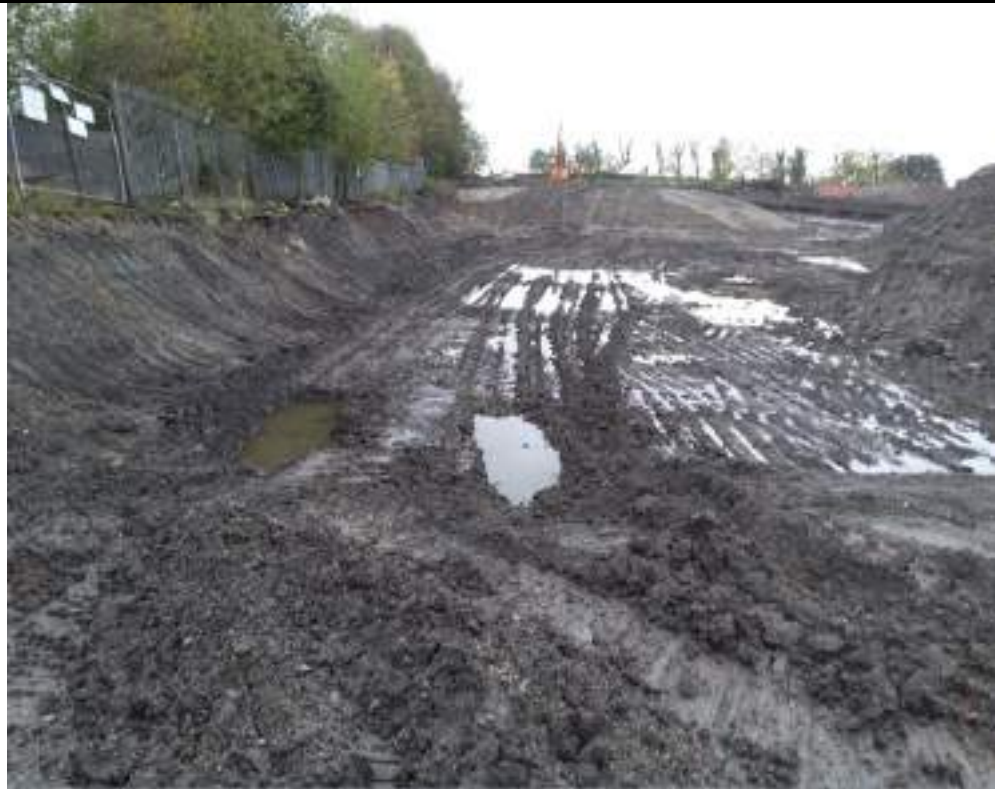
Photograph 7: Northeastern boundary of the site. Looking towards the south.

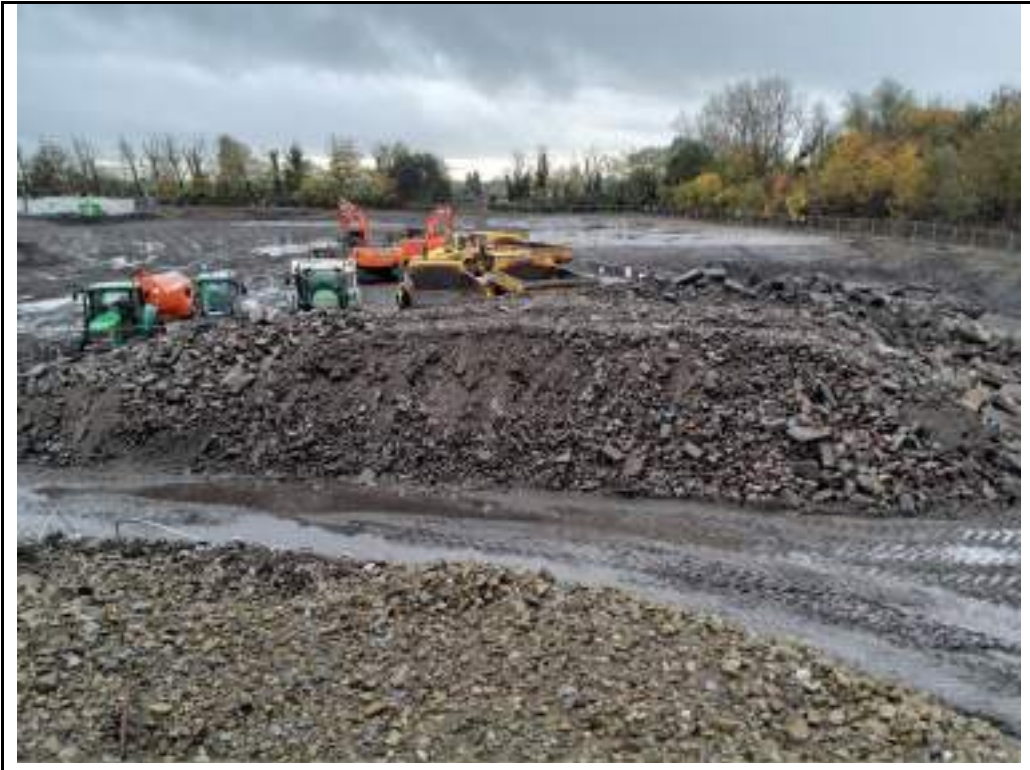
Photograph 9: Stockpile of concrete and oversized materials in northwestern part of the site.

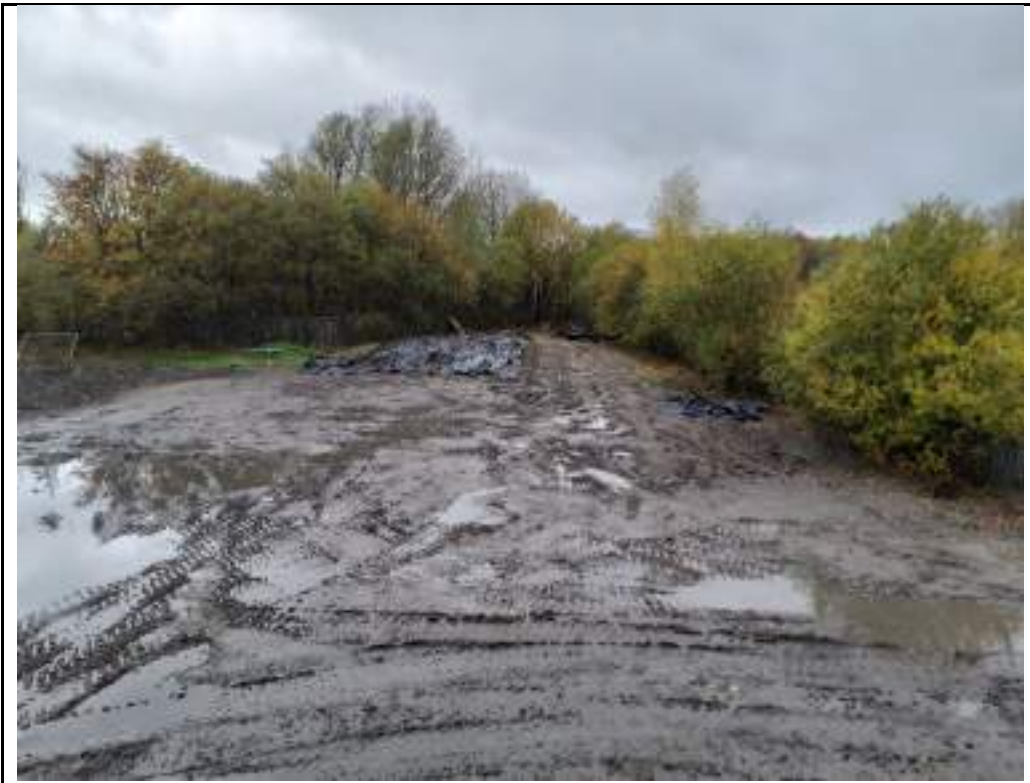
Photograph 10: Stockpile of TPH contaminated materials in western boundary of the site.

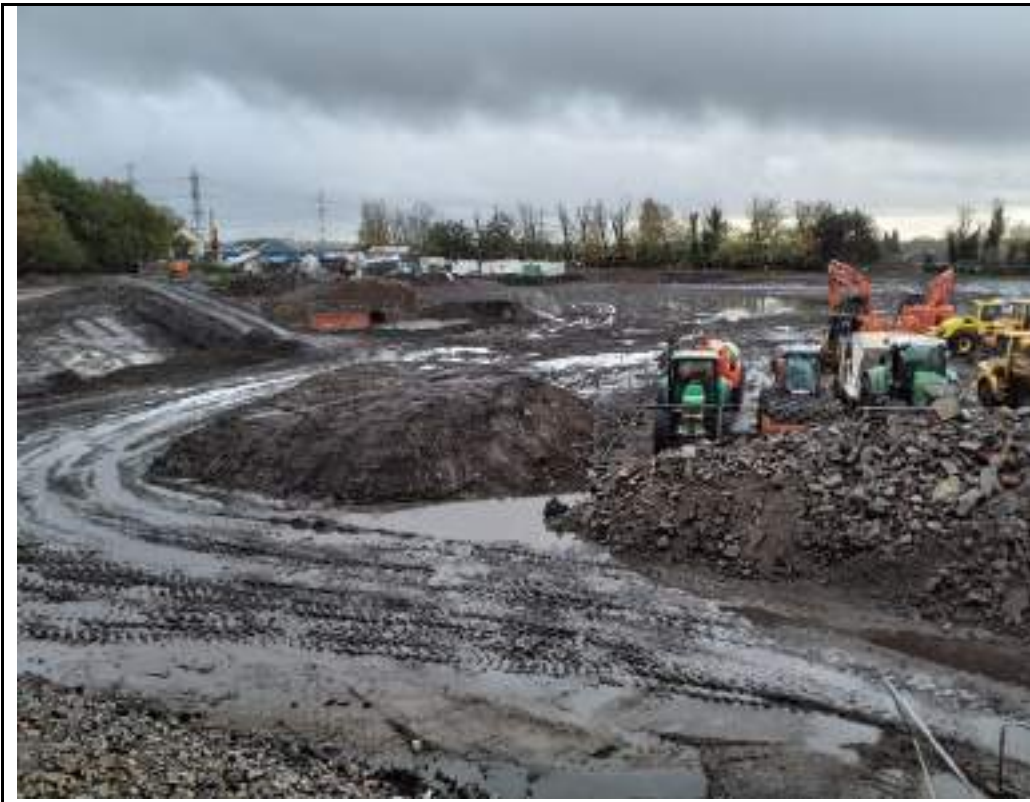
Photograph 11: Overview of the site. Looking towards the south.
