**SITE VISIT REPORT 15220-HYD-XX-XX-SVR-GE-1018**

**SHEET NO.: 6 of 18**

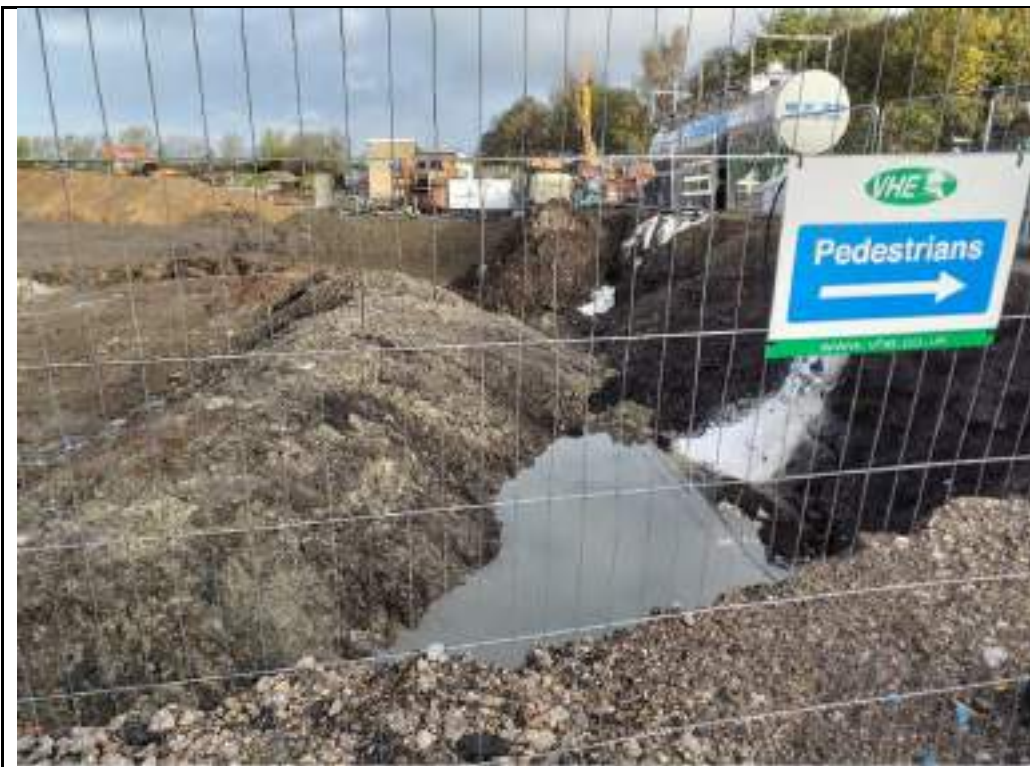
Photograph 12: Standing water and stockpile of unsuitable materials in southeastern part of the site.
