| SITE VISIT REPORT 15220-HYD-XX-XX-SVR-GE-1035 | | SHEET NO.: 1 of 20 | |
| Project: Stopes Road, Bolton | | Date: 09/11/22 | |
| Client: Harworth | | Weather: Cloudy | |
| Doc Ref: 15220-HYD-XX-XX-SVR-GE-1035 | | Status & Revision: S2 – P1 | |

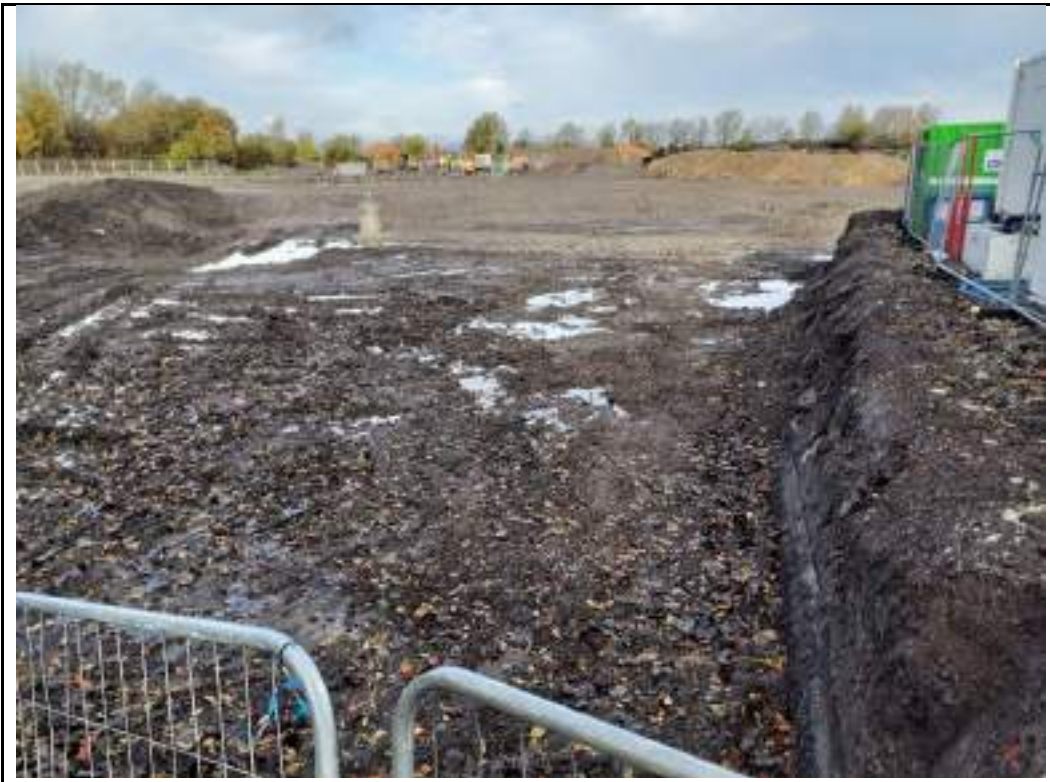
Photograph 14: Backfilled area in southern part of the site.

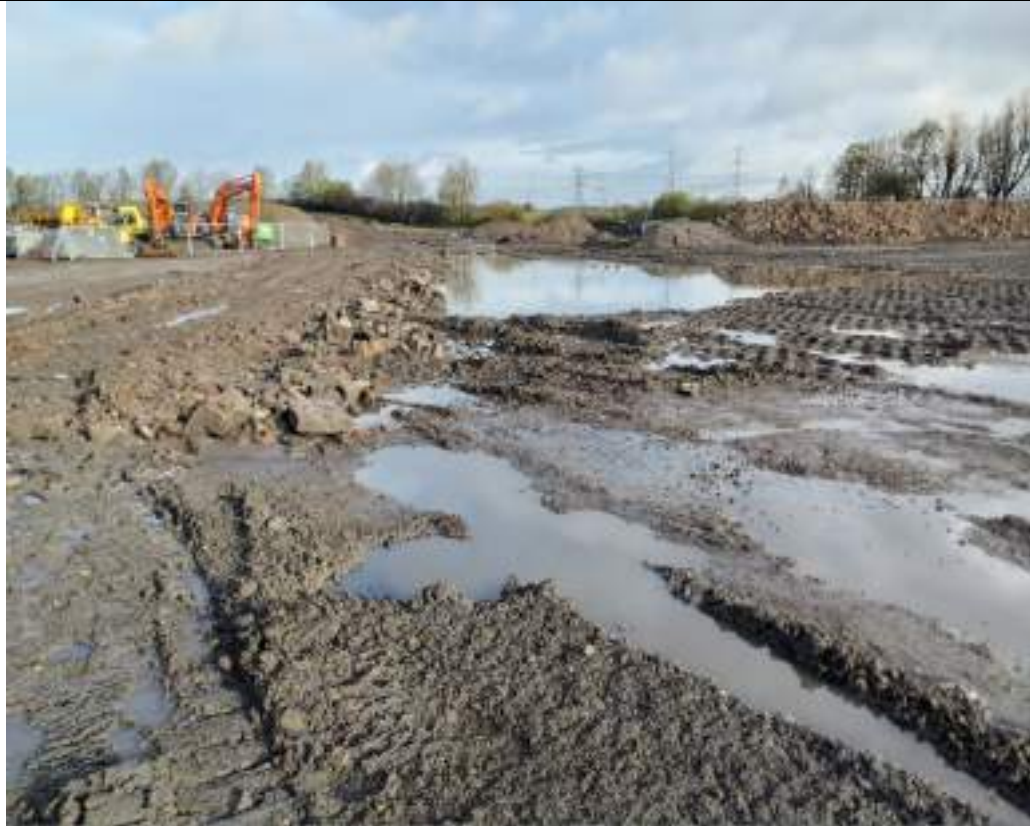
Photograph 15: Standing water in southeastern part of the site.

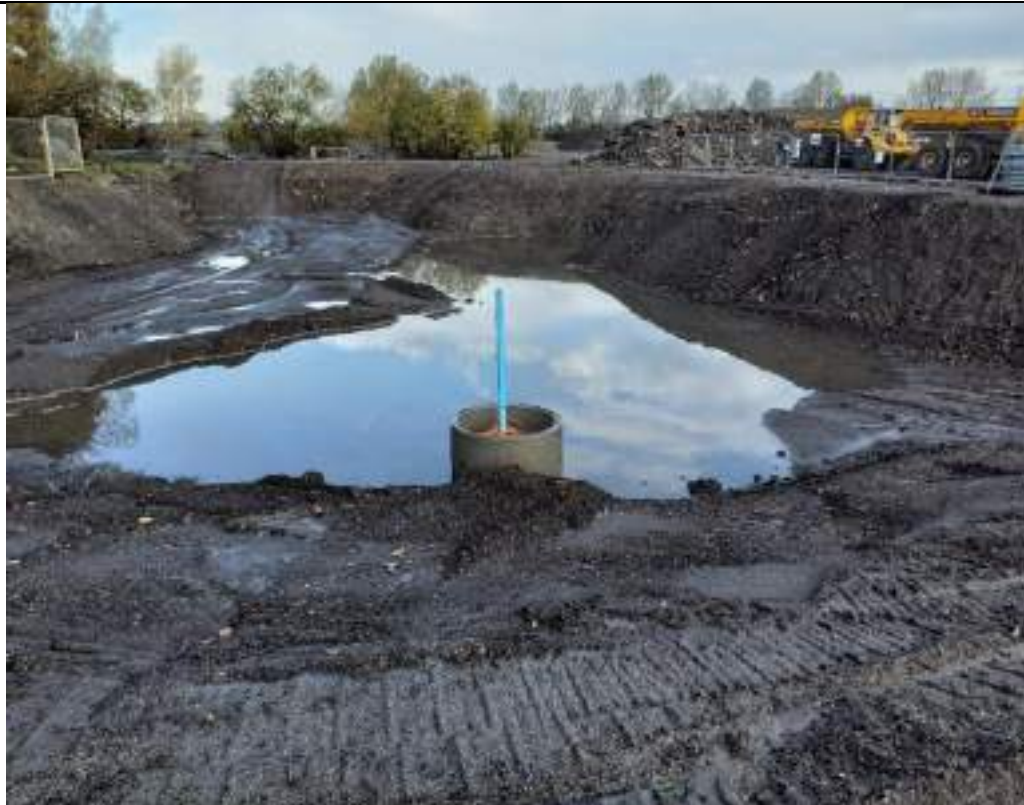
Photograph 16: Standing water in western boundary of the site.

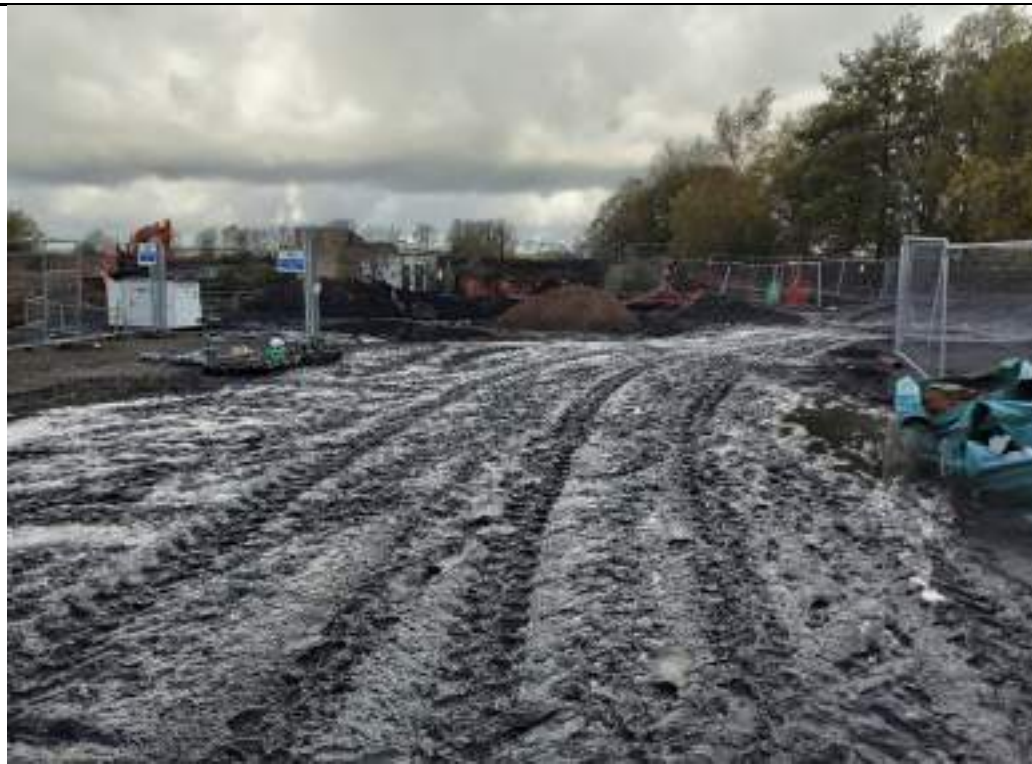
Photograph 2: Grouting platform after completion of grouting shaft no.6 in eastern part of the site.

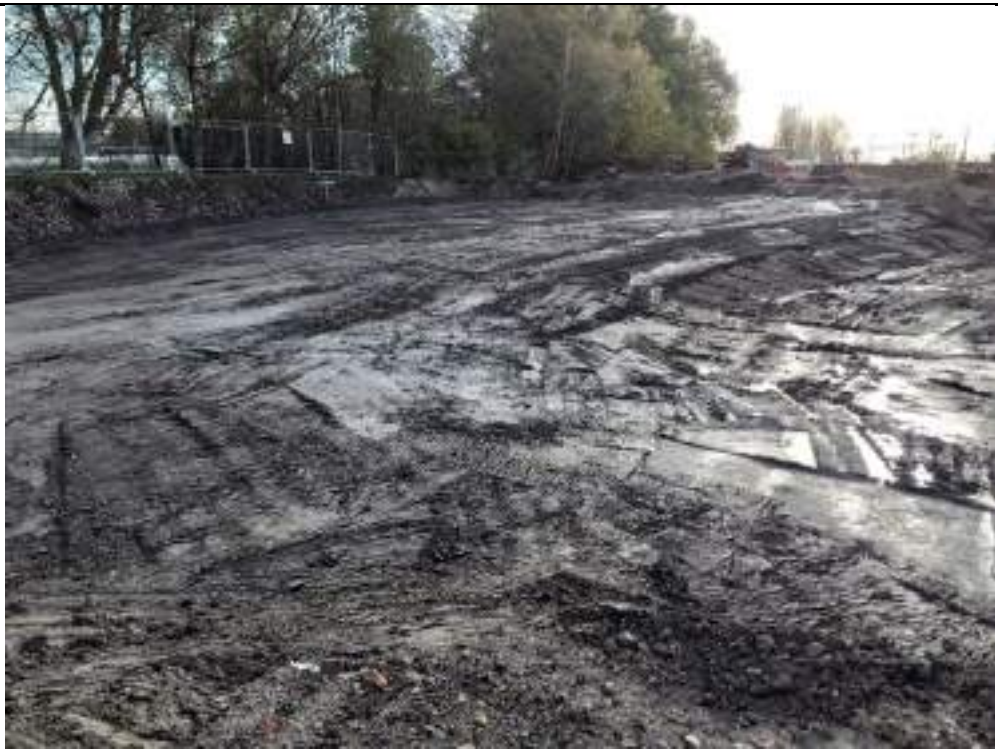
Photograph 4: Eastern part of site backfilled with lime treated soil.

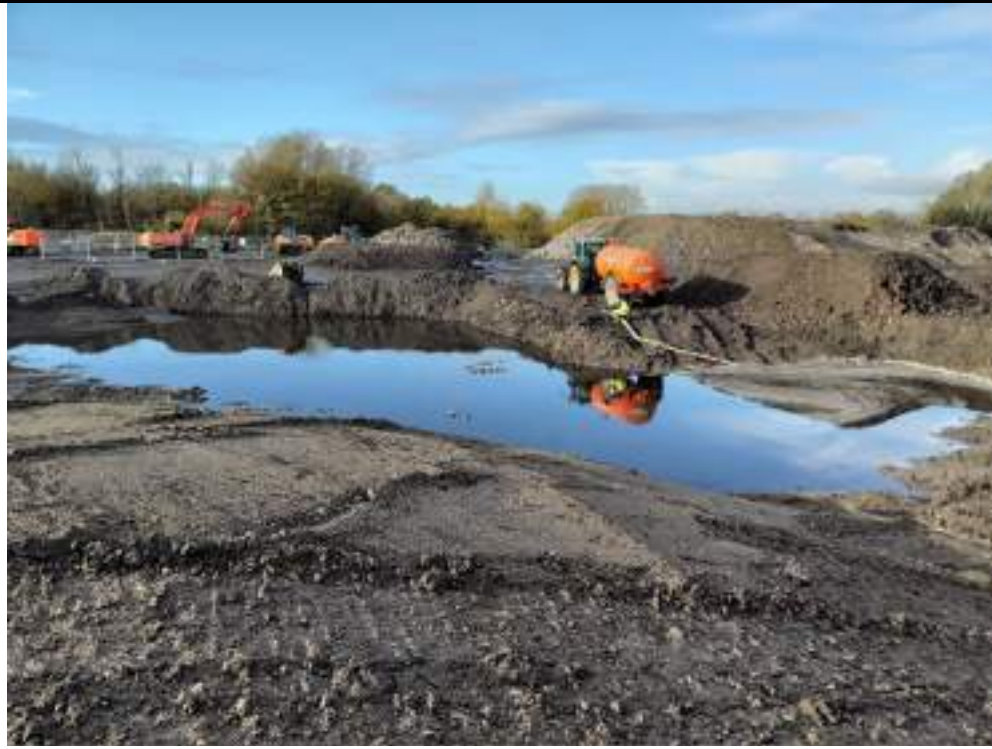
Photograph 5: Dewatering excavation in the northeast.

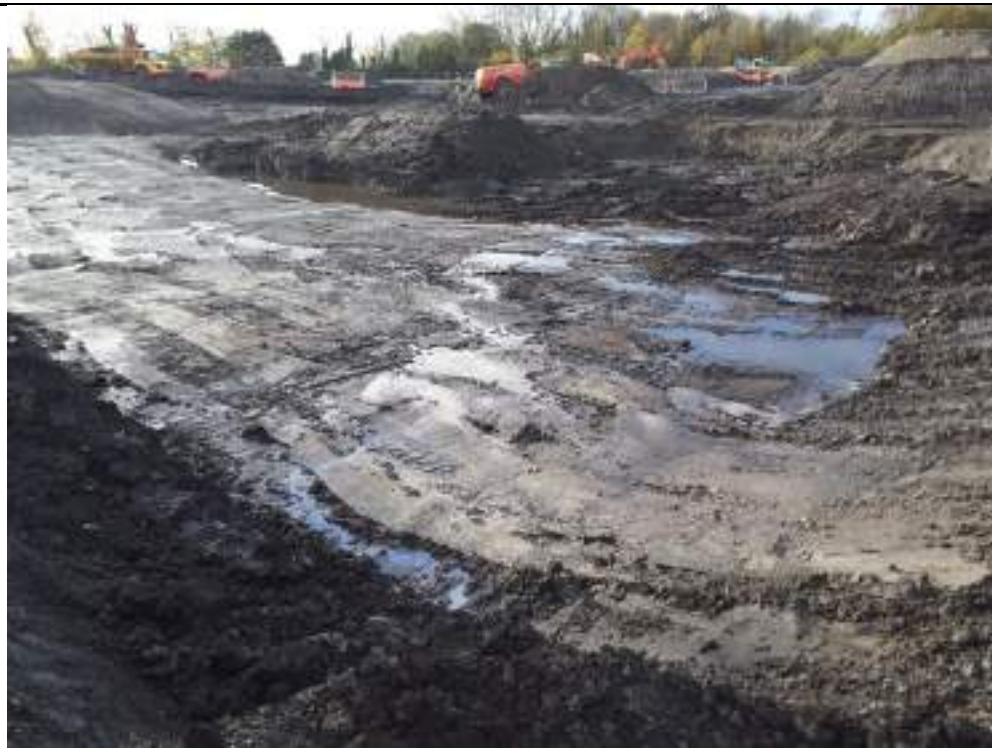
Photograph 6: Excavation in the northeast where organic made Ground was removed.

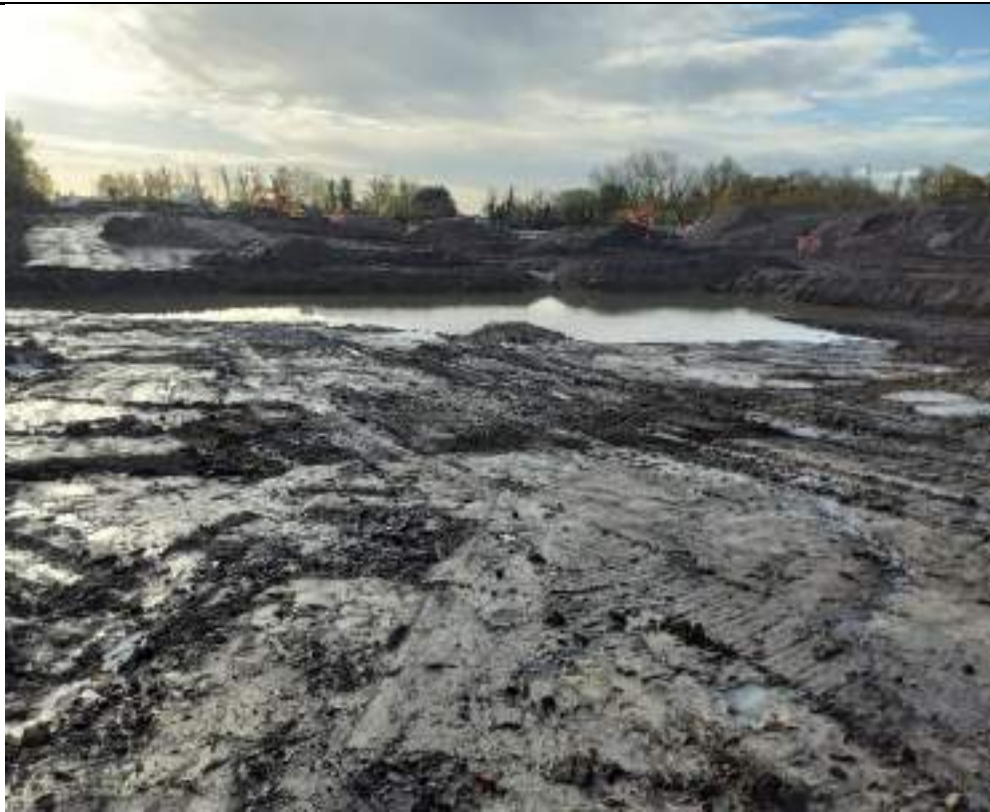
Photograph 8: Standing water in the northeast.

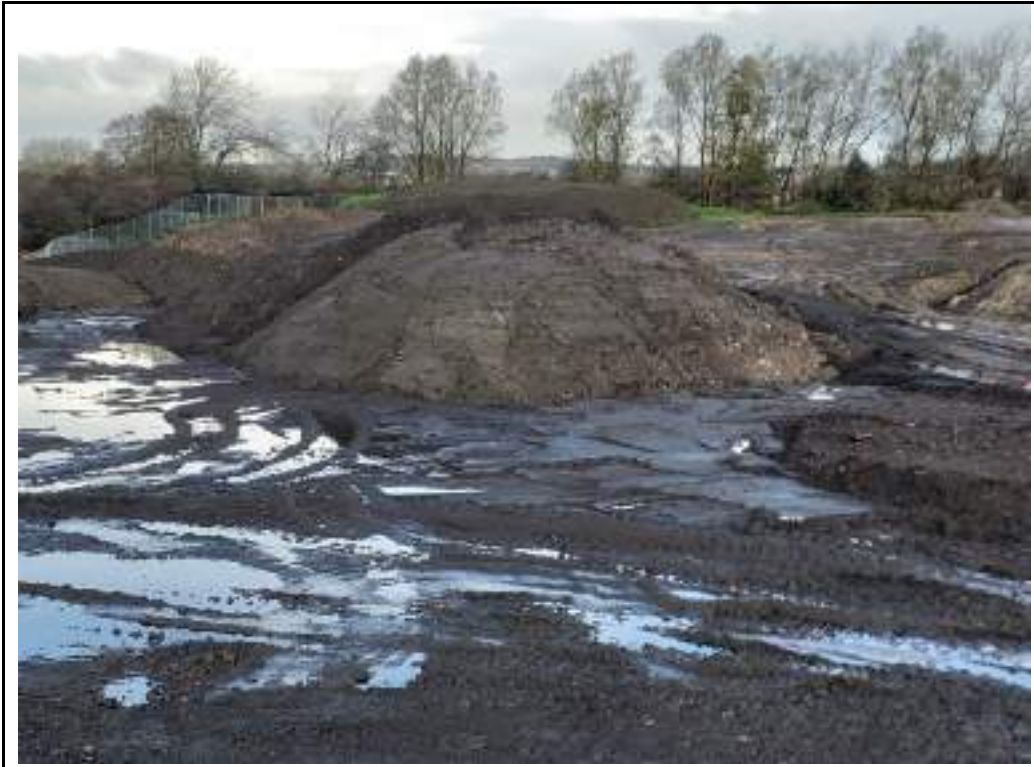
Photograph 9: Stockpile of peat materials in the northwest excavated from the northeastern part of the site.

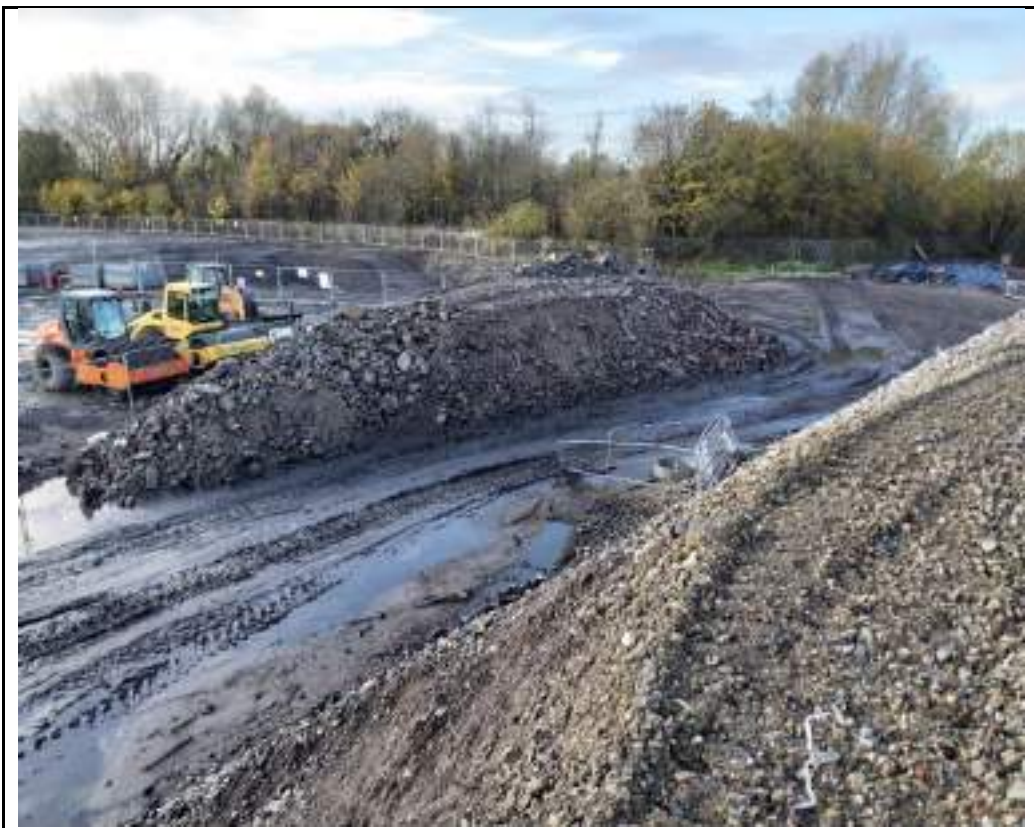
Photograph 10: Stockpile of oversized materials and concrete in the northwest.

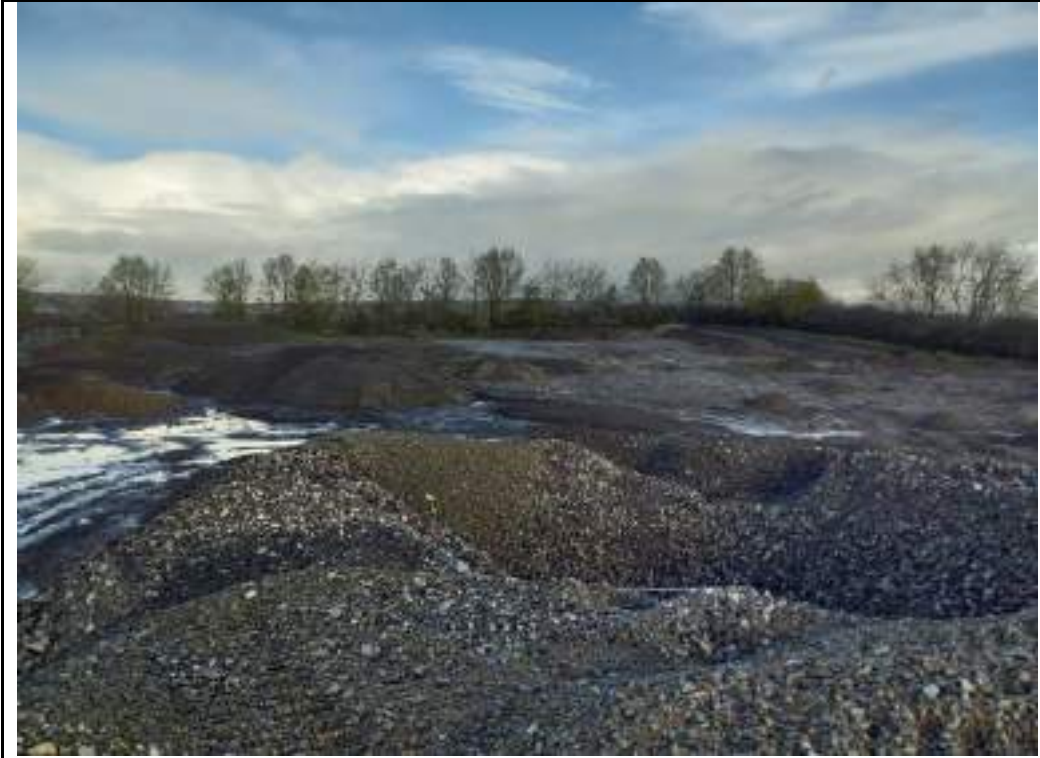
Photograph 11: Overview of stockpiles in the north. Looking towards the north.

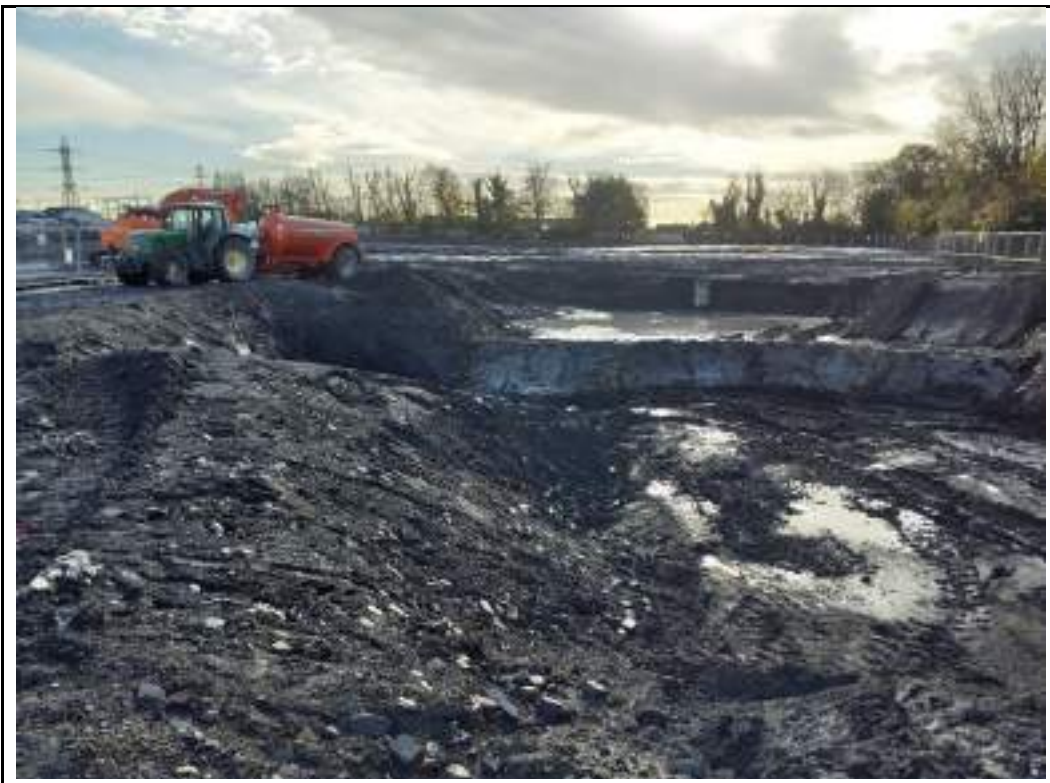
Photograph 14: Discharging water in excavation in the western boundary of site. Water pumped from excavation in the northeast.

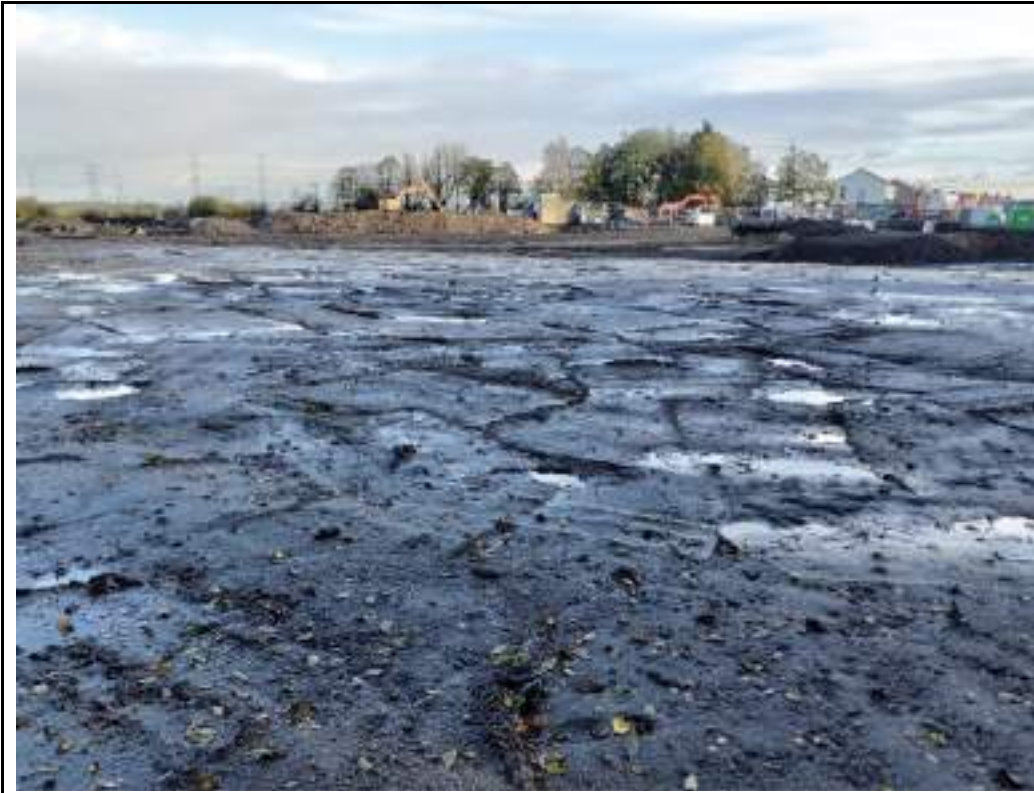
Photograph 19: Overview of the southern part of site. Looking towards the northeast.

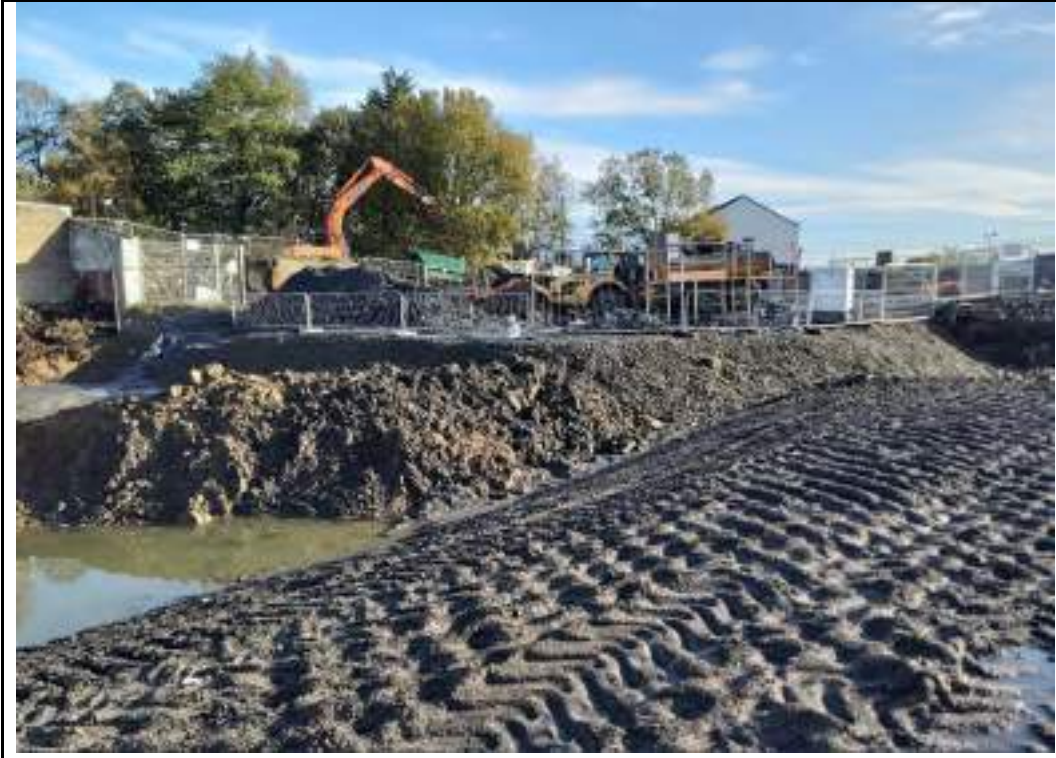
Photograph 21: Mine shaft treatment platform after completion of grouting shaft no.006.

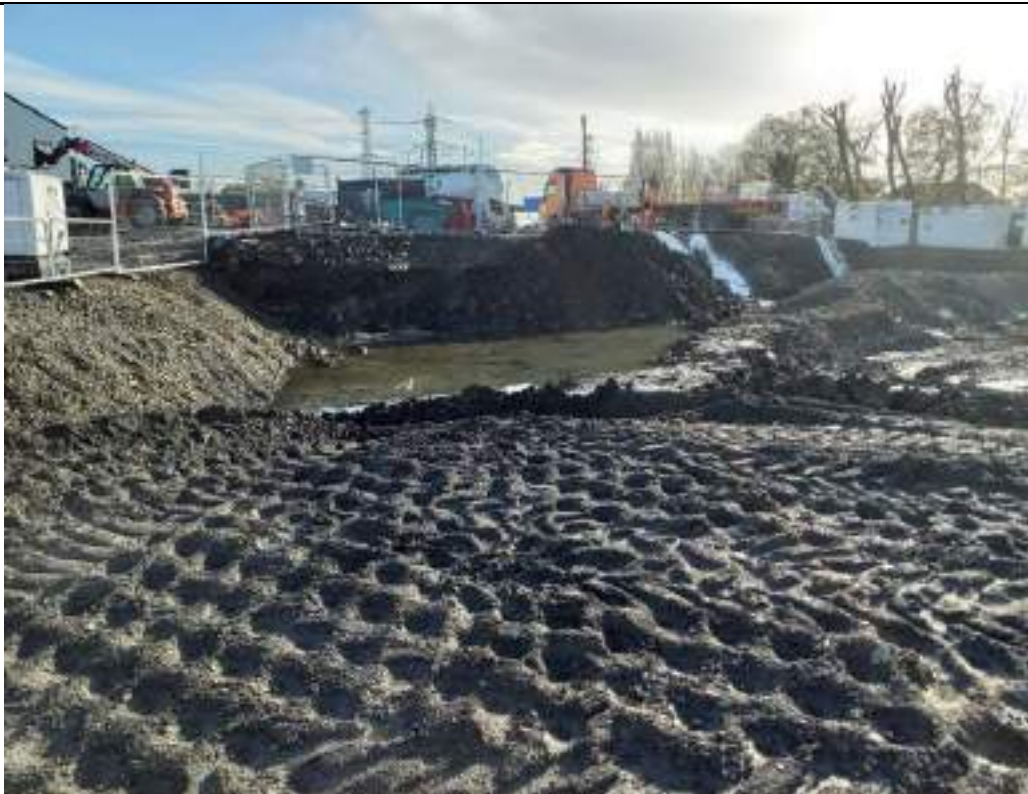
Photograph 22: Standing water in the southwest of shaft treatment platform.

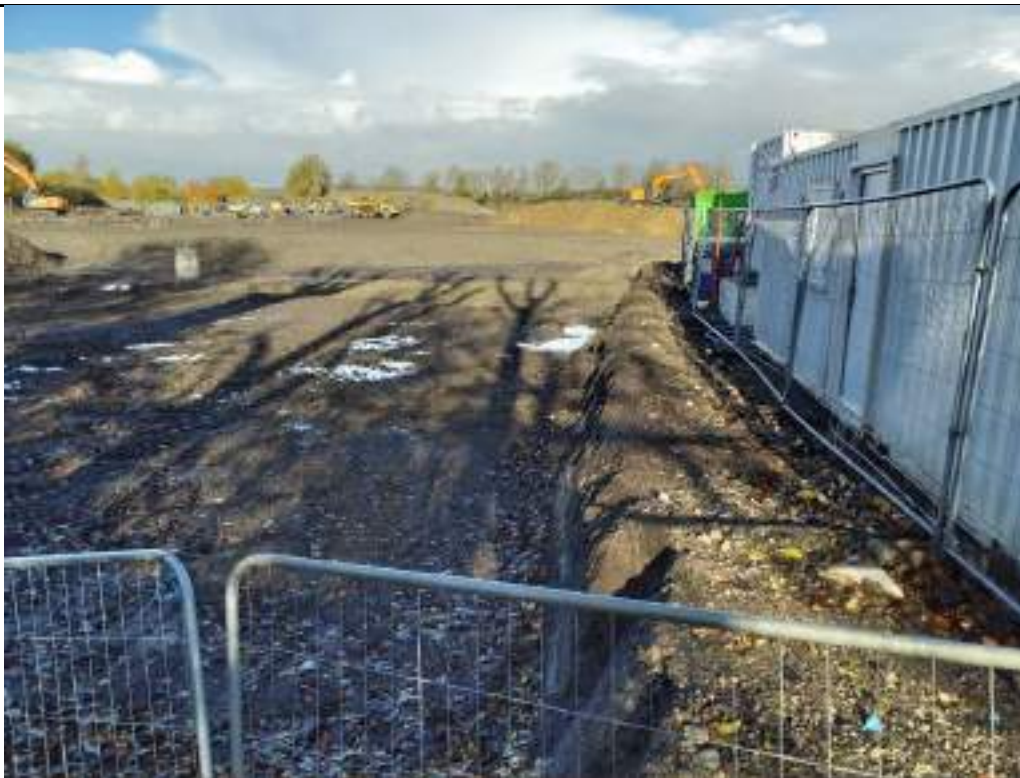
Photograph 24: Backfill in the northwest of VHE compound.

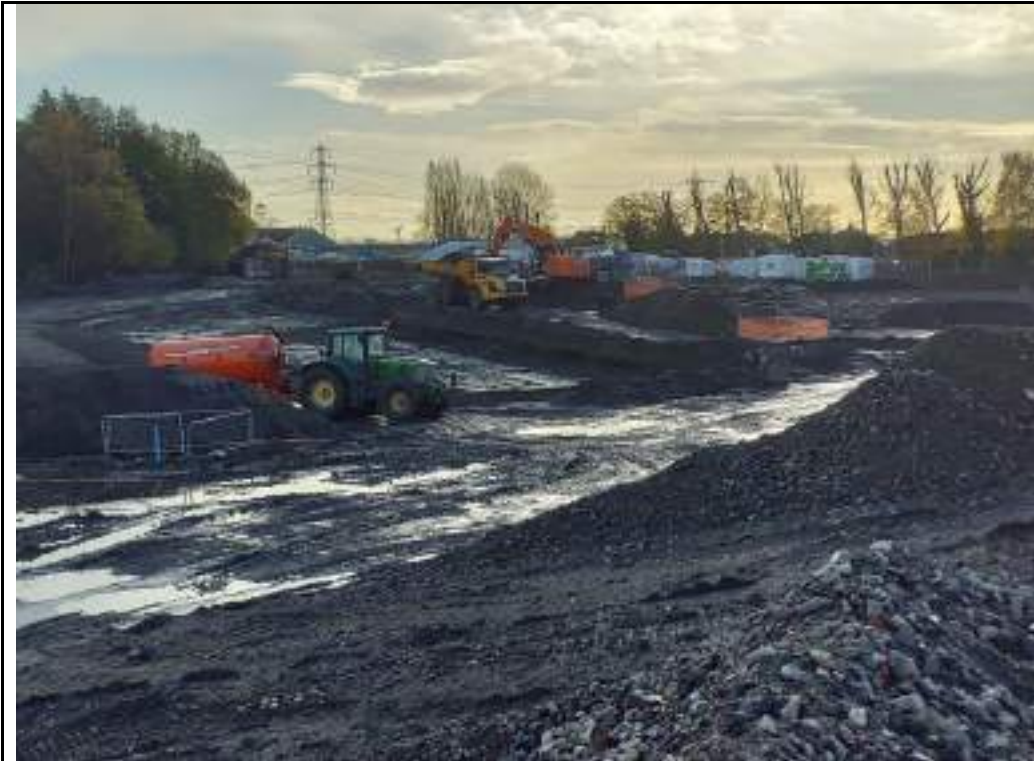
Photograph 25: Loading deleterious material into truck in the southeast.

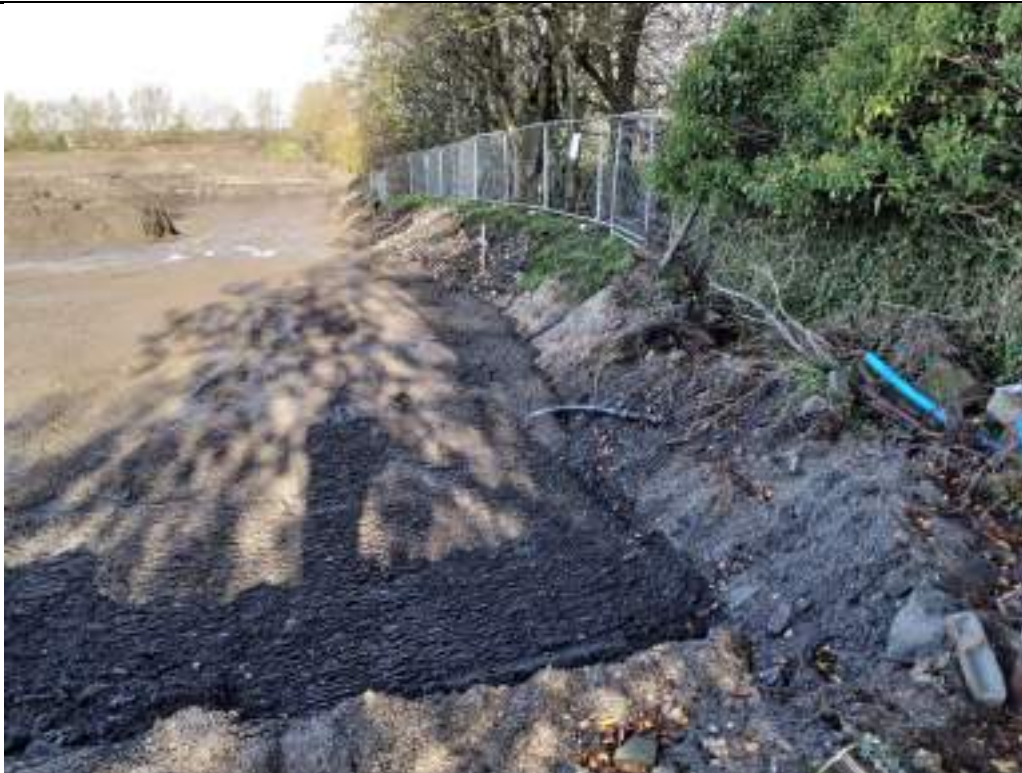
Photograph 28: Southeastern boundary of site. Looking towards the north.

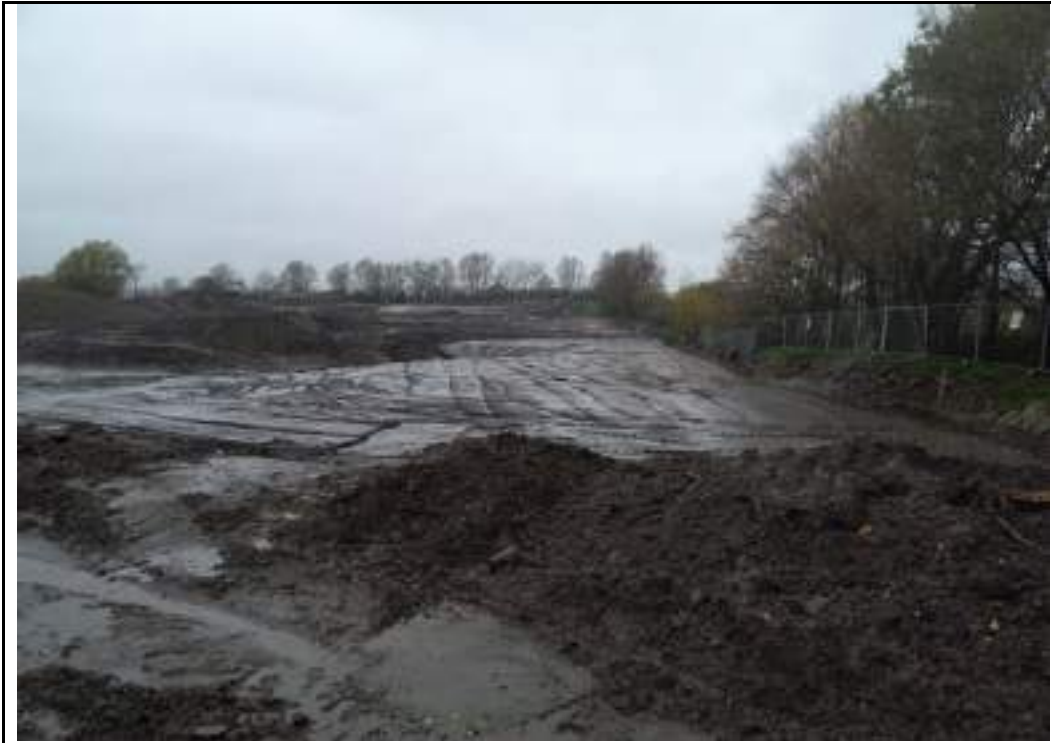
Photograph 1: Overview of eastern part of the site. Looking towards the north.

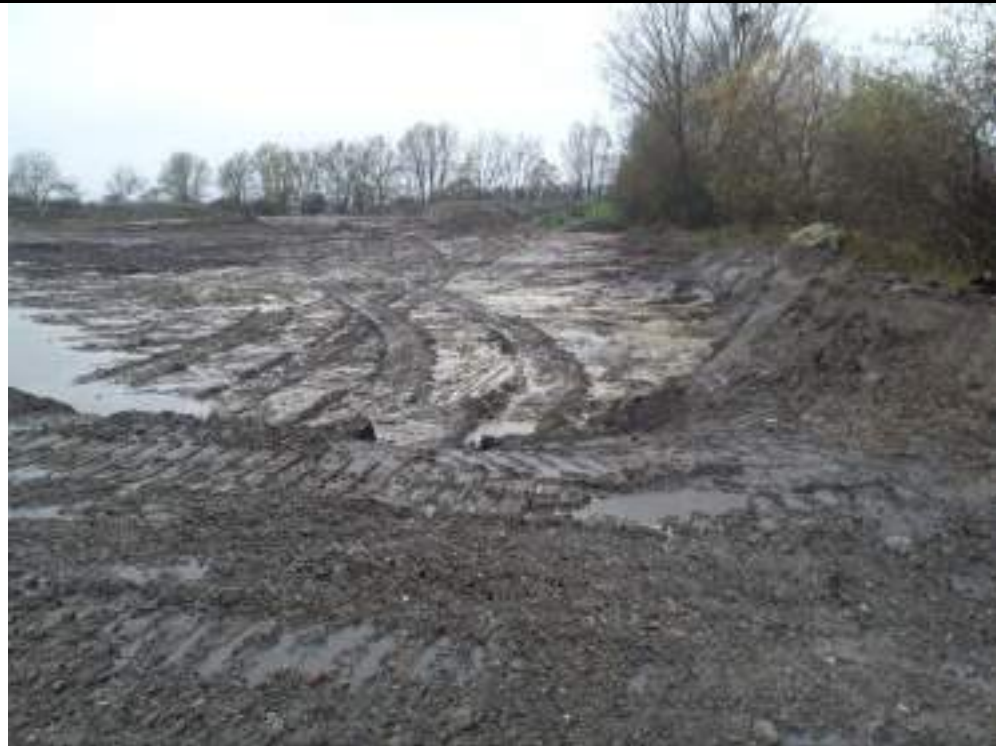
Photograph 5: Excavation in the northeast.

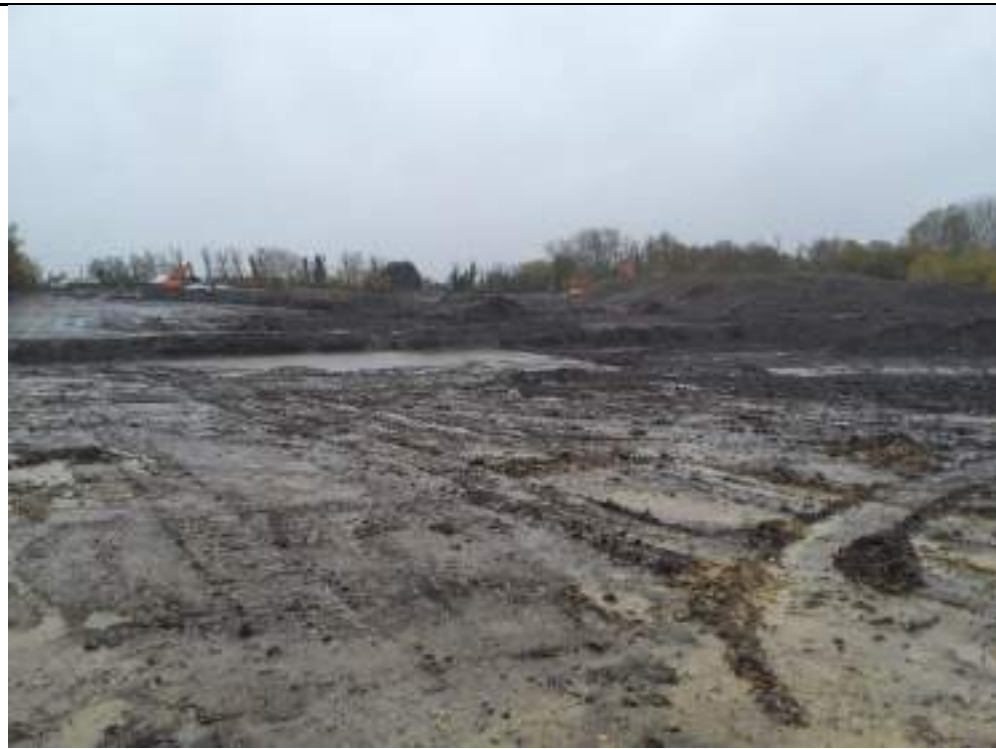
Photograph 6: Standing water in the northeast.

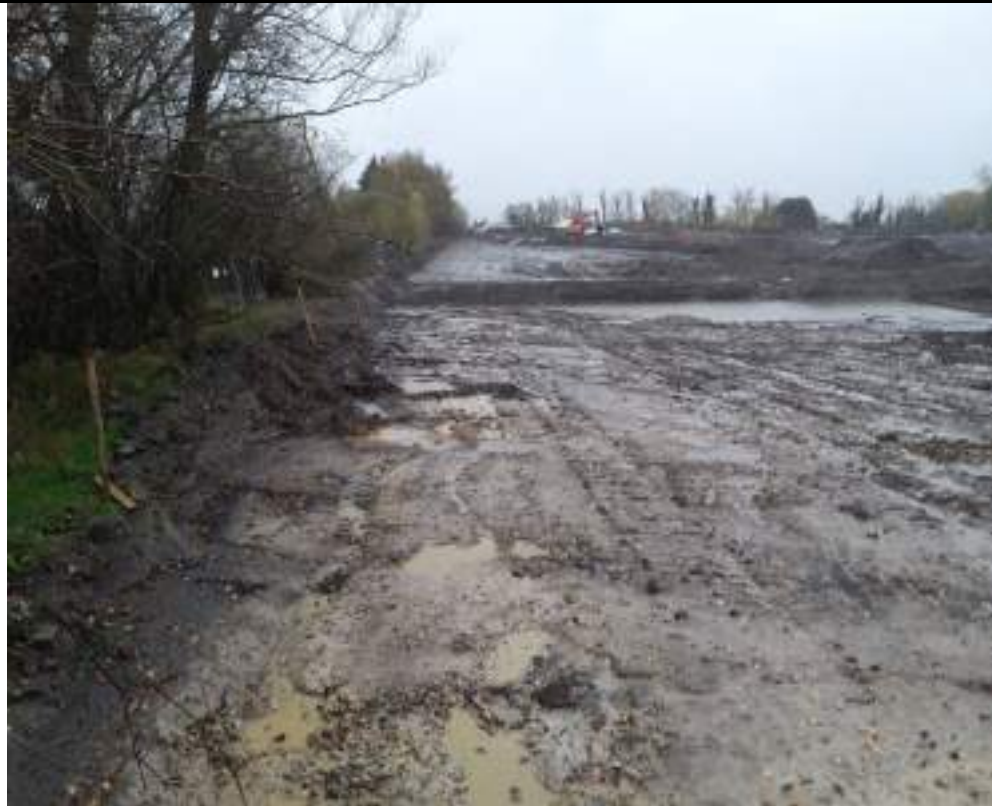
Photograph 7: Eastern boundary of the site. Looking towards the south.

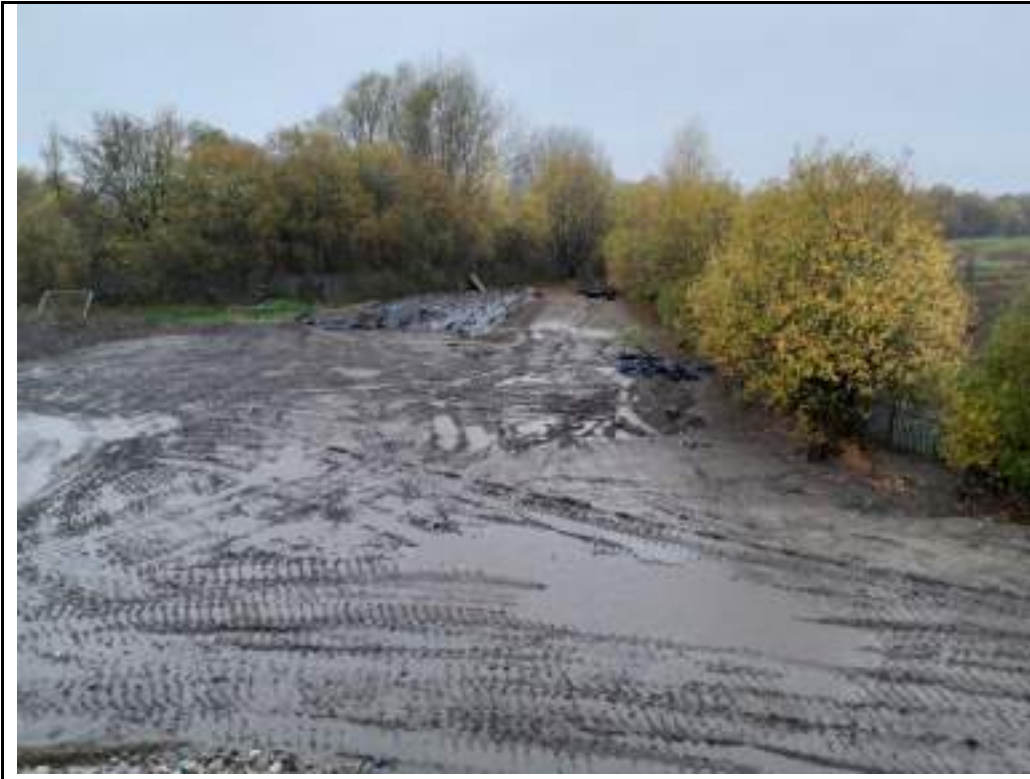
Photograph 11: Stockpile of TPH contaminated materials in the west.

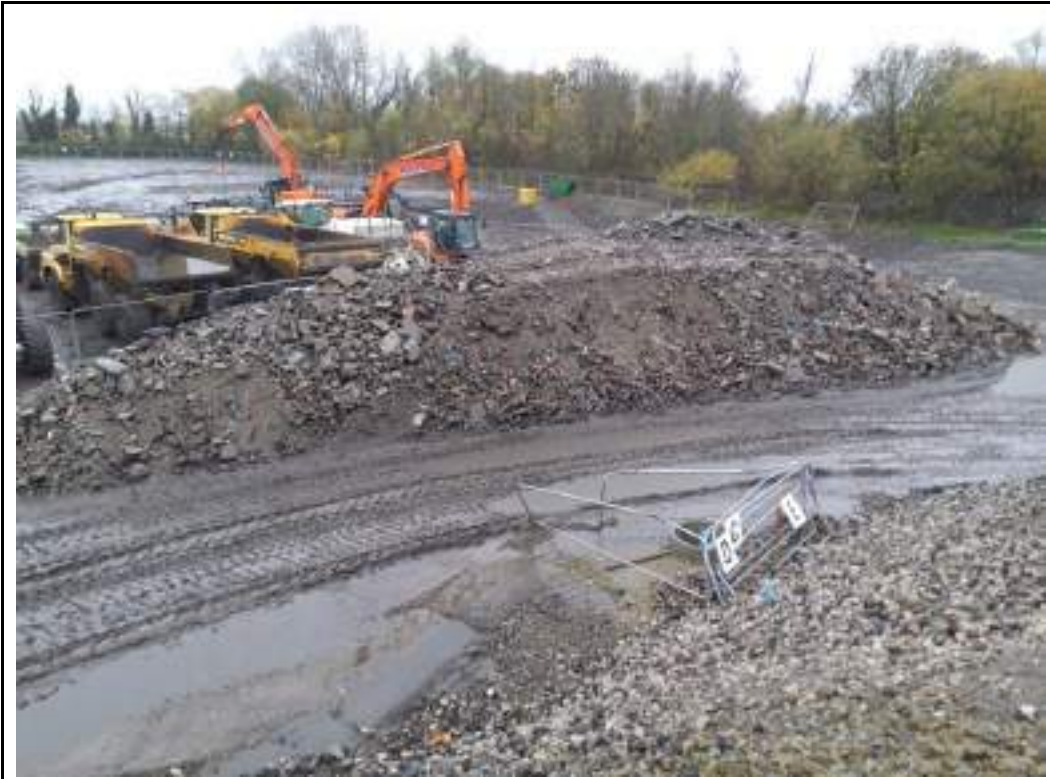
Photograph 93: Stockpile of oversize and concrete materials in the west.

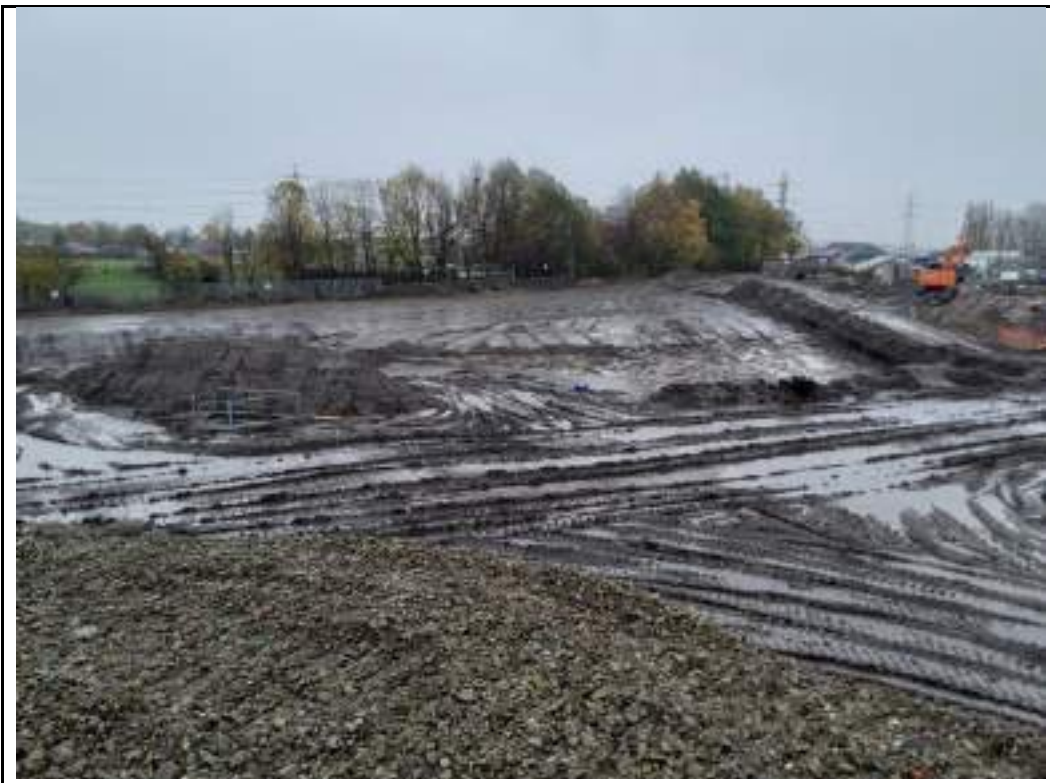
Photograph 14: Backfilled area in the east. Looking towards the east.

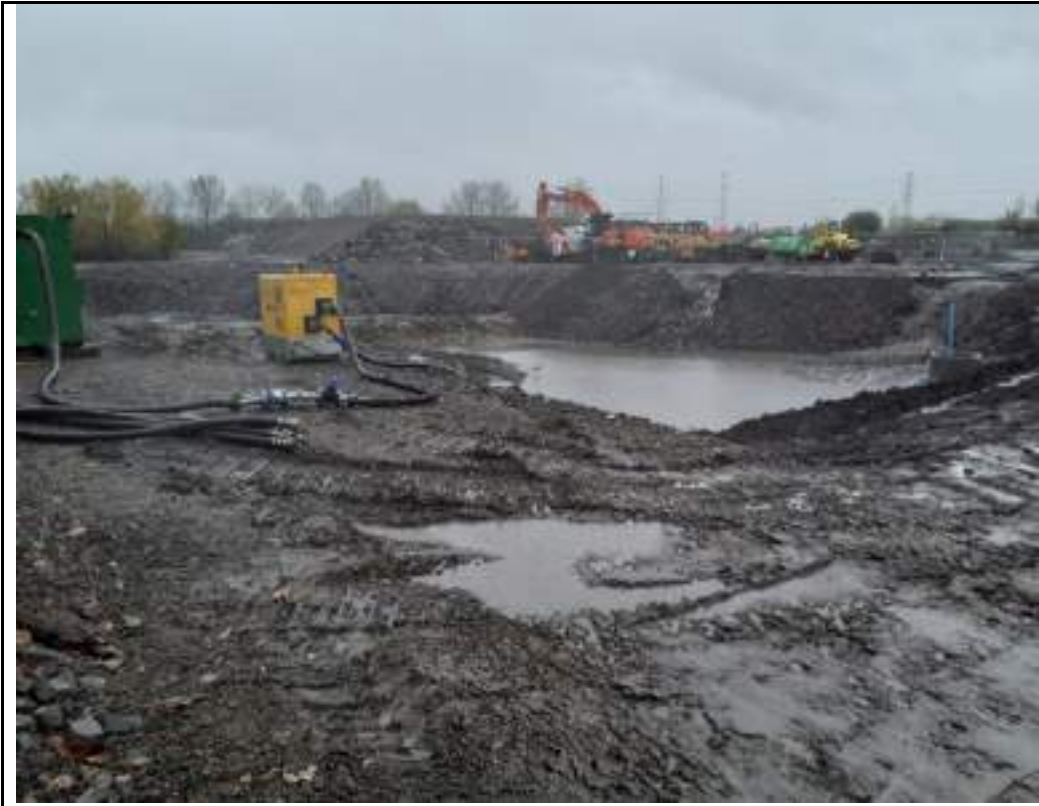
Photograph 15: Standing water and dewatering tools in the west.

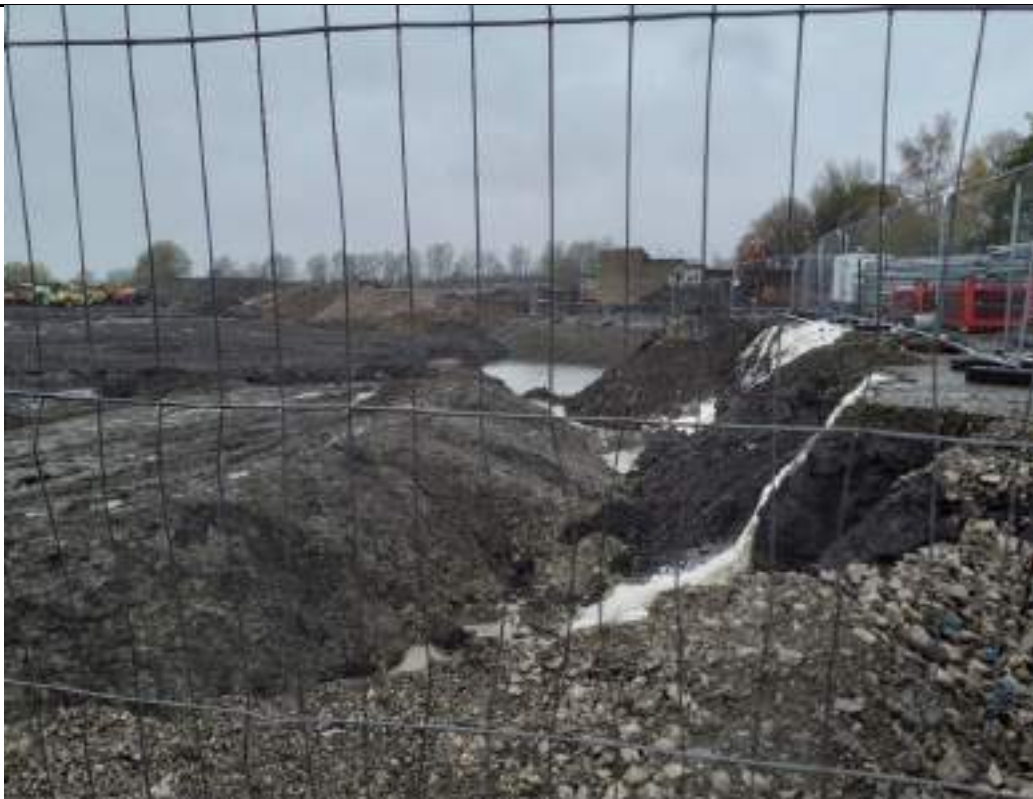
Photograph 18: Standing water in the southeast.

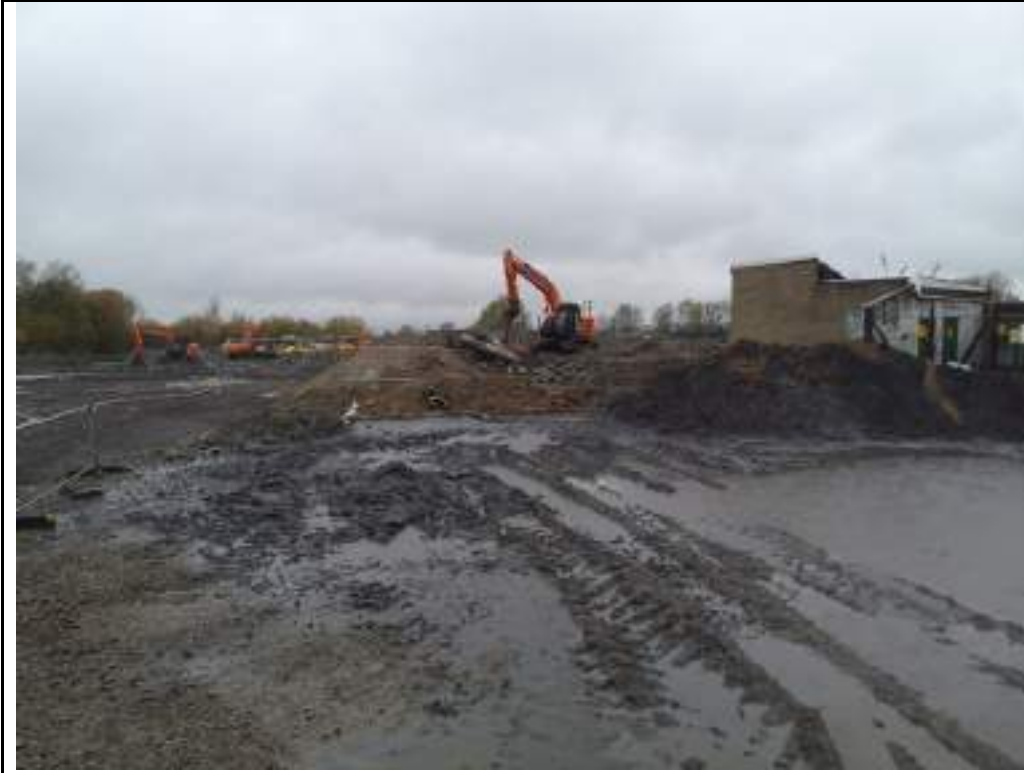
Photograph 19: Removing and breaking concrete in the southeast.
