| SITE VISIT REPORT 15220-HYD-XX-XX-SVR-GE-1035 | | SHEET NO.: 1 of 20 | |
| Project: Stopes Road, Bolton | | Date: 09/11/22 | |
| Client: Harworth | | Weather: Cloudy | |
| Doc Ref: 15220-HYD-XX-XX-SVR-GE-1035 | | Status & Revision: S2 – P1 | |

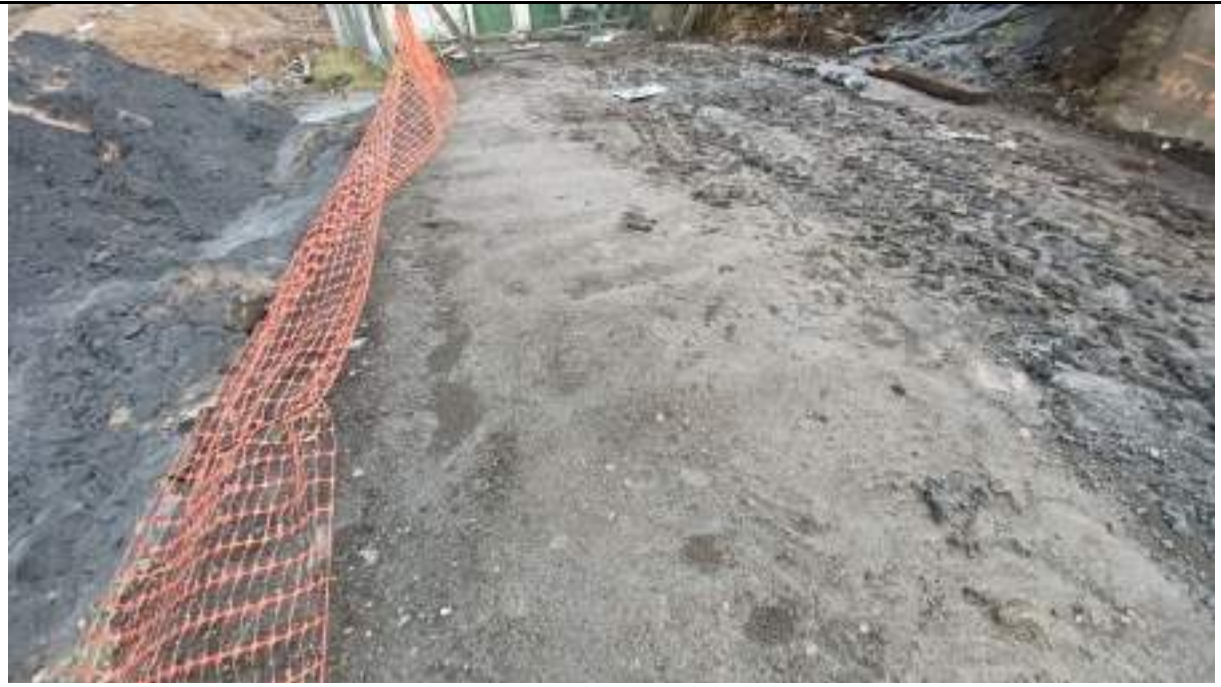
Photograph 1: Location of shaft 006 – treatment complete

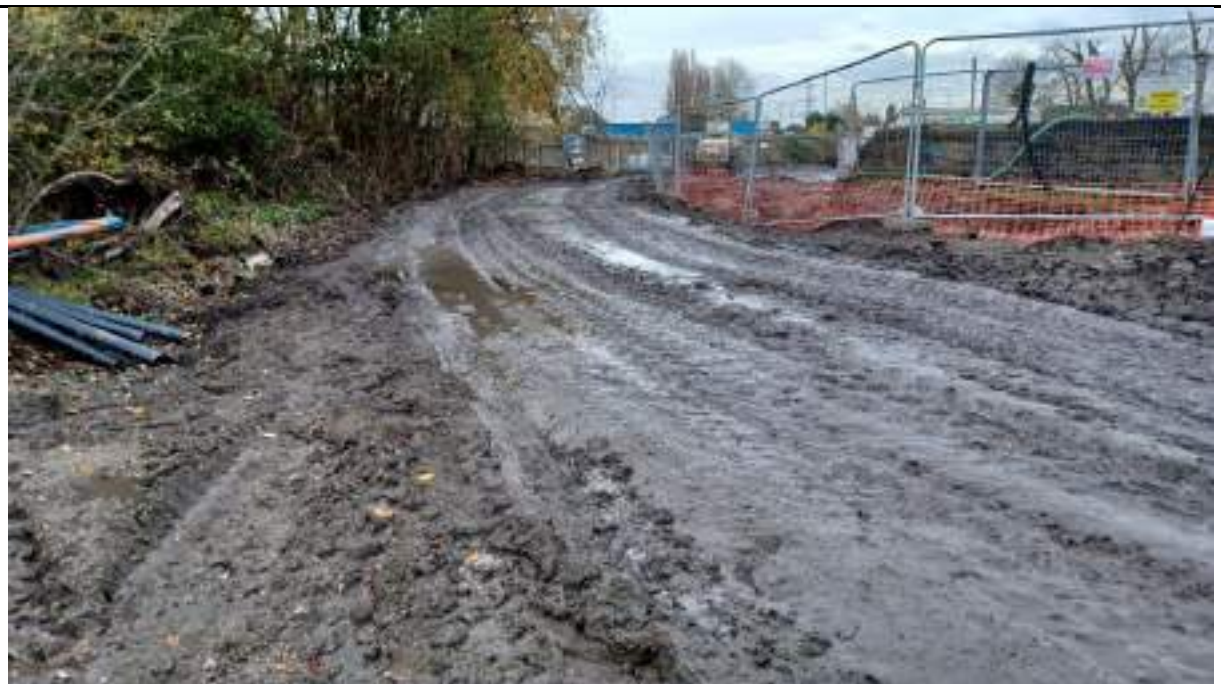
Photograph 2: Raised area behind retaining wall – VHE propose to leave some of the area in place

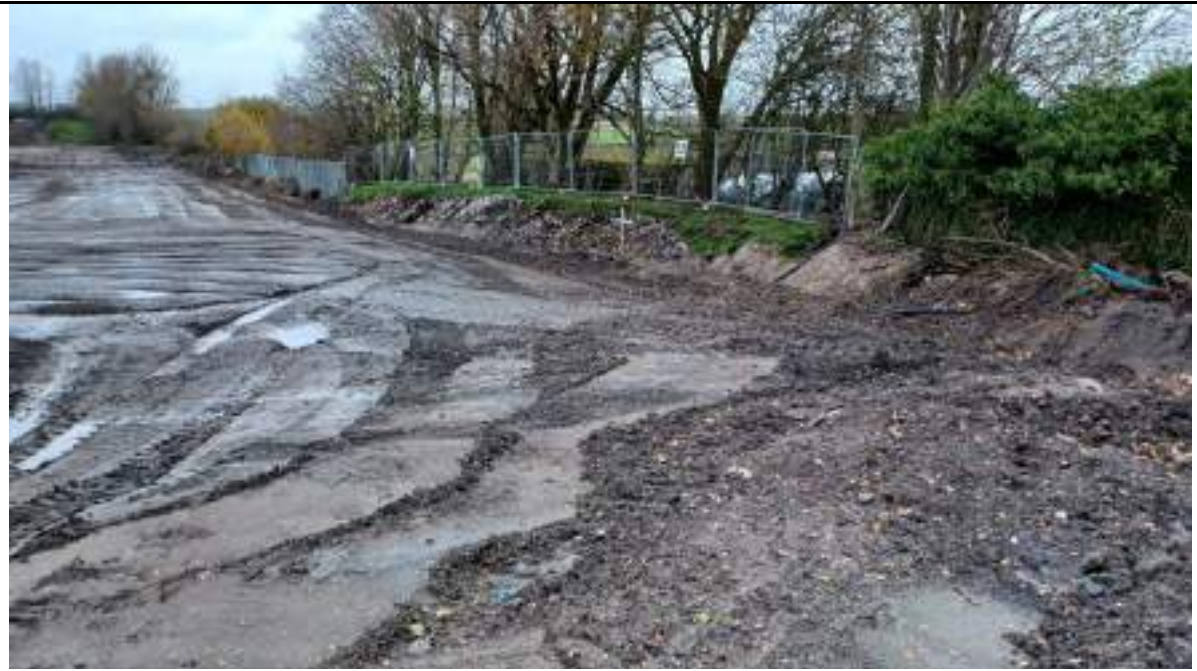
Photograph 3: Eastern boundary of the site. Looking towards the north. Boundary checks required by VHE

| Hydrock Comment | Contractor Proposal/Solution | Action Status |
|---|---|---|
| Boundary Survey | VHE to provide boundary survey to demonstrate compliance with contract | Discrepancy noted in southwestern boundary with regards to standoff (09/09/22)<br>Additional survey provided 28/09 but no charge to boundary.<br>Meeting of 18/11 – VHE to check boundary and re-excavate where necessary |

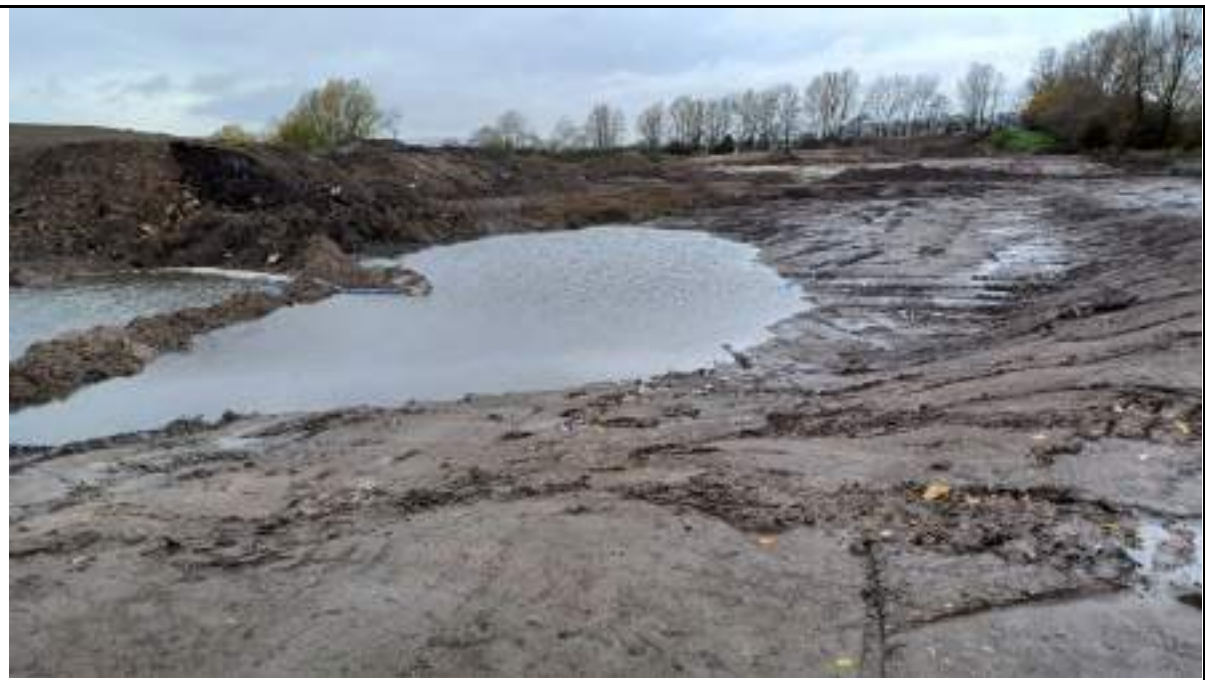
Photograph 4: Fill proof rolled to shed water. Significant standing water

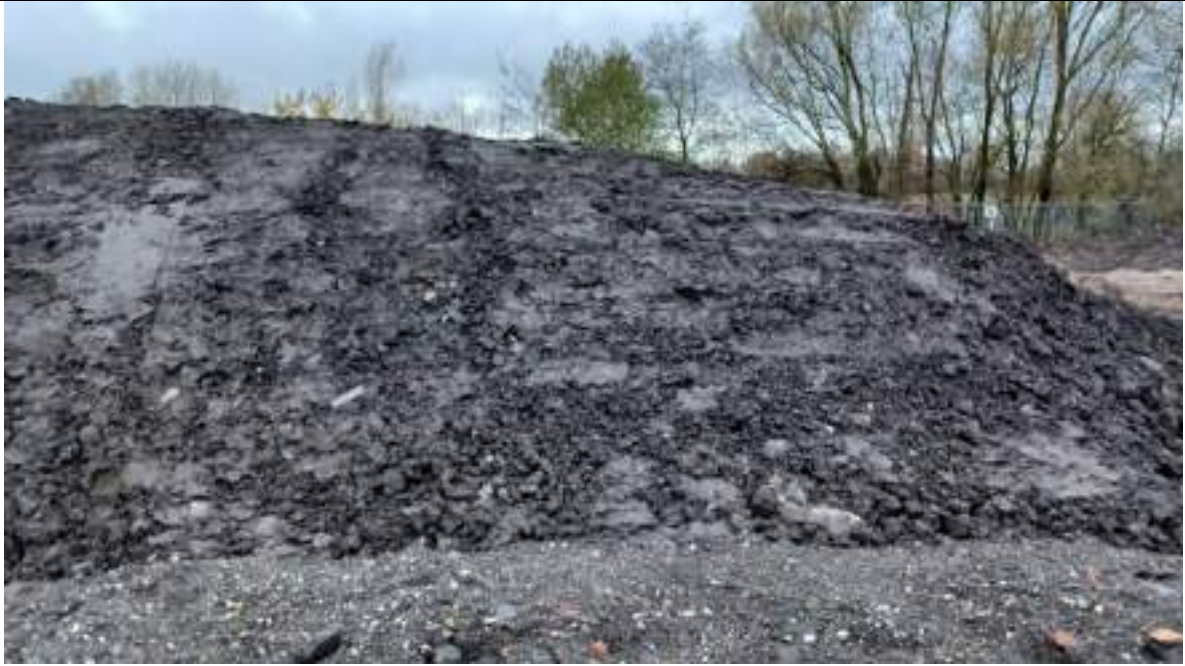
Photograph 7: Organic material stockpiled separately for placement in borrow pit

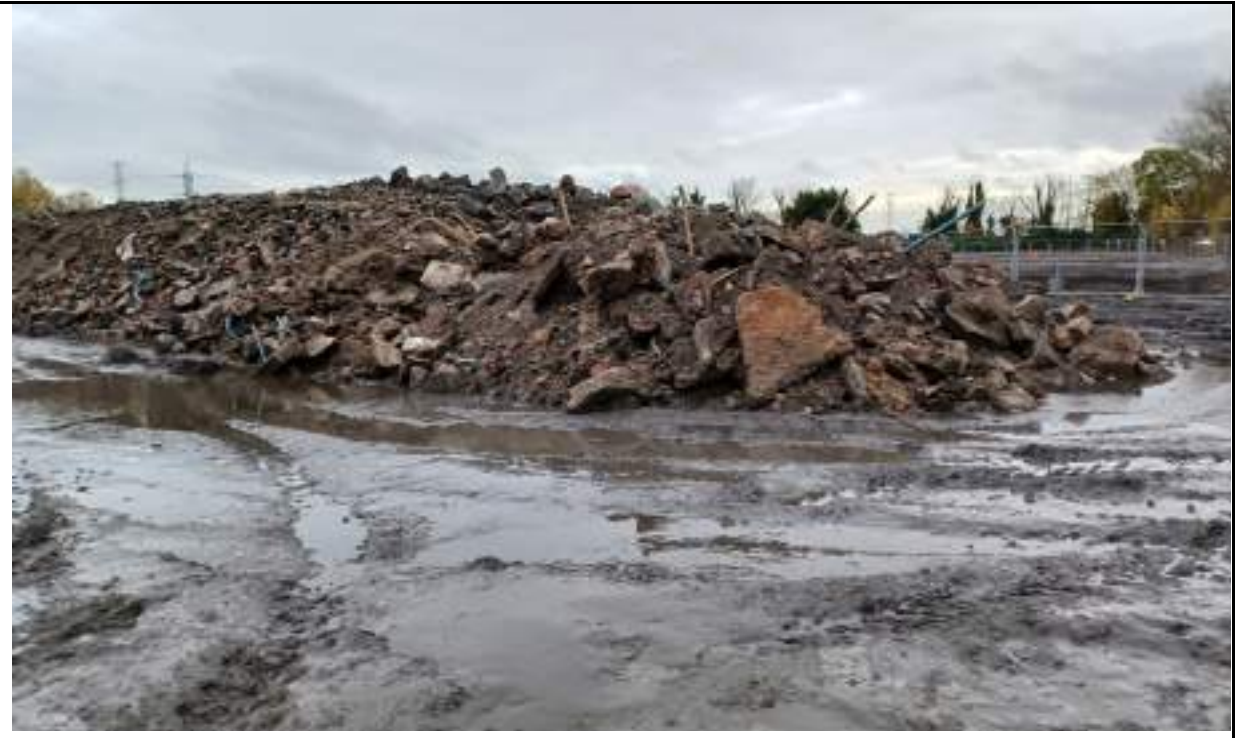
Photograph 9: Oversize material to be crushed and processed

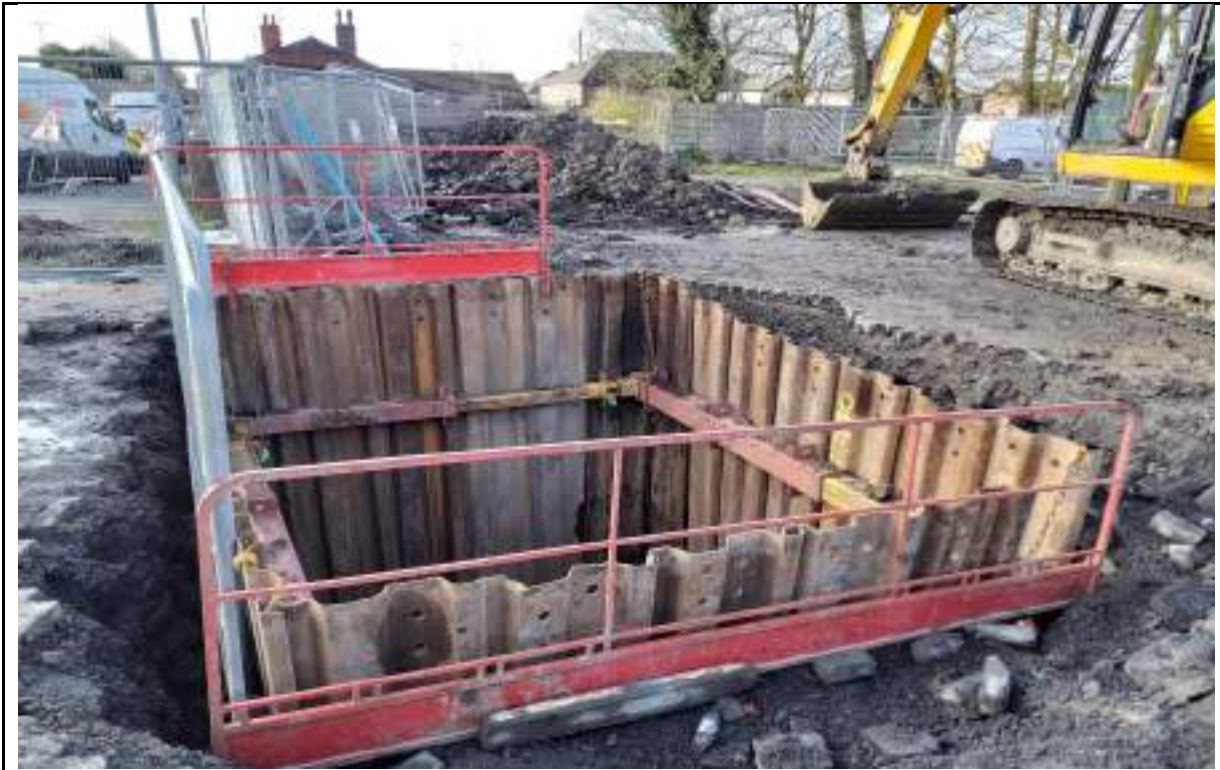
Photograph 1: Excavation and installation of sheet piles for drainage in the southeast.

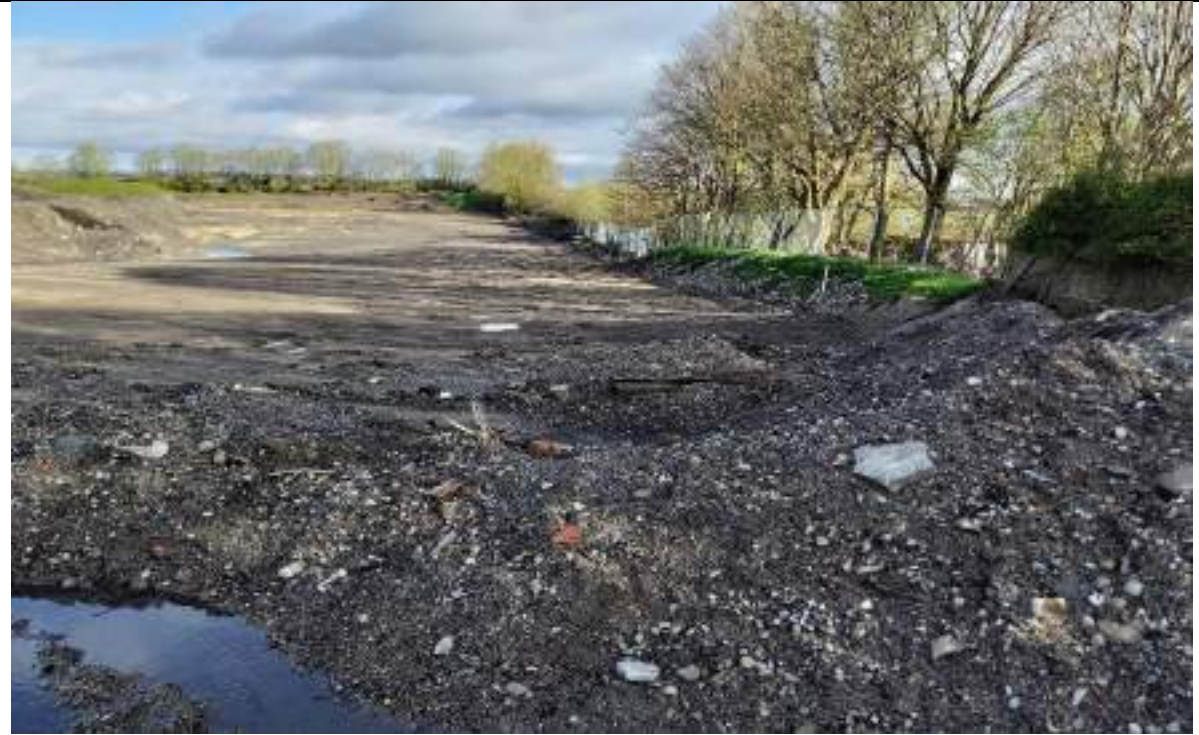
Photograph 3: Eastern boundary of the site. Looking towards the north. Boundary checks required by VHE.

| Hydrock Comment | Contractor Proposal/Solution | Action Status |
|---|---|---|
| Boundary Survey | VHE to provide boundary survey to demonstrate compliance with contract | Discrepancy noted in southwestern boundary with regards to standoff (09/09/22) Additional survey provided 28/09 but no charge to boundary.<br>Meeting of 18/11 – VHE to check boundary and re-excavate where necessary. Fence to be re-located and additional soils remediated |

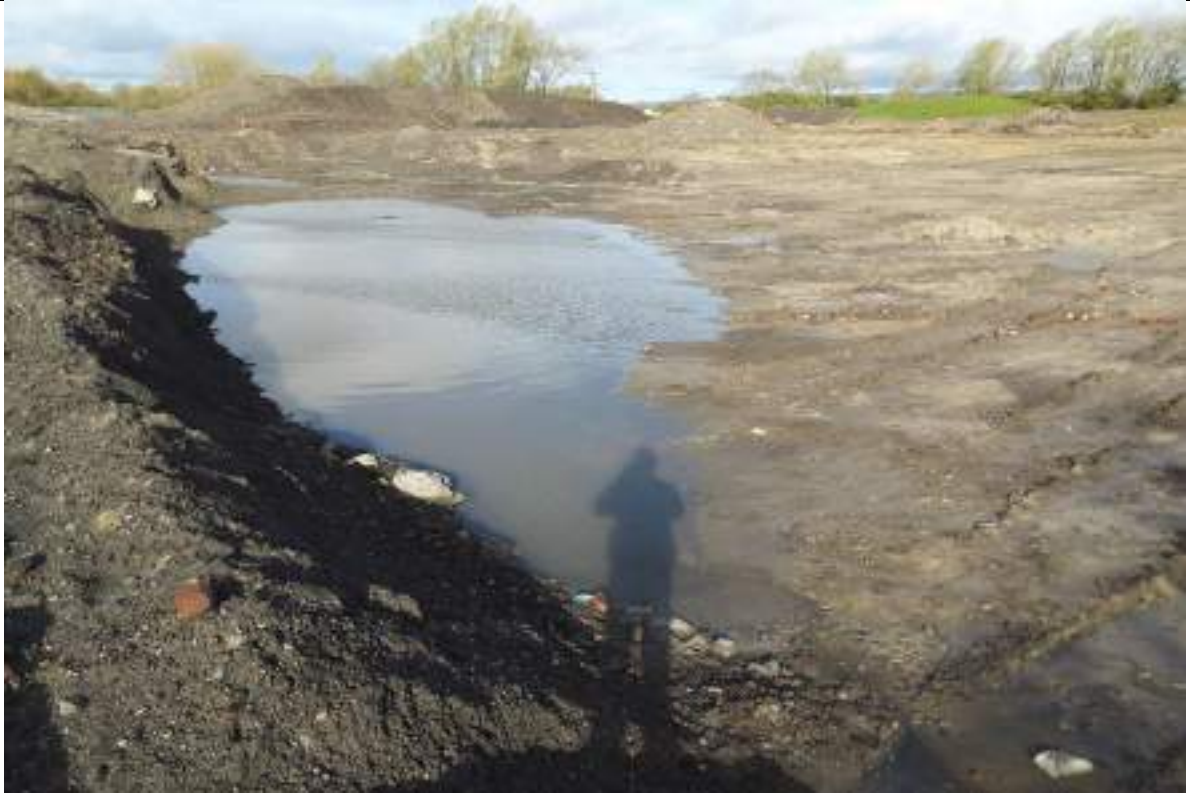
Photograph 5: Standing water in the north.

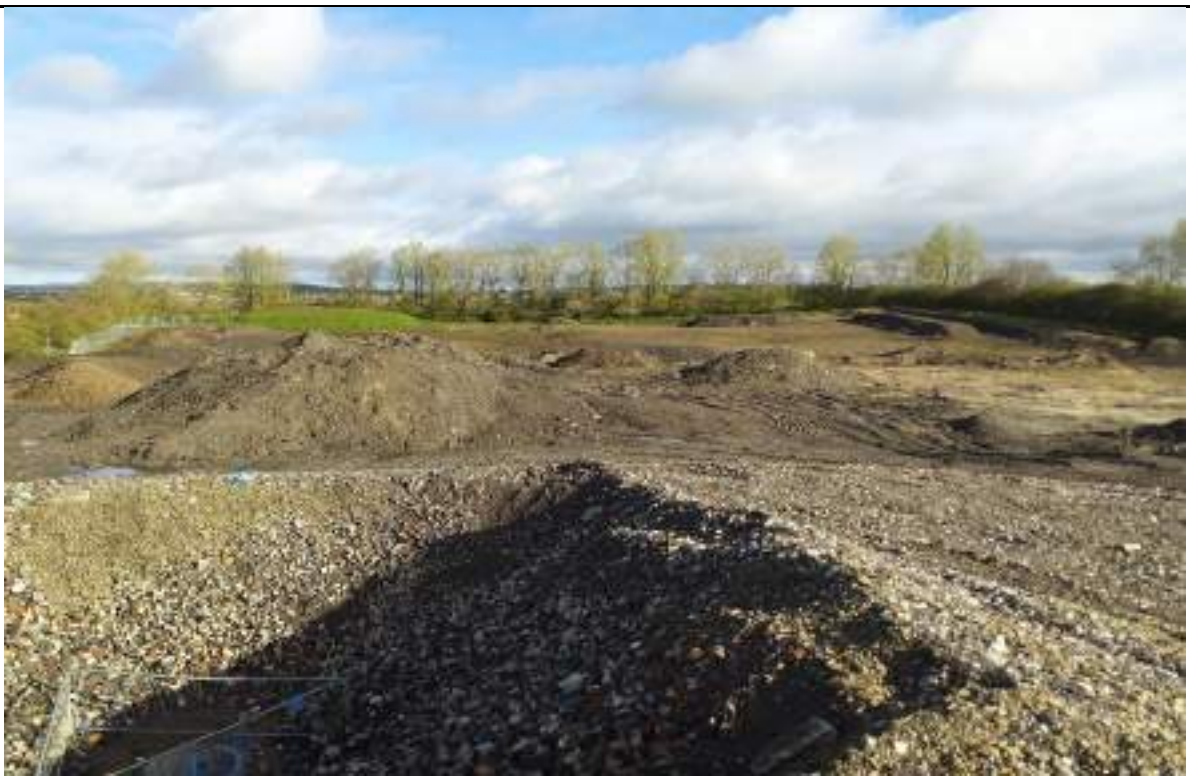
Photograph 6: Stockpiles of excavated peat, organic and unsuitable material in the north.

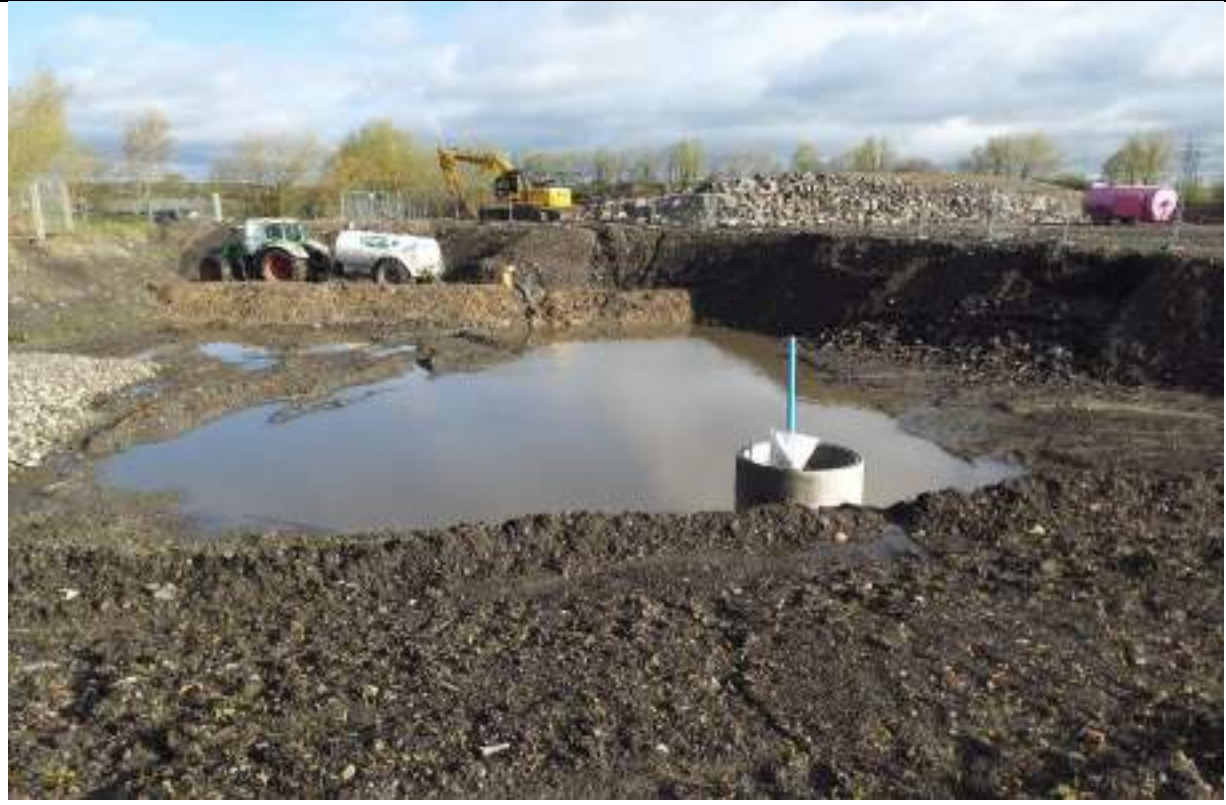
Photograph 9: Pumping standing water near abstraction well in the west.

| Hydrock Comment | Contractor Proposal/Solution | Action Status |
|---|---|---|
| Borehole / abstraction well decommissioning | Abstraction well to be located as far as possible. Borehole to be grouted. | Records to be provided to Hydrock.<br>Details to be presented in final validation report. |

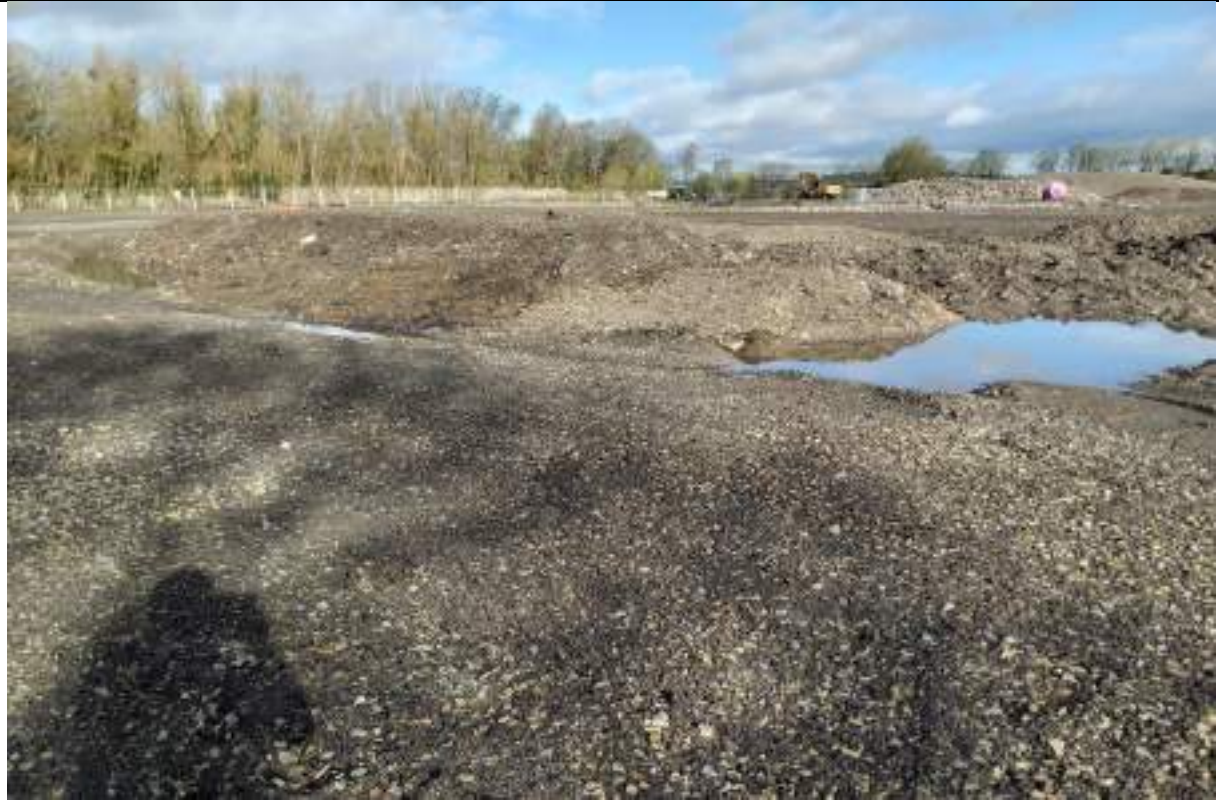
Photograph 11: Standing water in the south.

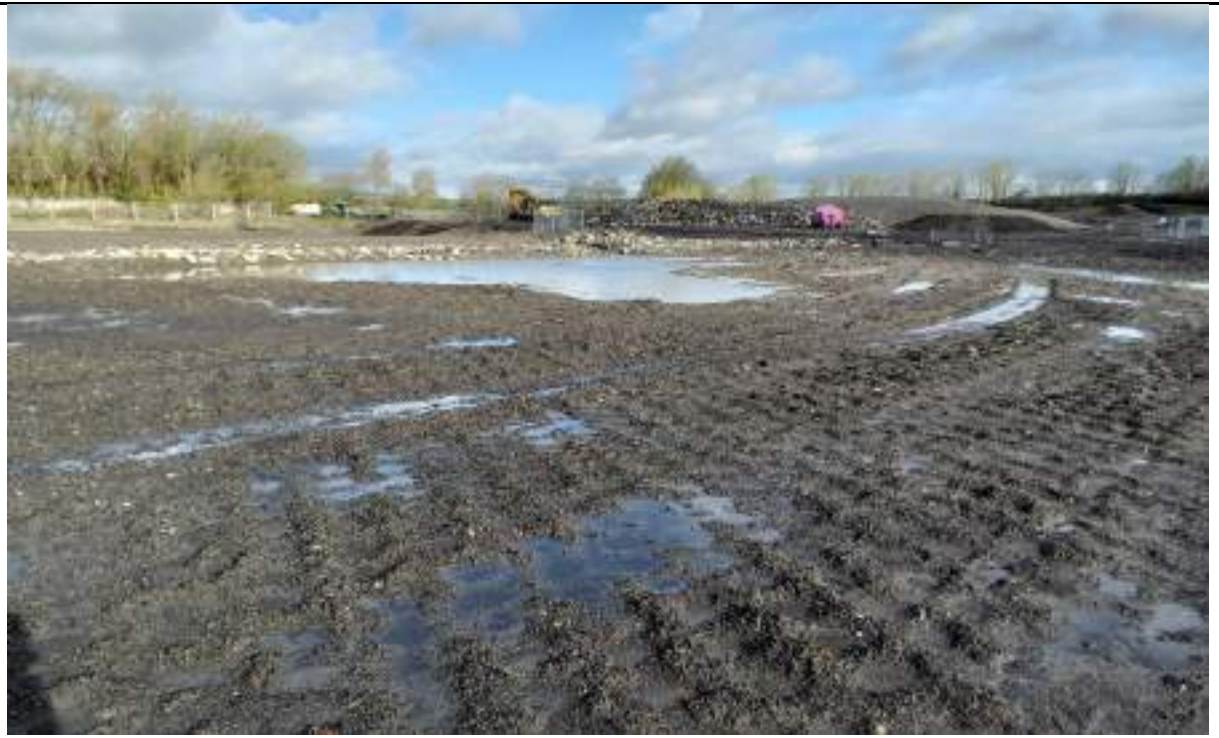
Photograph 12: Standing water in the centre of the site.

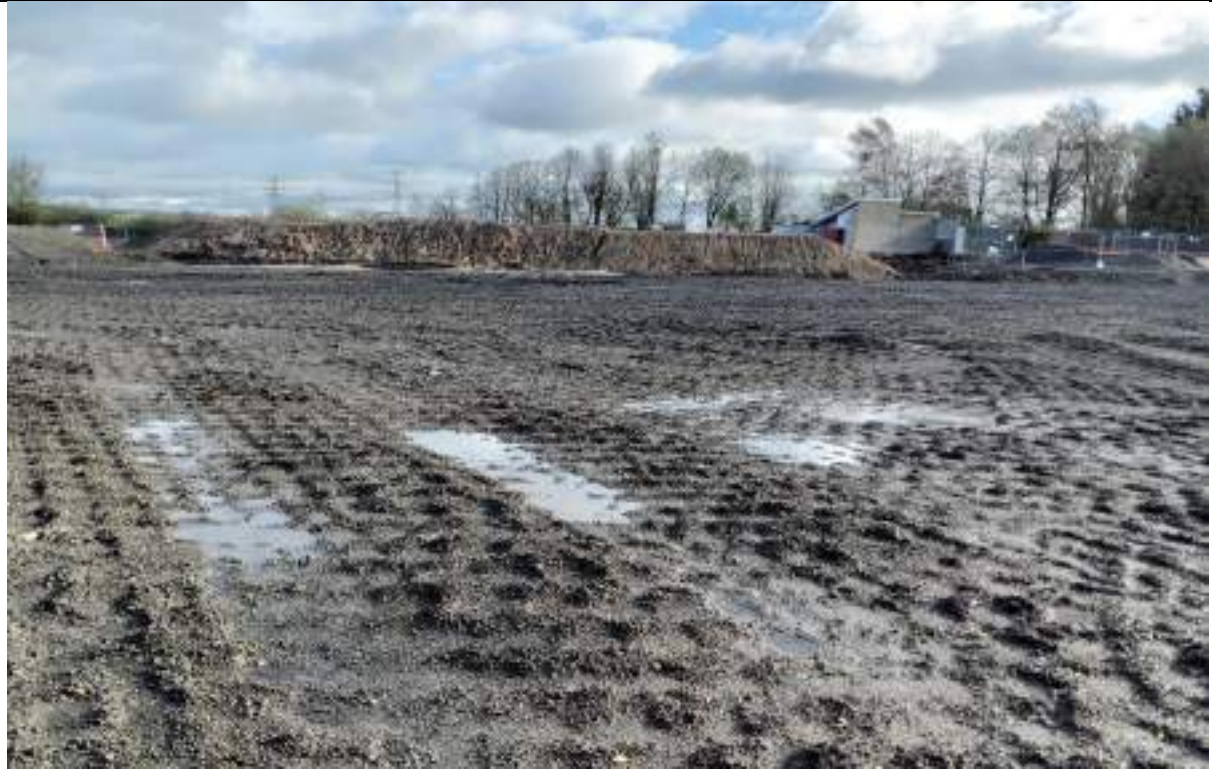
Photograph 13: Stockpile of brown glacial clay in the east. Source testing outstanding.

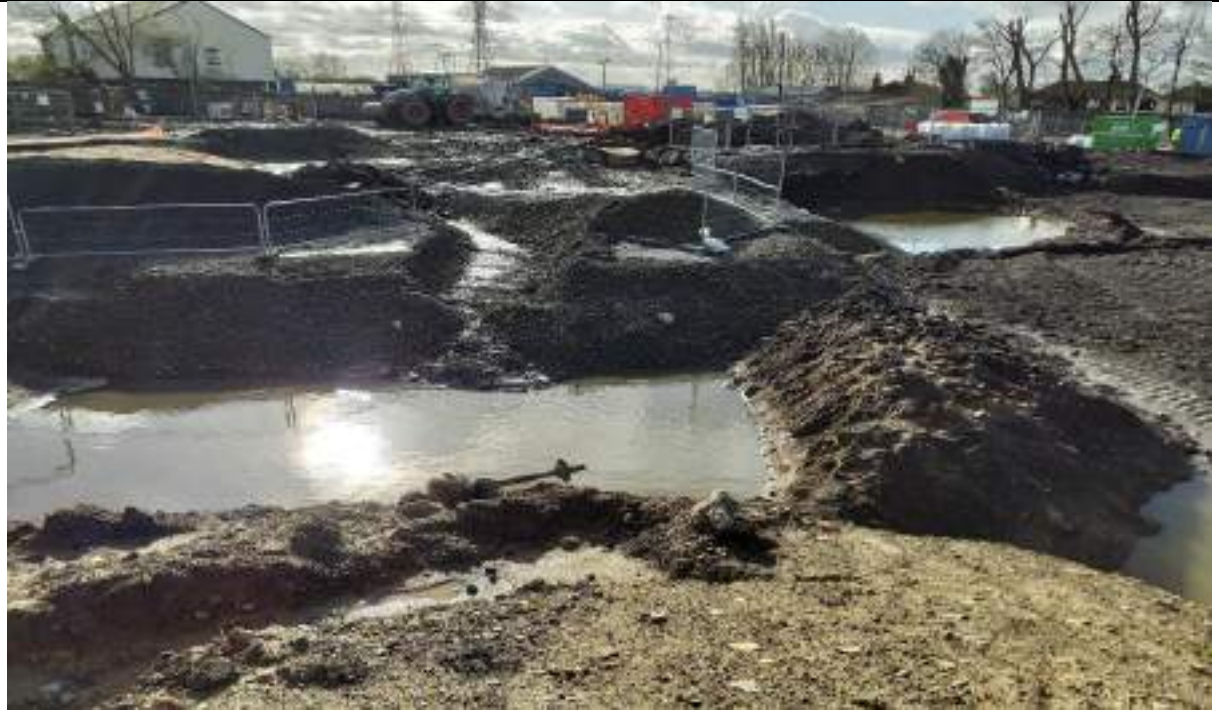
Photograph 15: Standing water in the southeast.

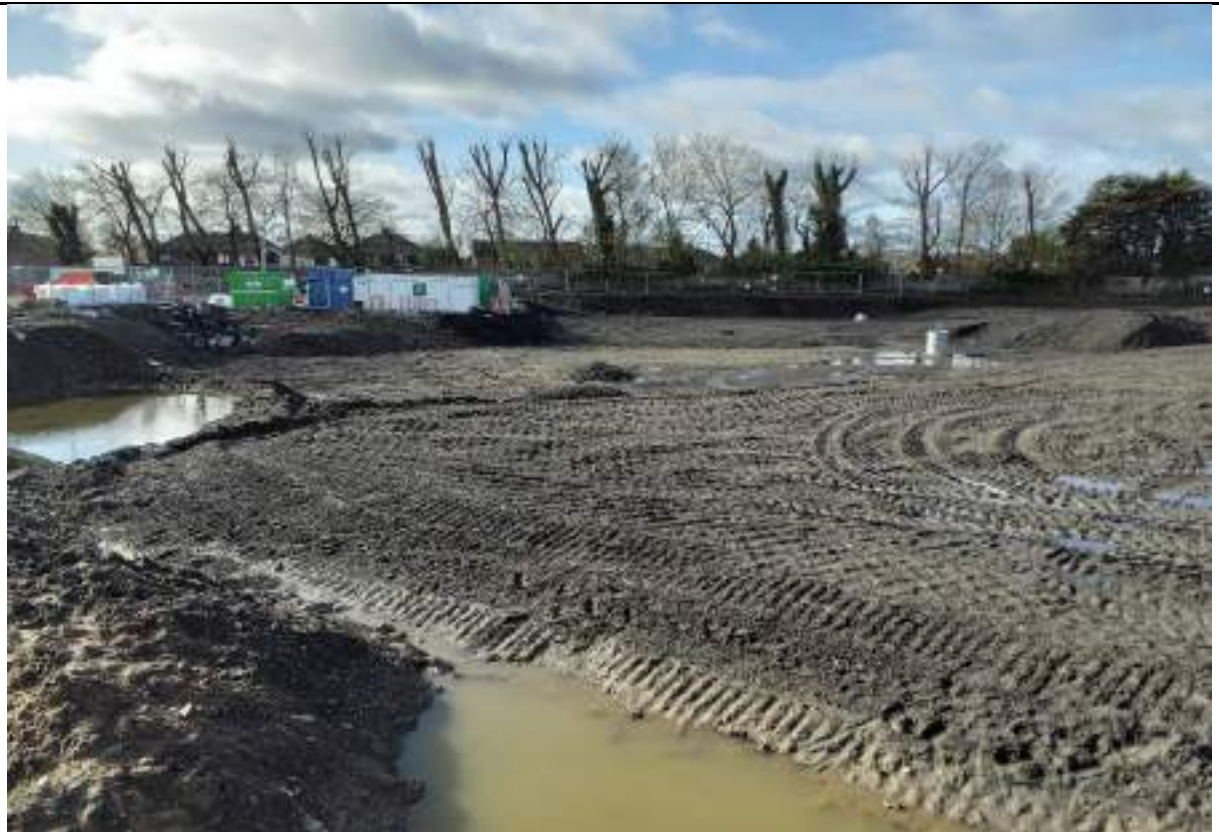
Photograph 16: VHE compound area in the southeast.

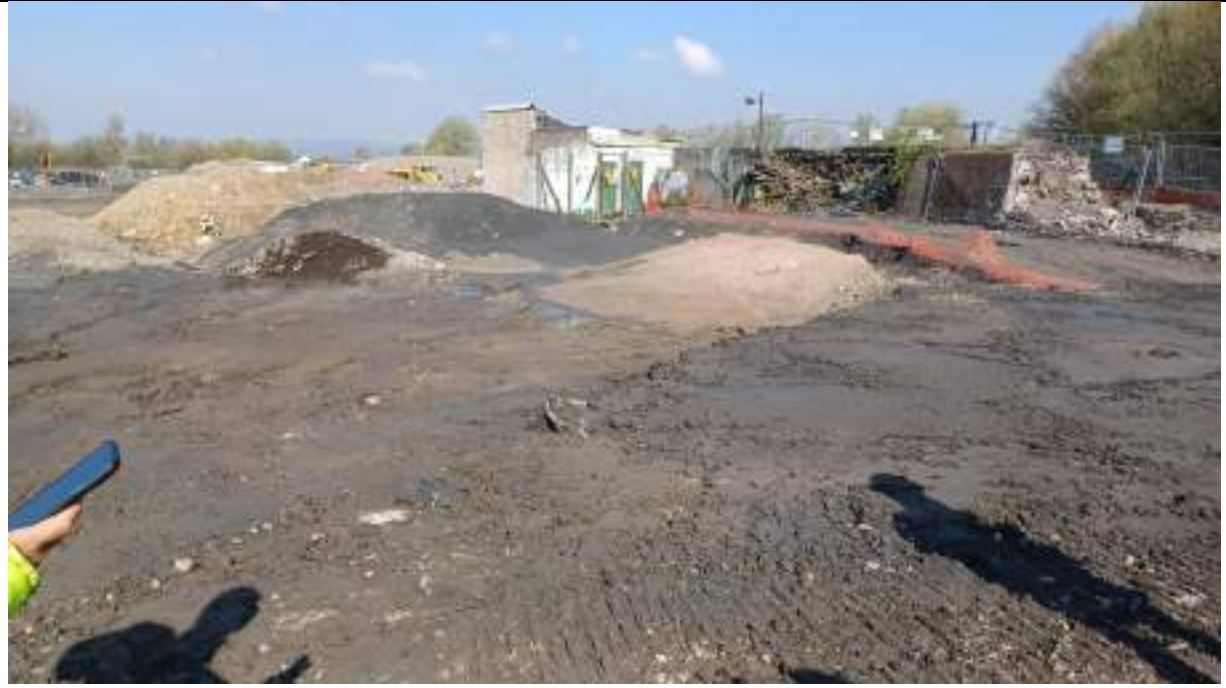
Photograph 1: Location of Shaft 006. Surplus pfa and sand still present at the site

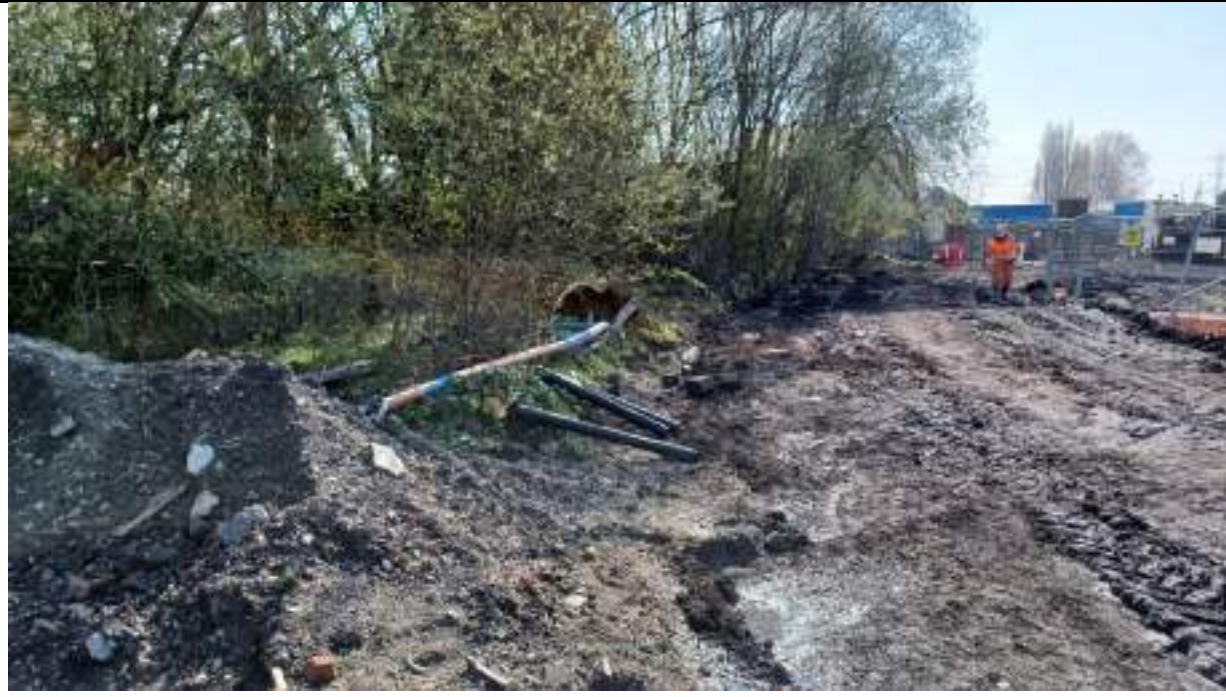
Photograph 2: Southeastern boundary where additional excavation required between electric cable and site boundary

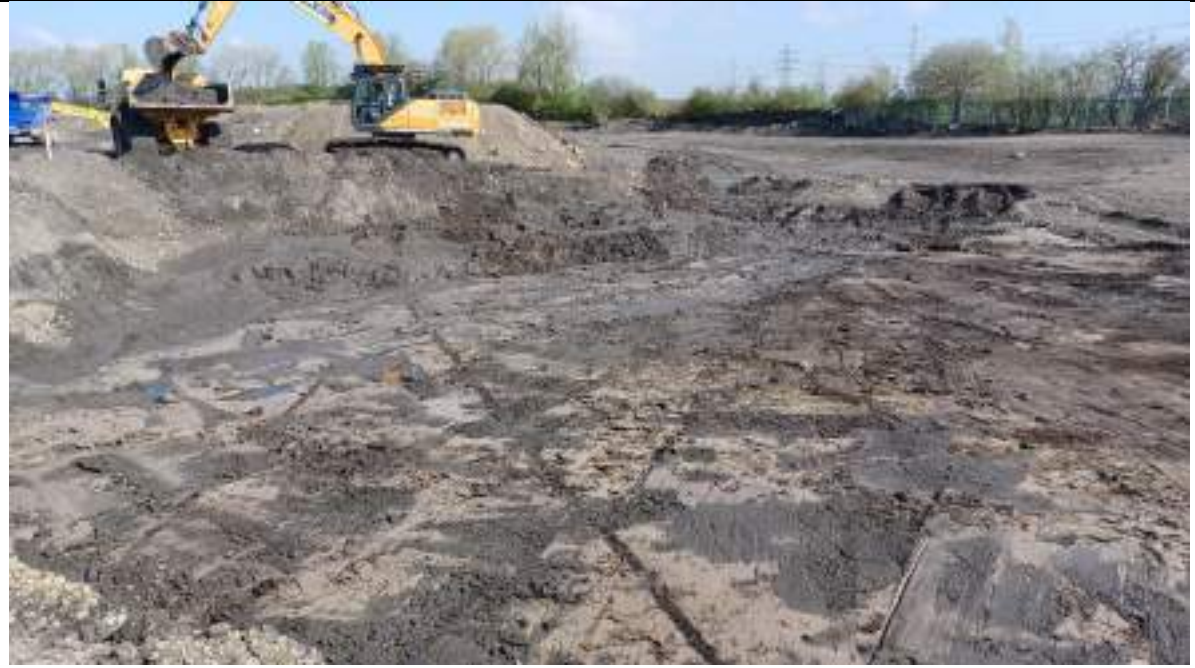
Photograph 3: Removal of sediment and silt from area of ponded water in the northeast. Natural Glacial Till exposed at the base.

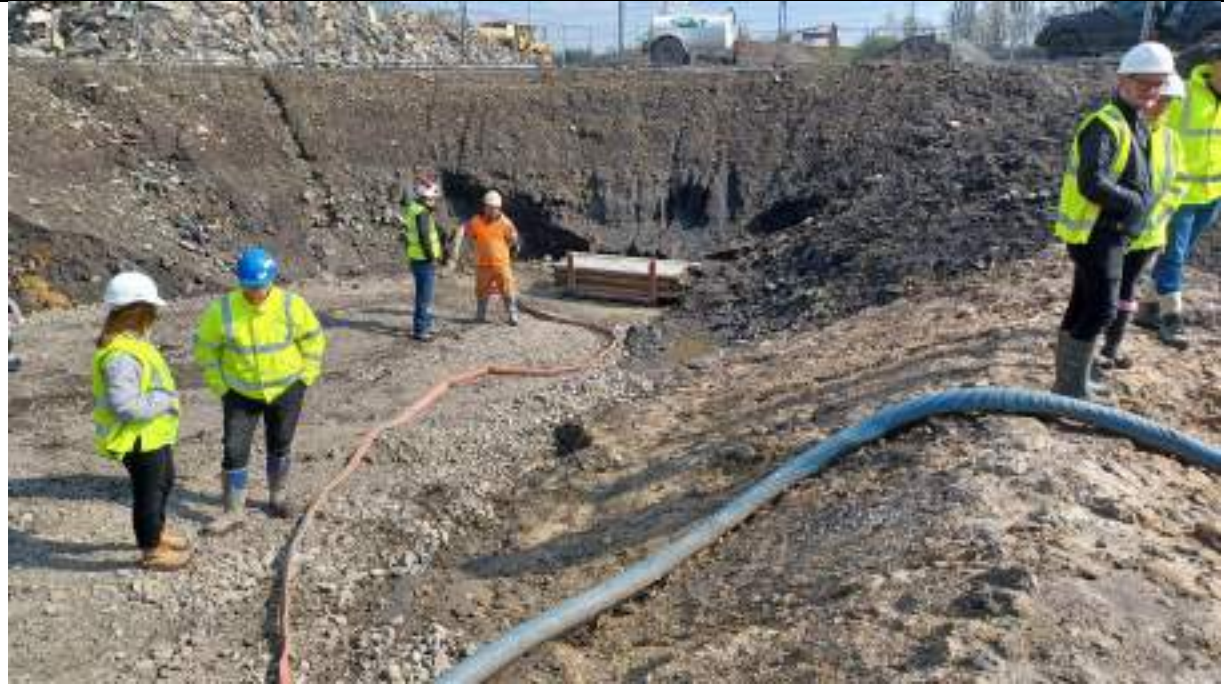
Photograph 9: Over-steepened slopes around abstraction borehole to be re-profiled

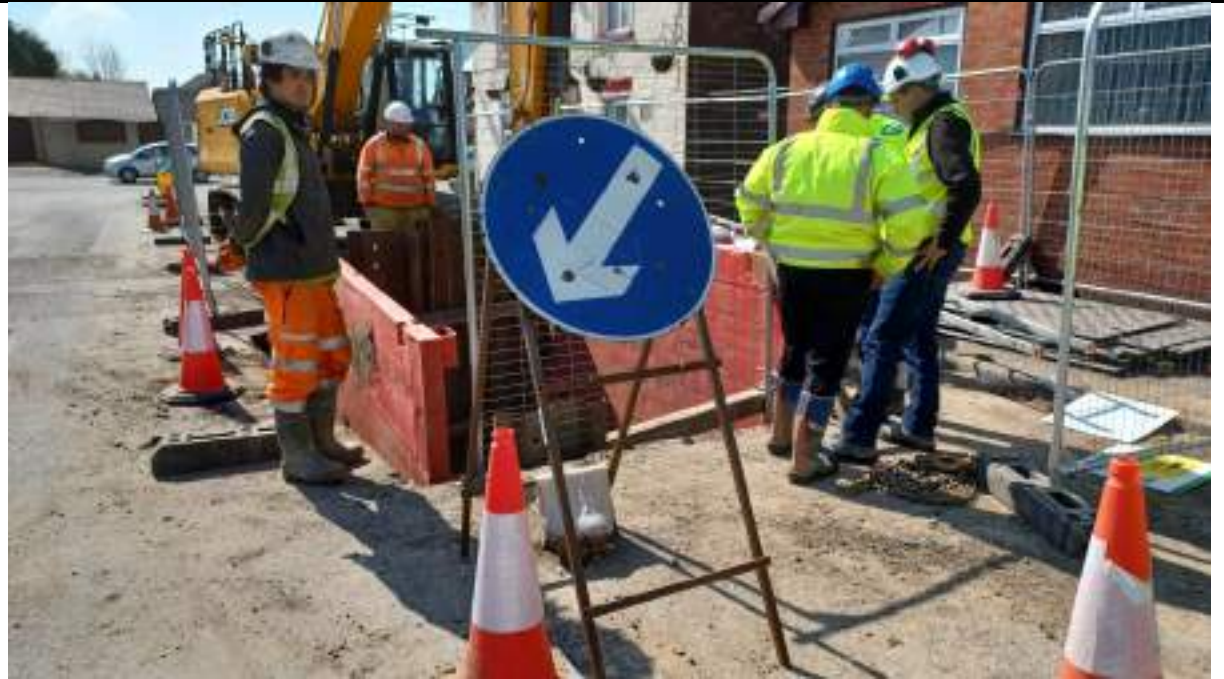
Photograph 10: Southern end of thrust bore excavation on Stopes Road for drainage connection

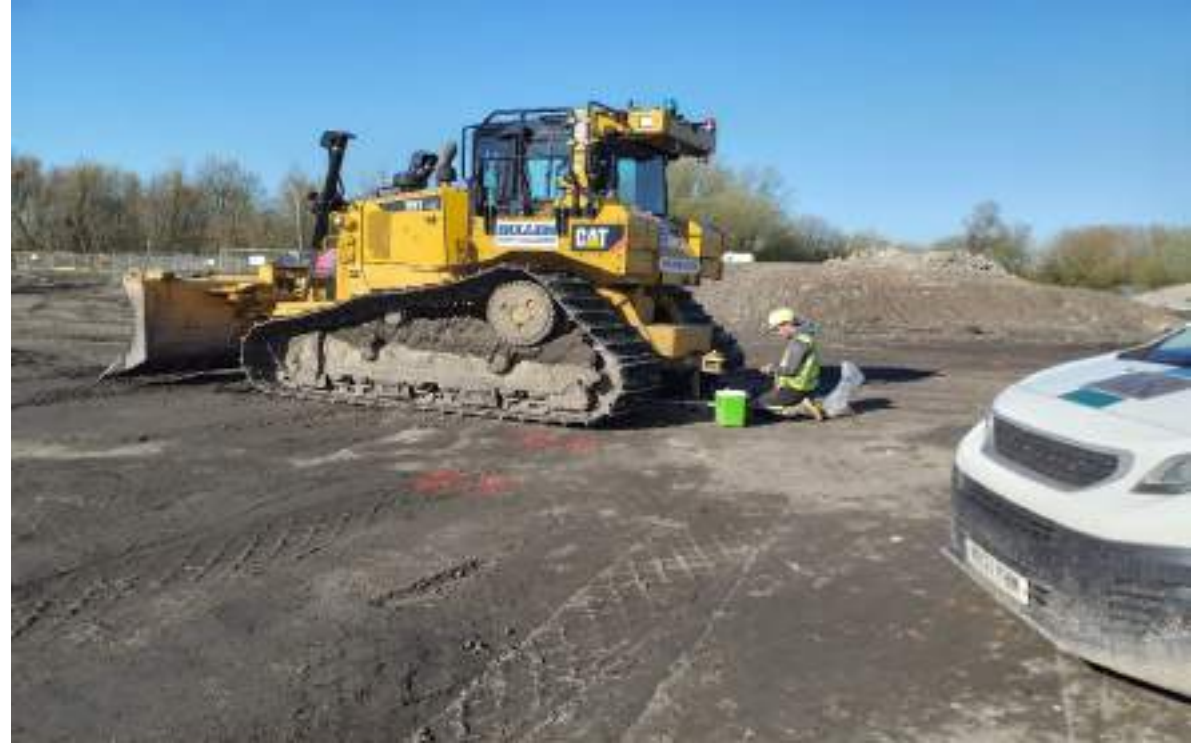
Photograph 3: Plate load testing on fill material in the center east.

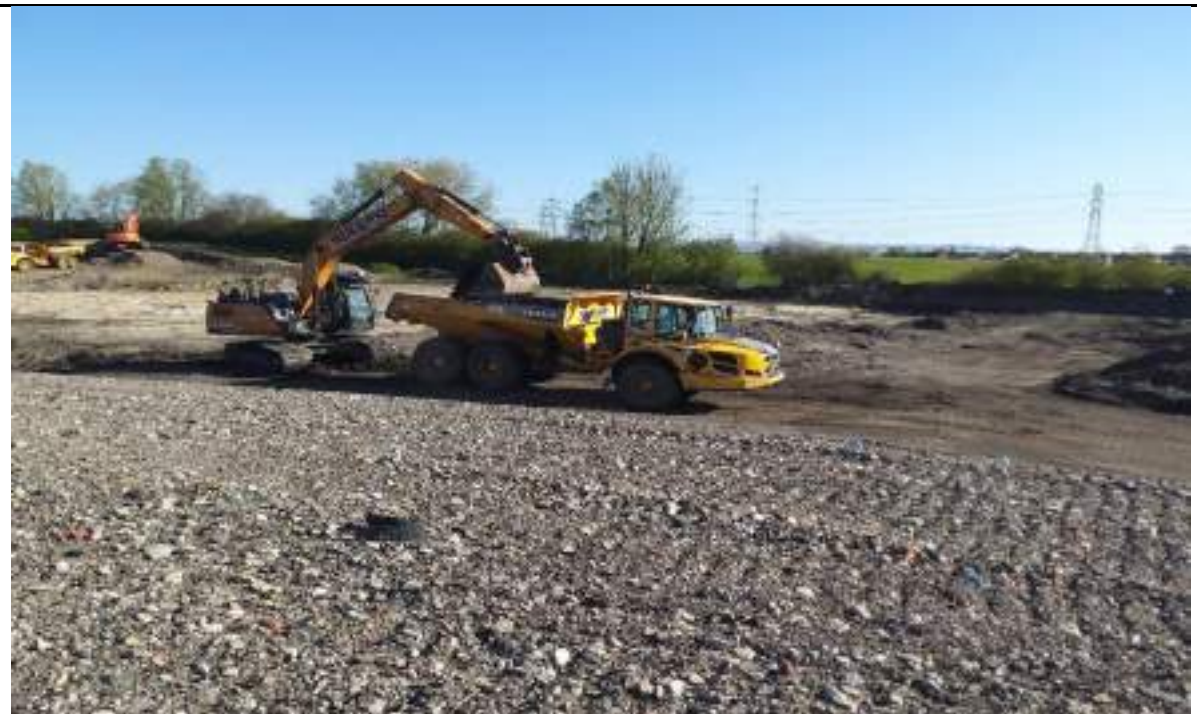
Photograph 4: Excavation of dark landfill Made Ground in the north.

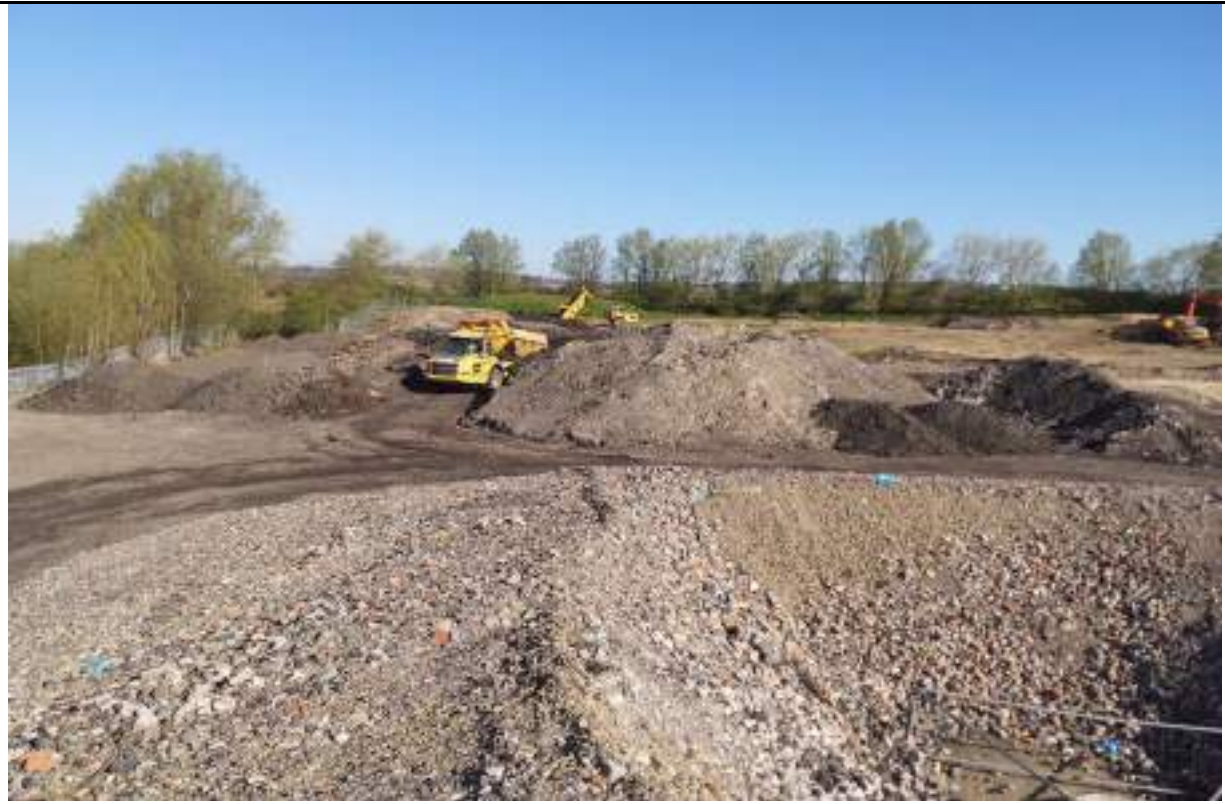
Photograph 5: Stockpiling excavated dark landfill Made Ground and unsuitable material in the northwest. Material from excavation in the north and stockpile of unsuitable material in the northeast.

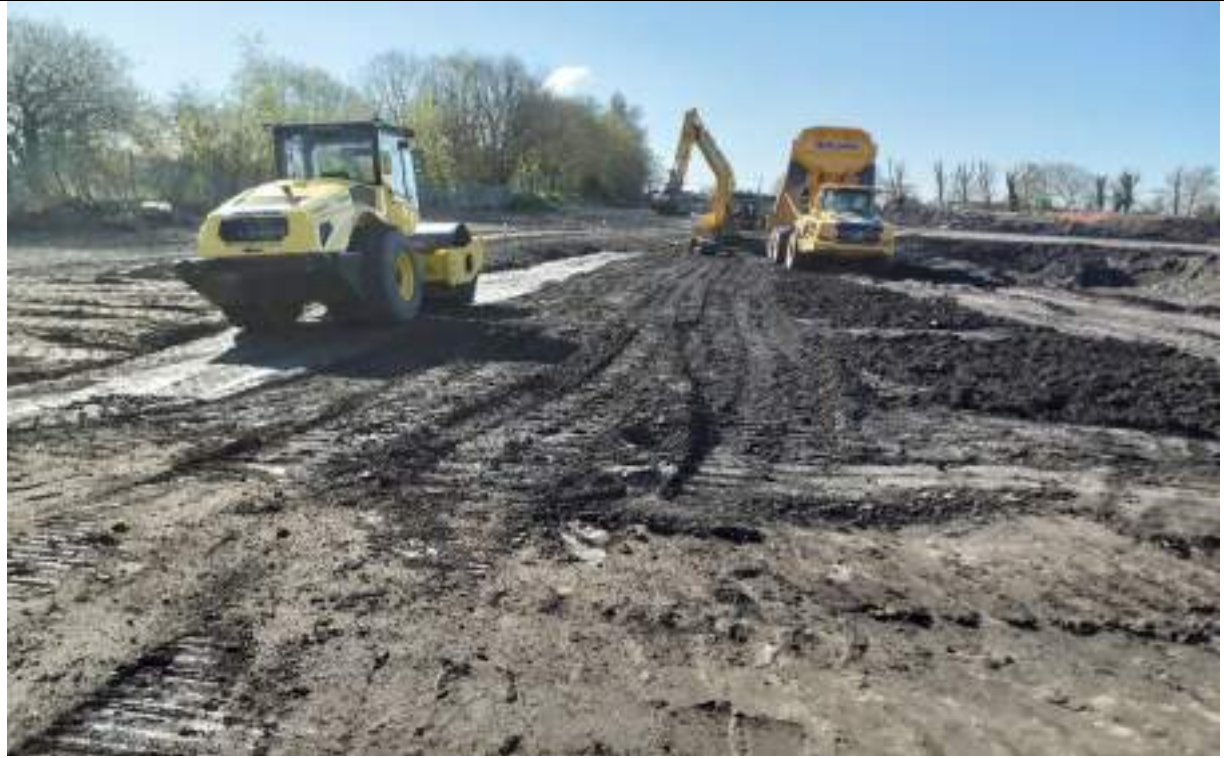
Photograph 7: Placing fill and proof rolling of fill material in the northeast.
