| SITE VISIT REPORT 15220-HYD-XX-XX-SVR-GE-1035 | | SHEET NO.: 1 of 20 | |
| Project: Stopes Road, Bolton | | Date: 09/11/22 | |
| Client: Harworth | | Weather: Cloudy | |
| Doc Ref: 15220-HYD-XX-XX-SVR-GE-1035 | | Status & Revision: S2 – P1 | |

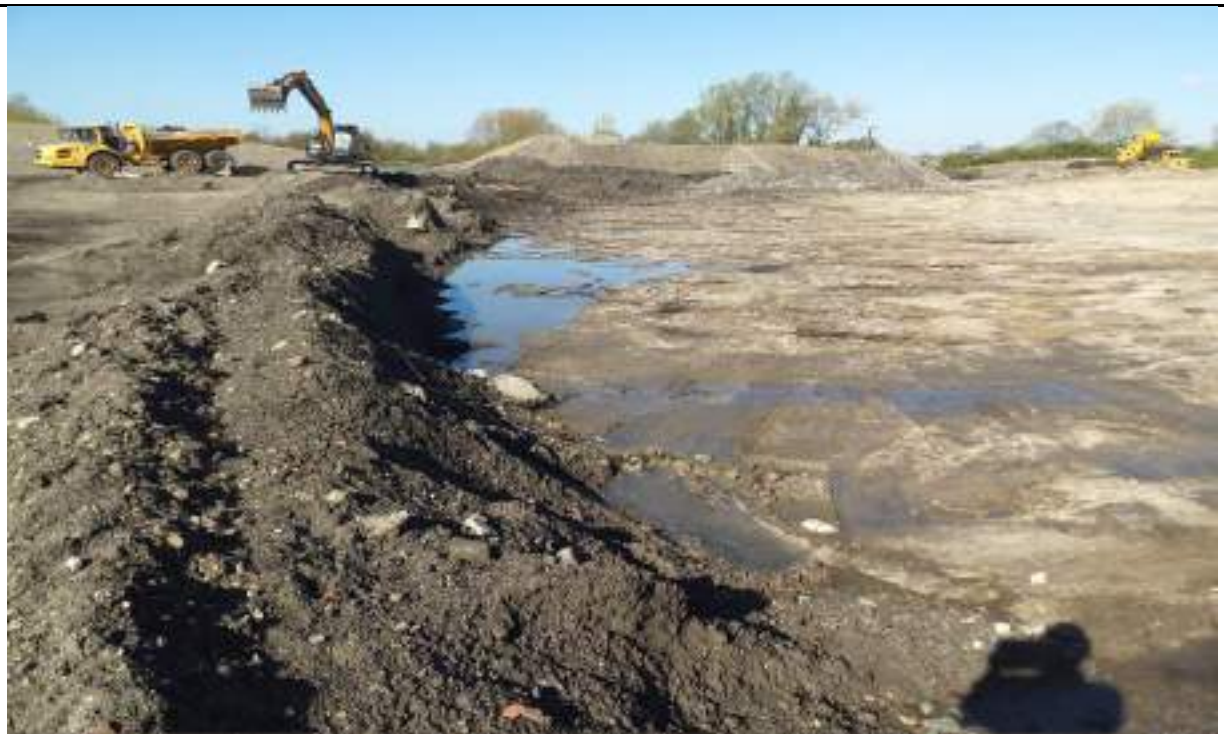
Photograph 8: Standing water in excavation in the northeast. Glacial till is visible at the base of excavation.

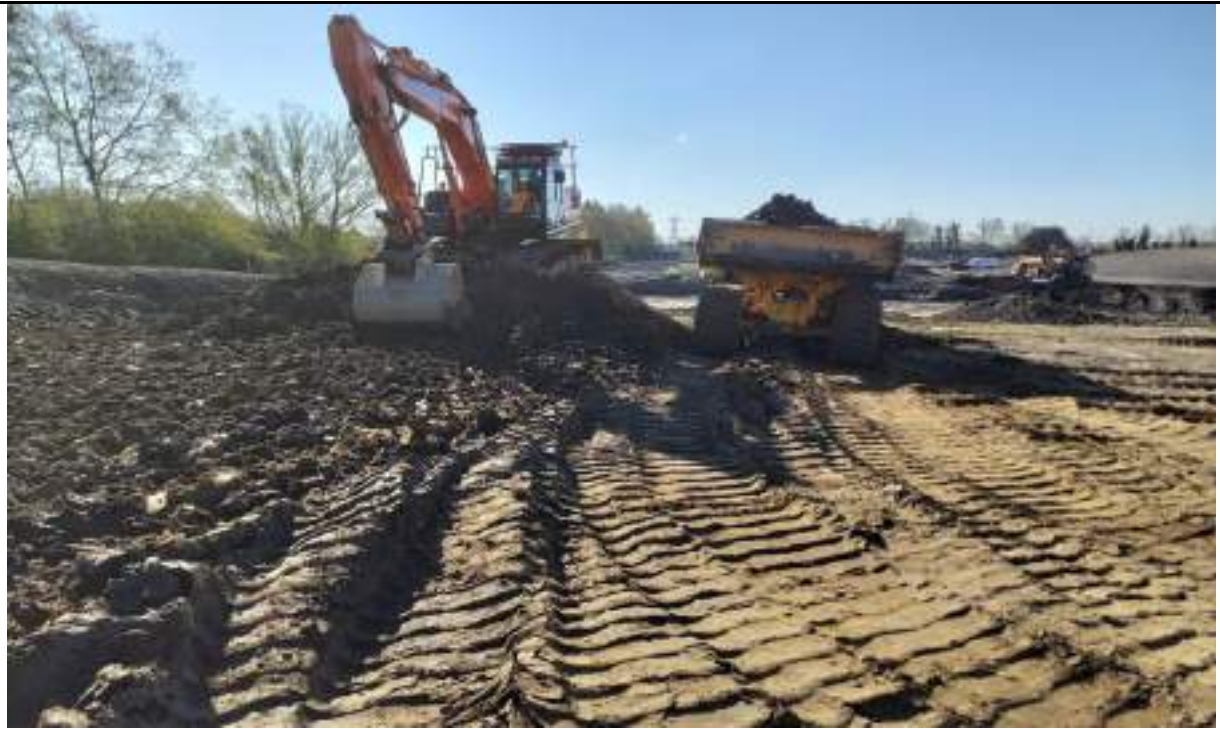
Photograph 9: Transferring stockpile of unsuitable material in the northeast to the northwest.

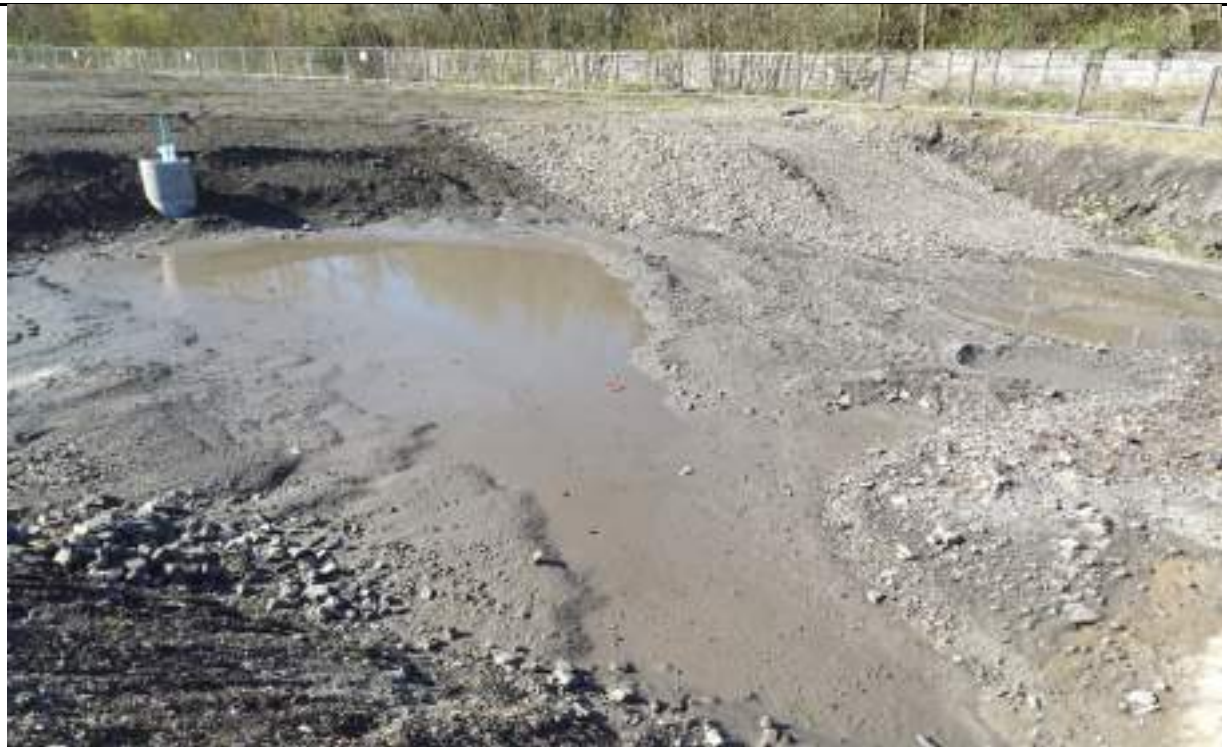
Photograph 10: Standing water in excavation in the west. Water to be removed before placing fill.

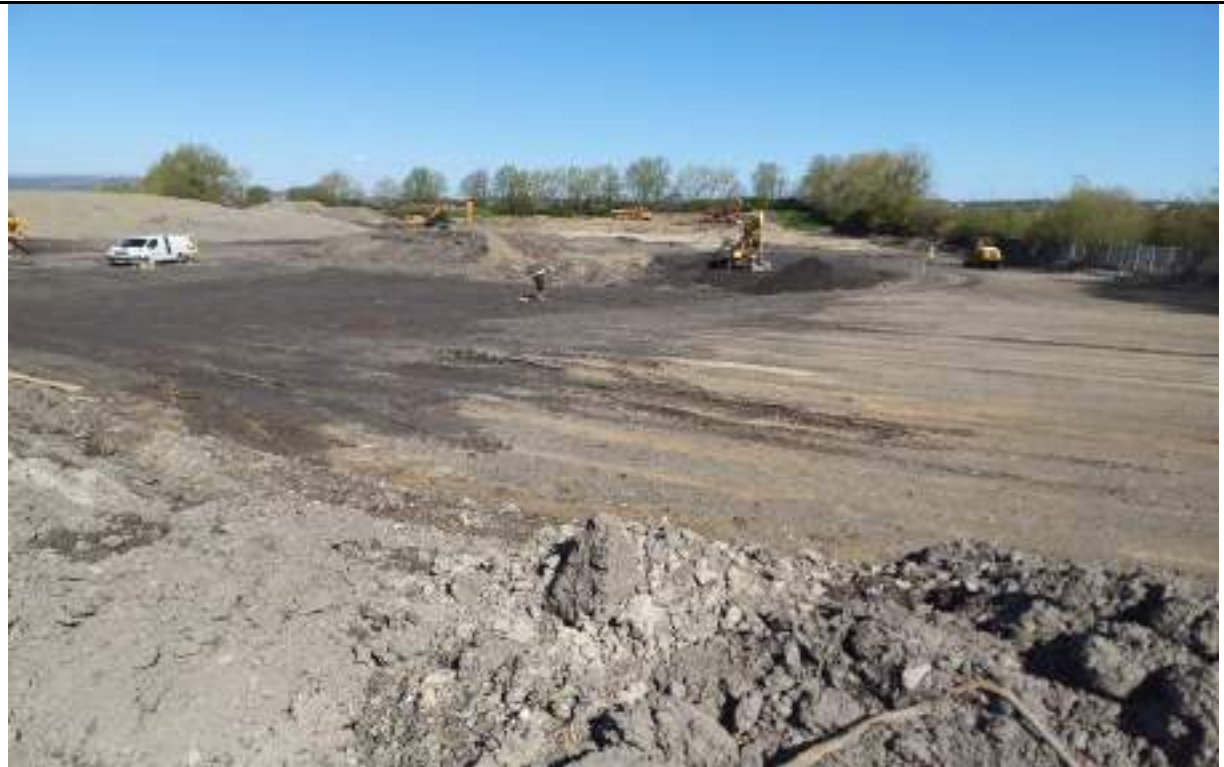
Photograph 11: NDG testing on fill material in the center east.

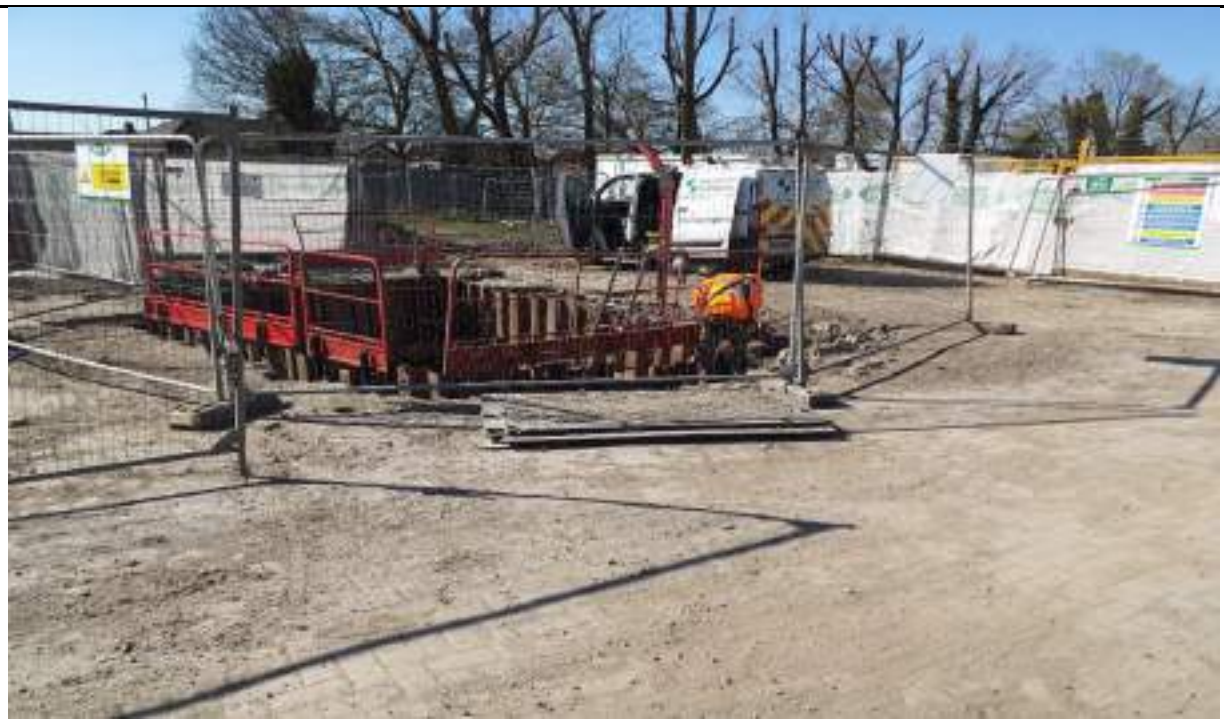
Photograph 12: Thrust bore excavation for drainage in the southeast close to entrance gate completed. Waiting for boring.

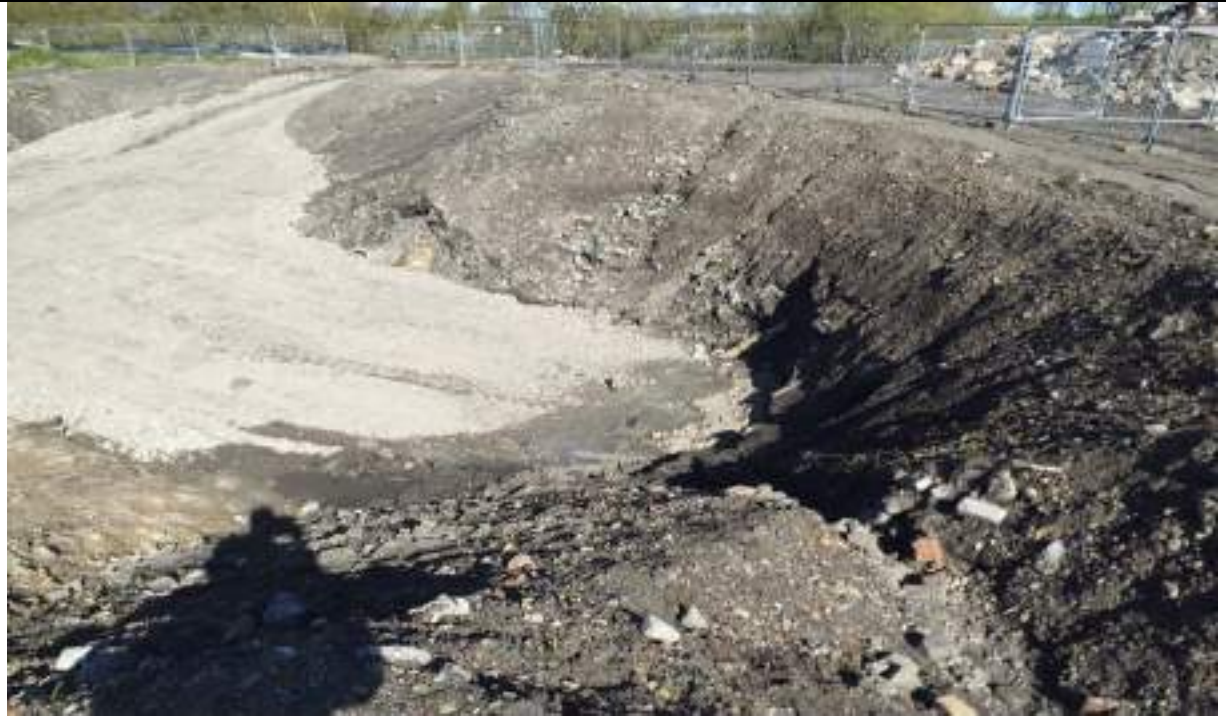
Photograph 13: Grouting of abstraction well in the northwest completed. Over-steepened slopes around abstraction borehole to be re-profiled

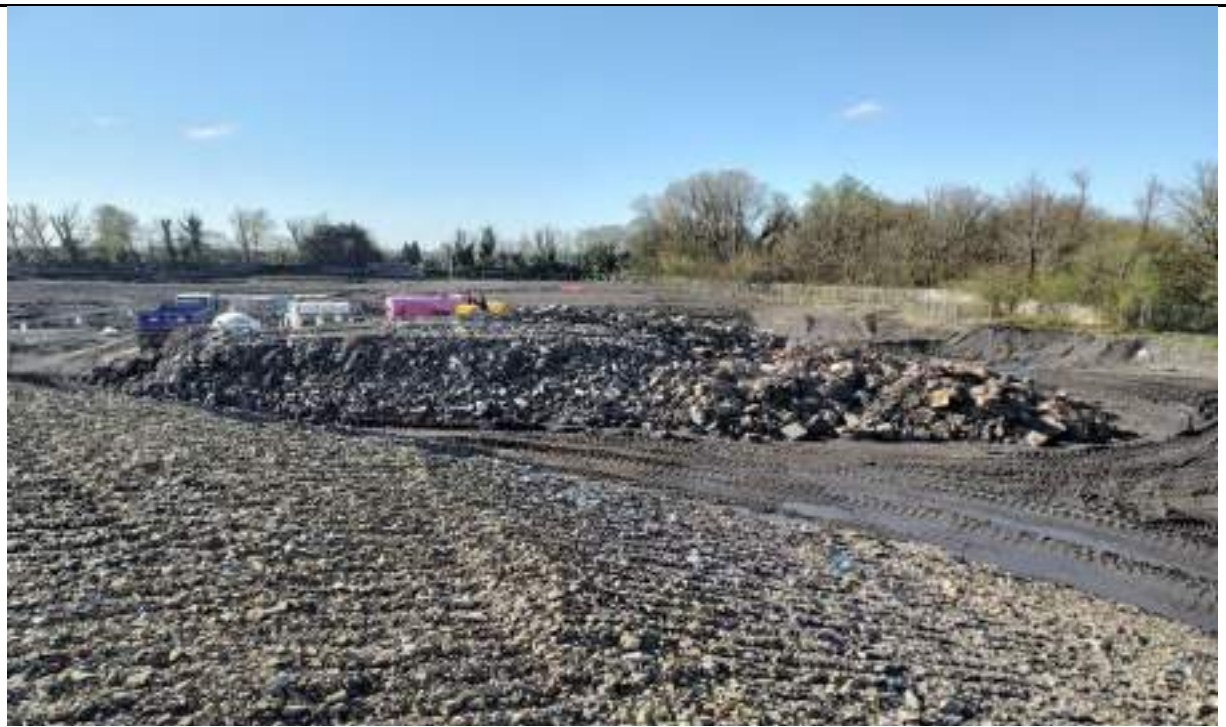
Photograph 14: Stockpile of oversize and deleterious material in the center west.

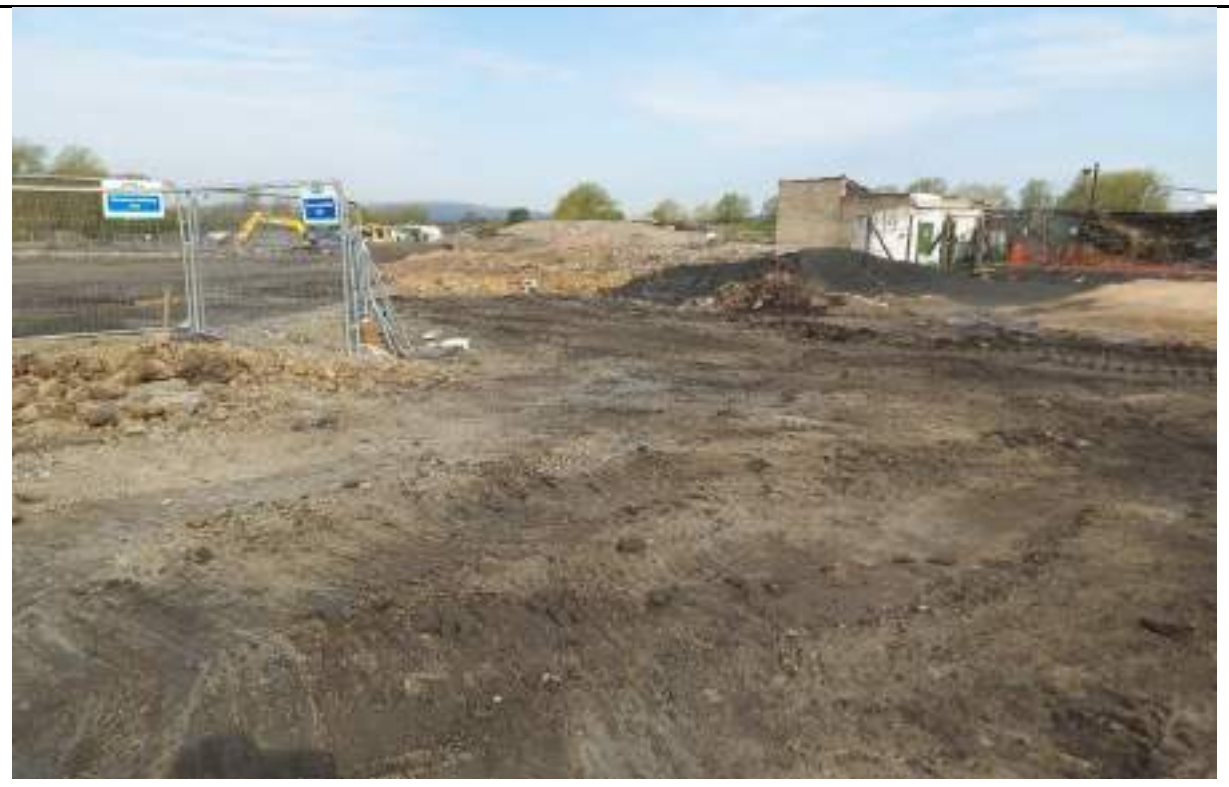
Photograph 2: Temporary new road constructed in the southeast near grouted shaft no. 006.

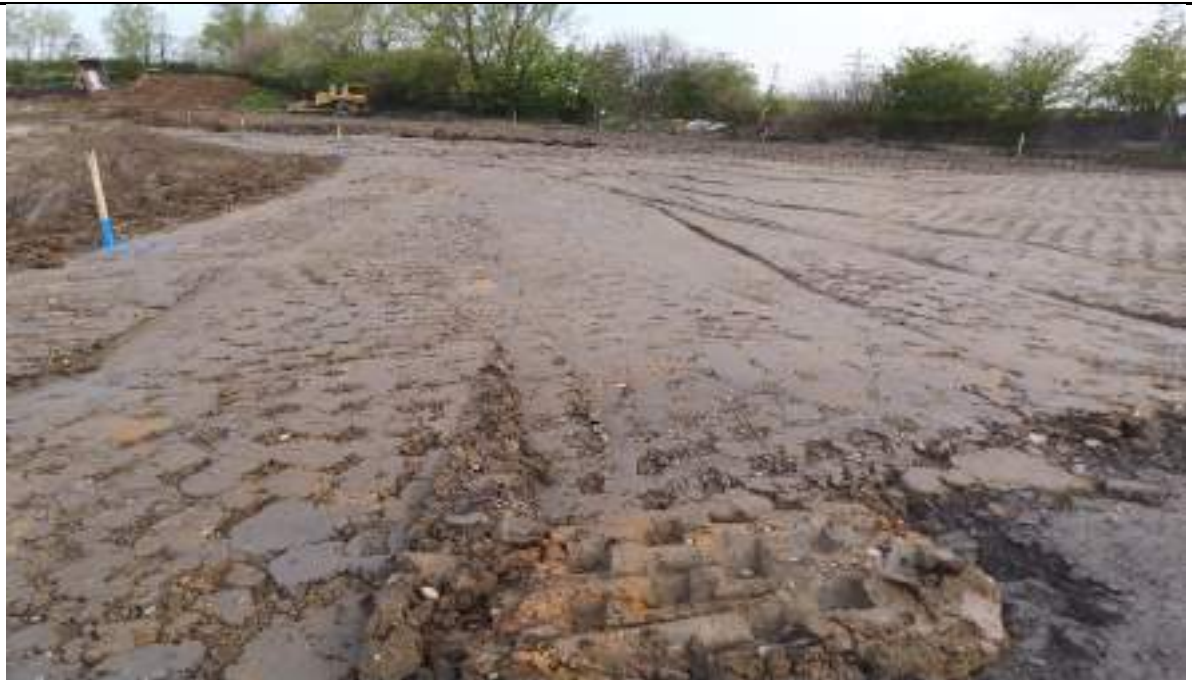
Photograph 4: Placed fill in the northeast and proof rolled with sheepfoot roller. Material from Glacial Till excavation of borrow pit.

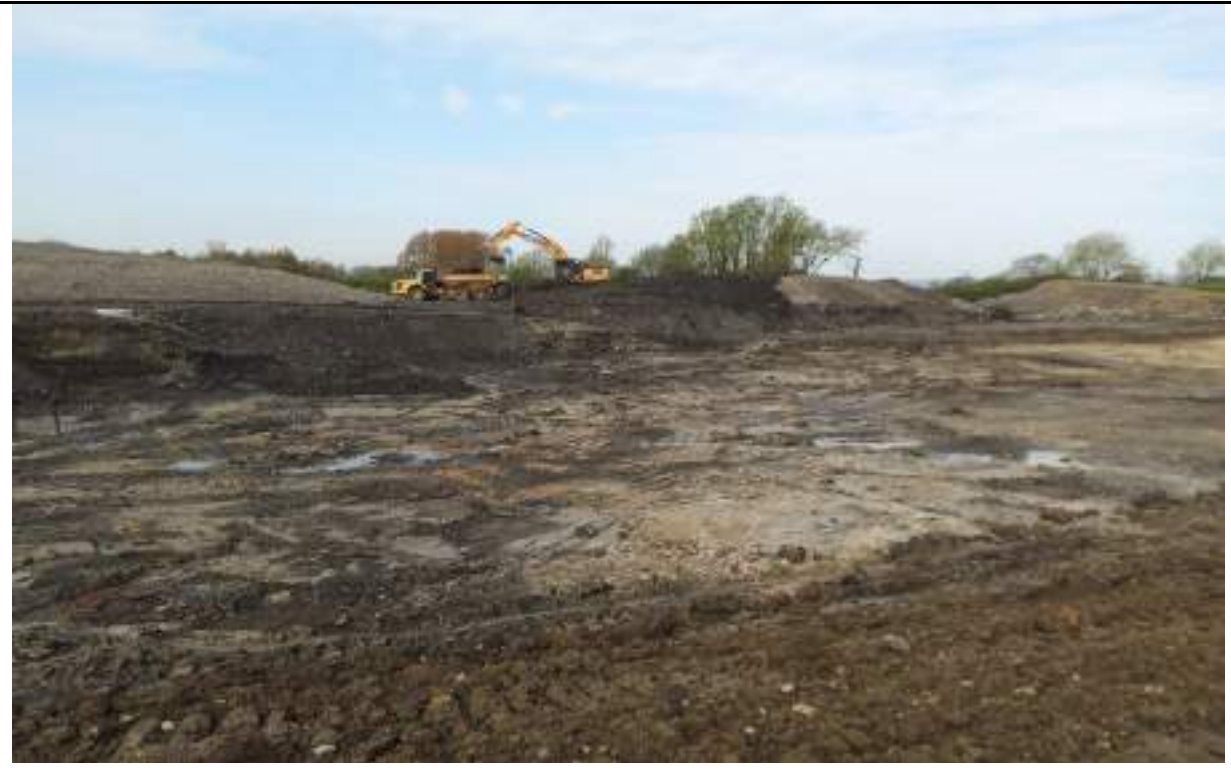
Photograph 5: Transferring peat from peat stockpile to borrow pit

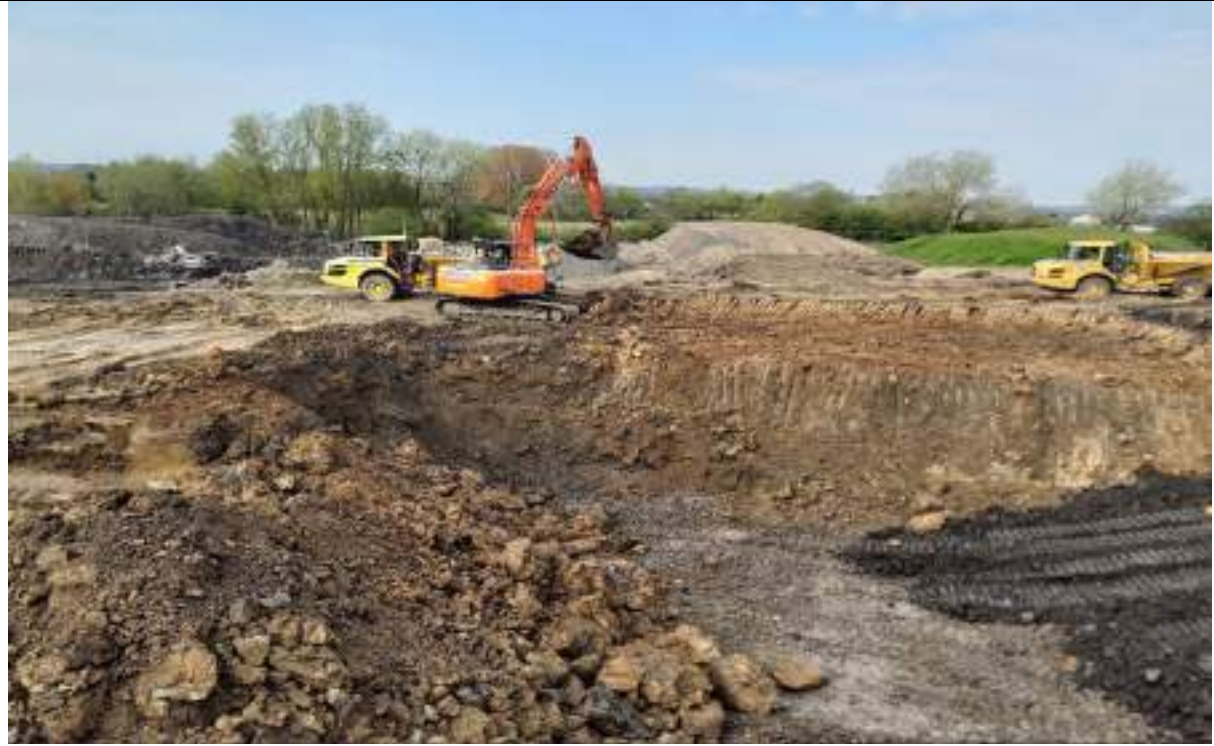
Photograph 7: Excavation of Glacial Till from the borrow pit in the north.

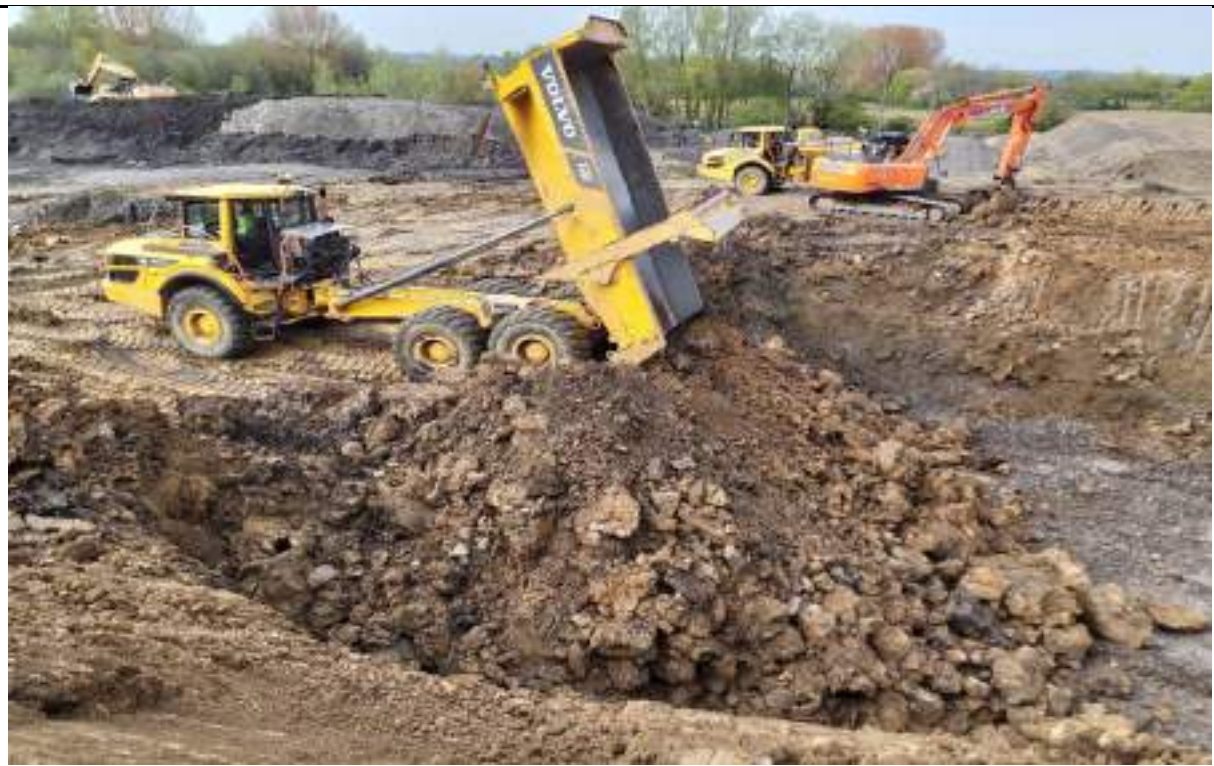
Photograph 8: Unloading excavated unsuitable Glacial Till in the south of the borrow pit.

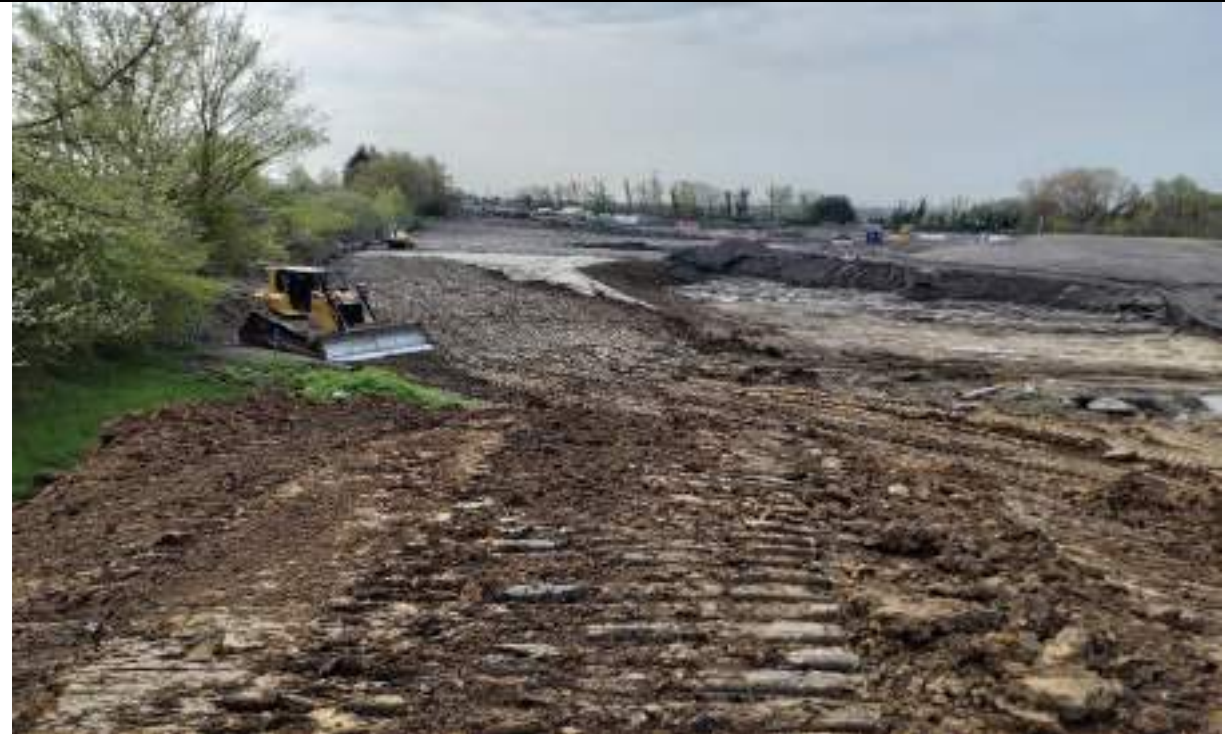
Photograph 9: Placed fill in the east using excavated dark landfill Made Ground from the centre north.

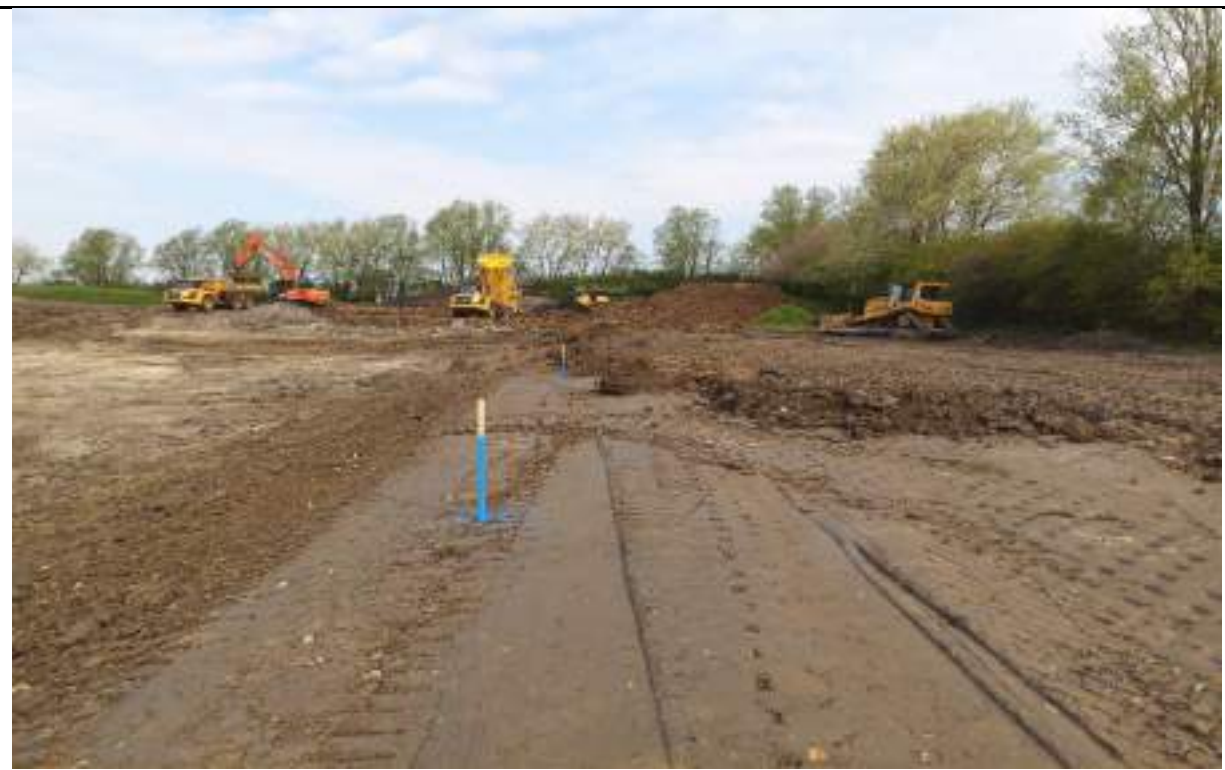
Photograph 10: Stockpile of excavated material from borrow pit in the northeast.

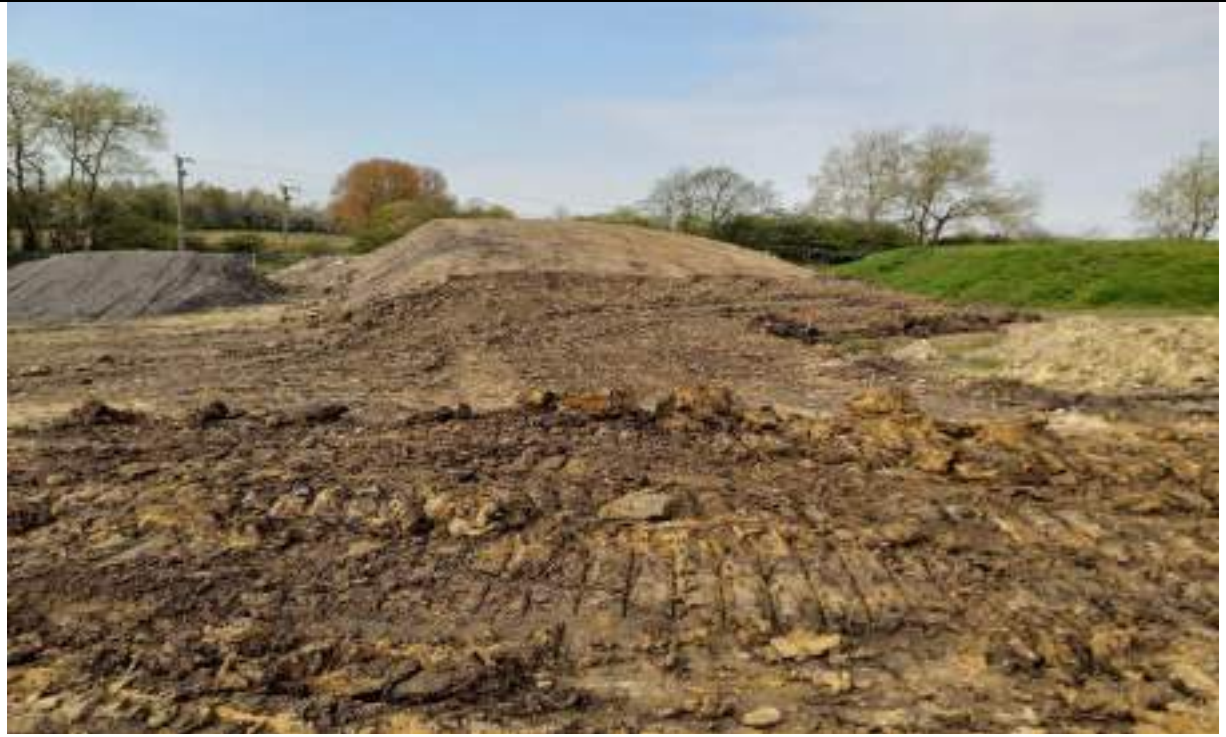
Photograph 11: Stockpiles of topsoil and unsuitable materials in the northwest.

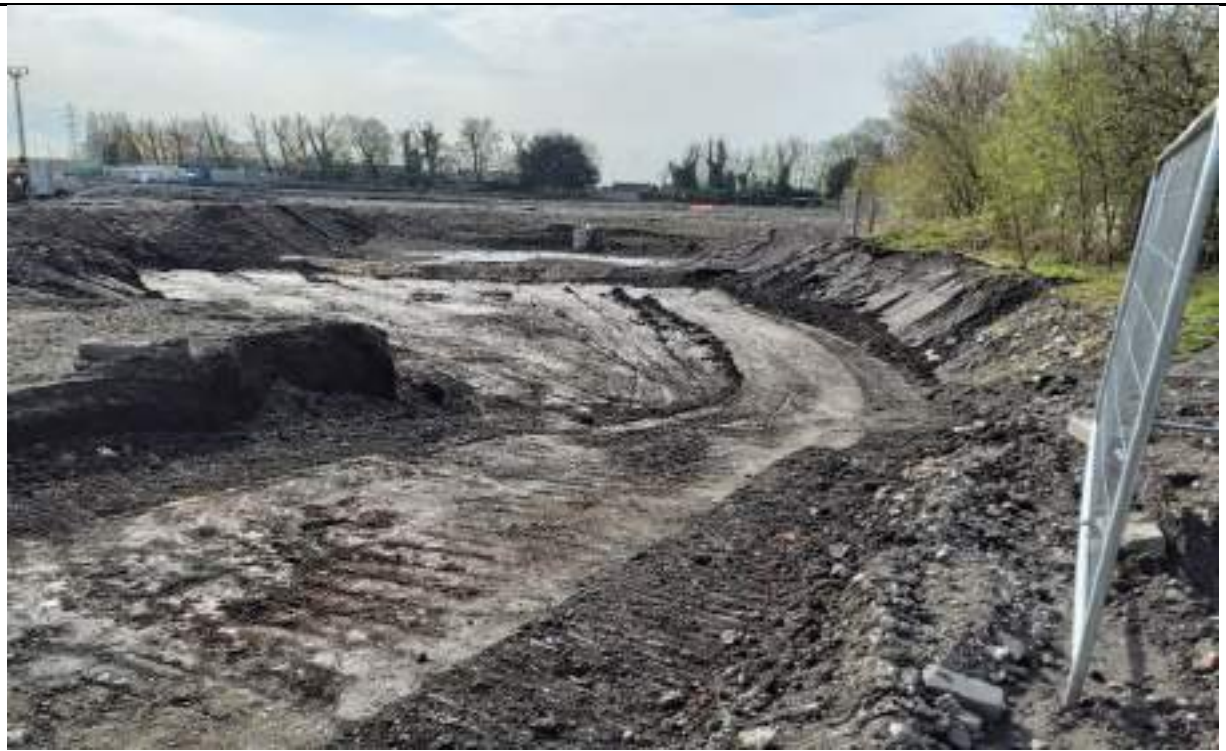
Photograph 12: Standing water and placed fill in the western boundary. Fill material is from hotspot 7 stockpile in the west.

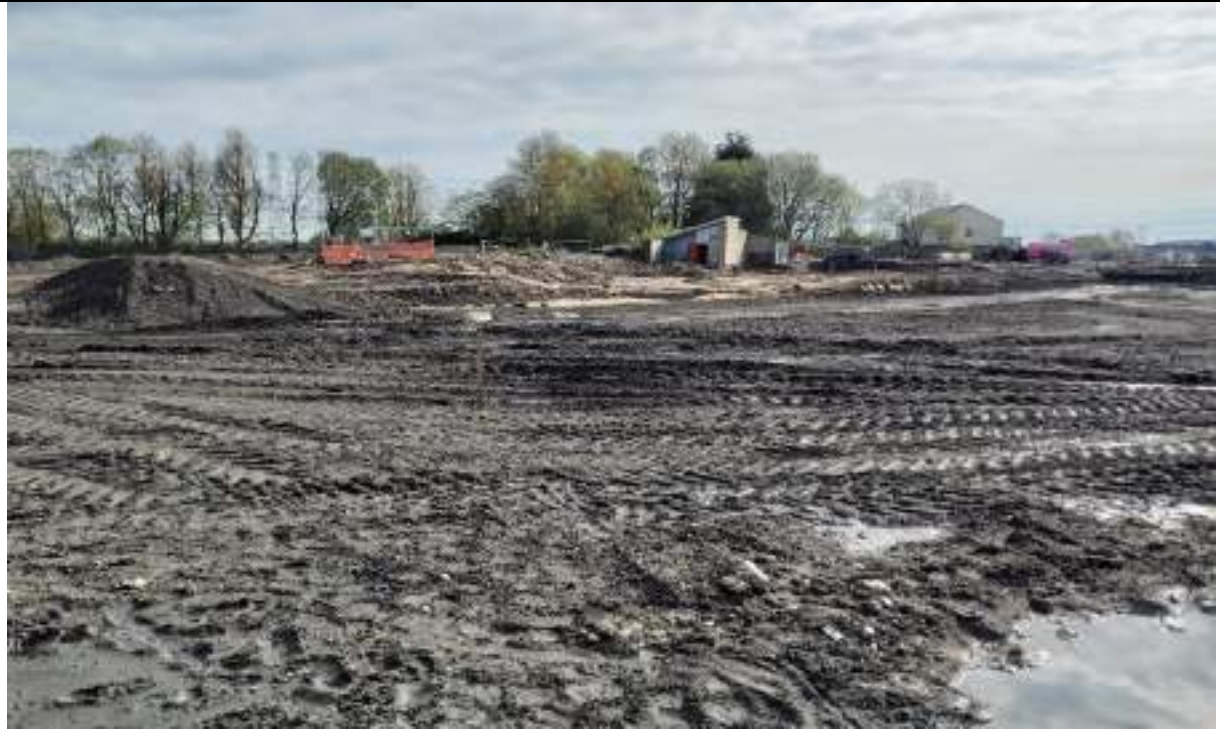
Photograph 13: Stockpile of yellow unsuitable Glacial Till moved to the borrow pit.

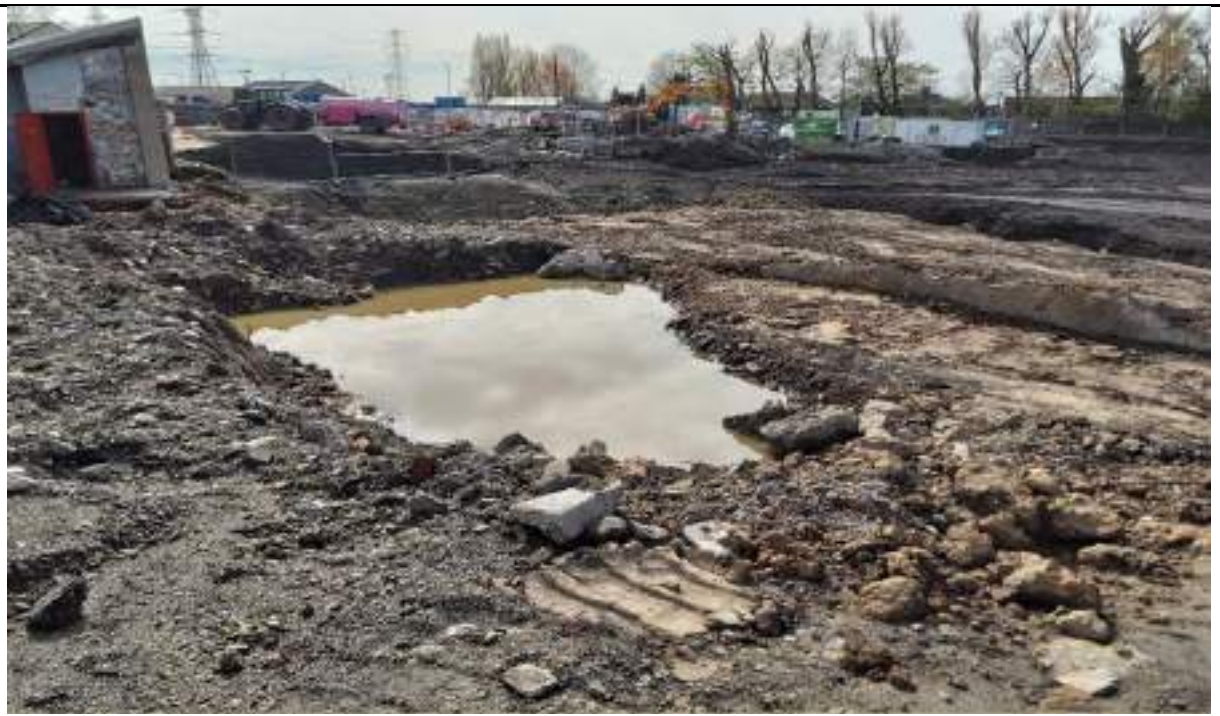
Photograph 14: Standing water in the southeast.

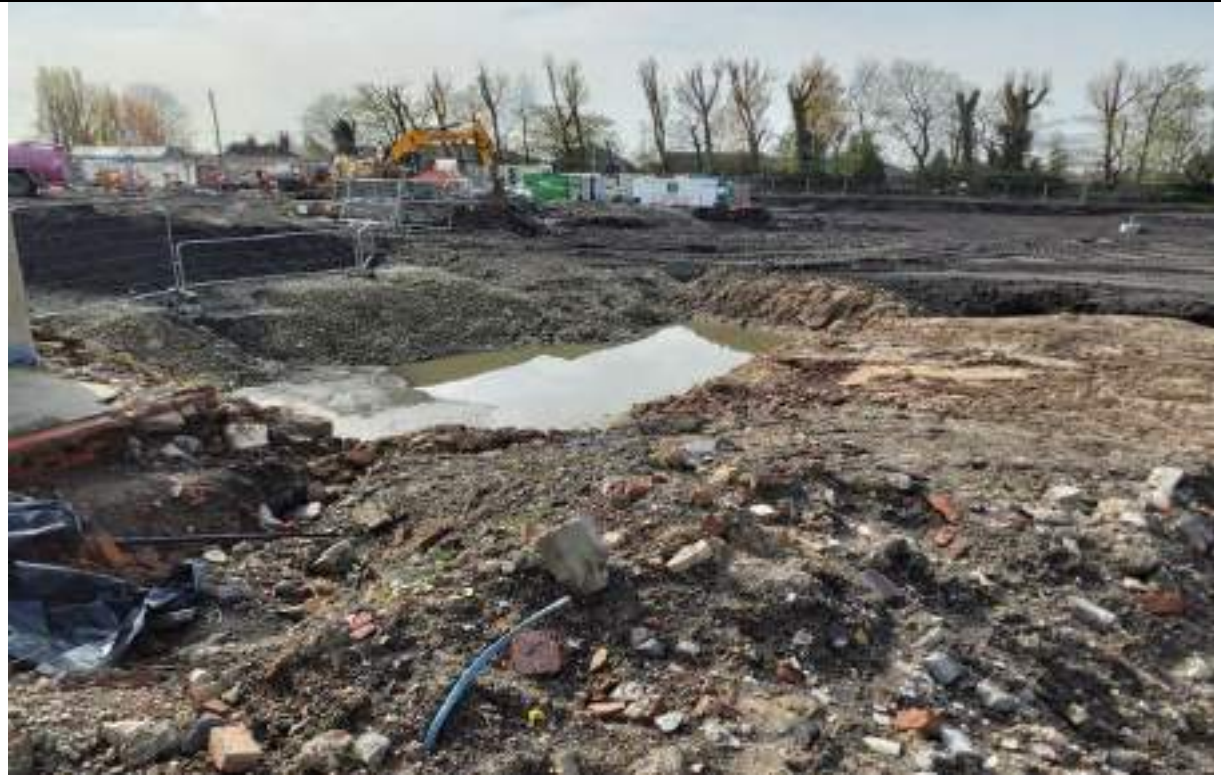
Photograph 15: Second standing water in the southeast.

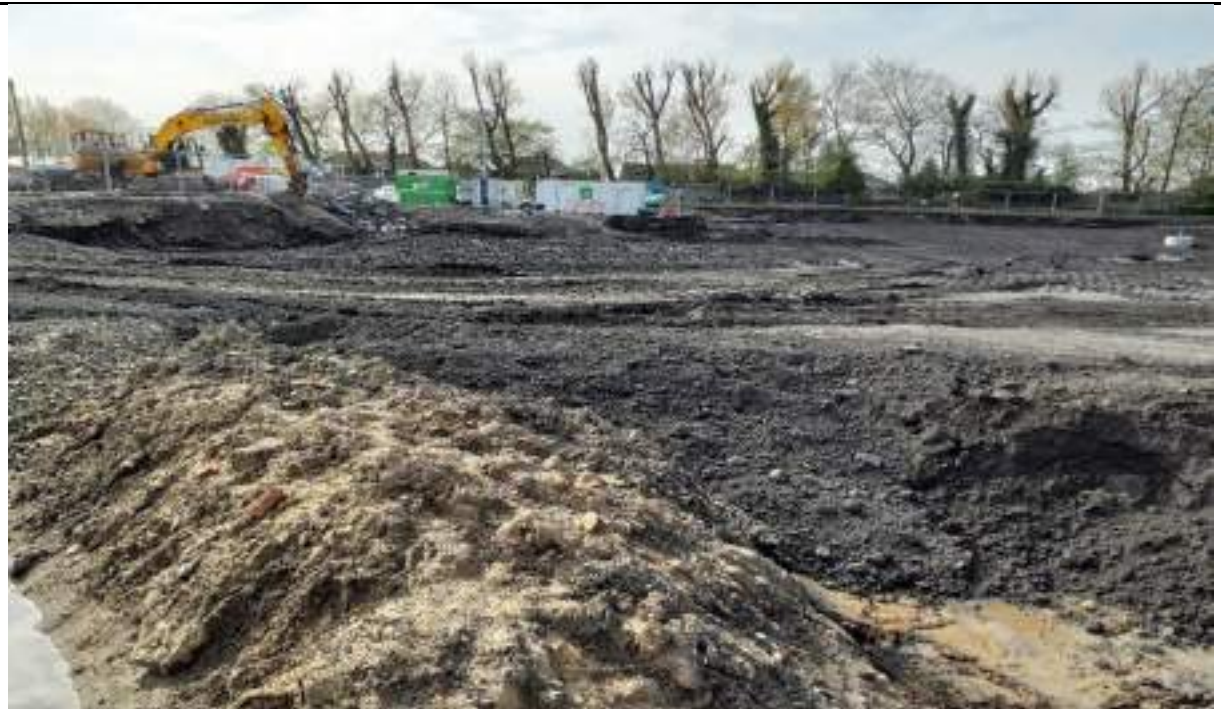
Photograph 16: Placed fill in the southeast. Fill proof rolled with sheepfoot roller.

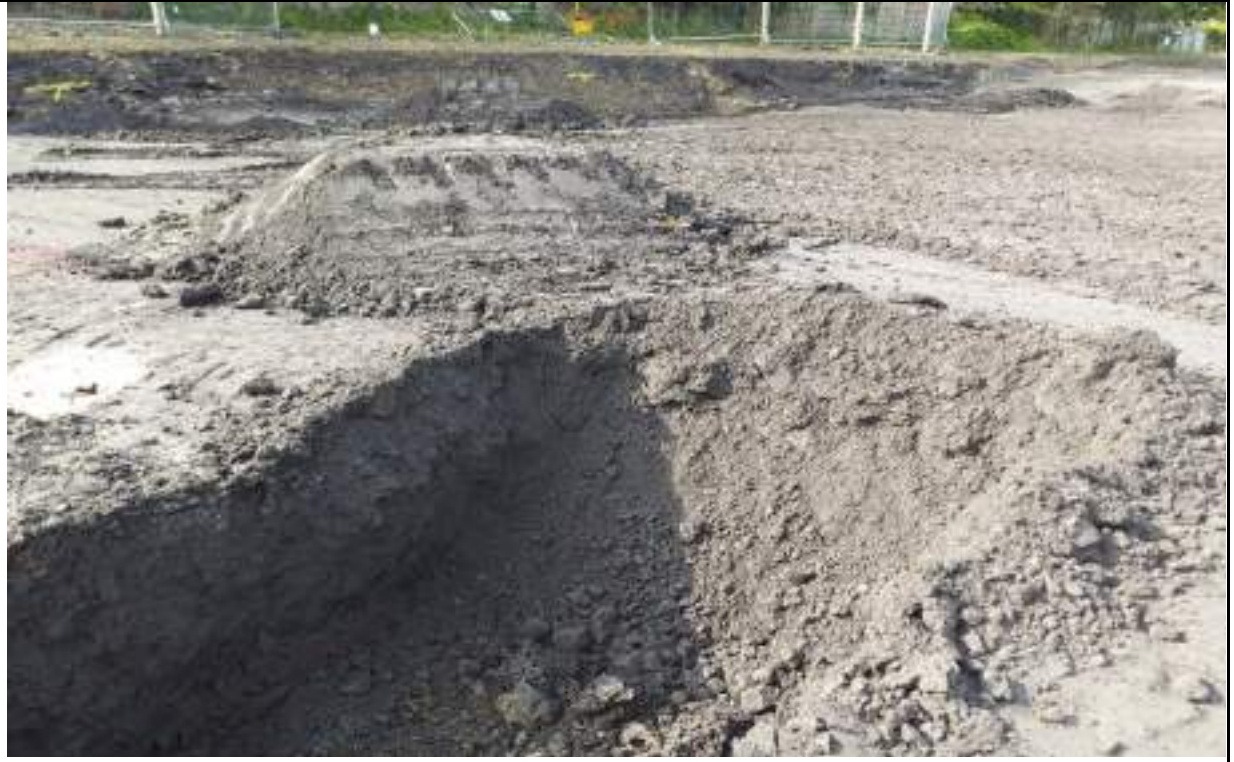
Photograph 17: 3 no. trial pits for groundwater monitoring in the southeast.

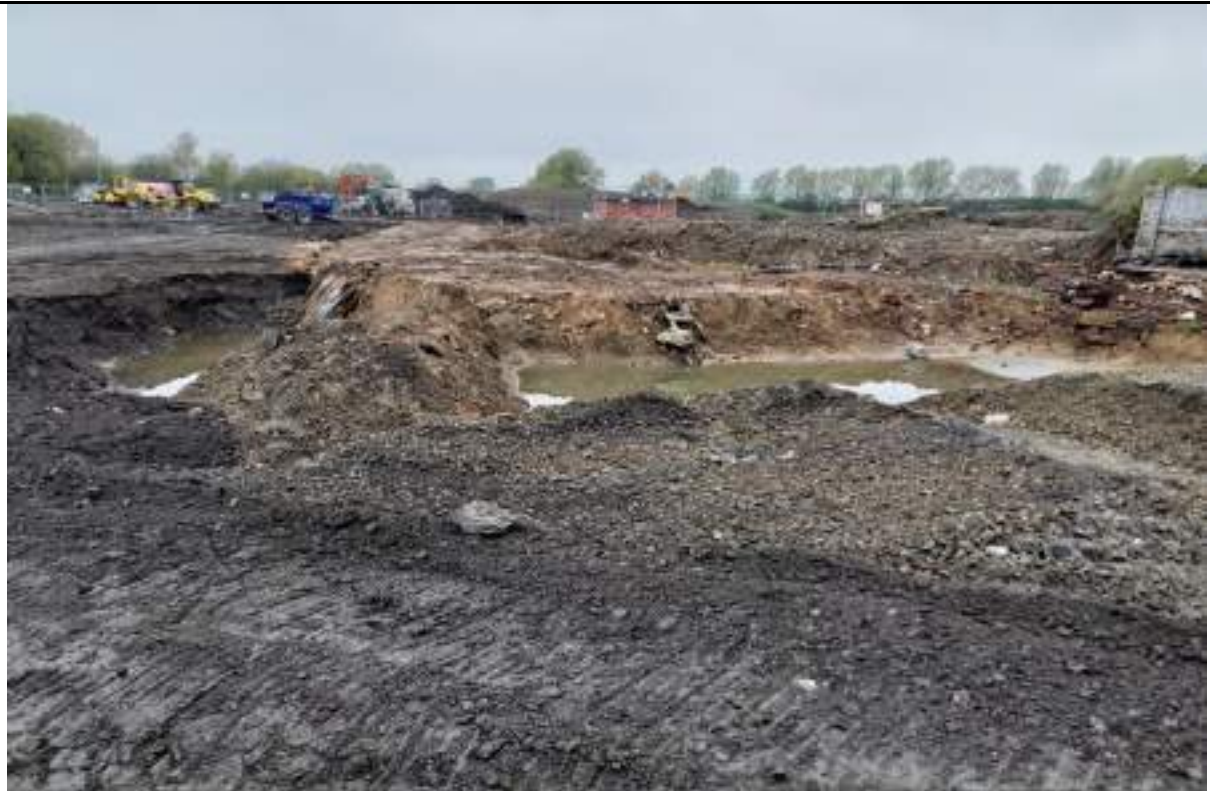
Photograph 1: Standing water in the southeast.

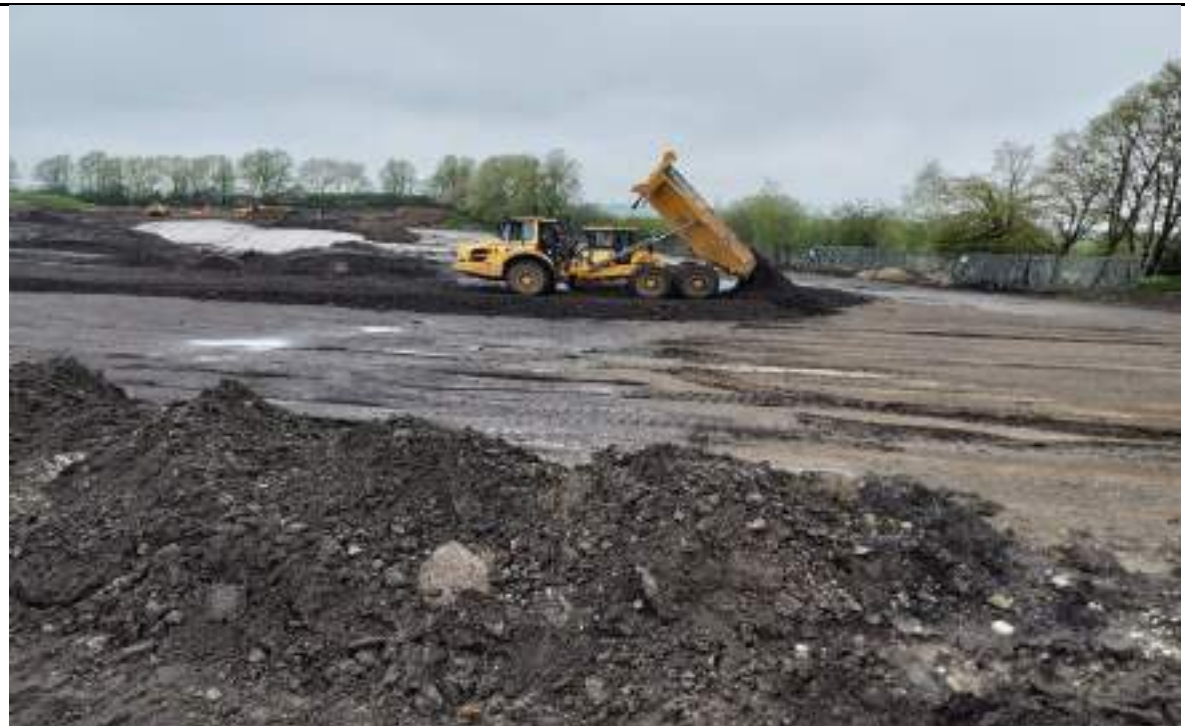
Photograph 4: Placing 6F2 material in the east. Material from 6F2 stockpile.

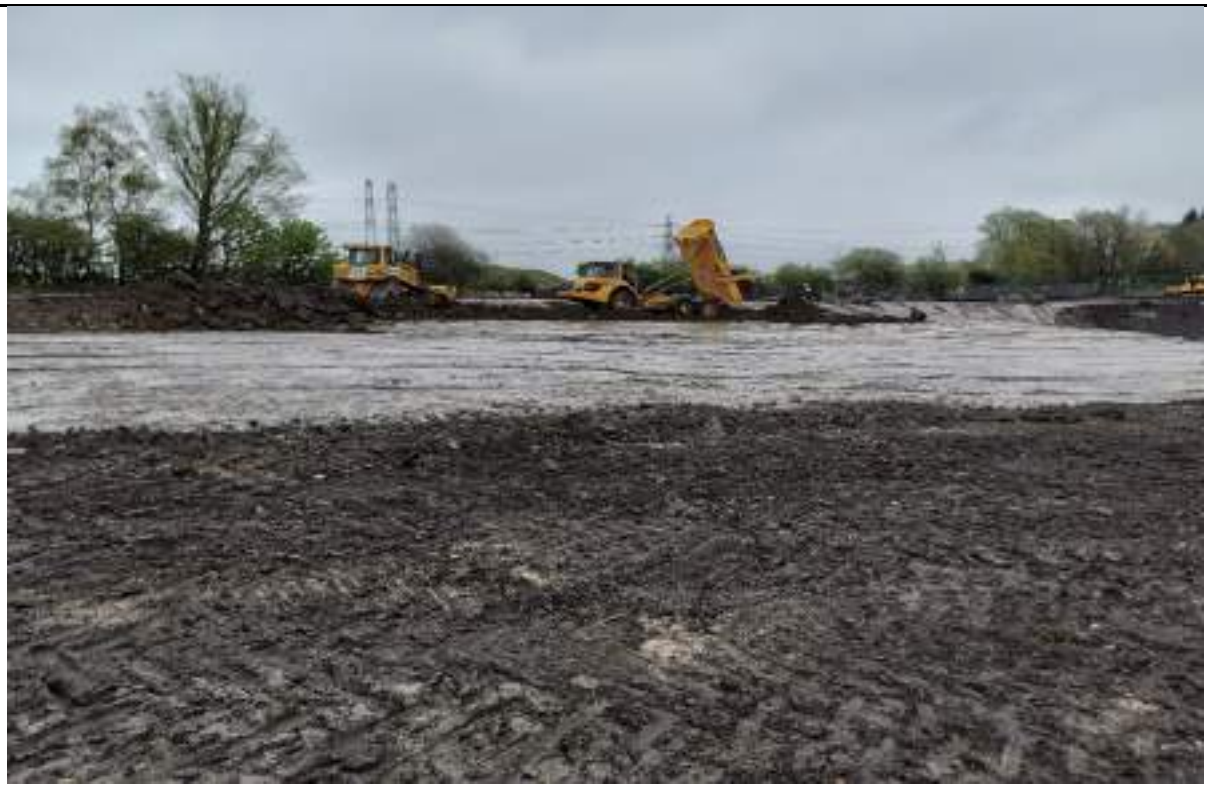
Photograph 8: Placing fill in the northeast. Glacial till material from the borrow pit.
