| SITE VISIT REPORT 15220-HYD-XX-XX-SVR-GE-1035 | | SHEET NO.: 1 of 20 | |
| Project: Stopes Road, Bolton | | Date: 09/11/22 | |
| Client: Harworth | | Weather: Cloudy | |
| Doc Ref: 15220-HYD-XX-XX-SVR-GE-1035 | | Status & Revision: S2 – P1 | |

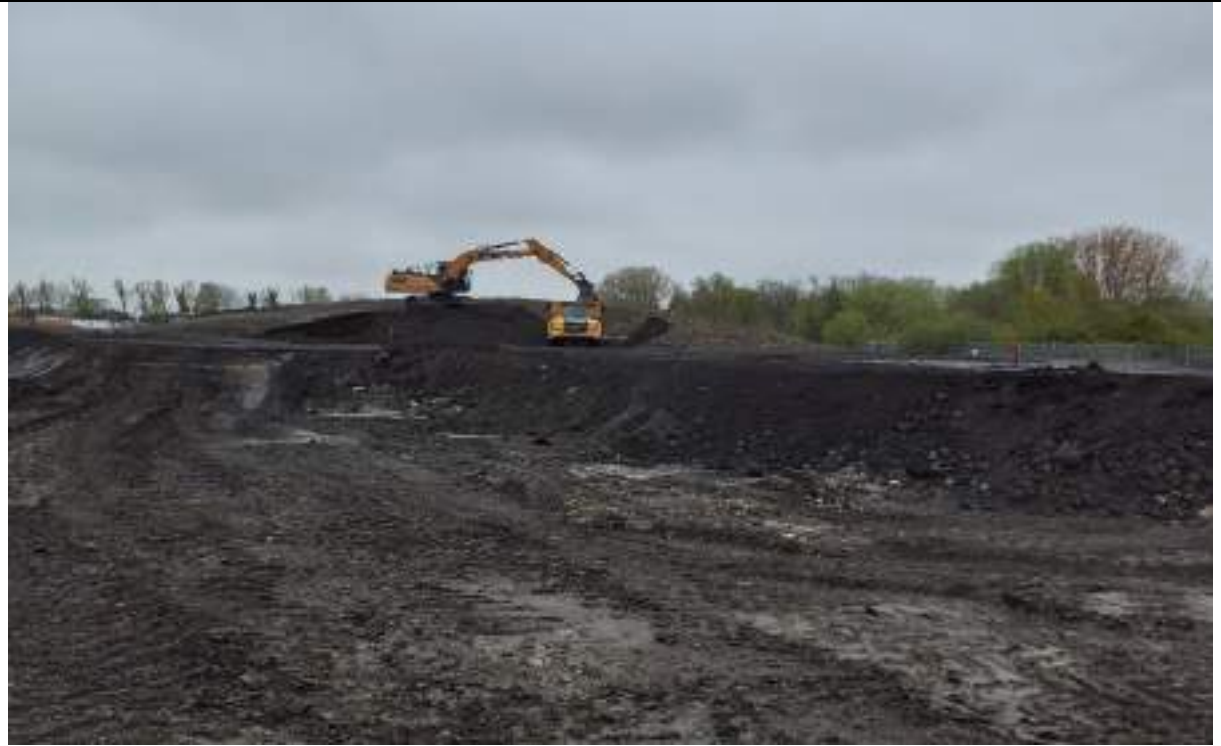
Photograph 9: Removing 6F2 material for capping the eastern part of the site.

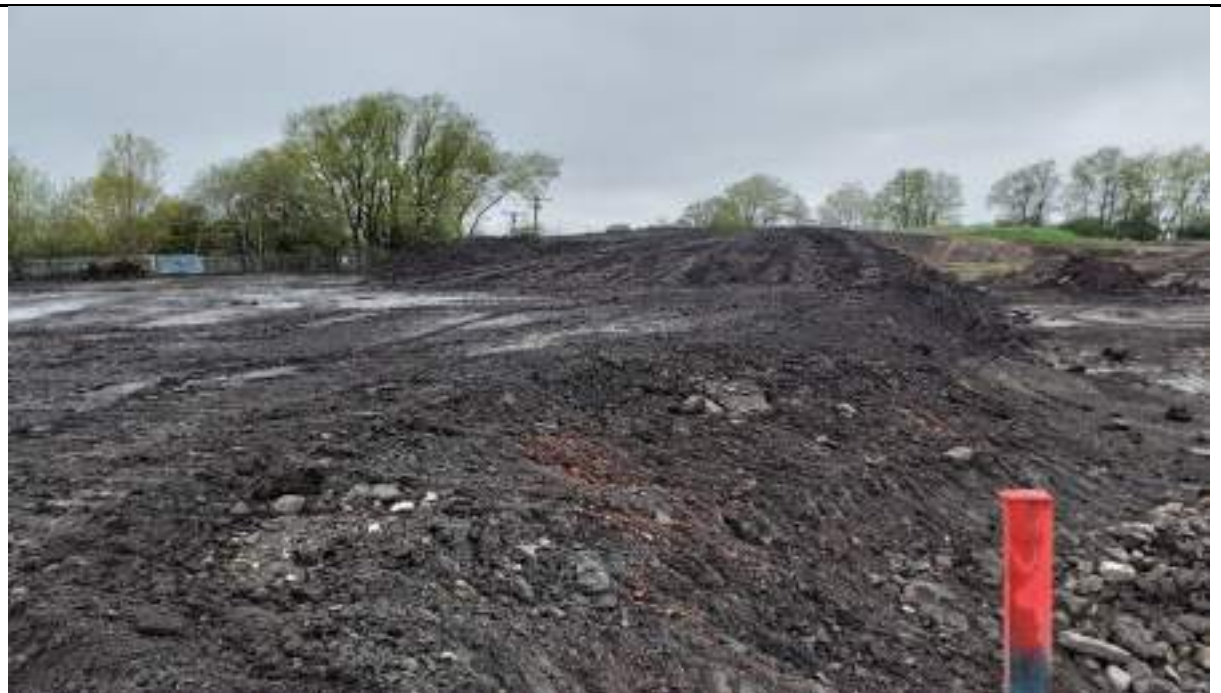
Photograph 10: Stockpile of peat and organic material in the northwest.

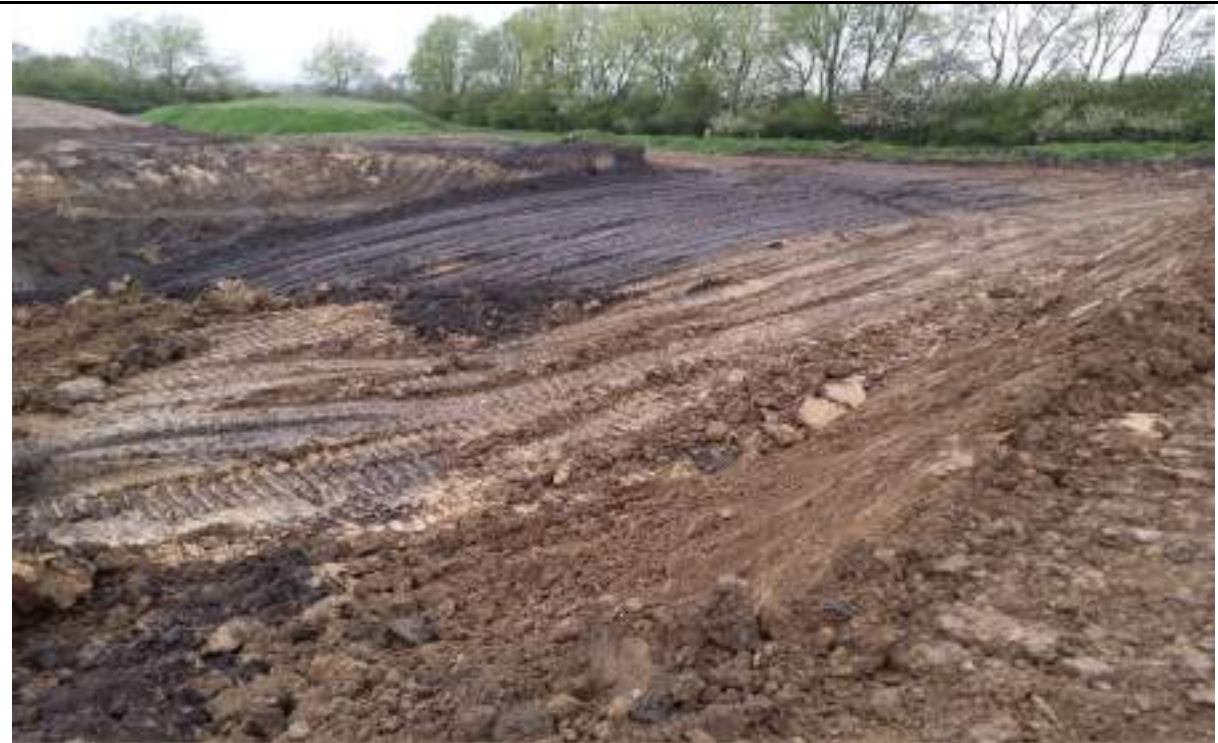
Photograph 11: The eastern part of the borrow pit backfilled with peat (from peat stockpile) and low strength Glacial Till (from borrow pit excavation).

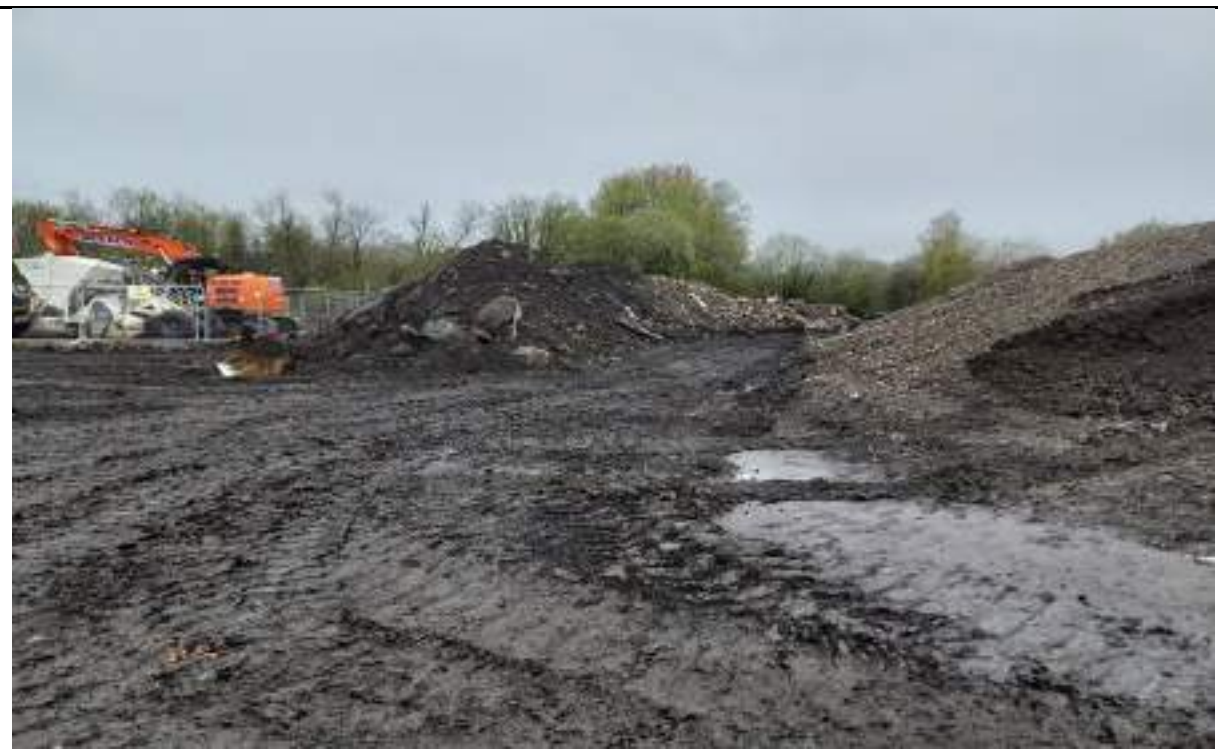
Photograph 12: Stockpile of concrete and oversized material in the northwest.

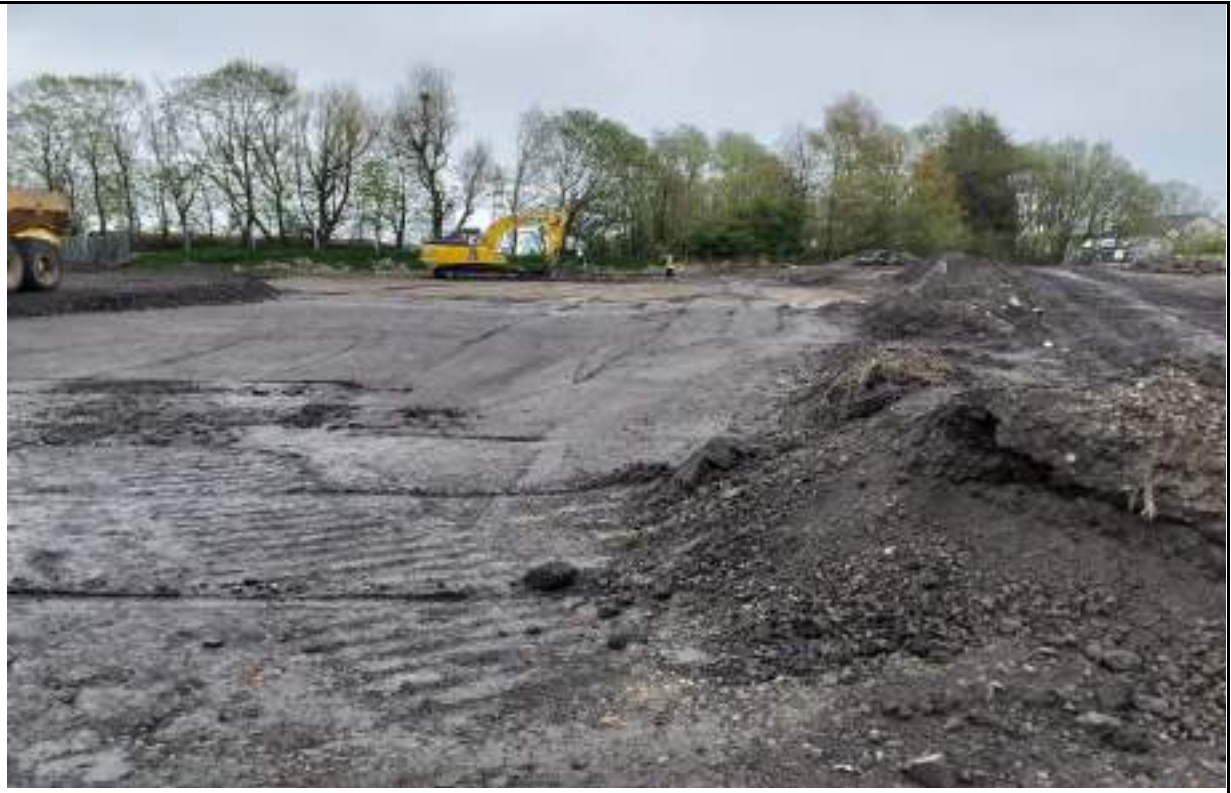
Photograph 13: Site surveying in the east.

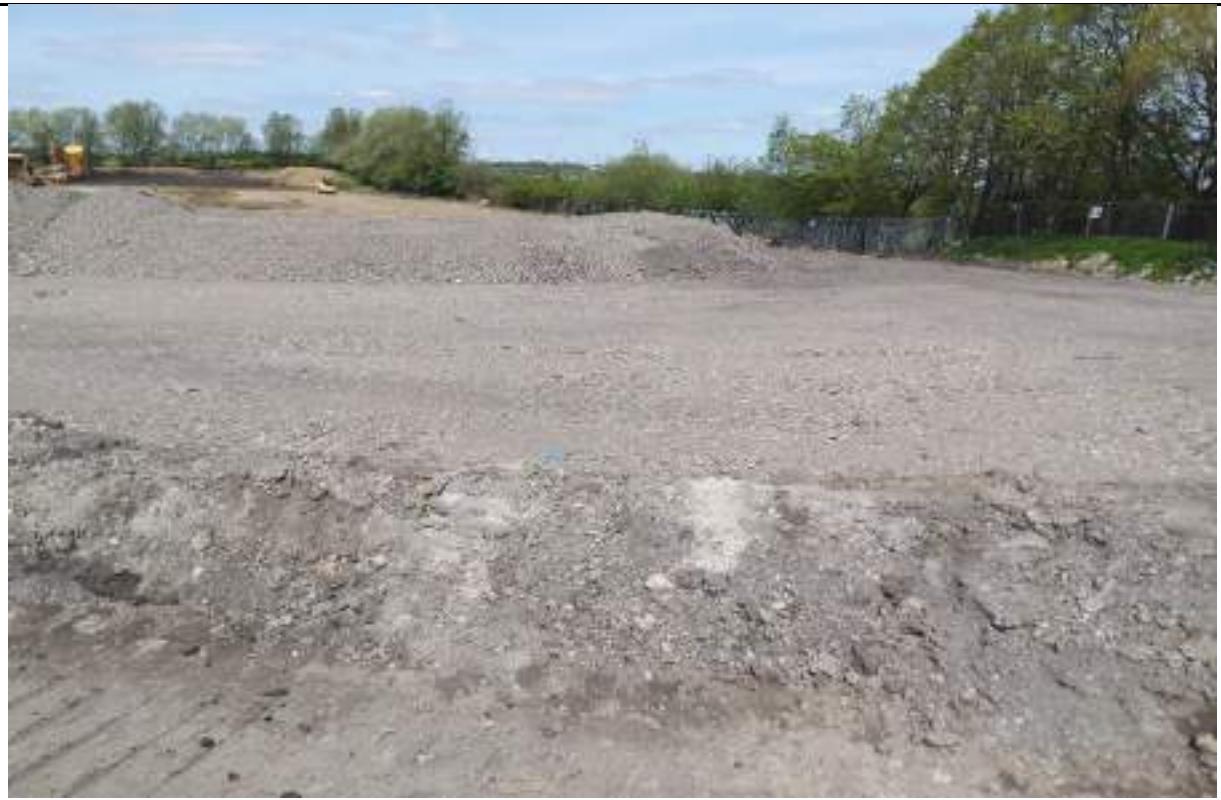
Photograph 2: 6F2 material placed in the east.

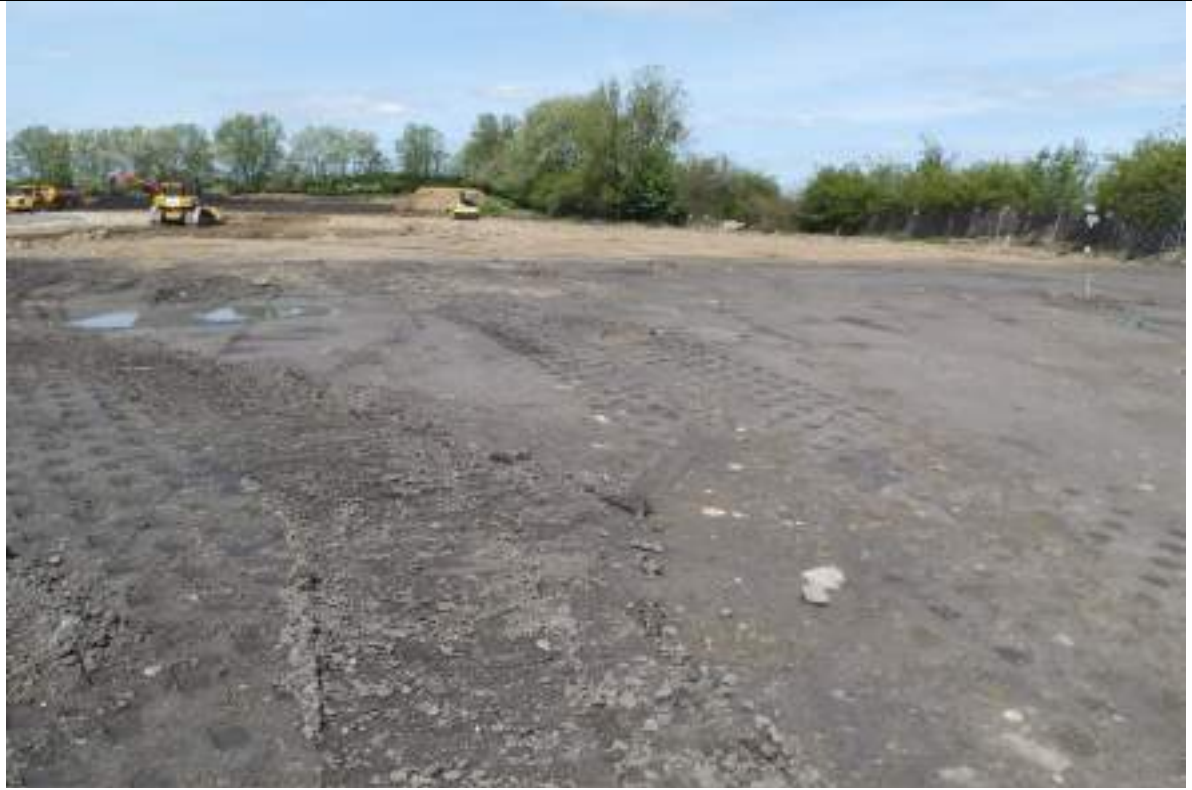
Photograph 3: placed fill in the northeast.

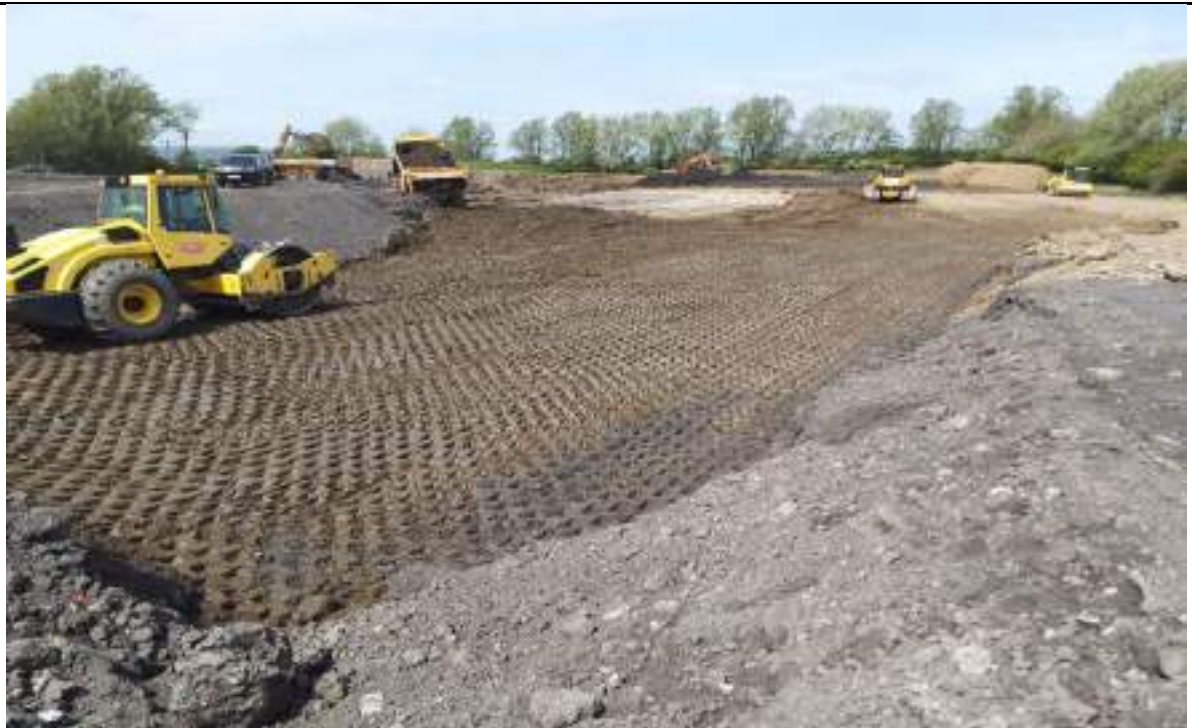
Photograph 4: Placing fill and proof rolling with sheepfoot roller in the center northeast. Material from Glacial Till excavation in the borrow pit.

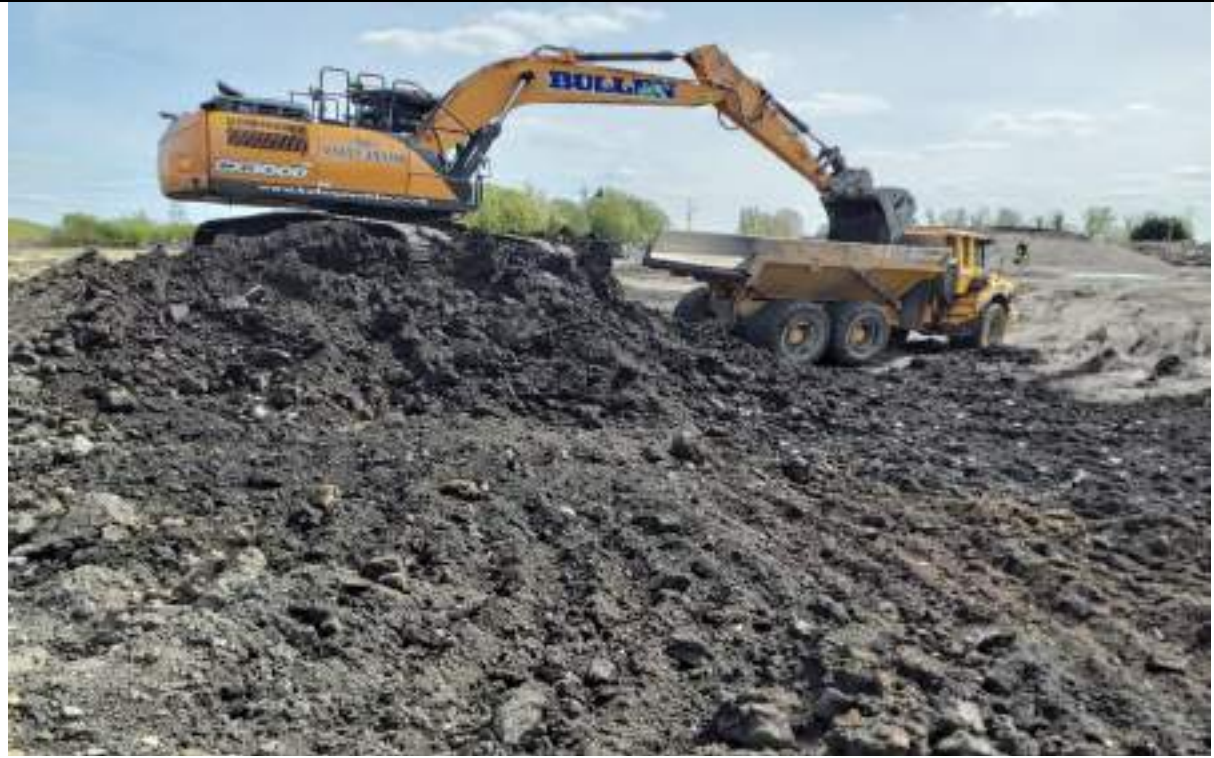
Photograph 5: Removal of peat stockpile to backfill the borrow pit.

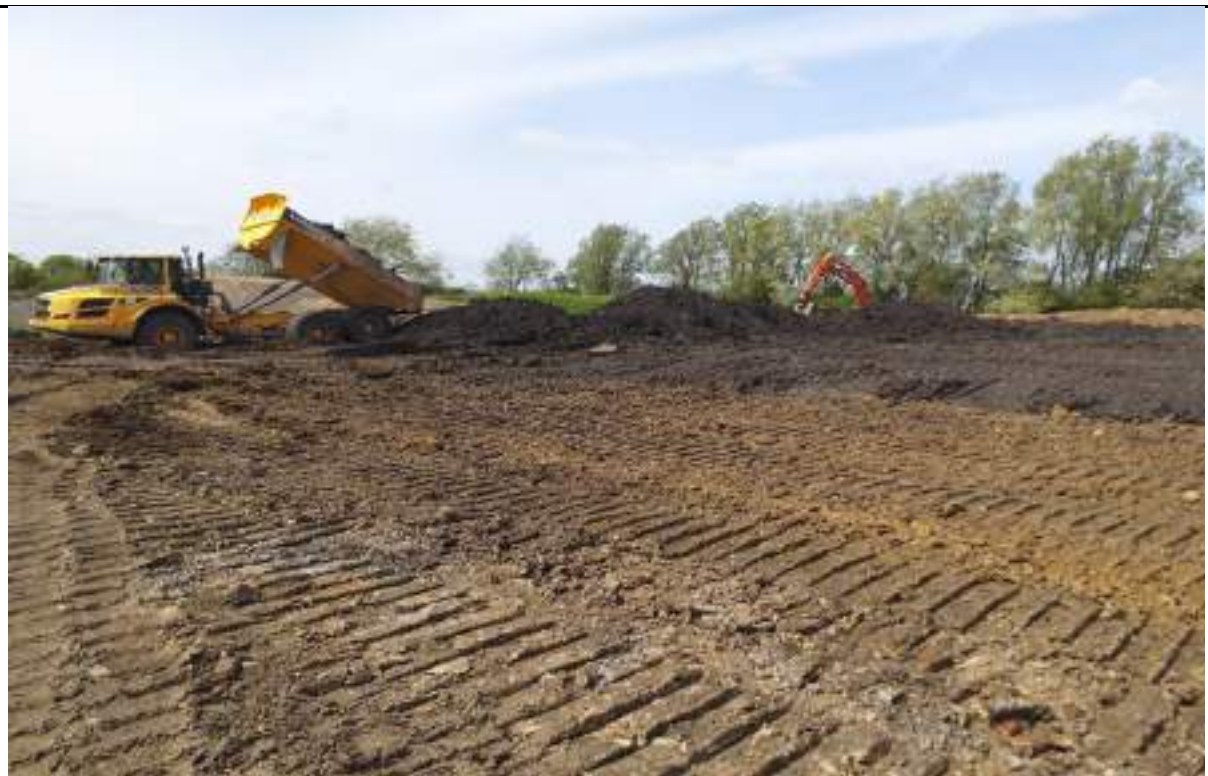
Photograph 6: Backfilling borrow pit using peat material from peat stockpile in the northwest.

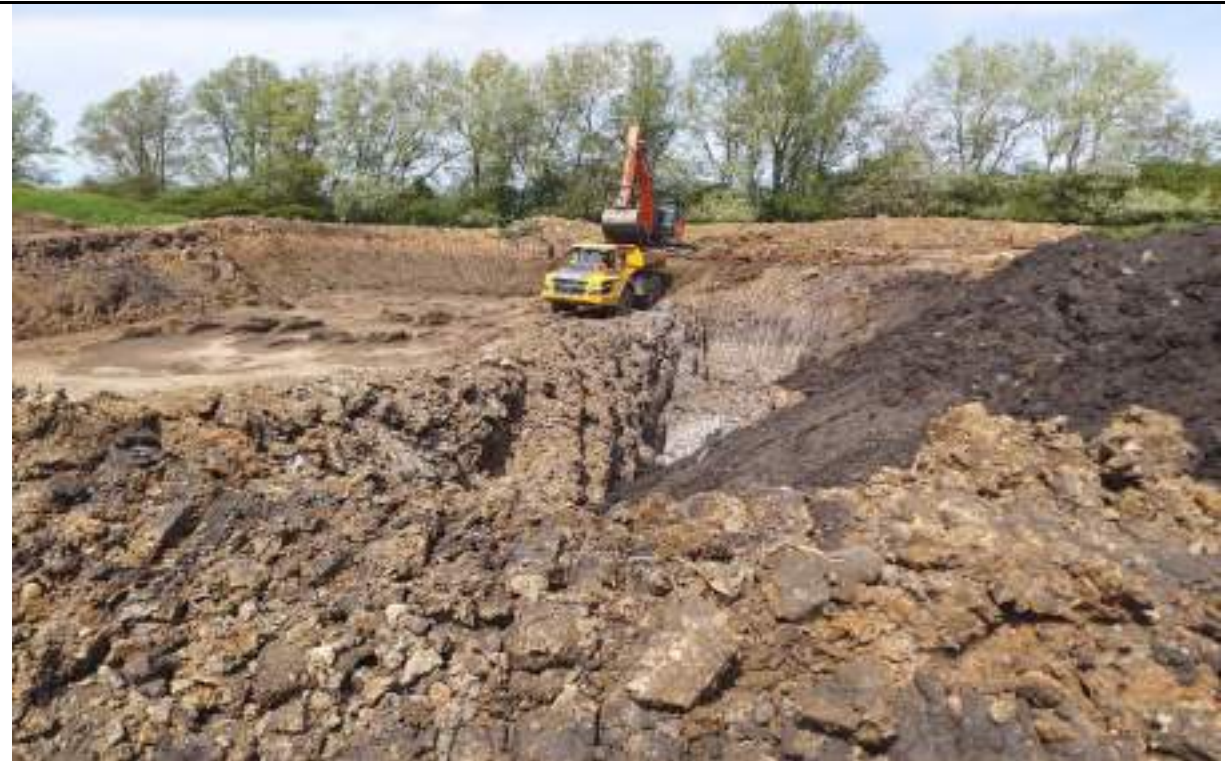
Photograph 7: Excavation of Glacial Till from the borrow pit in the centre north.

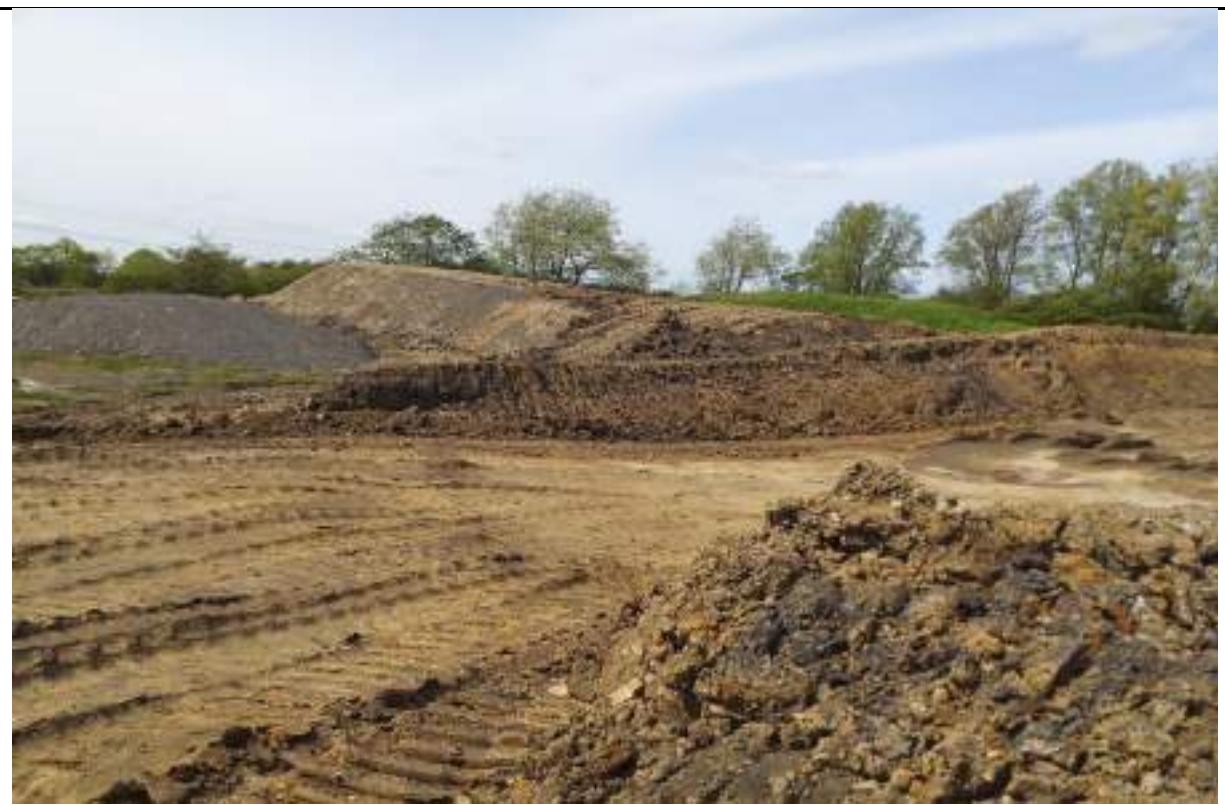
Photograph 8: Stockpiles of topsoil and unsuitable material in the northwest.

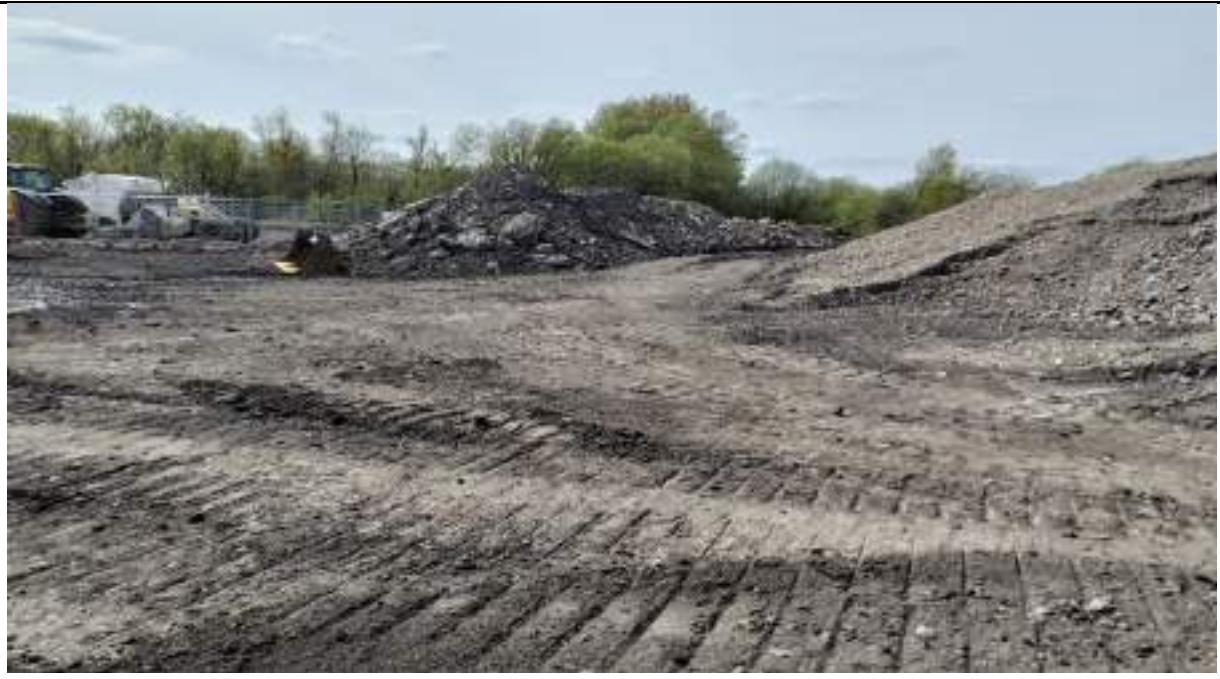
Photograph 10: Stockpile of oversized and concrete material in the western part of the site.

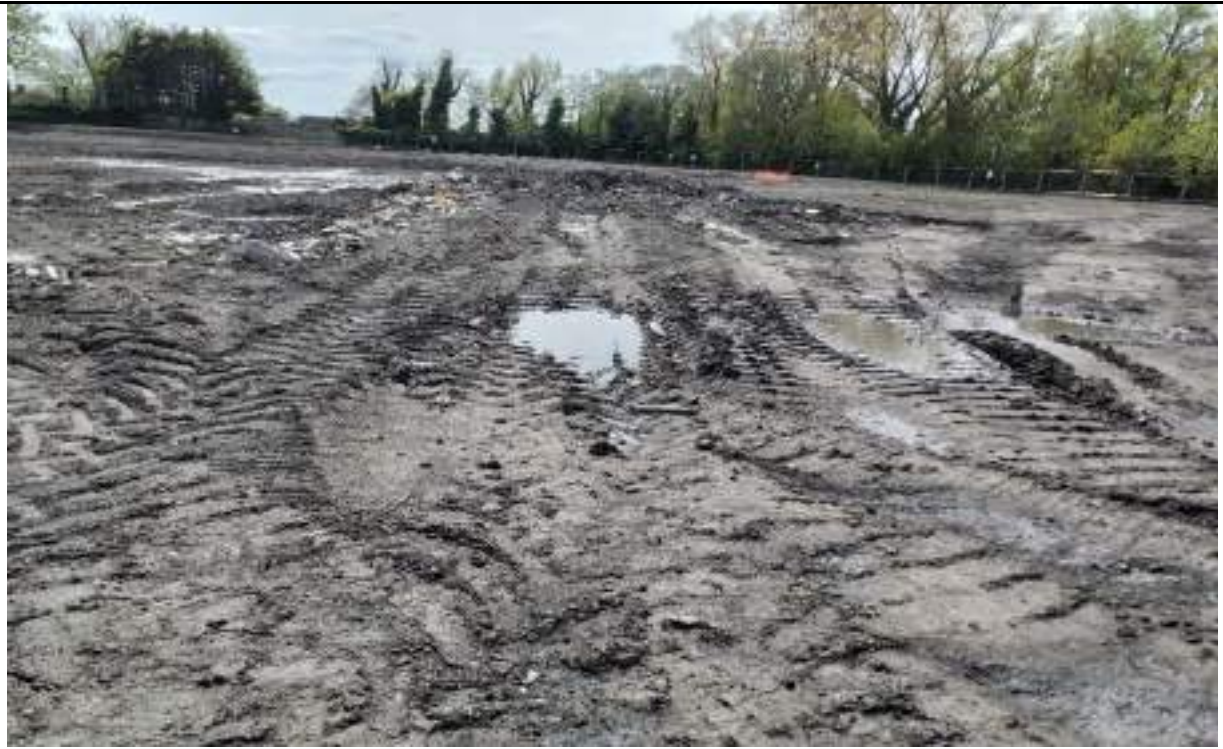
Photograph 11: Temporary Road constructed with oversize material during the wet season in the southwest to be removed.

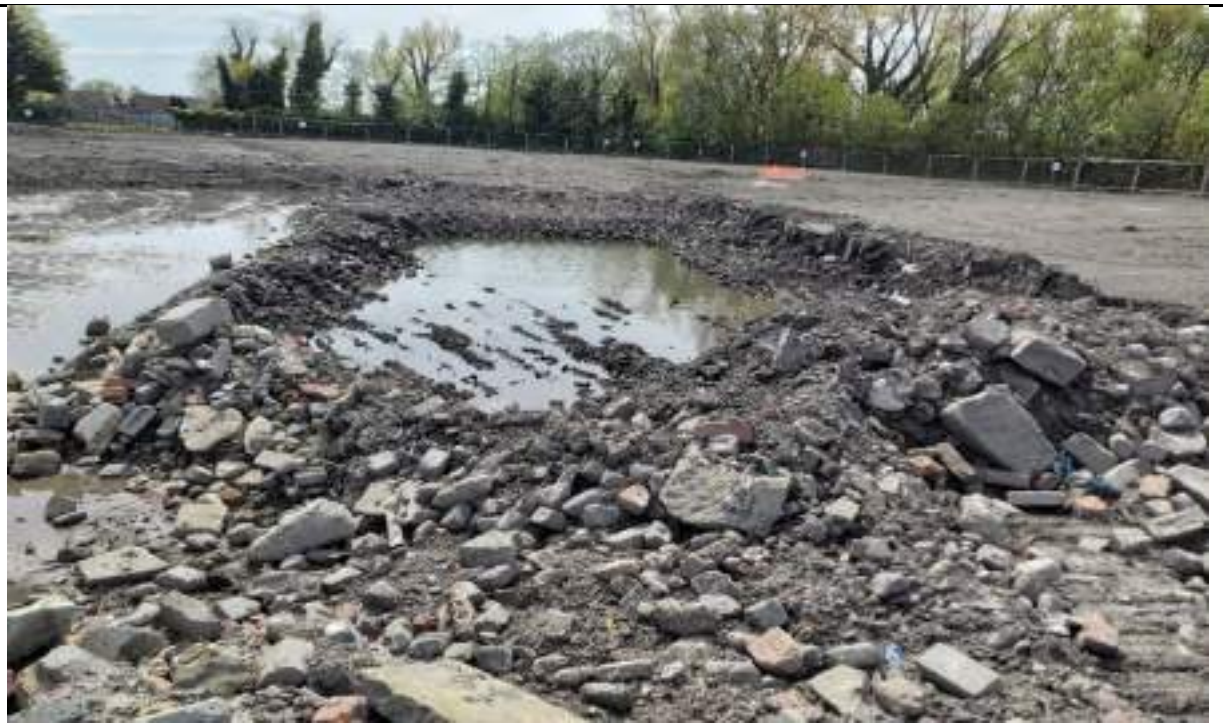
Photograph 12: Standing water and oversize material of temporary road in the southwest.

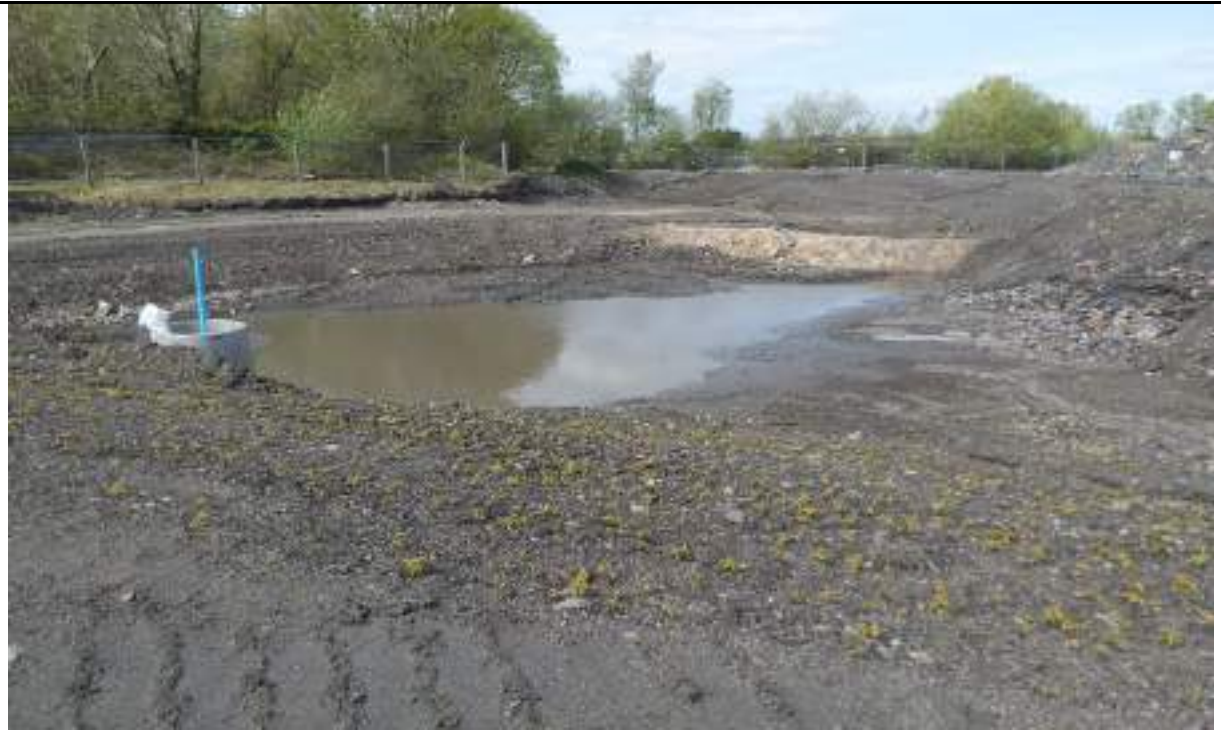
Photograph 13: Standing water in the western boundary.

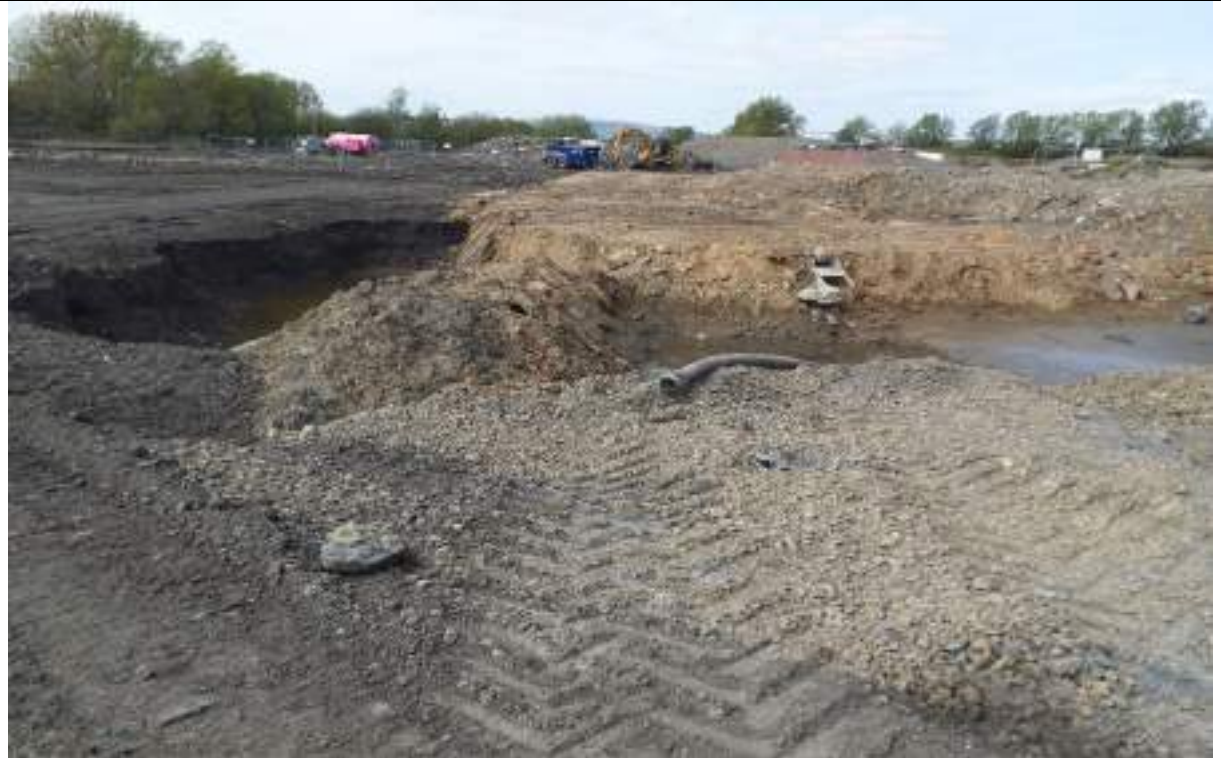
Photograph 15: Standing water next to the unsuitable Glacial Till material stockpile in the southeast.

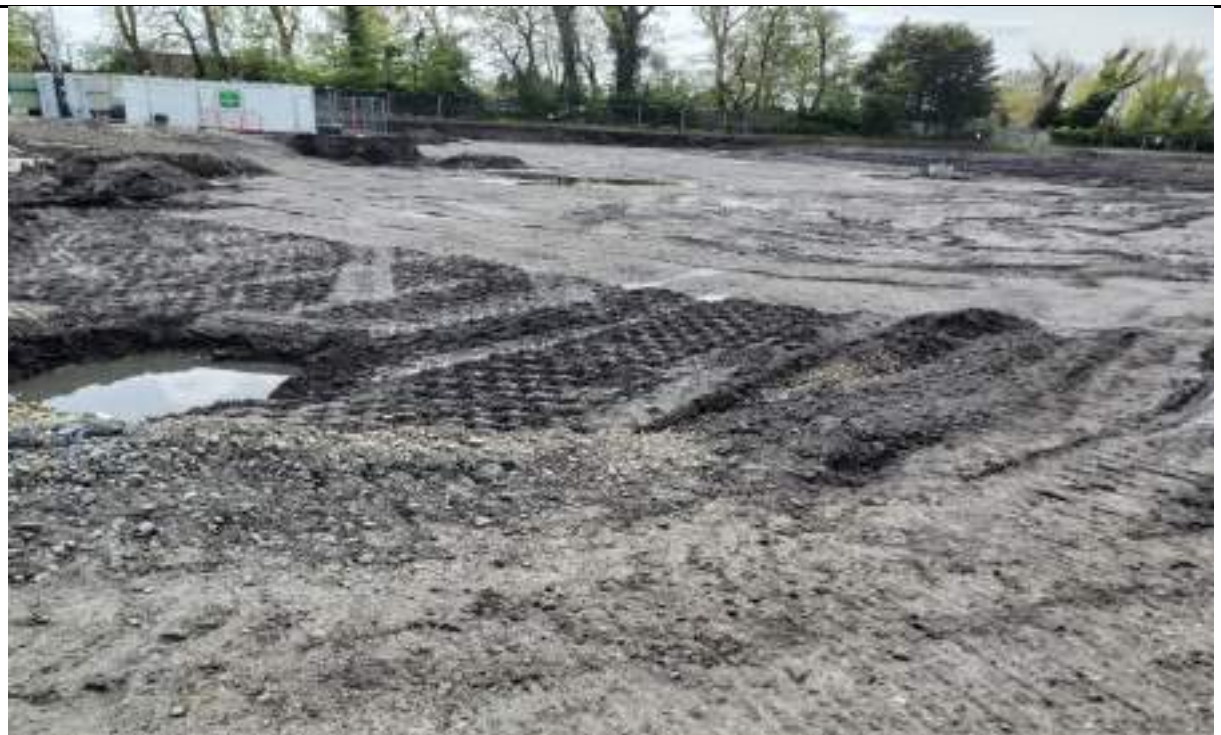
Photograph 16: Trial pits for groundwater monitoring in the southeast. Three trial pits in the centre south are filled with water.

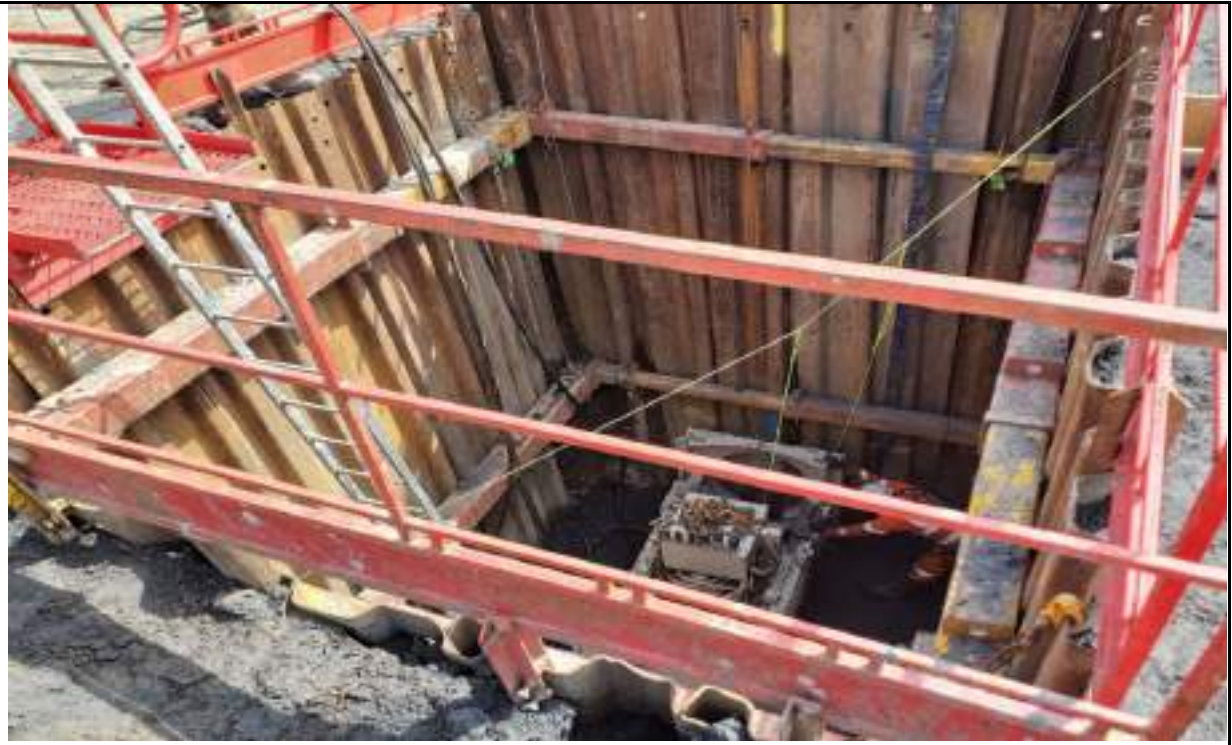
Photograph 16: Preparation of thrust bore drainage for boring in the southeast.

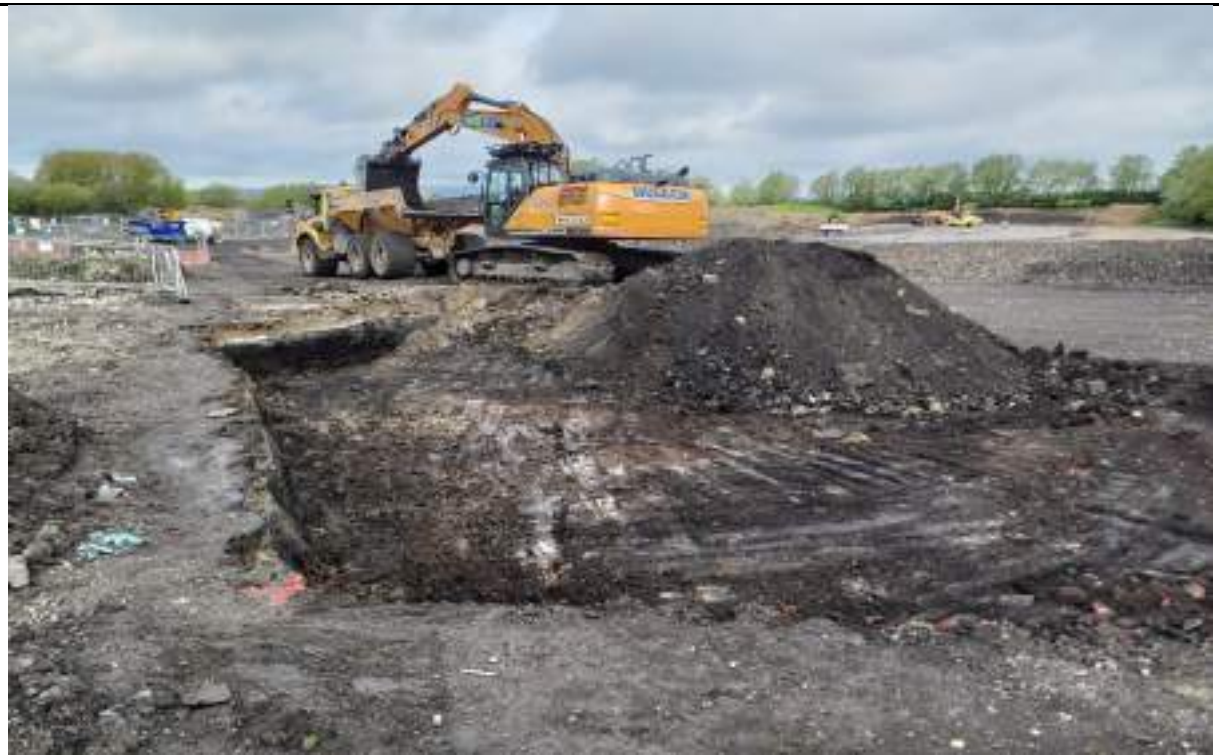
Photograph 2: Excavation of landfill Made Ground in the eastern boundary.

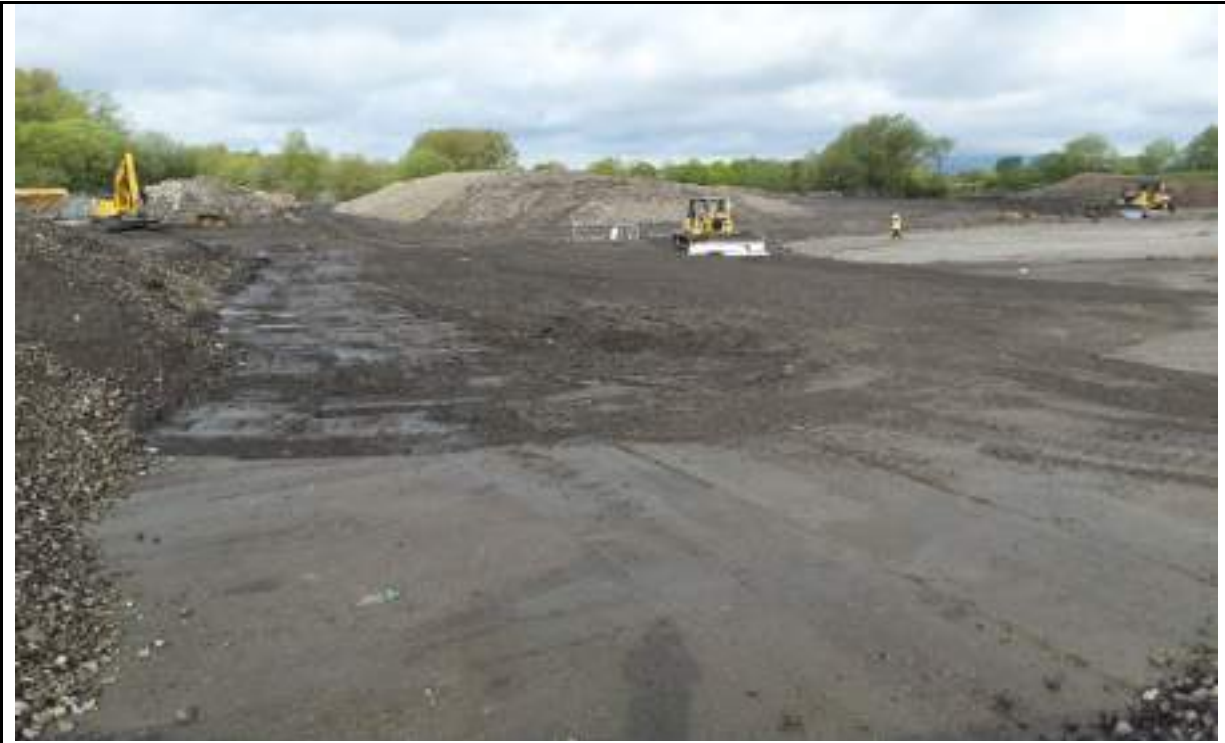
Photograph 3: Stockpiles of 6F2 and oversize materials in the northwest.

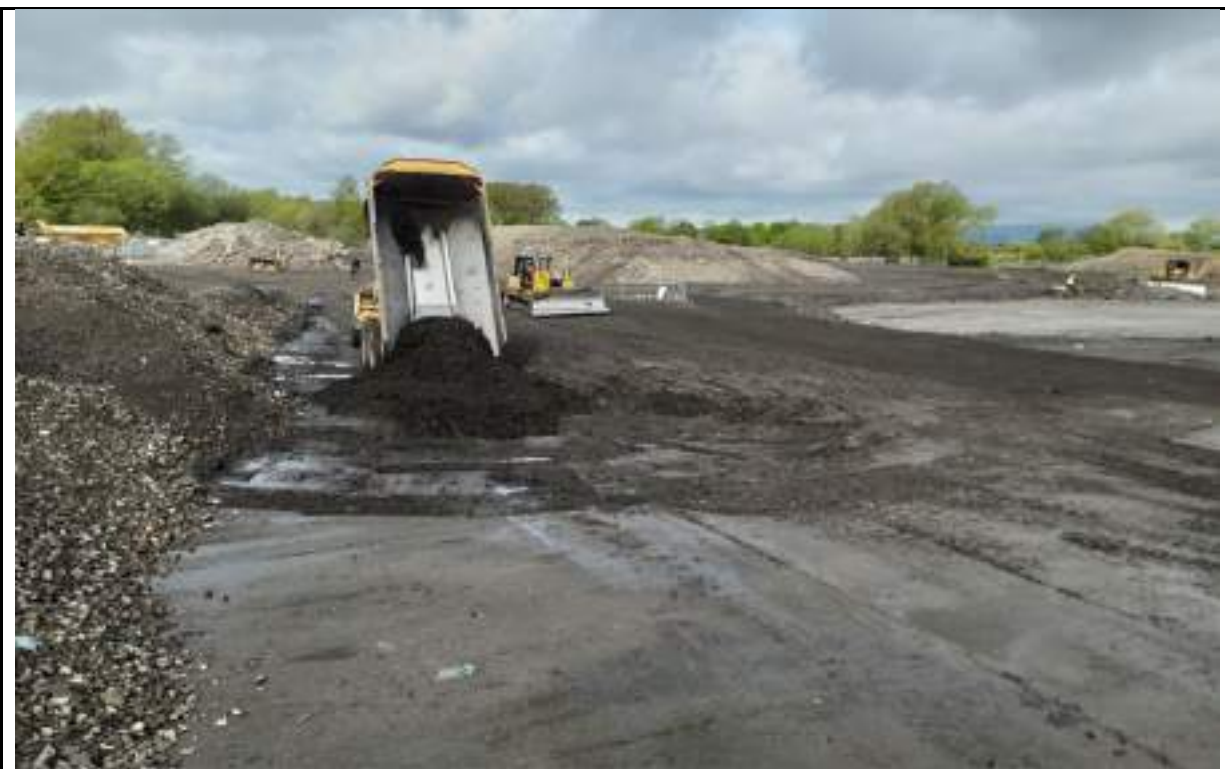
Photograph 4: Placing fill in the centre east of the site. Material from excavation of landfill Made Ground in the east.

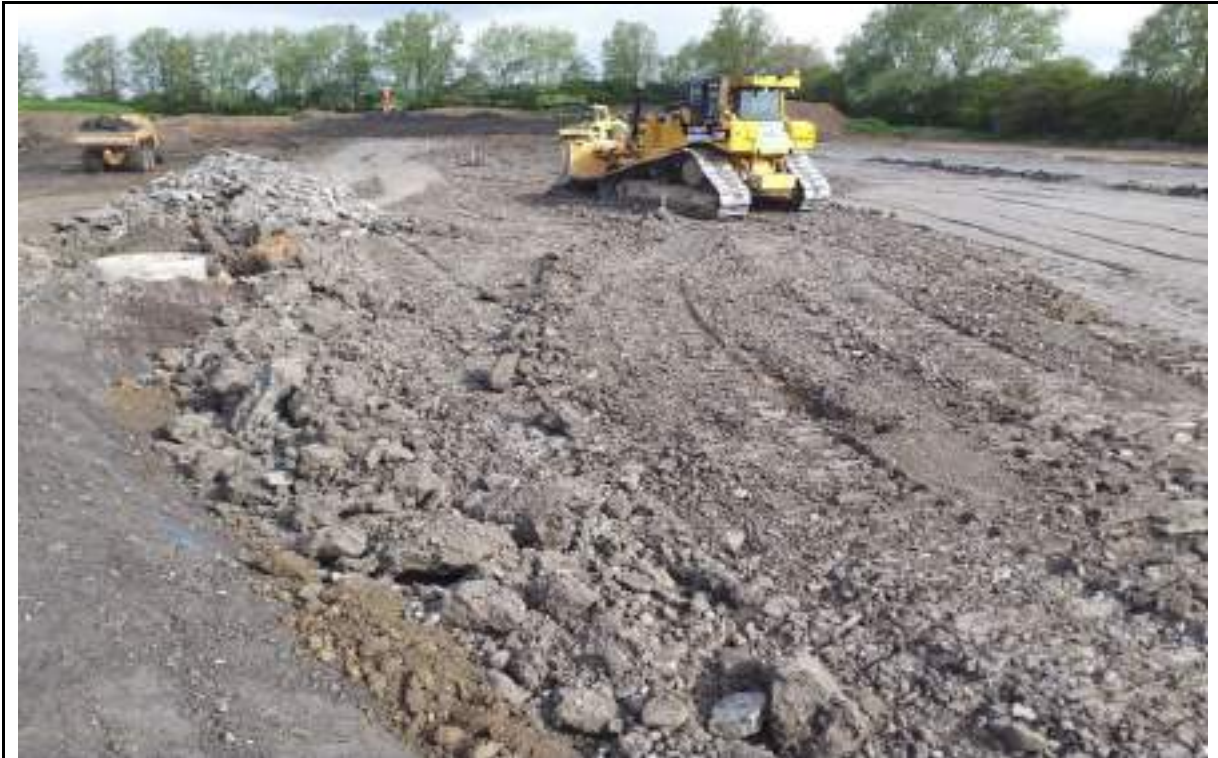
Photograph 5: Placing excavated mudstone from borrow pit in the centre northeast. Fill is proof rolled using sheepfoot roller.

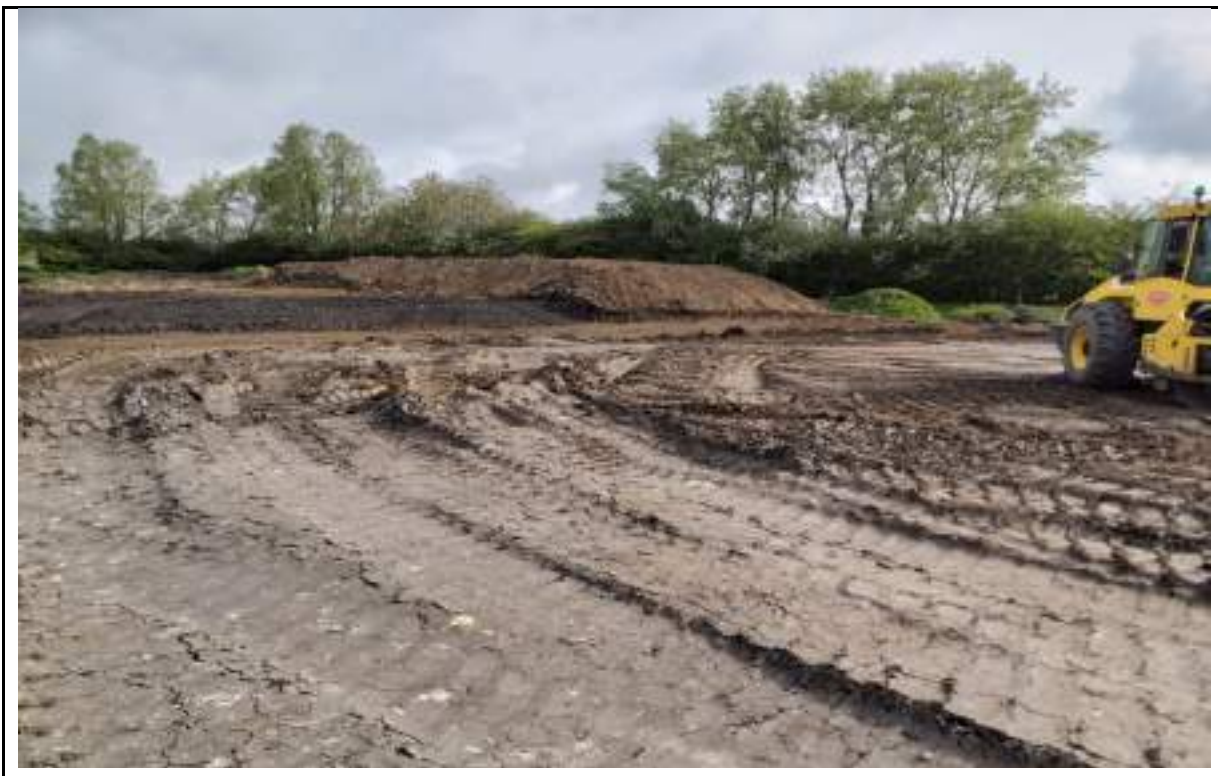
Photograph 6: Stockpile of low strength Glacial till excavated from the borrow pit.
