| SITE VISIT REPORT 15220-HYD-XX-XX-SVR-GE-1035 | | SHEET NO.: 1 of 20 | |
| Project: Stopes Road, Bolton | | Date: 09/11/22 | |
| Client: Harworth | | Weather: Cloudy | |
| Doc Ref: 15220-HYD-XX-XX-SVR-GE-1035 | | Status & Revision: S2 – P1 | |

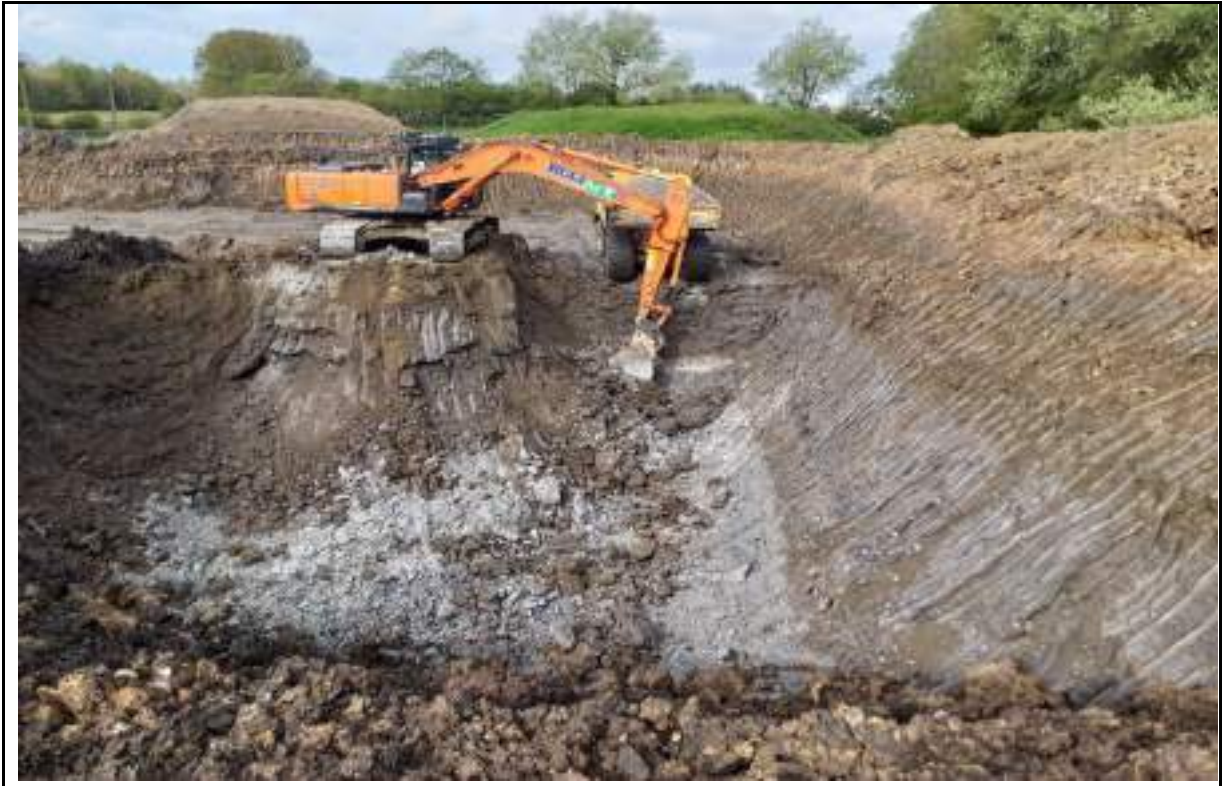
Photograph 7: Excavation of mudstone from the borrow pit in the north.

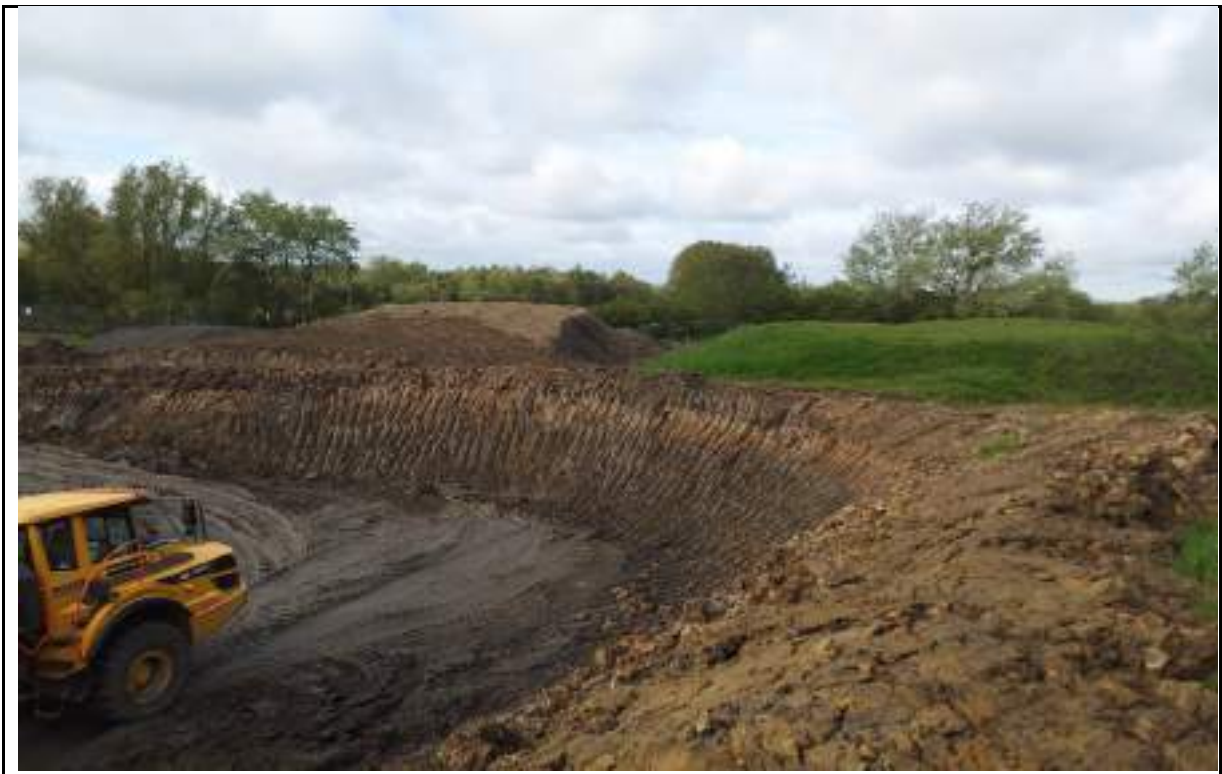
Photograph 8: Stockpiles of topsoil and unsuitable material in the western side of the borrow pit.

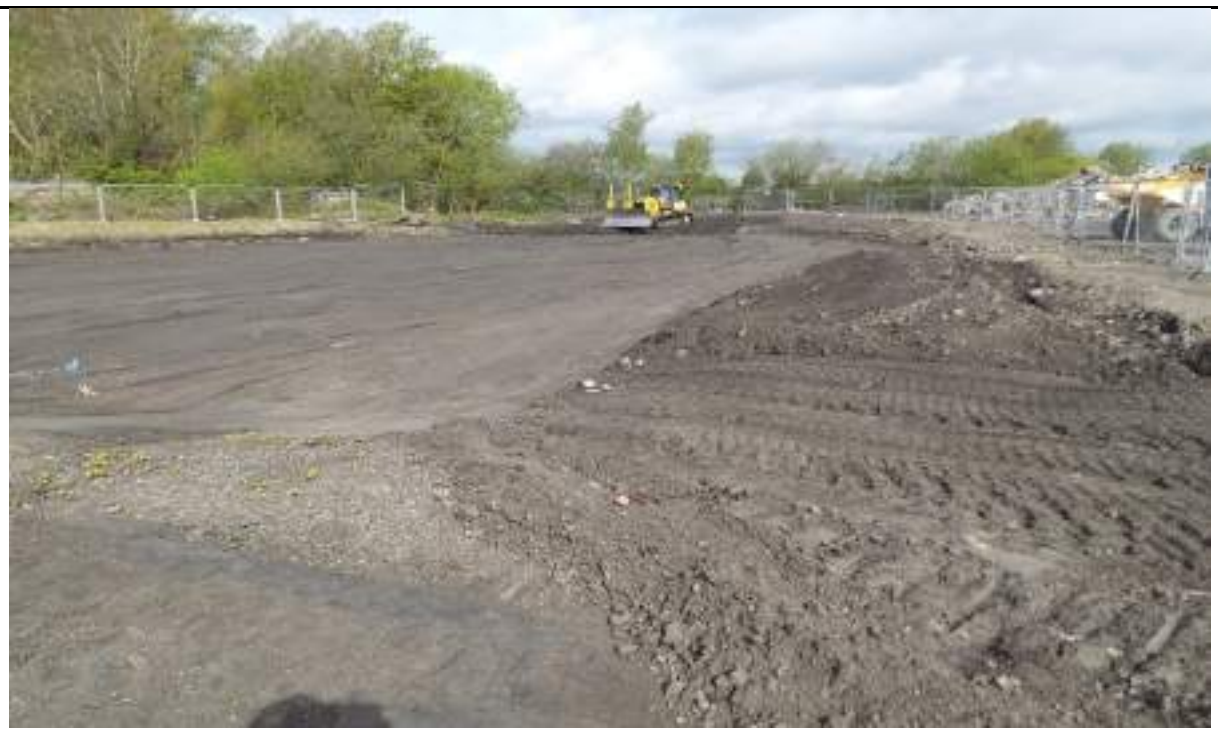
Photograph 10: Placing fill in the western boundary near grouted abstraction well. Material from excavated landfill Made Ground in the eastern boundary.

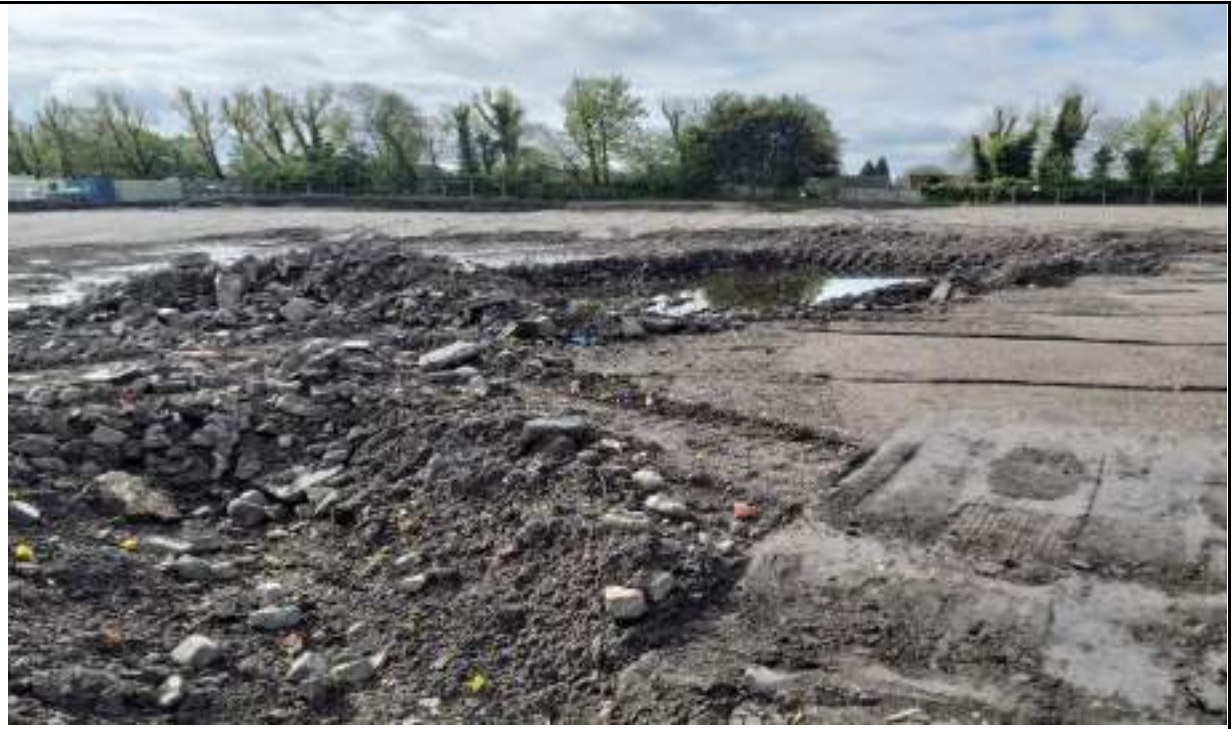
Photograph 11: Standing water adjacent to temporary road constructed with oversize material during the wet season.

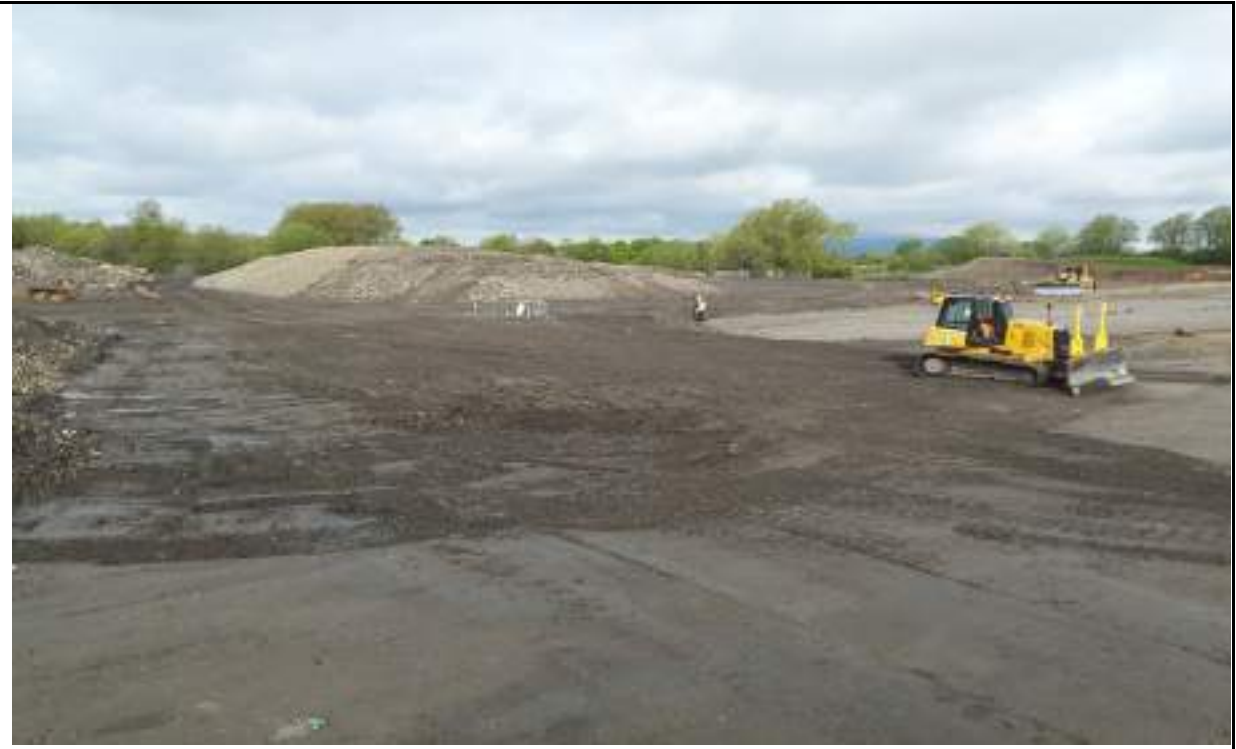
Photograph 13: Surveying the site in the centre north.

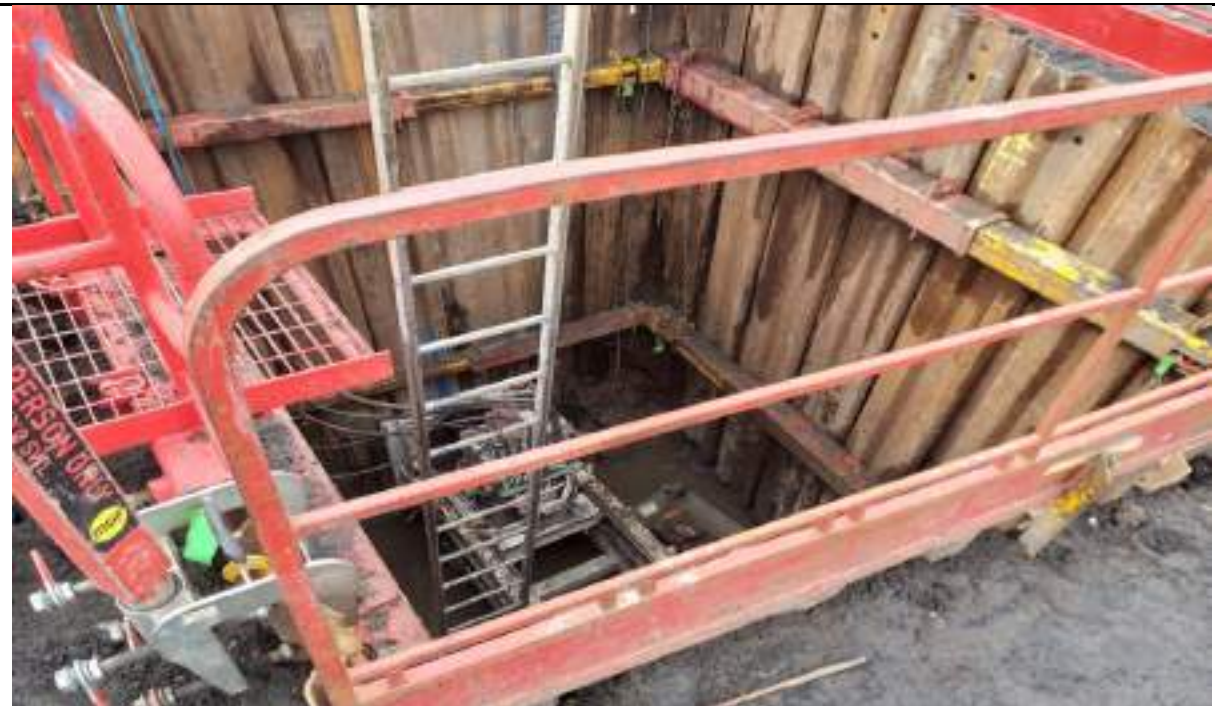
Photograph 14: Preparation of thrust bore drainage for boring in the southeast.

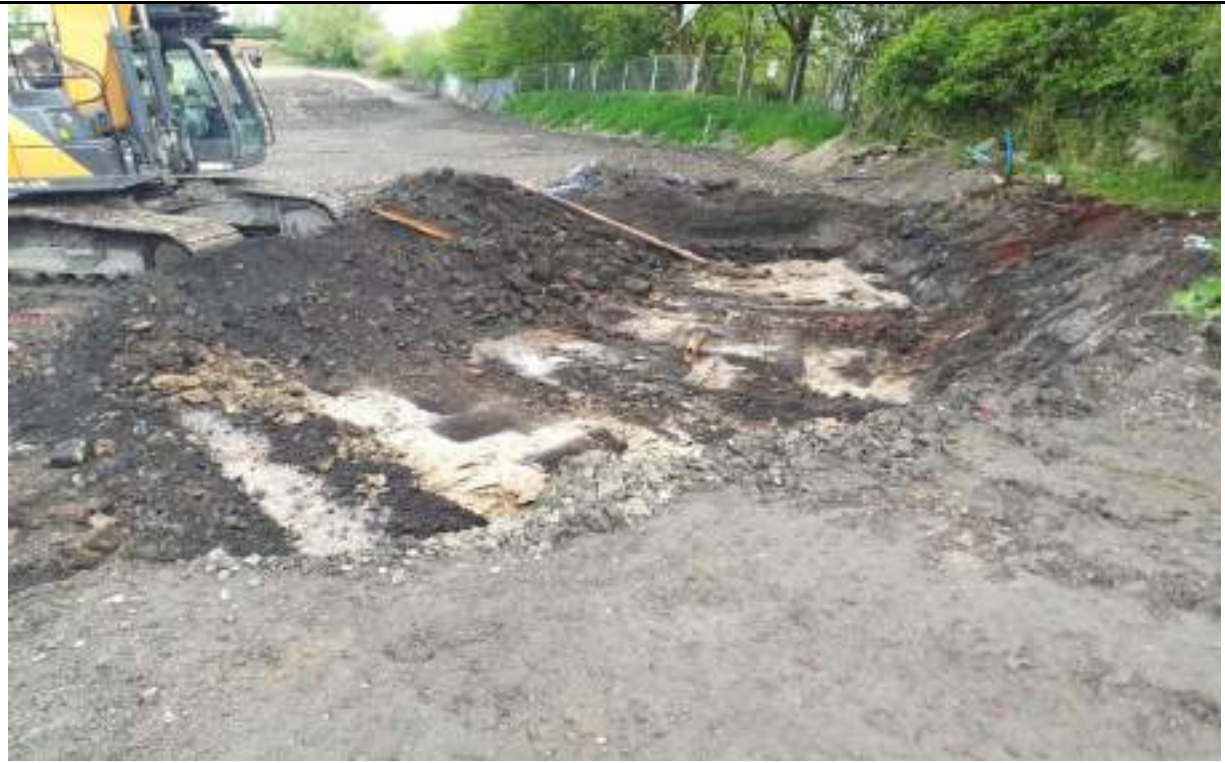
Photograph 1: Excavation of landfill Made Ground in the eastern boundary. Base of excavation is glacial till.

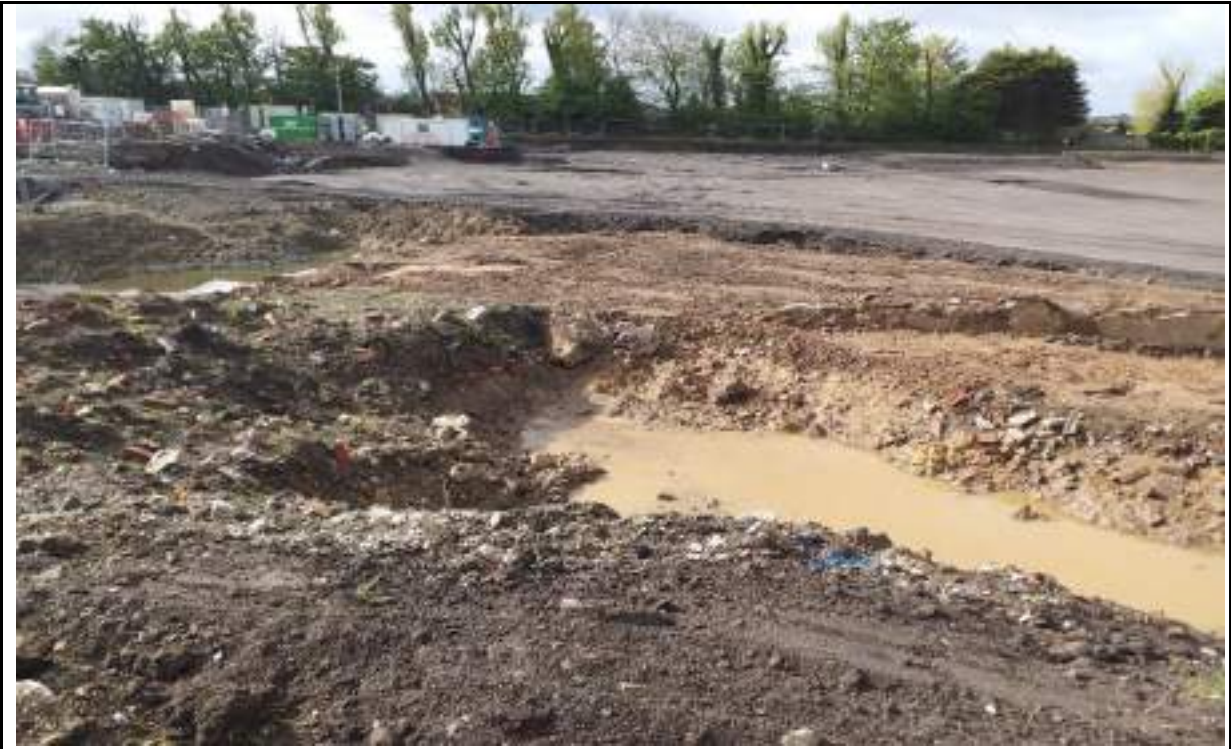
Photograph 3: Standing water in the southeast.

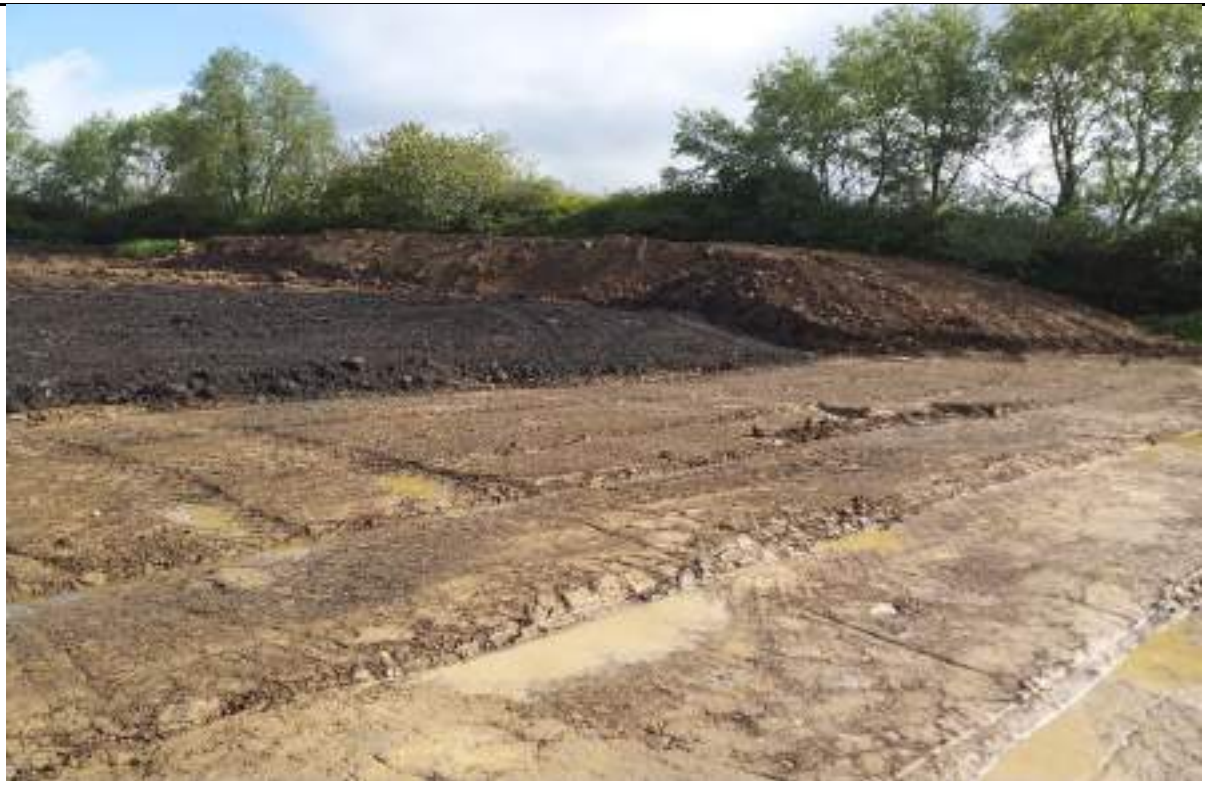
Photograph 8: Stockpiles of low strength glacial till excavated from the borrow pit area in the northeast.

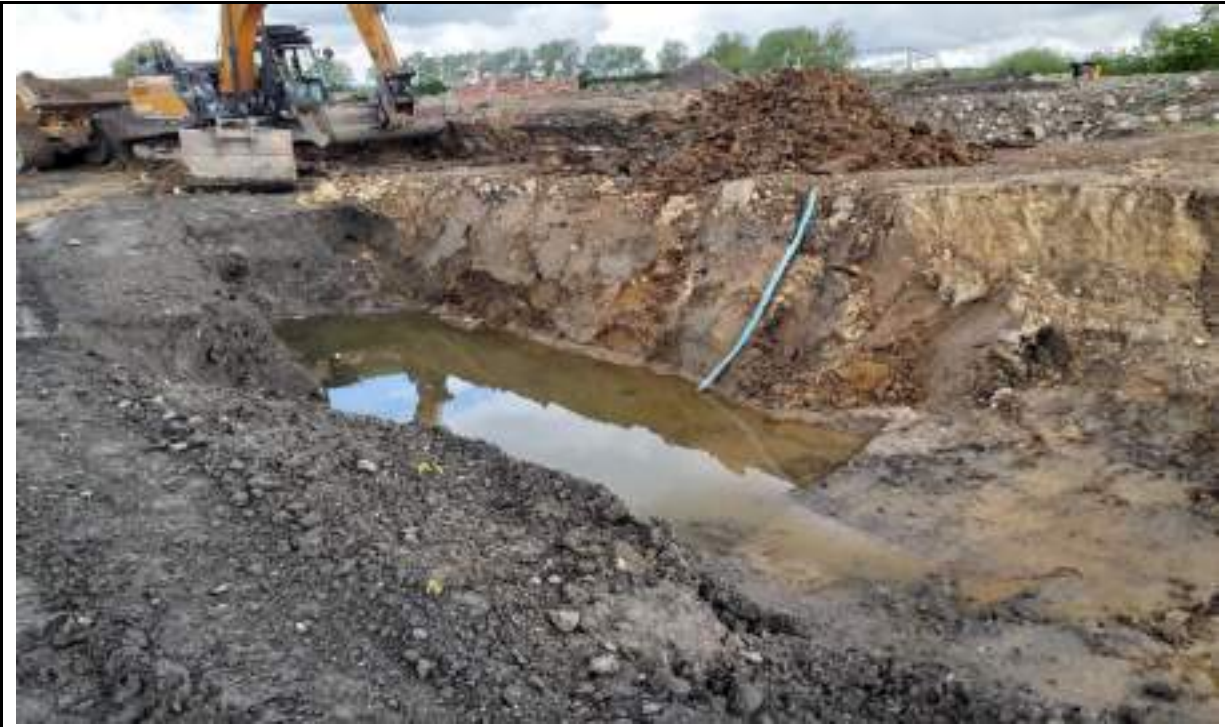
Photograph 3: Standing water next to Glacial Till excavation in the east.

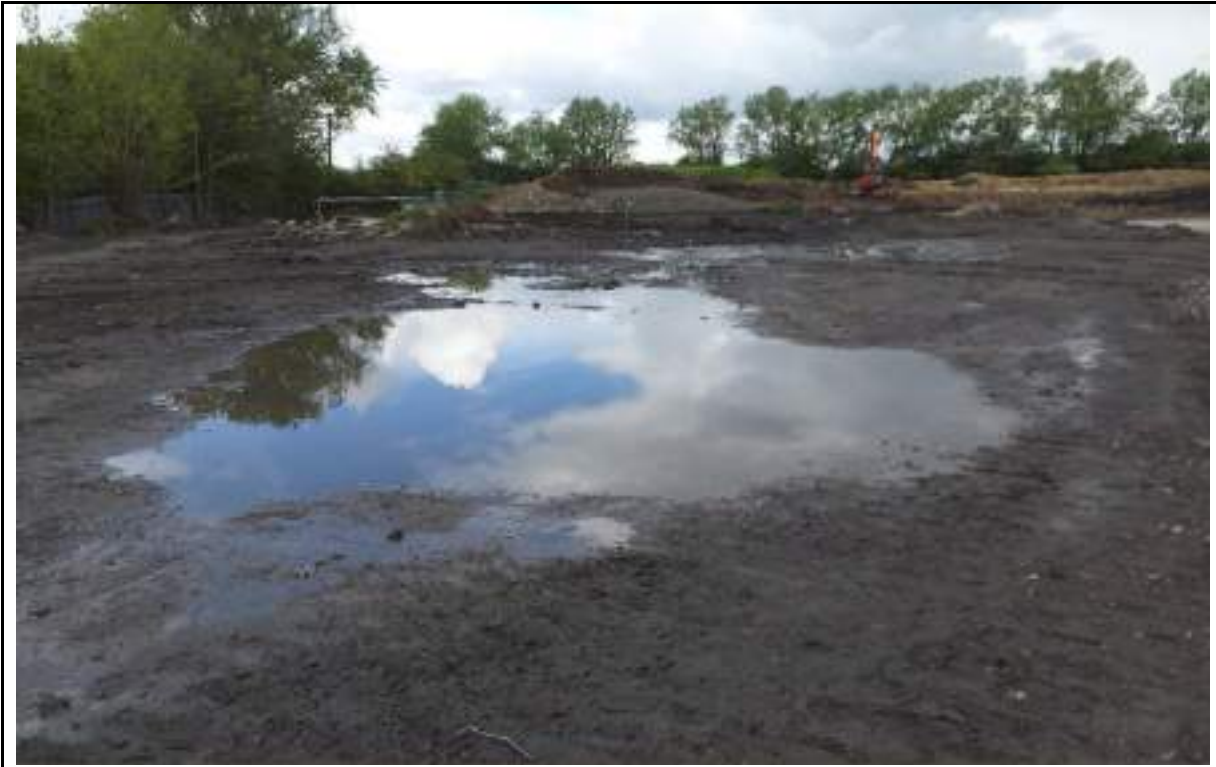
Photograph 5: Standing water in the northwest.

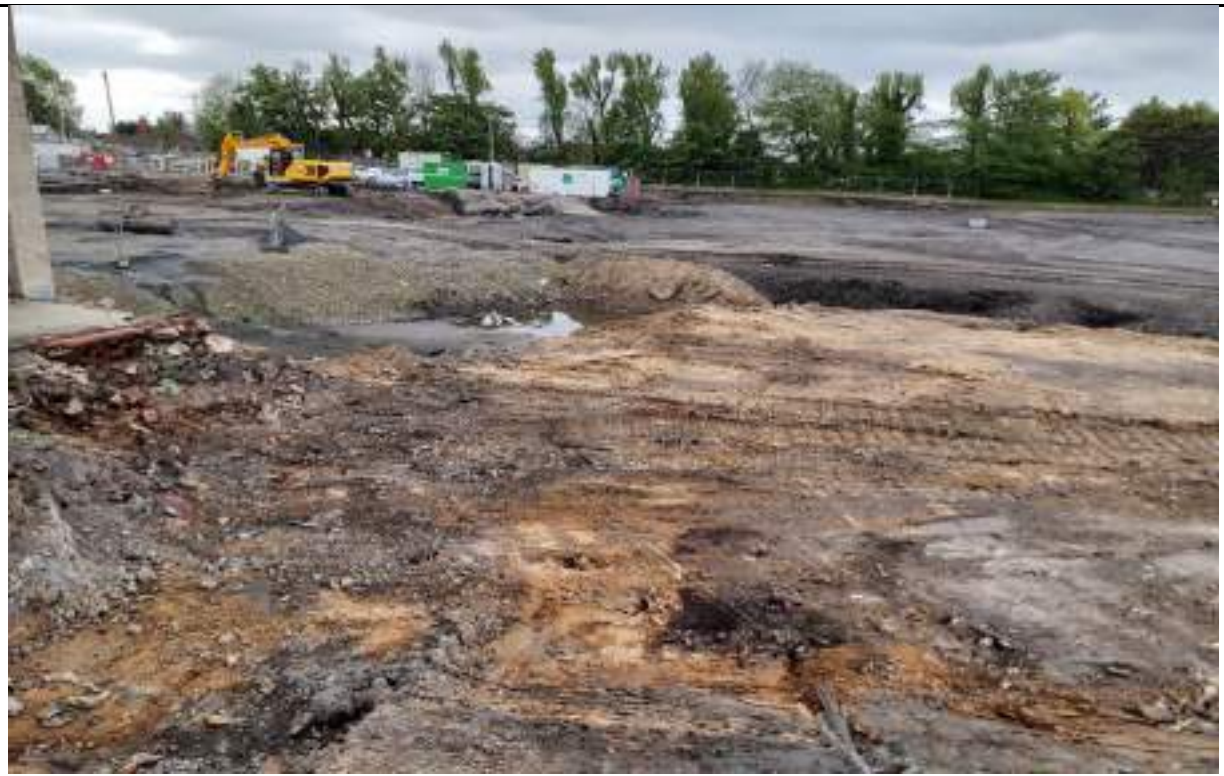
Photograph 2: Standing water in the southeast.

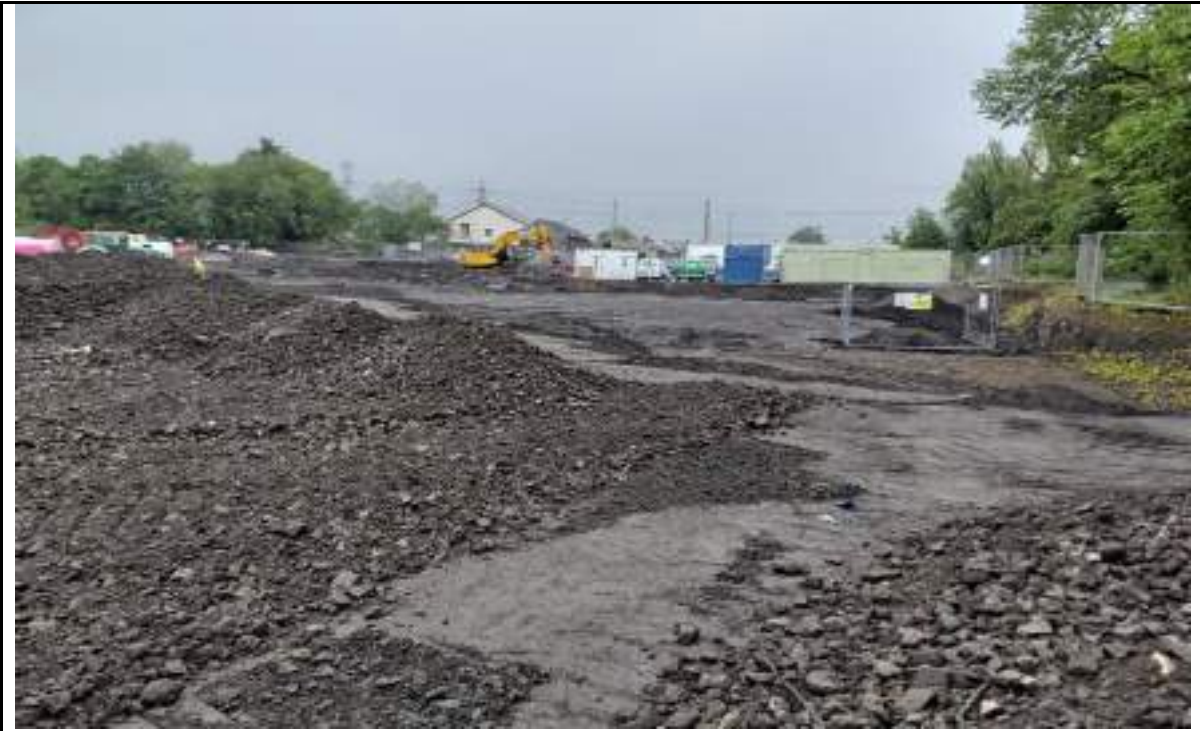
Photograph 3: Southern boundary of the site. Looking towards the east. A layer of fill to be placed to reach to the FGL.

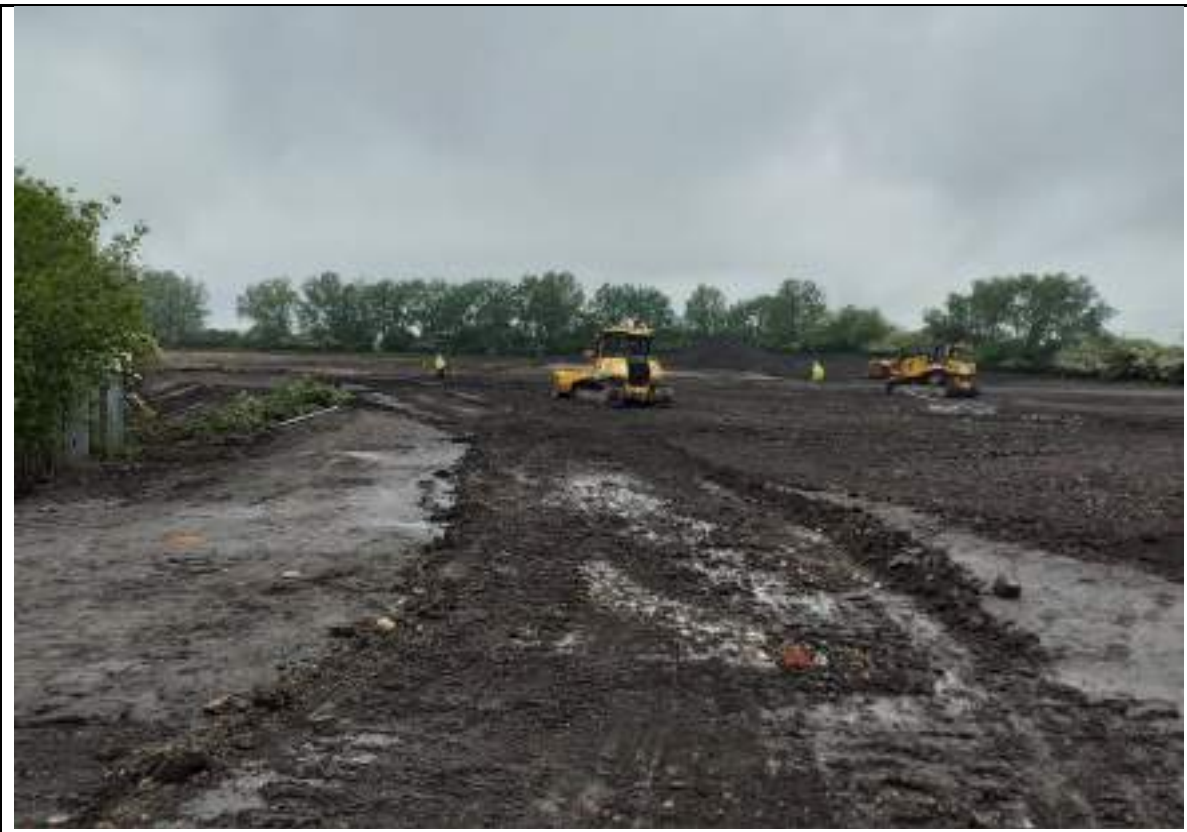
Photograph 6: Trimming place fill in the northwest. Surveyor is checking levels.

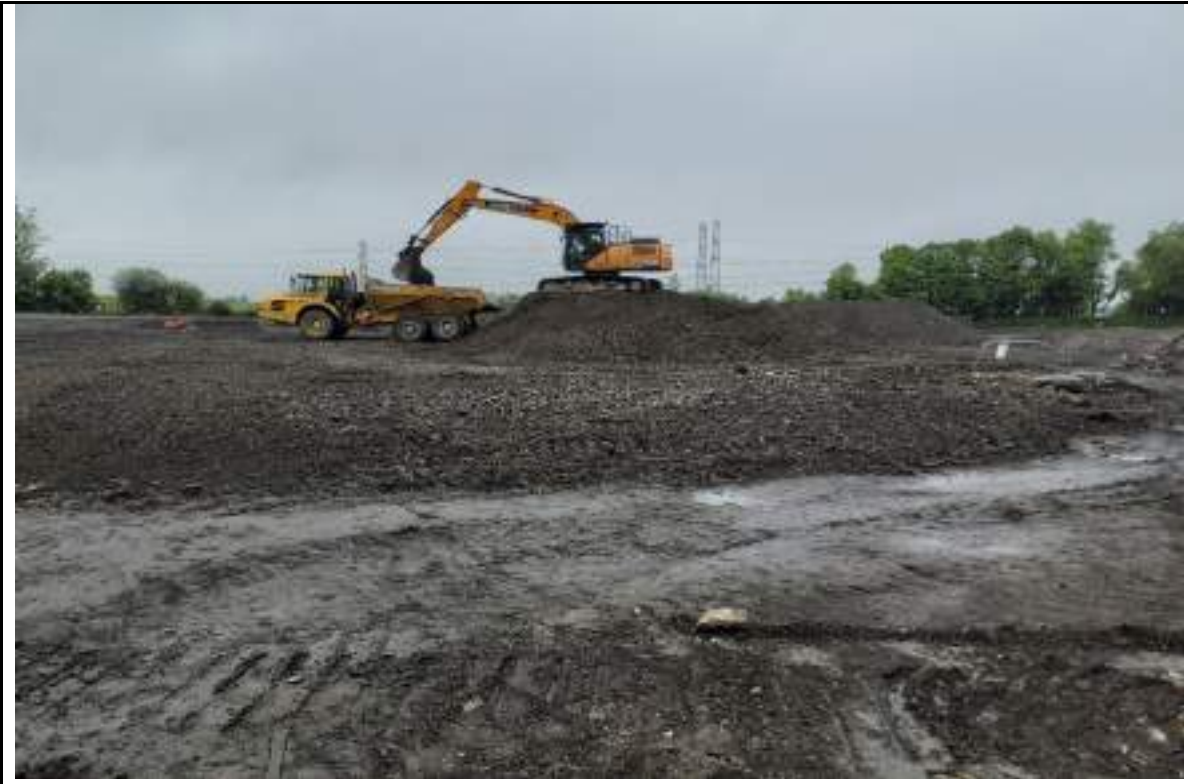
Photograph 7: Removing stockpile of 6F2 material for capping of the southwest.

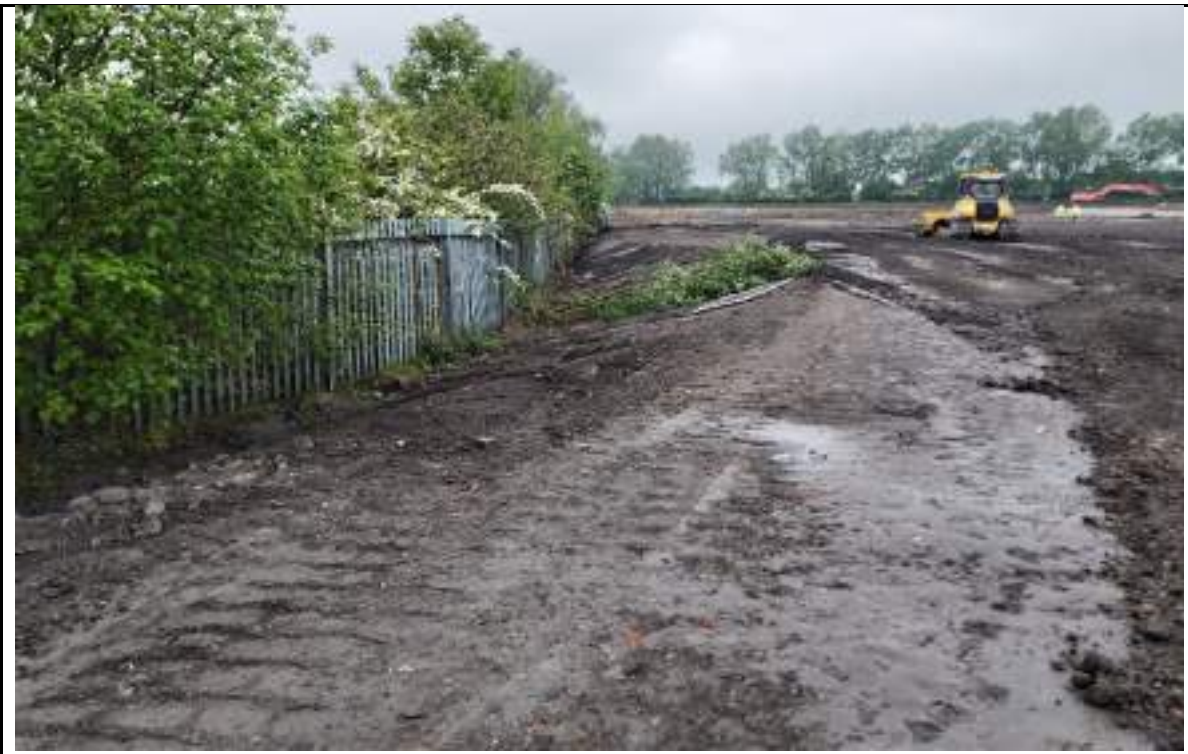
Photograph 8: Place fill sides battered in the northwest.

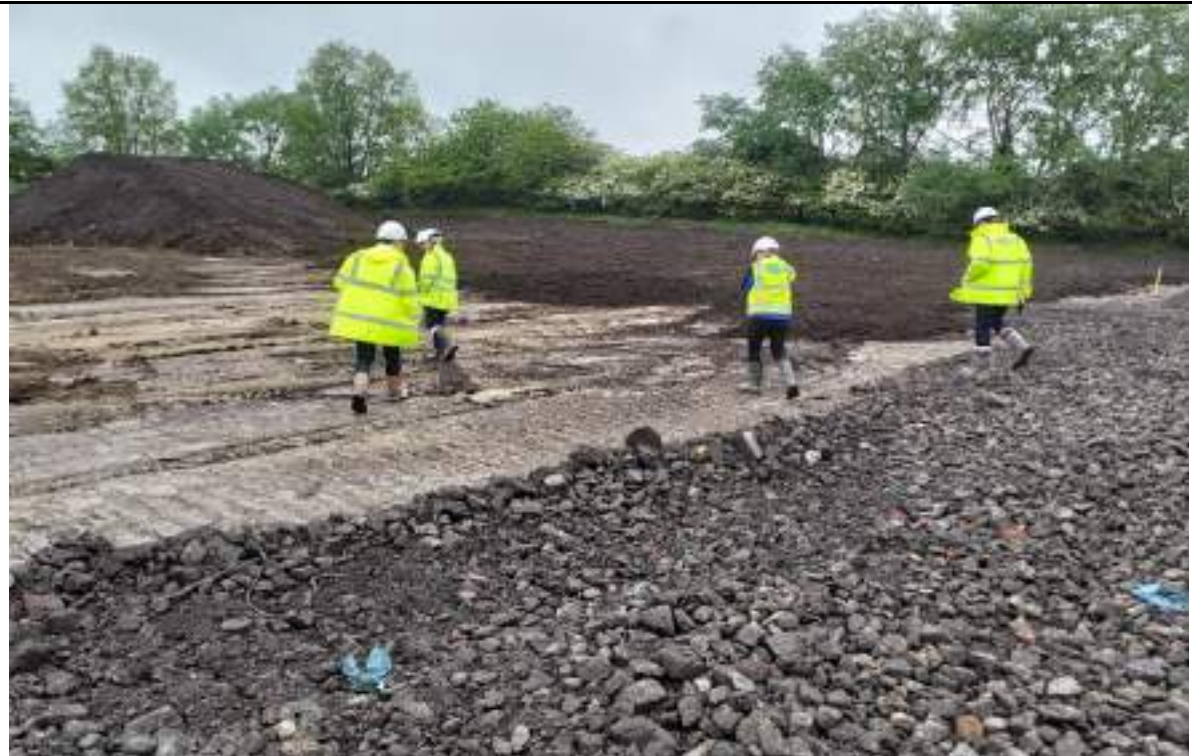
Photograph 11: Placed topsoil and stockpile of topsoil in the POS in the northeast.

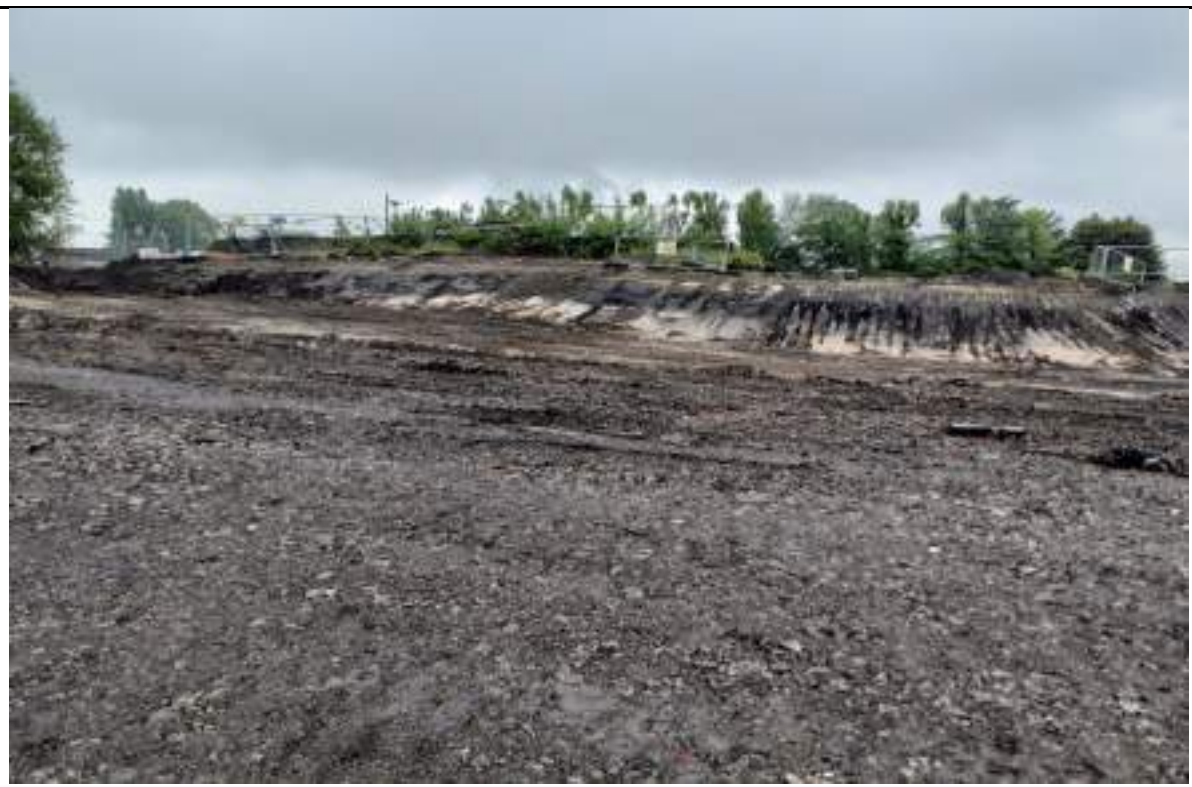
Photograph 12: Battered slope behind transformer house.

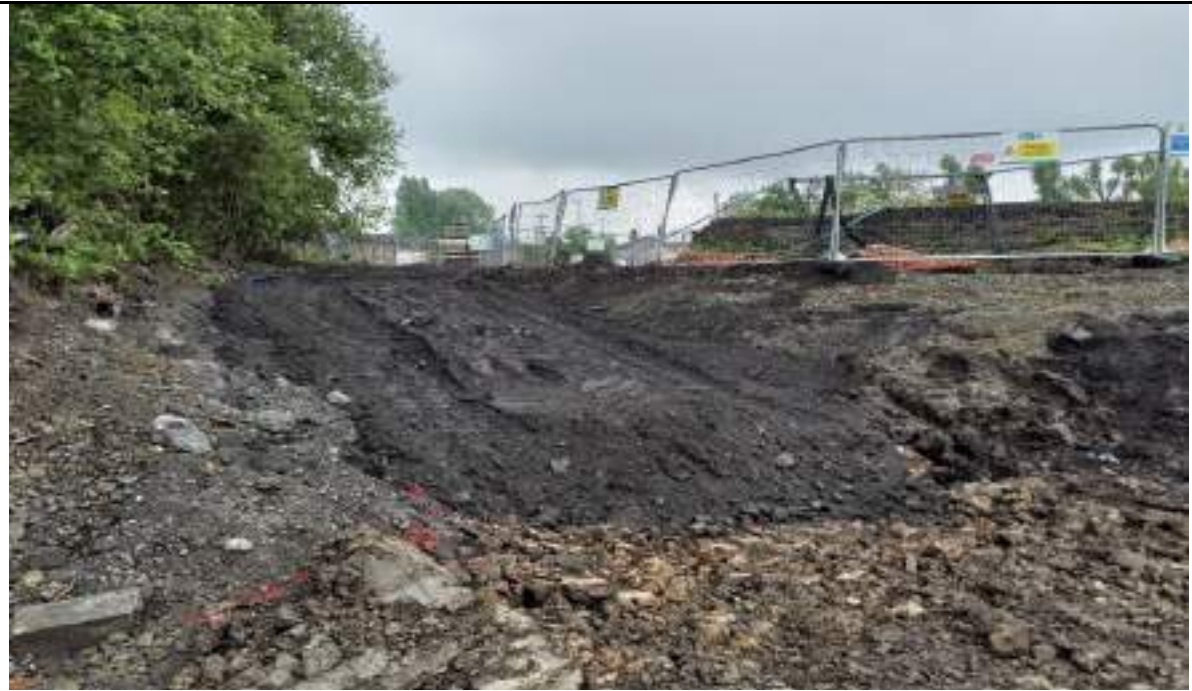
Photograph 113: Furnace Made Ground used to construct haul road in the southeast.

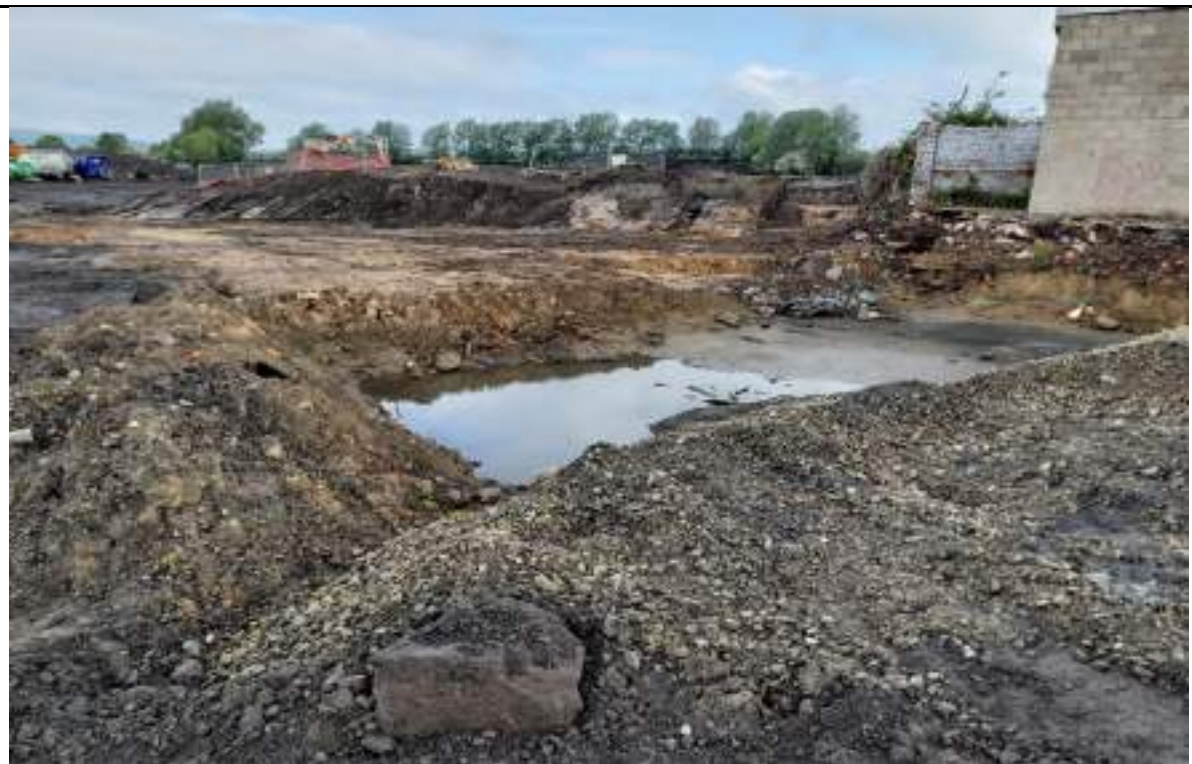
Photograph 14: Standing water in the southeast.

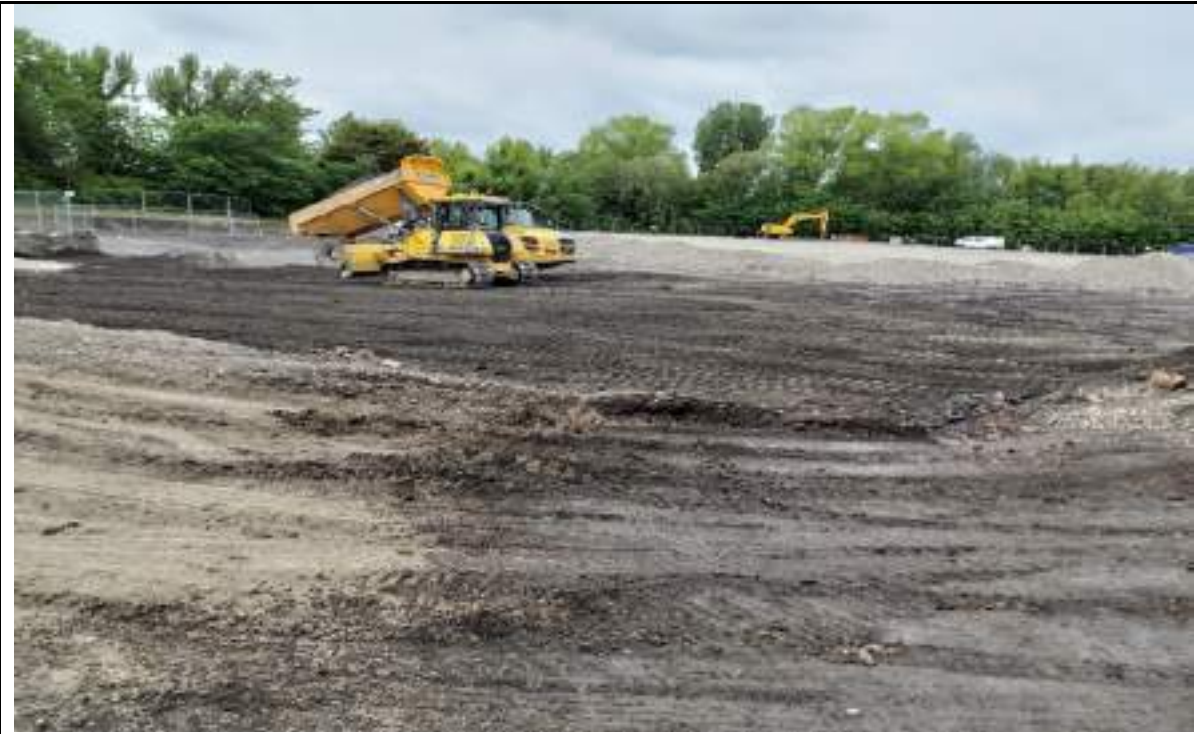
Photograph 1: Placing fill in the southeast near VHE compound. Fill material from stockpiles of fine material from crusher in the northwest.

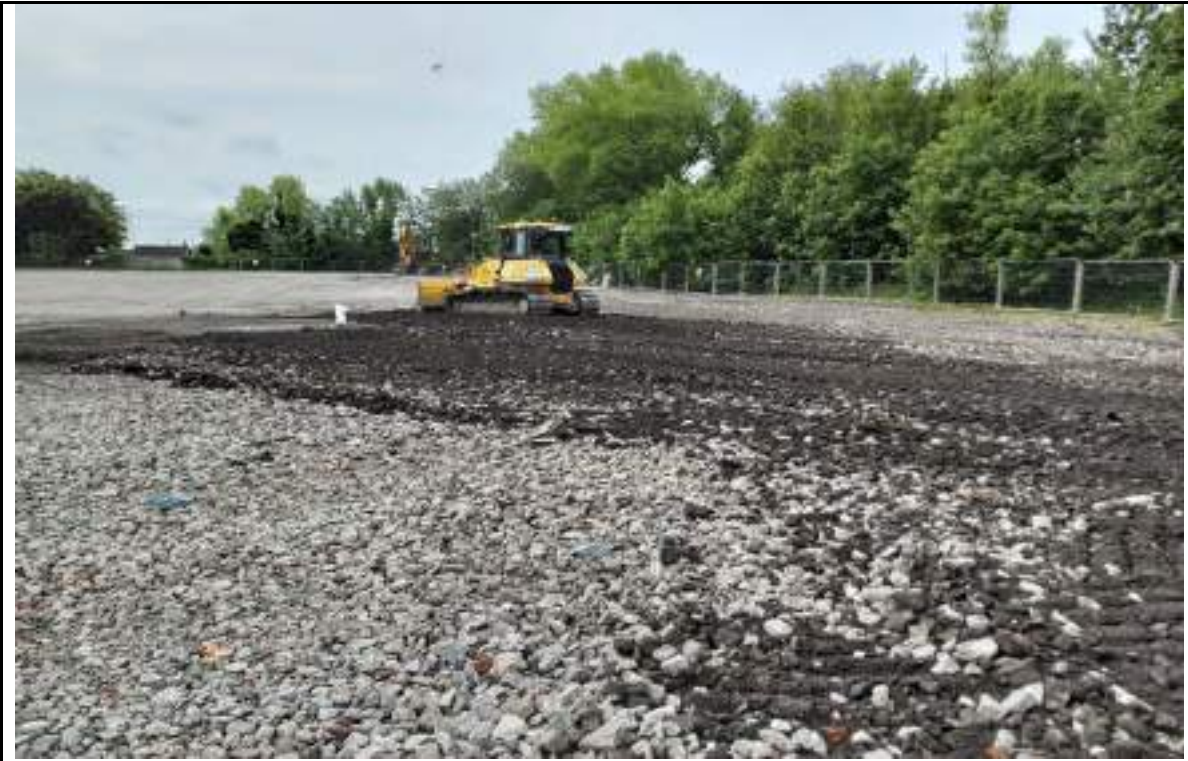
Photograph 3: Placing and levelling 6f2 material in the west.

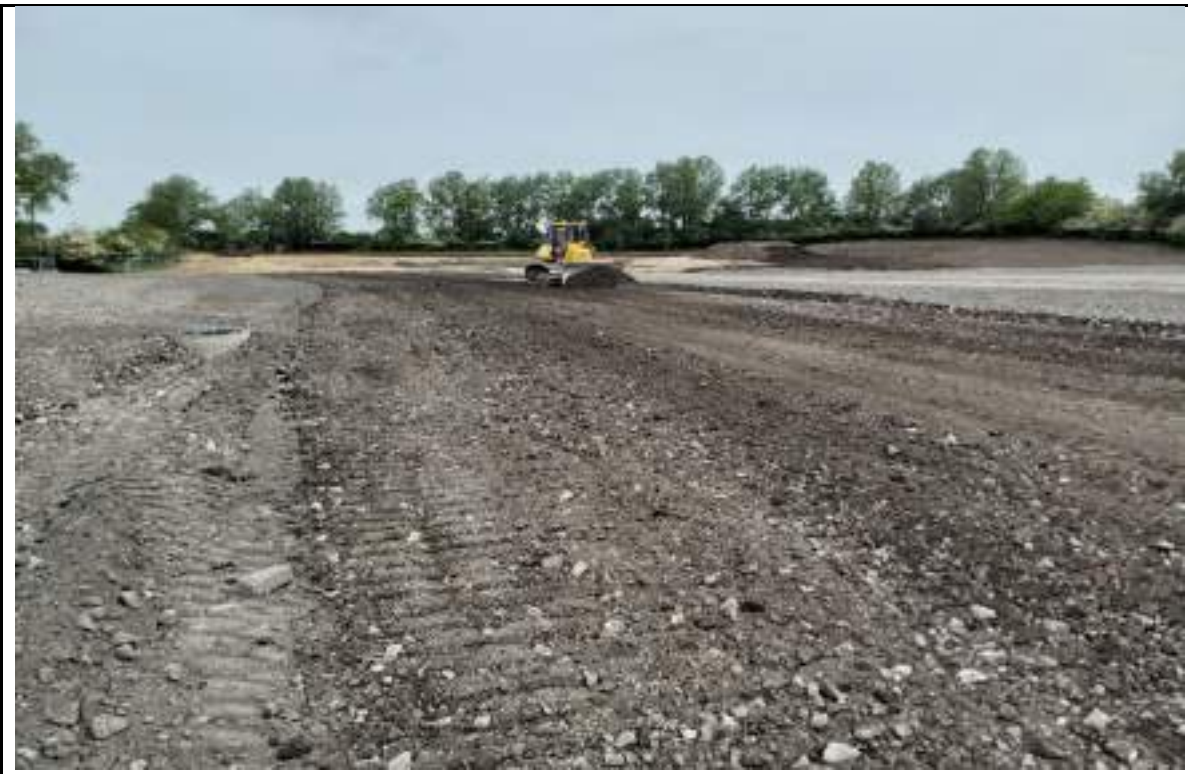
Photograph 4: Placing and levelling 6f2 material in the northwest.

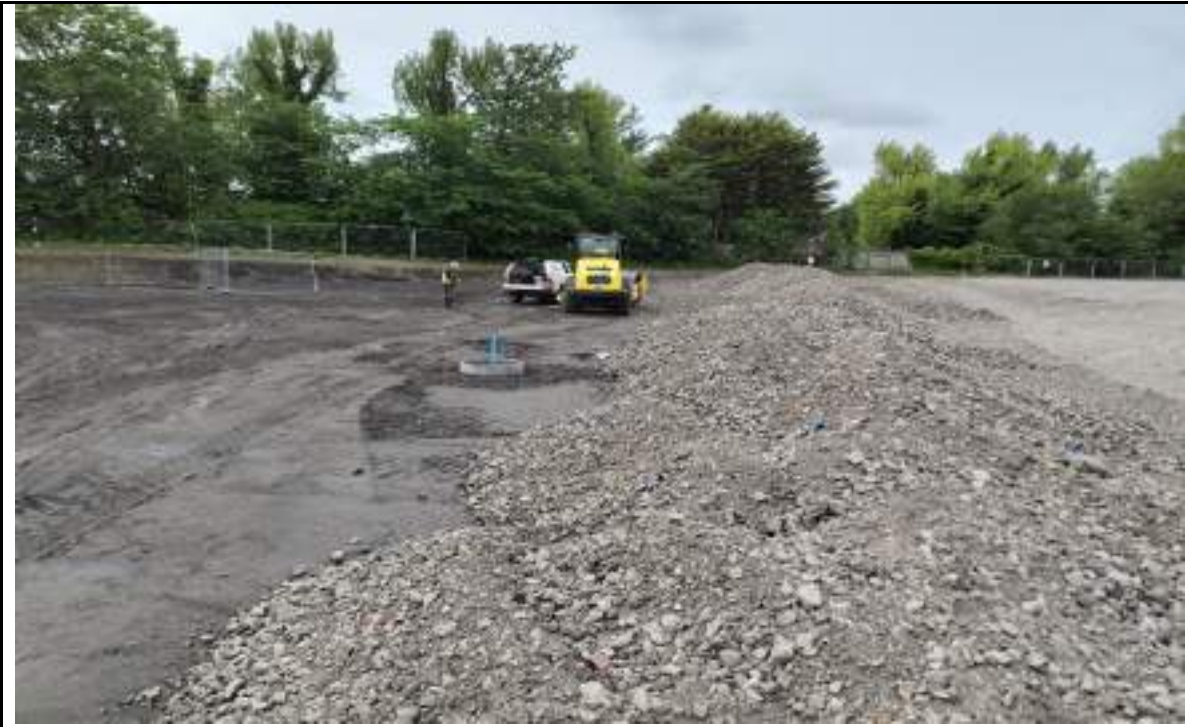
Photograph 5: Plate load testing on final layer of general fill in the south.
