| SITE VISIT REPORT 15220-HYD-XX-XX-SVR-GE-1035 | | SHEET NO.: 1 of 20 | |
| Project: Stopes Road, Bolton | | Date: 09/11/22 | |
| Client: Harworth | | Weather: Cloudy | |
| Doc Ref: 15220-HYD-XX-XX-SVR-GE-1035 | | Status & Revision: S2 – P1 | |

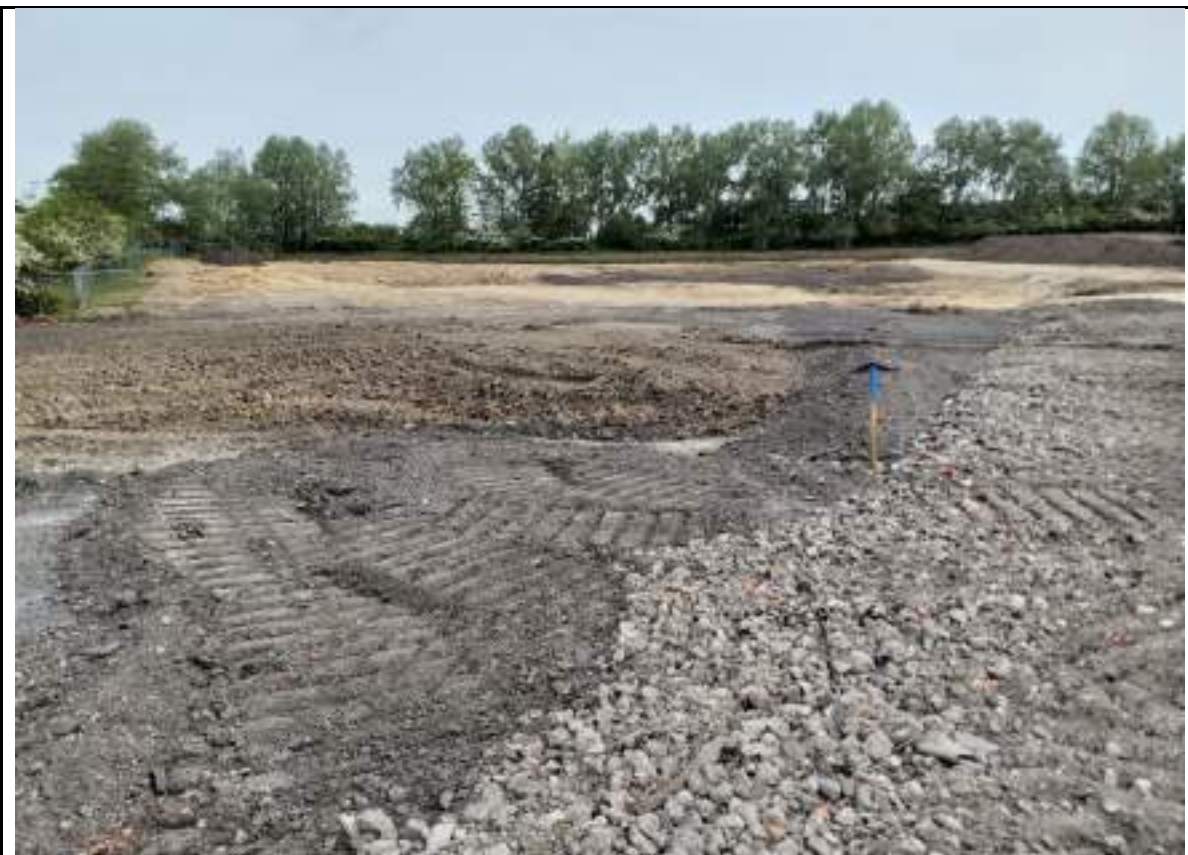
Photograph 6: The northwestern part of POS area still needs filling to reach final level.

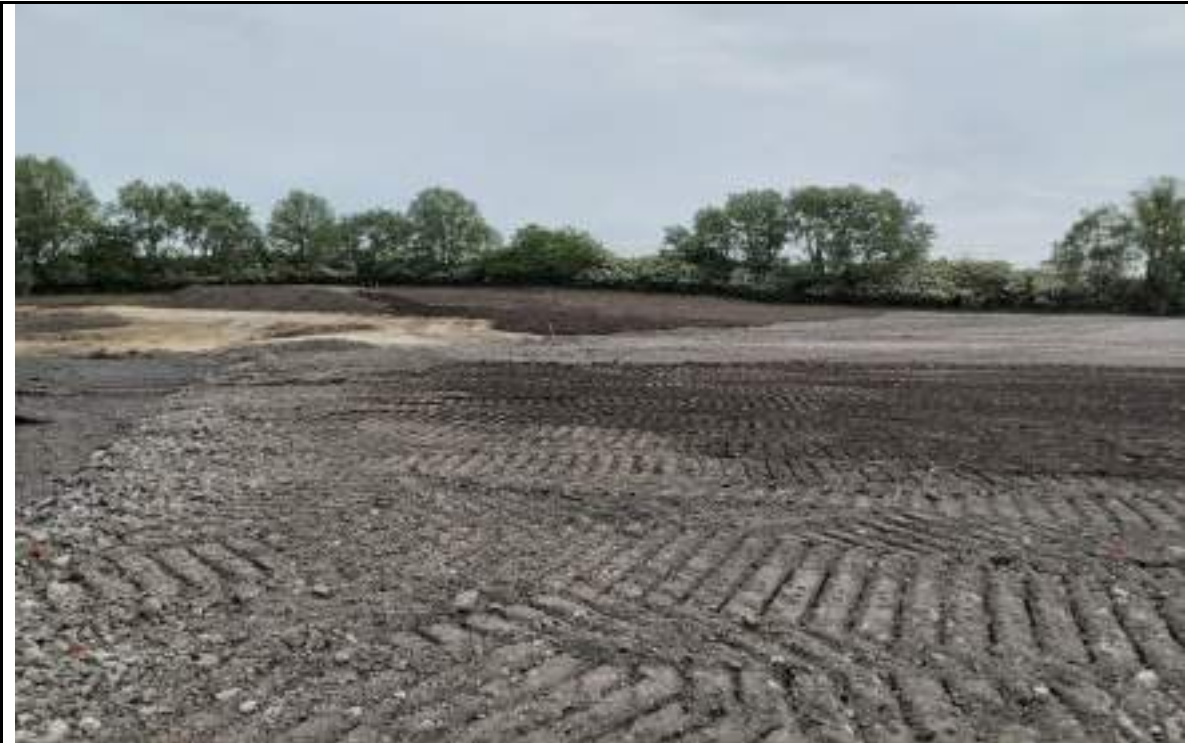
Photograph 7: Placed topsoil and stockpile of topsoil in the POS in the northeast.

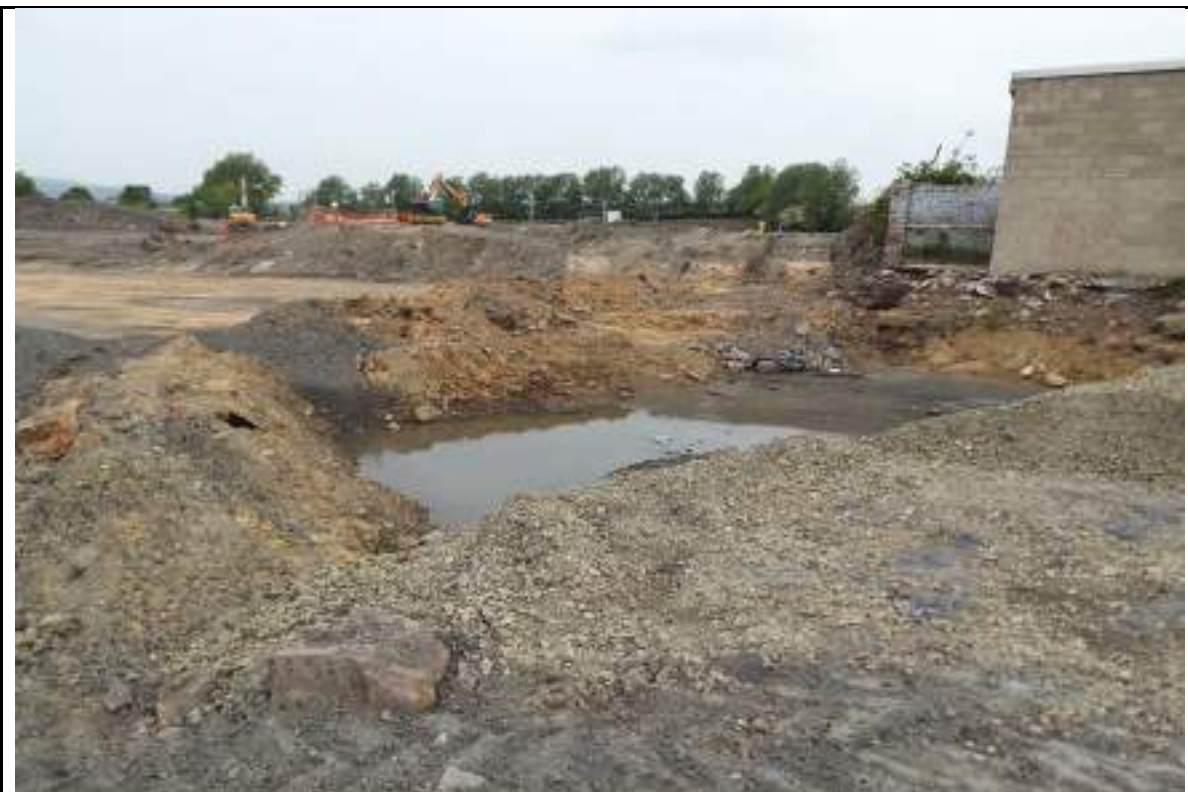
Photograph 8: Standing water in the southeast.

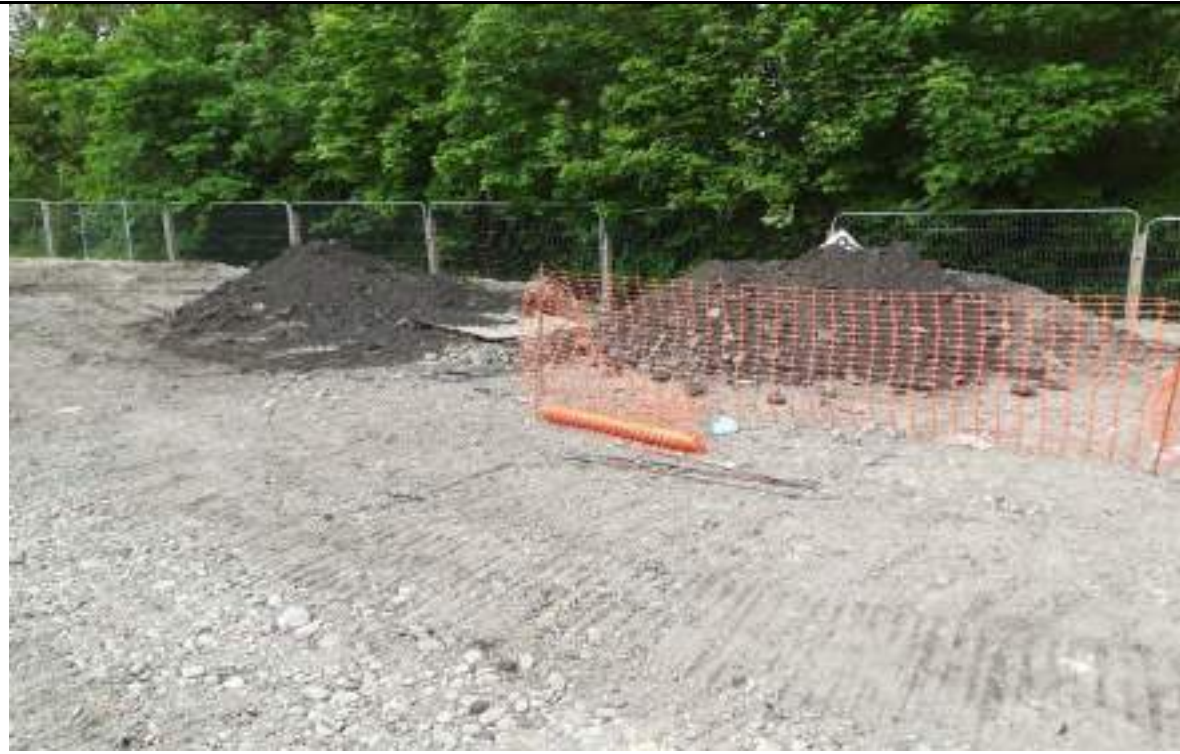
Photograph 9: Excavation for construction of manhole drainage in the southwest.

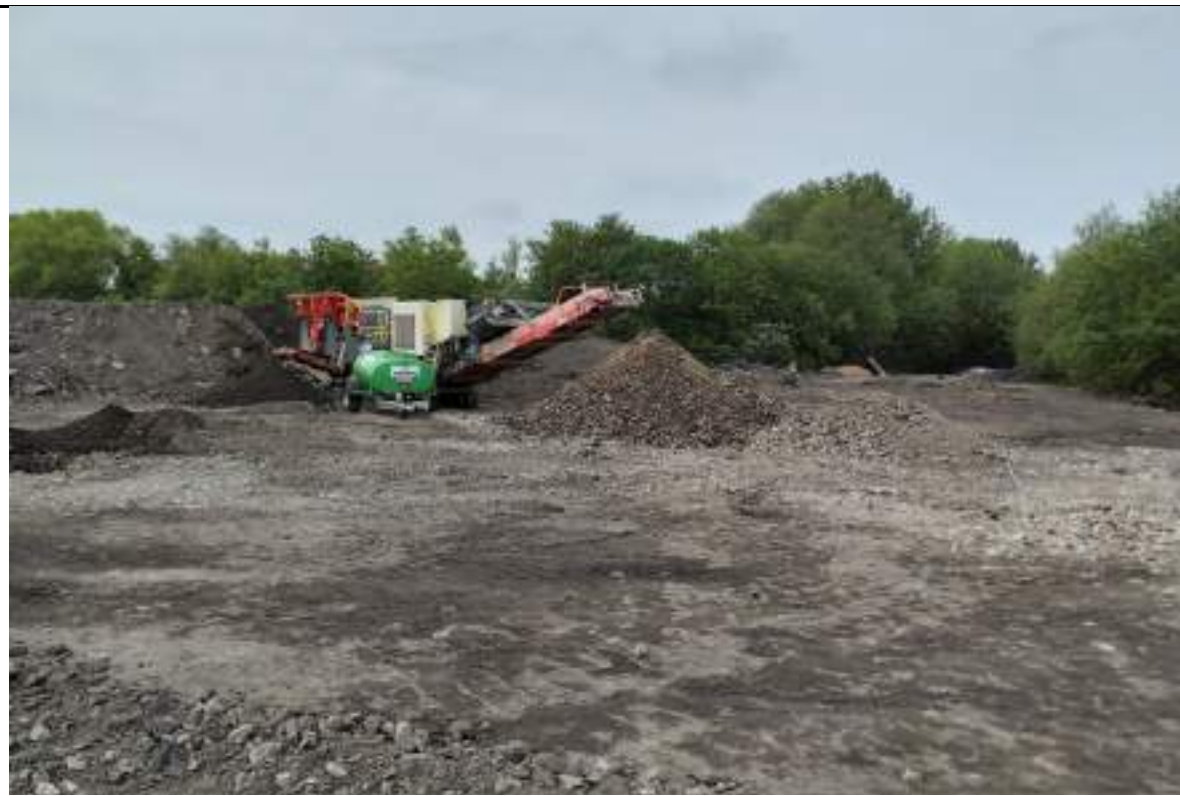
Photograph 10: Crusher and stockpile of oversize and concrete material in the northwest.

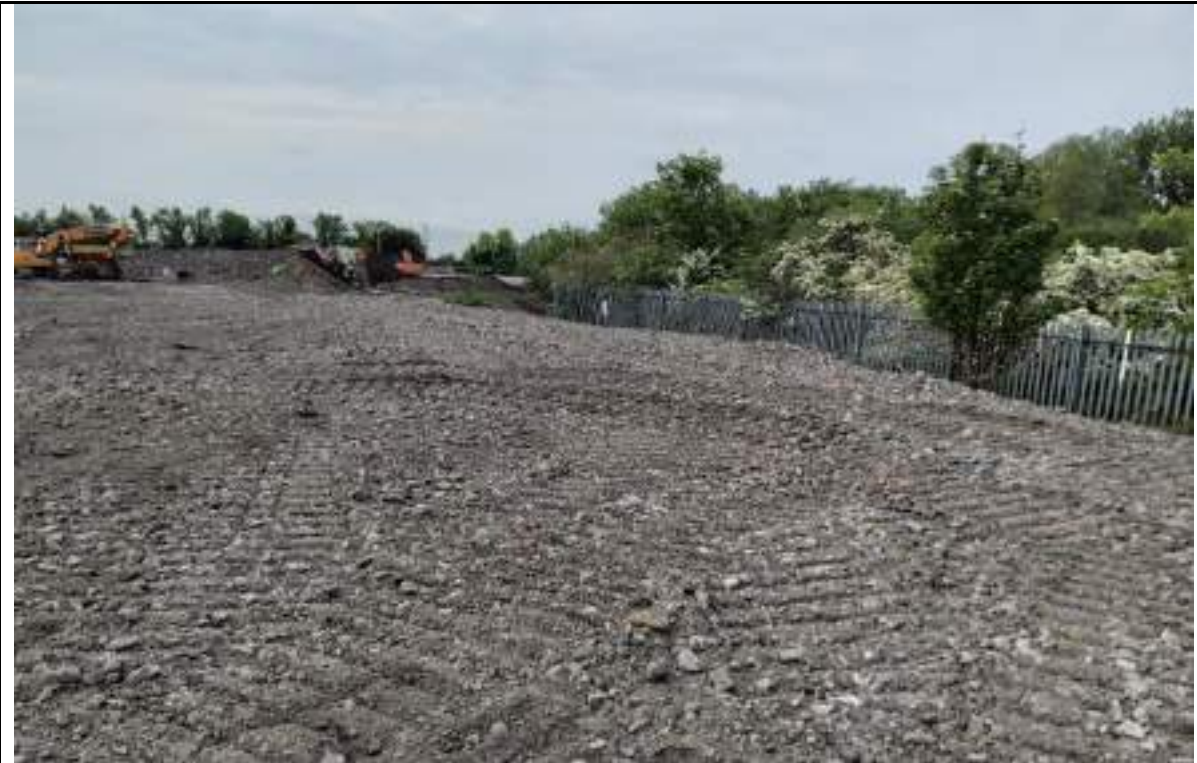
Photograph 11: Capping layer in the western boundary of the site. Looking towards the south.

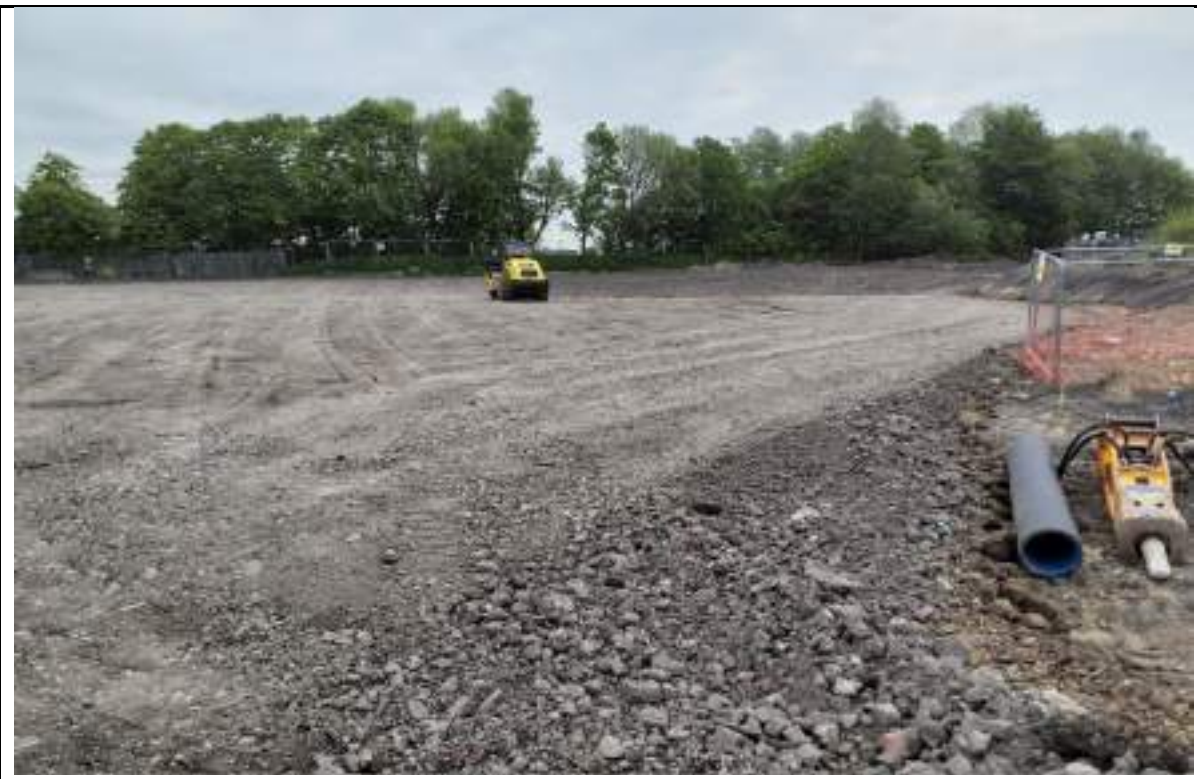
Photograph 12: Proof rolling of capping and in the east.

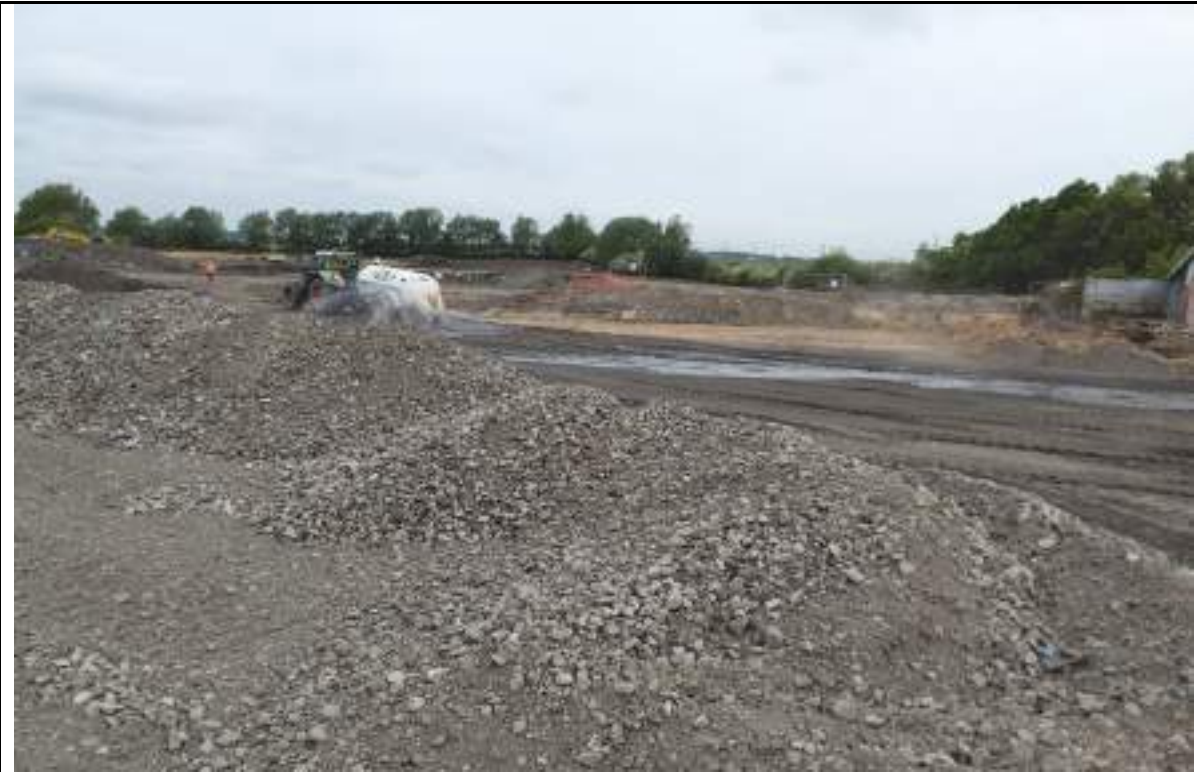
Photograph 113: Dust suppression unit controlling dust on site.

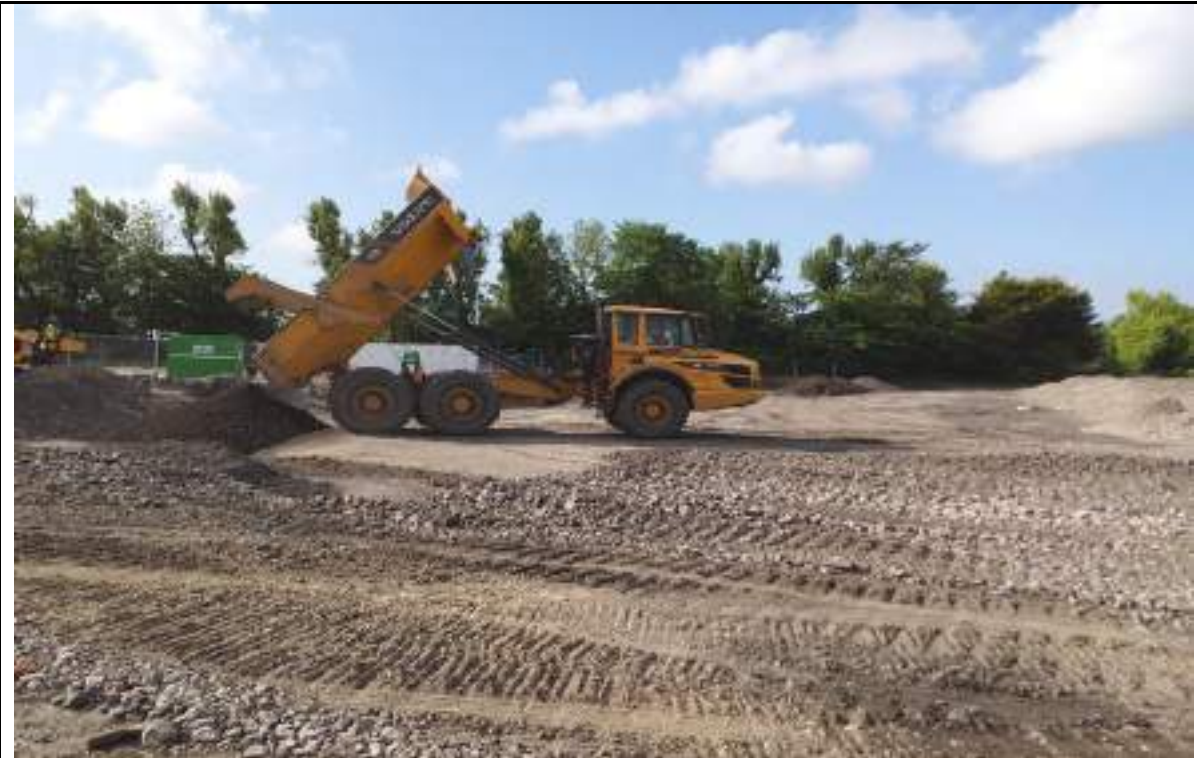
Photograph 1: Placing fill in the southeast near VHE compound. Fill material from crusher's fine materials in the northwest.

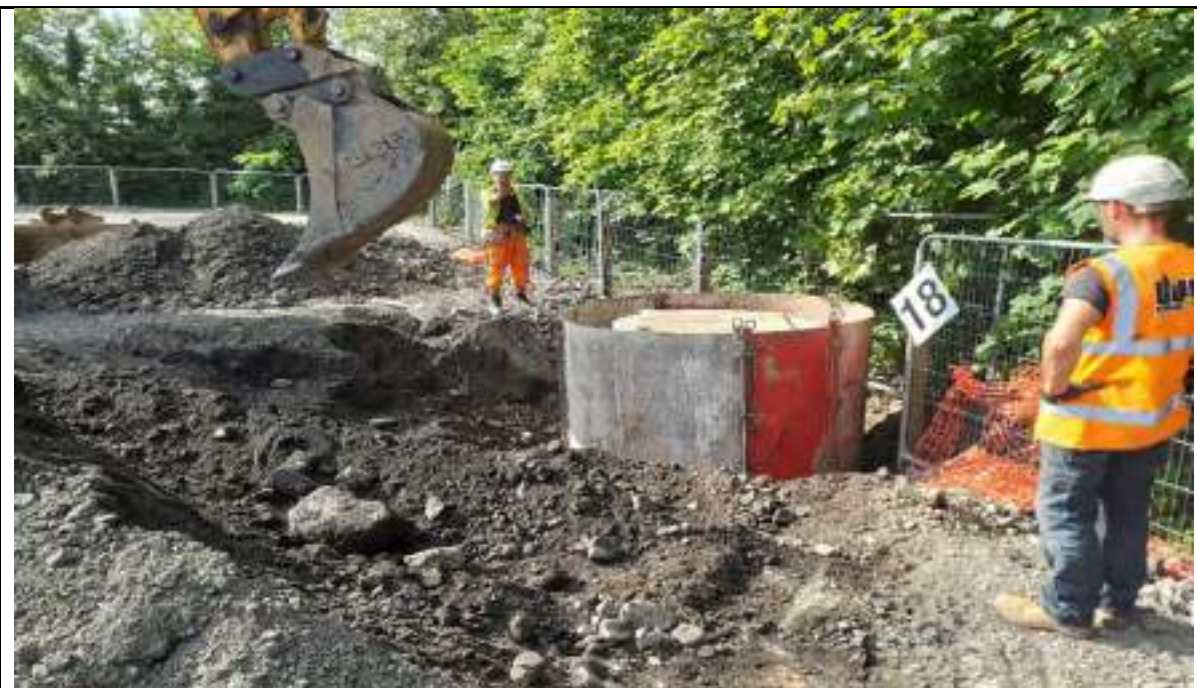
Photograph 2: Backfilling constructed drainage manhole in the southwest. Level raise is necessary for placing drainage manhole.

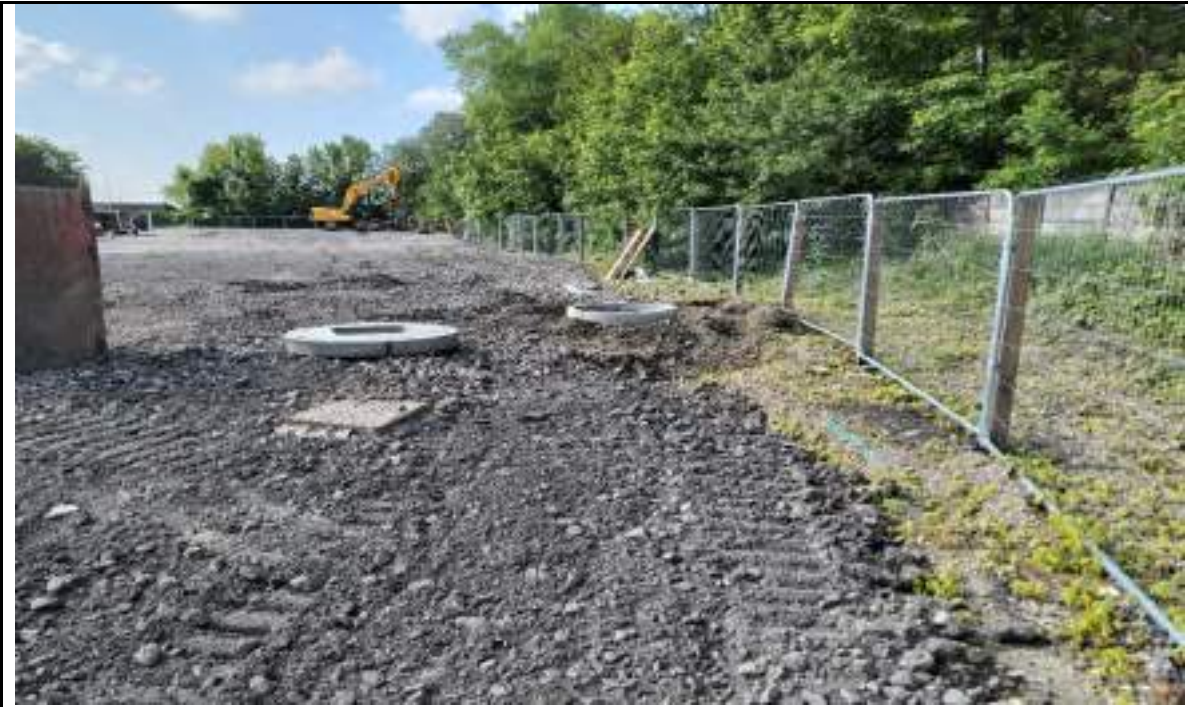
Photograph 3: Location of second drainage manhole placed in the western boundary.

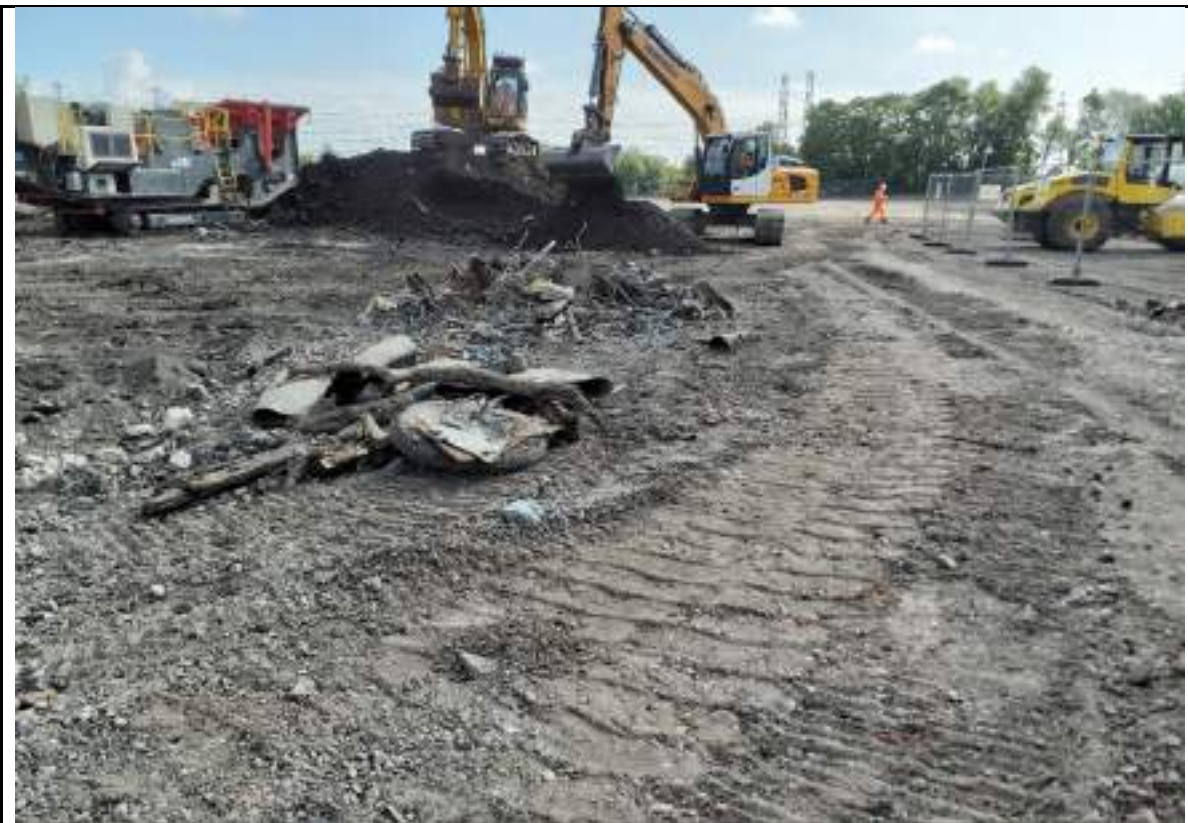
Photograph 4: Stockpile of deleterious material in the northwest.

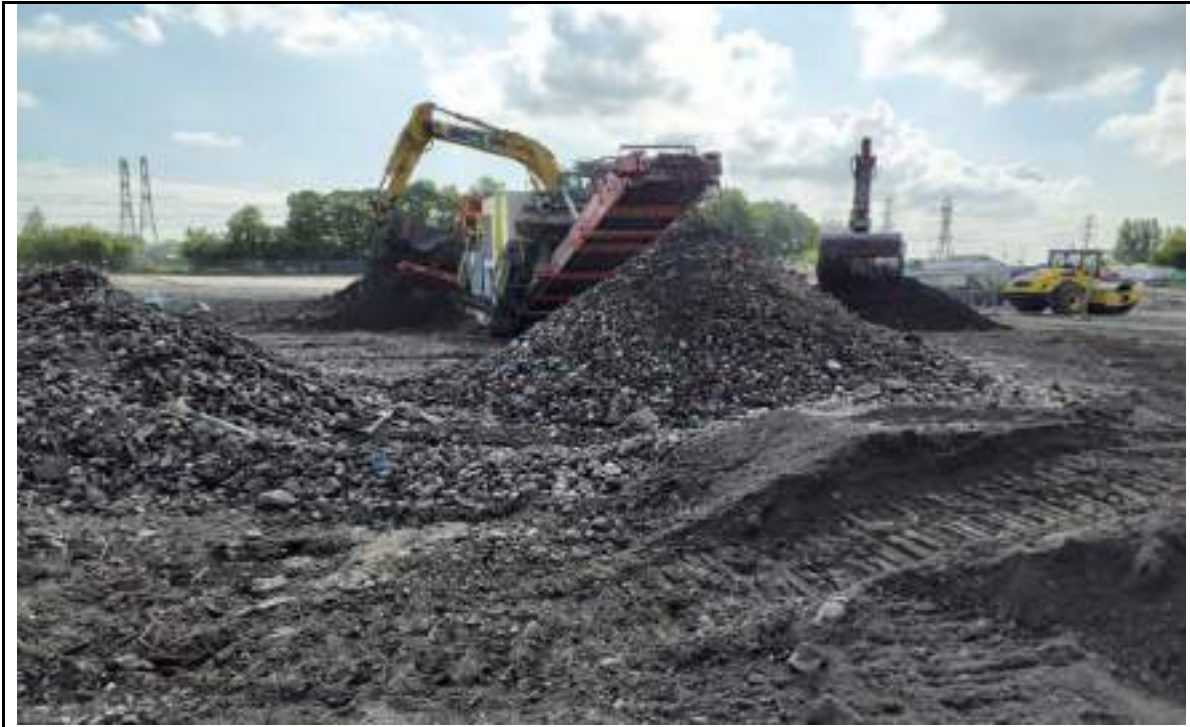
Photograph 5: Crushing stockpile of oversize and concrete materials in the northwest.

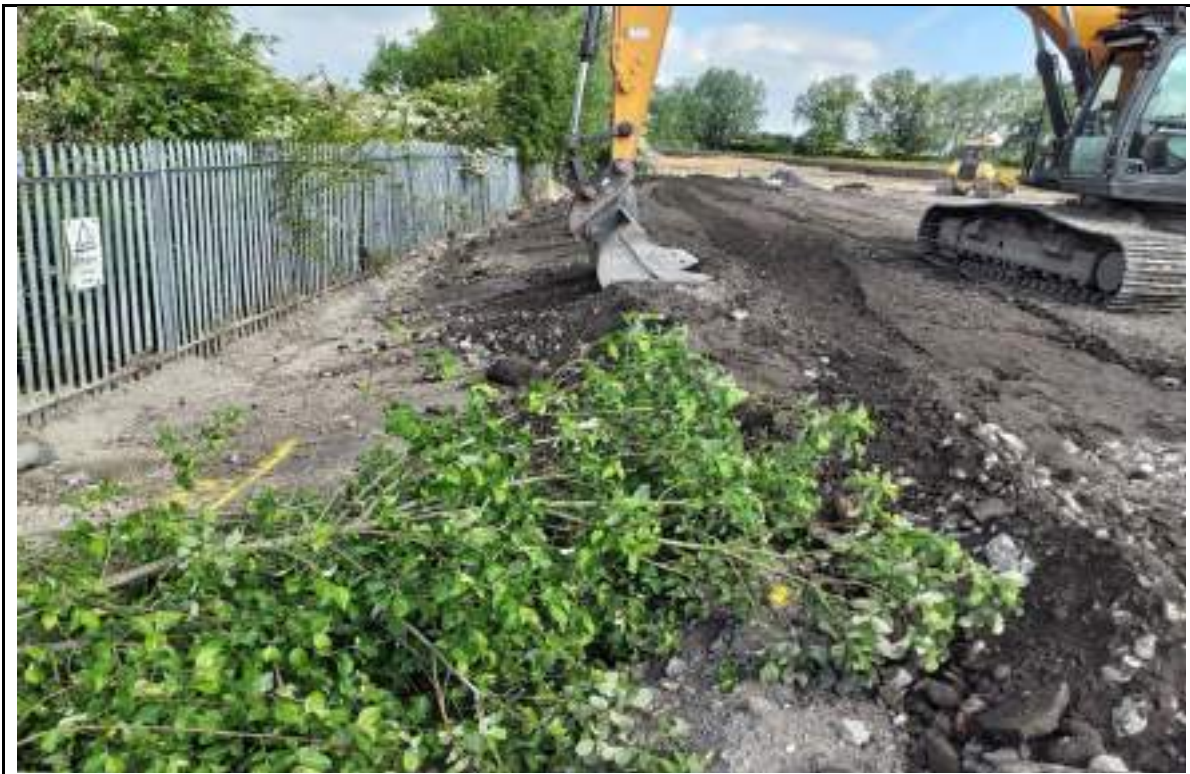
| Personnel Present: | | | |
|---|---|---|---|
| Excavation and site surveying | ✓ | | Re-excavation of the northwest boundary to rectify boundary dispute due to missing cut in the northwest. Site surveying is being done. |

Photograph 6: Rectifying boundary dispute in the northwestern boundary. Re-excavation and refilling are undertaken.

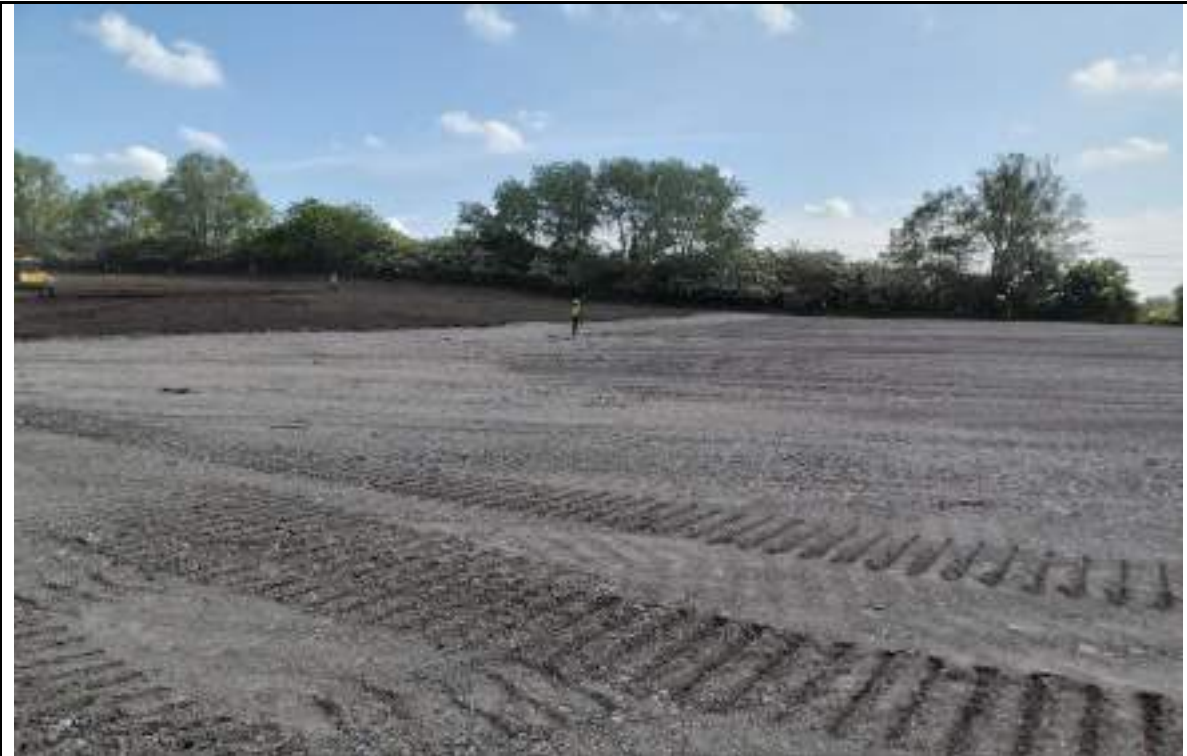
Photograph 7: Site surveying in the northern part of the site.

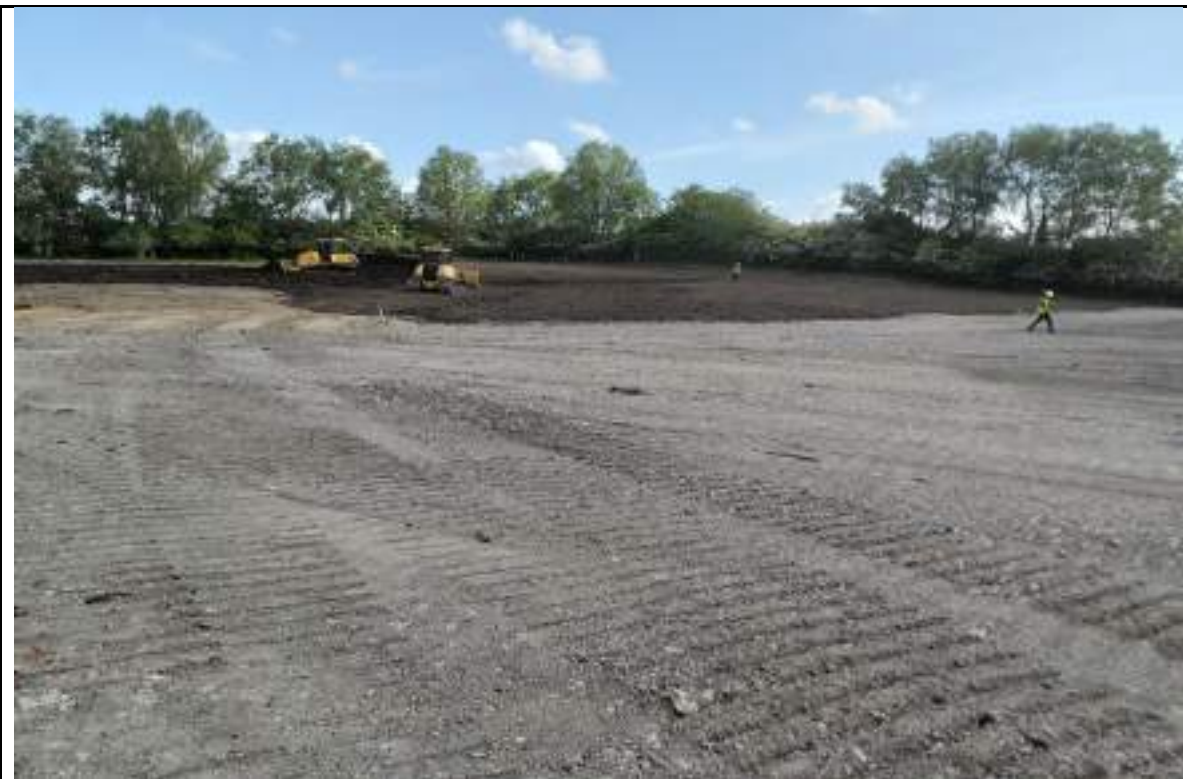
Photograph 8: Placing topsoil in the POS area in the north.

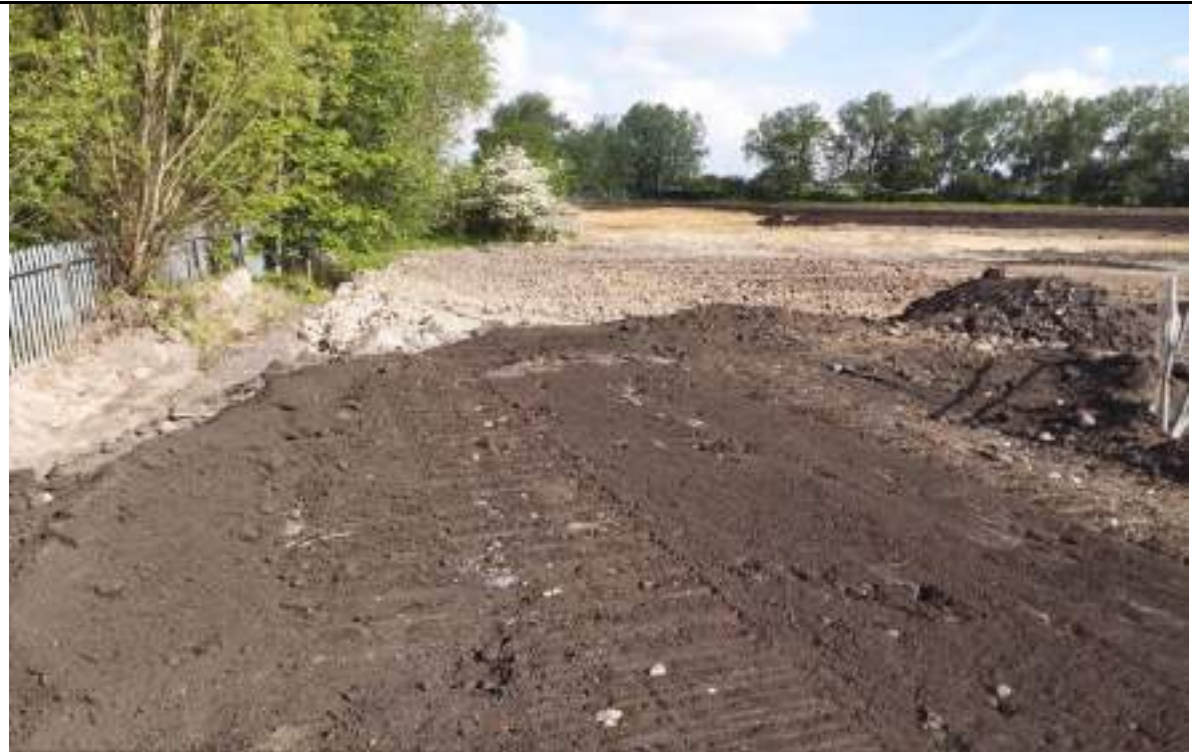
Photograph 11: POS area in the northwest still needs fill to reach final level.

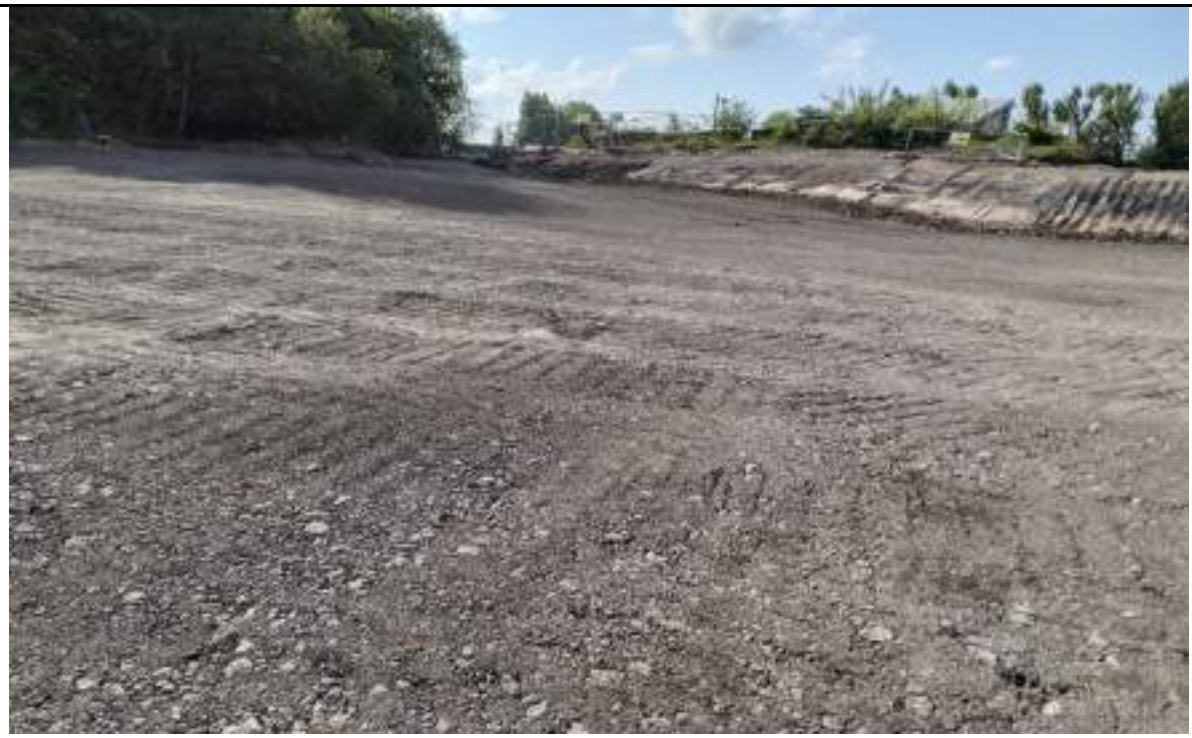
Photograph 12: Capping layer placed in the east and haul road in the southeast.

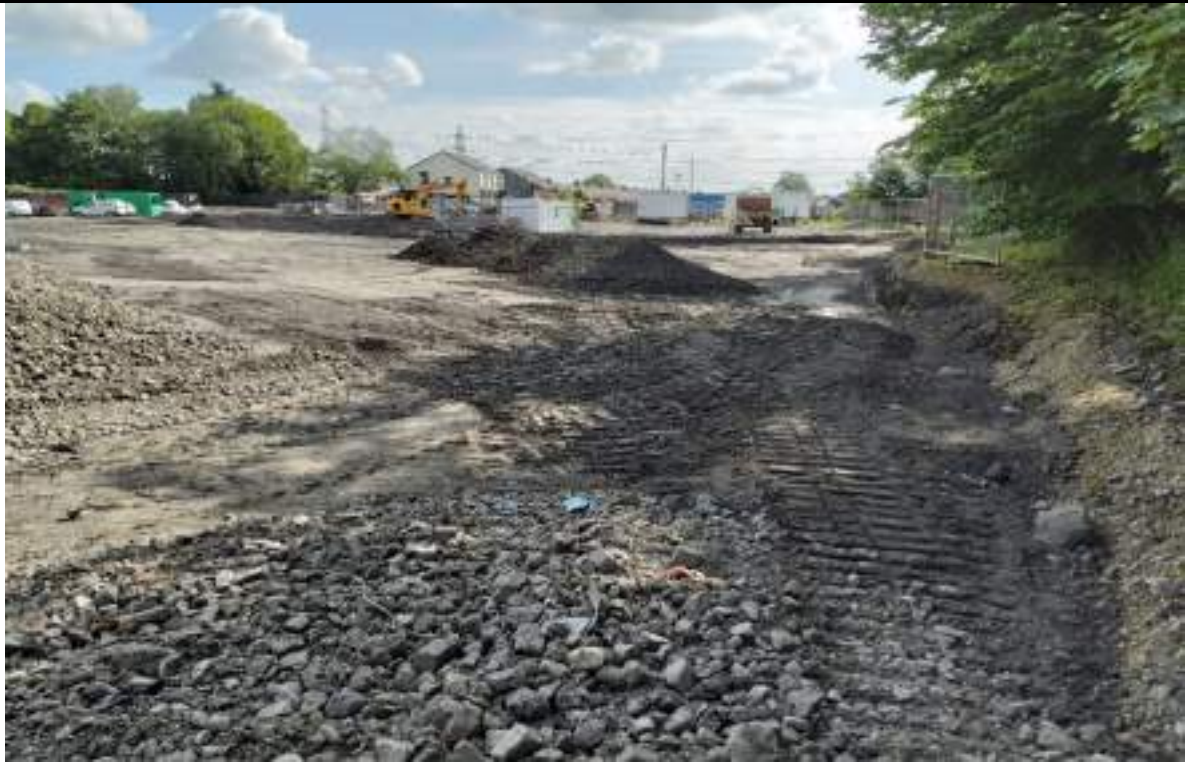
Photograph 113: Demobing VHE's compound in the southern boundary.

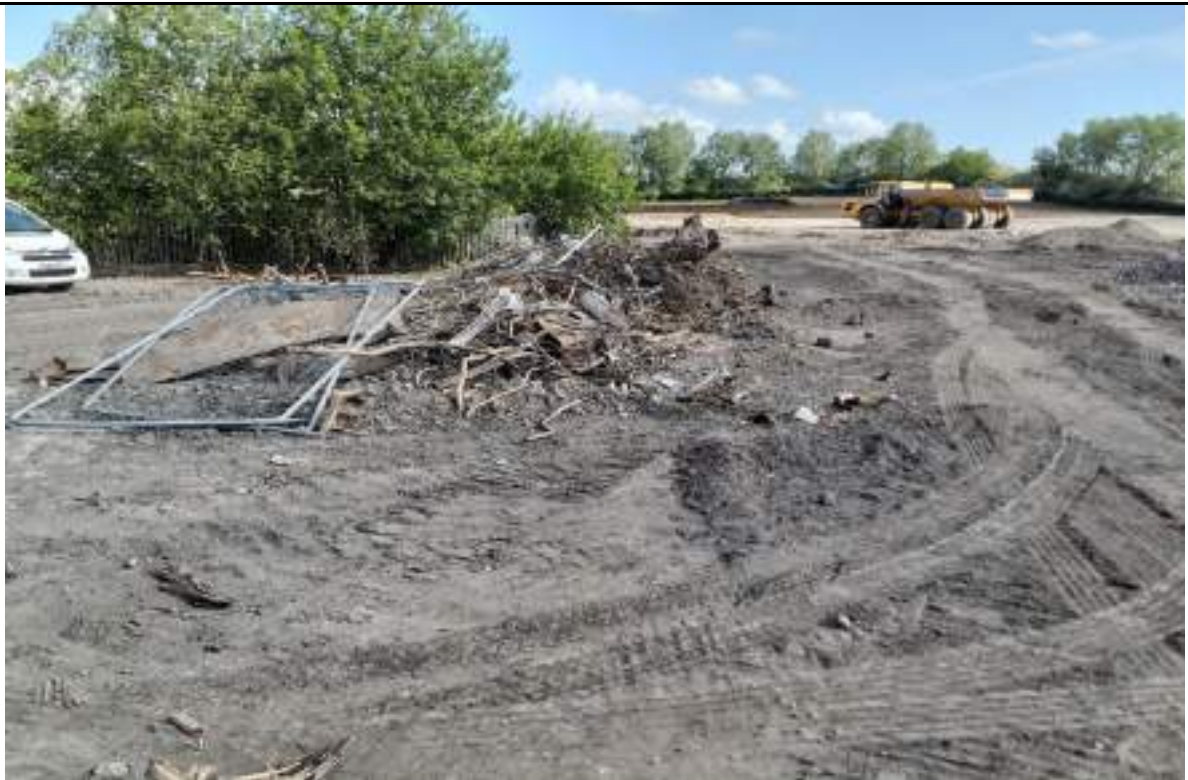
Photograph 124: Stockpile of deleterious material in the northwest.

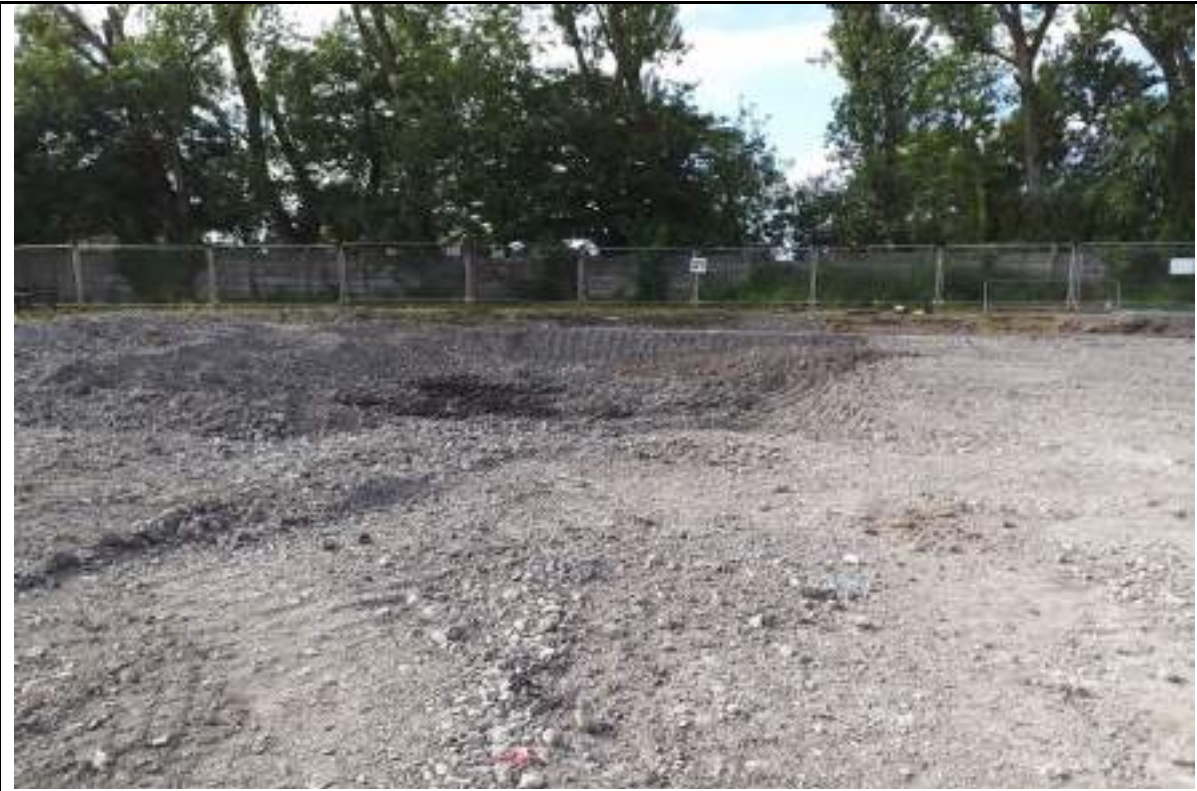
Photograph 1: Re-excavation of 6F2 material in the southeast.

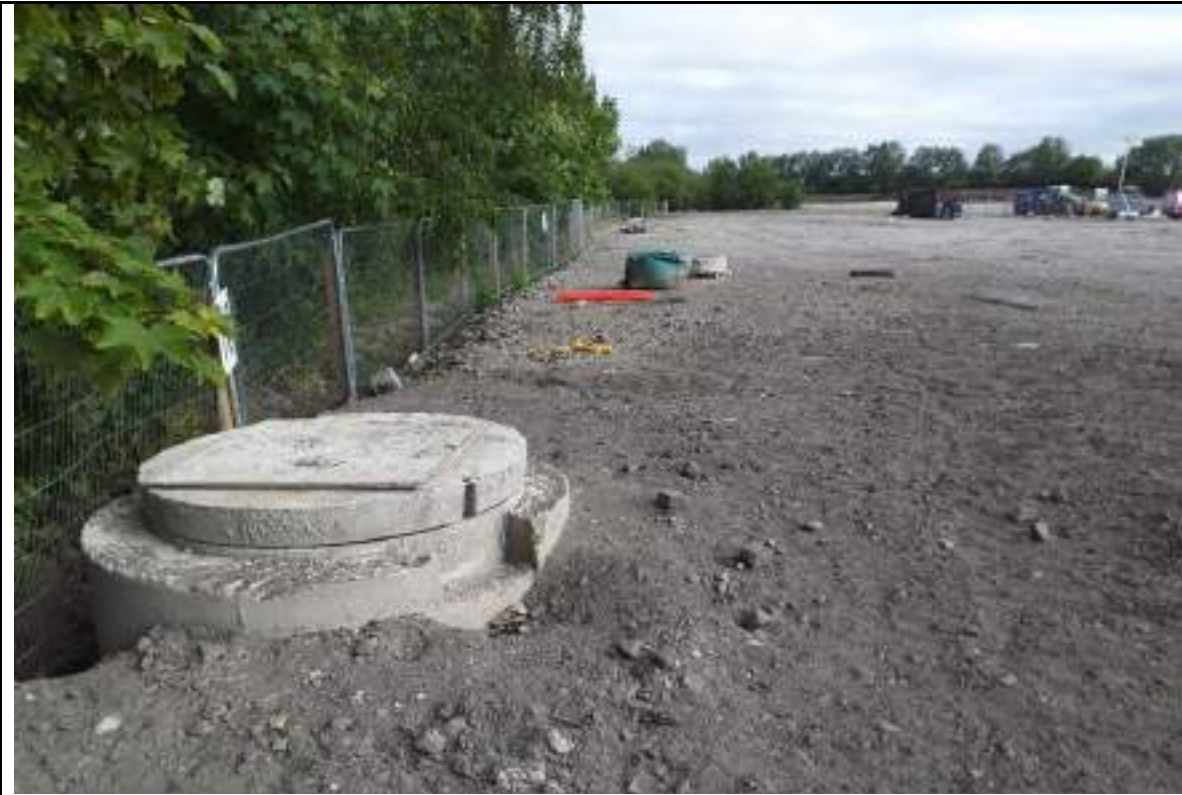
Photograph 3: Construction of two drainage manhole in the western boundary completed.

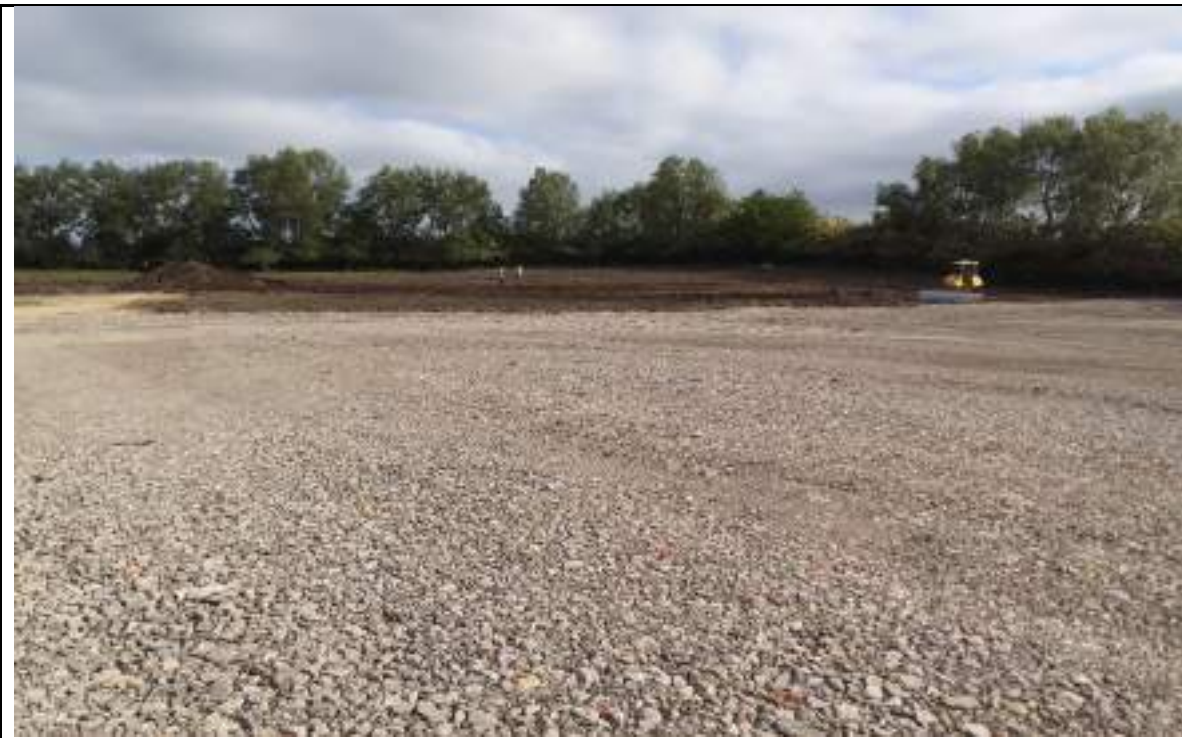
Photograph 4: Placing and levelling topsoil in the POS in the north. Surveyors are controlling levels.

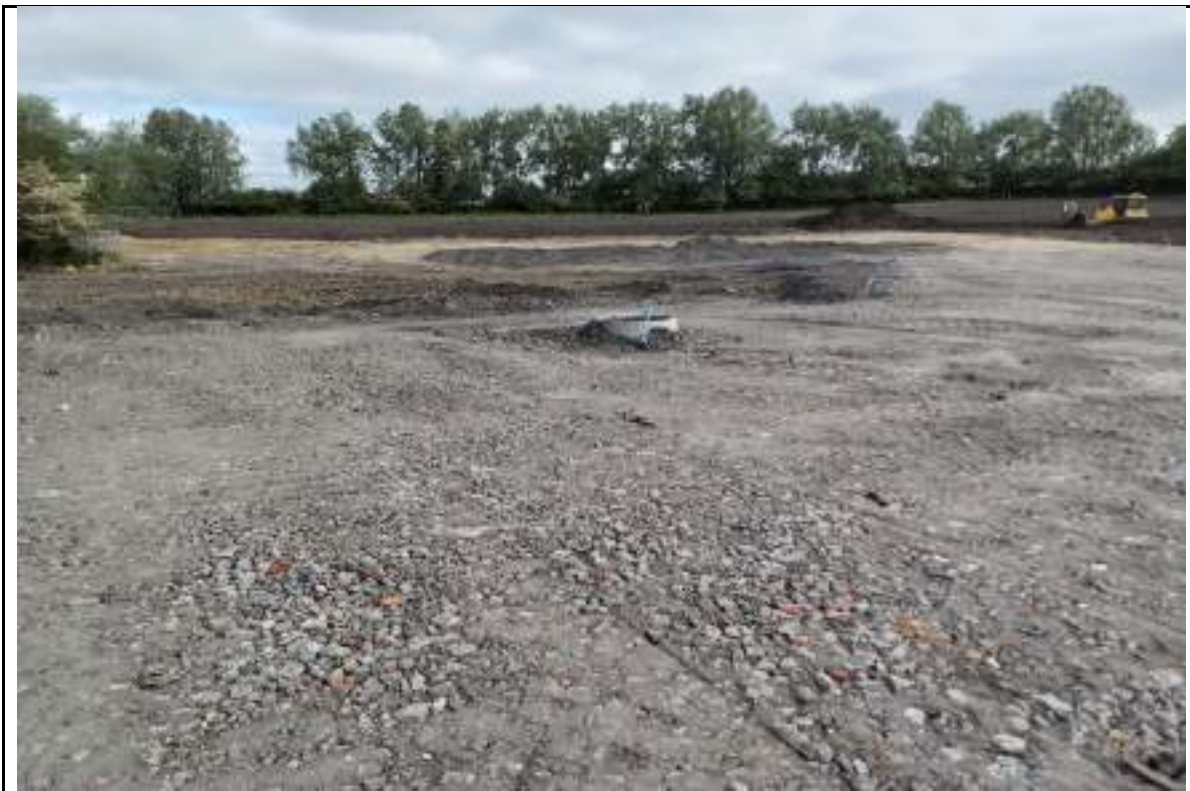
Photograph 6: Area in the northwest still needs filling material.
