| SITE VISIT REPORT 15220-HYD-XX-XX-SVR-GE-1035 | | SHEET NO.: 1 of 20 | |
| Project: Stopes Road, Bolton | | Date: 09/11/22 | |
| Client: Harworth | | Weather: Cloudy | |
| Doc Ref: 15220-HYD-XX-XX-SVR-GE-1035 | | Status & Revision: S2 – P1 | |

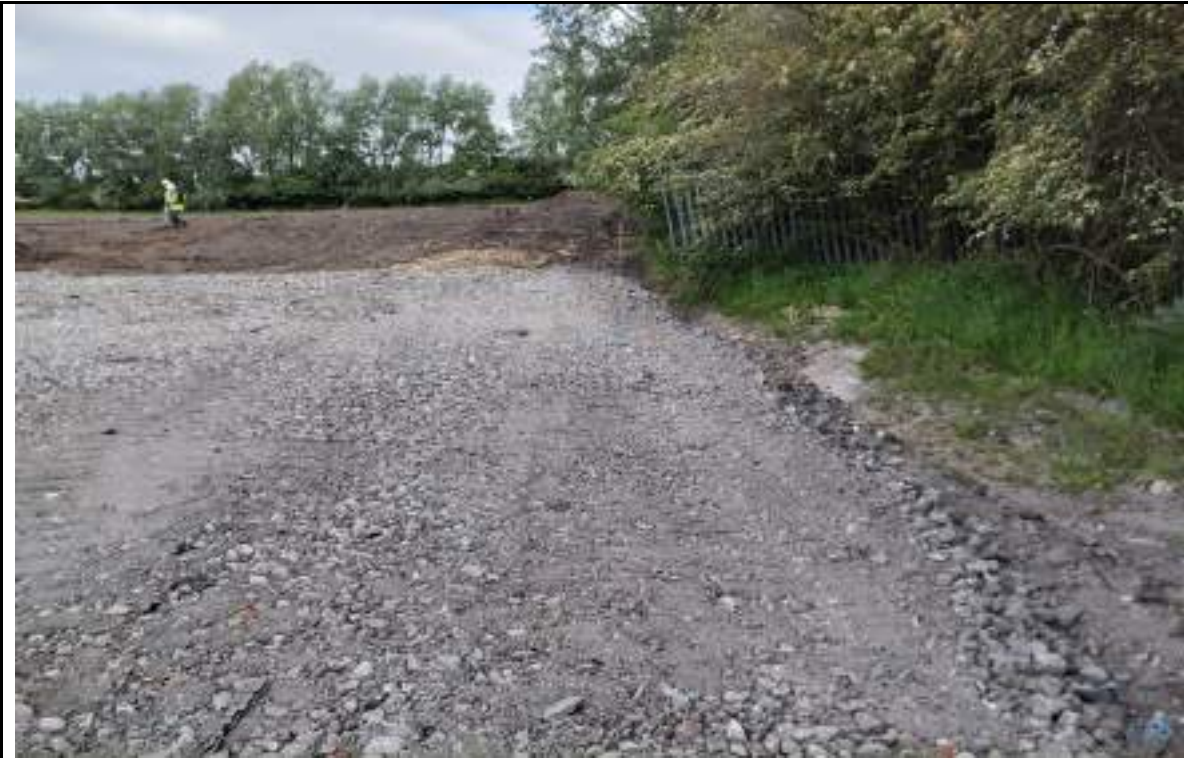
Photograph 7: The northeastern boundary of the site. Looking towards the north.

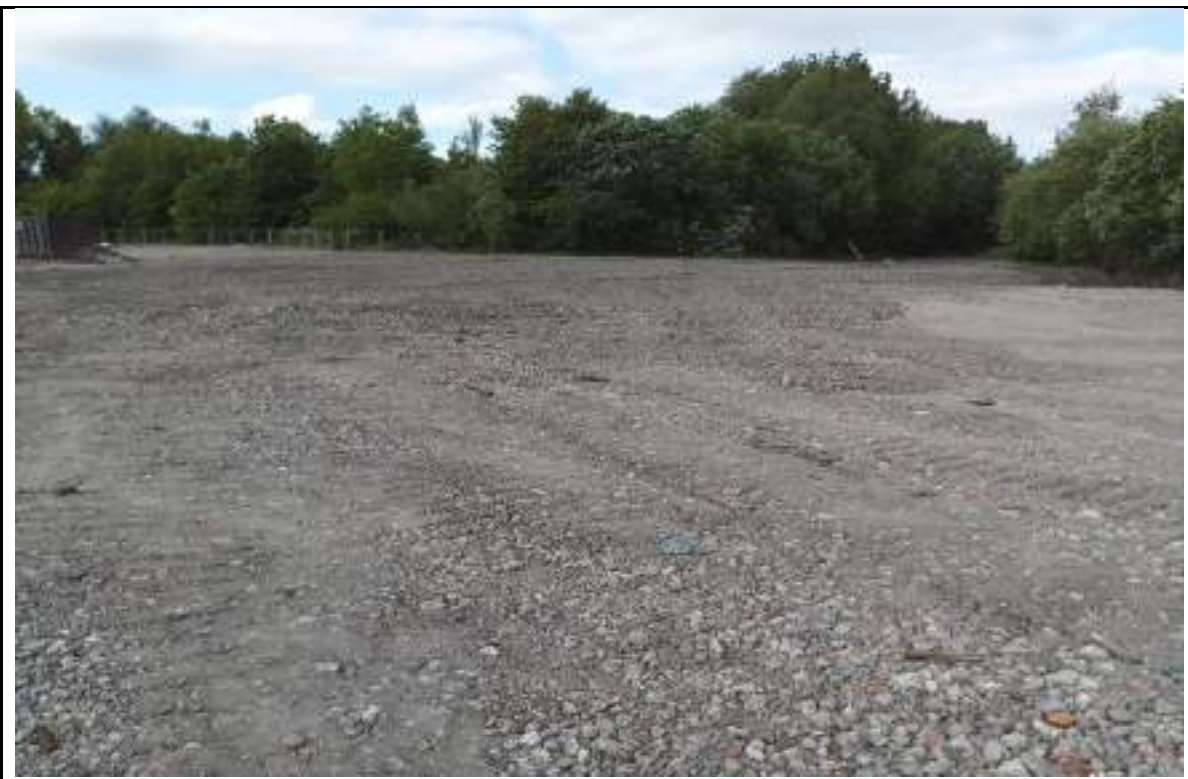
Photograph 8: Capping layer placed in the northwest.

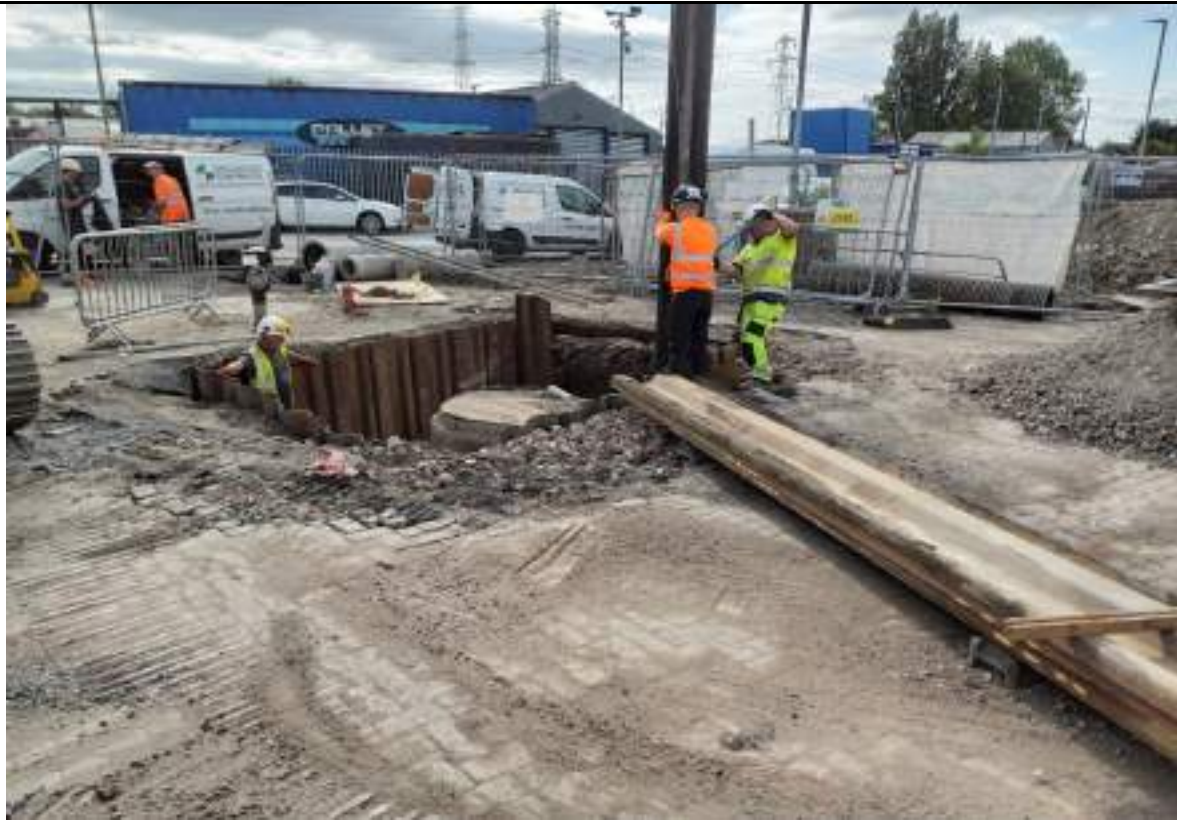
Photograph 9: Removing sheet piles around thrust boring drainage excavation in the southeast.

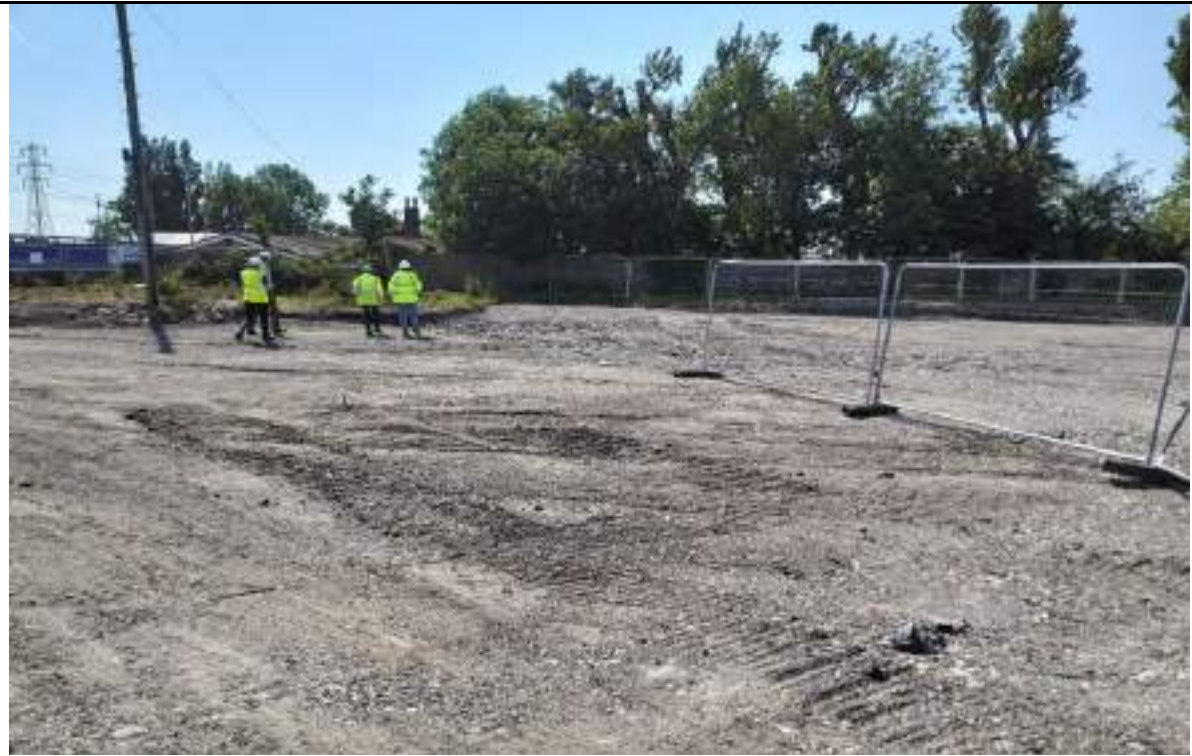
Photograph 1: Running layer placed in the southeast, near location of shaft no.8 and the main gate area.

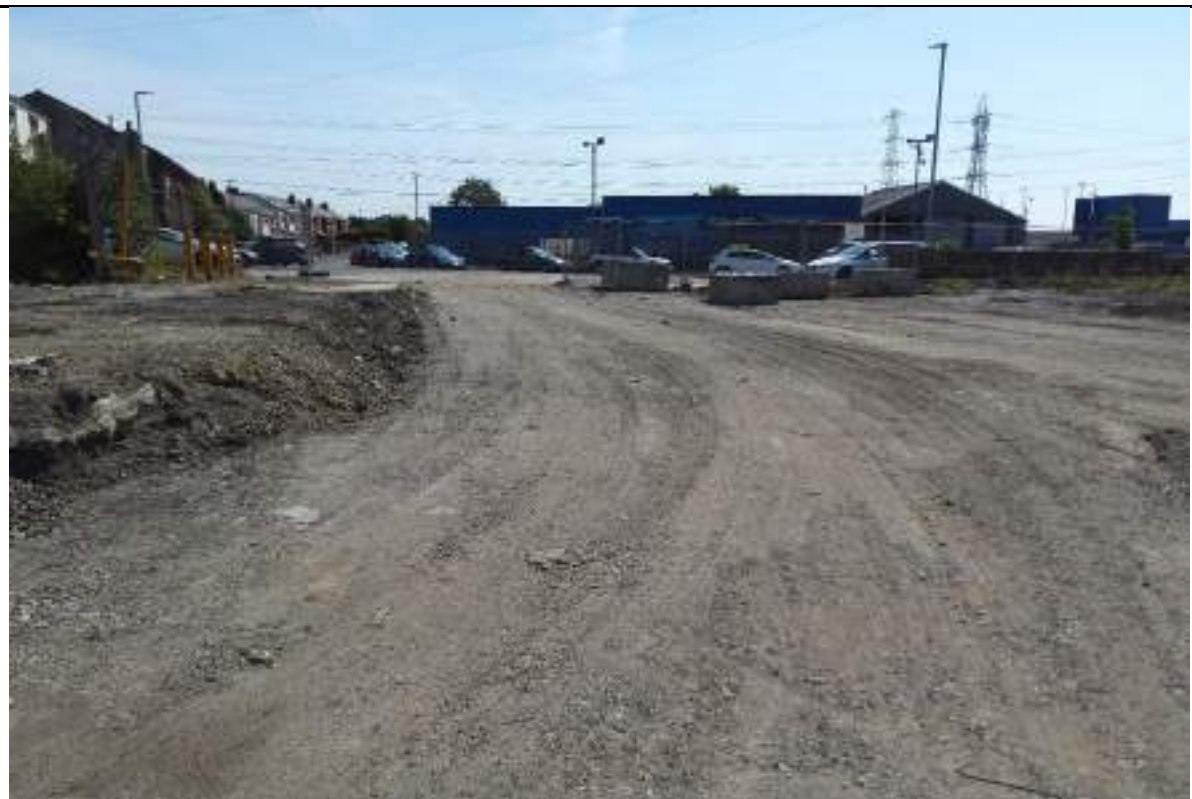
Photograph 2: Completed earthworks in the main gate area.

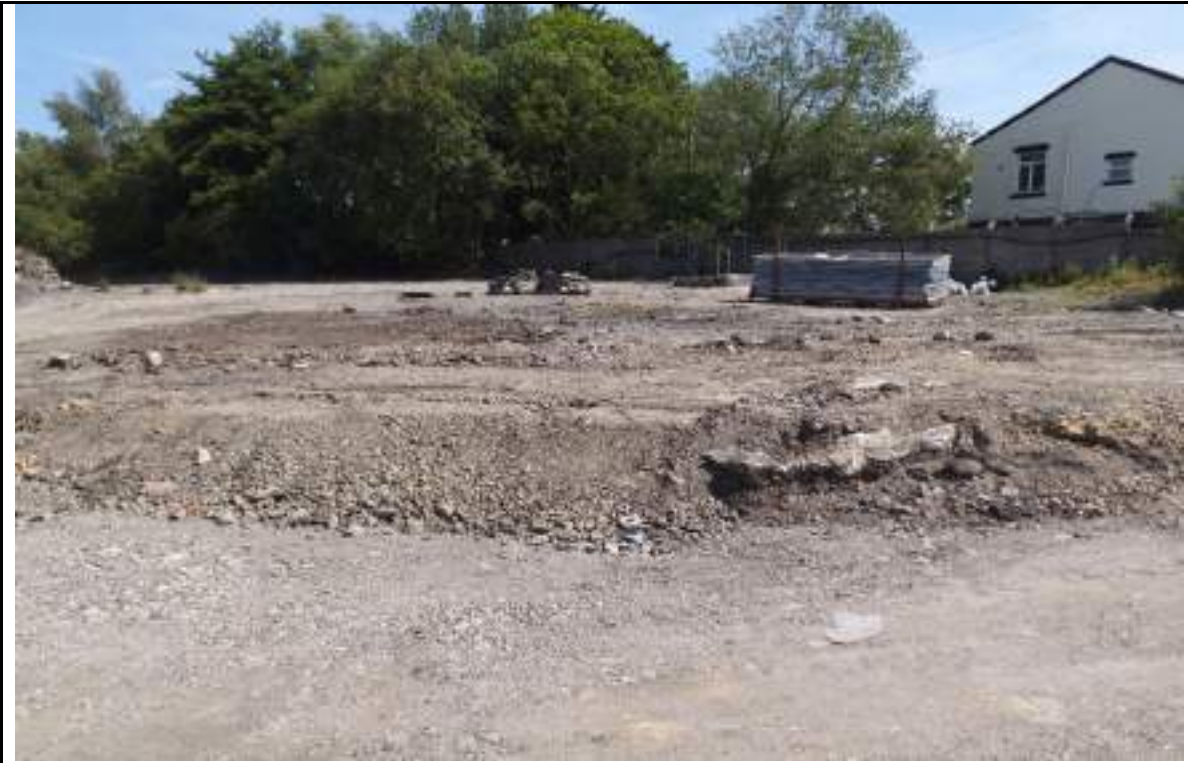
Photograph 3: Shaft no.7 area, not included in earthworks area.

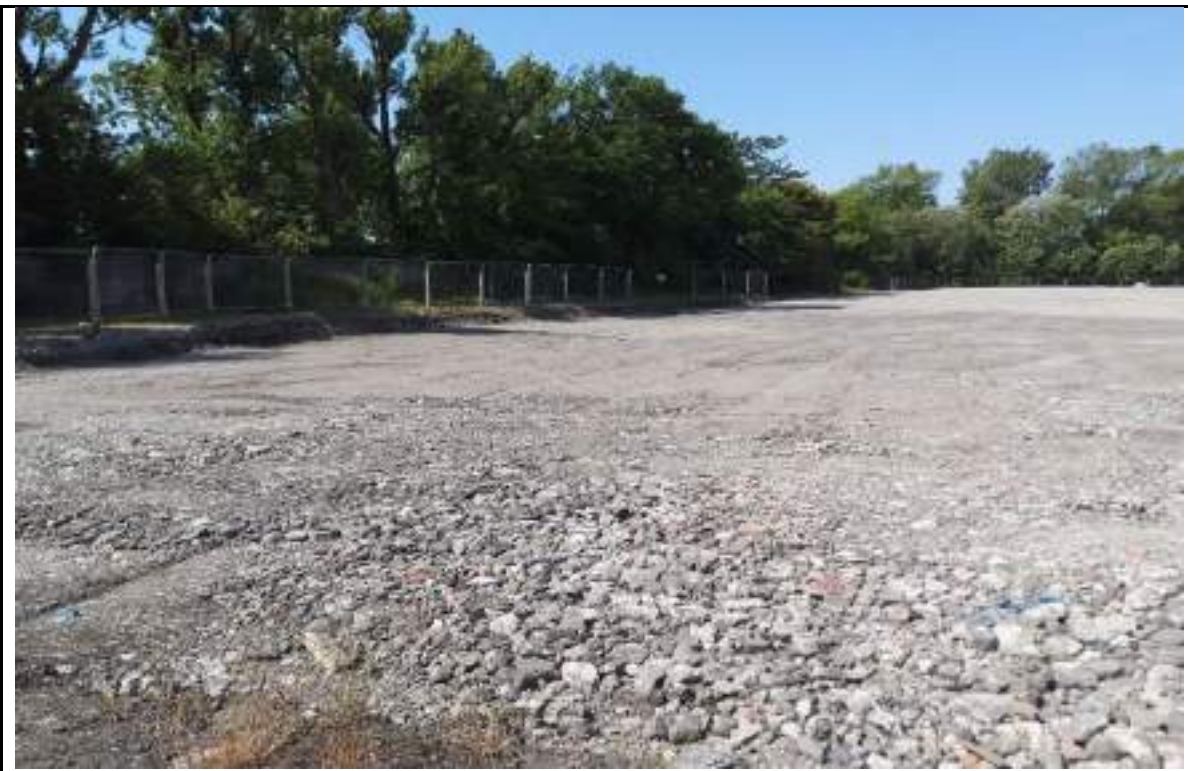
Photograph 4: The southern boundary of the site.

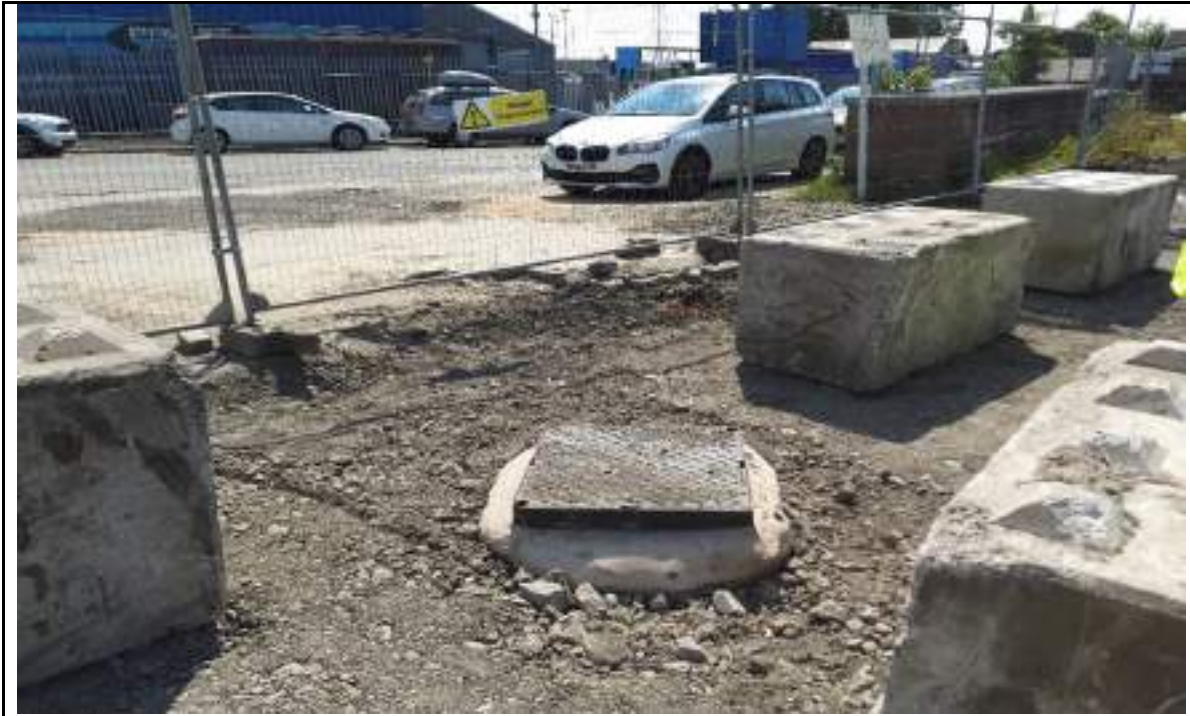
Photograph 5: Drainage manhole in the southeast.

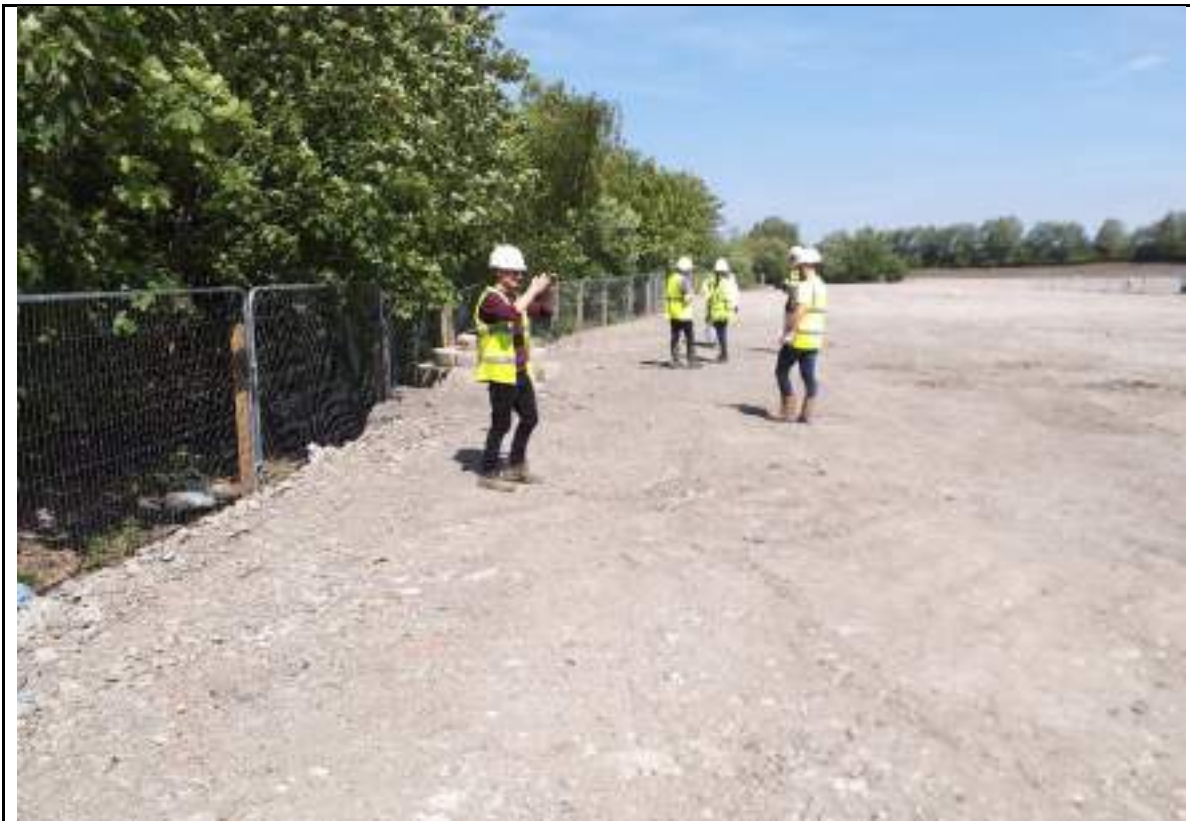
Photograph 6: Drainage manhole in the western boundary.

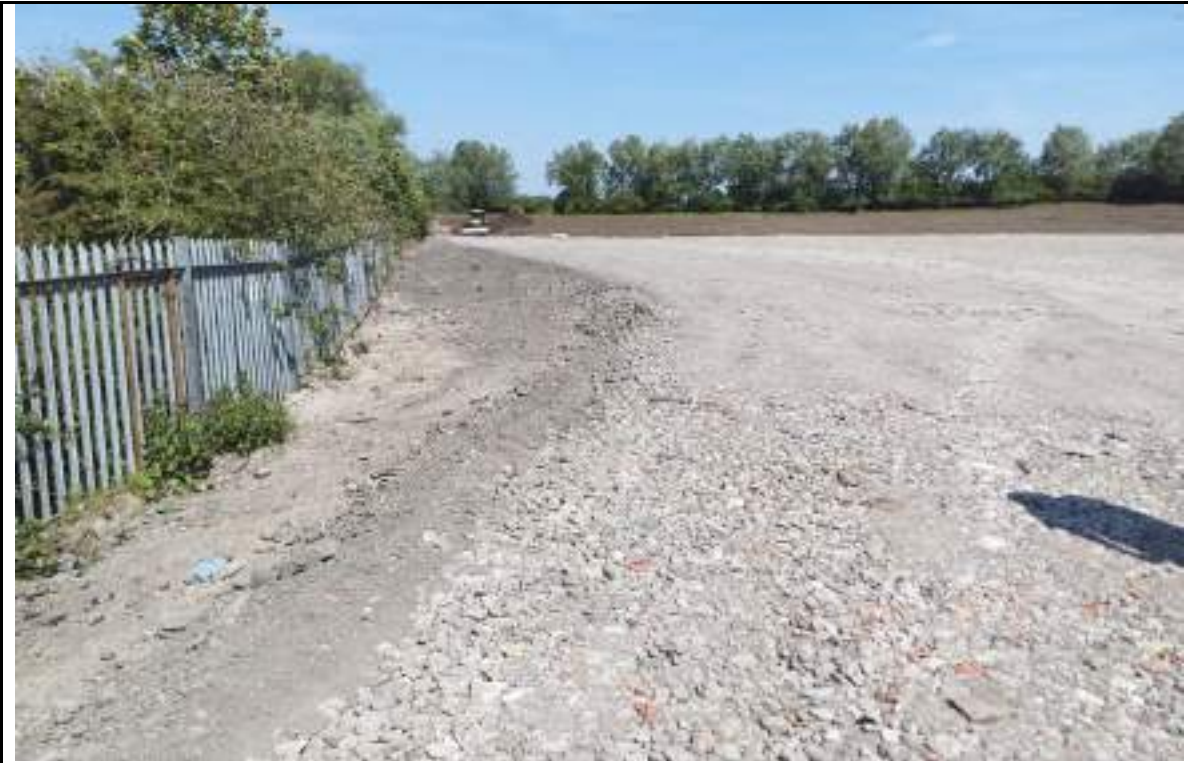
Photograph 7: The northwestern boundary of the site. Looking towards the north.

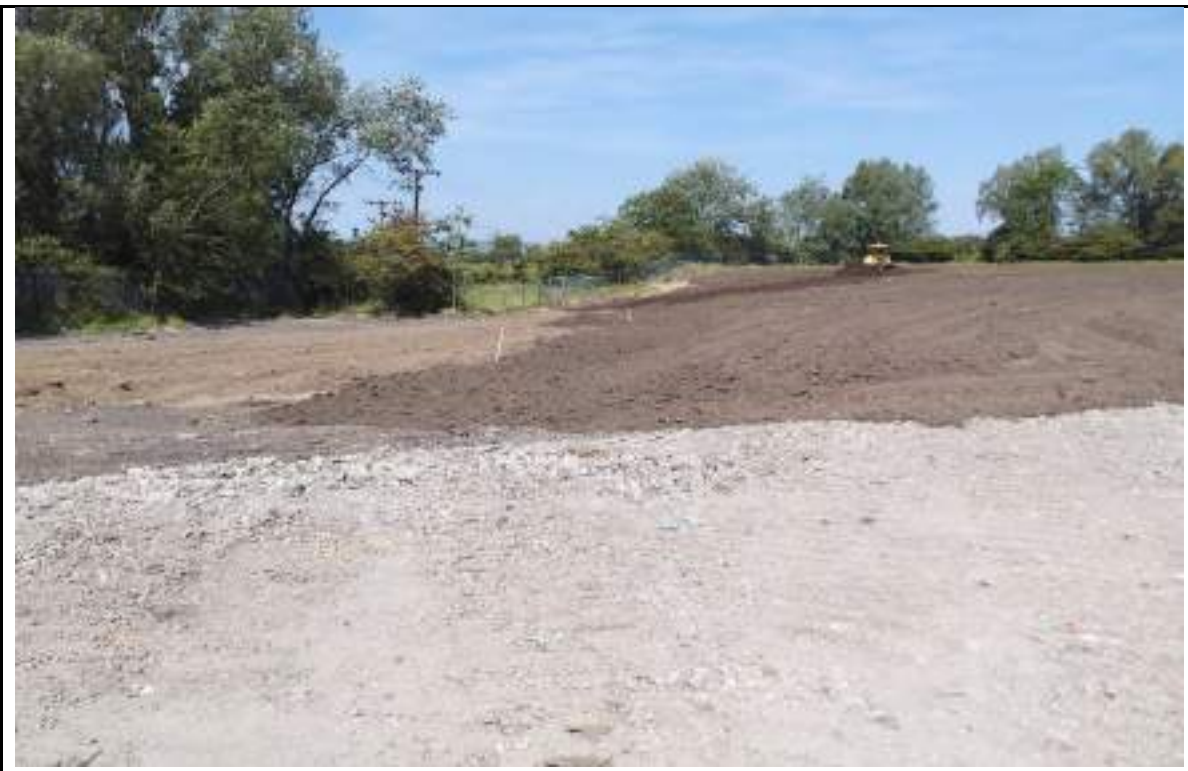
Photograph 8: Placing topsoil in the northwest of POS area.

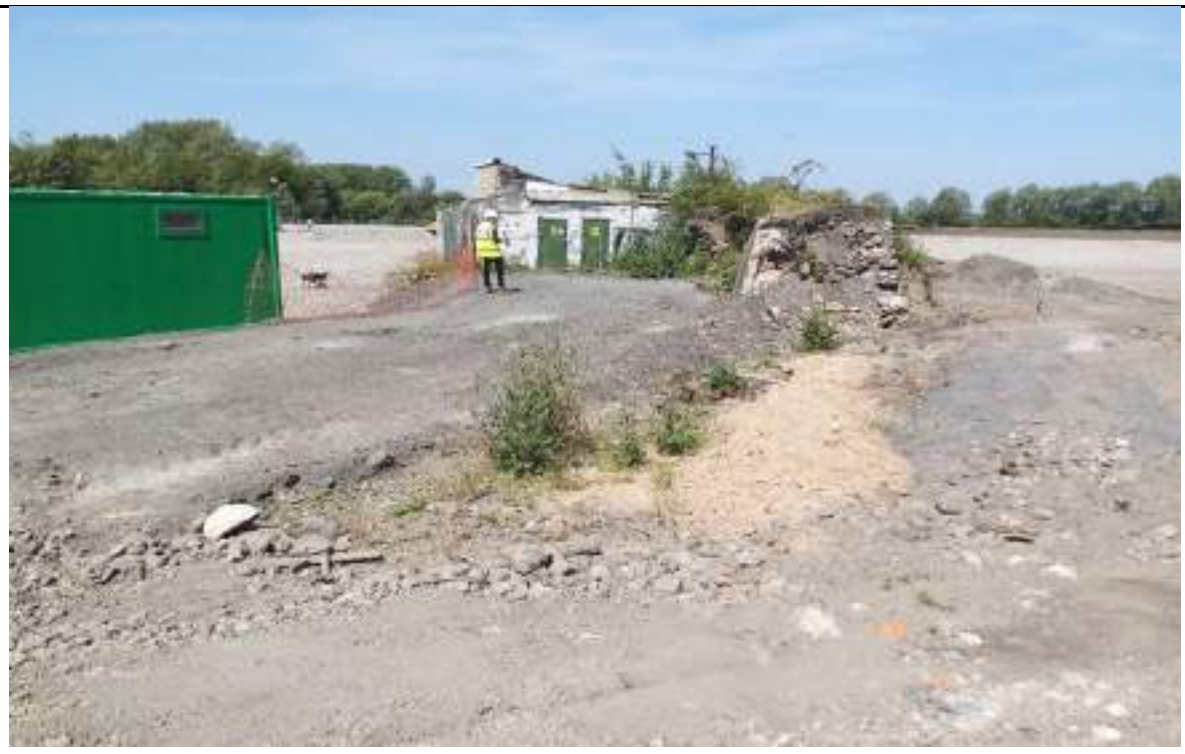
Photograph 10: Grouted shaft no.6 next to electricity transformer in the centre east.

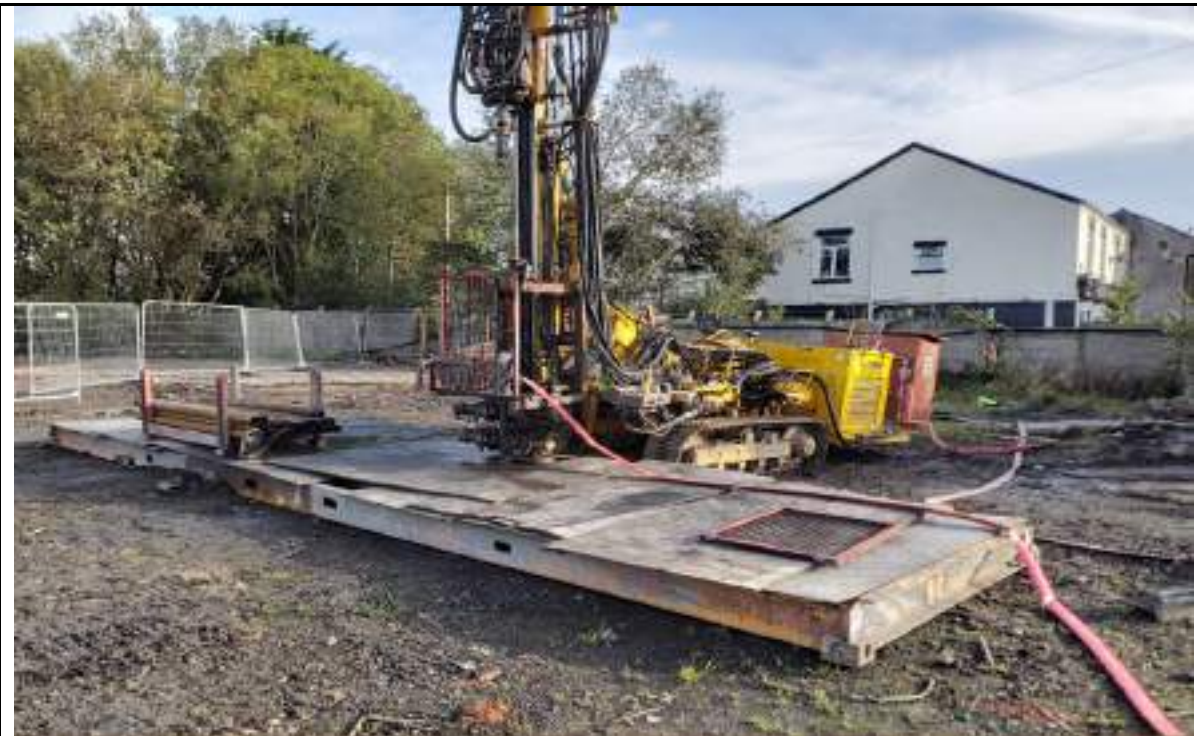
Photograph 1: Drilling rig and platform on top of shaft no.007.

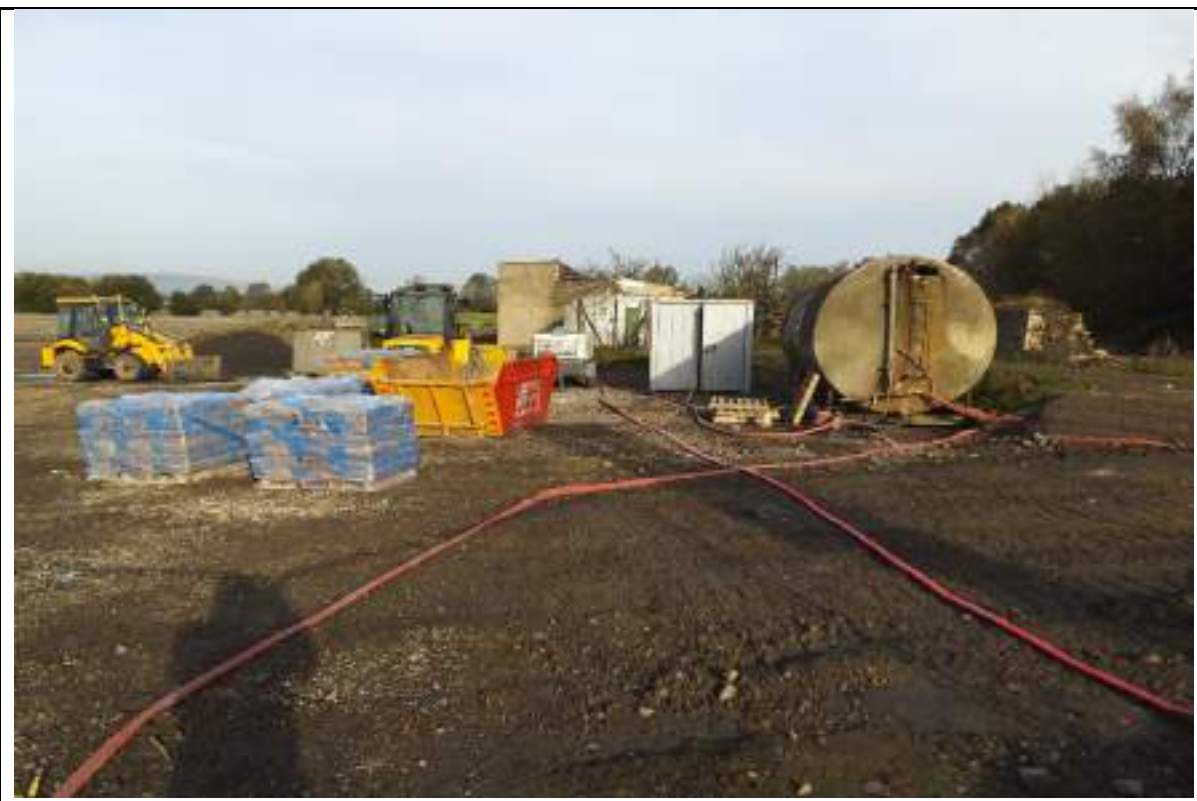
Photograph 2: PFA and OPC stockpiles, water tank and grout mixer adjacent to the shaft no.007.

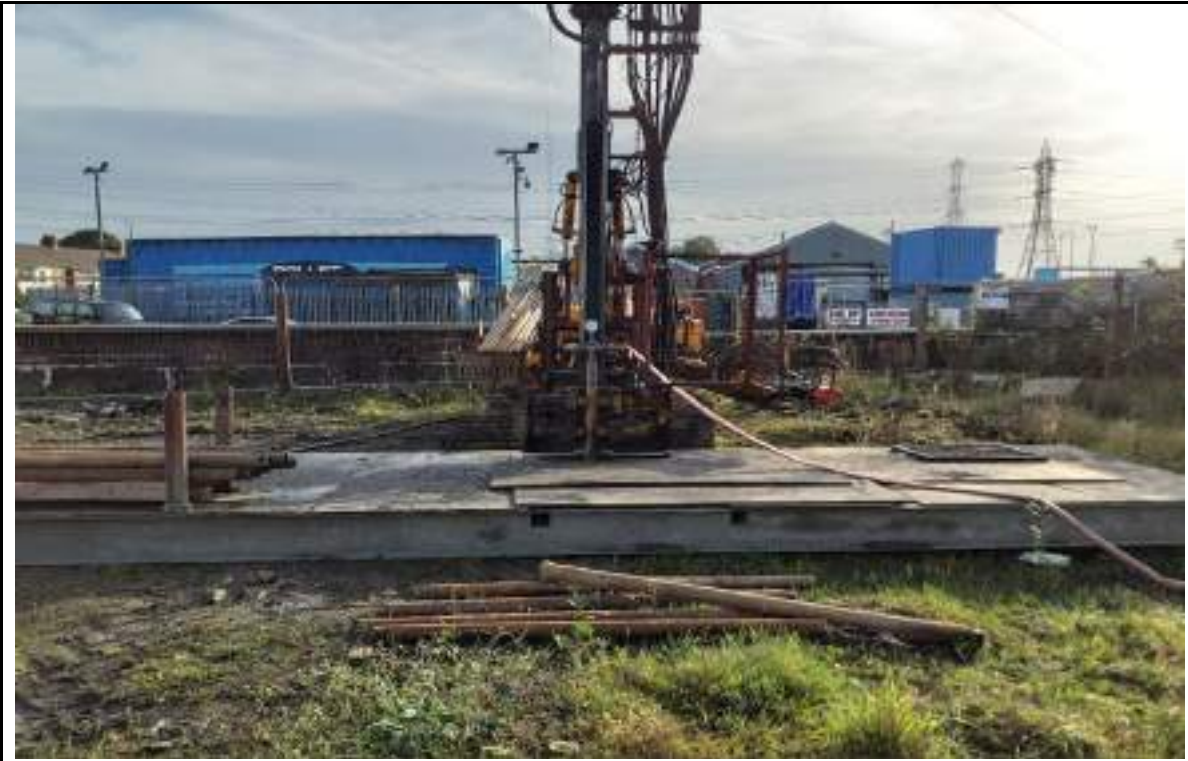
Photograph 3: Drilling rig and platform on top of shaft no.008.

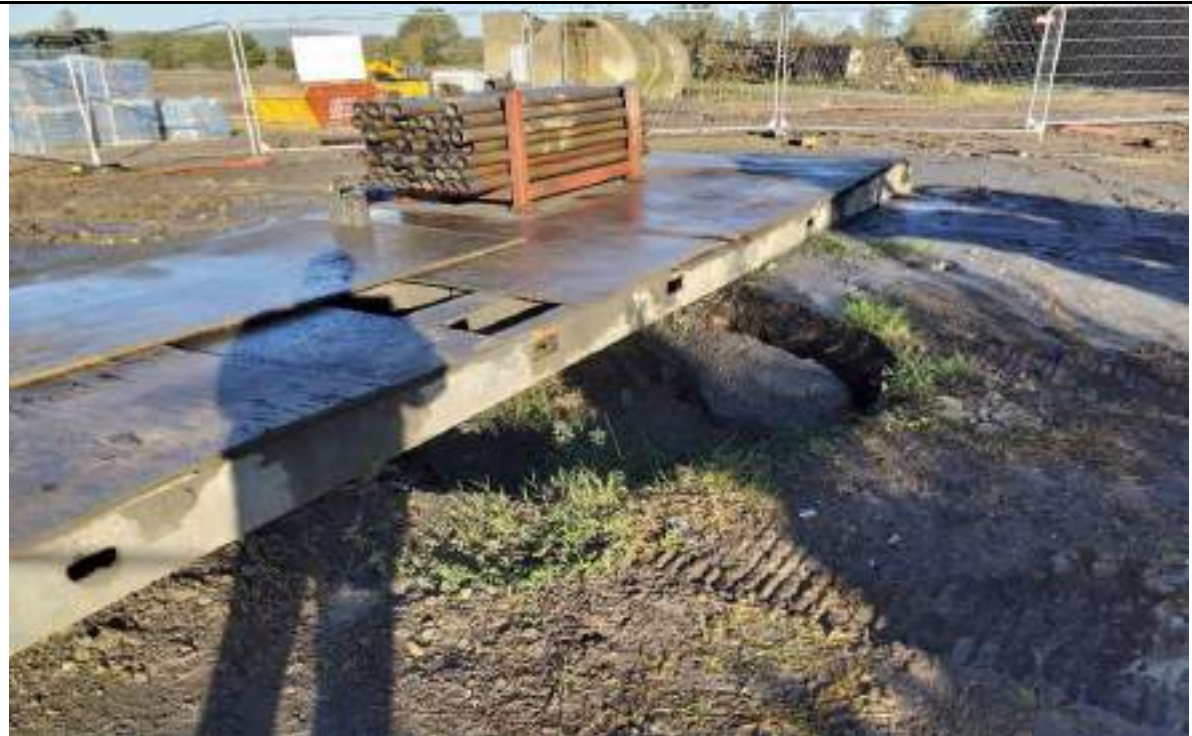
- A crack was observed on top of shaft no.7 yesterday and the shaft's surface was settled up to 1m today.
- M&J removed the rig and the frame and backfilled the shaft surface.
- No groundwater strike was reported.
- Gas monitoring is being undertaken. No gas emission was discovered.
- M&J supervisor confirmed that grout testing including cube, flow, bleed and water content tests are undertaken.
- Total grout take for shaft no.7 was 33.5T so far.
- Total grout take for shaft no.8 was 42.4T so far.
- Bleed test value was reported 980/1000 and flow test was reported 480mm on Tuesday 10.10.2023.
- Bleed test value was reported 970/1000 and flow test was reported 490mm on Wednesday 11.10.2023.

Photograph 1: Settlement of shaft no.7 original backfill.

- DM discussed importing 6F2 material for covering the culvert and Made ground turn over in the shaft treatment areas.
- Discussed location, depth and upstream of the culvert. SG stated that depth of the culvert is 4m in the east and 2m in the west.
- Hydrock requested monitoring data from VHE.
- Verification report was discussed.
- JW recommended dynamic risk assessment for shaft no.7 surface cracking and settlement.

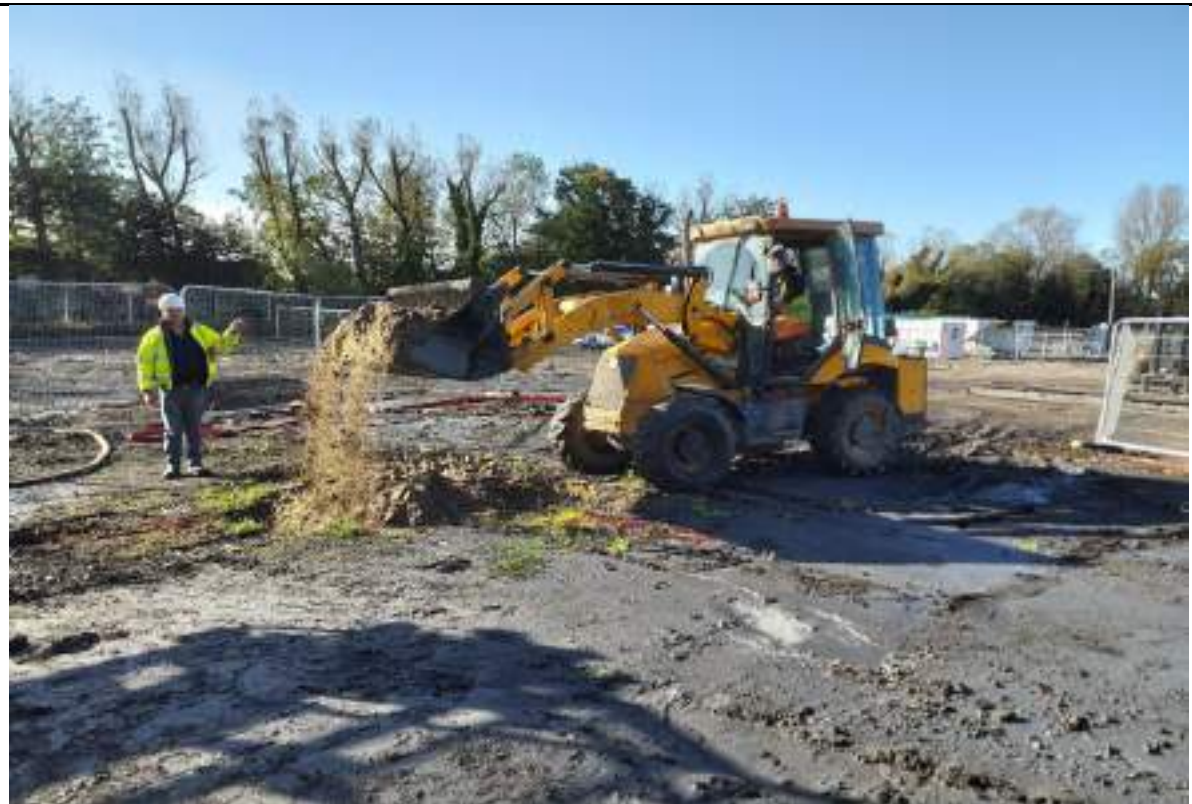
Photograph 2: Backfilling the shaft no.7 surface settlement.

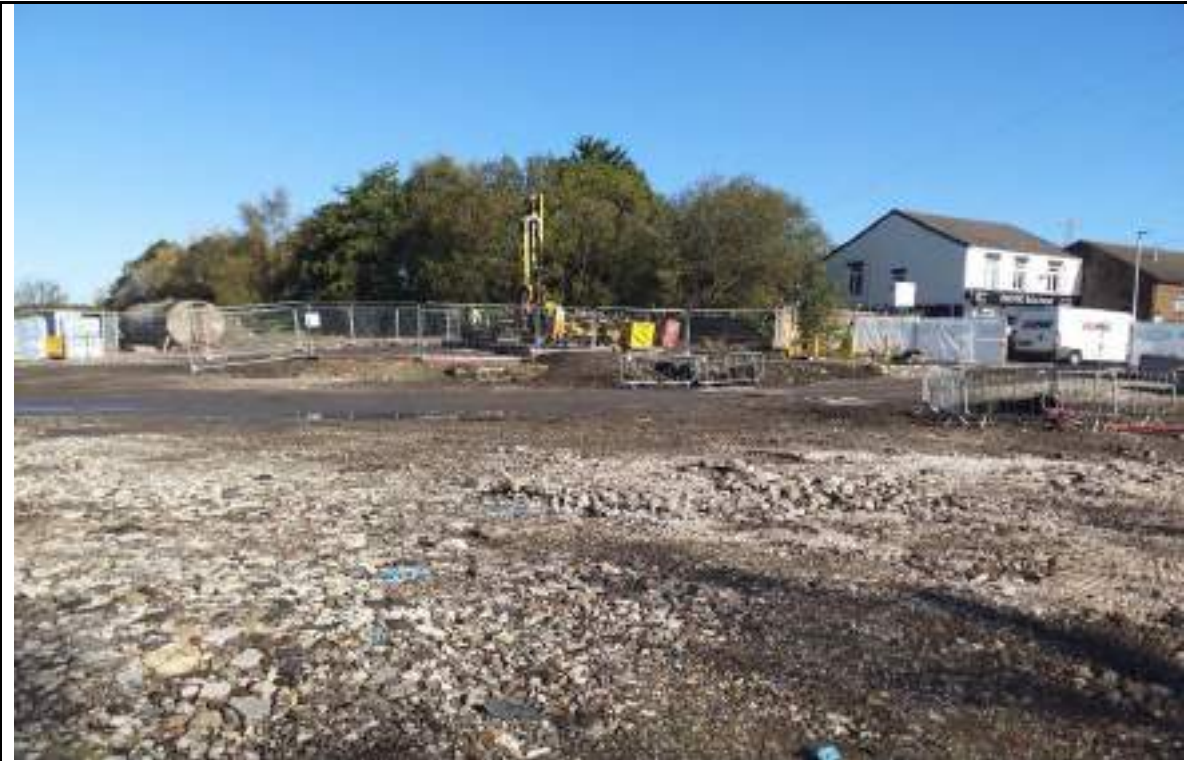
Photograph 3: Grouting started after backfilling of the shaft no.7.

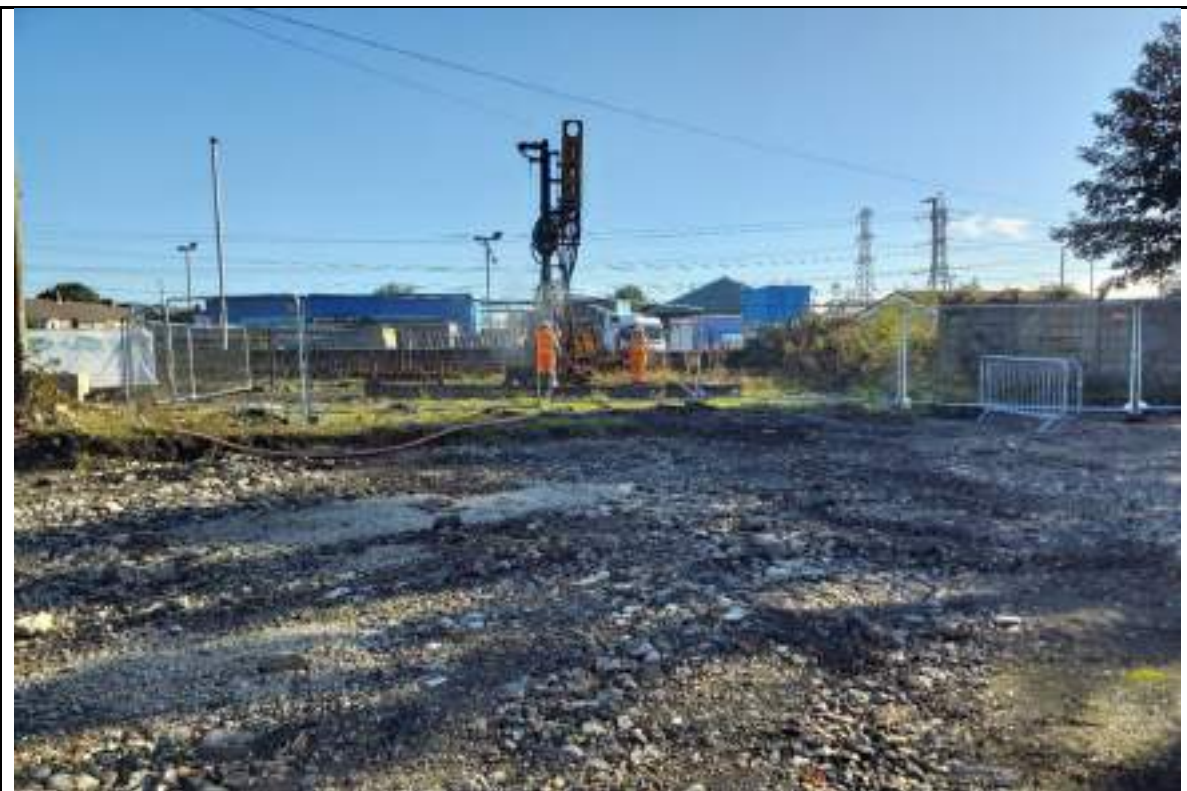
Photograph 4: Grouting of shaft no.8.

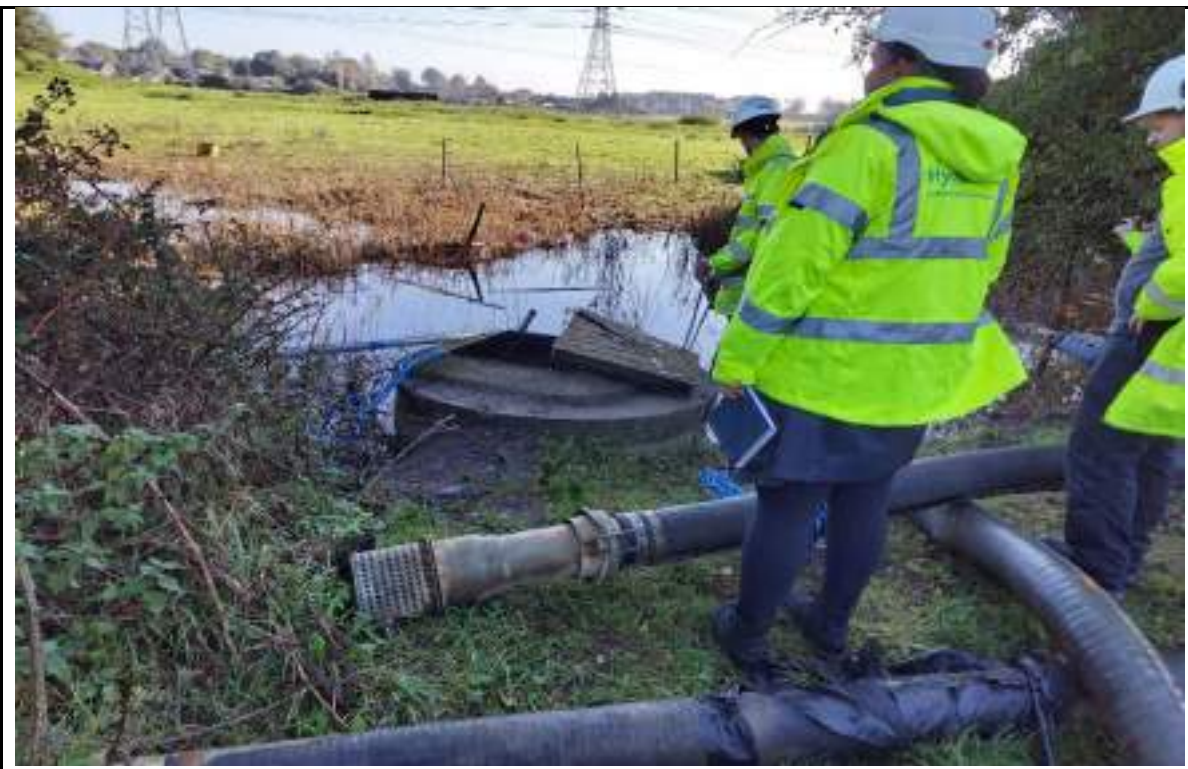
| Hydrock Comment | Contractor Proposal/Solution | Action Status |
|---|---|---|
| Culvert replacement program | Drainage, excavation and backfill | VHE is pumping water from the culvert. |

Photograph 6: Manhole of the culvert and pumping equipment in the west outside boundary of the site.

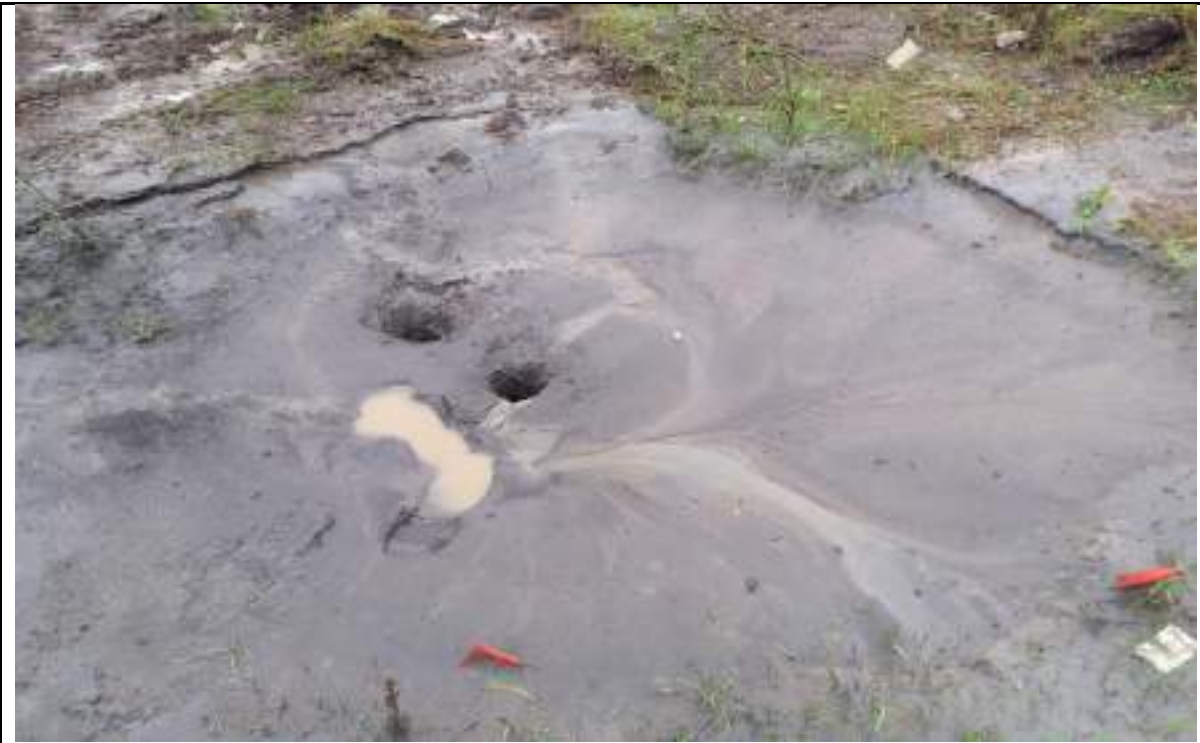
Photograph 1: Grouted boreholes for shaft no.8.

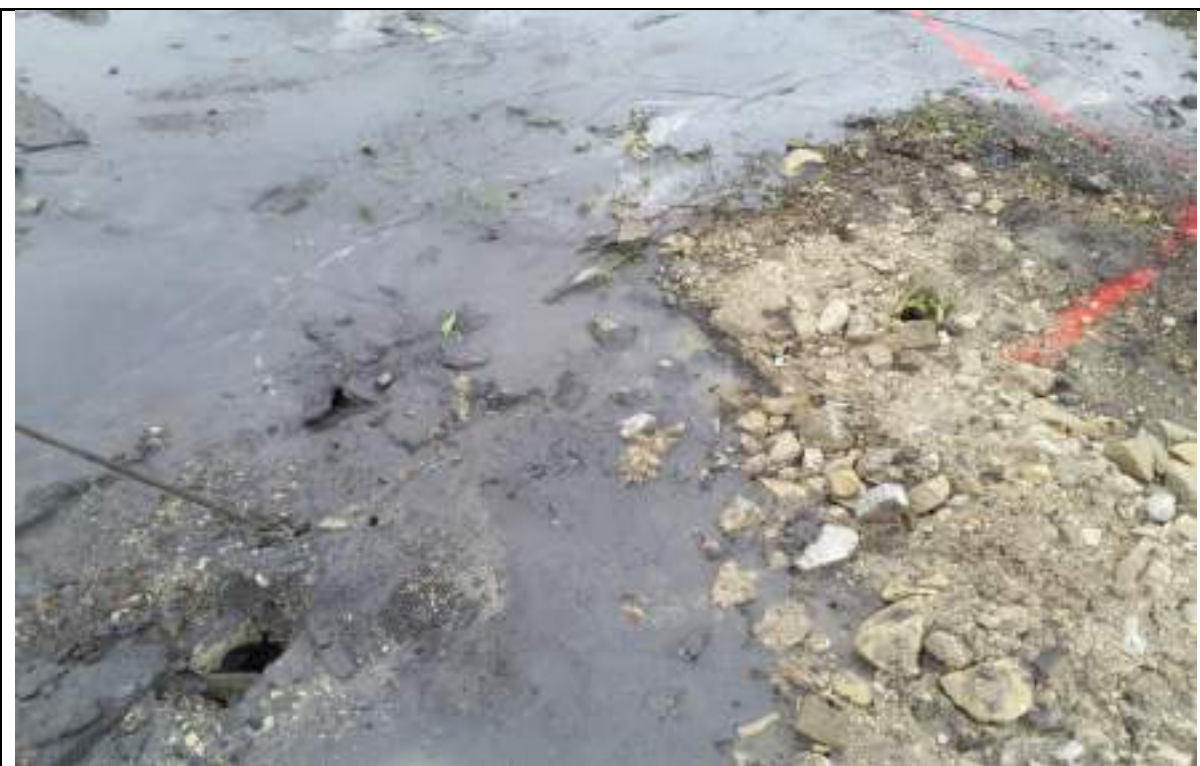
Photograph 2: Grouted boreholes for shaft no.7. Surface settlement of the shaft was backfilled by imported 6F5 material.

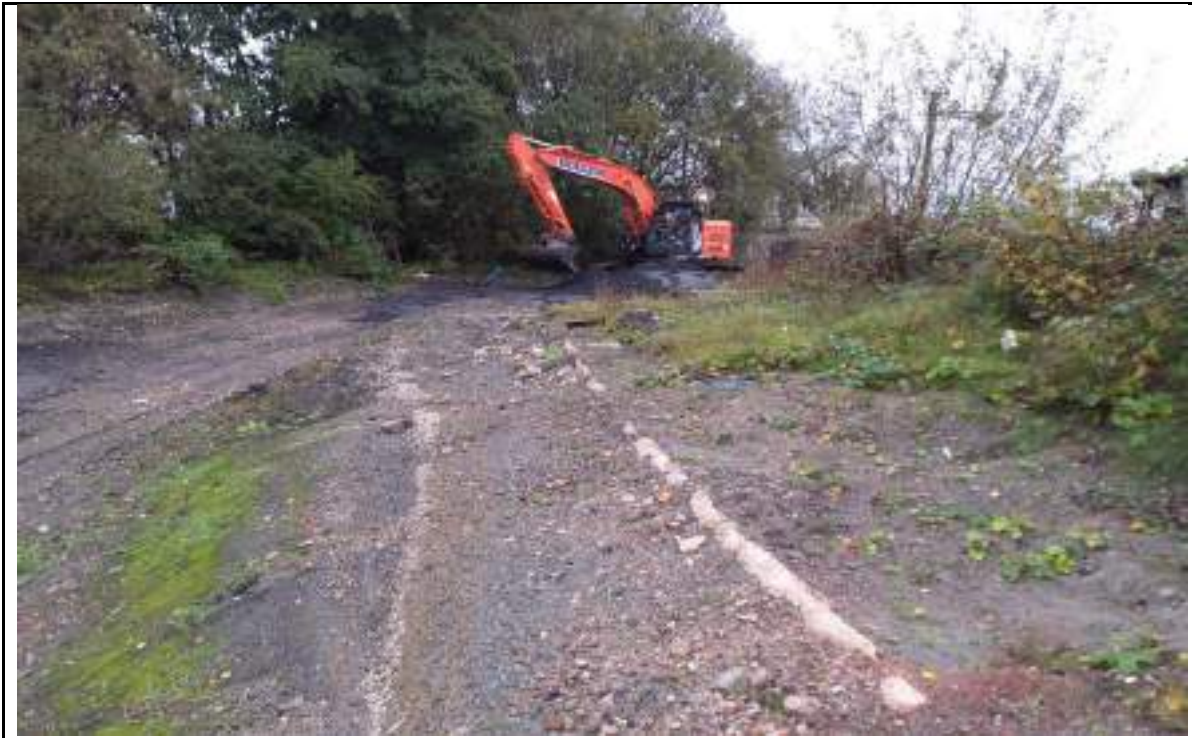
Photograph 3: Excavator removing surplus PFA material on access road in the southeast.

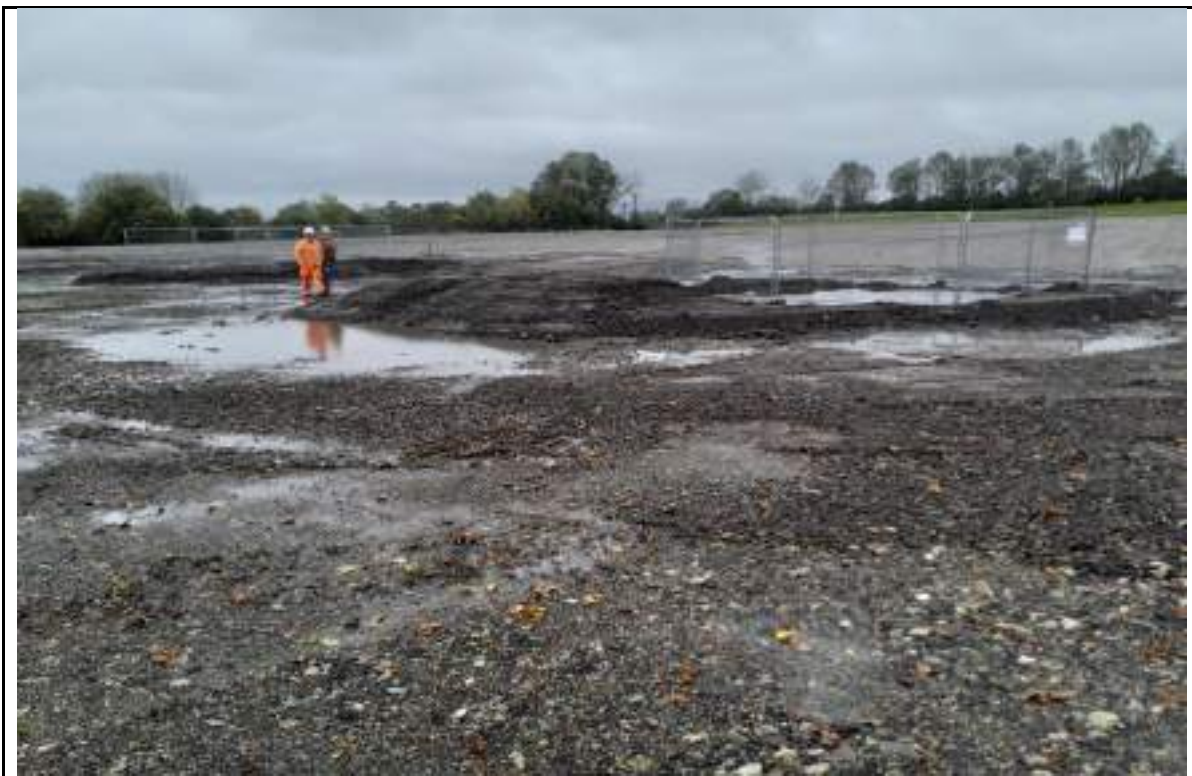
- Deep pits (6m) were excavated to find the culvert location. The culvert was found in the two of excavations in the central and the western part of the site, however the culver was not found in the excavations in the eastern part of the site.
- Hydrock requested imported 6F5 material test certificate.
- Made Ground turnover and associated Geochemical testing in the location of shafts no. 7 and 8. SG stated that testing company will be on site today to collect samples.

Photograph 4: Excavations in the centre and east of the site to find culvert location. Both excavations covered with water.
