| SITE VISIT REPORT 15220-HYD-XX-XX-SVR-GE-1035 | | SHEET NO.: 1 of 20 | |
| Project: Stopes Road, Bolton | | Date: 09/11/22 | |
| Client: Harworth | | Weather: Cloudy | |
| Doc Ref: 15220-HYD-XX-XX-SVR-GE-1035 | | Status & Revision: S2 – P1 | |

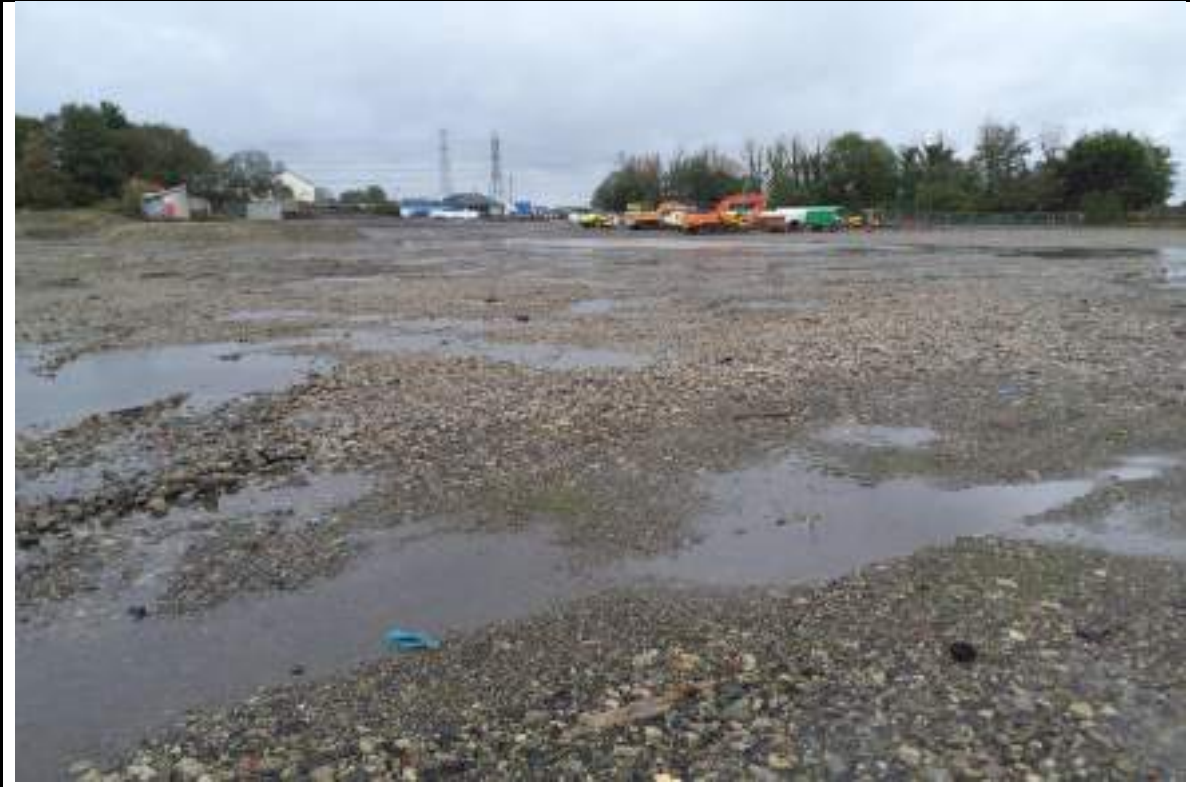
Photograph 5: Stockpile of imported 6F5 material and VHE earthwork machinery in the southeast.

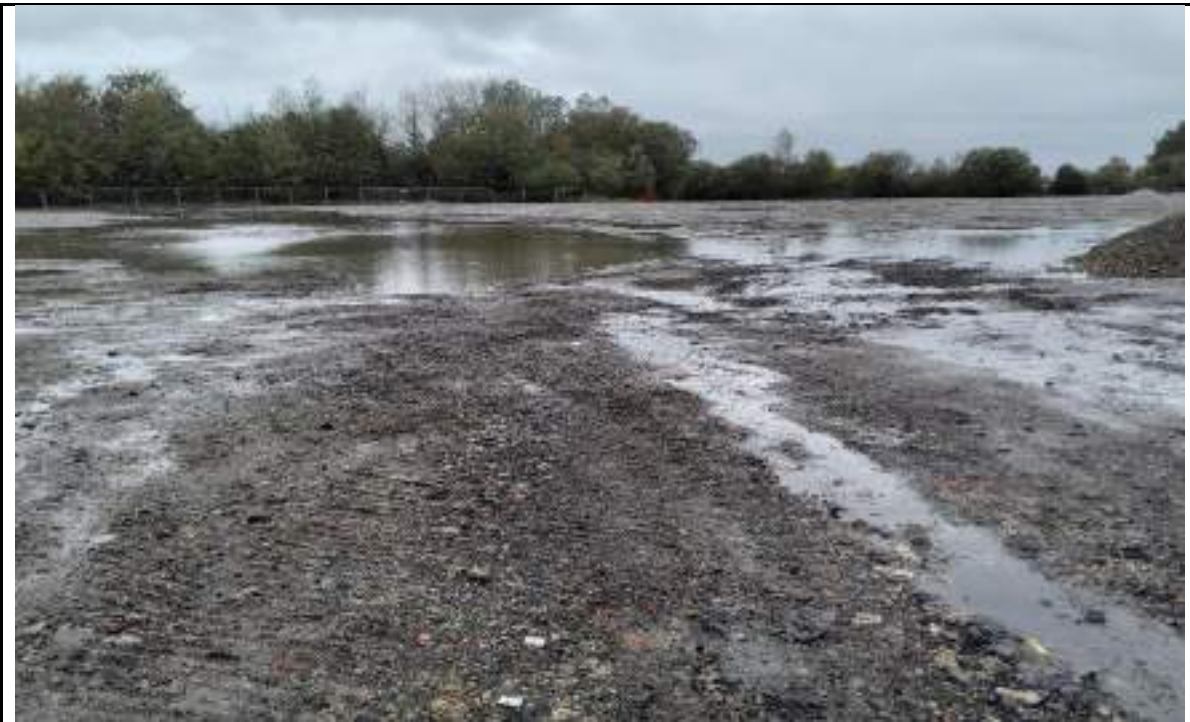
Photograph 6: Standing water in the centre of the site.

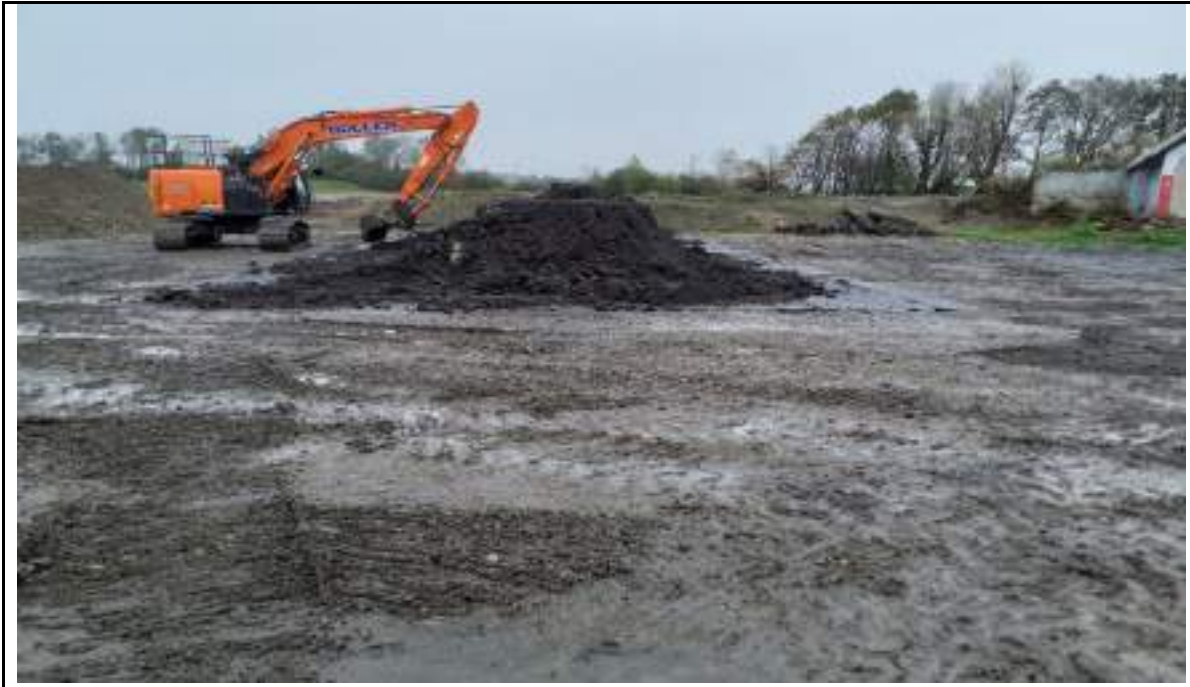
Photograph 3: Stockpile of potentially TPH contaminated material on a black visqueen barrier adjacent to electrical substation. Material excavated from location of shaft no.7.

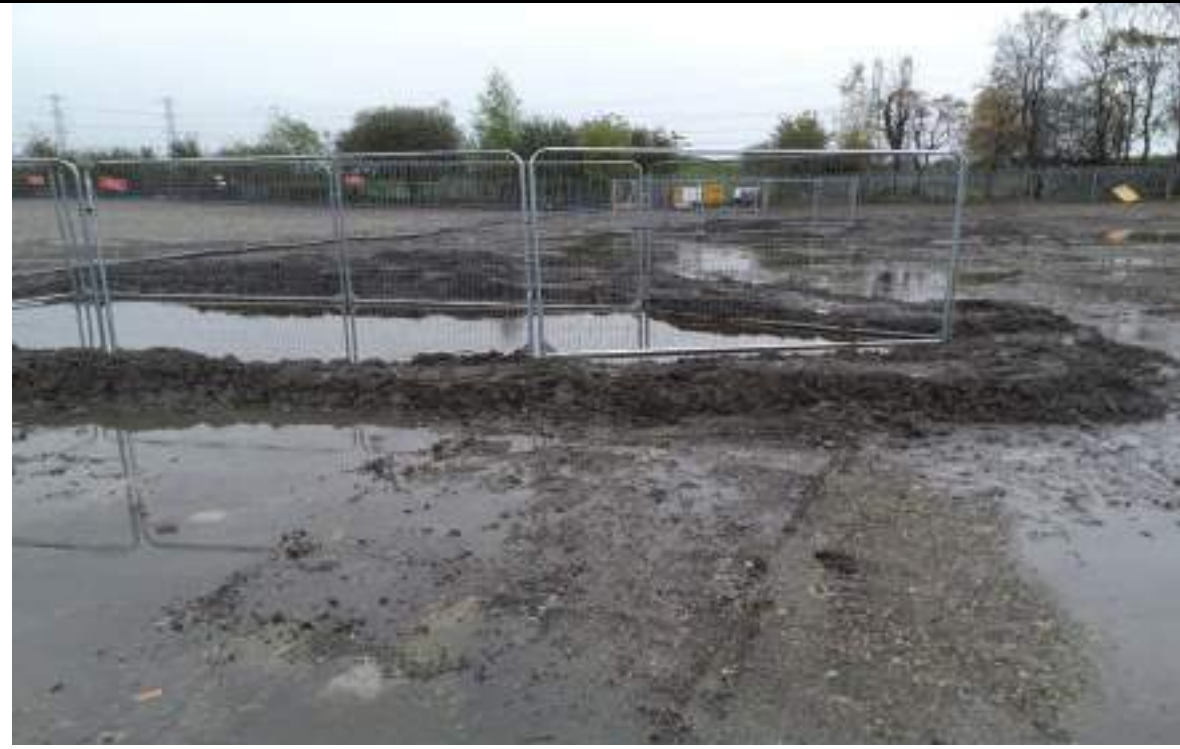
Photograph 5: Excavations in the centre and east to find location of culvert.

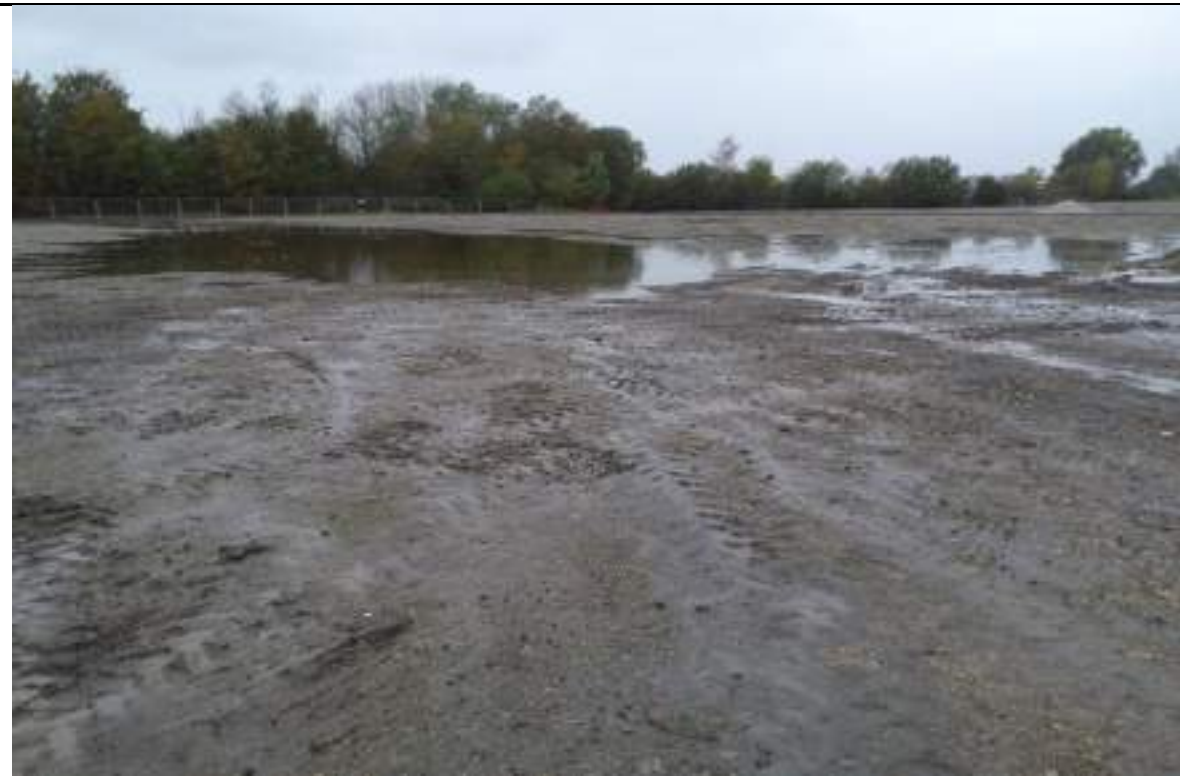
Photograph 6: Standing water in the centre of the site.

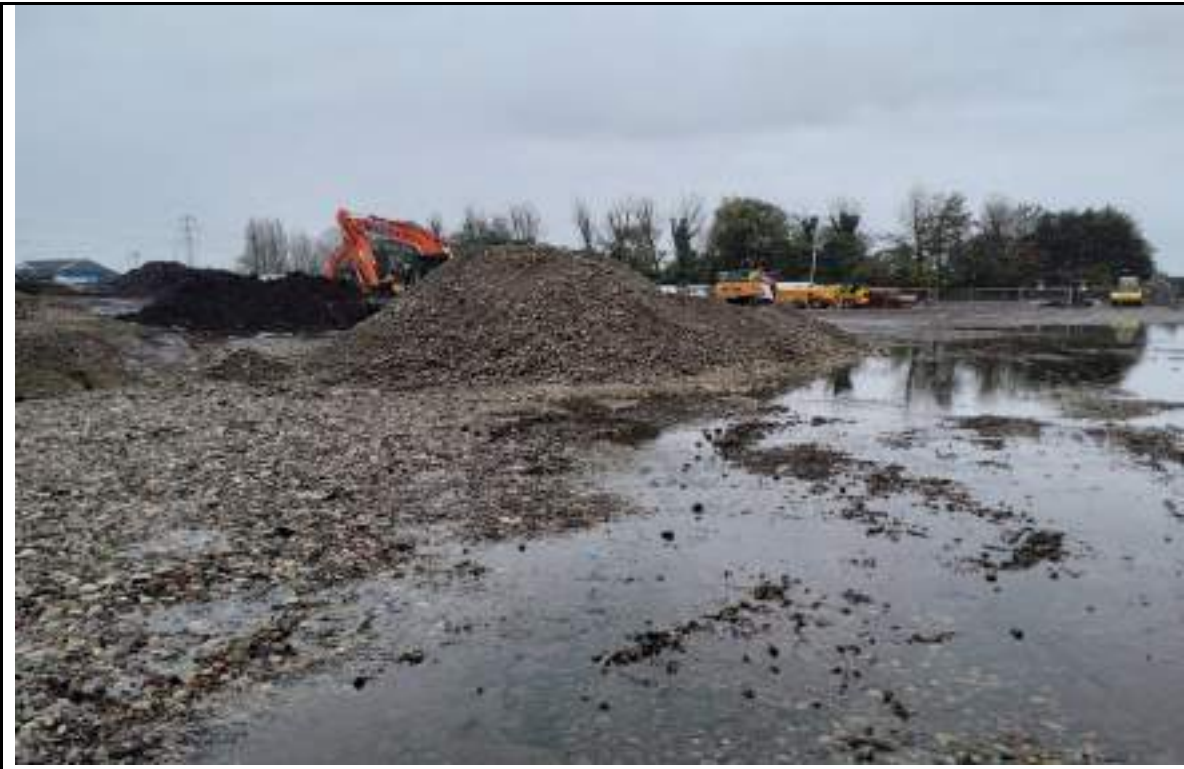
Photograph 7: Stockpile of 6F5 imported material in the southeast adjacent to electrical substation.

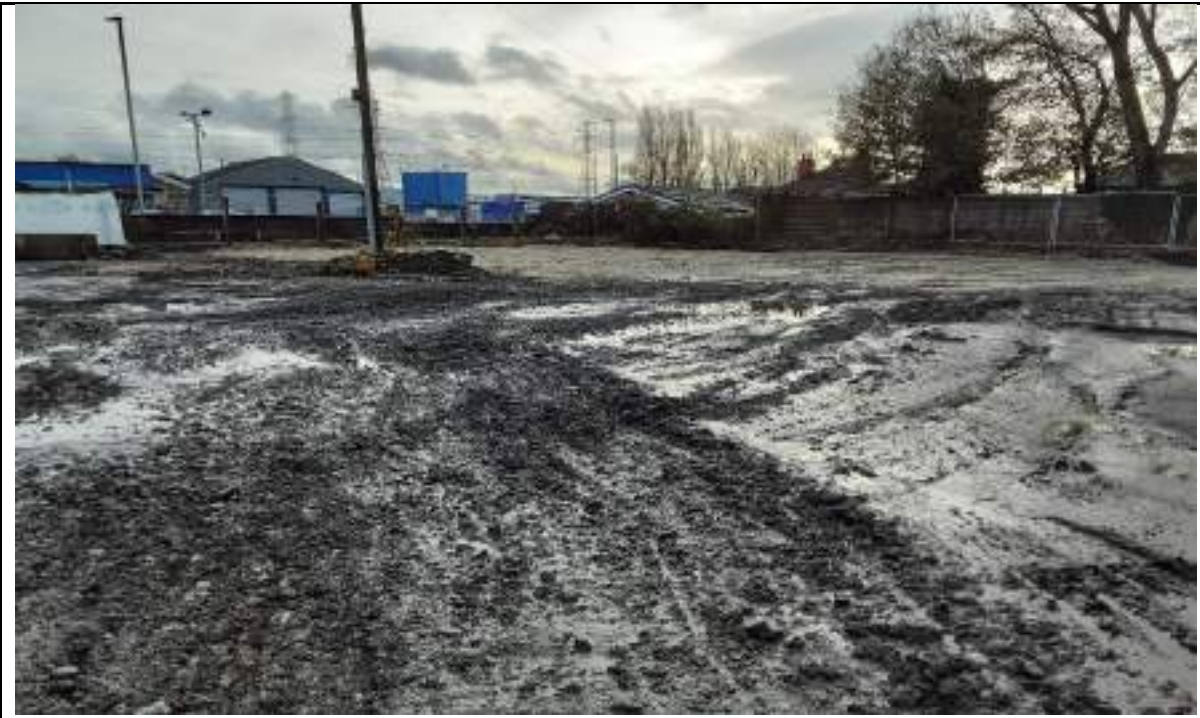
Photograph 1: Shaft no.8 backfilled with 6F5 material.

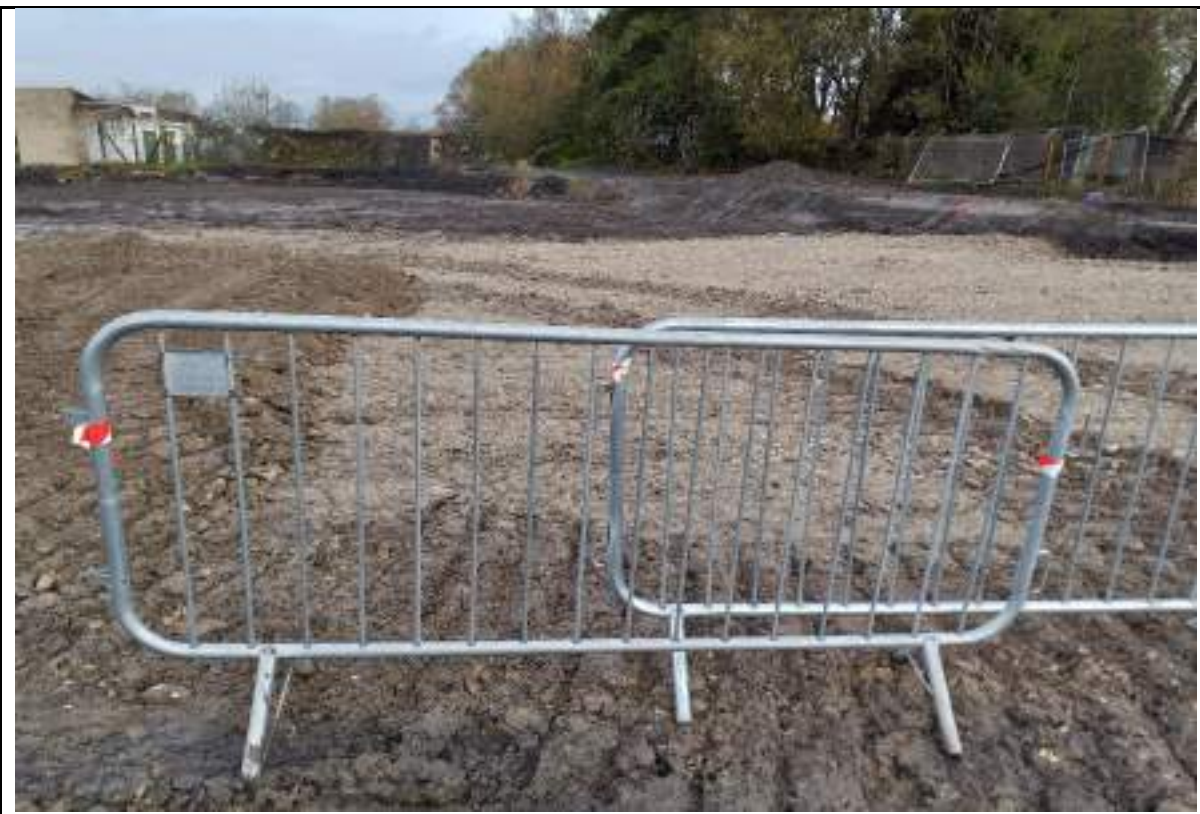
Photograph 2: Ongoing backfilling of excavation in location of shaft no.7 with 6F5 material

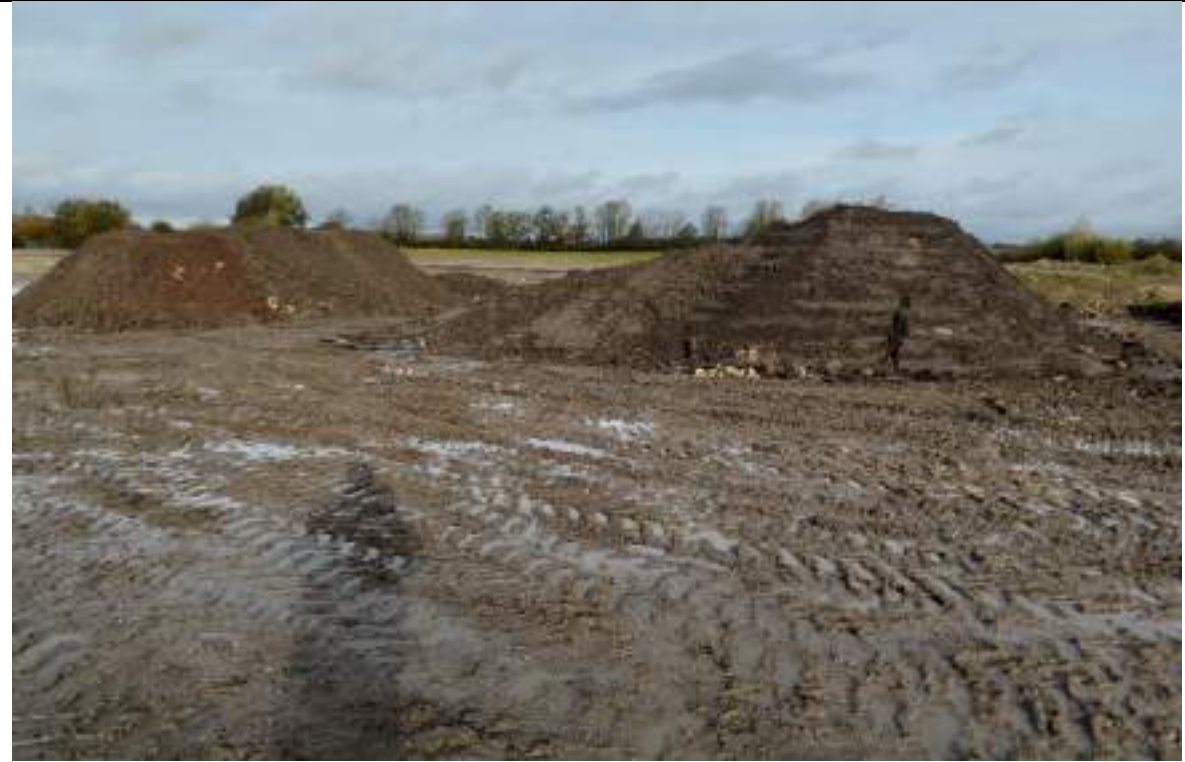
Photograph 3: Stockpile of potentially TPH contaminated material on a black visqueen barrier adjacent to electrical substation and wet material stockpile. Material excavated from location of shaft no.7.

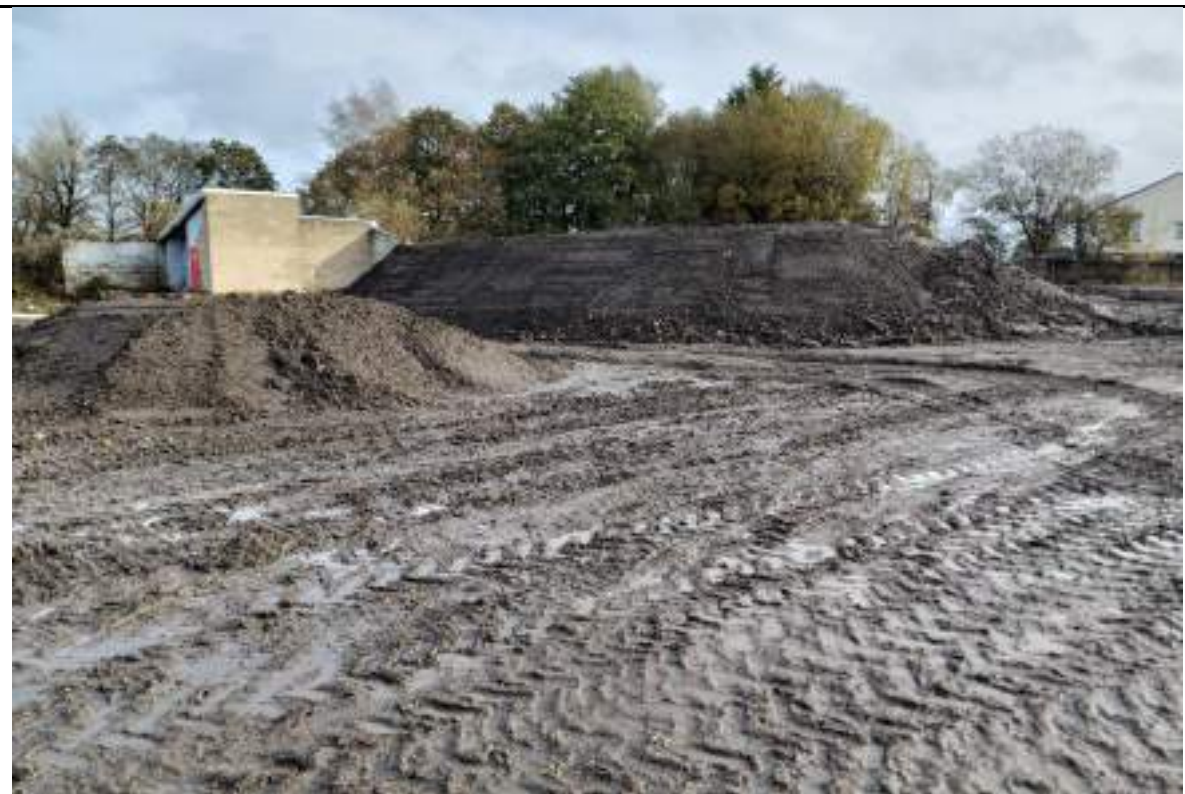
Photograph 4: Stockpile of wet unsuitable material in the southeast.

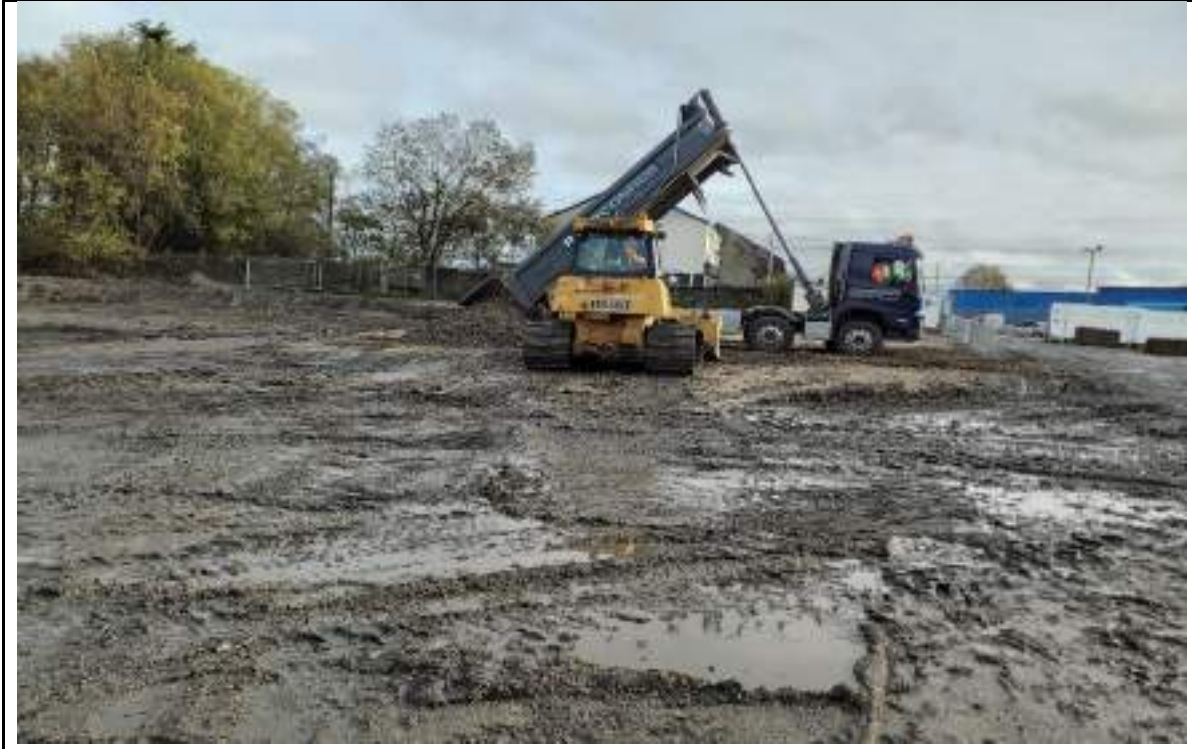
Photograph 5: Importing 6F5 material for backfilling of excavation in the location of shaft no.7.

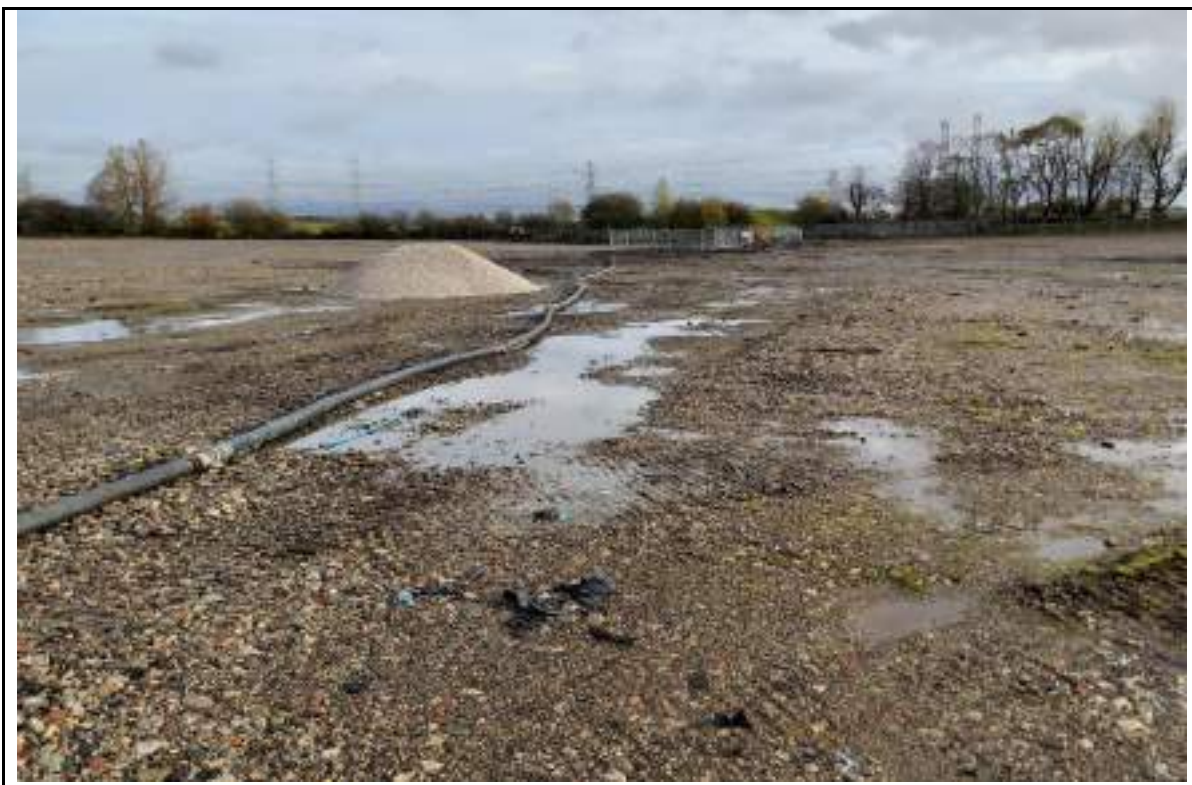
Photograph 6: Pumping water from culvert to the northern and western sewer system.
