**SPURR HOUSE, POLE LANE, BURY**  
**HIGHWAY DILAPIDATION SURVEY**

| 1 | <b>Pole Lane - Junction with Parr Lane</b> |

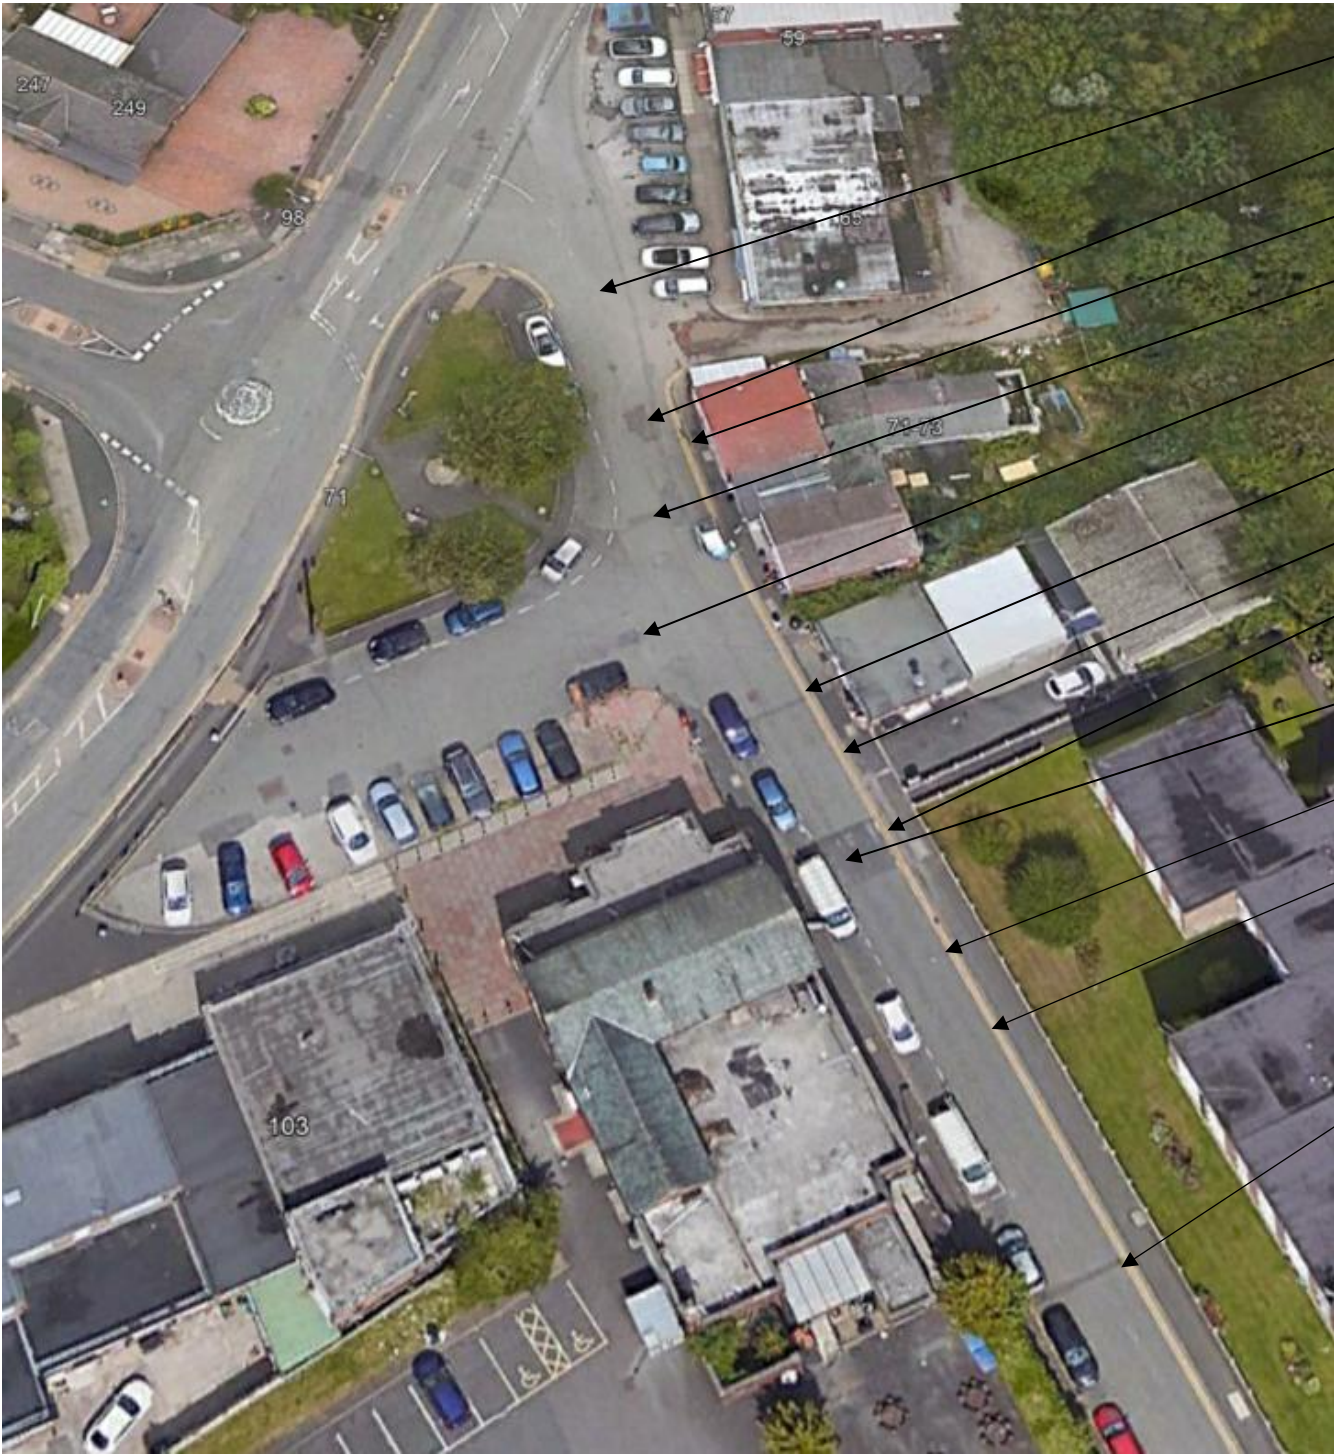
| 1.0 | <p>Specific area of damage has been highlighted in the following sections and highlighted in the key plan below.<br/>More general photographs can be found in the attached files.</p> <div><div><div>1.1</div><div>1.2</div><div>1.3</div><div>1.4</div><div>1.5</div><div>1.6.1</div><div>1.6.2</div><div>1.7.1</div><div>1.7.2</div><div>1.8.1</div><div>1.8.2</div><div>1.9</div></div></div> |

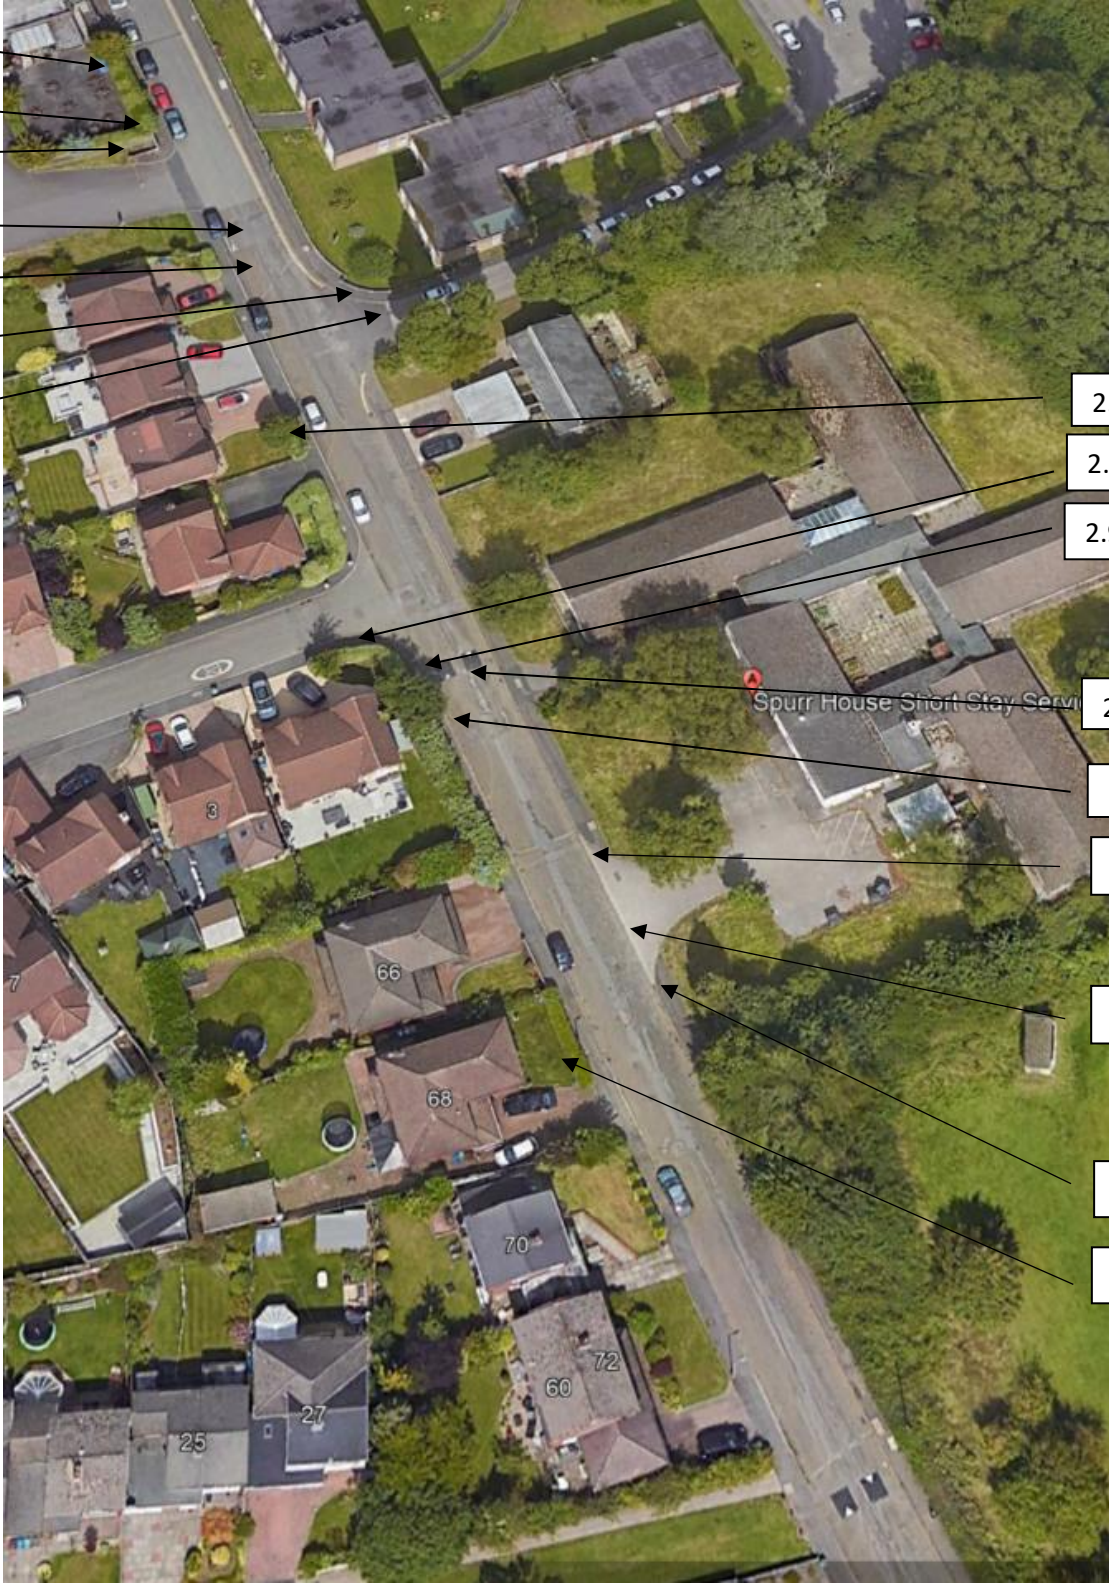
| 2.0 | <p>Specific area of damage has been highlighted in the following sections and highlighted in the key plan below.<br/>More general photographs can be found in the attached files.</p> <div><div><div>2.1</div><div>2.2.1</div><div>2.2.2</div><div>2.3</div><div>2.4</div><div>2.5</div><div>2.6</div></div><div><div>2.7</div><div>2.8</div><div>2.9</div><div>2.10</div><div>2.11</div><div>2.12</div><div>2.13</div><div>2.14</div><div>2.15</div></div></div> |
