**RE: NX418 PLOTS 1, 2, 3, 4, 5, 6 & 7 GAS & COVER SYSTEM VALIDATION REPORT –  
LAND AT RECTORY LANE, EAST LANCASHIRE PAPER MILL ISLAND SITE, RADCLIFFE**

NX418 Land at Rectory Lane, ELPM Radcliffe

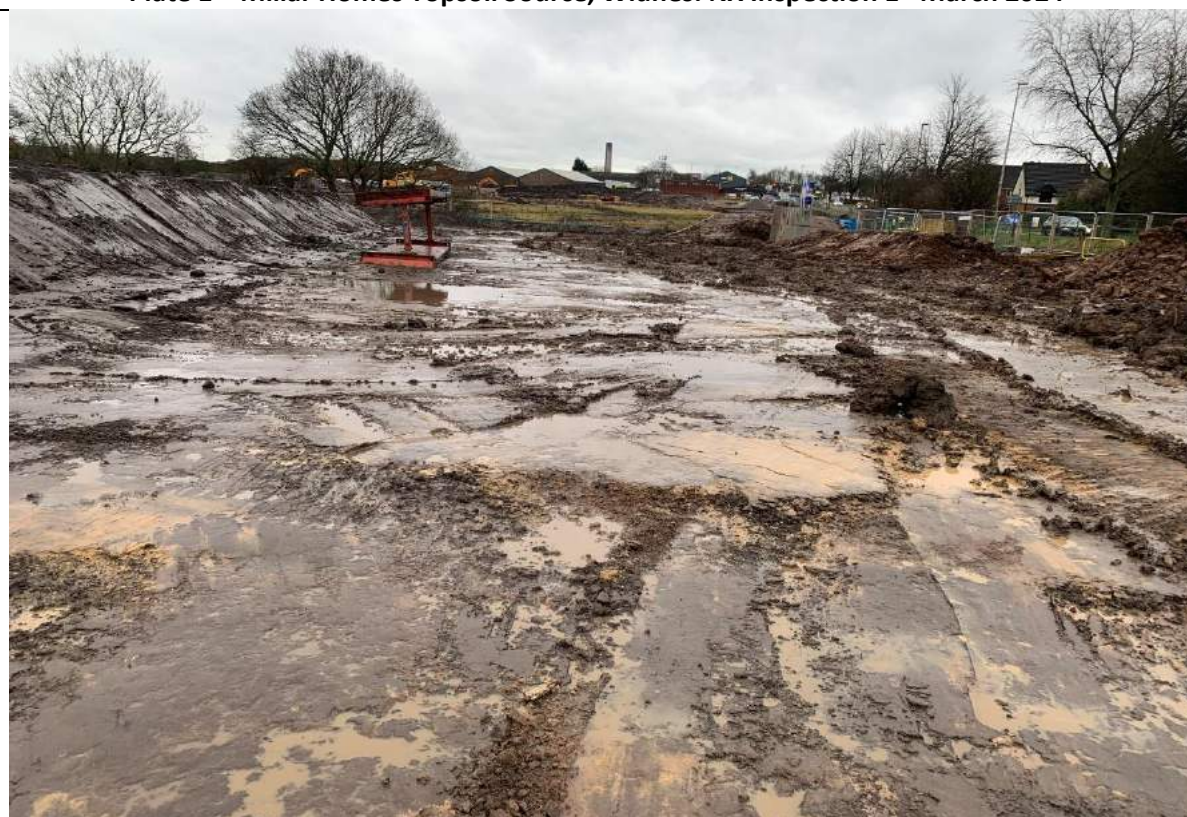
**Plate 2 – Millar Homes Topsoil Source, Widnes. NX Inspection 1<sup>st</sup> March 2024**

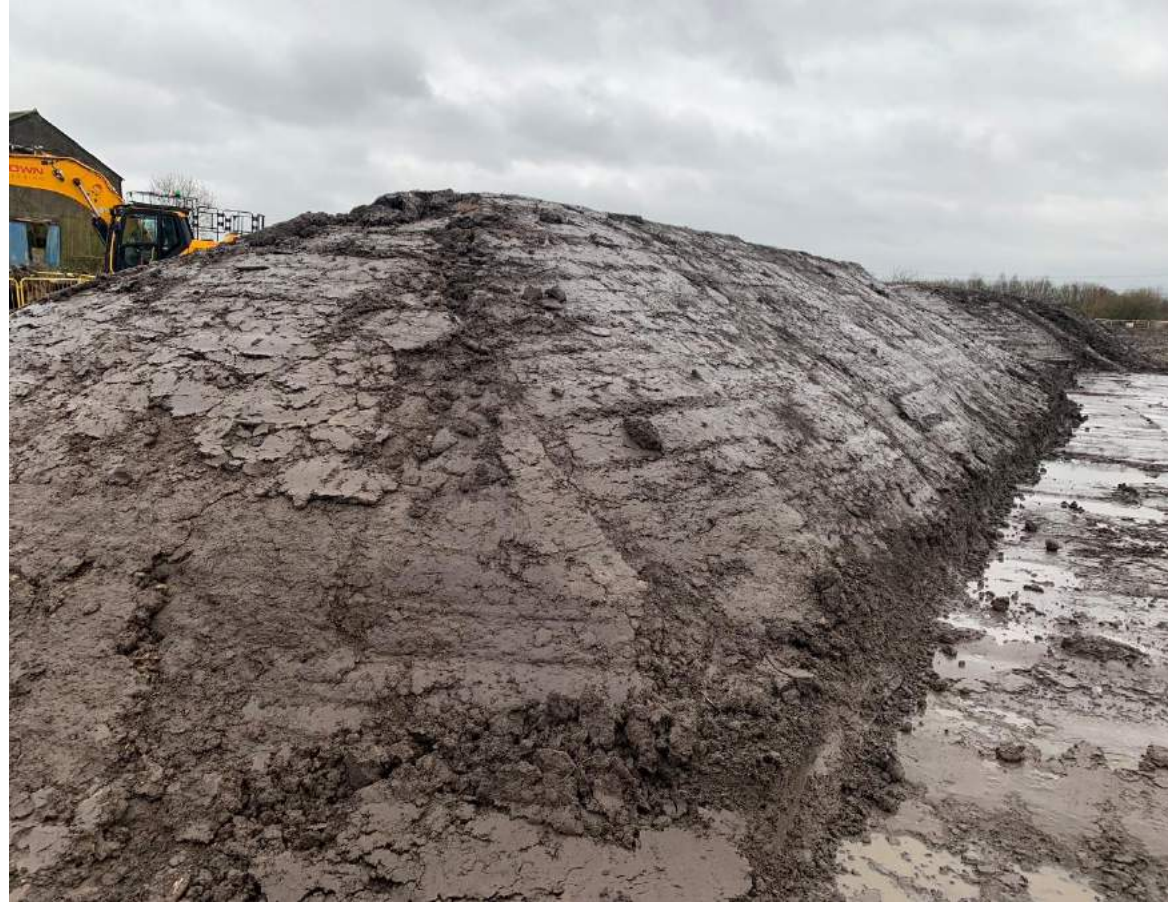
**Plate 3 – Millar Homes Topsoil Source, Widnes. NX Inspection 1<sup>st</sup> March 2024**

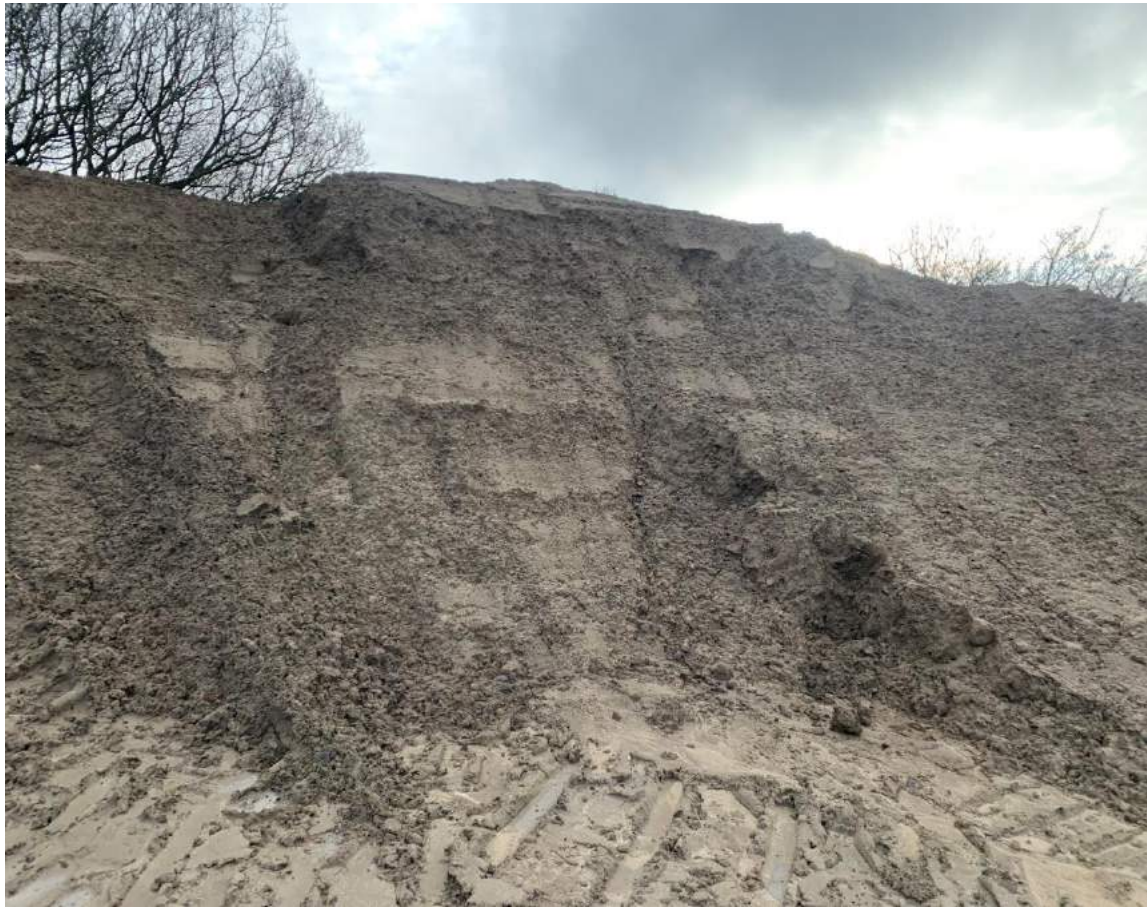
**Plate 3 – Marchington Quarry, Glossop. NX Inspection 20<sup>th</sup> March 2024**

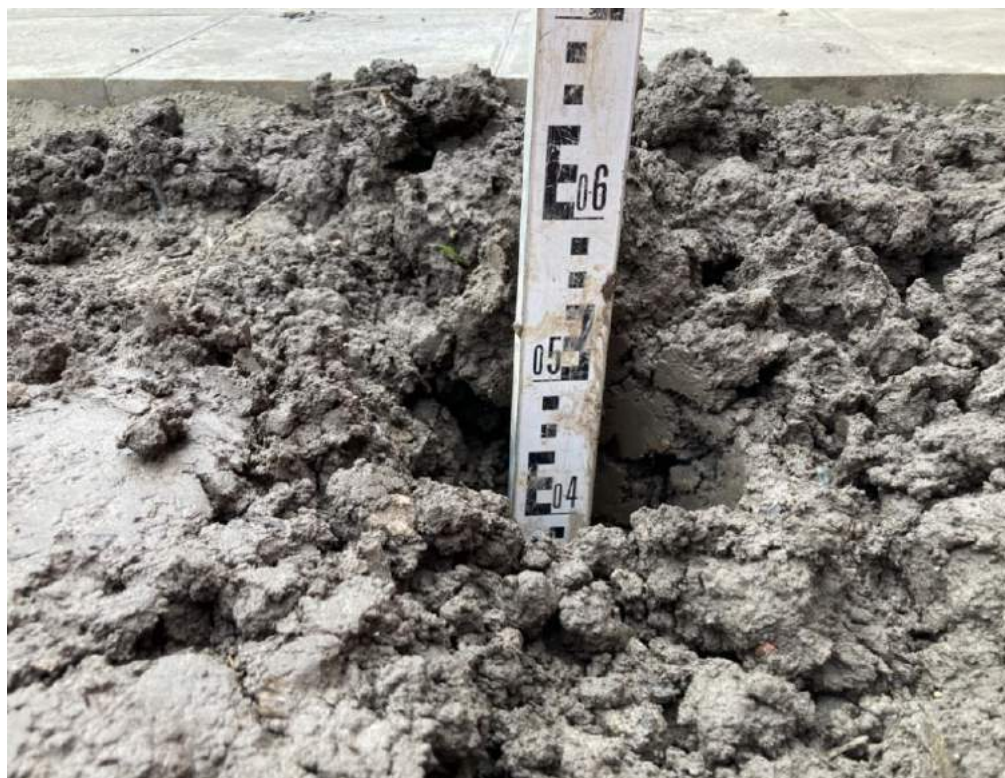
**Plate 8 – Plot 2 front garden cover system GL to 0.60mbgl with 0.15m of topsoil.**
