**Issue Date**  
23<sup>rd</sup> May 2023

**Reference Number**  
HCA03405

## Asbestos Demolition Survey

Whitefield Fire Station

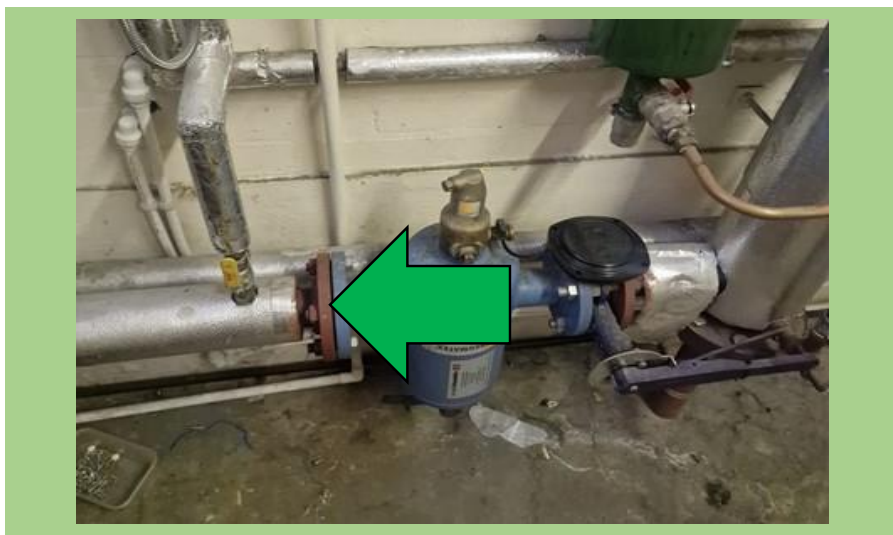
| Sample Number | 1 | No Asbestos Detected |

| Floor, Room | Ground floor, G.01 | Location | Pipework flanges |
| Material | Gaskets | Quantity | 14 units |

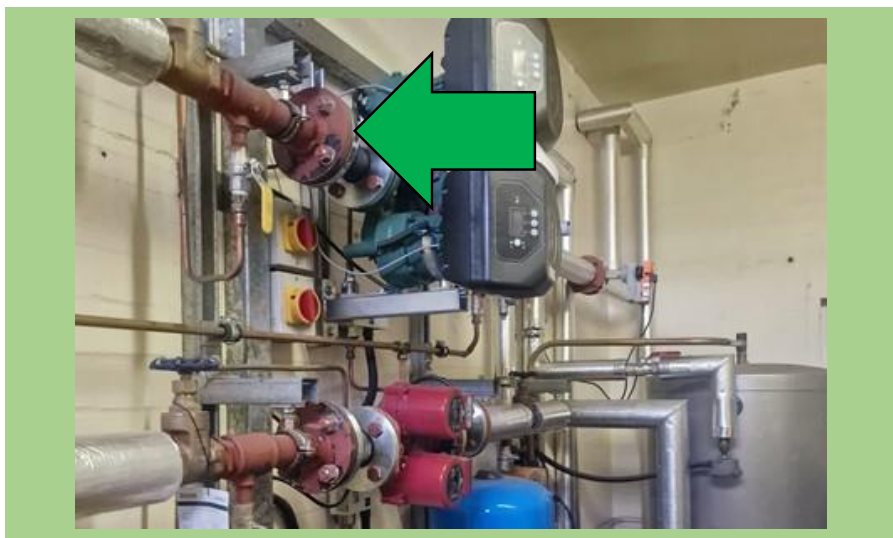
| Sample Number | 2 | No Asbestos Detected |

| Floor, Room | Ground floor, G.01 | Location | Small pipework flanges |
| Material | Gaskets | Quantity | 2 units |

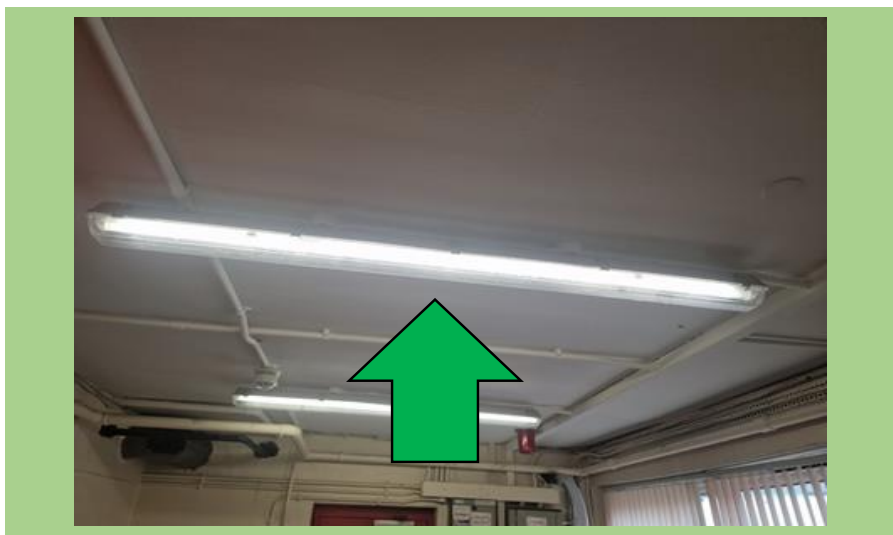
| Sample Number | 5 | No Asbestos Detected |

| Floor, Room | Ground floor, G.02 | Location | Ceiling |
| Material | Plasterboard | Quantity | 12 sq.m. |

This non-asbestos containing material is present throughout the fire station.

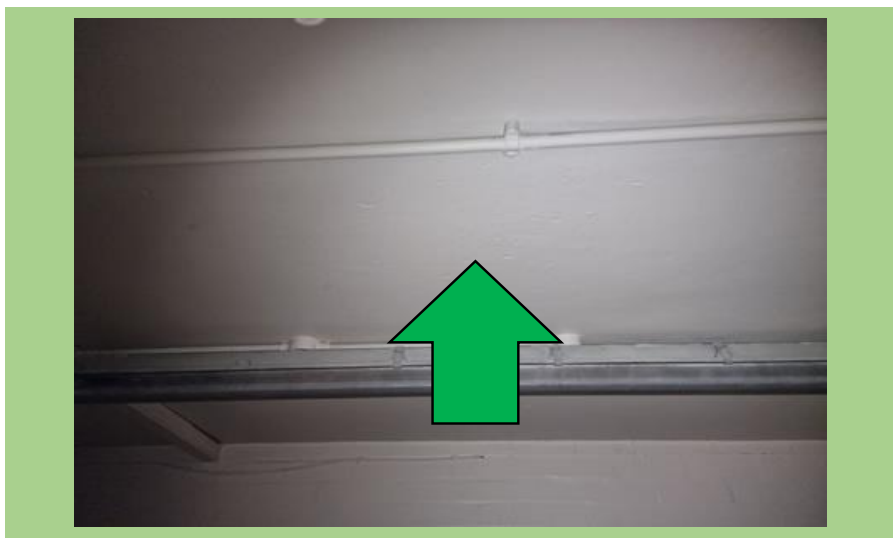
| Sample Number | 6 VI 5 | No Asbestos Detected |

| Floor, Room | Ground floor, G.03 | Location | Ceiling |
| Material | Plasterboard | Quantity | 6 sq.m. |

This non-asbestos containing material is present throughout the fire station.

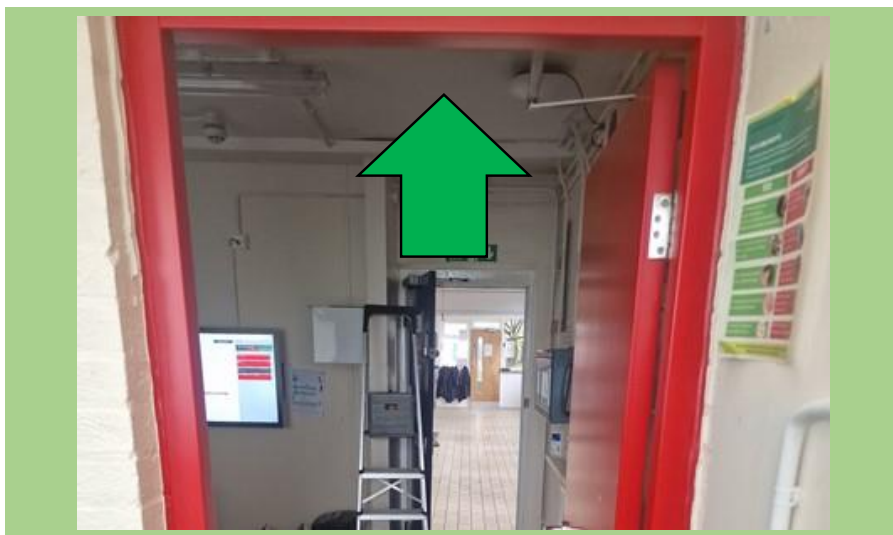
| Sample Number | 7 VI 5 | No Asbestos Detected |

| Floor, Room | Ground floor, G.04 and G.04a | Location | Ceilings |
| Material | Plasterboard | Quantity | 16 sq.m. |

This non-asbestos containing material is present throughout the fire station.

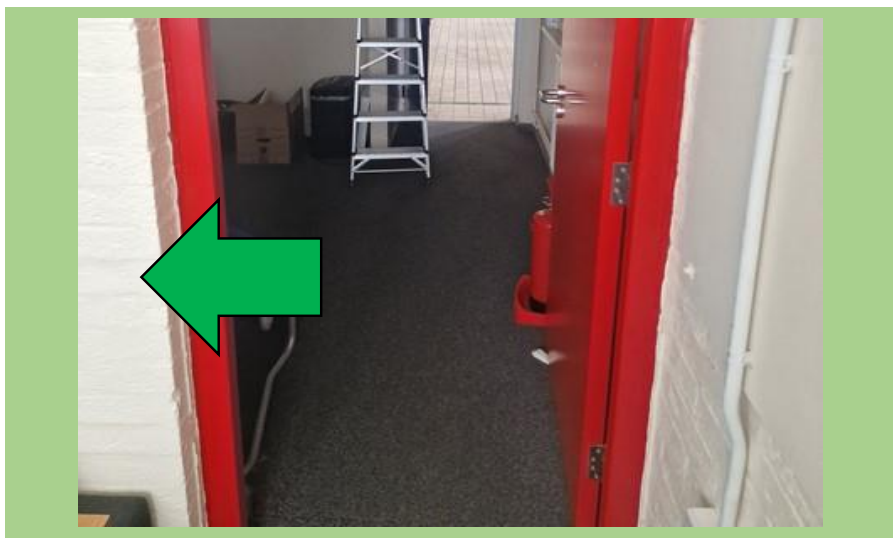
| Sample Number | 8 | No Asbestos Detected |

| Floor, Room | Ground floor, G.04a | Location | Walls |
| Material | Textured coating | Quantity | 14 sq.m. |

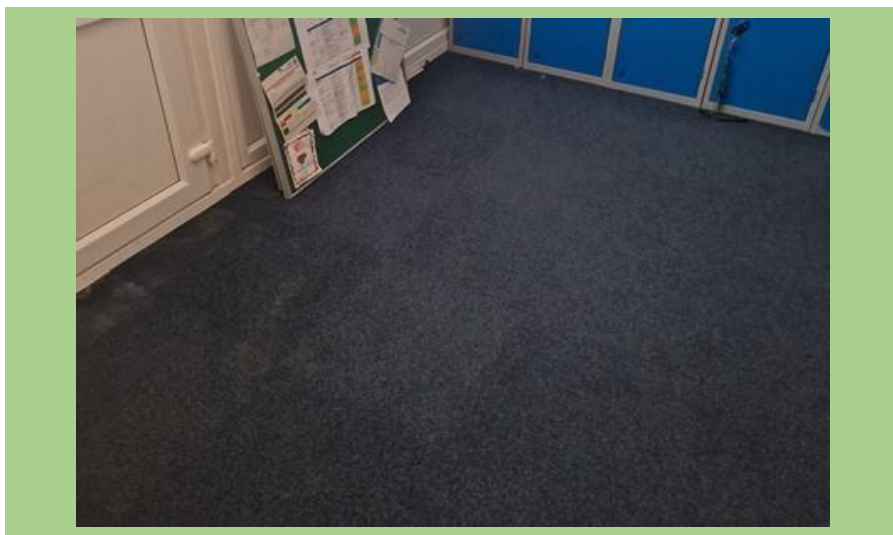
| Sample Number | 9 | No Asbestos Detected |

| Floor, Room | Ground floor, G.05 | Location | Floor, beneath the carpet tiles |
| Material | Screed | Quantity | 14 sq.m. |

This non-asbestos containing material is present throughout the fire station.

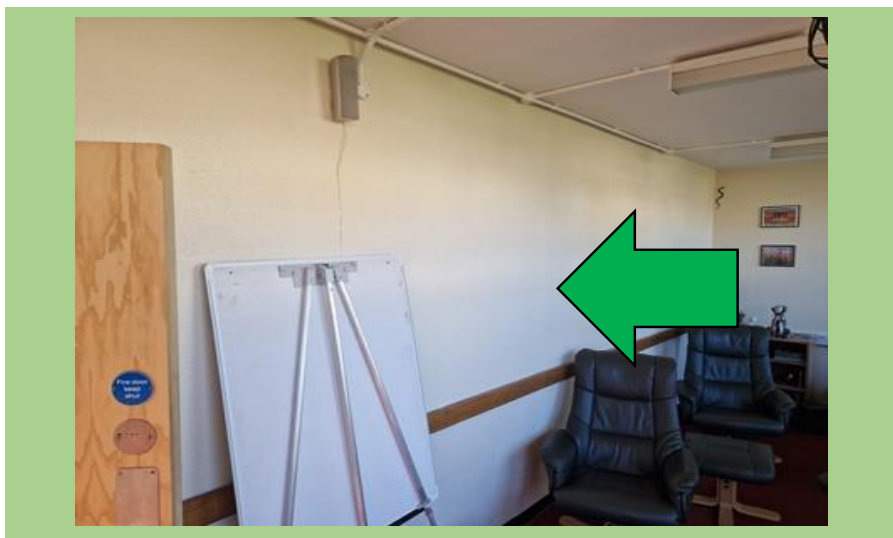
| Sample Number | 10 | No Asbestos Detected |

| Floor, Room | Ground floor, G.10 | Location | Coating to the walls |
| Material | Paper | Quantity | 16 sq.m. |

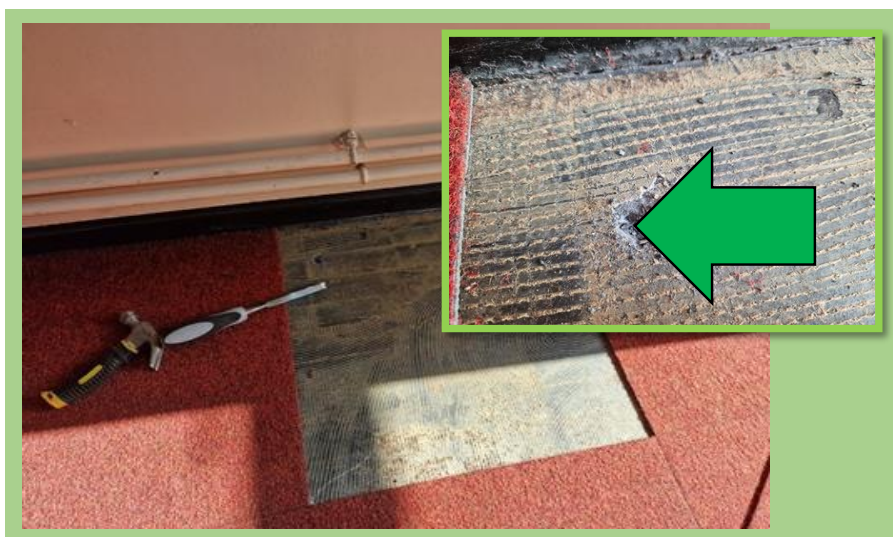
| Sample Number | 11 | No Asbestos Detected |

| Floor, Room | Ground floor, G.10 | Location | Floor, beneath the carpet tiles |
| Material | Composite levelling screed | Quantity | 16 sq.m. |

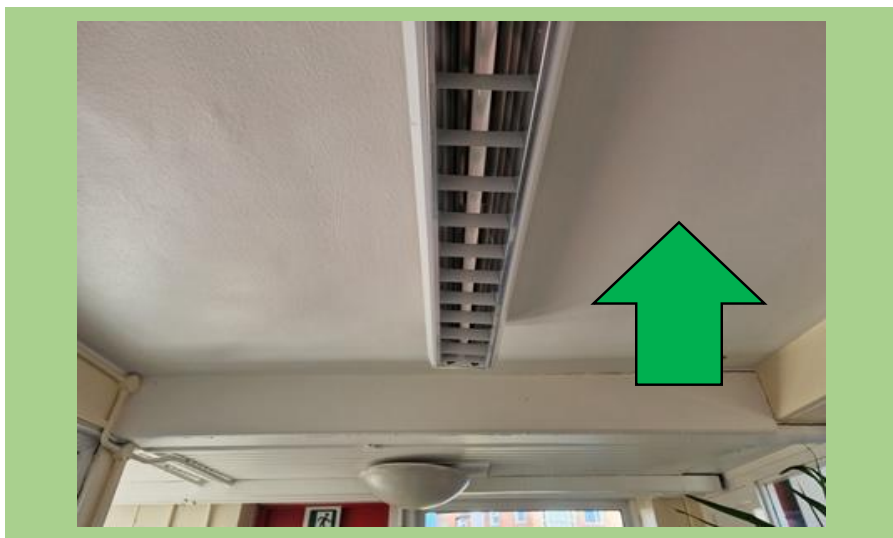
| Sample Number | 12 | No Asbestos Detected |

| Floor, Room | Ground floor, G11 | Location | Ceiling |
| Material | Plasterboard | Quantity | 16 sq.m. |

This non-asbestos containing material is present throughout the fire station.

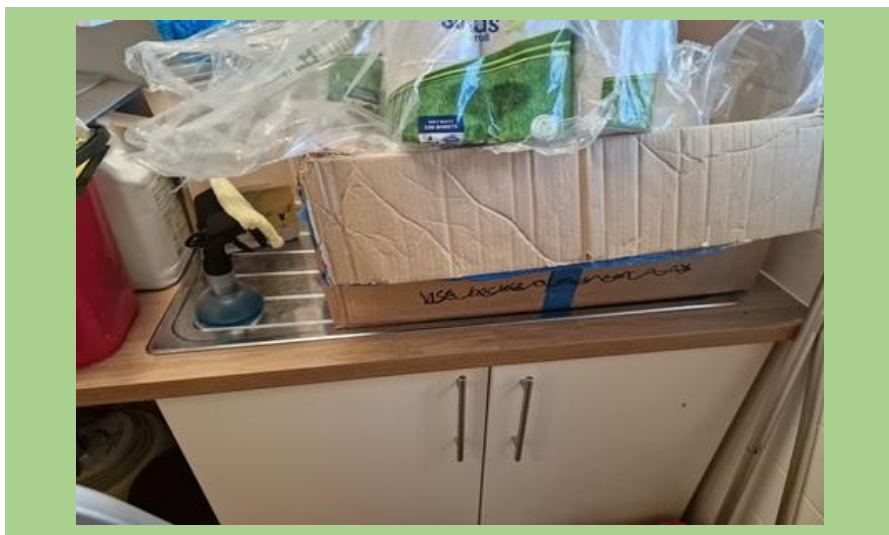
| Sample Number | 13 | No Asbestos Detected |

| Floor, Room | Ground floor, G.12 | Location | Adhered to the underside of the sink unit |
| Material | Bituminous pad | Quantity | 1 unit |

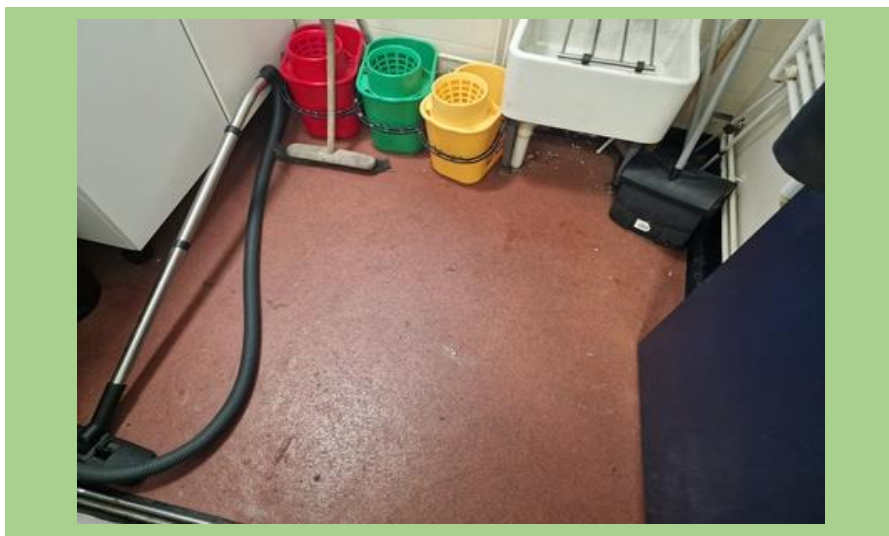
| Sample Number | 14 | No Asbestos Detected |

| Floor, Room | Ground floor, G.12 | Location | Floor, beneath the linoleum |
| Material | Screed | Quantity | 8 sq.m. |

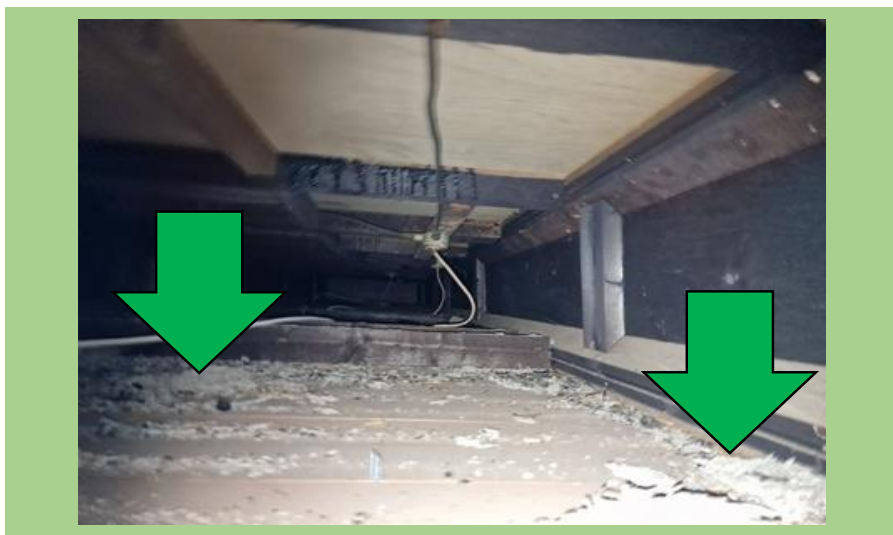
| Sample Number | 15 | No Asbestos Detected |

| Floor, Room | Ground floor, G.14 | Location | Top of the secondary timber ceiling |
| Material | Strawboard debris | Quantity | 30 sq.m. |

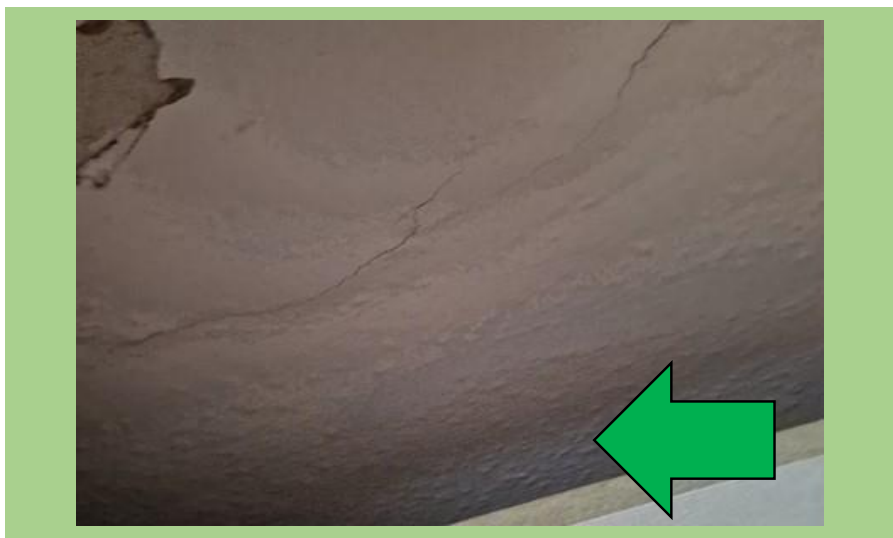
| Sample Number | 16 | No Asbestos Detected |

| Floor, Room | Ground floor, G.15 | Location | Ceiling, above the suspended ceiling |
| Material | Textured coating | Quantity | 14 sq.m. |

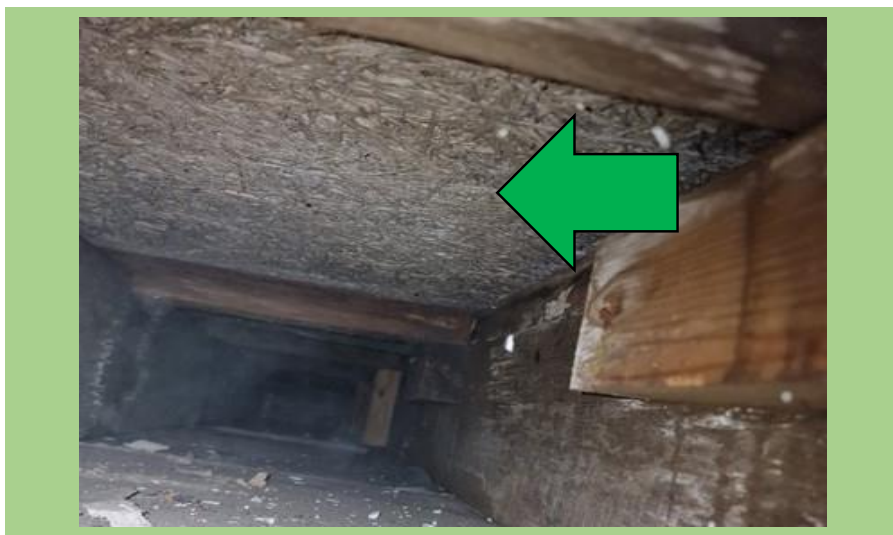
| Sample Number | 17 | No Asbestos Detected |

| Floor, Room | Ground floor, G.17 | Location | Underside of the roof |
| Material | Strawboard | Quantity | 450 sq.m. |

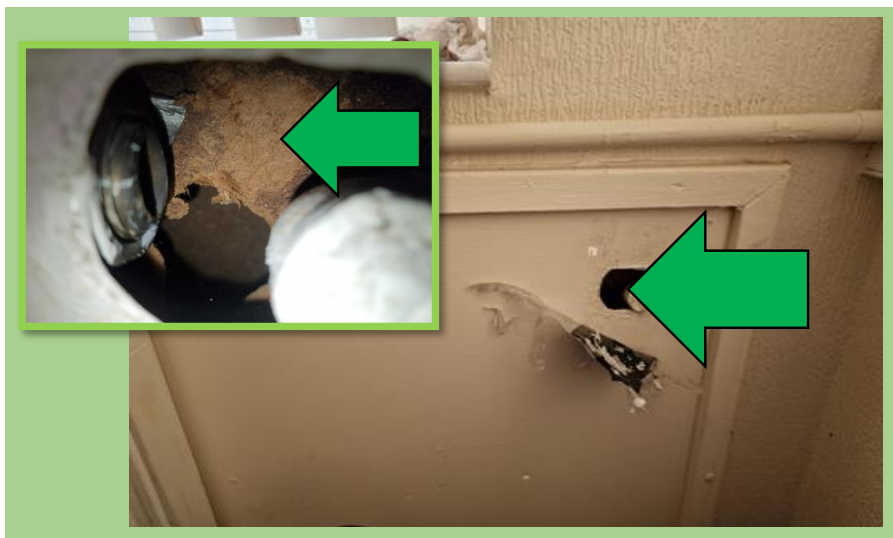
| Sample Number | 18 | No Asbestos Detected |

| Floor, Room | Ground floor, G.21 | Location | Panelling behind the metal wall cladding, beneath the window |
| Material | Fibreboard | Quantity | 3 sq.m. |

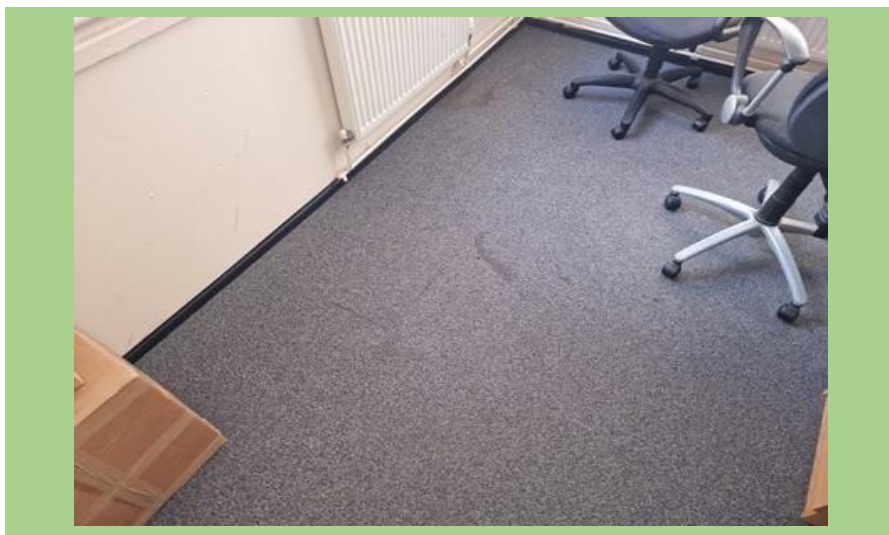
| Sample Number | 19 | No Asbestos Detected |

| Floor, Room | Ground floor, G.21 | Location | Floor, beneath the carpet tiles |
| Material | Composite levelling screed | Quantity | 10 sq.m. |

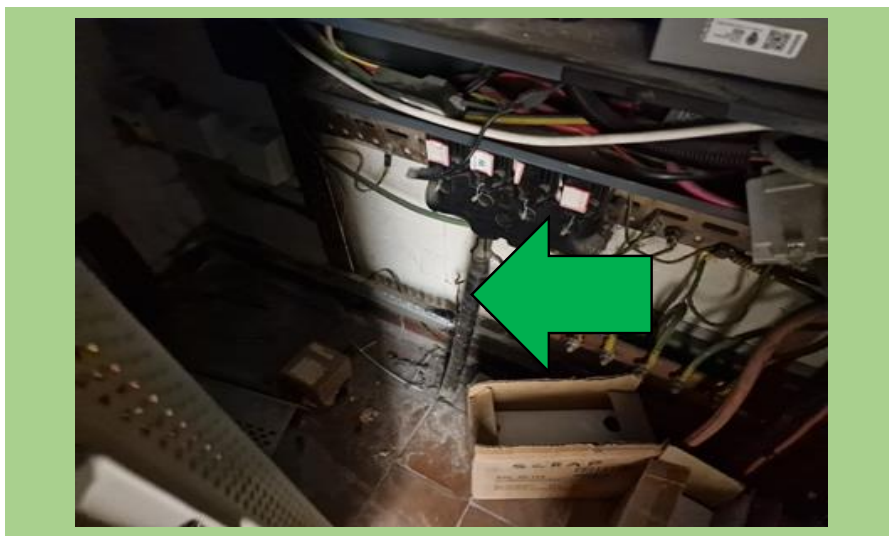
| Sample Number | 21 | No Asbestos Detected |

| Floor, Room | Ground floor, G.22 | Location | Electrical incomer cable |
| Material | Bituminous textile | Quantity | 0.2 lin.m. |

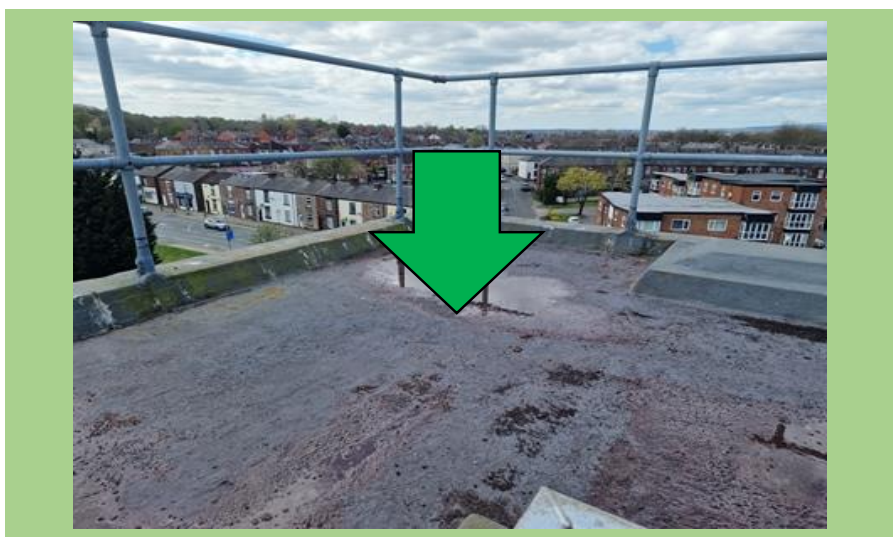
| Sample Number | 22 | No Asbestos Detected |

| Floor, Room | External, tower, RF.01 | Location | Flat roof |
| Material | Core sample | Quantity | 10 sq.m. |

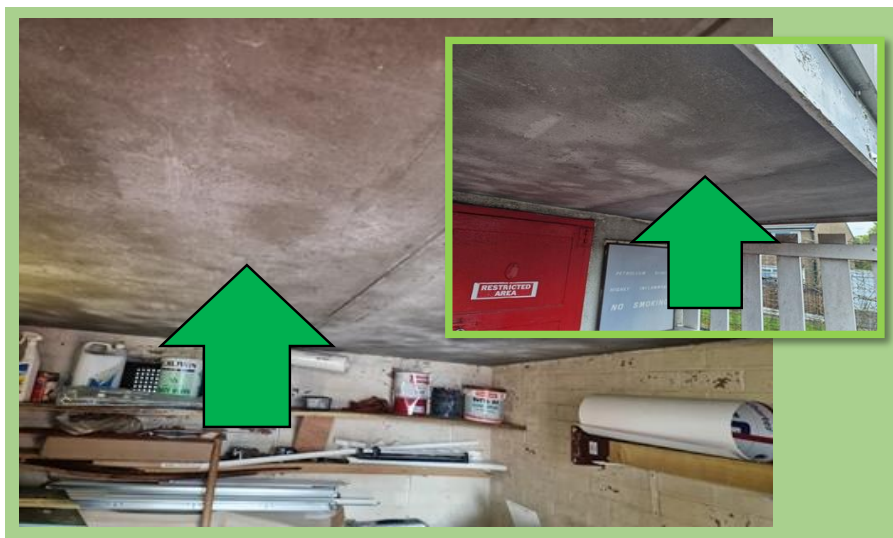
| Sample Number | 23 | No Asbestos Detected |

| Floor, Room | Ground floor, G.26 | Location | Store ceiling and canopy |
| Material | Cement sheeting | Quantity | 12 sq.m. |

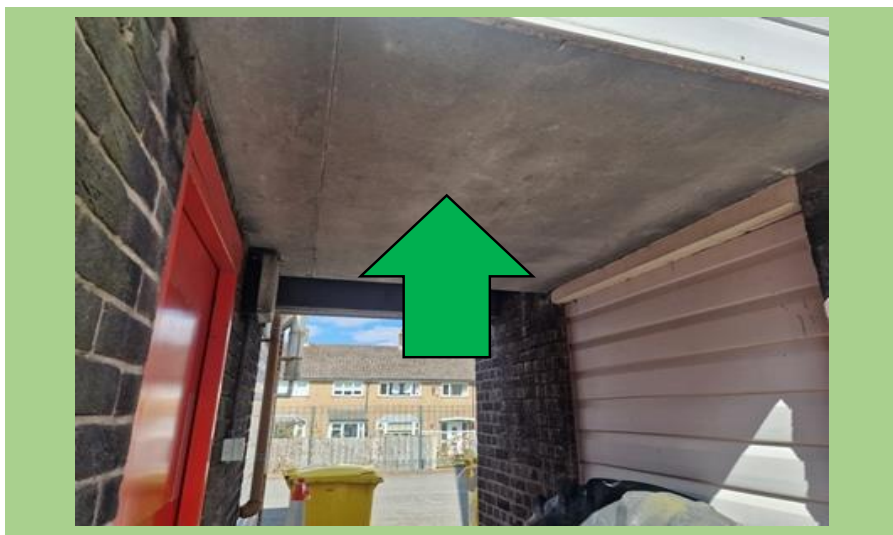
| Sample Number | 24 VI 23 | No Asbestos Detected |

| Floor, Room | External | Location | Canopy ceiling, hose room/tower |
| Material | Cement sheeting | Quantity | 6 sq.m. |

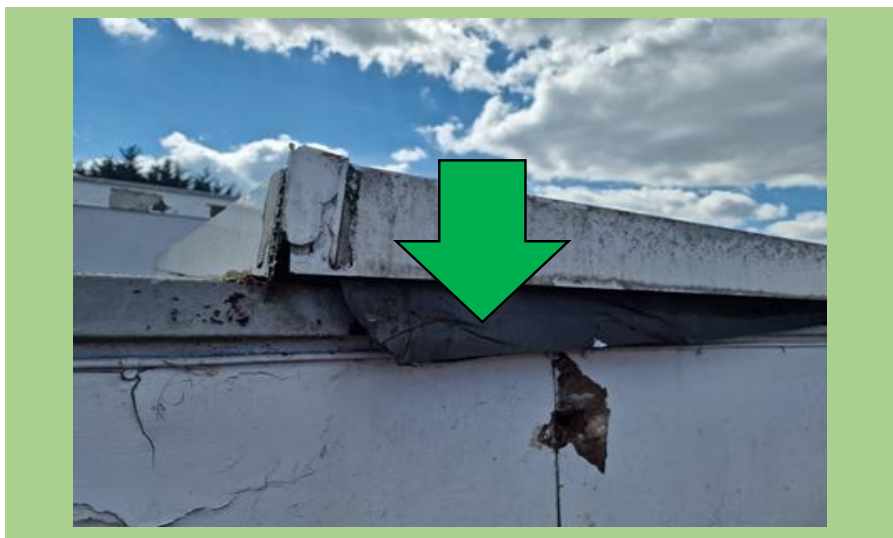
| Sample Number | 26 | No Asbestos Detected |

| Floor, Room | External, roof | Location | Flashing |
| Material | Bituminous membrane | Quantity | 30 lin.m. |

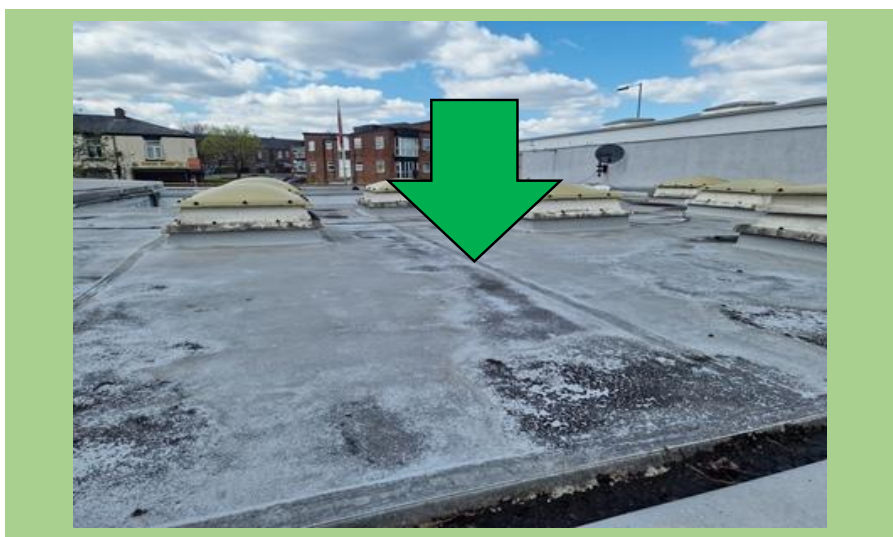
| Sample Number | 27 | No Asbestos Detected |

| Floor, Room | External | Location | Flat roof |
| Material | Core sample | Quantity | 450 sq.m. |

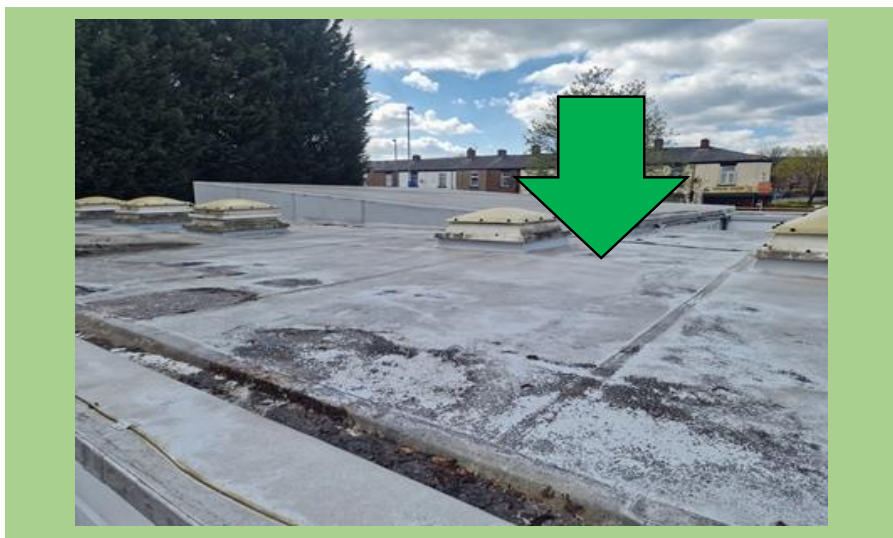
| Sample Number | 28 | No Asbestos Detected |

| Floor, Room | External | Location | Flat roof |
| Material | Core sample | Quantity | 450 sq.m. |

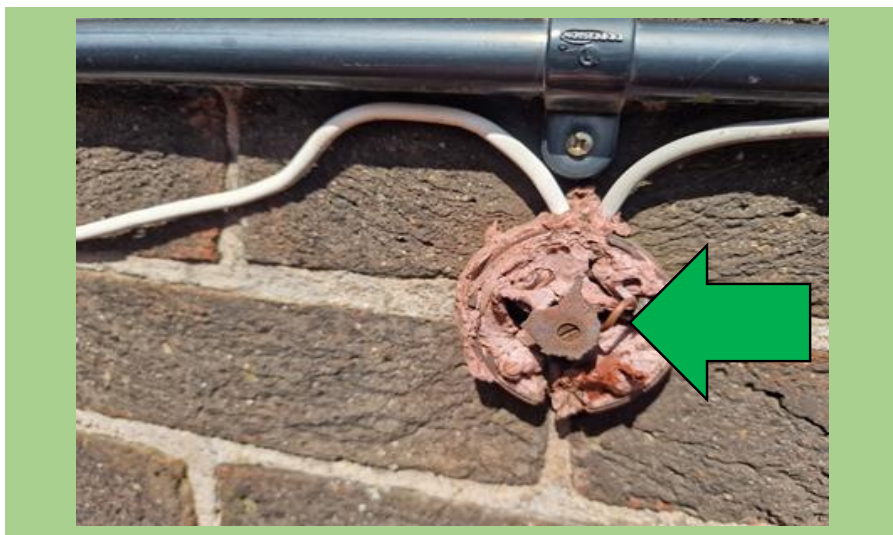
| Sample Number | 29 | No Asbestos Detected |

| Floor, Room | External | Location | Wall mounted electrical junction unit |
| Material | Mastic | Quantity | 1 unit |

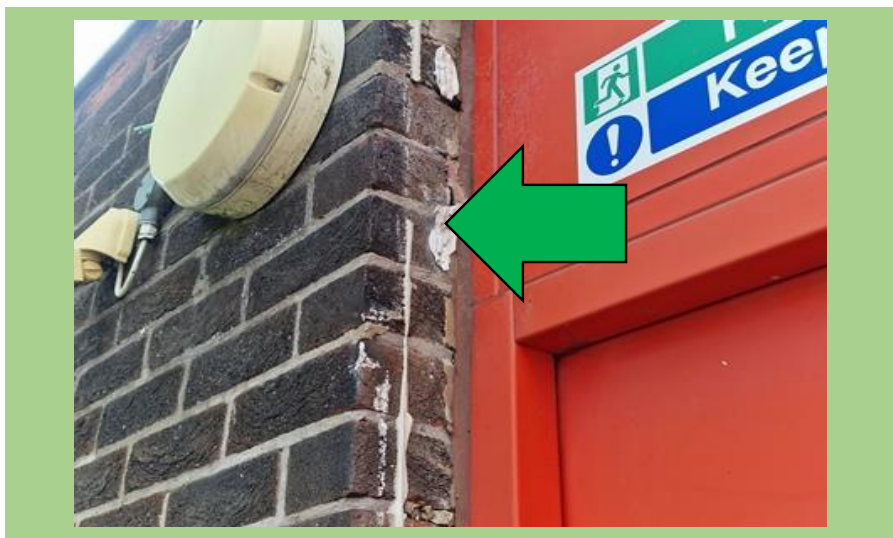
| Sample Number | 30 | No Asbestos Detected |

| Floor, Room | External | Location | Wall |
| Material | Mastic residues | Quantity | 0.1 lin.m. |

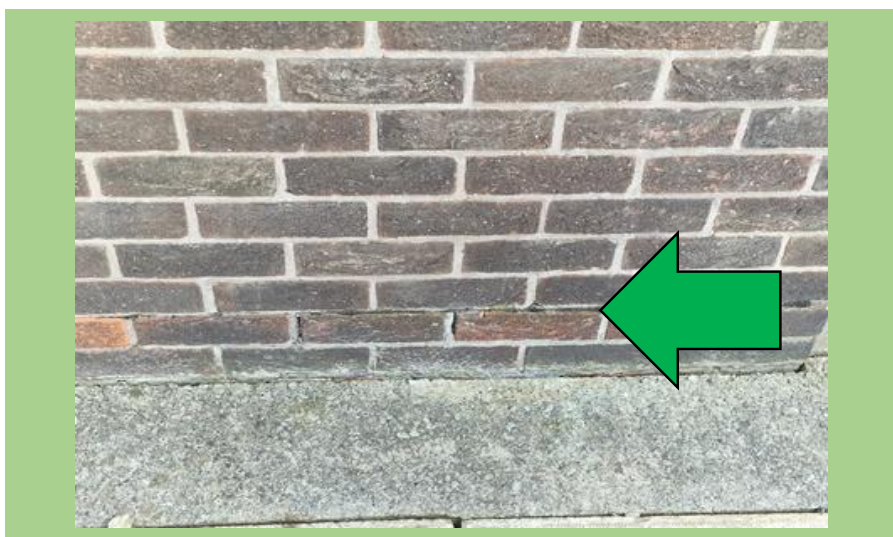
| Sample Number | 31 | No Asbestos Detected |

| Floor, Room | External | Location | Damp proof course, low level brickwork |
| Material | Bituminous membrane | Quantity | 150 lin.m. |
