## BURY ART MUSEUM, BURY

**Condition Survey**  
Chambers Conservation Ltd.

Issues: - **Issue 4 31<sup>st</sup> July 2023**

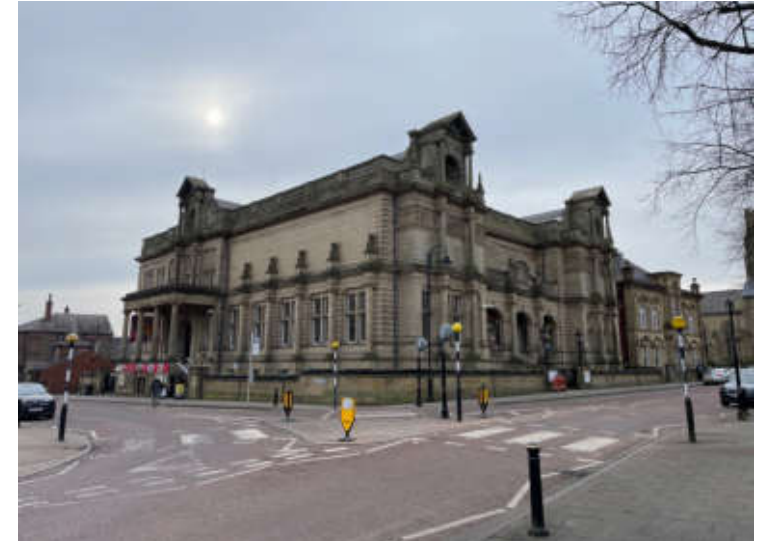
01 General view from Silver Street. (2022)

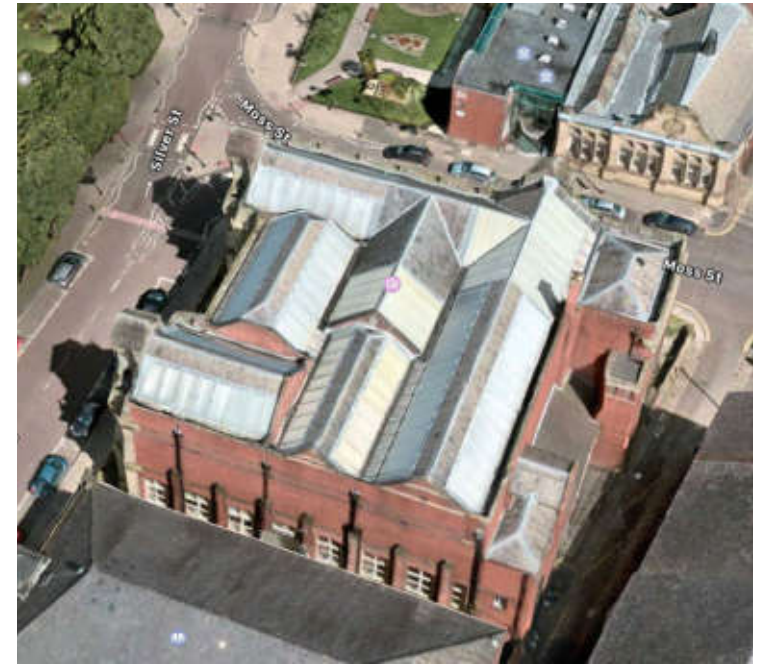
03 Oblique (aerial) view of roof, looking North. (c) Google.

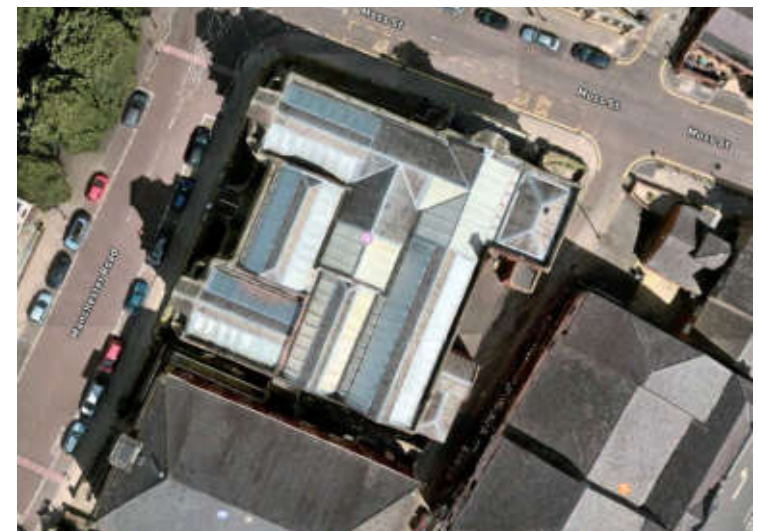
04 Aerial view of roof, orientated to North (c) Google.

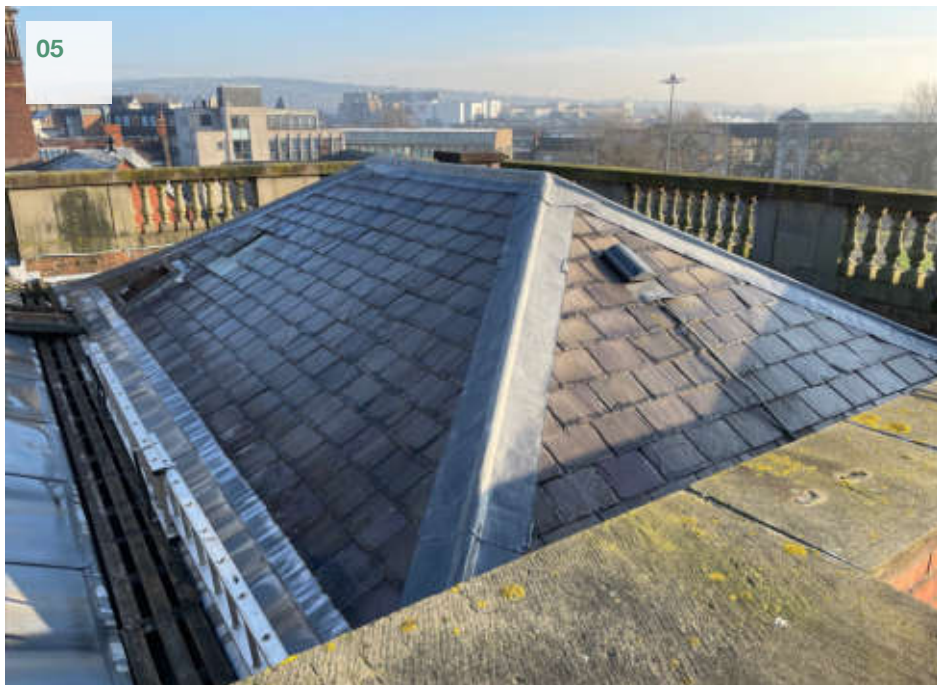
**05** General View of Roof Area 01

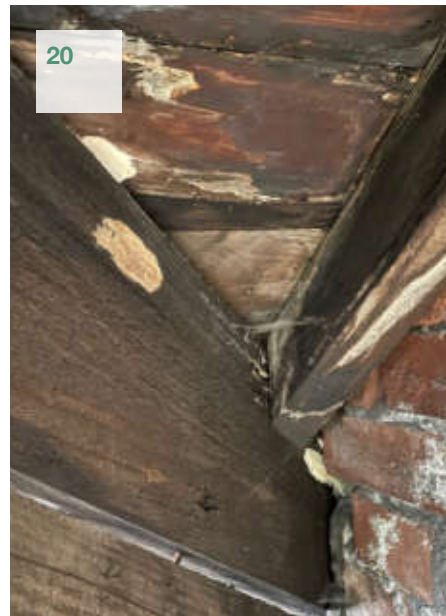
- 5.1.45 RL05 & 06 (part of Roof Area 11) form an angled valley, lined in lead, to the western slope (N). To the base of this area there is a crack where the valley meets the base of the main valley gutter and a mastic repair to the metal adjacent. This area needs to be relaid and there is evidence of rot and decay internally here (see roof void).

**18.** Mastic repair and crack below valley gutter between RL05 & 06.

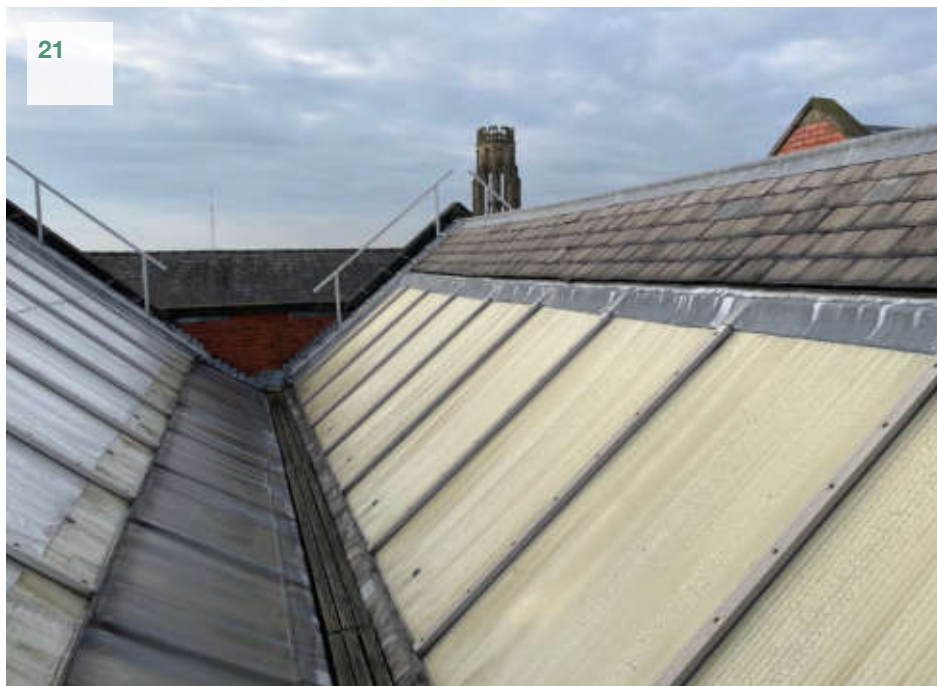
**21.** General view of Roof Area 07, to the right, from the eastern side (looking South).

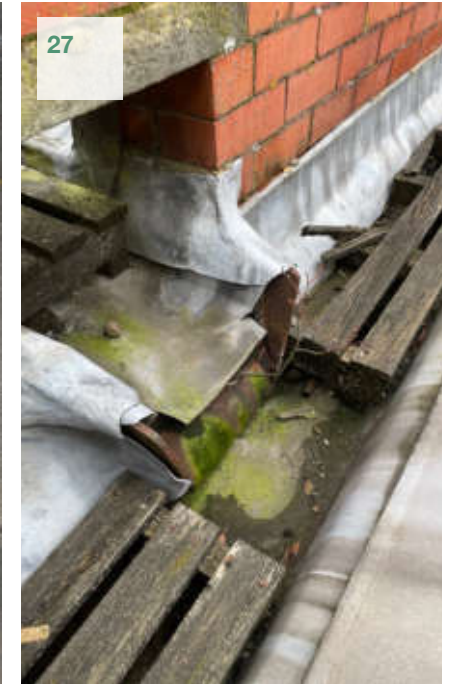
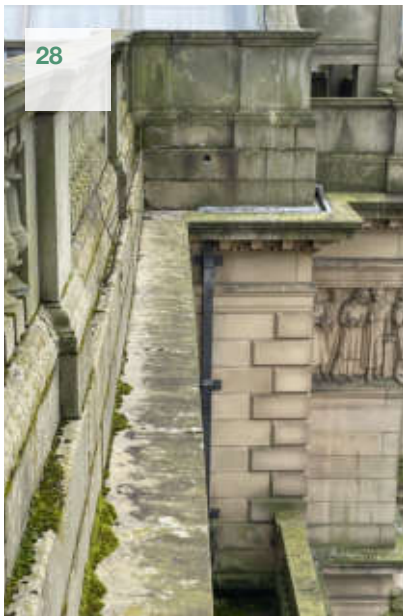
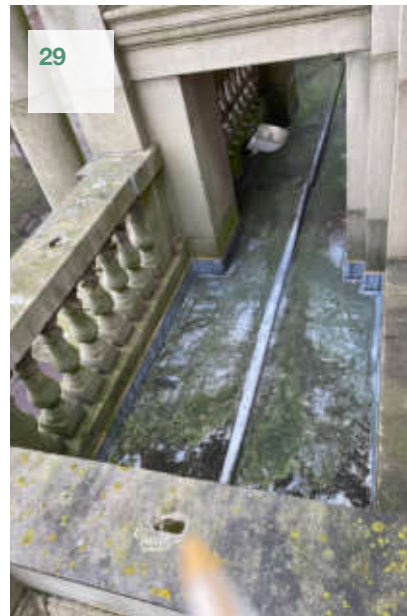
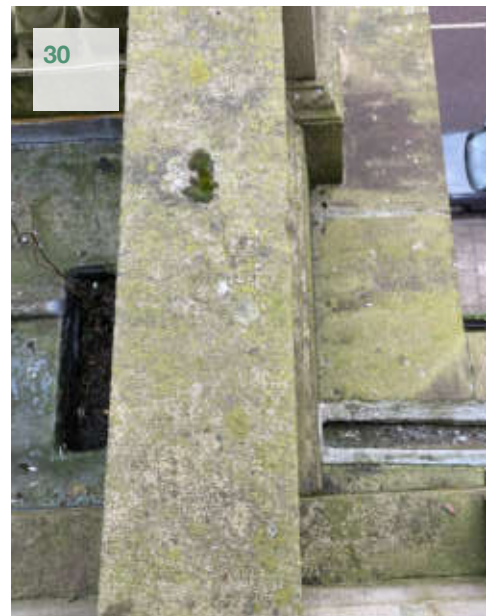
- 5.1.76 Roof area 08A covers the arched recess to the south-western corner of the building.
- 5.1.77 It comprises a lead roof, traditionally detailed, partly covered by the pedimented stone gable above.
- 5.1.78 The roof drains to the north, where there is a sump connected to a gutter channel cut into the sky-face of the cornice. This drains into RWP12. The roof looks in good condition but the sump looks blocked (it is full of debris and there is a small tree growing from it) and needs clearing and testing.

- 25.** General view of gutter to Roof Area 08 (south). (looking east).
- 26.** General view of gutter (north). Gable of roof area 09 on right.
- 27.** Outlet from Gutter to Roof Area 09, note iron lining, zinc, lead etc.
- 28.** View from Roof 11 (parapet to Roof 09 on left). Showing lead downpipe (RWP 12) taking water from Roof 08. Note the lead channel in the parapet which takes water from roof area 08A.
- 29.** Area 08A looking down from 08.
- 30.** Area 08A sump and channel outlet (lead-lined) in cornice.

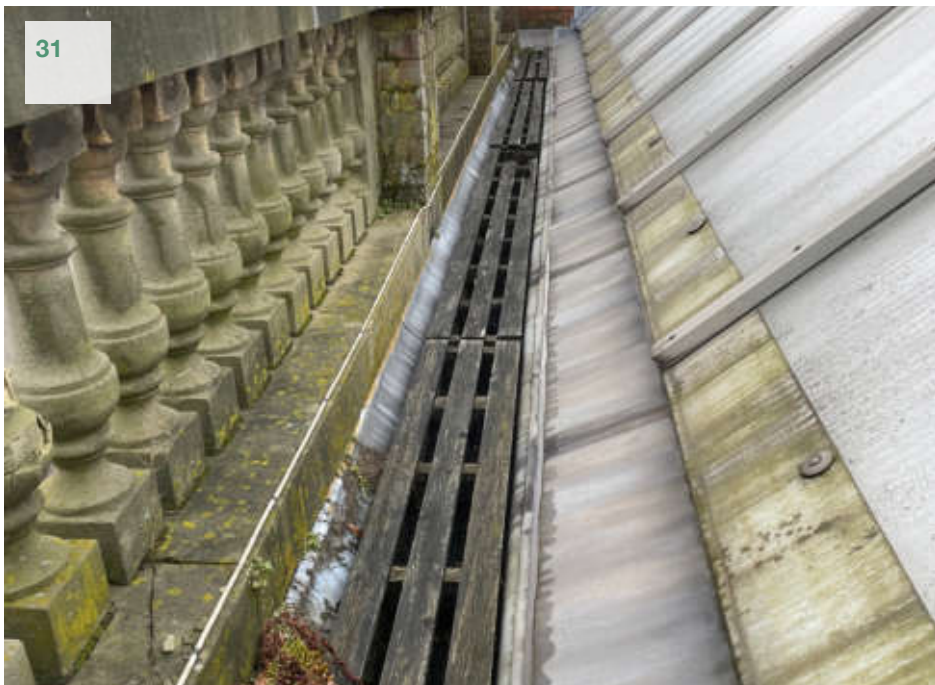
**31.** General view of gutter to Area 09, looking North. Note growth above flashing.

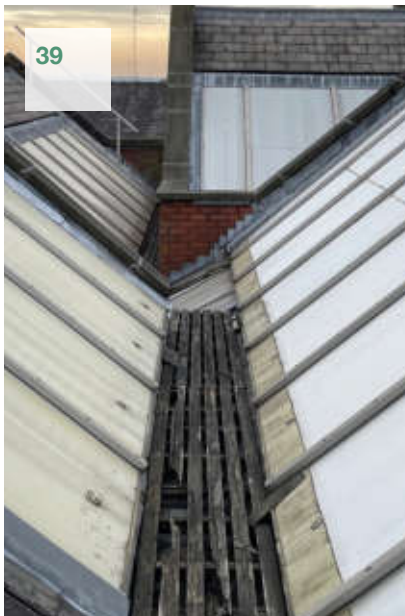
- 36.** Roof 09A over library entrance looking south. Note curtailed pipe and accumulation of moss/growth.
- 37.** Roof 09A over library entrance looking north. Corresponding pipes, again curtailed below.
- 38.** The valley between area 09 and 10 is terminated in a small parapet.
- 39.** Mix of materials and awkward junction (detail) as noted above.

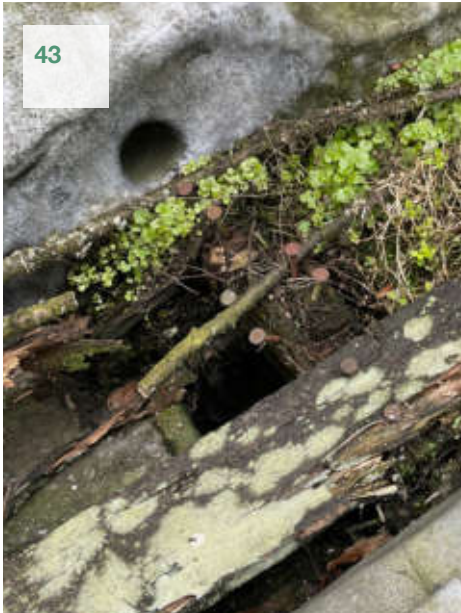
- 40. General view of (south) gutter, looking west.
- 41. Outlet (to RWP13) showing build-up of debris, general saturation of parapet etc.
- 42. Outlet from west gutter to area 09, in poor condition.
- 43. Outlet and overflow. The overflow is above the point where water would enter the building and is therefore ineffective.
- 44. Roof 12 general view from above.

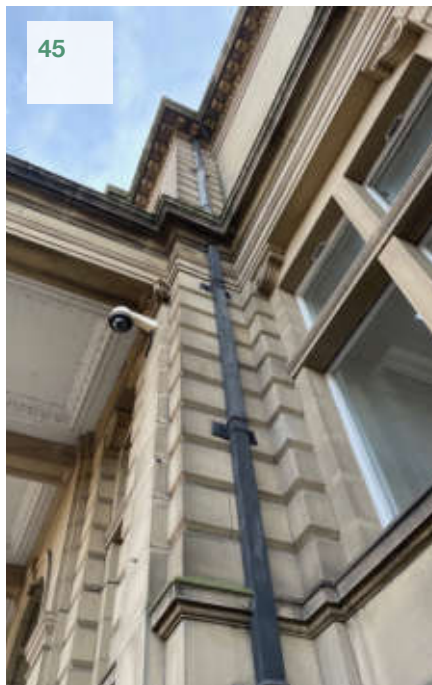
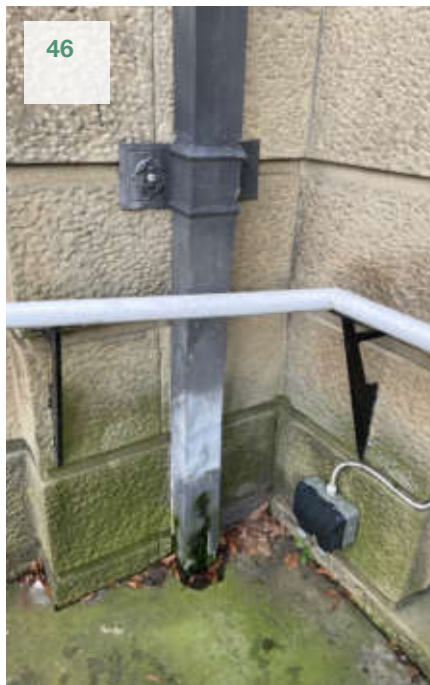
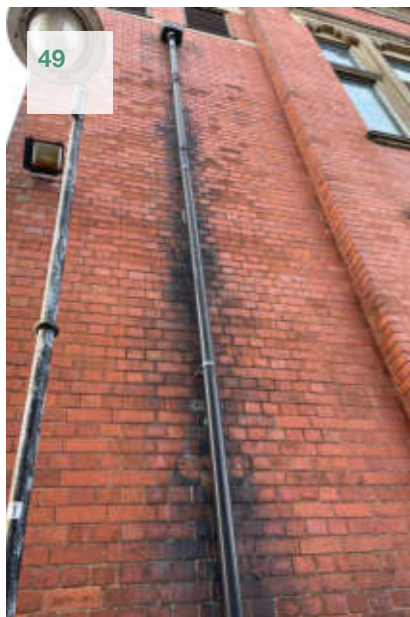
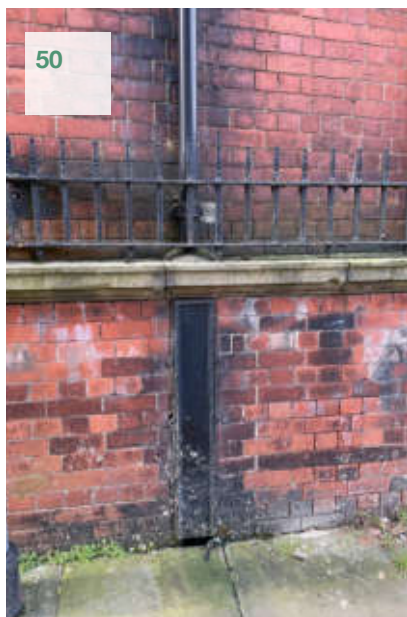
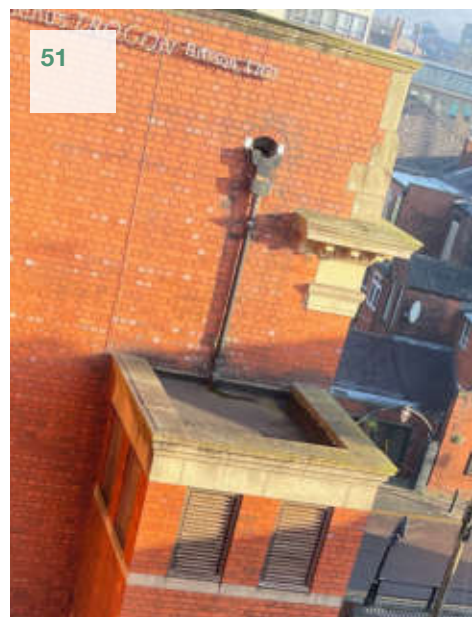
- 45. RWP01
- 46. Damage to leadwork of RWP01 at ground level.
- 47. RWP02 (upper)
- 48. RWP02 (lower)
- 49. RWP03 (upper)
- 50. RWP03 (lower)
- 51. RWP04

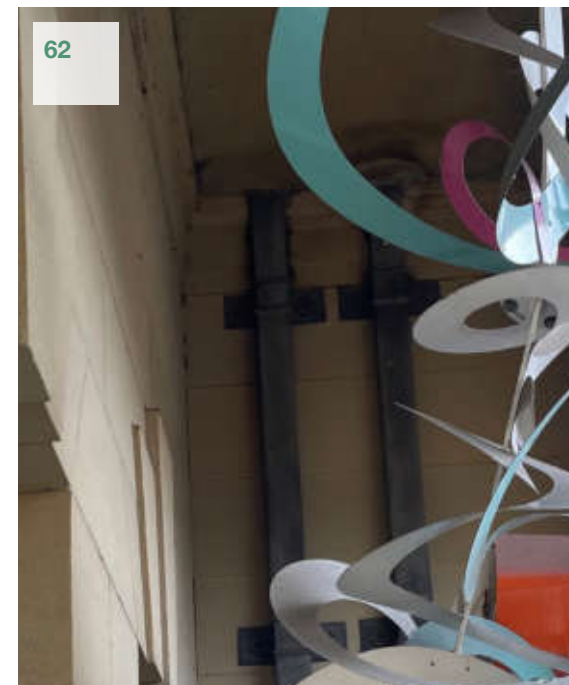
- 52. RWP05
- 53. RWP06
- 54. RWP07
- 55. RWP08
- 56. RWP07 & 08 low level.
- 57. RWP09 (upper)
- 58. RWP09 hopper and split above buttress.

- 5.3.28 There are some localised areas of damage to the corbelled detail along Roof Area 05, and some piecing in may be needed at the head of RWP 07.
- 5.3.29 The stone banding, copings, cills and buttress copings are also generally in good condition. There is localised deterioration adjacent to RWP 09 and 10, but this is not currently significant (the water retention is causing some limited failure in the face of the stone).

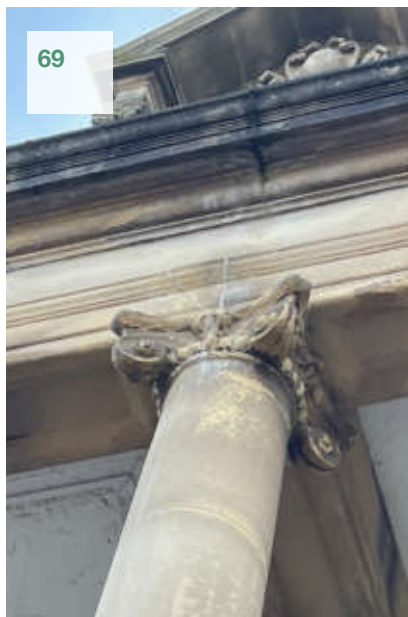
- 5.3.11 This saturation has caused significant staining and the stone is extensively friable. There is deterioration around the capitals which has been exacerbated by the application of cement mortars.

- 5.3.12 There is spalling masonry and loose stone between the capitals and cracking immediately adjacent which requires further investigation.
- 5.3.13 This is significant especially as it sits above the main public entrance area. It is recommended the stone is protected with lead flashings over the blocking course and cornice, these would serve as a flashing to the roof (see roofs for works to Roof Area 12) and protect the stonework below. Some repairs to the stonework is also required.

- 66. Portico and entrance (eastern end)
- 67. Staining at high level above the cornice to the raised pediment and swept parapets.
- 68. Fixings in stonework to east of the entrance.
- 69. Staining, spalling stone and crack above the columns to the entrance portico.
- 70. Staining, spalling stone and crack above the columns to the entrance portico.
- 71. Staining, spalling stone and crack above the columns to the entrance portico.

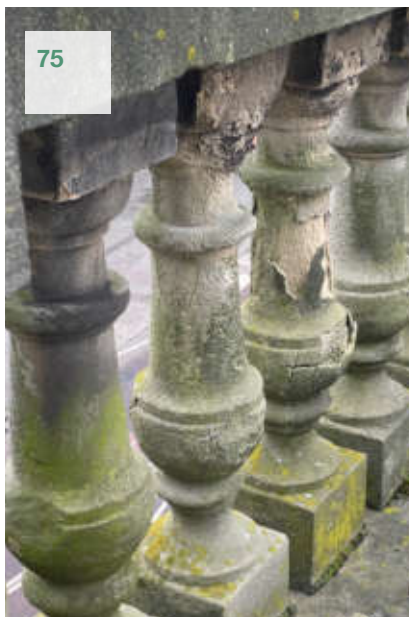
- 5.3.22 There is also some blistering to the frieze above the northern arch to the Library entrance portico. This may be associated with water ingress from the roof above. See roof for works to Roof Area 09A.

- 72. Library Entrance
- 73. Growth above cornice level.
- 74. Staining from leaking parapet gutter.
- 75. Friable stone to balusters.
- 76. Blistering to frieze above arches.
- 77. Extensive moisture retention at low-level caused by concrete surfacing and ineffectual drainage provision.

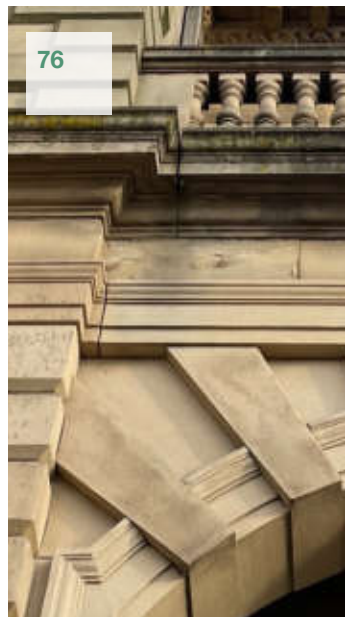
- 5.3.23 There is extensive moisture retention to the lower sections of wall in a number of locations which is likely to result in penetrating damp internally. This is caused by a combination of ineffectual drainage and the hard concrete surfacing around the building. A low-impact hot-steam clean would identify any repairs necessary and drainage needs to be surveyed thoroughly, cleaned and capacity improved.

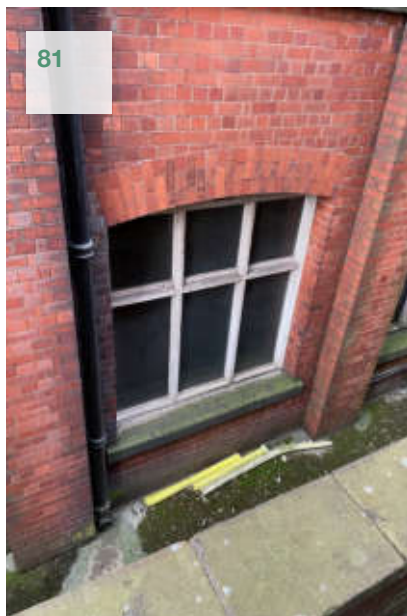
- 5.3.27 There is moisture retention to the lower sections of wall in a number of locations which is likely to result in penetrating damp internally. This is caused by a combination of ineffectual drainage and the hard concrete surfacing around the building.

- 78. General view from Back Knowsley Street.
- 79. Junction with connecting bridge.
- 80. Staining below the string course.
- 81. Wall extending into the light well, there is moisture retention in the brickwork at low level.

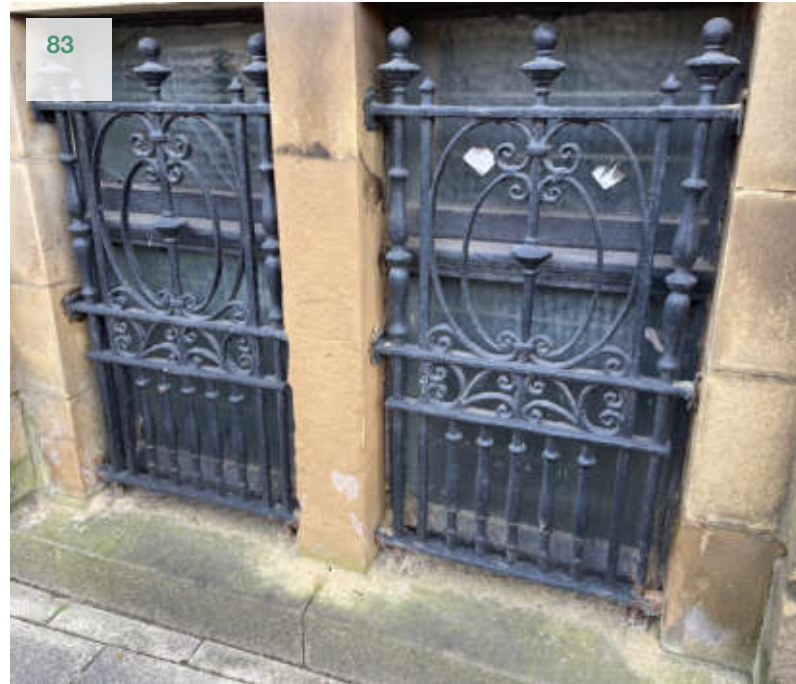
- 5.3.14 The plinth wall below the portico is stained, but again generally in reasonable condition, however the central mullion (stone) between windows WLG04 and 05 has been repaired in cement render and is in poor condition a new section of stone will be needed.

- 82. WLG02 & 03
- 83. WLG04 & 05
- 84. WLG06
- 85. WLG017
- 86. WLG027
- 87. DLG04

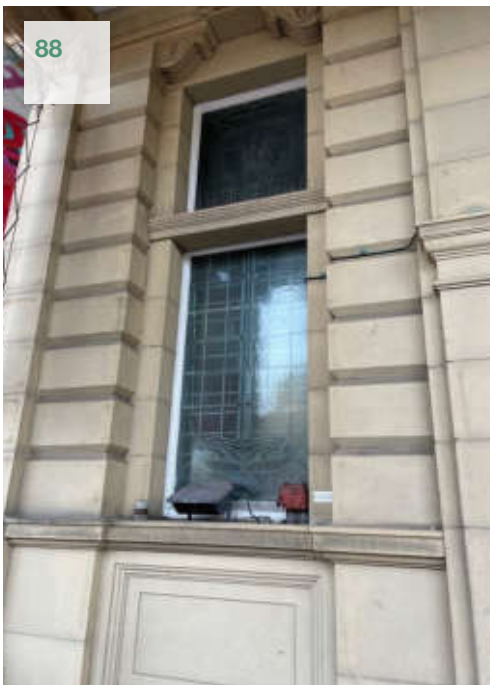
- 5.3.7 To the west is the accessible ramp. This has an impervious surface which retains some moisture in the adjacent stonework.
- 5.3.8 Within the portico there is some iron staining above WG05 and WG06, this may be historic.

- 88. WG05
- 89. WG07
- 90. WG017 & 018
- 91. WG020
- 92. DG01
- 93. Glazing detail showing over-glass to WG037

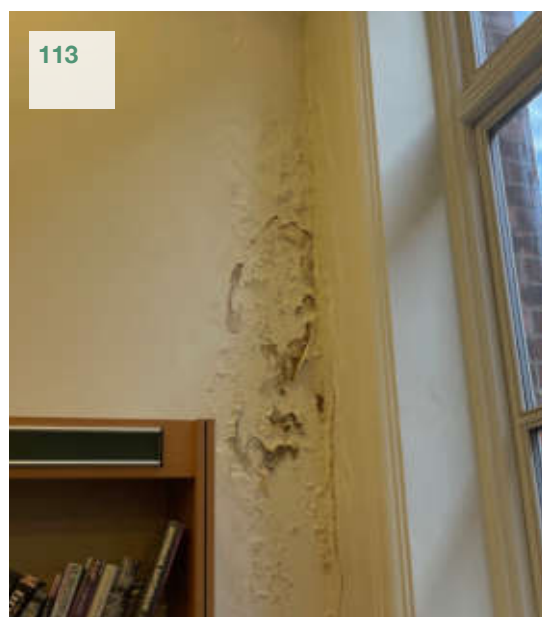
- 5.7.24 There are a number of areas of water ingress in the library, to the south-eastern corner and around the downstand beams adjacent to DG12. The ingress around the south-east corner (adjacent to RWP 08) is particularly severe and there is a lot of migrating salts and damage to the plasterwork which needs repair (once the issues are addressed, see roof).

- 109.** Entrance Hall, General View
- 110.** Sculpture Gallery, General View (G0016)
- 111.** Sculpture Gallery, Lantern (G0015).
- 112.** Library, General View (G0014)
- 113.** Library, Water ingress & consequent migrating salt damage

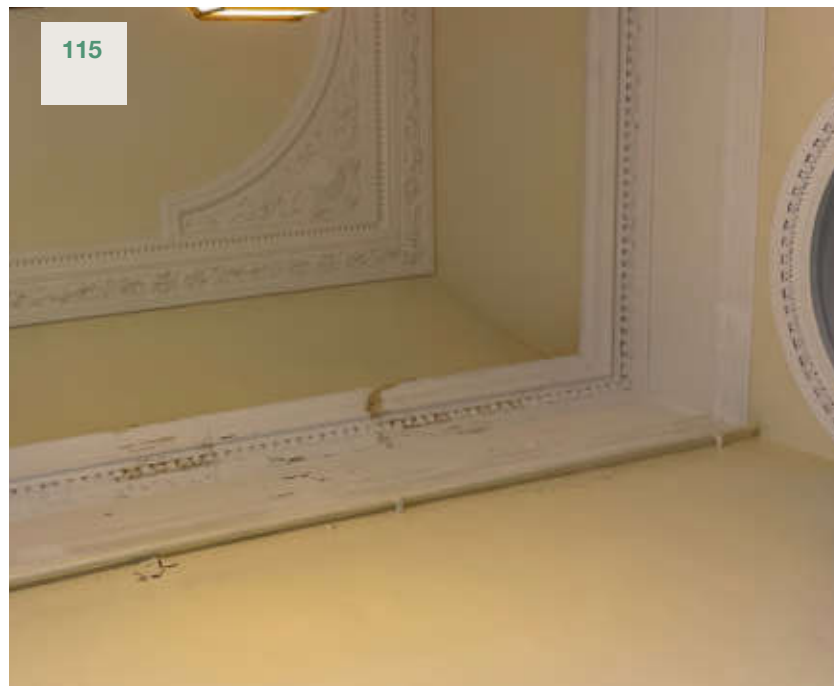
115

- 5.7.32 The ceiling has a deep cornice and sweeps up to form a vault above, with decorative plasterwork and lantern suspended centrally.
- 5.7.33 The plasterwork is quite badly damaged by water ingress on the south wall. This is associated with the gutter/outlet from roof area 01 (RWP02). This will need conservation and repair once the works to the gutter and outlet are undertaken. There is a risk of underlying rot in the cornice bearing structure. There are cracks also to the north and south, whilst not substantial, these should be monitored regularly.

**115** Water ingress and staining to cornice, staircase.

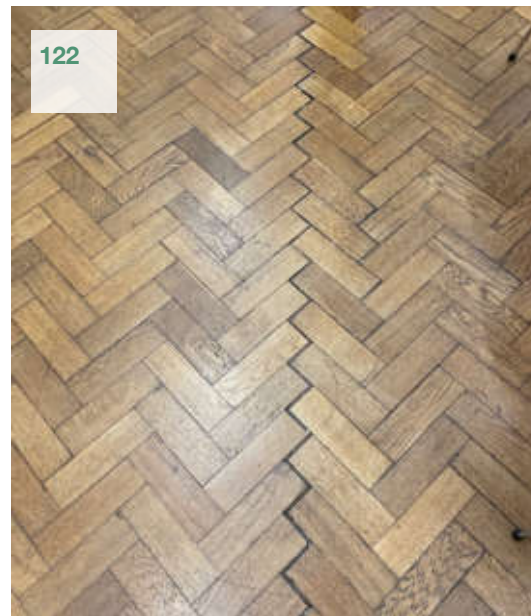
**121.** Significant water ingress to F0015 and consequent damage to plasterwork.

**122.** Crack to floor F0015.

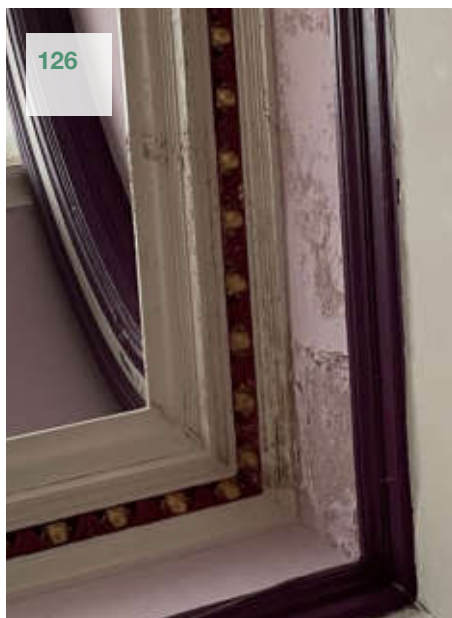
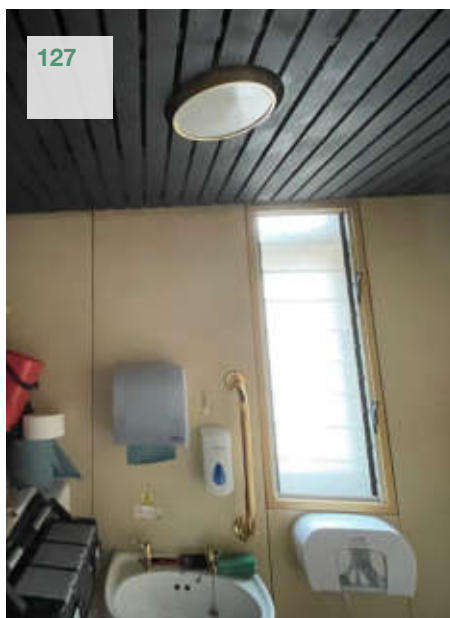
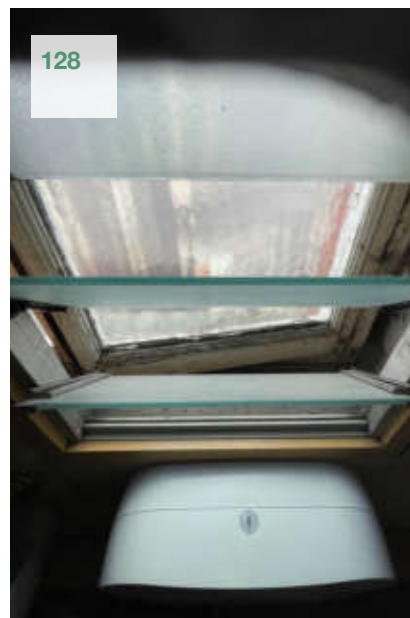
- 123.** Art Shop, General View
- 124.** Art Shop, Water Ingress
- 125.** False Ceiling and Original Over, F0011.
- 126.** Water ingress F0011
- 127.** WC and internal window lining F0010
- 128.** Internal window lining F0010 prevents operation of the original window.

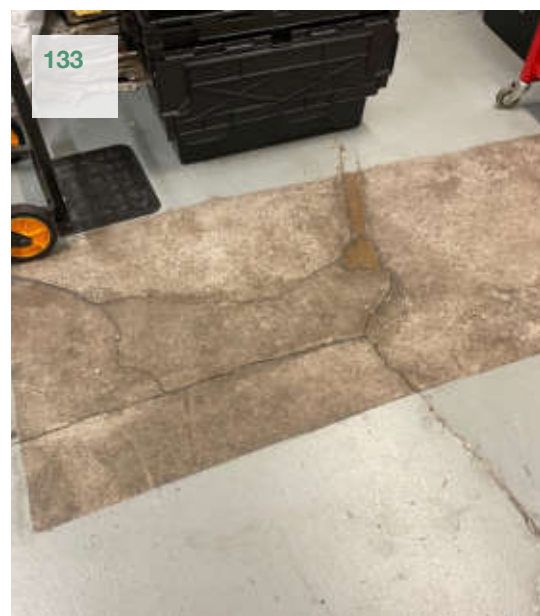
- 129.** Store/Electric Room under entrance stairs (LG0009).
- 130.** Office General view LG0013
- 131.** Gap around modern lobby LG0013
- 132.** Store/Work Room General view. LG0025
- 133.** Crack to floor LG0025

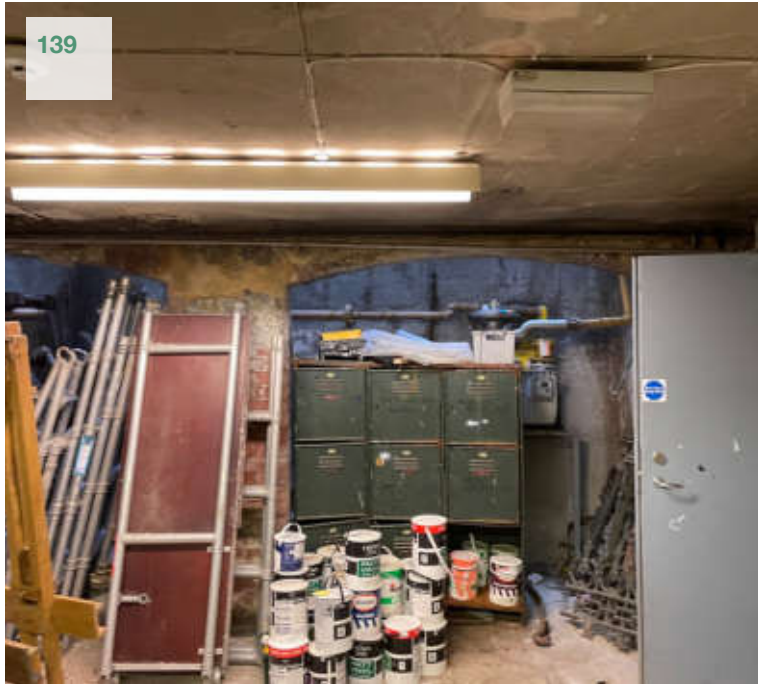
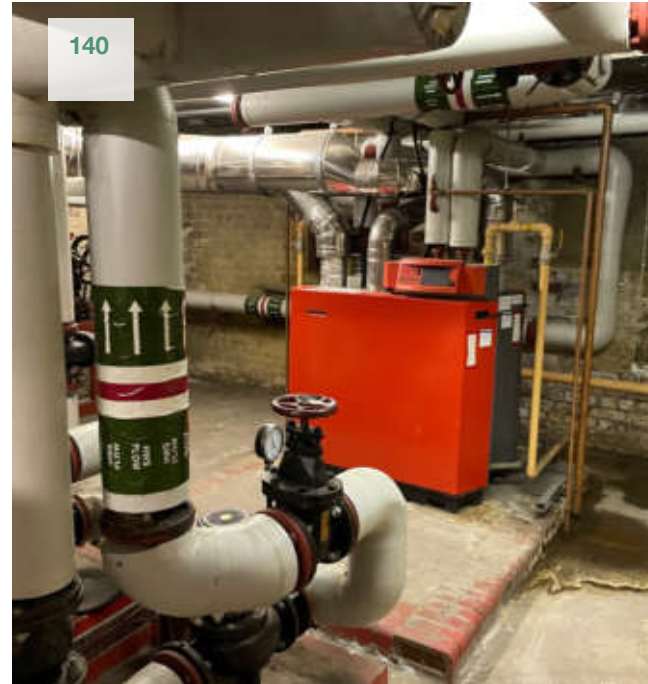
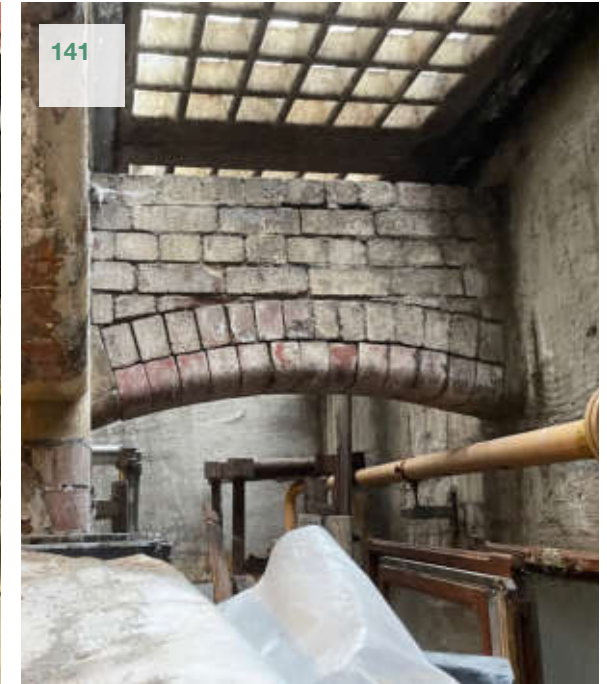
**139.** B0002 General view
