**Full application for the restoration of Windy Bank farmhouse, Church Road,  
Shuttleworth, Bury**

Planning application No 72471

**Structural Report**

Ref: JB.051125.A

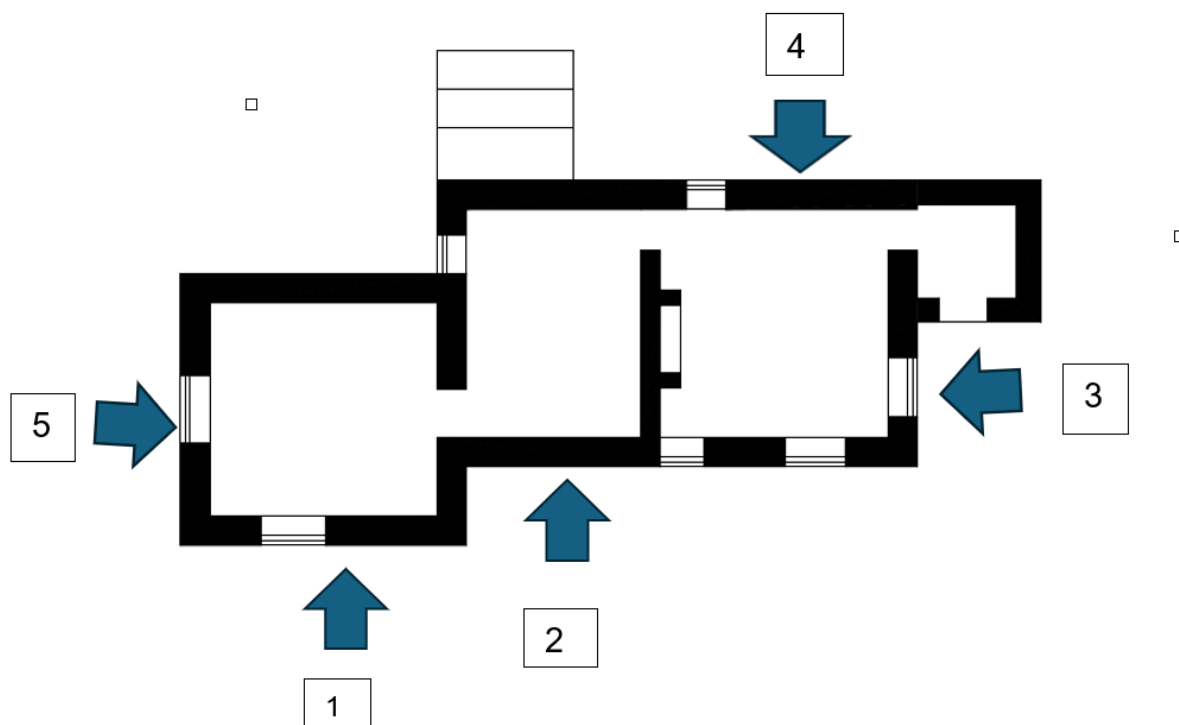
The external walls have been checked in terms of their alignment. The following photographs relate to the following Plan: -

All the external walls (and mirrored on the inside) are plumb , with only photos No 4 showing a minor, insignificant amount of bowing. No walls demonstrate subsidence, other movement or significant cracking despite their longevity.

Therefore, there is no reason to doubt, by their thickness and structural condition , that they cannot be repaired and extended upwards to meet the roof, as was the original construction.
