| <b>BAY 11a. EXISTING CONDITION AND REMEDIAL WORKS.</b> | | | |

| <b>BAY 12. EXISTING CONDITION AND REMEDIAL WORKS.</b> | | | |

| <b>BAY 12a. EXISTING CONDITION AND REMEDIAL WORKS.</b> | | | |

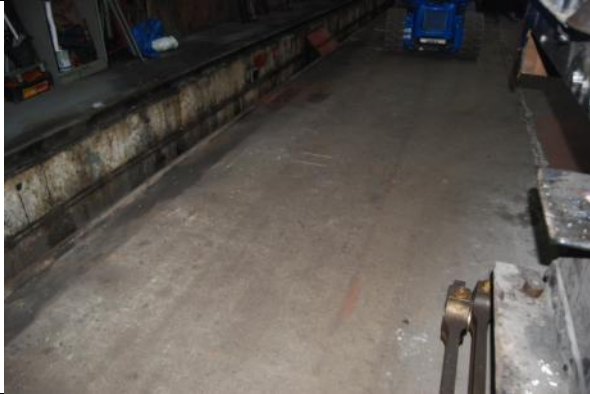
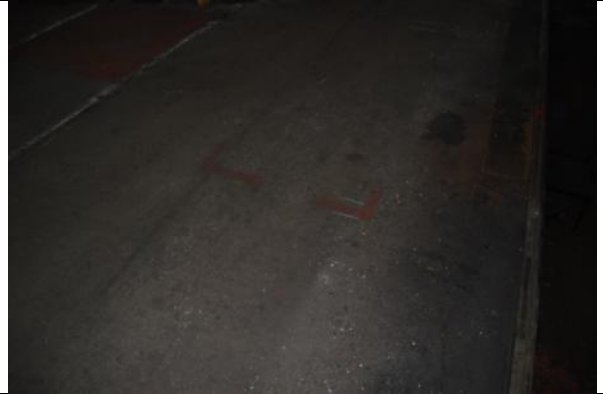
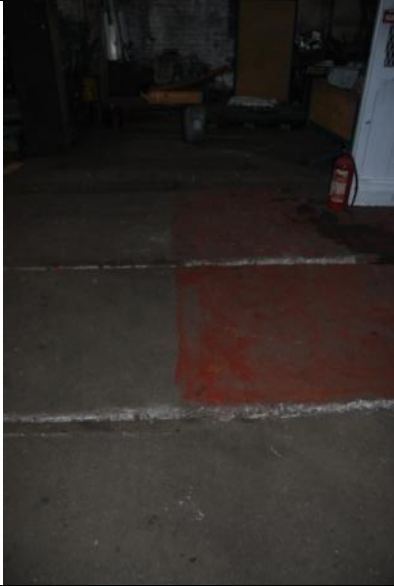
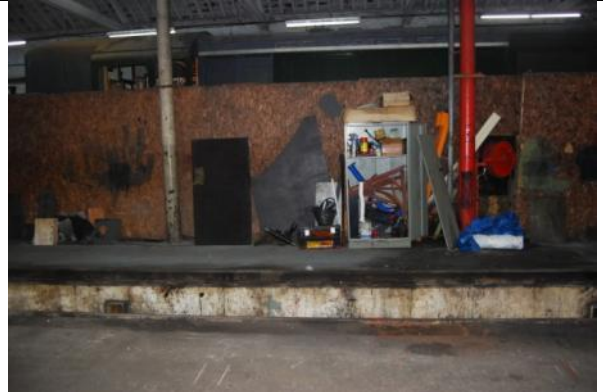
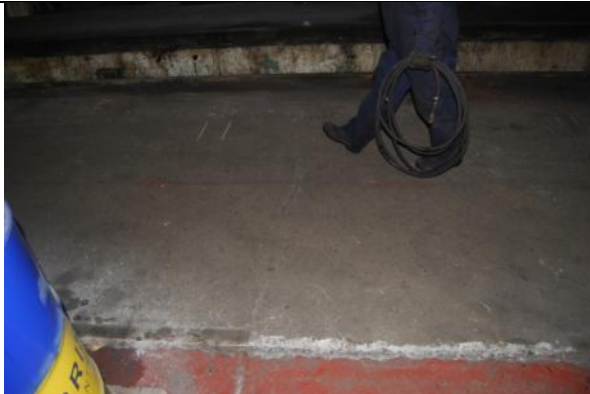
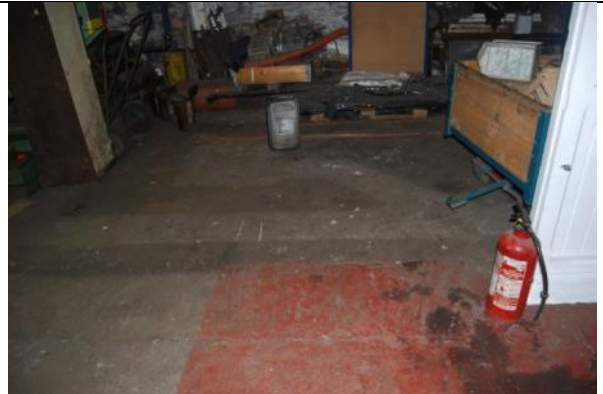
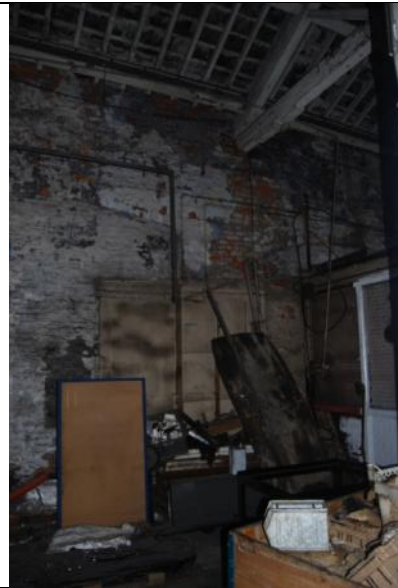
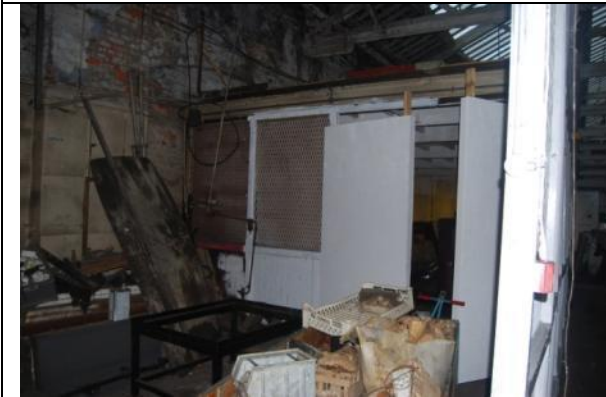
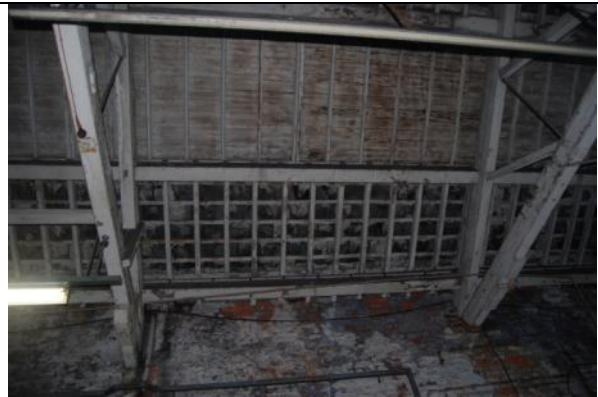
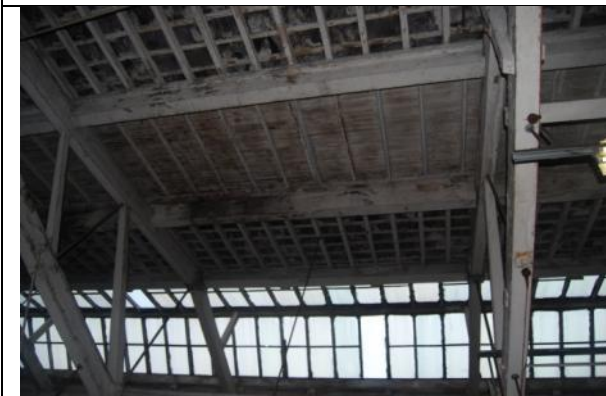
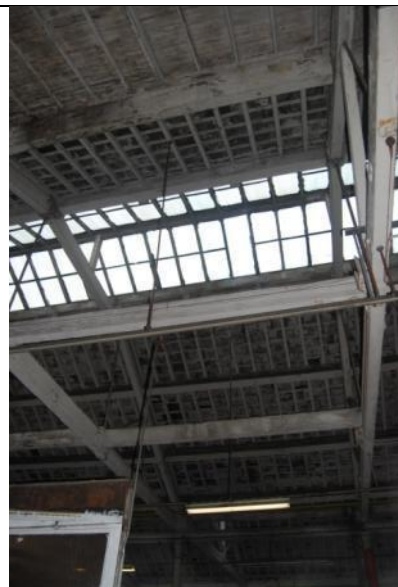
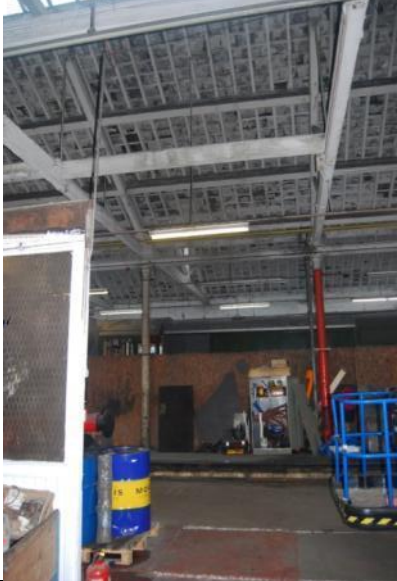
Bay 11

| Timber lantern | Condition | Areas of rainwater ingress, defective flashings and timbers exhibit high moisture content | |
| Slating | Condition | Areas of perished timber battens are noted and defective parging generally | |
| TRUSS 11<br>GL13 | Condition | Corroded brackets<br>Evidence of previous structural repairs | |

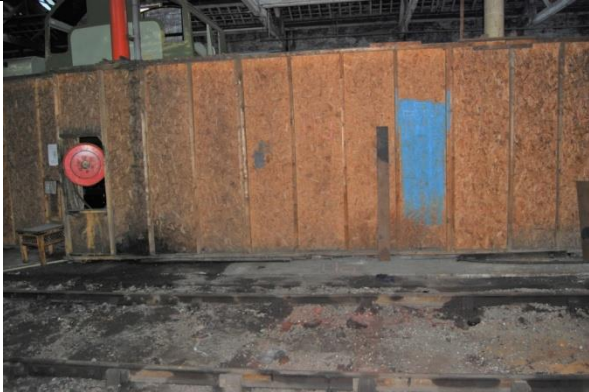
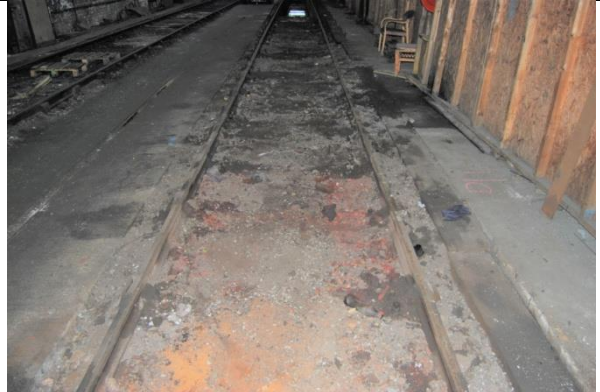
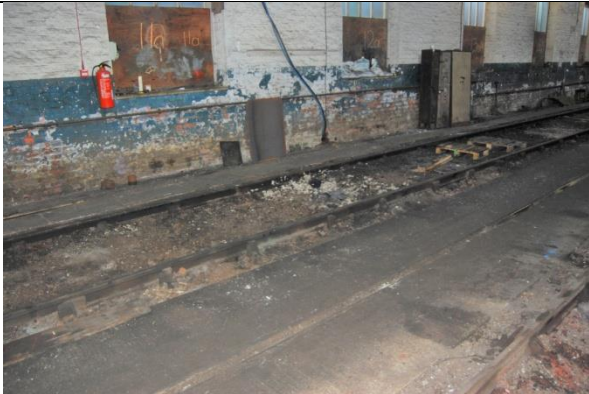
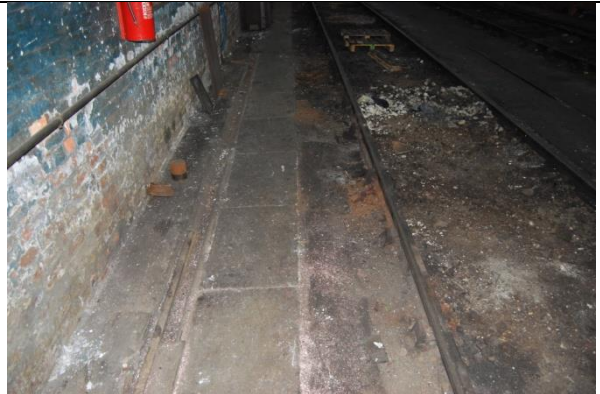
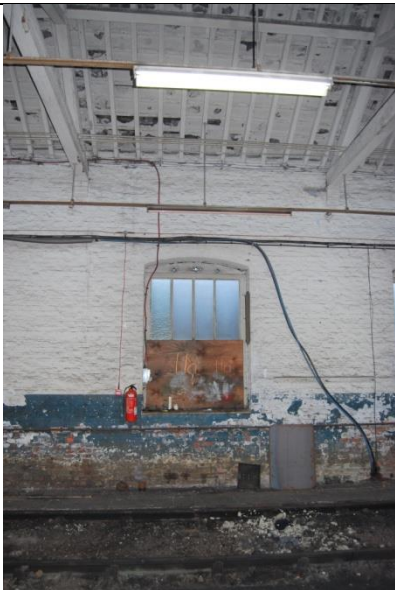
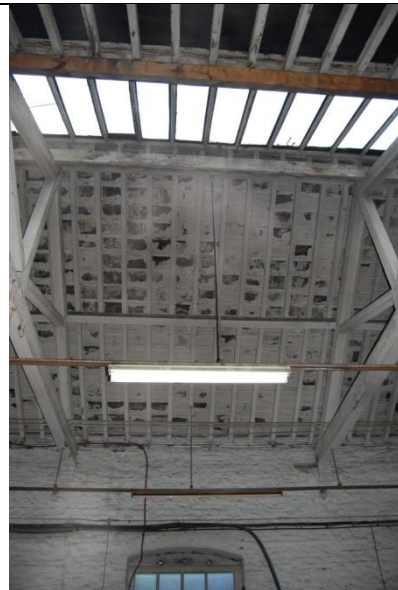
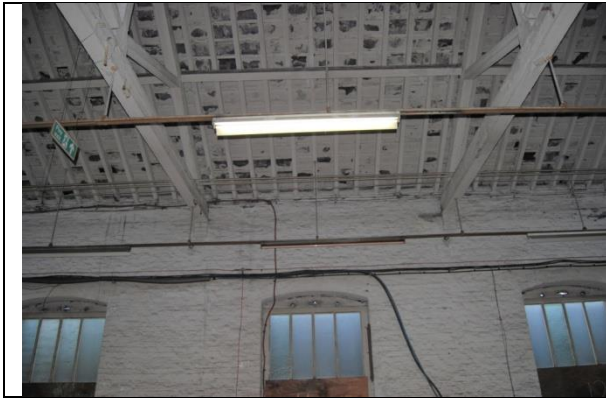
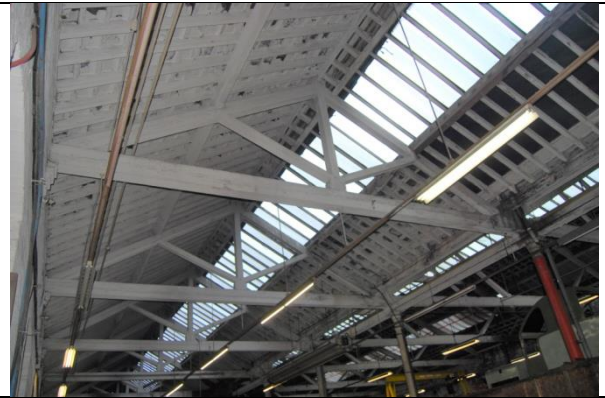
**Bay 11a**

| <p><b>General description</b></p> <p>The roof is pitched and formed with principal trusses supporting purlins, rafters, battens and slates over. The timber ridge is supported between the king posts. The west slope has had repairs at low level adjacent the valley gutter, where there is roofing felt between purlins P9 and valley beam B1 which was carried out in association with valley gutter repairs. The slates are parged and this is in a deteriorating condition.</p> <p>The slates are parged and this is in a deteriorating condition.</p> <p>There is a glazed rooflight (between Purlins P9 and P10 to the west slope, formed with traditional timber rafters/glazing bars.</p> <p>The rooflights maintain various glazing types i.e Clear glass, Perspex and Georgian-wired glass. A safety film appears to have been fitted to the external face of the glazing, and sections have been boxed in/boarded over due to broken panes. It is in a deteriorating condition with various repairs to glazing, rafters and</p> | | | |

| <p>flashings. Water ingress is evident along its length.</p> <p>Purlins are supported by the adjacent trusses T48 and T49</p> <p>T48 comprises a timber king-post truss of substantial proportions. Along GLA the truss is supported on a brick corbel and seated on a timber wall plate built into the wall.</p> <p>At eaves level the rafters are seated on a timber wall plate built into the brickwork, which runs between Bay 1a and Bay 18a. There is brickwork infill above the wall plate to the u/side of the slates.</p> <p>The roof timbers are generally limewashed.<br/>Corrosion noted to steel brackets/straps.</p> | | | |

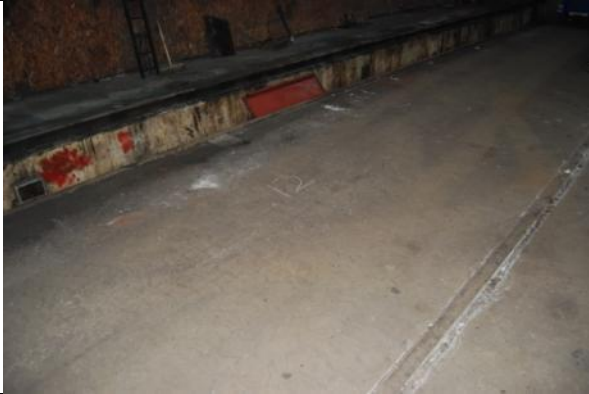
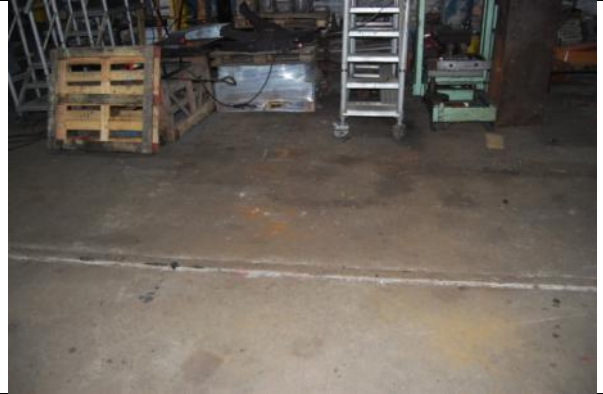
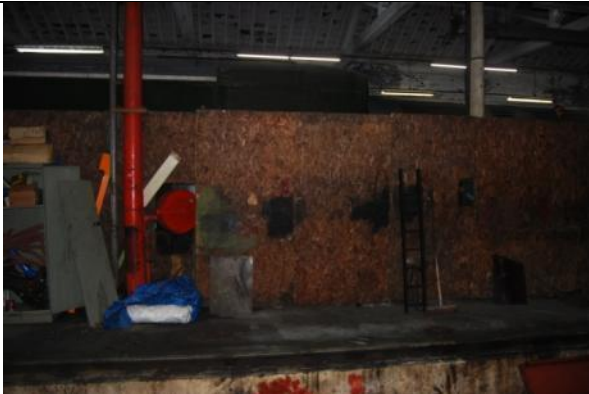
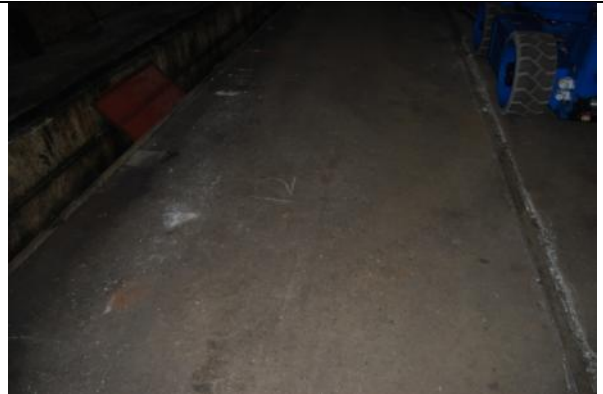
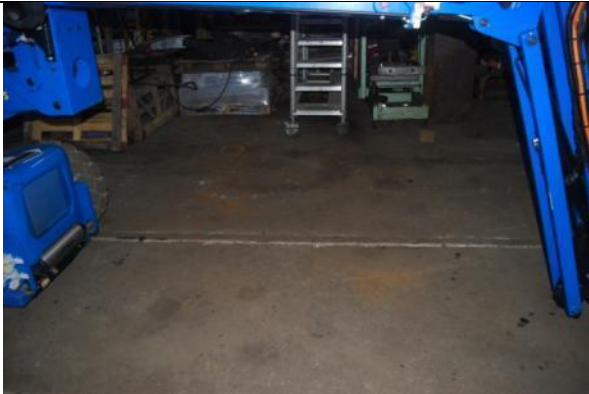
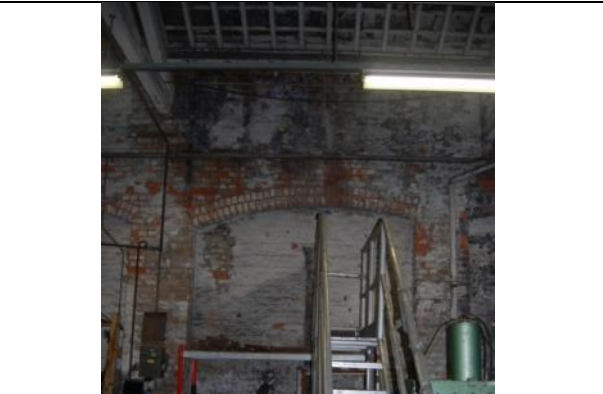
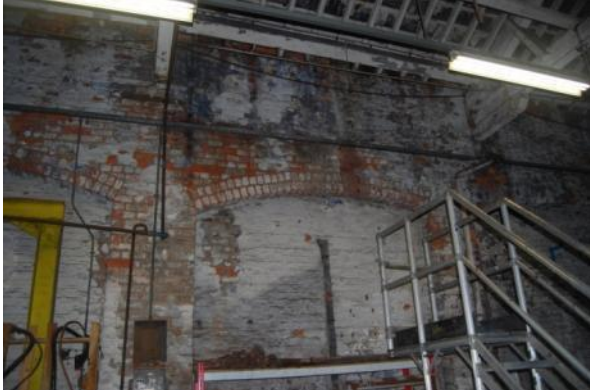
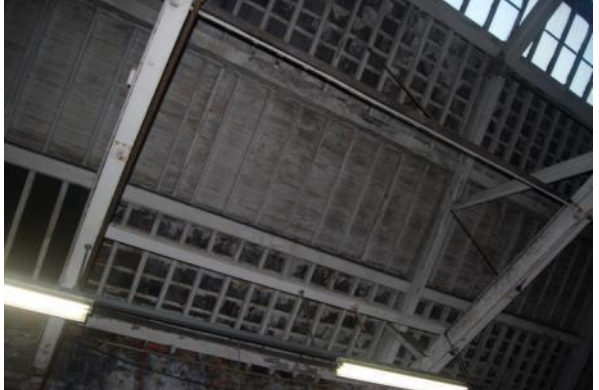
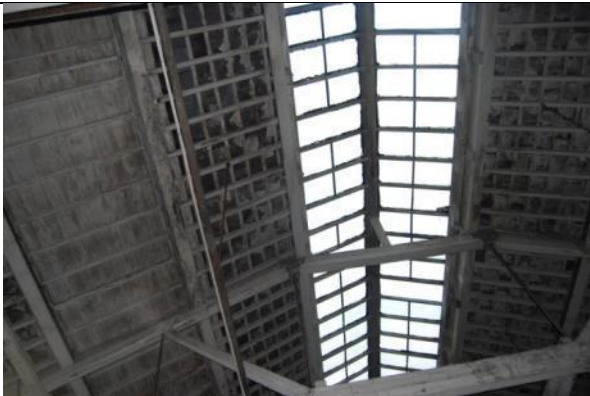
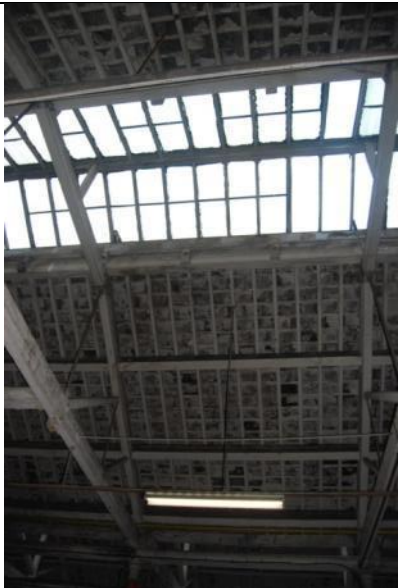
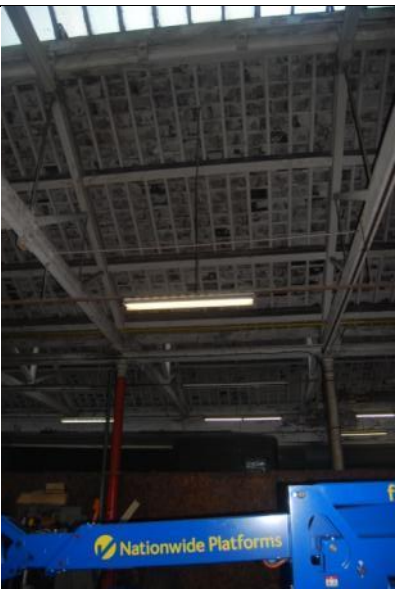
Bay 12

| <b>General description</b><br><p>The roof is pitched and formed with principal trusses supporting purlins, rafters, battens and slates over. The slates are parged and various repairs have been undertaken over the years. There is a continuous glazed rooflight to the west slope, formed from traditional timber glazing bars and at ridge level the apex has a glazed lantern light formed with timber glazing bars and various glazing types i.e Perspex and Georgian-wired glass.</p> <p>The roof is under-boarded (between purlins 1 and 2) on the line of the lantern light.</p> <p>Purlins are supported by the adjacent trusses T11 and T12.</p> <p>The trusses are formed from substantial timbers with bottom boom, principal rafter and collar with timber struts and steel hangers. The upper chord supports a ridge post and the lantern construction over. The roof timbers are generally limewashed.</p> <p>Trusses have deformed through shrinkage leaving the steel hangers loose. Corrosion noted to steel brackets/straps.</p> | | | |

| Timber lantern | Condition | Areas of rainwater ingress, defective flashings and timbers exhibit high moisture content | |
| Slating | Condition | Areas of perished timber battens are noted and defective parging generally | |
| TRUSS 12 GL14 | Condition | Corroded brackets | |

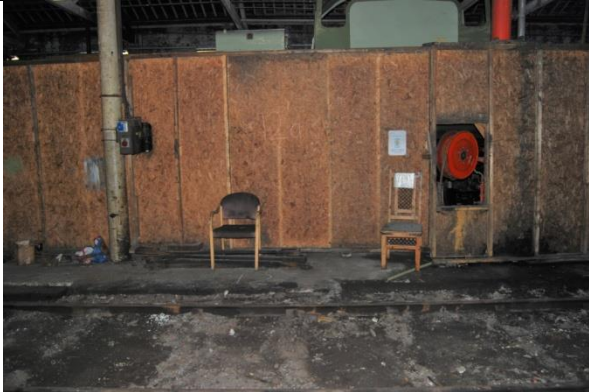
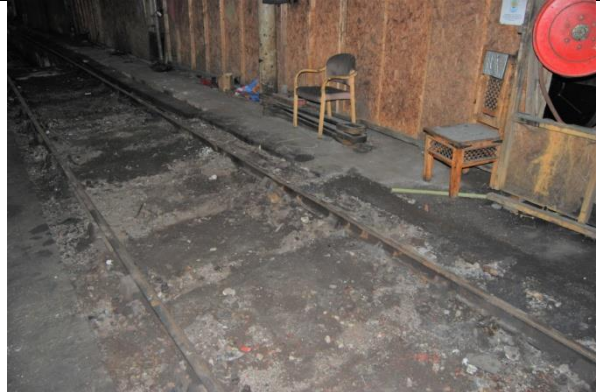
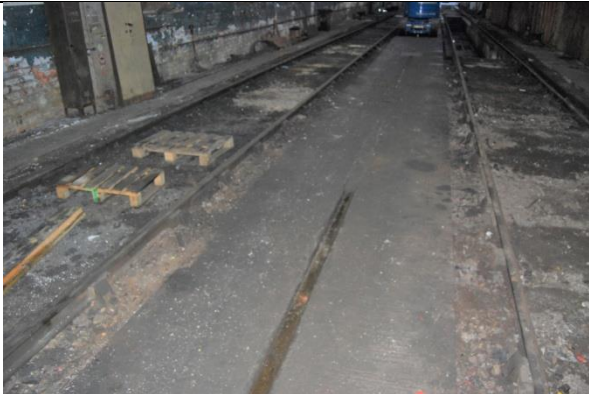
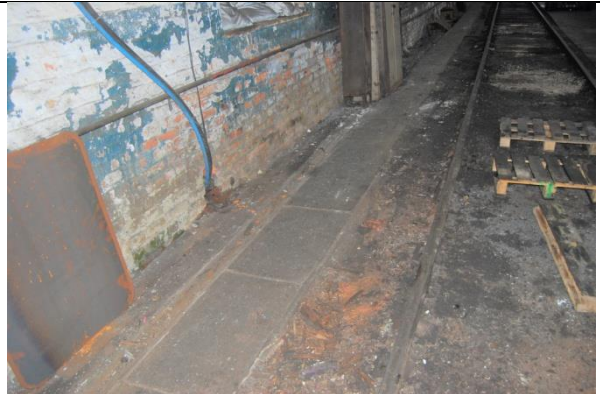
Bay 12a

| <p>The roof is pitched and formed with principal trusses supporting purlins, rafters, battens and slates over. The timber ridge is supported between the king posts. The slates are parged and this is in a deteriorating condition.</p> <p>There is a glazed rooflight (between Purlins P9 and P10 to the west slope, formed with traditional timber rafters/glazing bars.</p> <p>The rooflights maintain various glazing types i.e Clear glass, Perspex and Georgian-wired glass. A safety film appears to have been fitted to the external face of the glazing, and sections have been boxed in/boarded over due to broken panes. It is in a deteriorating condition with various repairs to glazing, rafters and flashings. Water ingress is evident along its length.</p> <p>Purlins are supported by the adjacent trusses T47 and T48</p> | | | |

| <p>T47 comprises a timber king-post truss of substantial proportions. Along GLA the truss is supported of a brick corbel and seated on a timber wall plate built into the wall.</p> <p>At eaves level the rafters are seated on a timber wall plate built into the brickwork, which runs between Bay 1a and Bay 18a. There is brickwork infill above the wall plate to the u/side of the slates.</p> <p>The roof timbers are generally limewashed.<br/>Corrosion noted to steel brackets/straps.</p> | | | |
| Slating | Condition | Areas of perished timber battens are noted and defective parging generally. | |
| TRUSS<br>T47<br>GL14 | Condition | Corroded brackets and perished timbers. | |

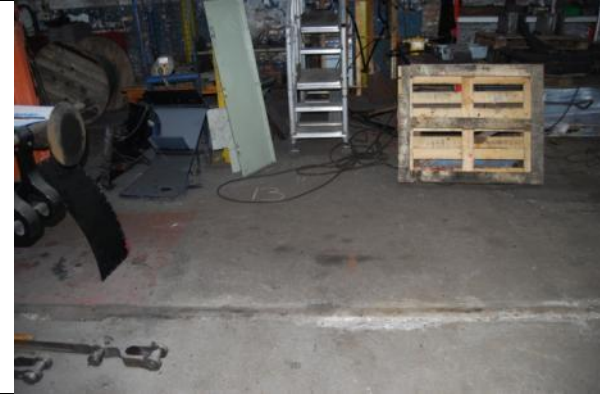
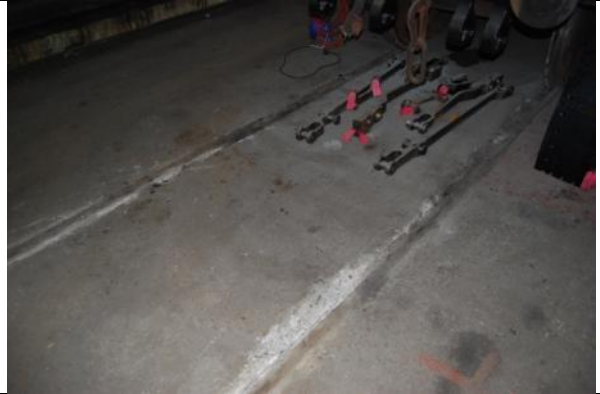
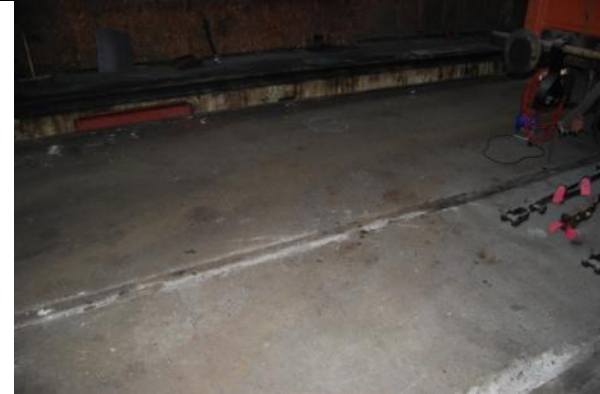
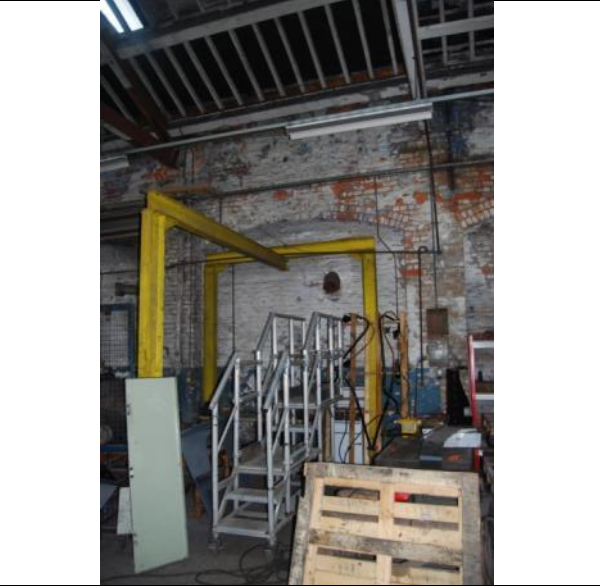
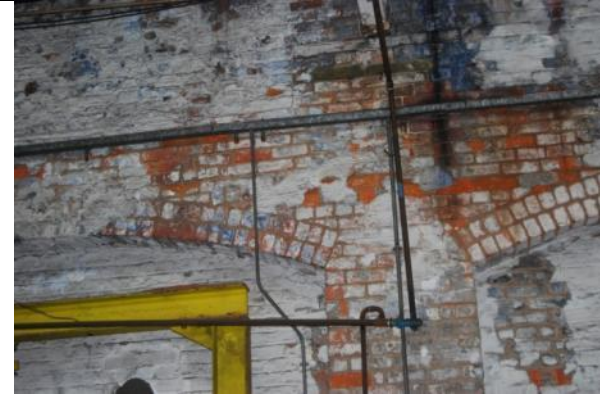
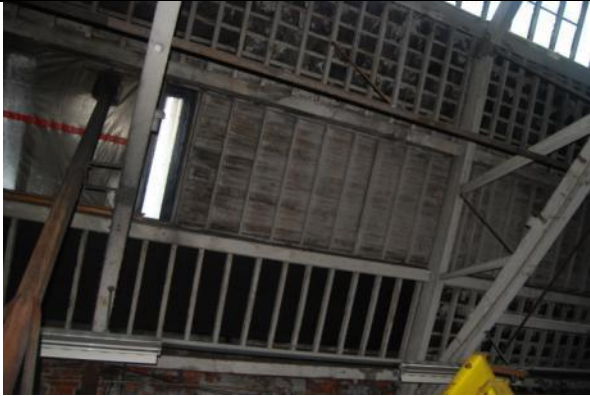
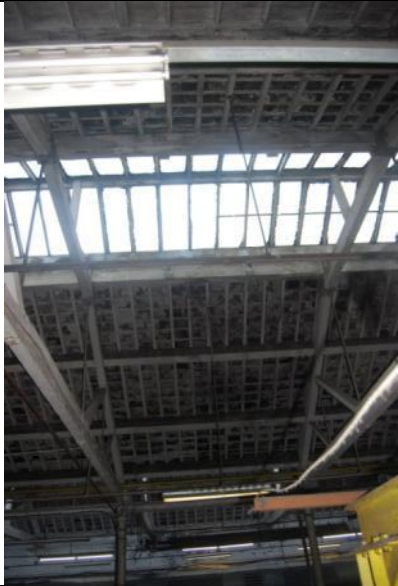
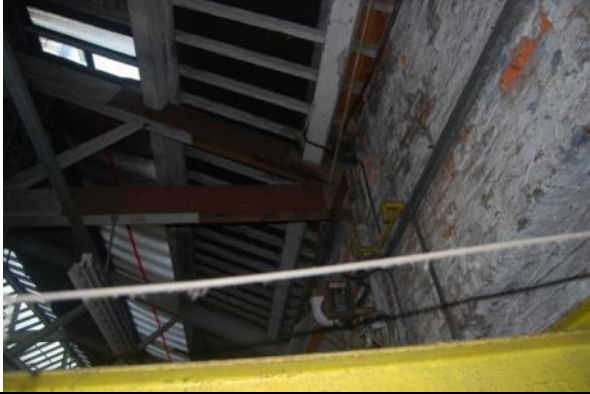
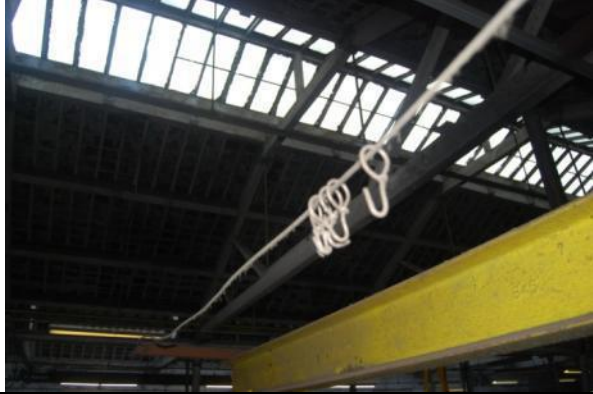
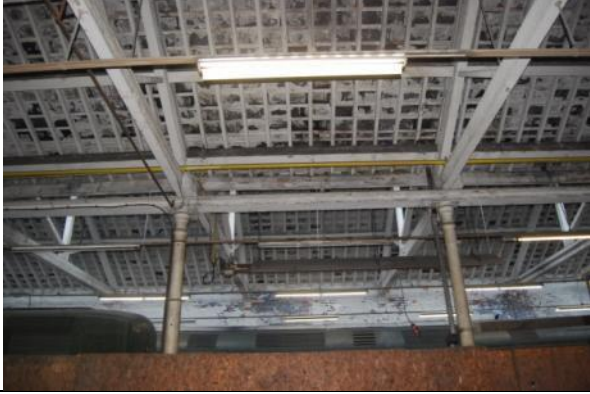
**Bay 13**

| <p><b>General description</b></p> <p>The roof is pitched and formed with principal trusses supporting purlins, rafters, battens and slates over. The slates are parged and various repairs have been undertaken over the years. There is a continuous glazed rooflight to the west slope, formed from traditional timber glazing bars and at ridge level the apex has a glazed lantern light formed with timber glazing bars and various glazing types i.e Perspex and Georgian-wired glass.</p> <p>The roof is under-boarded (between purlins 1 and 2) on the line of the lantern light. The lowest section of roof between purlins P1 and P2 has been felted. Reroofed retaining existing rafters.</p> <p>Purlins are supported by the adjacent trusses T12 and T13.</p> <p>The trusses are formed from substantial timbers with bottom boom, principal rafter and collar with timber struts and steel hangers. The upper chord supports a ridge post and the lantern construction over. The roof timbers are generally limewashed.</p> <p>Trusses have deformed through shrinkage leaving the steel hangers loose. Corrosion noted to steel brackets/straps.</p> | | | |

| Timber lantern | Condition | Areas of rainwater ingress, defective flashings and timbers exhibit high moisture content | |
| Slating | Condition | Areas of perished timber battens are noted and defective parging generally | |
| TRUSS 13 GL15 | Condition | Corroded brackets<br>Previous structural repairs | |

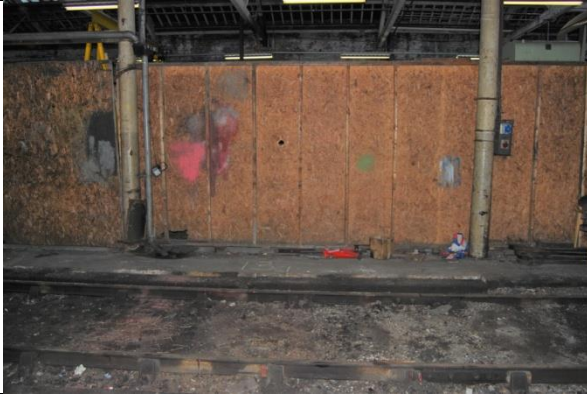
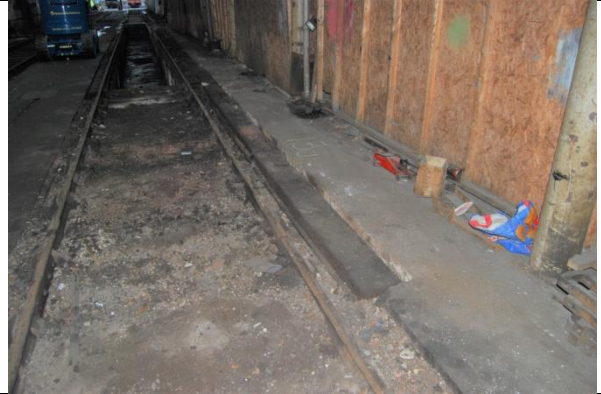
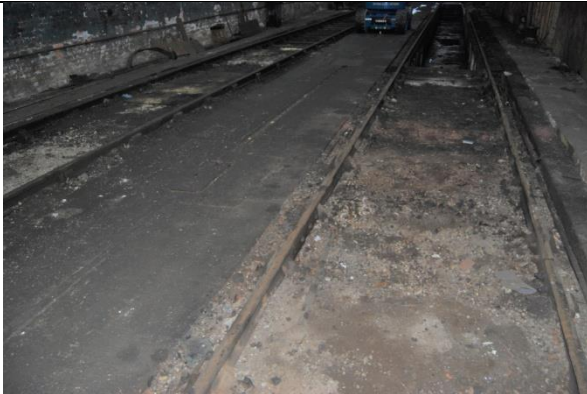
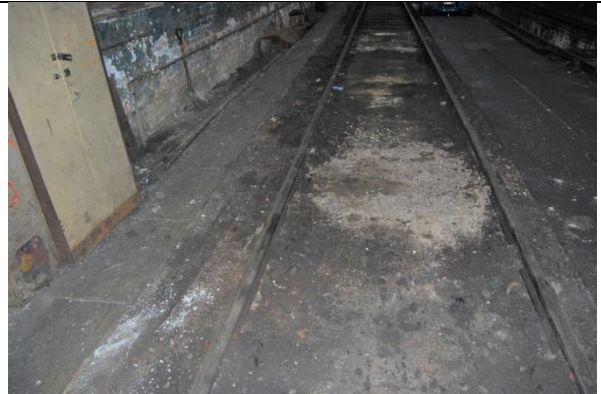
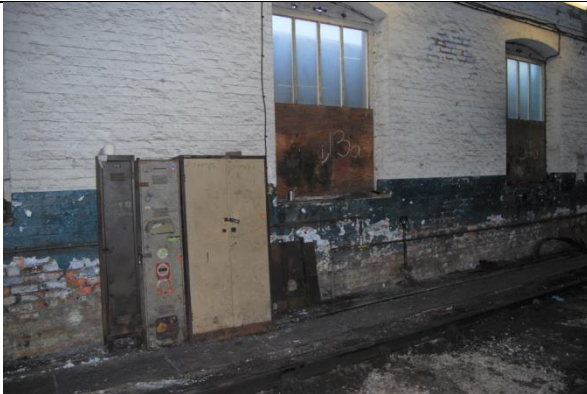
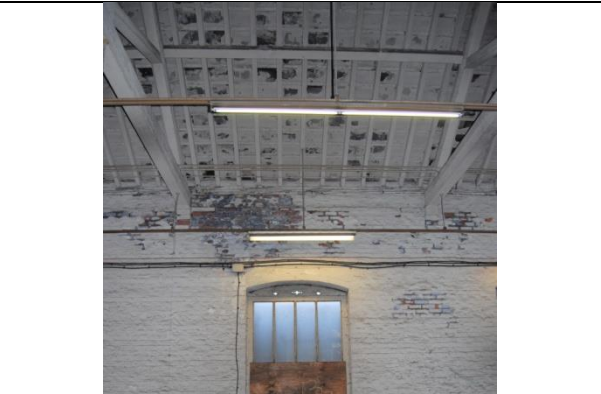
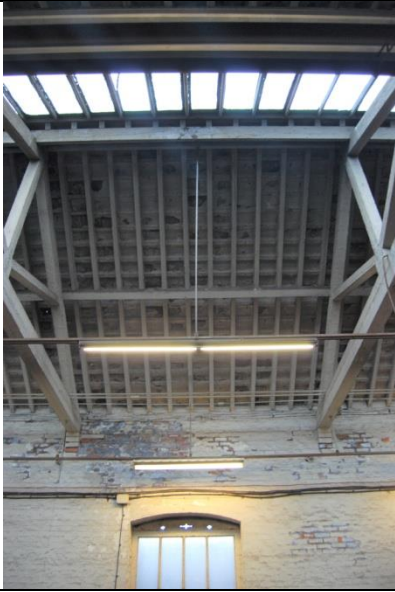
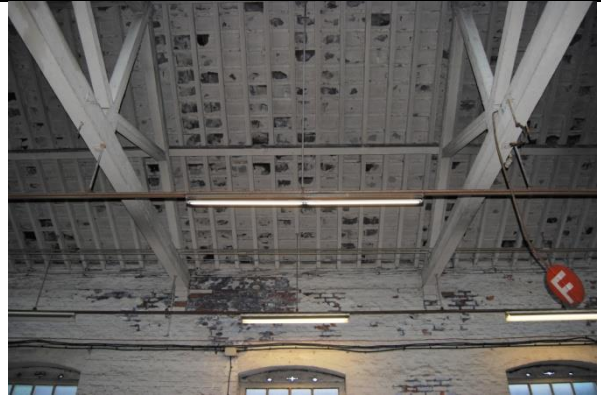
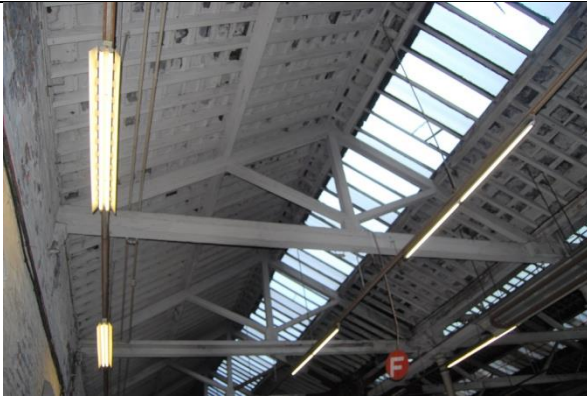
Bay 13a

| <b>General description</b><br>The roof is pitched and formed with principal trusses supporting purlins, rafters, battens and slates over. The timber ridge is supported between the king posts. The slates are parged and this is in a deteriorating condition.<br><br>There is a glazed rooflight (between Purlins P9 and P10 to the west slope, formed with traditional timber rafters/glazing bars.<br><br>The rooflights maintain various glazing types i.e Clear glass, Perspex and Georgian-wired glass. A safety film appears to have been fitted to the external face of the glazing, and sections have been boxed in/boarded over due to broken panes. It is in a deteriorating condition with various repairs to glazing, rafters and flashings. Water ingress is evident along its length.<br><br>Purlins are supported by the adjacent trusses T46and T47 | | | |

| <p>T46 comprises a timber king-post truss of substantial proportions. Along GLA the truss is supported of a brick corbel and seated on a timber wall plate built into the wall.</p> <p>At eaves level the rafters are seated on a timber wall plate built into the brickwork, which runs between Bay 1a and Bay 18a. There is brickwork infill above the wall plate to the u/side of the slates.</p> <p>The roof timbers are generally limewashed.<br/>Corrosion noted to steel brackets/straps.</p> | | | |
| Slating | Condition | Areas of perished timber battens are noted and defective parging generally. | |
| TRUSS<br>T46<br>GL15 | Condition | Corroded brackets and perished timbers. | |

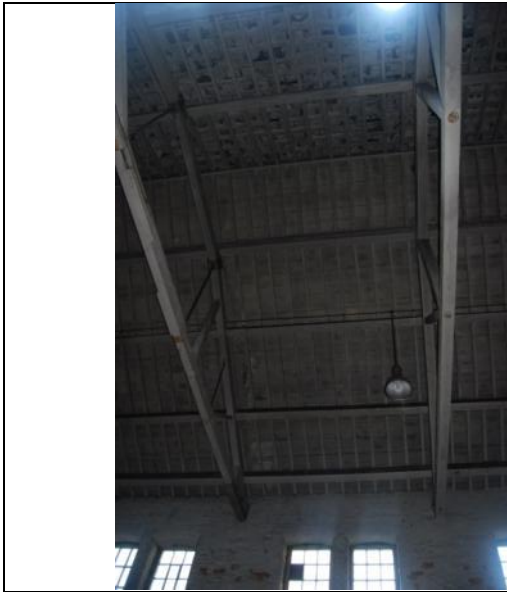
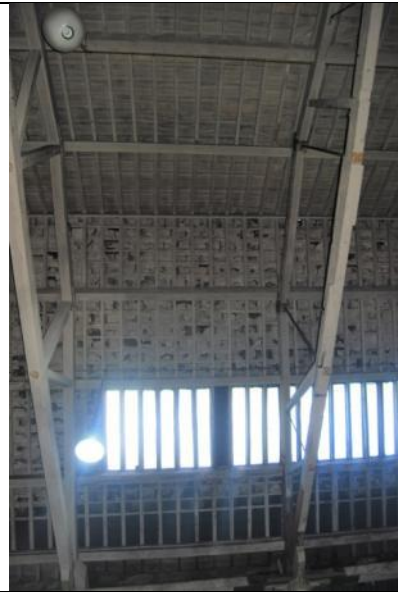
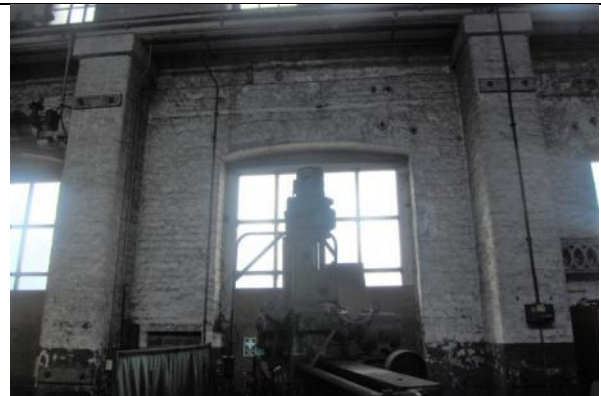
| ROOF COVERINGS | | | |
|---|---|---|--|
| <p><b>General description</b></p> <p>The roof is pitched and formed with principal trusses supporting purlins, rafters, battens and slates over.</p> <p>The roof has been partially renovated. The west slope has been recovered with breathable felt battens and slates over. Some damage to felt.</p> <p>The east slope has had repairs at low level adjacent the valley gutter, where there is roofing felt between purlins P19 and P20 which was carried out in association with valley gutter repairs. The slates are parged and this is in a deteriorating condition.</p> <p>Purlins are supported by the adjacent trusses T21 and T22.</p> <p>The queen post collar truss T21 (GL23) is formed from substantial timbers with bottom boom, principal rafter and collar with timber struts. There are steel bracket connections. The upper chord supports a ridge post and construction over. The roof timbers are generally limewashed.</p> <p>Corrosion noted to steel brackets/straps.</p> <p>At the time of inspection water was pouring into the bay along the valley line.</p> | | | |
