## **REMEDiation STRATEGY REPORT**

**FOR  
9 CHATSWORTH AVENUE,  
PRESTWICH,  
MANCHESTER,  
M25 1LZ**

**PREPARED FOR  
TURNKEY INDEPENDENT  
PROPERTY SERVICES LIMITED**

**REPORT NO. 7832D  
JULY 2024**

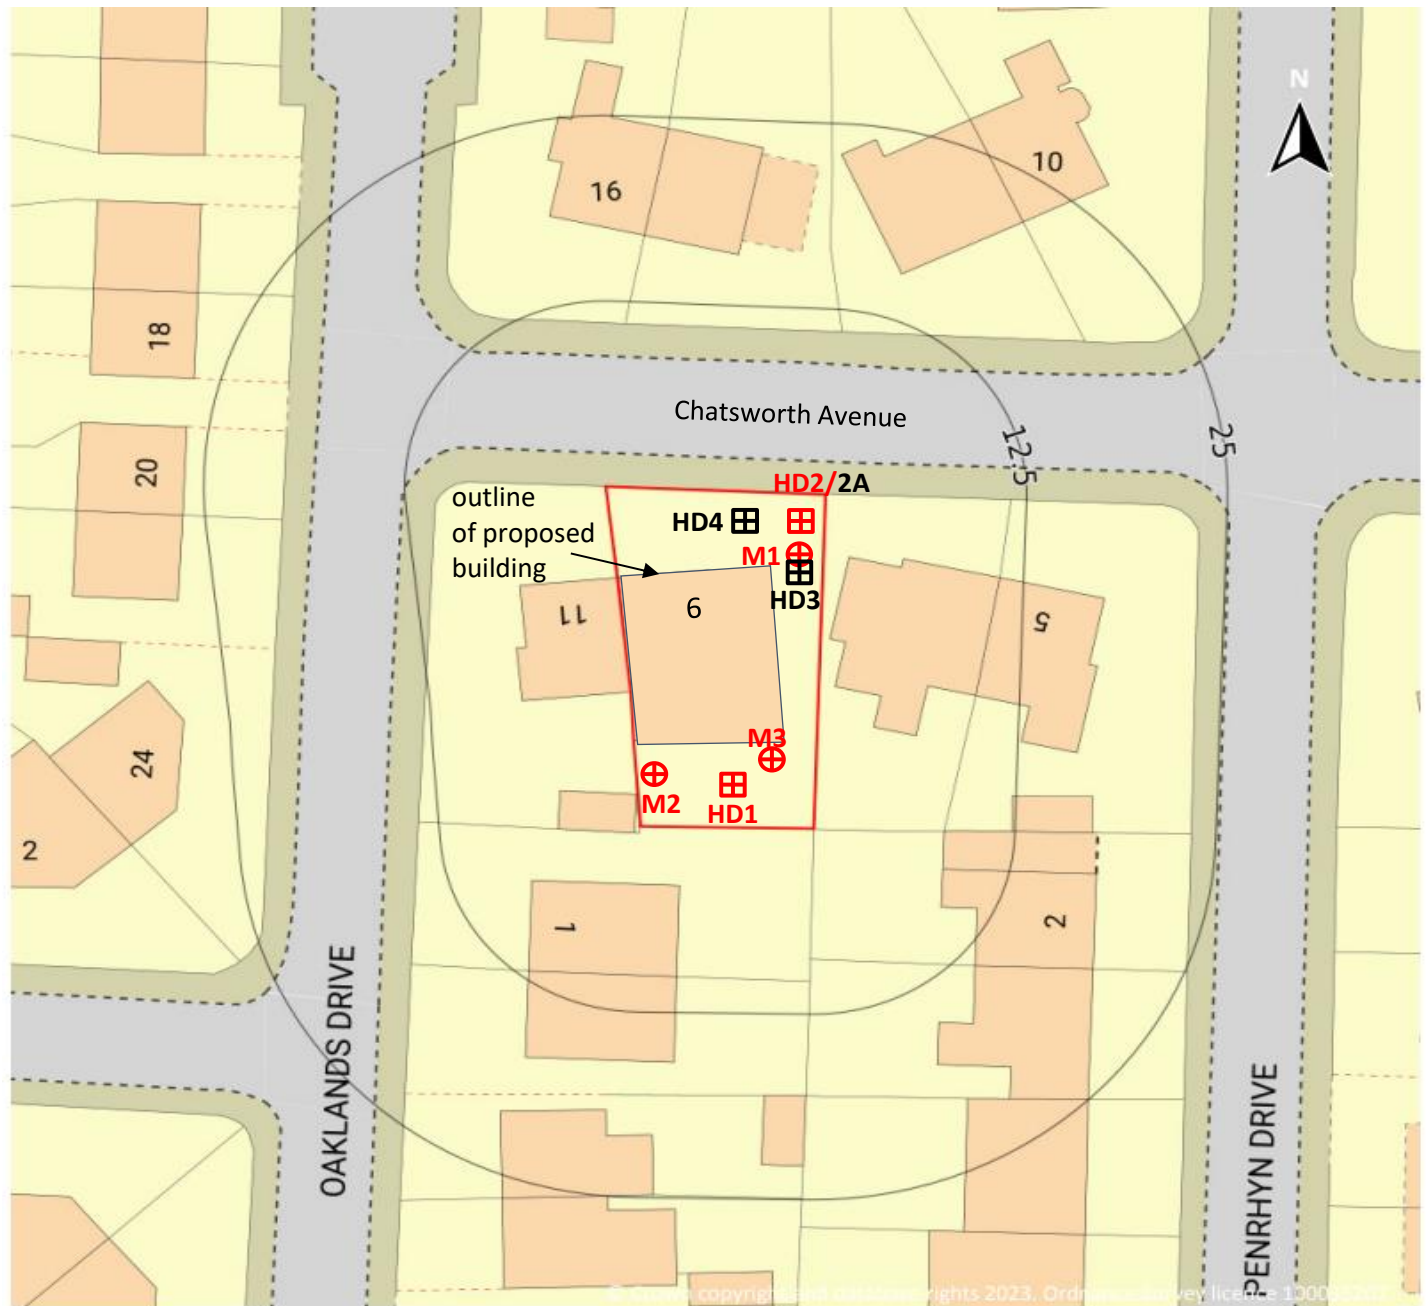
7832A

7832B

Following recommendations provided in the initial report, an additional Phase II Ground Investigation was undertaken, ref. 7832B and dated March 2024, and comprised three hand dug trial pits excavated to a depth of 1.00m. The positions of the exploratory holes are given on Figure 2.
