## LAND OFF LANCASTER AVENUE, WHITEFIELD, MANCHESTER

### Phase 1 - Preliminary Risk Assessment

Report Ref: BEK-23024-1

February 2023

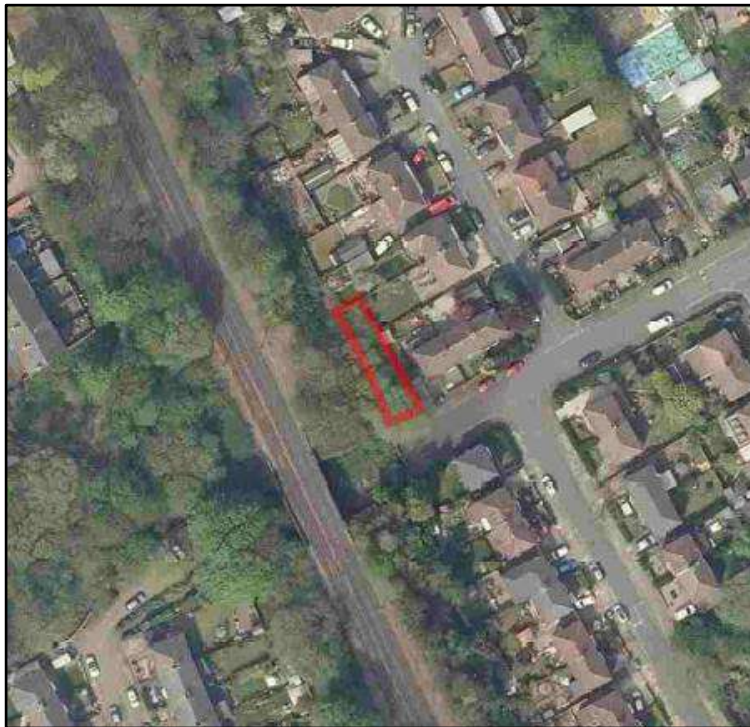
- 3.7 The site remains vacant. Progress Mill is absent. There are no other significant changes to the surrounding area.

*Figure 4: Aerial Image from 2019*

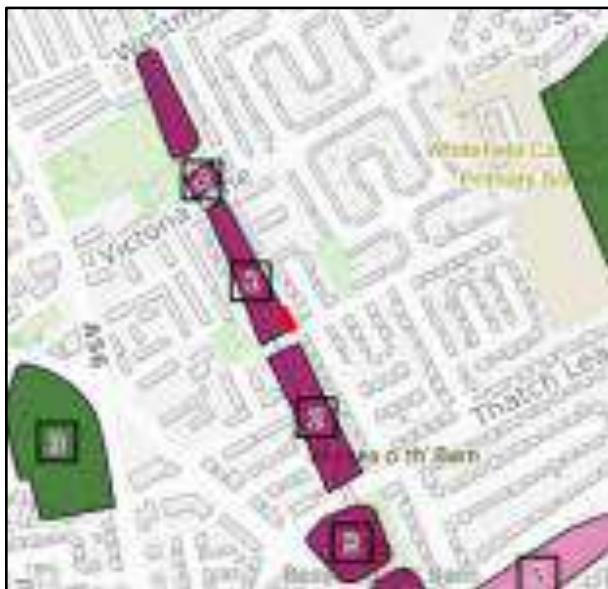
4.1.4 According to the Enviro&GeoInsight report the site is underlain with made ground on which is associated with the railway line to the west. (see Figure 5).

*Figure 5: Artificial and Made Ground Map*
