## 6155 Bevis Green, Bury - EA Bespoke Permit - Risk Assessment (Issue 1 - February 2021)

Environmental management system for the realignment/diversion of the un-named tributary of Pigs Lee Brook and the treatment of associated silts.

**Former Tetrosyl Works,  
Walmersley Old Road,  
Bury.  
BL9 6RG**

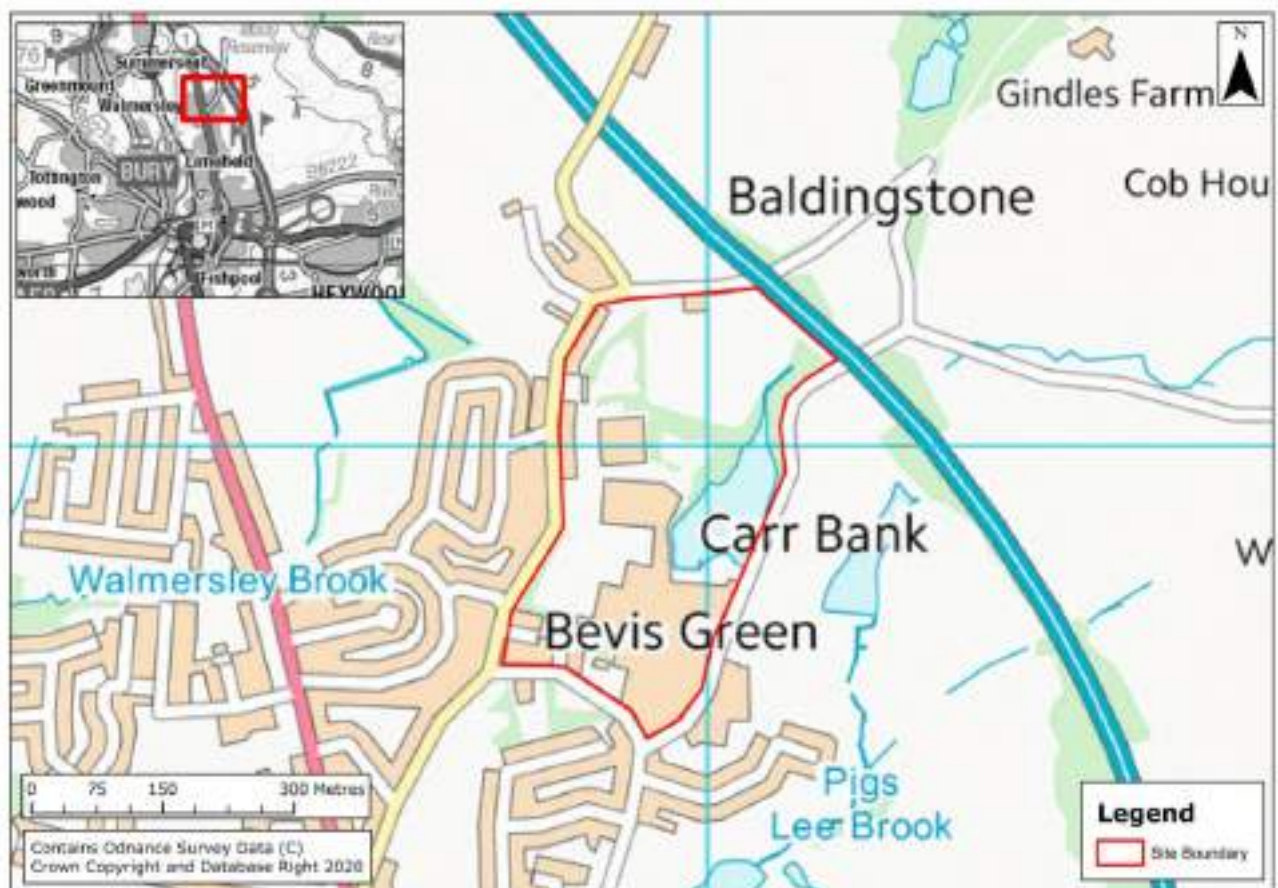
Figure 1-1: Site Location

Figure 1-1 displays the site location and the catchment area of the watercourse, which is unnamed and is a tributary of Pigs Lee Brook. The watercourse rises on the southern edge of Harden Moor near Nangreaves and flows primarily south towards the site. The outflow from the reservoir is controlled by a weir in which the channel is culverted and then flows into open channel before discharging into Pigs Lee Brook.

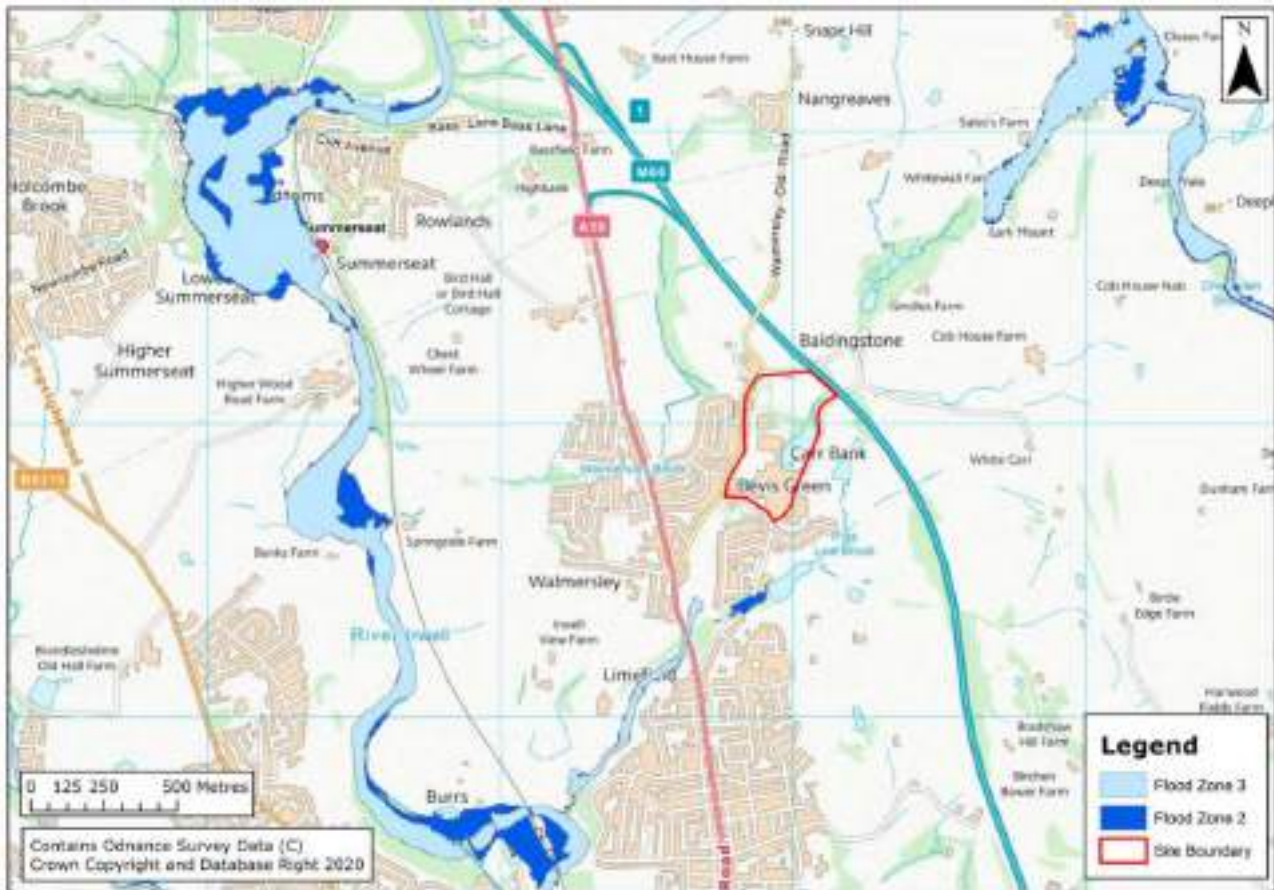
Figure 2-1: Current Flood Risk

Figure 2-1 displays the Environment Agency Flood Zone Mapping across the site, illustrating that the site is located within Flood Zone 1. Downstream of the site where the watercourse converges with the River Irwell is in Flood Zone 3 which follows the route of the existing watercourse. To the north of the site the Cheesden Brook is within Flood Zone 2 and 3 which follows the route of the watercourse except to the north of the site the is flooding of the floodplain, however, this does not impact upon the unnamed watercourse of the site.

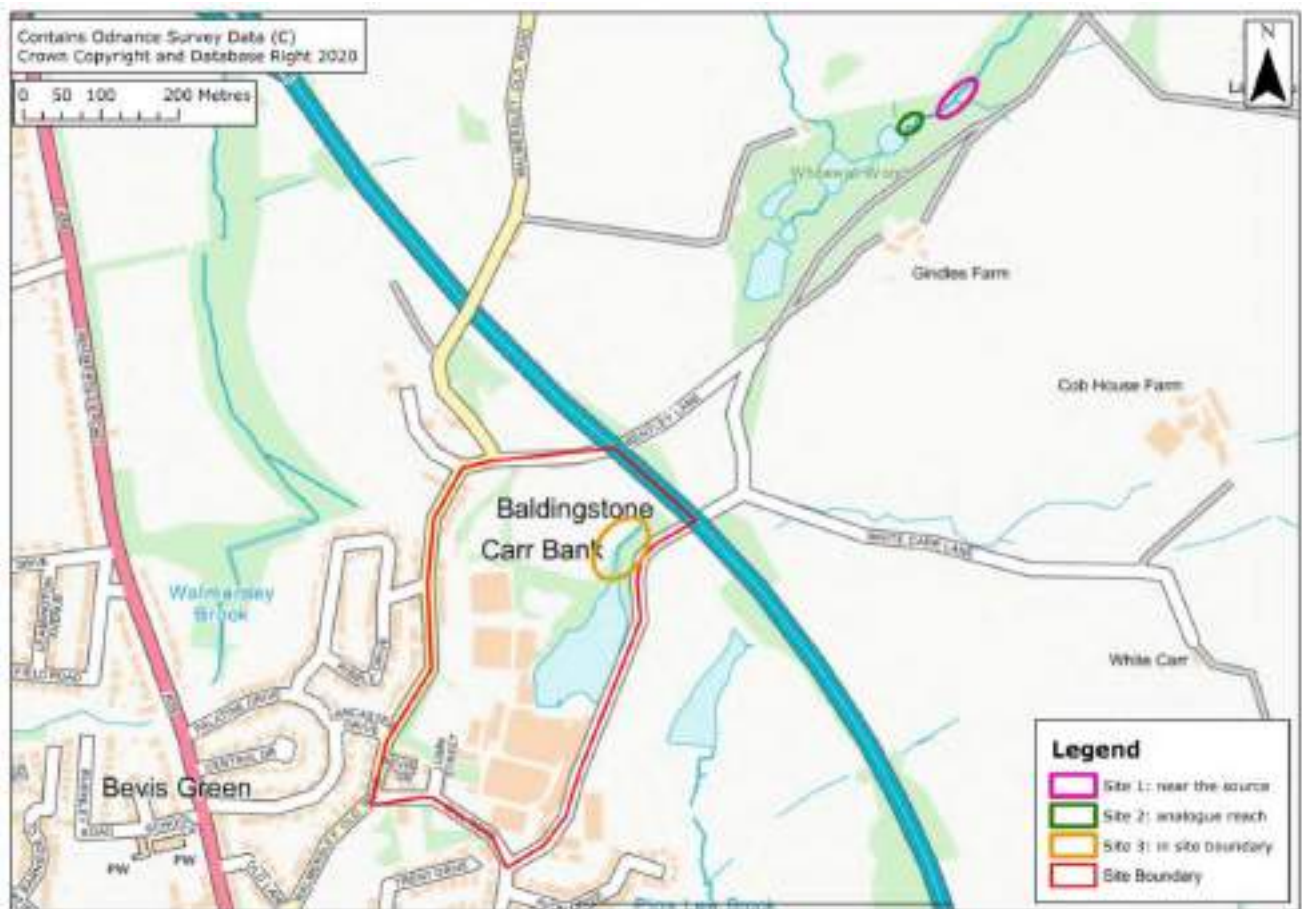
Figure 3-1: Survey Locations

A walkover assessment was completed on the 15th July 2020 by Rebecca Thrower (geomorphologist) and Emma Wright (geomorphologist) of the watercourse through the site and upstream of the site boundary. The purpose of surveying the watercourse upstream of the site was to identify analogue reaches to gain an understanding of the geomorphic conditions of the river when not confined to culverts.

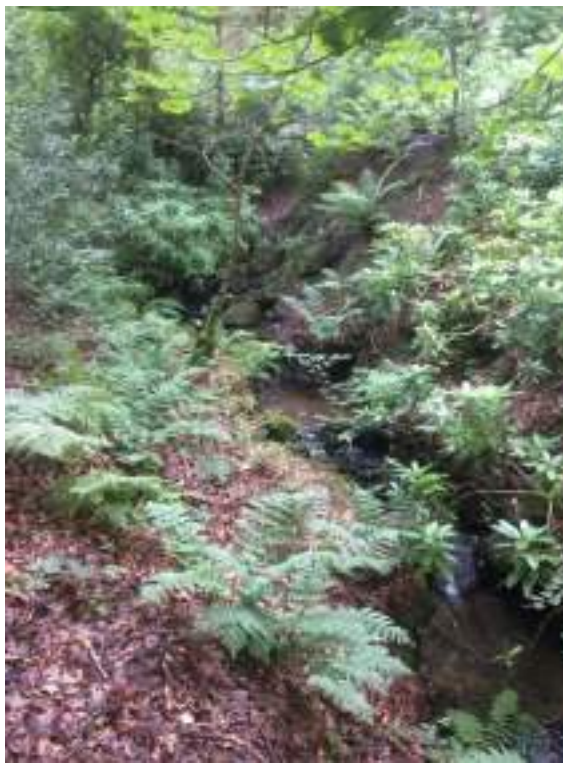
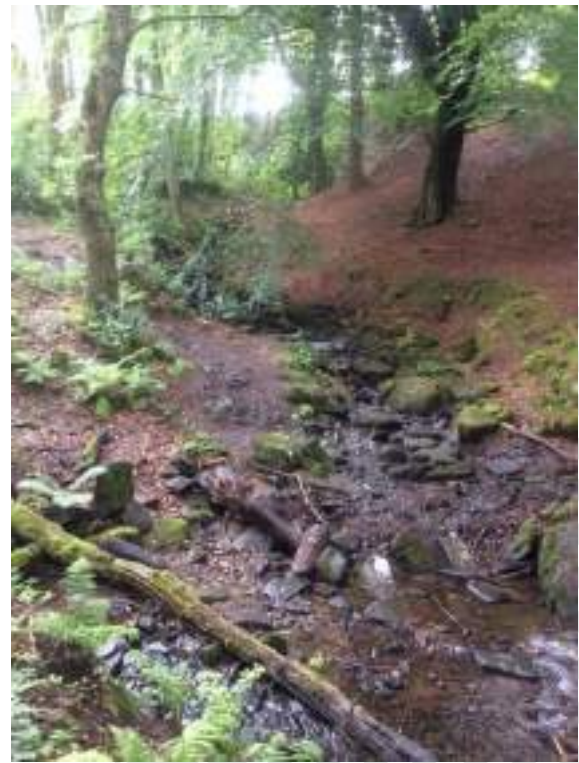
Figure 3-2: Upstream steep morphology

Upstream of the site (approximately 0.6km) the watercourse is a single thread river that flows through an alluvial channel. At this point in the catchment the watercourse is confined to a steep valley and displays both boulder cascade and cobble step pool morphologies (Figure 3-2). The channel is very narrow, approximately 0.5m wide, and steep with coarse bed material (gravels, cobbles, boulders) indicating an active supply of sediment to the reach. Some bank erosion was evident immediately downstream of the confluence between the two watercourses, where the channel gradient reduces and sediment has been deposited (Figure 3-4). The river is confined by the steep valley and therefore limited floodplain is evident; however, downstream the valley floor widens and this creates some floodplain. The confinement of the valley and lack of floodplain for flows to spill onto concentrates energy in channel and increases the size of the material that can be transported.

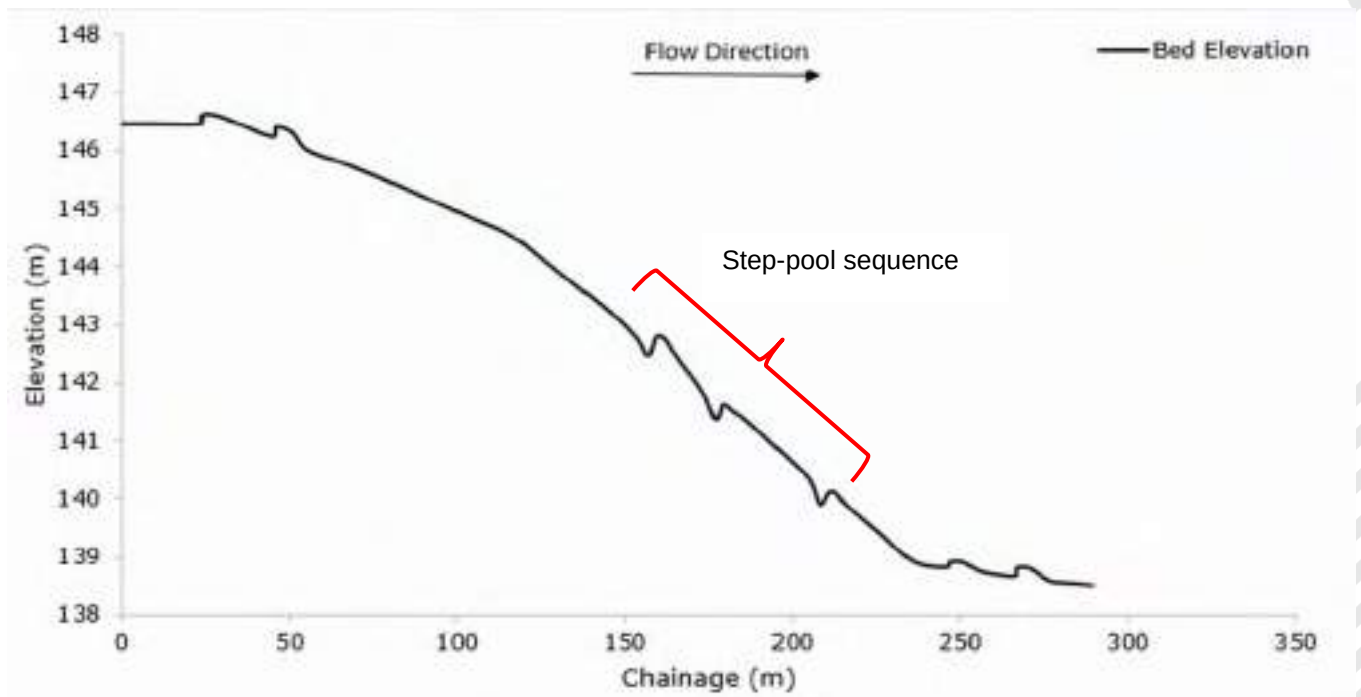
Figure 3-3: Long section to demonstrate the step-pool (step-pool) sequence

This reach could be used to define characteristics of the new channel if the gradient is to be of similar steepness. Figure 3-3 depicts the long section throughout the site but specifically the step-pool sequences that occur within the steeper gradient. This can be used as an analogue to determine the in-channel features within an area of steeper gradient.

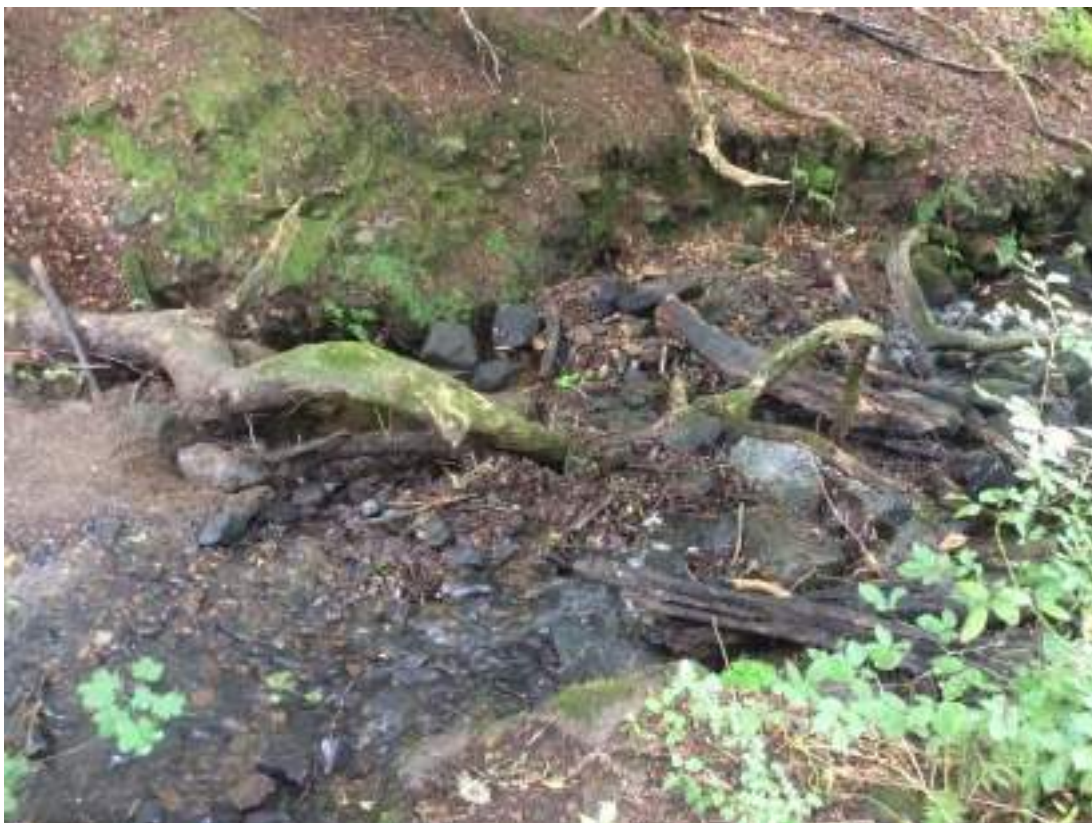
Figure 3-4: Large woody debris supplied into the channel with bank erosion

The riparian zone consists of a broadleaf woodland providing a large supply woody debris and leaf litter into the channel (Figure 3-4).

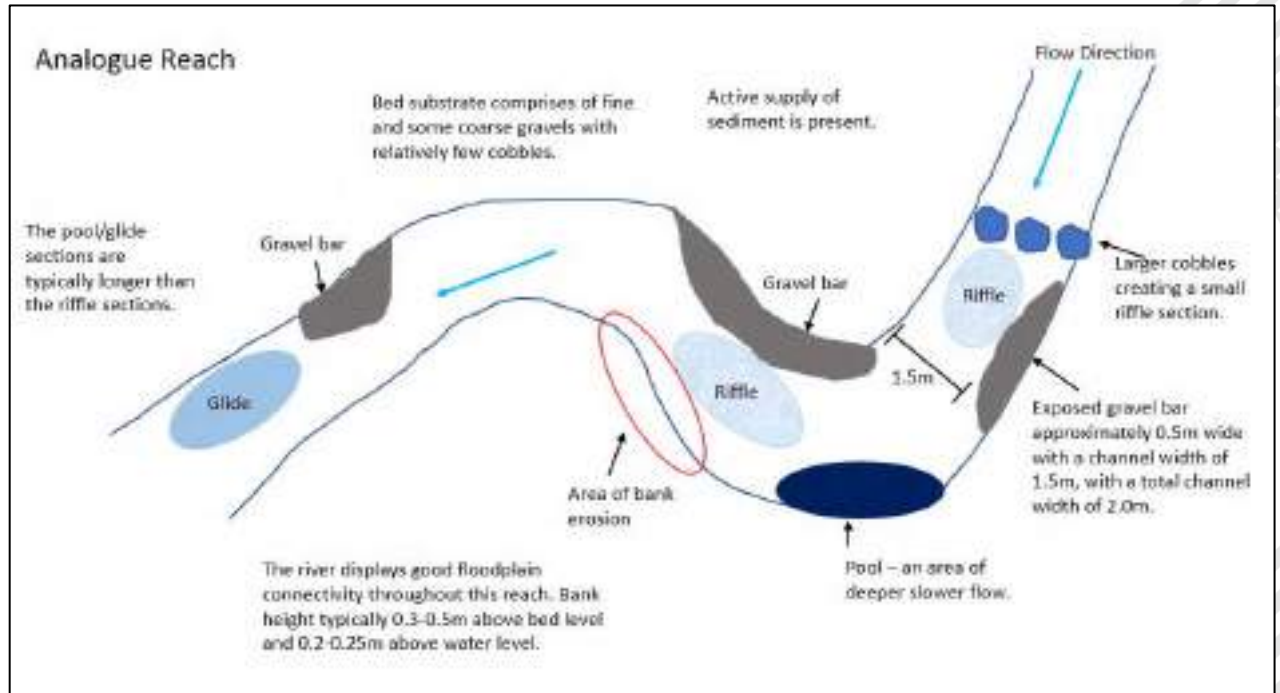
Figure 3-5: Site sketch of the reach to be used as the analogue reach (for lower gradient reaches)

Figure 3-5 shows a basic site sketch with the key hydromorphic processes of the reach illustrated. It was determined that this reach and the upstream reach would be used as analogue sites to inform the key hydromorphic features within the new channel construction at the site, therefore incorporating both the higher and lower gradient channel morphologies.

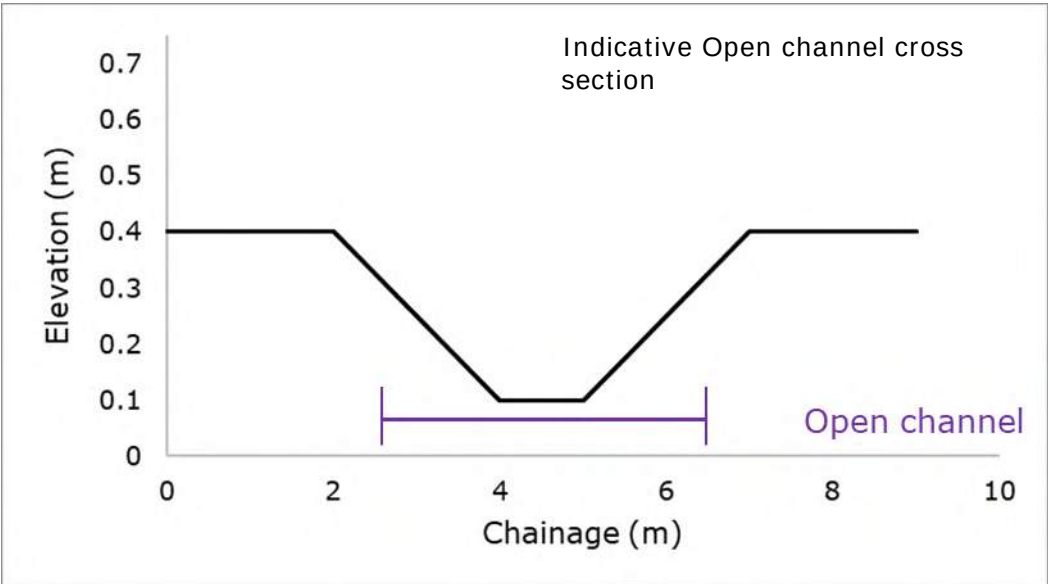
Figure 3-6: Indicative open channel section

A series of indicative cross sections were developed from using the channel measurements from the site visit. These sections provide a guide to the development of the cross sections.

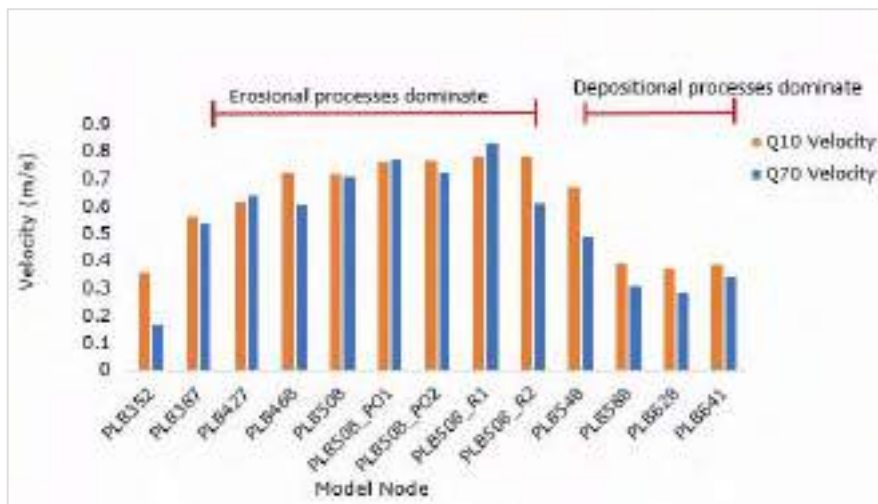
Figure 5-1: Velocities across the site (Baseline) sequence\*

Velocities throughout the site have been extracted from the hydraulic model. Figure 5-1 shows the channel velocities with the open river channel sections without the presence of any in-channel features. The data shows that the gradient steepens, as shown in the long section in Figure 5-2, there is a correlated increase in the in-channel velocities. As the bed gradient become shallower these velocities reduce. It is anticipated to observe erosional process occurring in the steeper sections where the velocities are high, whilst where the gradient becomes shallower it is anticipated to observe a more depositional environment. The Hjulström curve depicts the relationship between the size of the sediment and the velocity that is required to either transport it, erode or deposit it. Within the Q10 flows the velocities range from 0.3-0.7m/s. The calculated entrainment values for the same event would be capable of entraining, transporting and deposition of small gravels between 6-38mm.

\* \*Note not to scale, total model length is 289m and the distance between the model nodes vary.

The hydraulic model was developed to include the addition of a step-pool sequence within the stepper sections of the long profile to represent the bed conditions observed upstream from the site. These features have also been introduced to manage the high velocities shown in Figure 5-1, which could lead to a highly erosive channel if left designed as a uniform channel. In the shallower gradient areas at the start and end of the reach, a bar feature has been included to determine the influence this would have on the in-channel velocities.

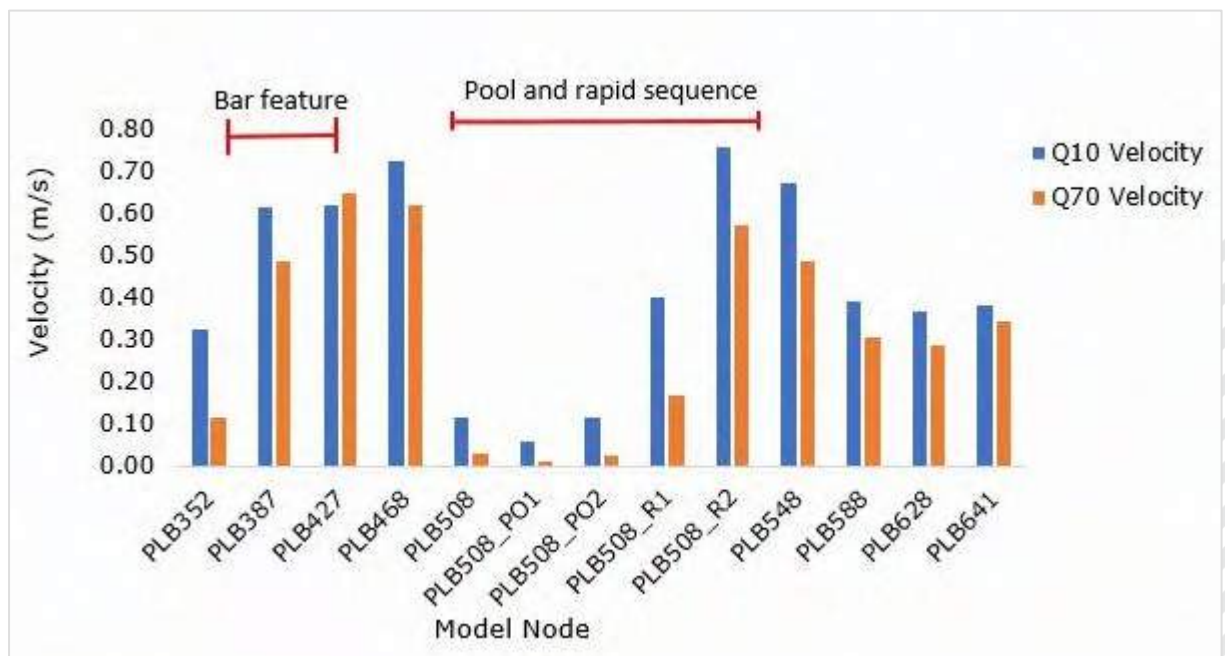
Figure 5-3: Velocities across the site (post development) sequence \*

Figure 5-3 shows the results of this scenario in terms of modelled velocities.

\*Note not to scale, total model length is 289m and the distance between the model nodes vary.

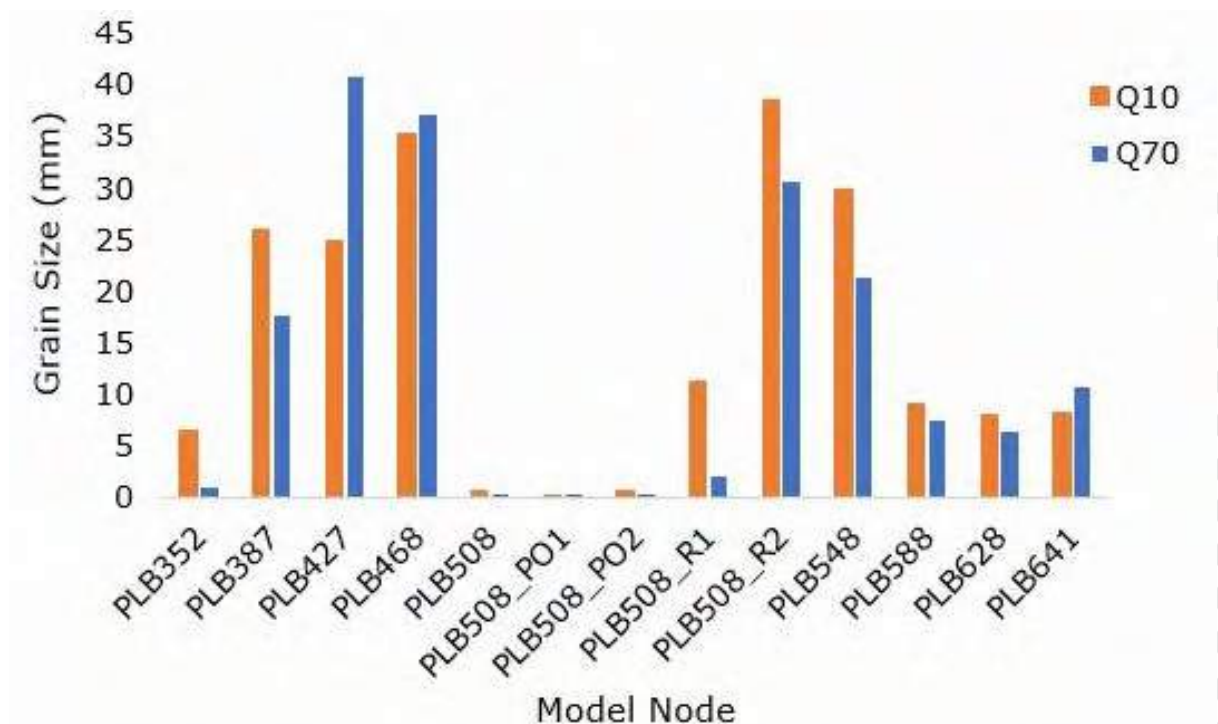
Figure 5-4: Entrainment values across the site\*

The shear stress and entrainment values were determined for the modelled cross sections for the site, using the Shields equation. Entrainment is the value in which the maximum size of sediment can be transported during a particular flood or low flow event. Figure 5-4 depicts the entrainment values at both Q10 and Q70 flow exceedances for the post development. The graph shows that the typical grain size that is mobilised and entrained during Q10 flows ranges from 6-38mm, which represent flows that are exceeded only 10% of the time and are therefore relatively high flows (compared to other low flows), suggests the new channel would be capable of sustaining bedform development. This is regarded as a positive outcome as bedform development leads to diverse morphology and creates in-channel habitat, such as those observed in the analogue reaches upstream.

Velocity is used in the calculation of shear stress and so the results share similar trends. Figure 5-4 shows that typically there is a greater size of sediment which is entrained within the open channel compared to those with a bar feature present. This indicates that at Q10 flows, larger sediment would be entrained and transported through the open channel sections, which are deeper and slightly narrower than the overall channel with the bar features. Whereas at bar feature cross-section, the slight reduction in maximum grain size entrainment would mean coarser sediment is deposited. This enables bars to form as they are created through depositional processes. Immediately downstream of the bar features there is the potential for riffles to form as an extension of the bar and which would provide flow diversity within the channel.

Immediately upstream of the modelled step-pool on the steeper section, there is a drop in the shear stress and entrainment associated with the pool feature, as a result in the reduced flow velocity. The modelled step-pool sequence is shown to reduce velocities overall when compared to the results without them in. This will help manage velocities in the reach which is seeking to mimic the high gradient slope observed in the headwater streams.

The recorded entrainment values outputted from the hydraulic model, is comparable to observations made on the walkover assessment of the analogue reach. Small gravels were observed typically within the open channel, with larger, coarser gravels identified on the exposed bar features. Whilst, further upstream in areas of steeper gradients step-pool sequences dominated observing very coarse bed material (gravels, cobbles, boulders) indicating an active sediment supply.

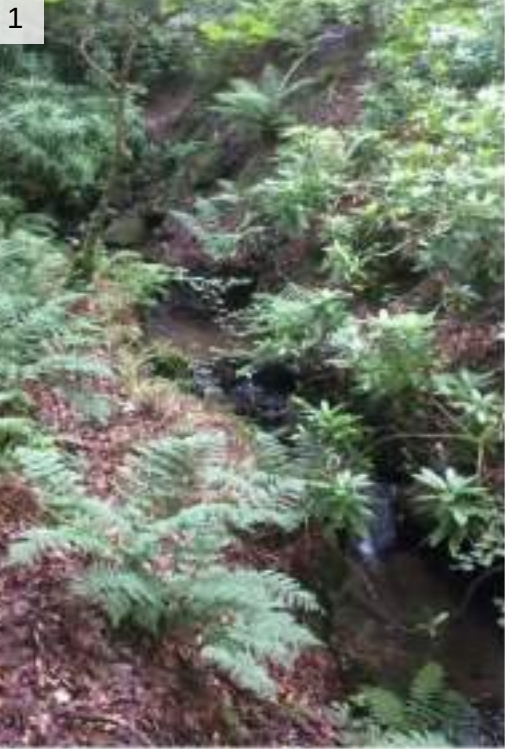
(1) Analogue reach displaying a step-pool morphology with steeper bed gradient. A similar concept could be achieved at the site, but with a wider channel as required.

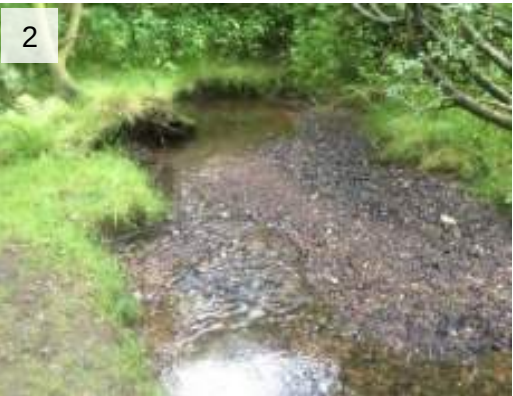
The shallower bed gradient at either end of the new channel will reduce in-channel velocities and allow for depositional processes to dominate. It is anticipated that bar features will form (2), reducing the channel width and introducing morphological diversity.

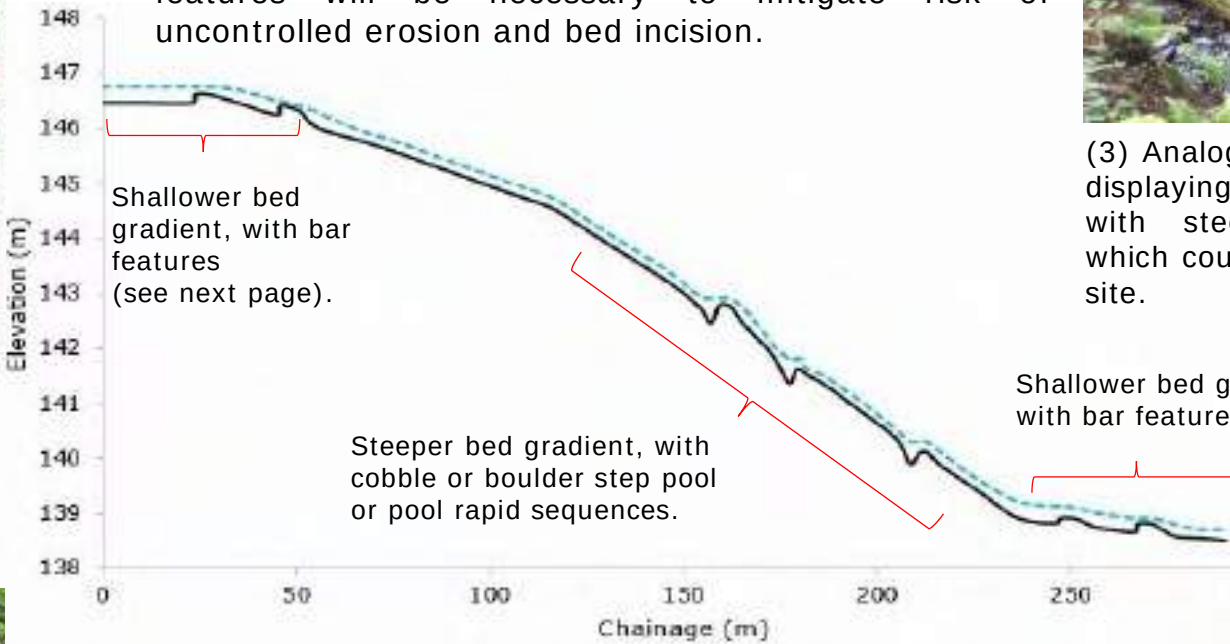
Within areas of steeper bed gradient, features mimicking either step pool or cascade morphology should be created along this reach. Coarser bed material will form the step or rapid (areas of raised bed level) whilst material upstream of the rapid will be scoured out to form a pool, with increased water depths and reduced in-channel velocities. It is expected to see sediment deposition within the pool as a result. Erosional processes will dominate throughout this reach. Appropriate placement and sizing of features will be necessary to mitigate risk of uncontrolled erosion and bed incision.

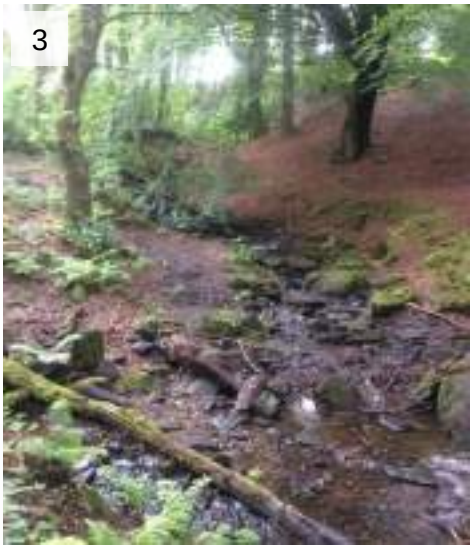
(3) Analogue reach photograph displaying a cascade channel with steeper bed gradient, which could be achieved at the site.

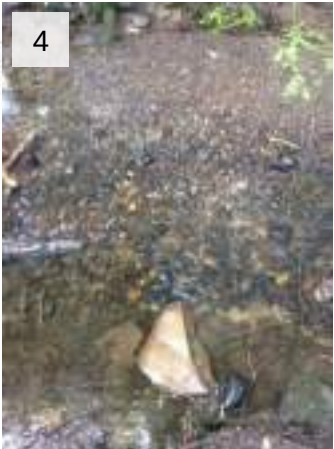
(4) Typical sediment identified downstream of the step pool/ cascade reaches, predominately consisting of coarse gravels.

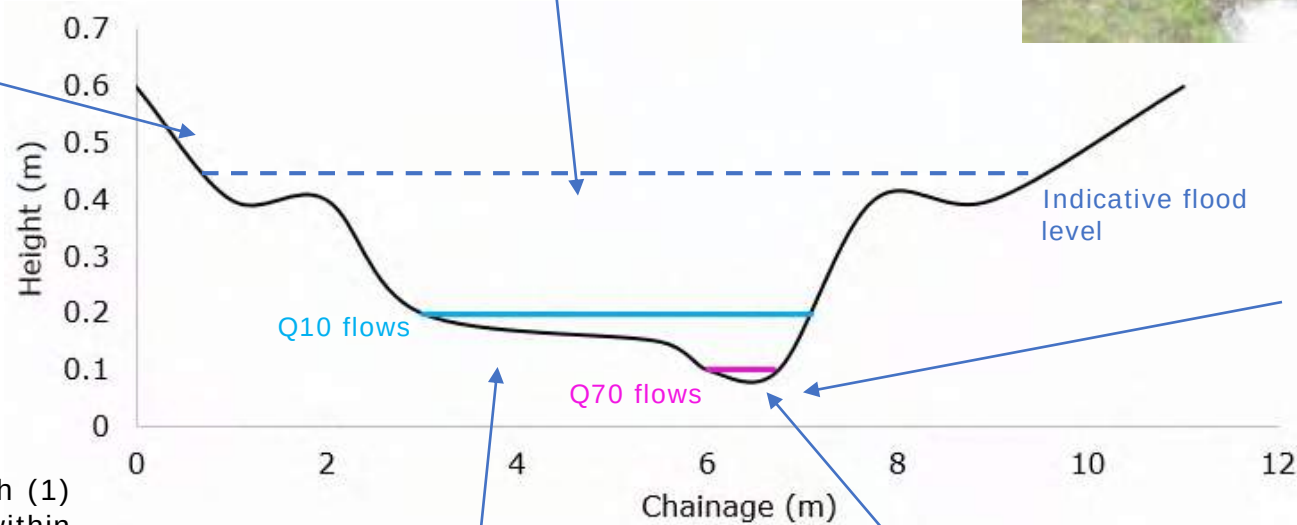
The gradient of this slope will depend on the difference between the desired bed level and proposed site ground levels.

The flows at Q70 will be contained within the low flows channel (pink line), whilst larger flow events such as Q10 will submerge the bar (blue line).

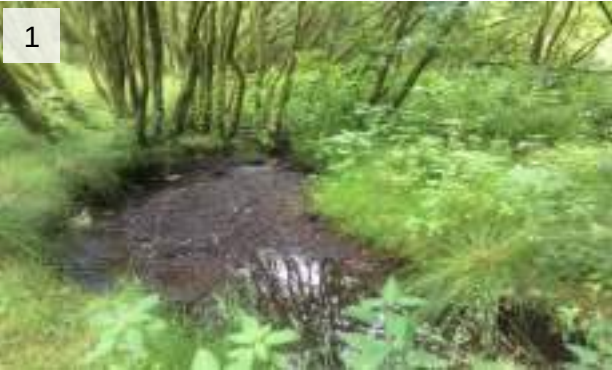
Analogue reach photograph (1) displaying a bar feature within an area of gentler gradient.

Bank heights are relatively shallow which is representative of the analogue reach and is important for maintaining a hydraulic connection to the riparian zone during larger flows.

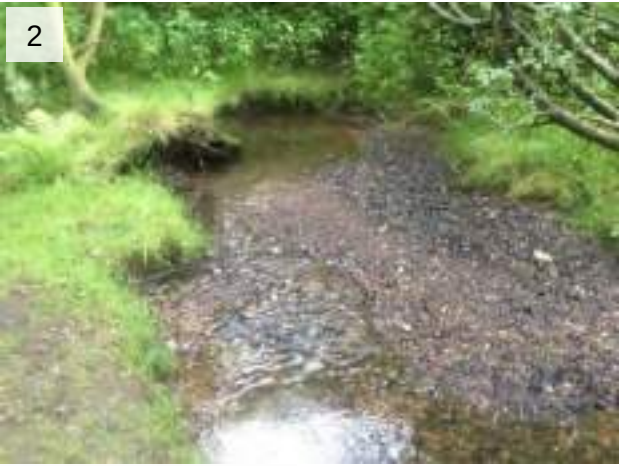
Narrower low flows channel adjacent to the bar to encourage fine sediment to be transported downstream, as seen in the analogue reach. Generally, the channel is wider with bar features (compared with 'open channel' section) to encourage deposition during higher flows and varied channel morphology.

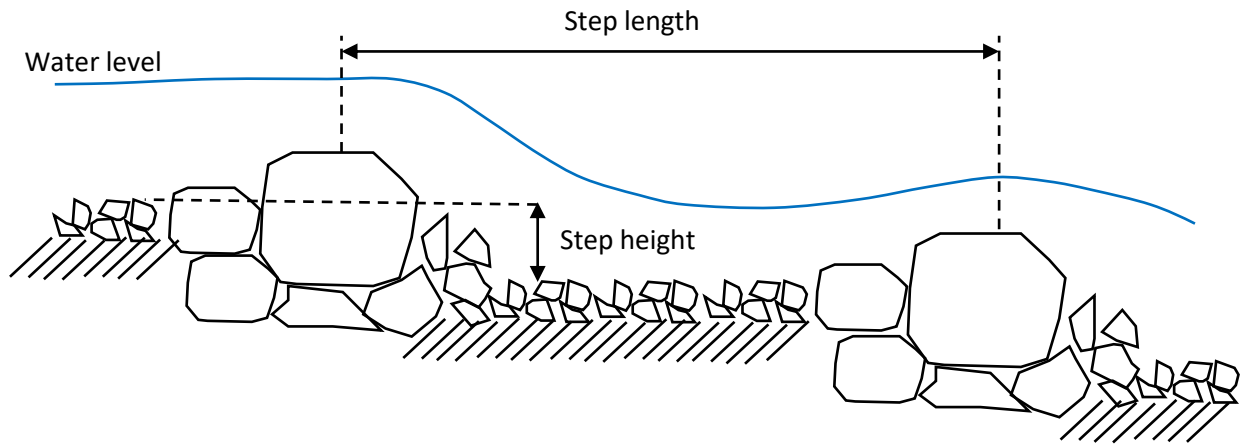
## Bevis Green – Indicative Step Pool

This document presents a concept design comprising of an indicative plan for the new channel. Further hydraulic modelling and analysis will be needed as part of a detailed design stage to determine the placement and size of in channel features including size of sediment) to progress the design for implementation

The spacing and size of step pools should be variable, in order to maintain a natural sediment flux, particularly during flood flows. Designs should avoid uniform dimensions for the step pools.

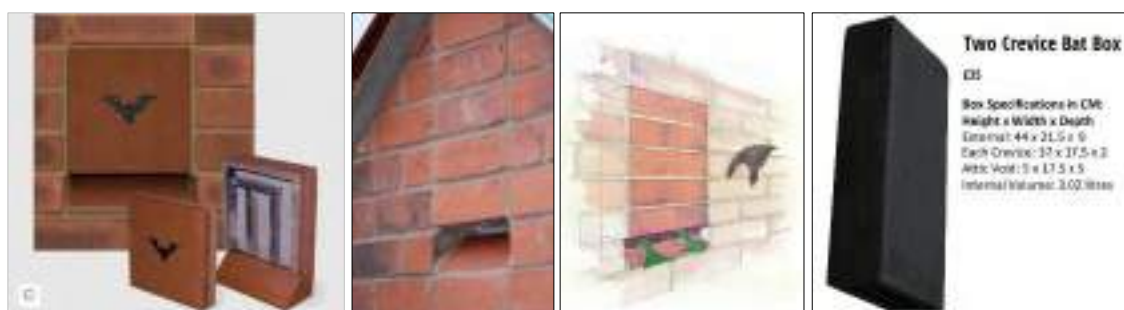
**Insert 1:** Examples of commercially available bat access panels and externally mounted boxes  
Left to right: IBstock Enclosed Bat Box 'c' (left); Habitat Bat Access Panels (centre left and centre right) and Greenwood's Ecohabitats box (right)

- 5.8.6 In addition to the mandatory compensatory provisions for roosting bats, required as part of the licensing process detailed at **Appendix 2**, it is recommended that the redeveloped site incorporates the installation of commercially available bat access panels at the new properties.
- 5.8.7 The bat access panels should be sited at least four metres above ground level, ideally facing or close to areas of landscape planting and existing linear features. The access panels should not be positioned over windows or doorways where bat droppings may become a nuisance. Once the site layout has been finalised, an ecologist will advise on appropriate positions for the bat access panels. Suitable bat access panels are available from NHBS Ecology ([www.nhbs.com](http://www.nhbs.com)) or Wild Care Shop ([www.wildcareshop.com](http://www.wildcareshop.com)) and are presented below:

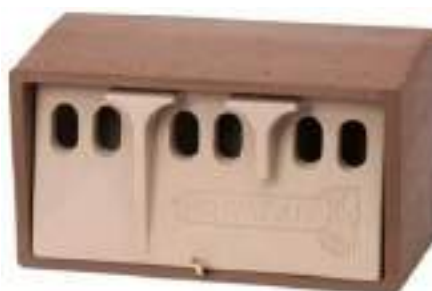
*Insert 2: Schwegler 1SP House Sparrow Nesting Terrace*

- 5.9.5 House sparrows are associated with suburban areas. Monitoring suggests a severe decline in the UK house sparrow population, estimated as dropping by 71 per cent between 1977 and 2008 with substantial declines in both rural and urban populations (RSPB, 2018).
- 5.9.6 The installation of house sparrow terrace nest boxes is recommended at the new properties. The boxes will be positioned over windows or doorways where droppings may become a nuisance. RSPB advice states that boxes should ideally be sited facing north to east, to avoid exposure to direct sunlight, which may cause overheating of chicks in the nest. An example of a suitable house sparrow bird box is given below, in **Insert**, below:

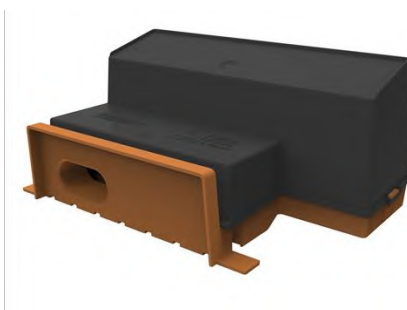
*Insert 3: Manthorpe GSWB Swift Nest Box*

- 5.9.7 Swift nest boxes should be installed beneath the eaves of taller properties, as shown in **Insert 3**, below.

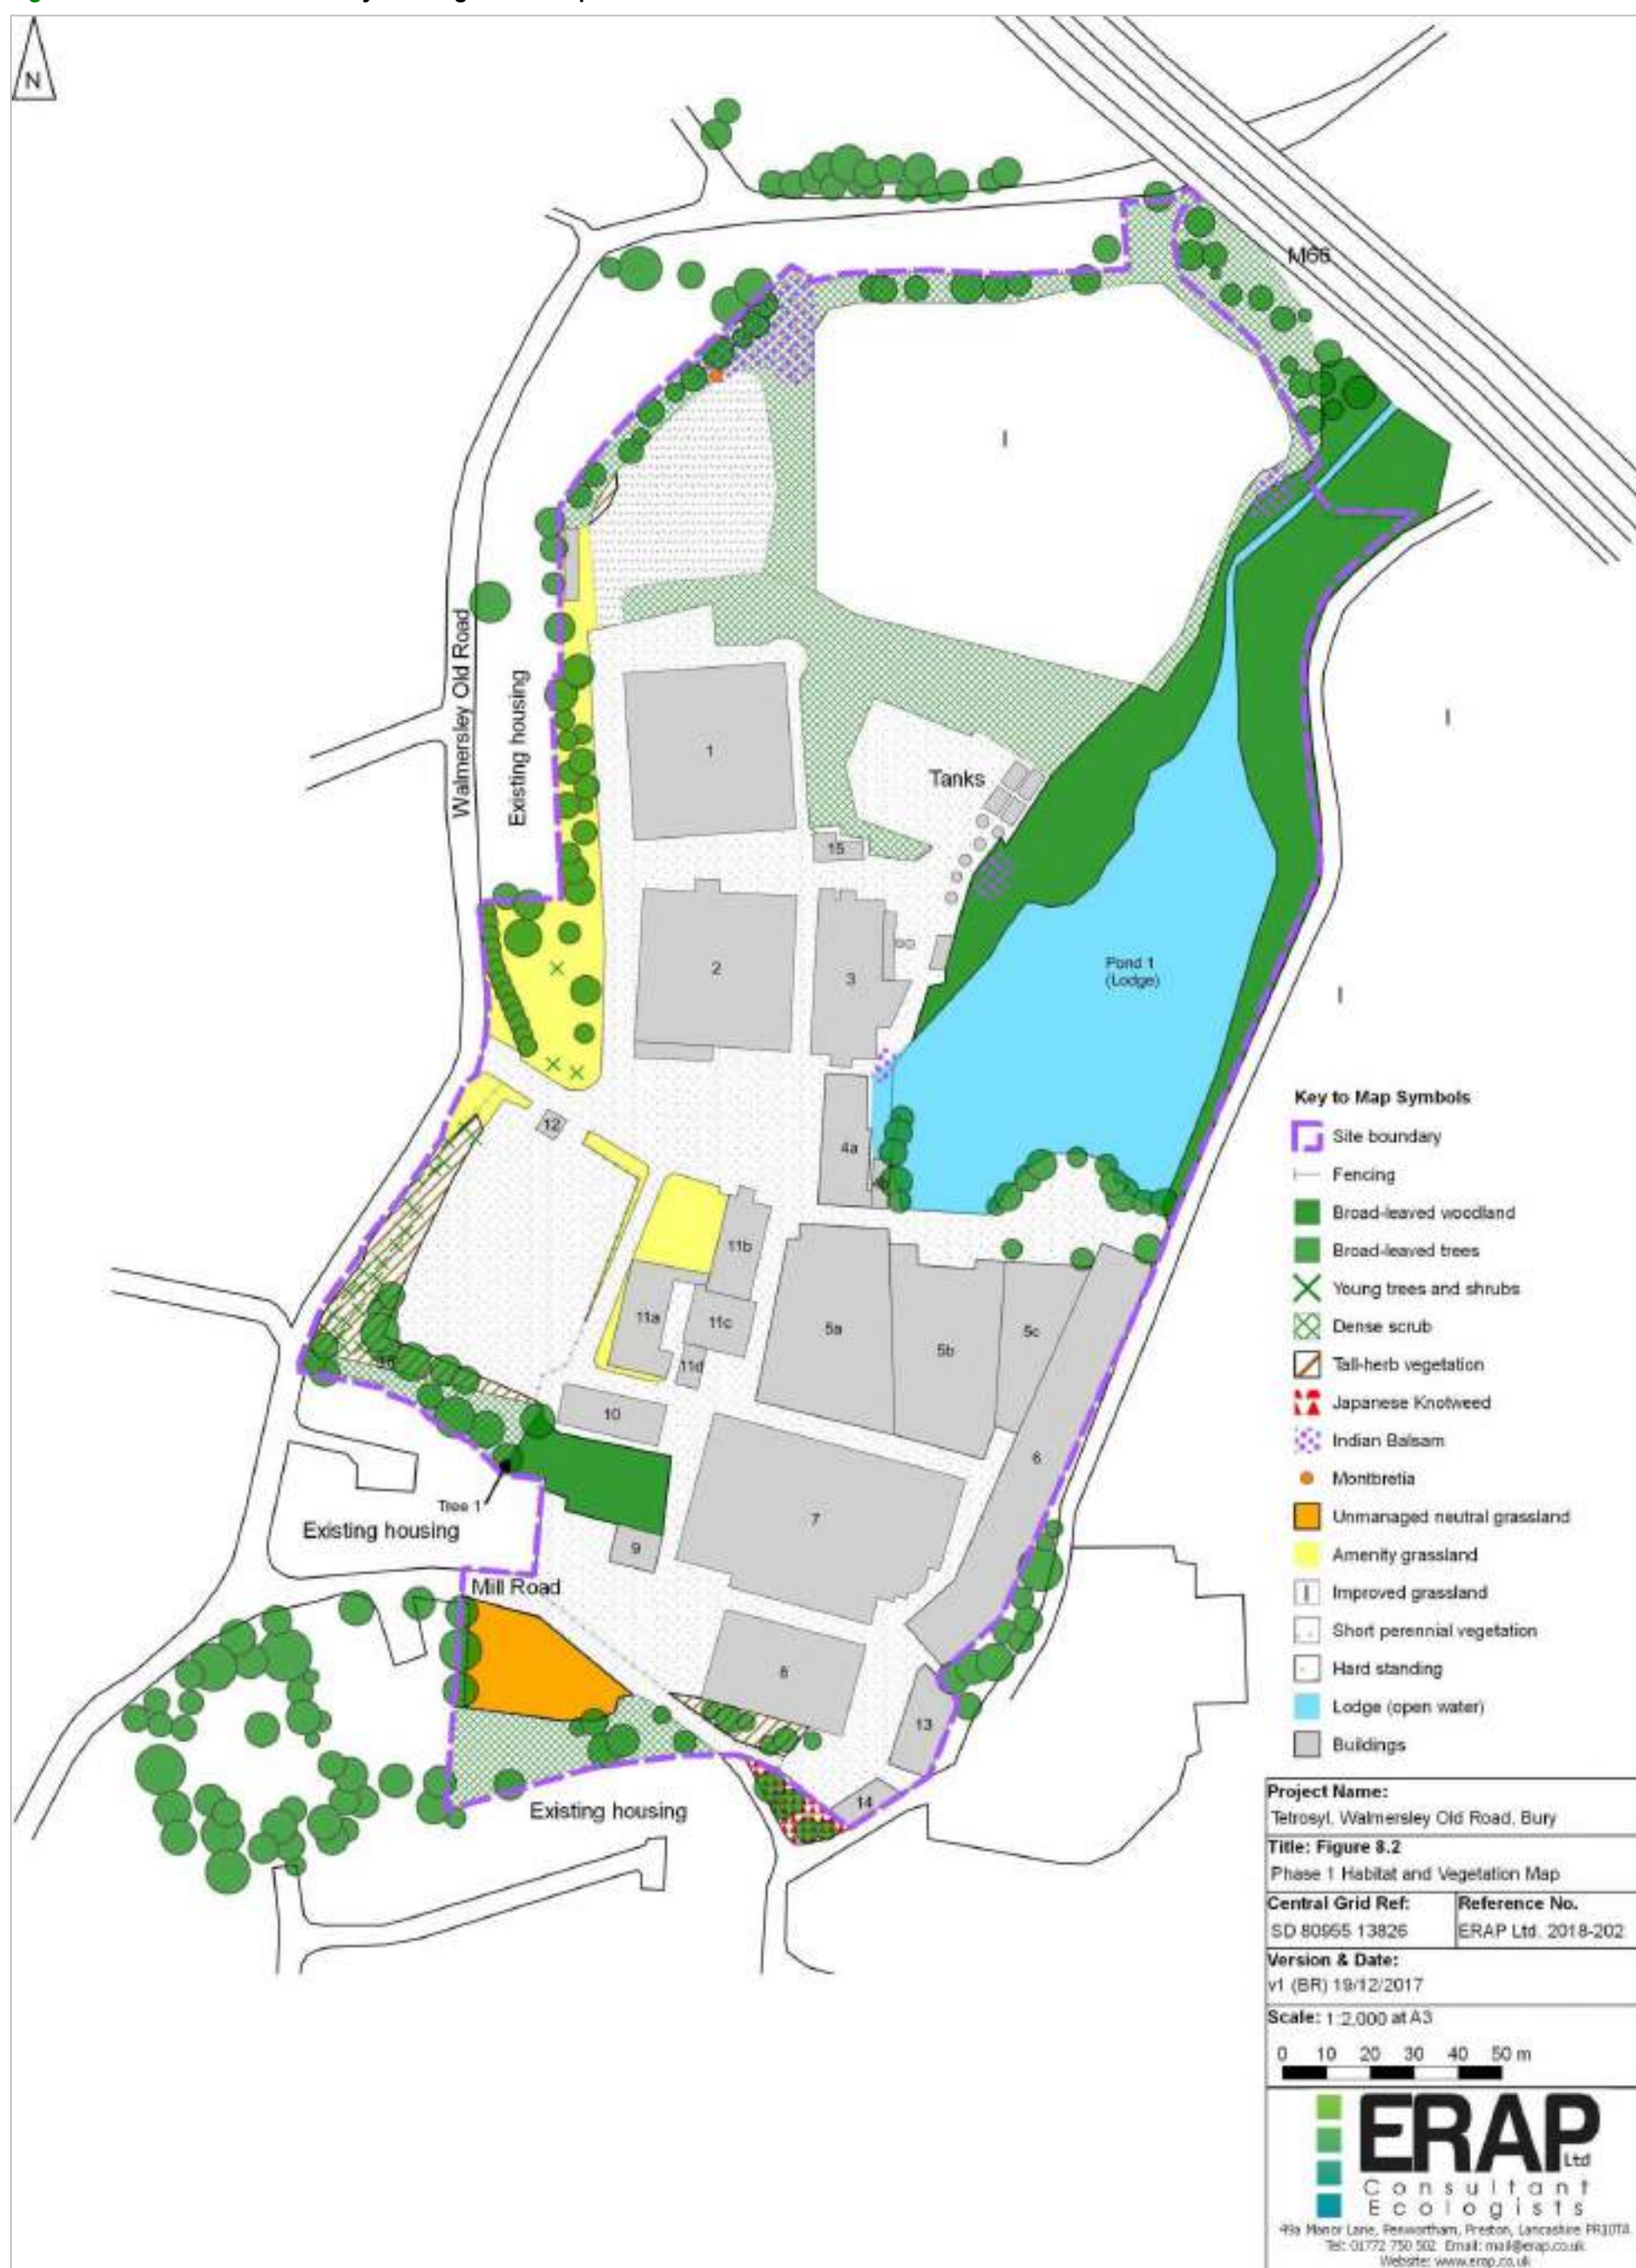
Figure 8.2: Phase 1 Habitat Survey and Vegetation Map

3.2.4 A Phase 1 Habitat Survey map appended at **Figure 8.2**. Photographs are appended at **Table 8.12**.

3.2.12 In the north-western corner of the site the shallow soils and compacted ground over a storage area have been colonised by a sparse cover of ruderal pioneer herbs such as Creeping Bent (*Agrostis stolonifera*), Strawberry (*Fragaria vesca*), Hairy Sedge (*Carex hirta*), Great Willowherb, Colt's-foot (*Tussilago farfara*), Herb Robert (*Geranium robertianum*), Common Ragwort (*Senecio jacobaea*), Dove's-foot Crane's-bill (*Geranium molle*) and Butterfly Bush (*Buddleia* sp.) saplings. A small stand of approximately 10 Southern Marsh-orchid (*Dactylorhiza praetermissa*) spikes were also found immediately north of Building 1. Indian Balsam plants are scattered around this area, as annotated on **Figure 8.2**.

3.2.14 As detailed on **Figure 8.2**, along both sides of the lodge and on steeply sloping ground to the south of Building 10 is established broadleaf woodland. Semi-mature to mature Pedunculate Oak (*Quercus robur*) dominates the canopy of the woodland in the north east of the site with locally frequent Goat Willow, Grey Willow and Sycamore.
